ARCHITECTURAL/HISTORIC INVENTORY FORM

1. Survey No. CO-AS-005-001		2. Survey name: Moreau Drive Neighborhood Survey	
3. County: Cole		4. Address: 1202 Elmerine Ave.	
5. City: Jefferson City	Vicinity: <input type="checkbox"/>	6. UTM: / /	7. Township/Range/Section: T: R: S:
8. Historic name (if known):		9. Present/other name (if known):	
10. Ownership: <input checked="" type="checkbox"/> Private <input type="checkbox"/> Public		11. Historic use (if known): Residential	11. Current use: Residential

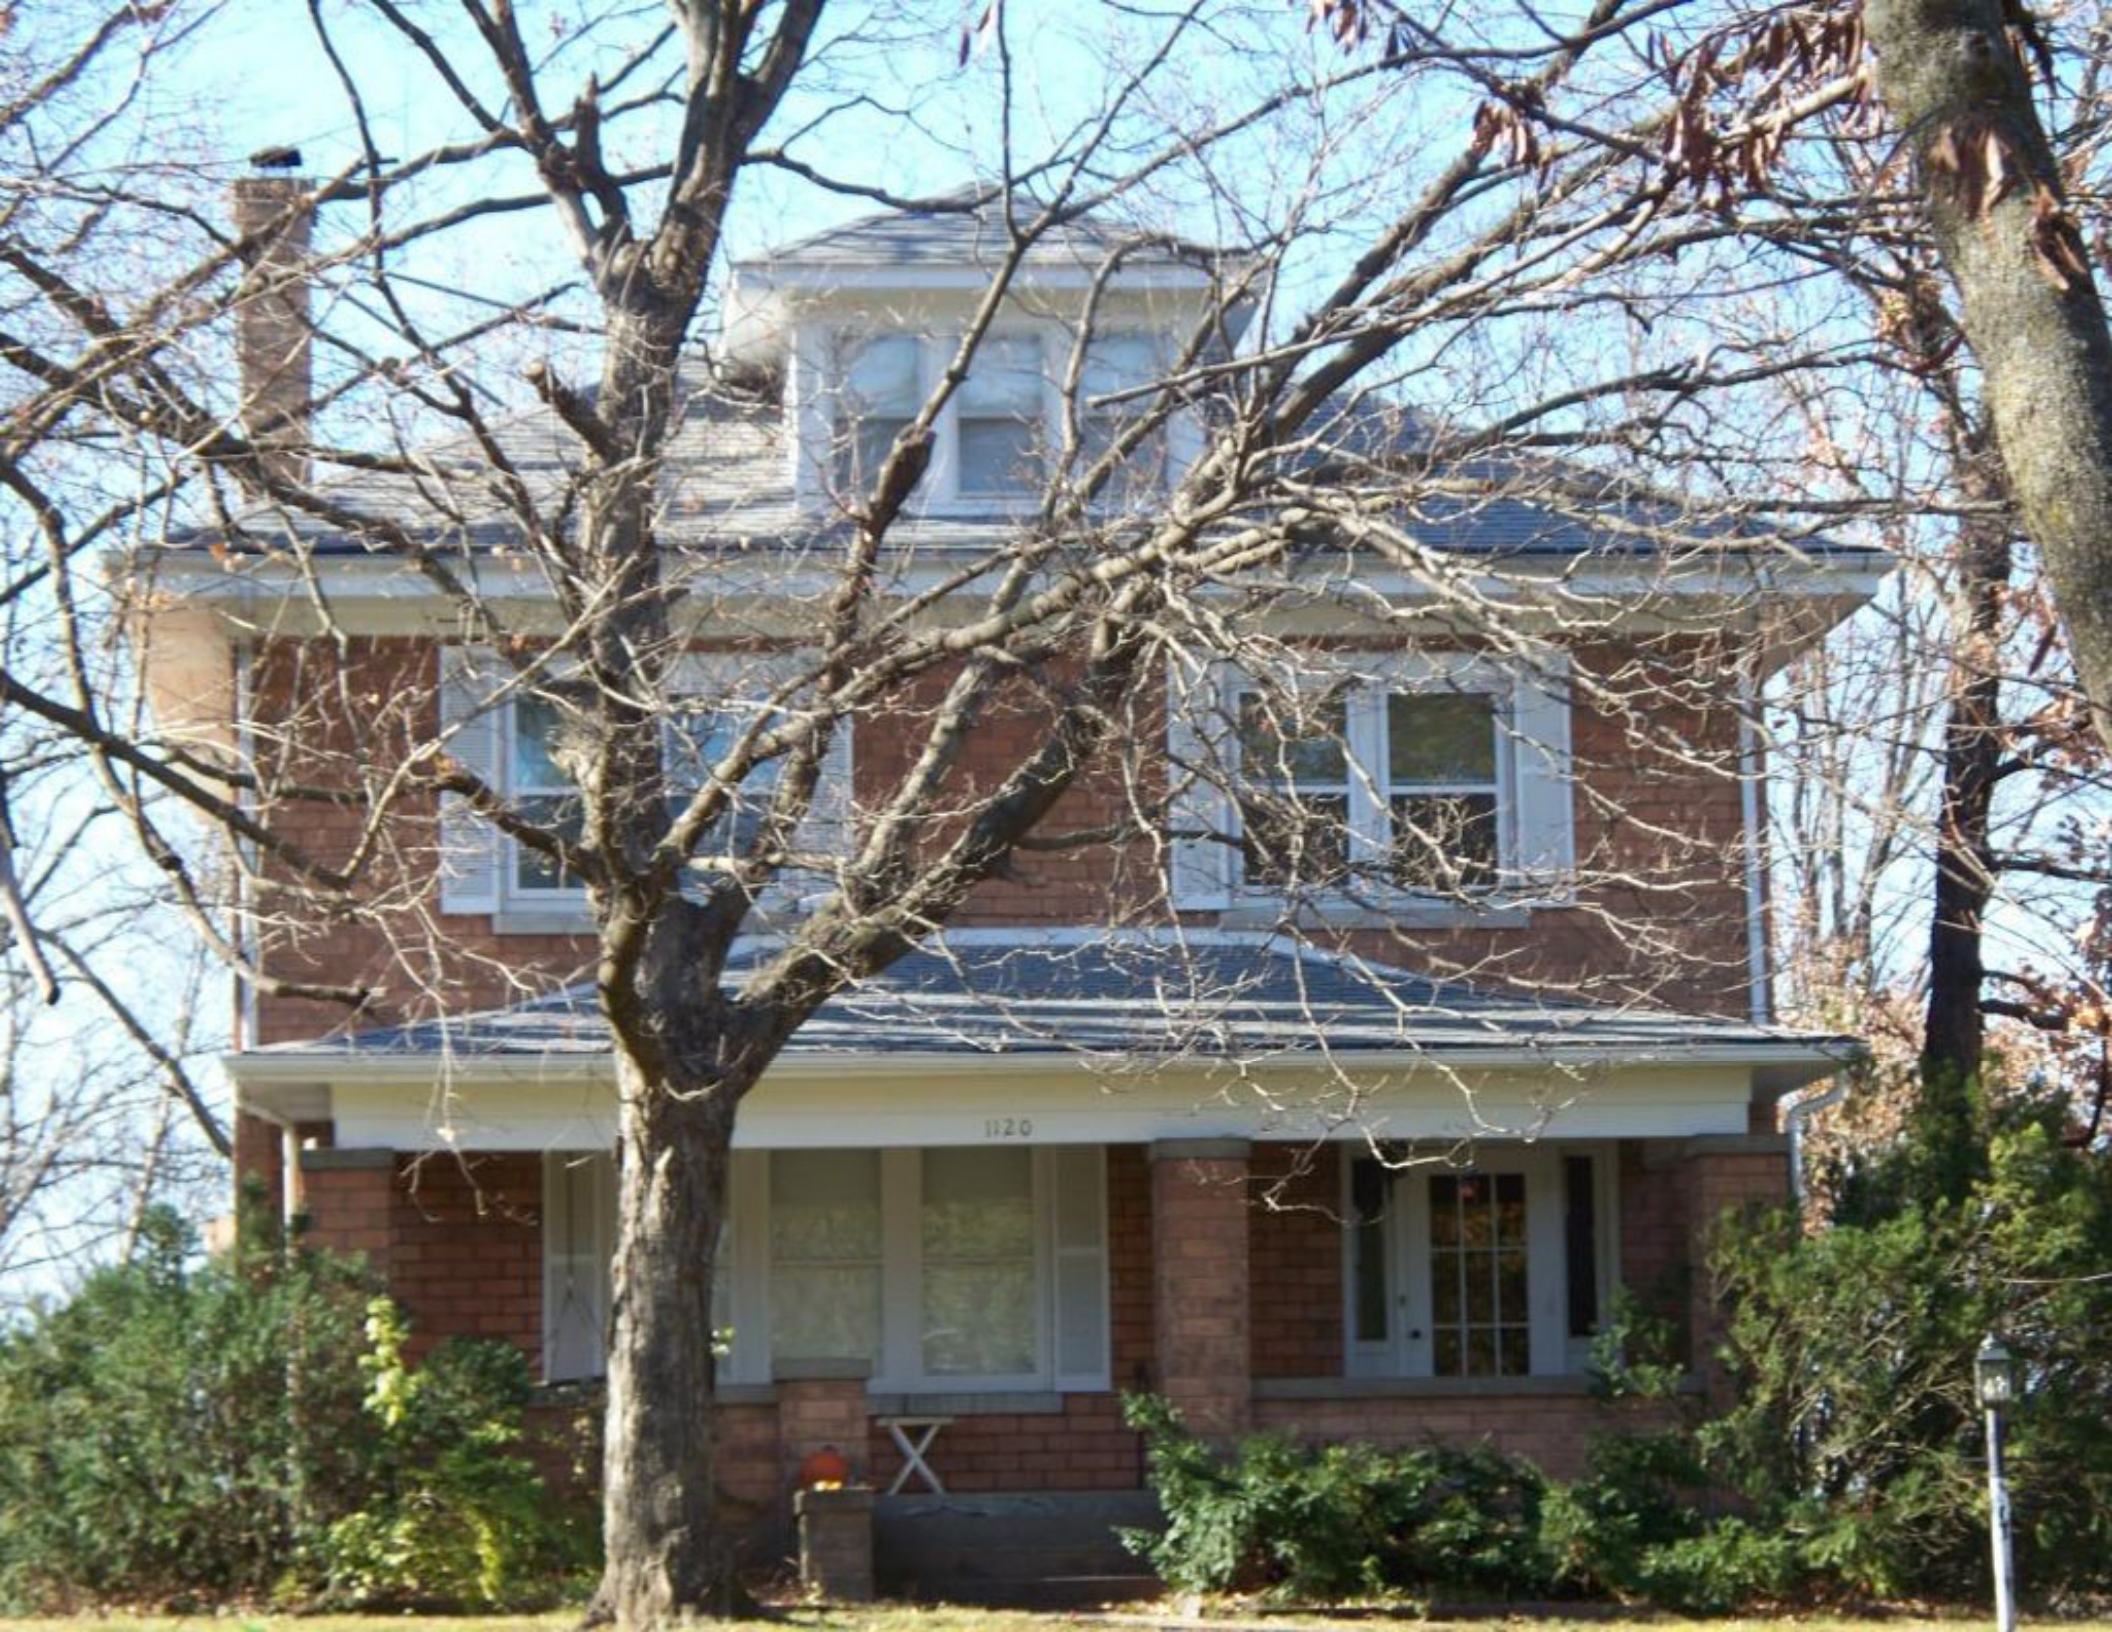
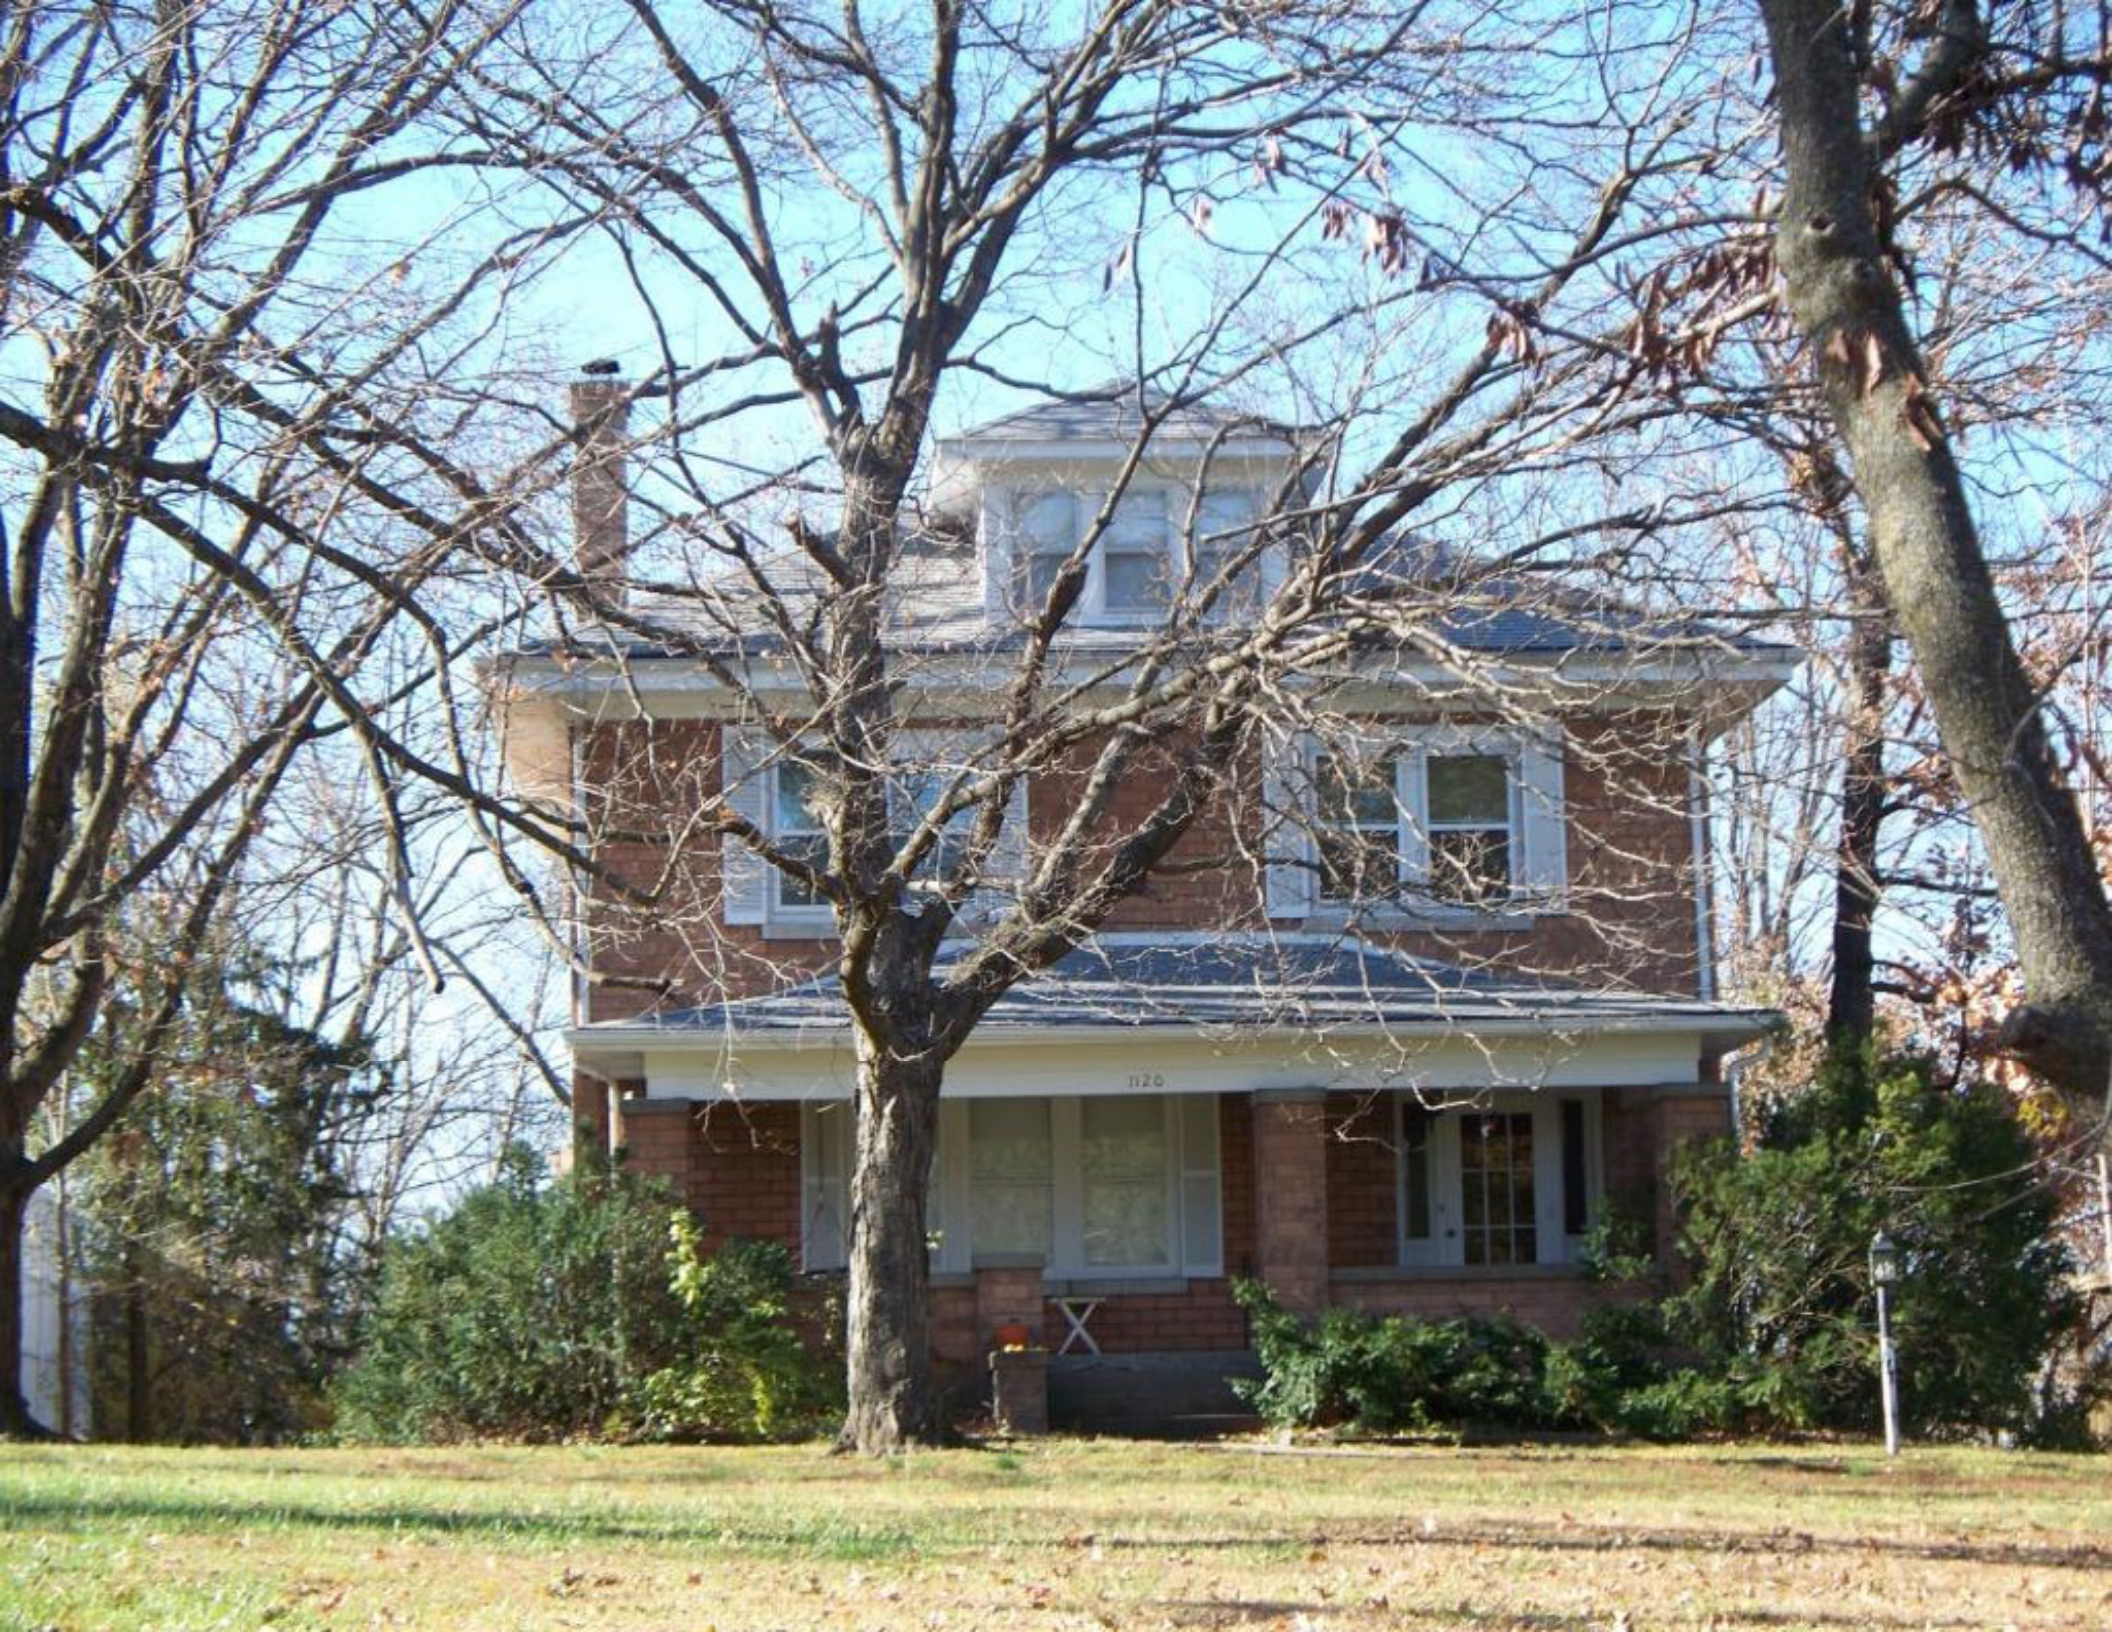
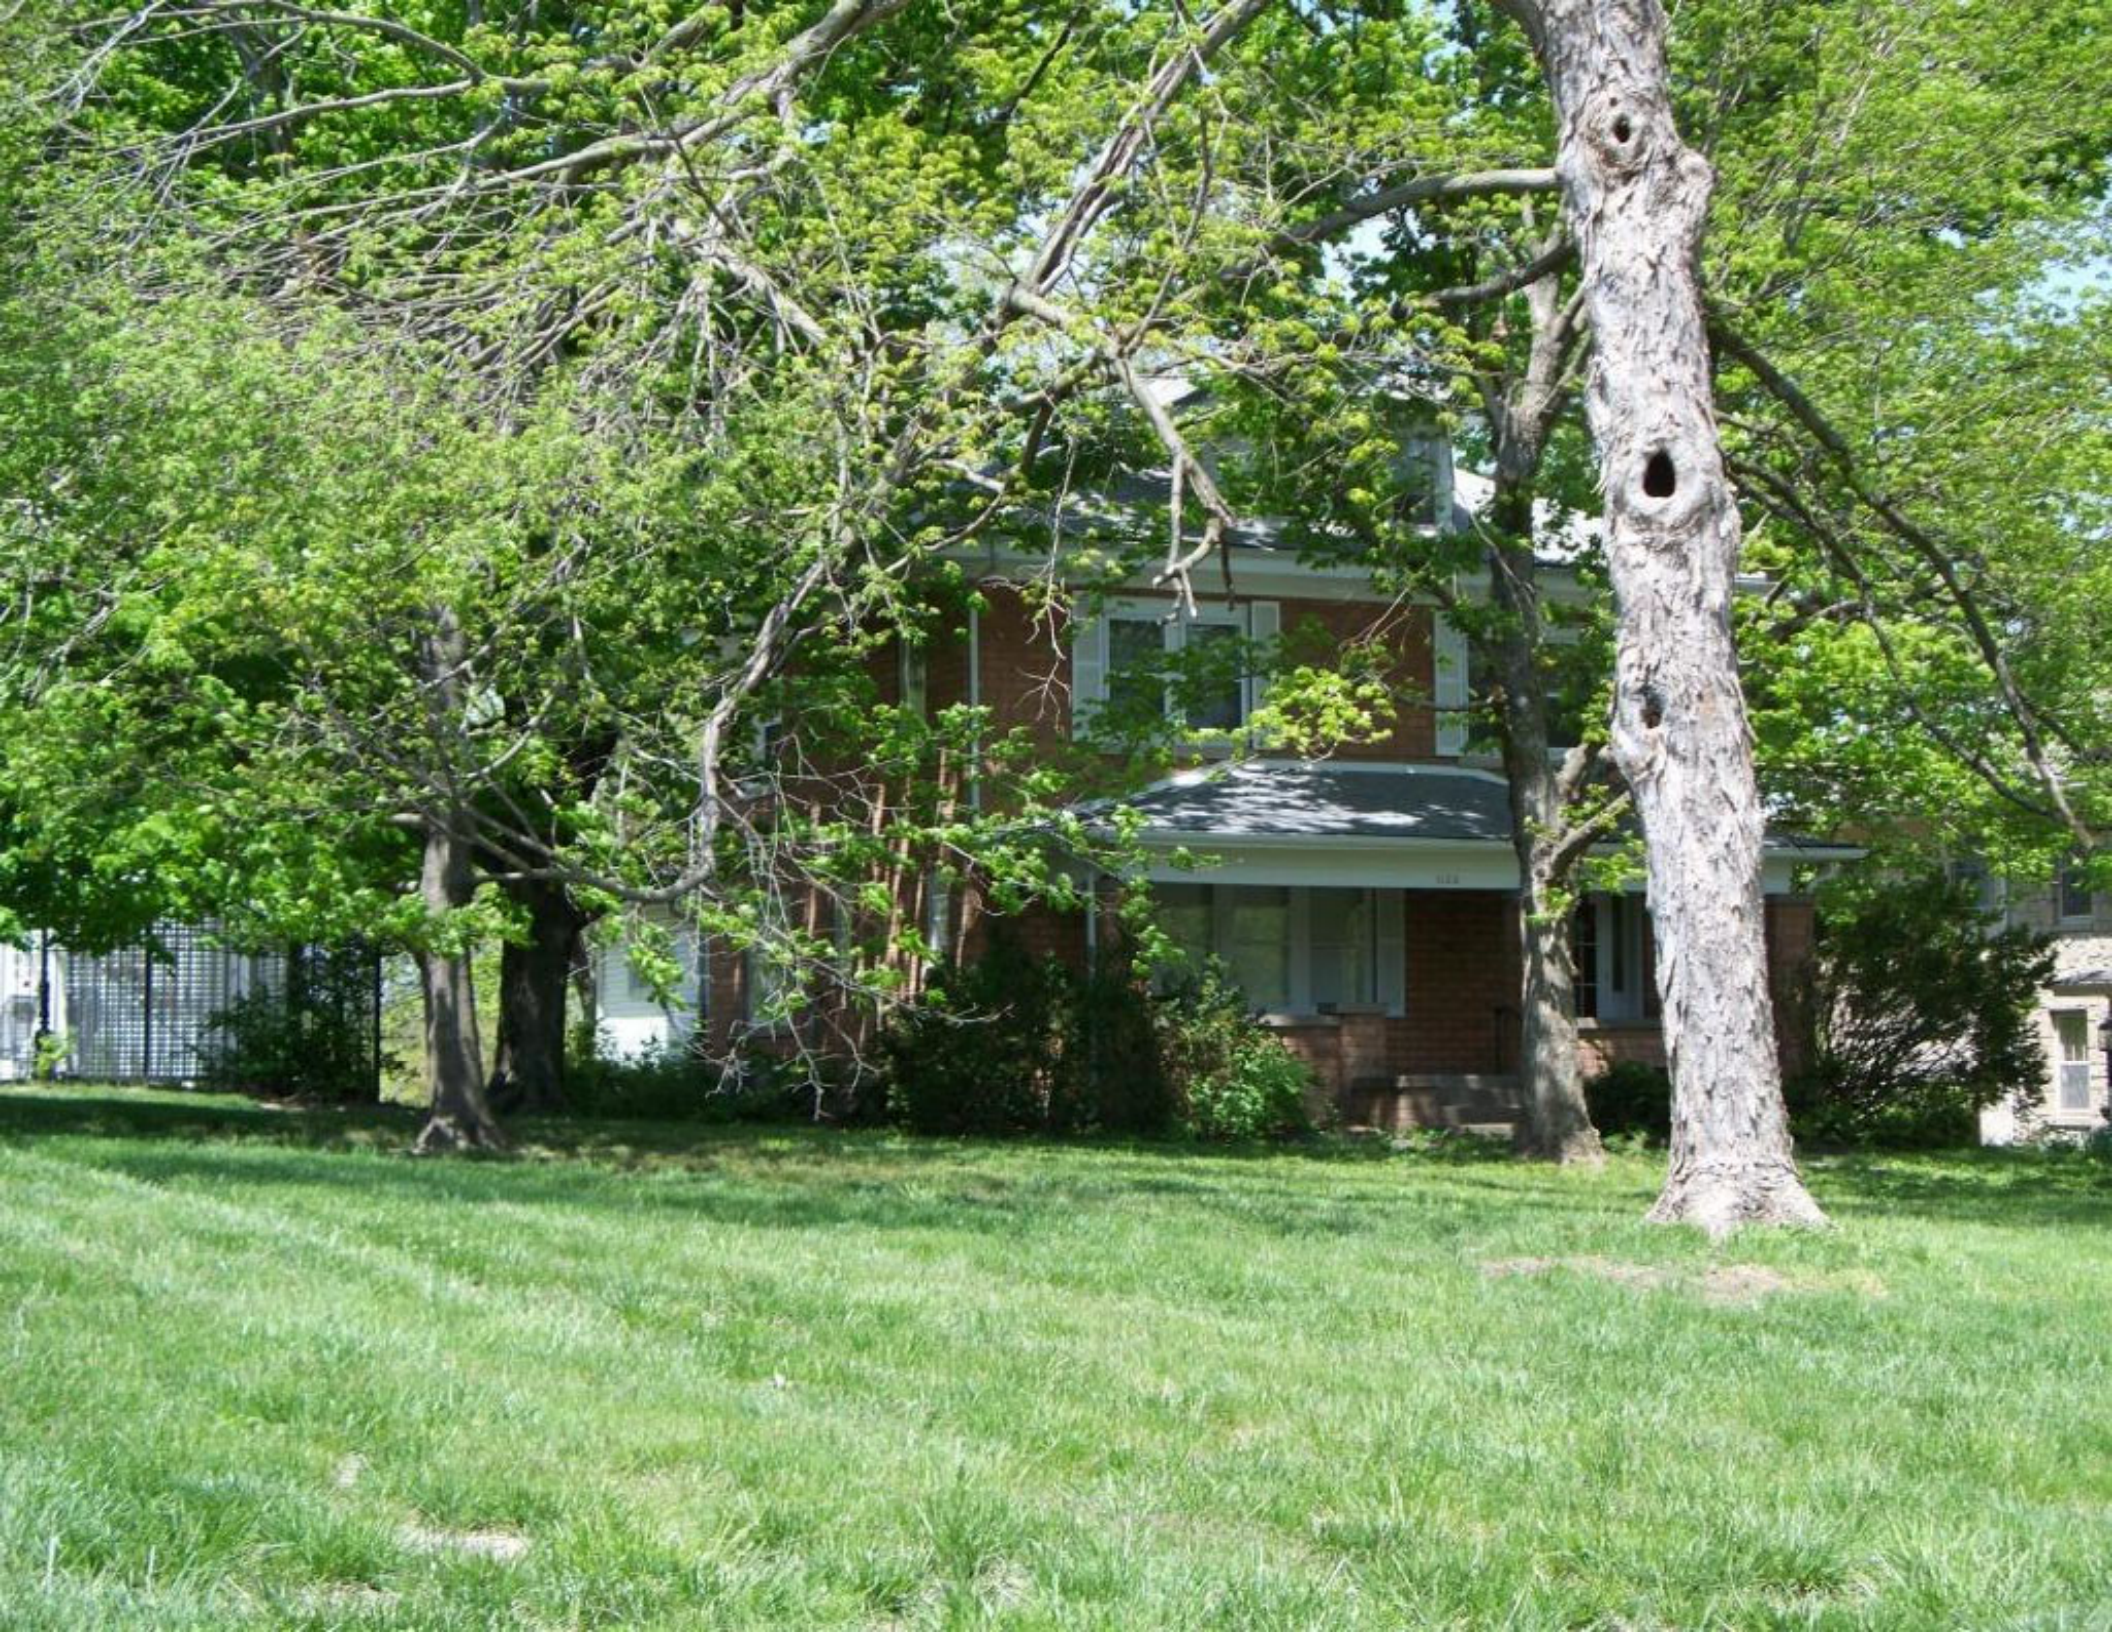
This is a two-and-a-half-story brick four square with a pyramidal dormer with three 1/1 vinyl windows in the center of the roof. The second floor has two sets of paired 1/1 vinyl windows. The first story has three 1/1 windows in one opening in the left bay while the entrance is offset to the right and appears to retain its original door and sidelights. All of the windows have shutters and stone lintels. The full open porch has brick knee-walls, brick piers and limestone caps that support a hipped roof.
