ARCHITECTURAL/HISTORIC INVENTORY FORM

1. Survey No. CO-AS-005-001		2. Survey name: Moreau Drive Neighborhood Survey	
3. County: Cole		4. Address: 1202 Elmerine Ave.	
5. City: Jefferson City	Vicinity: <input type="checkbox"/>	6. UTM: / /	7. Township/Range/Section: T: R: S:
8. Historic name (if known):		9. Present/other name (if known):	
10. Ownership: <input checked="" type="checkbox"/> Private <input type="checkbox"/> Public		11. Historic use (if known): Residential	11. Current use: Residential

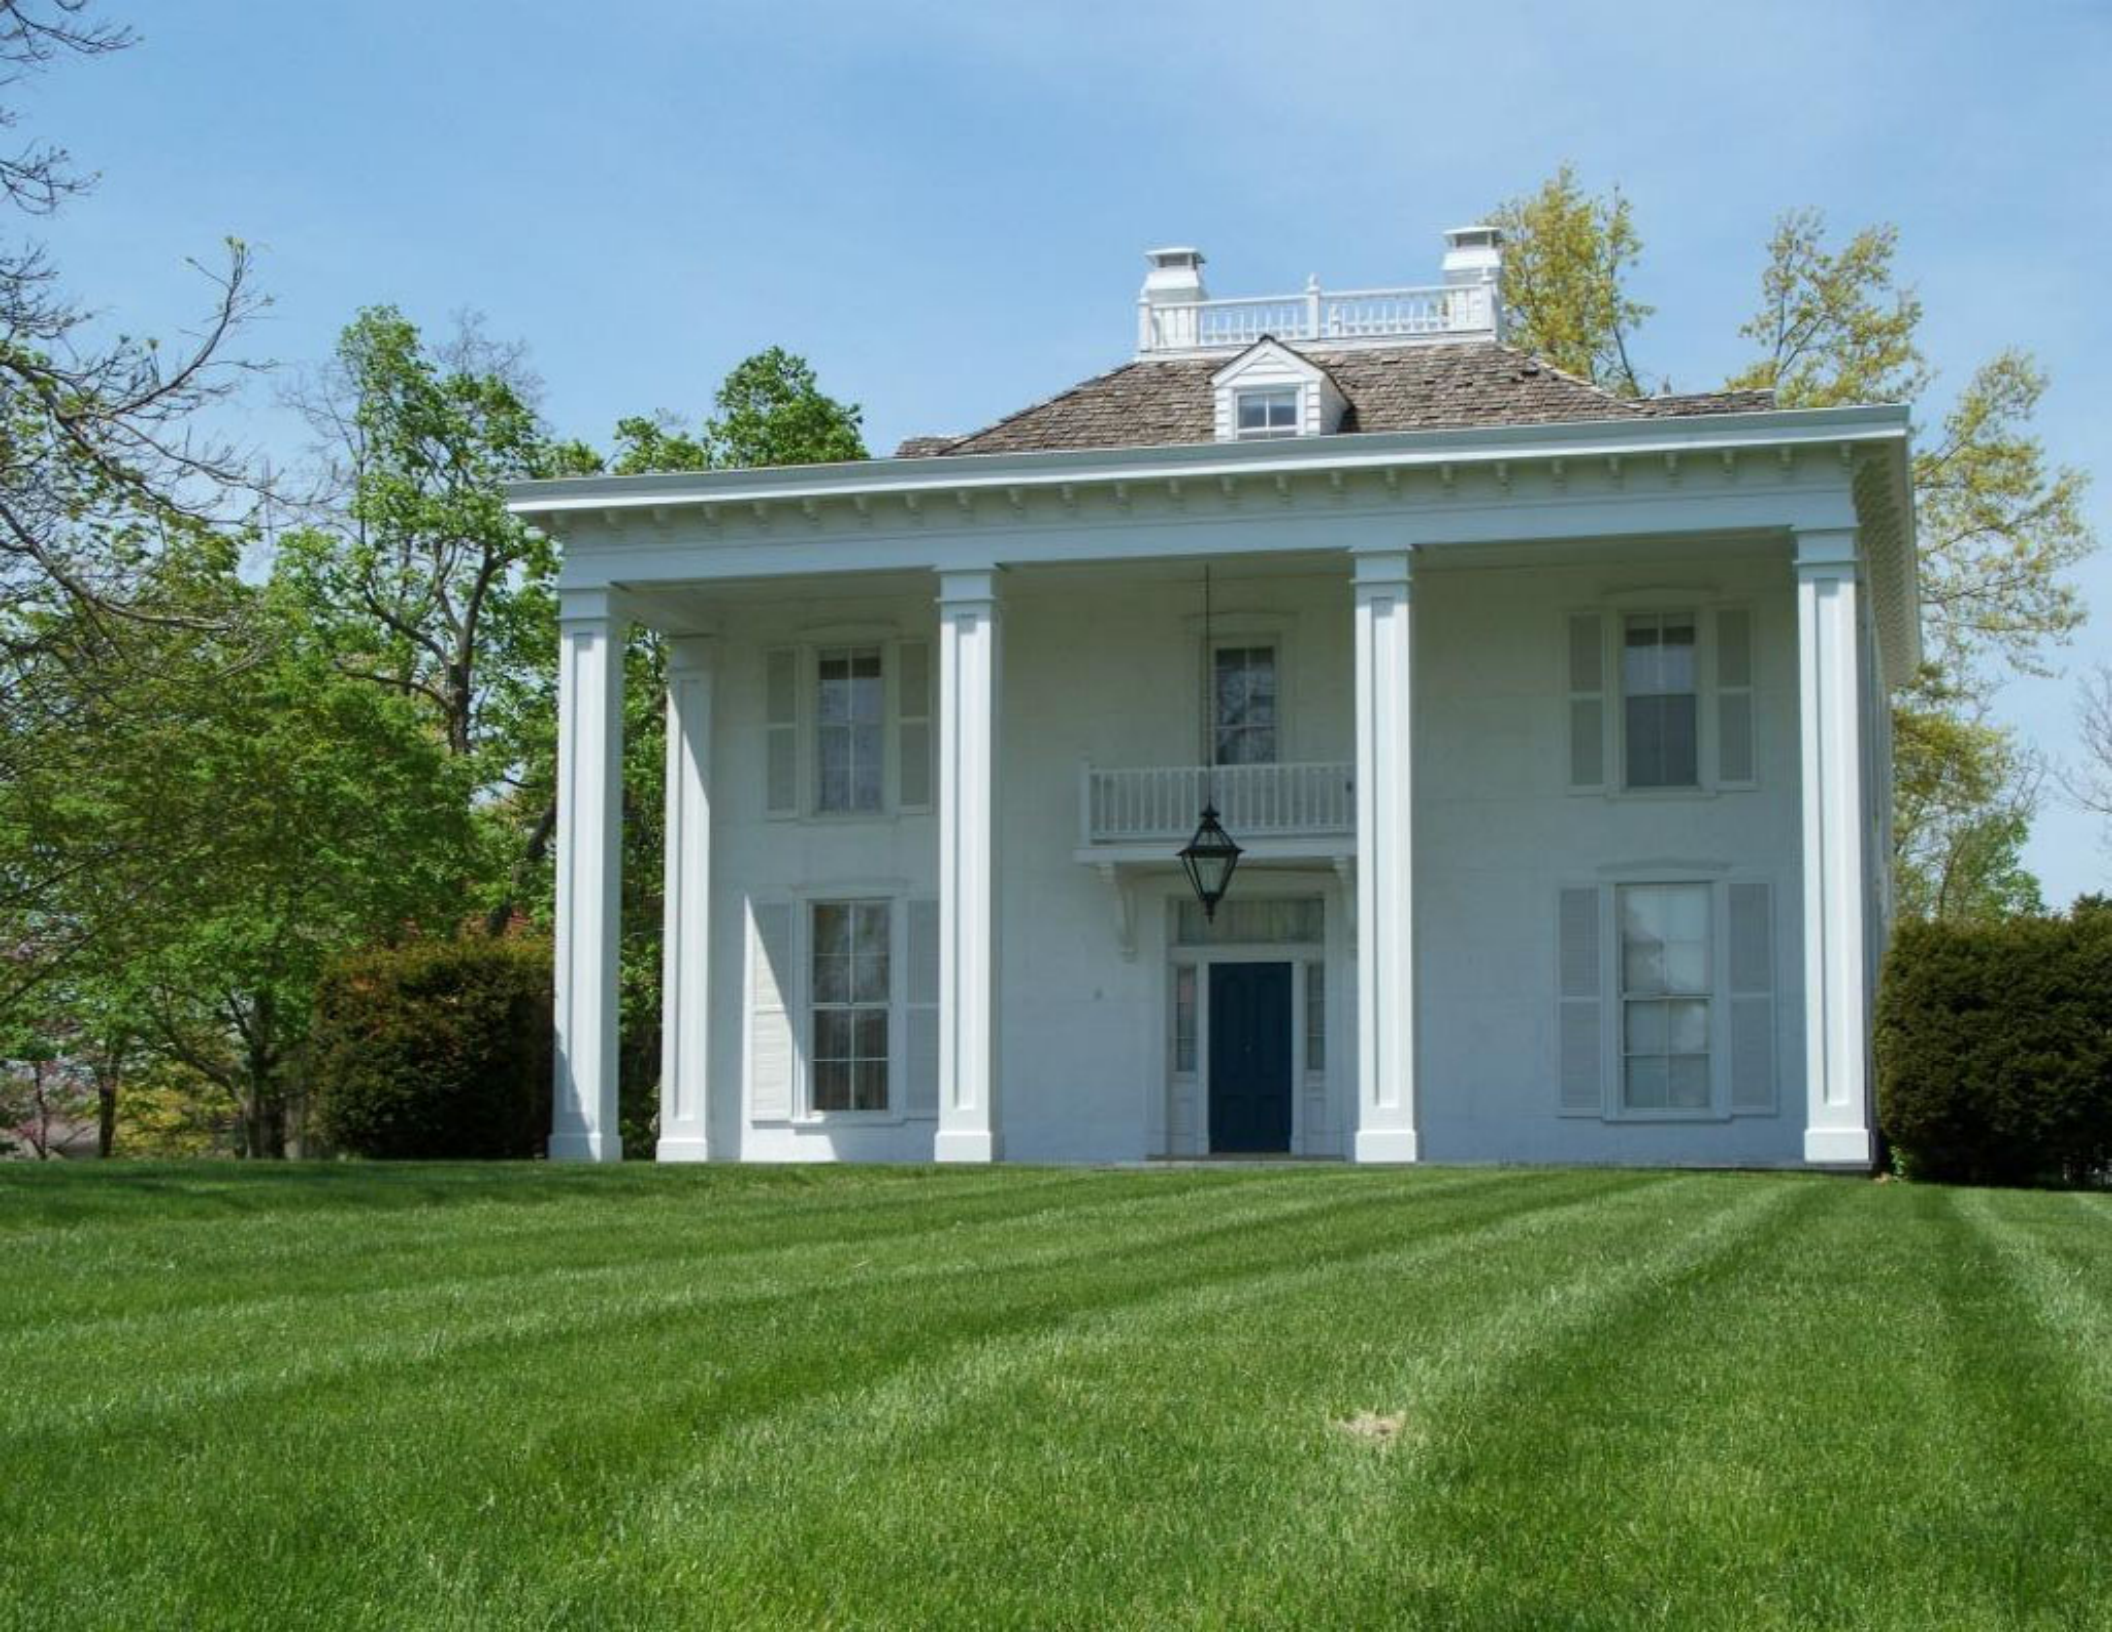
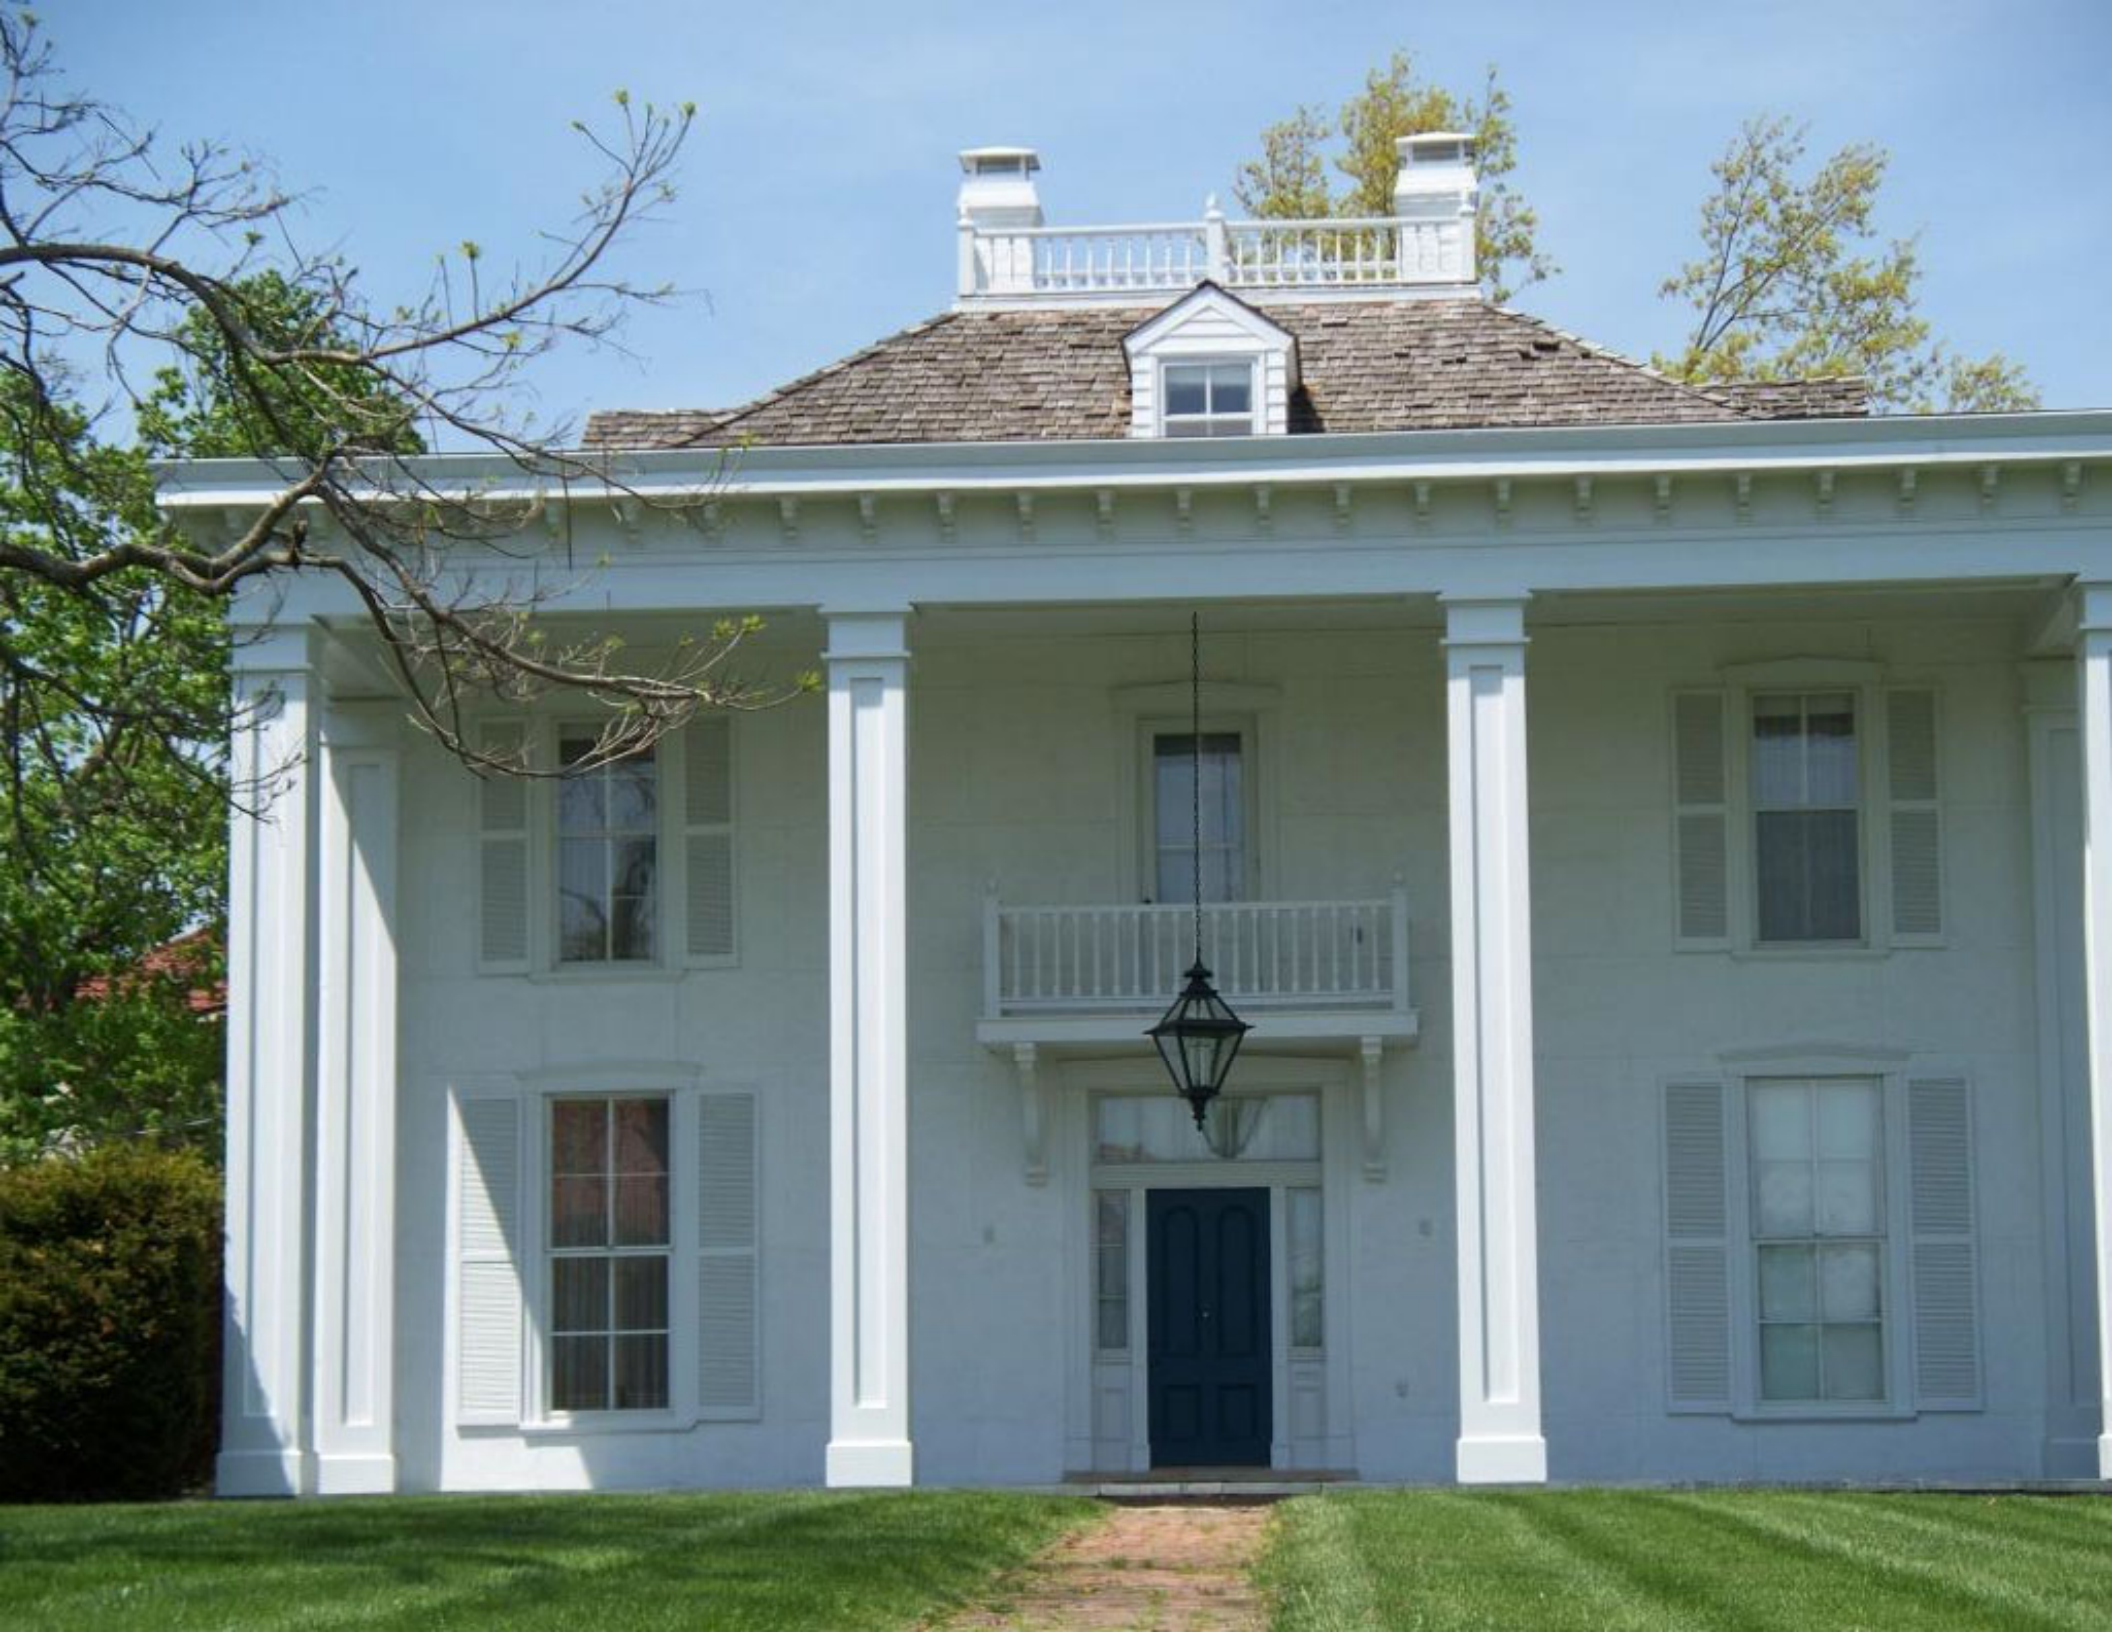
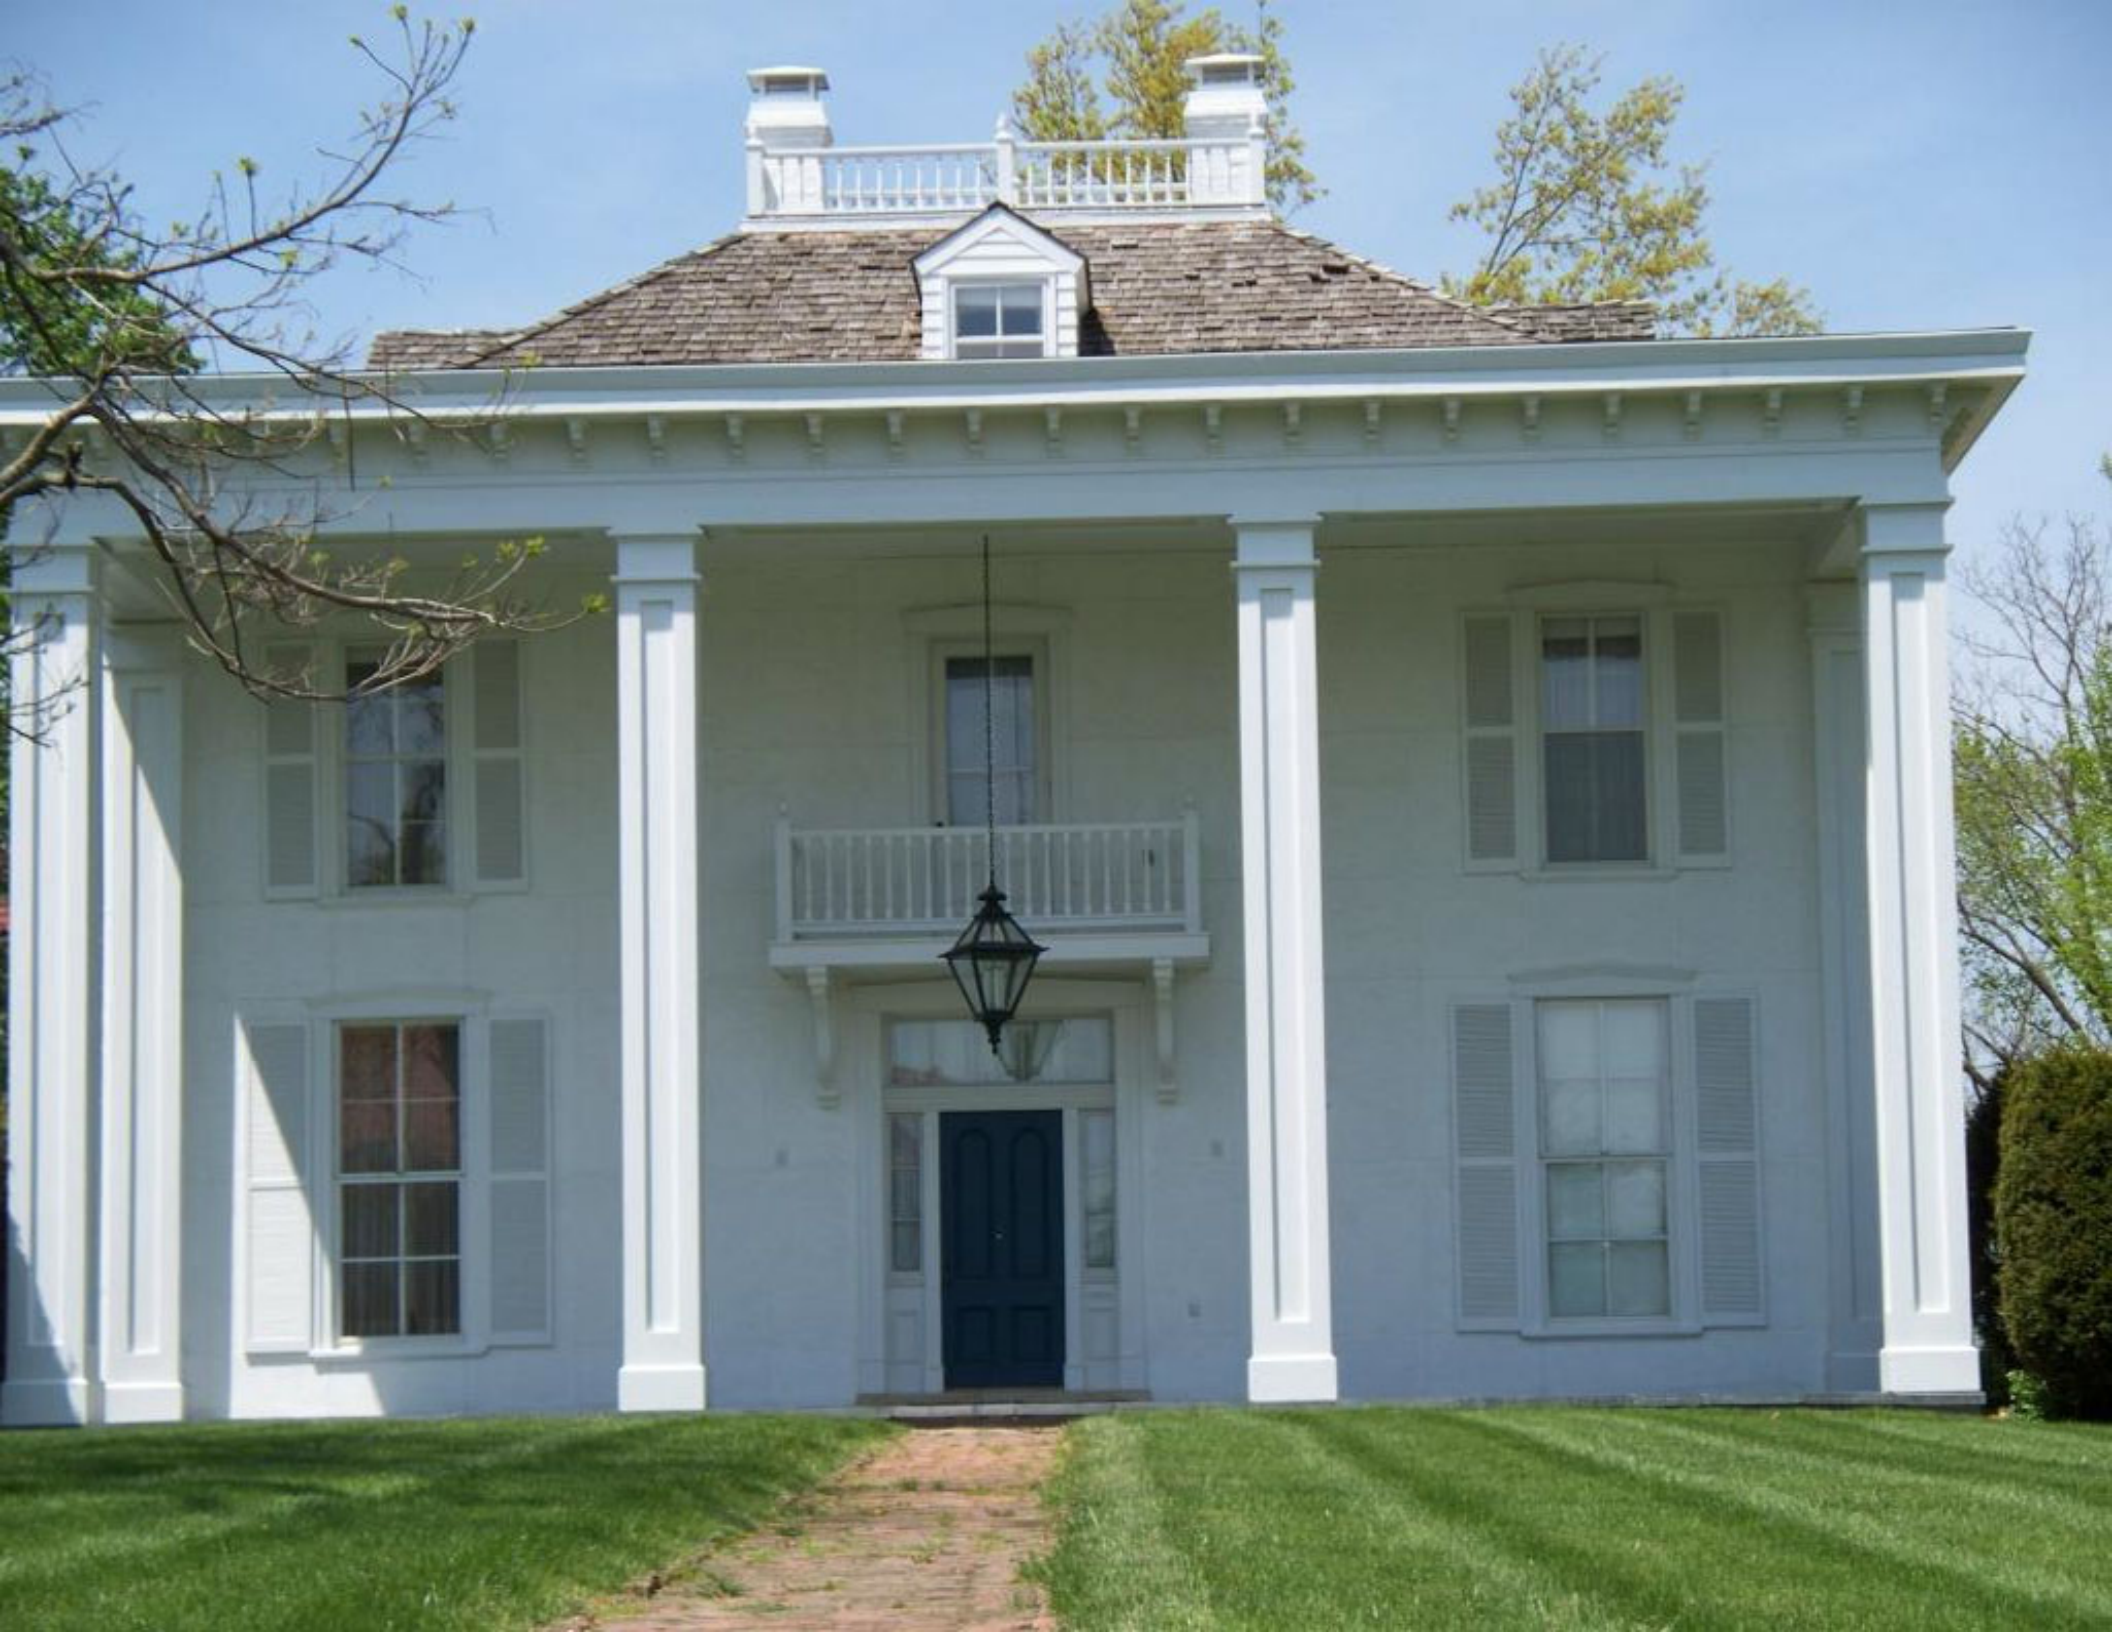
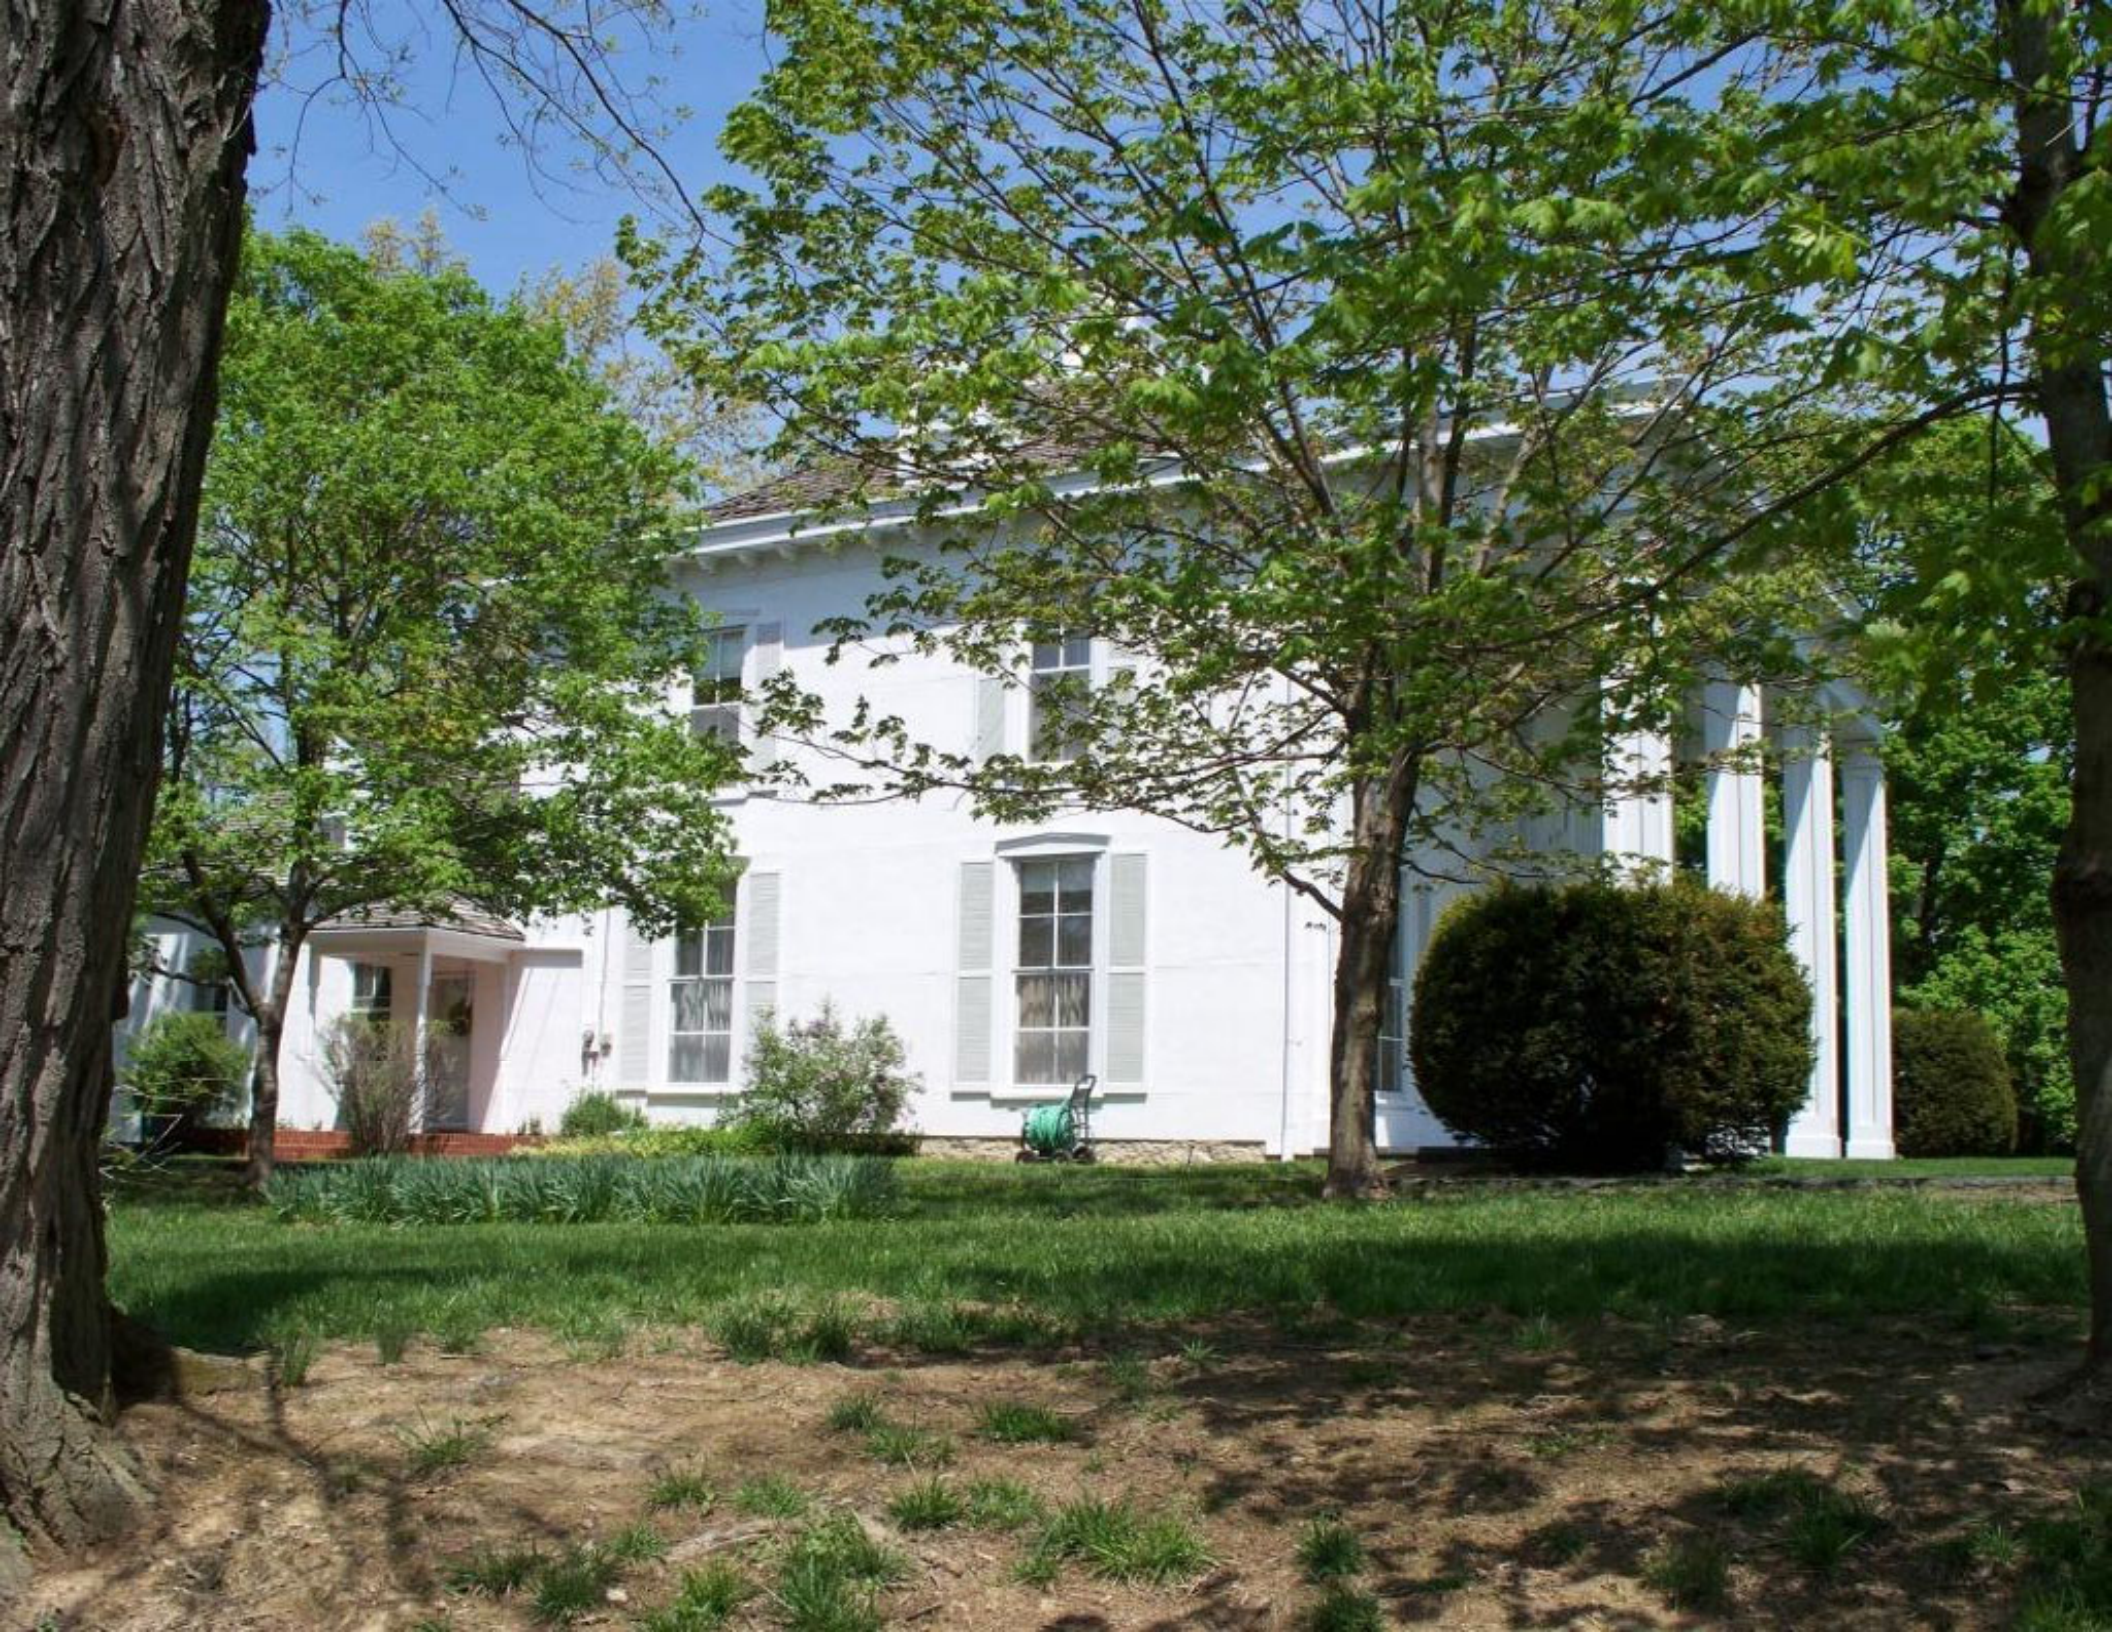
This property is classed as Greek Revival although it has some Colonial Revival features such as the hipped roof and symmetrical placement of the windows and shutters. The two-and-a-half-story house has a full façade porch with four square columns which meet a wide frieze with brackets under the cornice. This rise of the hipped roof is set back and features a small gable central dormer with a historic 2/2 window. Atop the roof is a widow's walk and central chimneys. The house appears to be clad in scored stucco or possibly Dryvit (which would be unfortunate). Even if the latter is the case, the property retains its integrity. It appears to retain its historic windows. There are two 4/4 windows with shutters and a center door with a balcony and railing on the second floor. The first floor has two 4/4 windows with shutter and a central entrance with sidelights and transoms. The above balcony acts as a hood for the entrance and features brackets. A large iron (?) light fixture hangs between the two central columns.

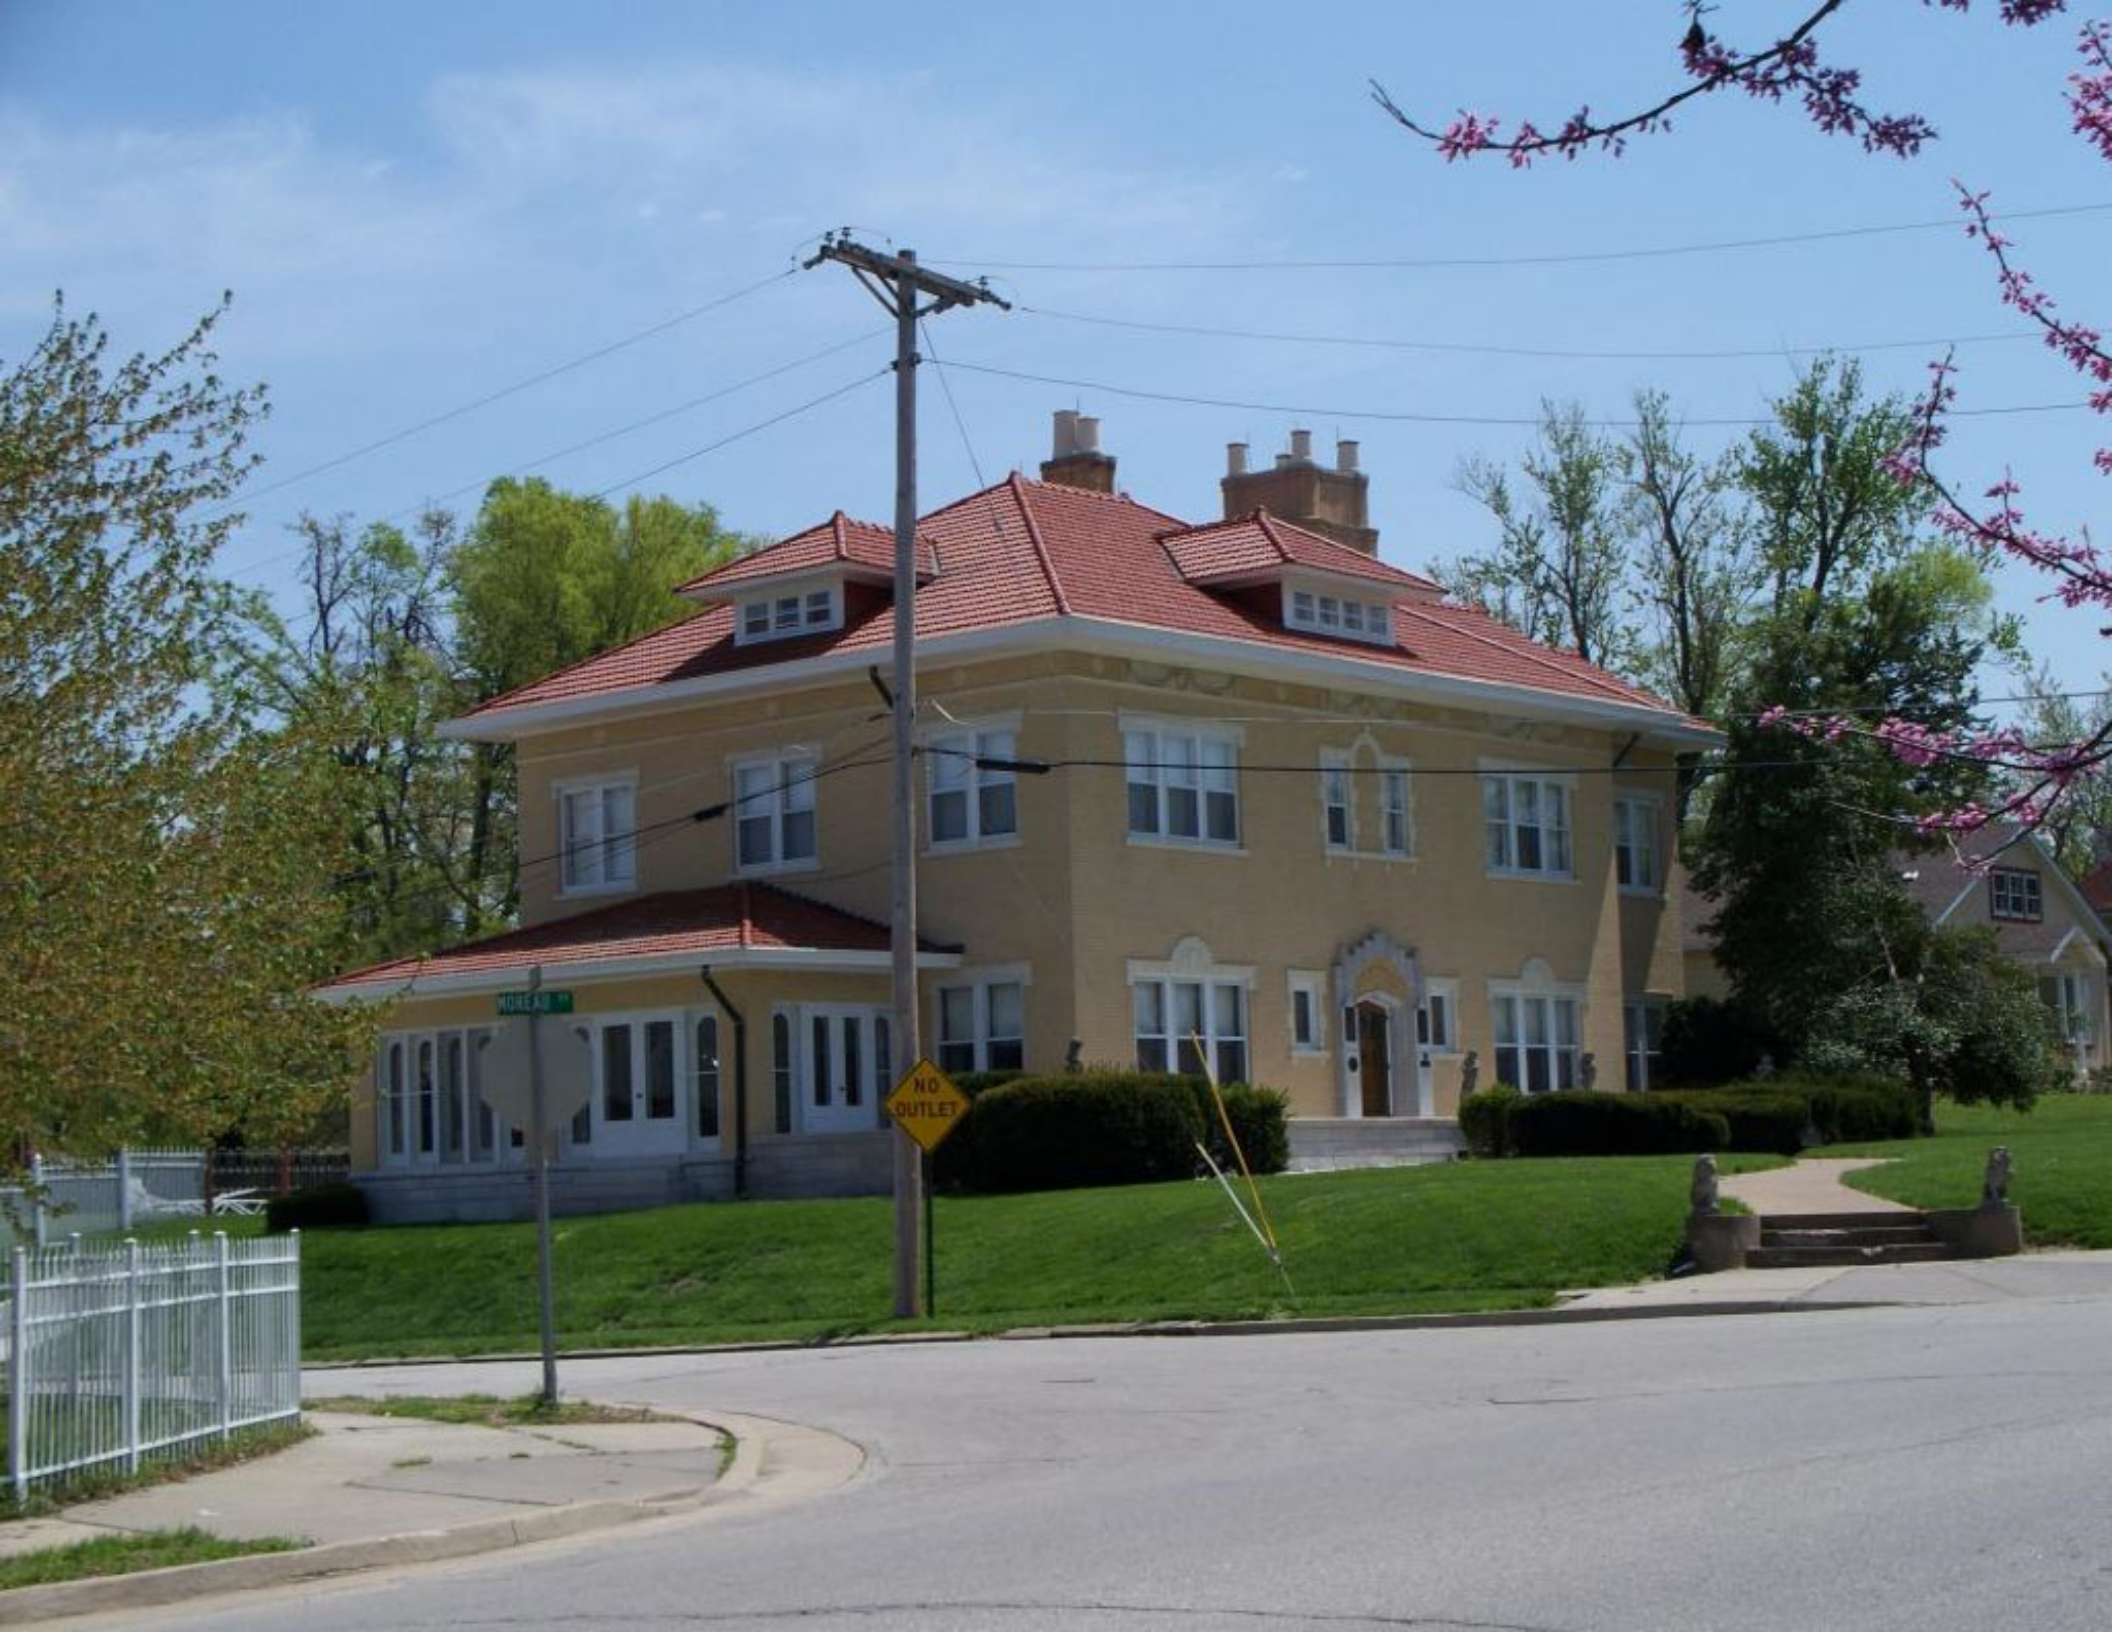
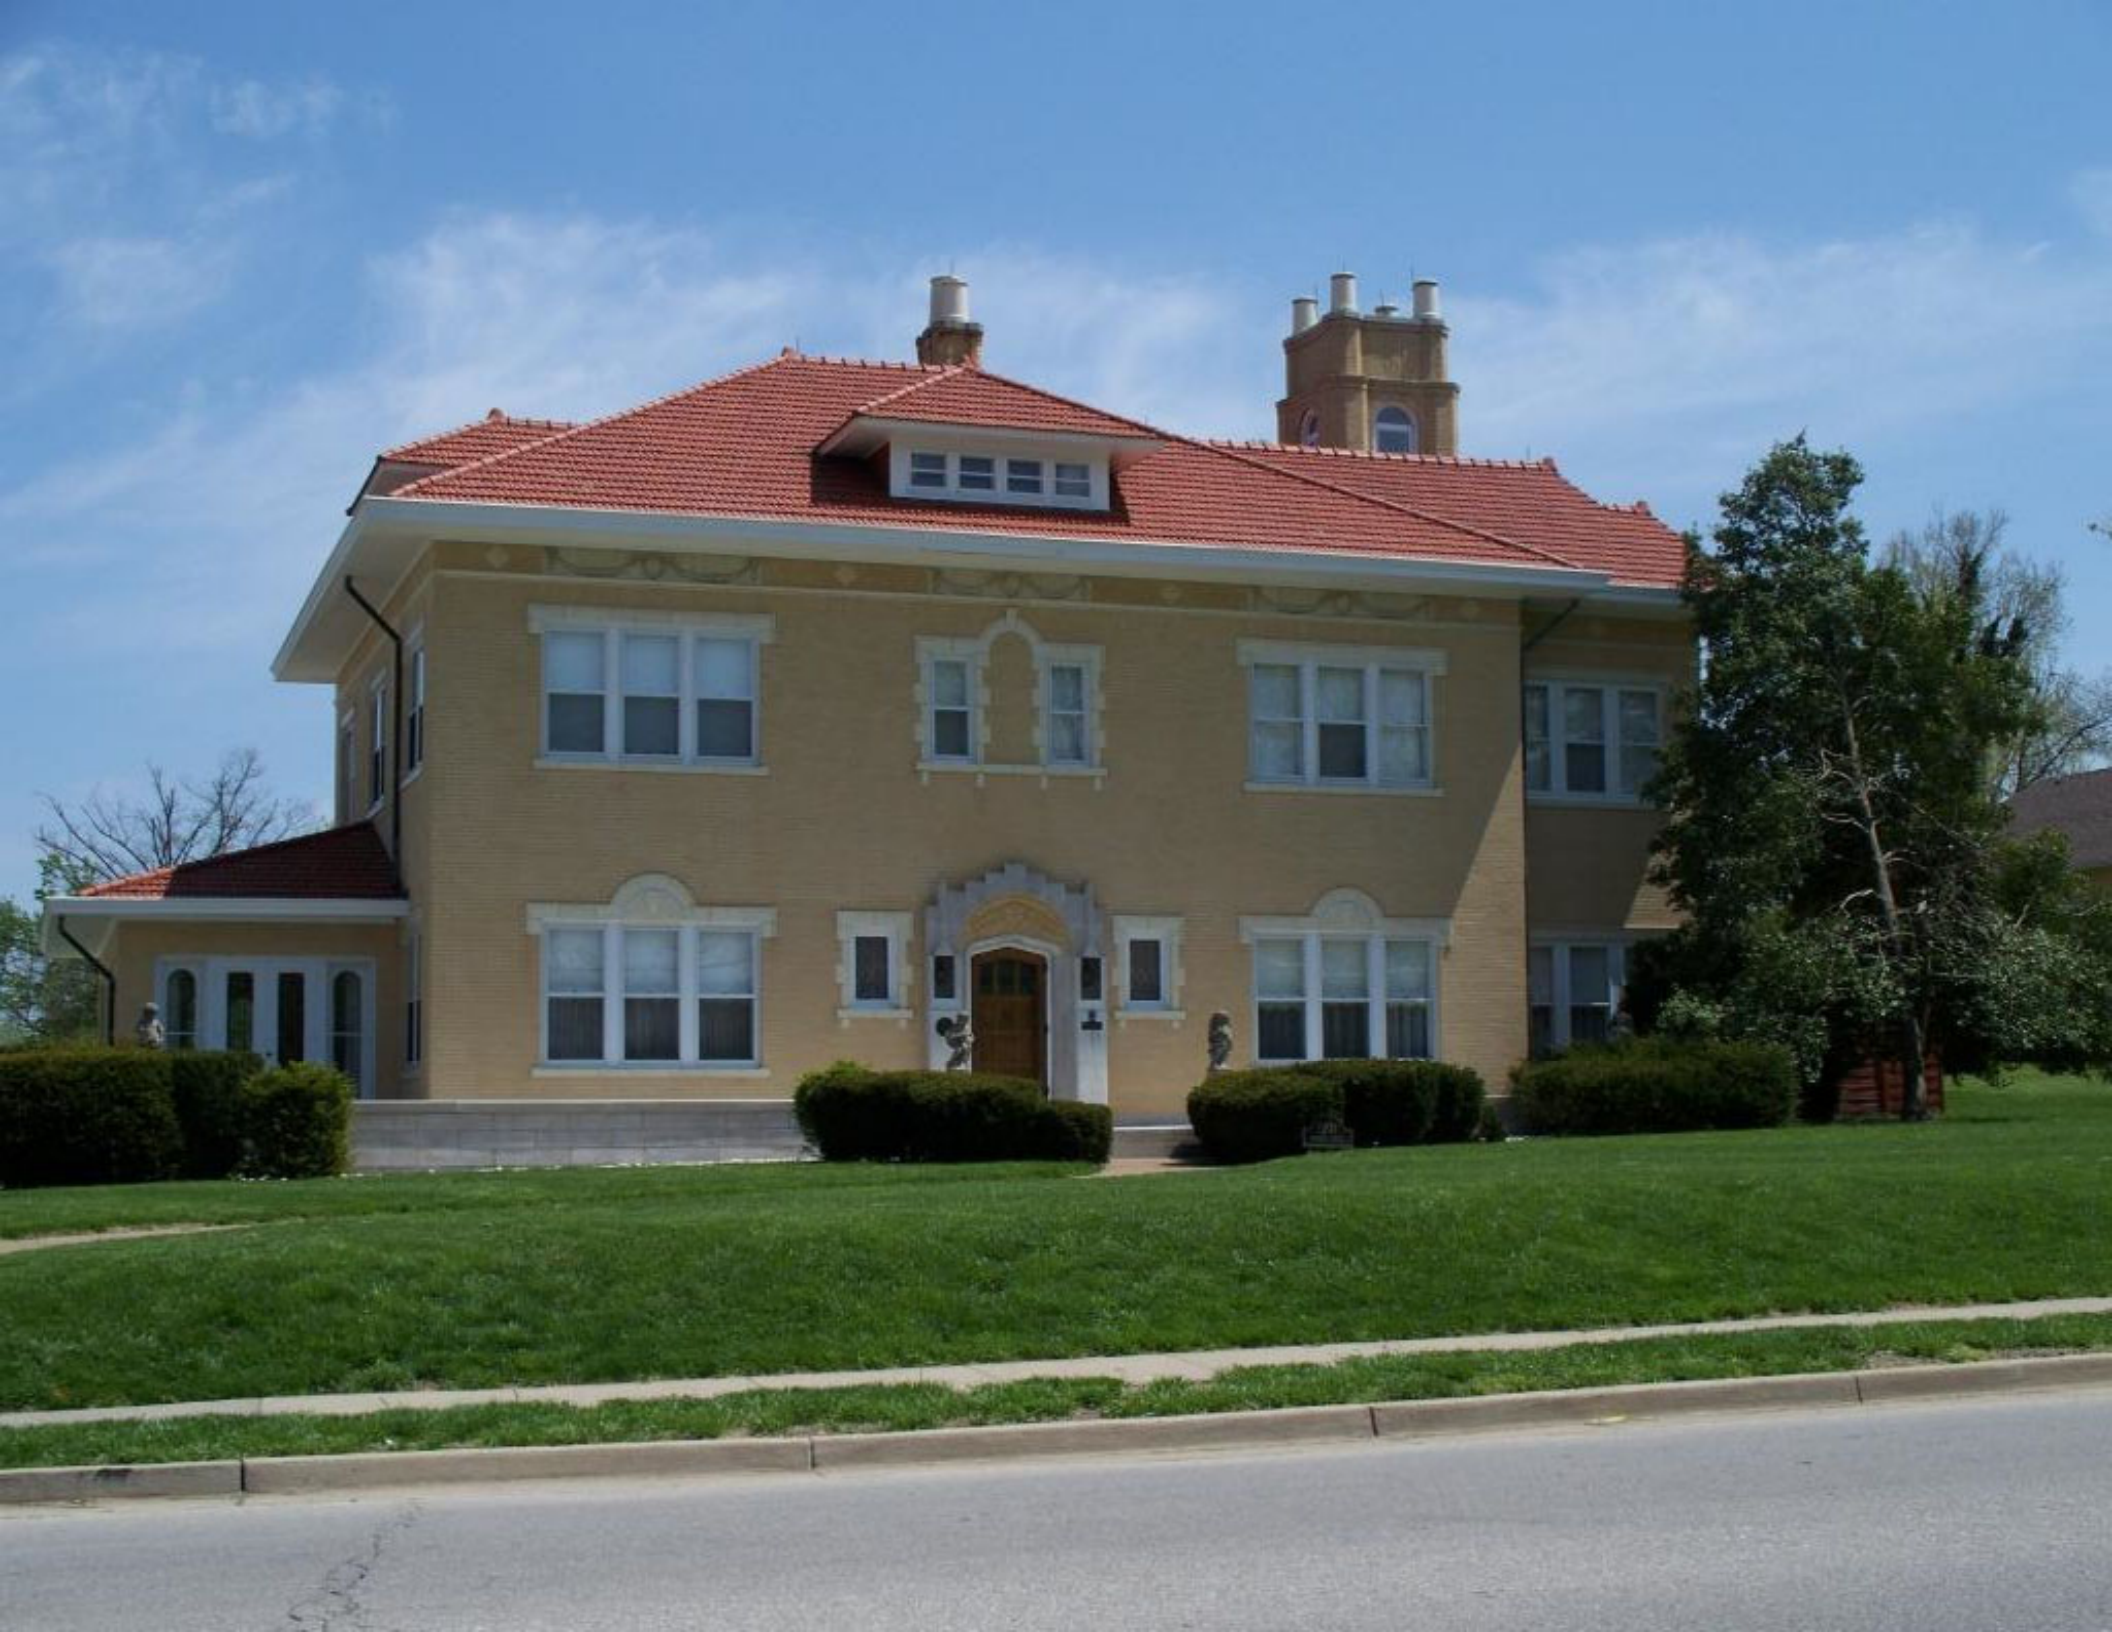
41. (cont.) This is the most ornate house in the survey boundary and one of the most grand in the City. The property has Classical, Art Deco, and Spanish Eclectic features, however the hipped red tile roof and use of arches most strongly identify with the Italian Renaissance style. It is a massive two-and-a-half story buff brick home with a cross-hipped roof and central pyramidal dormers, also tiled. The windows are historic one-over-one with storm windows. The wooden door appears to be original and has a unique Tudor arch. The stone surround mirrors this arch and extends into a floral bas-relief and stepped Art-Deco geometrical surround. There are two fixed stained glass windows in the surround and two additional stained glass windows flank the entrance and feature decorative stone quoining. This treatment repeats in the central bay on the upper floor around two replacement windows to connect in a decorative arch. The lower windows also have decorative lintels and reliefs. Stone decoration is seen again in the cornice in festoon and wreath reliefs. The property has a large square tower towards the back of the building that also appears to be utilized as a chimney, a smaller chimney is located centrally on the building. An enclosed one-story sunroom is to the north of the building and an enclosed sleeping porch and sunroom is set back on the south side of the building.
