ARCHITECTURAL/HISTORIC INVENTORY FORM

1. Survey No. CO-AS-005-001		2. Survey name: Moreau Drive Neighborhood Survey	
3. County: Cole		4. Address: 1202 Elmerine Ave.	
5. City: Jefferson City	Vicinity: <input type="checkbox"/>	6. UTM: / /	7. Township/Range/Section: T: R: S:
8. Historic name (if known):		9. Present/other name (if known):	
10. Ownership: <input checked="" type="checkbox"/> Private <input type="checkbox"/> Public		11. Historic use (if known): Residential	11. Current use: Residential

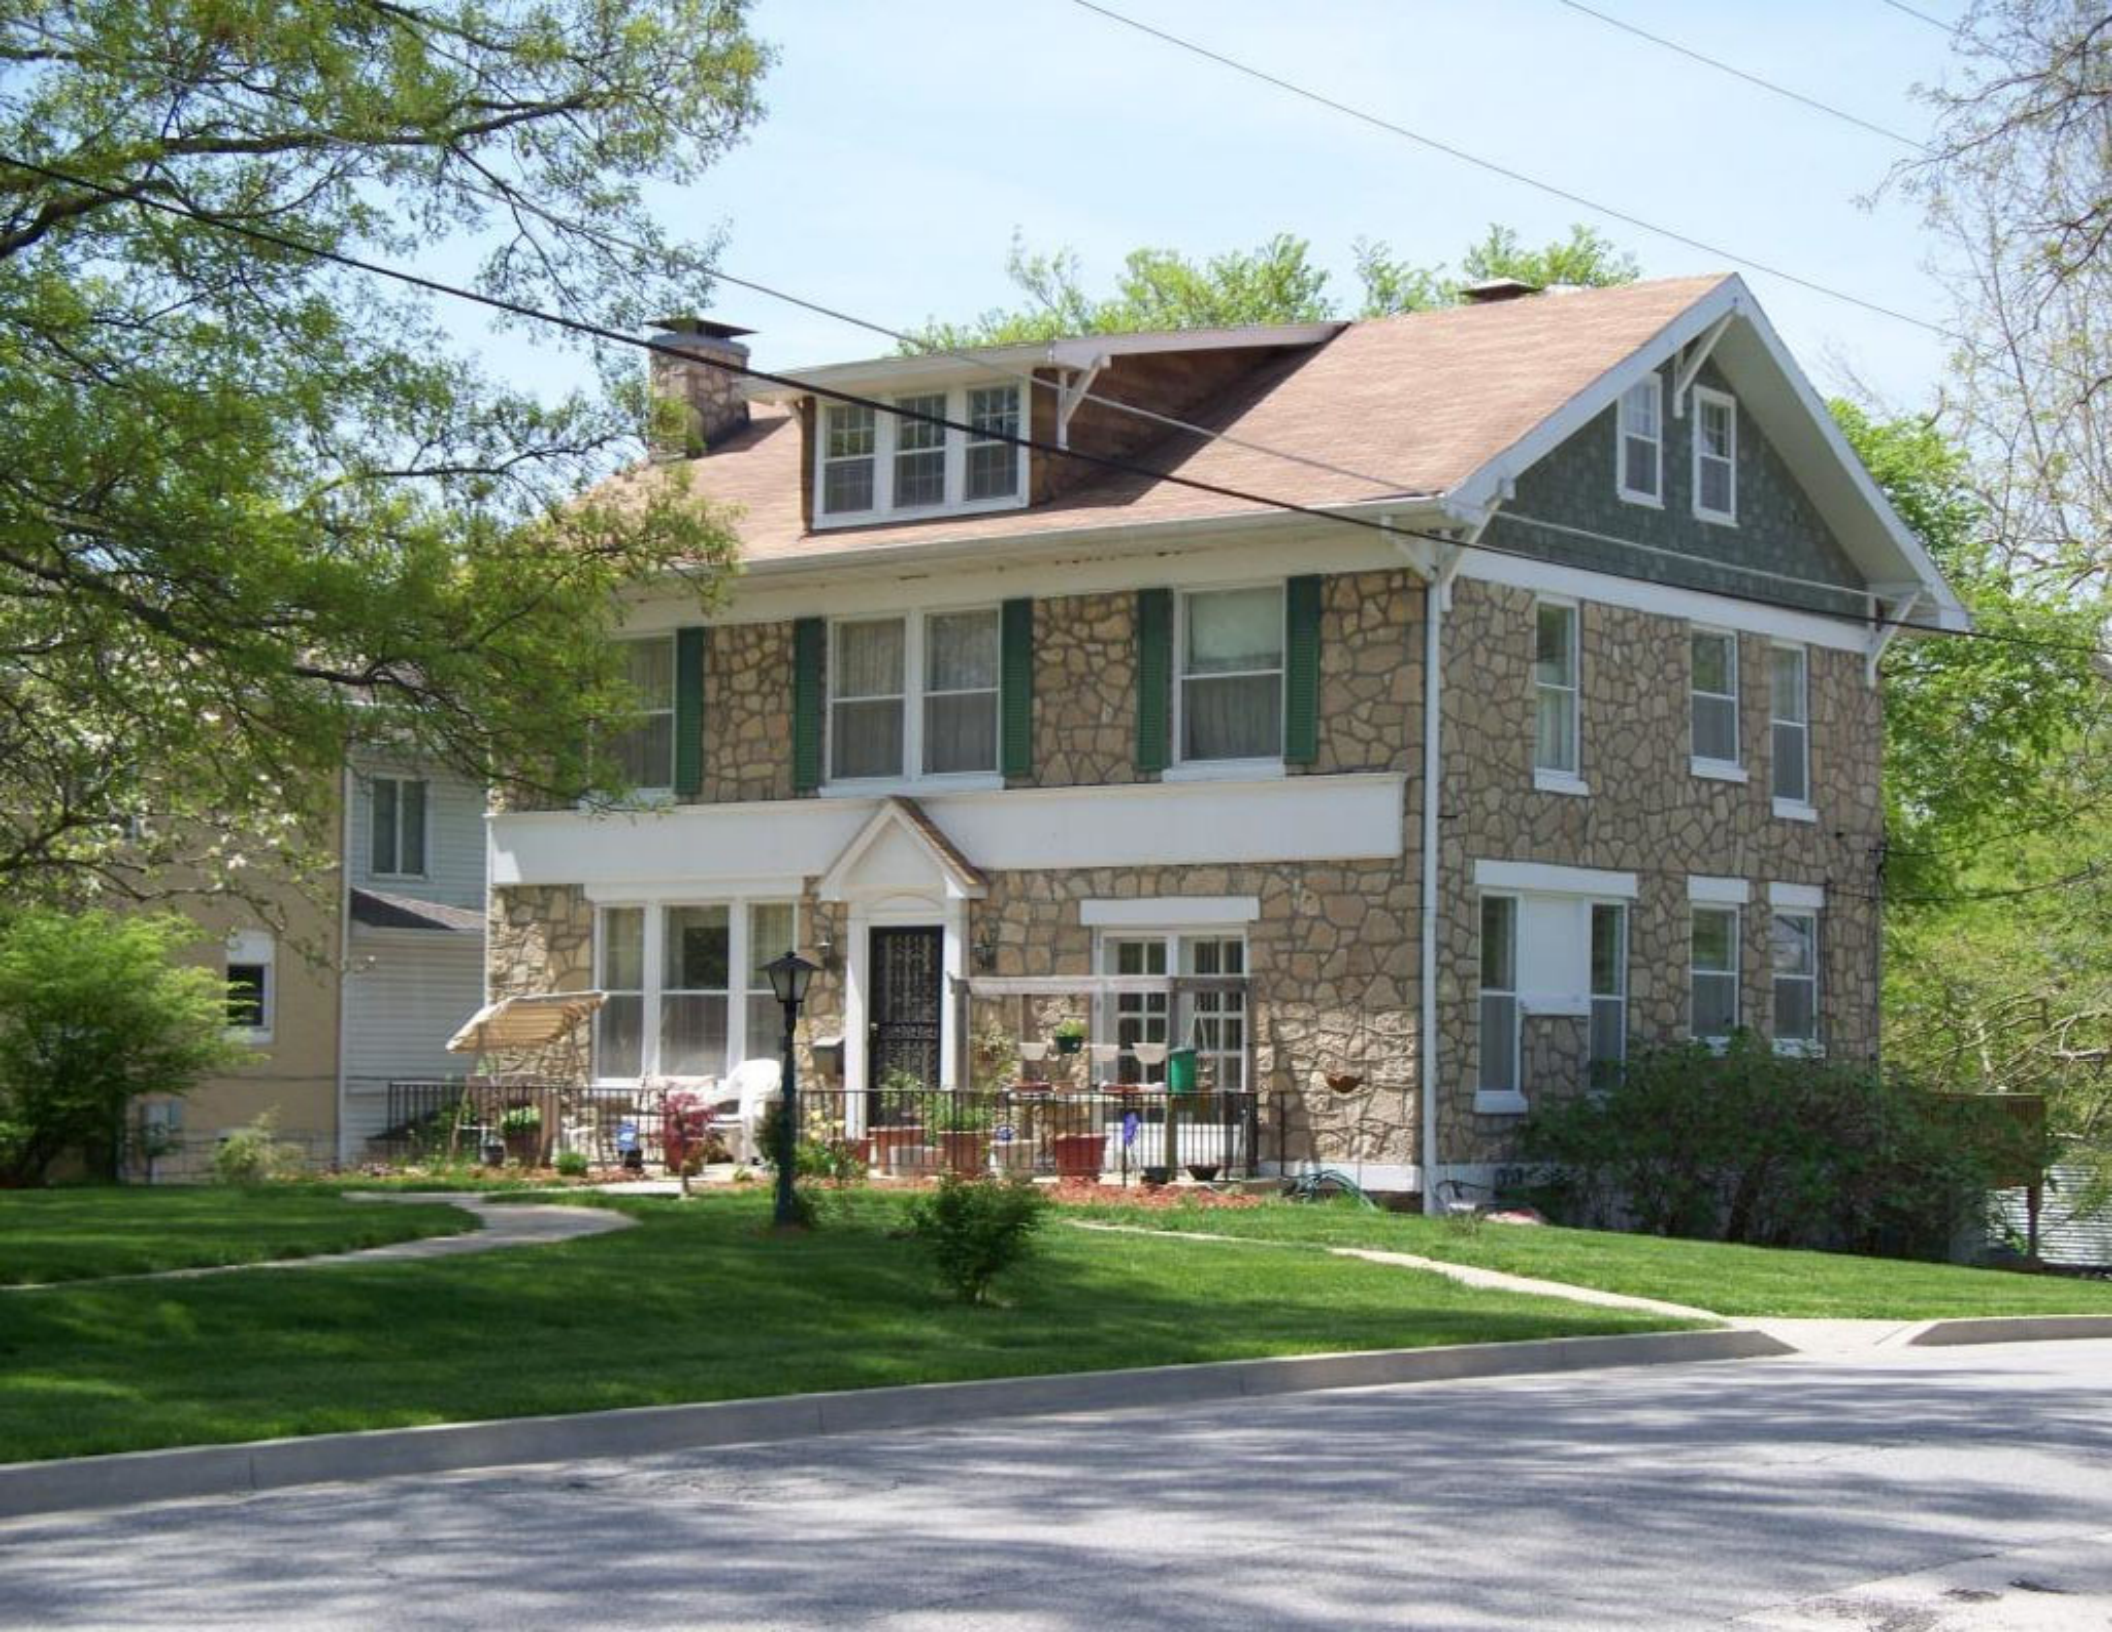
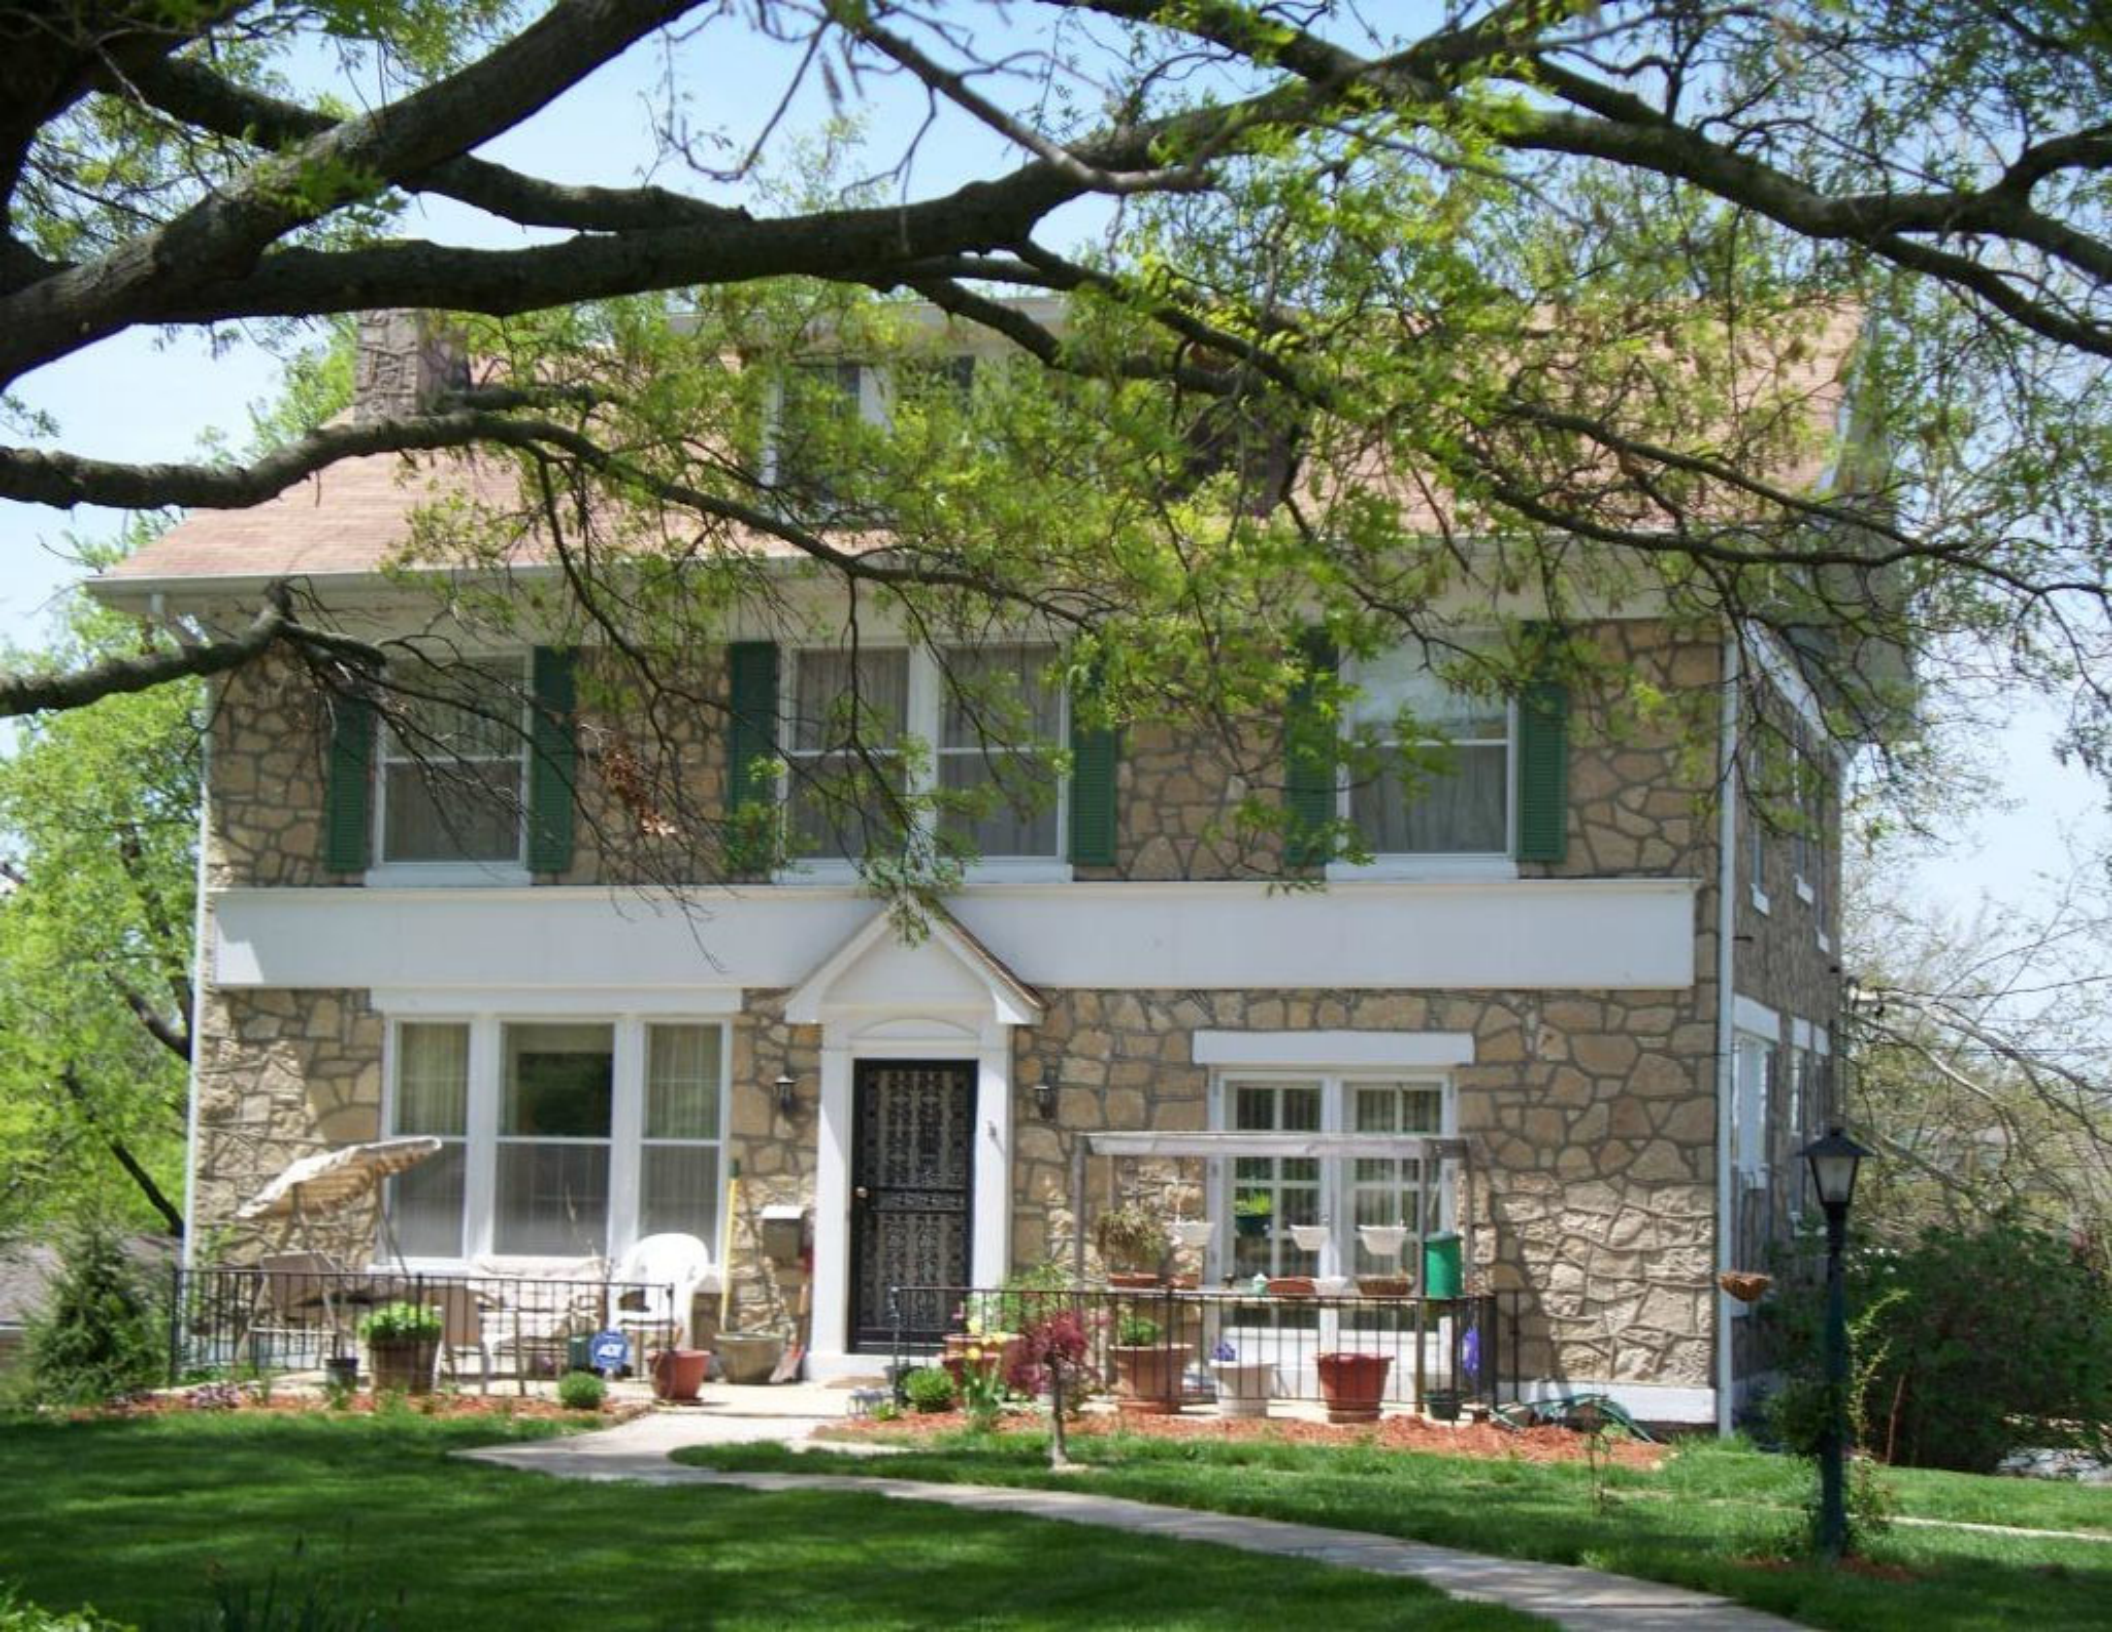
This two-and-a-half-story stone house has a side gabled roof with central shed dormer with brackets and three 6/6 windows that appear historic. There are 1/1 historic windows flanking paired 1/1 windows, all of which have shutters. There is a wide panel that divides the first and second stories. According to 1939, 1945 Sanborn maps there was a full width porch here. It's possible it was removed and this panel added to hide the evidence of the porch. The gabled central door surround projects slightly from the home and may not be original. There are a set of double doors in the right bay and a tri-part window in the left bay. A full-length concrete slab with metal railing serves as a porch.

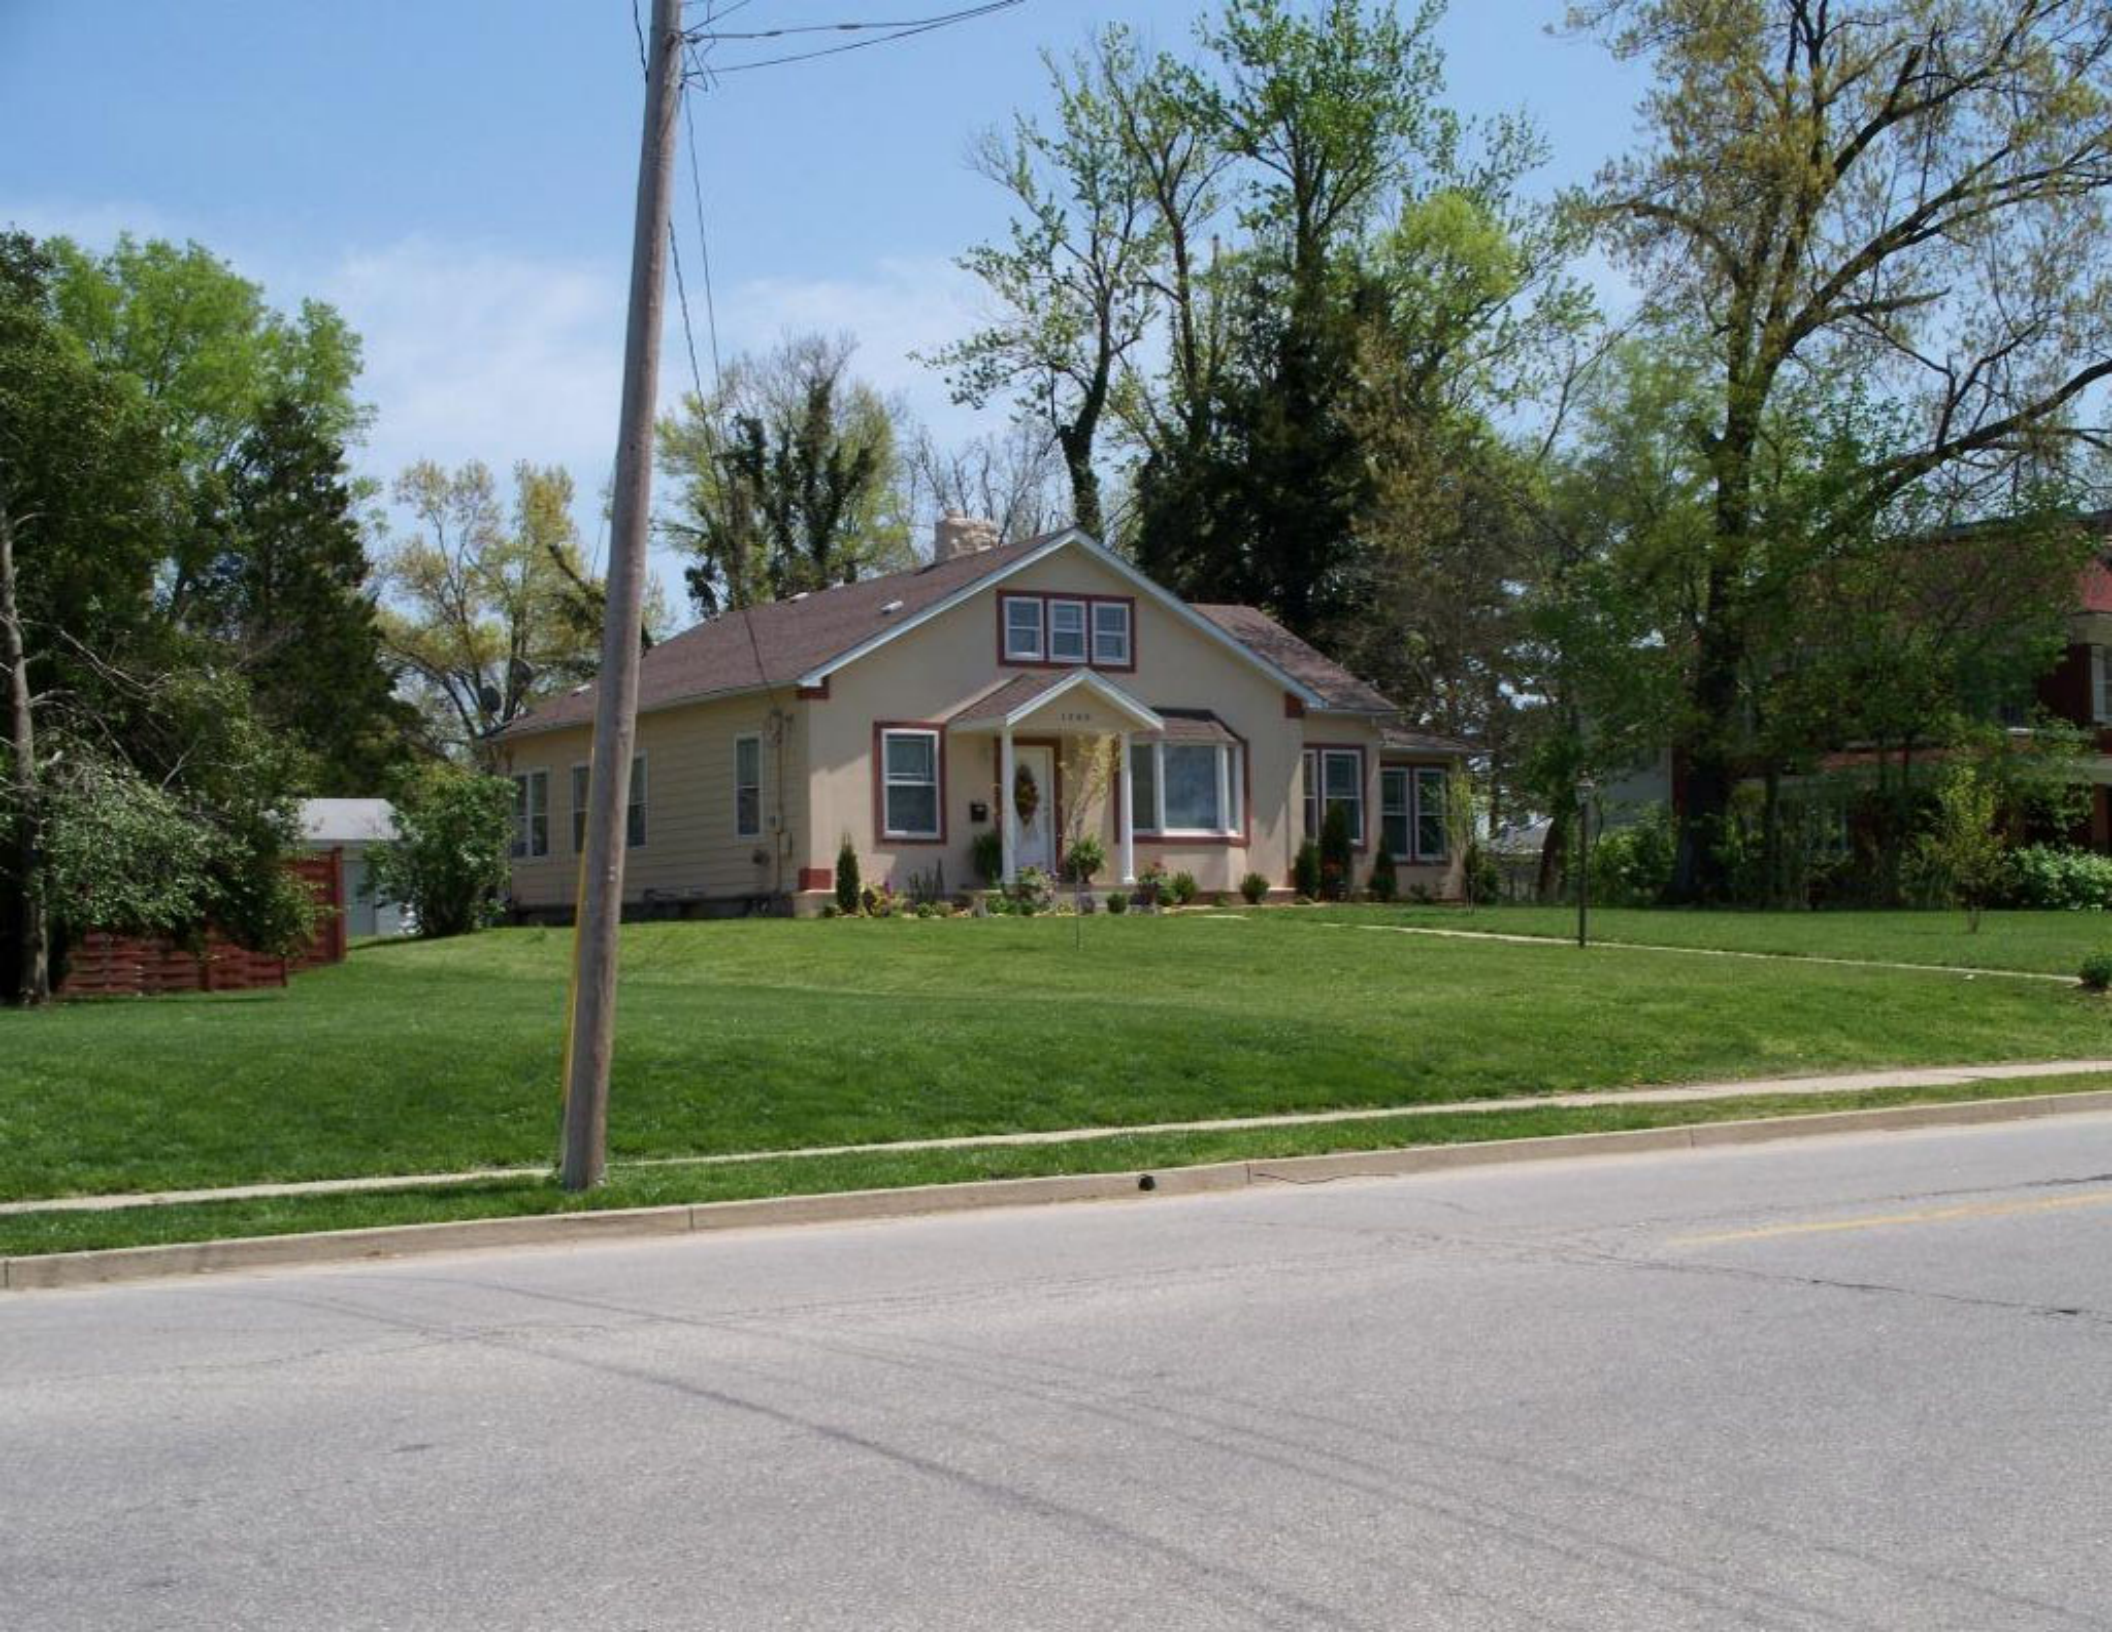
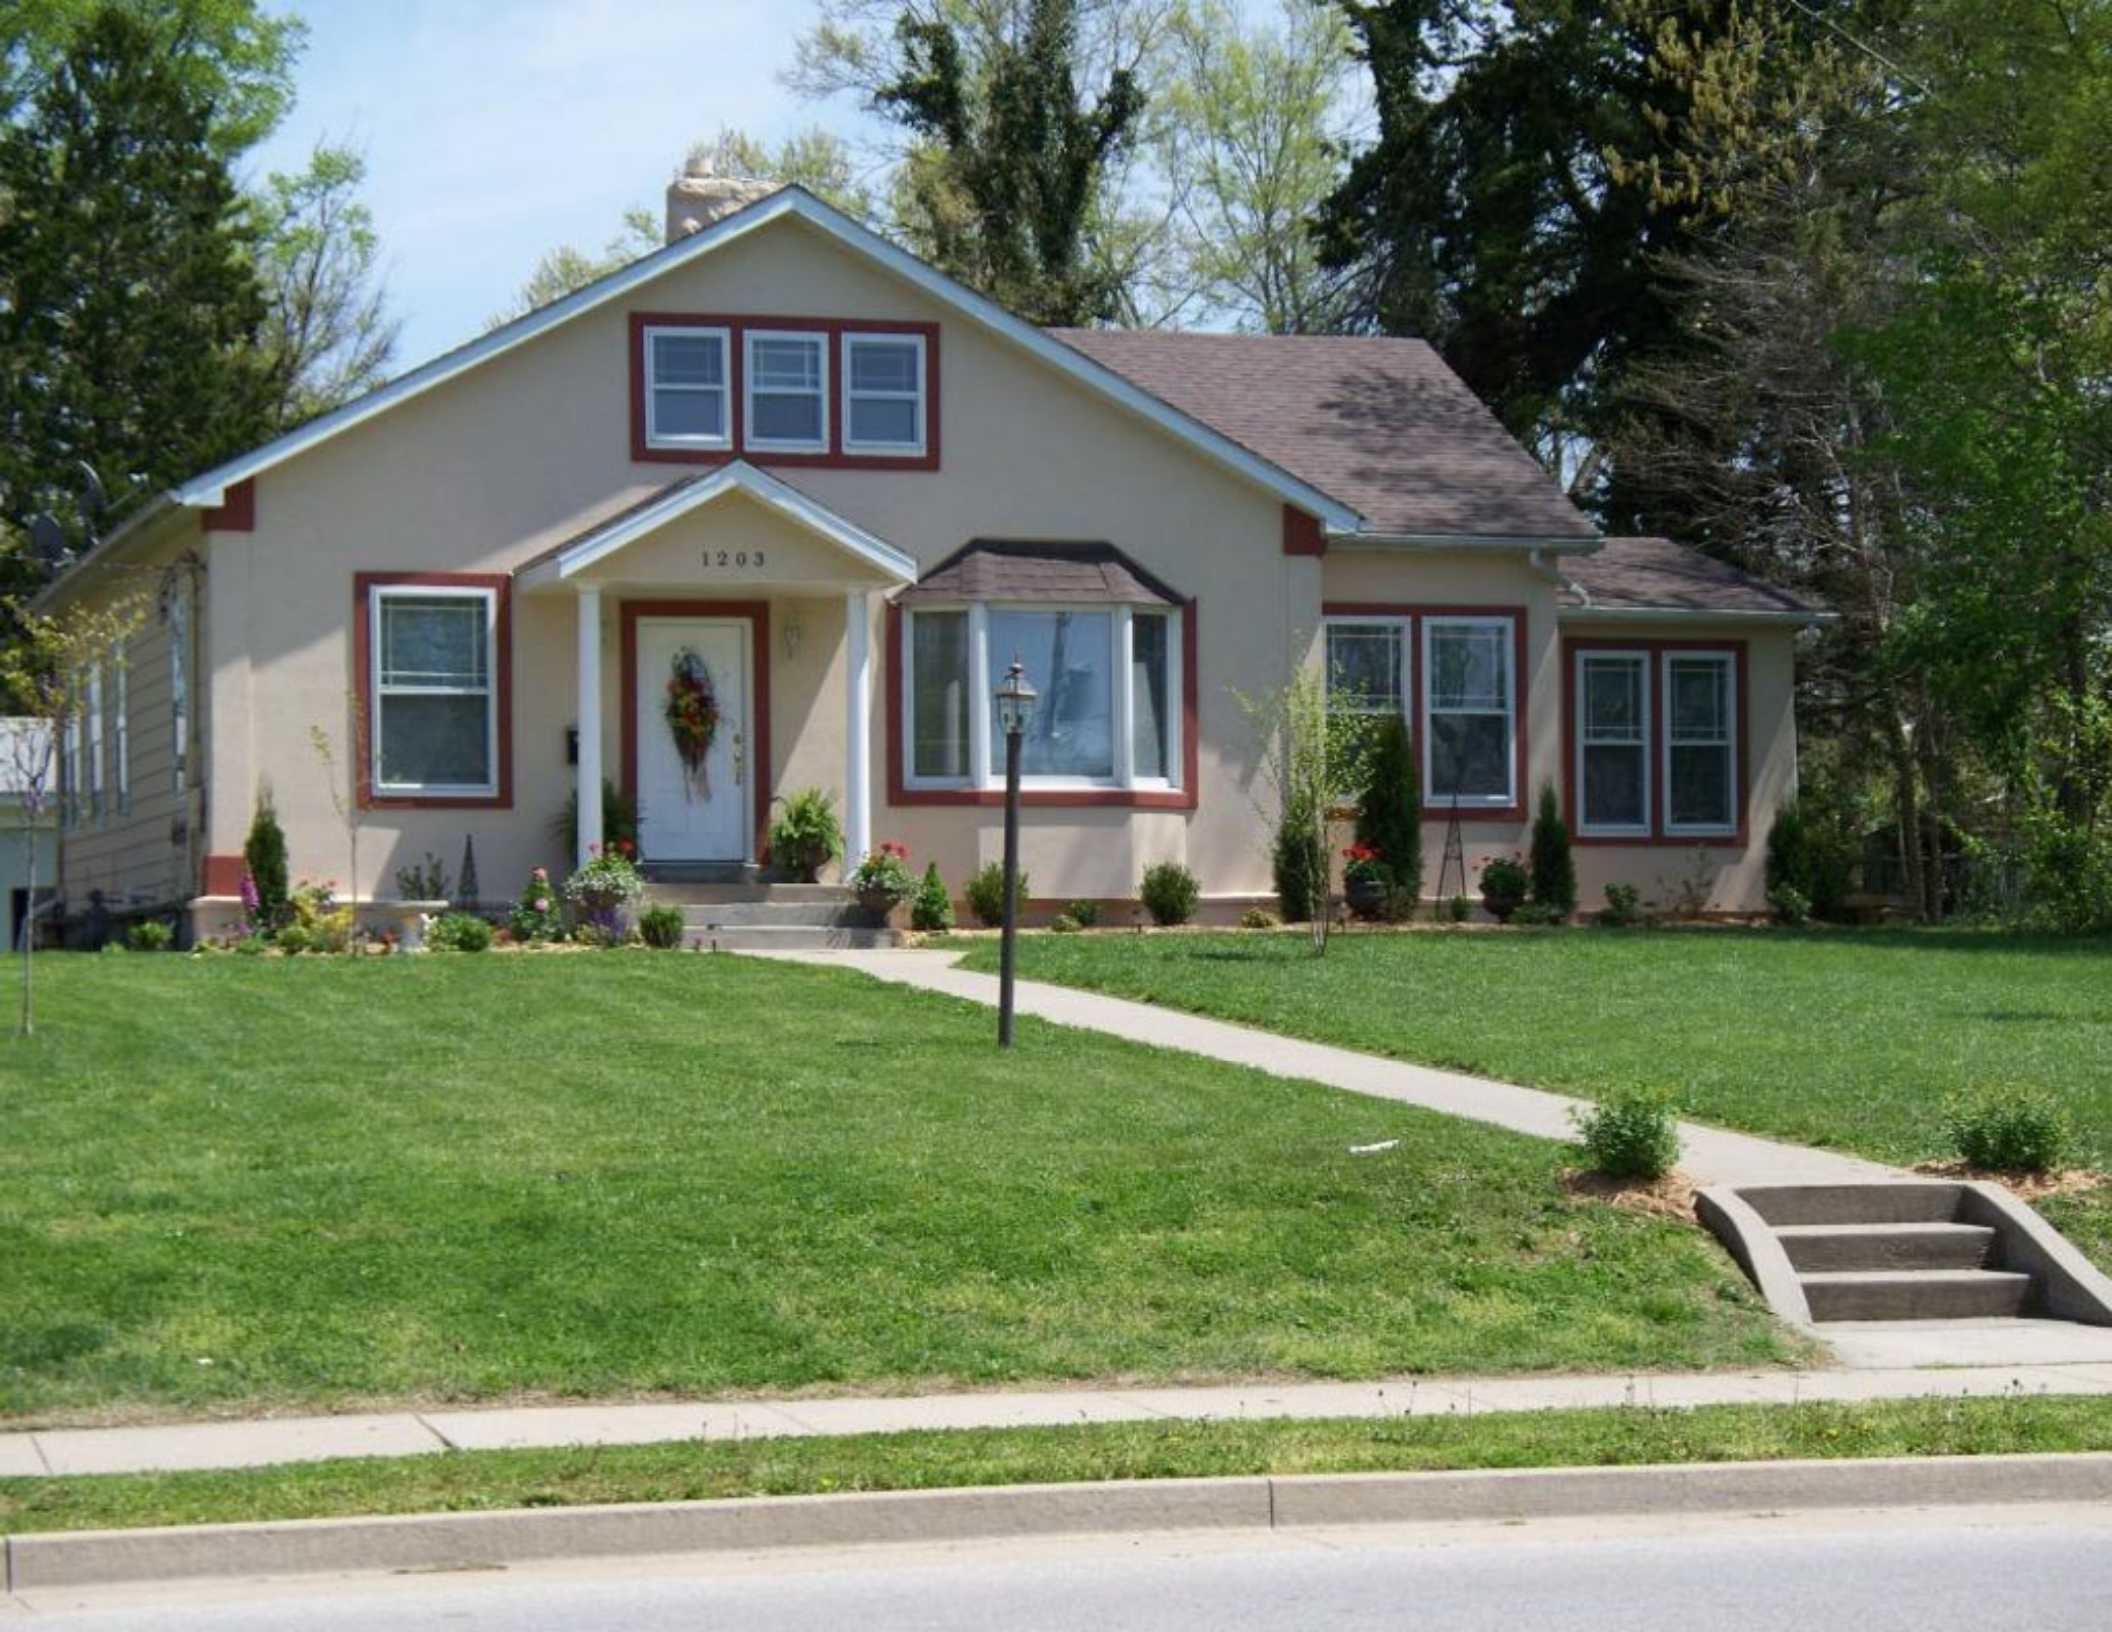
There is a detached garage behind the property, it does not appear historic.

41. (cont.) This one-and-a-half story stucco bungalow has a low stone chimney located in the middle of the roof. The front gable has a row of three windows that may be historic. The first floor has a one-over-one window on the left, a bay window on the other side of the door and a set of paired windows in both extensions of the properties. Except for the bay window, most appear historic and are covered with storm windows. The door appears to be a replacement as does the gabled portico. According to the 1943 Sanborn there was once a full length porch here. There is a shorter addition coming off the right wing of the house. All of it is stucco as is the gable in the portico, which suggests the changes happened at the same time. It is unknown exactly when this property was originally built but it now appears to be a 1930s bungalow that is in keeping with the character of the neighborhood. More research is necessary, but based upon the information provided this would be contributing to a historic district.

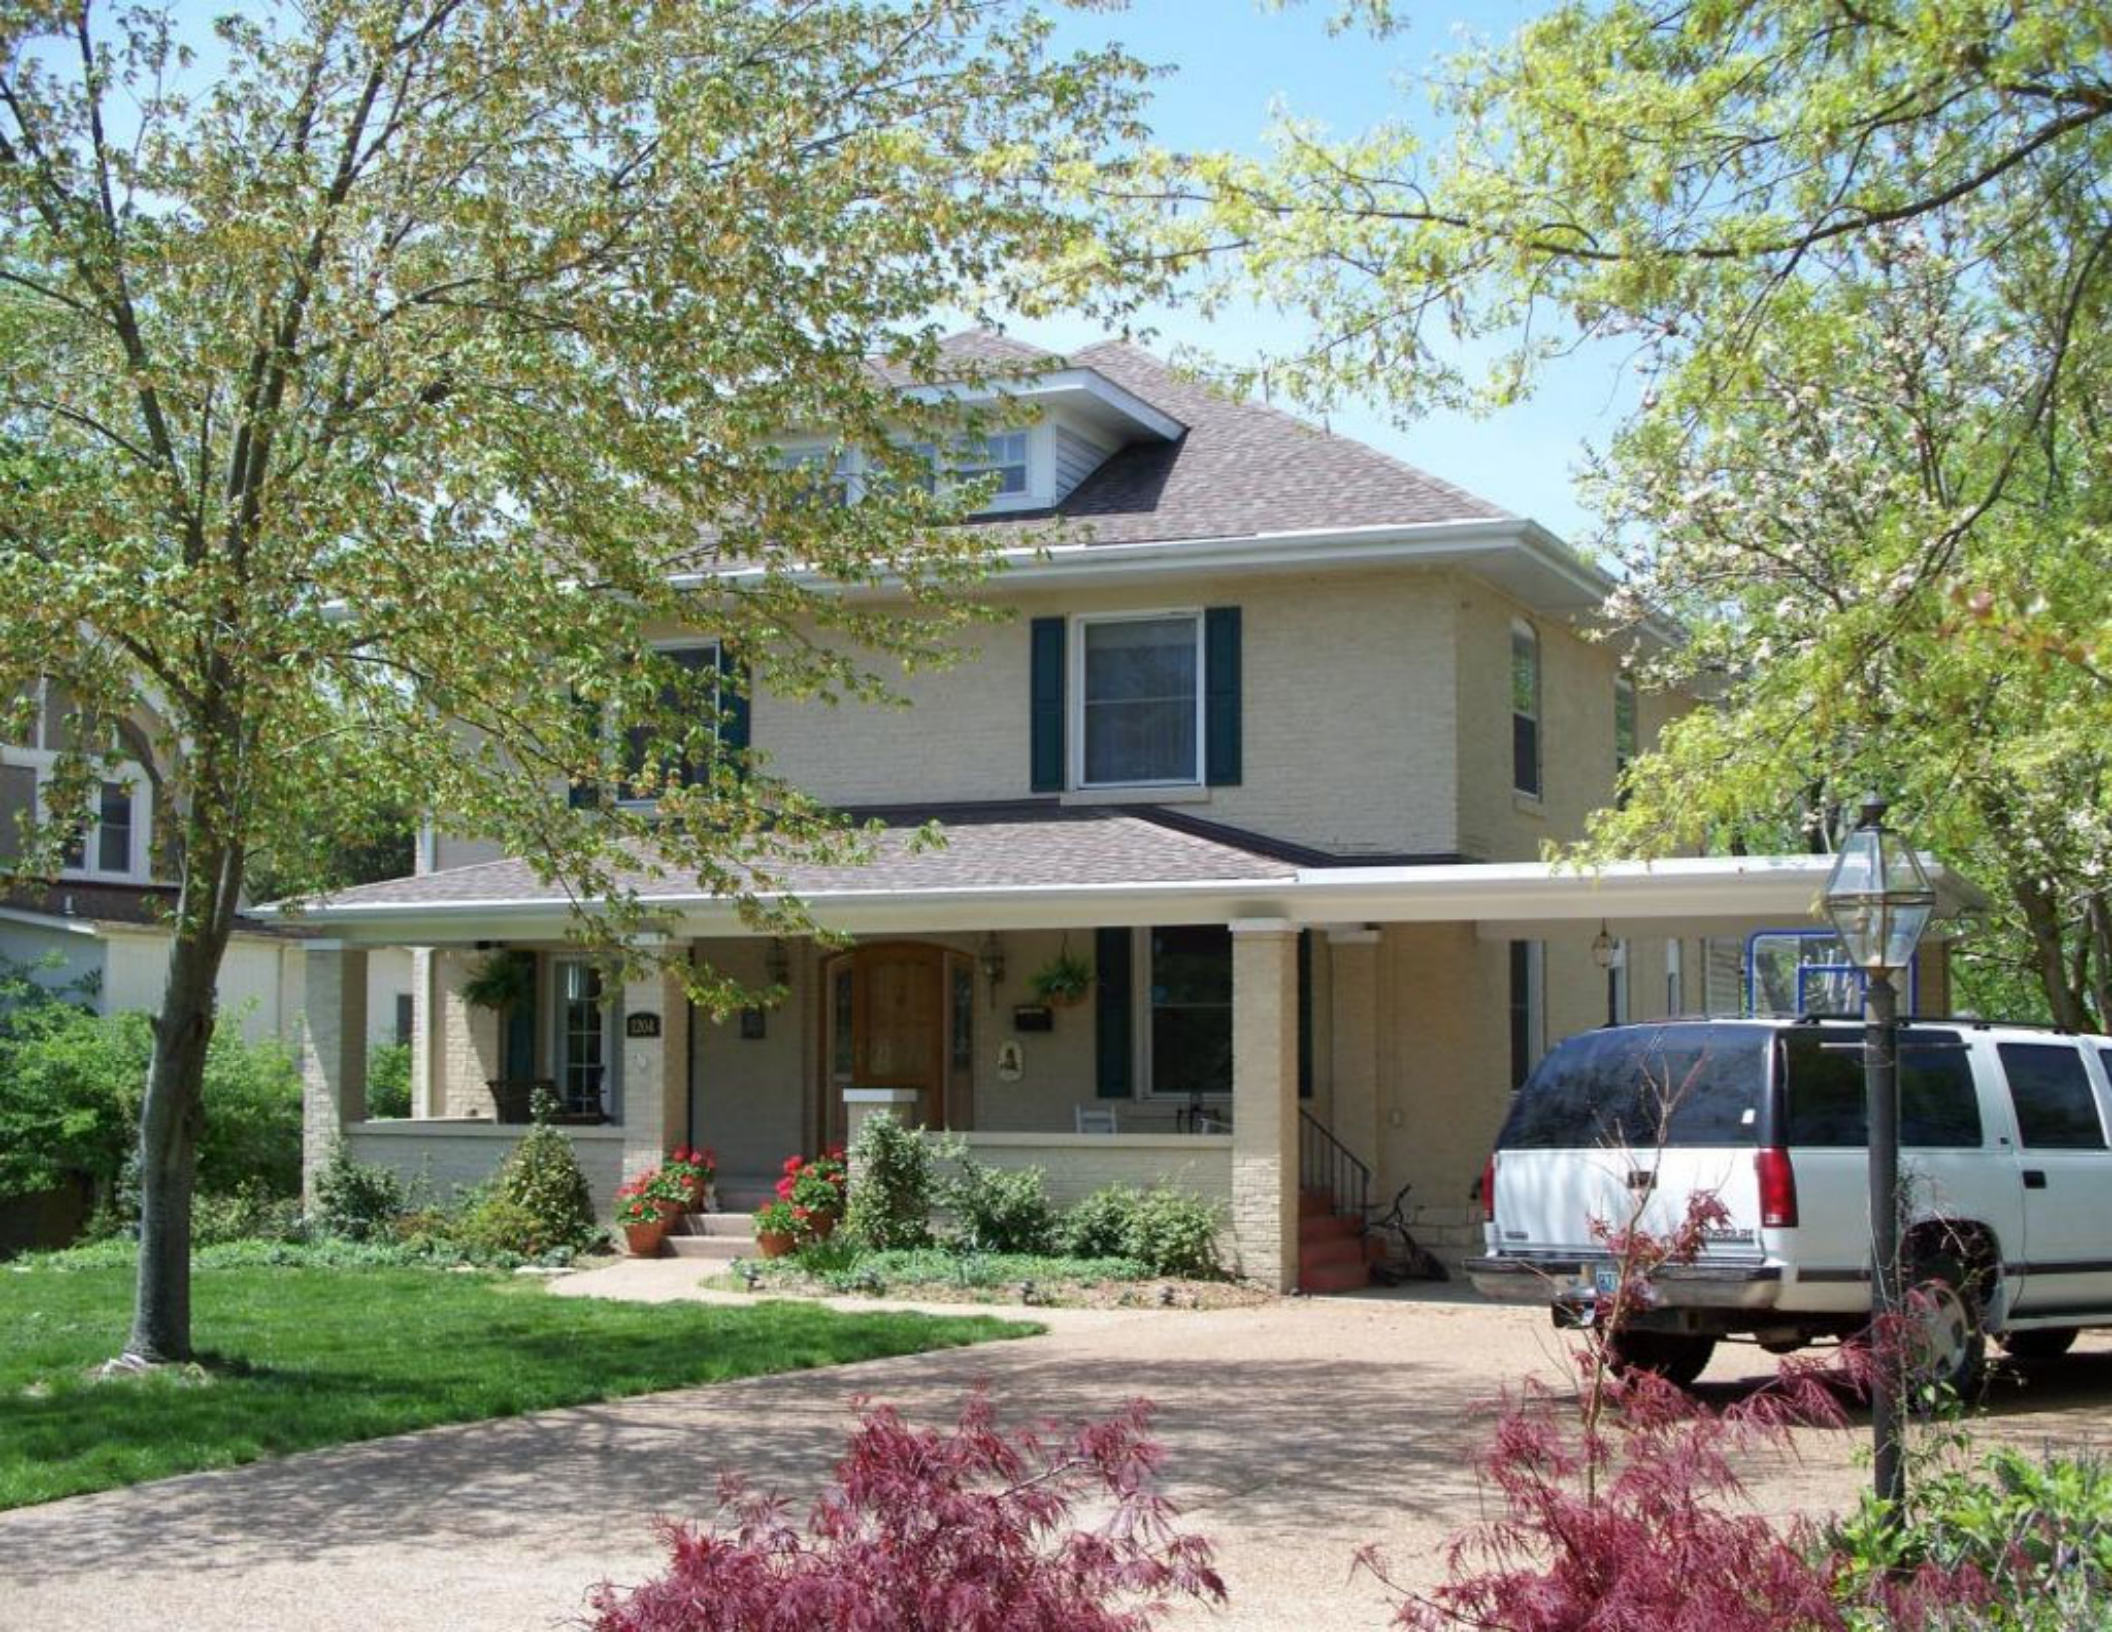
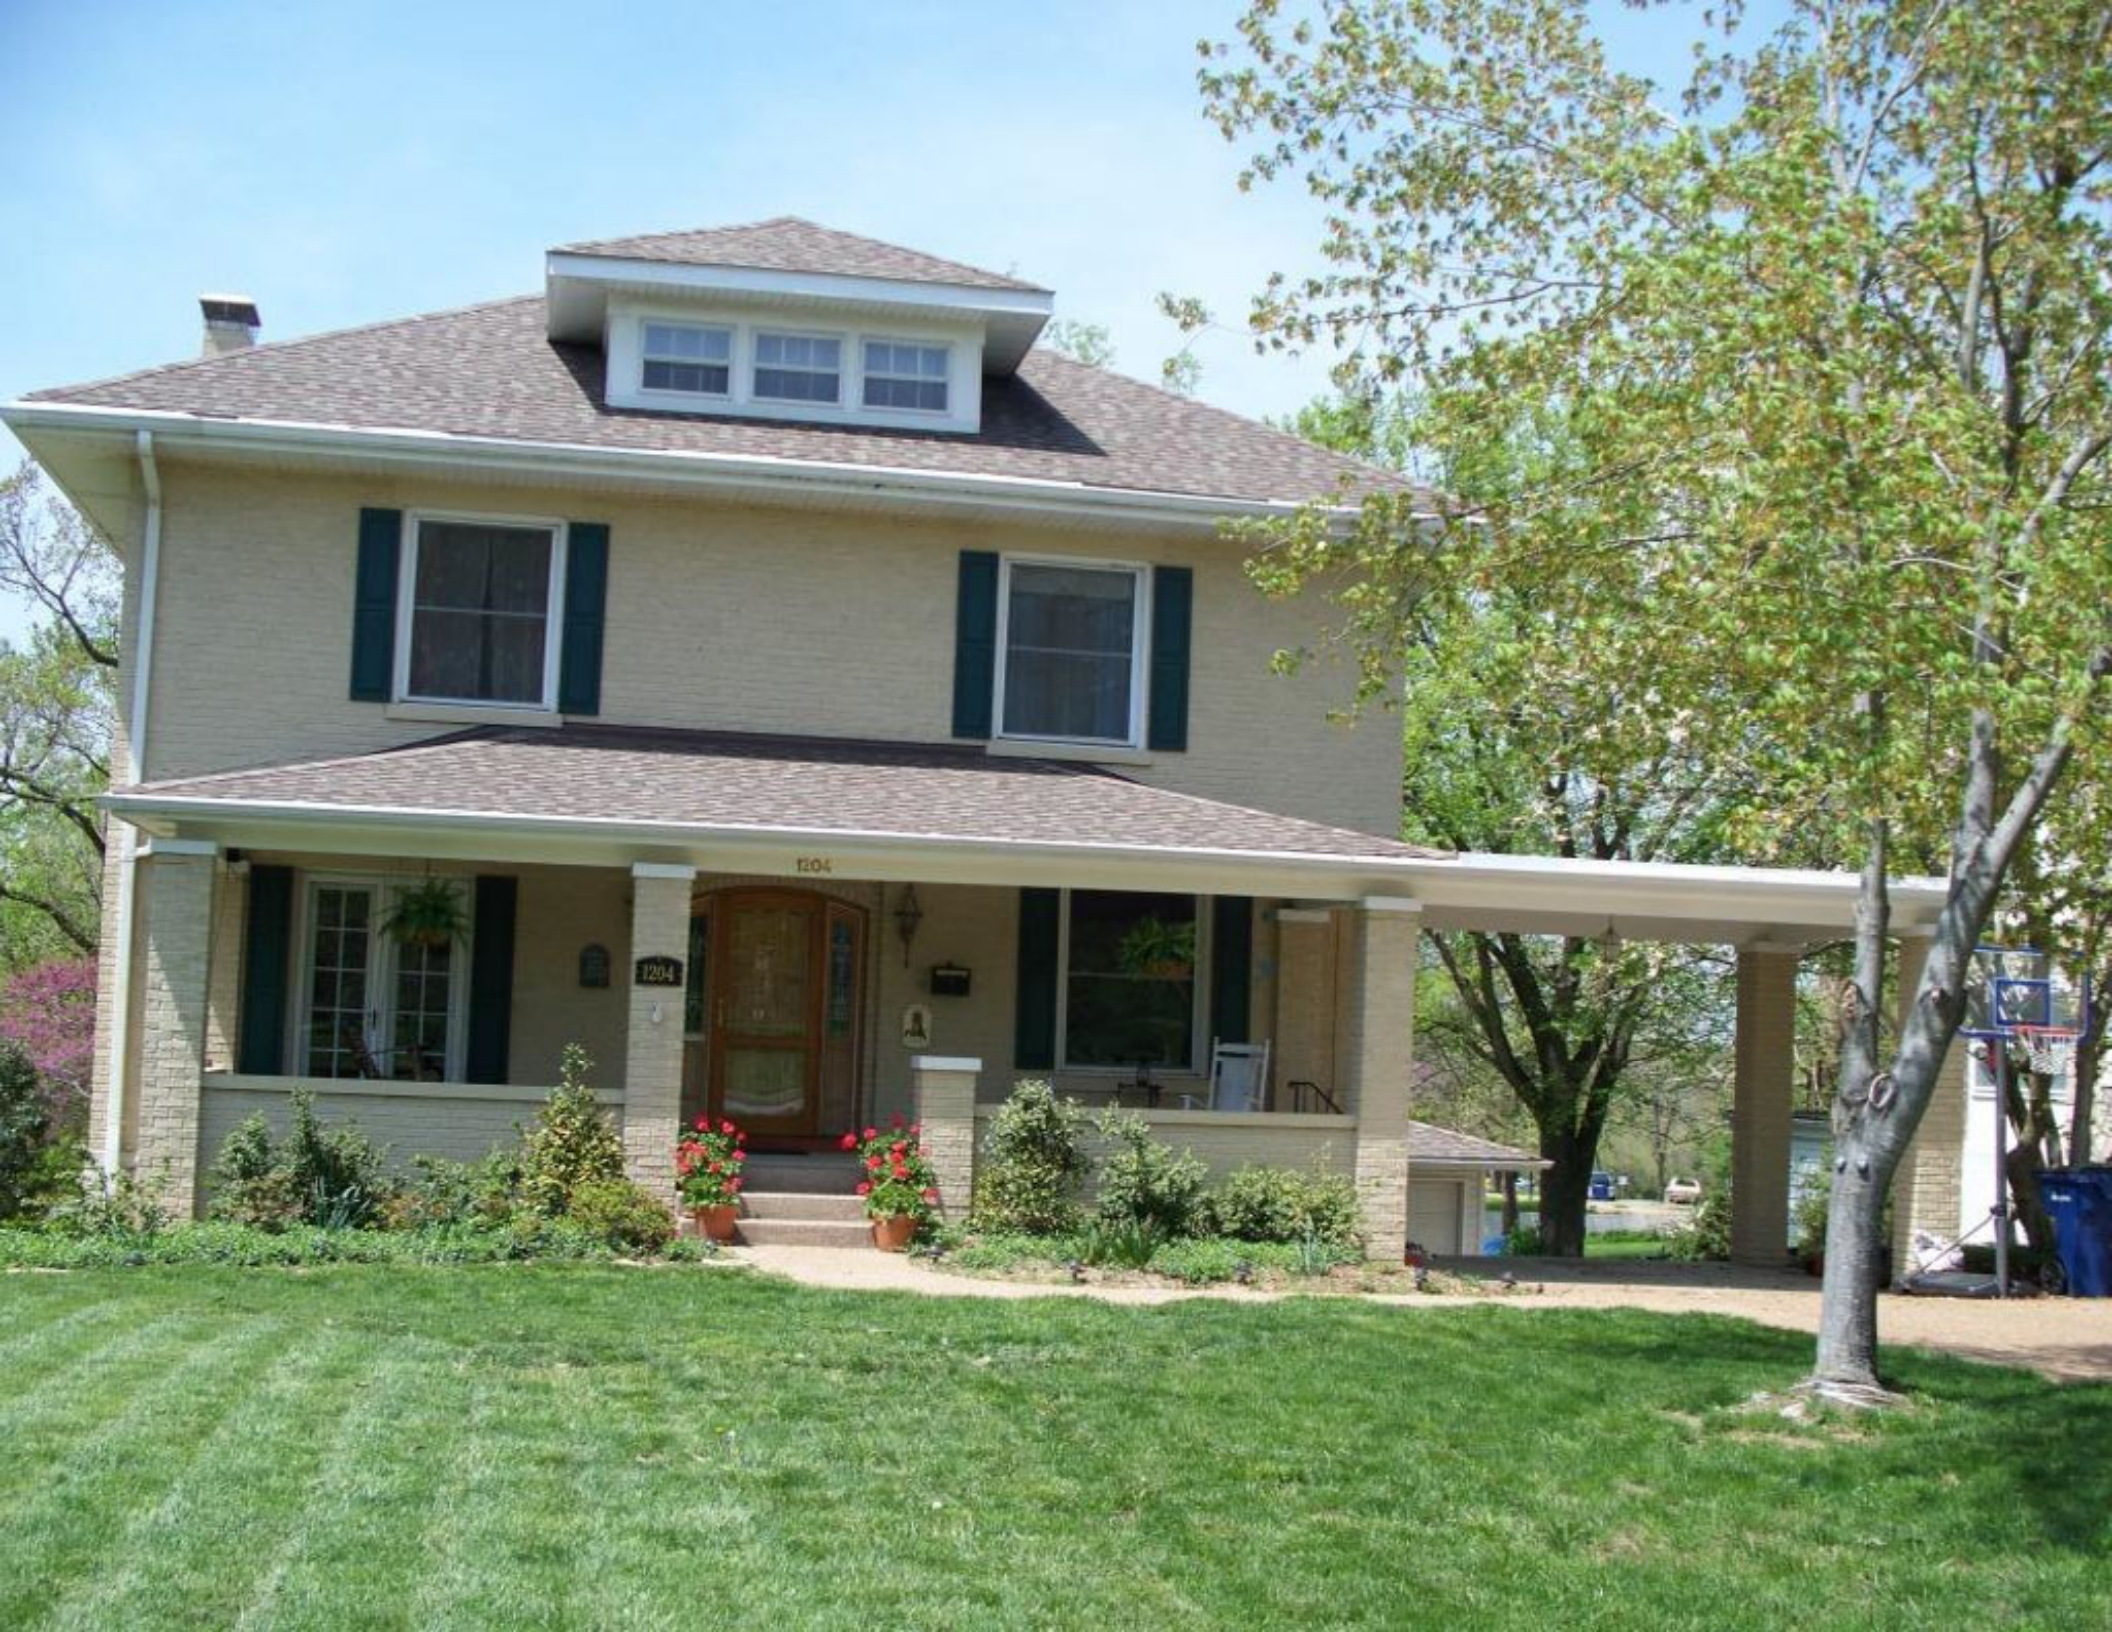
This two-and-a-half story brick residence has a pyramidal roof and a central pyramidal dormer with three 3/3 windows. A little wider than a typical four-square, it has the symmetry and shutters that are minimally associated with the Colonial Revival style. However, like several of the homes in the neighborhood, it also has somewhat Prairie style details such as the pyramidal/hipped roof, wide overhanging eaves and an attached porte-cochere.

The second story has two 1/1 windows and the first floor has an identical 1/1 in the right bay. The left bay has a double-door secondary entrance which seems to be another common feature in many of the homes in the neighborhood. The double-door and windows feature shutters. The full-width porch features brick piers, half walls, and extends to the porte-cochere. The roof over the porch is hipped and flares slightly while the roof of the porte-cochere is flat.
