ARCHITECTURAL/HISTORIC INVENTORY FORM

1. Survey No. CO-AS-005-001		2. Survey name: Moreau Drive Neighborhood Survey	
3. County: Cole		4. Address: 1202 Elmerine Ave.	
5. City: Jefferson City	Vicinity: <input type="checkbox"/>	6. UTM: / /	7. Township/Range/Section: T: R: S:
8. Historic name (if known):		9. Present/other name (if known):	
10. Ownership: <input checked="" type="checkbox"/> Private <input type="checkbox"/> Public		11. Historic use (if known): Residential	11. Current use: Residential

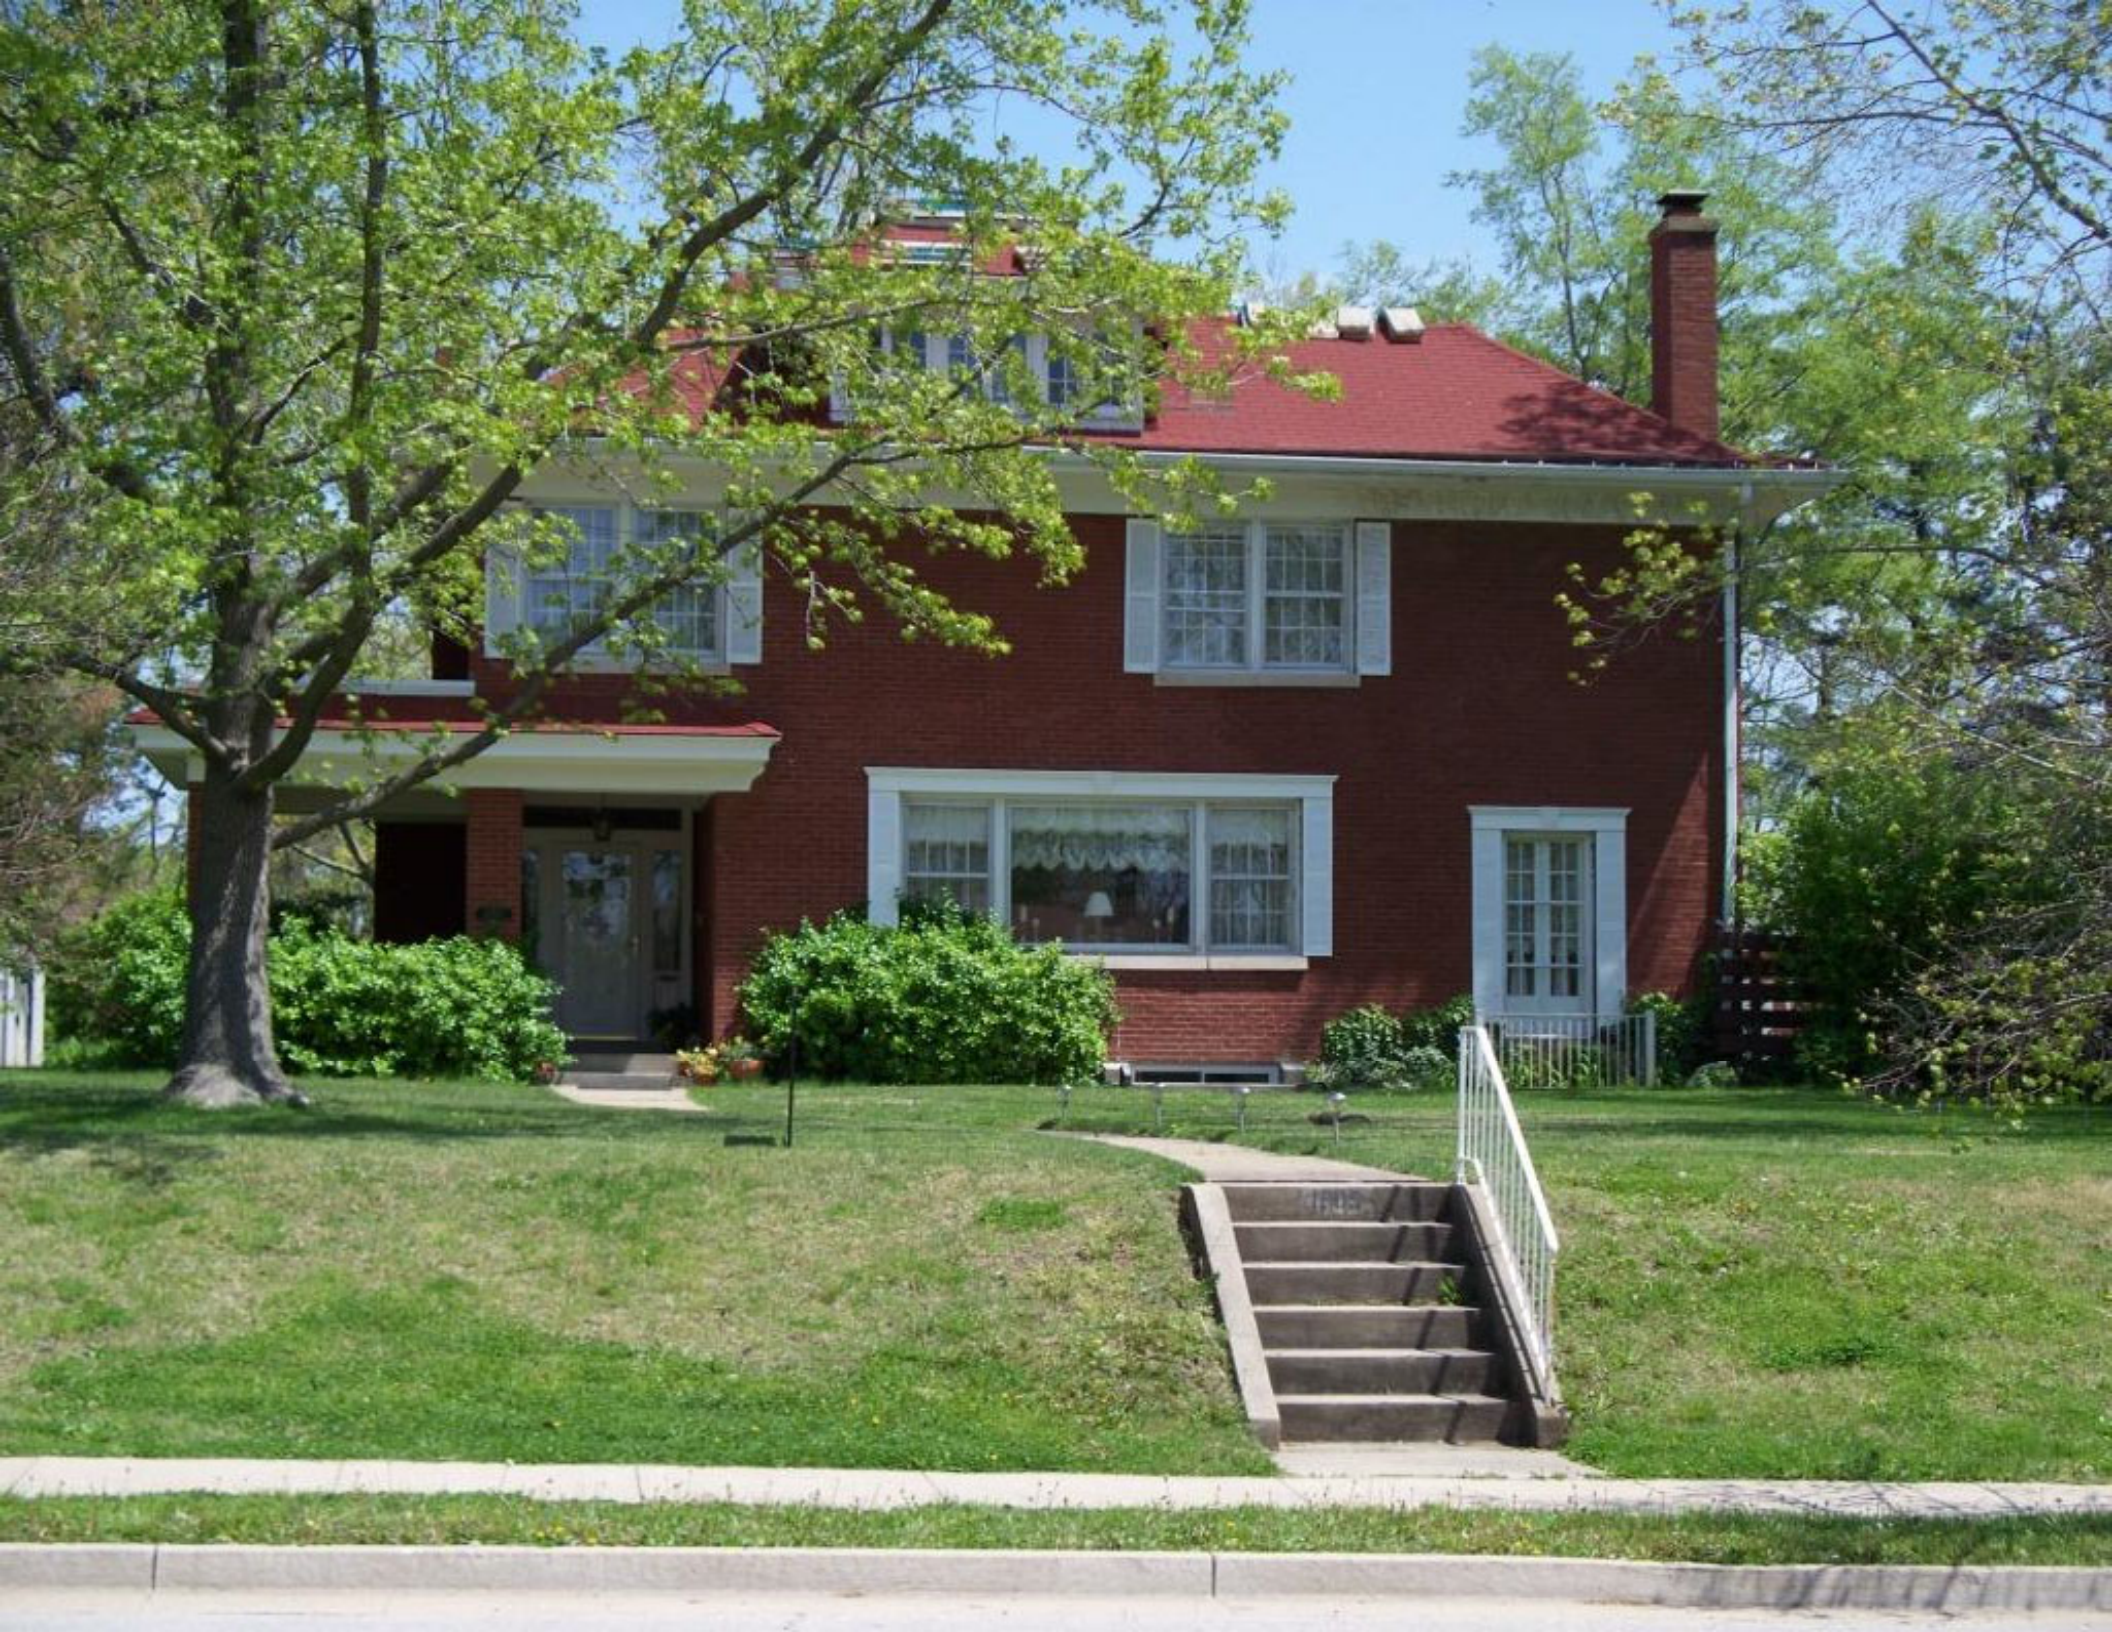
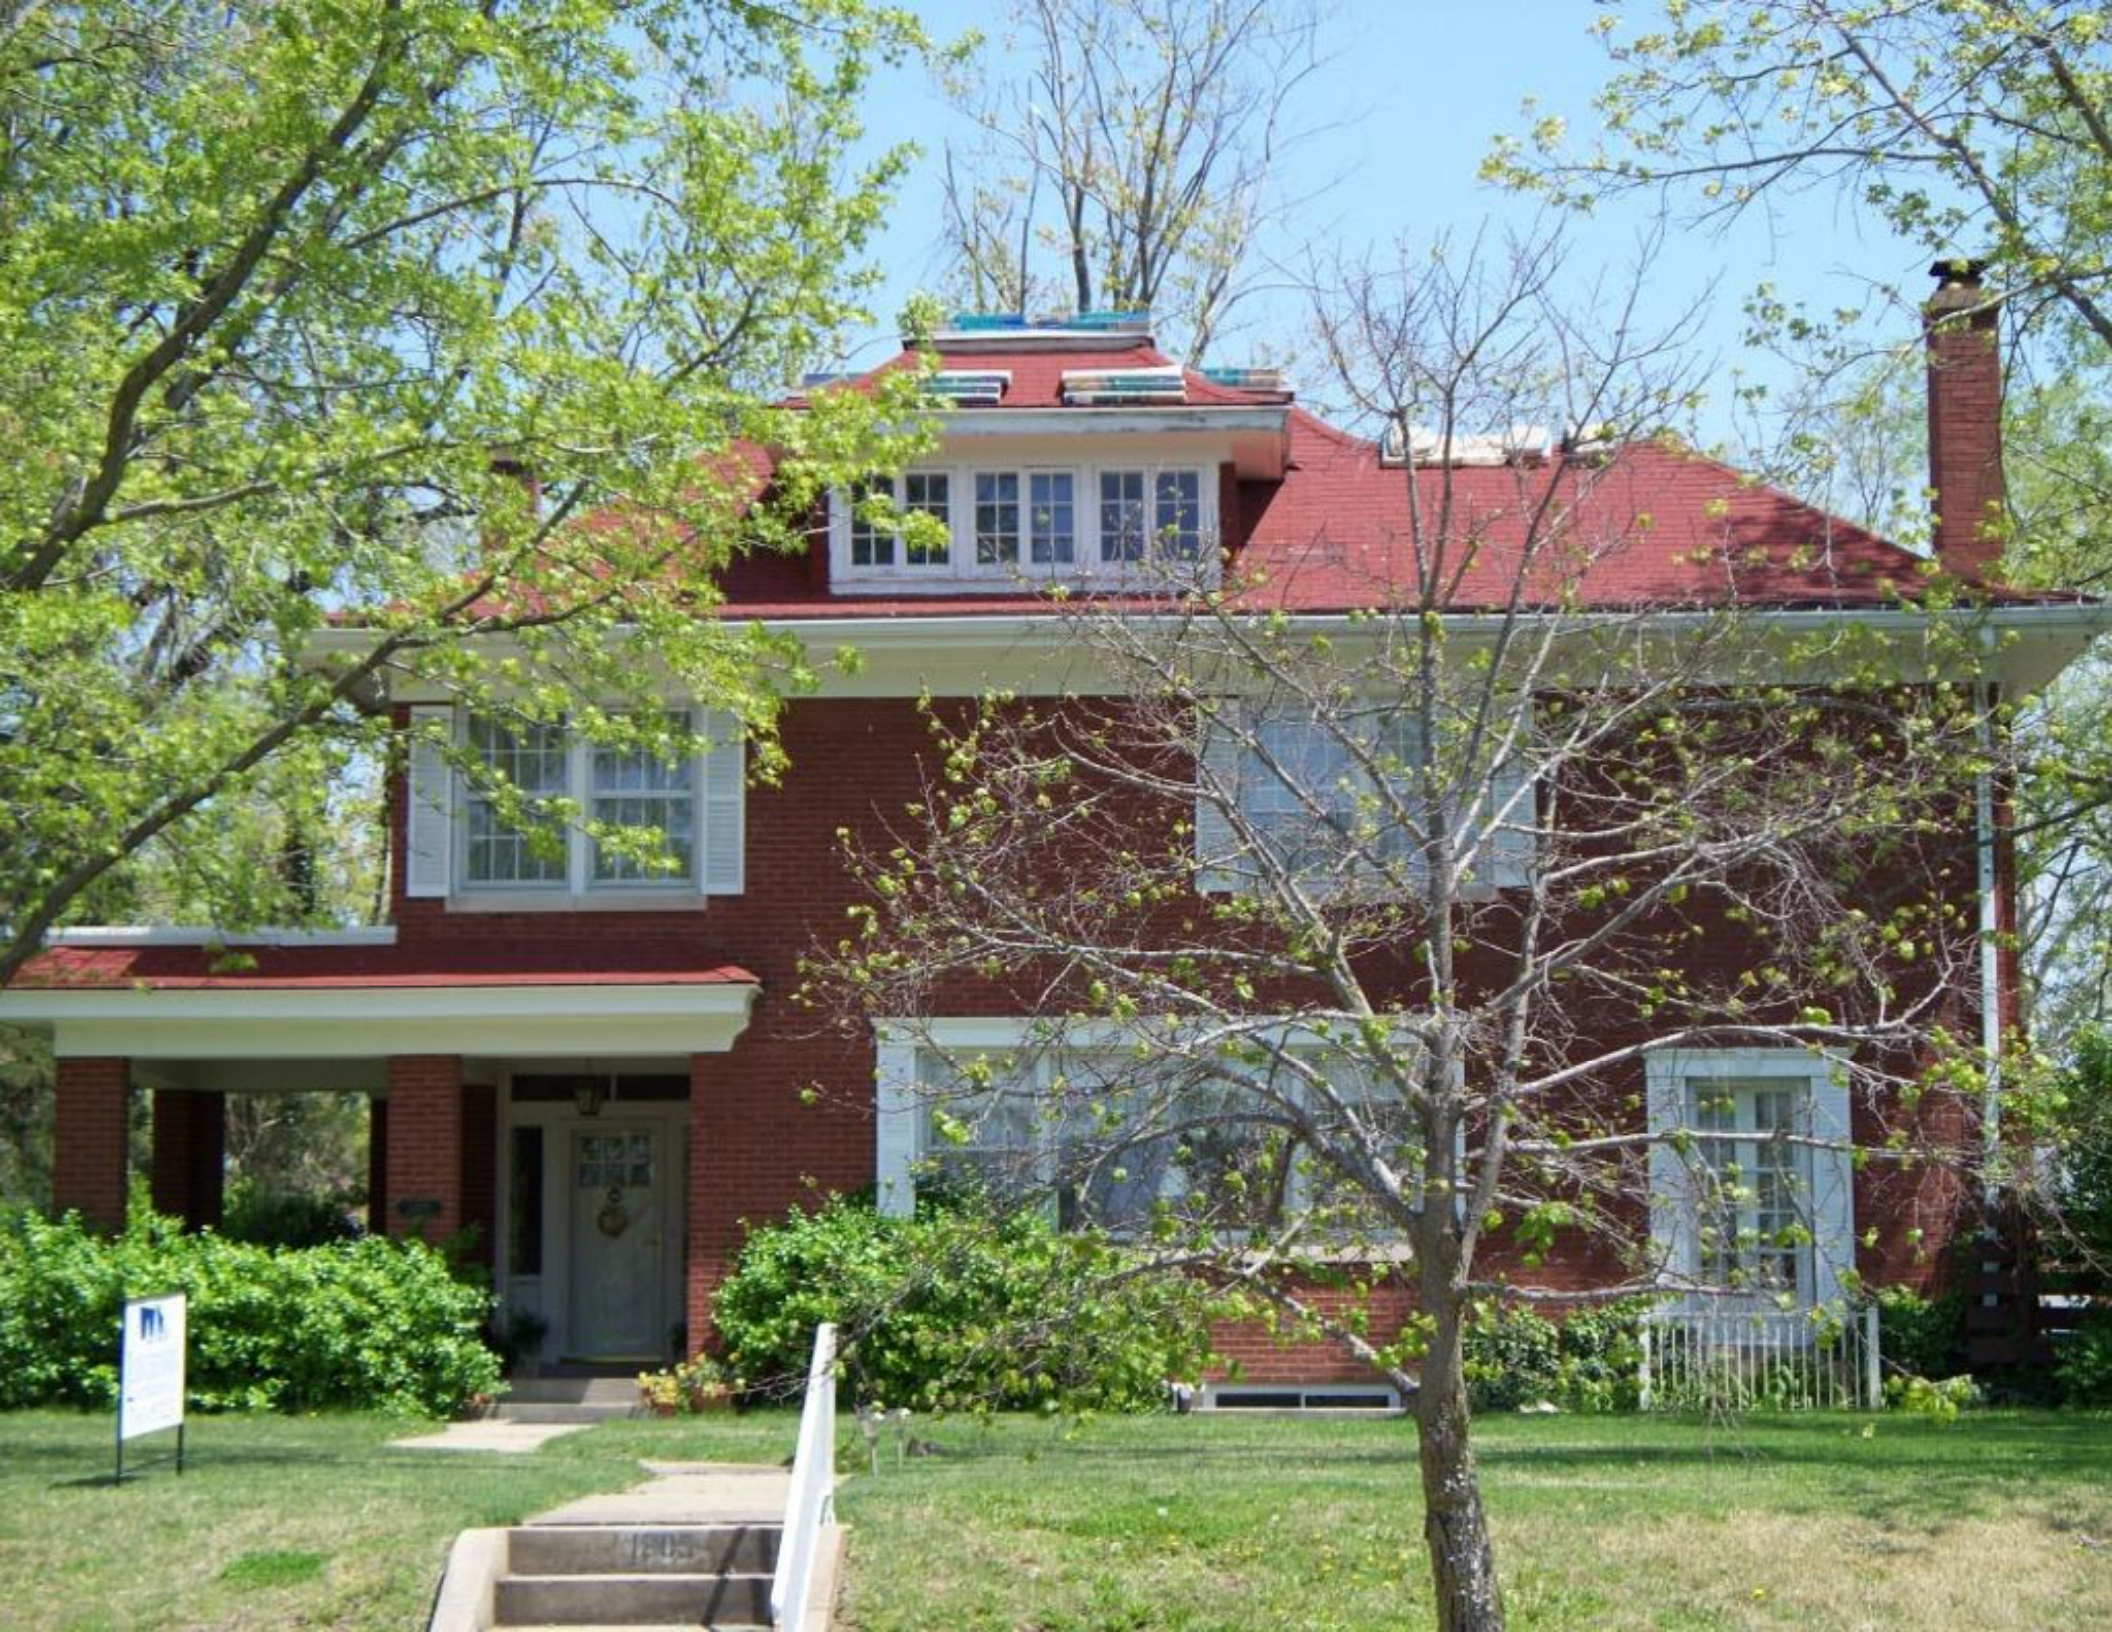
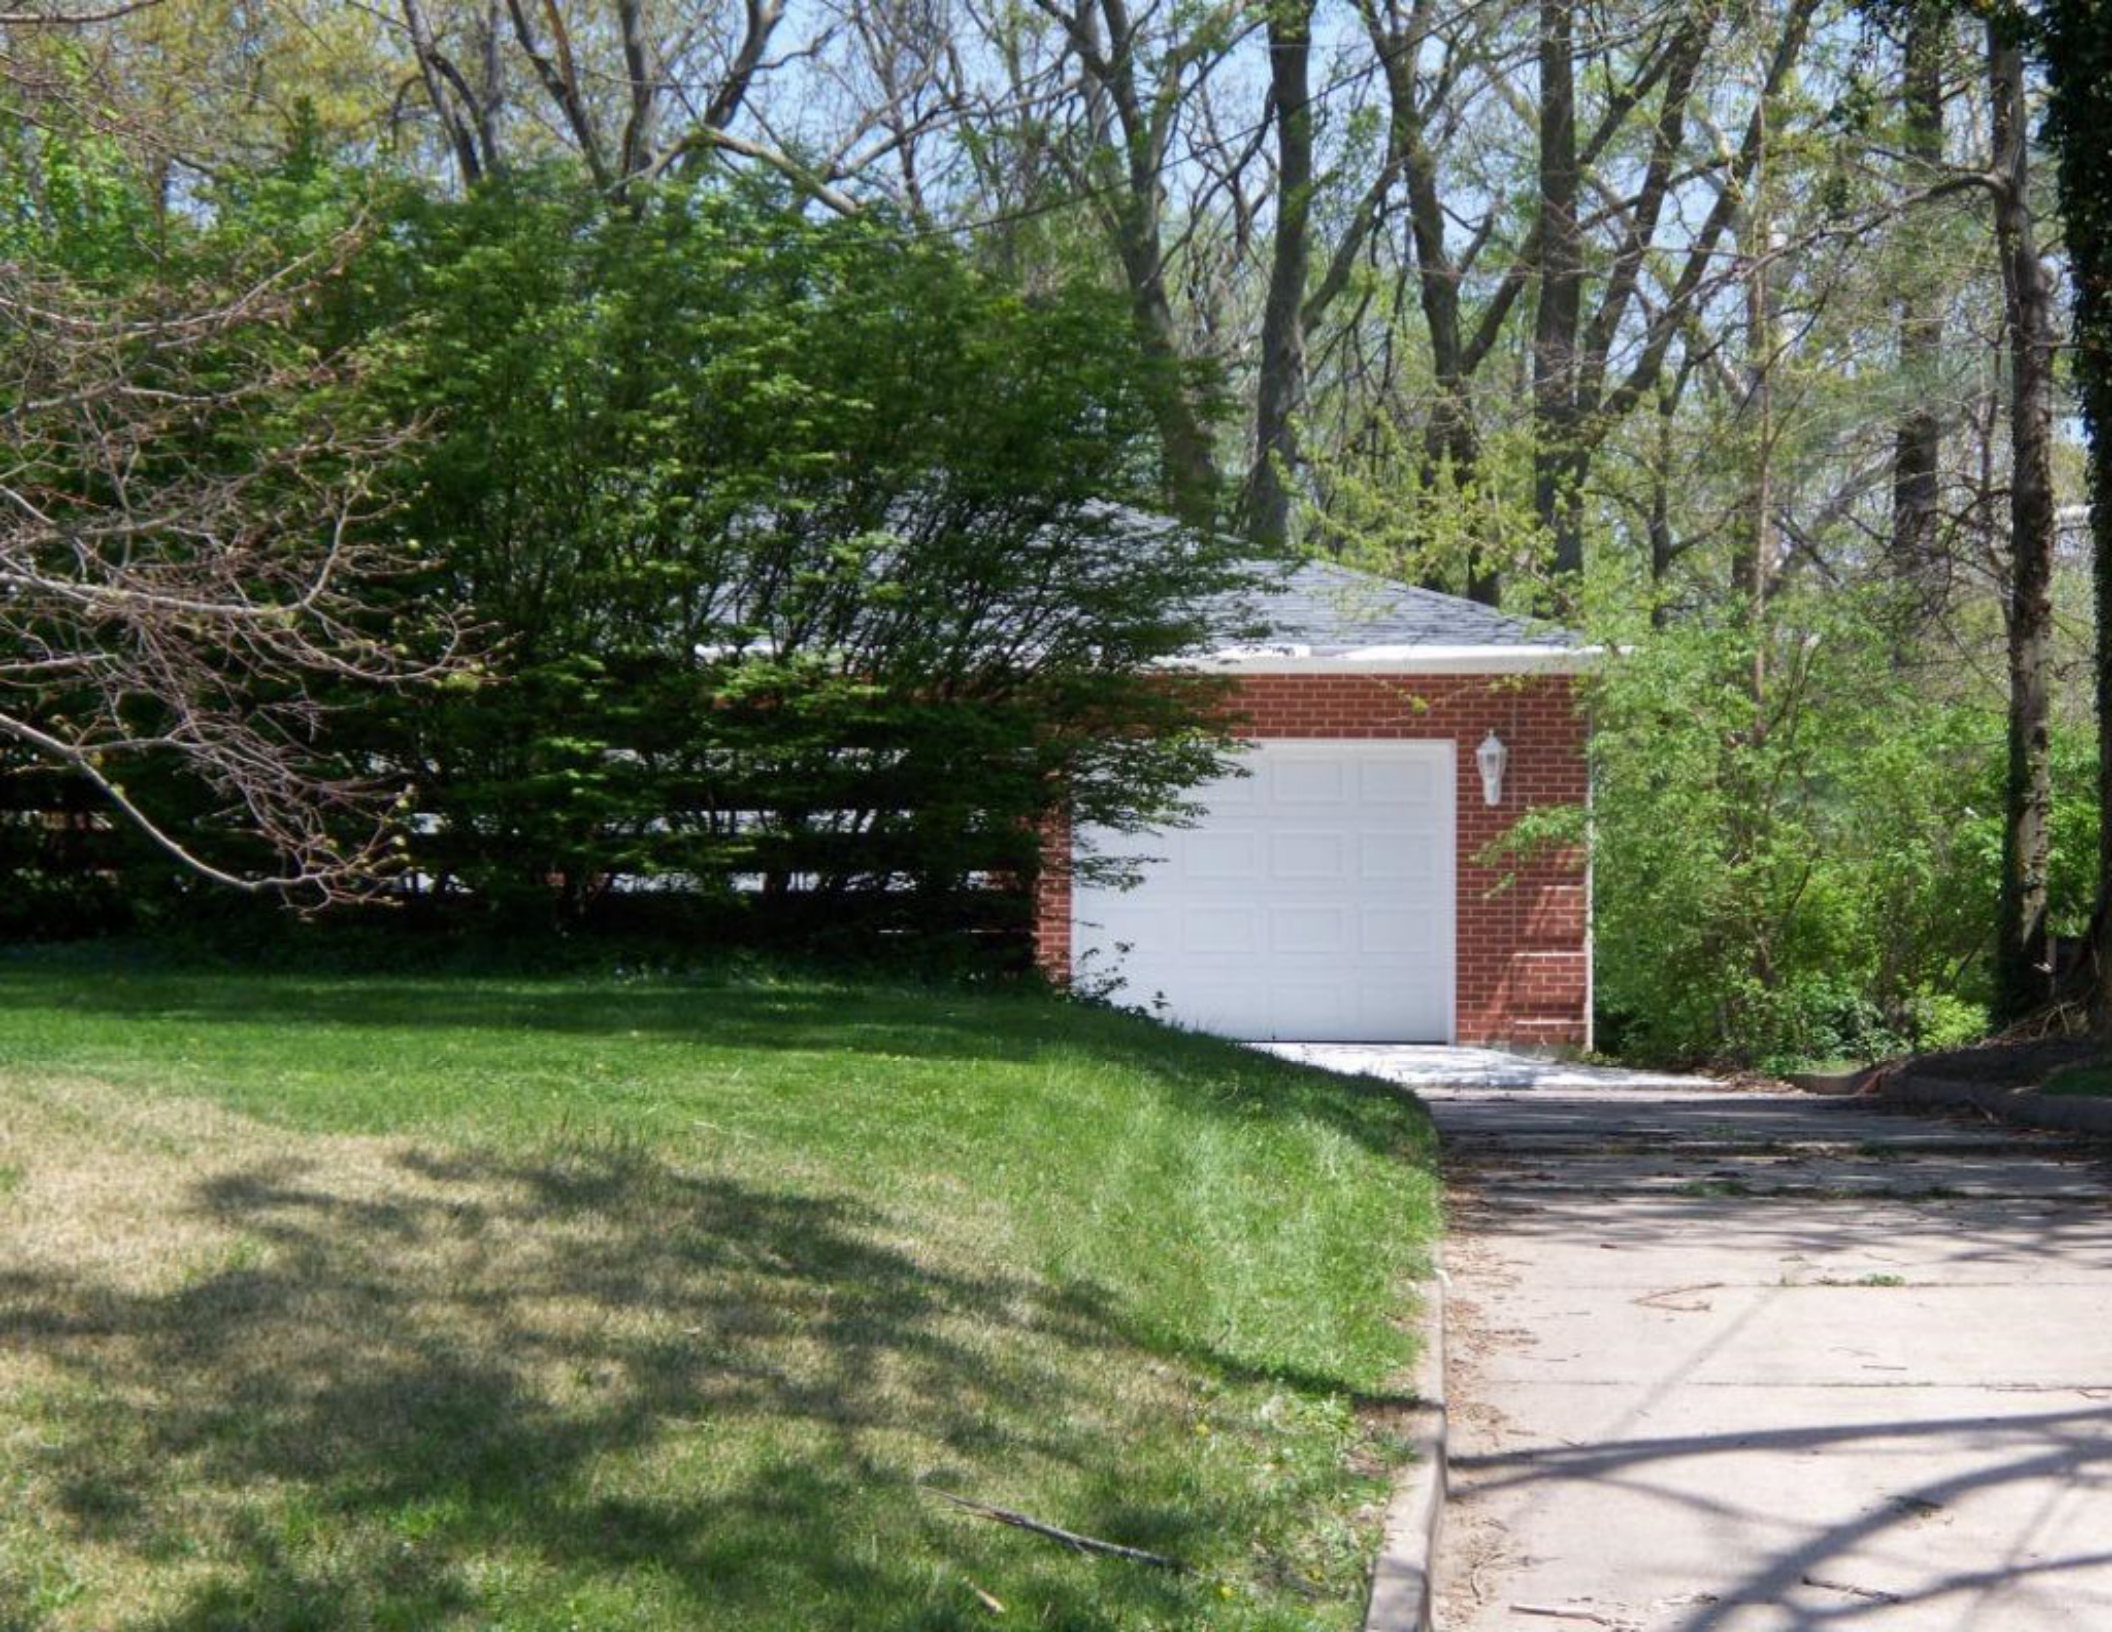
40. (cont.) Description of environment and outbuildings. Expand box as necessary, or add continuation pages.
There is a detached three car garage behind the property. It appears modern. N/C

41. (cont.) Stylistically this is a somewhat unusual brick house. It has an uneven hipped roof with wide eaves that flares slightly suggesting a bellcast shape. Likewise the central dormer with six original multi-light (6) casement windows has a hipped bellcast shape. All of the other windows are six-over-six and may be historic. The second floor has two sets of paired windows and shutters on stone sills asymmetrically placed on the façade. The ground floor- moving from the right- has a large multi-light door (10-light) with a decorative surround that mirrors the shutters and lintels of the row of six-over-six windows to the left. The entrance is recessed at the far left of the property and retains its original door, transom, and sidelights. A hipped roof projects slightly from the main façade and wraps around the left projecting further from the side of the property to create a wraparound porch. The porch is open but has at least three square brick pillars. A long brick chimney extends from the right side of the home and a shorter chimney from the left. The hipped roof with its overhanging eaves, asymmetrical façade, and bands of windows are most strongly associated with the Prairie style.

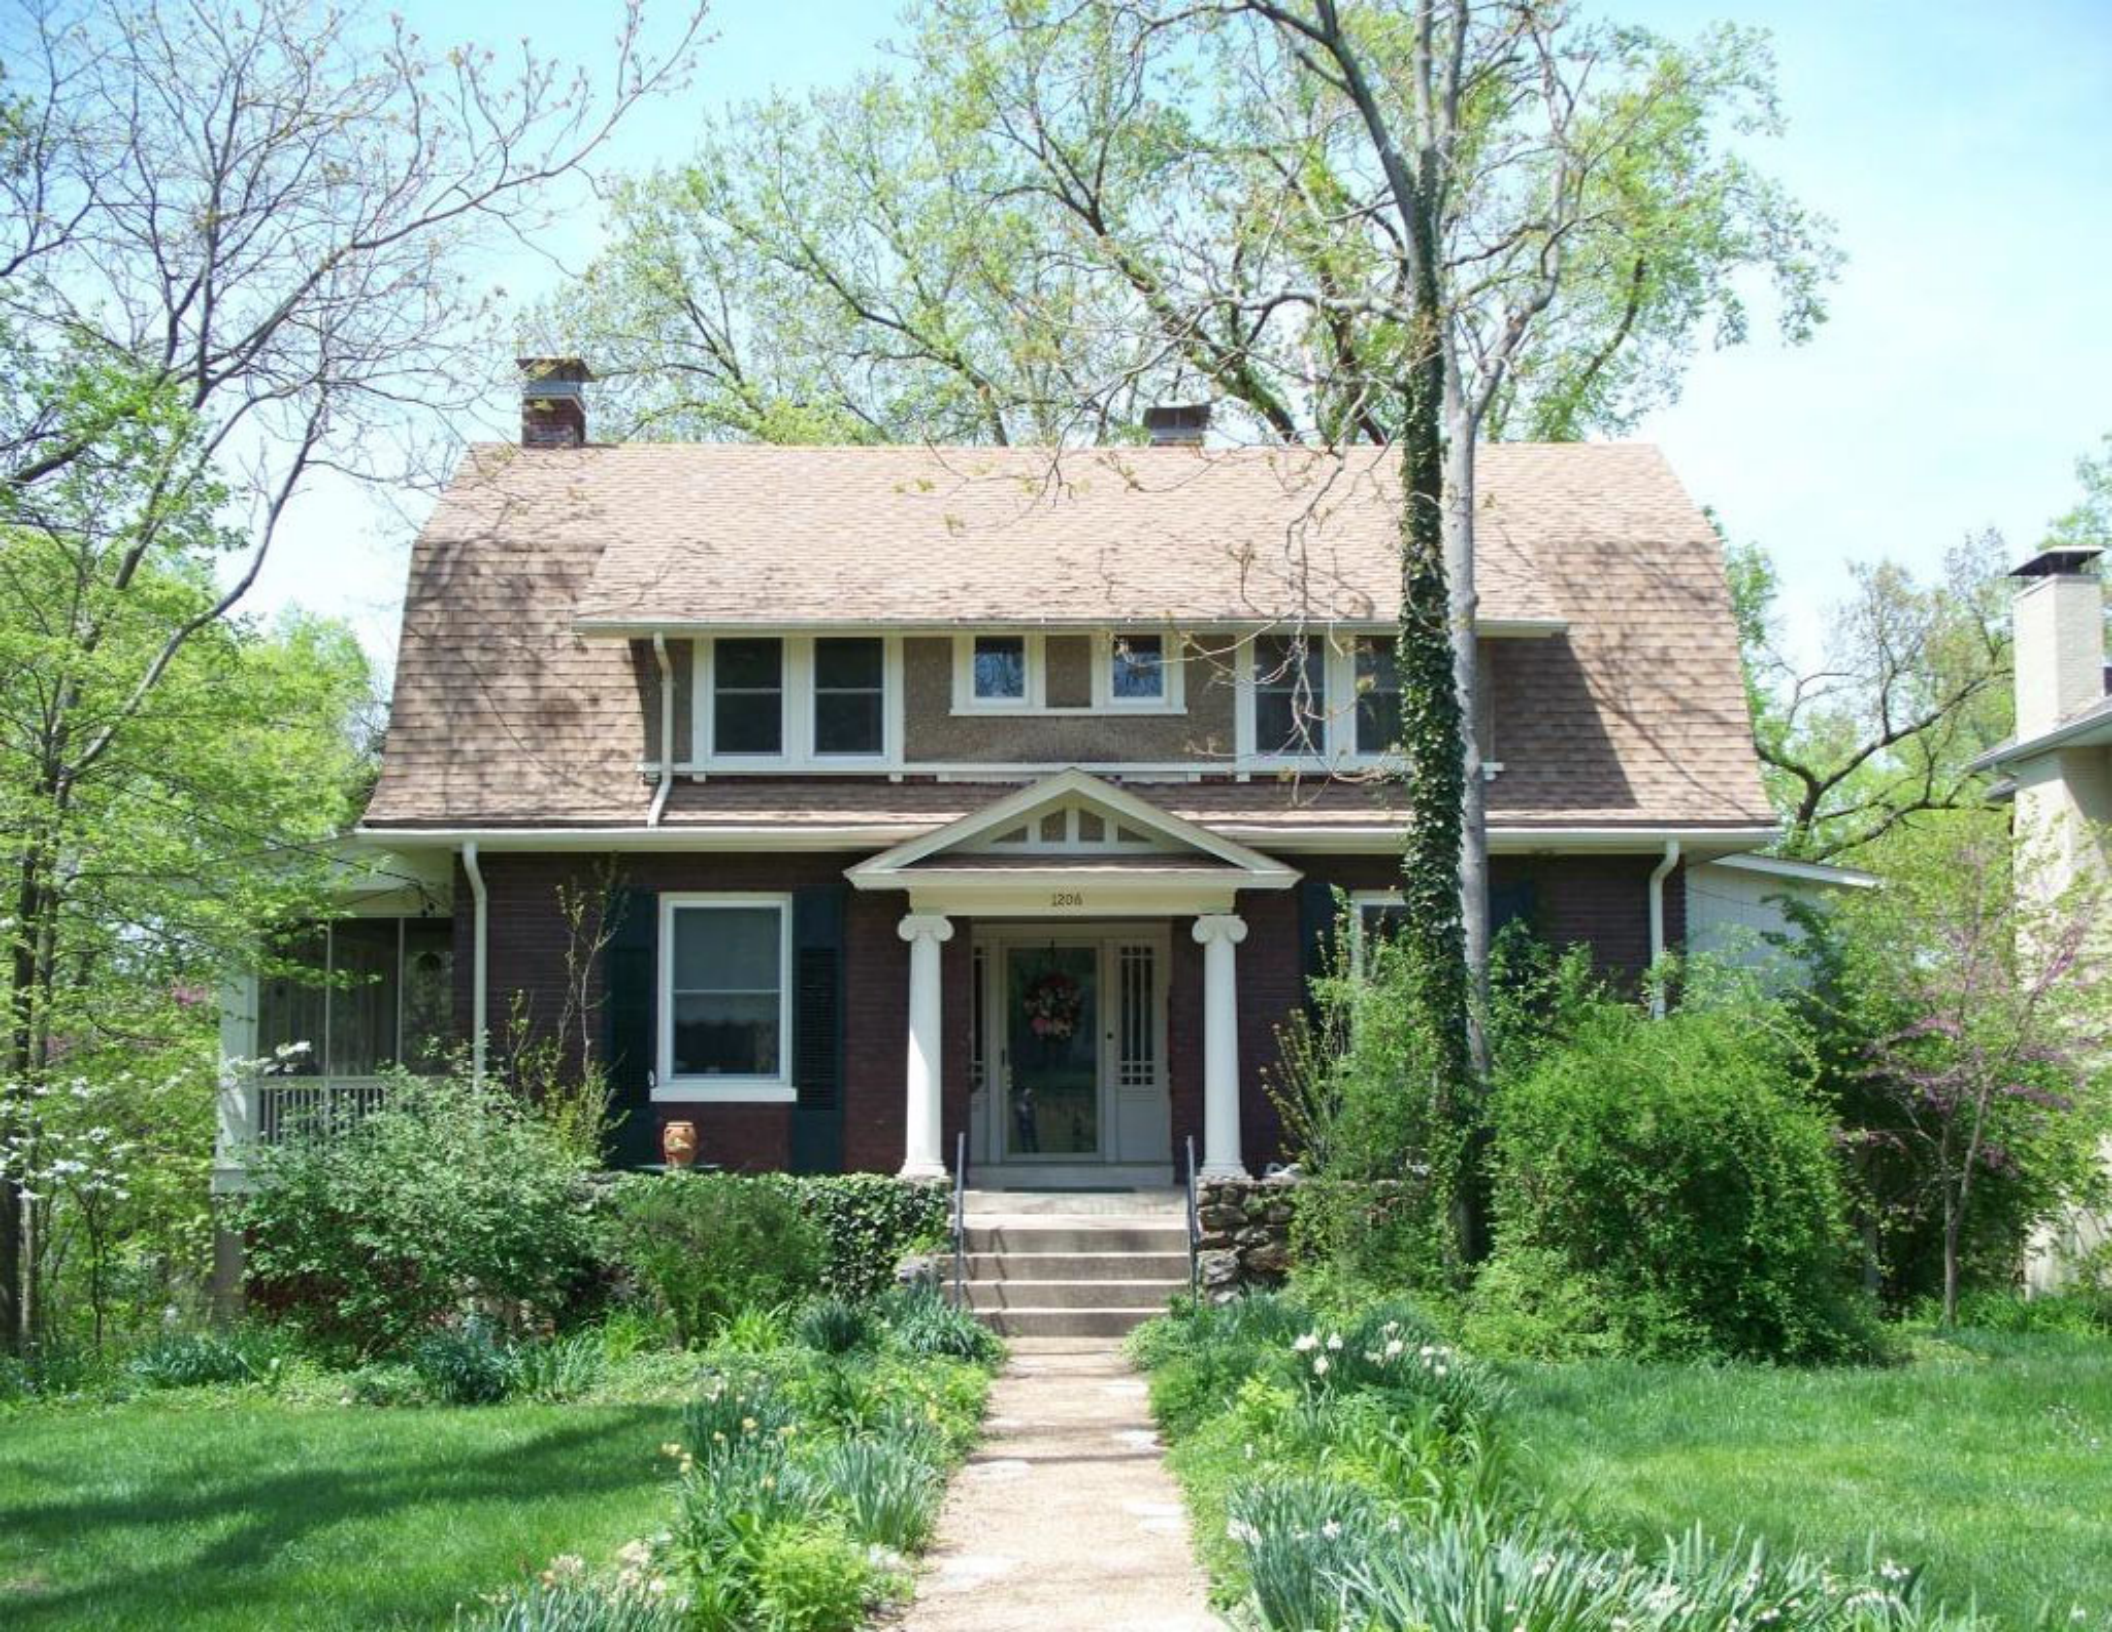
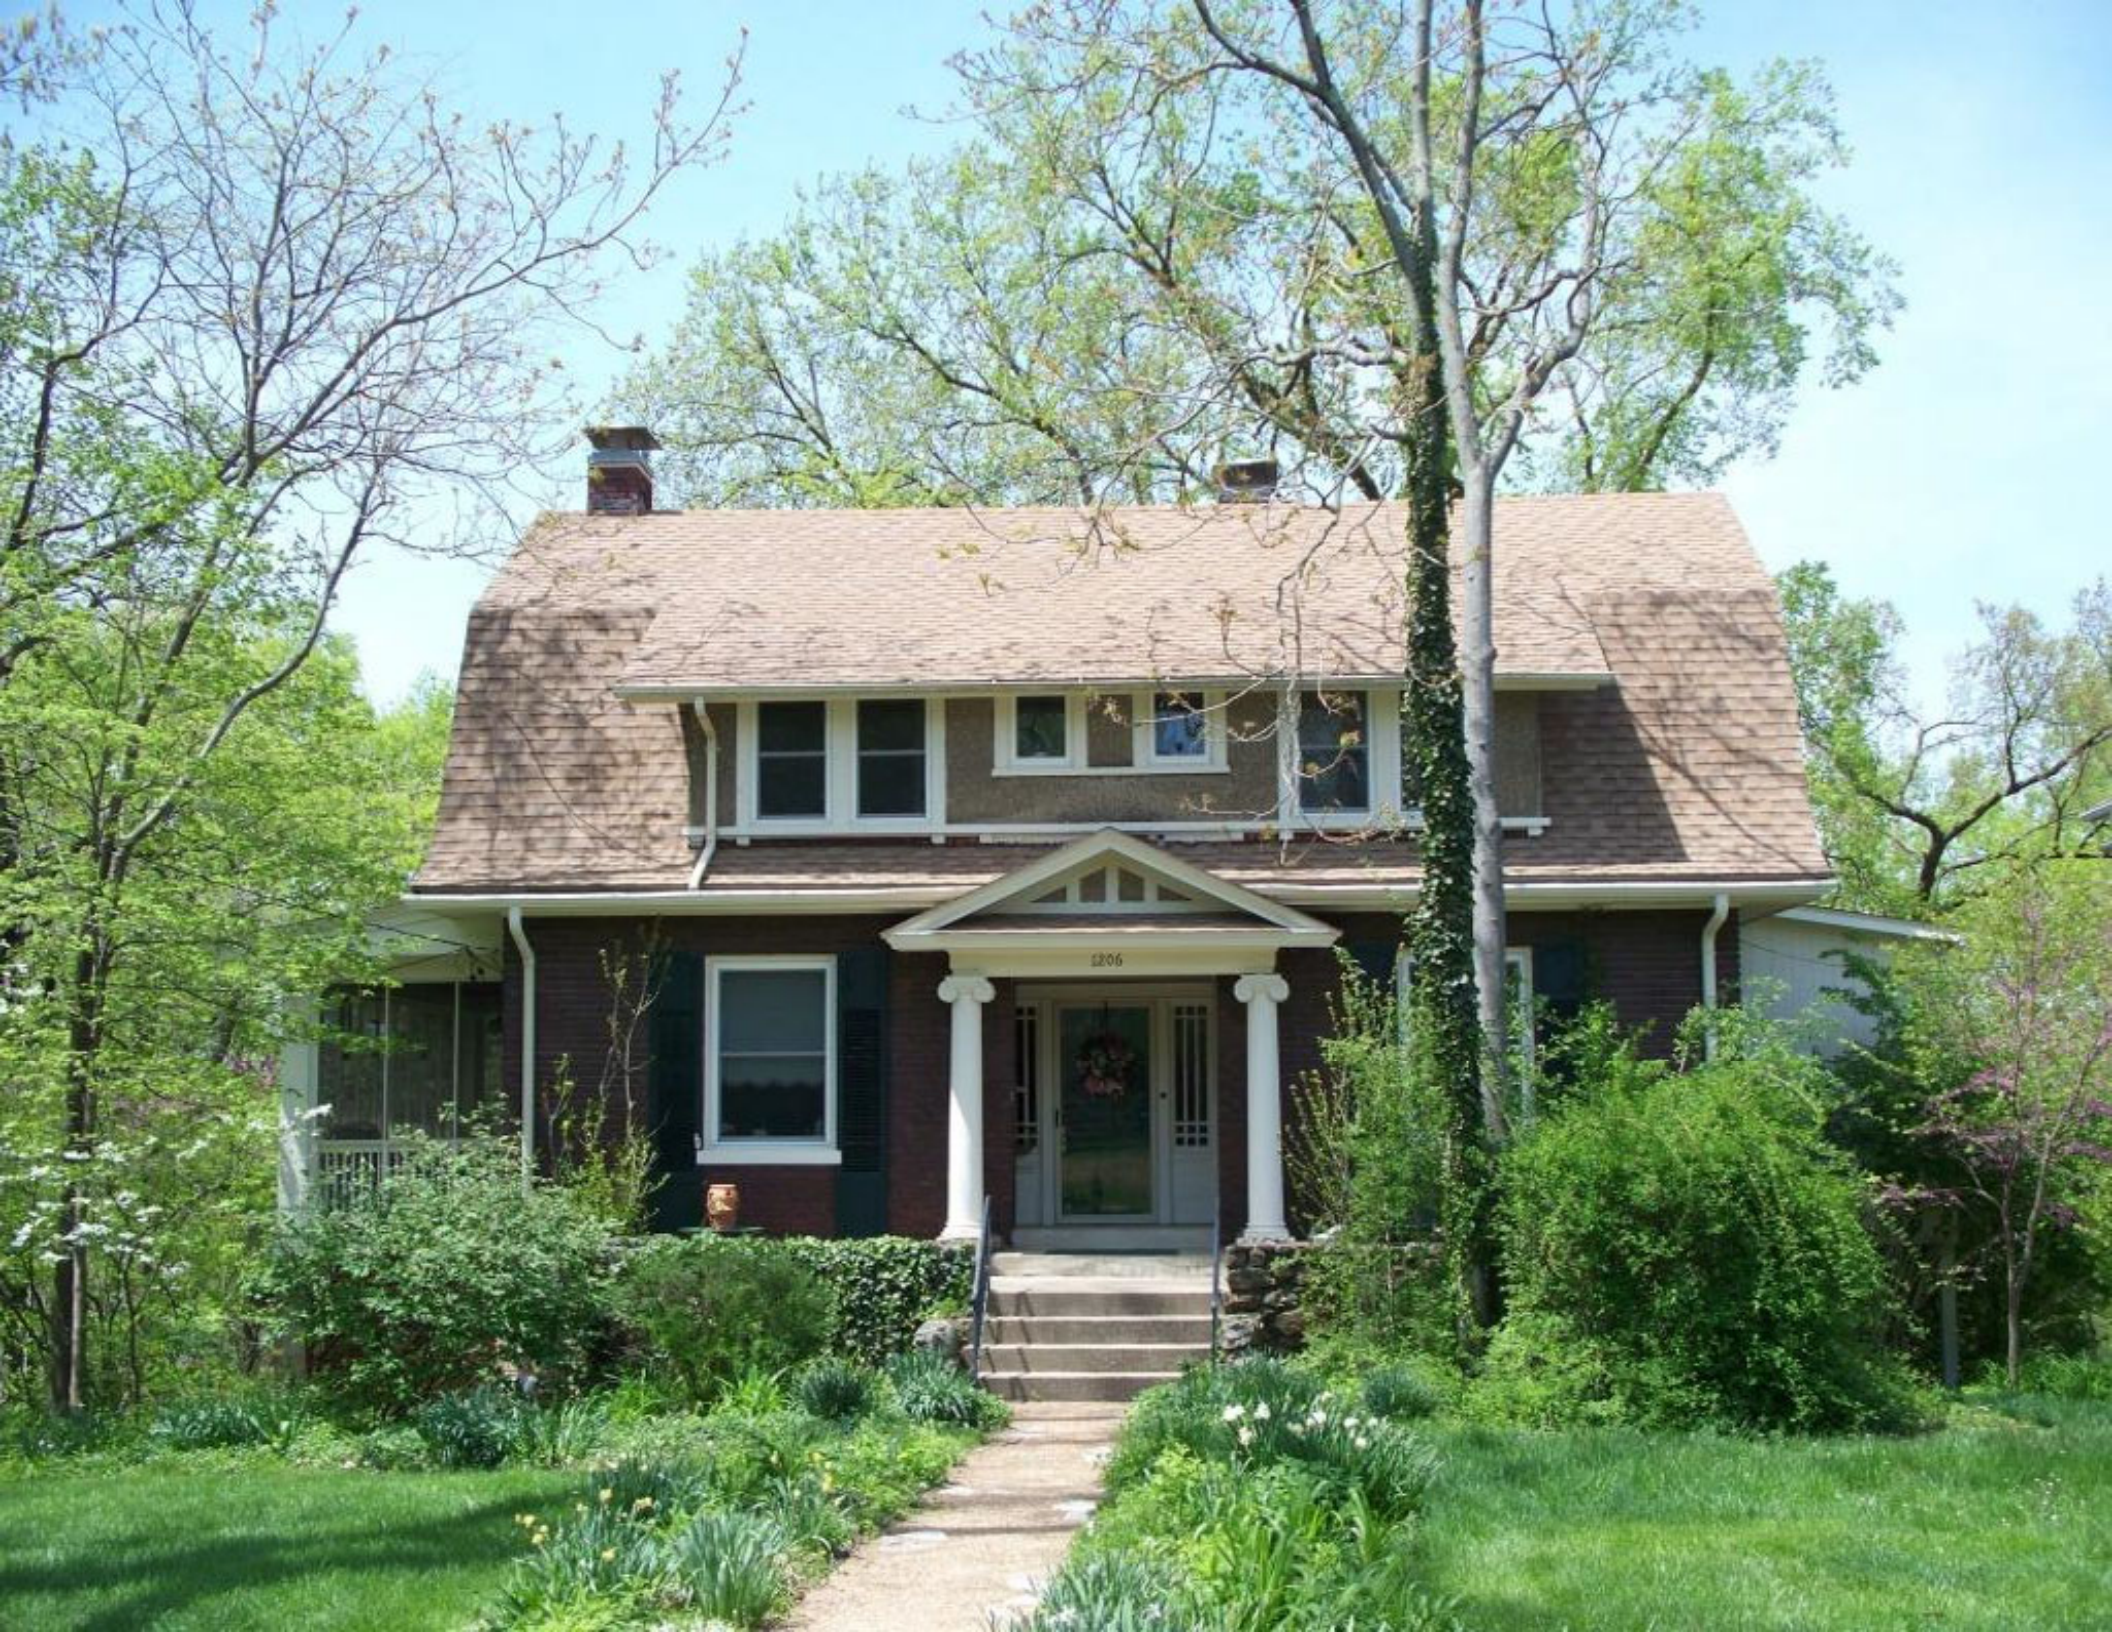
This is a very nice example of a Dutch Revival. The brick two-story property has a side gambrel roof with a large central dormer (3/4 façade wide) with two pairs of 1/1 windows and two smaller casement windows in the center. On the first floor are two historic 1/1 windows with shutters, which flank the entrance that has sidelights and possibly a transom (portico obscured view.) A gabled portico with Ionic columns extends from the entrance. A sun porch extends to the left of the property and appears to have a lower level. A small one-story addition with a shed roof extends from the right.
