ARCHITECTURAL/HISTORIC INVENTORY FORM

1. Survey No. CO-AS-005-001		2. Survey name: Moreau Drive Neighborhood Survey	
3. County: Cole		4. Address: 1202 Elmerine Ave.	
5. City: Jefferson City	Vicinity: <input type="checkbox"/>	6. UTM: / /	7. Township/Range/Section: T: R: S:
8. Historic name (if known):		9. Present/other name (if known):	
10. Ownership: <input checked="" type="checkbox"/> Private <input type="checkbox"/> Public		11. Historic use (if known): Residential	11. Current use: Residential

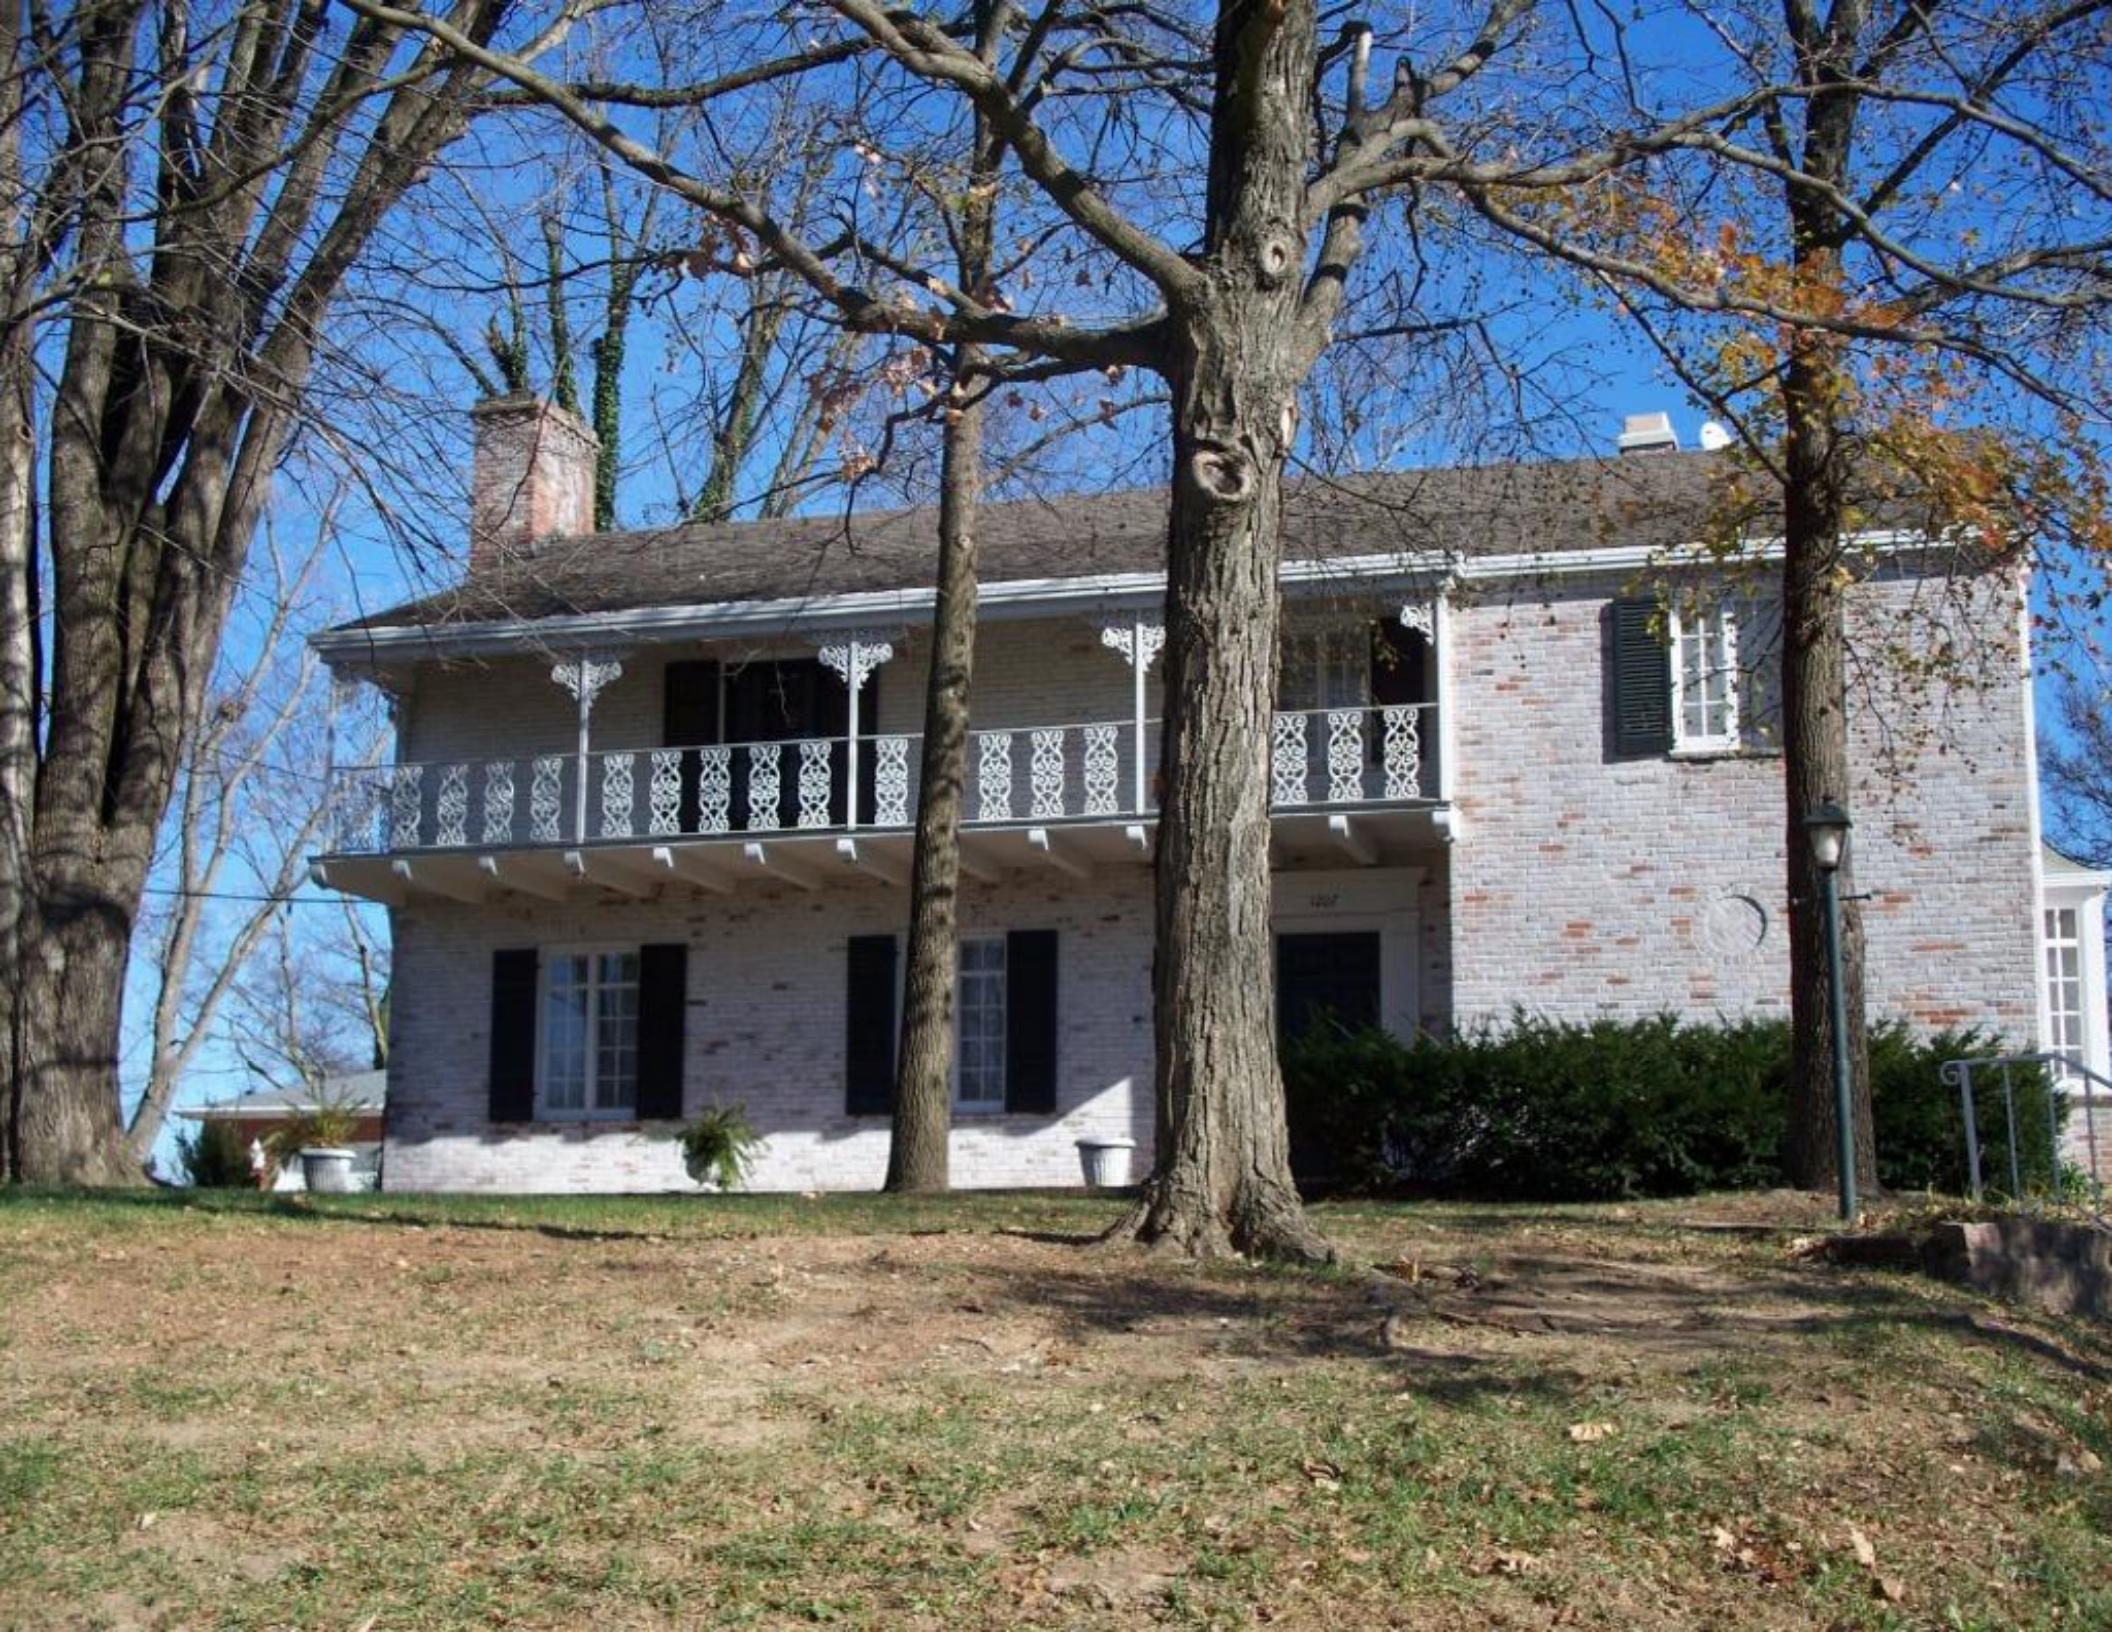
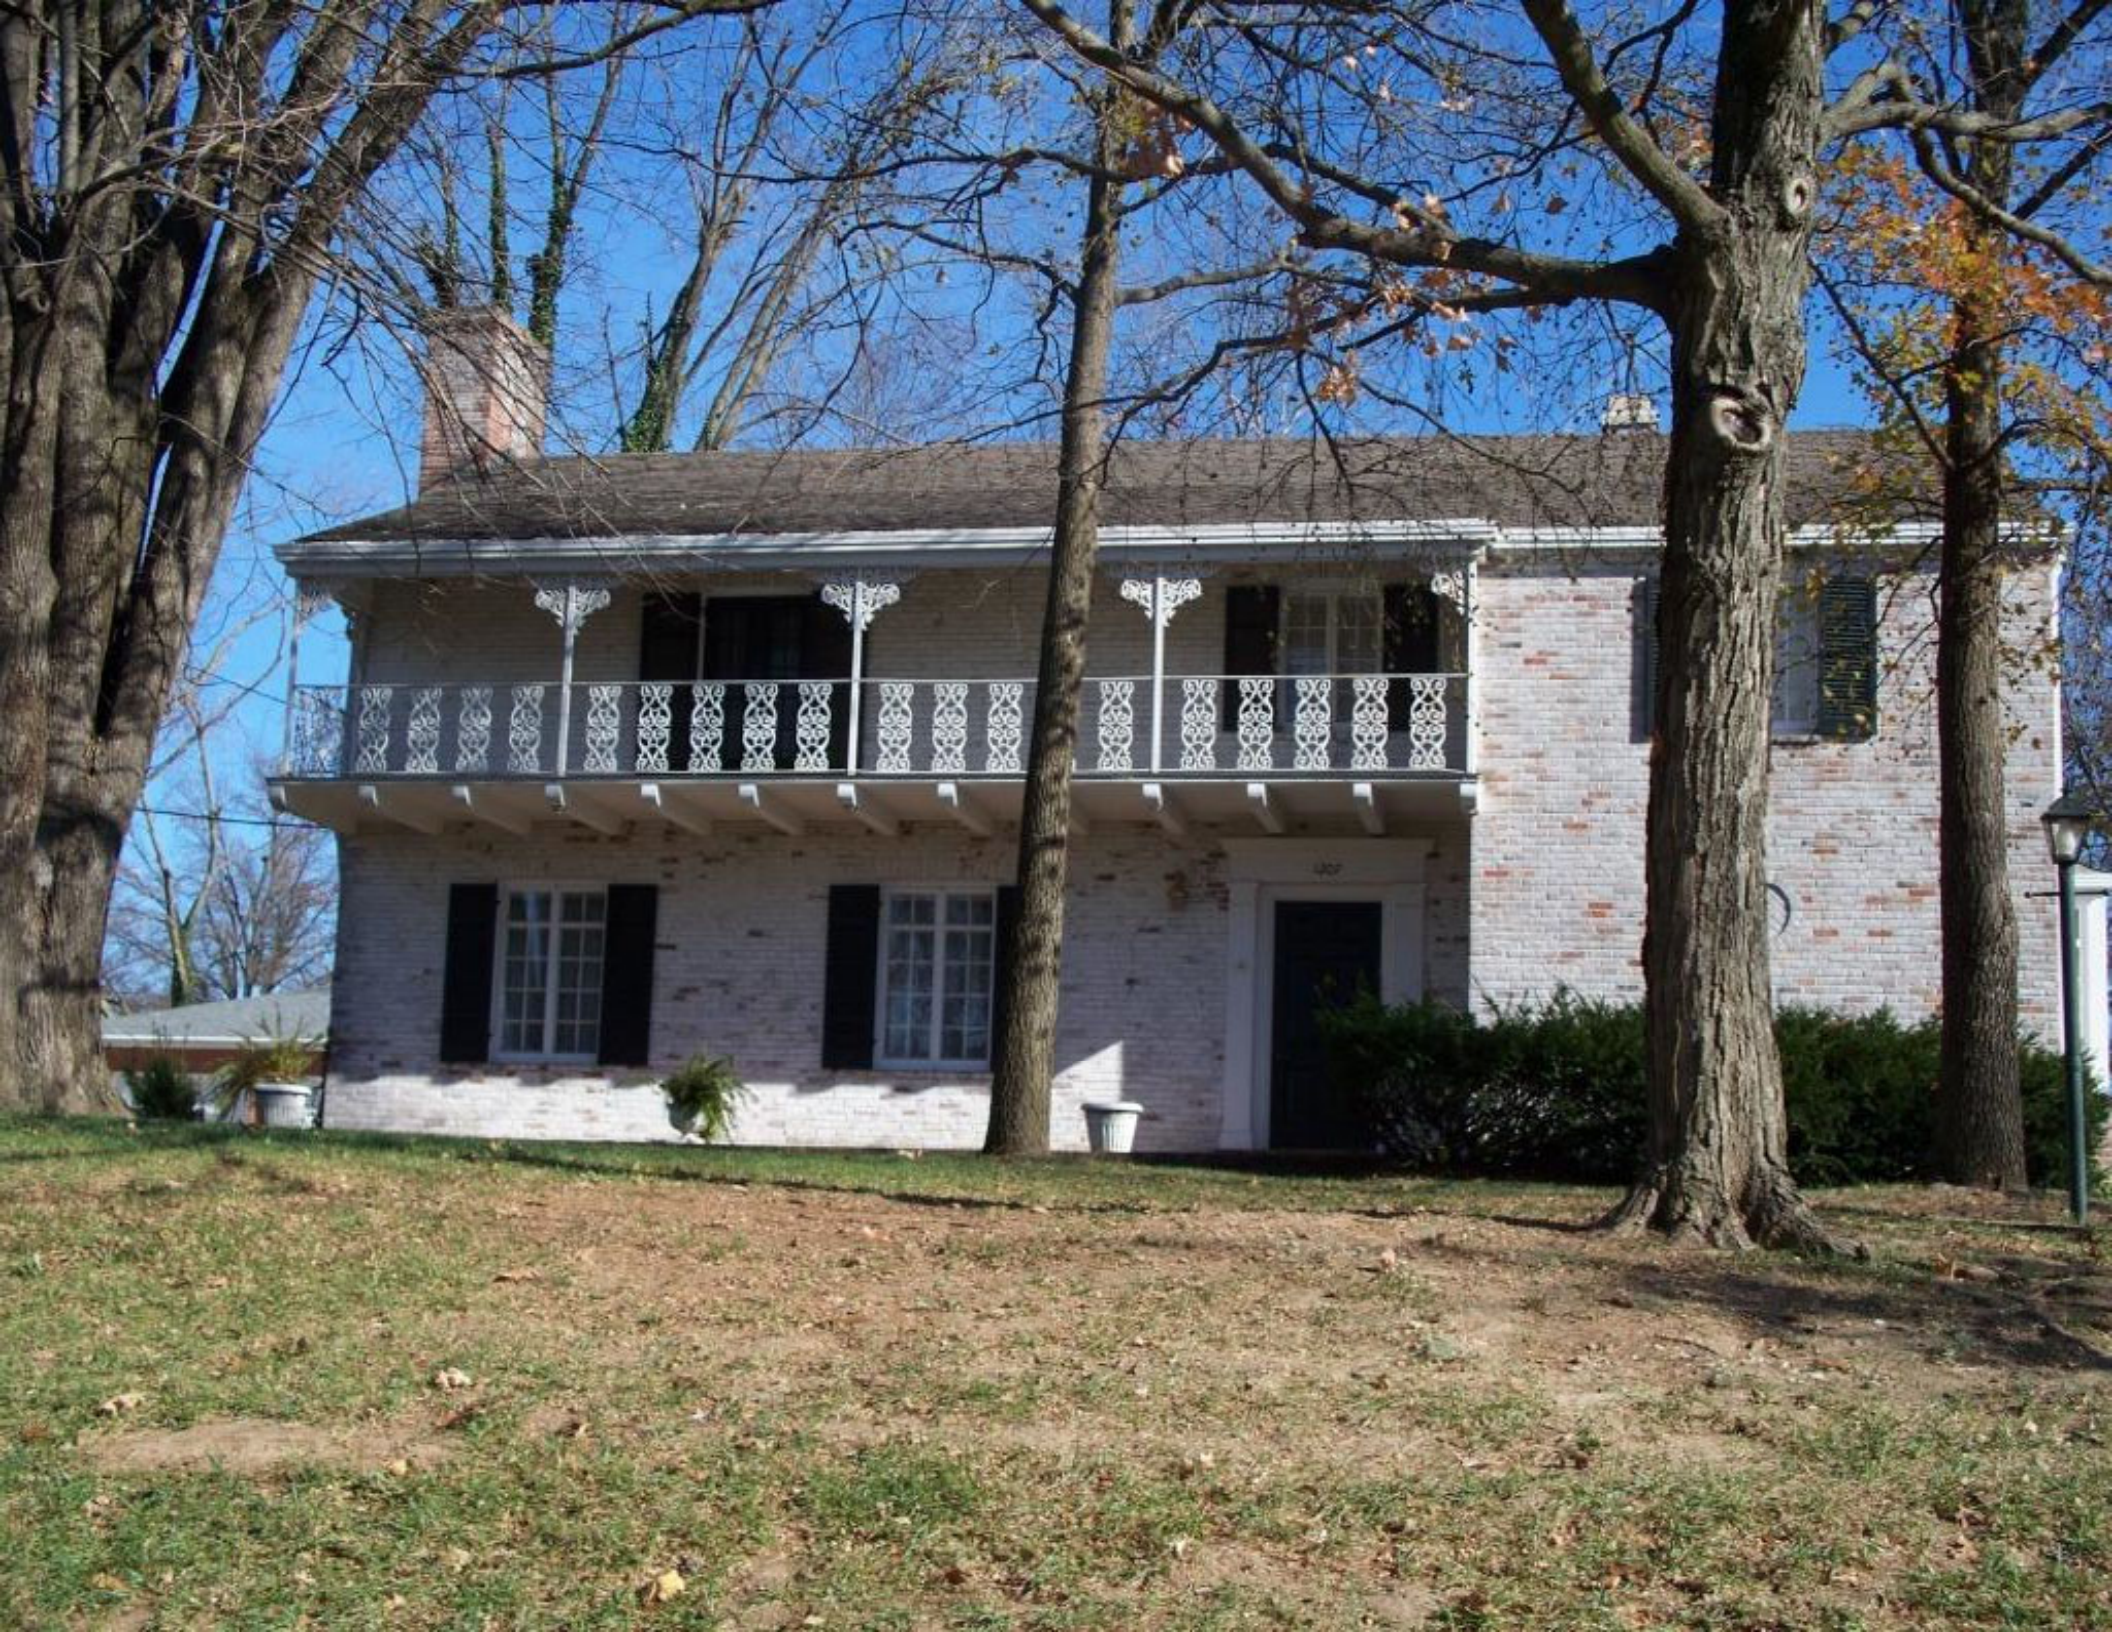
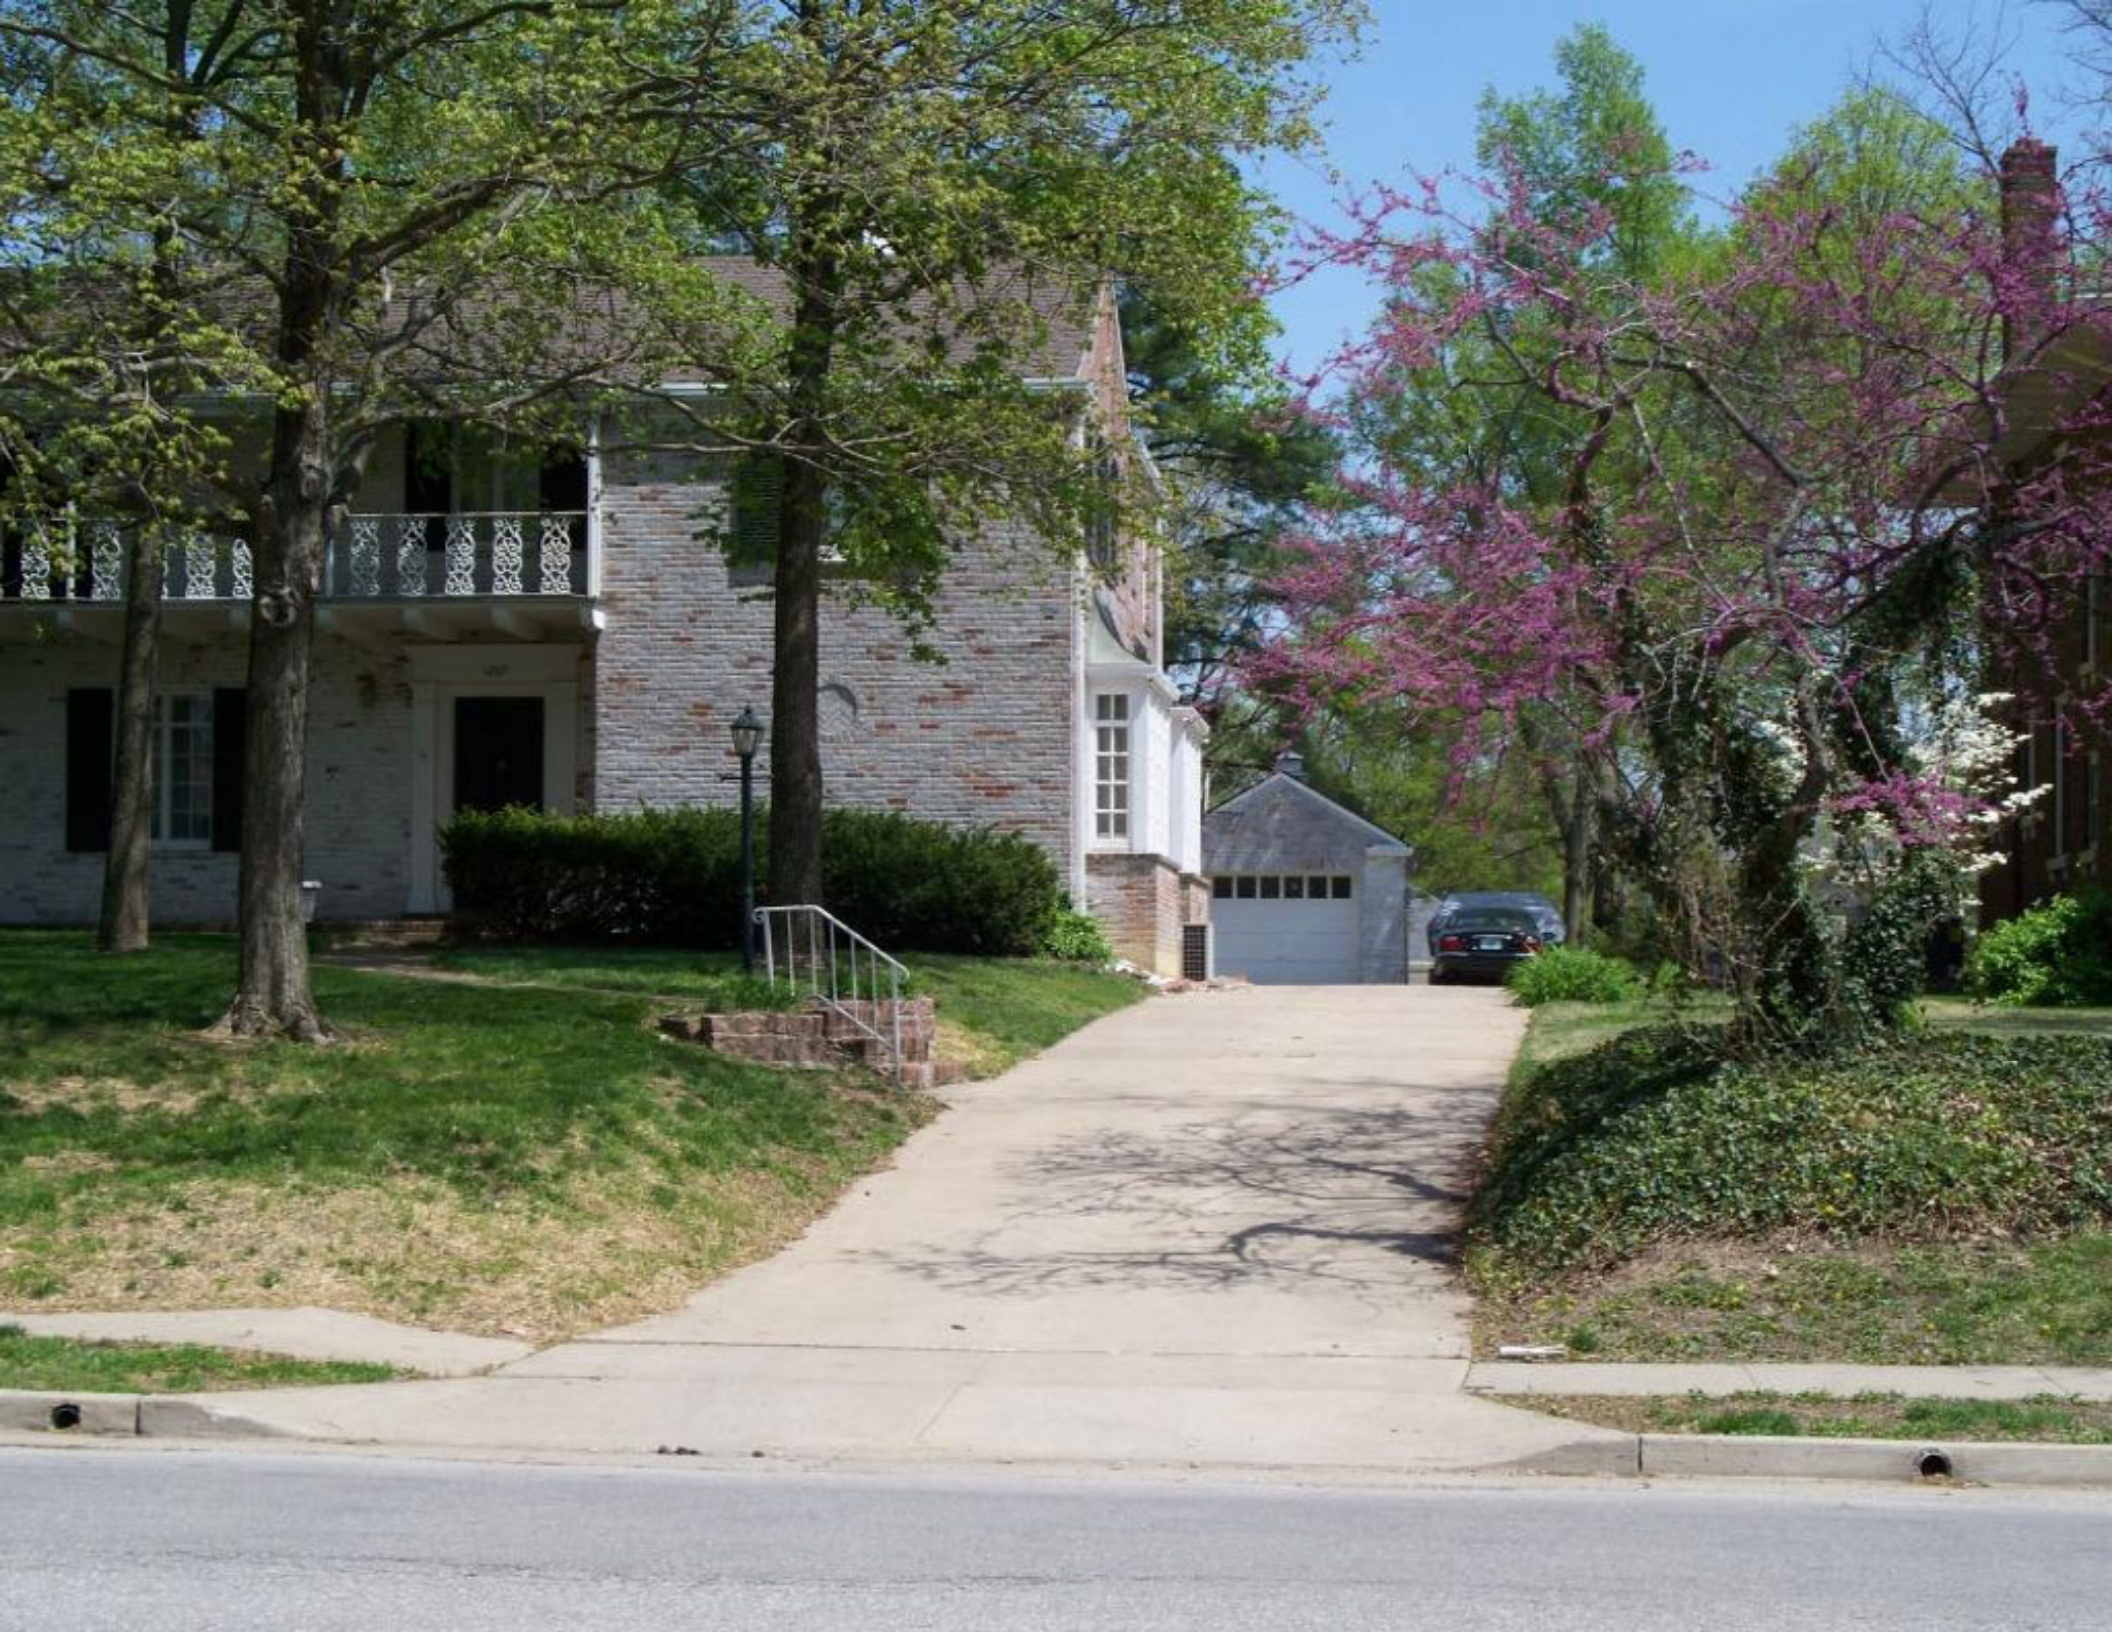
41. (cont.) Sources vary on the construction date of this property. It is not on the 1939 Sanborn Map but appears on the 1943 update. However, its features, especially the large chimney with brick detailing and narrow window openings suggest a much earlier building date. Kremer believes this property was built in 1910. It appears it was originally an I-House. From the south, the first bay projects slightly from the façade and has a single window opening on the second floor with two narrow eight-light casement windows with shutters. It appears there was an oculus window on the first floor but it has since been bricked up or may simply be a decorative feature since it is flush with the rest of the bay. Extending from this bay between the first and second story a porch extends to the end of the property. It serves as an overhang with rafter tails for the lower porch and the floor of the upper porch with a worked metal banister and beams. There are two sets of windows and shutters on each level that, although slightly longer, are identical to the window in the first bay. The brick house has been white washed on the front however on the side of the building is the original red brick. On the right side are two canted wooden bay windows with flaring metal hoods that appear to be resting on brick piers. Although this does not firmly fall into any one stylistic category, the fenestration suggests it is more of a Colonial Revival style house than anything.

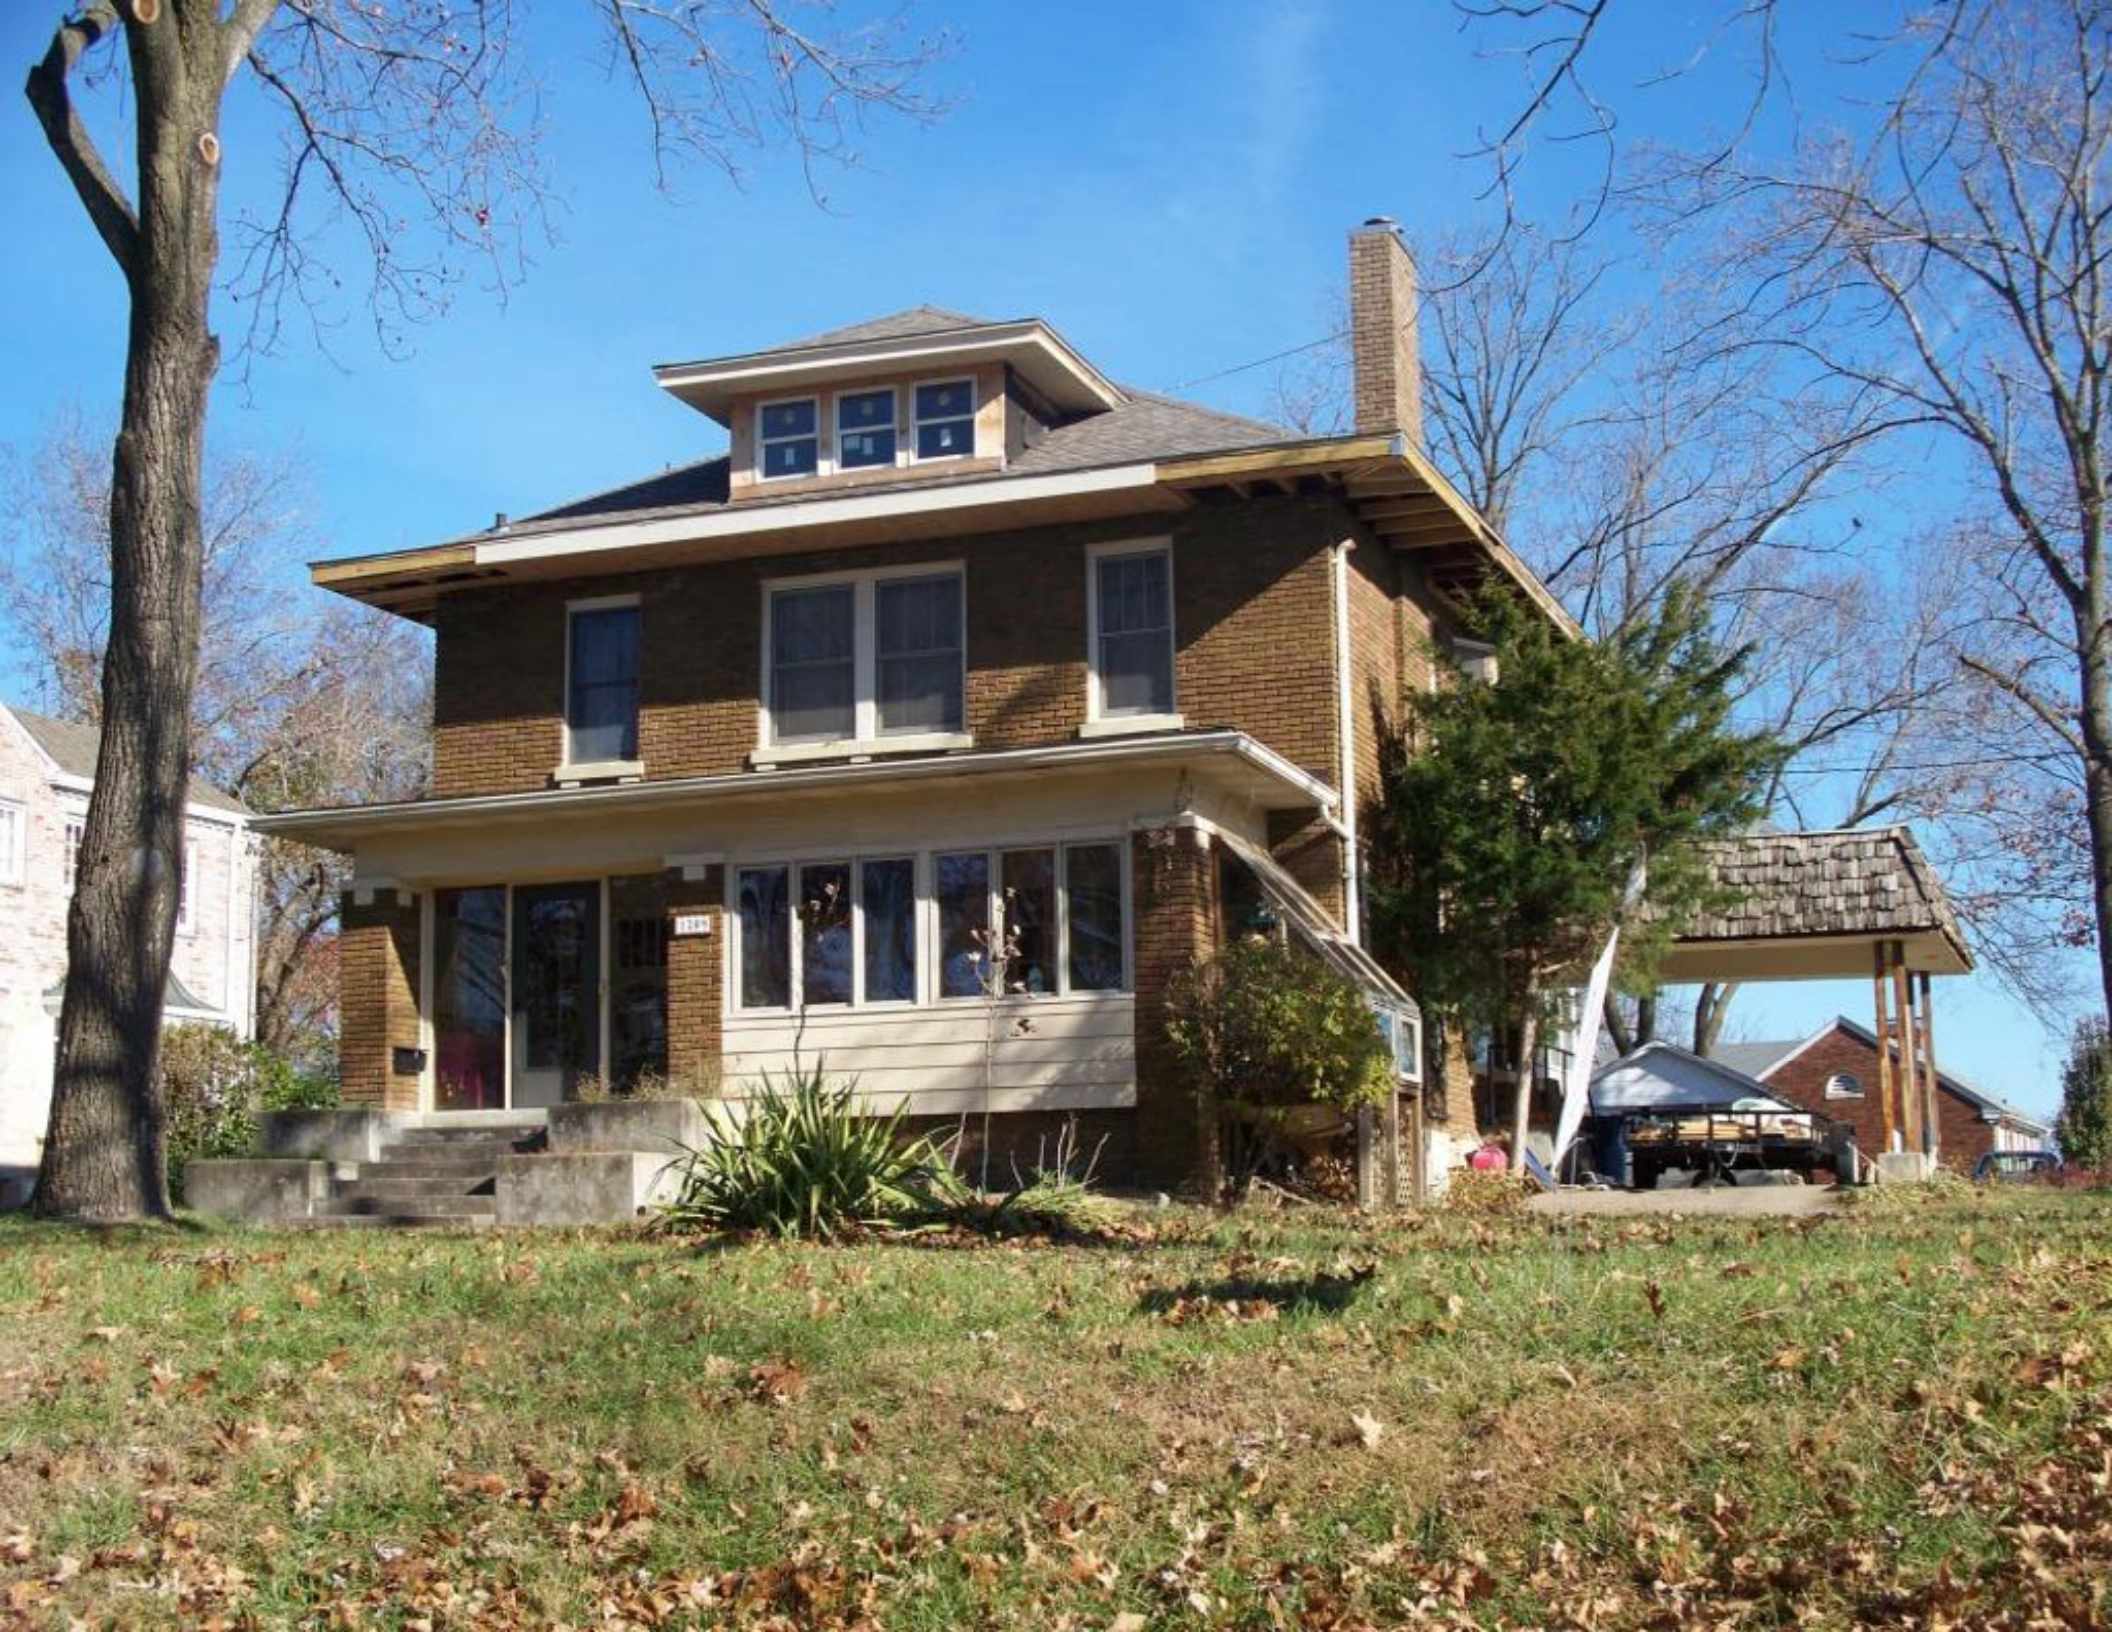
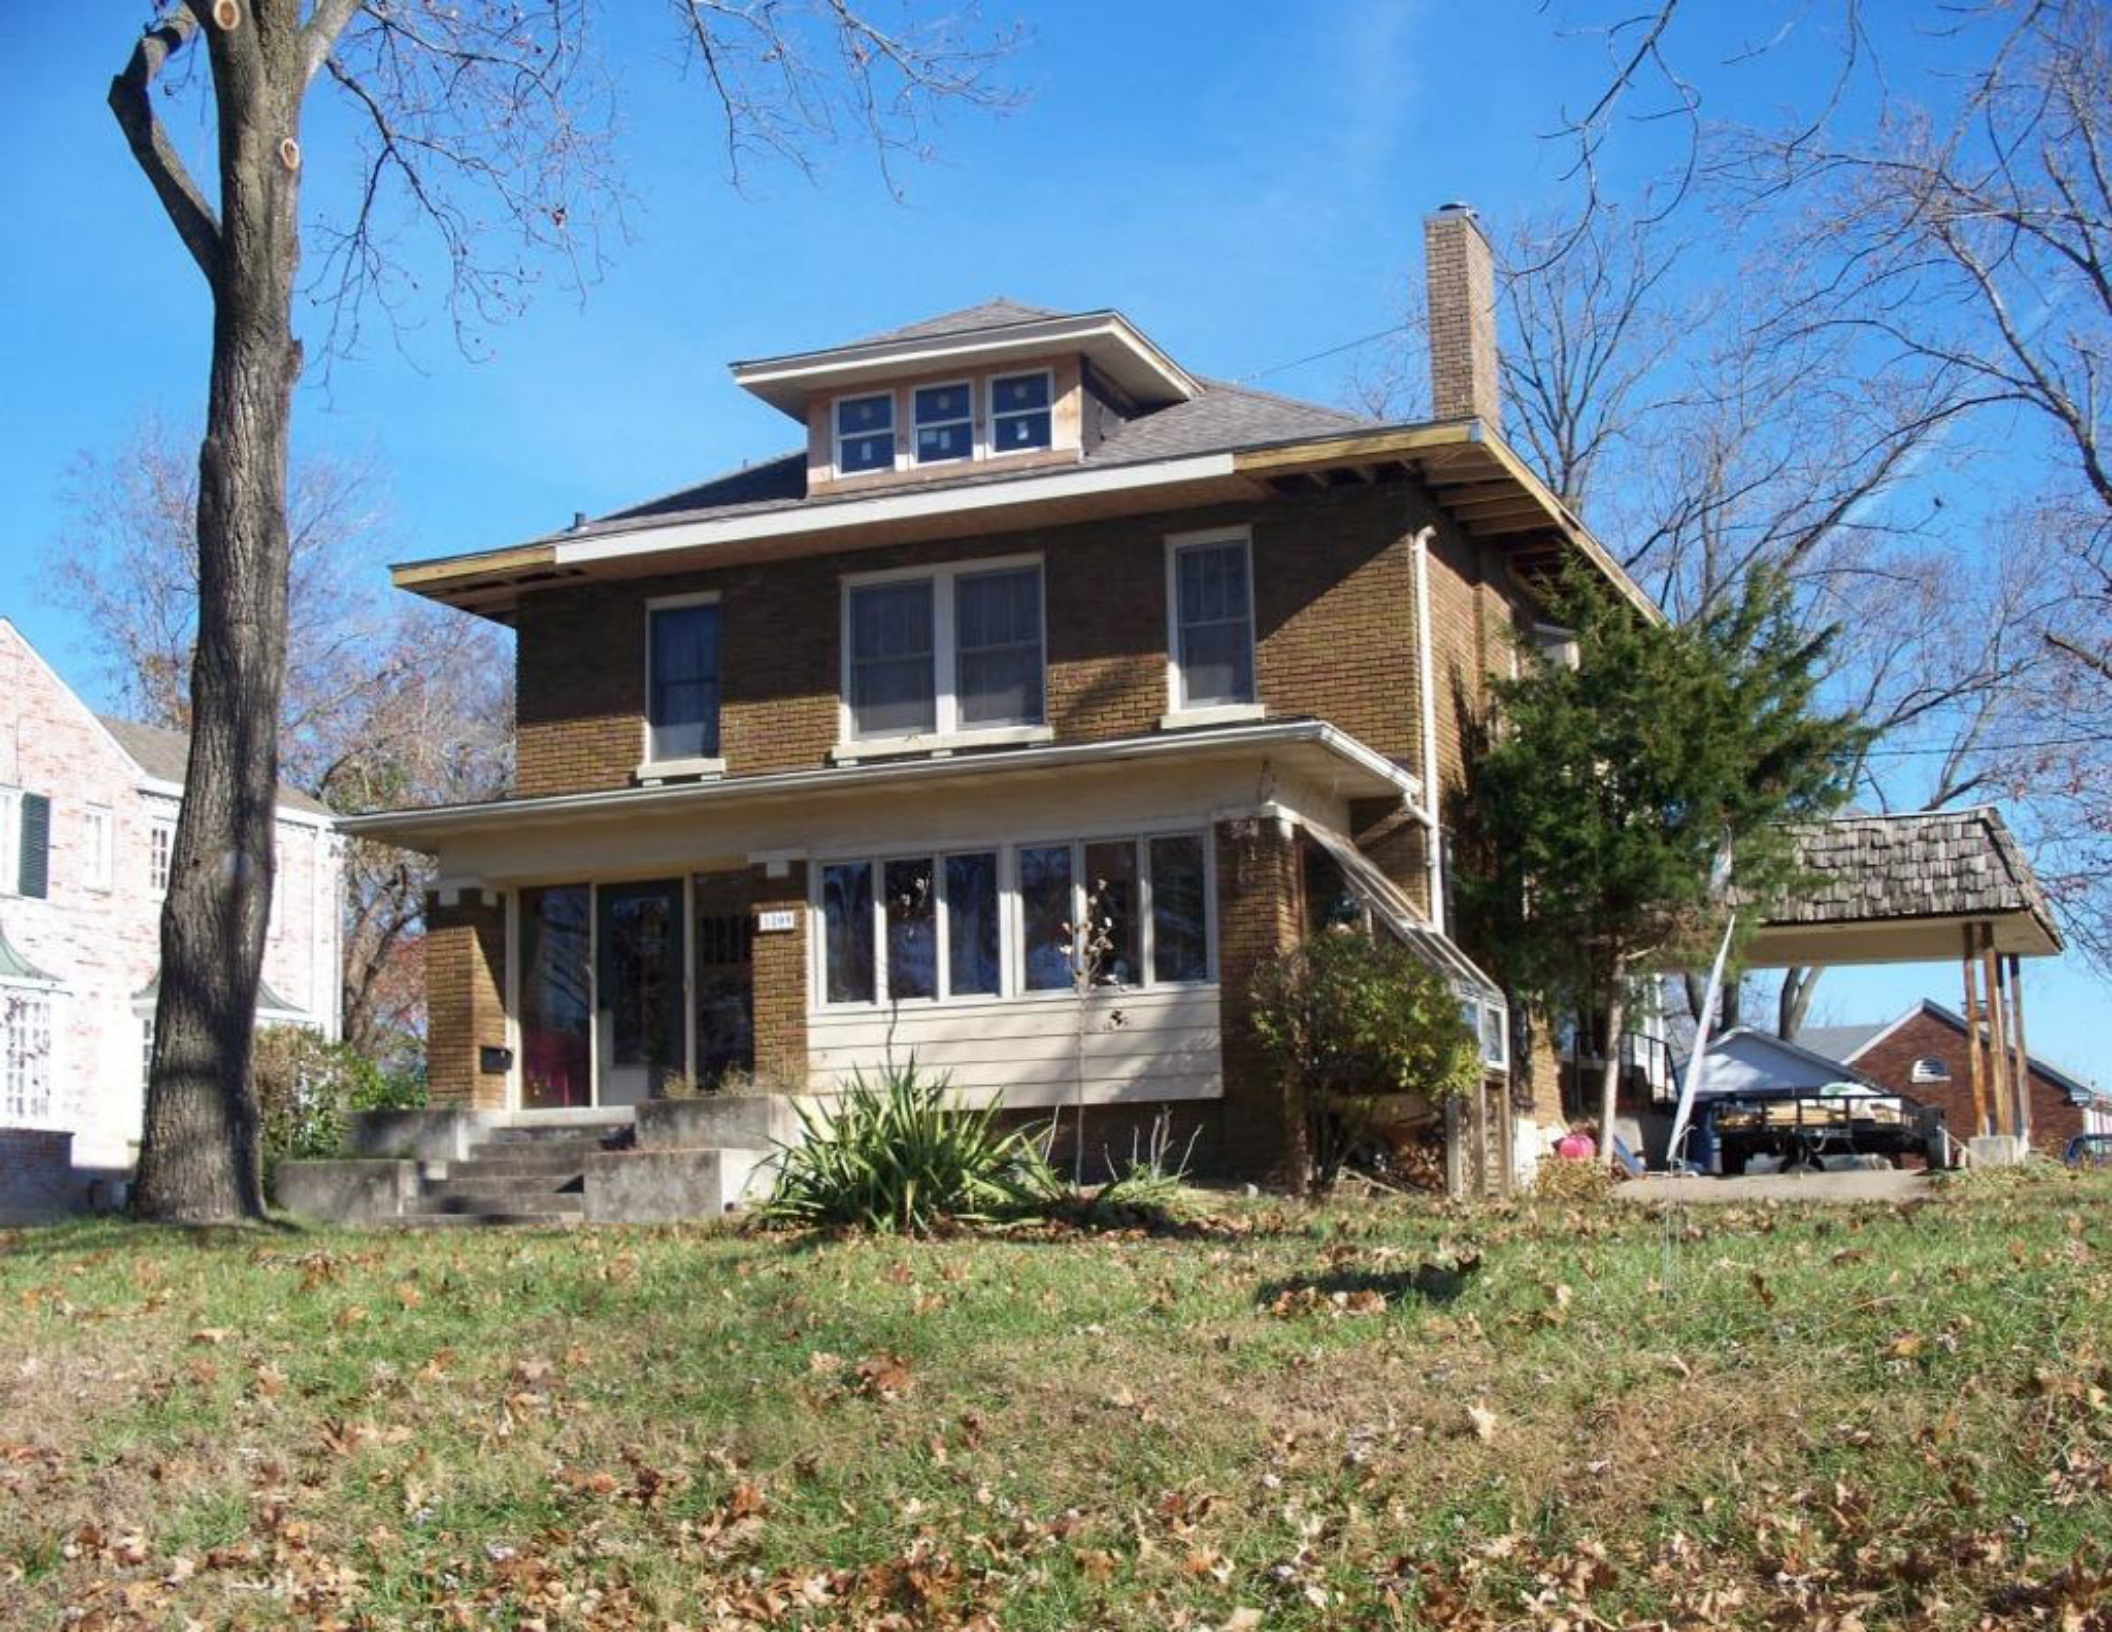
41. (cont.) This two-and-a-half story four square has minimal Prairie details with its low-pitched hipped roof, overhanging eaves, and the horizontal use of windows. There is a central gable with a hipped roof and three one-over-one replacement windows. The second floor retains three historic three-over one windows; one on the far right and central paired windows. A window on the far left appears to be an aluminum one-over-one replacement, all of the windows on this floor have stone sills and screen windows. The first story full width porch with square brick pillars has been enclosed with casement windows, siding, and a modern door and large sidelights. It appears to be used as a greenhouse as there is an attached glass planter extending from the right side of the house. Concrete stairs lead up to the building. A non-historic porte-cochere is situated towards the back of the house on the right side.
