ARCHITECTURAL/HISTORIC INVENTORY FORM

1. Survey No. CO-AS-005-001		2. Survey name: Moreau Drive Neighborhood Survey	
3. County: Cole		4. Address: 1202 Elmerine Ave.	
5. City: Jefferson City	Vicinity: <input type="checkbox"/>	6. UTM: / /	7. Township/Range/Section: T: R: S:
8. Historic name (if known):		9. Present/other name (if known):	
10. Ownership: <input checked="" type="checkbox"/> Private <input type="checkbox"/> Public		11. Historic use (if known): Residential	11. Current use: Residential

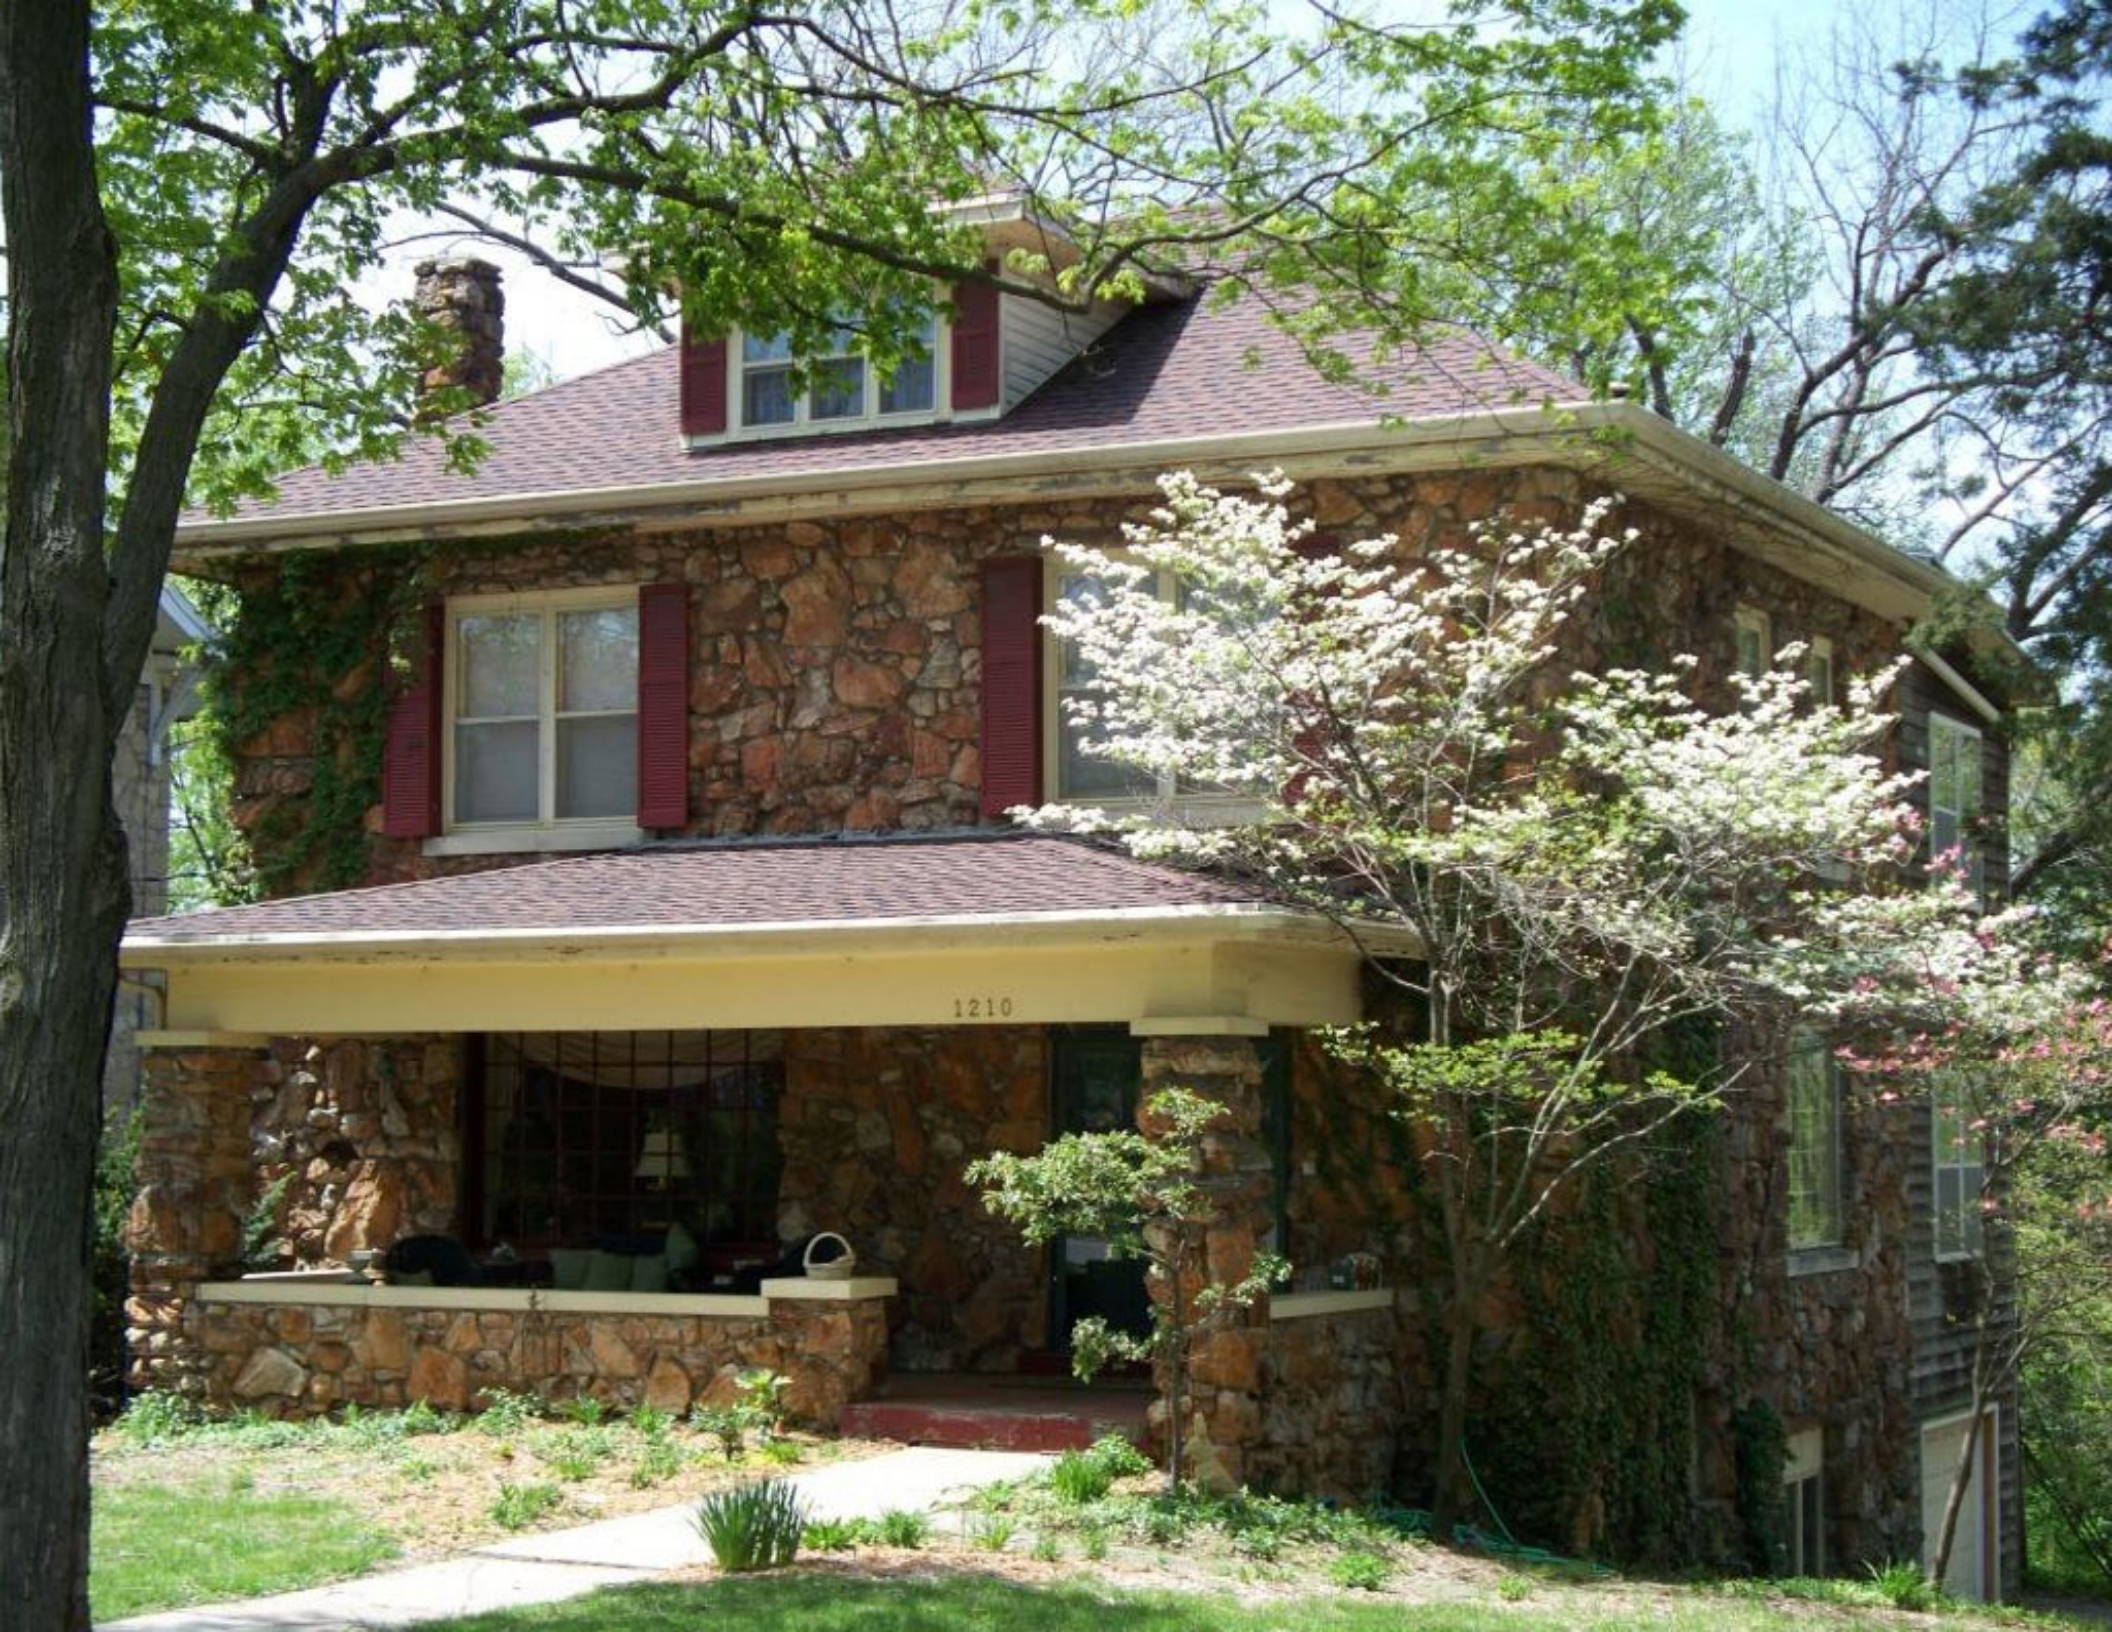
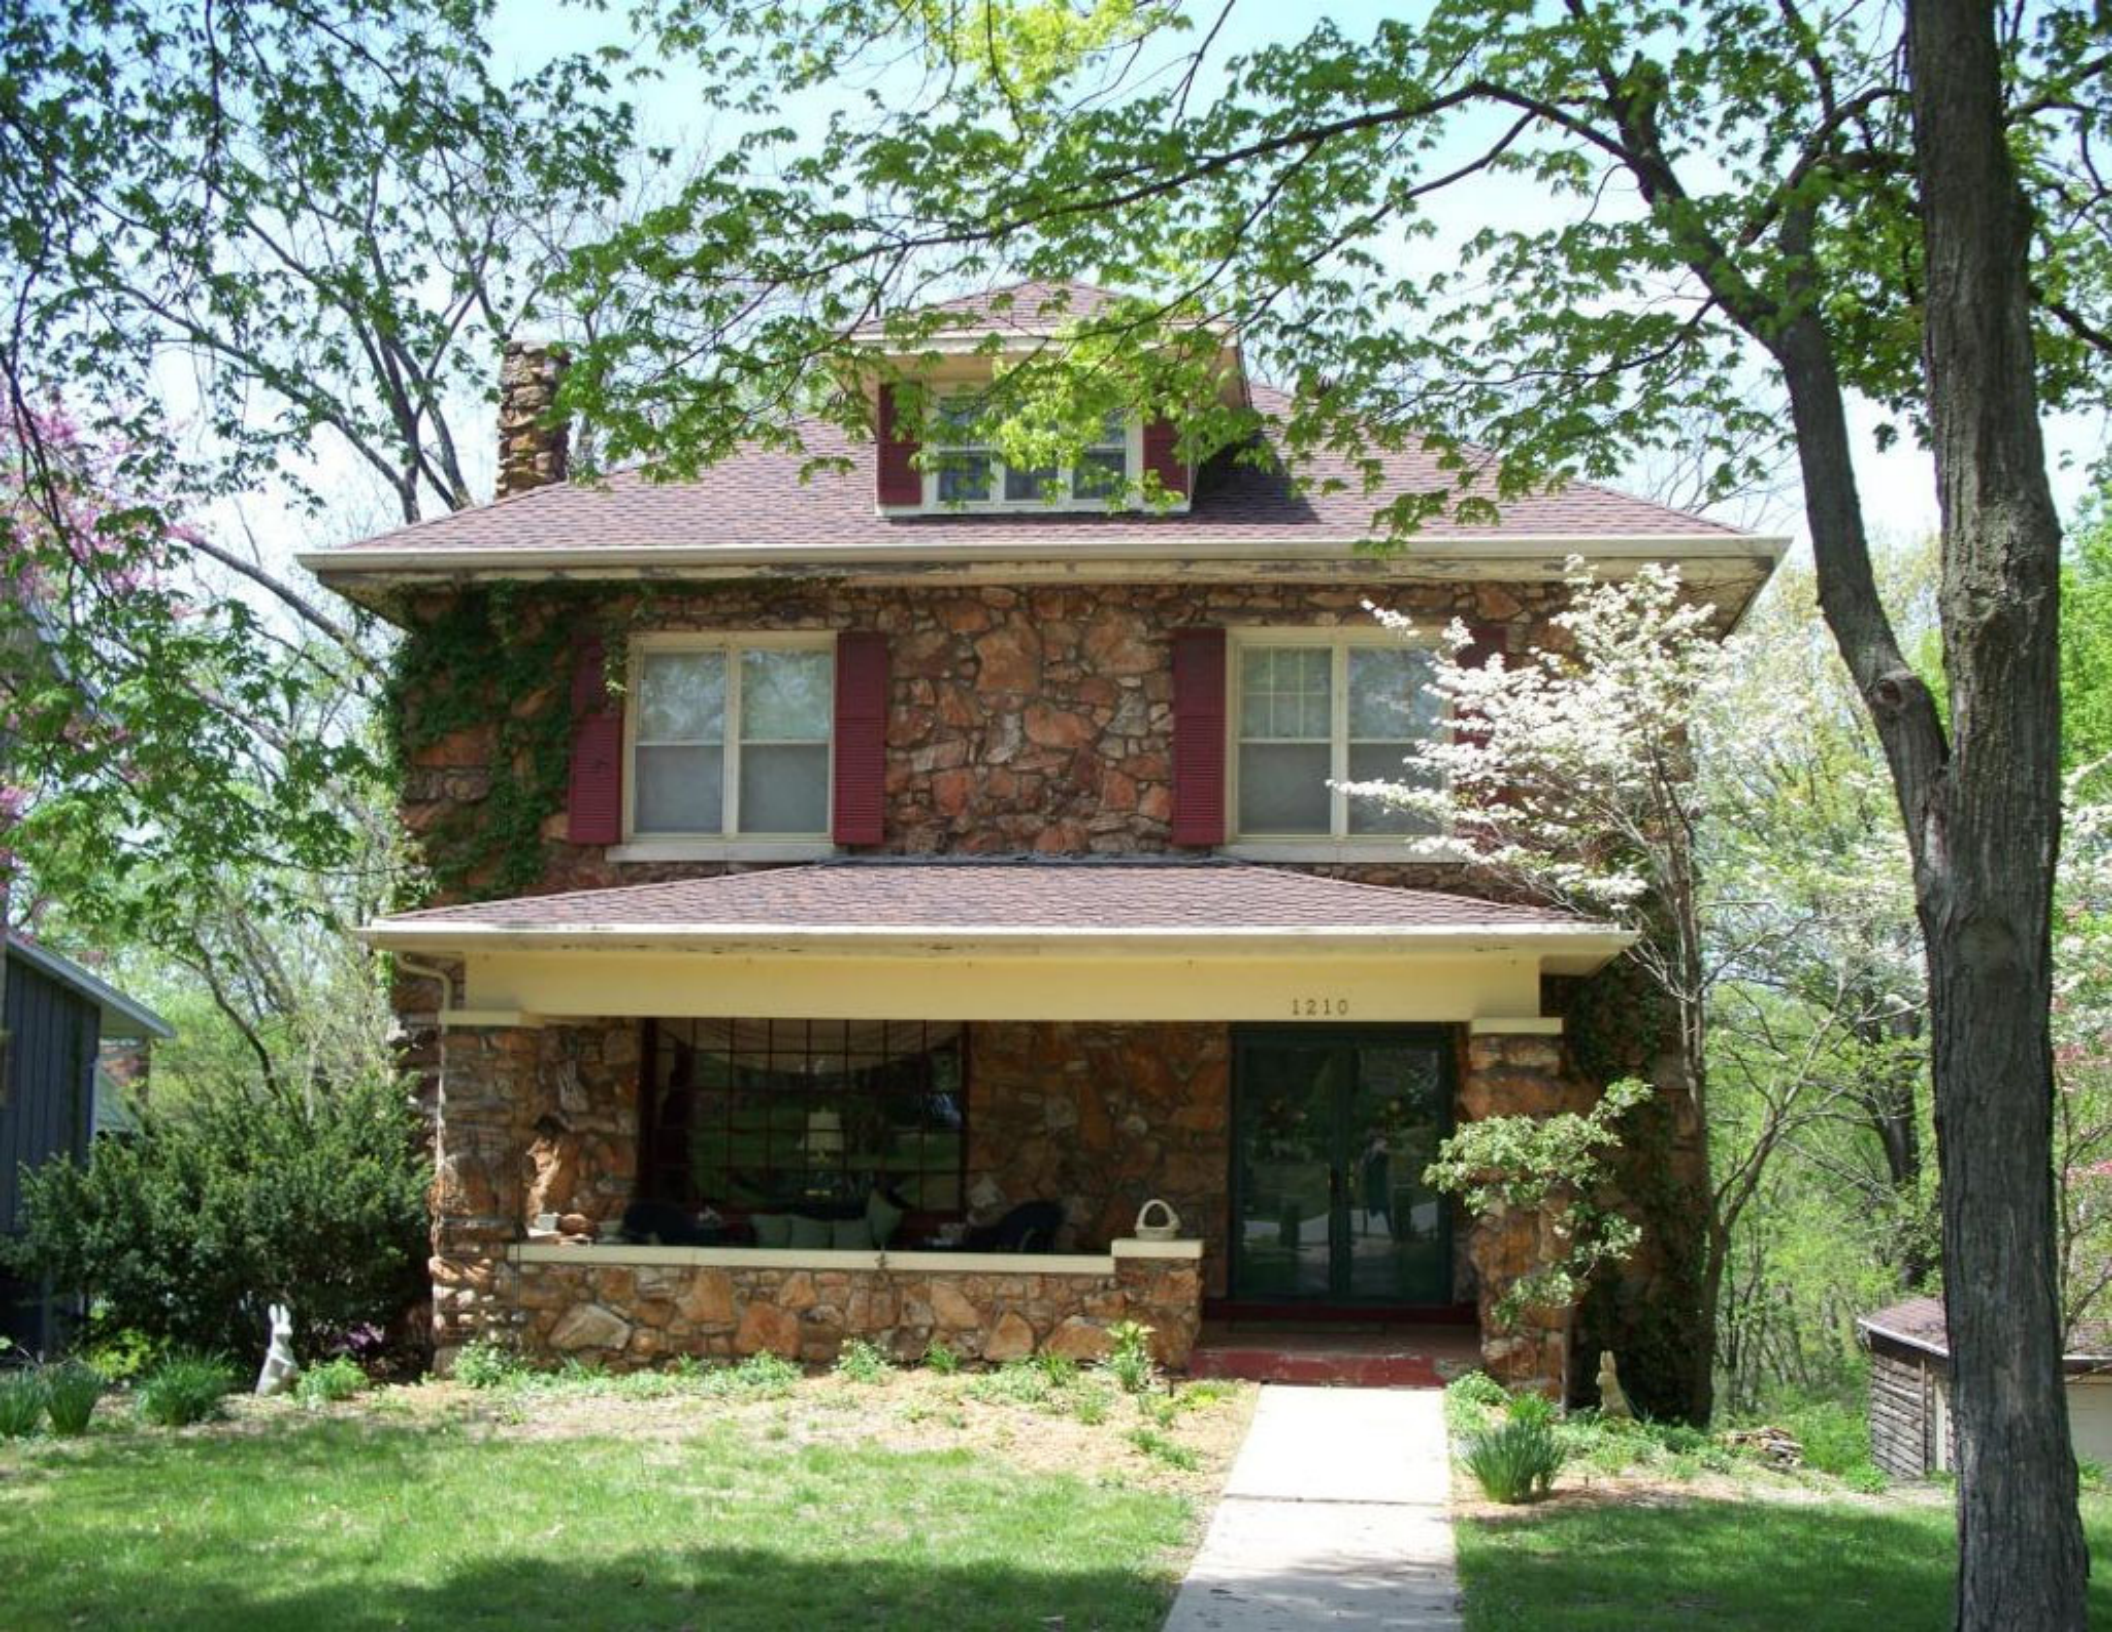
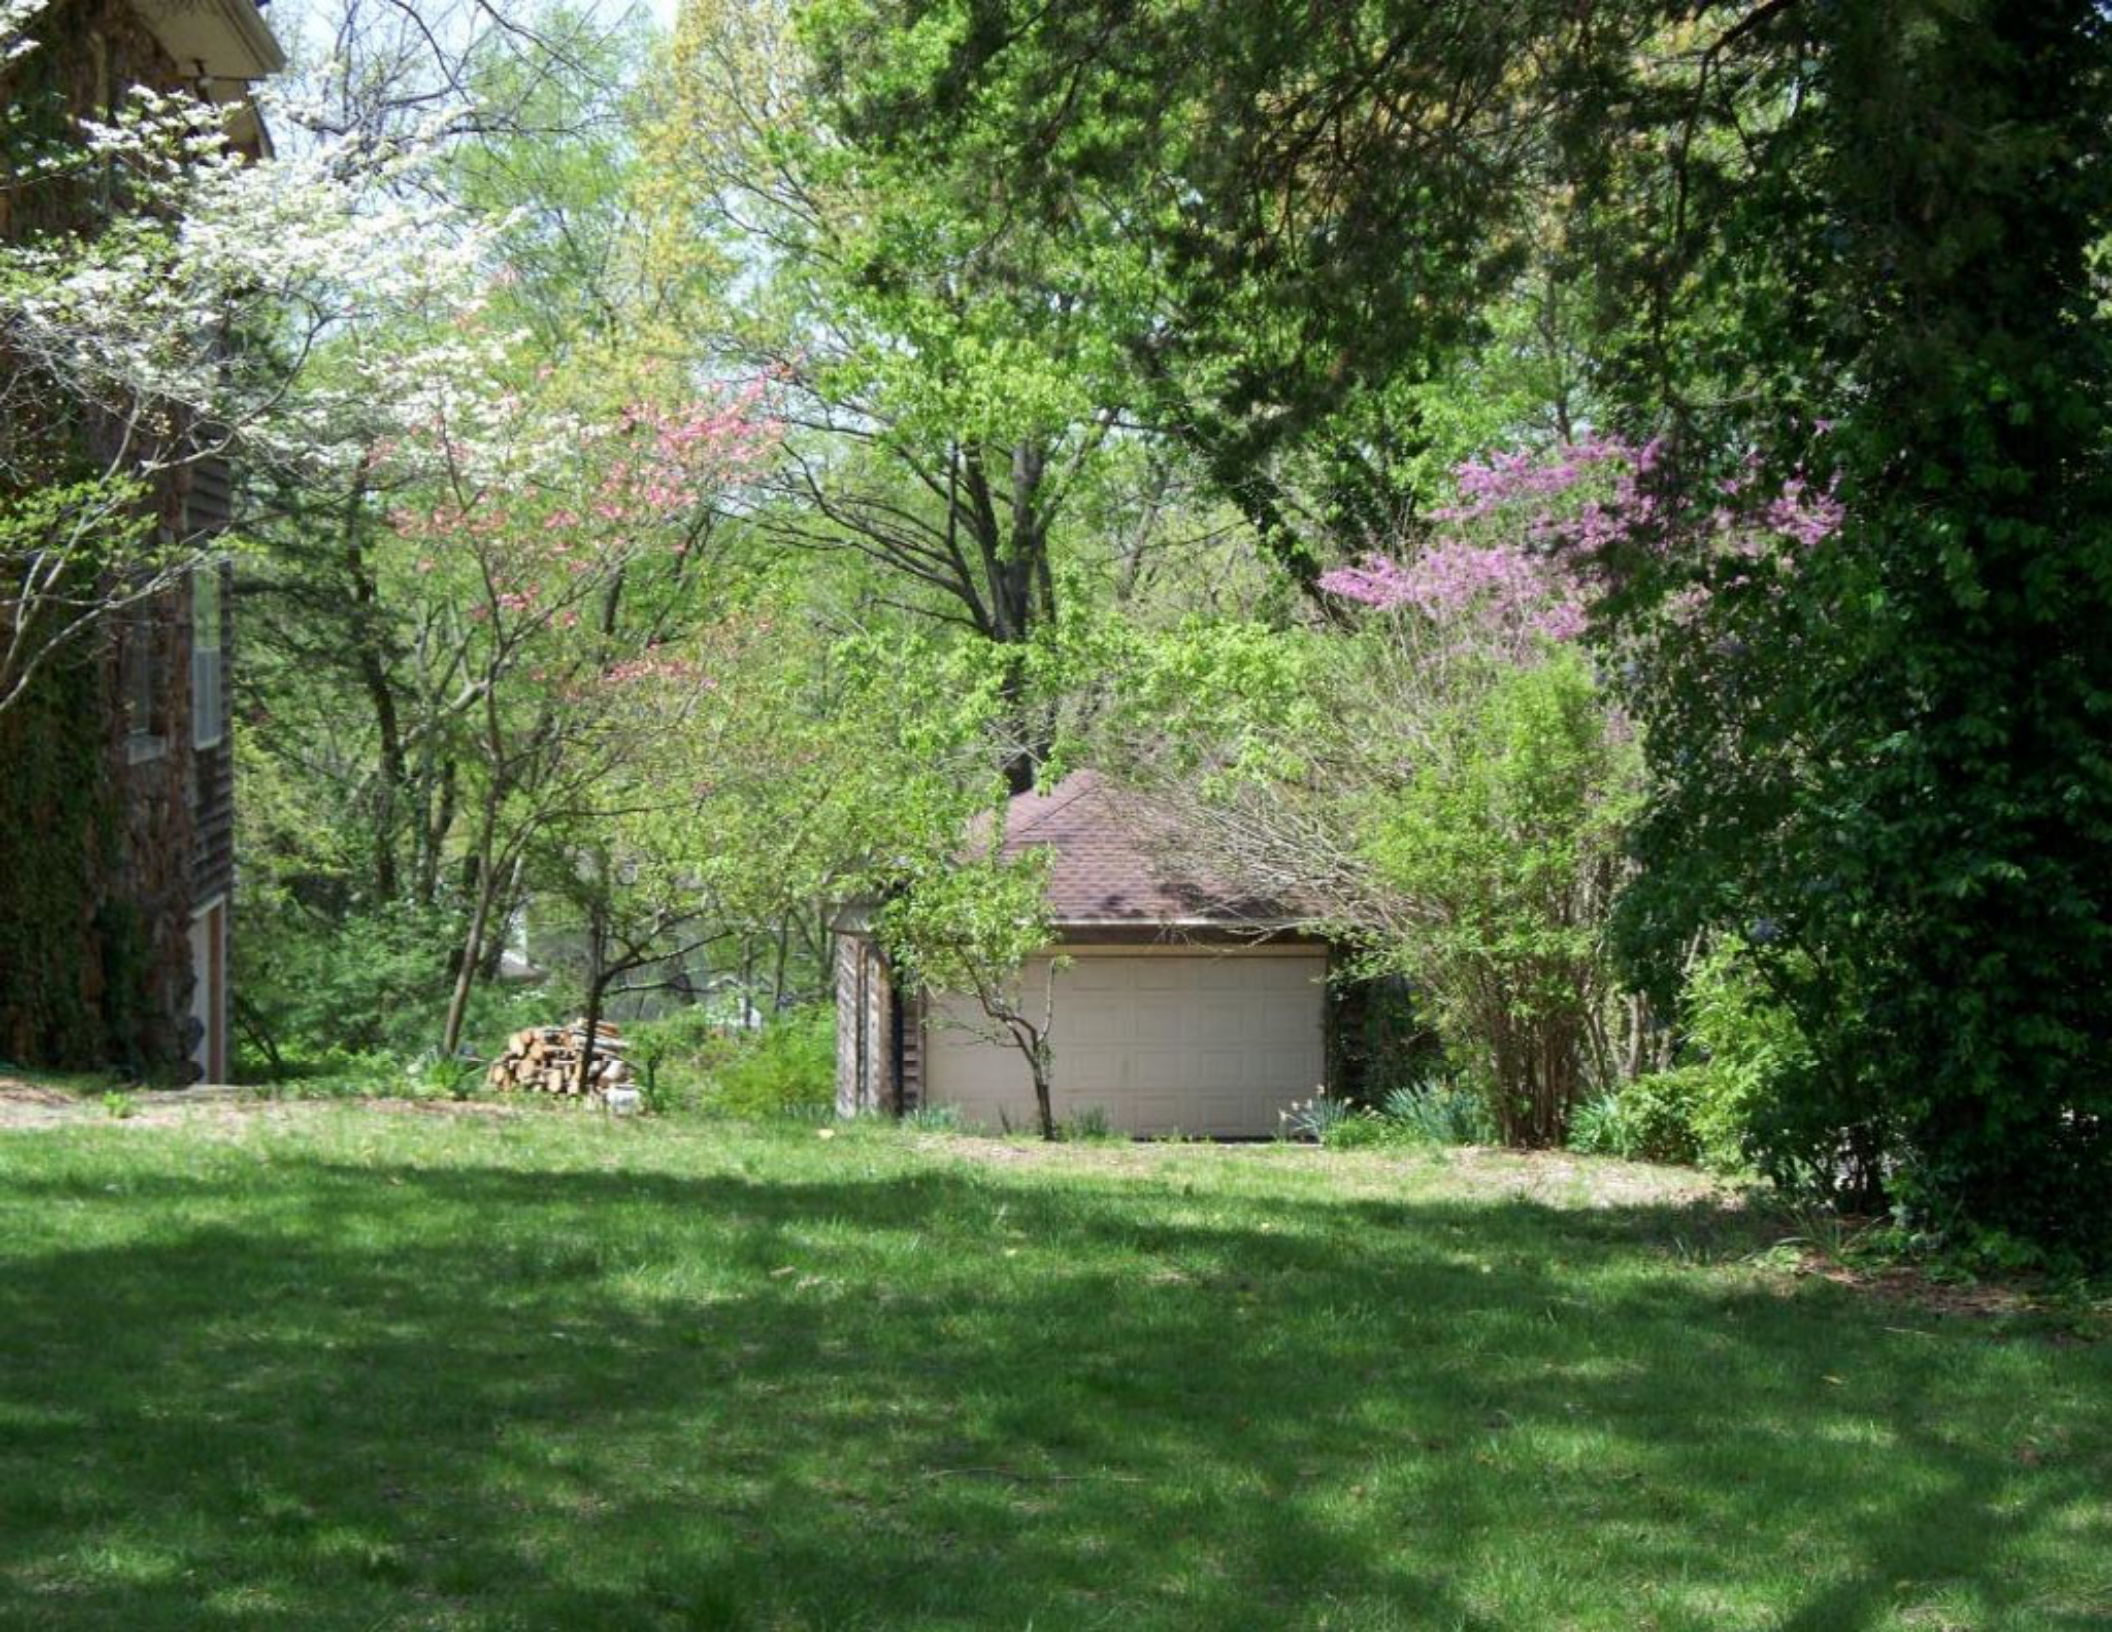
1210

40. (cont.) Description of environment and outbuildings. Expand box as necessary, or add continuation pages.
There is a garage with a hipped roof and wood siding set back from the property. There was a garage here historically around the same size so it could be contributing. However the door could be modern and with the siding could have some integrity issues.

41. (cont.)
This property has a façade of Ozark rock is 2 ½ stories tall, and has a central pyramidal dormer in the hipped roof. The dormer has three windows that appear historic. The second story has paired 1/1 windows in the left bay and 6/1 in the right. It's unknown which is historic, although it's probably those on the left. The first story has a large modern multi-light picture window in the left bay and a double-door entrance in the right bay. A full porch with hipped roof features stone knee-walls and piers. A stone chimney projects from the left of the house.

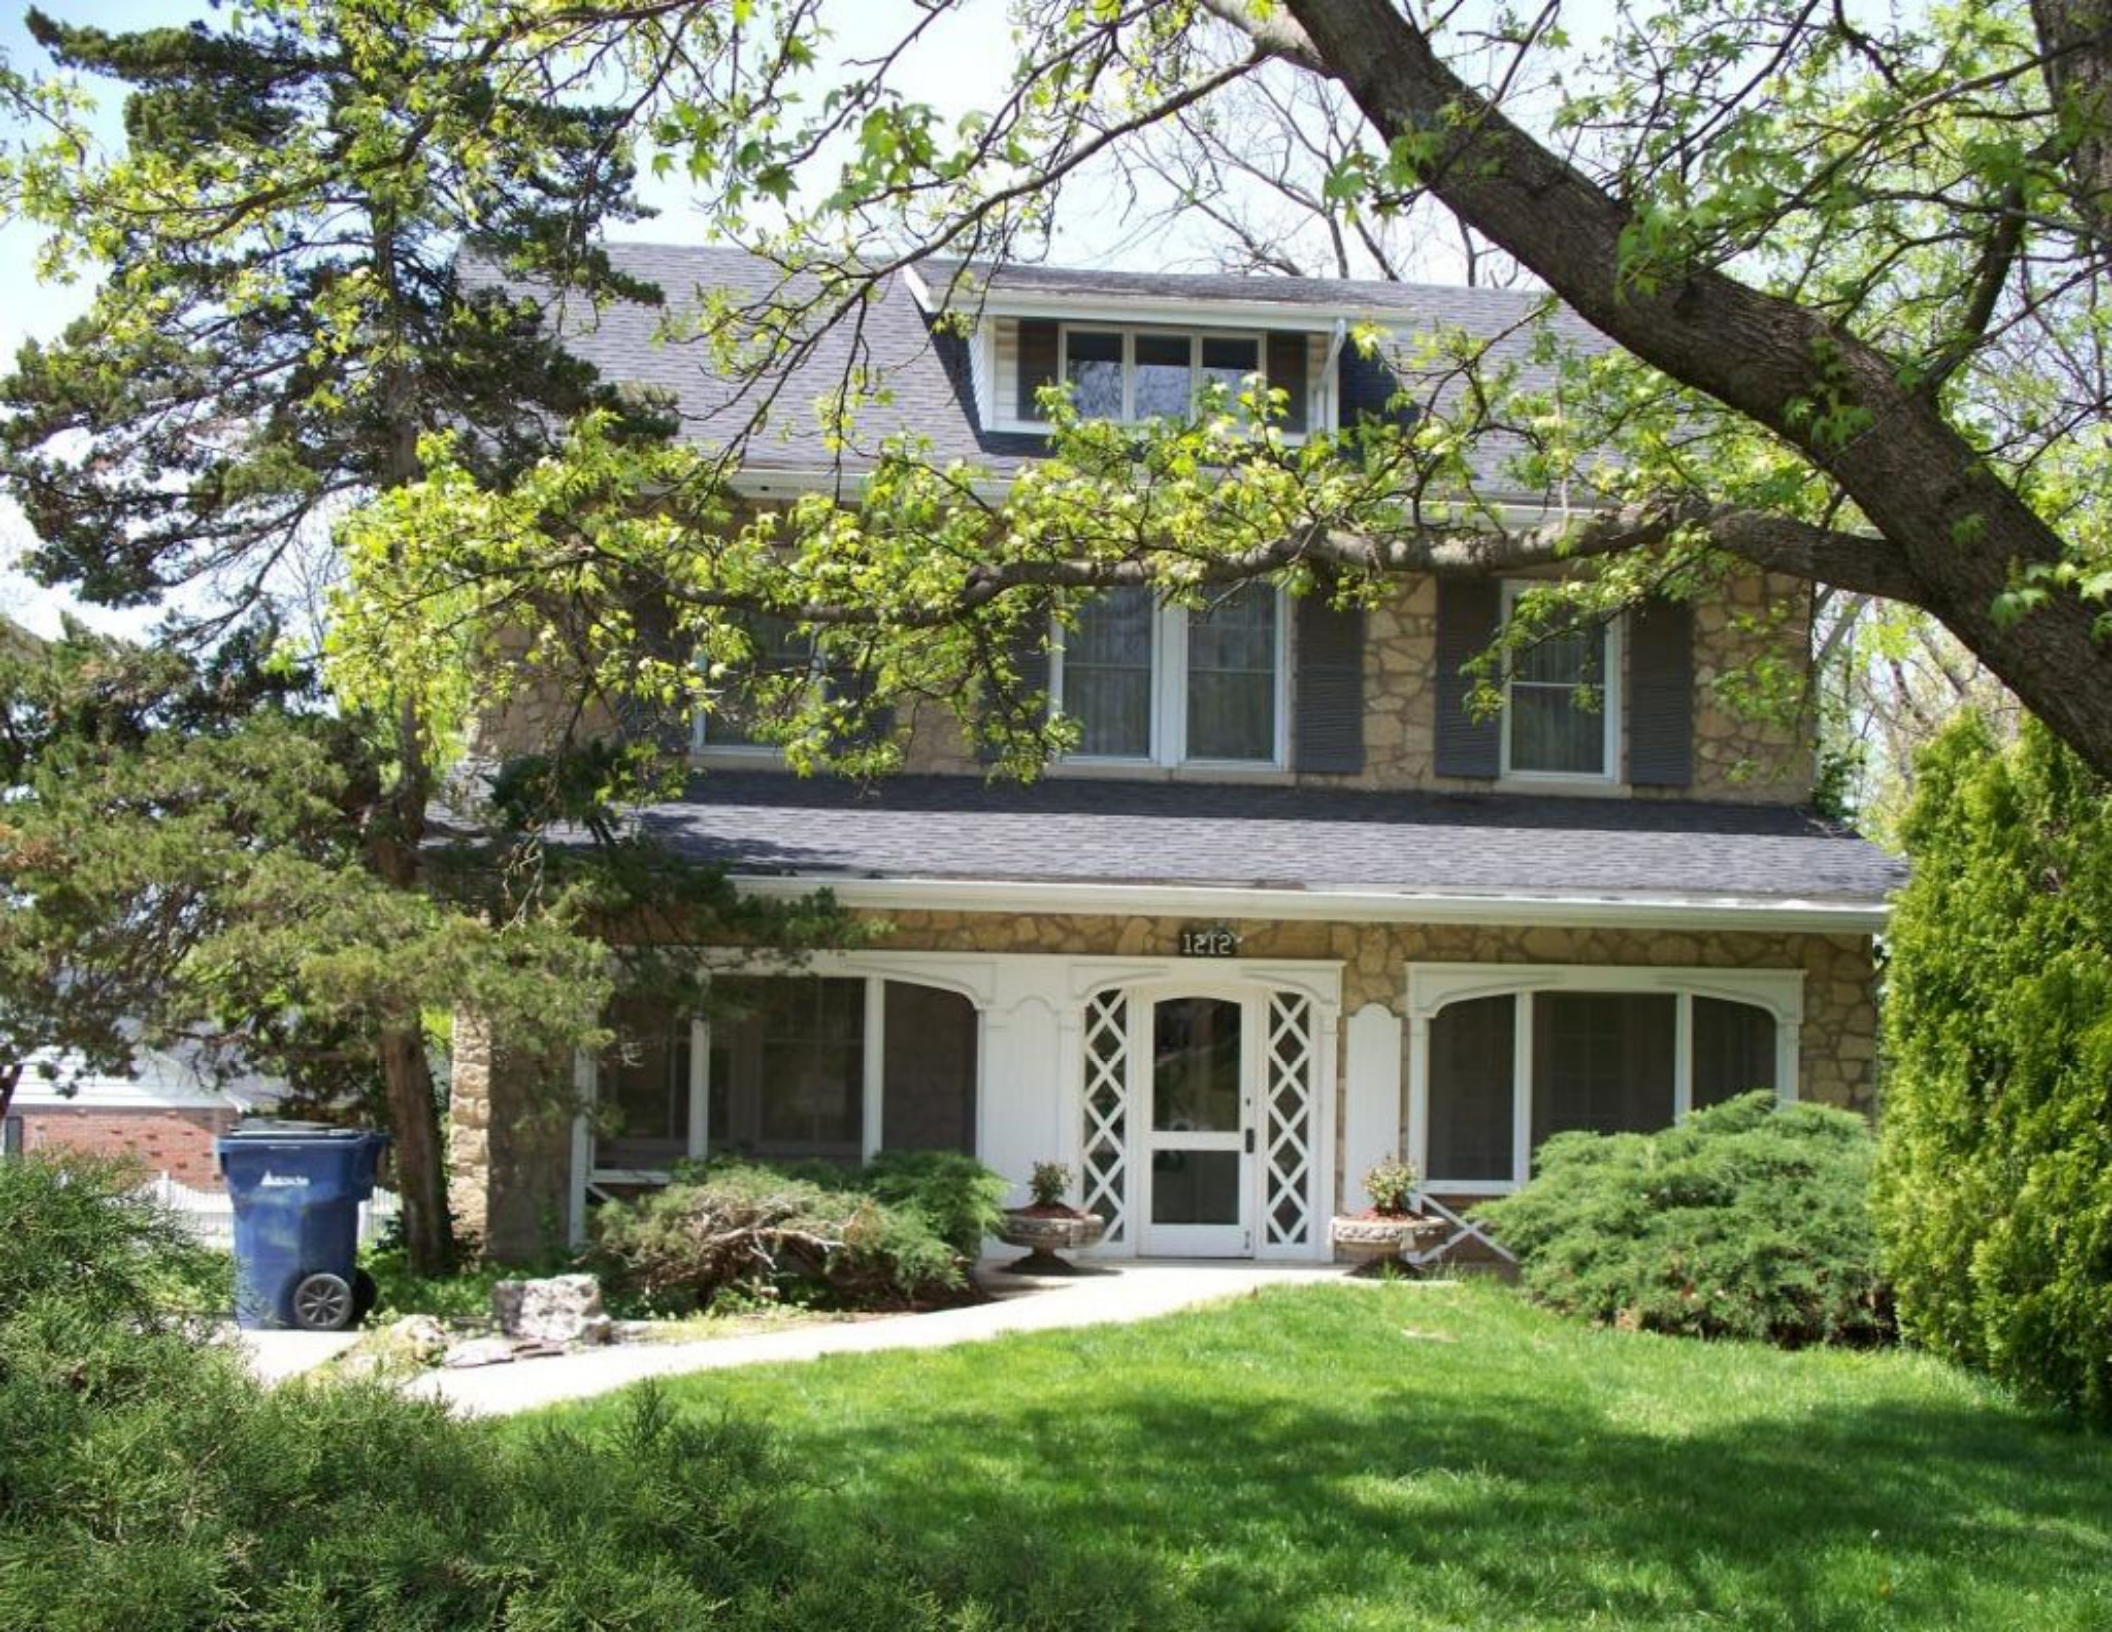
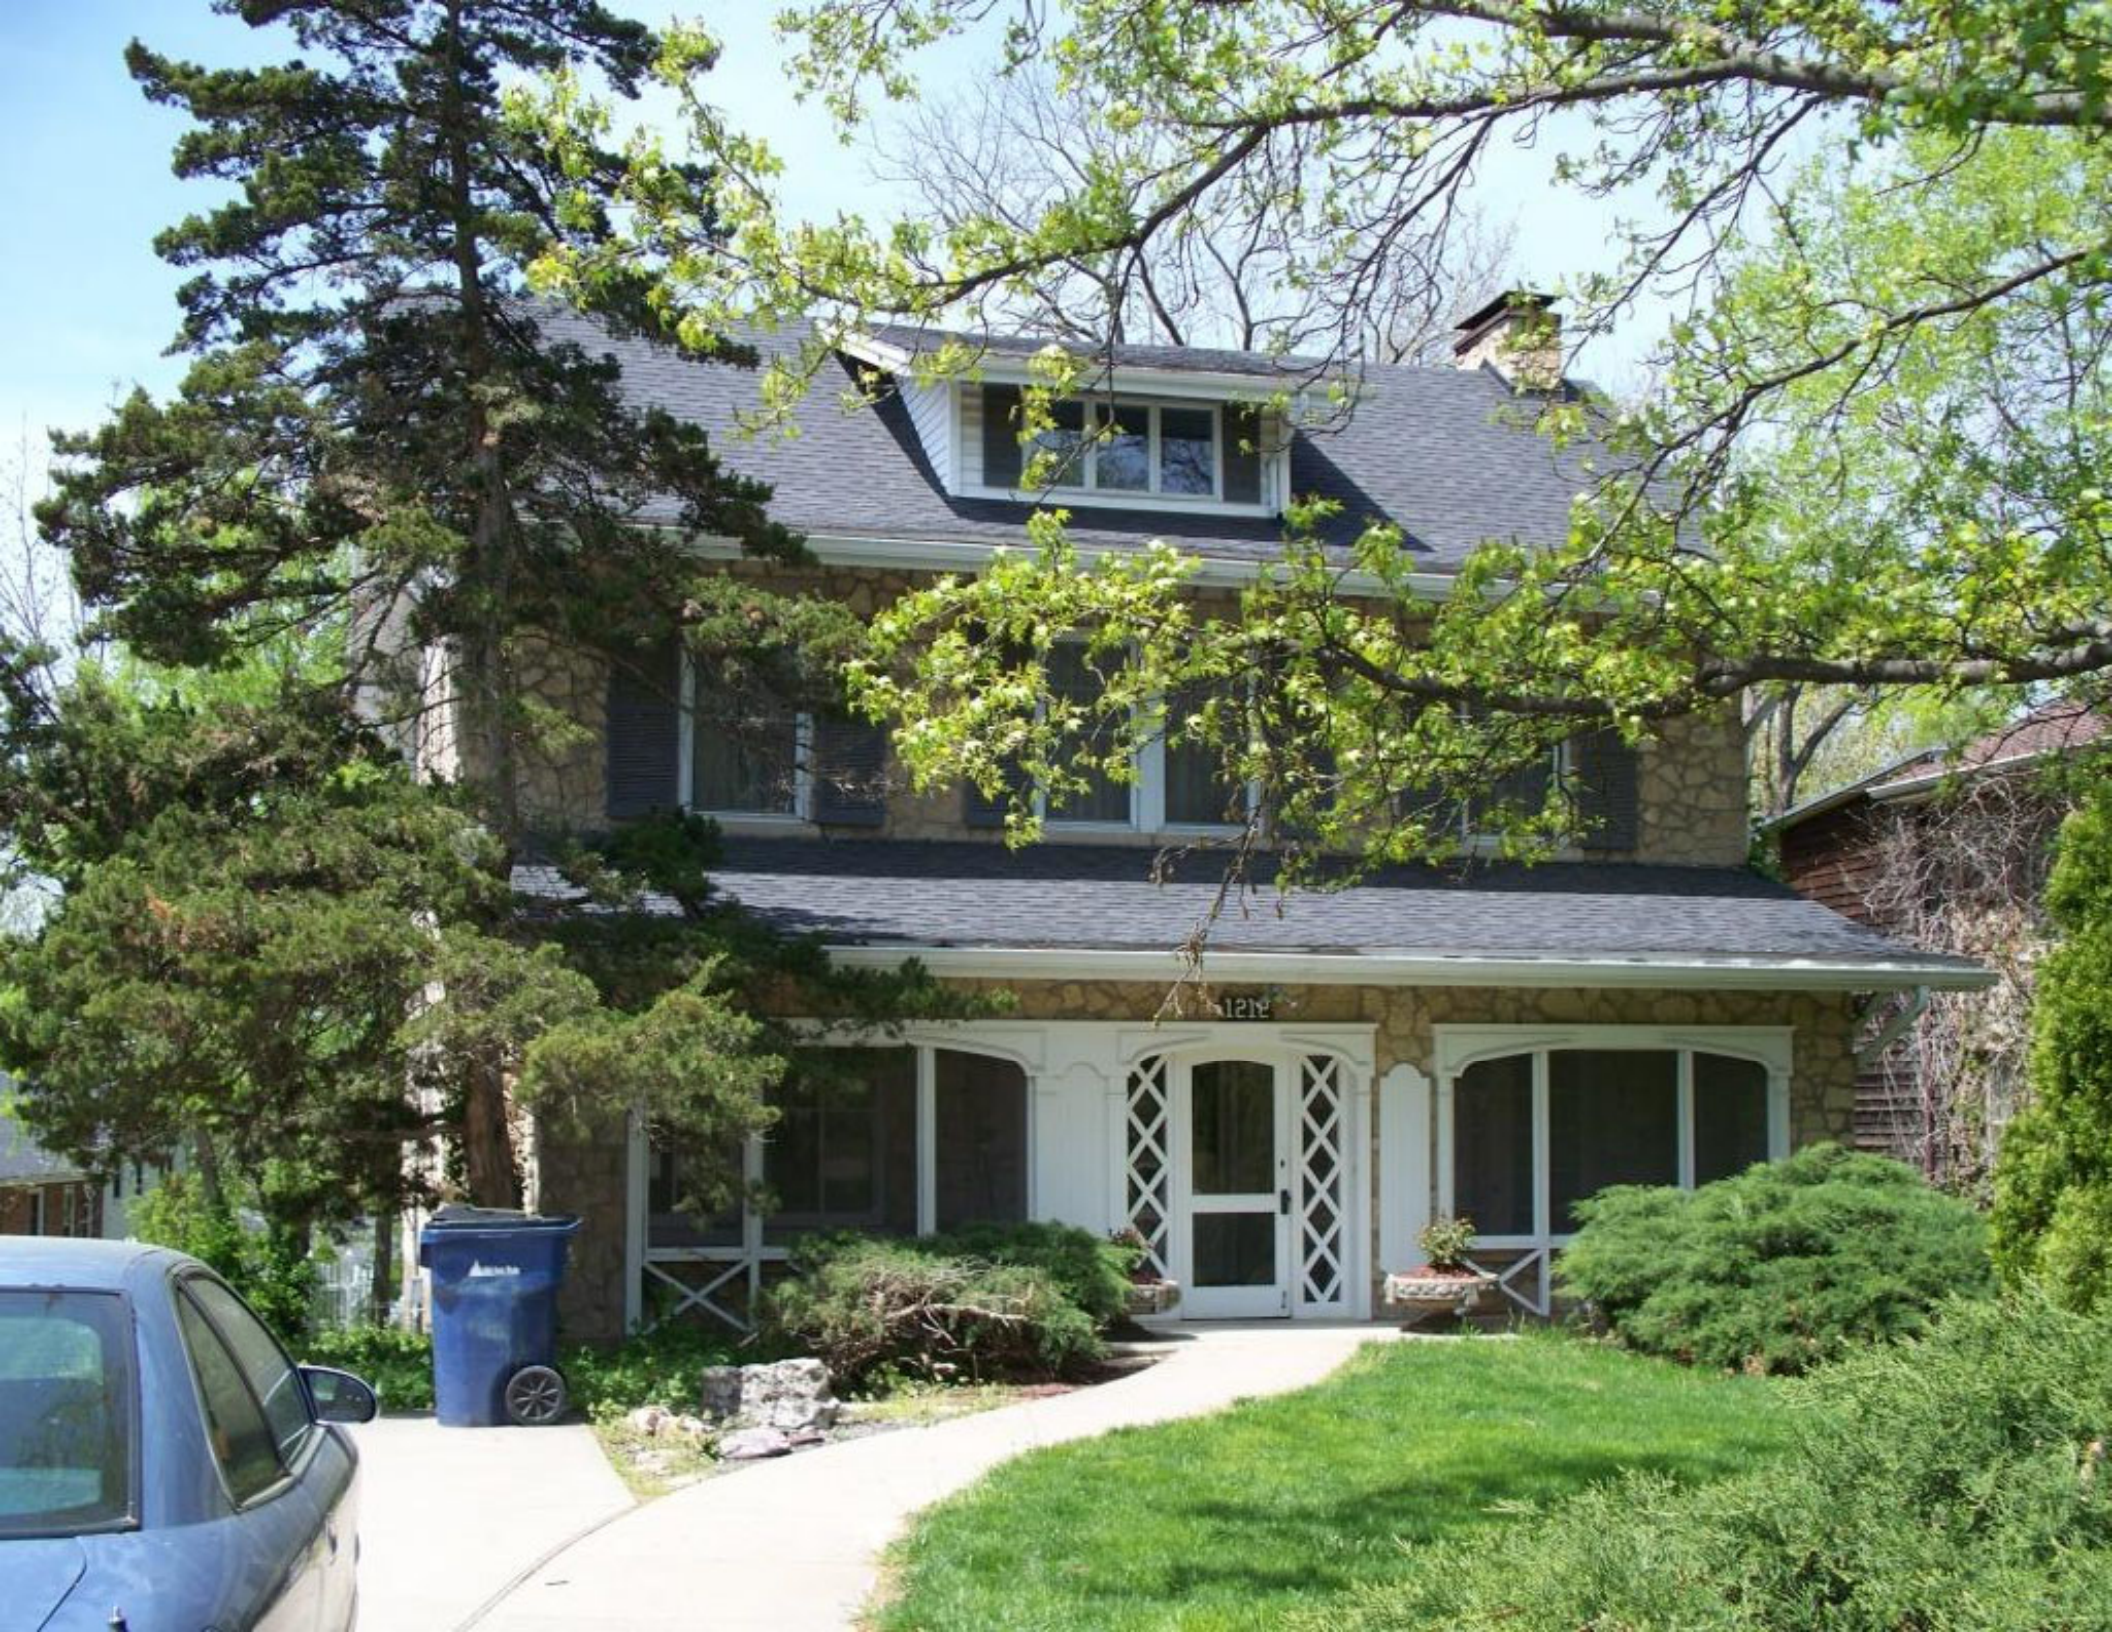
1212

This two-and-a-half (nearly three) story limestone house has a side-gable roof with central shed dormer with three casement windows and shutters. The second story has two modern(?) 8/1 windows flanking paired 6/1 historic windows. These windows also have shutters. The details of the first story are hard to make out as the full-width porch has been enclosed with screening. However there appears to be a secondary double-door entrance in addition to the central entrance. There are large paired windows in the left bay. It is unknown if they are historic or not. The porch extends from the property and features stone surrounds and a shed roof.
