ARCHITECTURAL/HISTORIC INVENTORY FORM

1. Survey No. CO-AS-005-001		2. Survey name: Moreau Drive Neighborhood Survey	
3. County: Cole		4. Address: 1202 Elmerine Ave.	
5. City: Jefferson City	Vicinity: <input type="checkbox"/>	6. UTM: / /	7. Township/Range/Section: T: R: S:
8. Historic name (if known):		9. Present/other name (if known):	
10. Ownership: <input checked="" type="checkbox"/> Private <input type="checkbox"/> Public		11. Historic use (if known): Residential	11. Current use: Residential

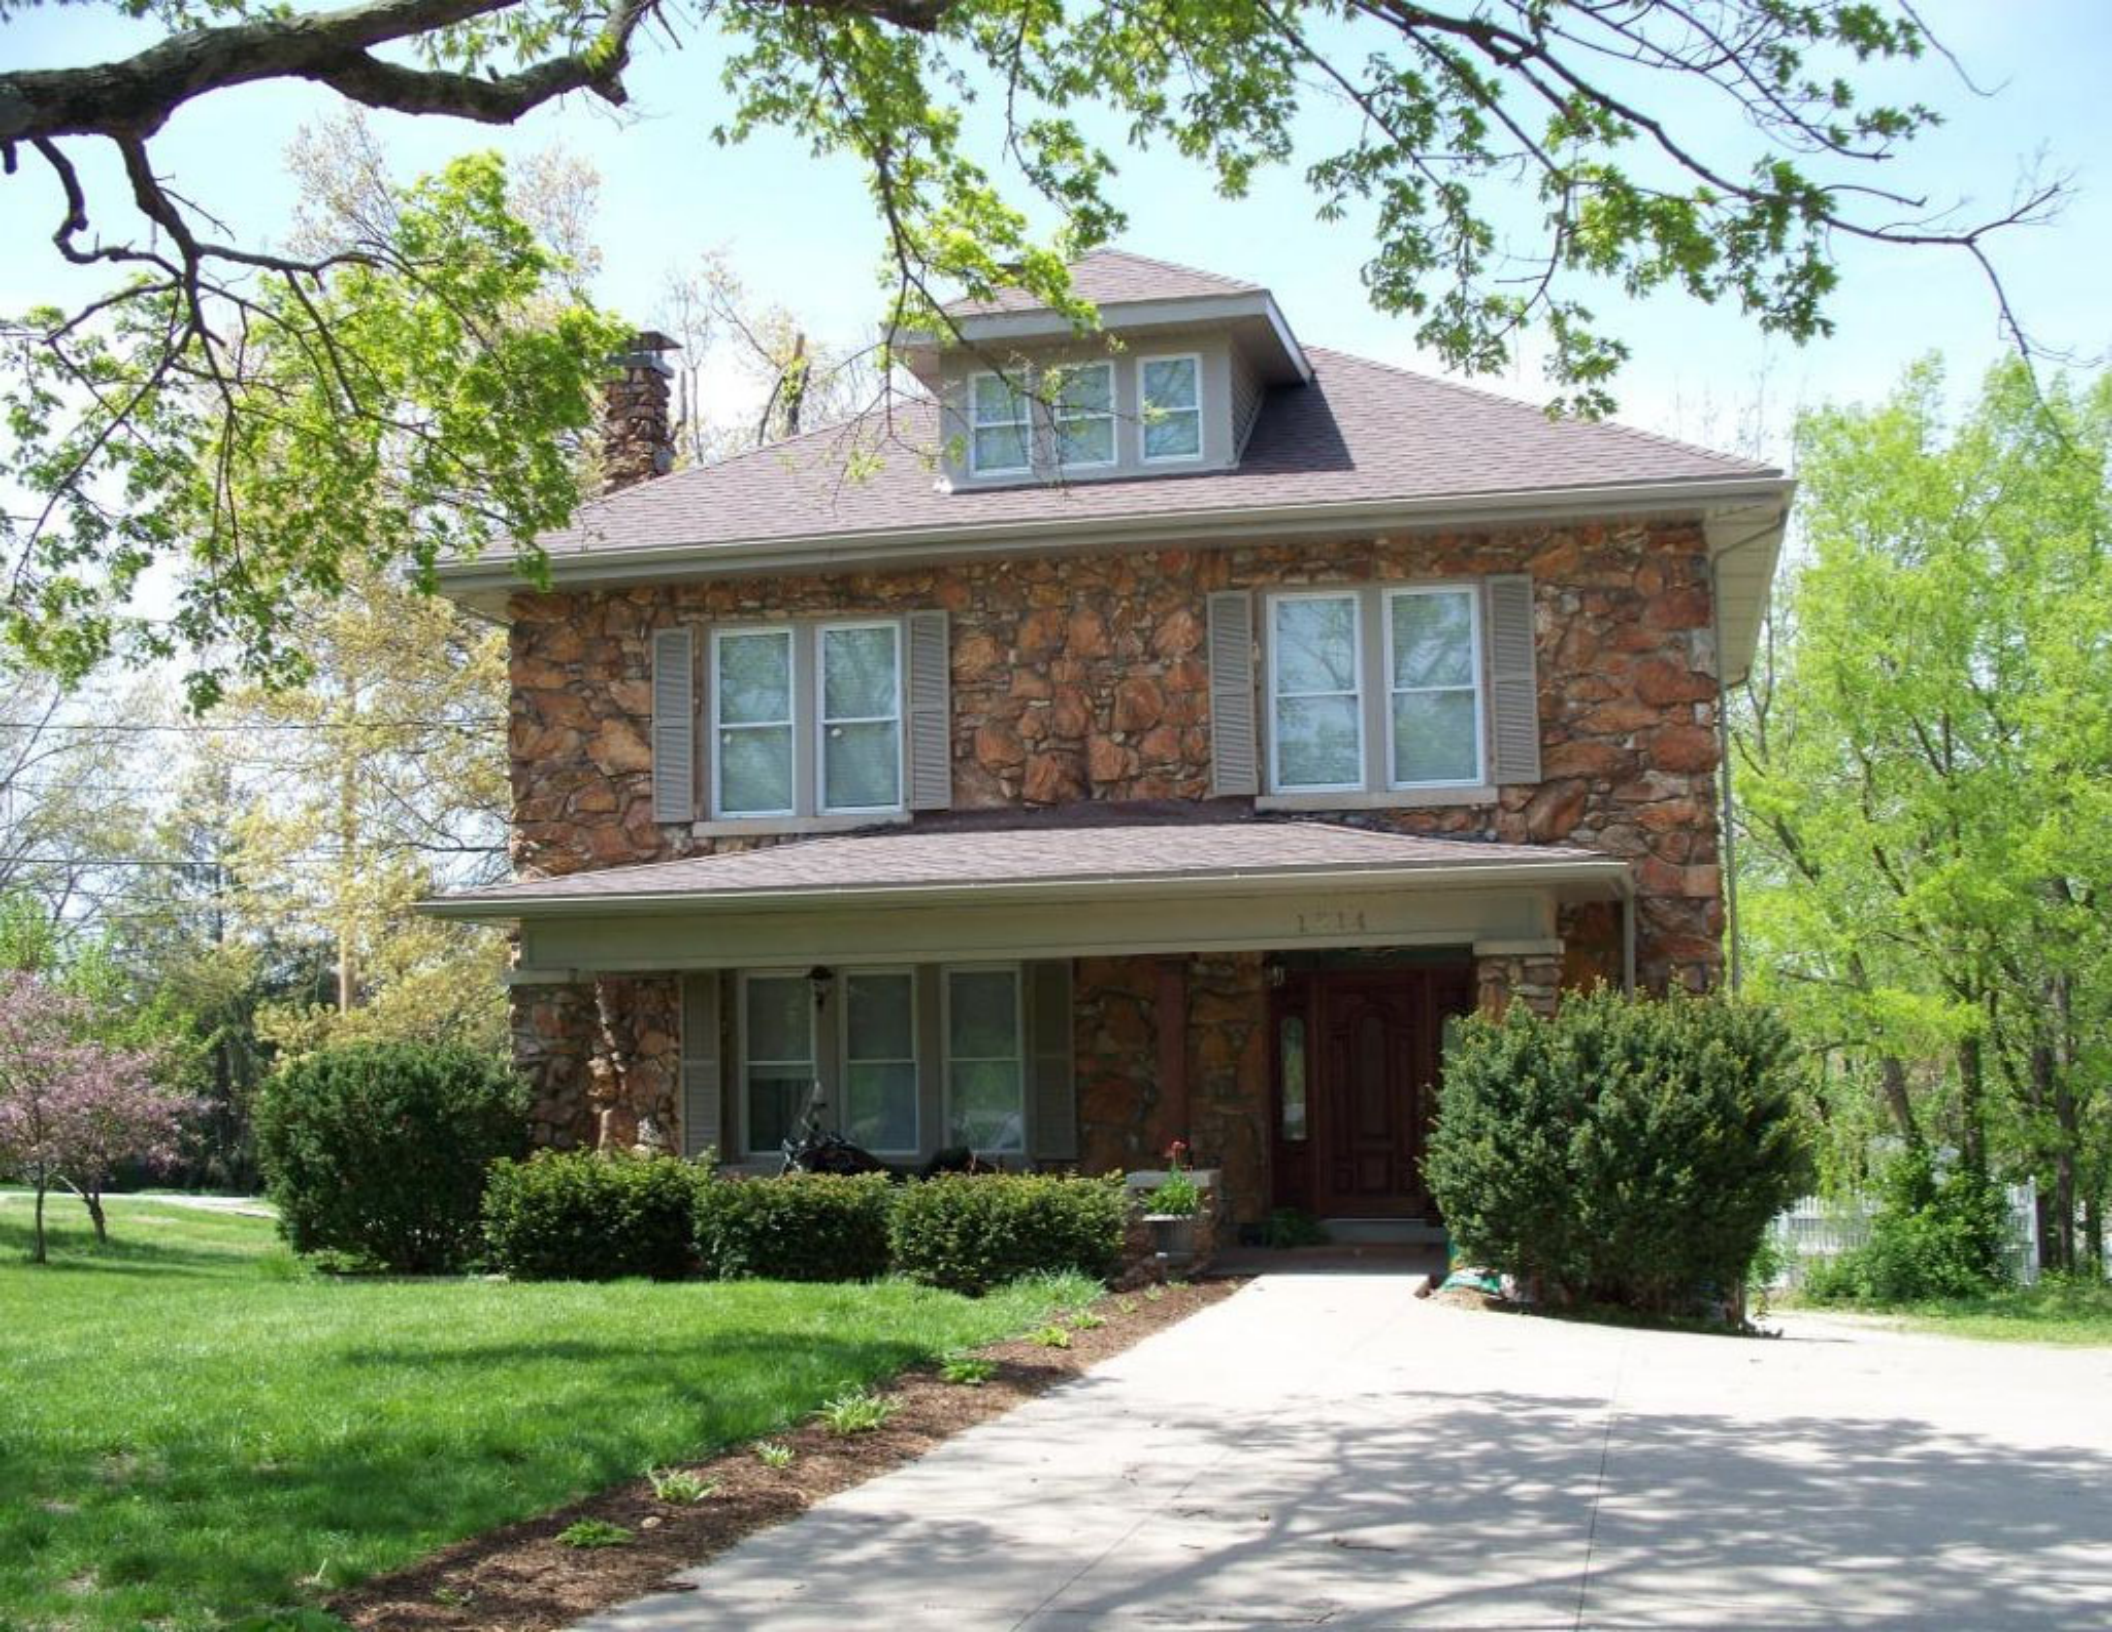
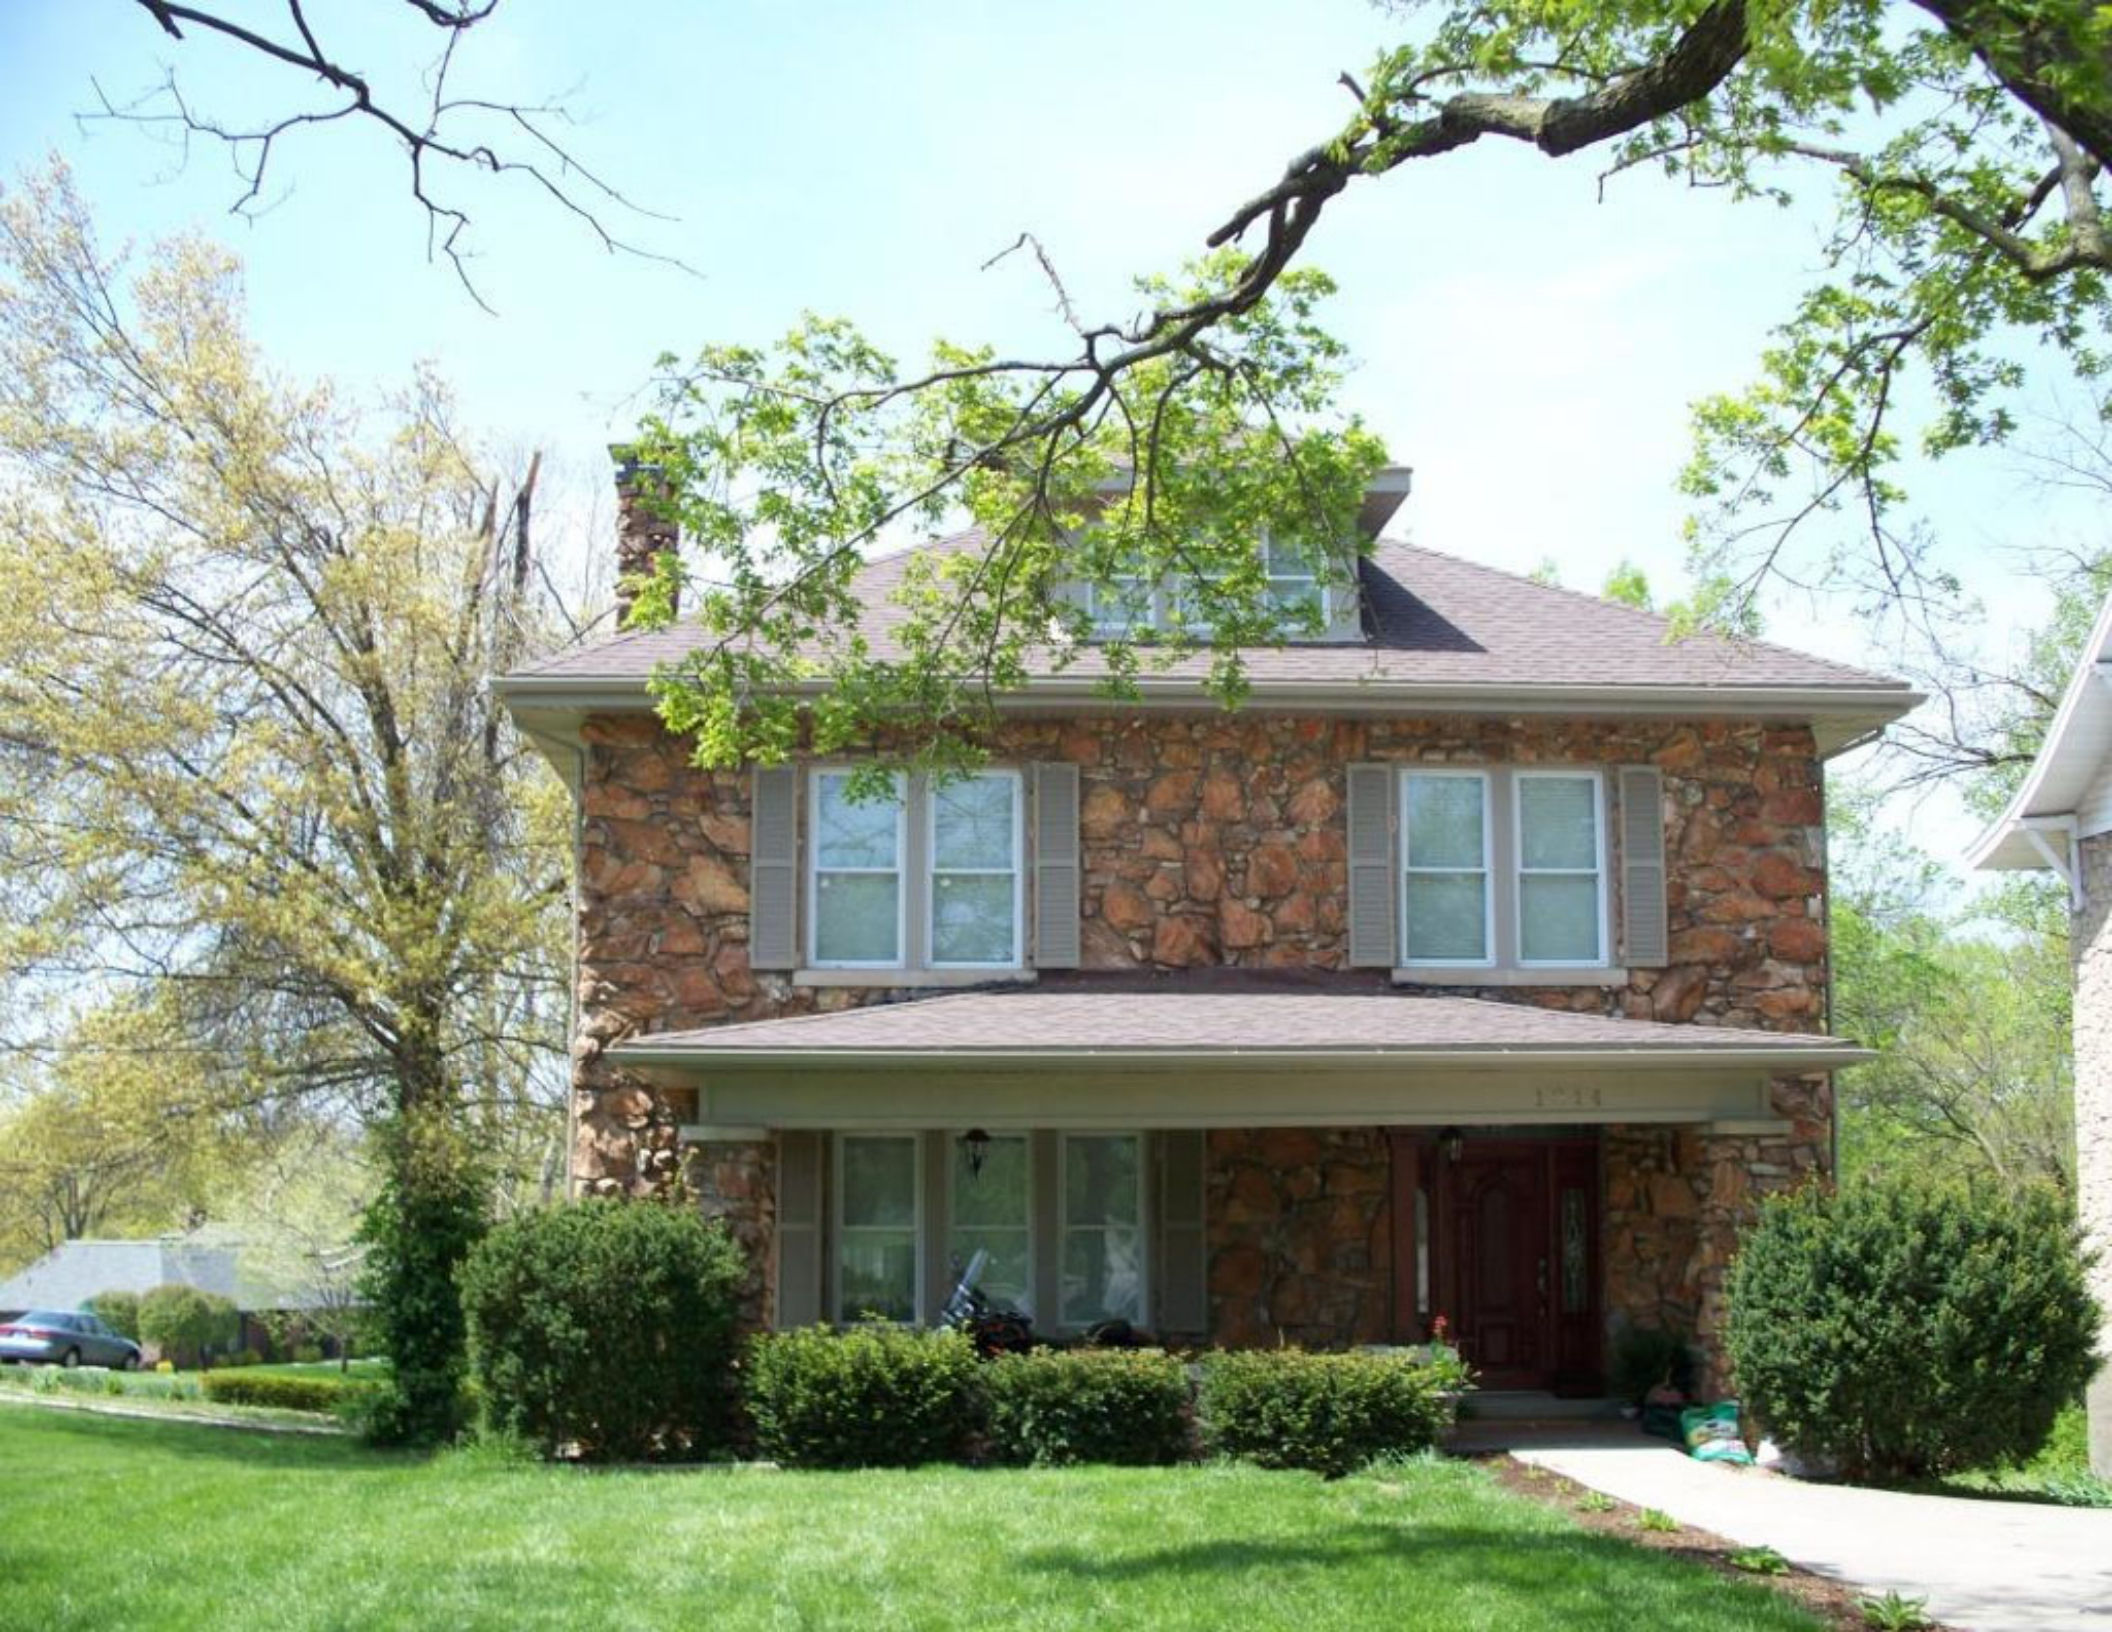
This two-and-a-half-story stone Colonial Revival has a pyramidal roof with a central pyramidal dormers with three 1/1 vinyl windows. The second floor has paired 1/1 vinyl windows and shutters. Likewise there are a row of three vinyl 1/1 windows with shutters in the left bay on the first floor. The entrance is located in the right bay and has sidelights, double-doors, and a transom. It's unknown if this is modern or historic. The full-width porch has stone pillars and a single wooden post on a stone pier. A stone chimney extends on the left side of the property.

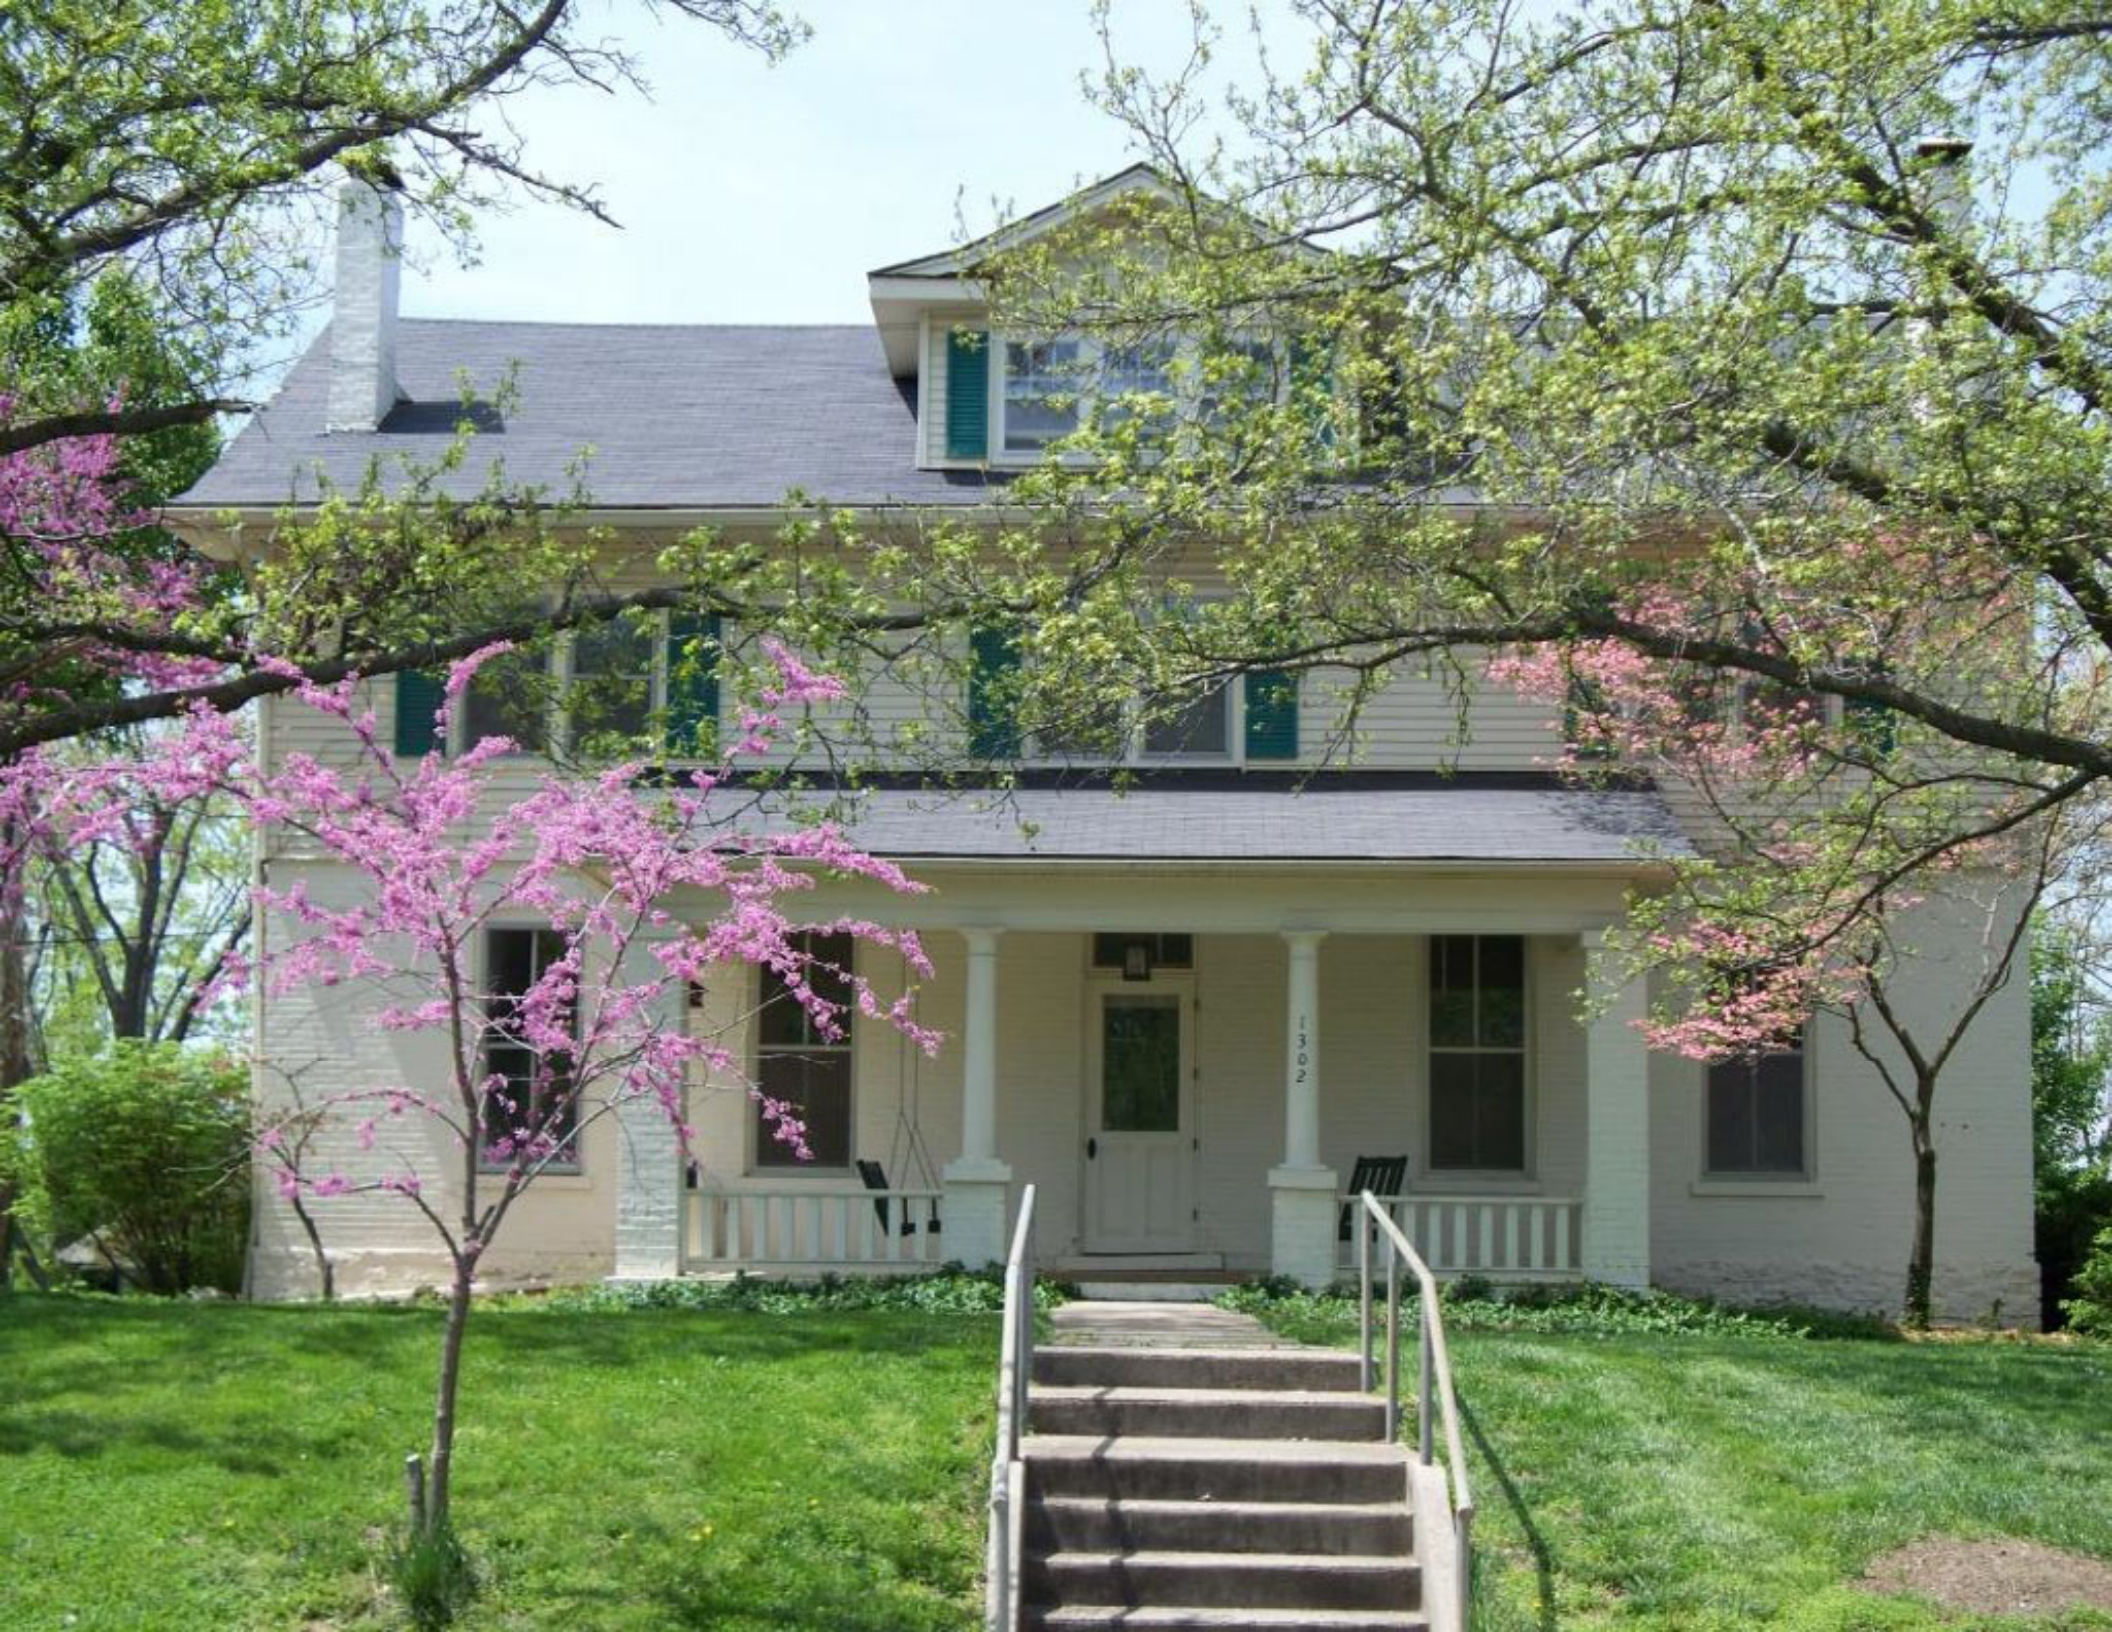
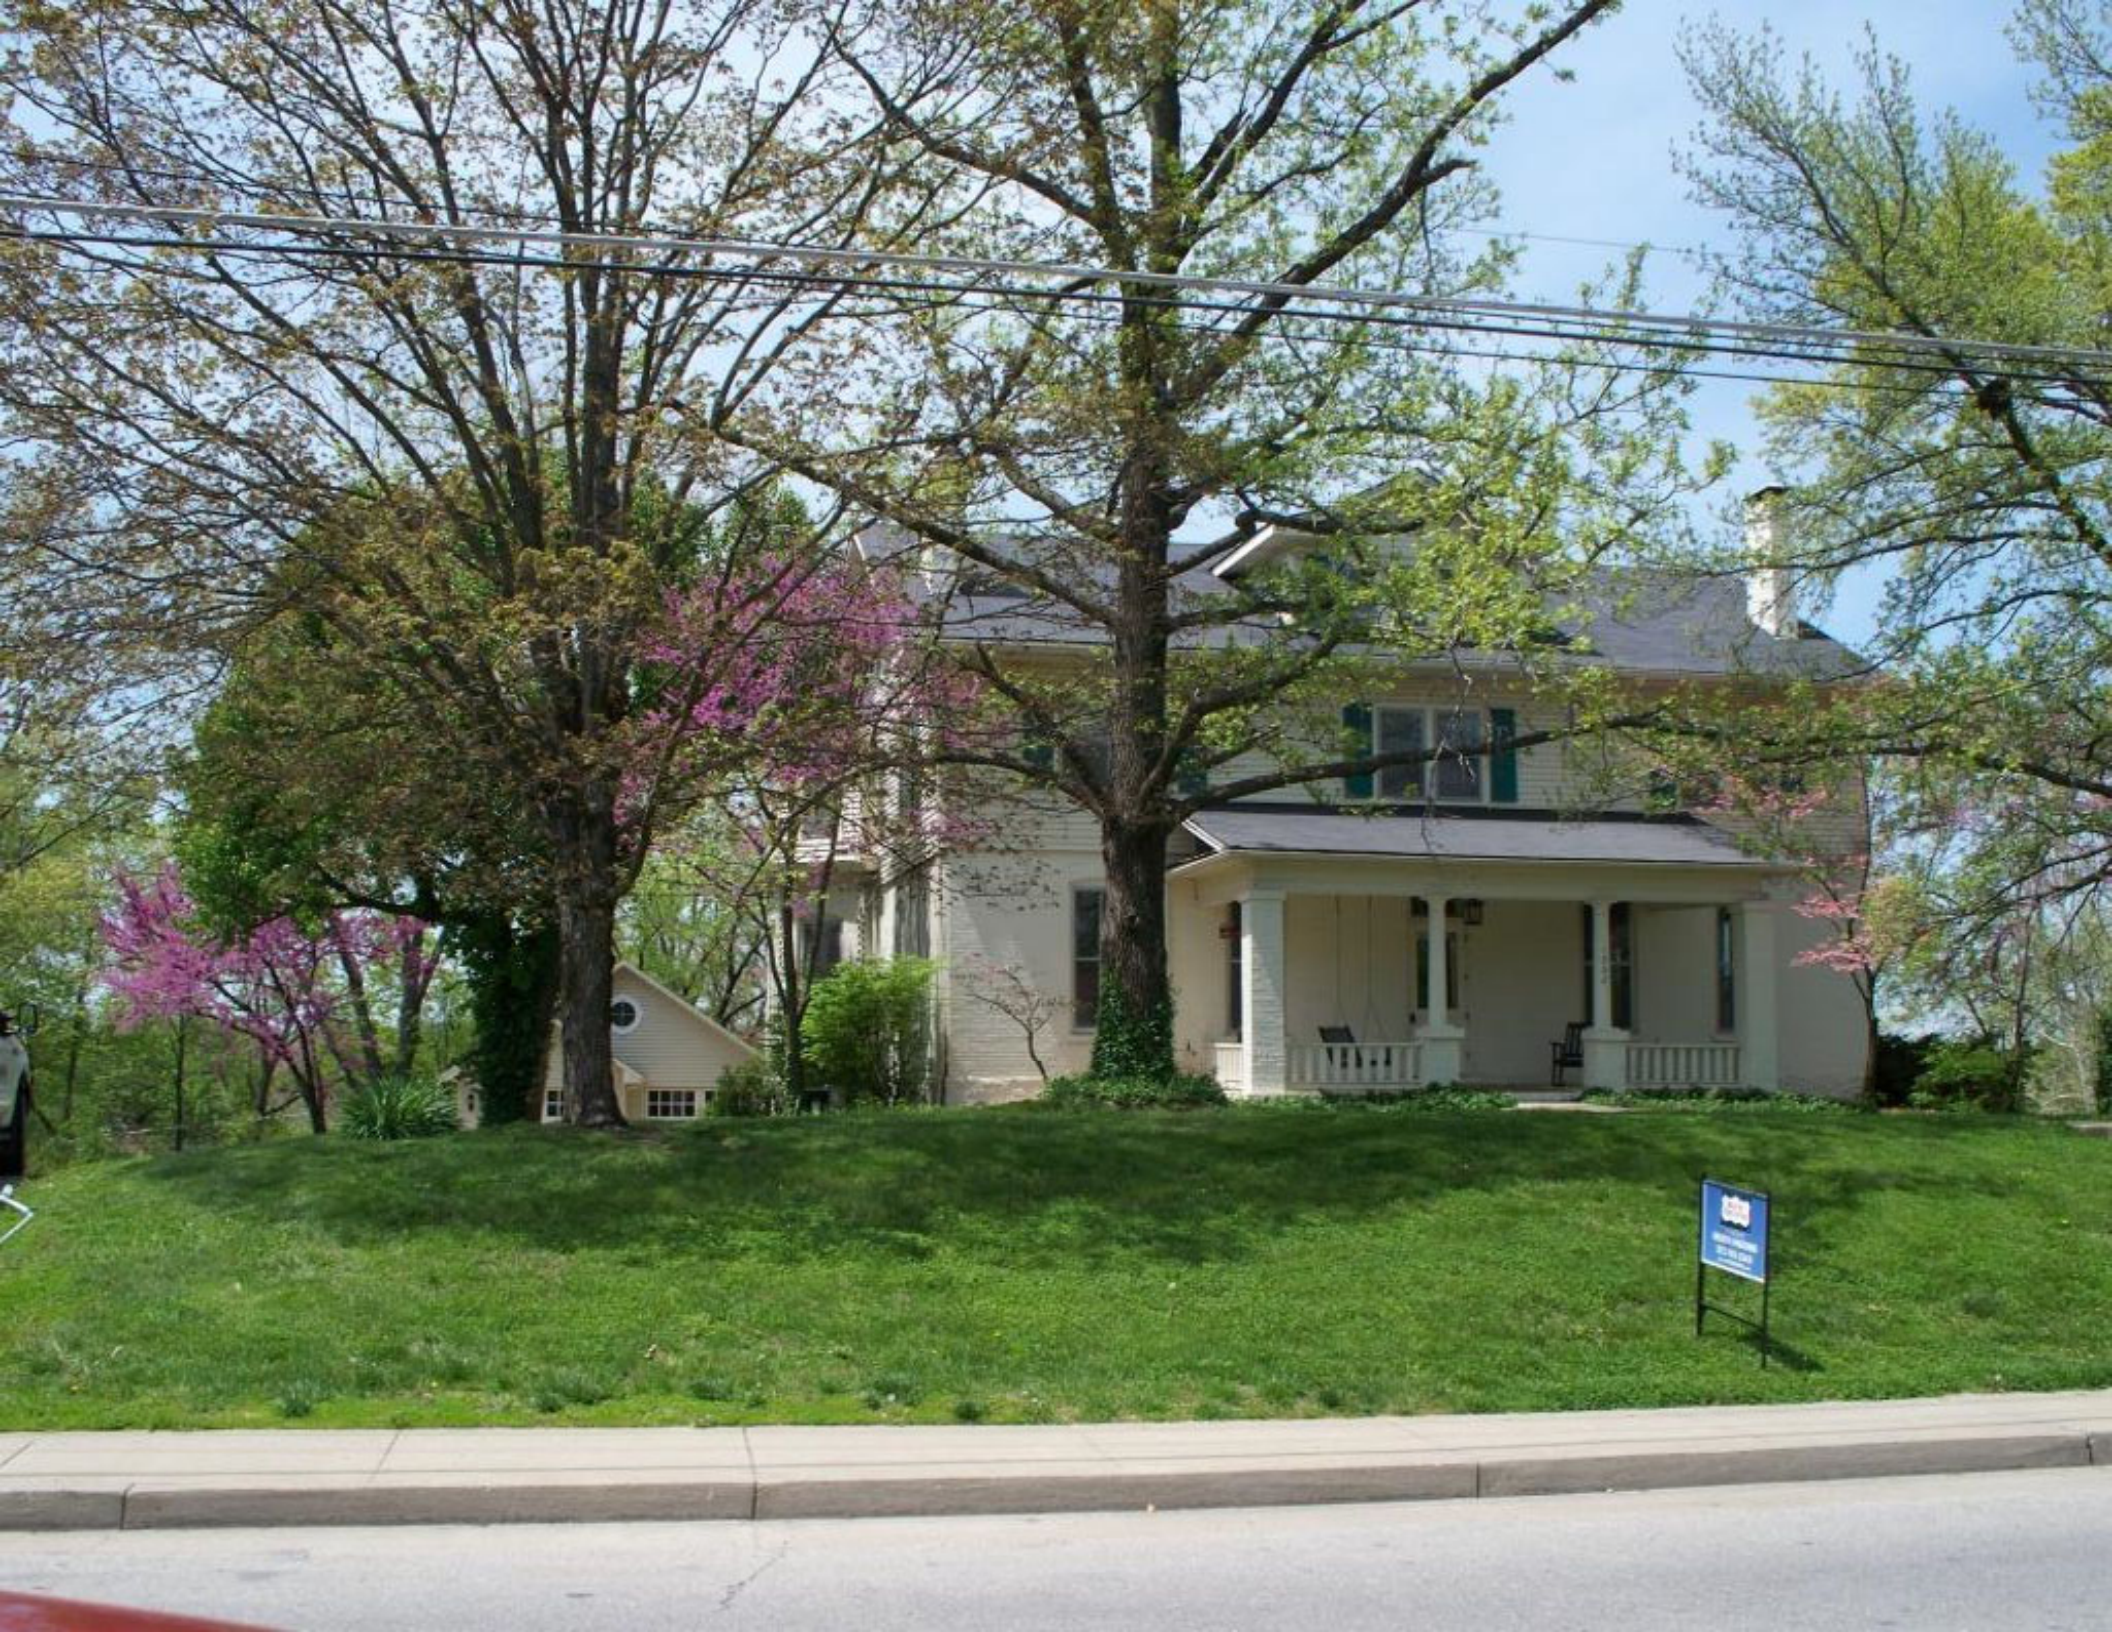
According to the Cole County Tax Assessors website, this cross gable one-story brick ranch was built in 1956 but its possible it was constructed much later. The first two bays (from the left) project slightly from the rest of the property and has the front gable of the cross gable roof. It contains two sets of paired 1/1 windows with screens and shutters. The third bay (from the left) contains the entrance with sidelights. The last bay has a row of four 1/1 windows with shutters. All windows have concrete sills. Due to its age it is currently considered non-contributing to the district. However if a 1960 period of significance or later is pursued it may contribute, however further research would be necessary to confirm its build date.

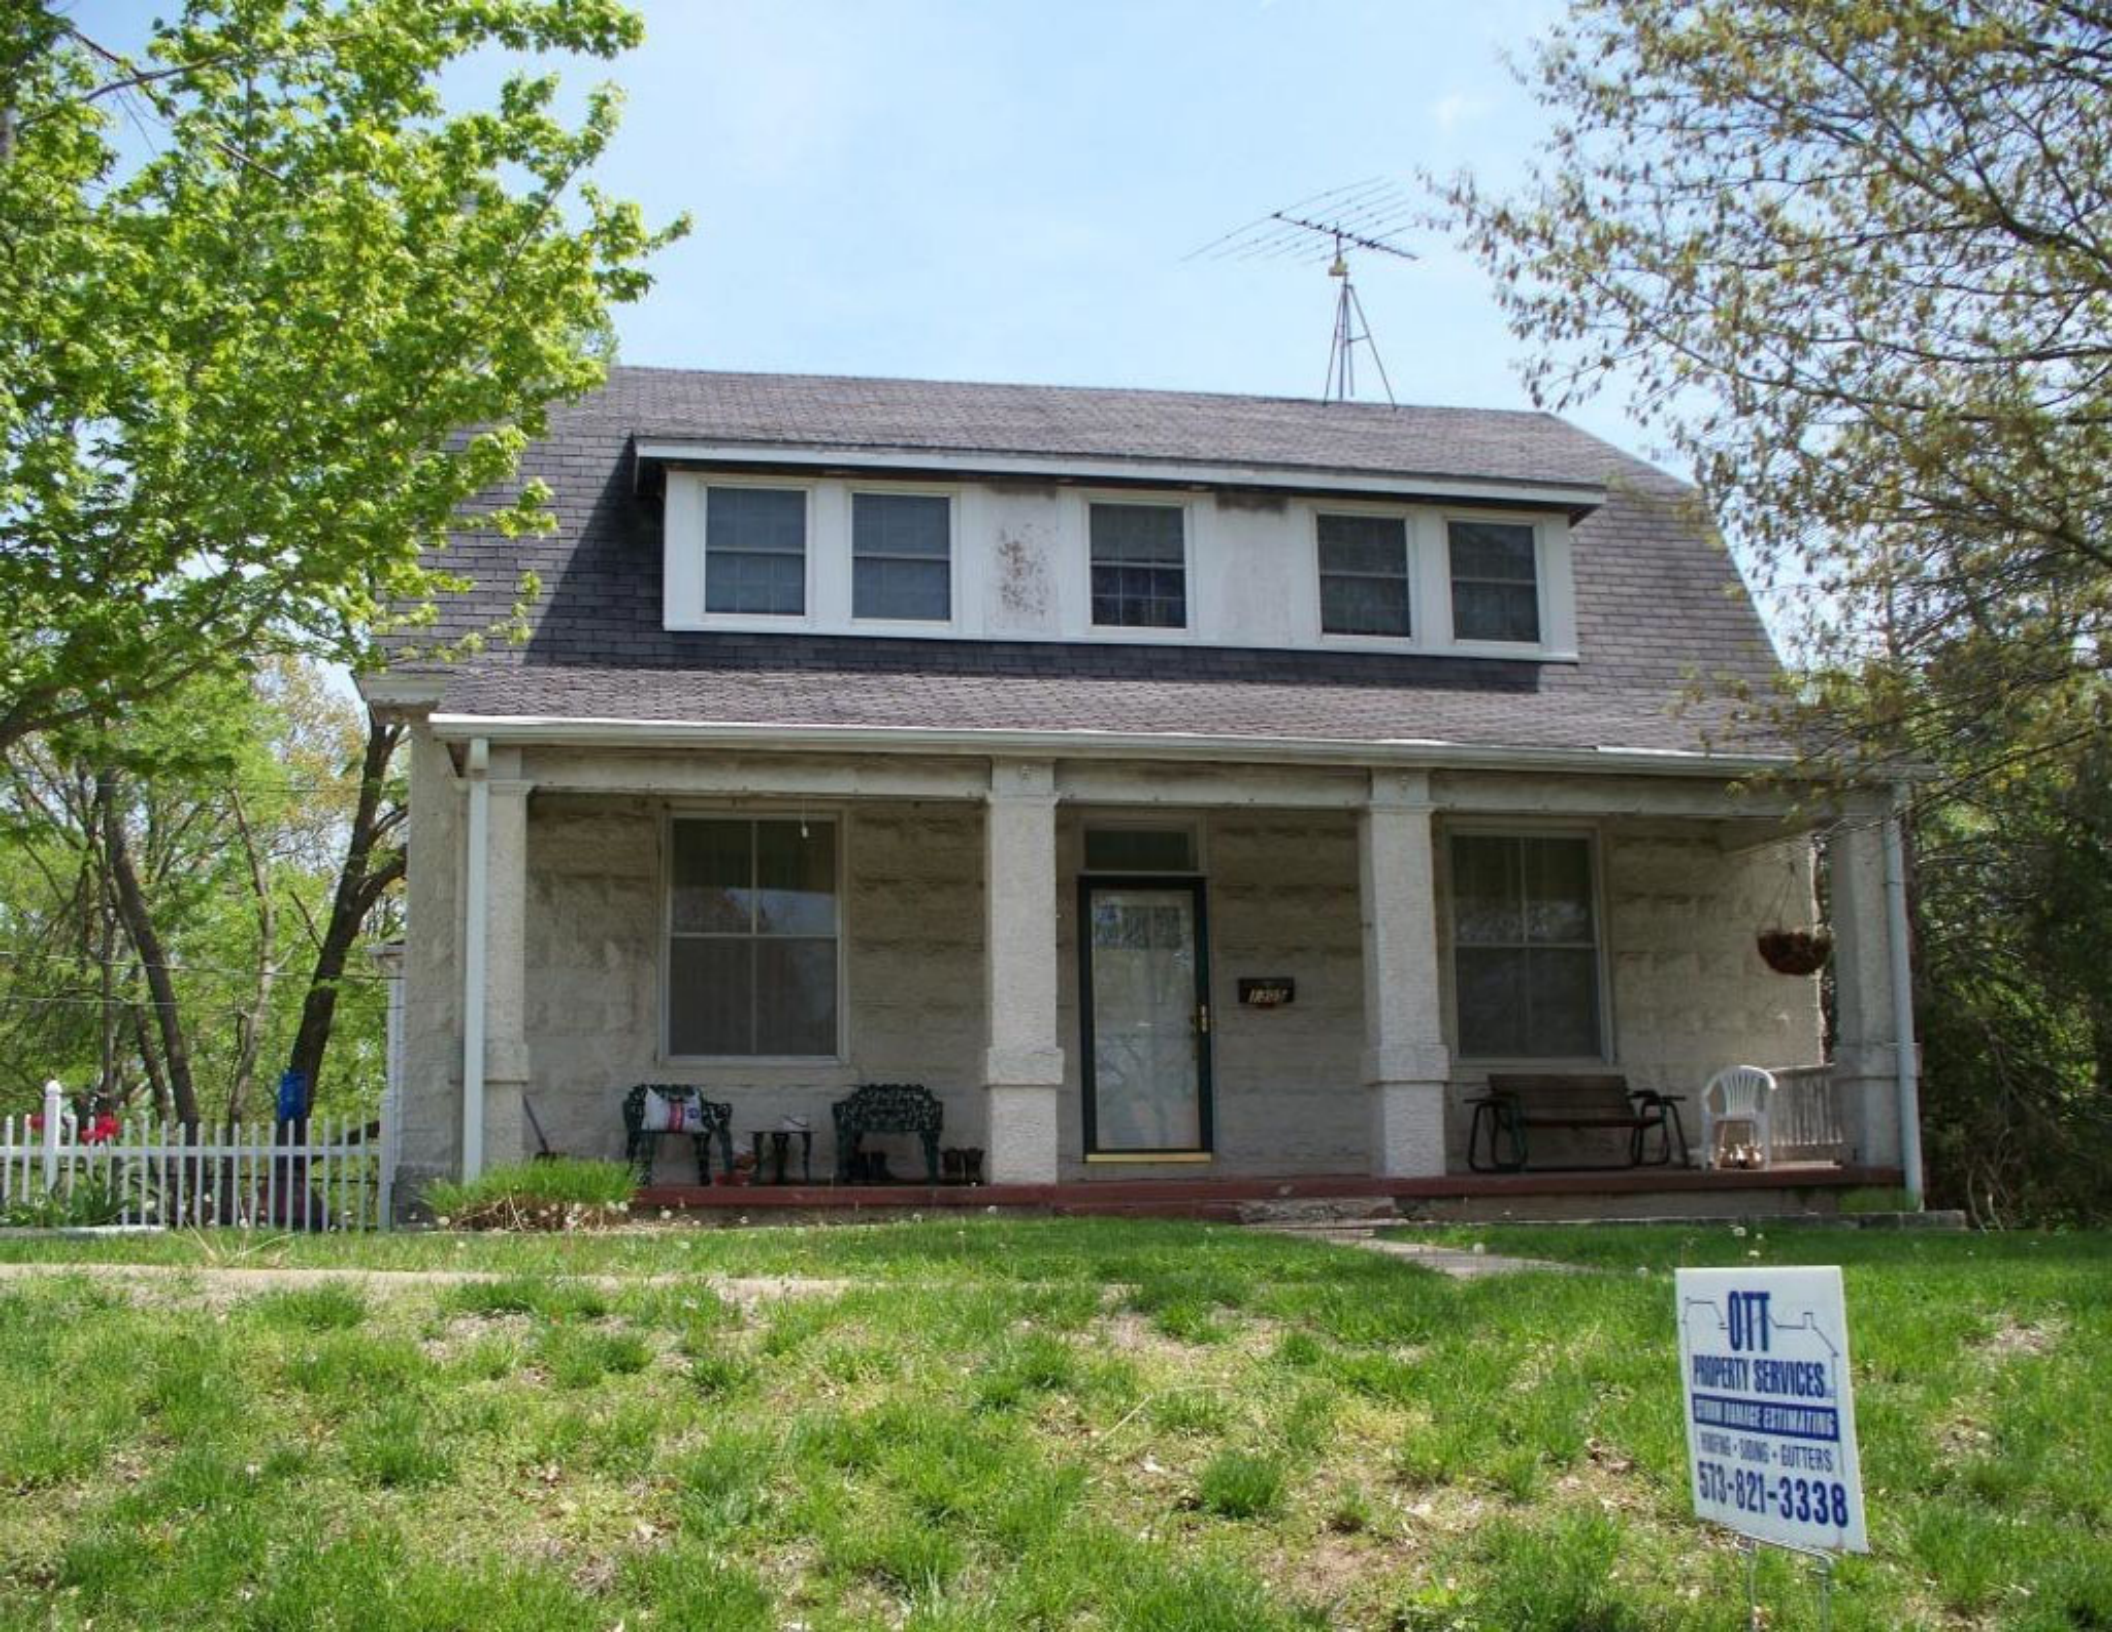
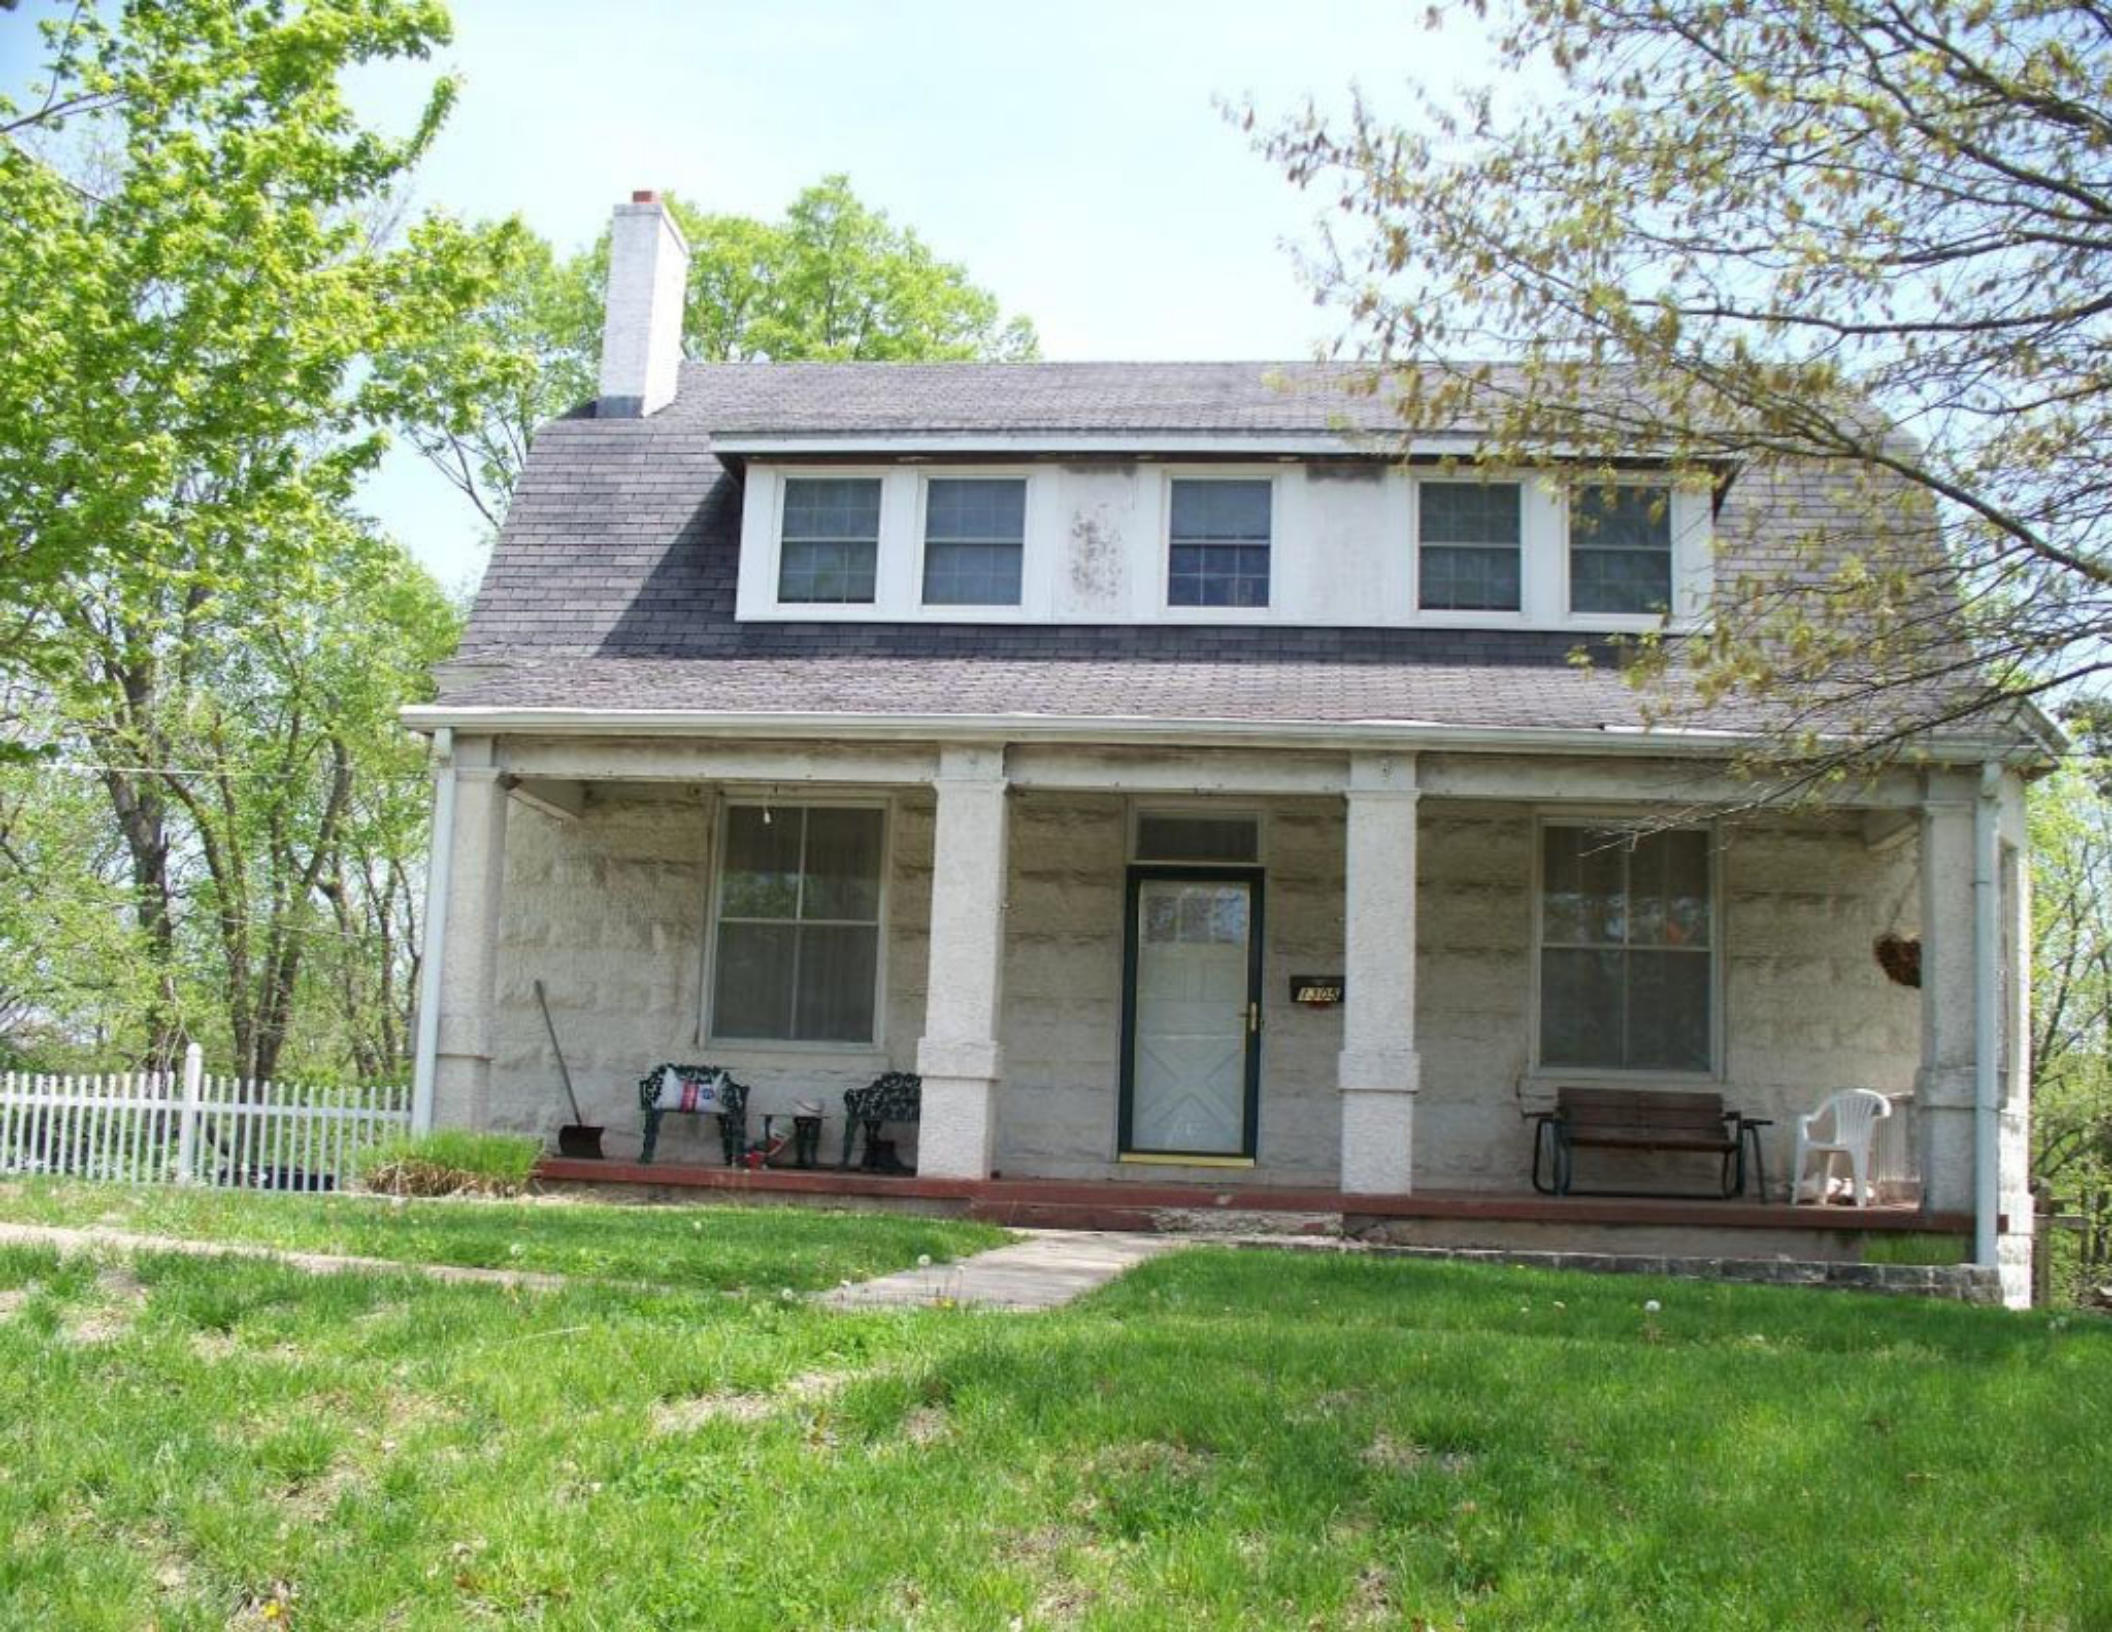
41. (cont.) This two-story Dutch Colonial has a side gambrel roof and a stamped block stucco or concrete façade that appears historic if not original to the property. The gallery porch has four square pillars on piers covered in the same material as the main façade. The entrance appears to retain its wooden original door with three fixed lights and transom. Although it's difficult to discern, the windows on either side of the door appear to be historic. The five windows in the dormer appear to be original 6 over 6. The dormer is centrally located and is nearly full width with a shed roof. A square chimney penetrates the roof on the left side of the building.
