ARCHITECTURAL/HISTORIC INVENTORY FORM

1. Survey No. CO-AS-005-001		2. Survey name: Moreau Drive Neighborhood Survey	
3. County: Cole		4. Address: 1202 Elmerine Ave.	
5. City: Jefferson City	Vicinity: <input type="checkbox"/>	6. UTM: / /	7. Township/Range/Section: T: R: S:
8. Historic name (if known):		9. Present/other name (if known):	
10. Ownership: <input checked="" type="checkbox"/> Private <input type="checkbox"/> Public		11. Historic use (if known): Residential	11. Current use: Residential

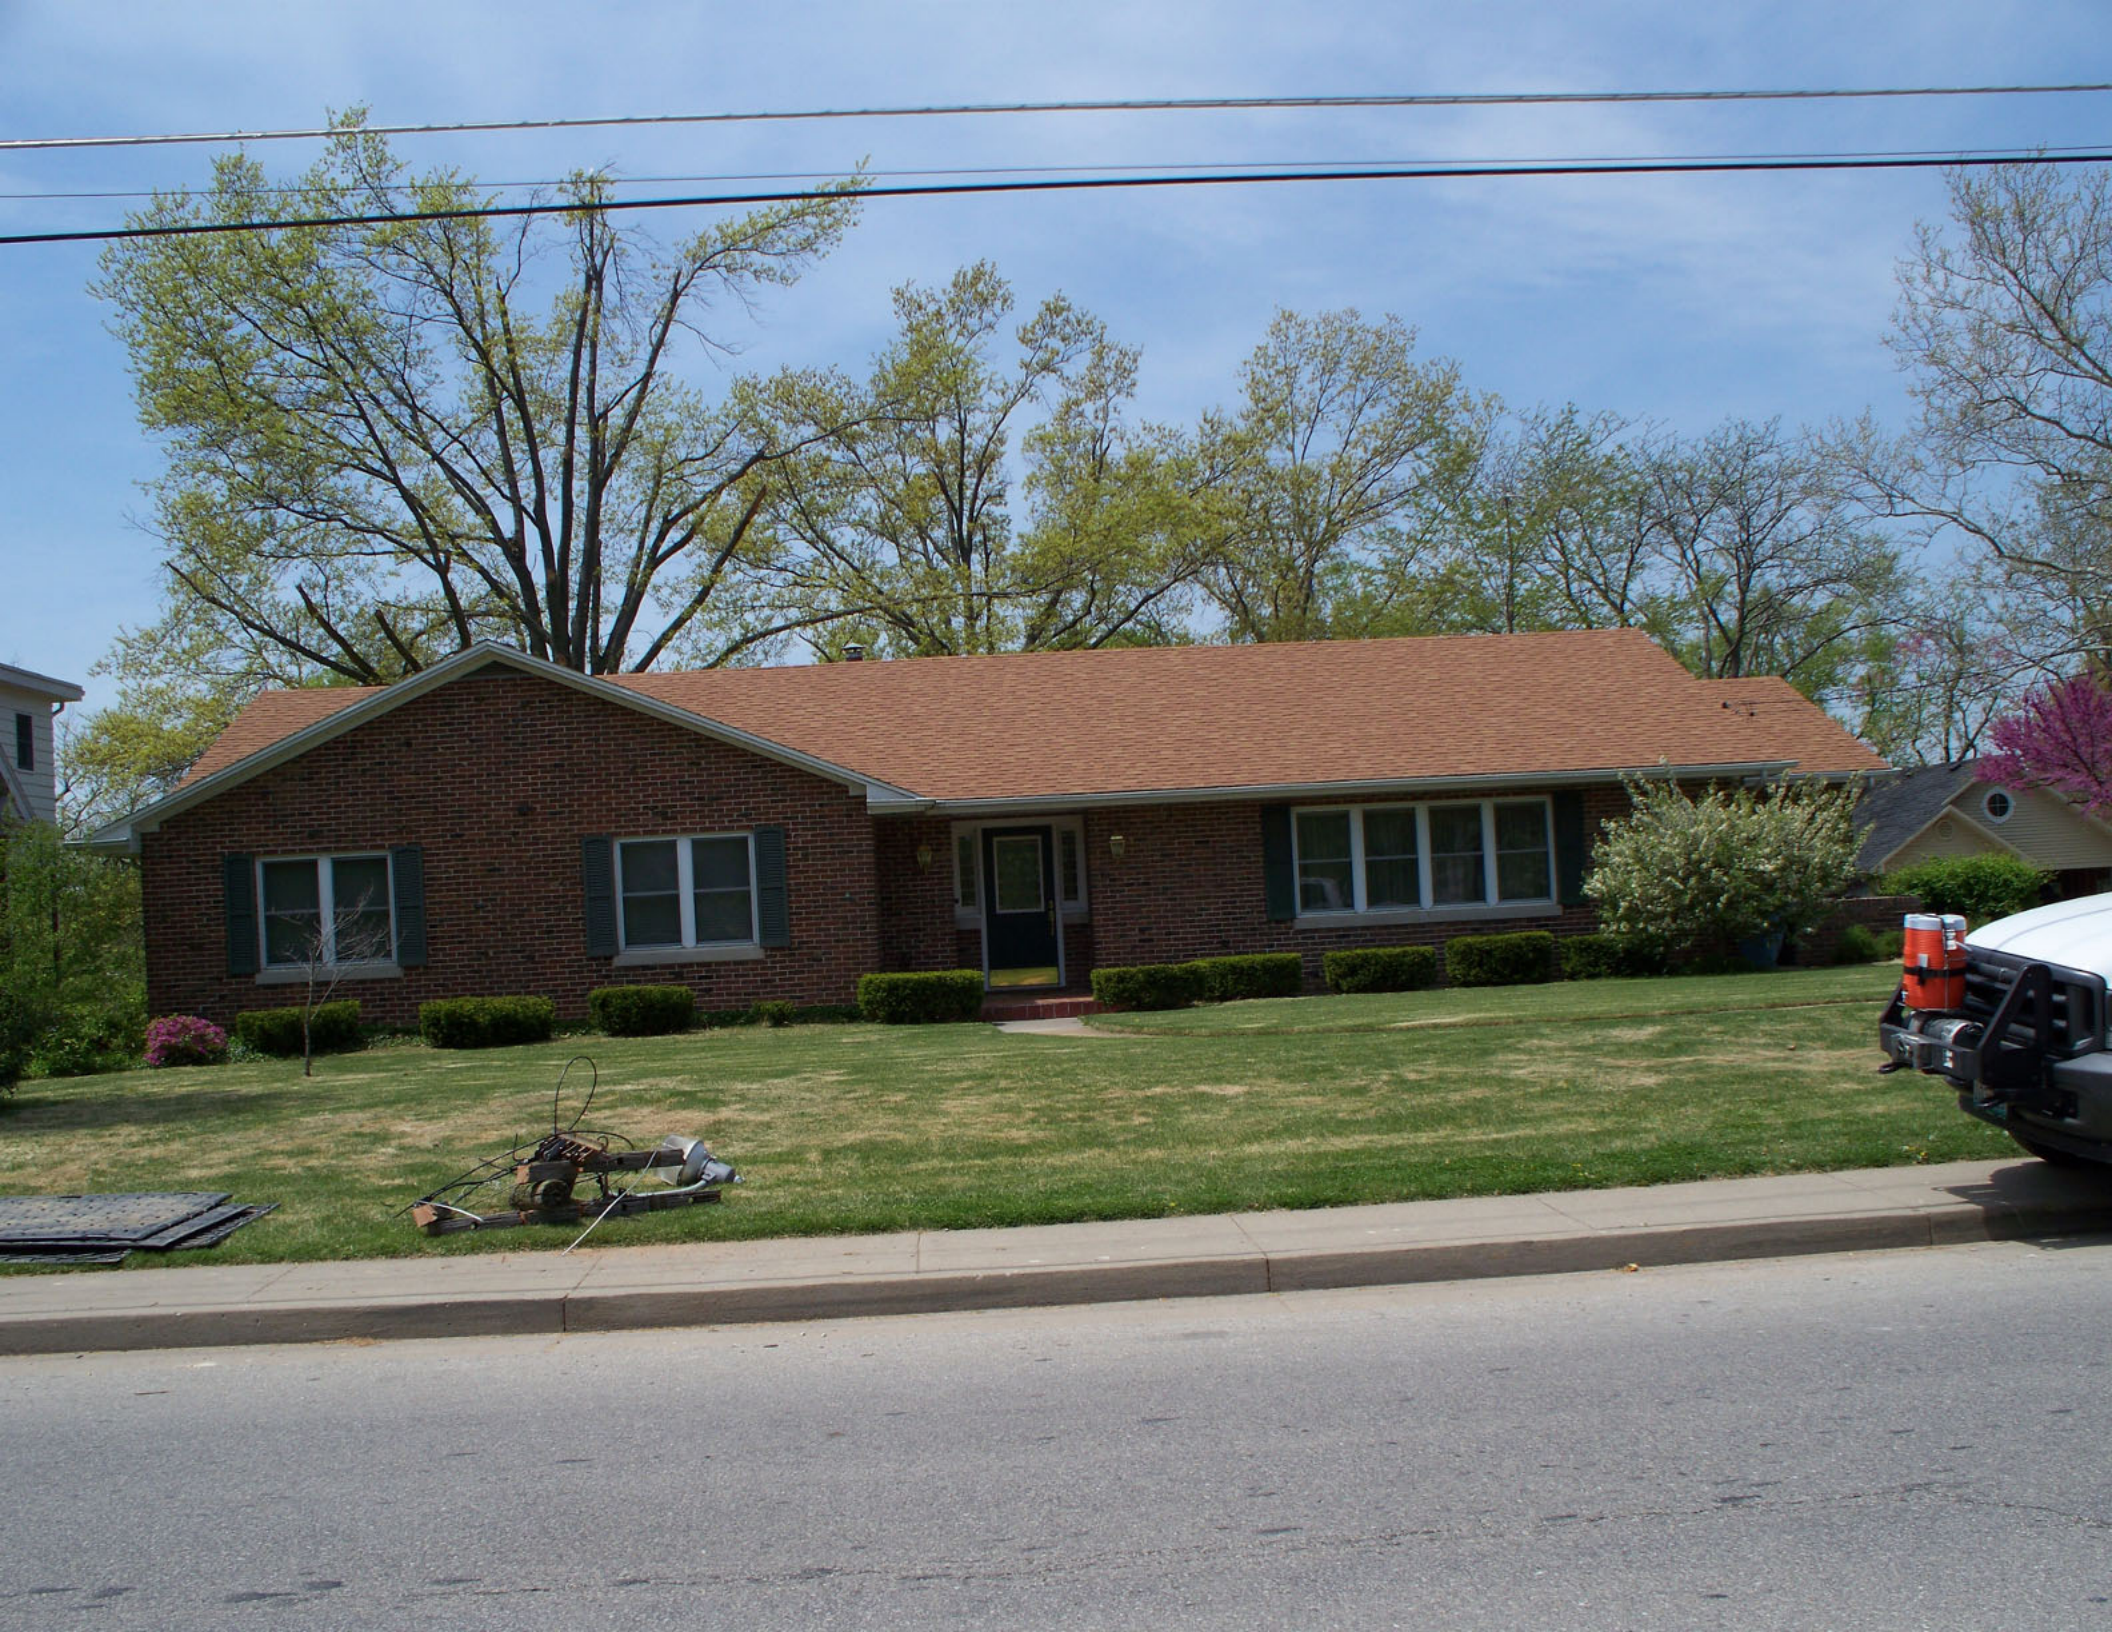
According to the Cole County Tax Assessors website, this cross gable one-story brick ranch was built in 1956 but it's possible it was constructed much later. The first two bays (from the left) project slightly from the rest of the property and has the front gable of the cross gable roof. It contains two sets of paired 1/1 windows with screens and shutters. The third bay (from the left) contains the entrance with sidelights. The last bay has a row of four 1/1 windows with shutters. All windows have concrete sills. Due to its age it is currently considered non-contributing to the district. However if a 1960 period of significance or later is pursued it may contribute, however further research would be necessary to confirm its build date.

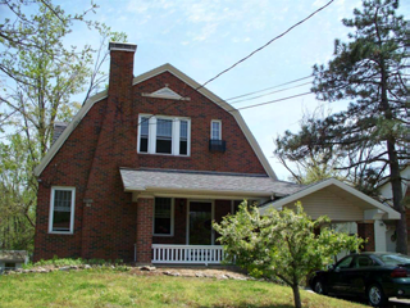
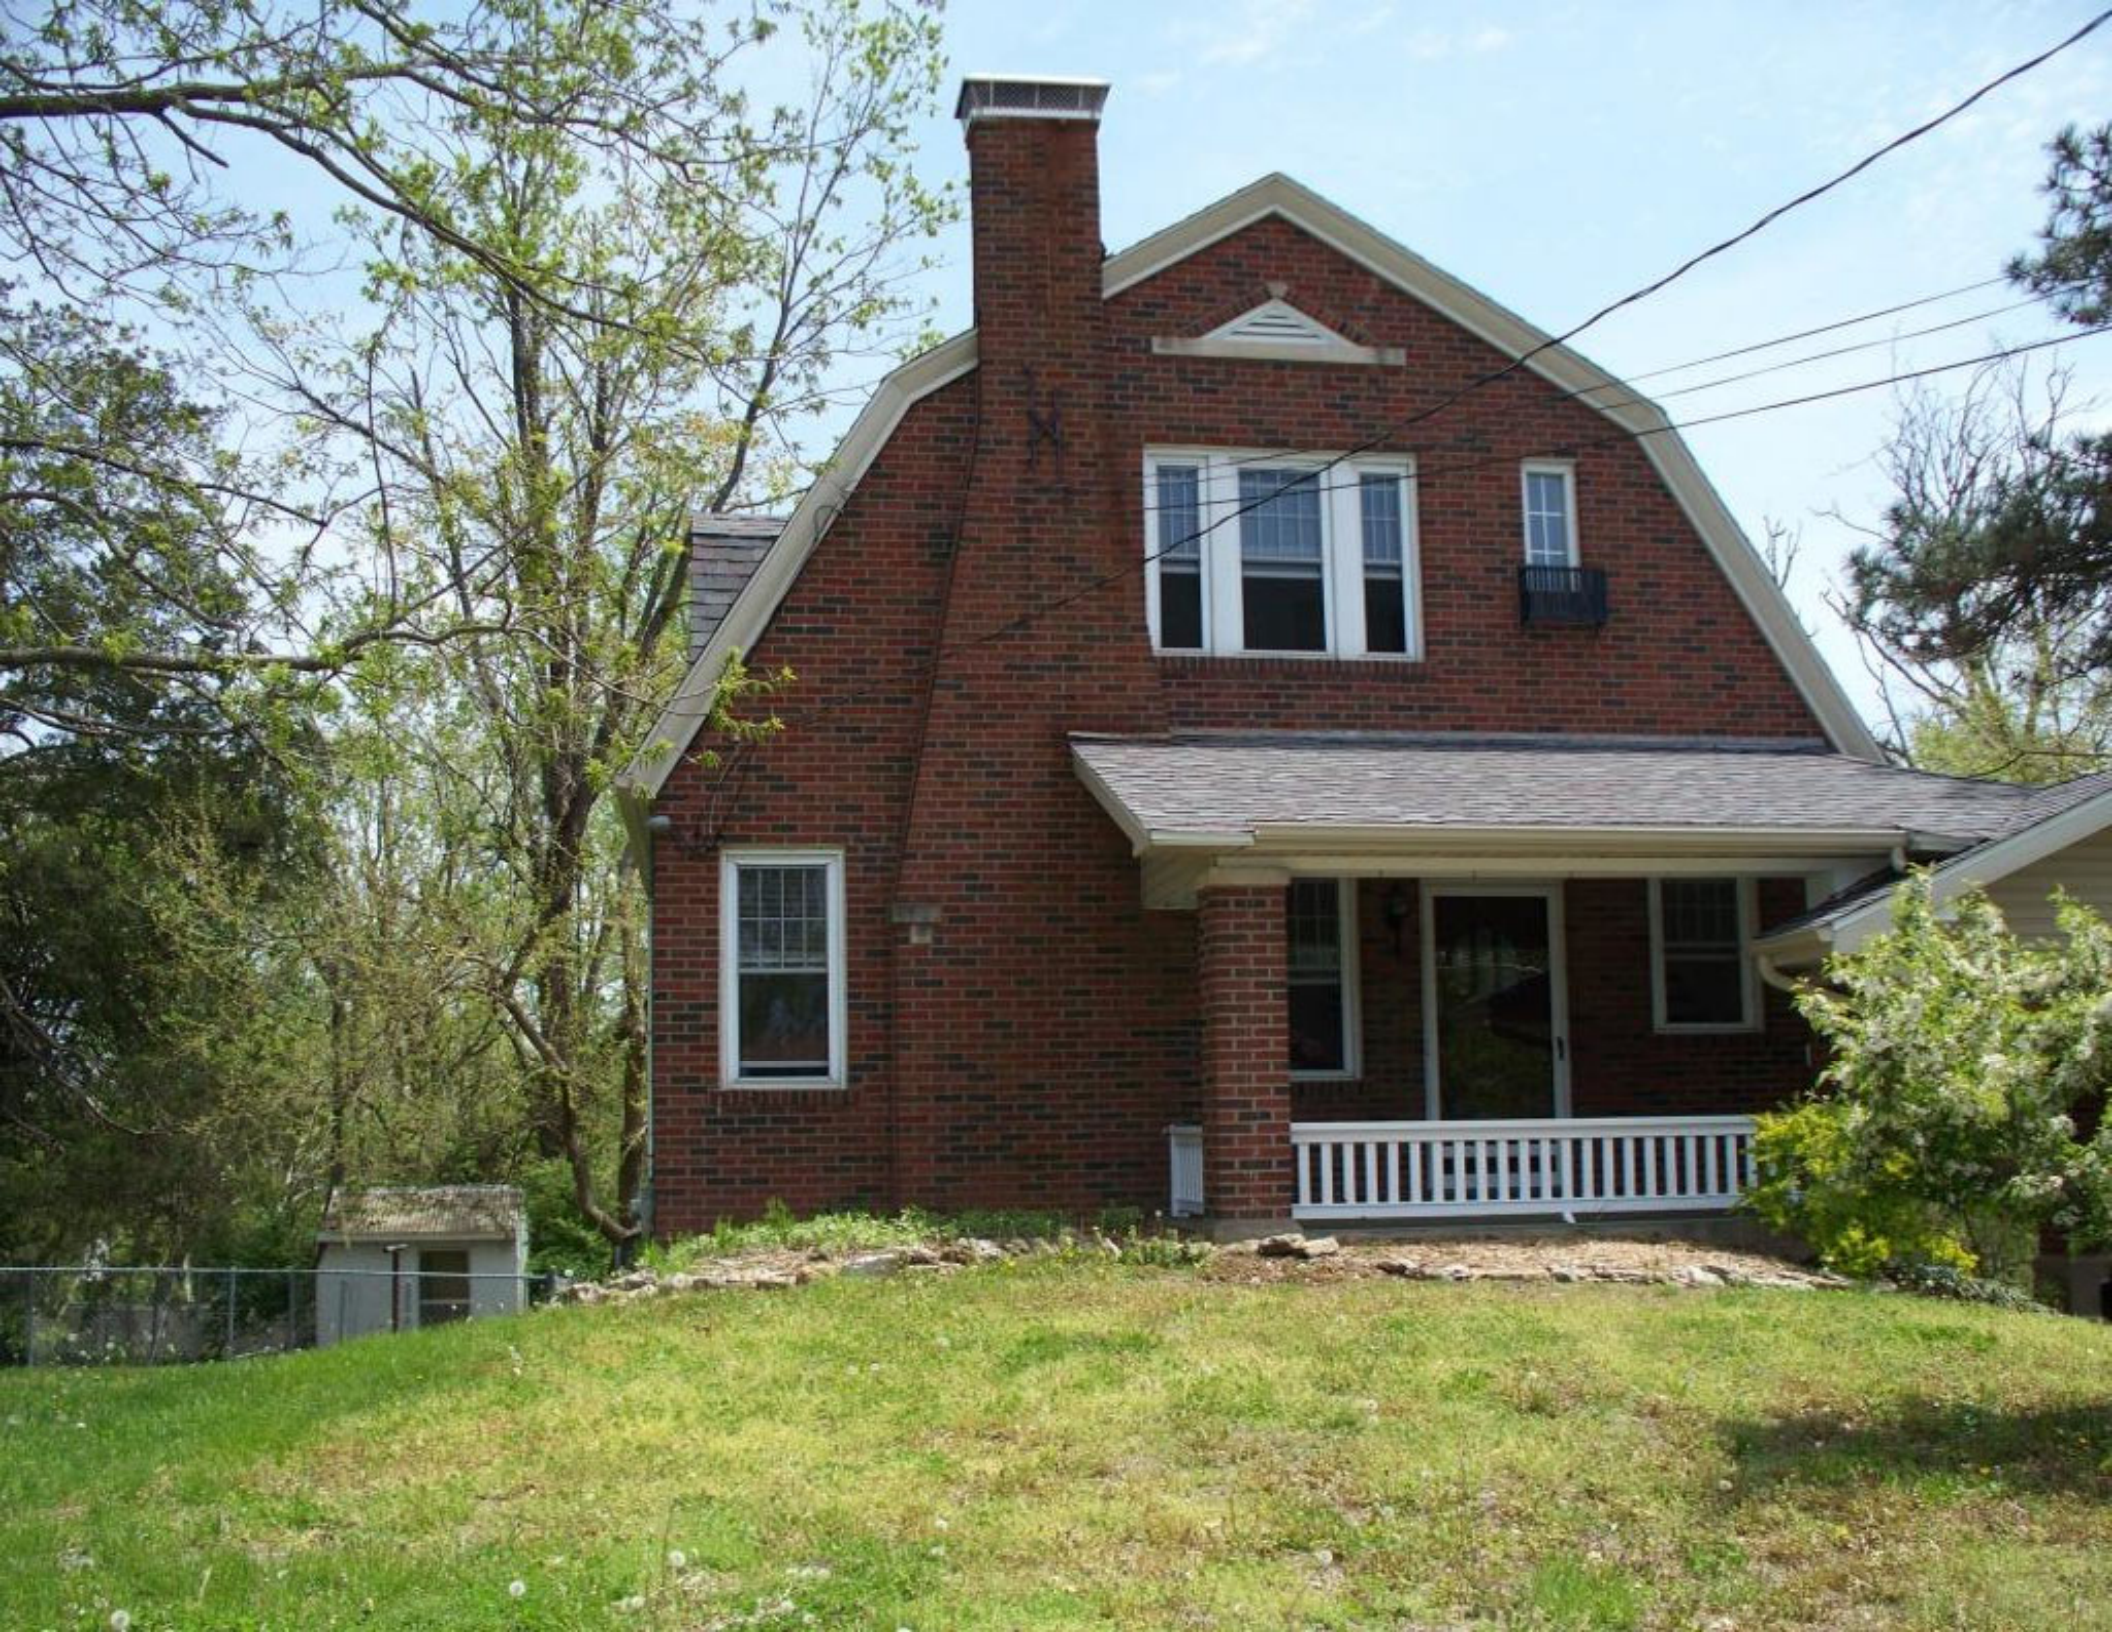
41. (cont.) The most prominent feature of this two story brick Dutch Colonial is the chimney that projects from the front façade. Its wide base narrows as it partially extends through the shed roof of the porch. The porch and entrance are accessed through an attached gabled porte-cochere with brick piers that appear original to the building. The porch has low wood railing with tightly spaced square balusters and brick piers with limestone caps. The entrance appears to have its original wood door and is flanked by an eight-over-one historic window on each side. On the far left side of the chimney is another eight-over-one historic window. The second story also has three paired eight-over-one historic windows in the central bay; the flanking windows are narrower. To the right of this pairing is a short three-by-three fixed glass historic window with decorative metal railing. In the uppermost gable of the gambrel roof is a pediment vent with surrounding brick detail and a thick limestone or concrete sill and keystone.

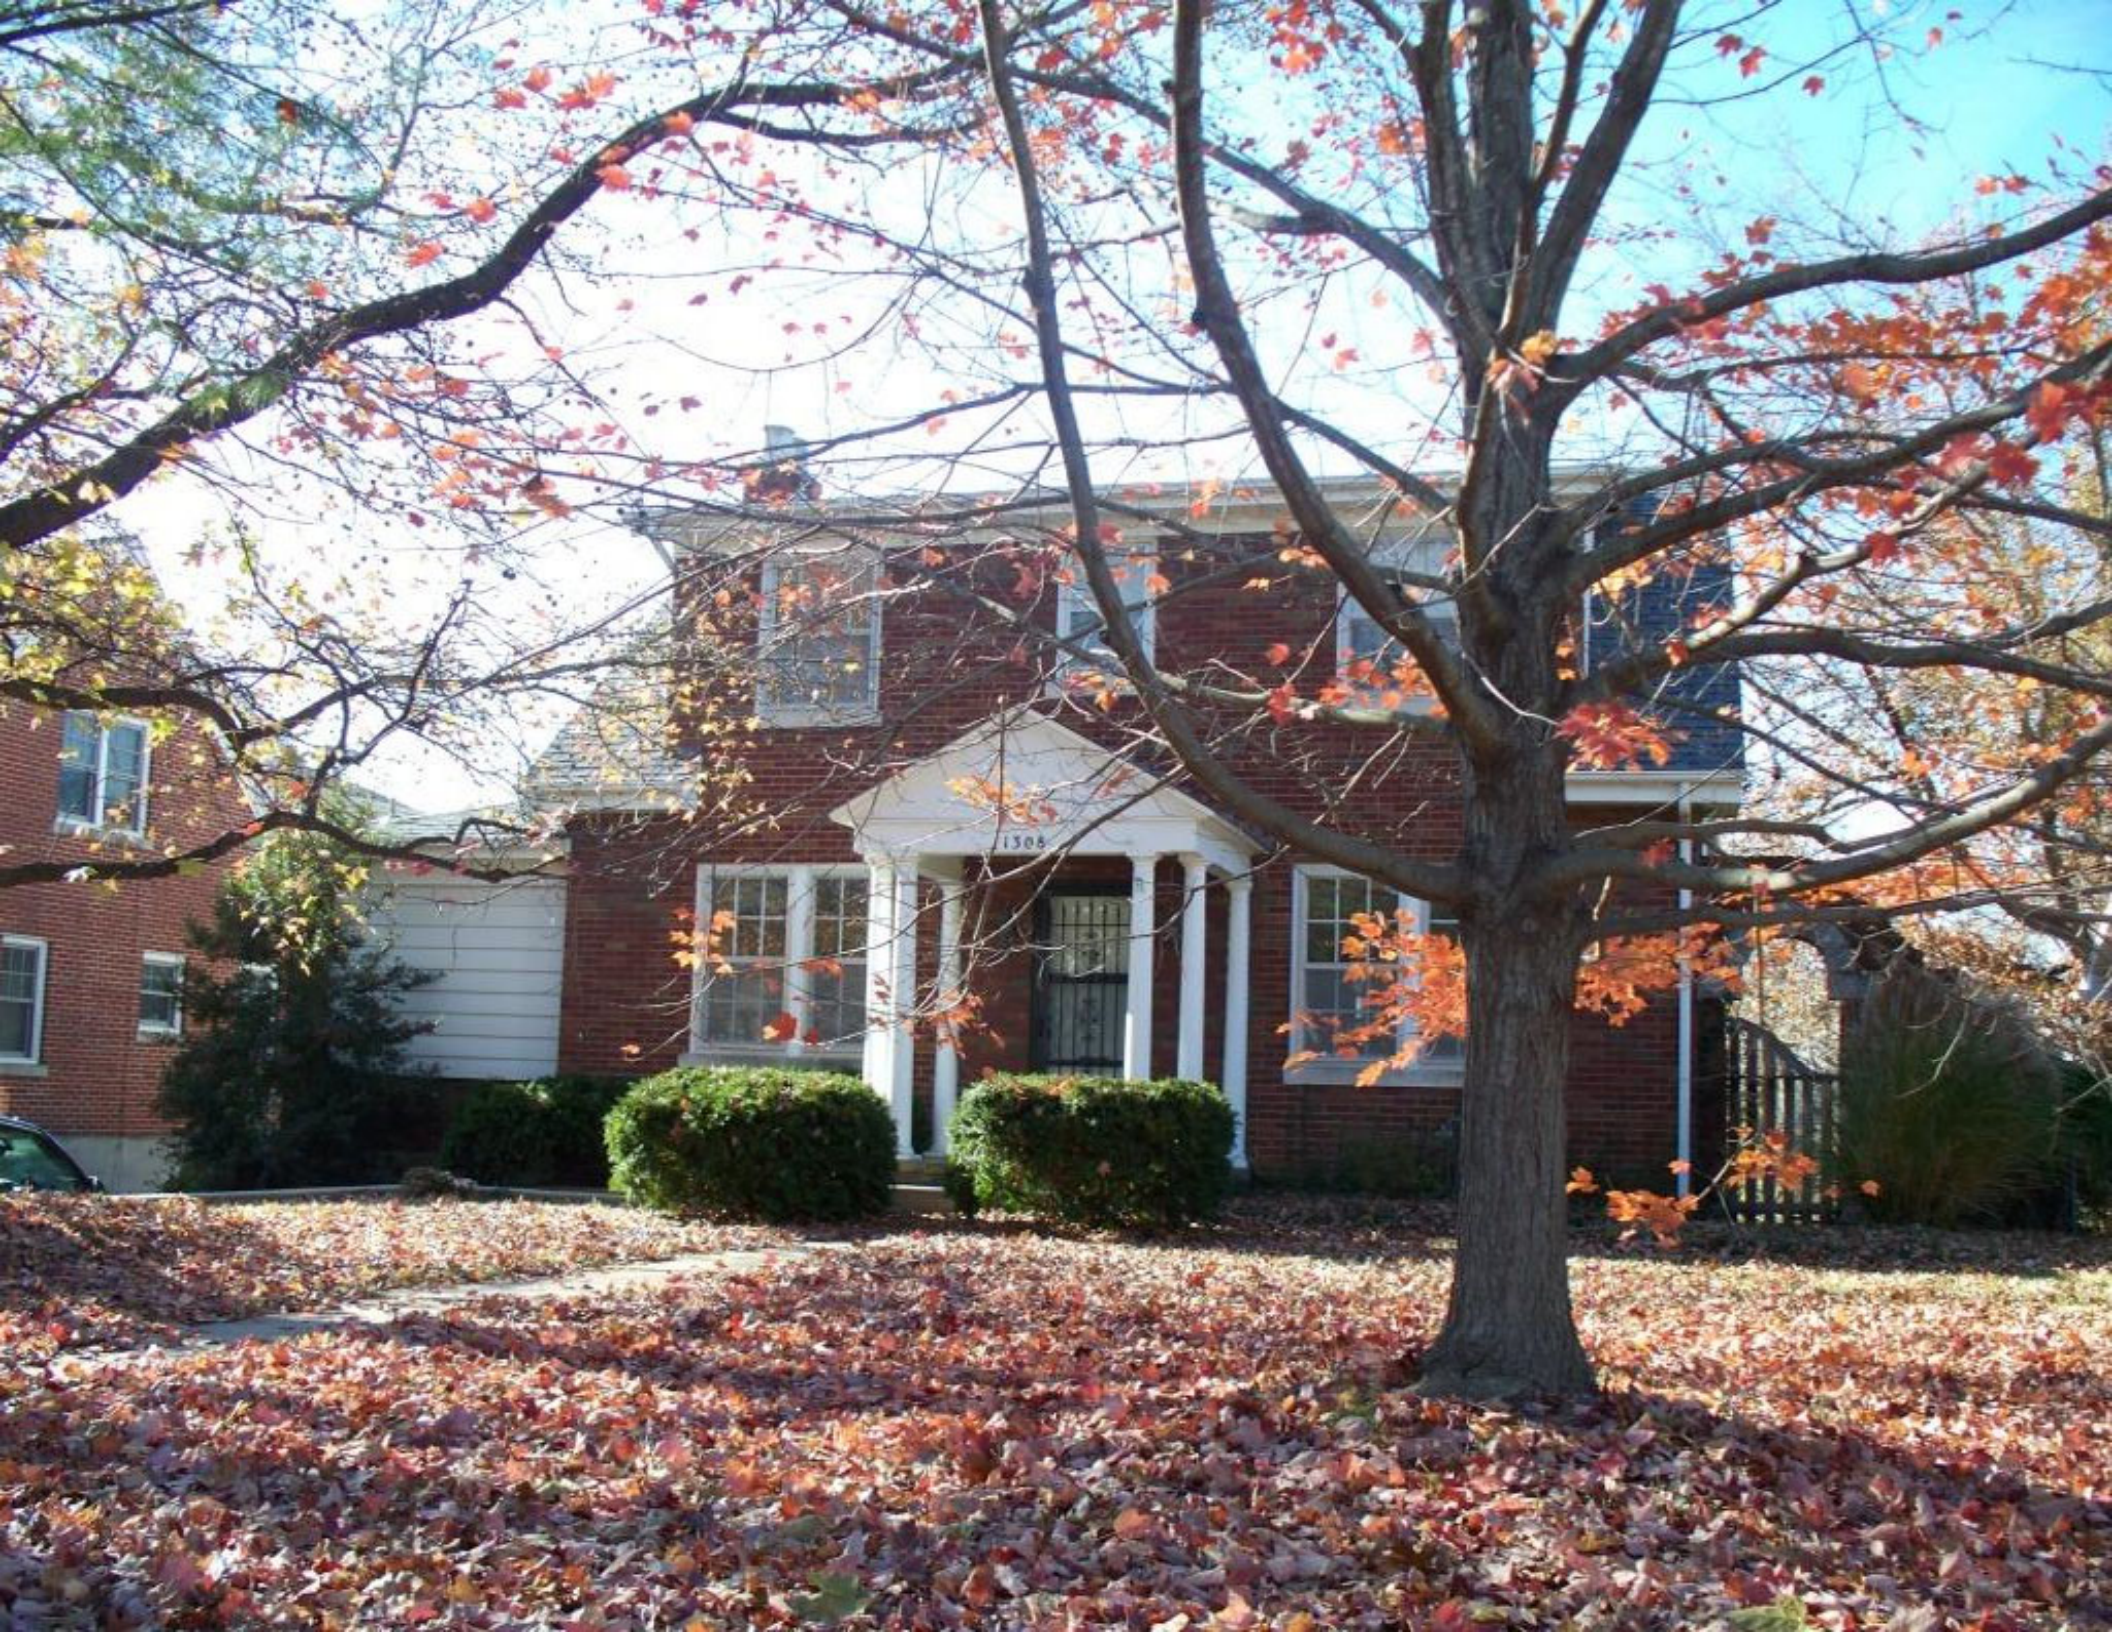
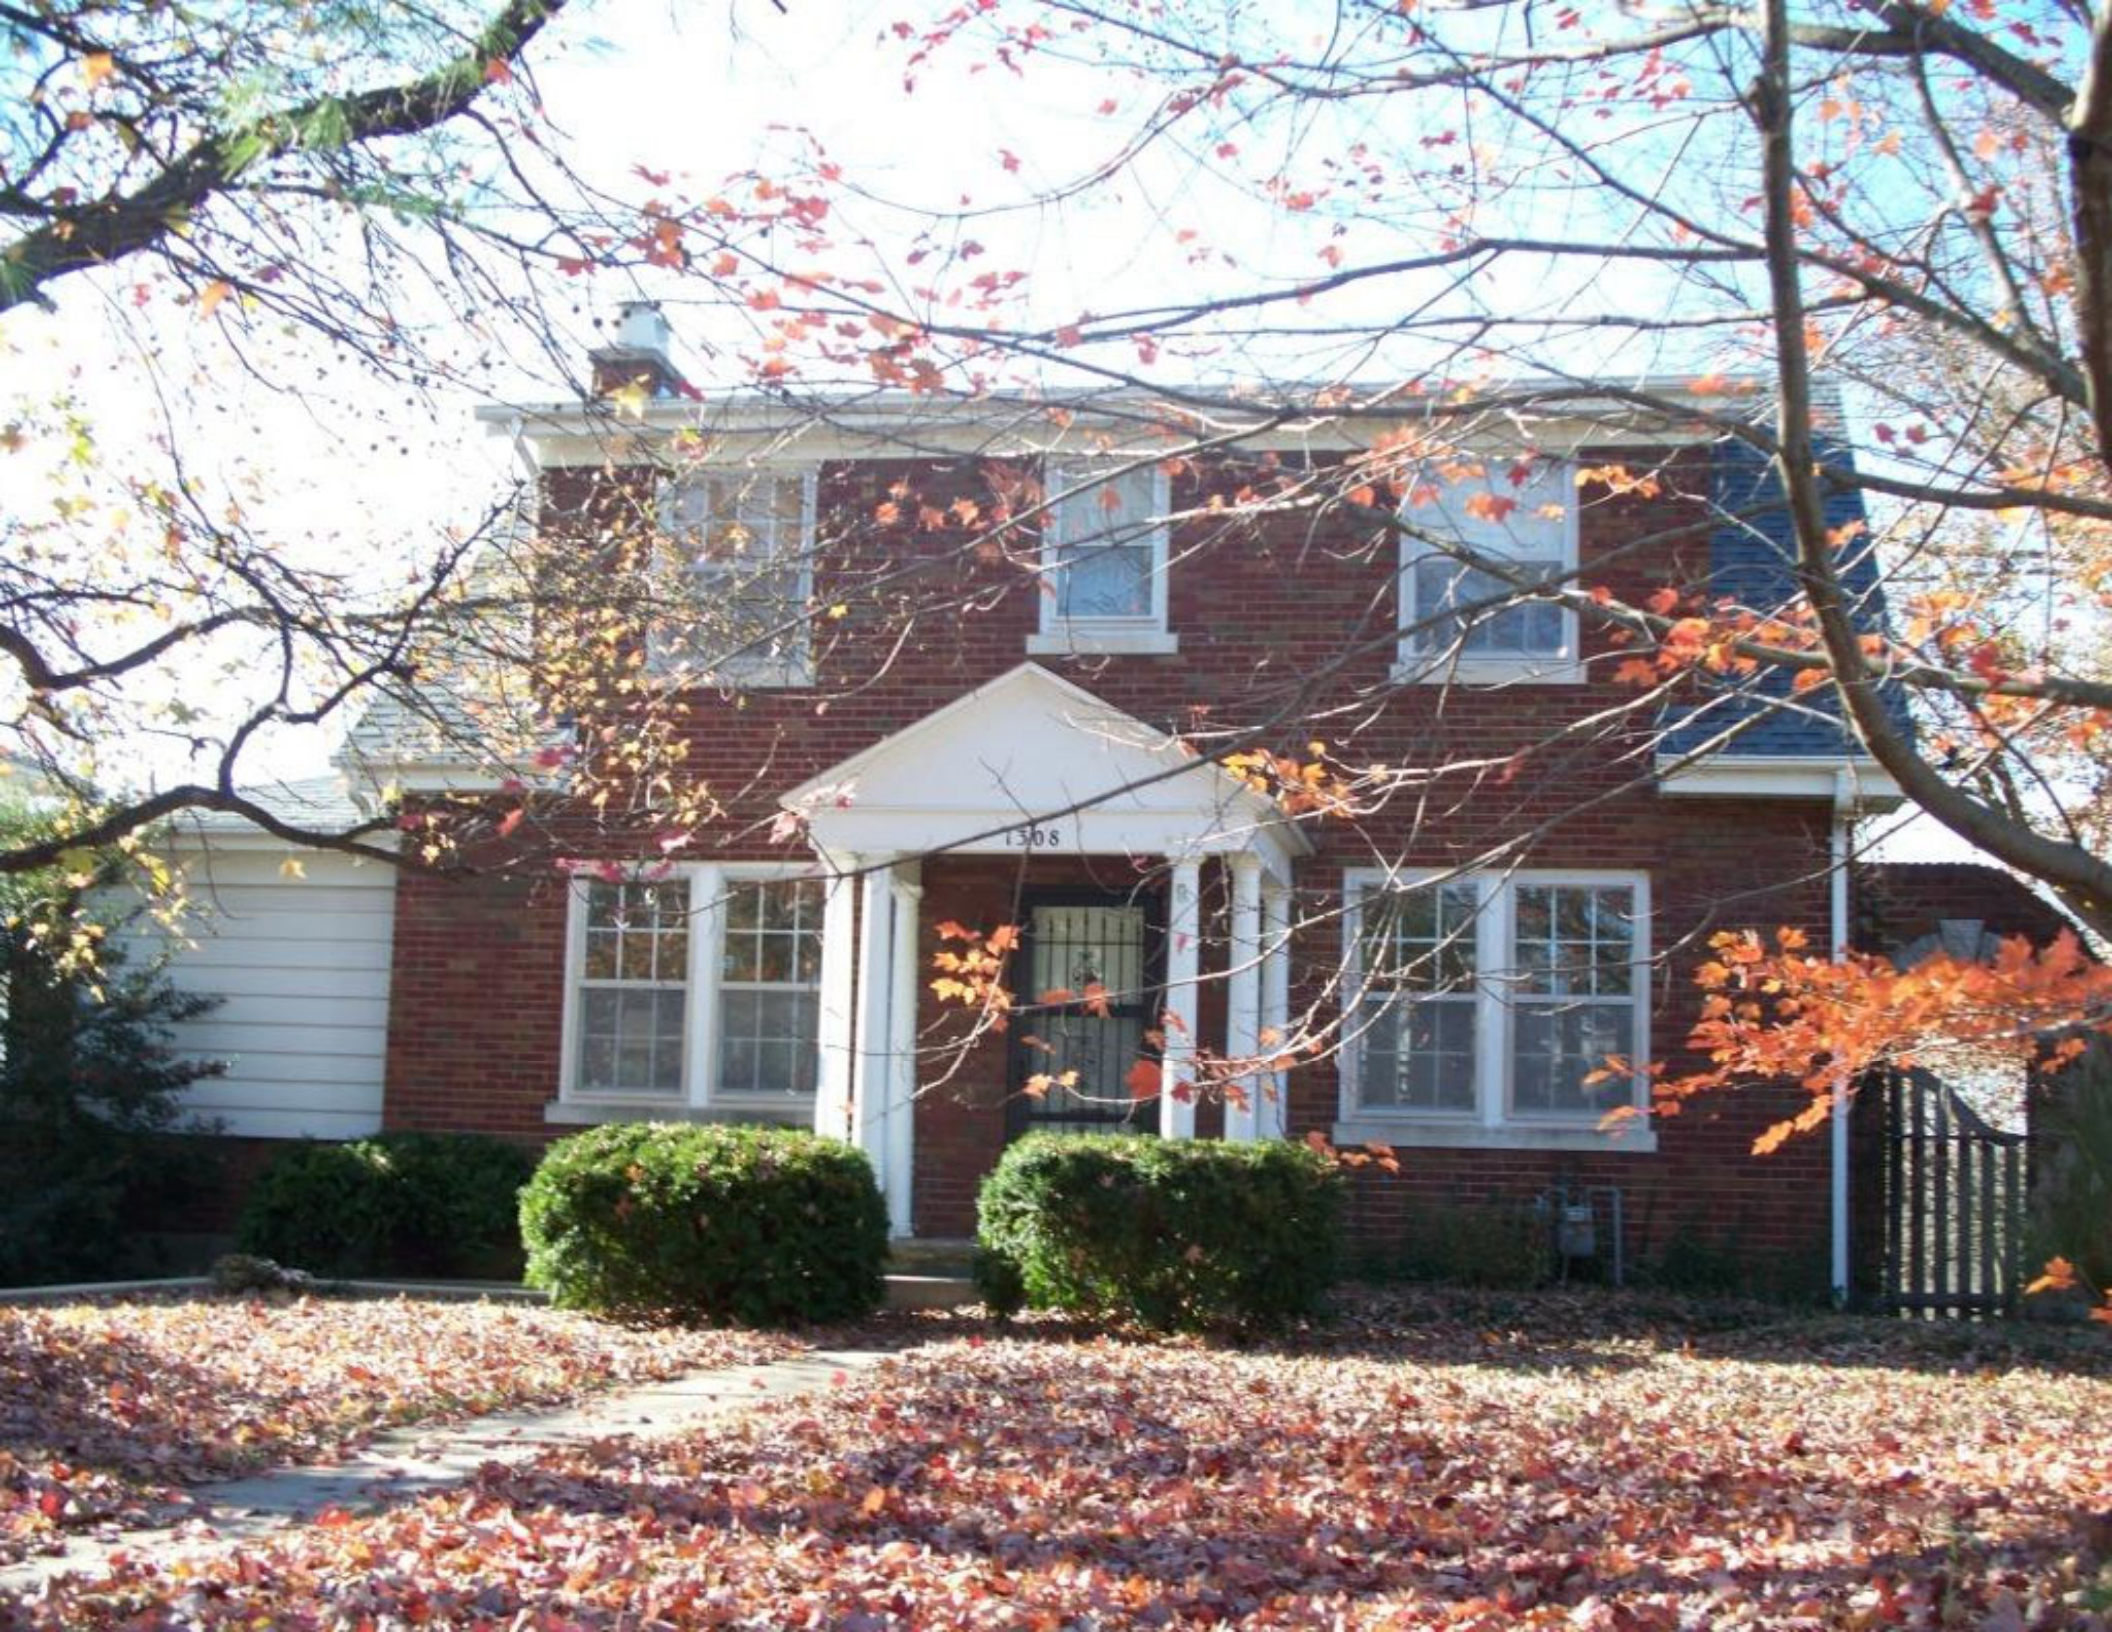
This property is labeled on the 1945 Sanborn map as 1304. It is a two-story brick Colonial Revival with a large wall dormer with a shed roof. The dormer contains two large 6/6 windows (if not historic then good replacement) flanking a smaller center 6/1 windows. The first story has two paired 6/6 windows; all windows have concrete sills. The centrally located entrance is surrounded by a Classical portico with pillars and pediment. There is a one story "addition" set slightly back from the façade on the left bay. It appears this was once a side porch (Sanborn confirms this) that was later enclosed with vinyl. Off the right hand side of the property is an attached archway with decorative keystone detailing that was added sometime after 1945.
