ARCHITECTURAL/HISTORIC INVENTORY FORM

1. Survey No. CO-AS-005-001		2. Survey name: Moreau Drive Neighborhood Survey	
3. County: Cole		4. Address: 1202 Elmerine Ave.	
5. City: Jefferson City	Vicinity: <input type="checkbox"/>	6. UTM: / /	7. Township/Range/Section: T: R: S:
8. Historic name (if known):		9. Present/other name (if known):	
10. Ownership: <input checked="" type="checkbox"/> Private <input type="checkbox"/> Public		11. Historic use (if known): Residential	11. Current use: Residential

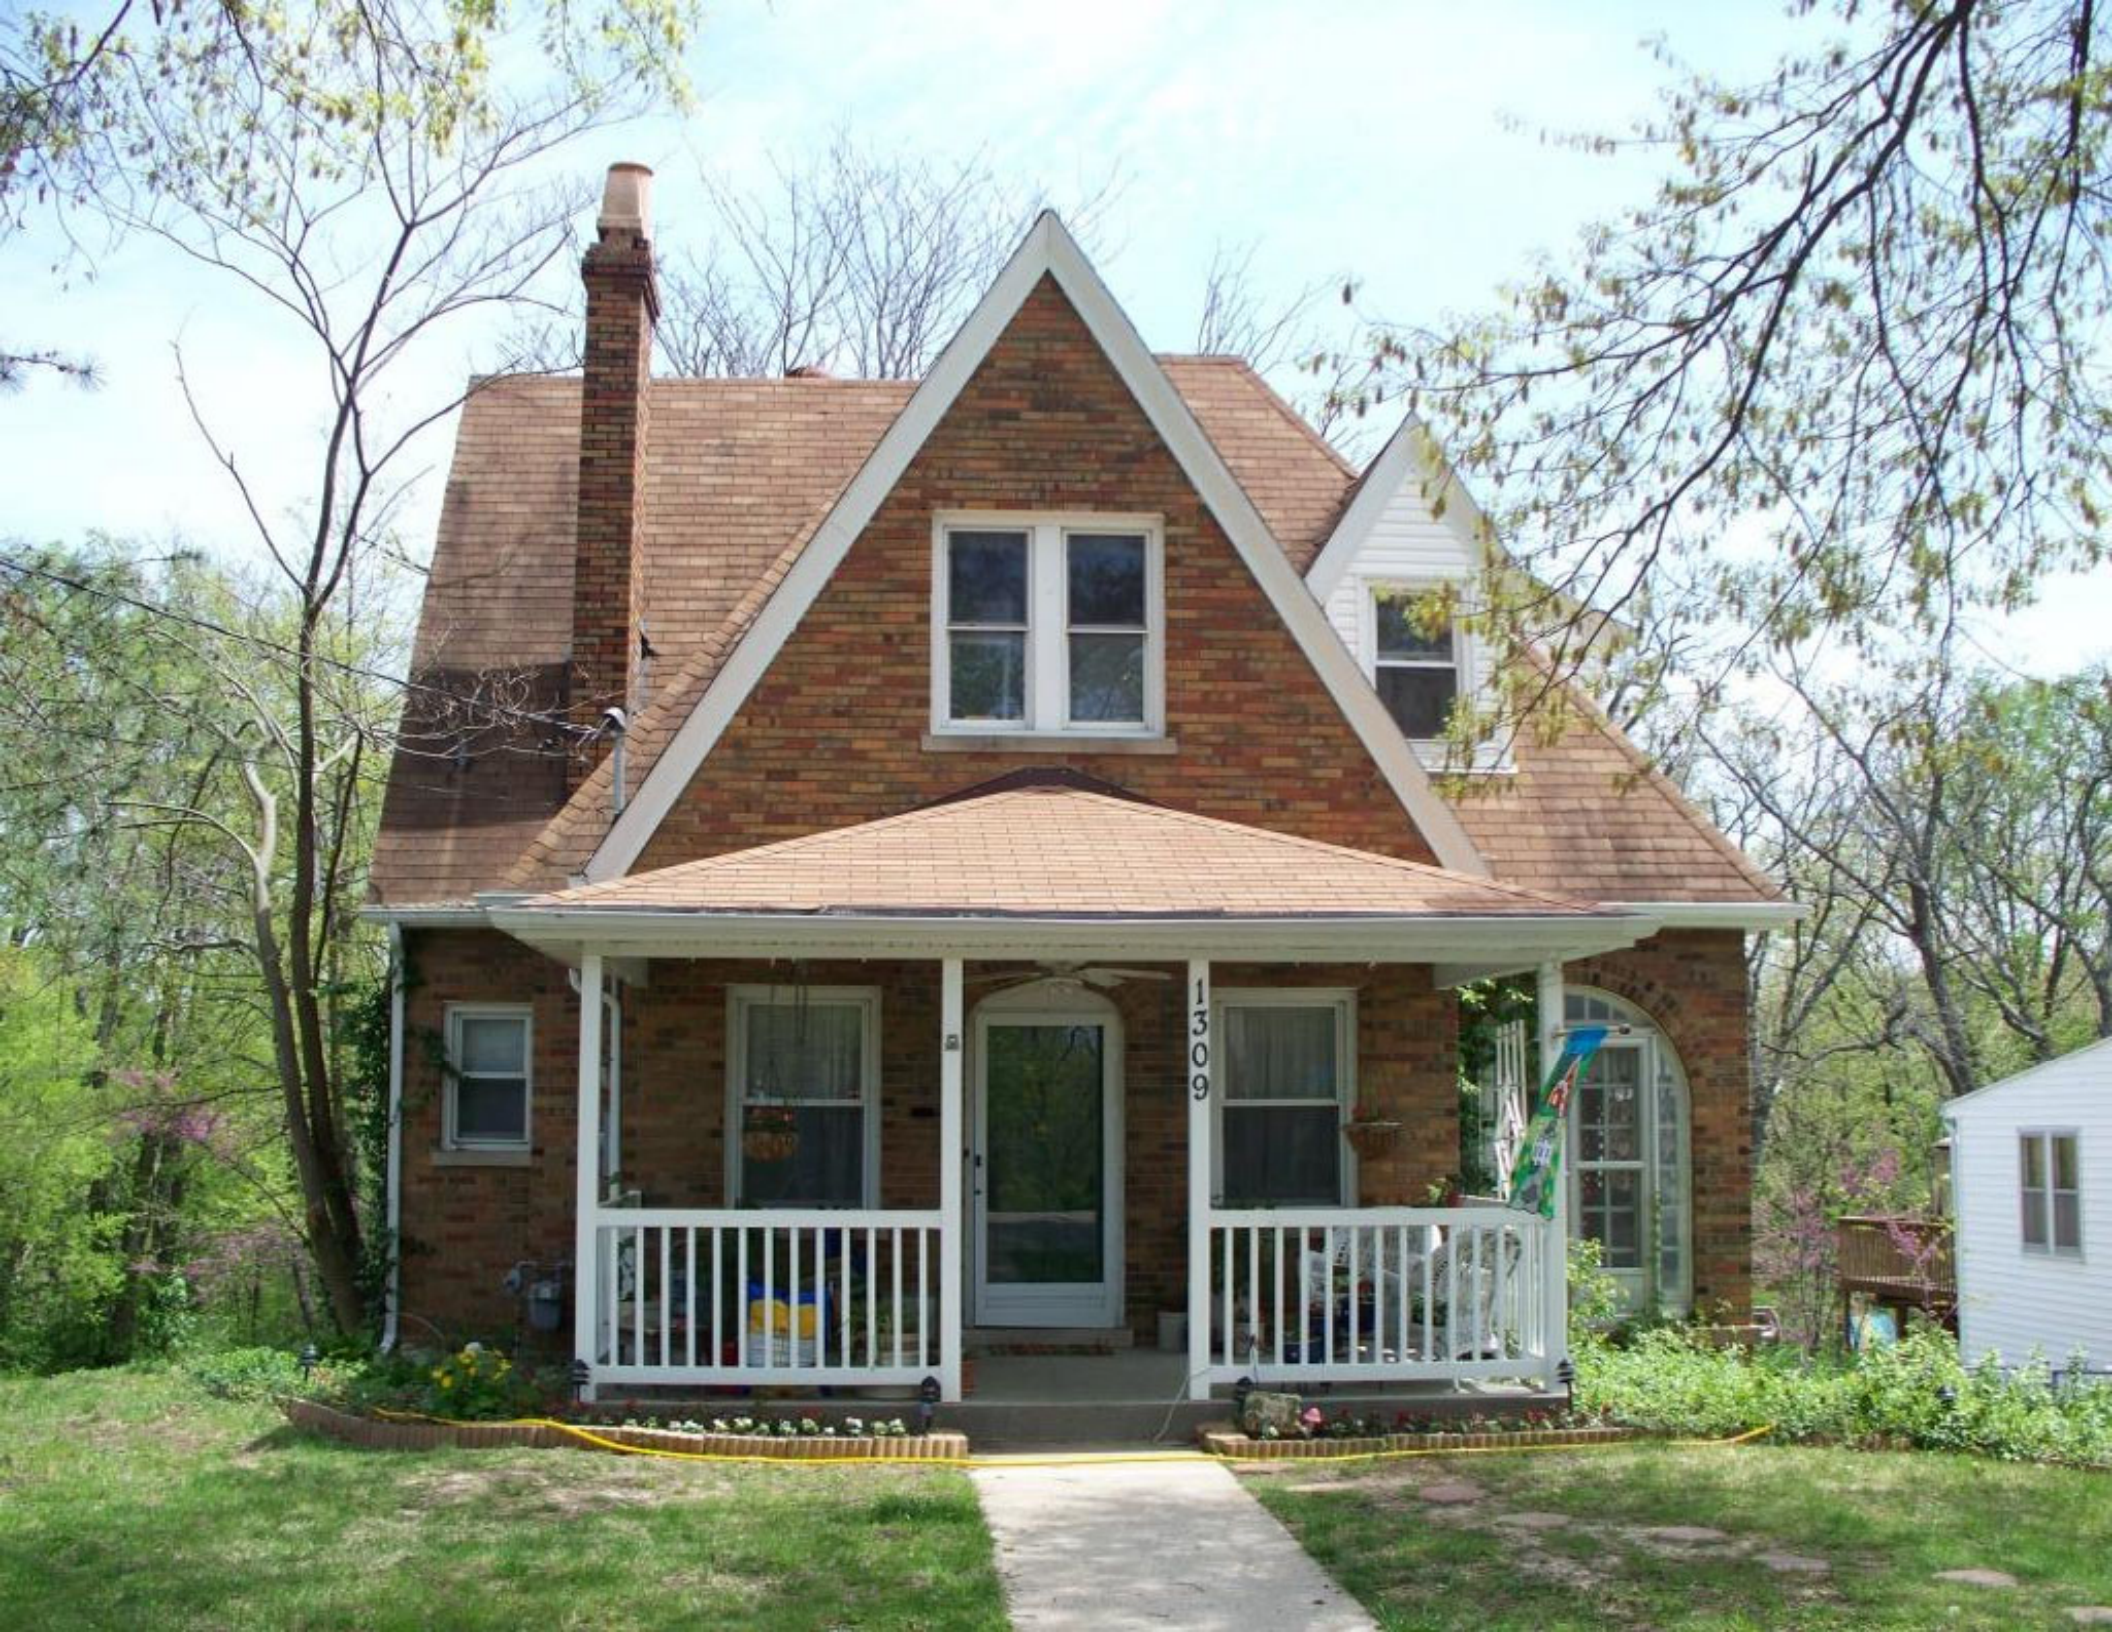
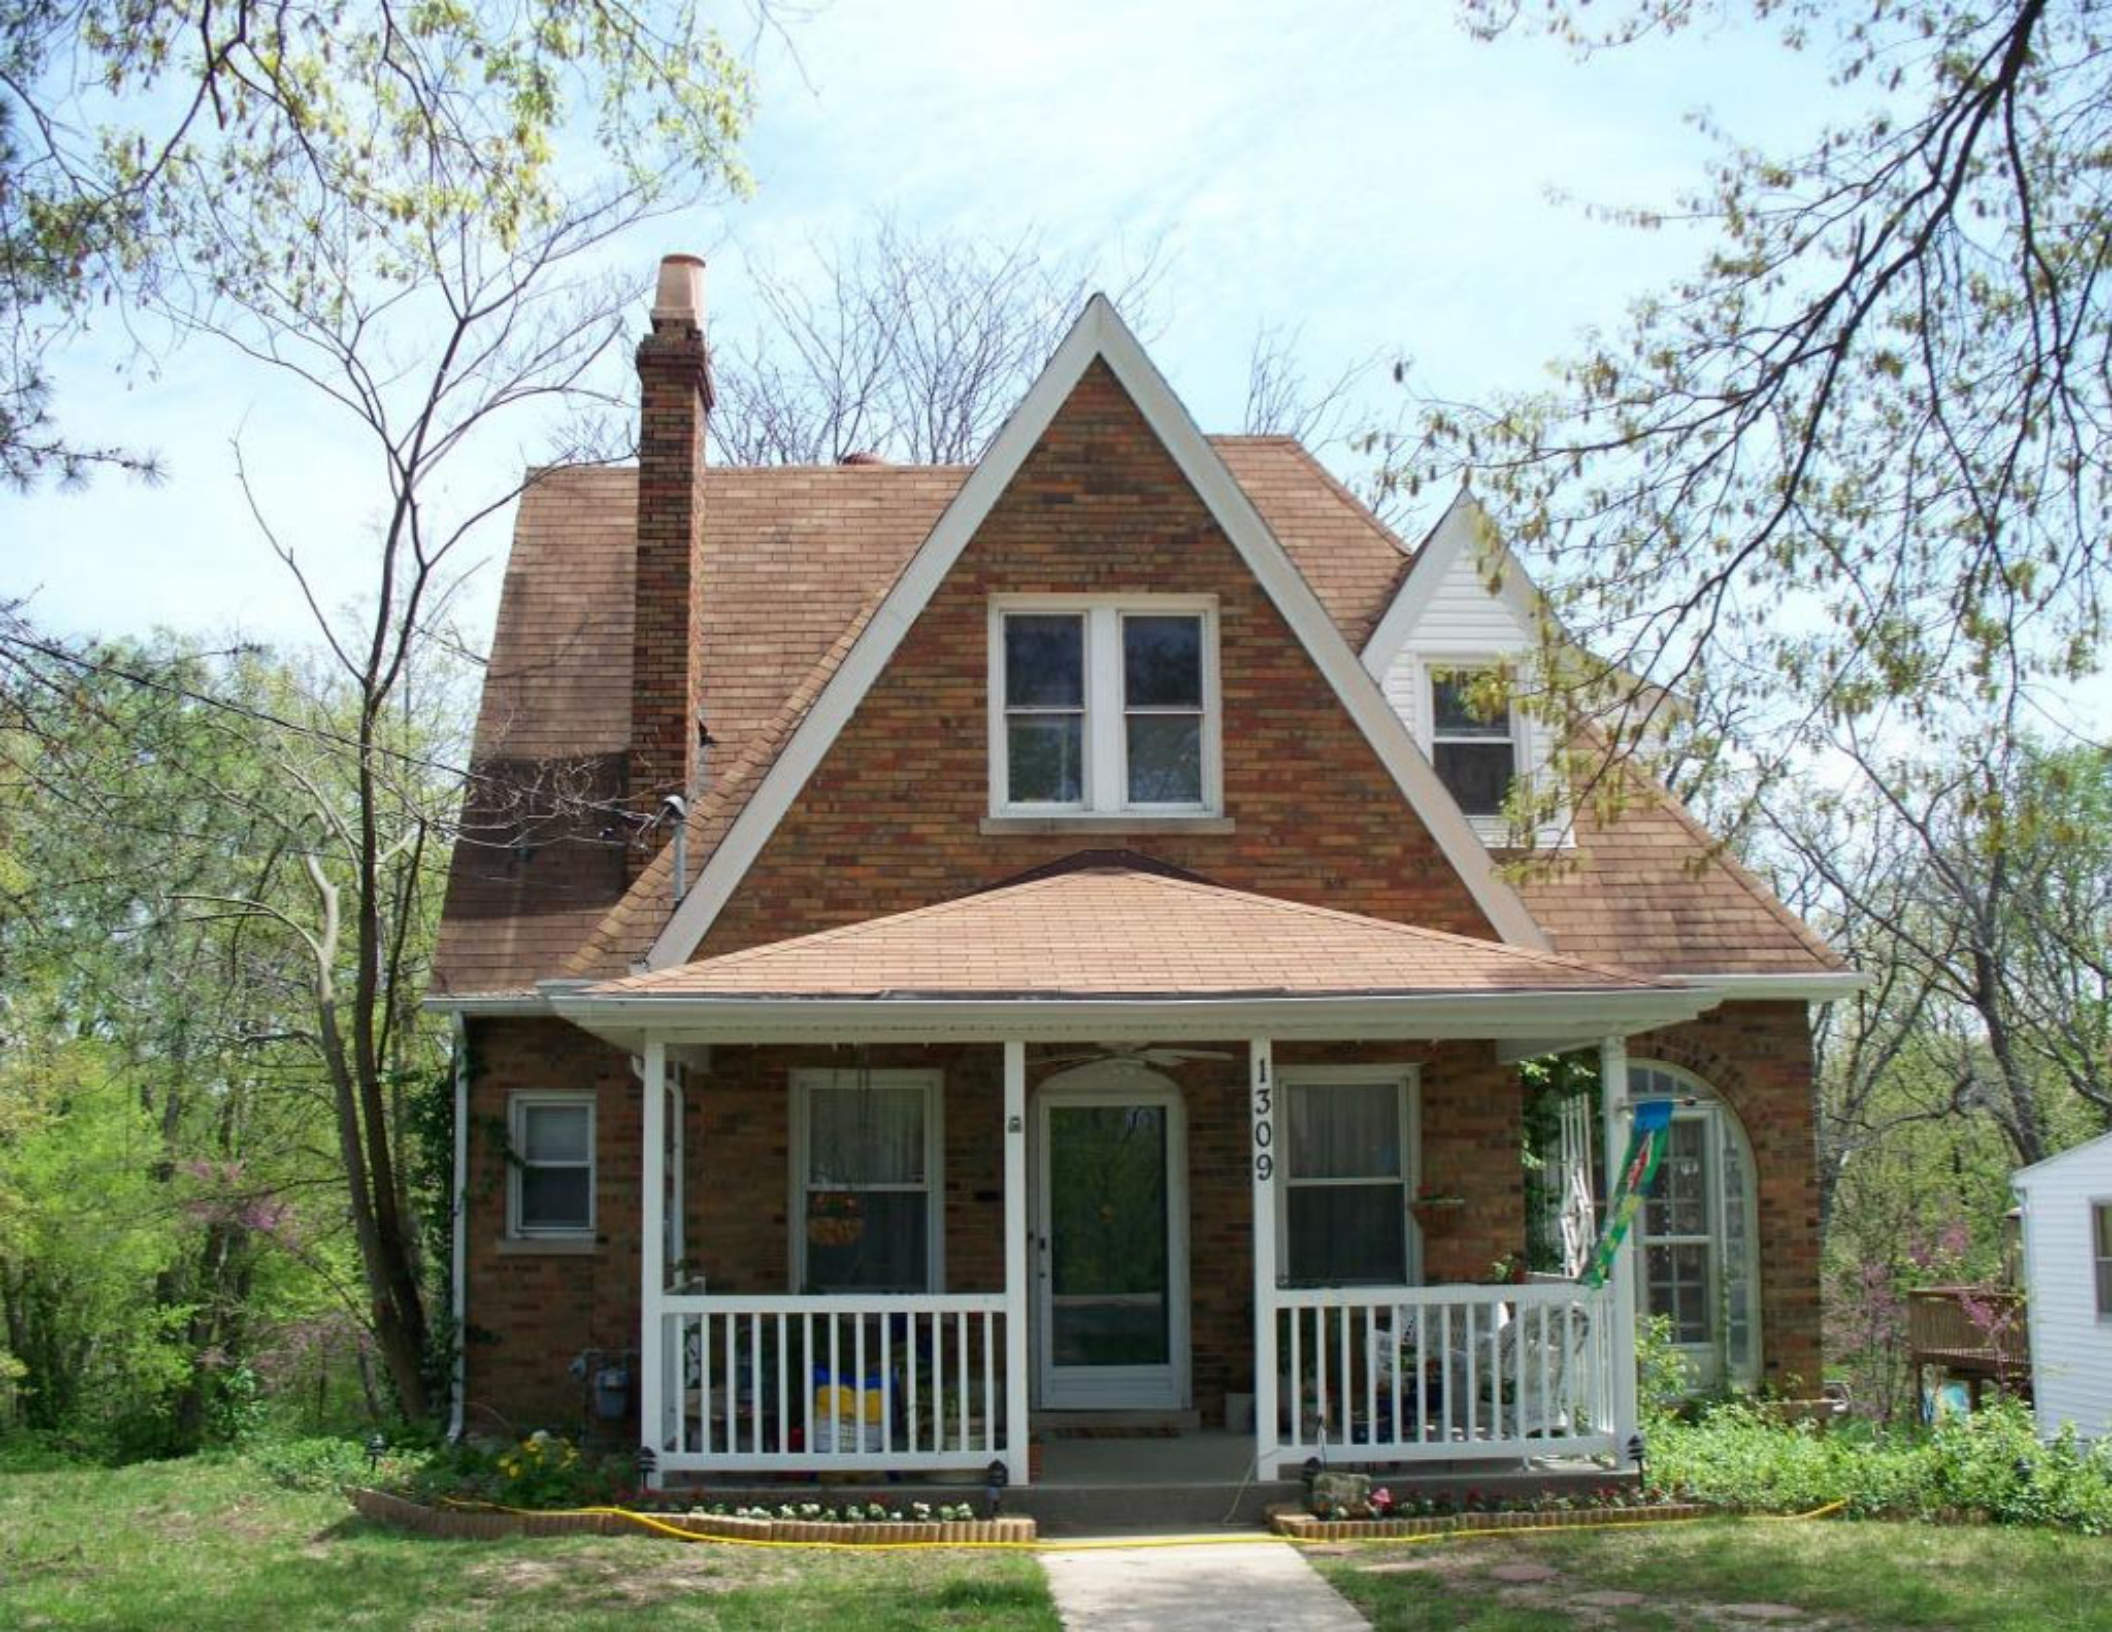
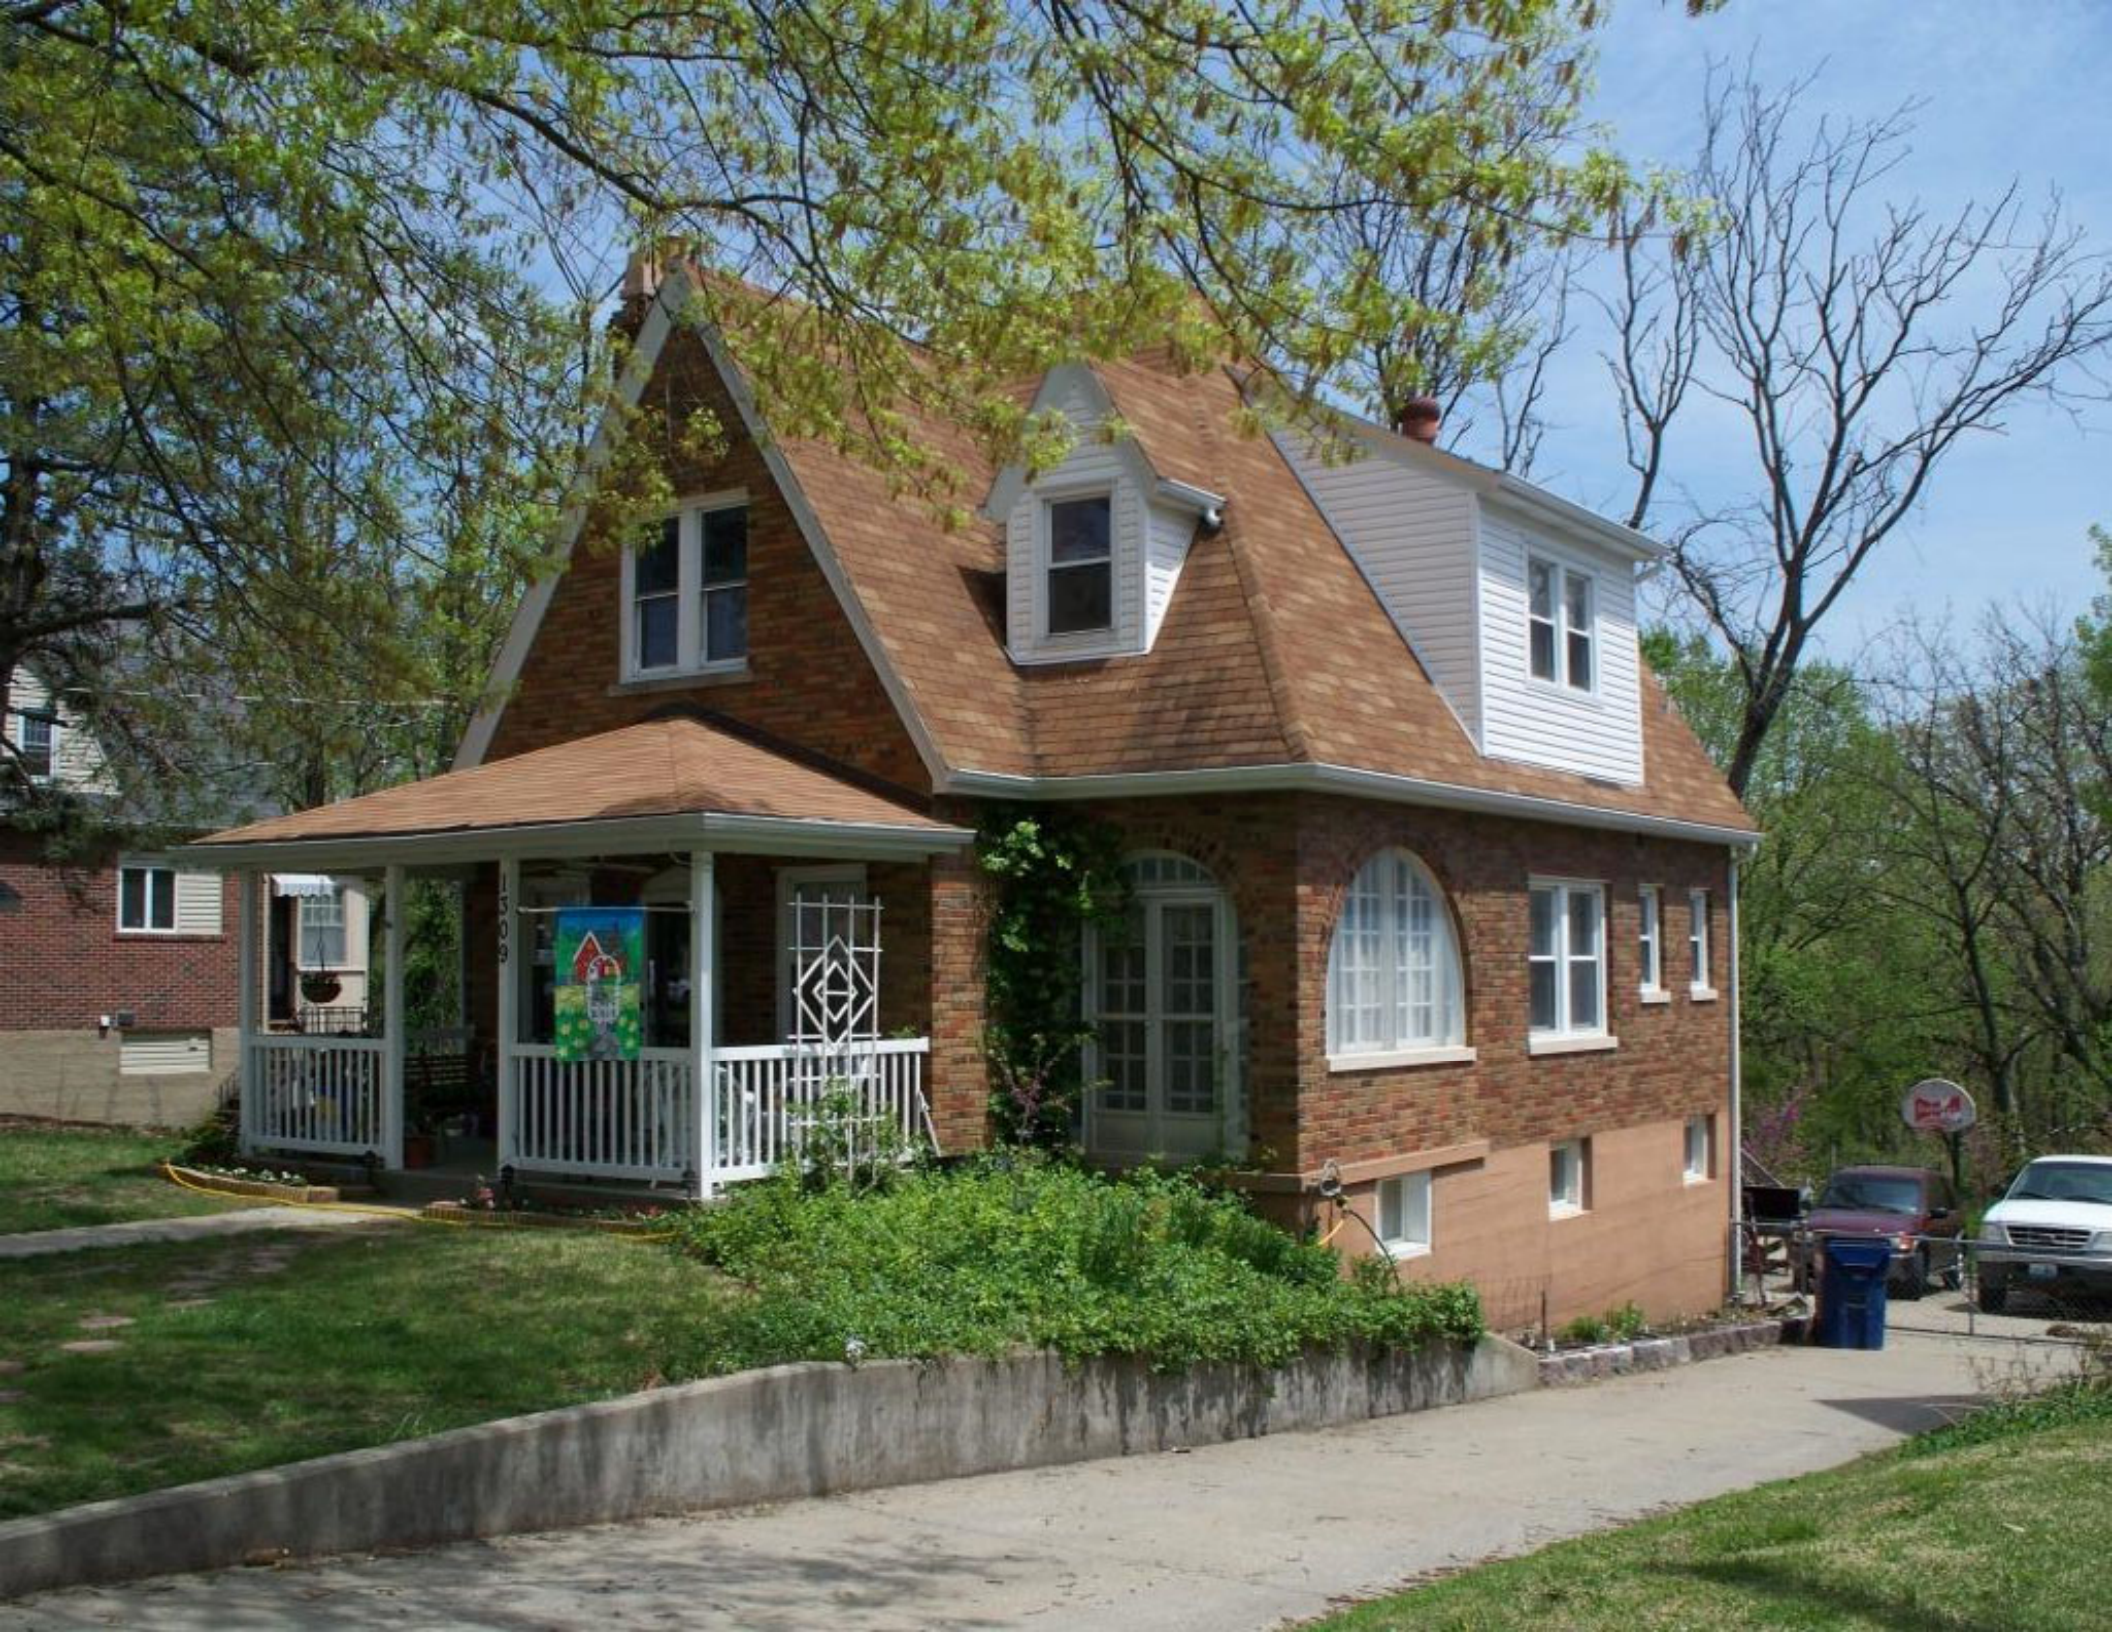
41. (cont.) This brick Tudor revival has a somewhat unusual roof shape. The central bay of the property projects slightly from the rest of the property. Its steeply pitched front gable crosses into a steeply pitched hipped roof with a wide dormer projecting from the right side giving the roof a somewhat shed-like appearance. On the front façade another gable dormer projects from the roof to the right of the central gable. It has a one-over-one historic window with vinyl infill. A paired one-over-one windows are centered in the central gable. The chimney extends on the left side of the gable. It has decorative projecting brick work at its top and a terracotta chimney cap. On the first floor from the left is a single one-over-one window. All of the property's windows have storms.
The central projecting bay has an open porch with railing and posts. It does not appear original to the property. One-over-one windows flank each side of the entrance which appears to have a historic door although the round opening has been partially enclosed at the top, most likely to accommodate the screen door. The bay to the right consists of a sunroom with arched openings enclosed with historic multi-paned double glass doors and sidelights.

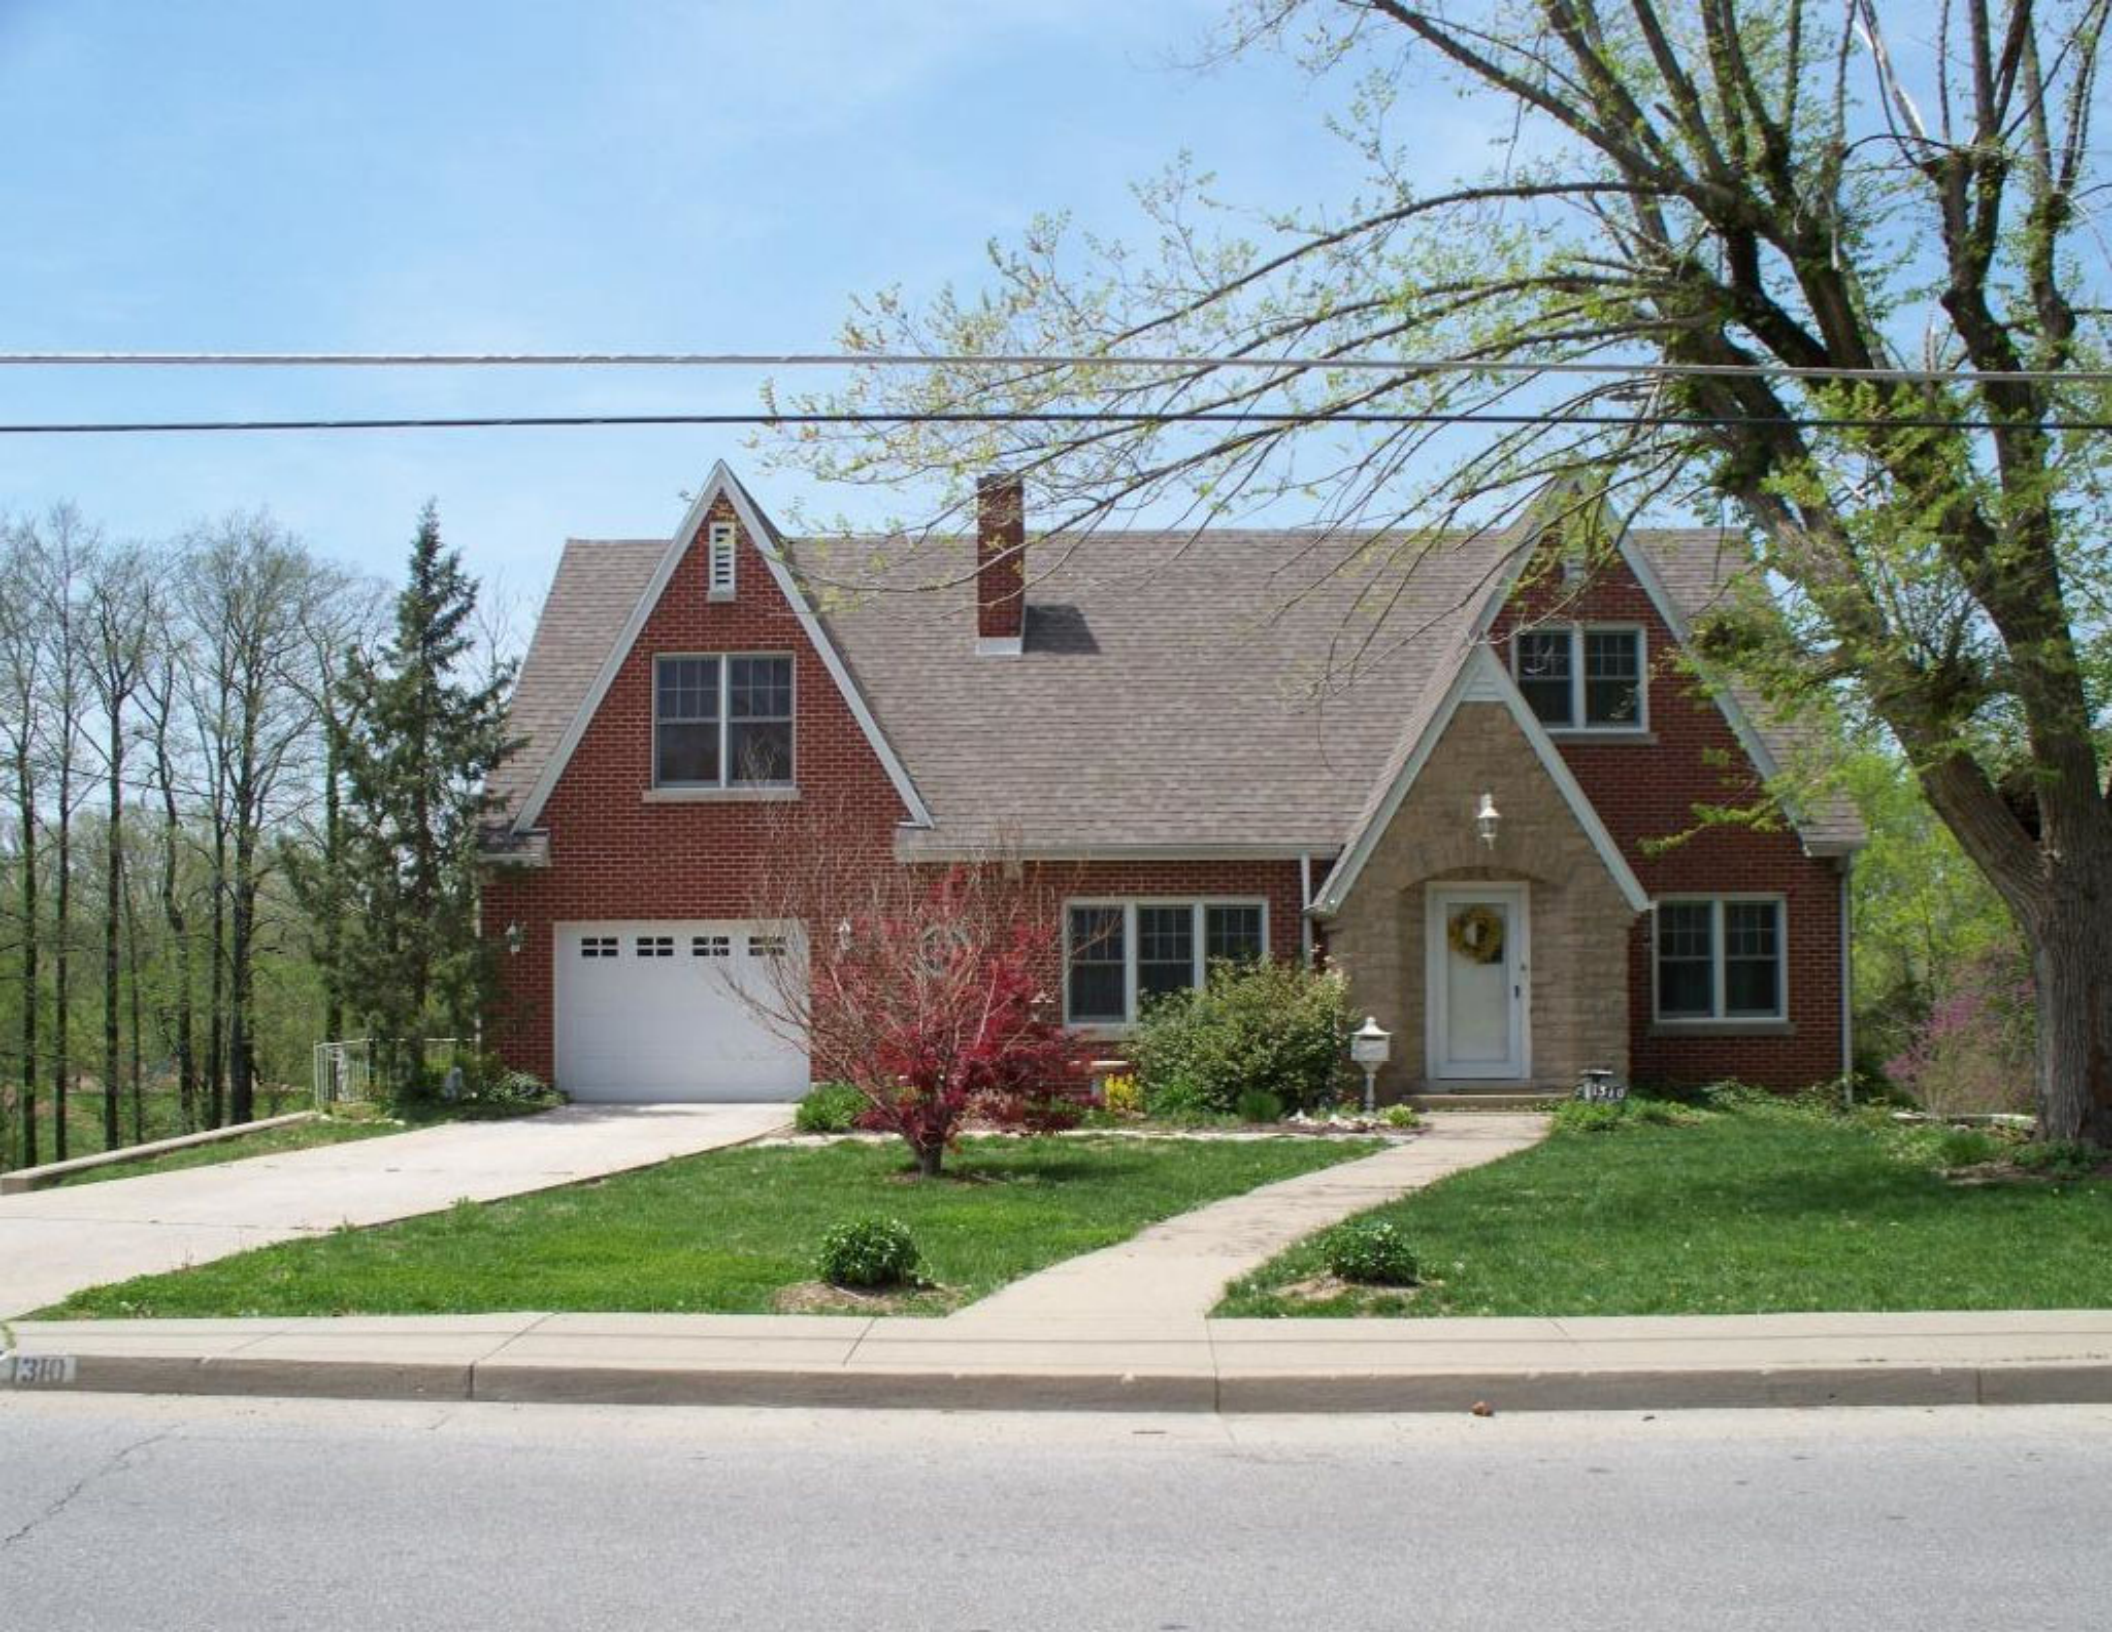
The Cole County Tax Assessors website states this property was built in 1941. The 1945 Sanborn does note a property here, however either this property was constructed and this later built on it, or the property has been extensively remodeled. The 1 1/2-2 story brick property appears to be a modern Neo-Tudor with the end bays having steep center gables. Paired modern 6/1 windows are in the upper levels of both gable ends along with a narrow vent. The left bay contains a one-car garage, and from the right, an oxeye and a row of three 6/1 windows. The next bay projects slightly and consists of stone and a slightly recessed entrance. The final bay has a final pair of 6/1 windows. Either due to its construction date or the amount of alterations (nearly double the original footprint) this property is considered non-contributing to the district. Although non-contributing, as infill/alterations go this is sympathetic to its surroundings.
