ARCHITECTURAL/HISTORIC INVENTORY FORM

1. Survey No. CO-AS-005-001		2. Survey name: Moreau Drive Neighborhood Survey	
3. County: Cole		4. Address: 1202 Elmerine Ave.	
5. City: Jefferson City	Vicinity: <input type="checkbox"/>	6. UTM: / /	7. Township/Range/Section: T: R: S:
8. Historic name (if known):		9. Present/other name (if known):	
10. Ownership: <input checked="" type="checkbox"/> Private <input type="checkbox"/> Public		11. Historic use (if known): Residential	11. Current use: Residential

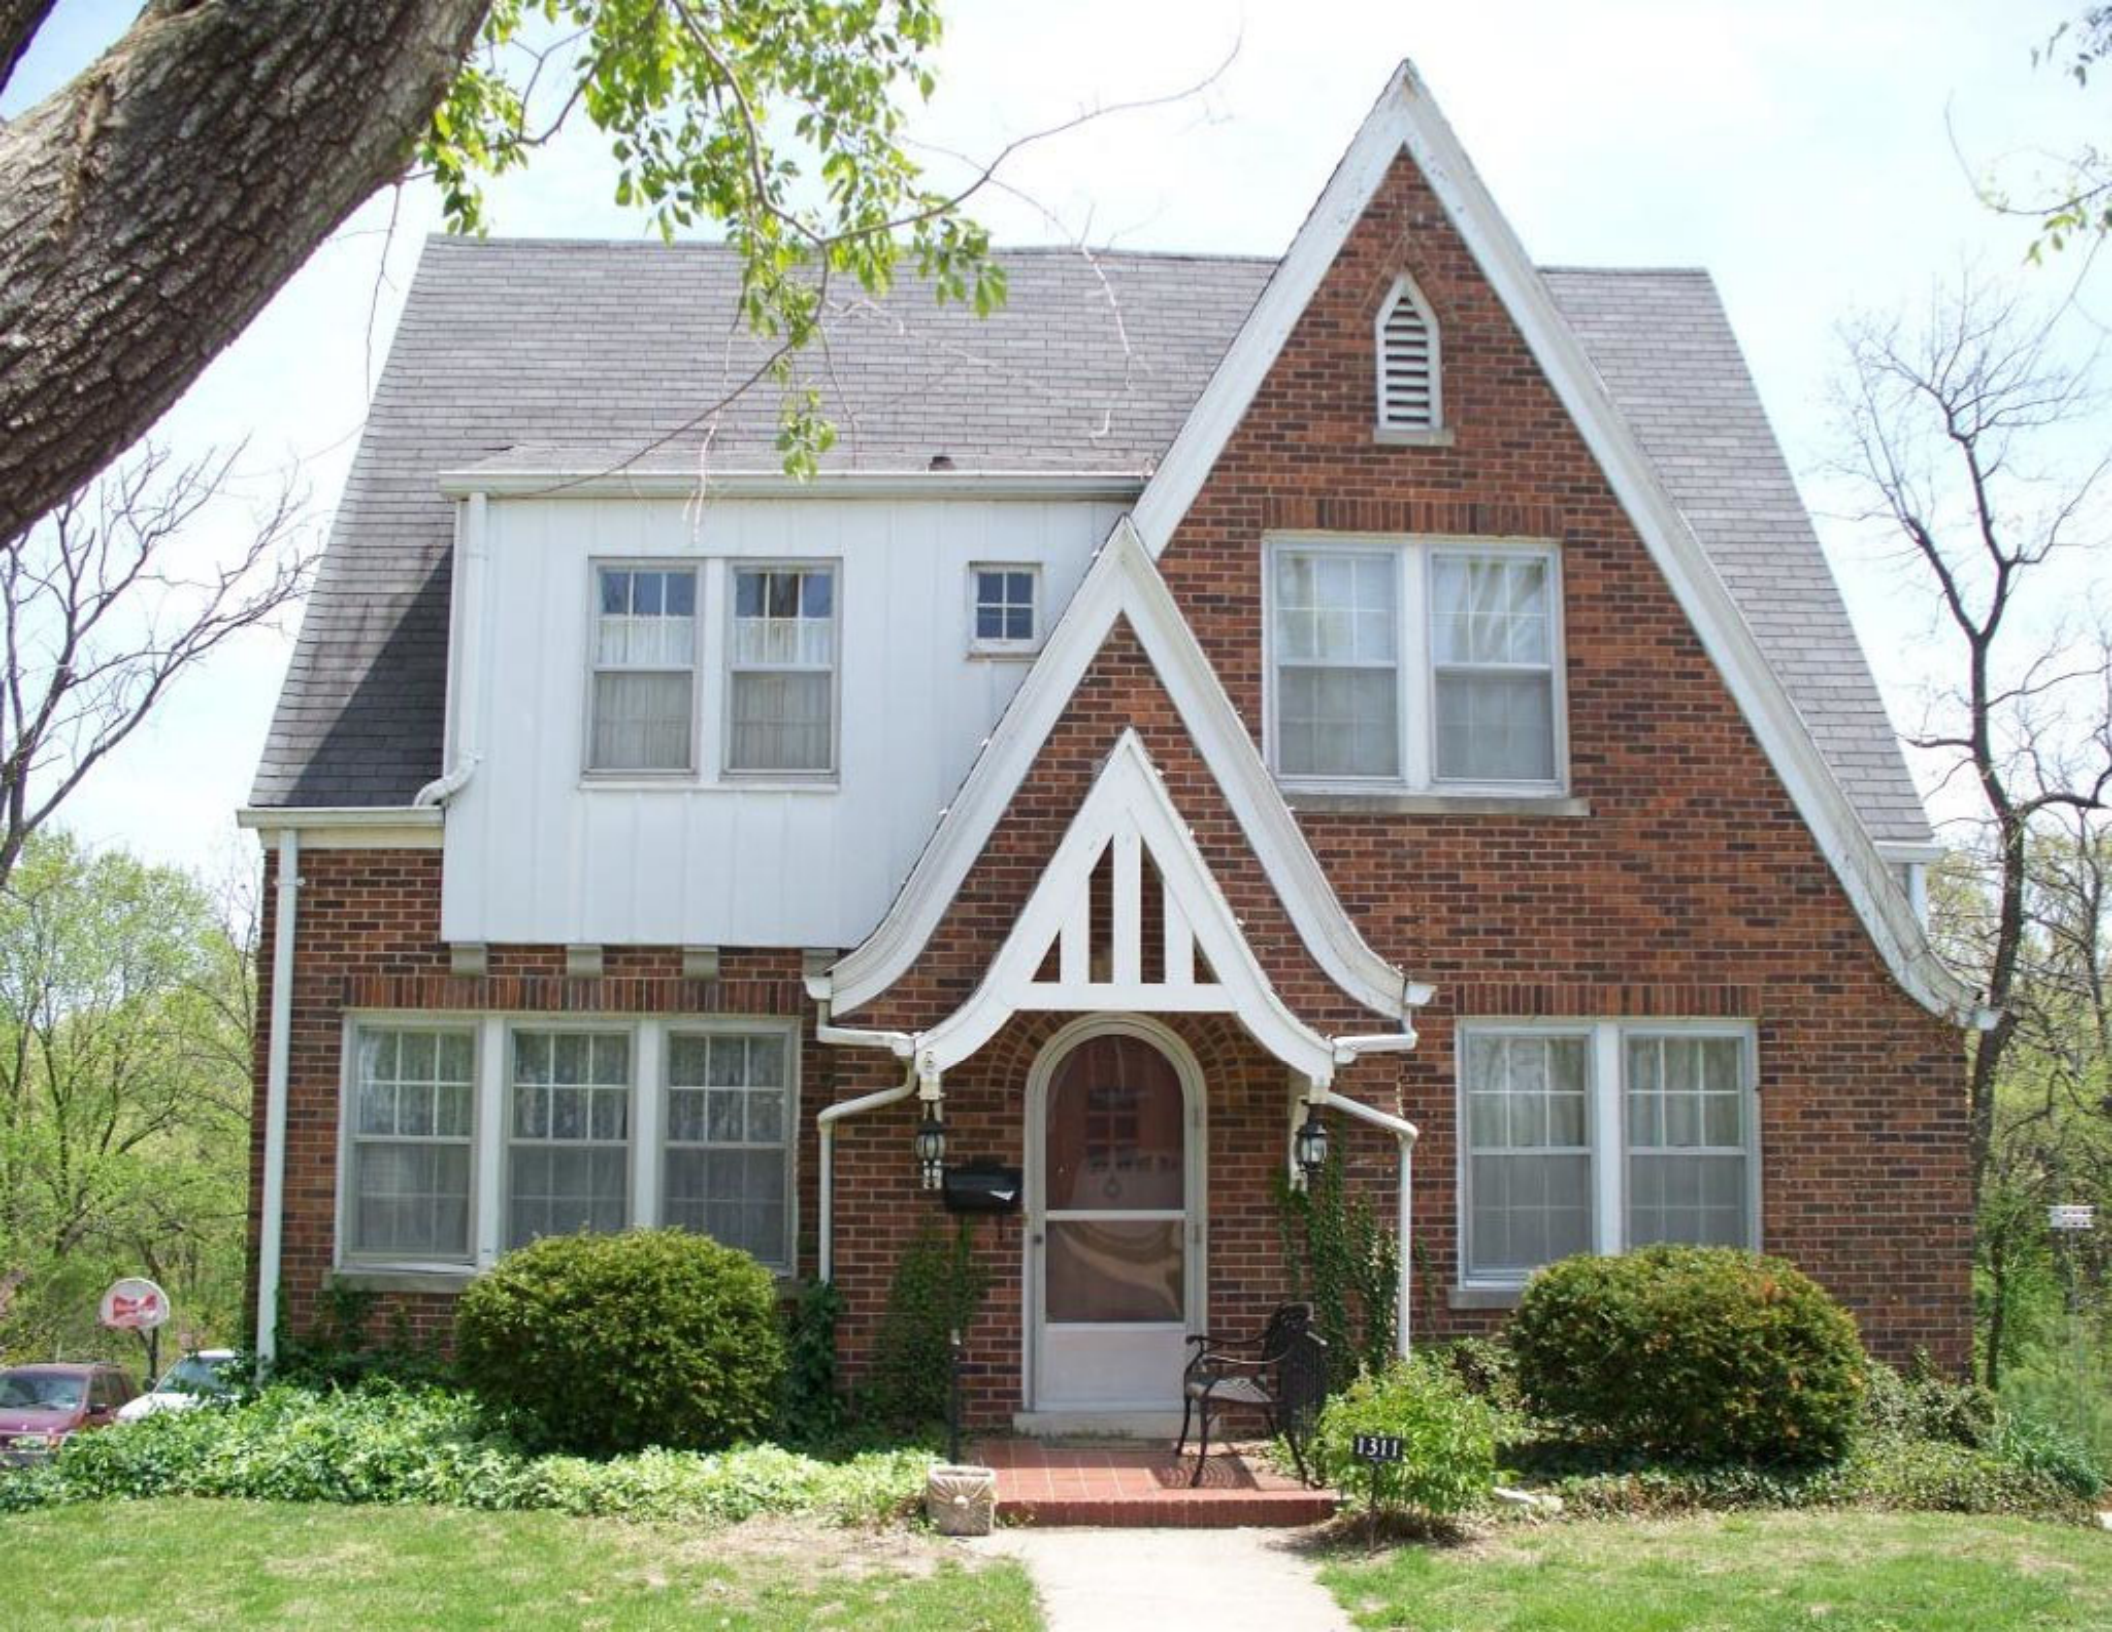
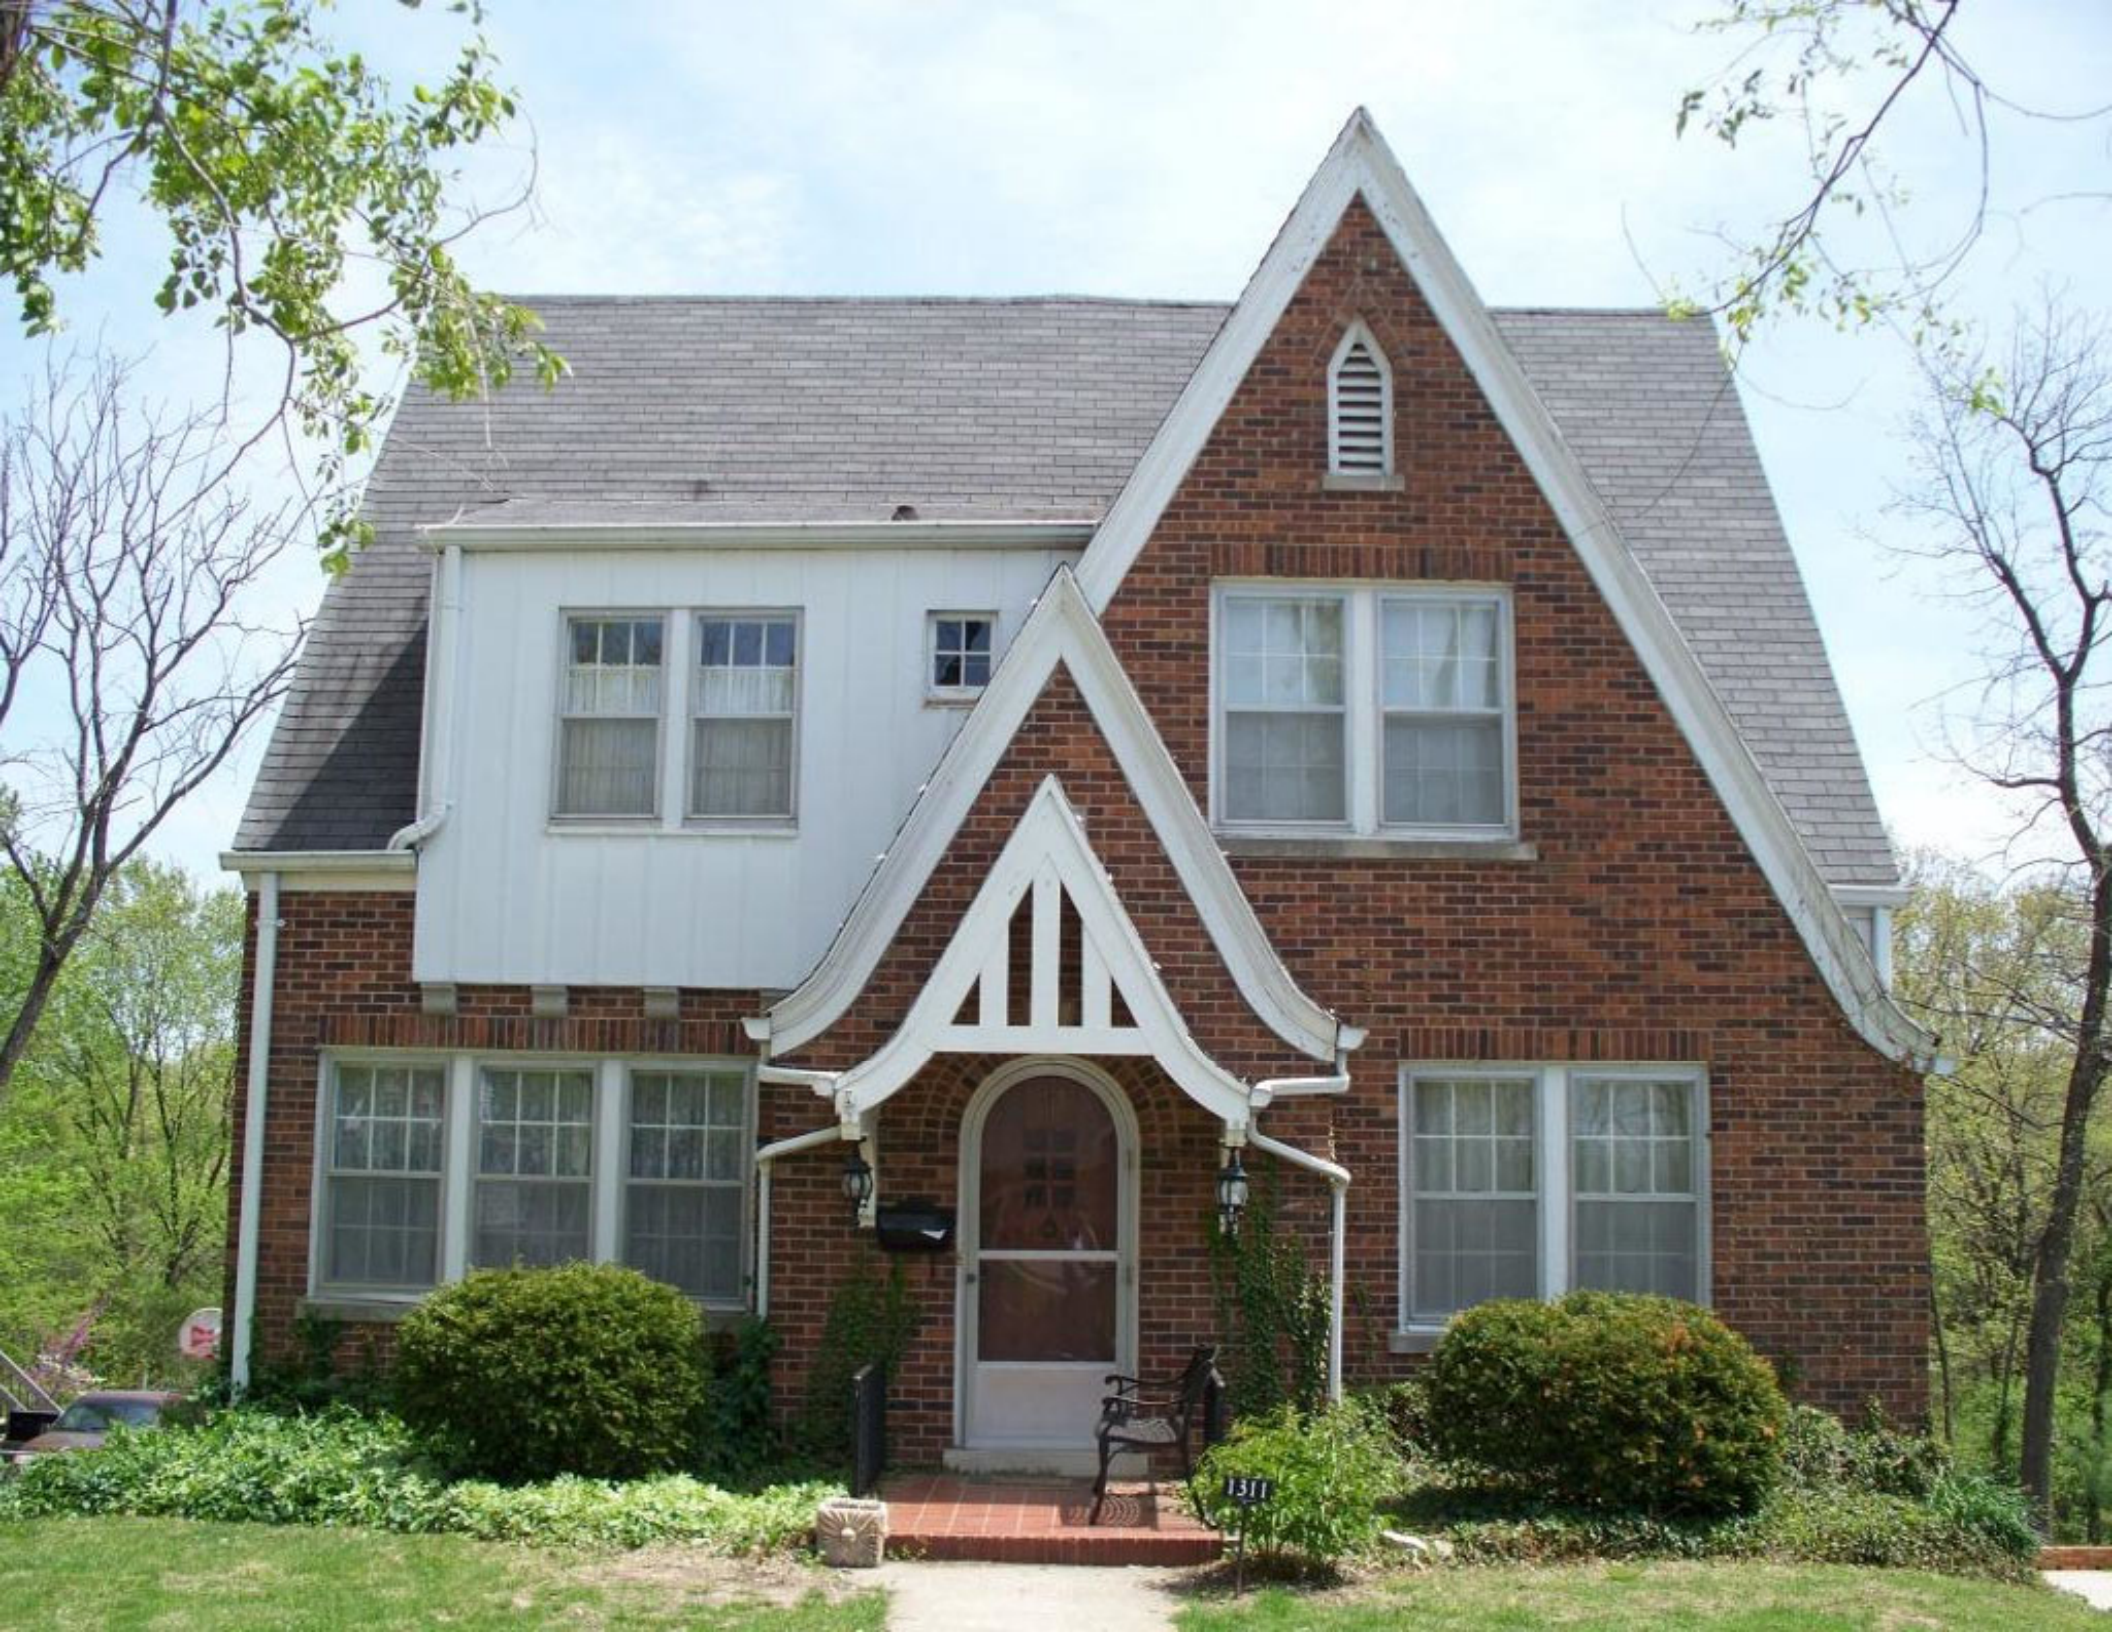
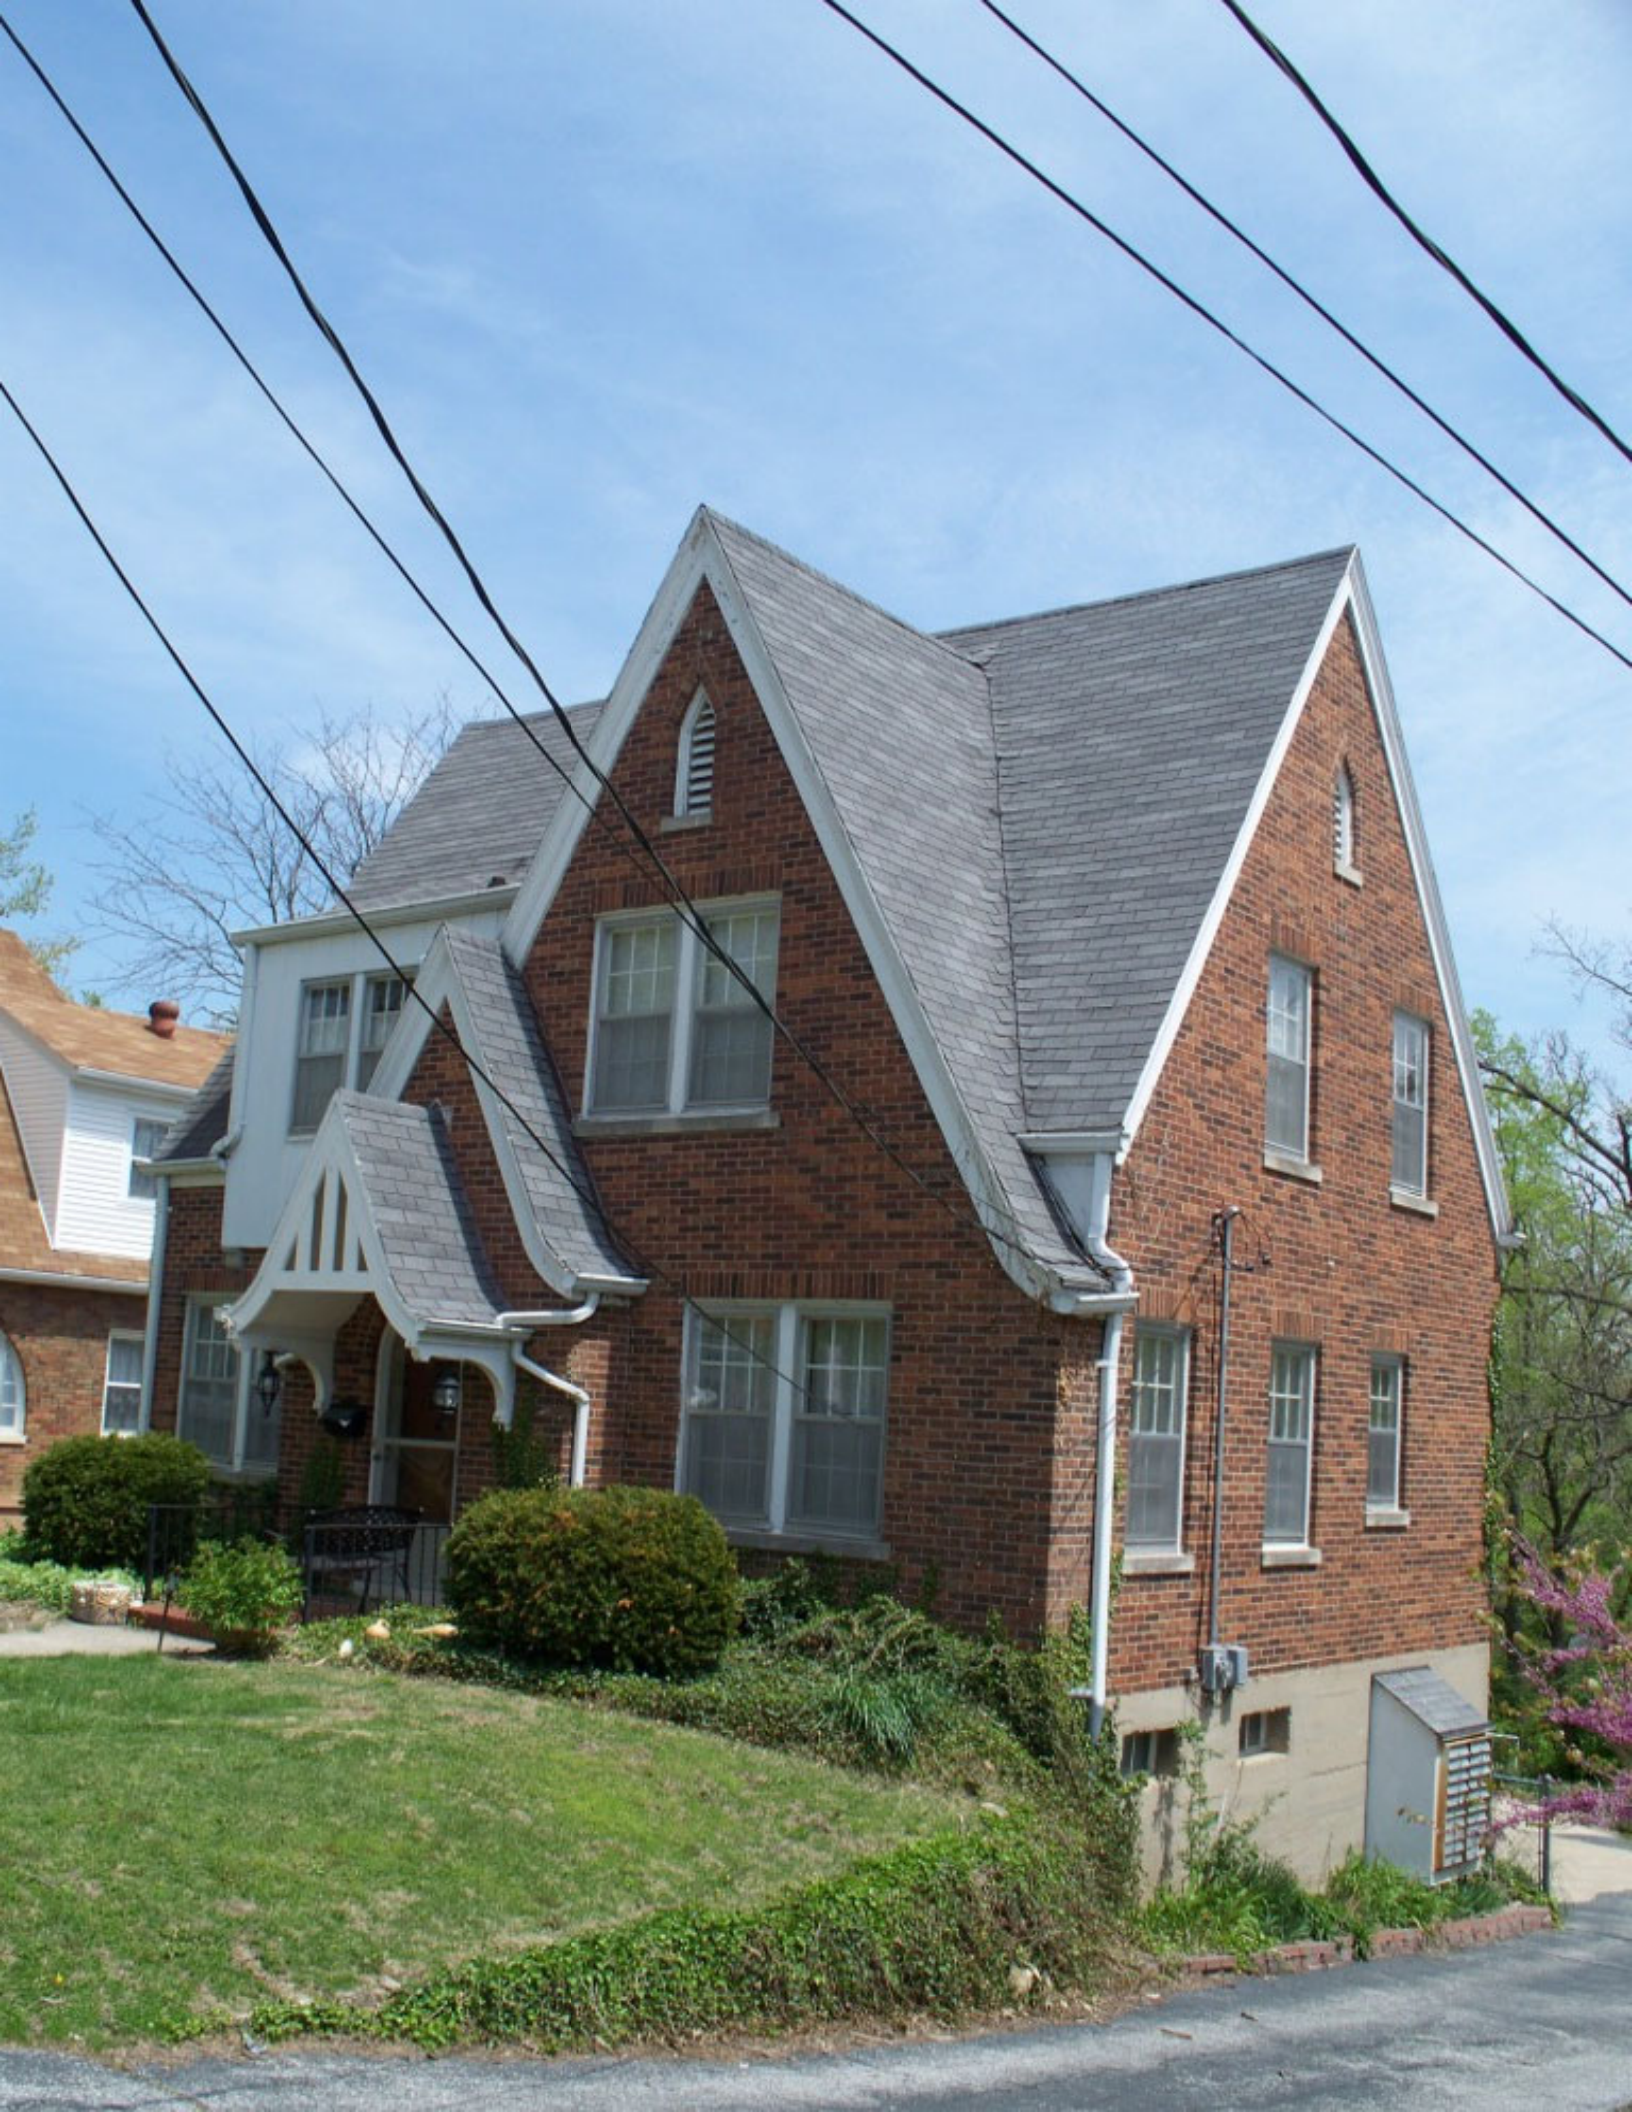
1371

41. (cont.) This two-story cross-gable brick Tudor Revival has a central arched entry and original rounded wooden door. A steeply gabled open hood with 'half-timbering' and brackets bolsters the property's Tudor style. The stoop consists of a simple raised brick tile with metal railing. There are two asymmetrical steeply gabled peaks; the smallest is at the entrance which projects slightly from the first bay (on the right) that has the latter steeply-pitched peak. This bay likewise projects from the rest of the side-gabled house, the only portion of which is visible from the main façade in the third bay (all the way to the left.) There are pairs of six-over-six historic windows with storms on the property. A pair are to the right of the entrance on both floors. A row of three windows are on the first floor to the left of the entrance. Above this a small addition has been added. Too wide to be considered a true dormer, it has a shed roof and a pair of six-over-six windows and a fixed glass 4 paneled casement window. The windows appear historic so the property may have been built this way or it was added early on. It appears to have been covered with metal siding. Four small stone brackets rest beneath it. There is a peaked vent in the uppermost dormer, this and the window openings and entrance has decorative brick work at the lentil and stone sills. The windows in the 'addition' have wooden sills.

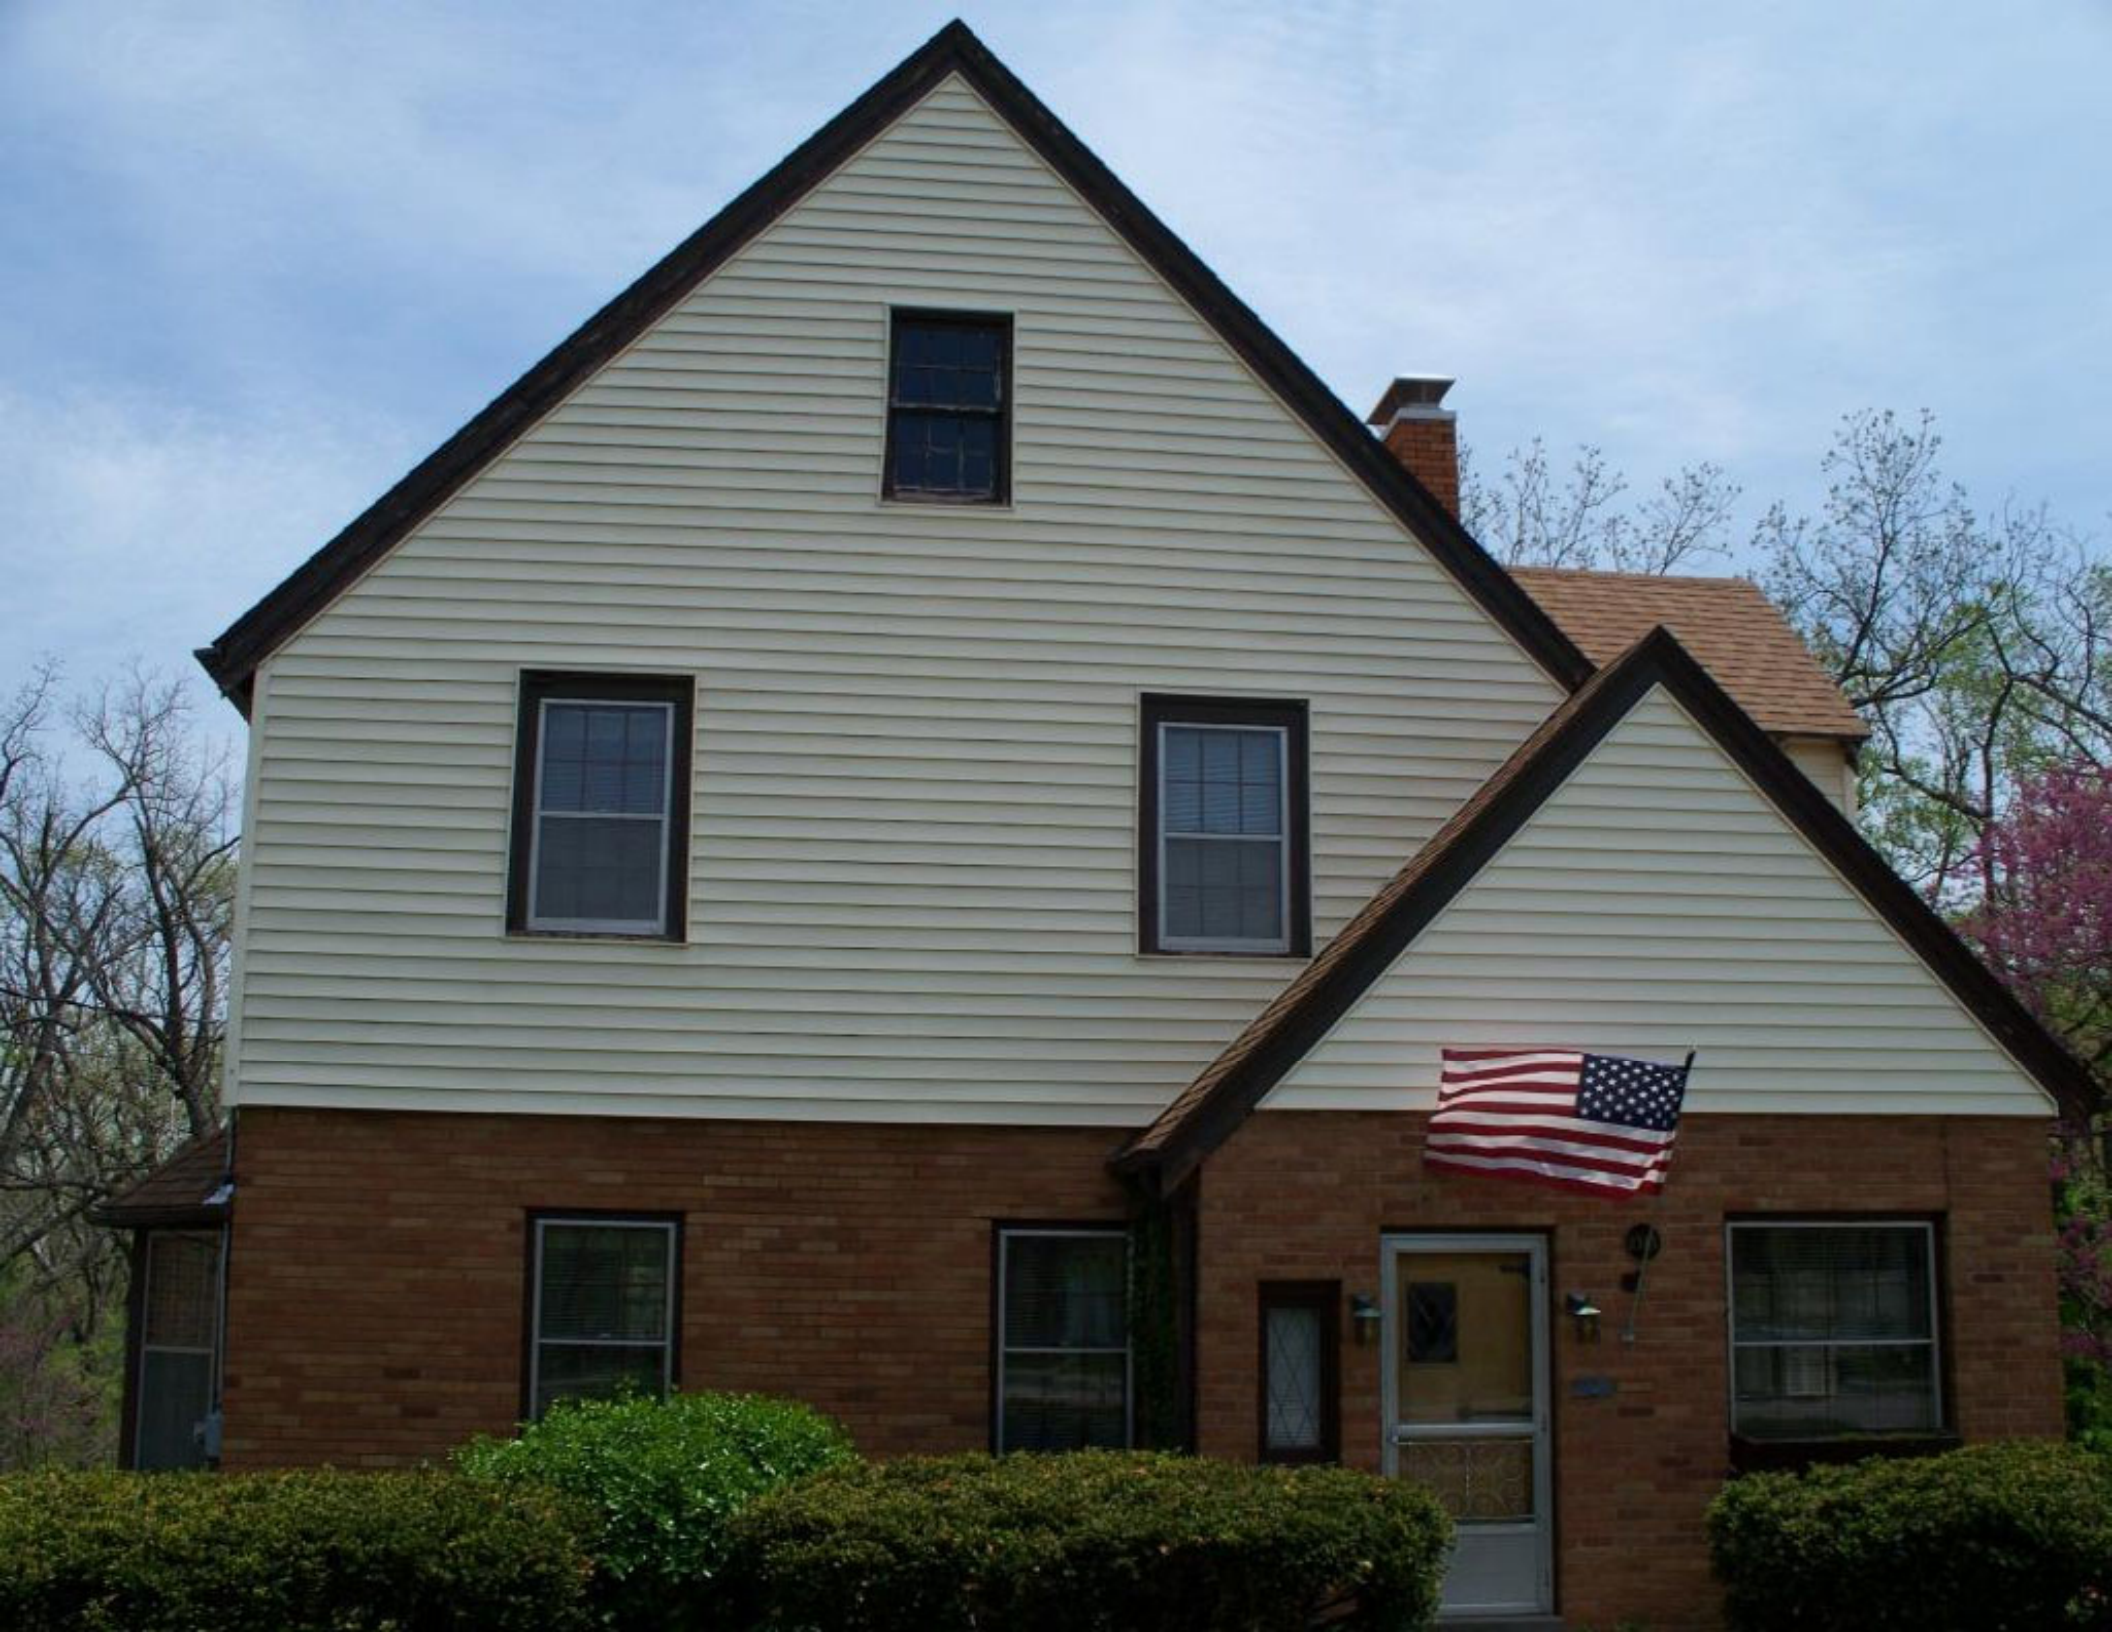
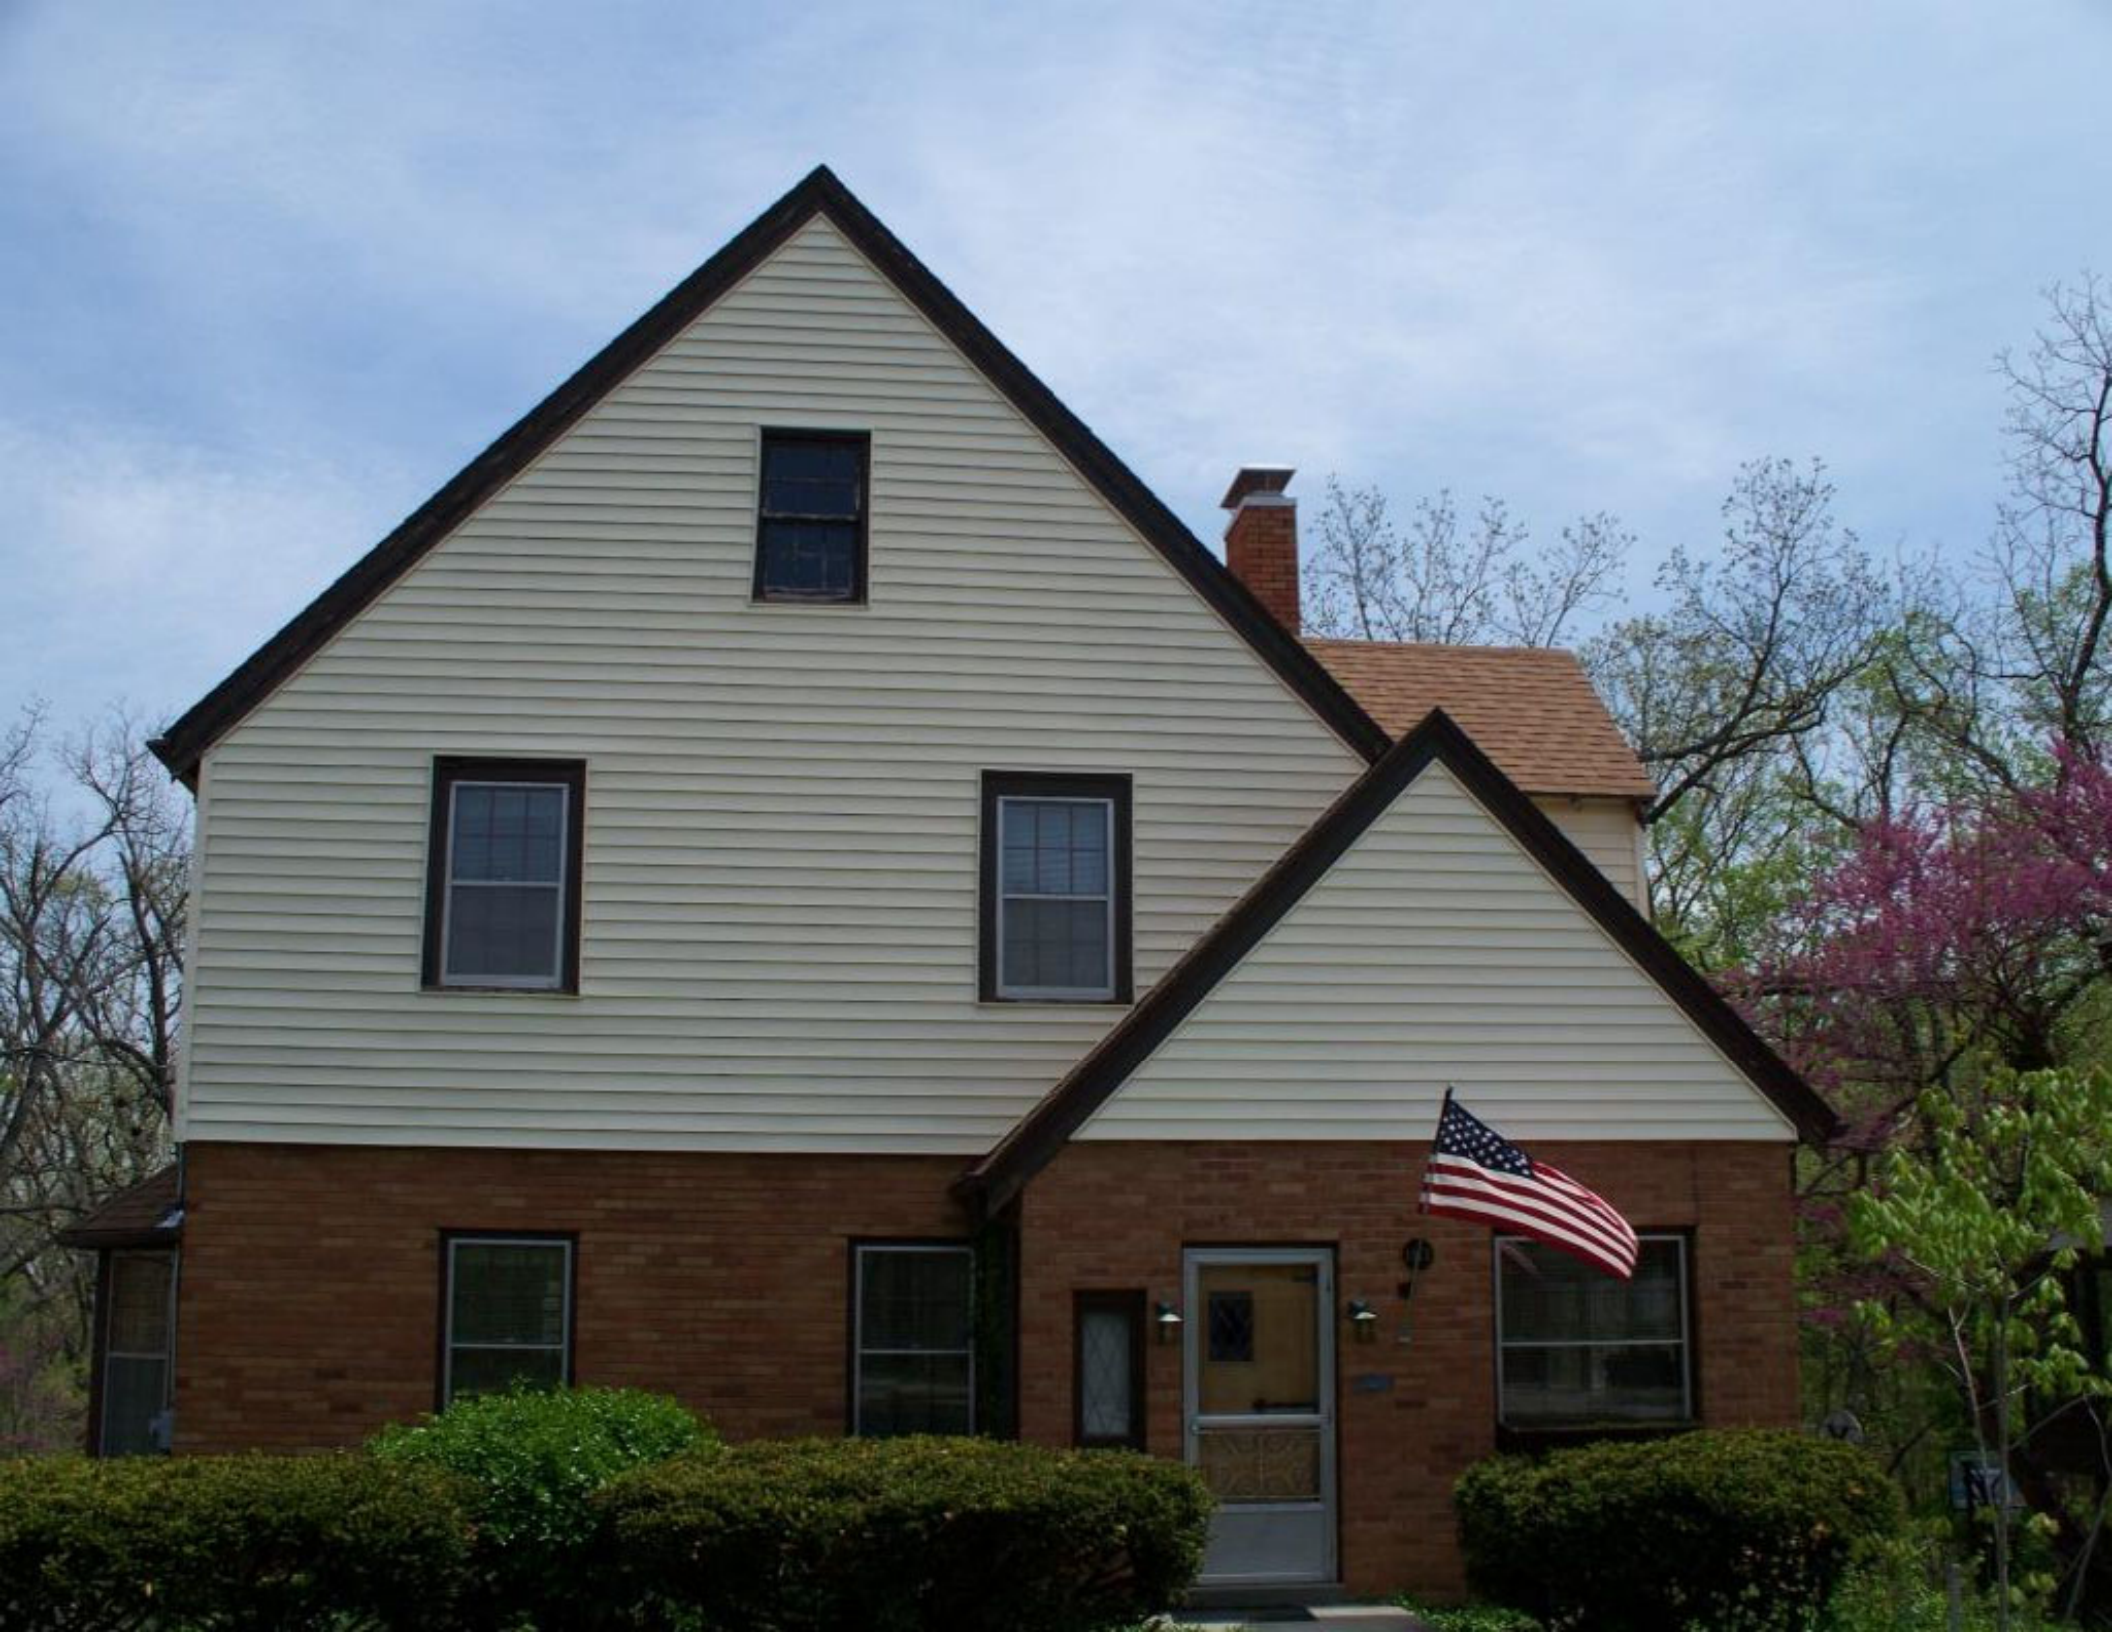
41. (cont.) Vinyl Siding has been applied to the upper stories of this house, which has altered its appearance. However it retains its shape, the original windows and entrance and is thus considered contributing to the district. The first bay (from the right) projects slightly and has a steep gable. The entrance is in this bay. It retains its original wooden door and fixed diamond-patterned casement window to the left and six-over-six window to the left. Vinyl is in the gable of this bay, which is offset from the central portion of the house. The vinyl runs in line with the rest of the property, there are two six-over-six windows on the second story and a single smaller six-over-six window on the top story. The first story is brick and has two six-over-six windows. It appears there are projecting bay windows on either side of the house. On the right there is a rear addition extending from side of the house behind the bay window. The windows appear historic and have storms.
