ARCHITECTURAL/HISTORIC INVENTORY FORM

1. Survey No. CO-AS-005-001		2. Survey name: Moreau Drive Neighborhood Survey	
3. County: Cole		4. Address: 1202 Elmerine Ave.	
5. City: Jefferson City	Vicinity: <input type="checkbox"/>	6. UTM: / /	7. Township/Range/Section: T: R: S:
8. Historic name (if known):		9. Present/other name (if known):	
10. Ownership: <input checked="" type="checkbox"/> Private <input type="checkbox"/> Public		11. Historic use (if known): Residential	11. Current use: Residential

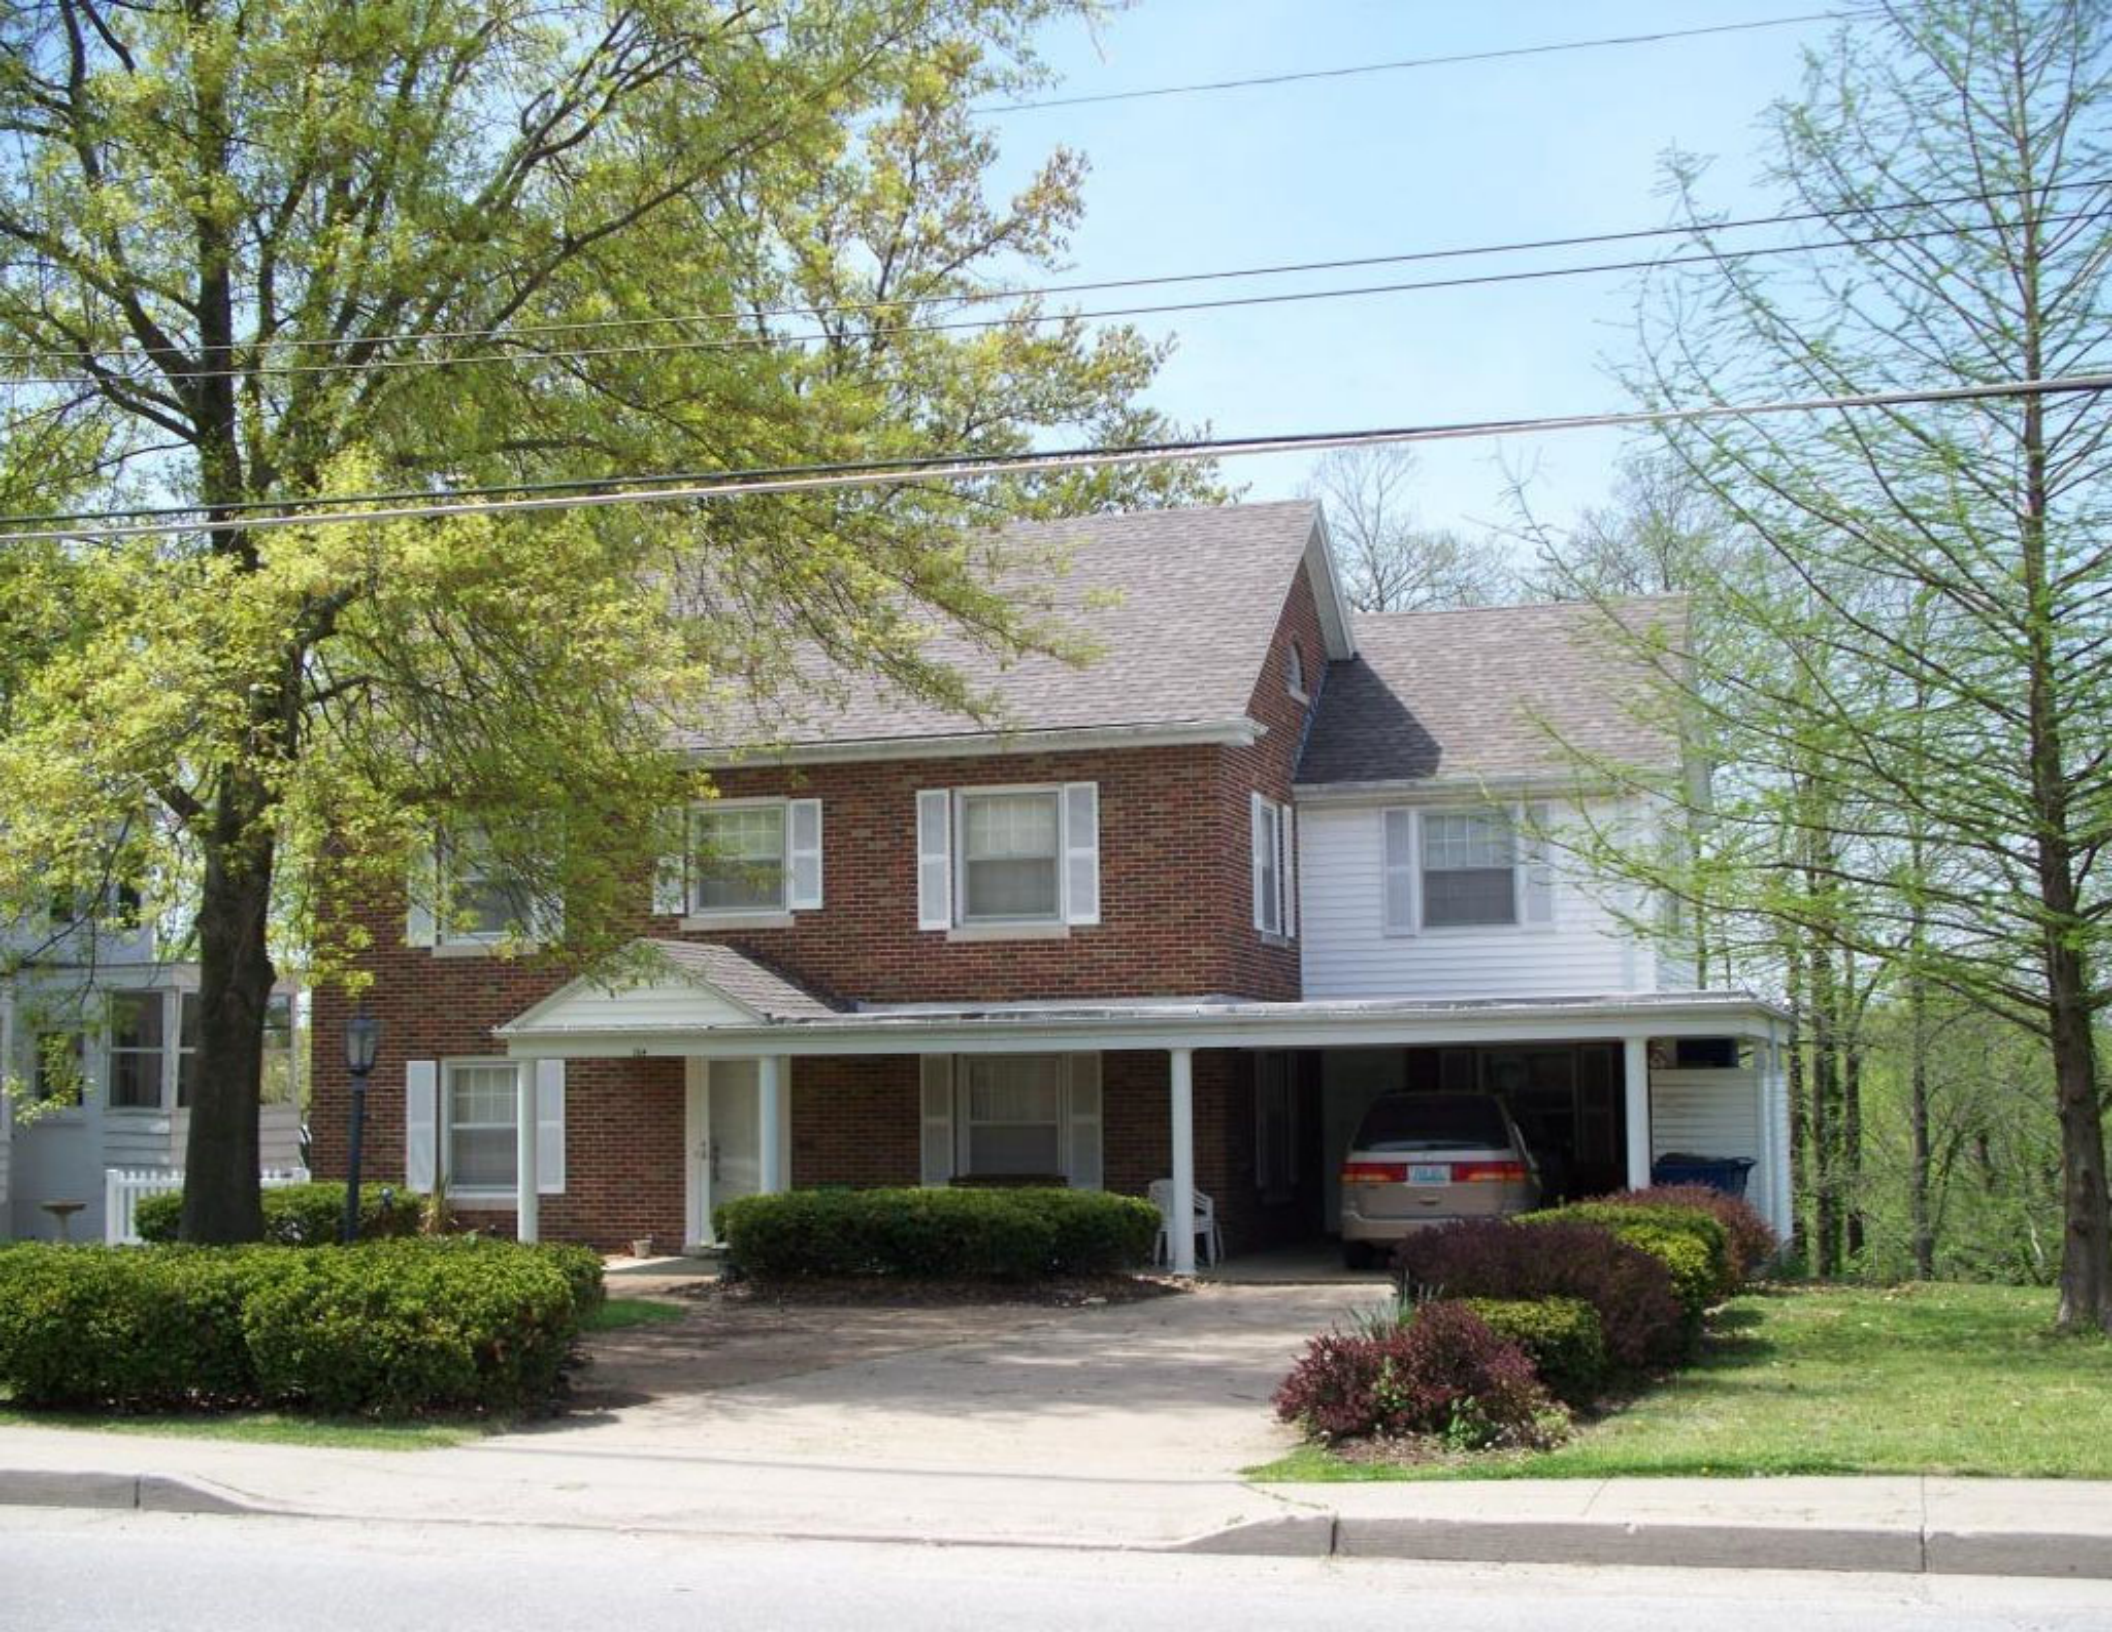
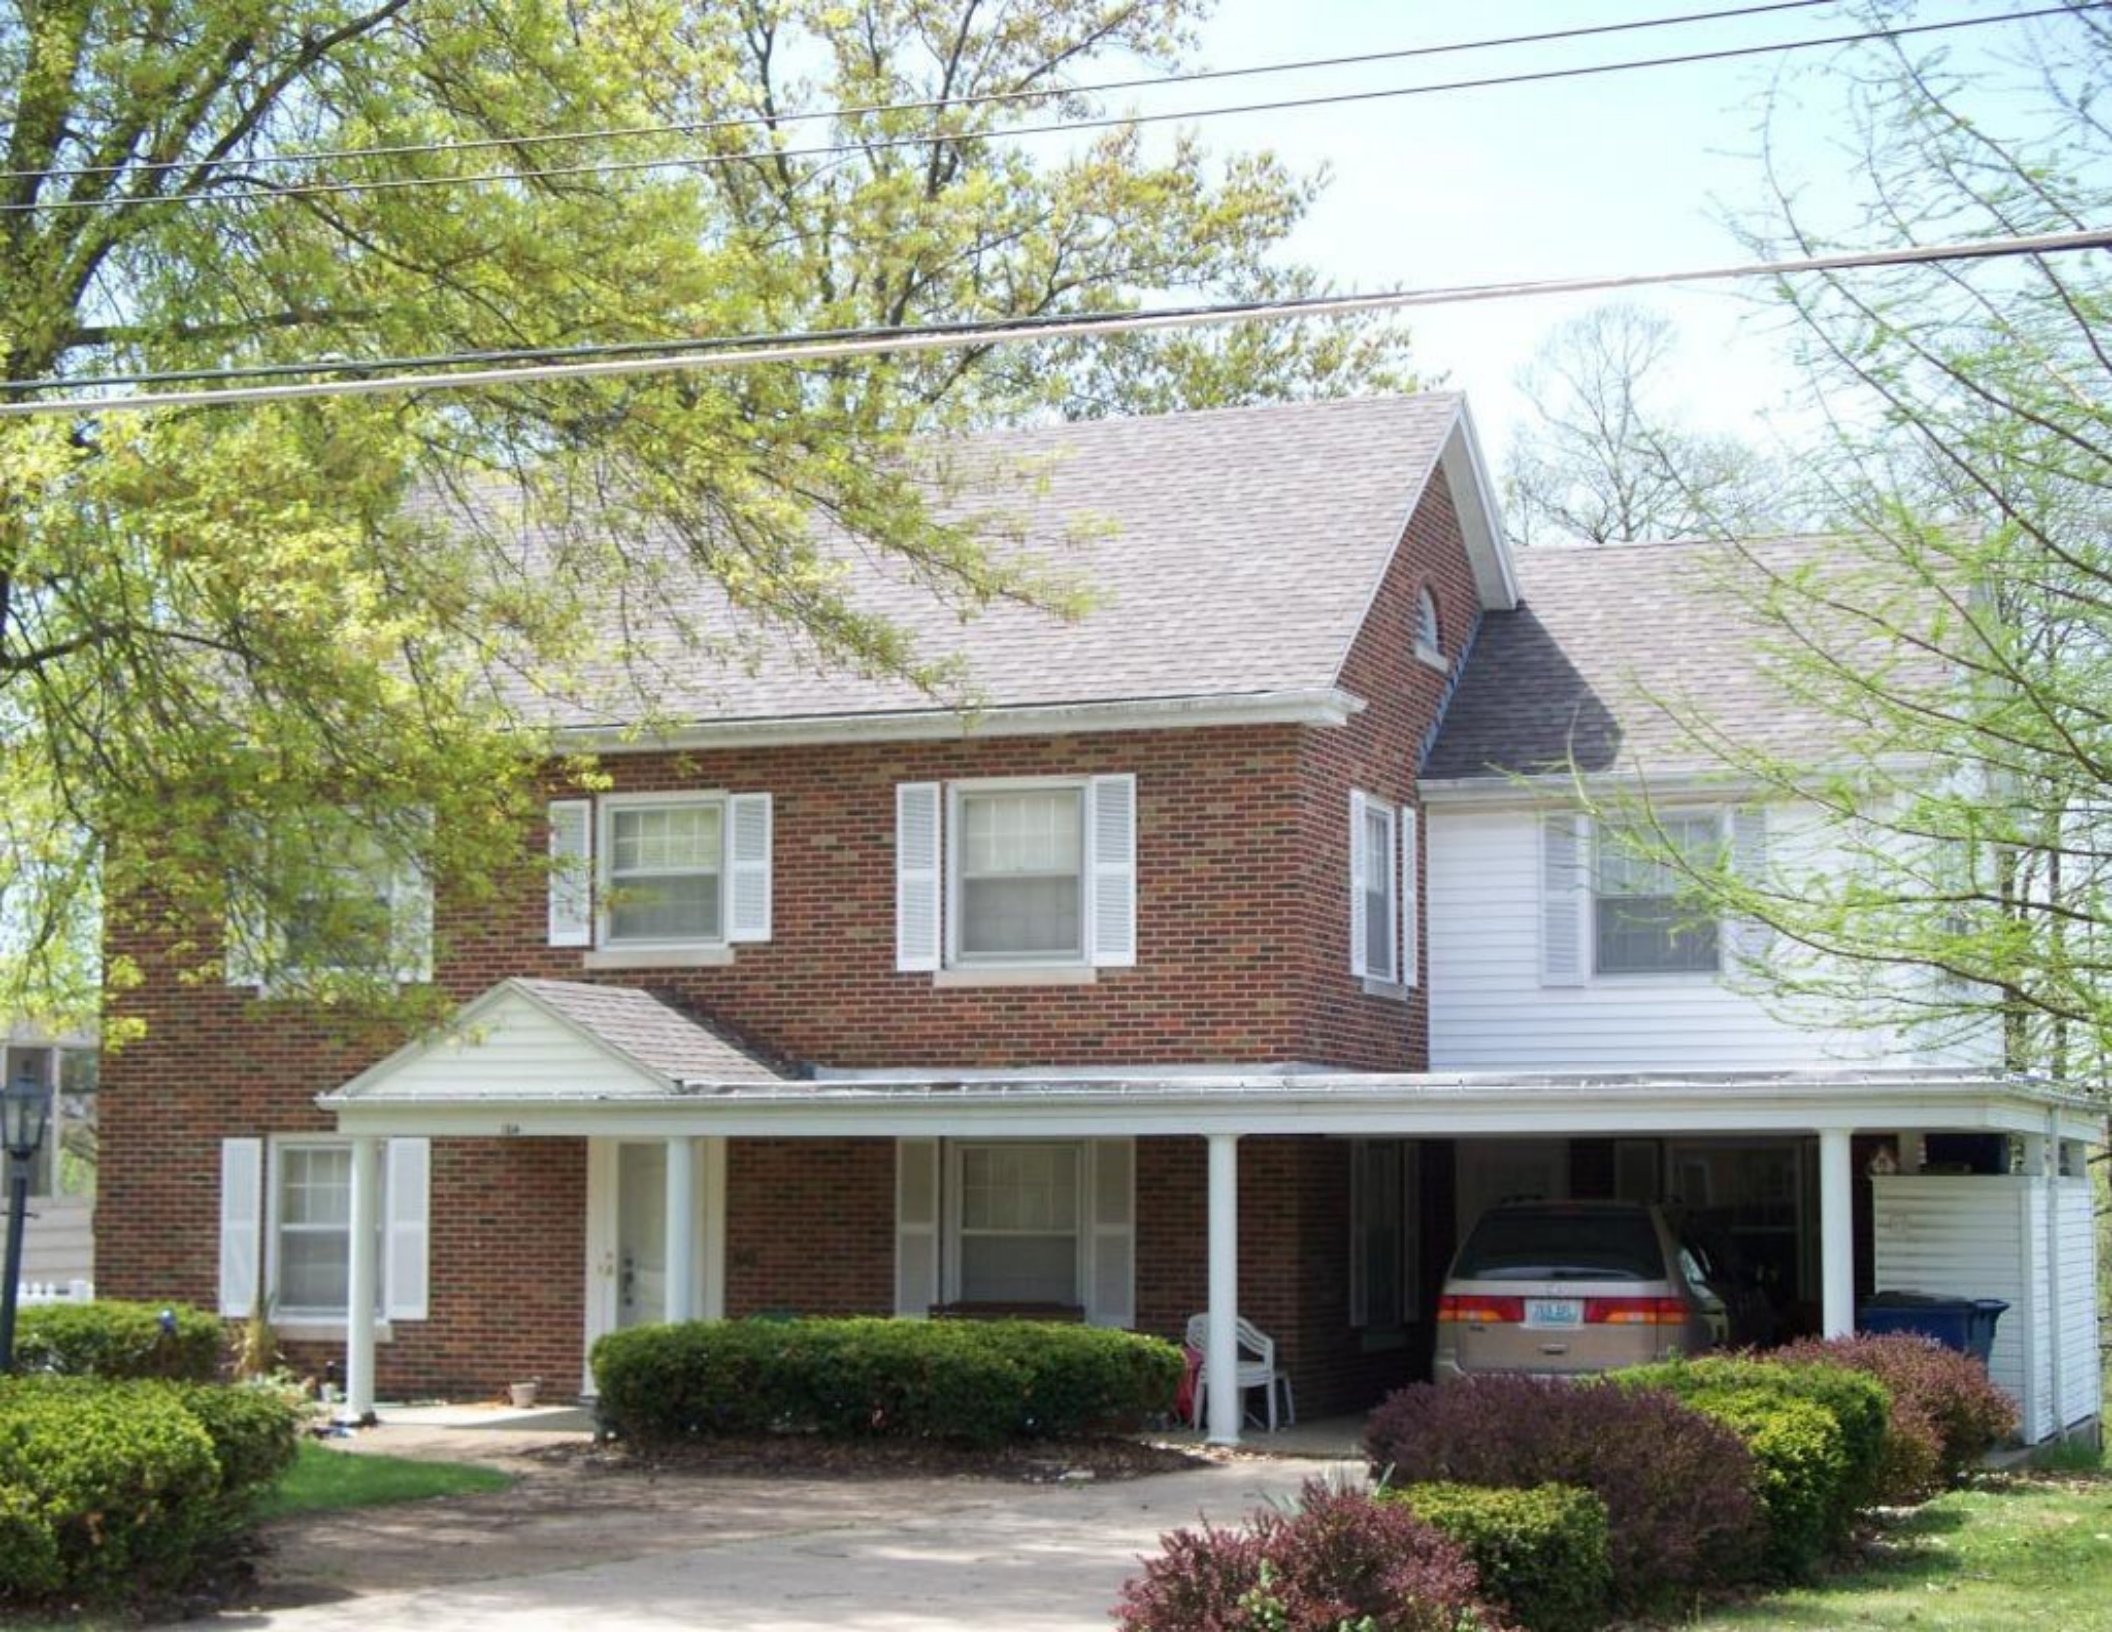
The modified wraparound porch/carport that stretches from the gabled portico to the projecting back wing of the house may compromise the property's historic integrity. The two story brick Colonial Revival has 6/6 windows may be historic or sympathetic replacements. There are two symmetrically placed windows flanking a slightly smaller window on the second floor and two windows flanking the central entrance on the first story. All windows have concrete sills and shutters. The two-story wing on the right side of the property is set back and clad in vinyl siding. The majority of the property looks intact so for the purposes of this survey it is considered contributing.

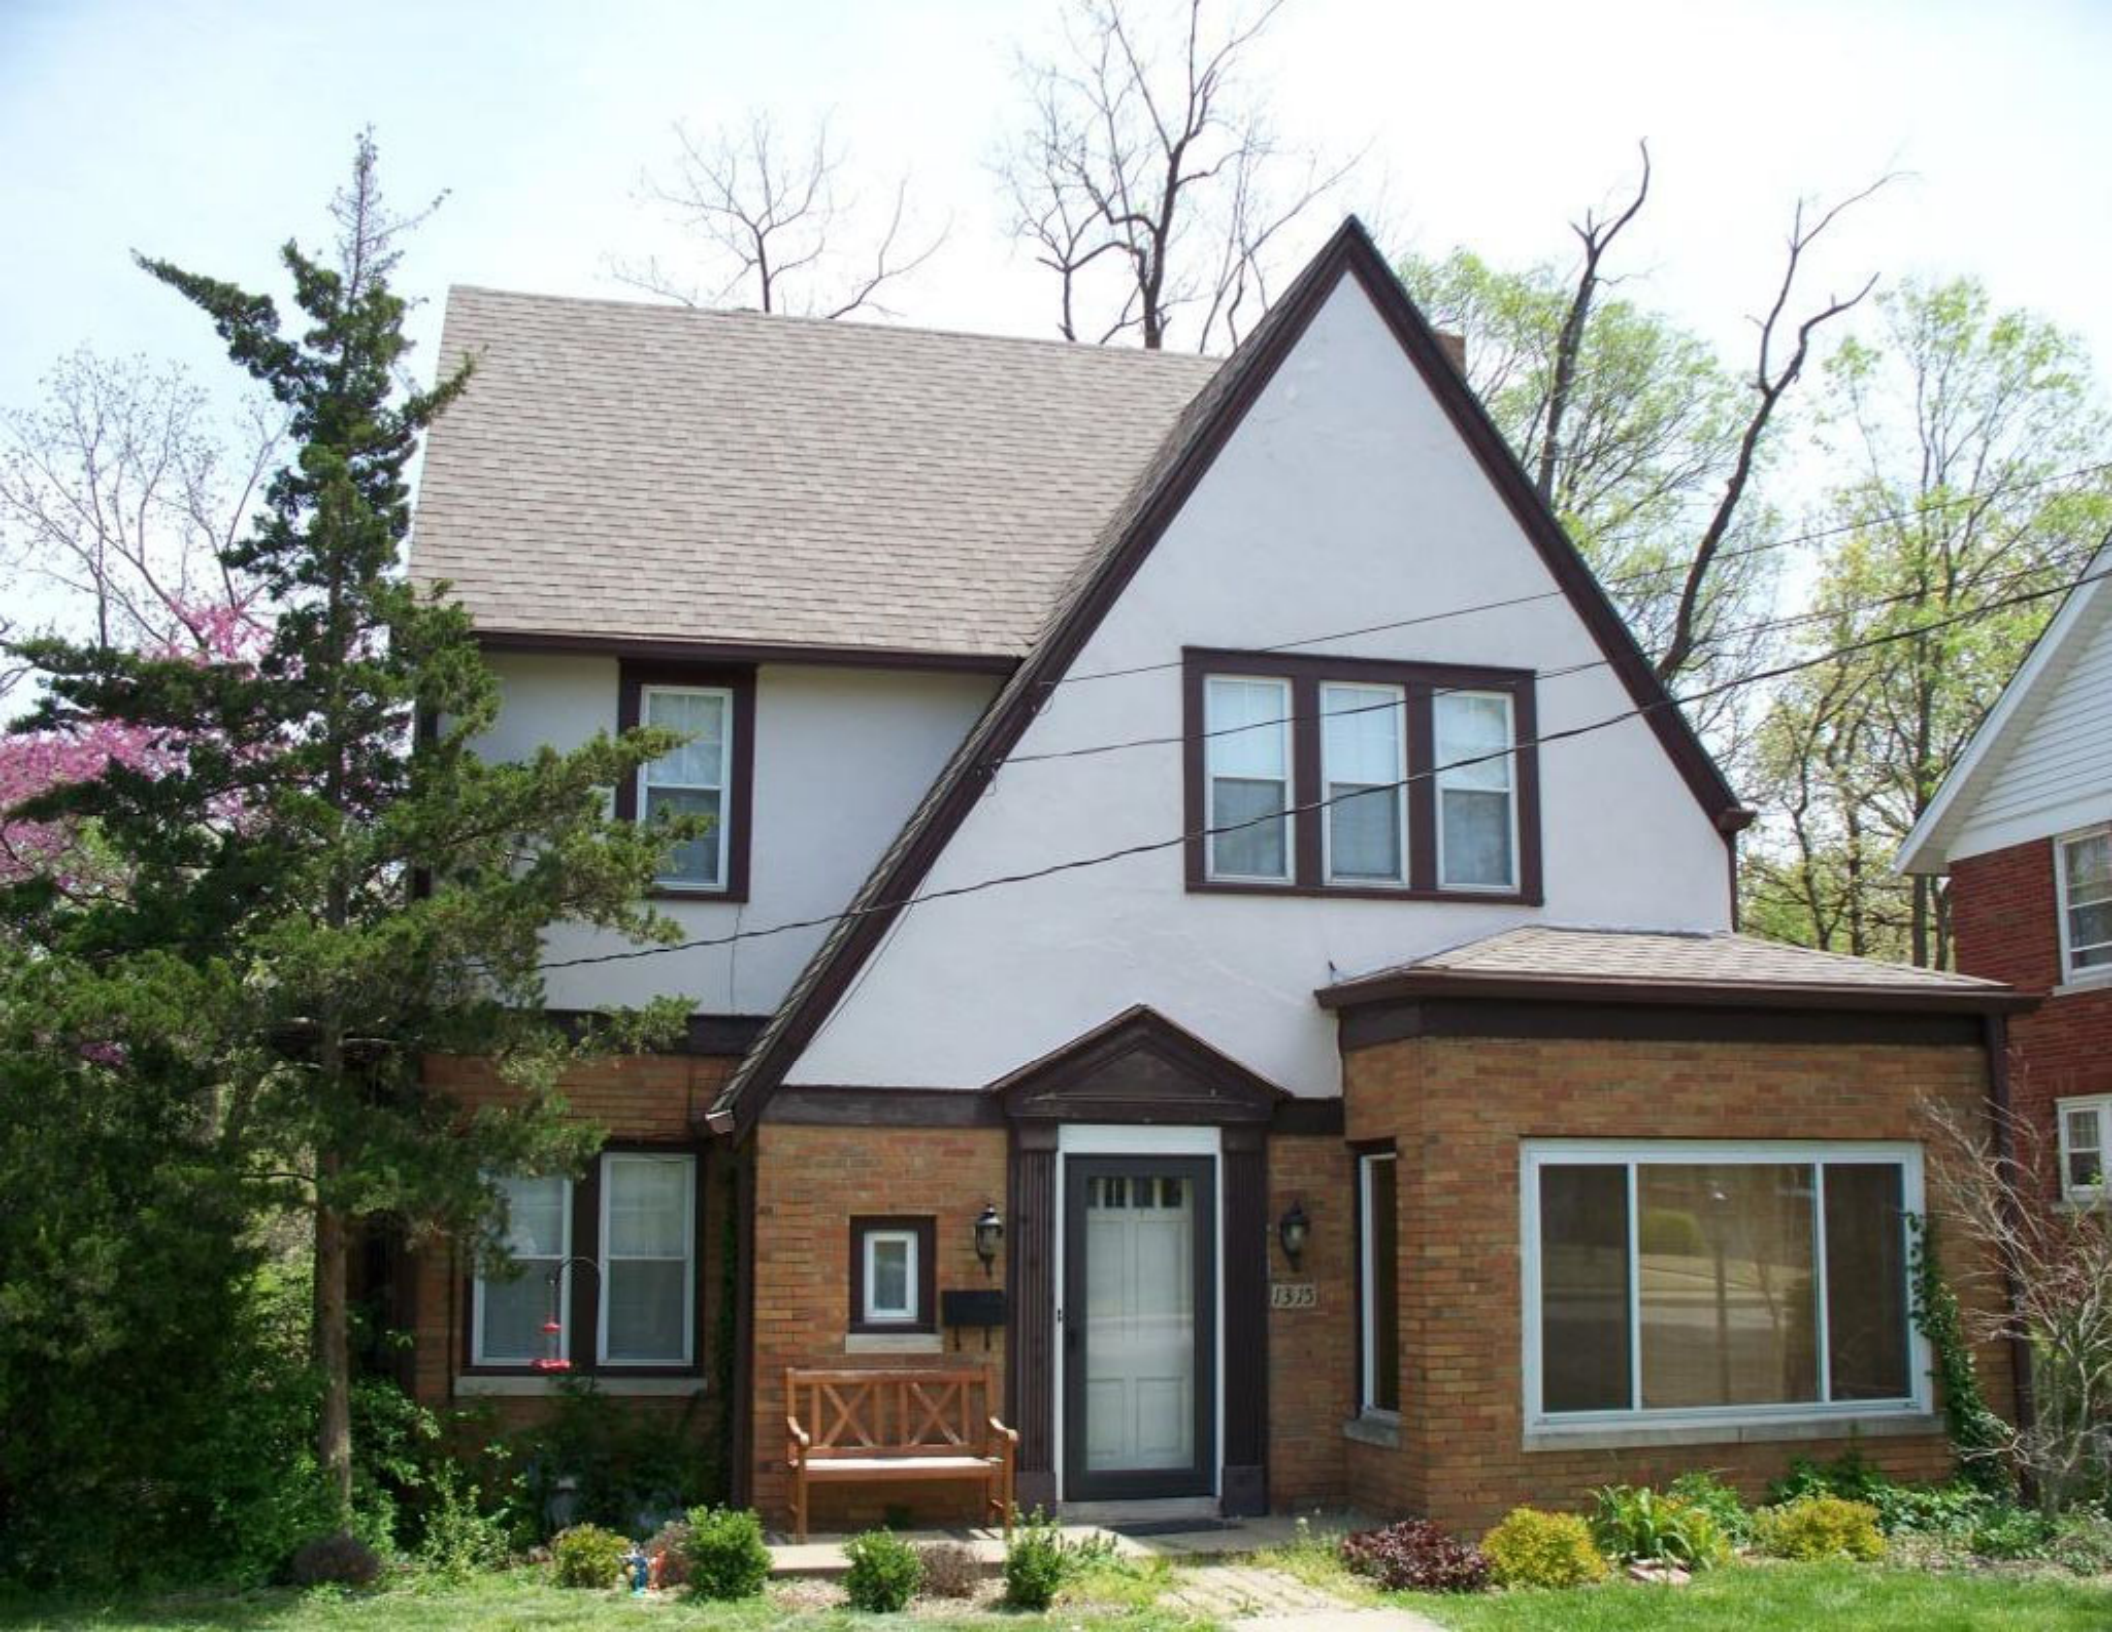
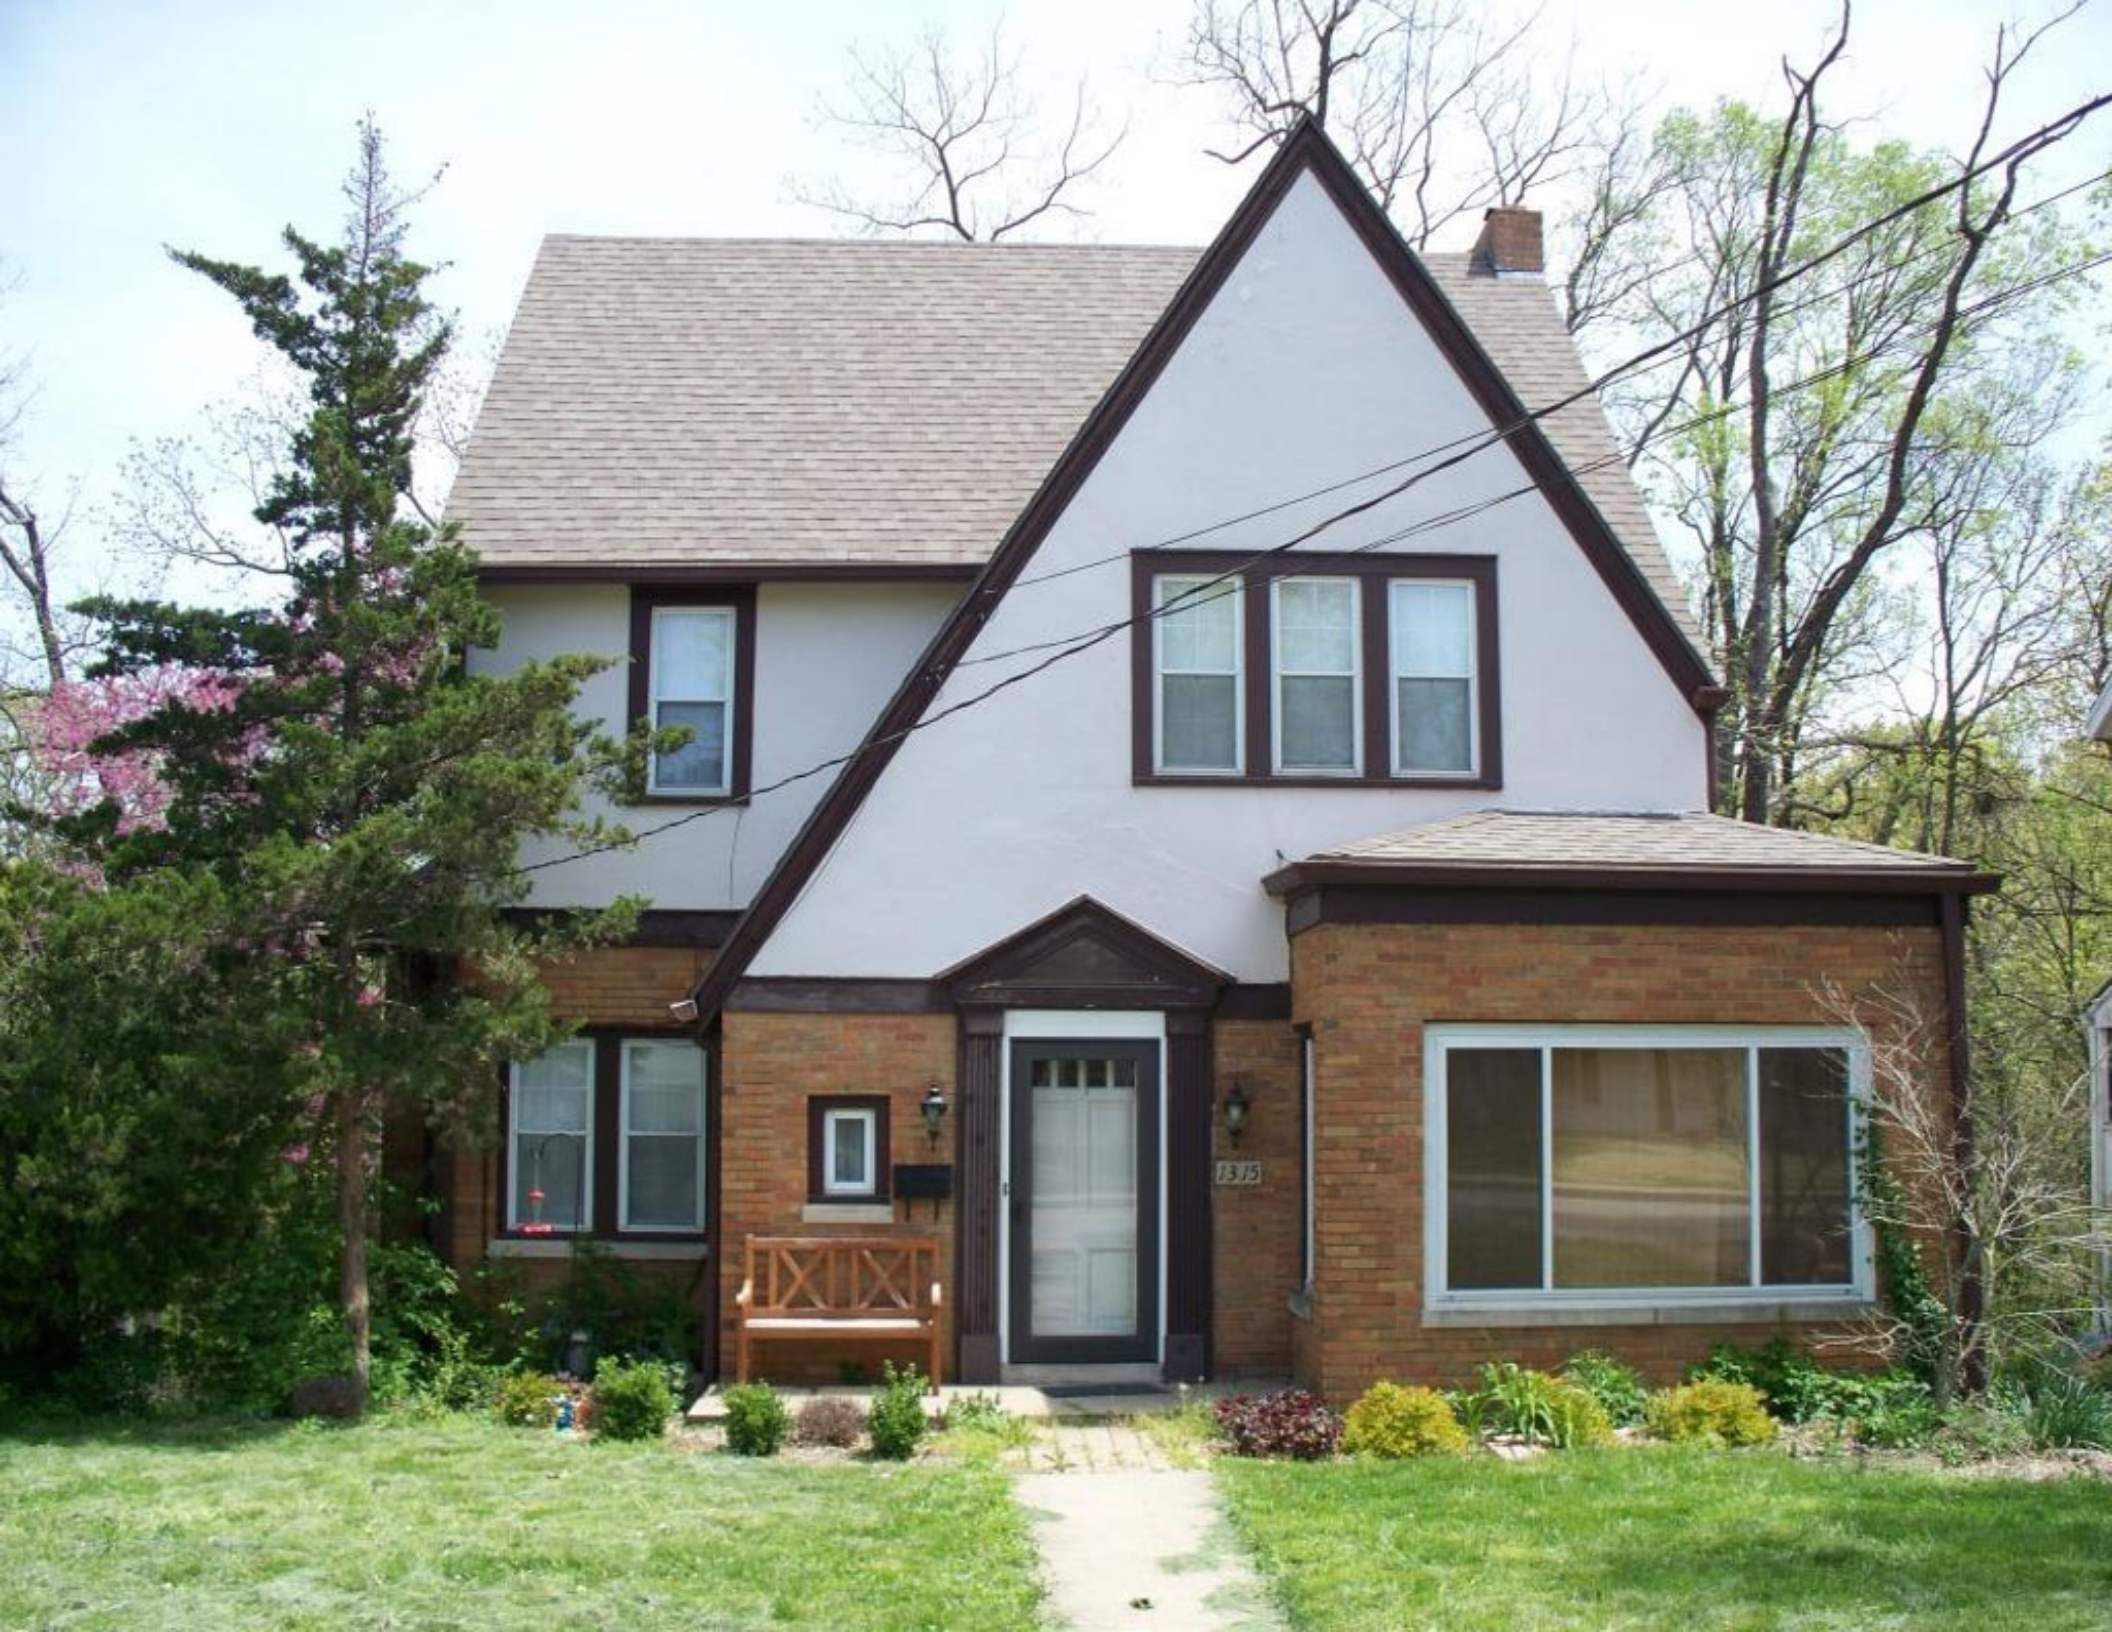
41. (cont.) This two-story Tudor Revival house has stucco on the upper story and brick on the lower. The main entrance is located in the front-gabled bay which projects off-center and to the right from the cross-gable back portion of the house. The entrance has a classical pediment door surround and what appears to be the original or historic door with four-light in the upper portion. To the left of the entrance, still within the front-gabled bay, is a small fixed window with limestone sill. A sunroom/porch projects from the right of the door and wraps around the side of the house. It has been enclosed with large one-pane tri-part windows on the main façade and a single fixed window on the side facing the entrance. The single bay set back on the left side of the property has paired four-over-four windows with a limestone sill. They appear historic. A single four-over-four is in this bay on the second floor, with a row of three four-over-four windows in the gabled bay. All windows have wooden surrounds, although the windows on the second floor lack sills.

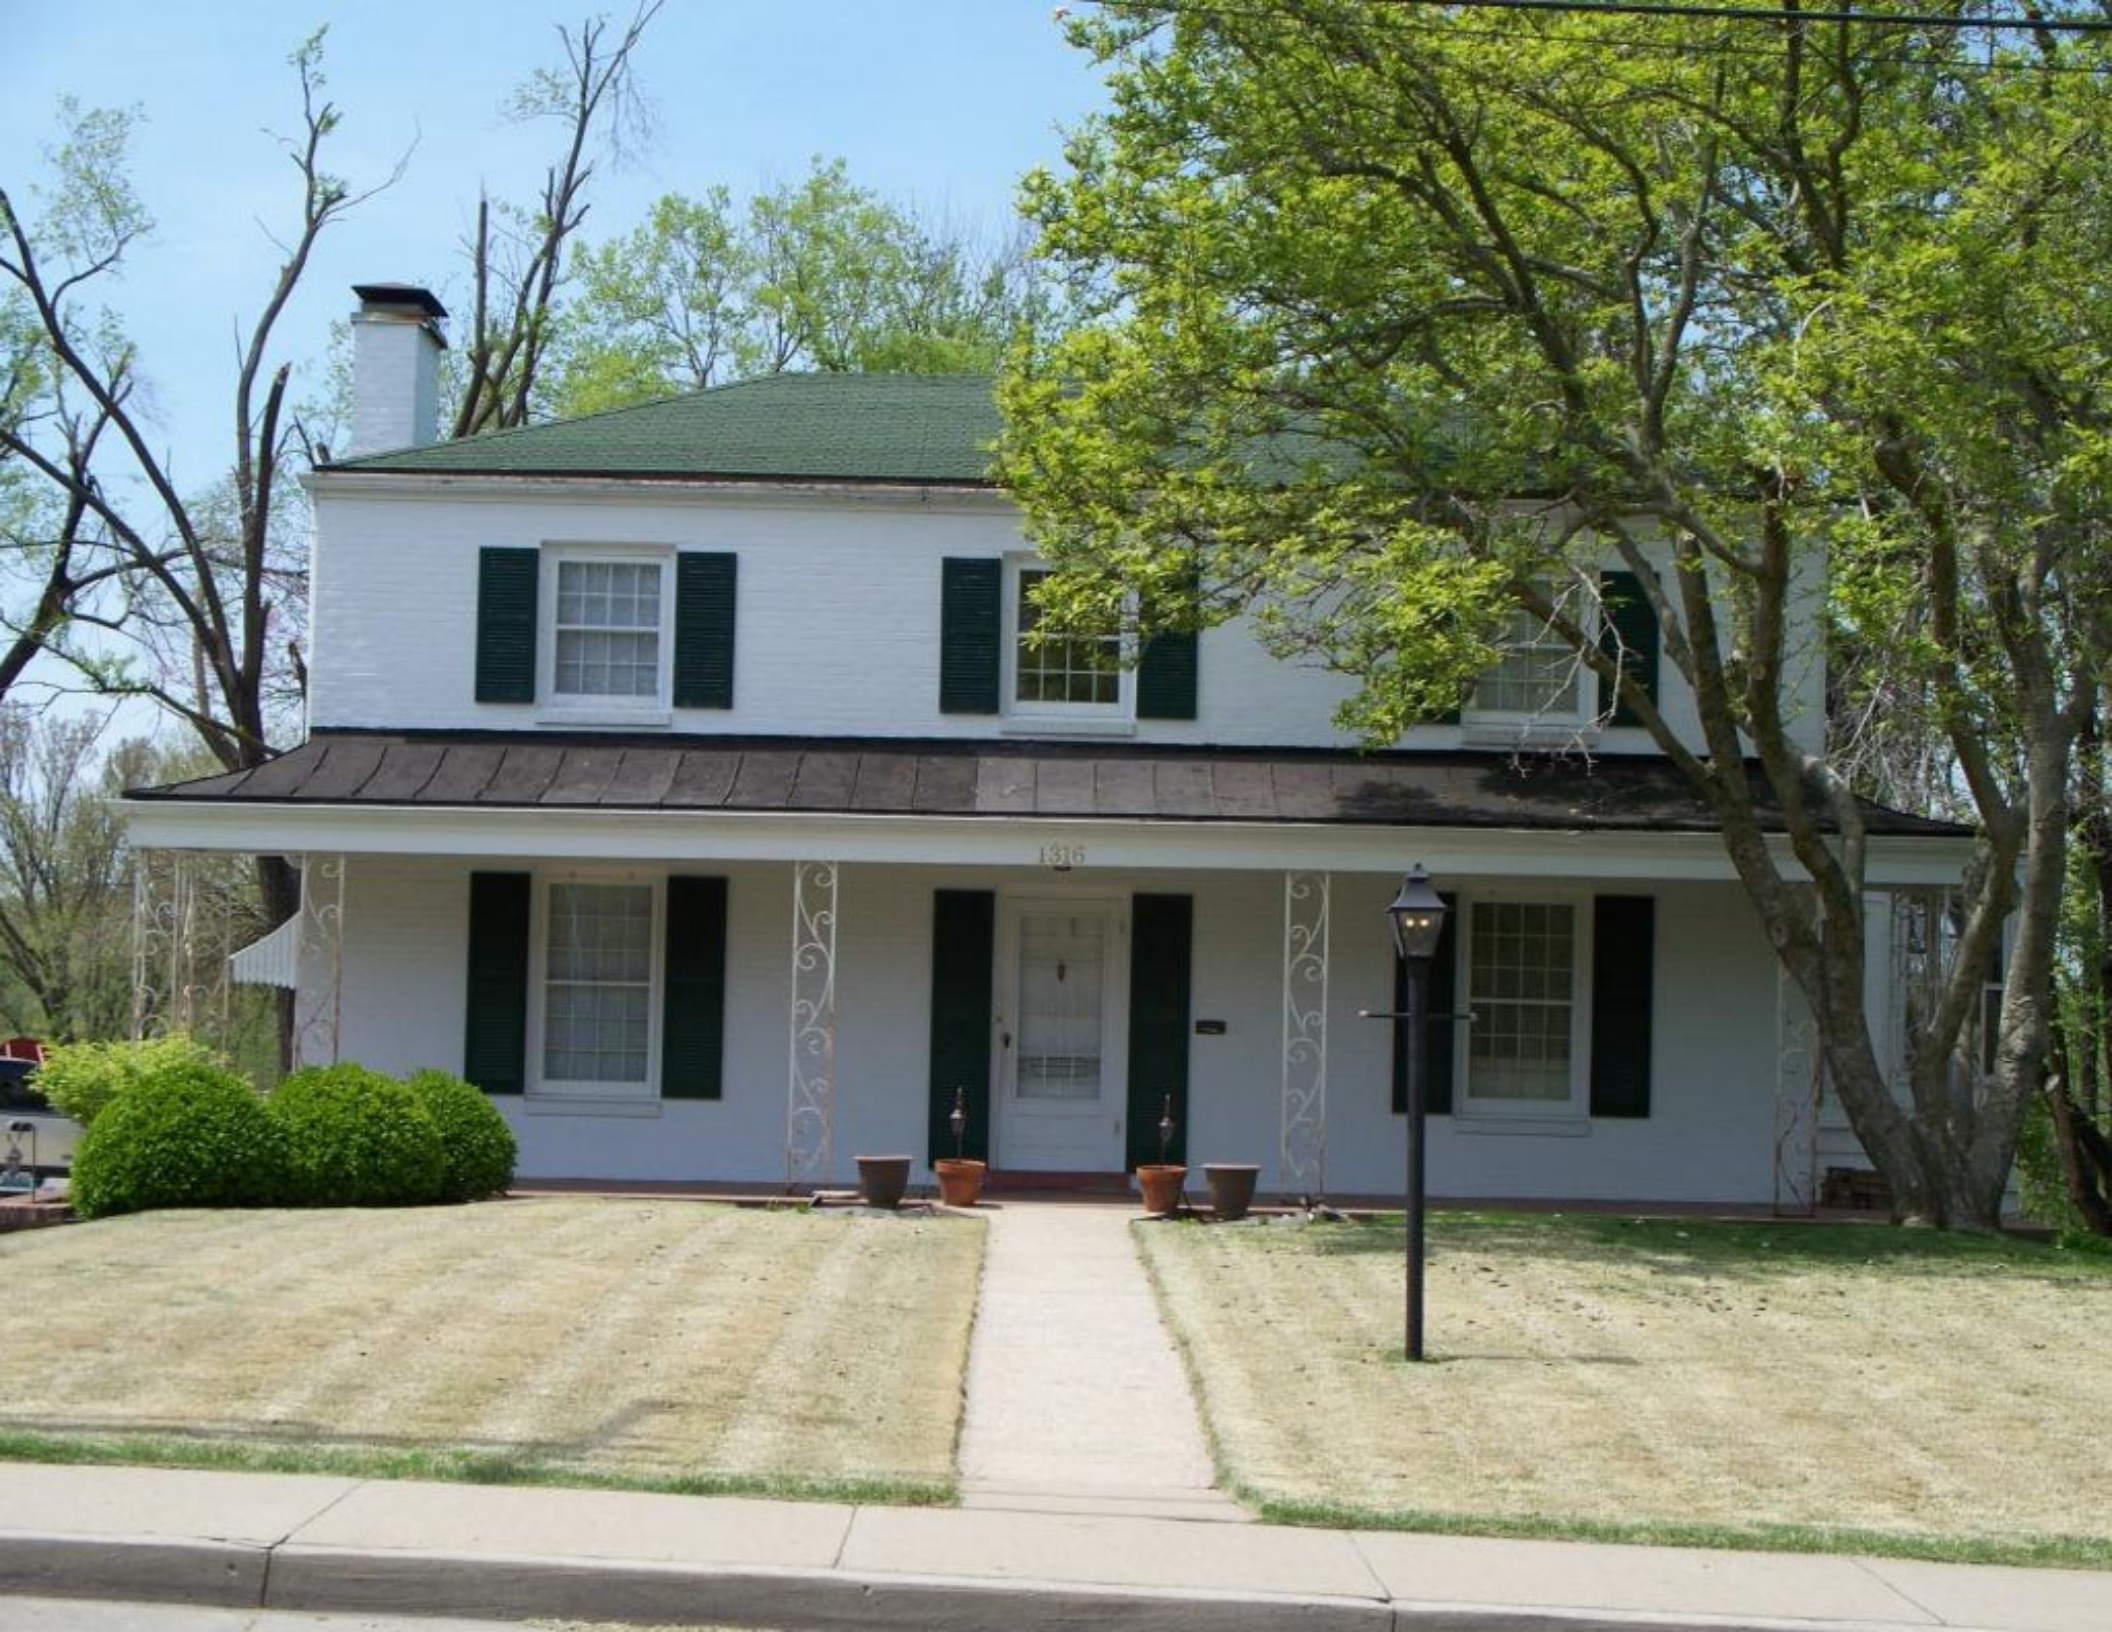
1316

This two story brick property has a hipped roof and three symmetrically placed 8/8 windows on the second floor and two 12/12 windows flanking the central entrance on the first story. All of the windows have shutters and limestone or concrete sills. The door also has full-width decorative shutters. The full-width porch has a flared hipped roof and decorative metal posts. The windows in the upper story appear historic while the first floor may be historic or sympathetic replacements. A brick chimney extends from the left side of the property.
