ARCHITECTURAL/HISTORIC INVENTORY FORM

1. Survey No. CO-AS-005-001		2. Survey name: Moreau Drive Neighborhood Survey	
3. County: Cole		4. Address: 1202 Elmerine Ave.	
5. City: Jefferson City	Vicinity: <input type="checkbox"/>	6. UTM: / /	7. Township/Range/Section: T: R: S:
8. Historic name (if known):		9. Present/other name (if known):	
10. Ownership: <input checked="" type="checkbox"/> Private <input type="checkbox"/> Public		11. Historic use (if known): Residential	11. Current use: Residential

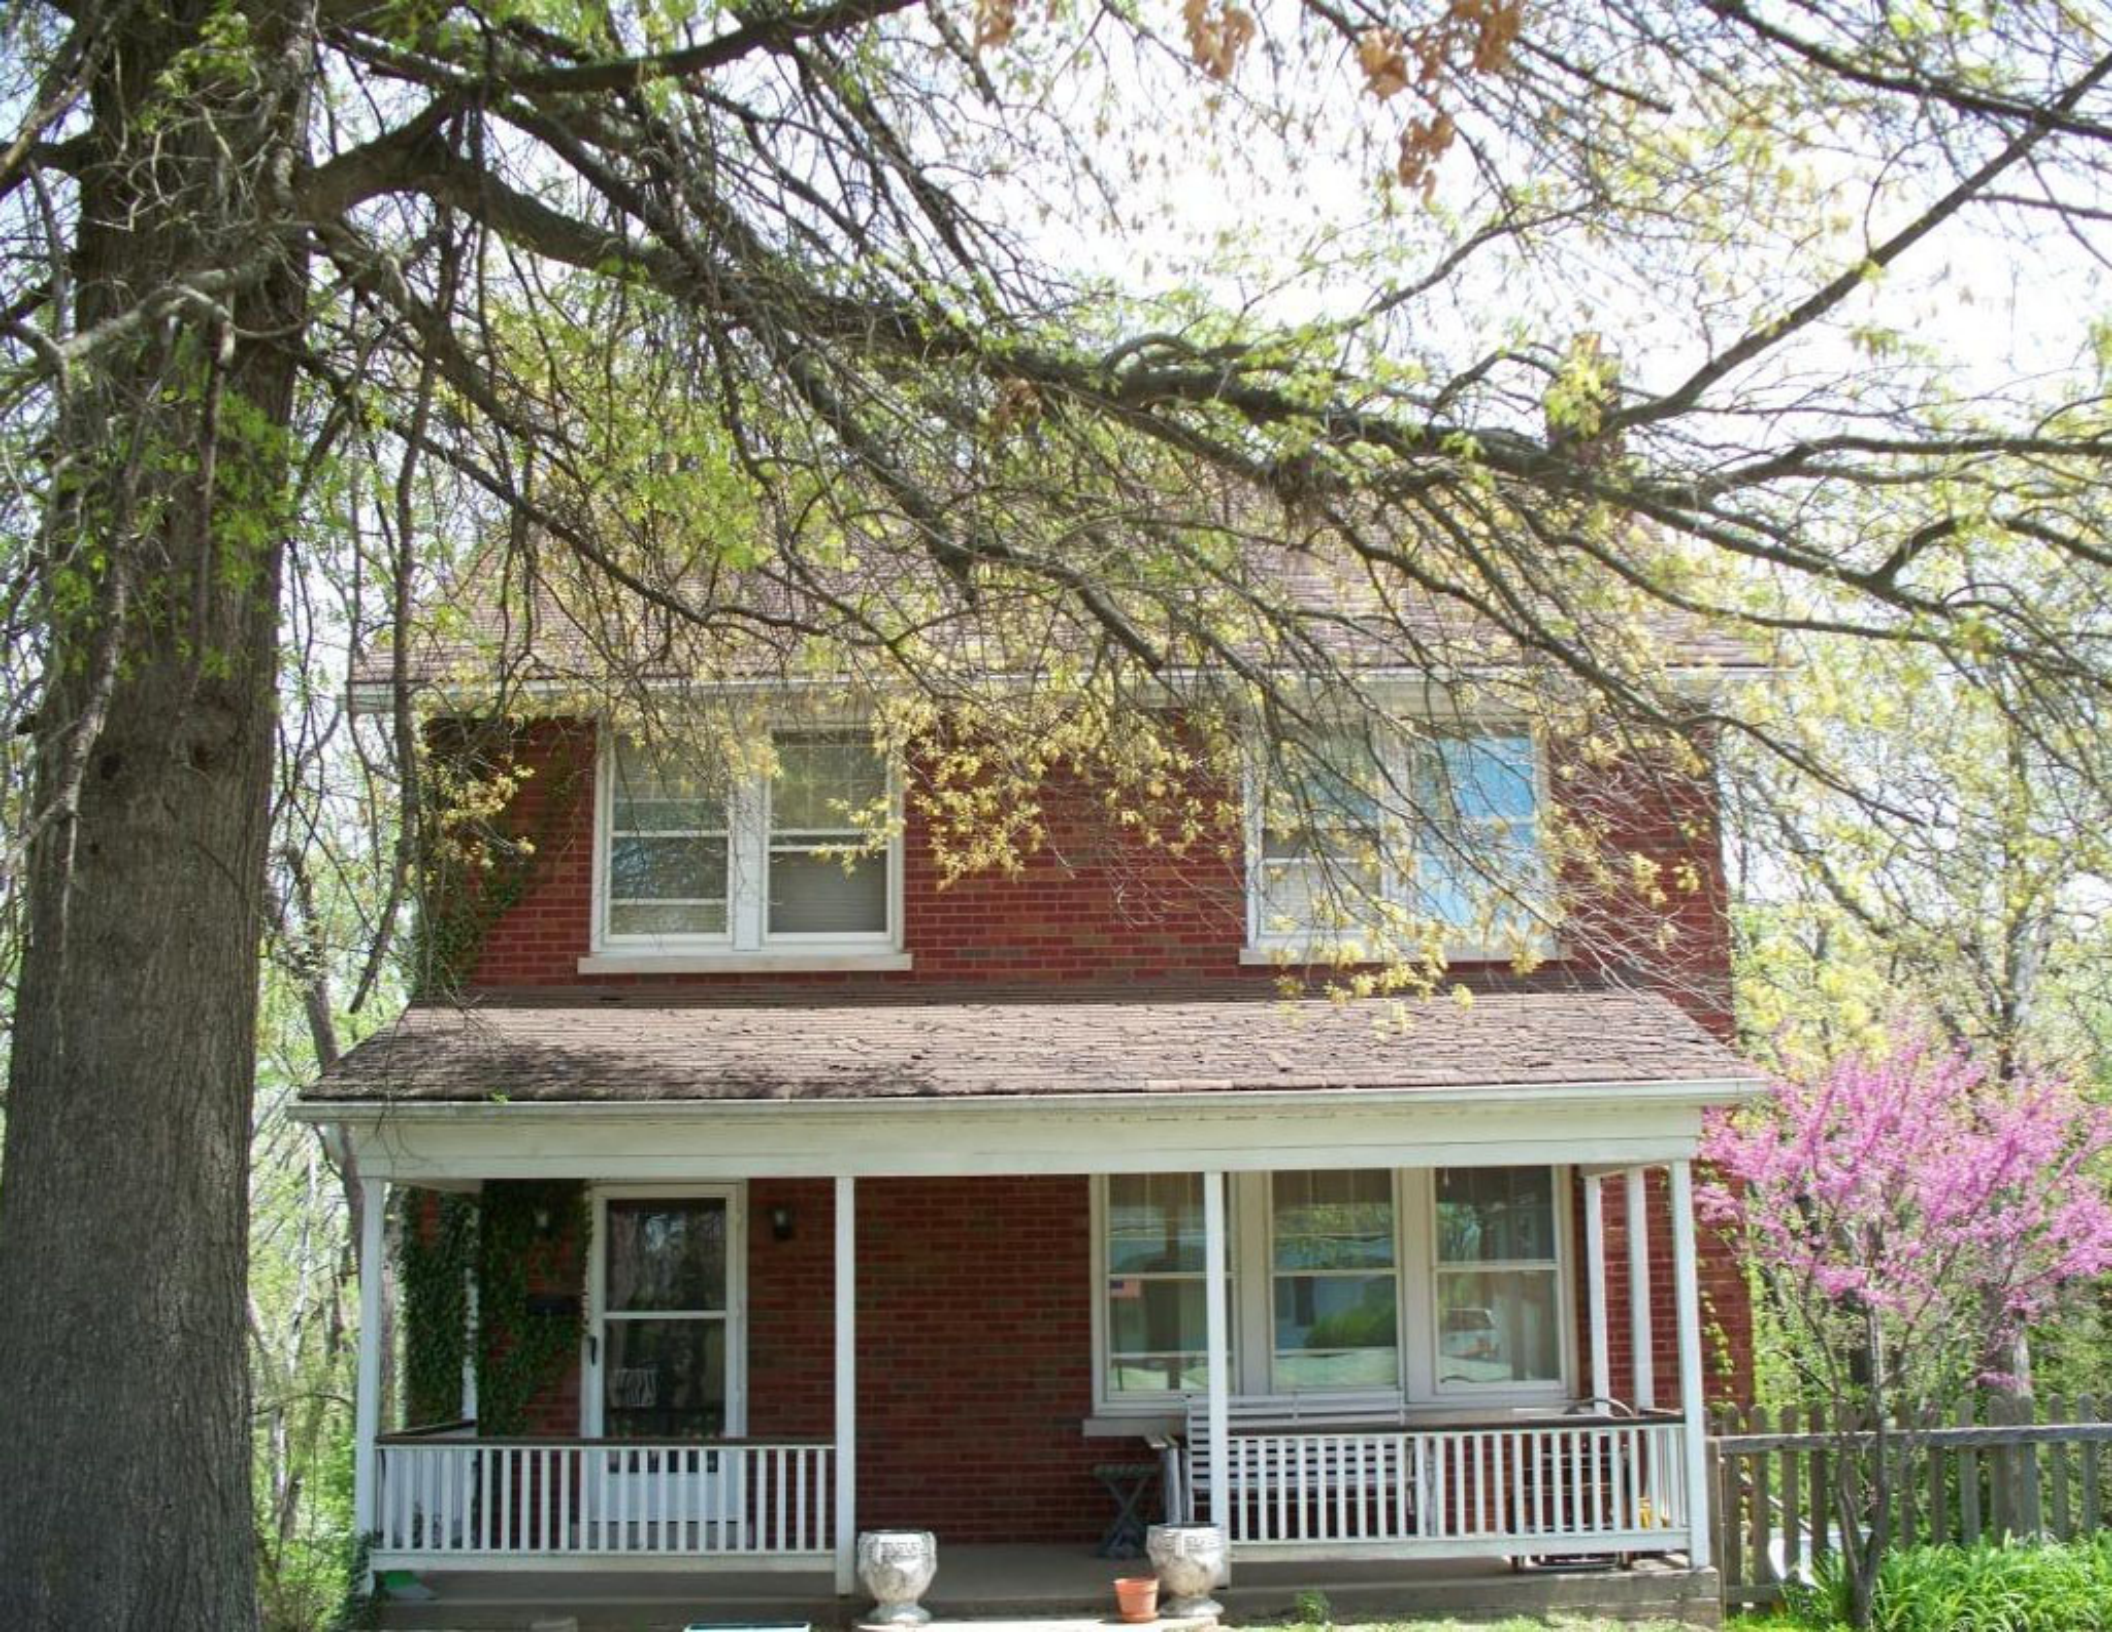
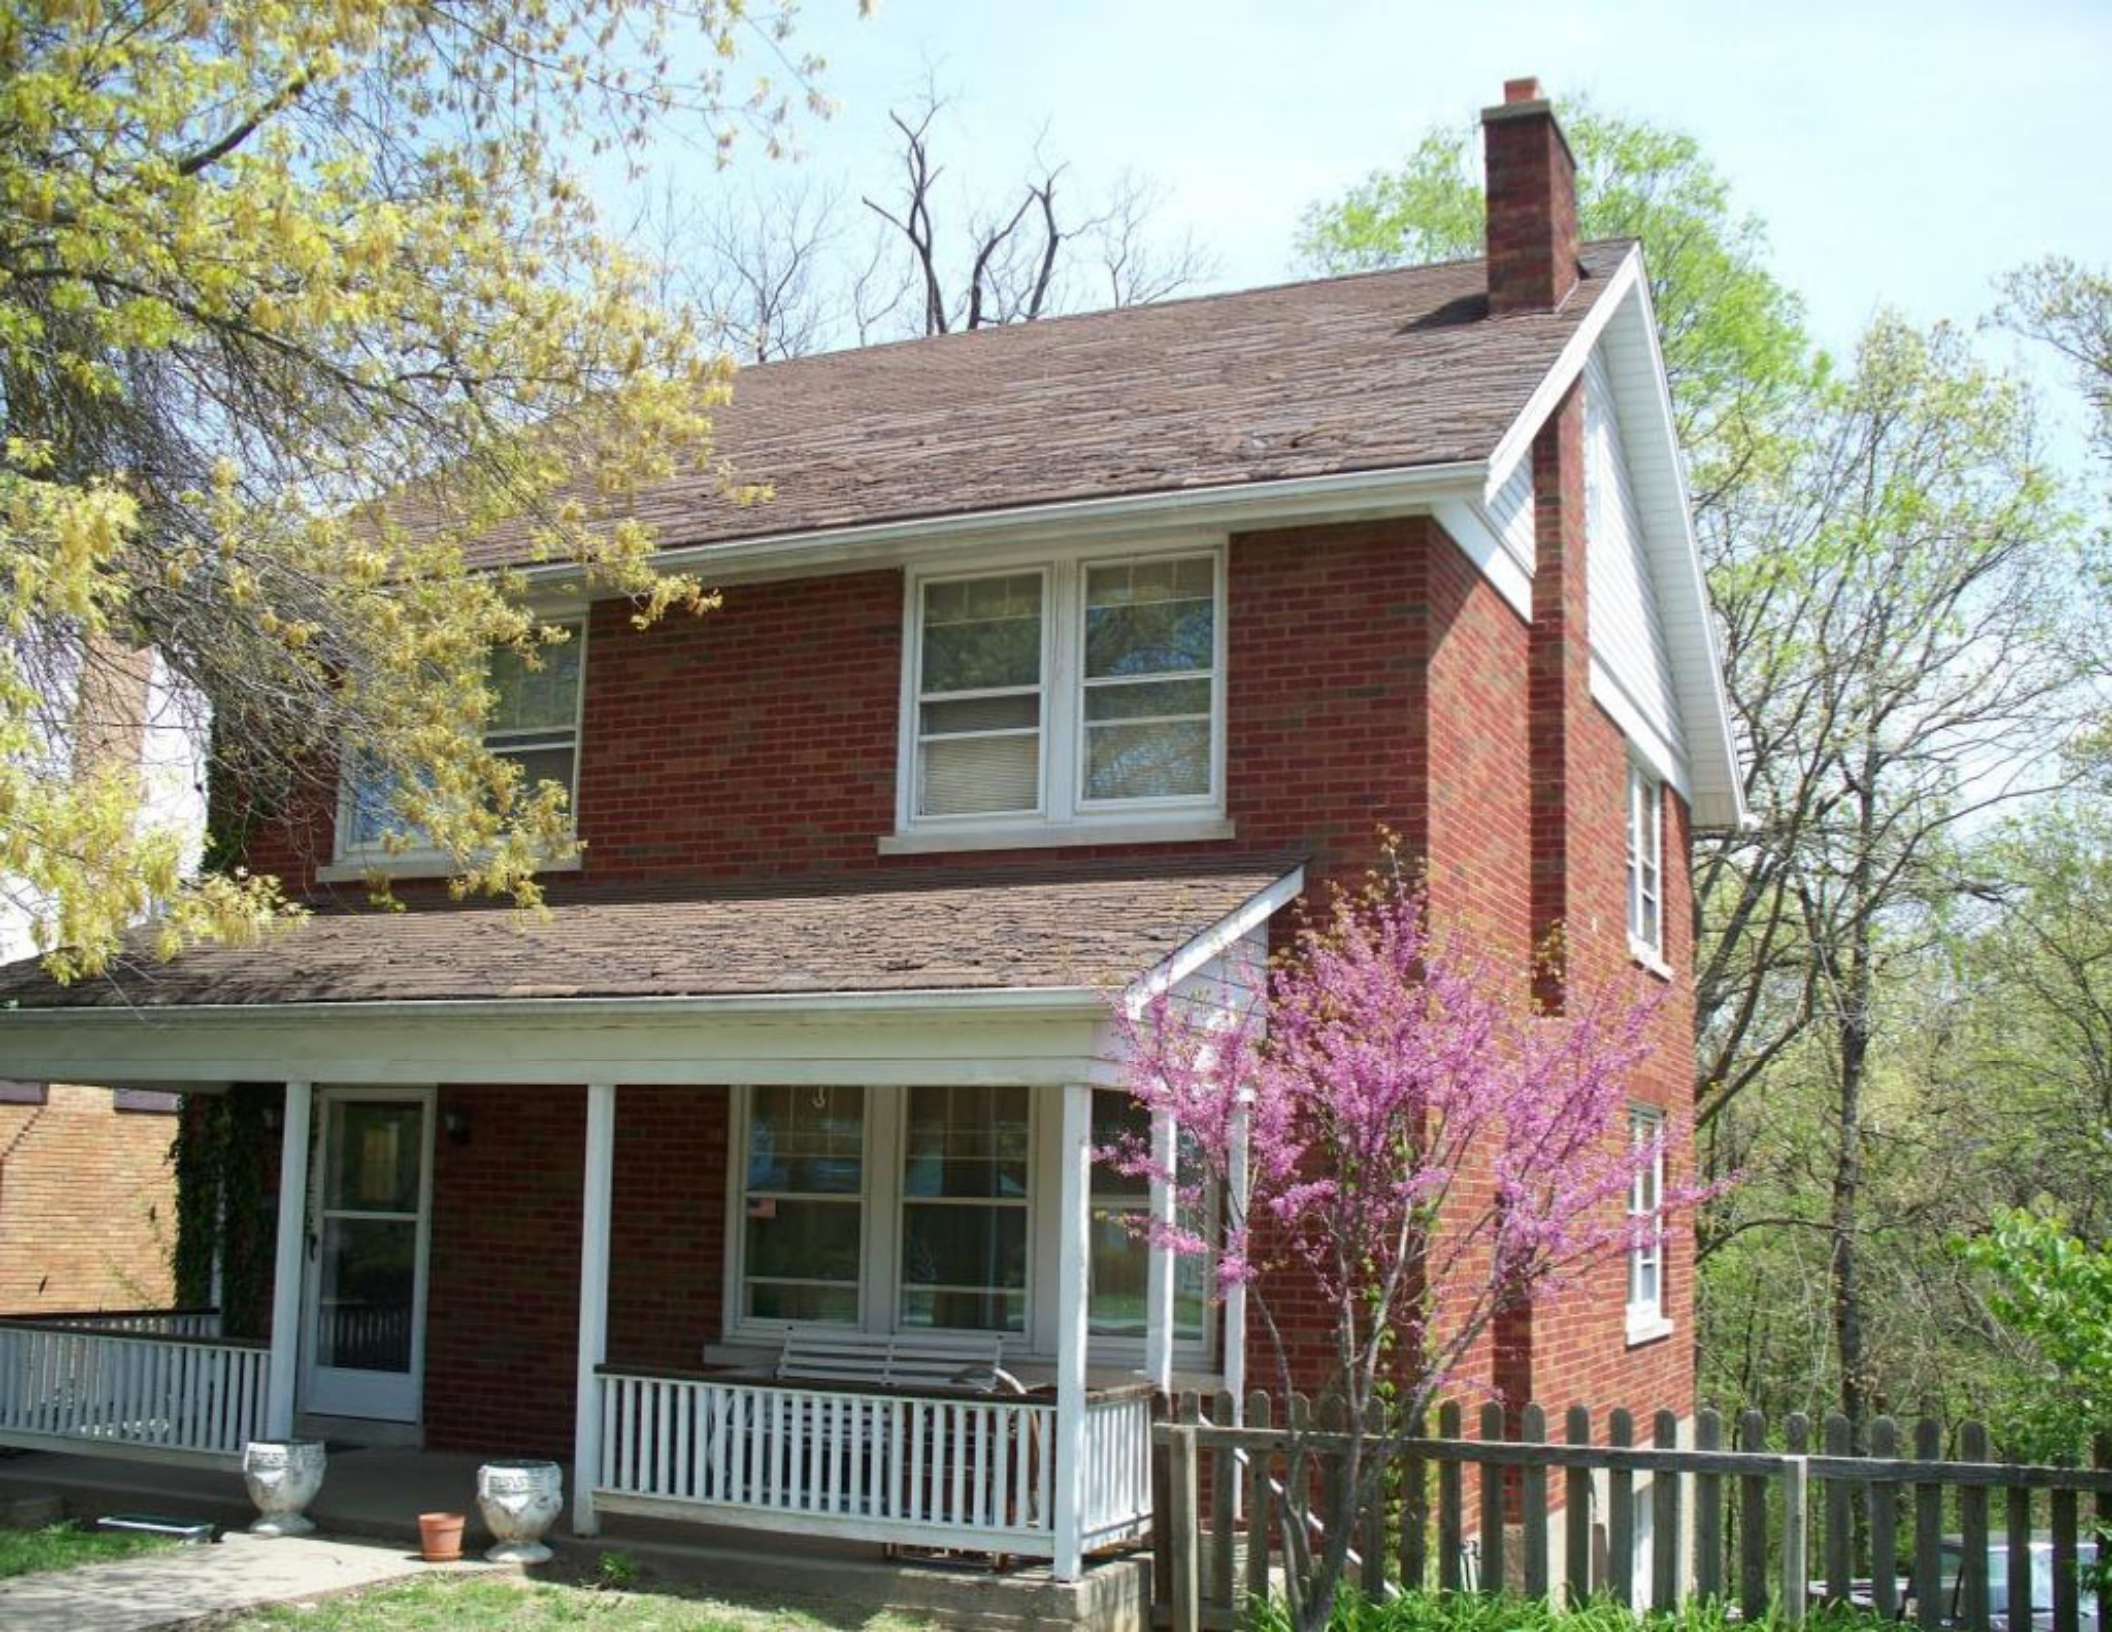
41. (cont.) The Tax Assessor's Office states this building was built in 1945. However it appears on the 1939 Sanborn Map, thus it is given a c. 1939 date on this form. This two-story brick four square has little detailing. There are two sets of historic paired six-over-six windows on the second floor with stone or concrete sills. Likewise there are a row of three six-over-six windows in the first bay (right side) on the first story. The entrance is offset to the left and appears to have its original wooden door. The concrete porch with wood railing and posts appears to be a replacement or modern (the Sanborn Map does not indicate it has a porch.) It has a shed asphalt shingle roof that blends well with the property.

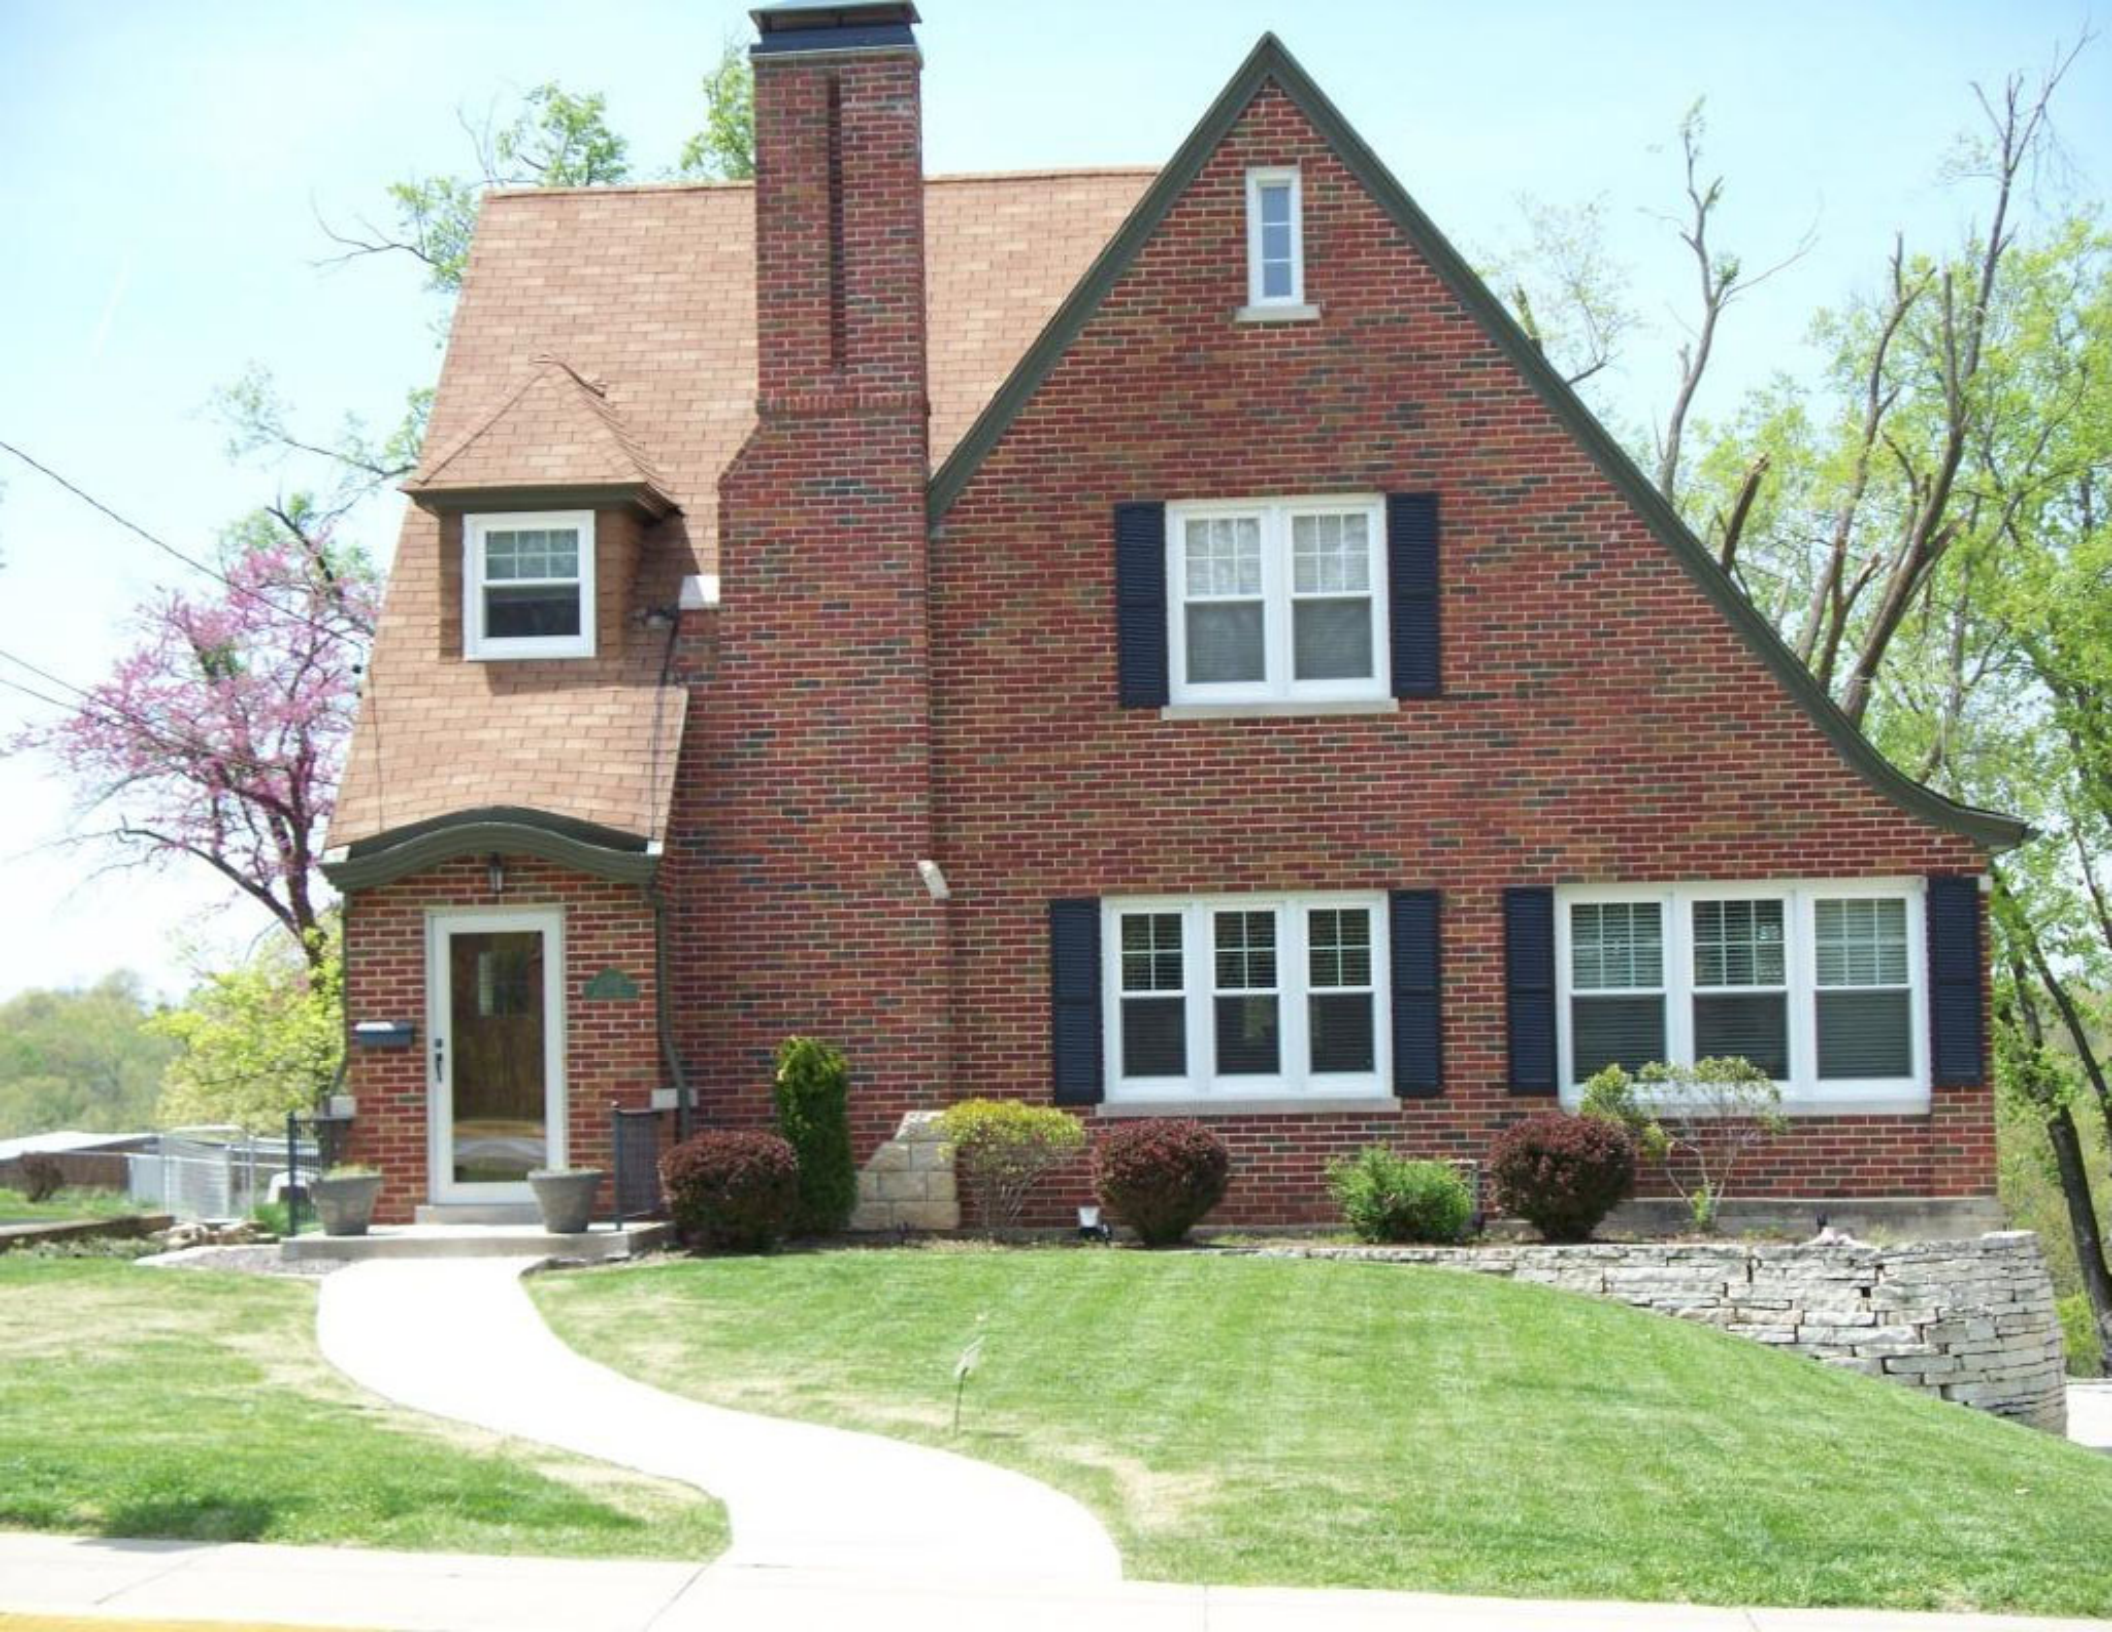
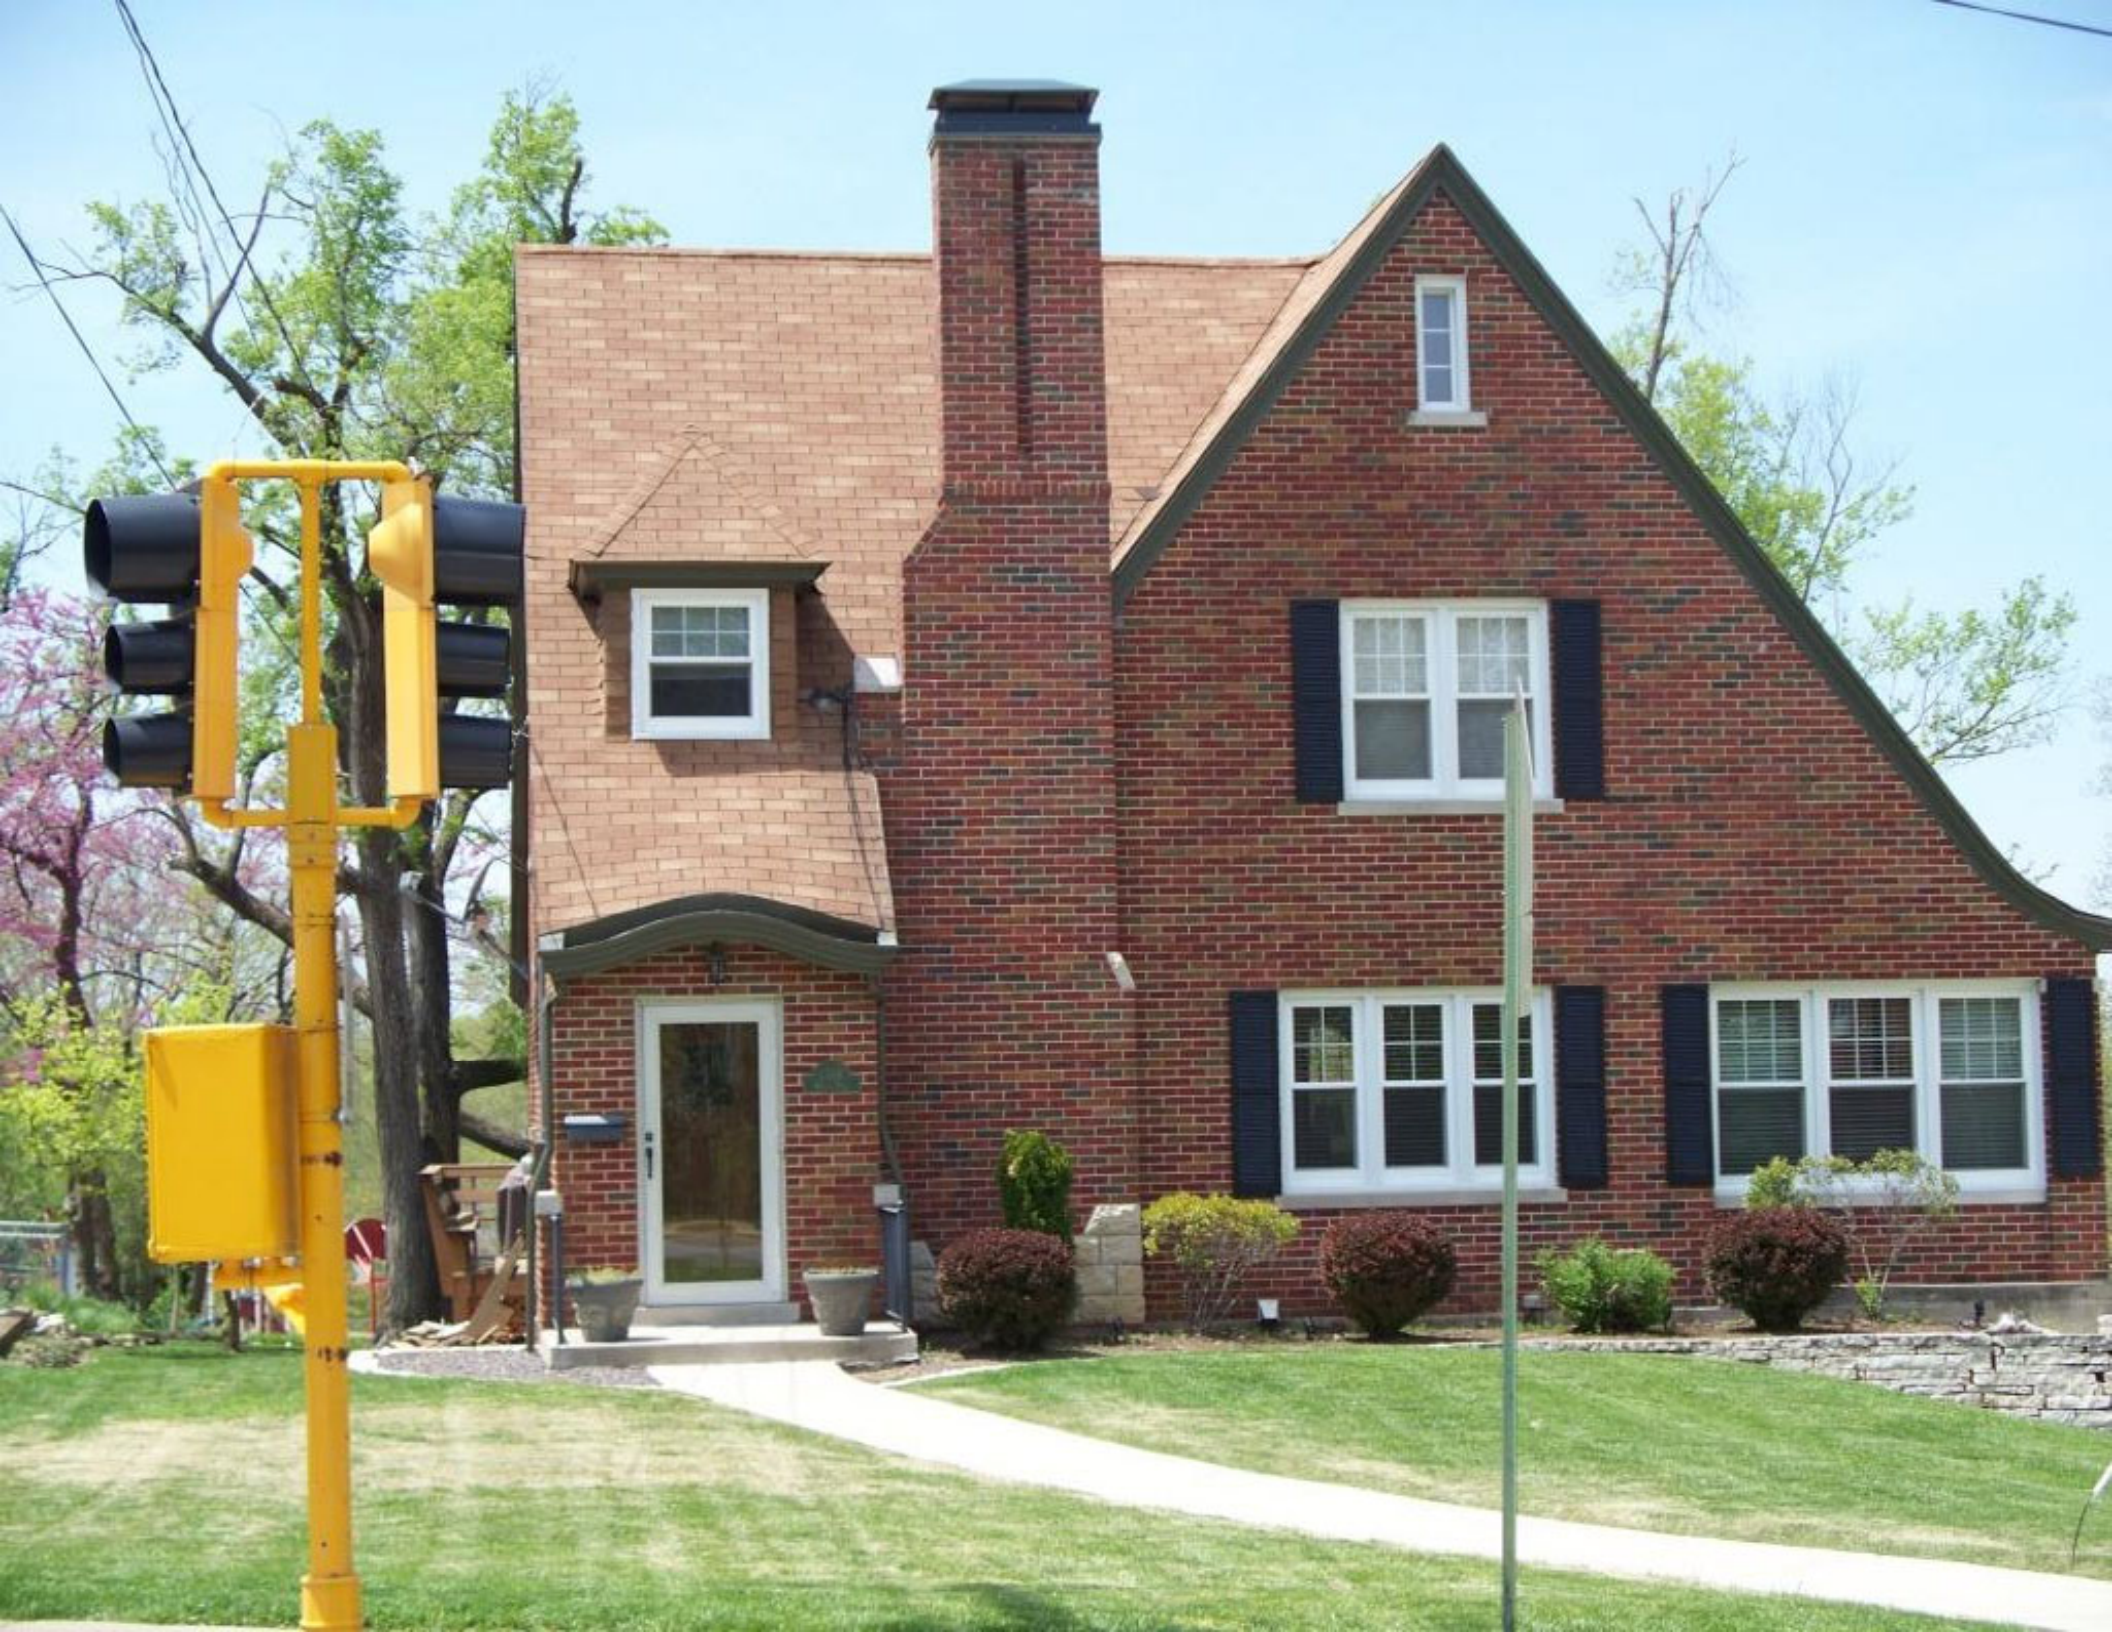
This brick Tudor Revival has a steeply pitched side gable that intersects with a large front gable offset to the right of the property. The front gable has a narrow three-light fixed casement window in the peak and paired 6/1 windows in the second story. This gable also contains the first two bays on the lower floor that consist of two tri-part windows. From the right 6/1 and then non-historic 4/1. The exterior chimney is also within these bays. It has stone detailing around the base and abuts the slightly projecting entrance bay. This bay has a slight eyebrow at the roofline and above, a pyramidal dormer with a 6/1 window. All of the windows have shutters and limestone or concrete sills. The wooden door appears original to the house.

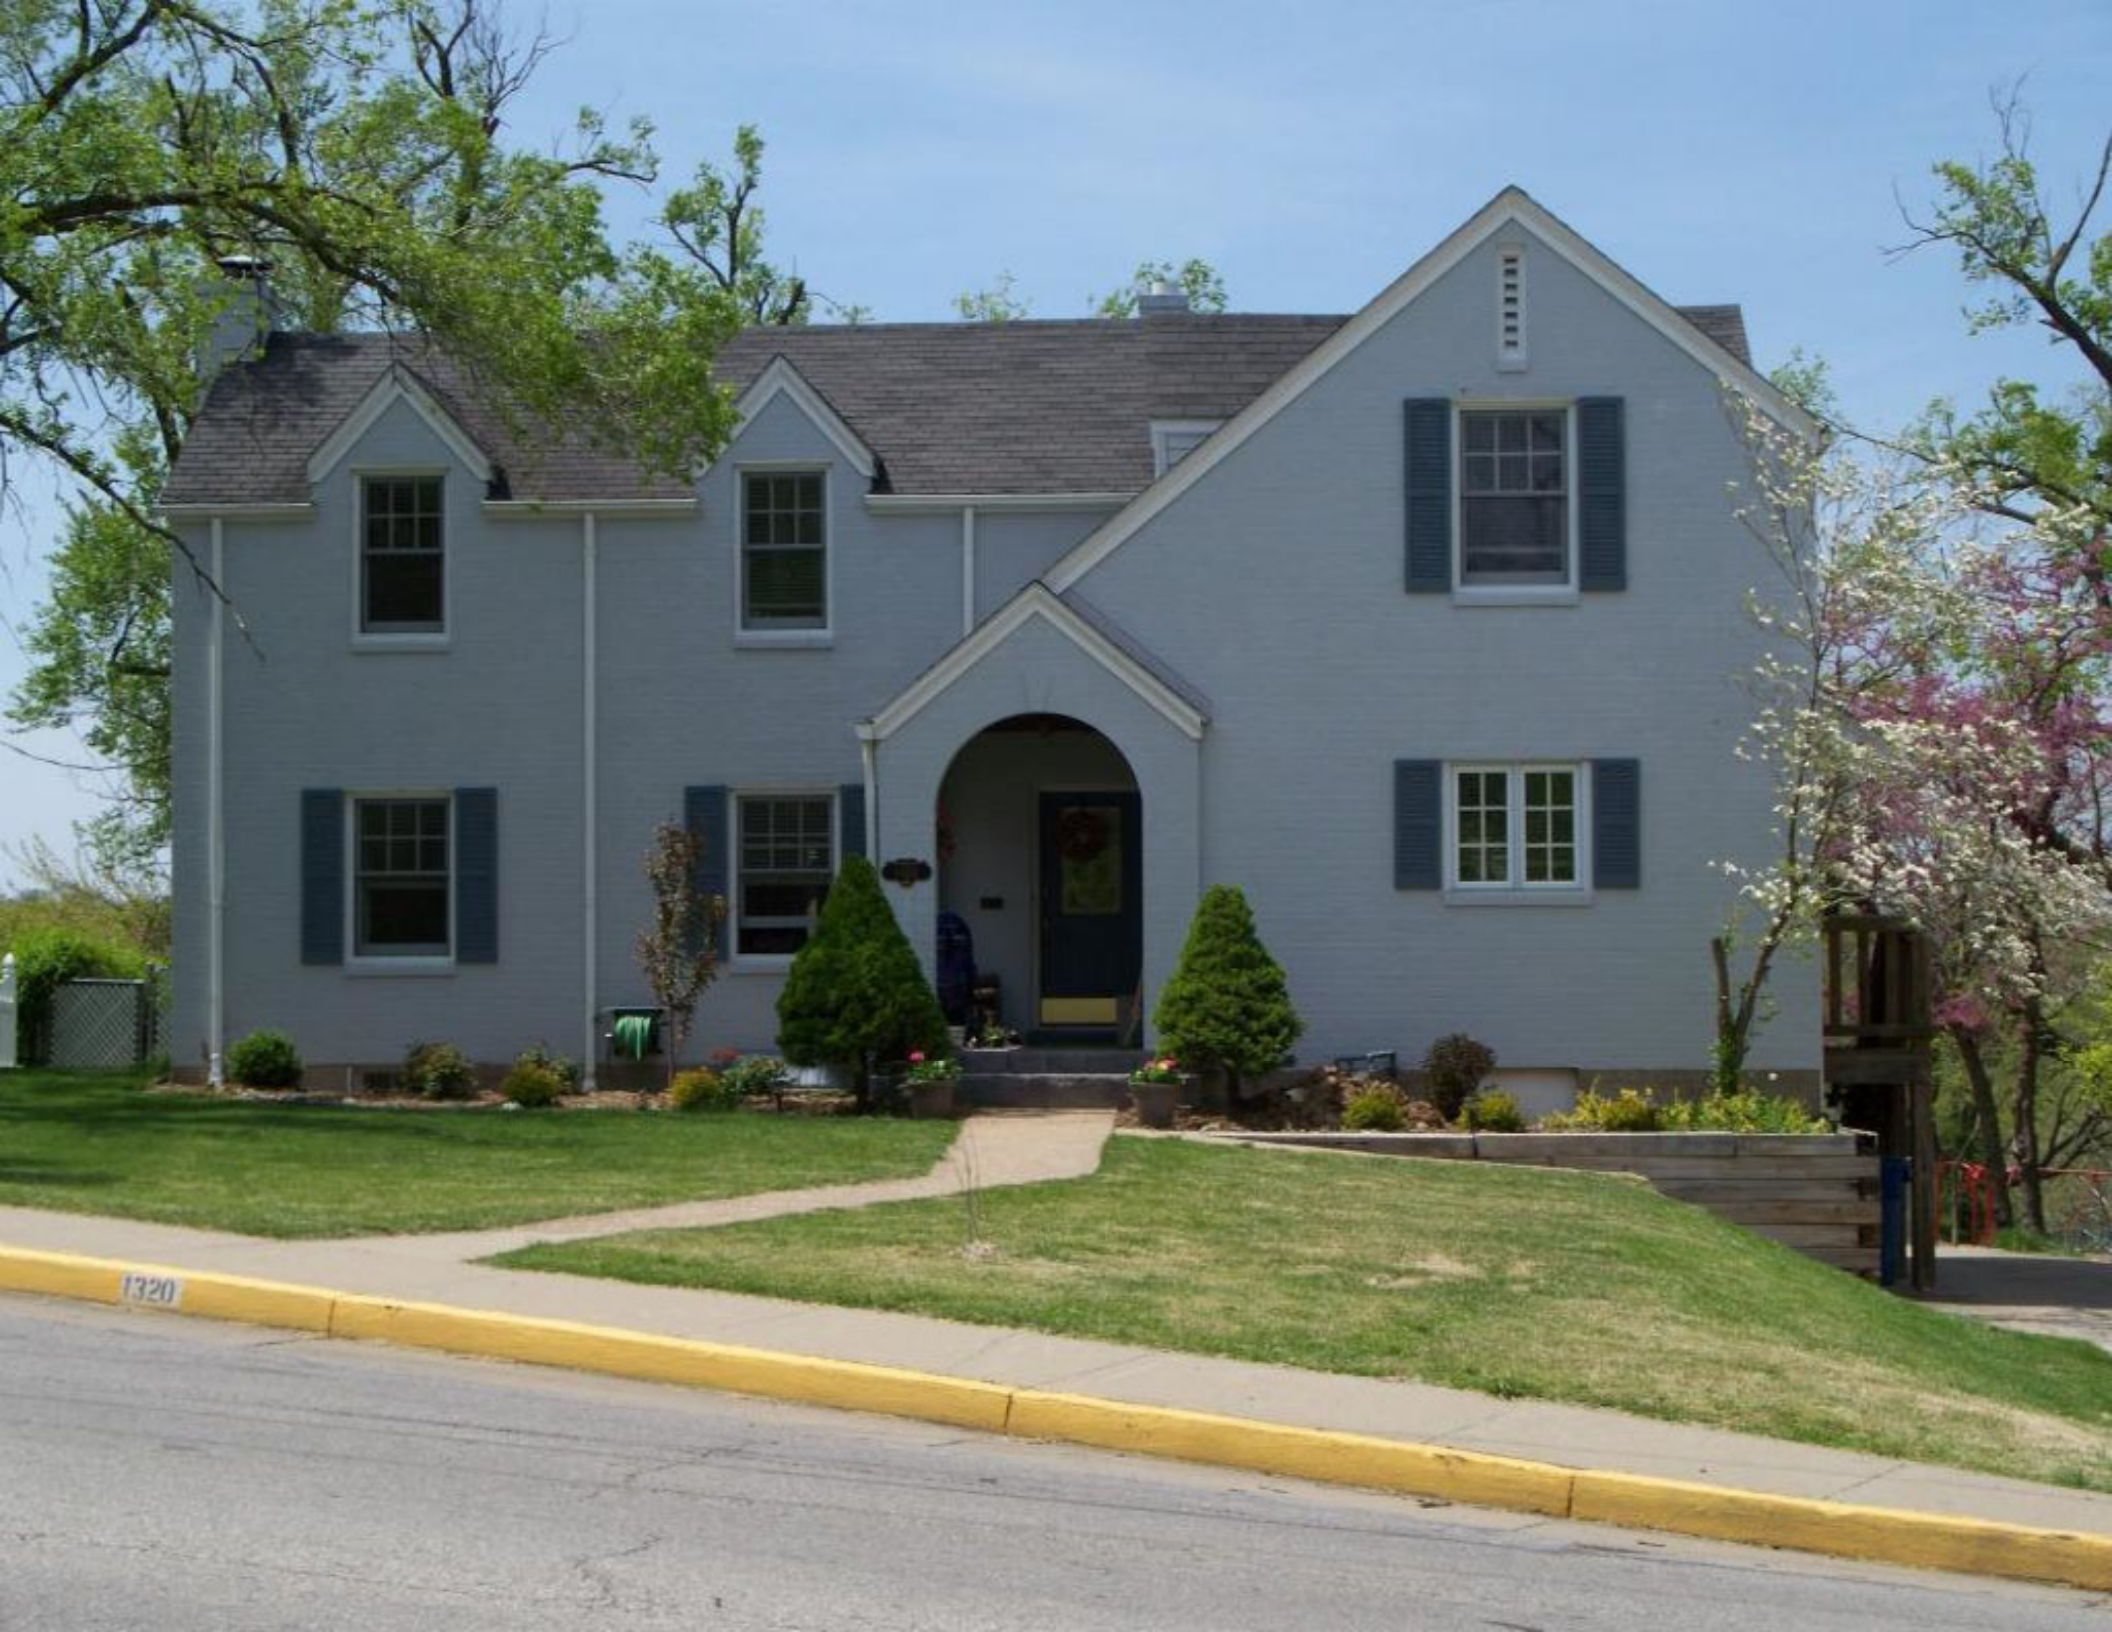
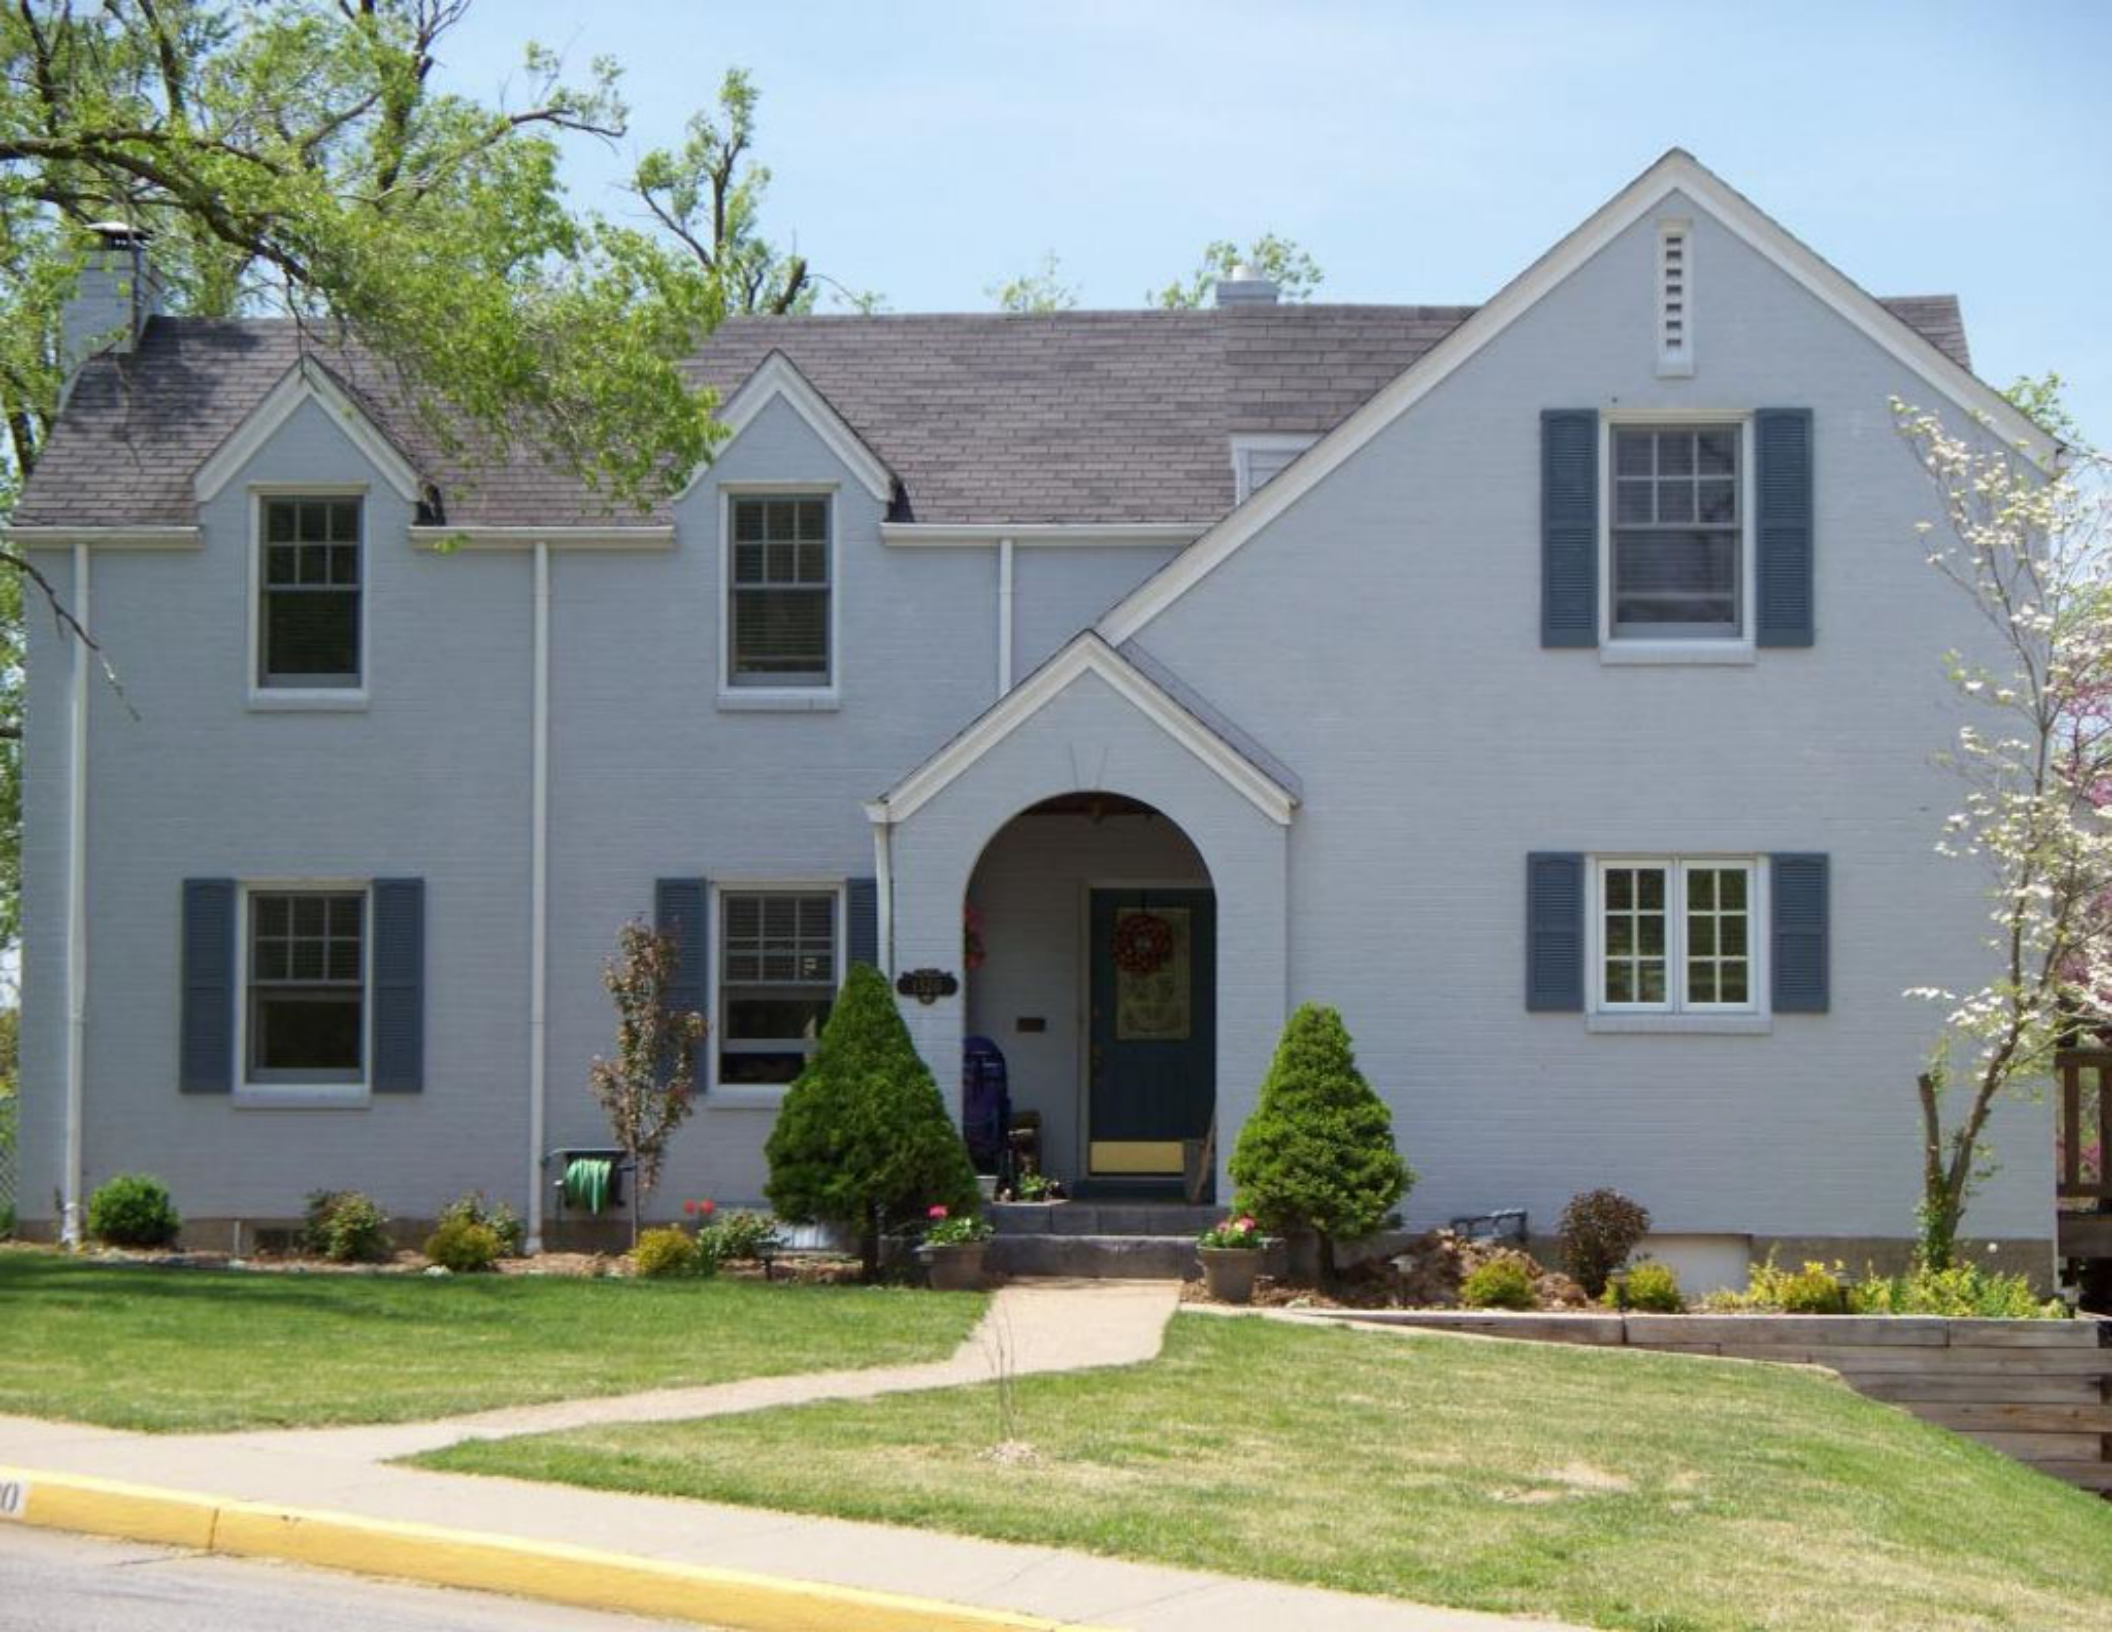
This two story brick property has a side gable roof that intersects with a projecting front gable in the last two bays on the right. The second story has two 6/1 windows with gabled peaks that pierce the roofline on the left side of the property. Beneath them are slightly wider 6/1 windows with shutters. The second story portion of the projecting front gable slopes sharply to the entrance. It has a vent in the peak and a 6/1 window with shutters on the second floor and paired 6 by 6 casement windows with shutters on the first floor. All of the windows have brick header sills. The entrance projects slightly from the front gable and features an arched opening and keystone. The entrance is recessed within and offset slightly to the left.
