ARCHITECTURAL/HISTORIC INVENTORY FORM

1. Survey No. CO-AS-005-001		2. Survey name: Moreau Drive Neighborhood Survey	
3. County: Cole		4. Address: 1202 Elmerine Ave.	
5. City: Jefferson City	Vicinity: <input type="checkbox"/>	6. UTM: / /	7. Township/Range/Section: T: R: S:
8. Historic name (if known):		9. Present/other name (if known):	
10. Ownership: <input checked="" type="checkbox"/> Private <input type="checkbox"/> Public		11. Historic use (if known): Residential	11. Current use: Residential

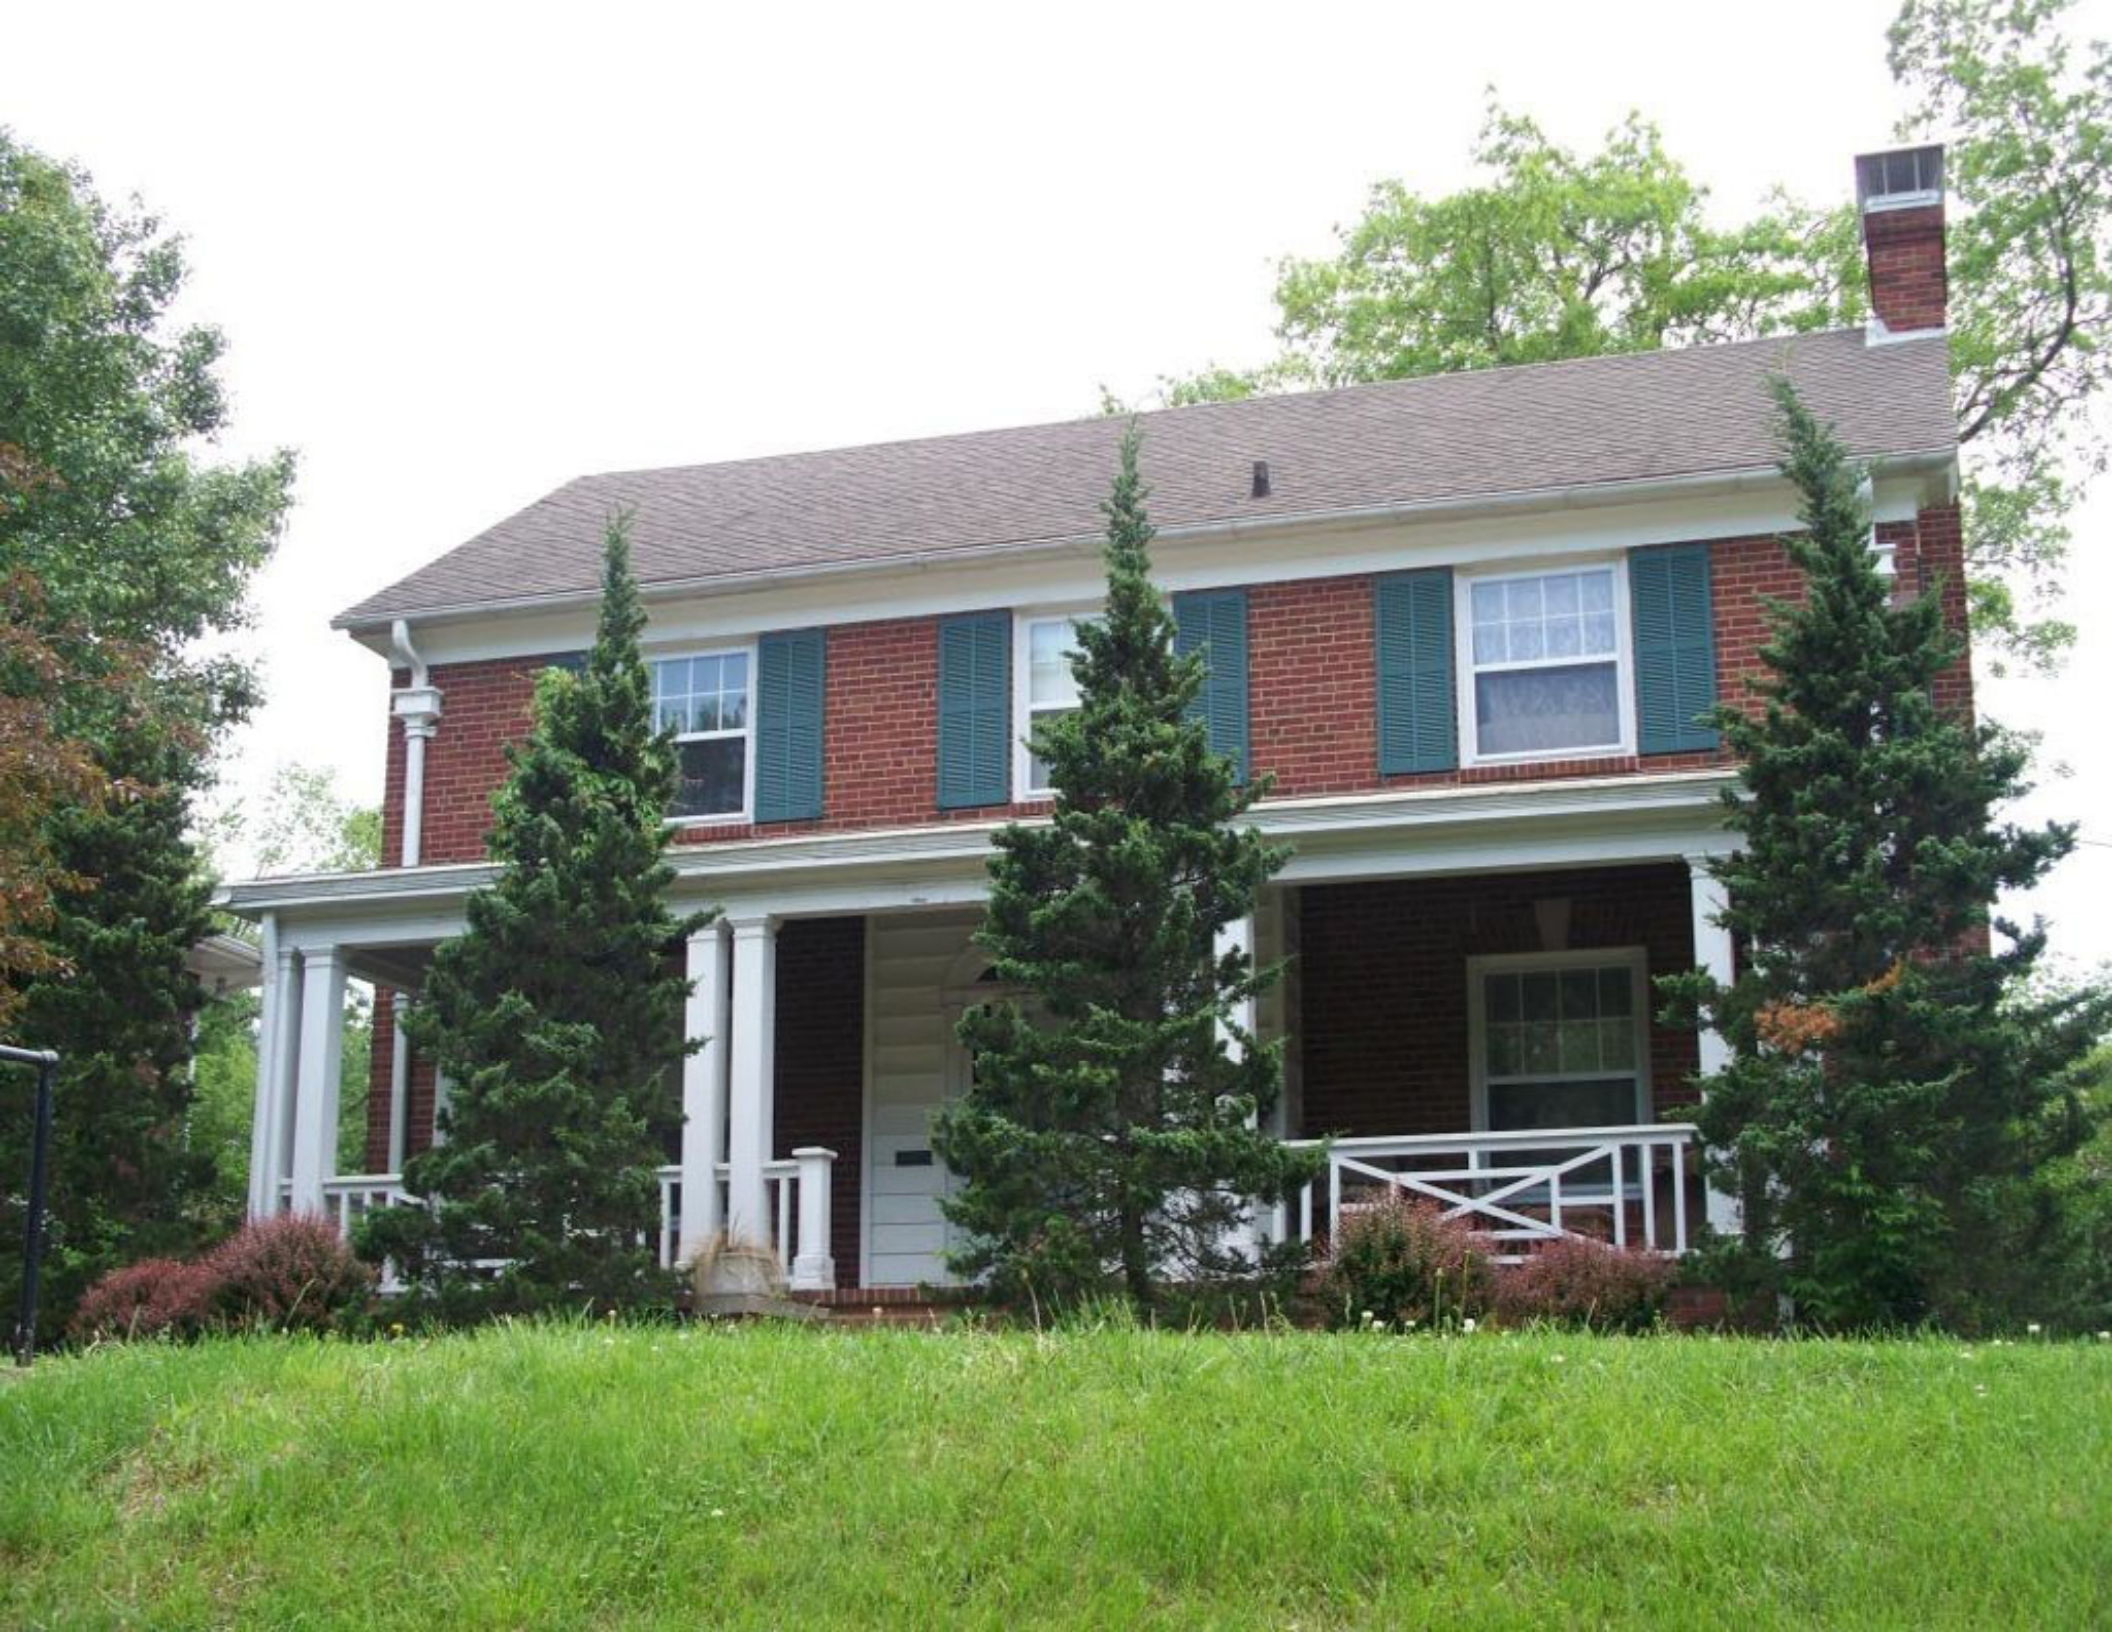
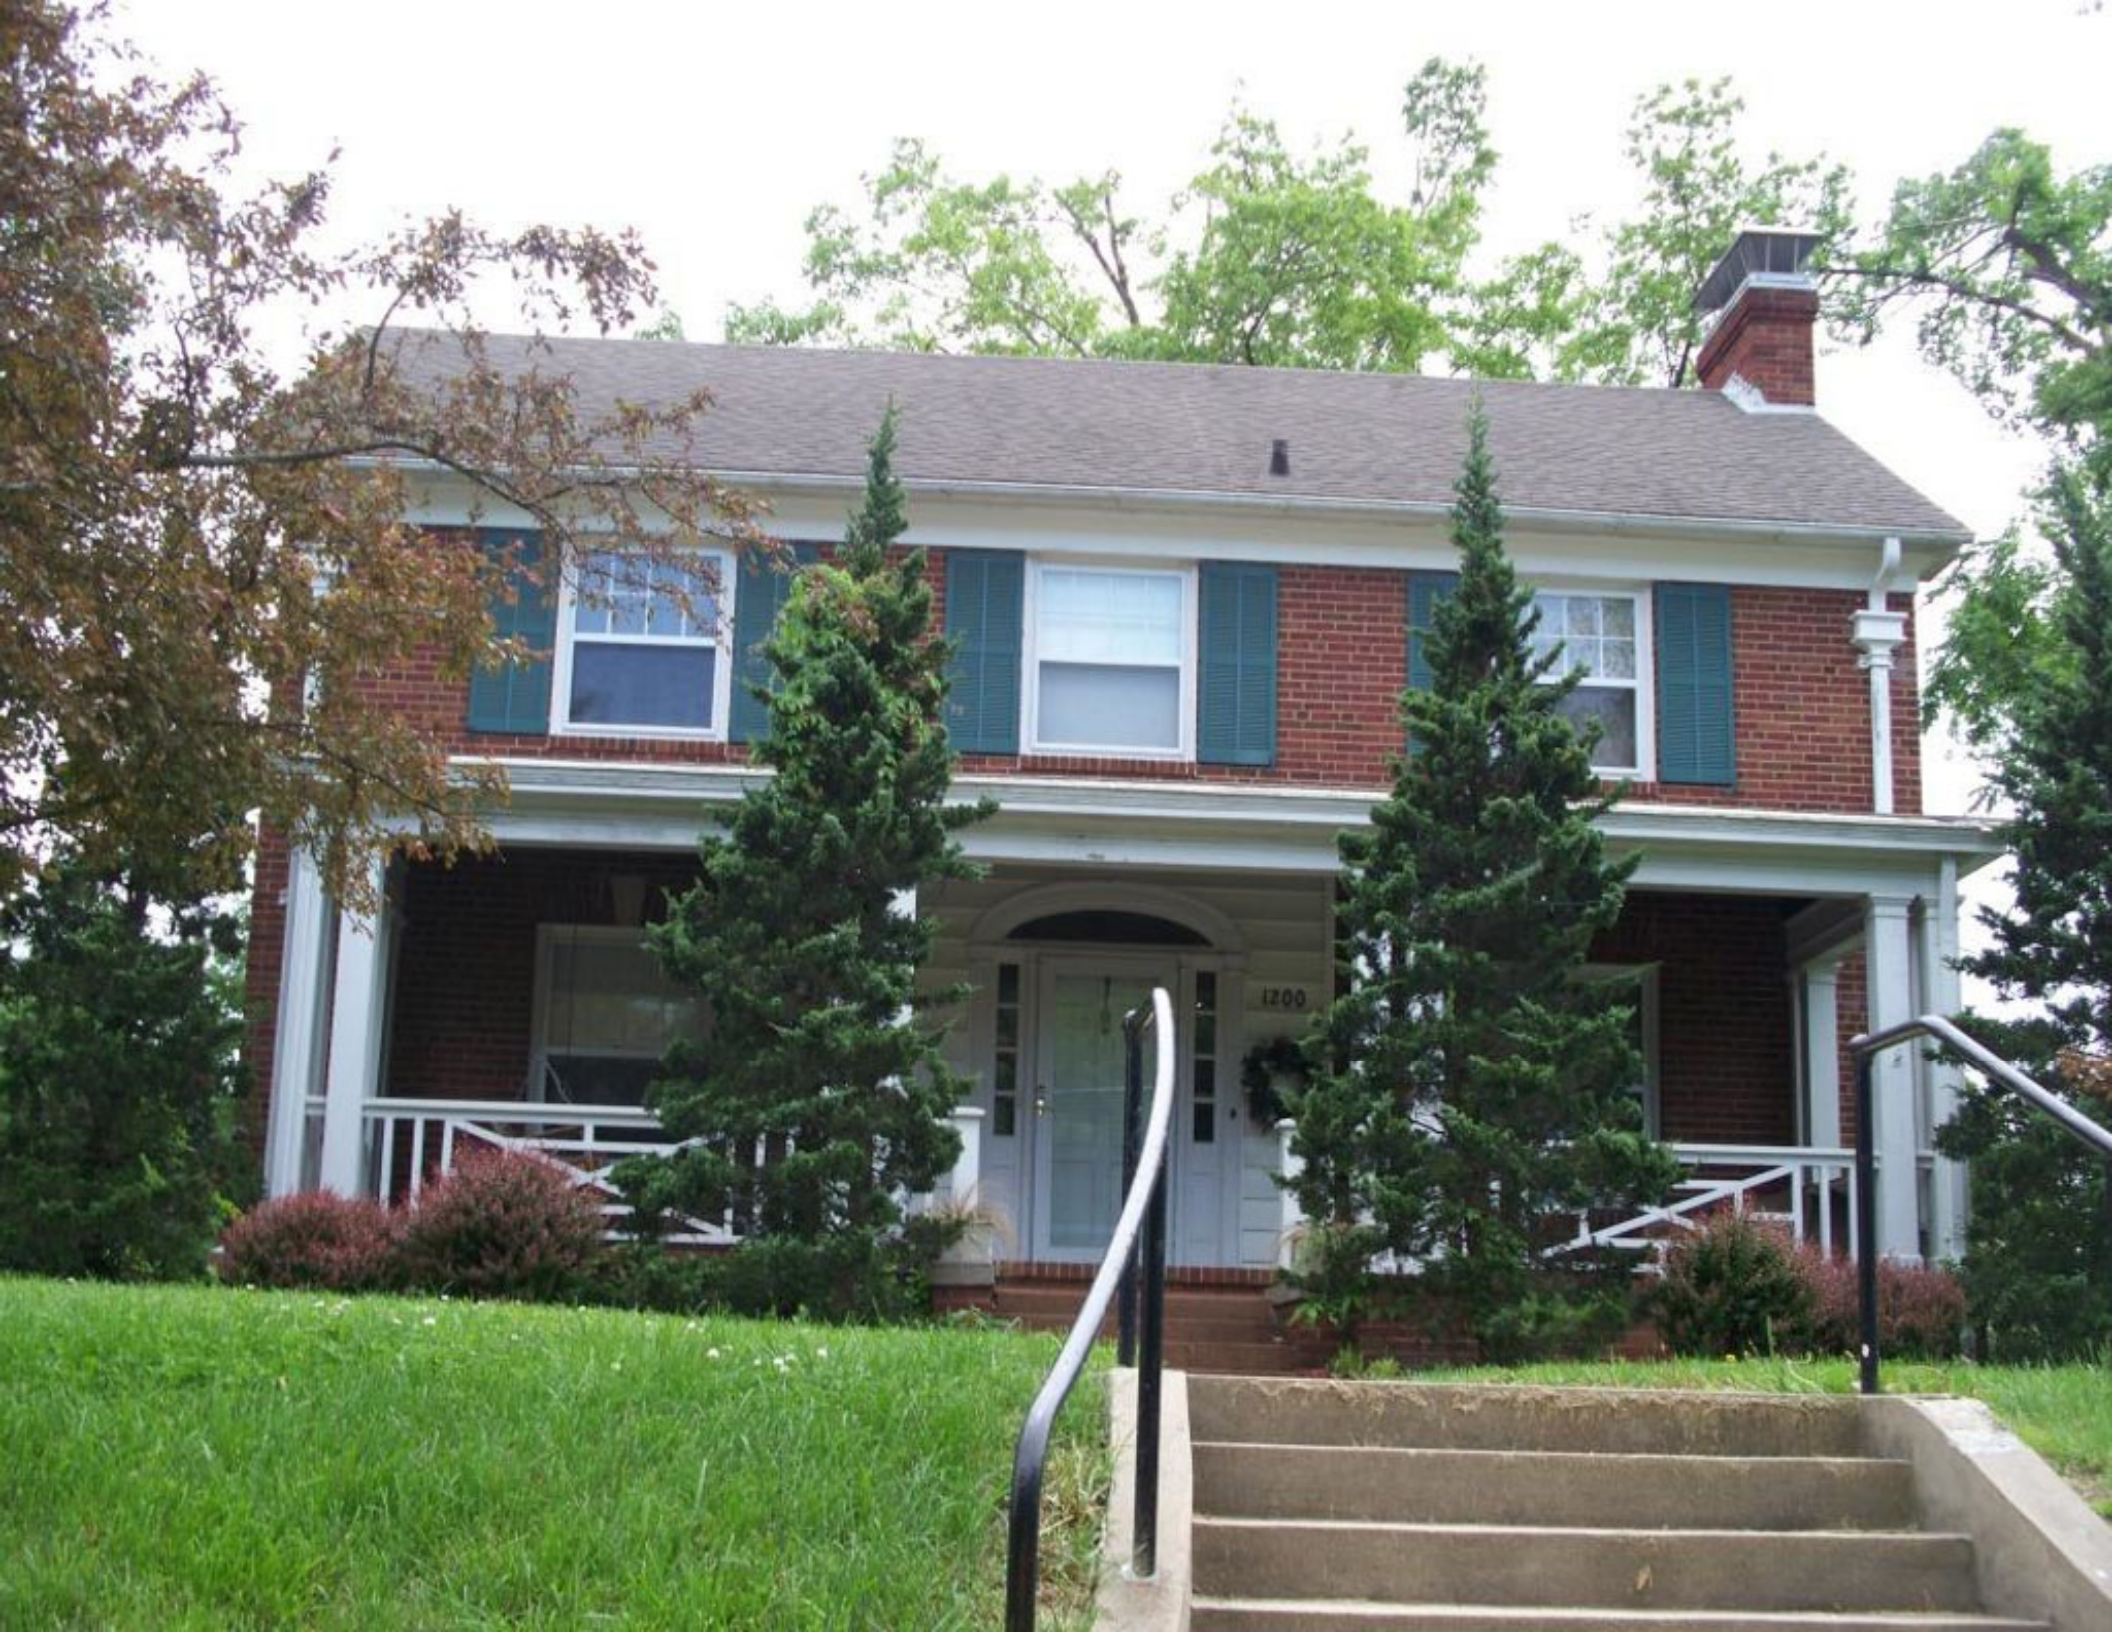
40. (cont.) Description of environment and outbuildings. Expand box as necessary, or add continuation pages.
There is a two-car garage with a gable roof clad in vinyl behind the property. A garage of similar size and placement is on the 1943 Sanborn map, thus it is considered contributing but more research may be necessary.

41. (cont.)
This is a two story brick Colonial Revival home with a side gabled roof. The second story has three 8/1 windows that may or may not be historic (probably modern) with shutters. The ground floor has two large 8/1 windows with flat arches and keystones. They flank the central bay which has been covered with wide siding and contains an arched entryway with sidelights. The full width porch has a shed roof and double square posts and decorative railing that is likely modern.

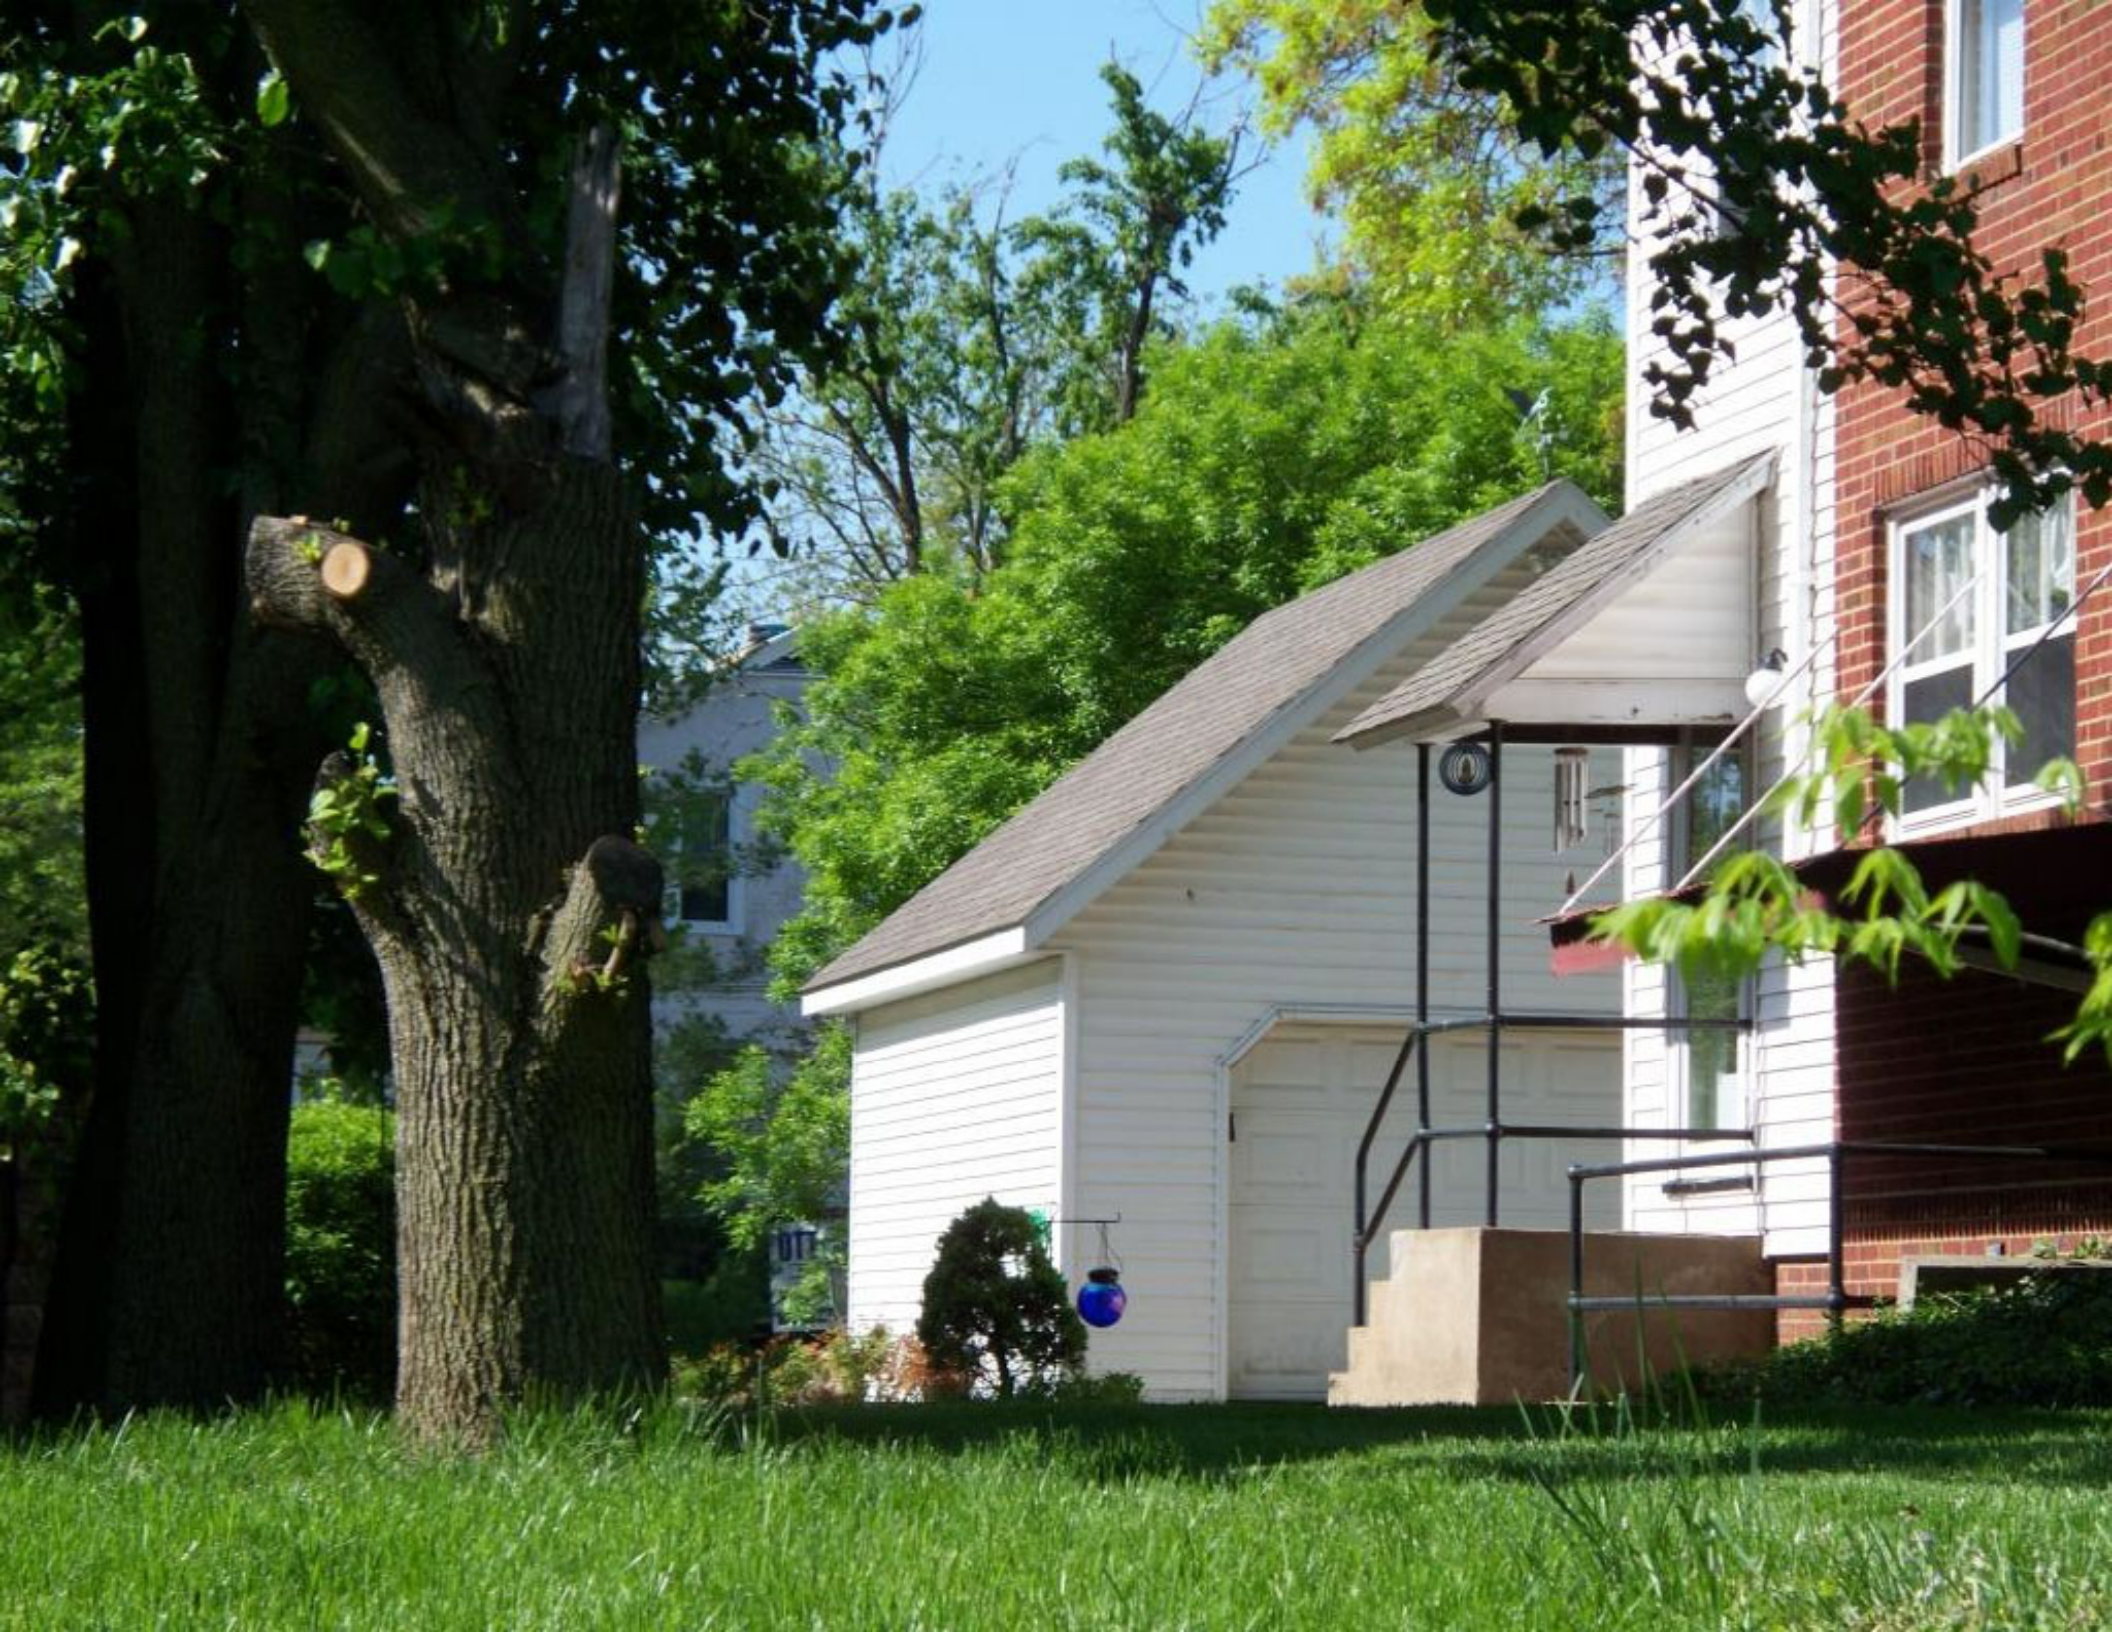
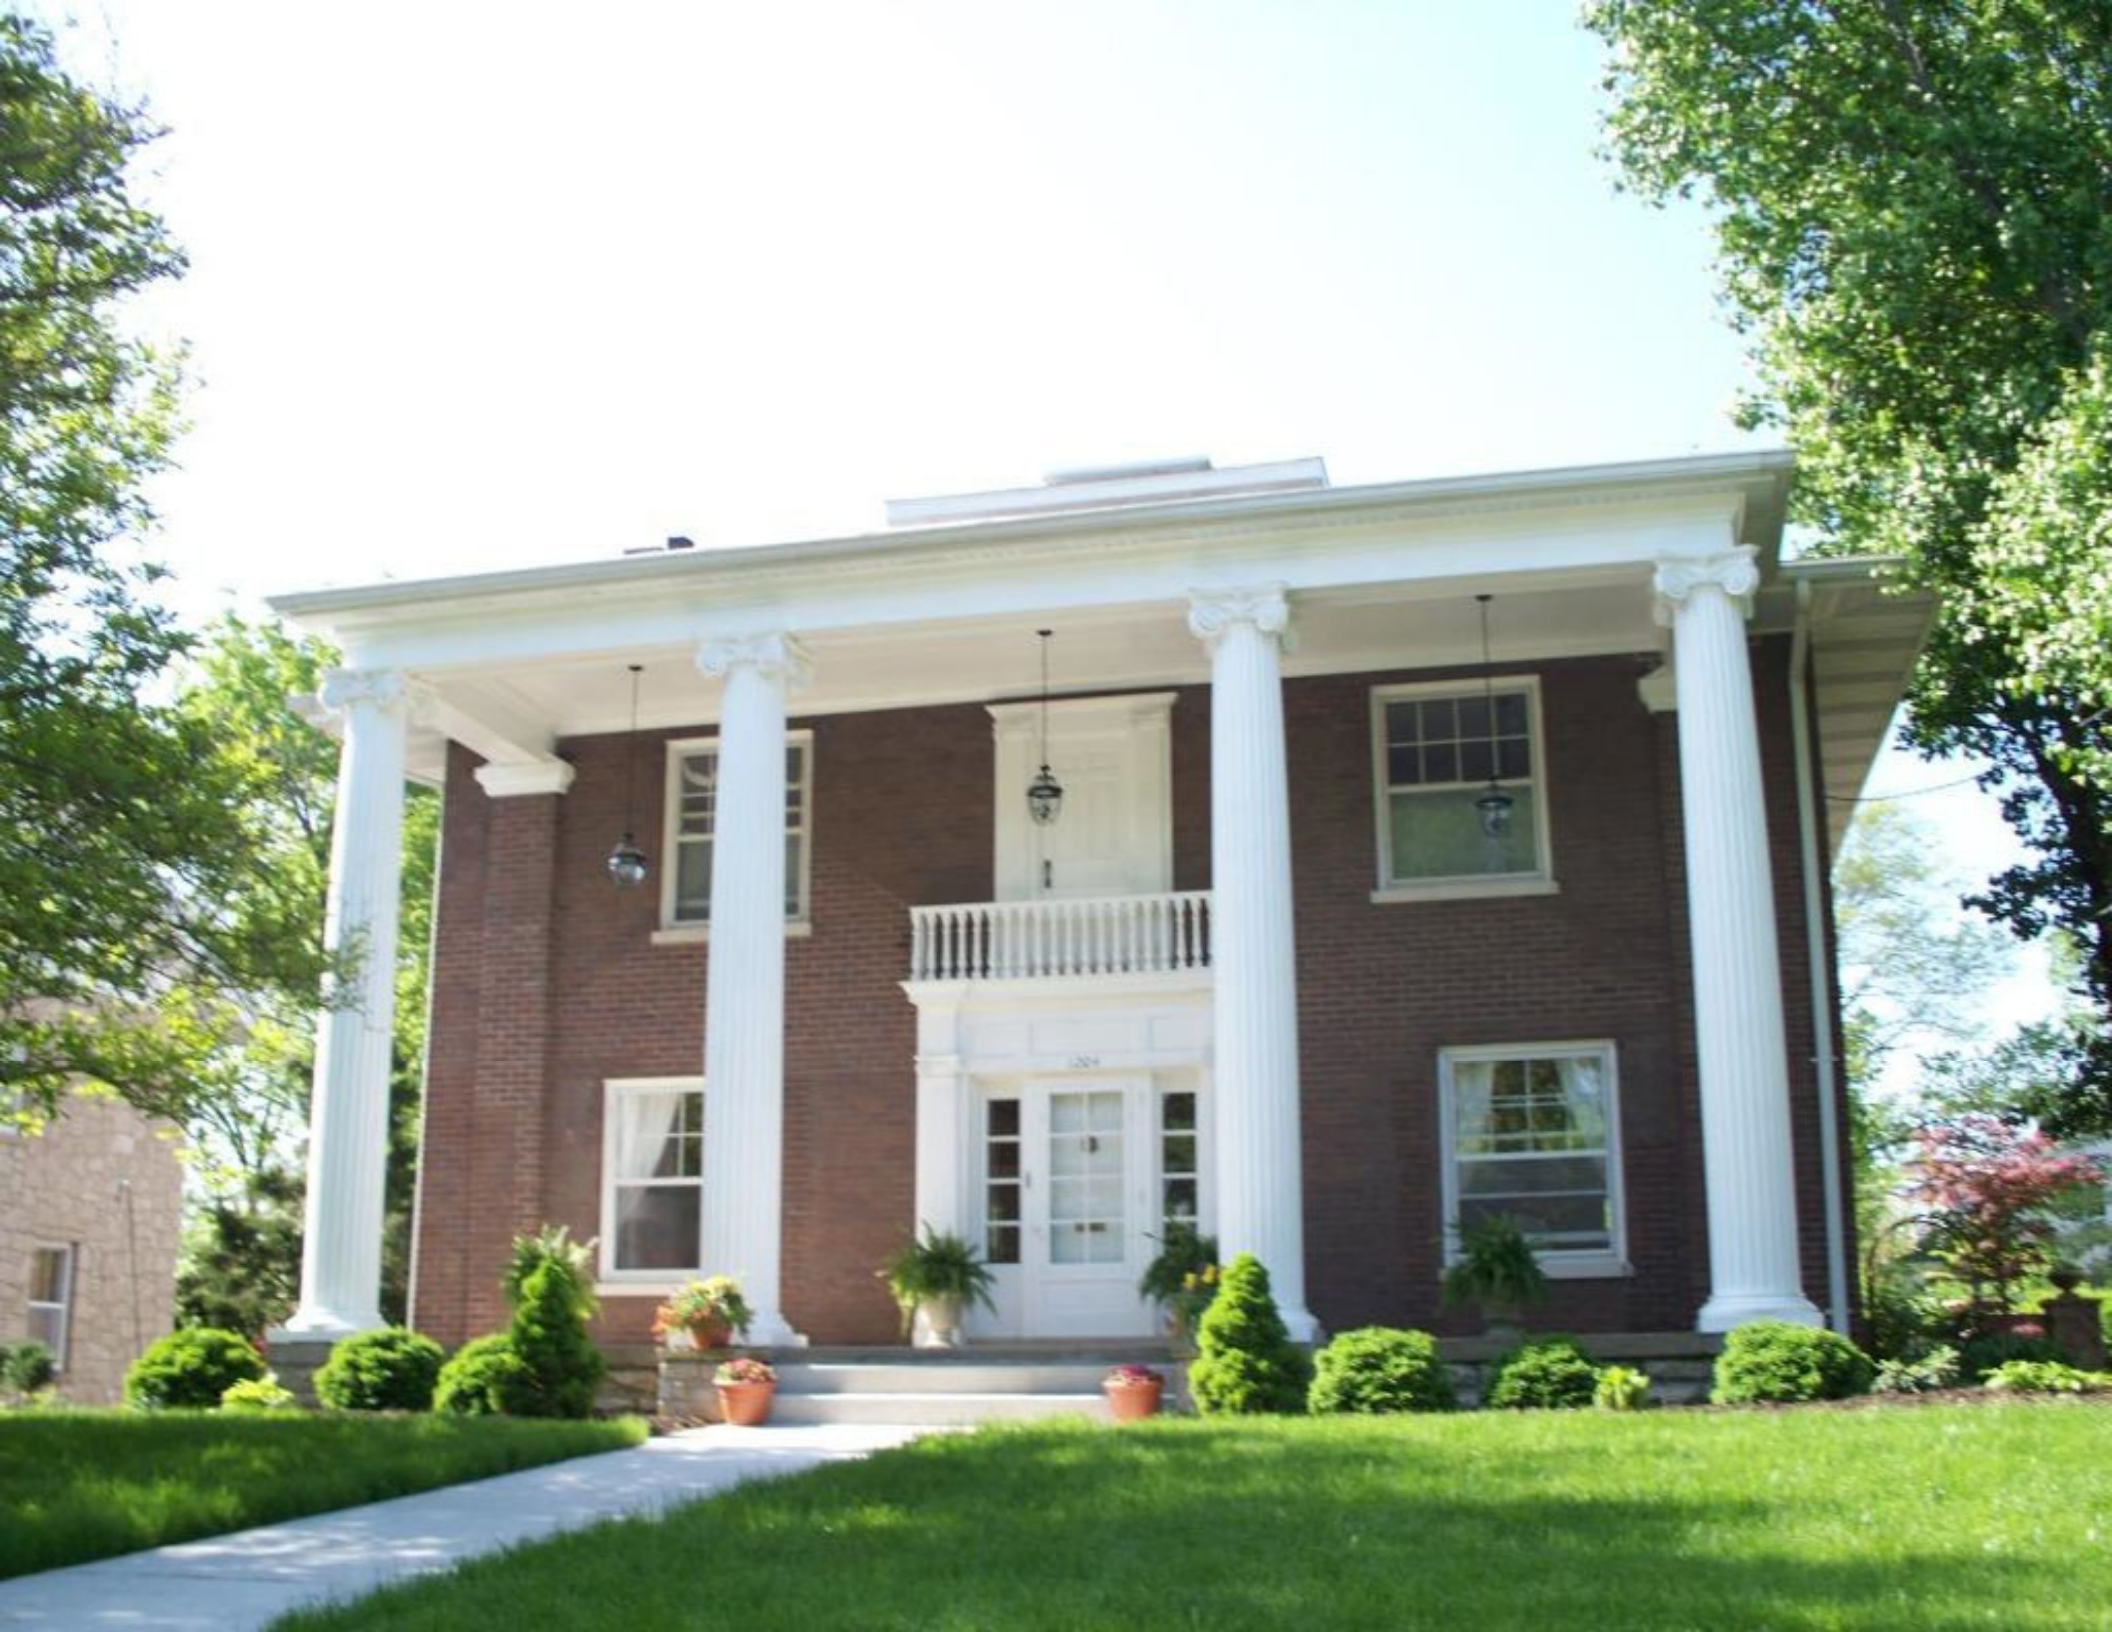
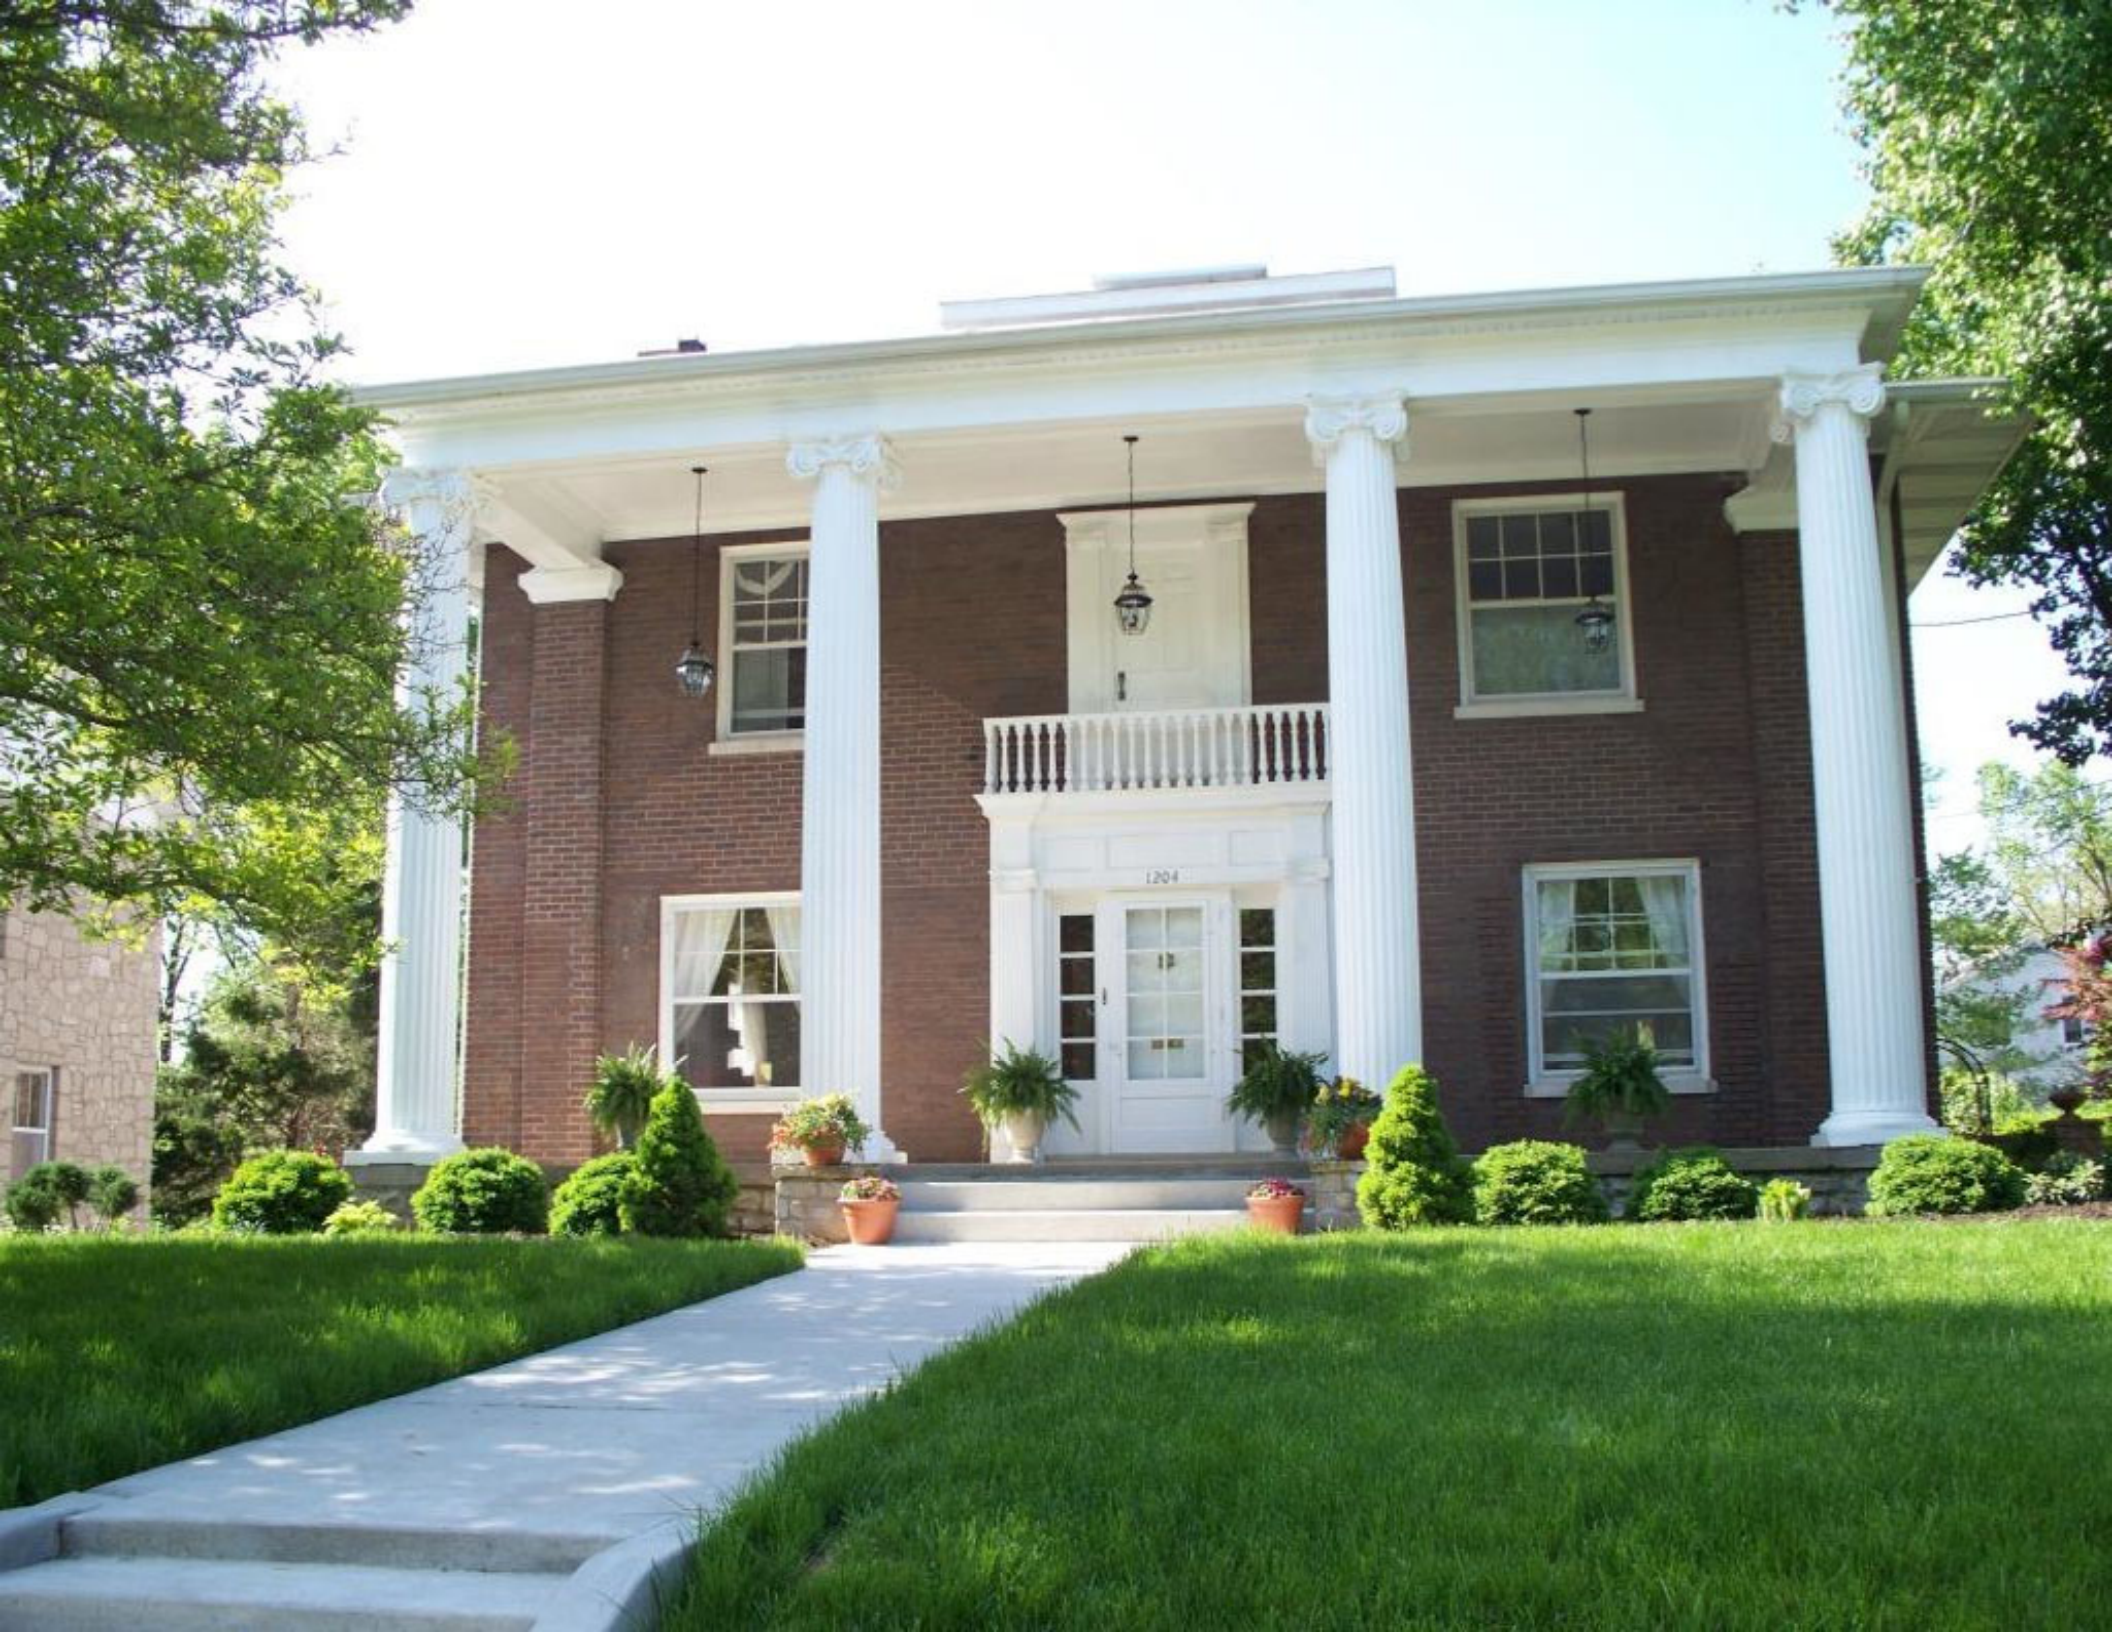
41. (cont.)
This is a 2 ½ story brick Greek Revival with a full façade open porch with four Ionic fluted columns and two brick pilasters. These support a large flat entablature that serves as a roof. The half story is perched above this and contains a bell cast dormer with five windows. The second story has two 8/1 windows (may or may not be historic) with limestone sills that flank an upper entrance with an ornate door surround and railing. The first floor has identical 8/1 windows with limestone sills flanking the main entrance that features an ornate paneled door surround and entablature. The door has sidelights and multi-paned glass outer door. The property may be individually eligible as good example of Greek Revival in Jefferson City.
