ARCHITECTURAL/HISTORIC INVENTORY FORM

1. Survey No. CO-AS-005-001		2. Survey name: Moreau Drive Neighborhood Survey	
3. County: Cole		4. Address: 1202 Elmerine Ave.	
5. City: Jefferson City	Vicinity: <input type="checkbox"/>	6. UTM: / /	7. Township/Range/Section: T: R: S:
8. Historic name (if known):		9. Present/other name (if known):	
10. Ownership: <input checked="" type="checkbox"/> Private <input type="checkbox"/> Public		11. Historic use (if known): Residential	11. Current use: Residential

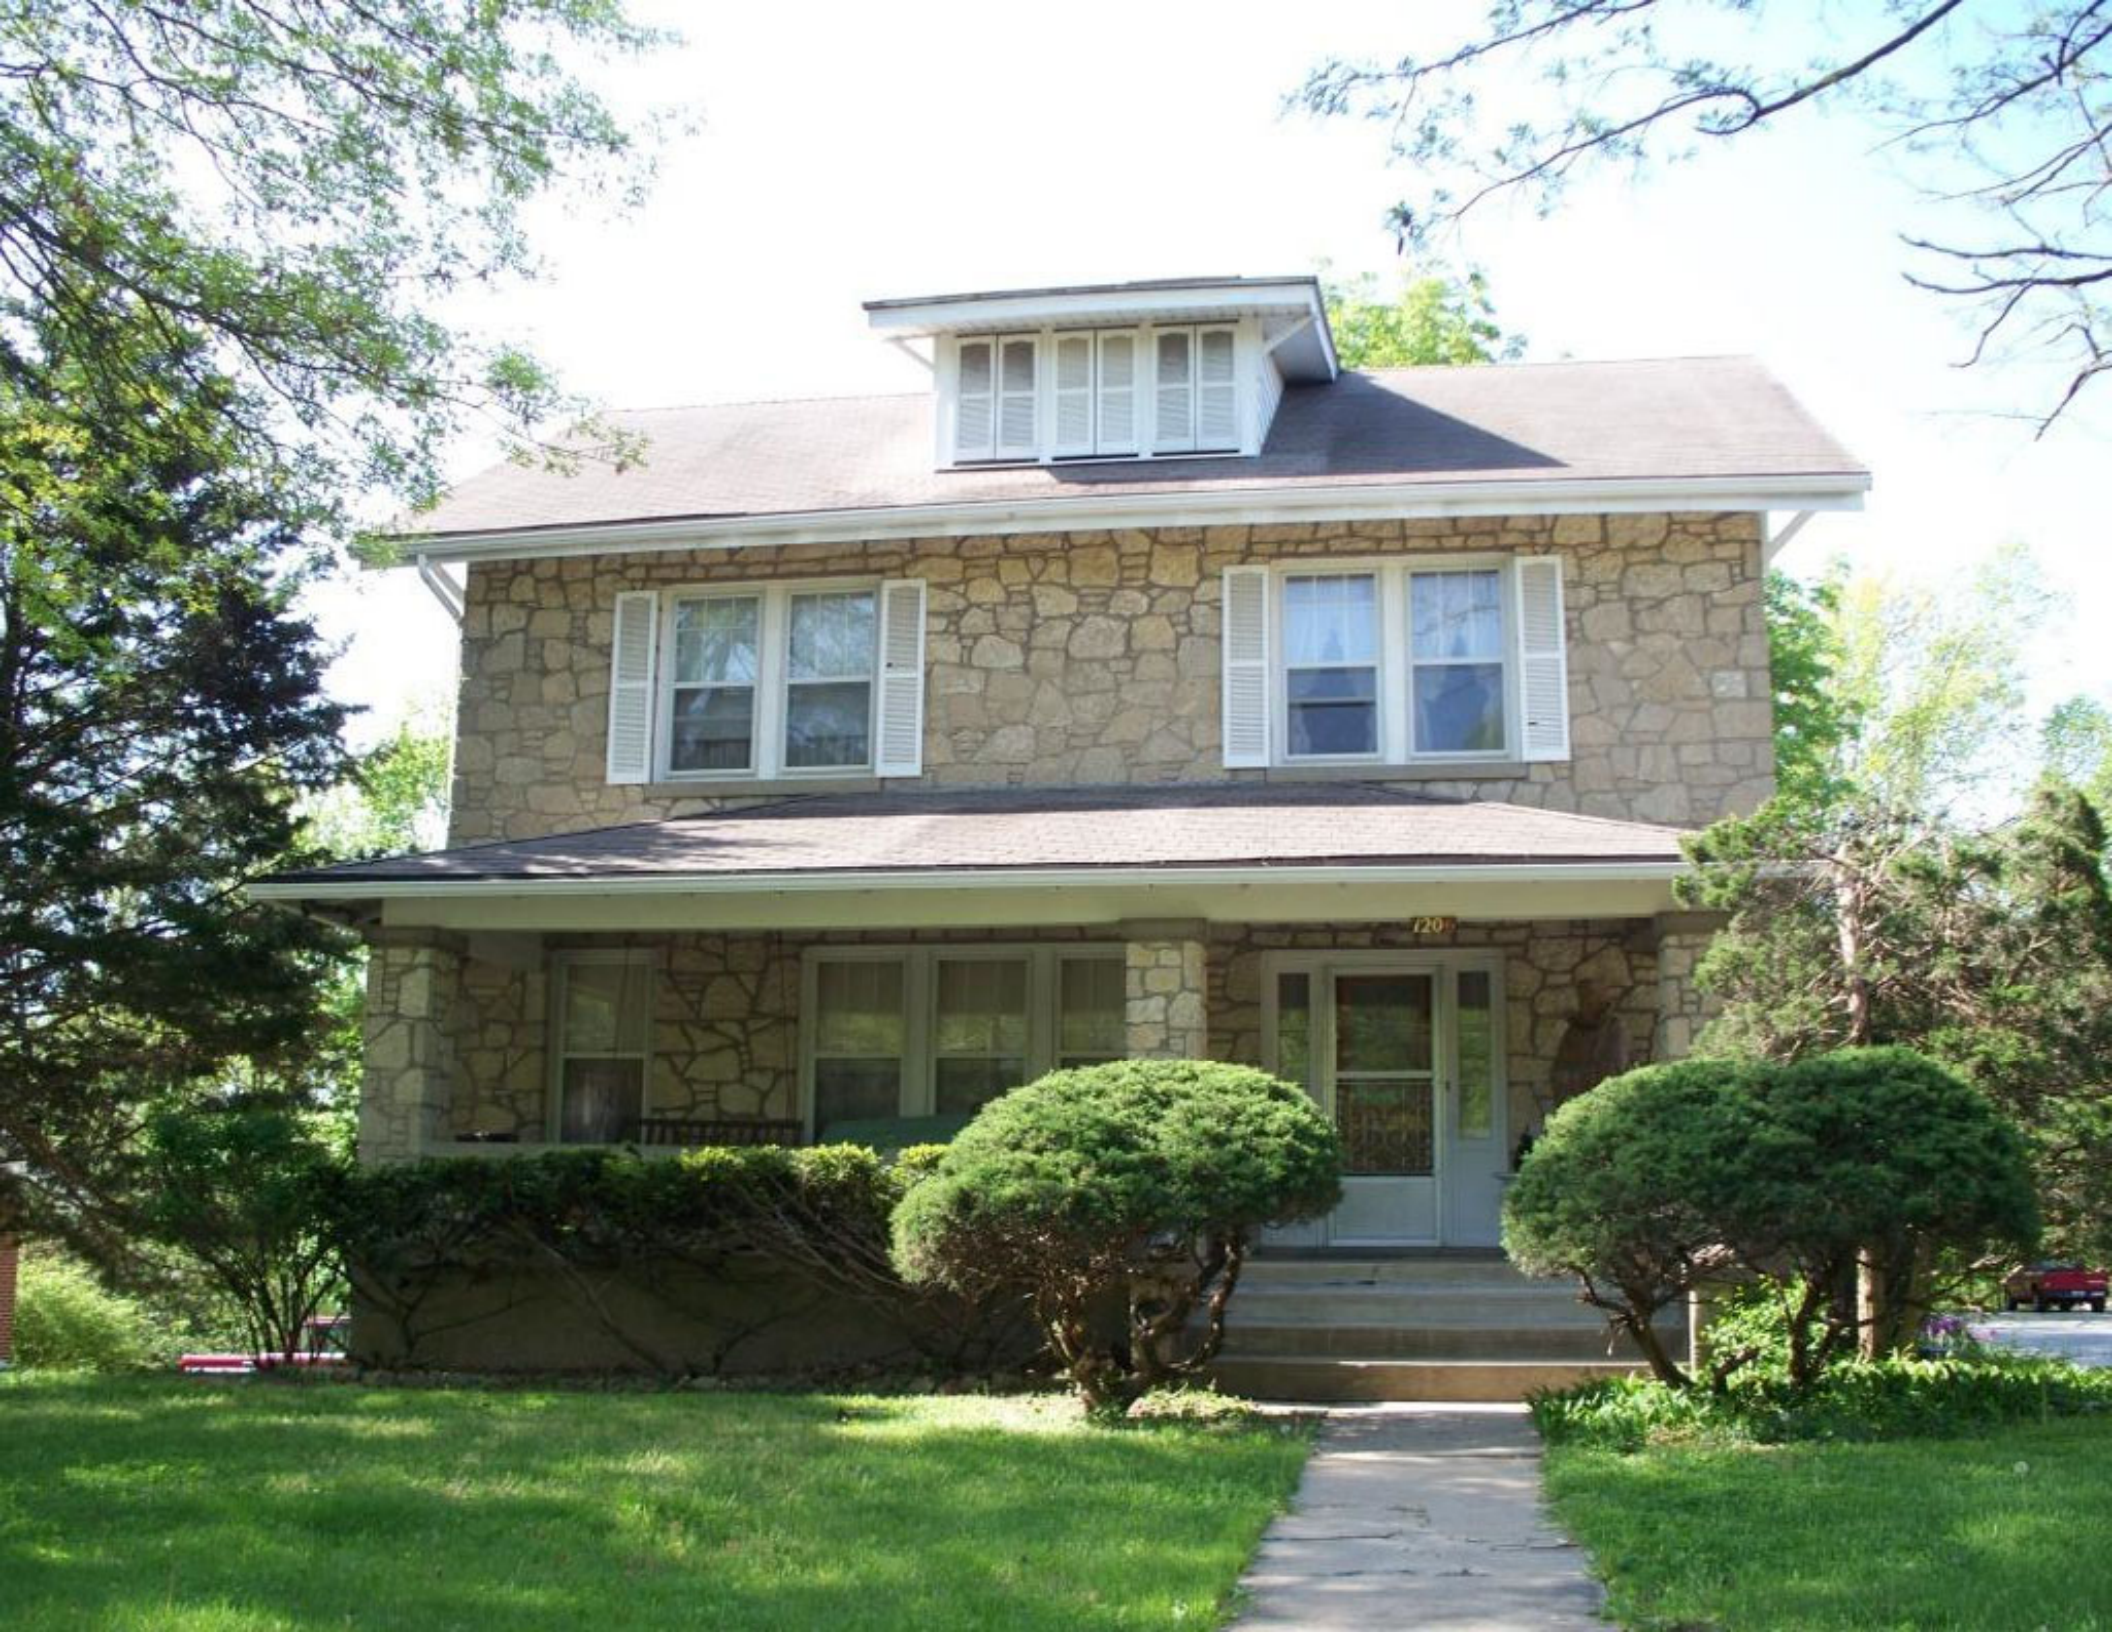
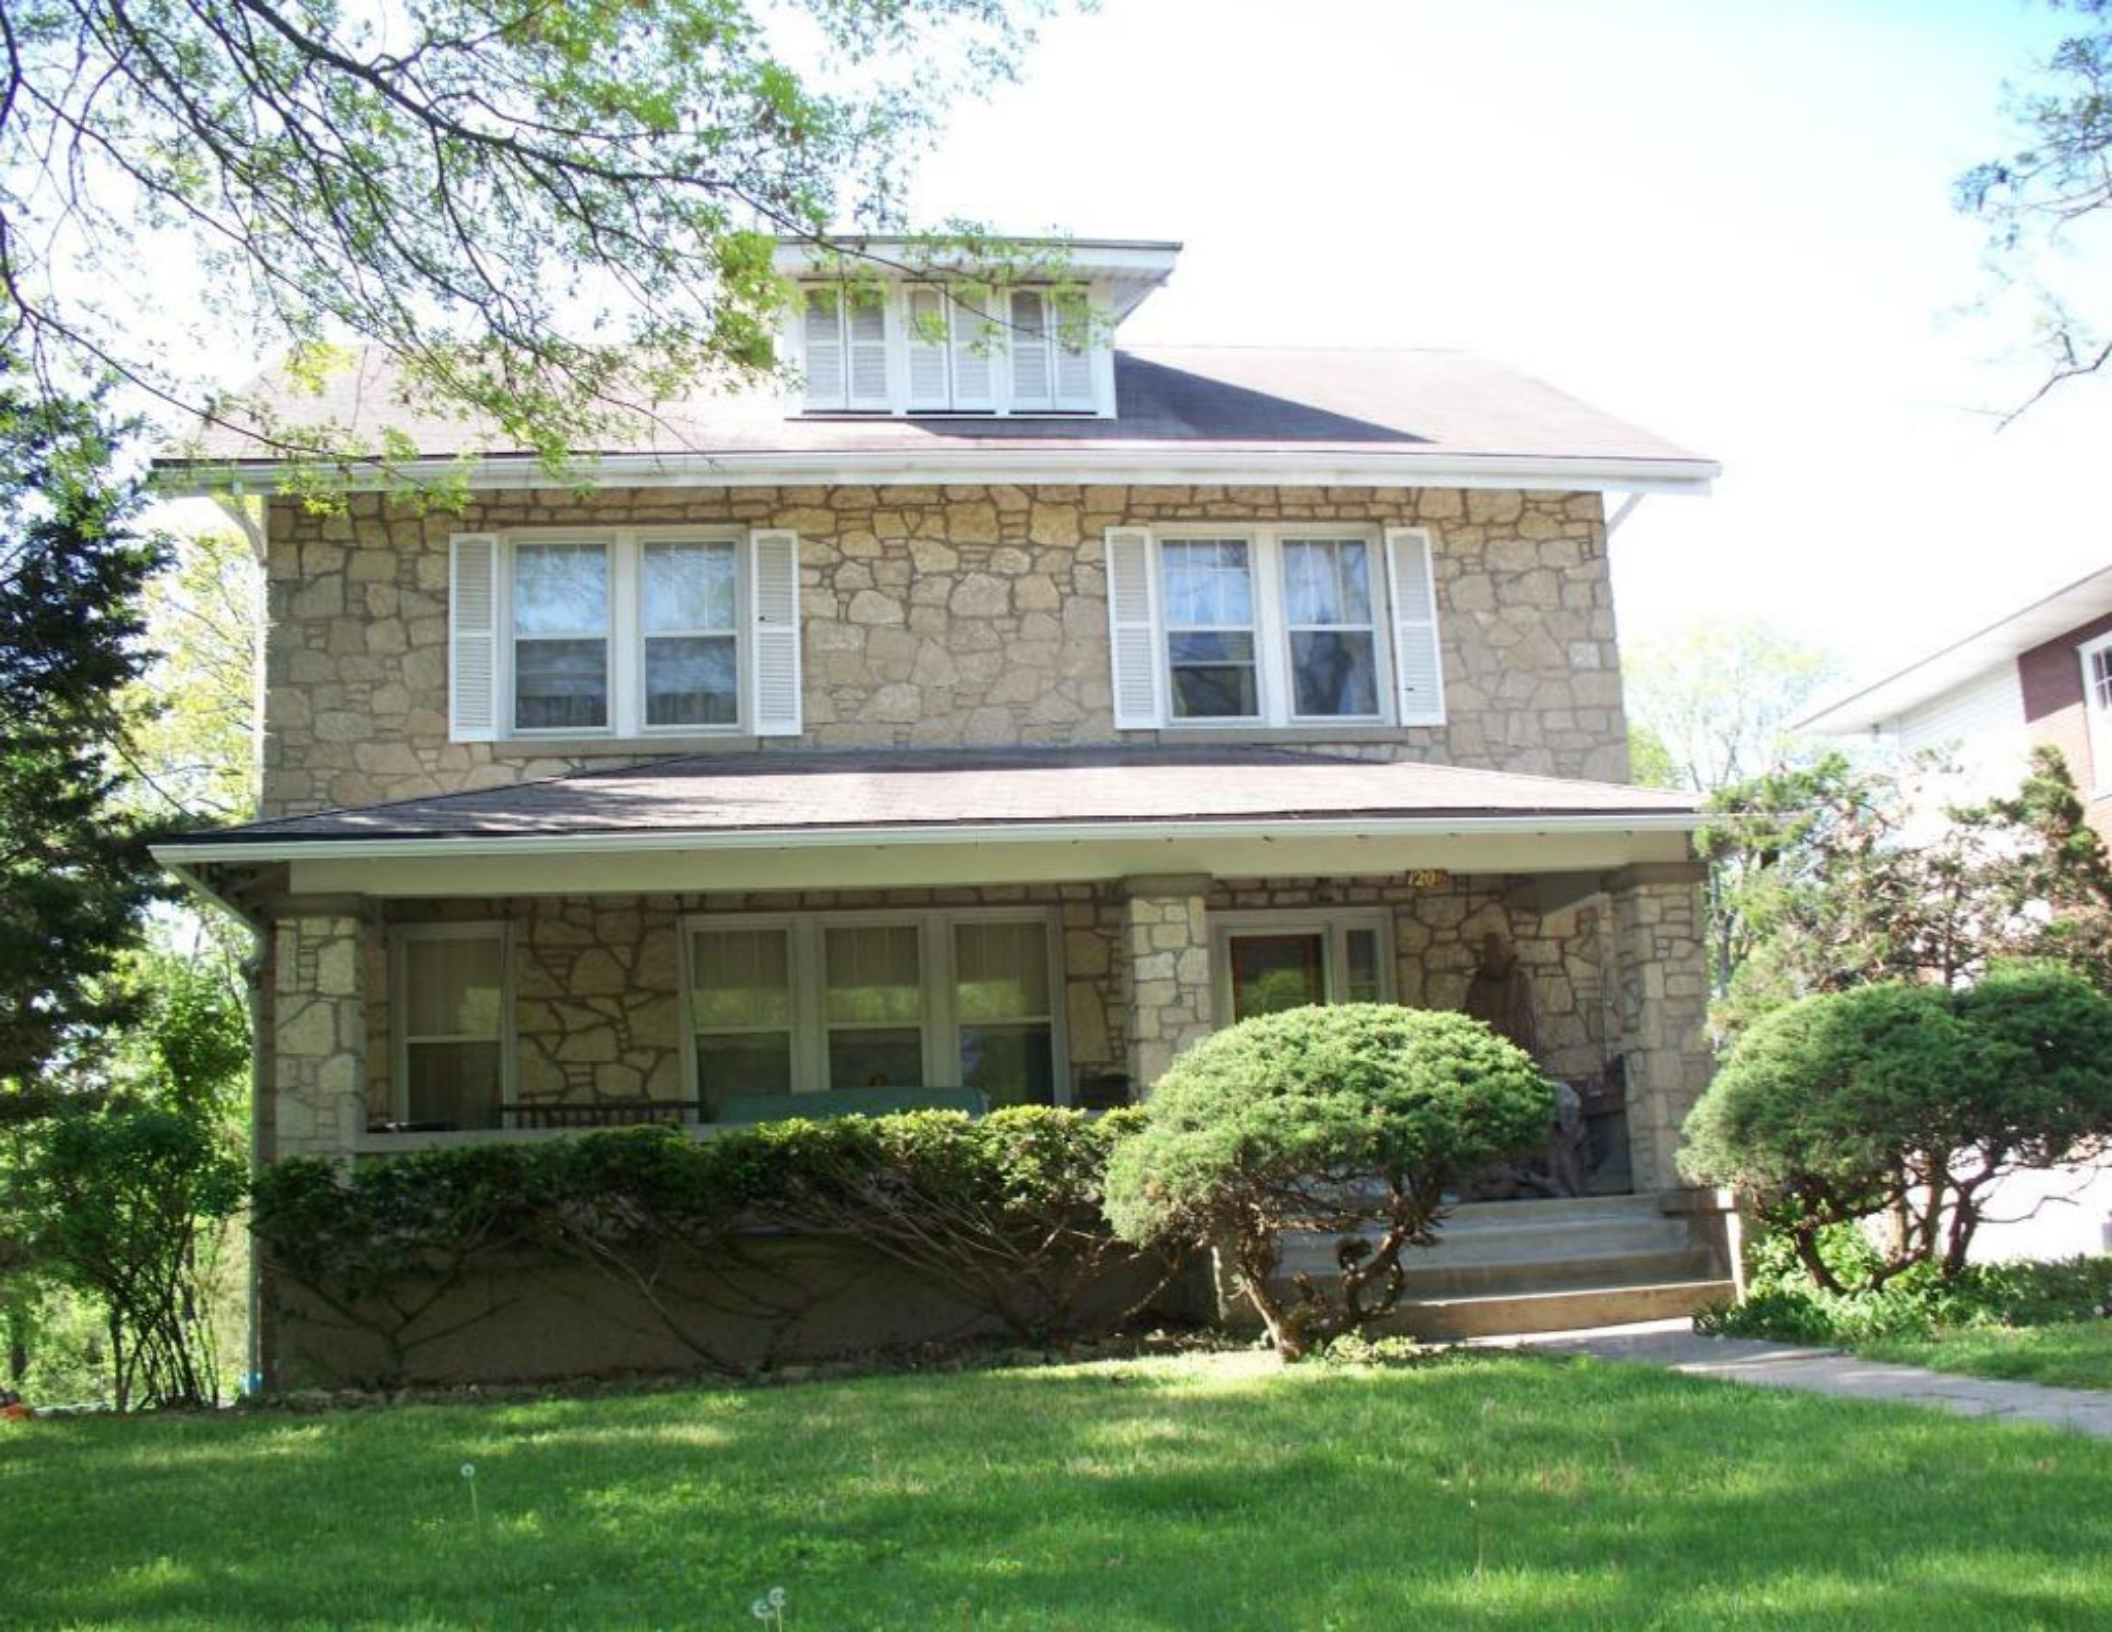
41. (cont.)
This is a 2 ½ story stone Four Square has a side gabled roof with a central shed dormer with brackets. The dormer has three pair of wooden shutters that were shut at the time of photography (window arrangement unknown). The upper floor has two paired historic 3/1 windows with shutters. The lower floor has a single 3/1 historic window in the left bay, a row of three 3/1 windows in the center bay and the entrance with sidelights is in the right bay. The entrance appears to retain its historic door and is covered by a metal screen door. The porch has a hipped roof and features stone piers and half walls capped in concrete or limestone. A set of concrete stair lead up to the entrance in the left bay.

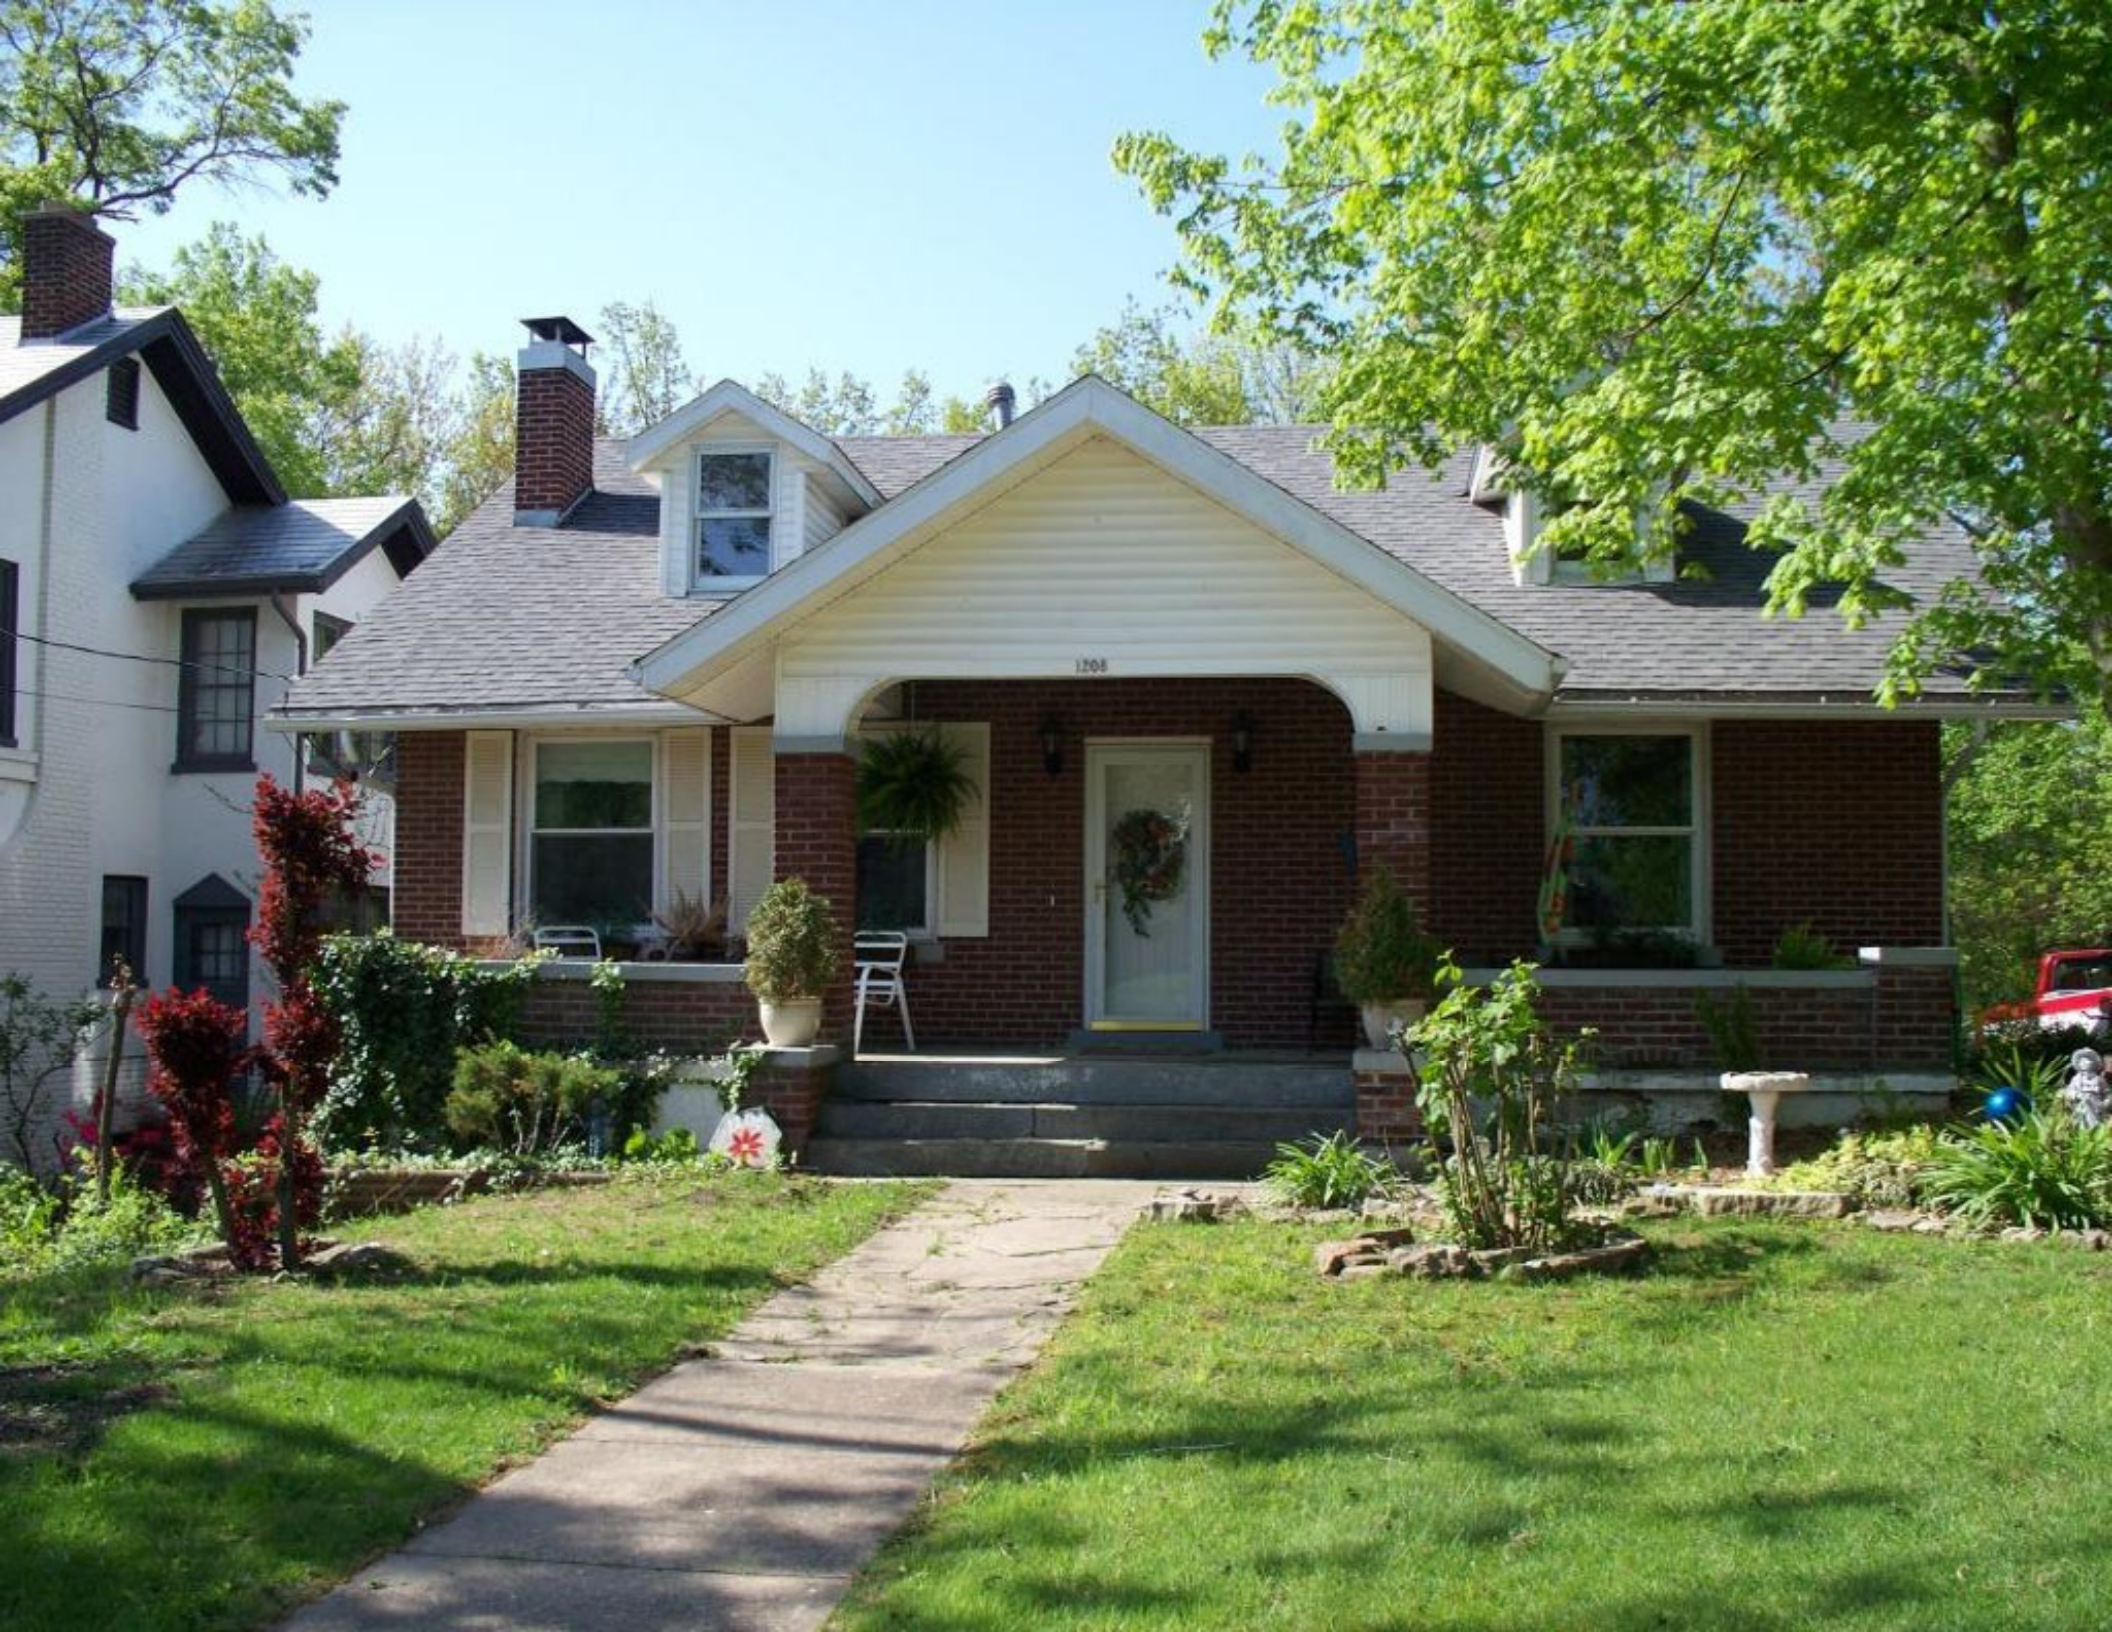
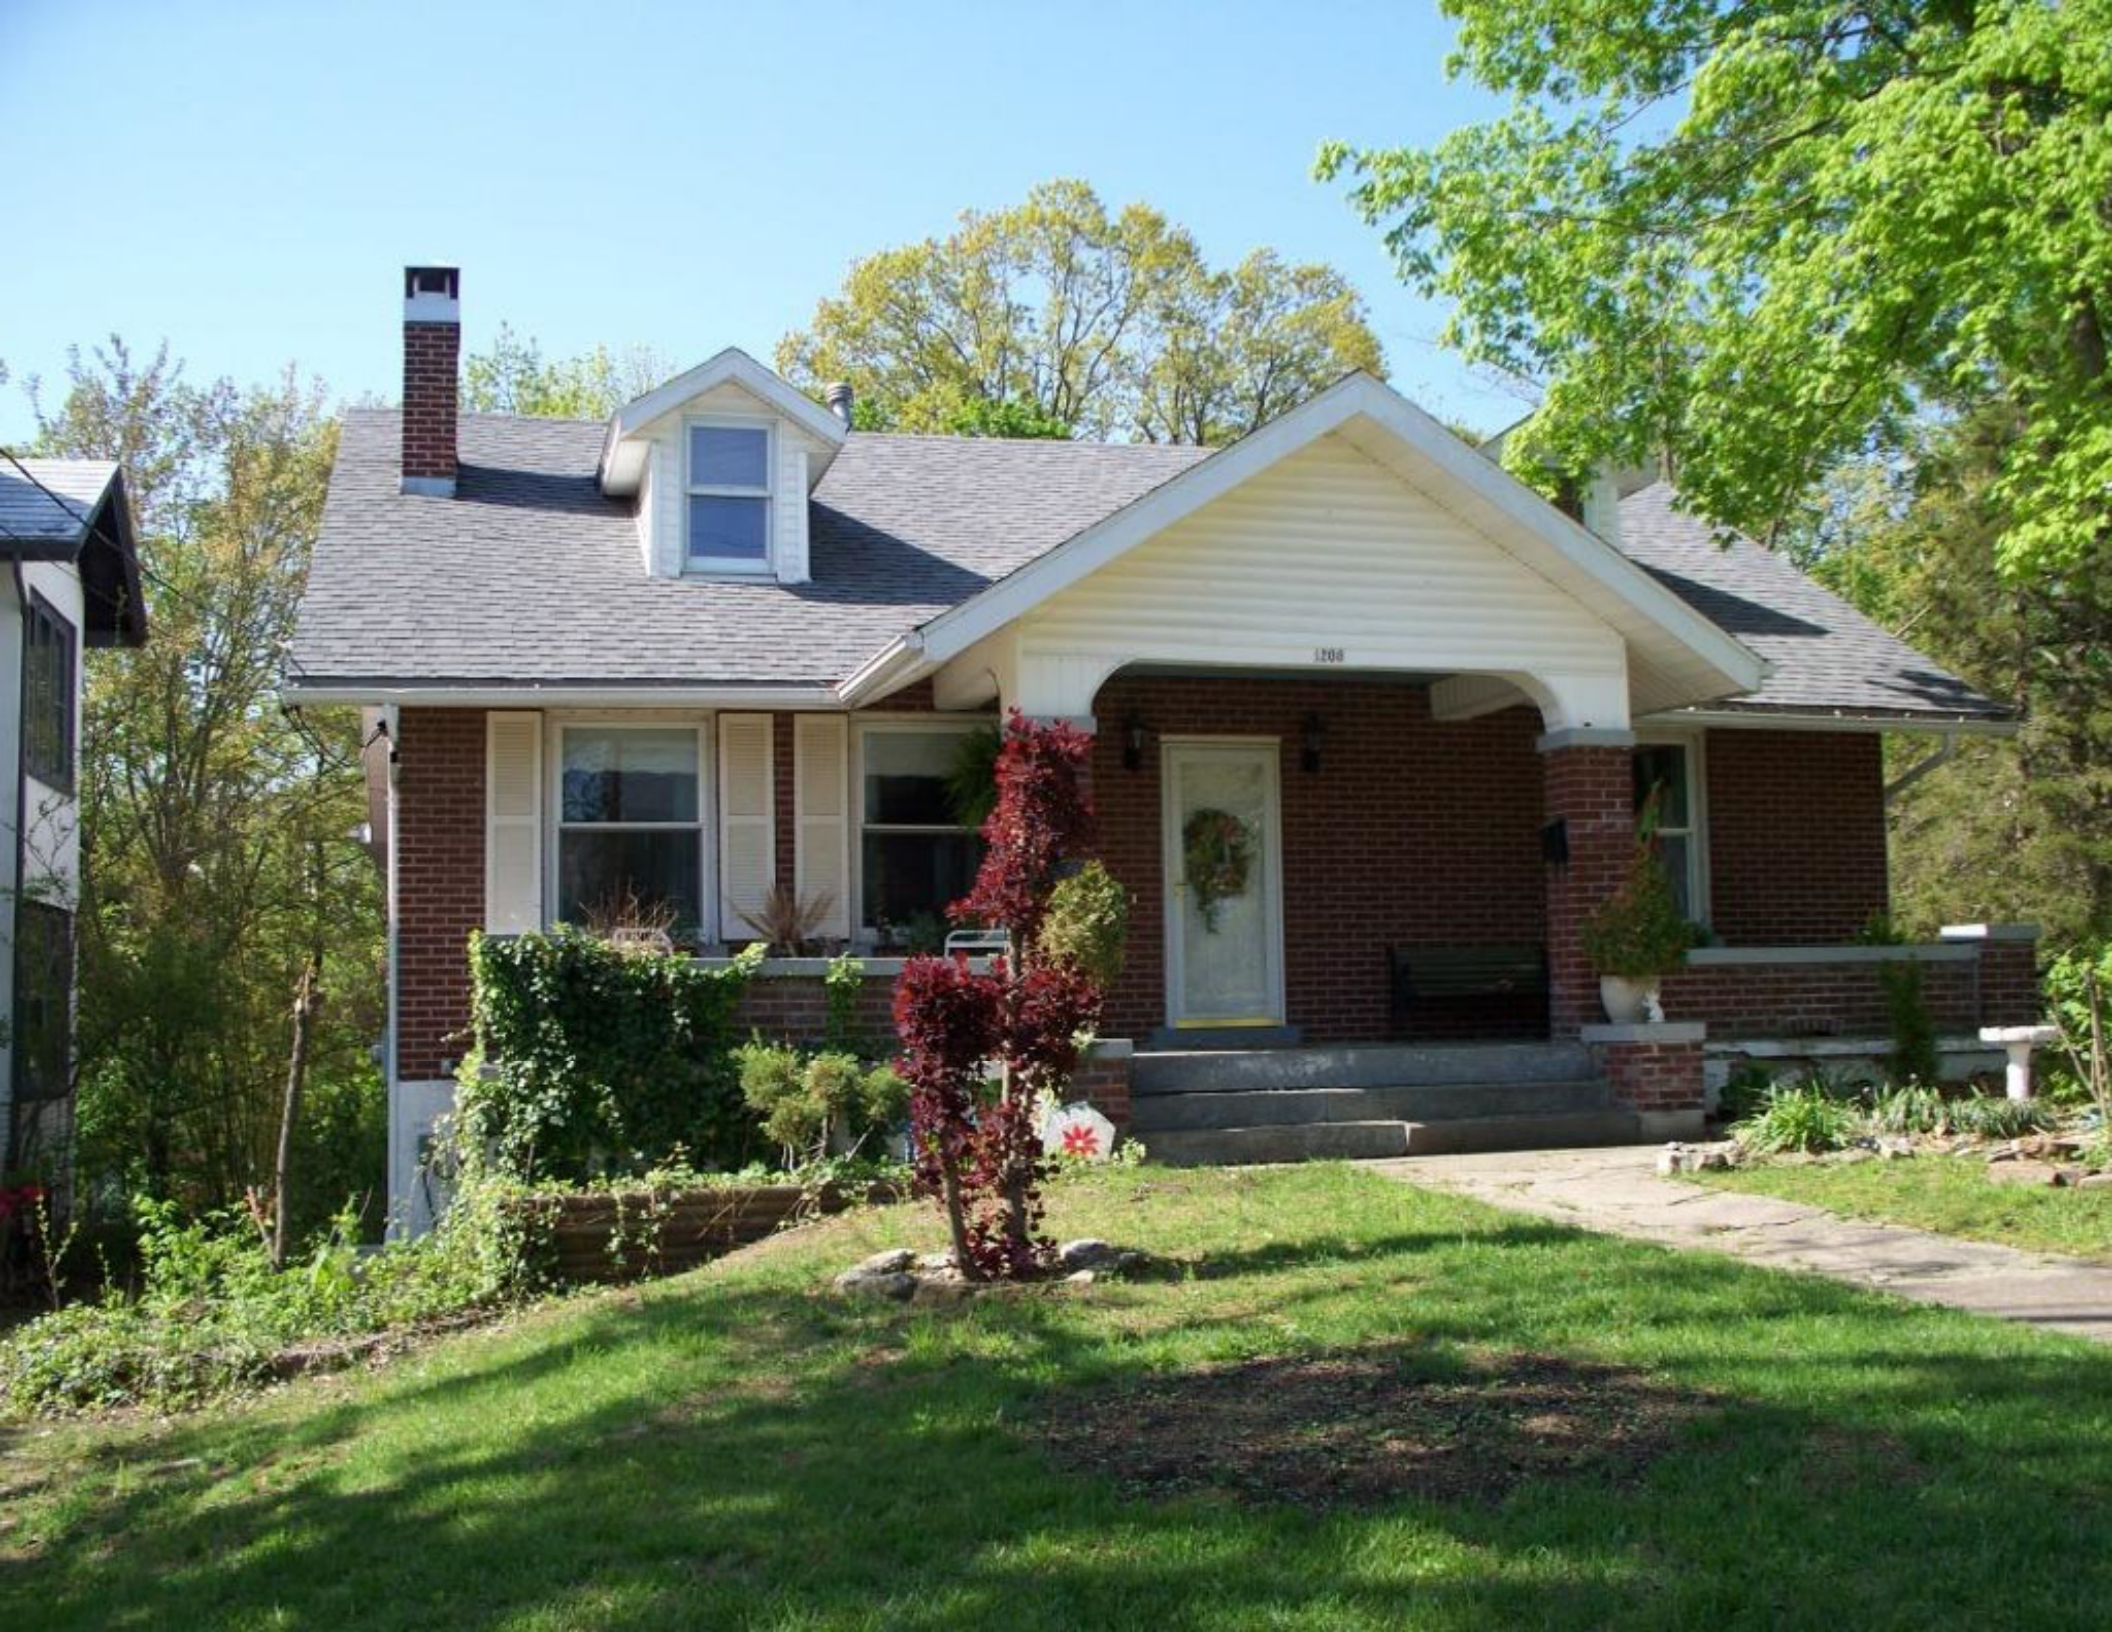
This 1 ½ story brick home is difficult to categorize. It has a side gabled roof with a central front gable projection clad in vinyl that covers the entrance. It has two gabled dormers clad in vinyl with 1/1 vinyl windows. The ground floor has two 1/1 replacement windows with shutters in the left bay, the entrance in the center, and a single 1/1 window in the right bay. The porch has a concrete floor and brick half-walls with eyebrow vents along the foundation line. The half-walls are capped in concrete. The porch is covered only in the center bay by the projecting front gable, which is supported by brick piers that form a wide basket handle arch. The property displays features that appear in a Cape Cod, Minimal Traditional, Colonial Revival, and the bungalow. Since the majority of the property is covered with a side gabled roof it is considered a side gabled type for the purposes of this survey.

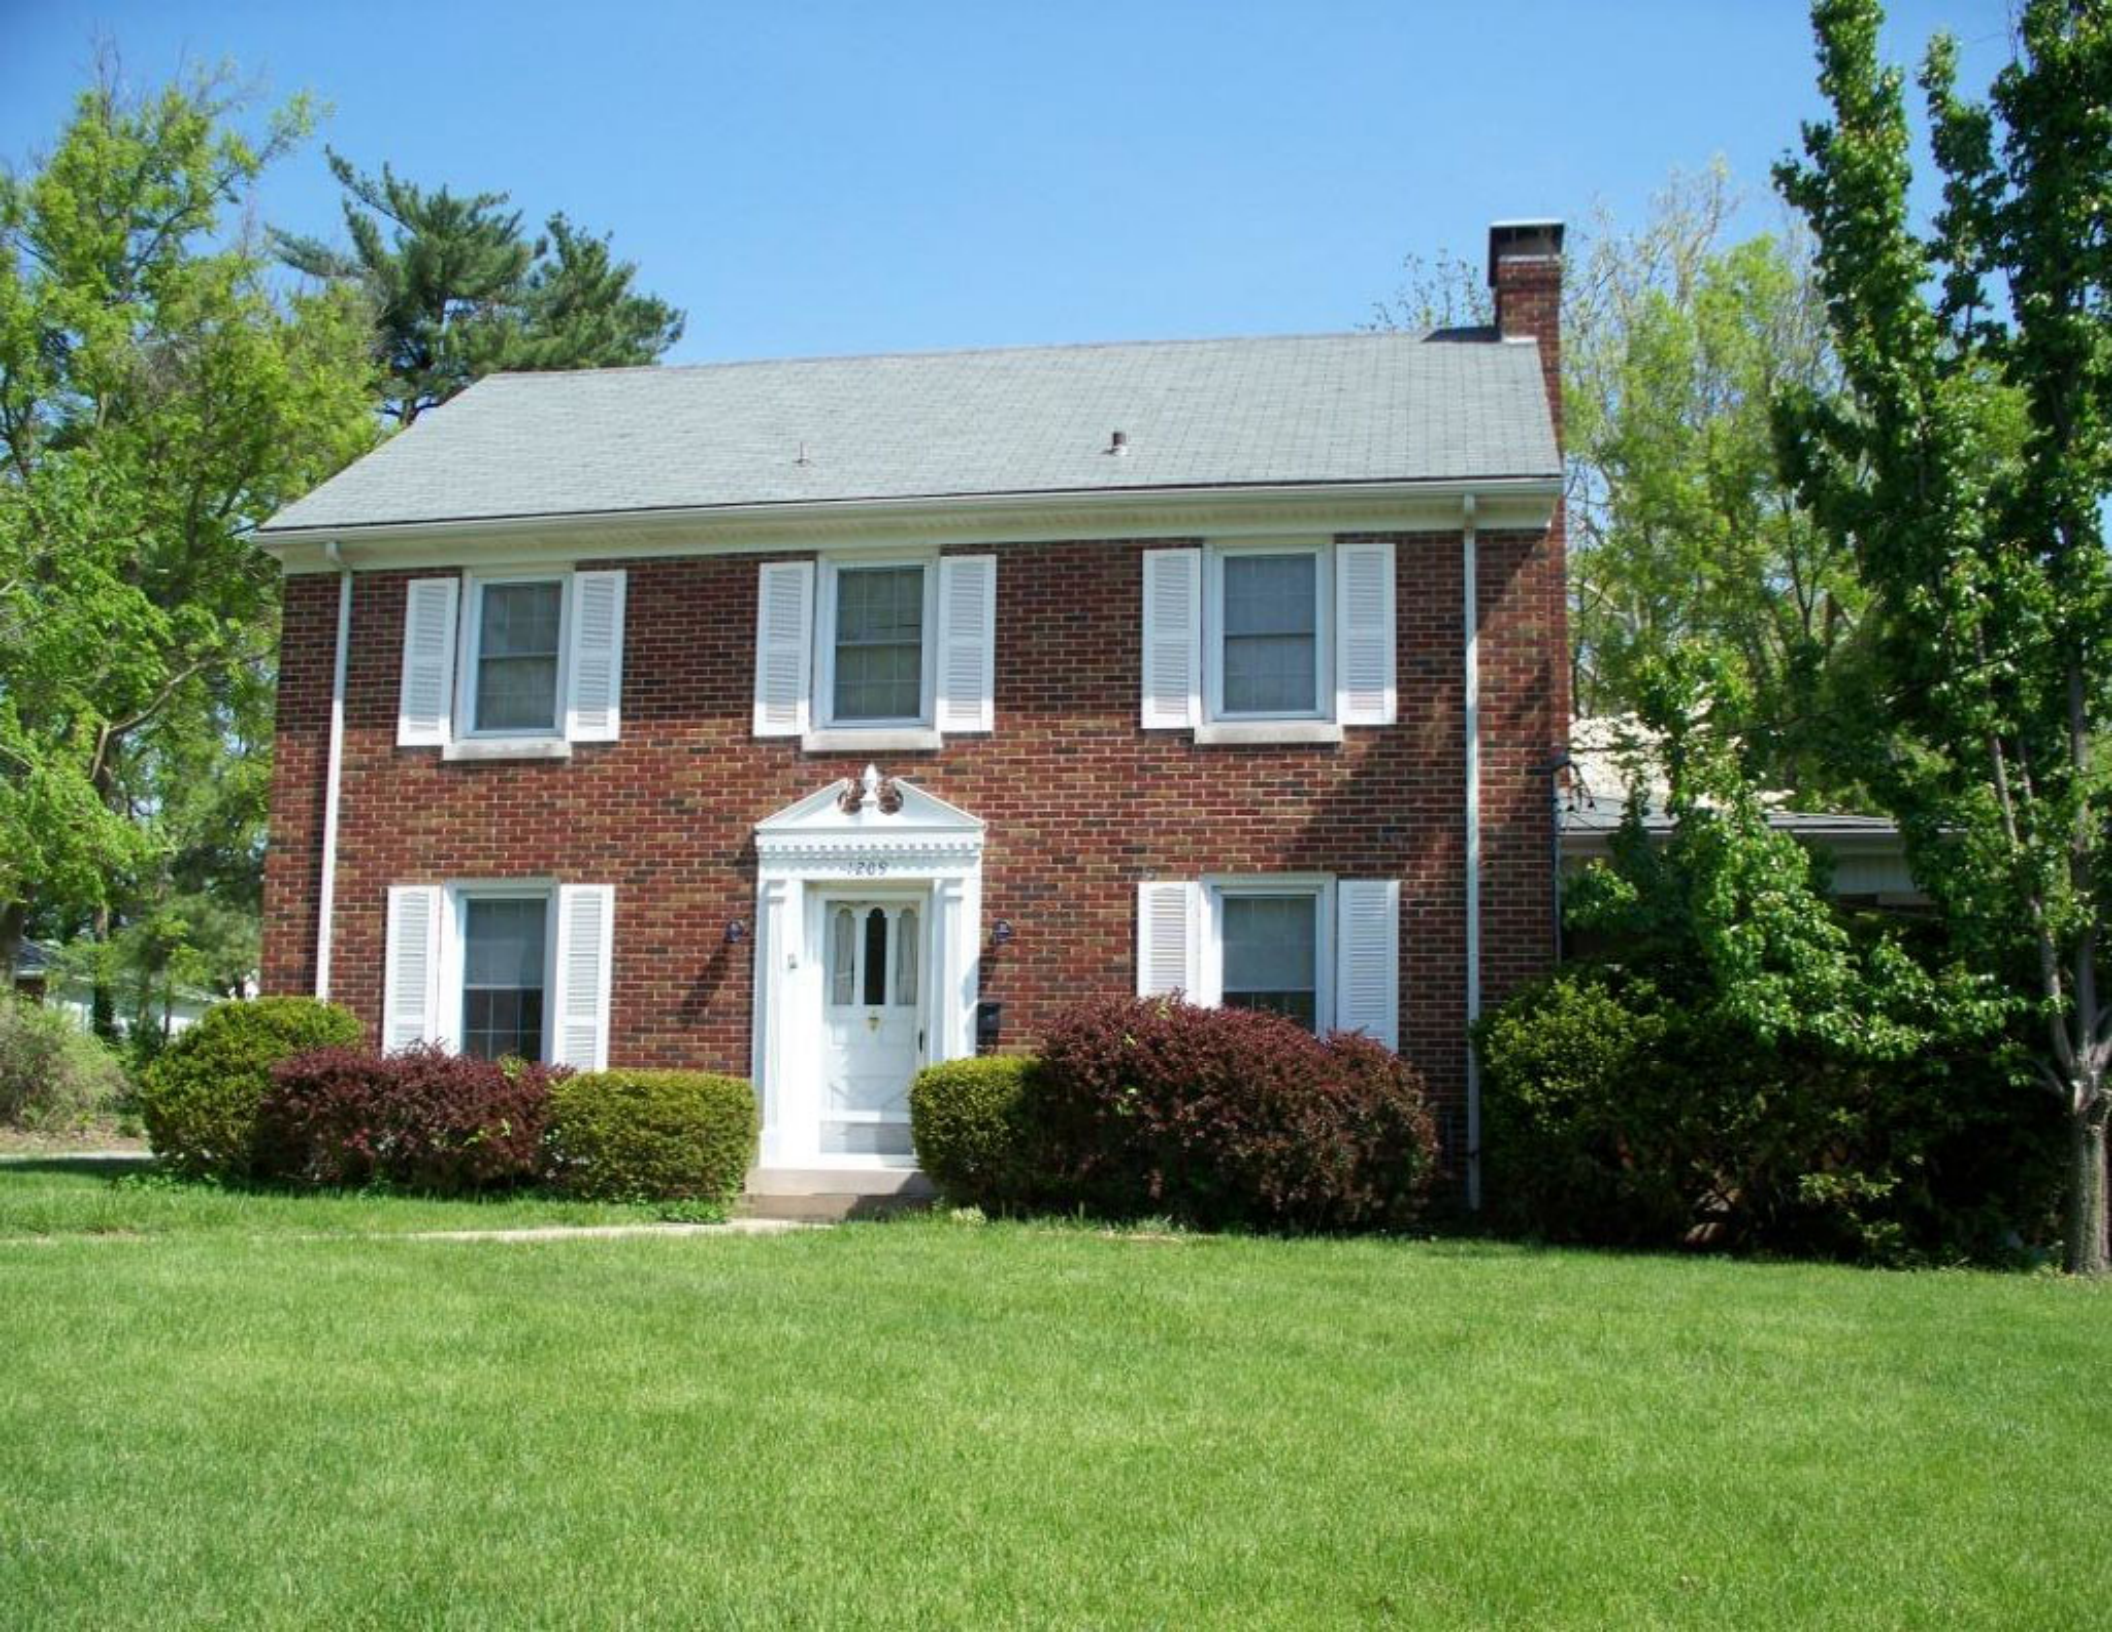
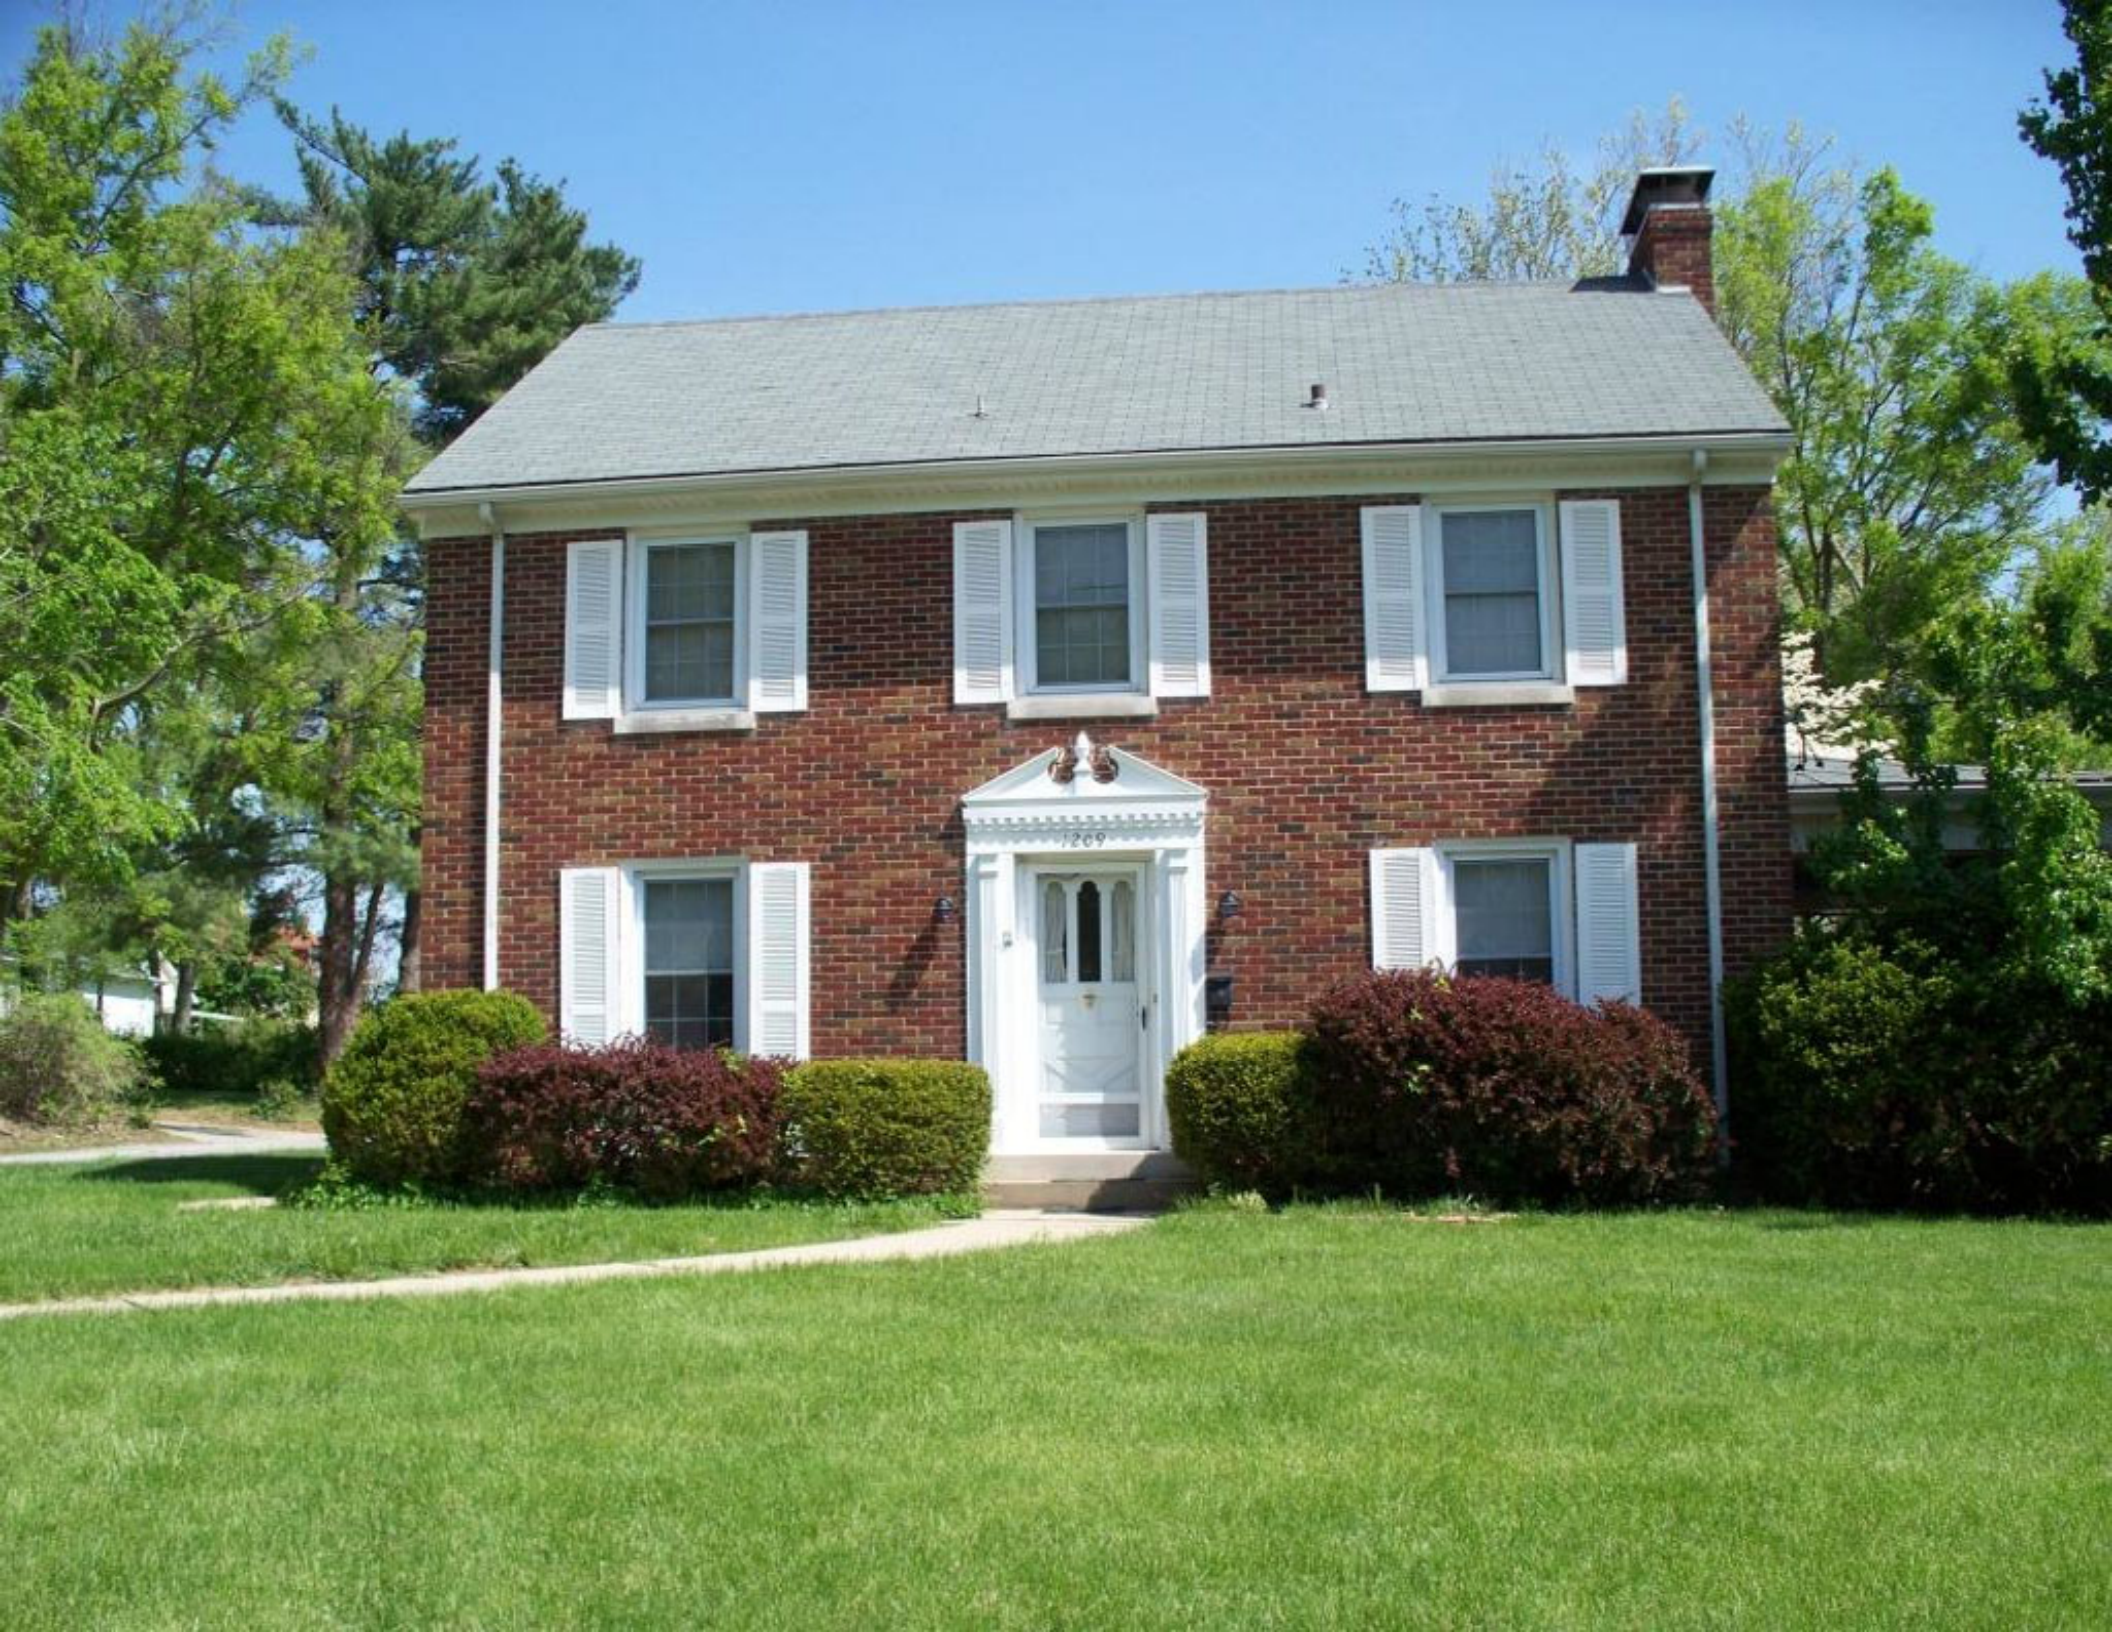
This two story brick Colonial Revival has a side gable roof and three 6/6 windows on the upper story with shutters. The lower floor has two slightly longer 6/6 windows with shutters flanking the entrance, which has an ornate broken pediment door surround. A concrete stoop leads to the entrance. There is an attached 1 story sun room with a shed roof set back on the right side (currently obscured).
