ARCHITECTURAL/HISTORIC INVENTORY FORM

1. Survey No. CO-AS-005-001		2. Survey name: Moreau Drive Neighborhood Survey	
3. County: Cole		4. Address: 1202 Elmerine Ave.	
5. City: Jefferson City	Vicinity: <input type="checkbox"/>	6. UTM: / /	7. Township/Range/Section: T: R: S:
8. Historic name (if known):		9. Present/other name (if known):	
10. Ownership: <input checked="" type="checkbox"/> Private <input type="checkbox"/> Public		11. Historic use (if known): Residential	11. Current use: Residential

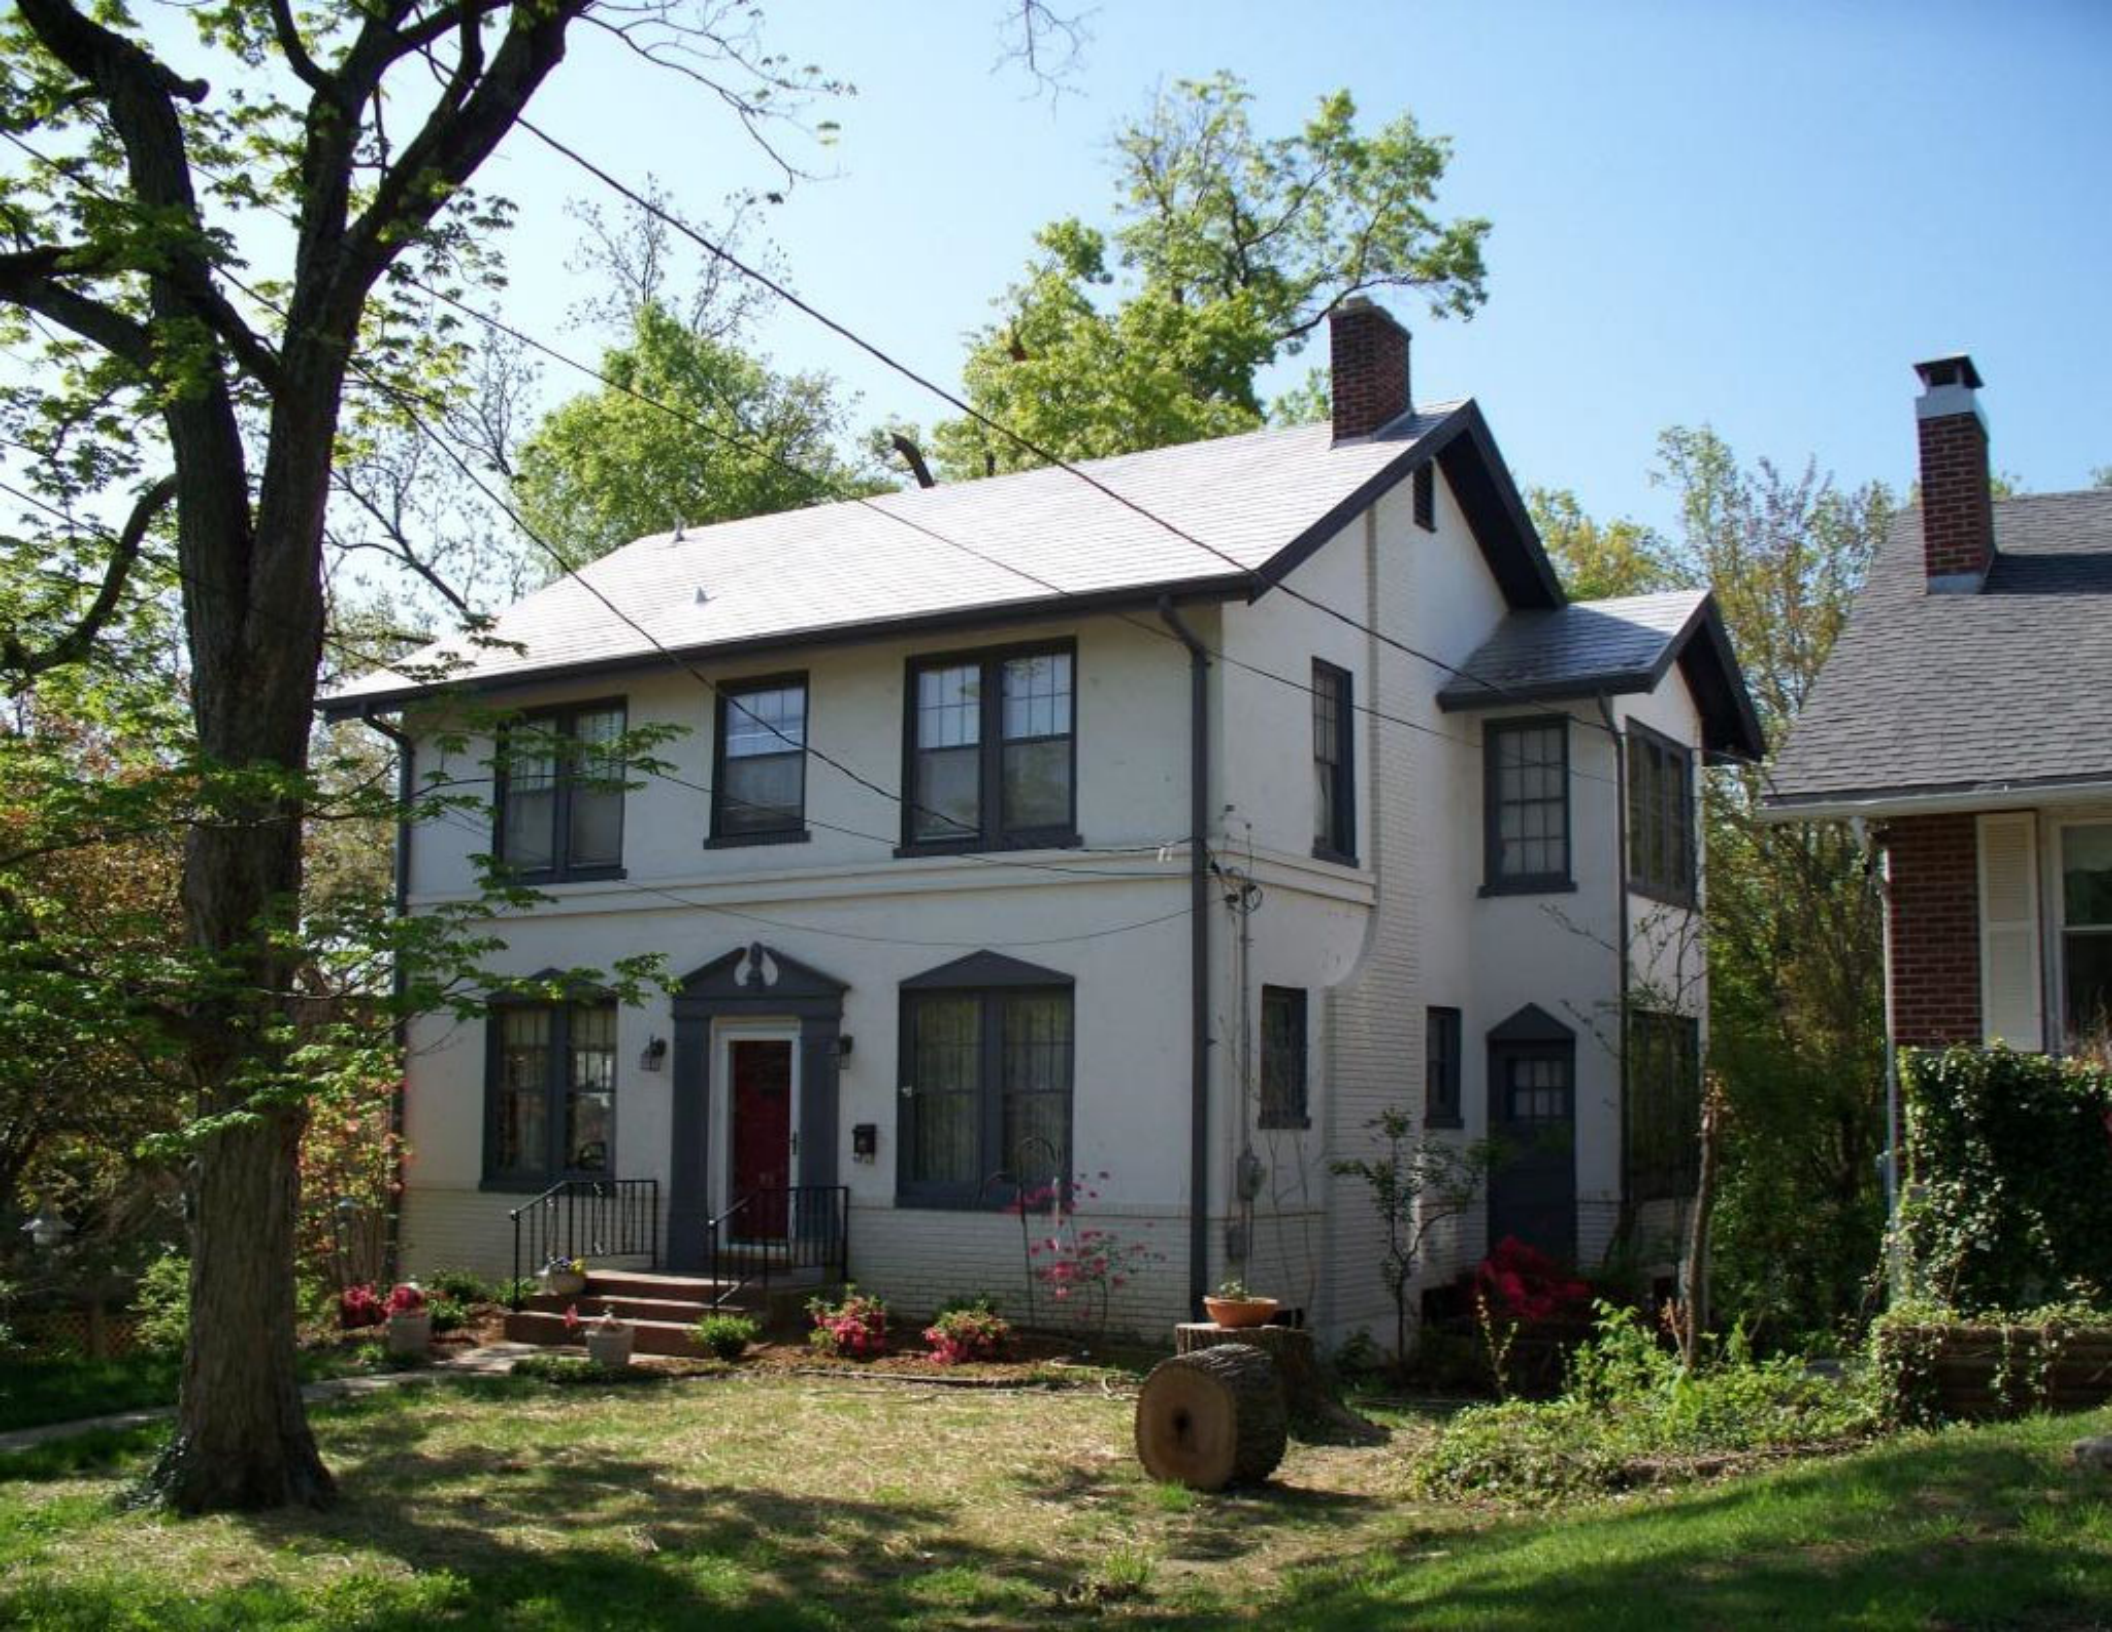
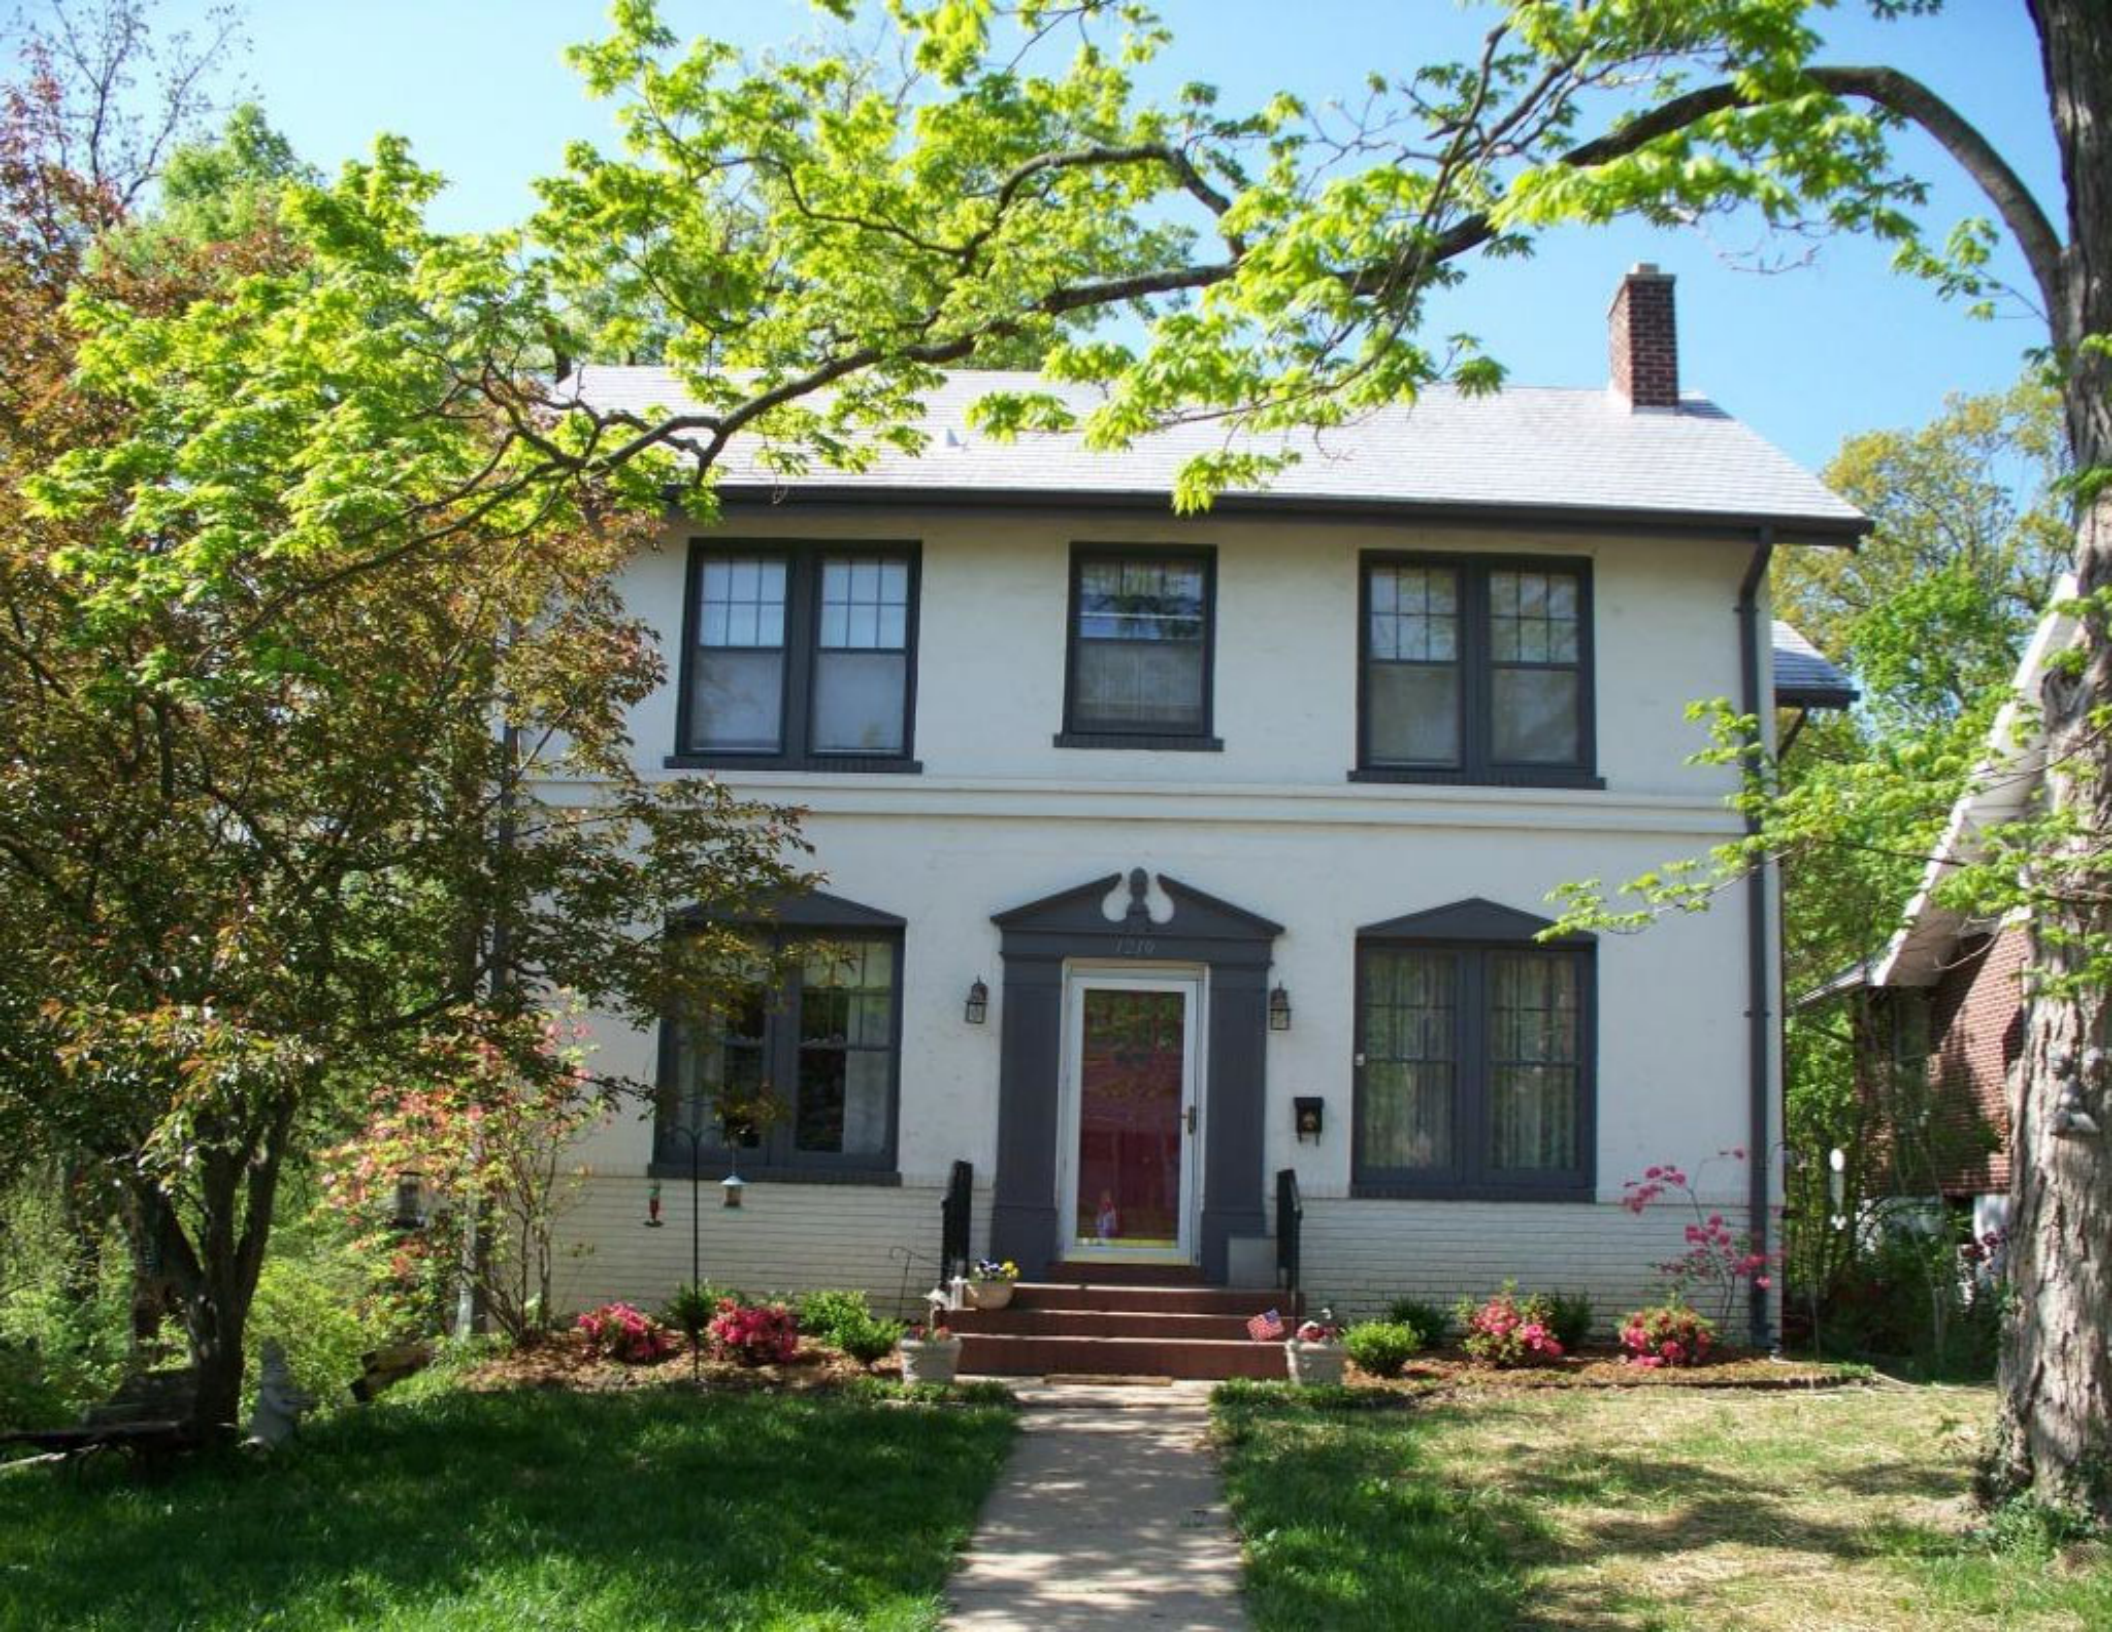
This two story stucco Colonial Revival has a side gable roof and two paired historic 6/1 windows flanking a shorter 6/1 window on the second floor. The lower floor is divided by molding that wraps partially around the sides of the property. The first floor has two 6/1 paired windows with low pitched labels flanking the entrance with an ornate broken pediment door surround. A stoop of three steps with metal railing leads up to the entrance. The lower portion of the property is clad in brick to the sill of the windows on the lower floor. On the right side of the property, set back, there is a two story half bay wing that protrudes from the main portion of the house and contains a secondary entrance and 6/6 historic window.

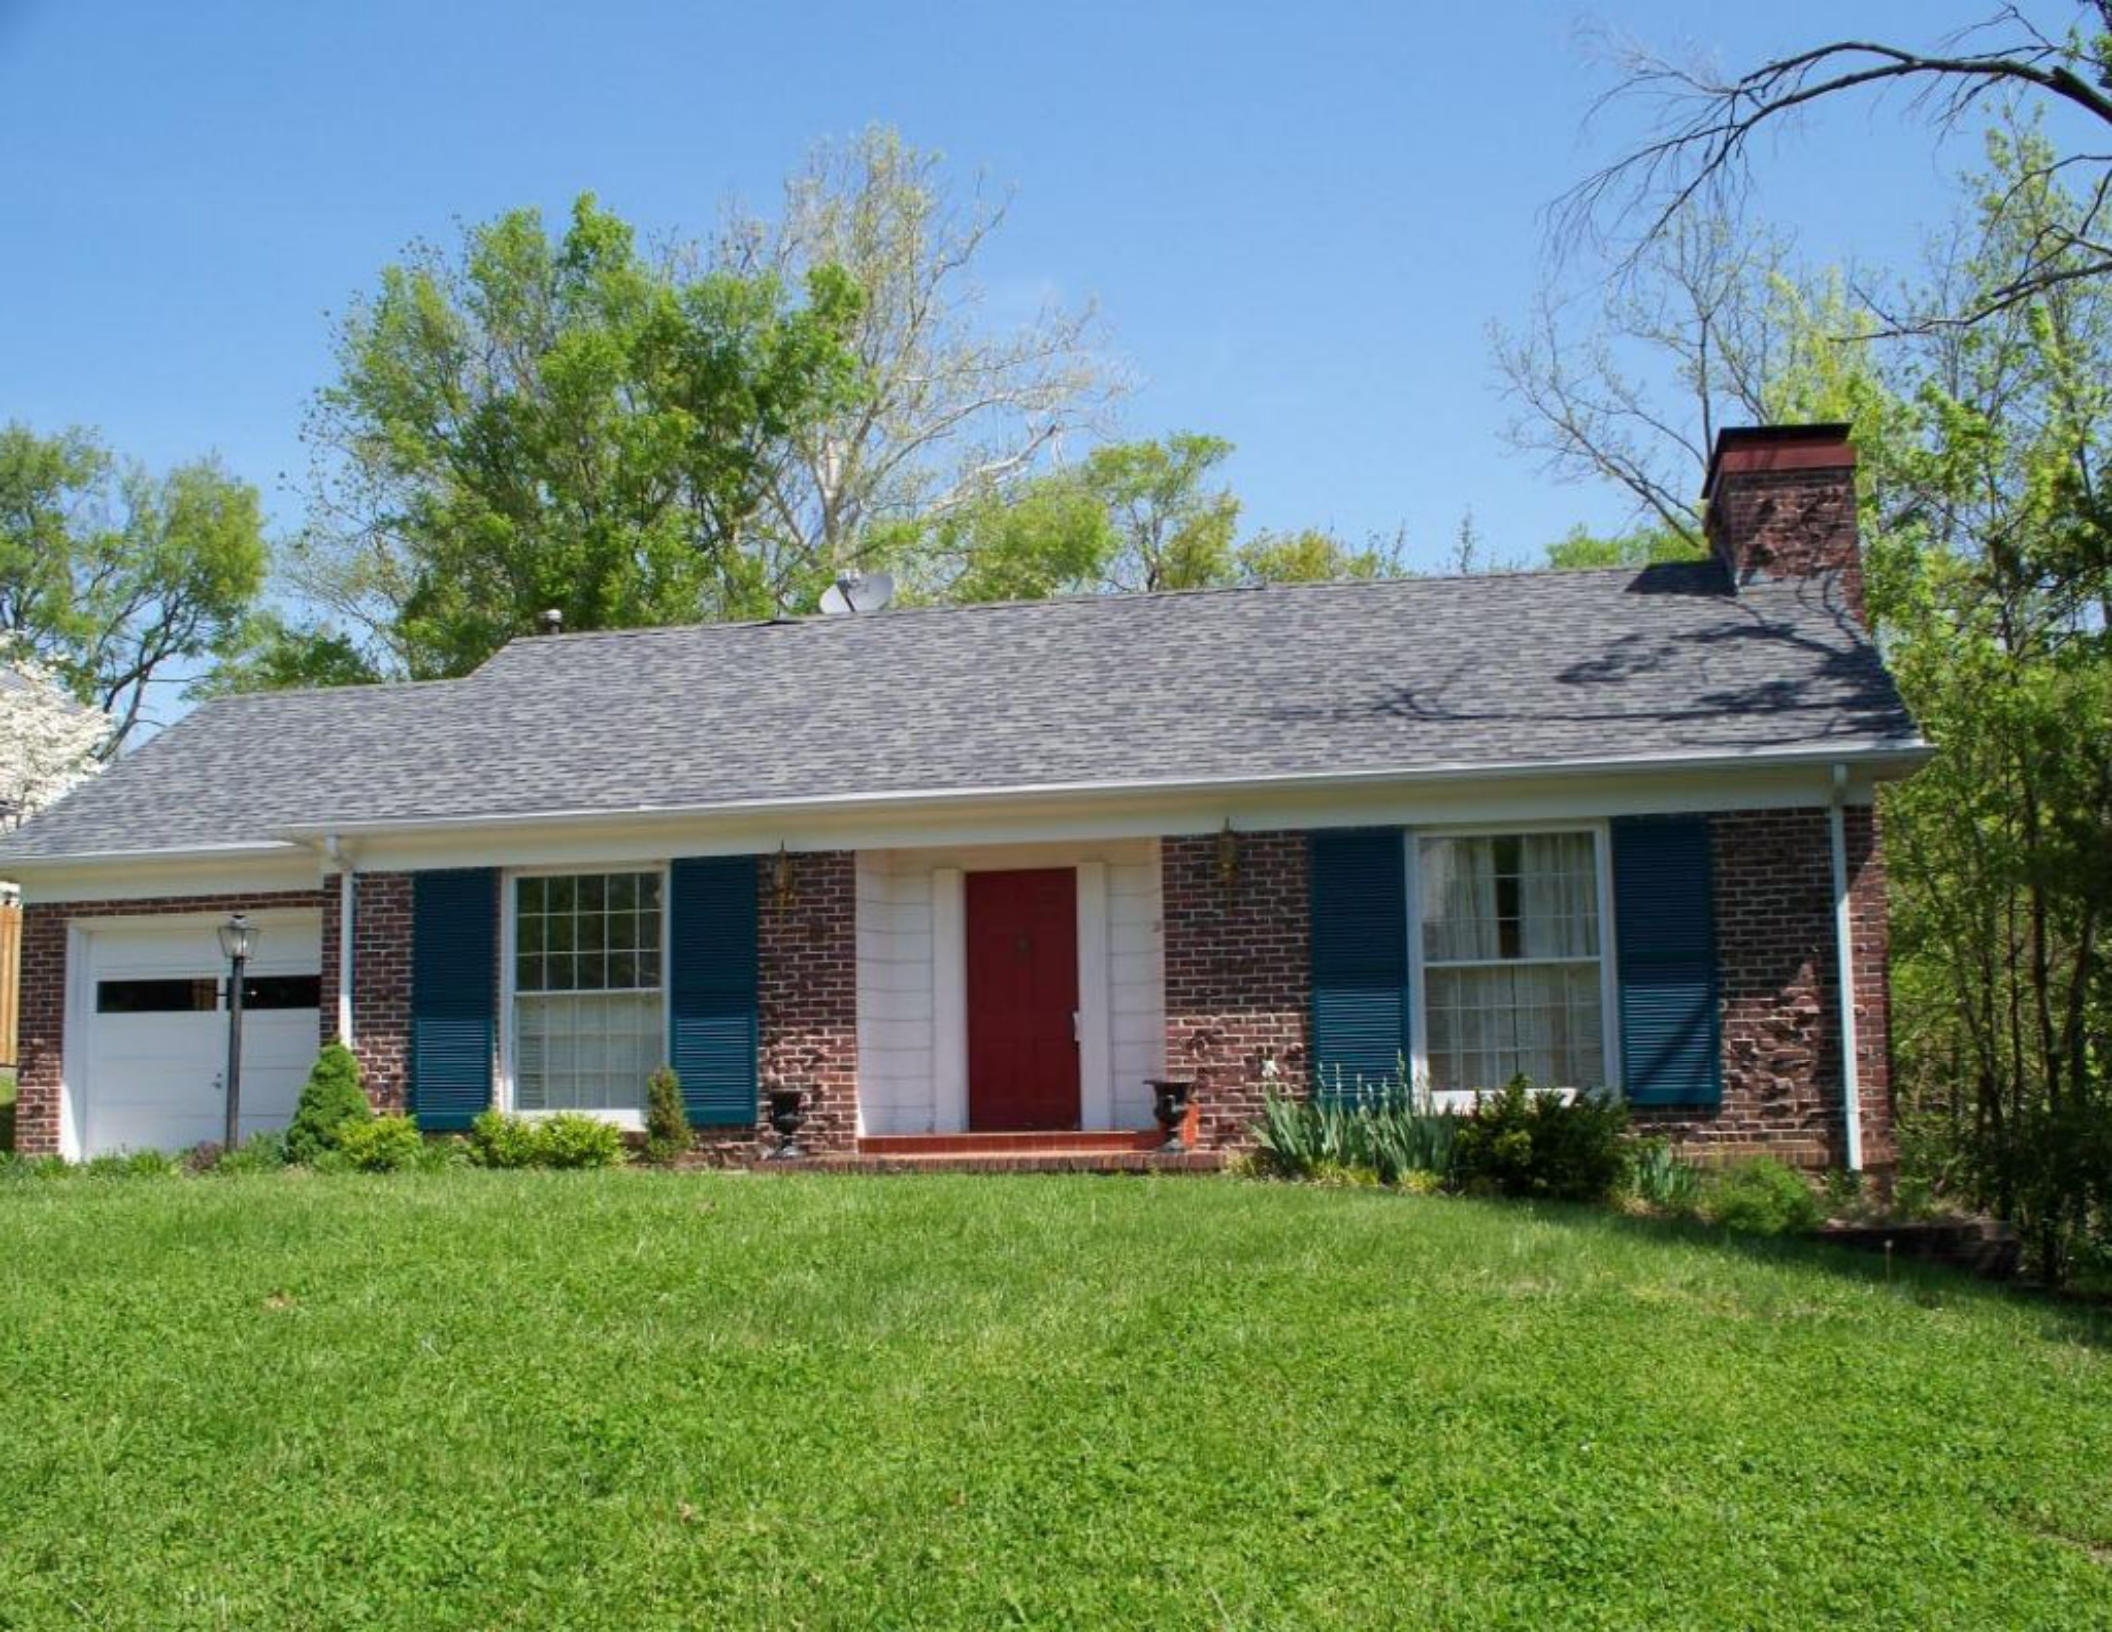
This one story brick Minimal Traditional has a side gabled roof. There are two large multi-light picture windows flanking a recessed entrances that is sided with wood or another material. A one-car garage is attached and set back from the left side.

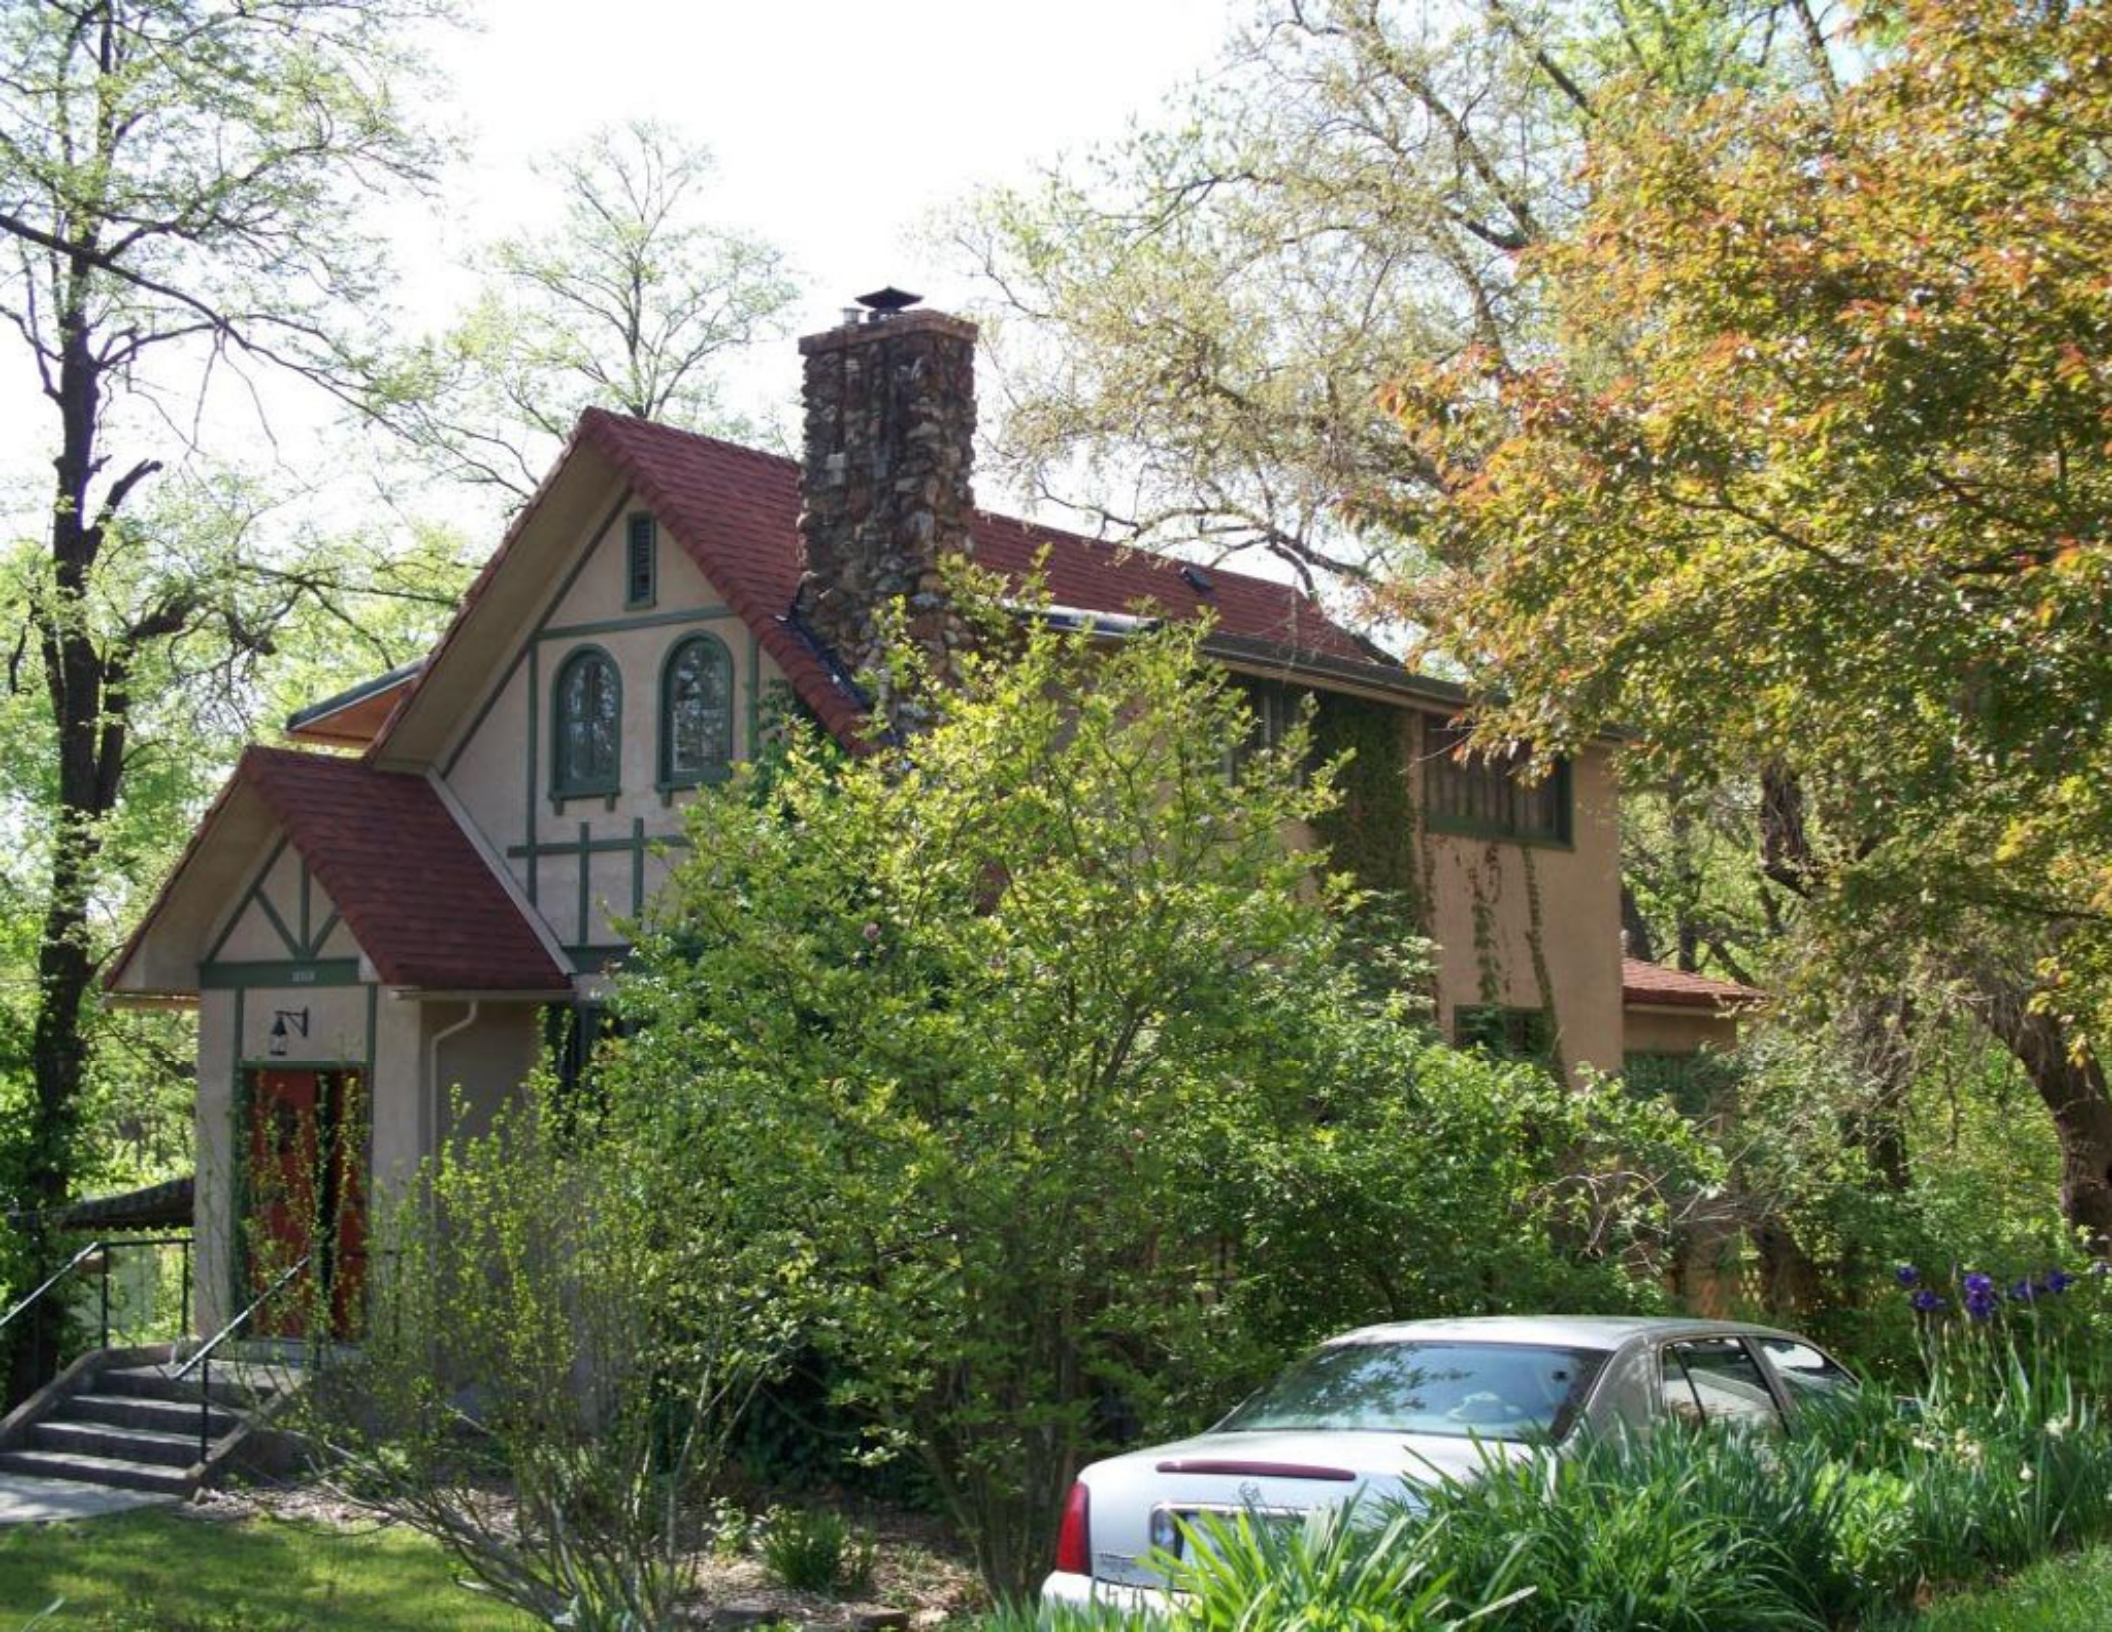
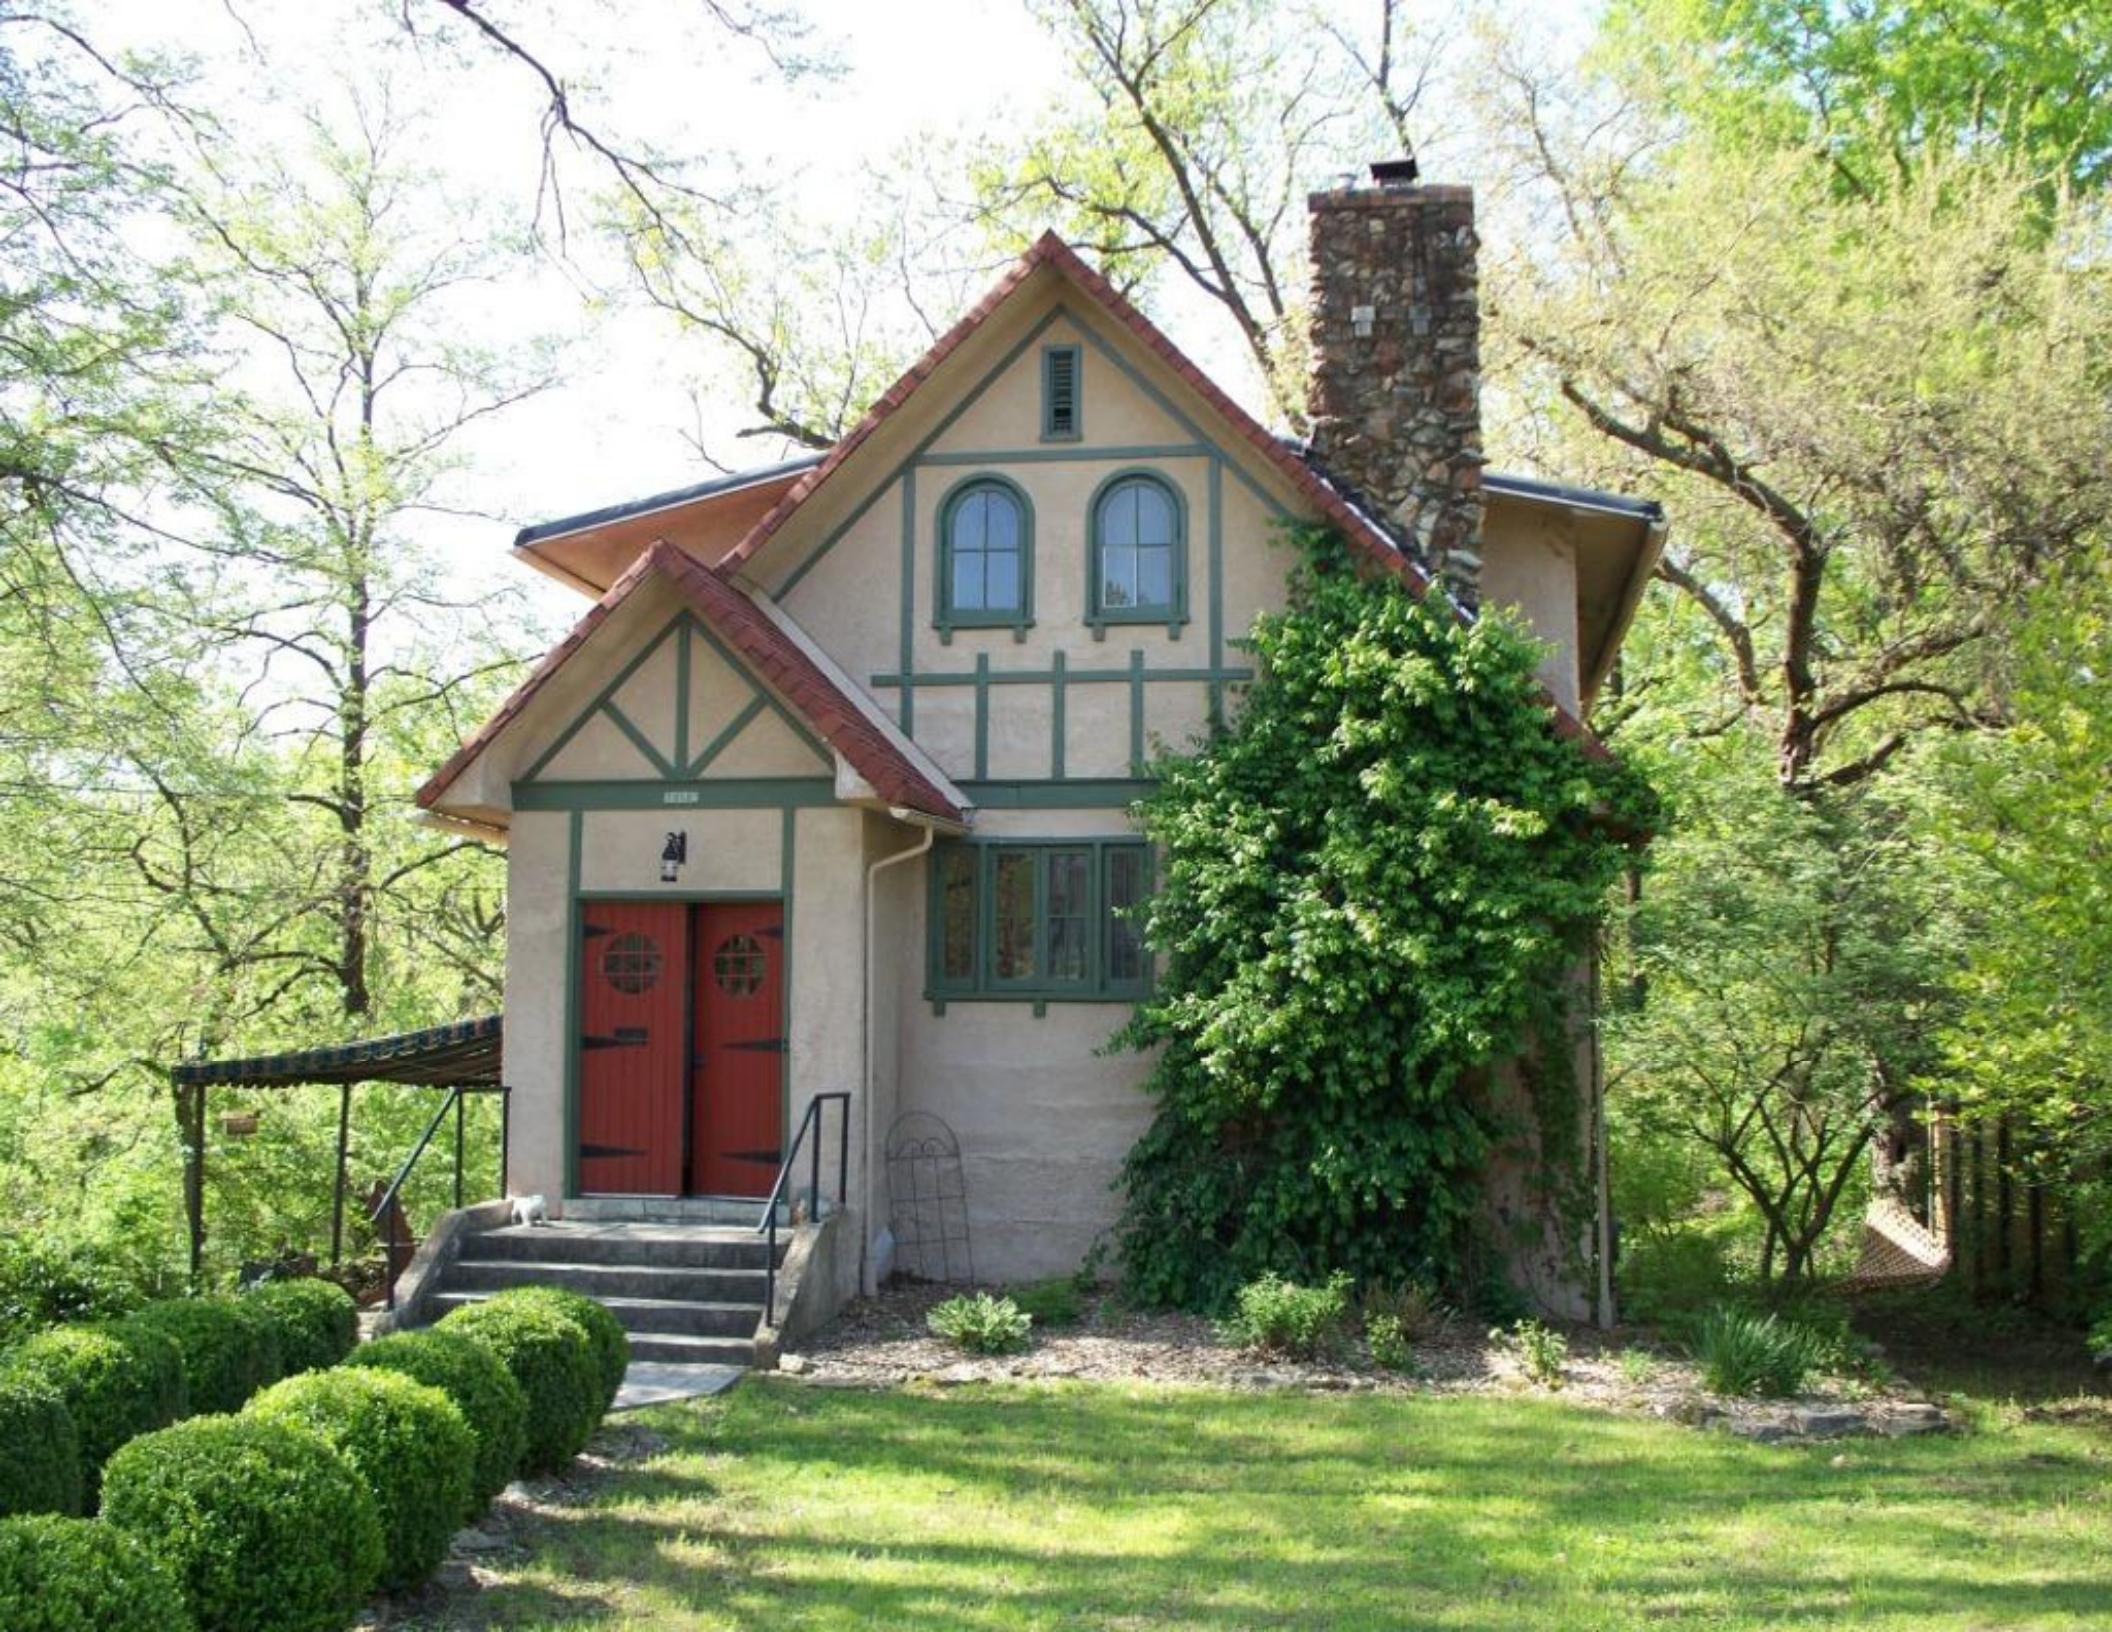
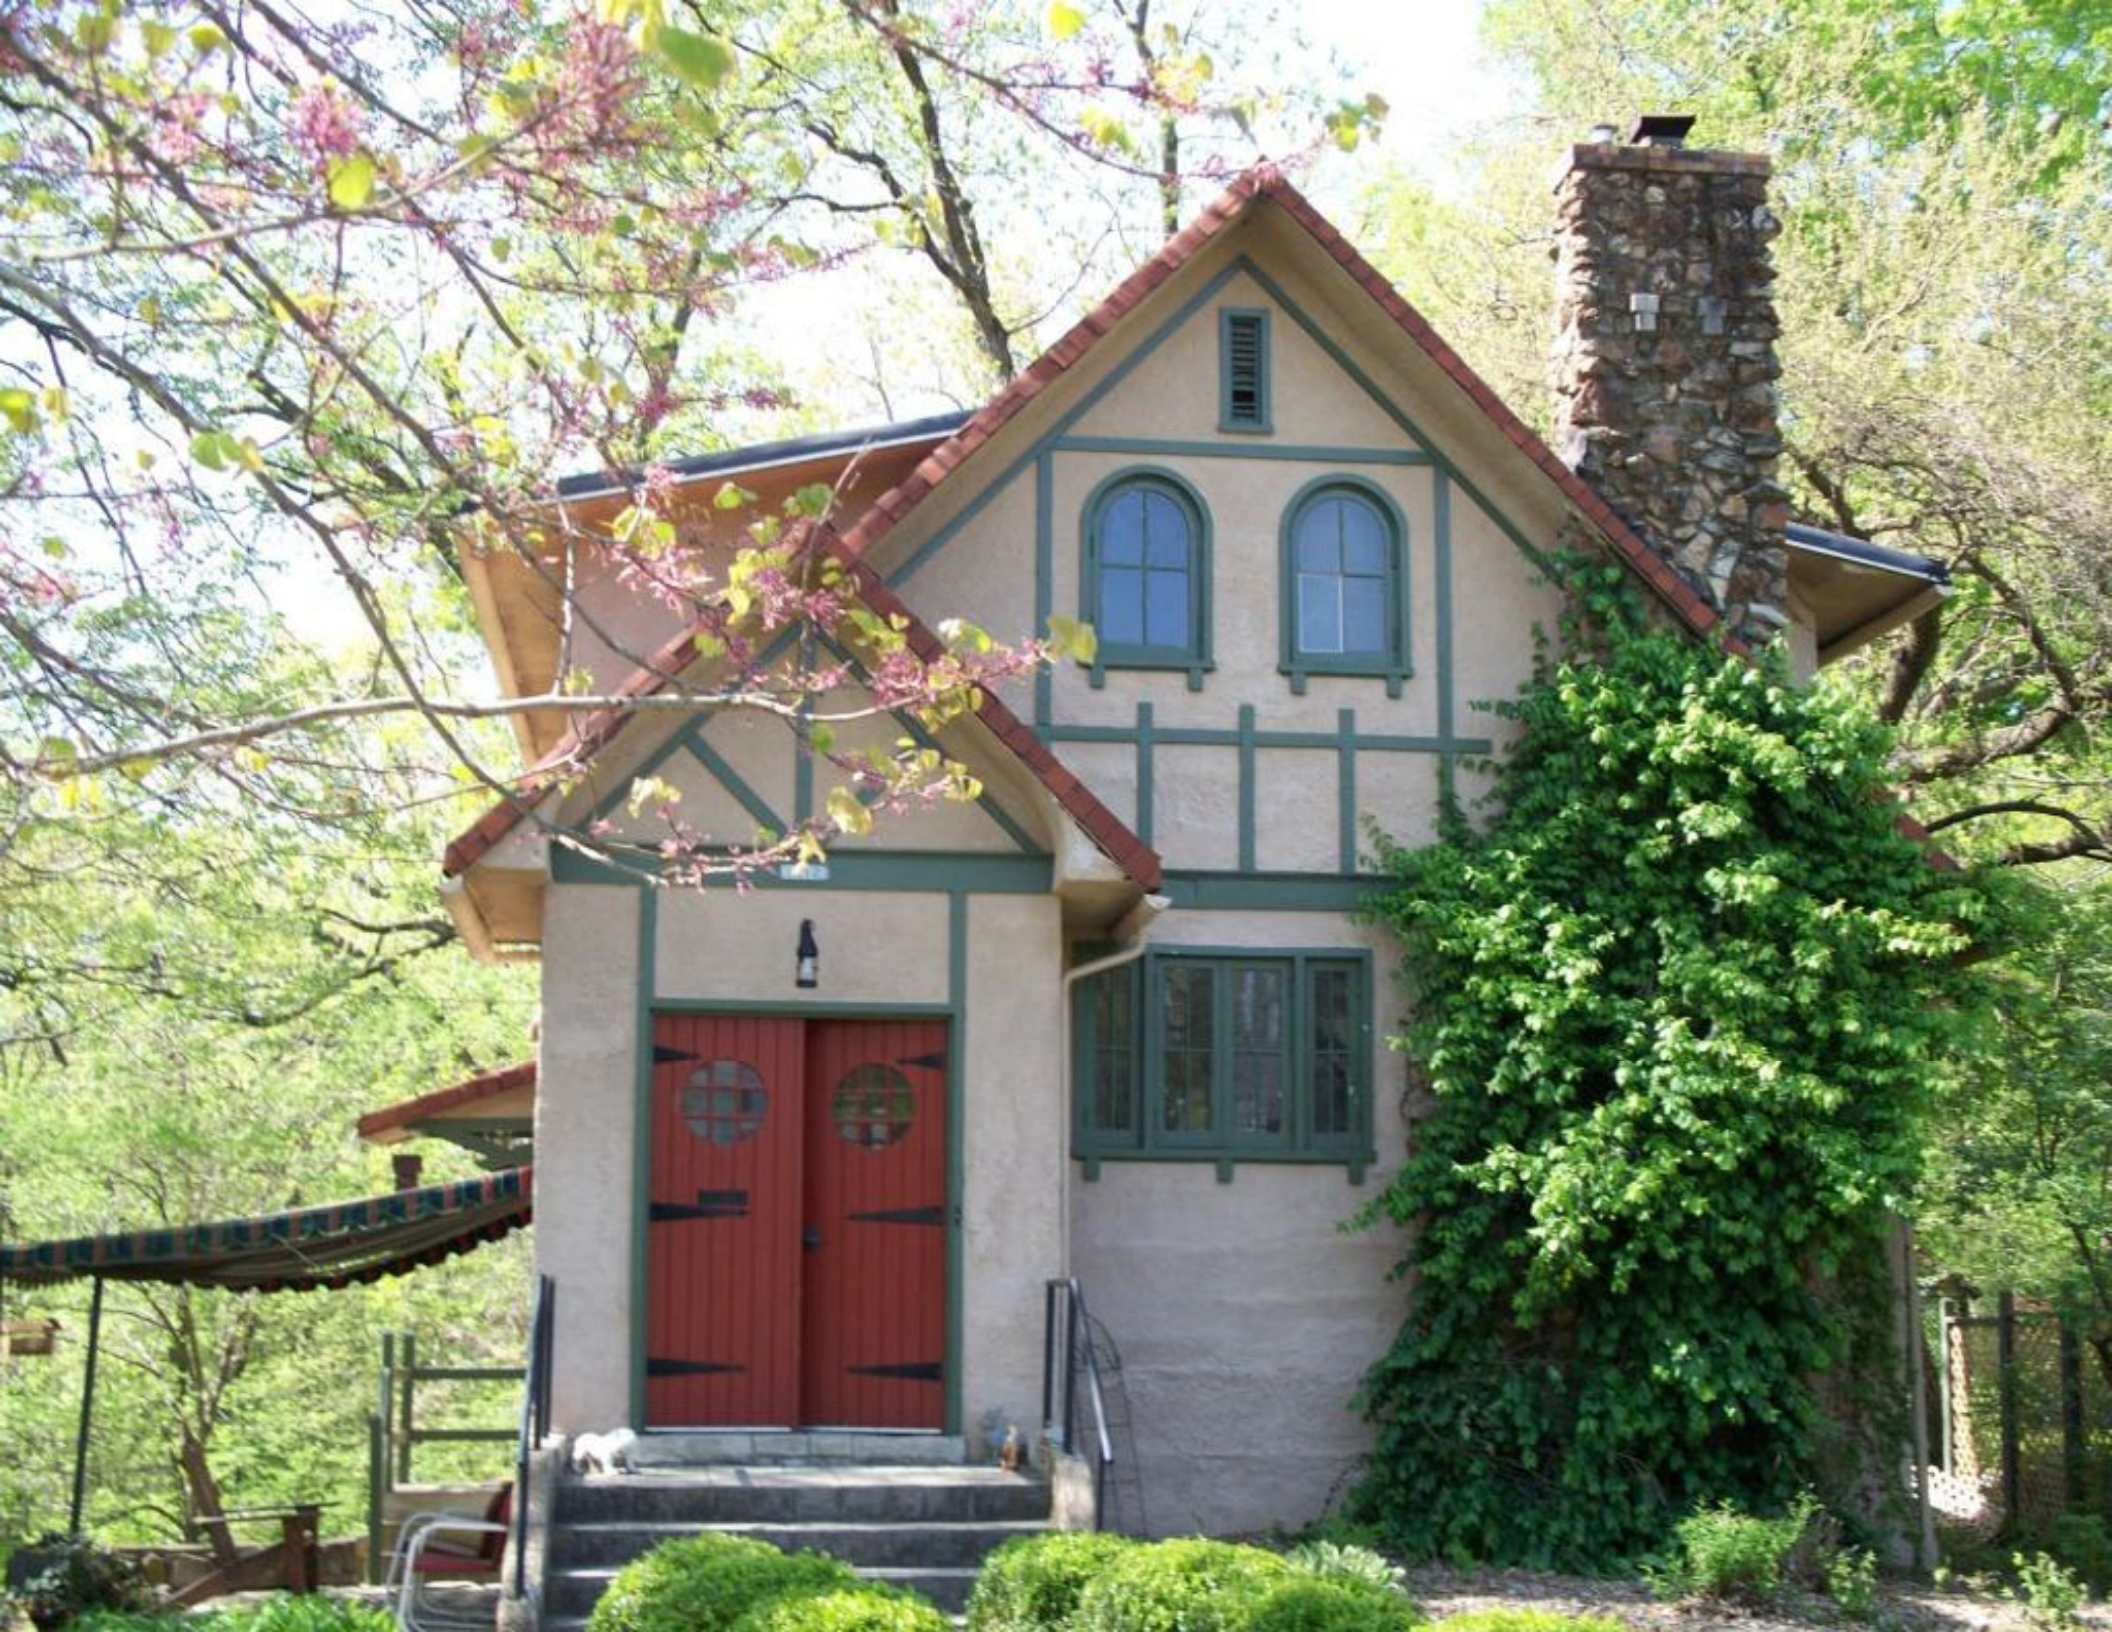
This one and a half story Tudor is clad in stucco and features wide eaves (wrapped in asphalt siding) and half timbering. The central front gable extends from a wider low pitched gable. It has a narrow rectangular vent in its peak and two arched four pane historic casement windows. From this gable a chimney extends from the right and is clad in stone/rock rubble. The right bay on the first floor features a small band of wooden casement windows. The left bay projects, has a gable roof and half timbering and contains the entrance which consists of two wooden doors. Each door contains a multi-paned oculus. A set of concrete stairs with pipe railing serves as a stoop to the entrance. This house displays excellent integrity and is a good example of the Tudor Revival style in Jefferson City and may be individually eligible.
