ARCHITECTURAL/HISTORIC INVENTORY FORM

1. Survey No. CO-AS-005-001		2. Survey name: Moreau Drive Neighborhood Survey	
3. County: Cole		4. Address: 1202 Elmerine Ave.	
5. City: Jefferson City	Vicinity: <input type="checkbox"/>	6. UTM: / /	7. Township/Range/Section: T: R: S:
8. Historic name (if known):		9. Present/other name (if known):	
10. Ownership: <input checked="" type="checkbox"/> Private <input type="checkbox"/> Public		11. Historic use (if known): Residential	11. Current use: Residential

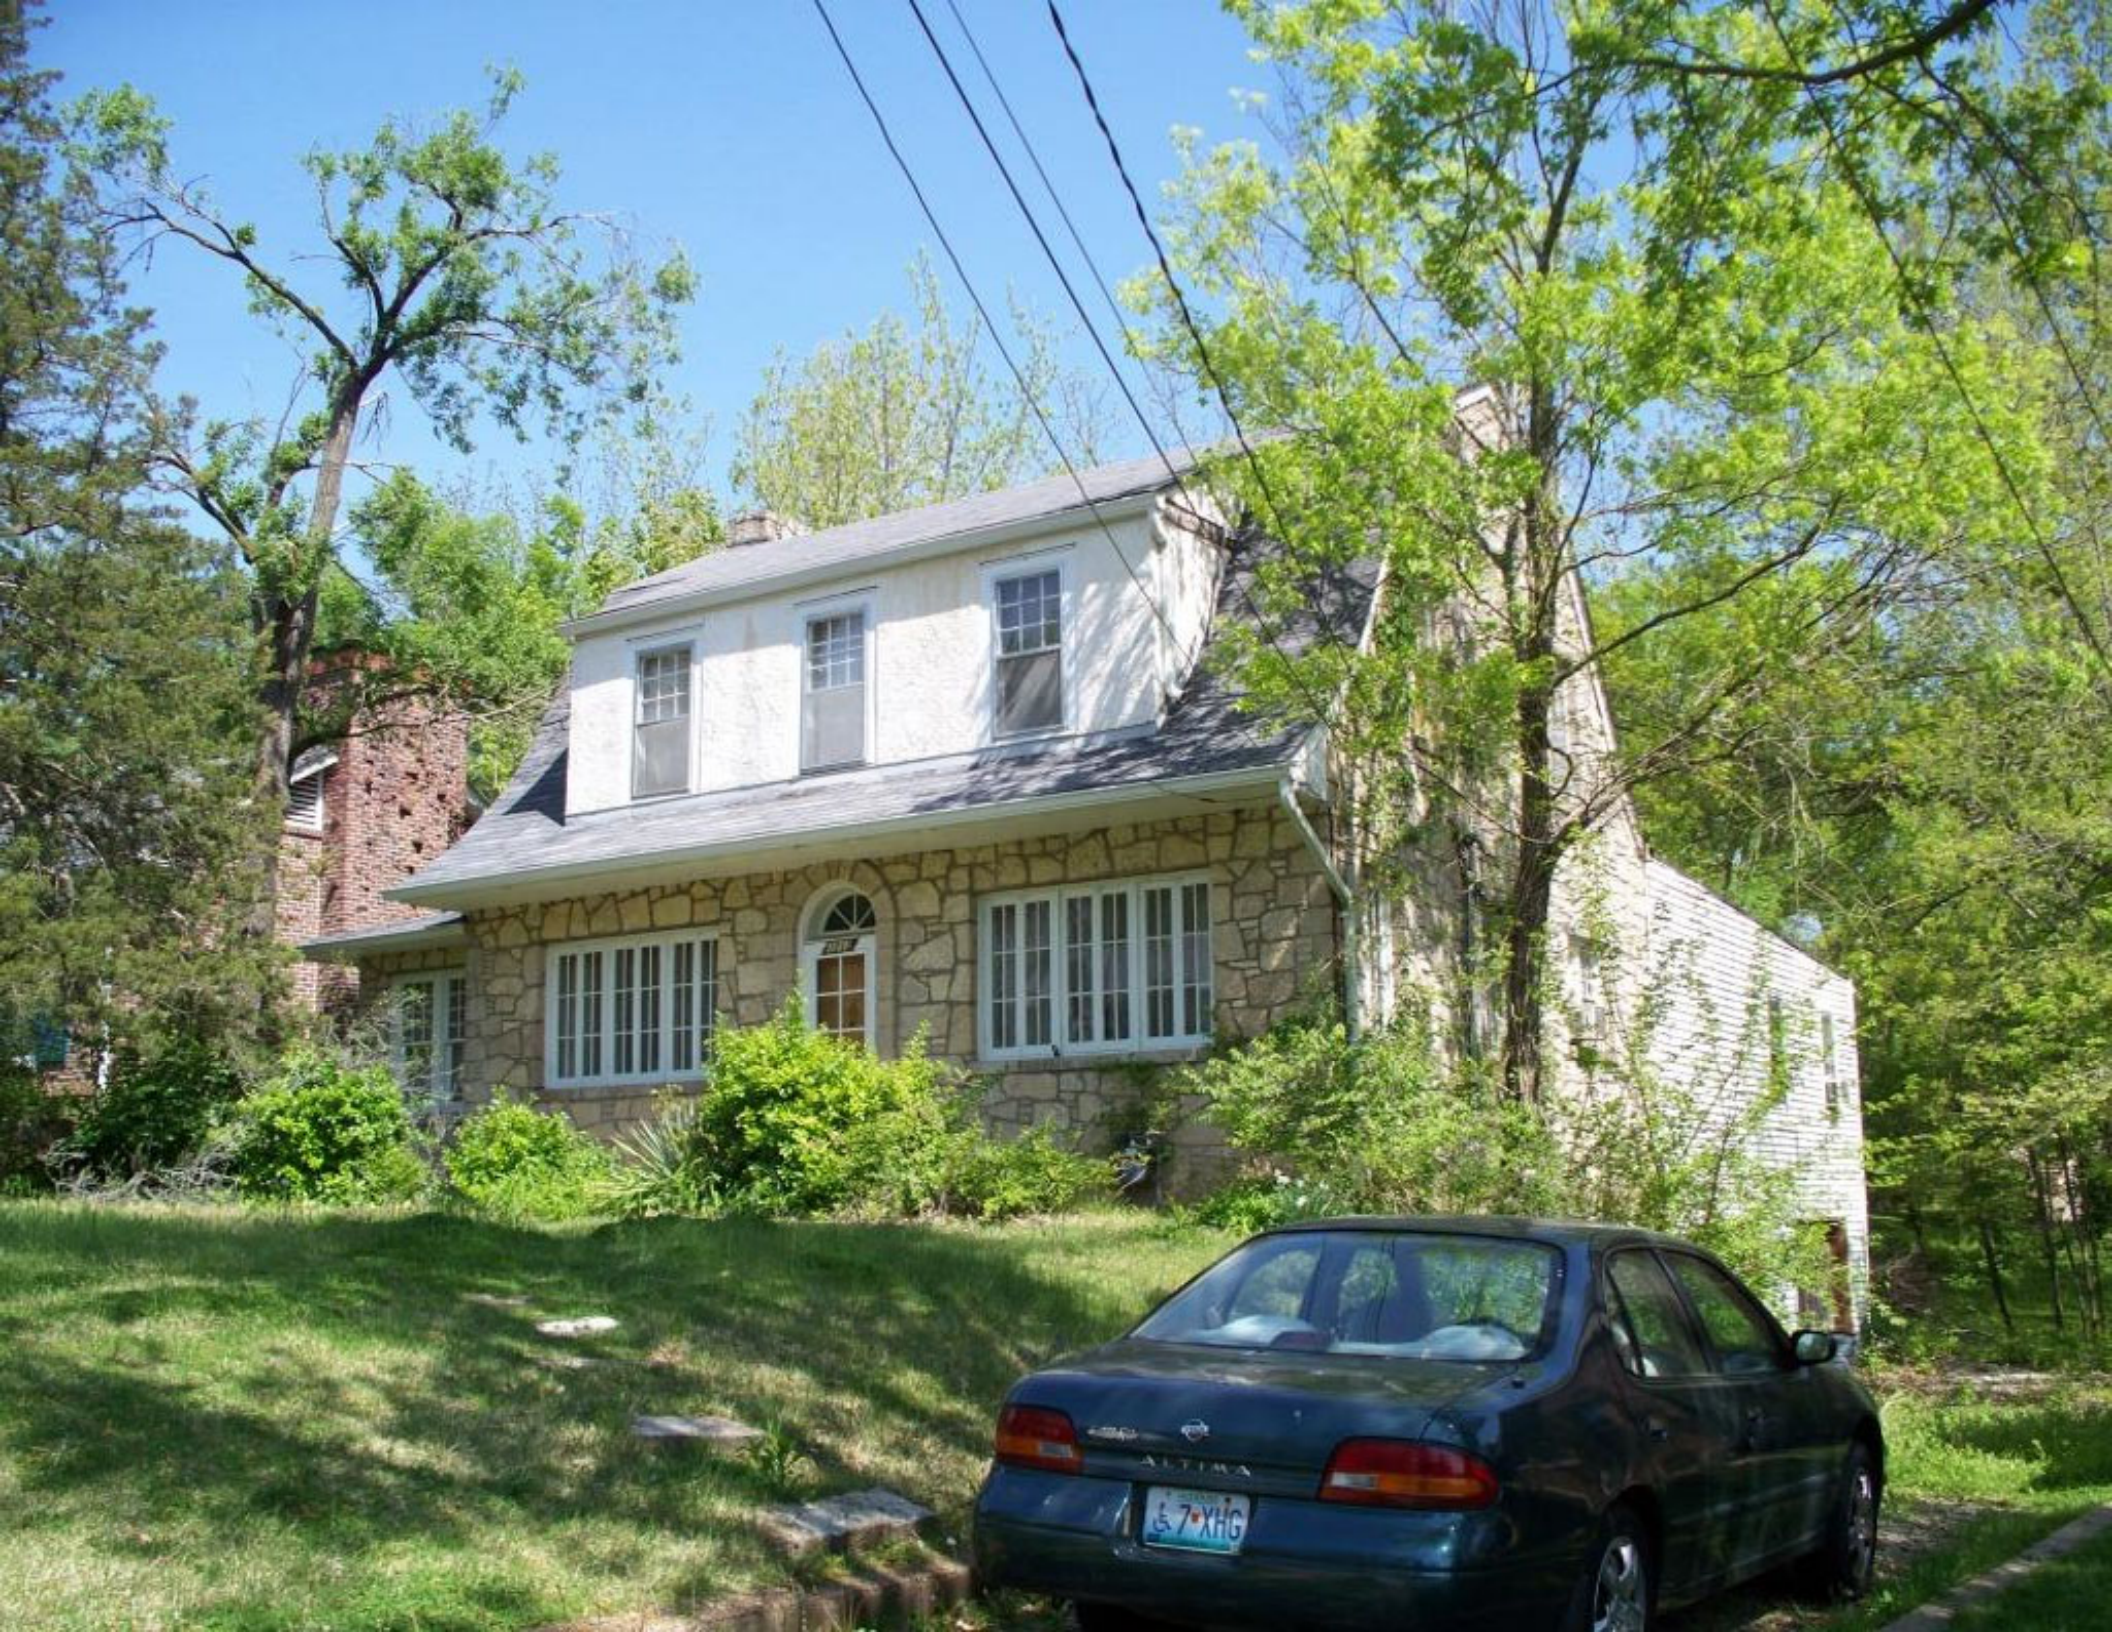
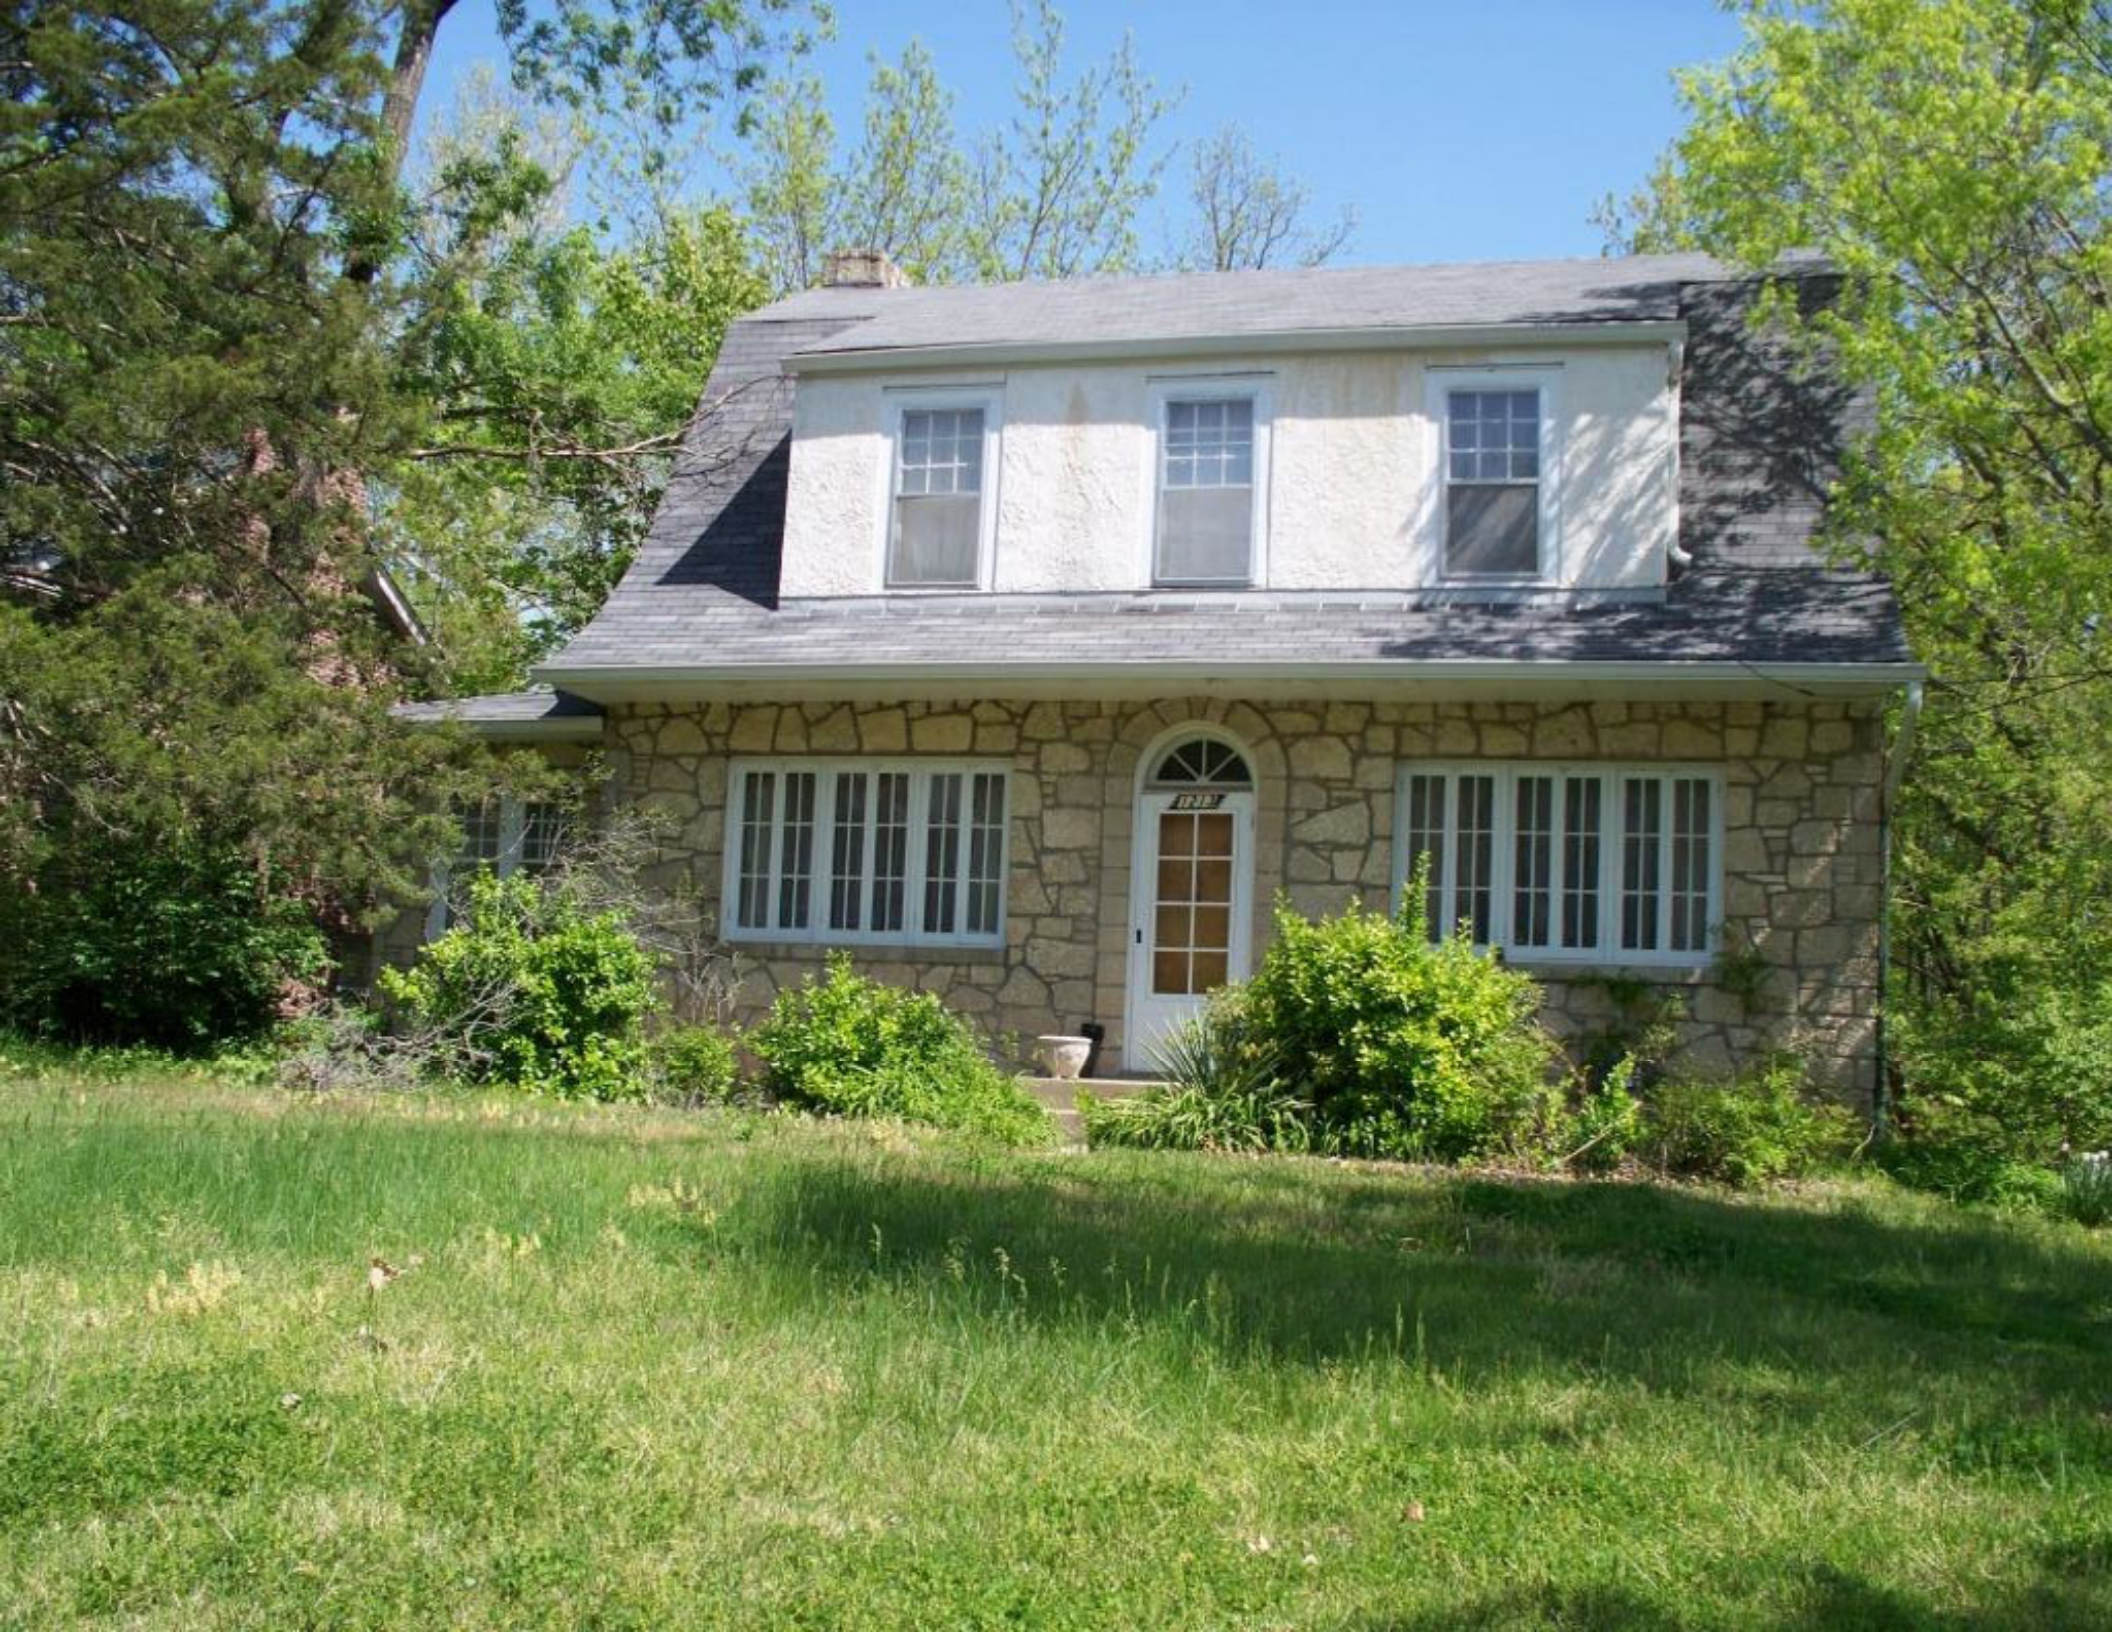
This two-story stone home has a side gambreled roof with a large stucco shed dormer with three historic 9/1 windows. The first floor has a row of three 6 by 6 historic casement windows in the left and right bays. In the center bay is an arched opening and a historic multi-light wooden door with fan light. An additional one-story sunroom is attached an set back on the left side. It has a shed roof and two 9/1 windows.

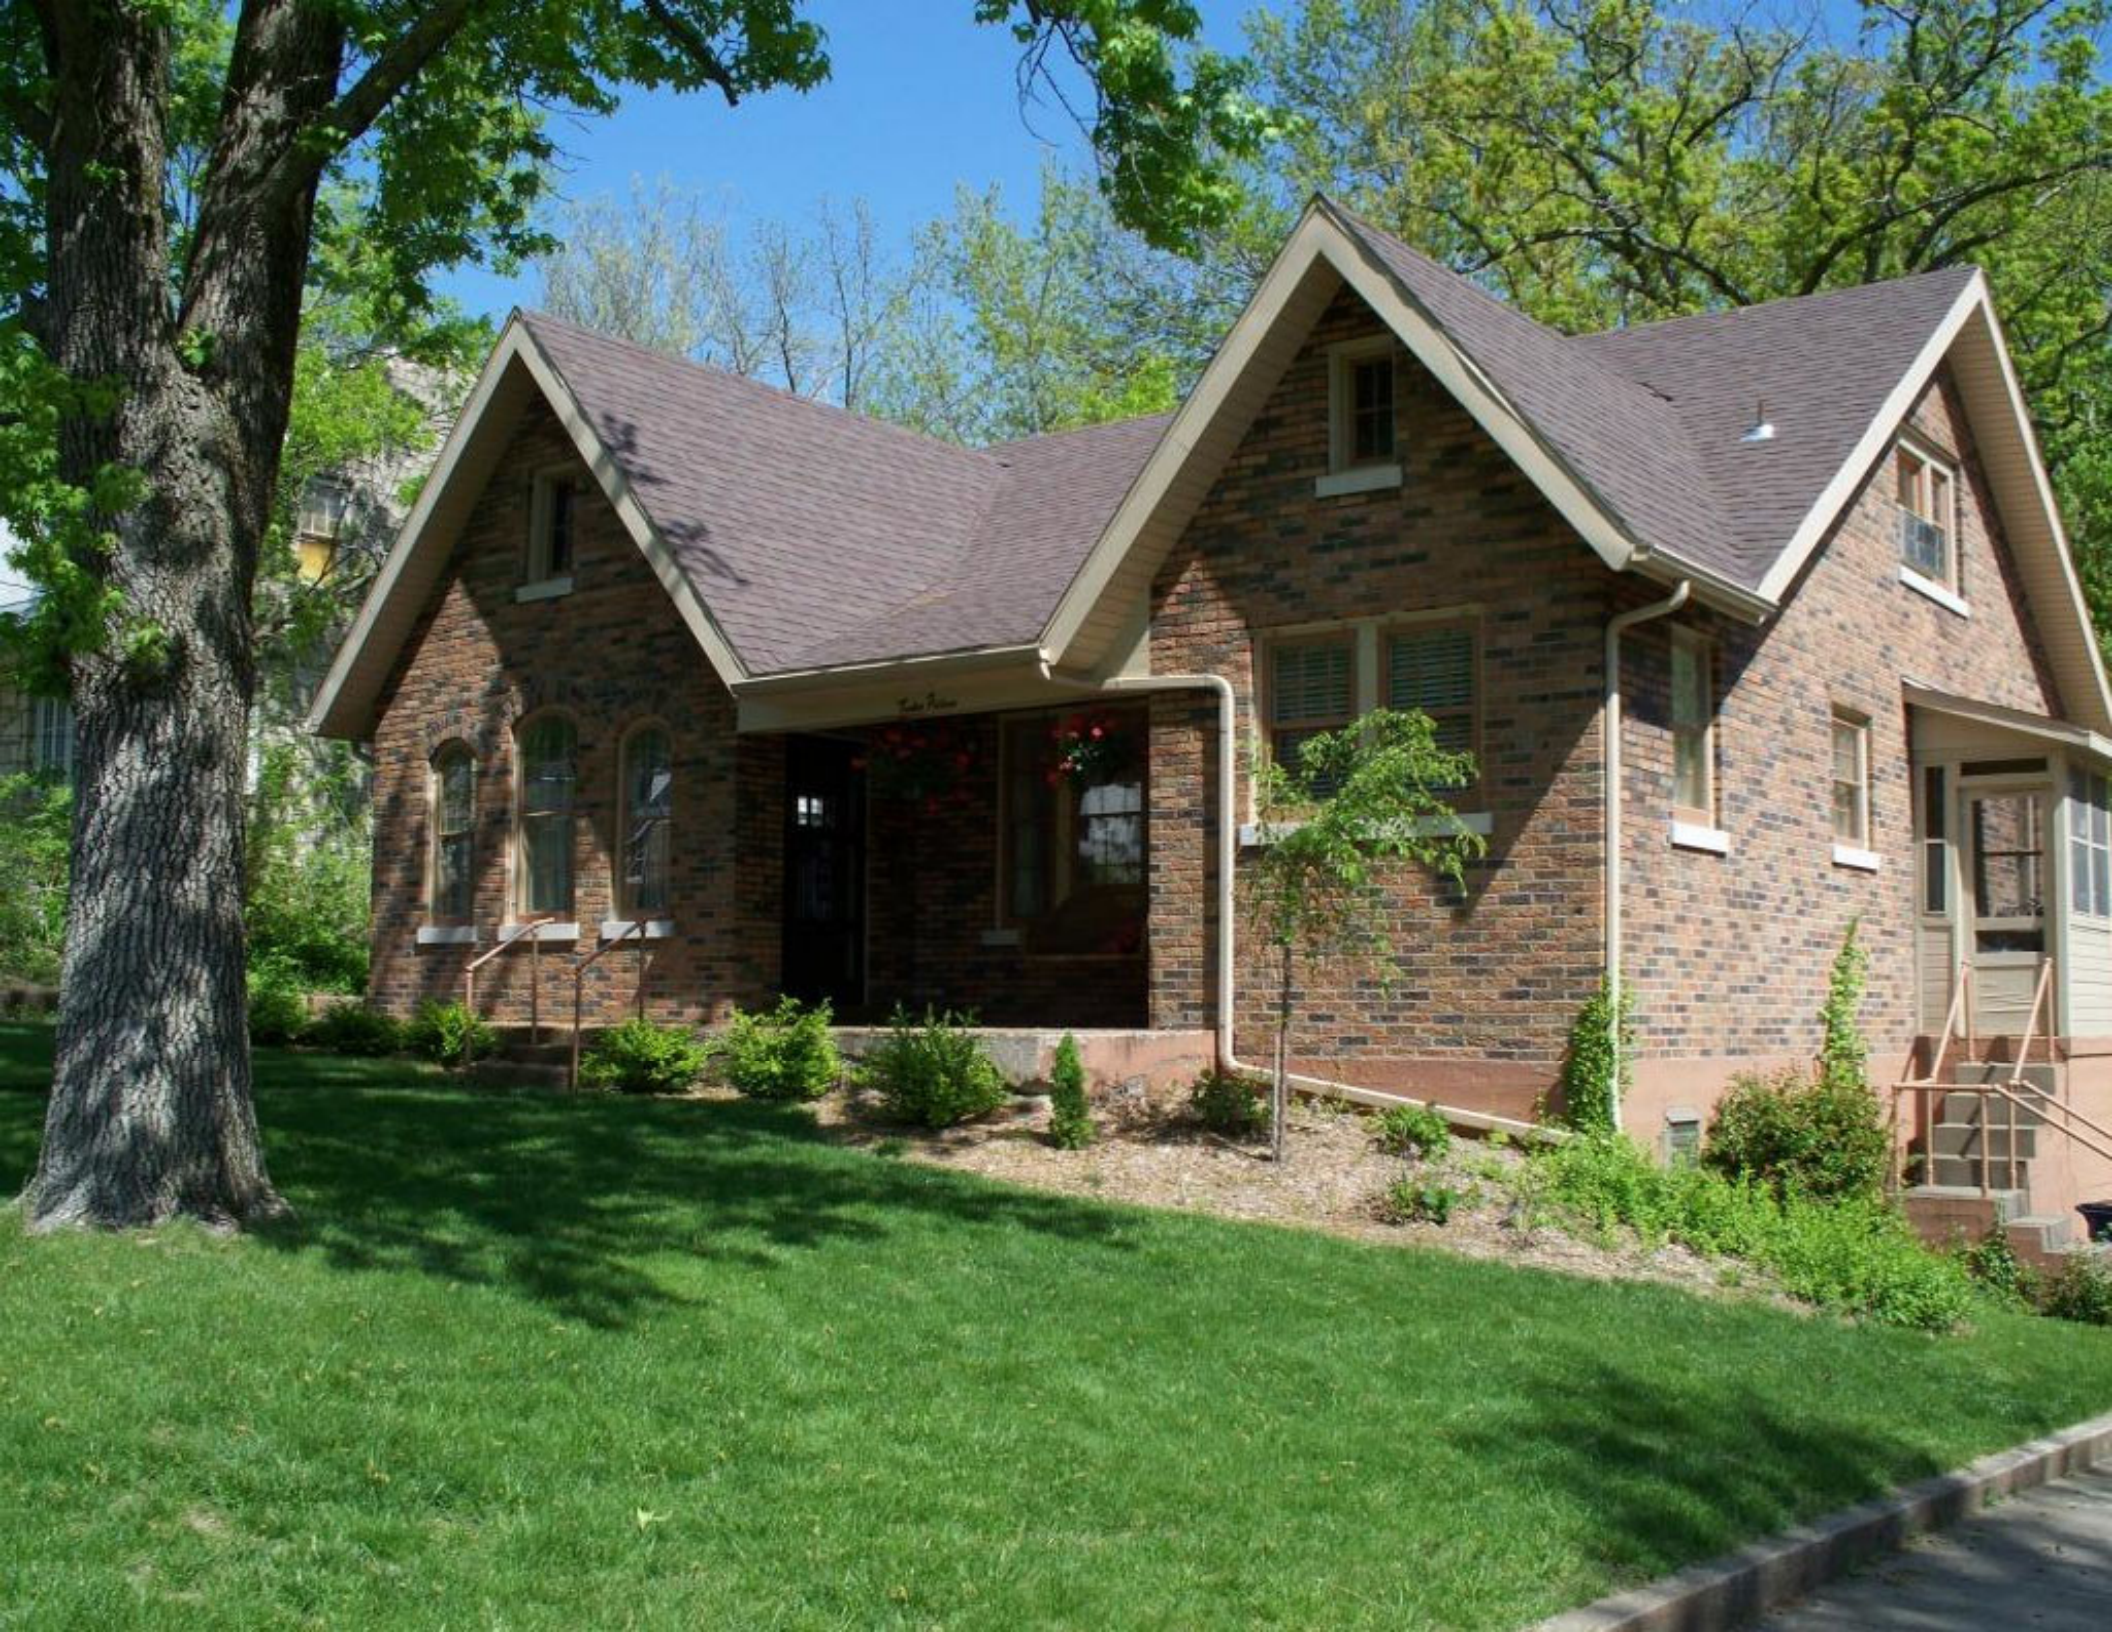
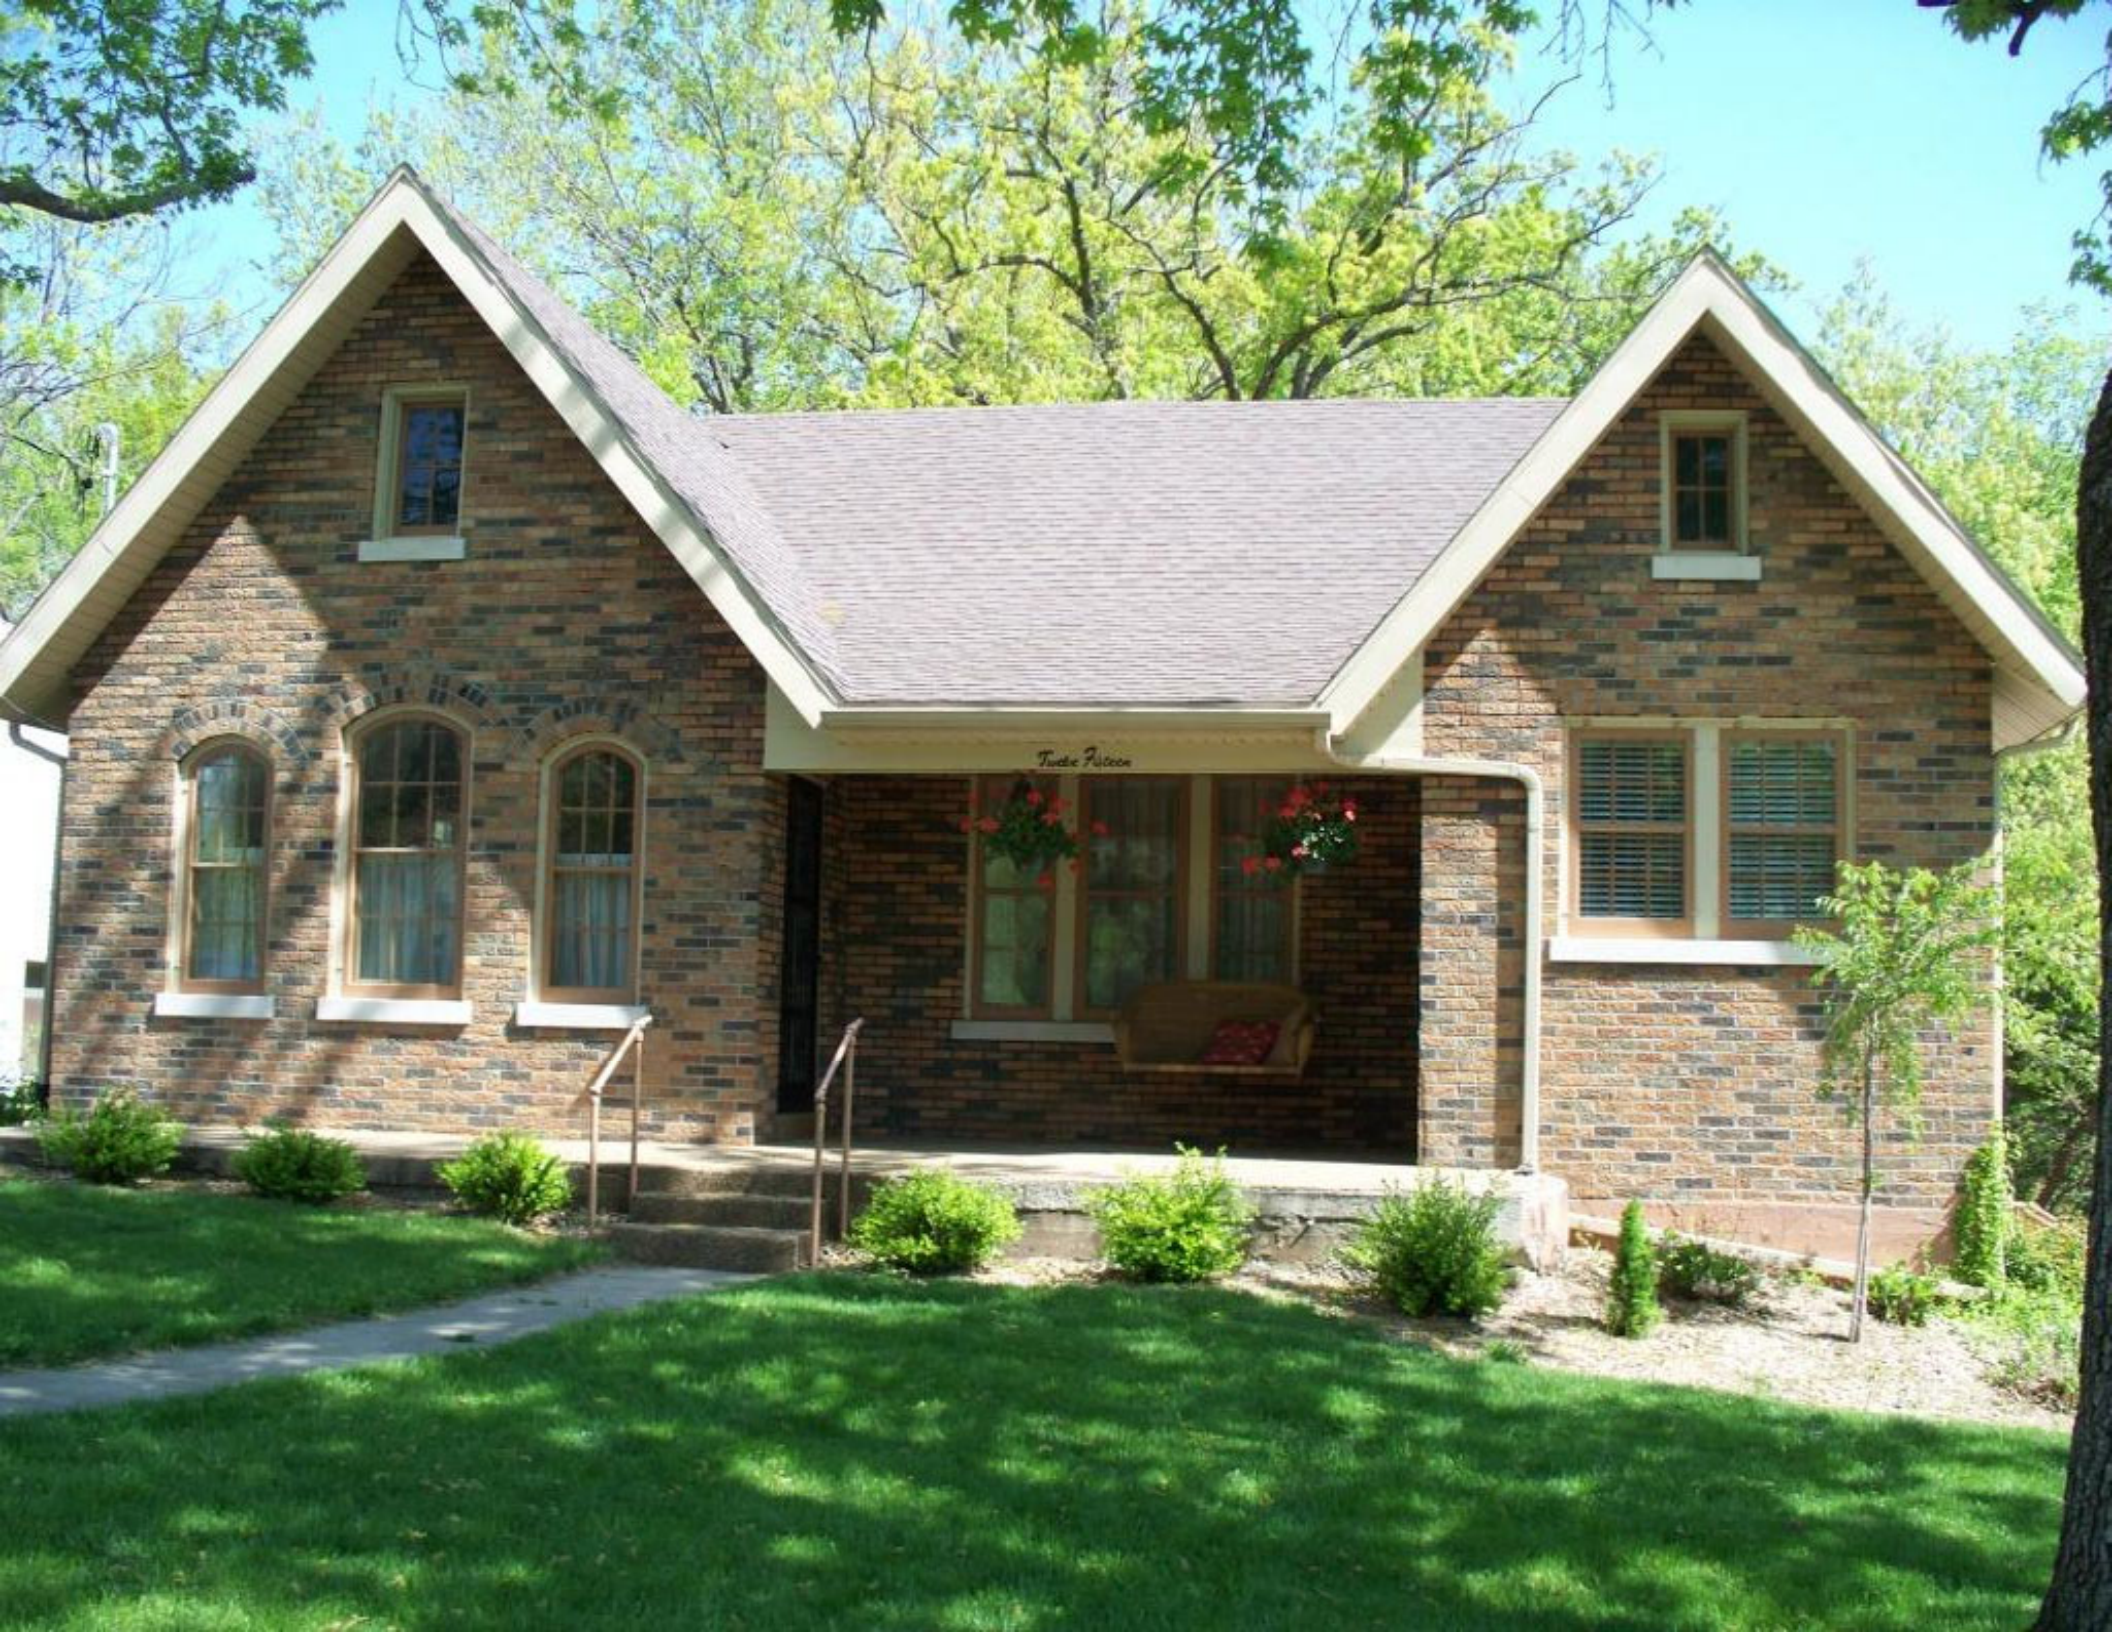
The date of the property needs further research. The Tax Assessor's office dates this property as 1957, however a property with the same footprint is on the 1948 Sanborn map. This 1 ½ story brick property has a front gable on the left and right bay and a side gable in the center. There is a single four light casement window that may be leaded in each gable peak. The left bay on the first floor has a row of three arched windows with 6/6 windows. The center bay is recessed and has a tri-part multi-light window and an entrance off to the left side. The final bay has paired 6/6 windows. This property is considered contributing as the windows look historic but further research may reveal a later date.

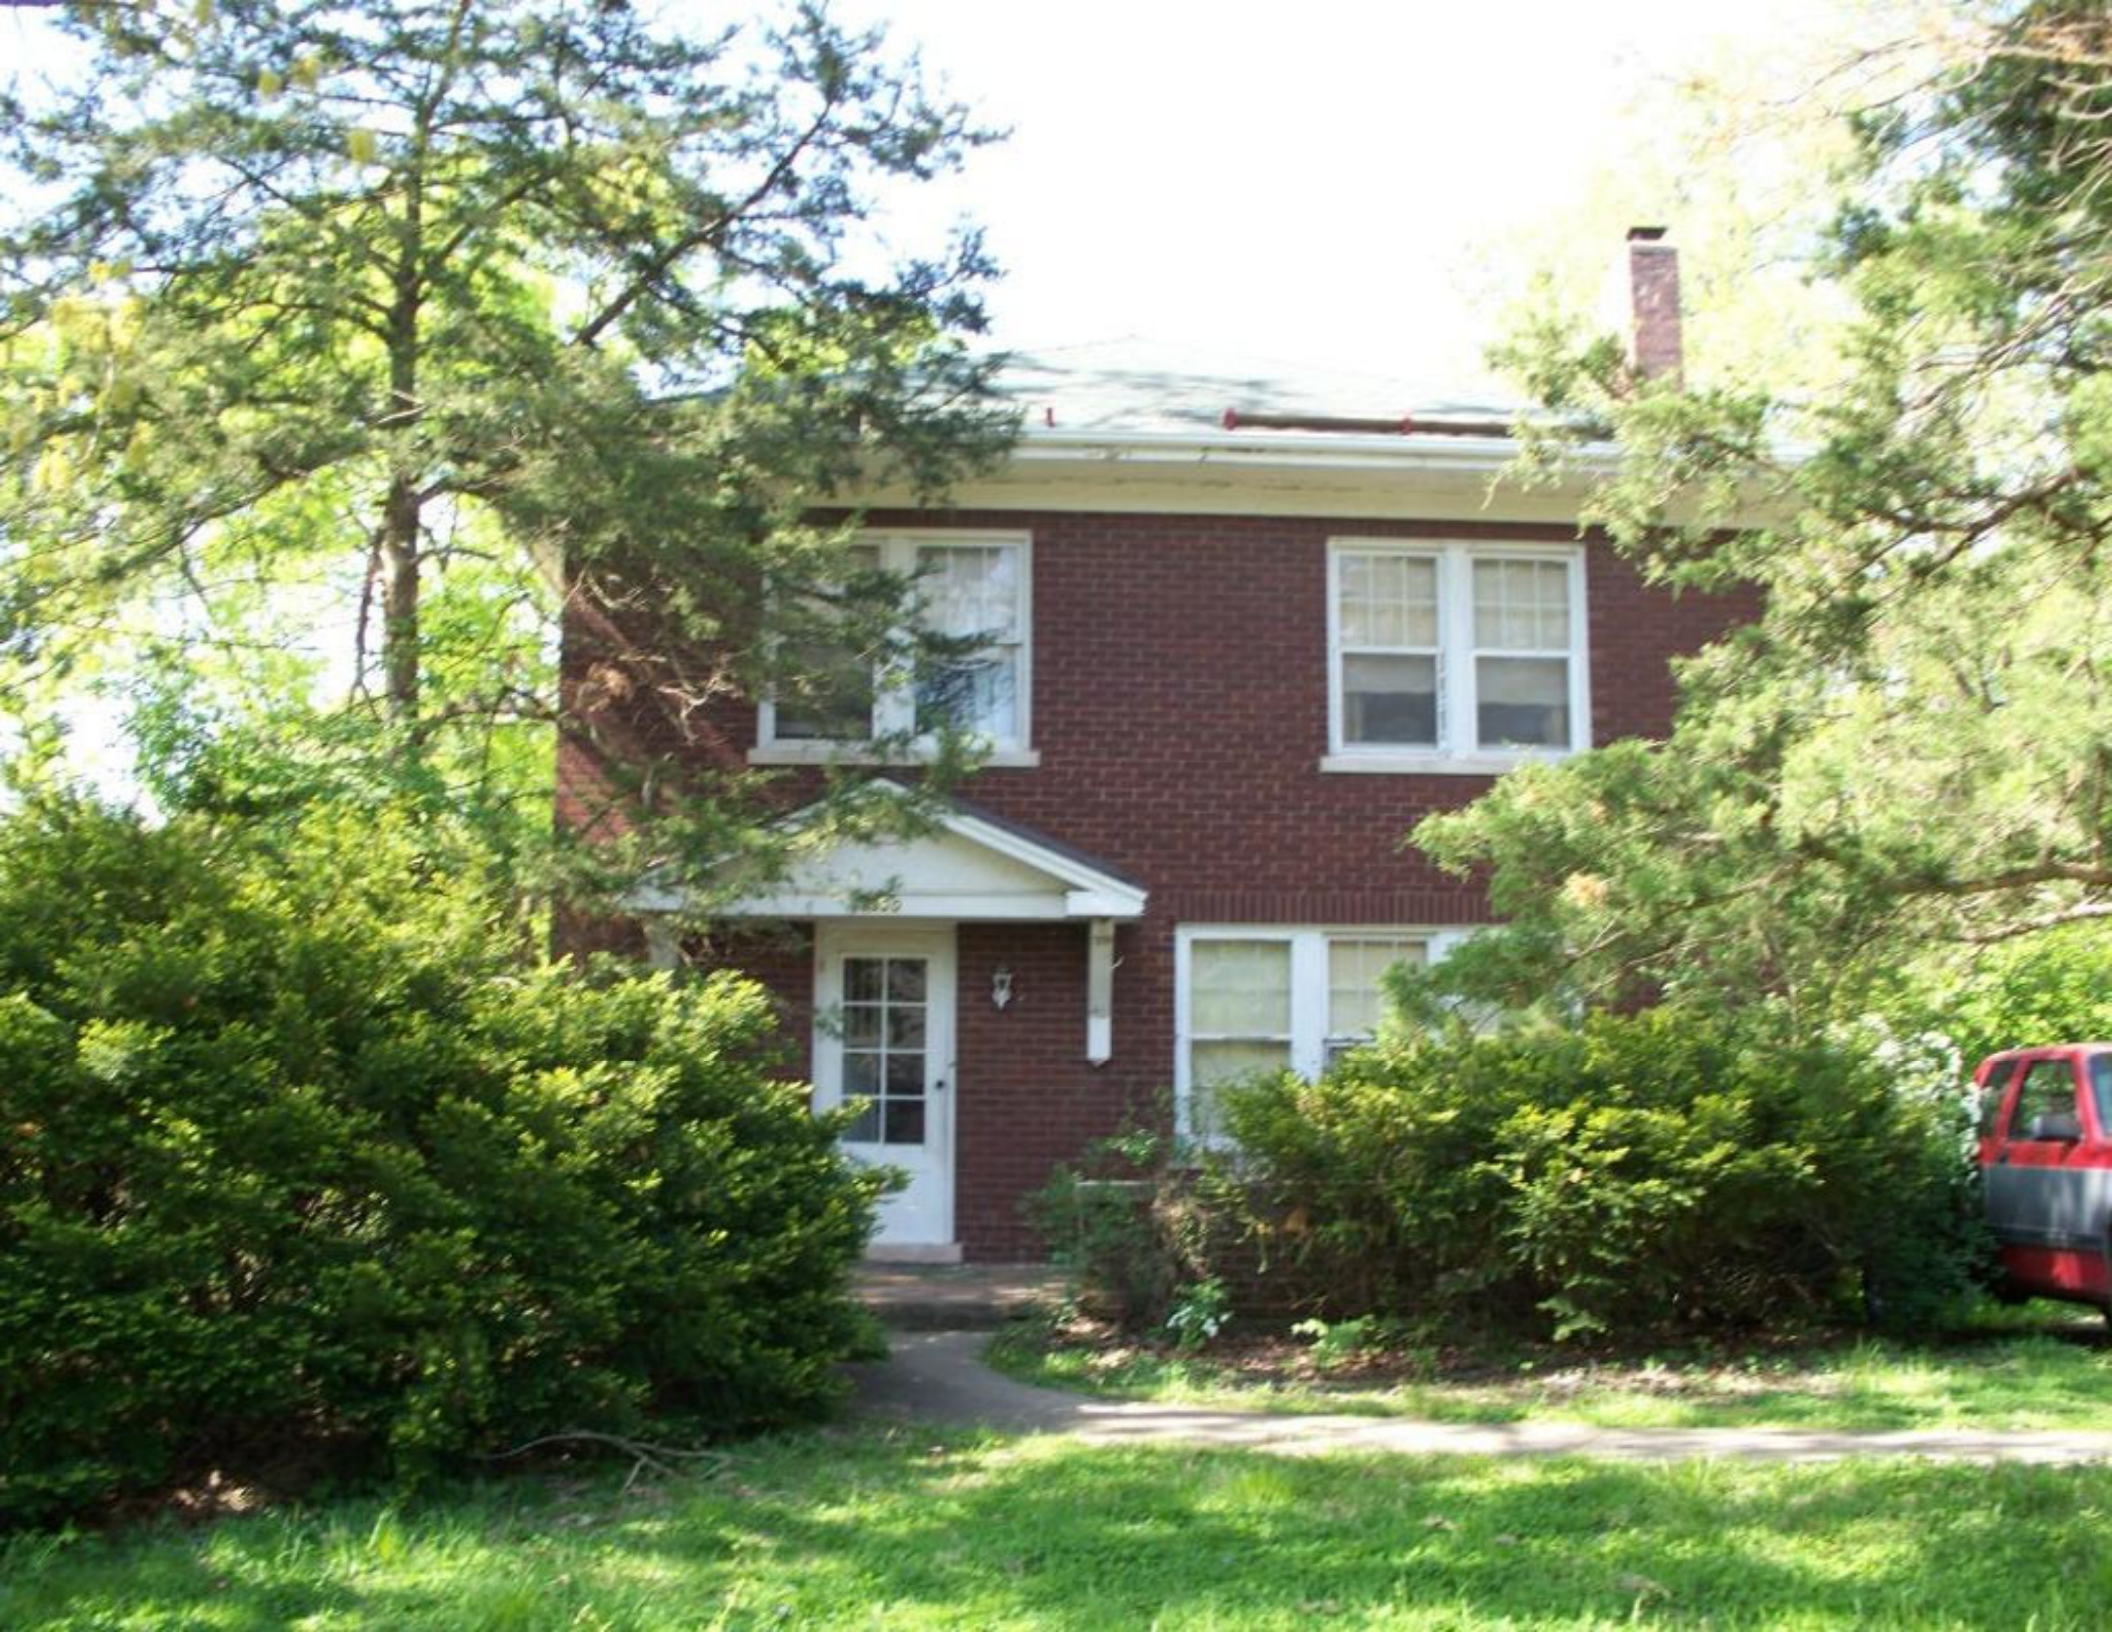
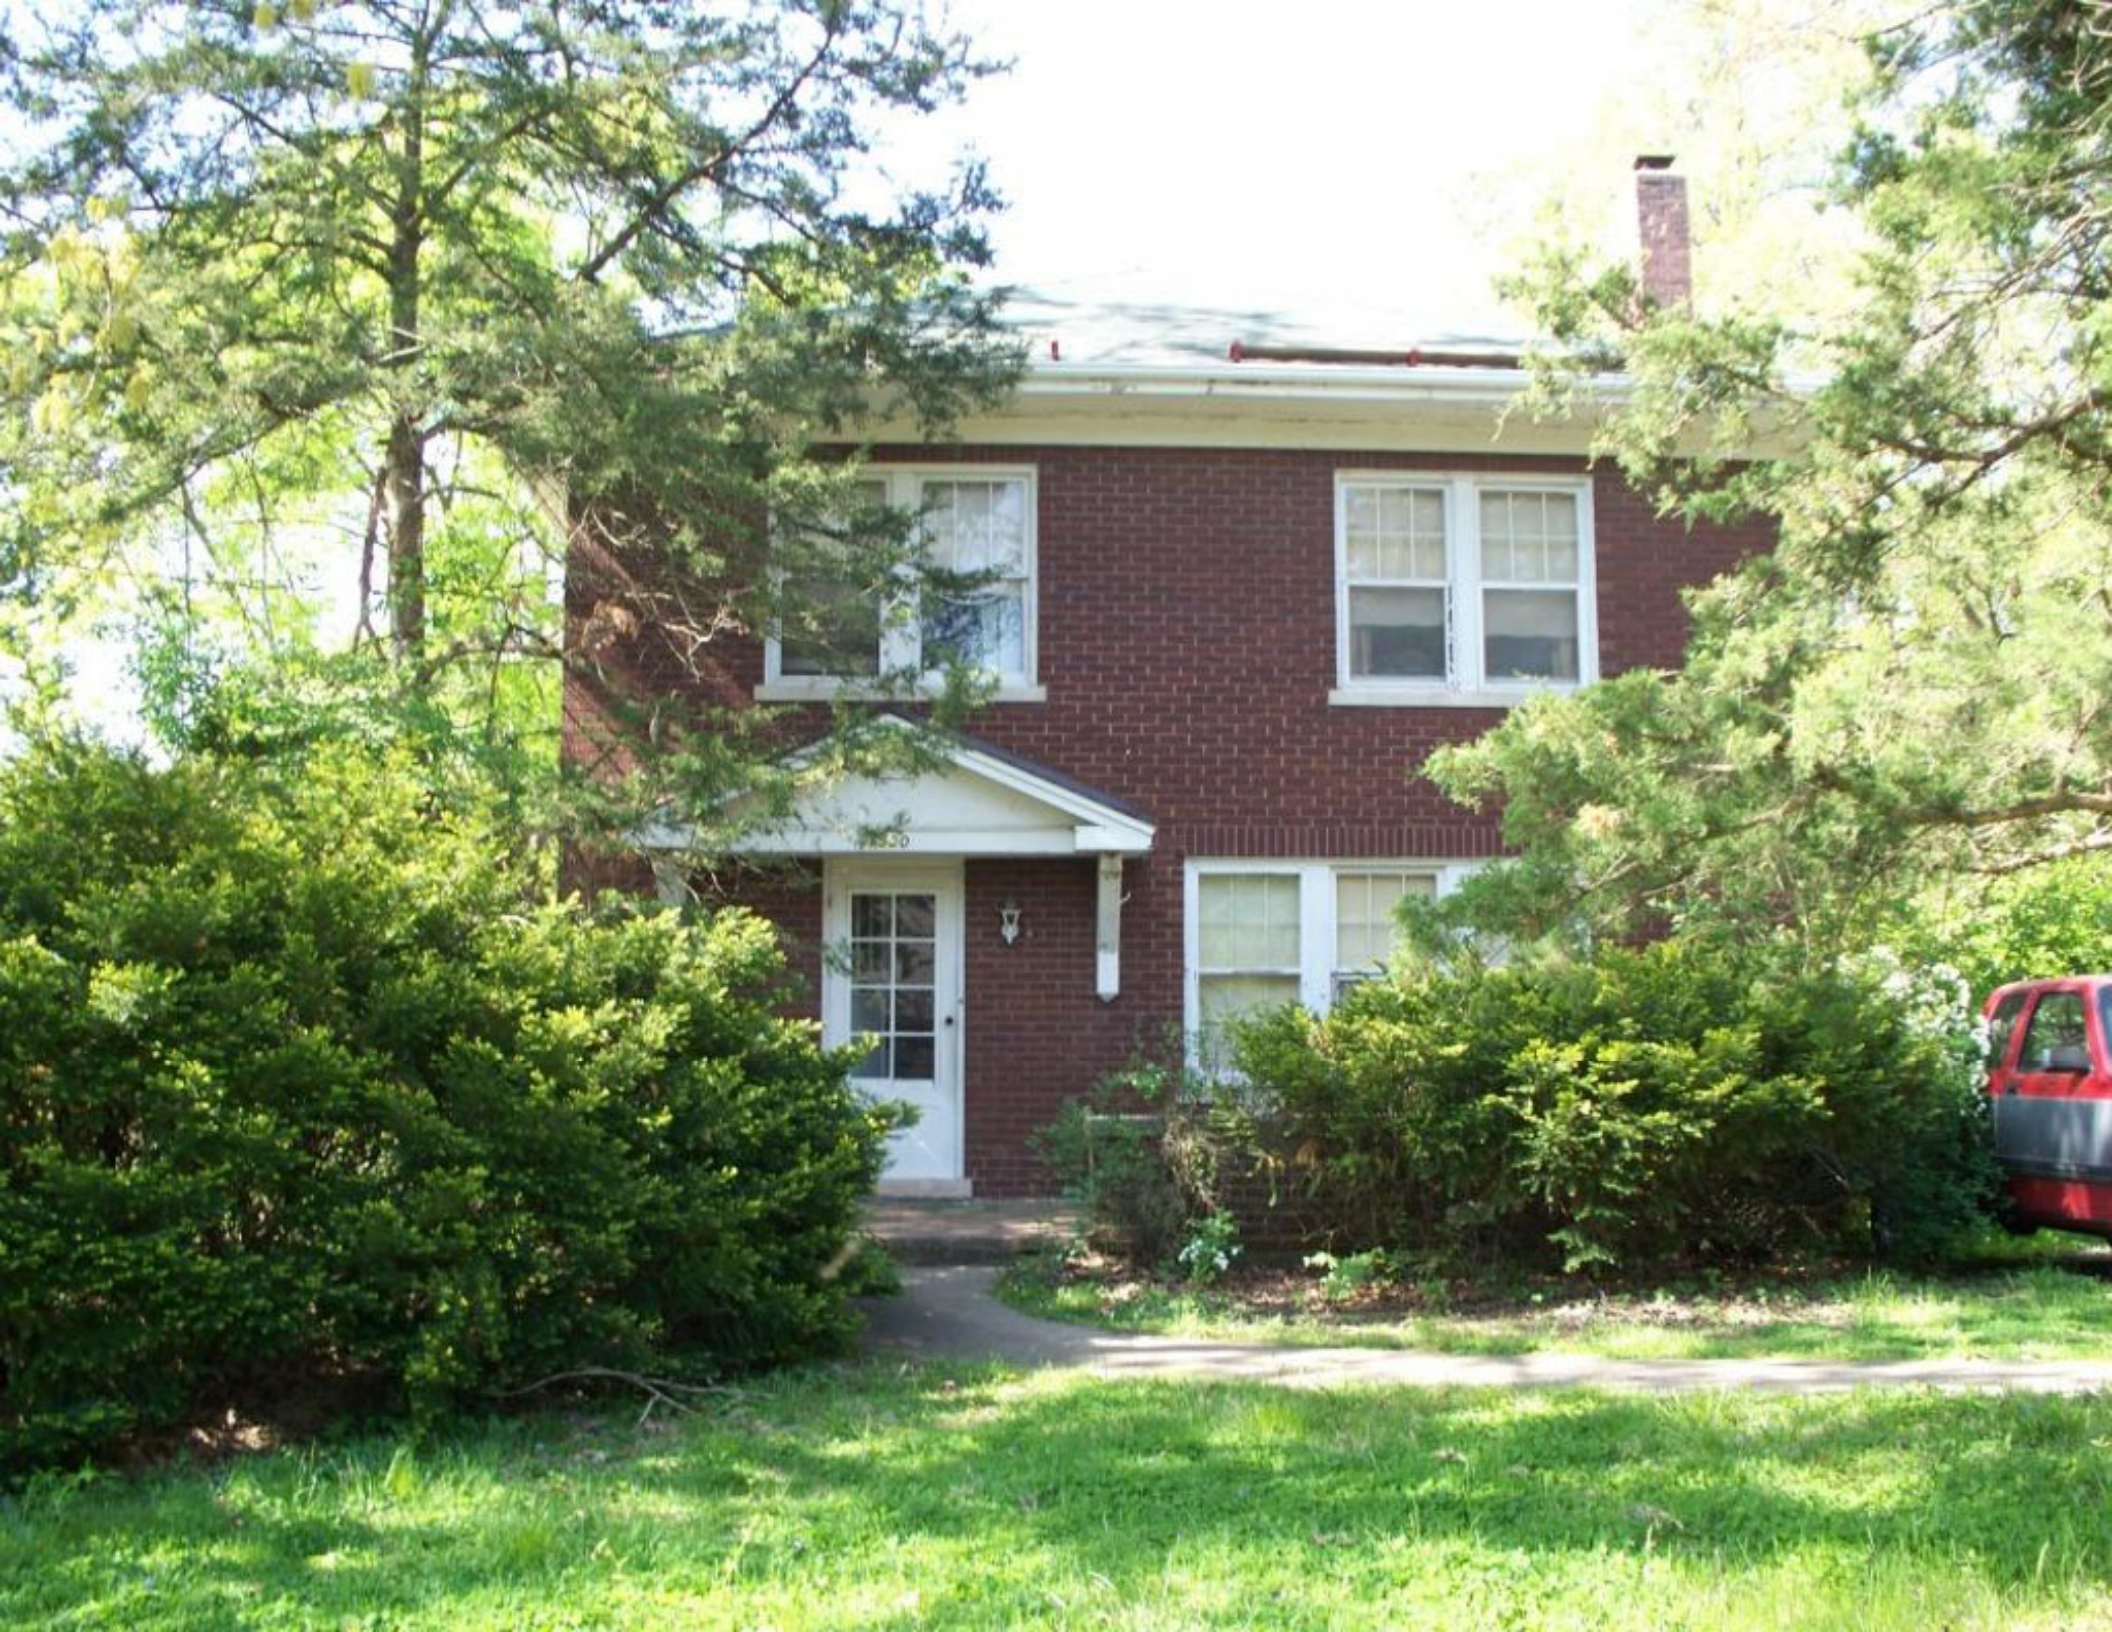
This brick four square has a hipped roof and paired 6/1 windows on the second floor that appear historic. The first floor has a pediment hood with brackets in the left bay. A concrete stoop extends over the width of the property and has a brick half wall in the right bay. The wooden multi-paned door in the left bay appears historic. In the right bay is a row of three 6/6 windows. All of the windows have concrete sills.
