ARCHITECTURAL/HISTORIC INVENTORY FORM

1. Survey No. CO-AS-005-001		2. Survey name: Moreau Drive Neighborhood Survey	
3. County: Cole		4. Address: 1202 Elmerine Ave.	
5. City: Jefferson City	Vicinity: <input type="checkbox"/>	6. UTM: / /	7. Township/Range/Section: T: R: S:
8. Historic name (if known):		9. Present/other name (if known):	
10. Ownership: <input checked="" type="checkbox"/> Private <input type="checkbox"/> Public		11. Historic use (if known): Residential	11. Current use: Residential

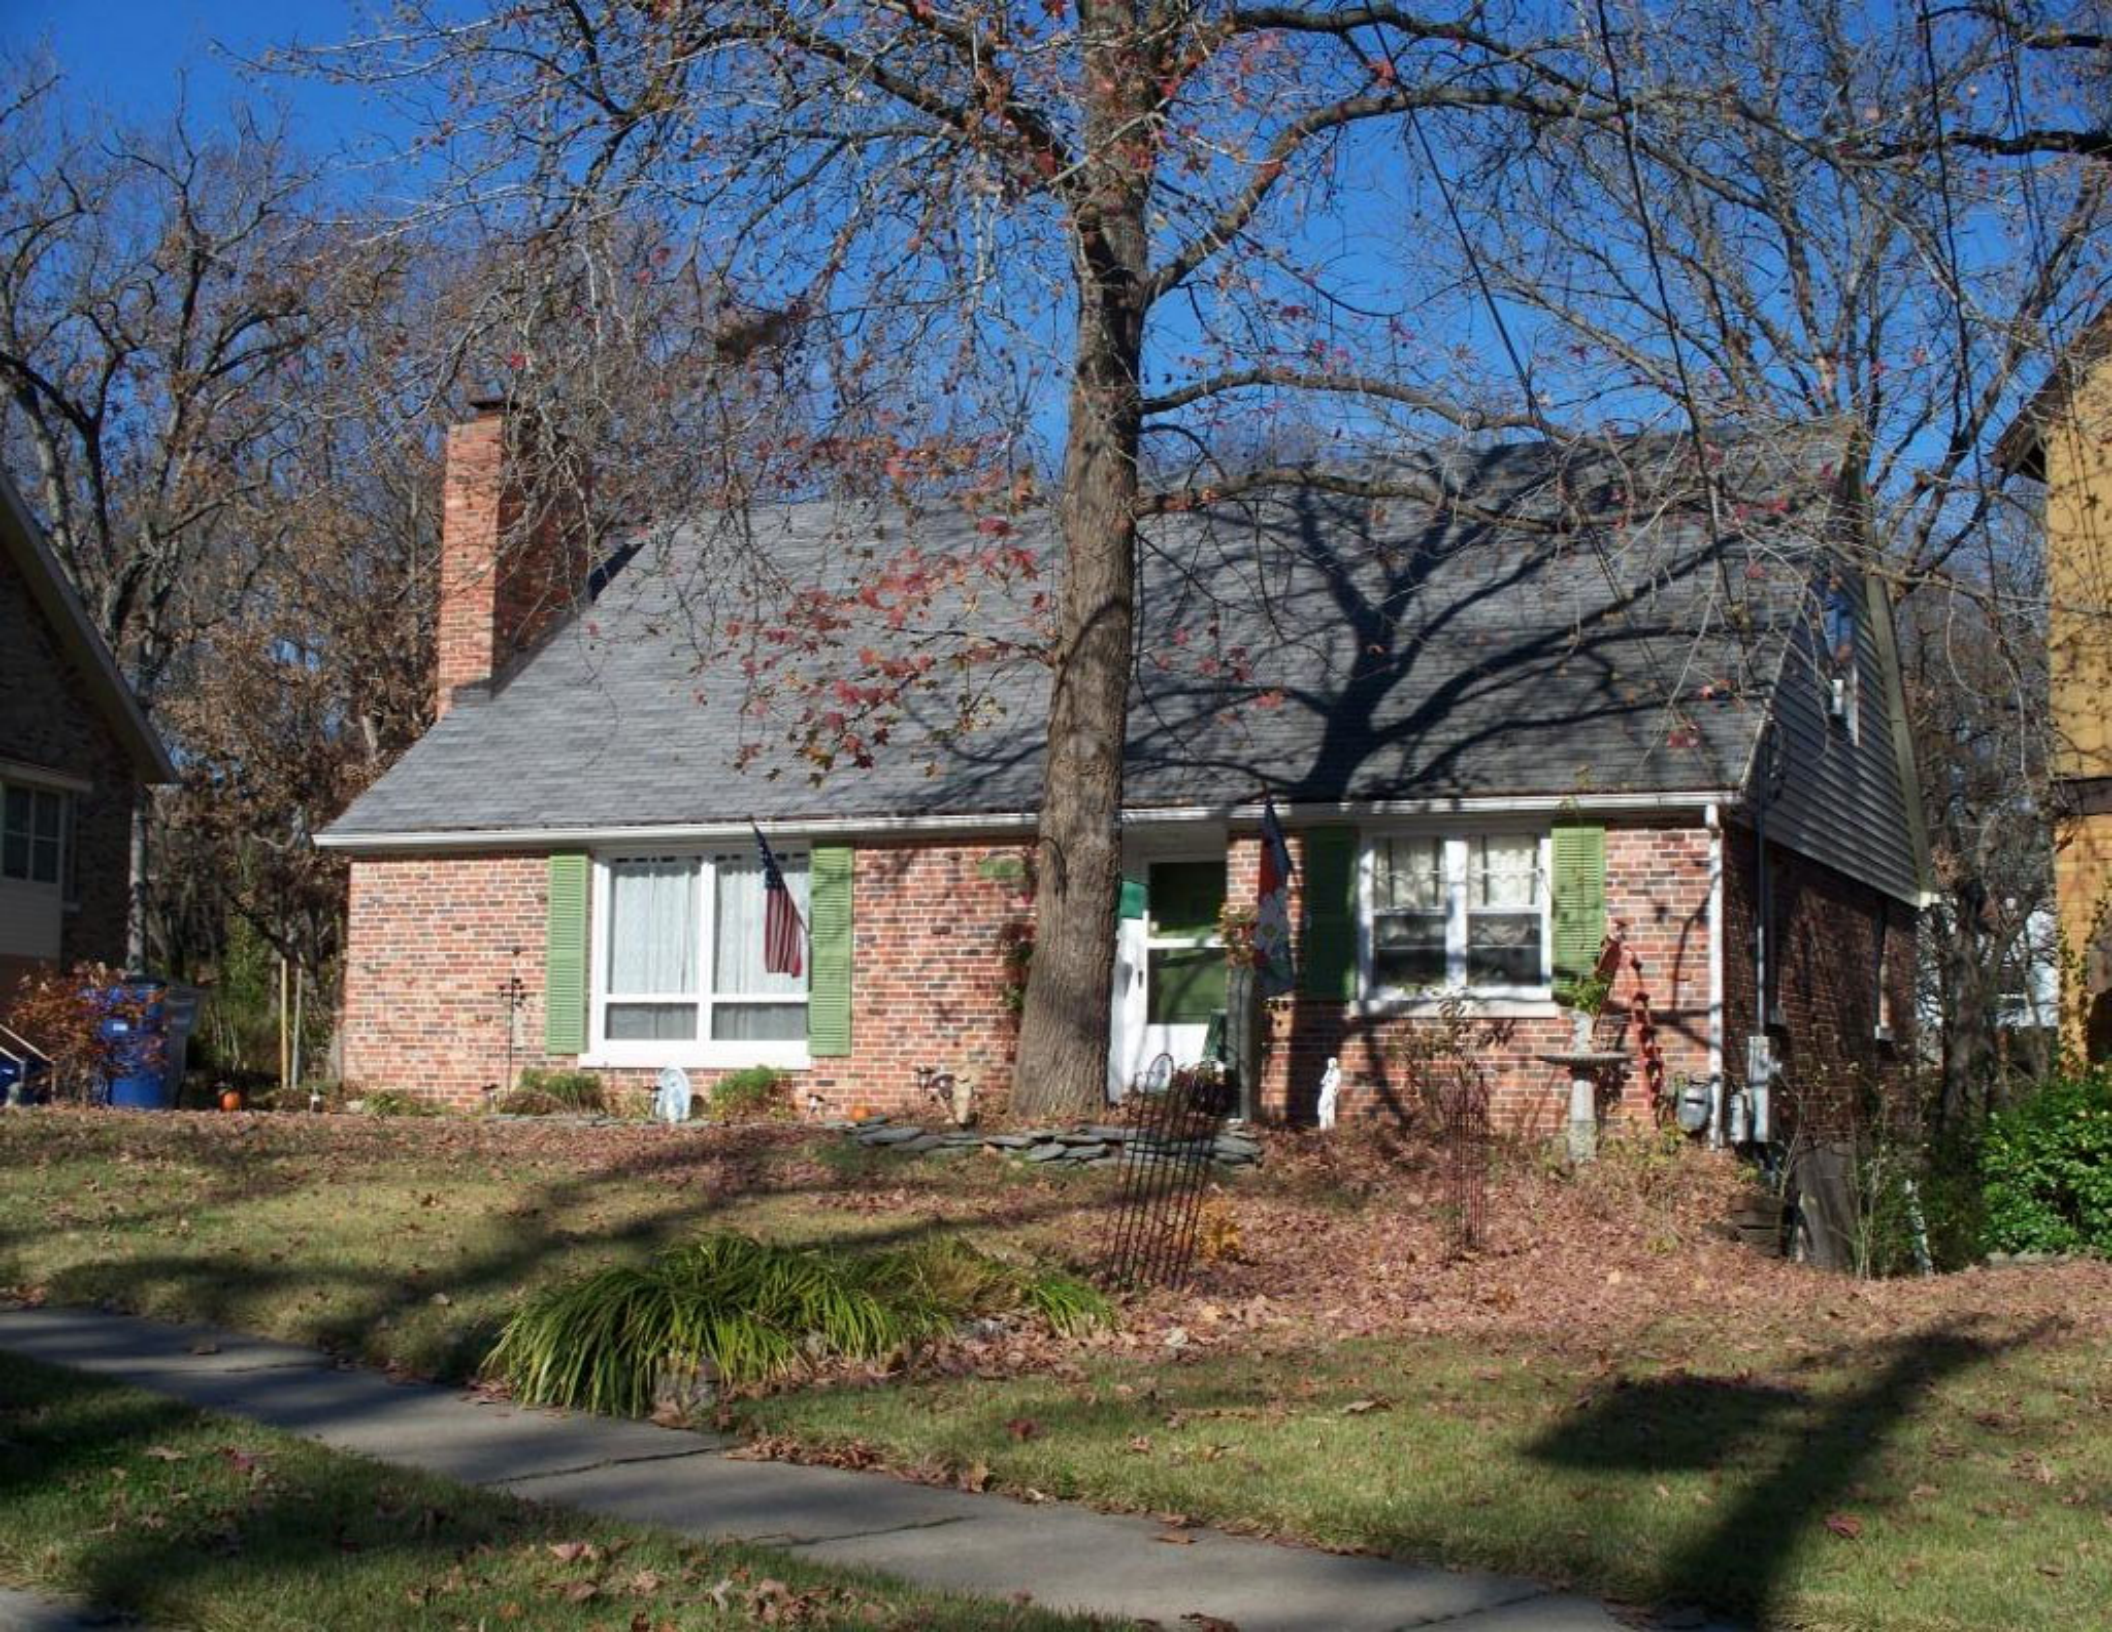
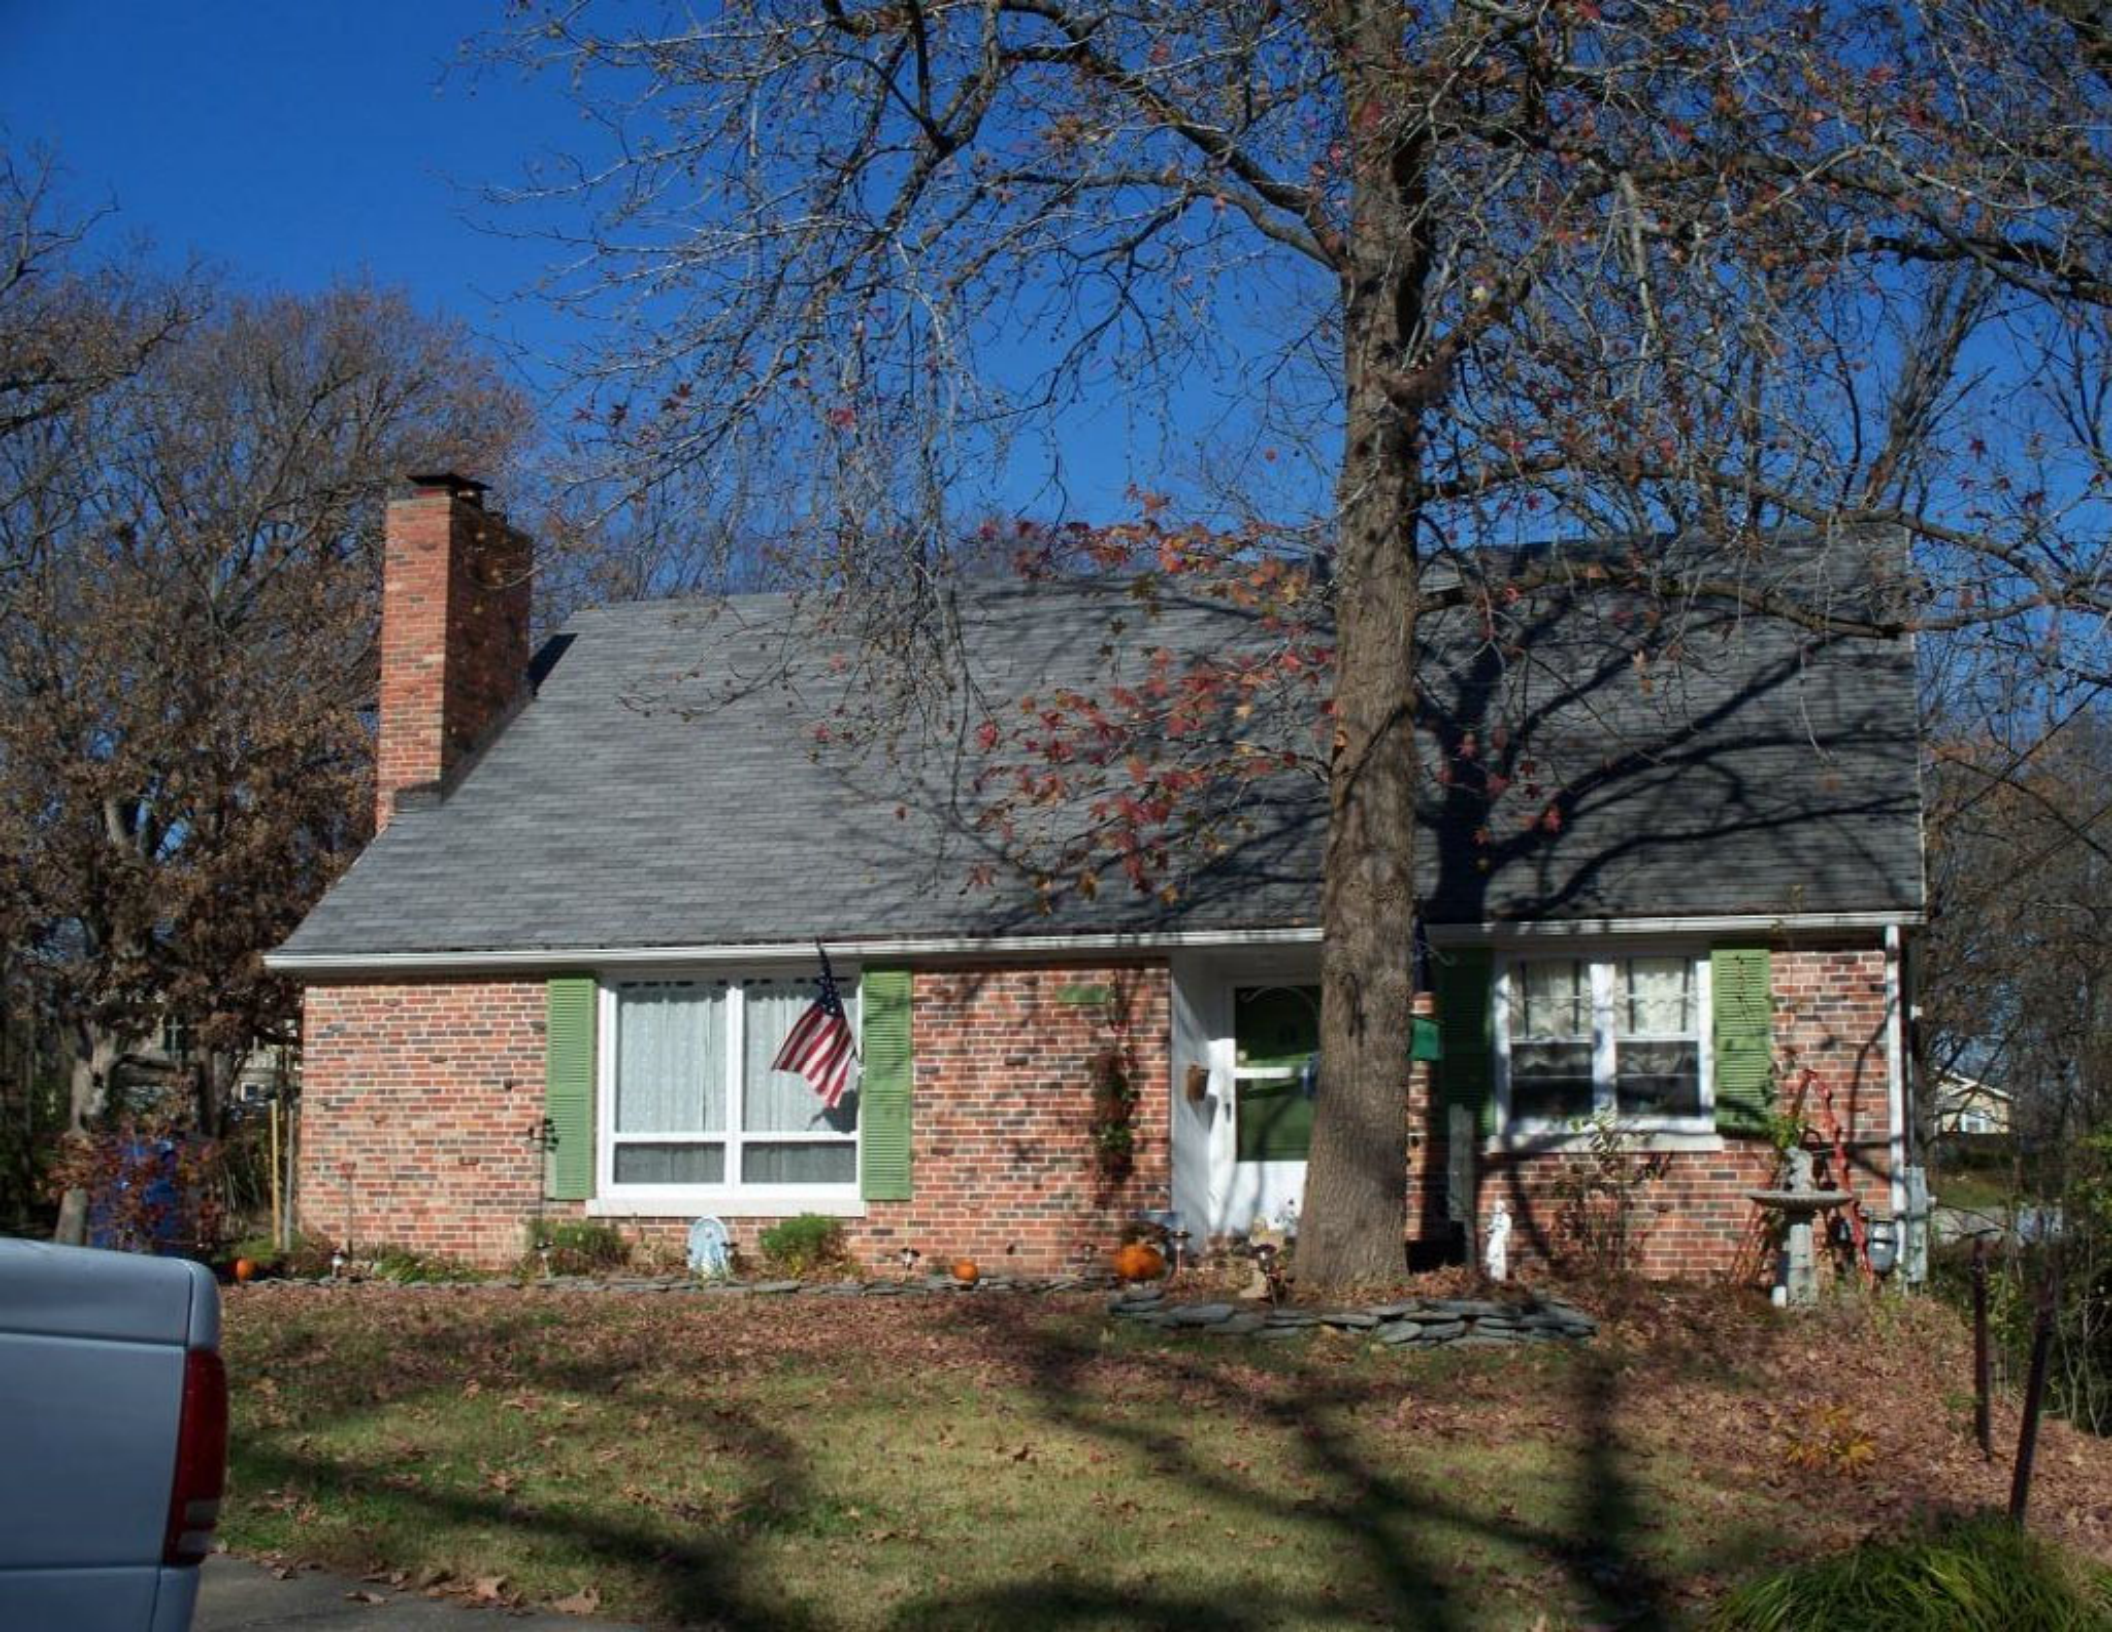
41. (cont.)
Due to build date this property is non-contributing. It has a deeply sloping side gable roof. With a large picture window in the left bay a recessed entrance and smaller paired windows in the right bay. All of the windows have shutters.

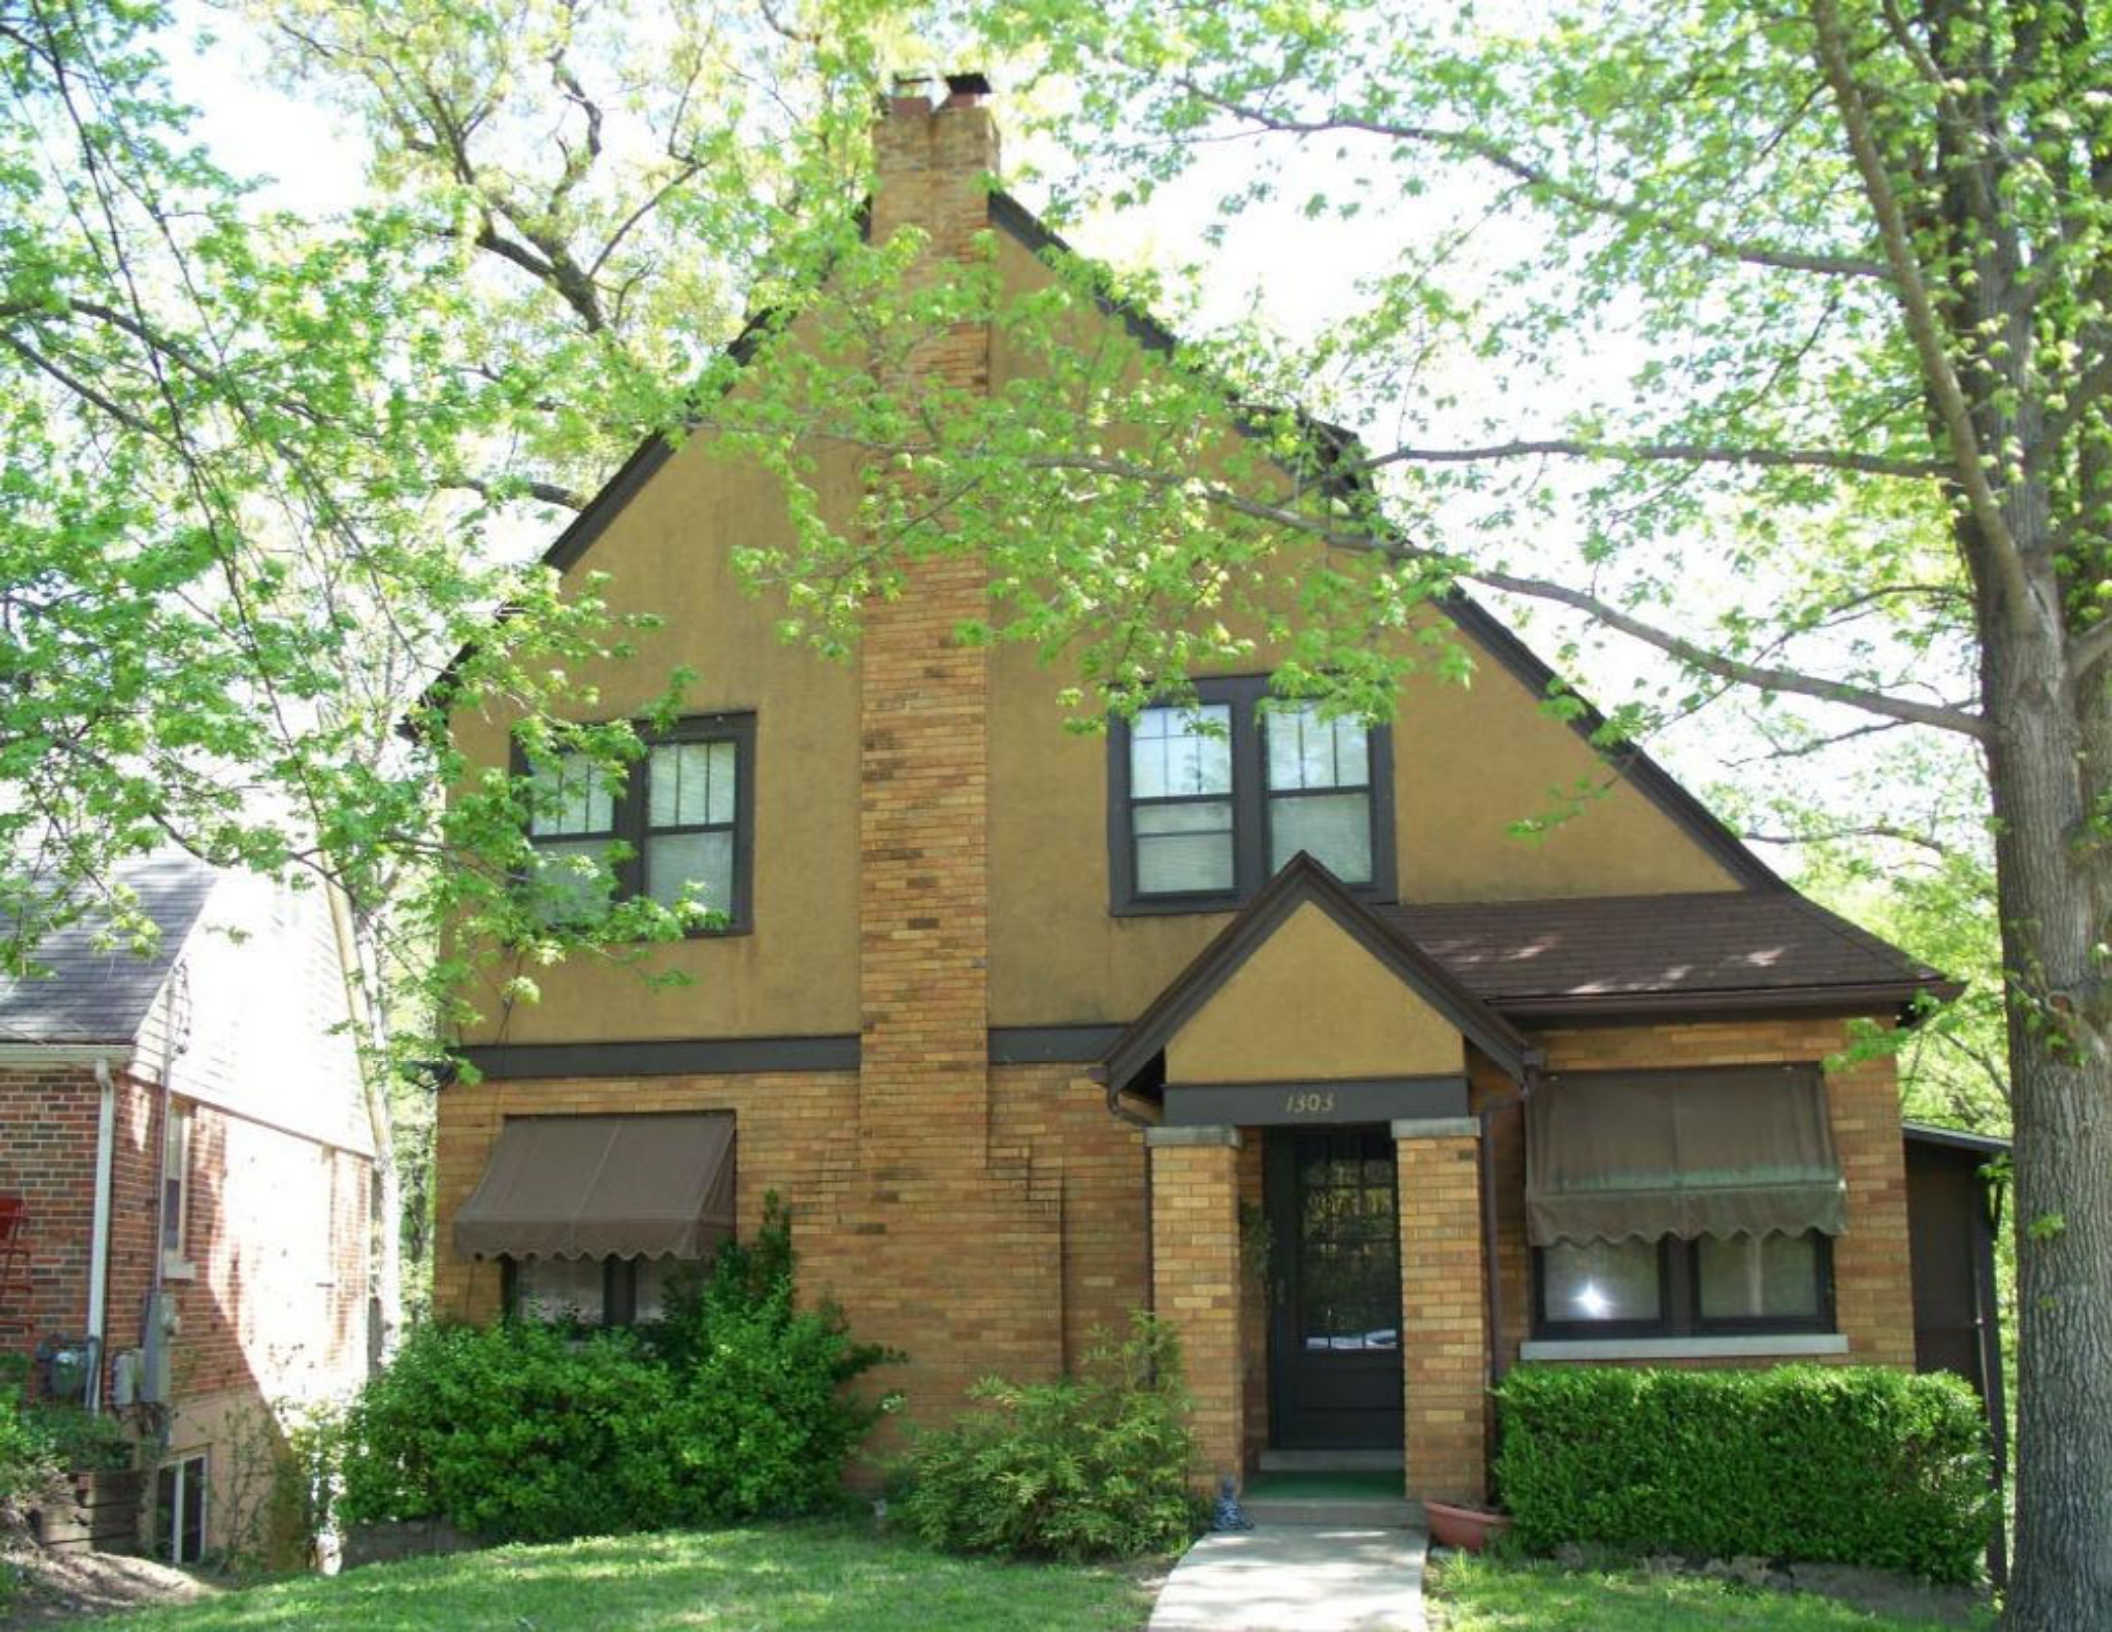
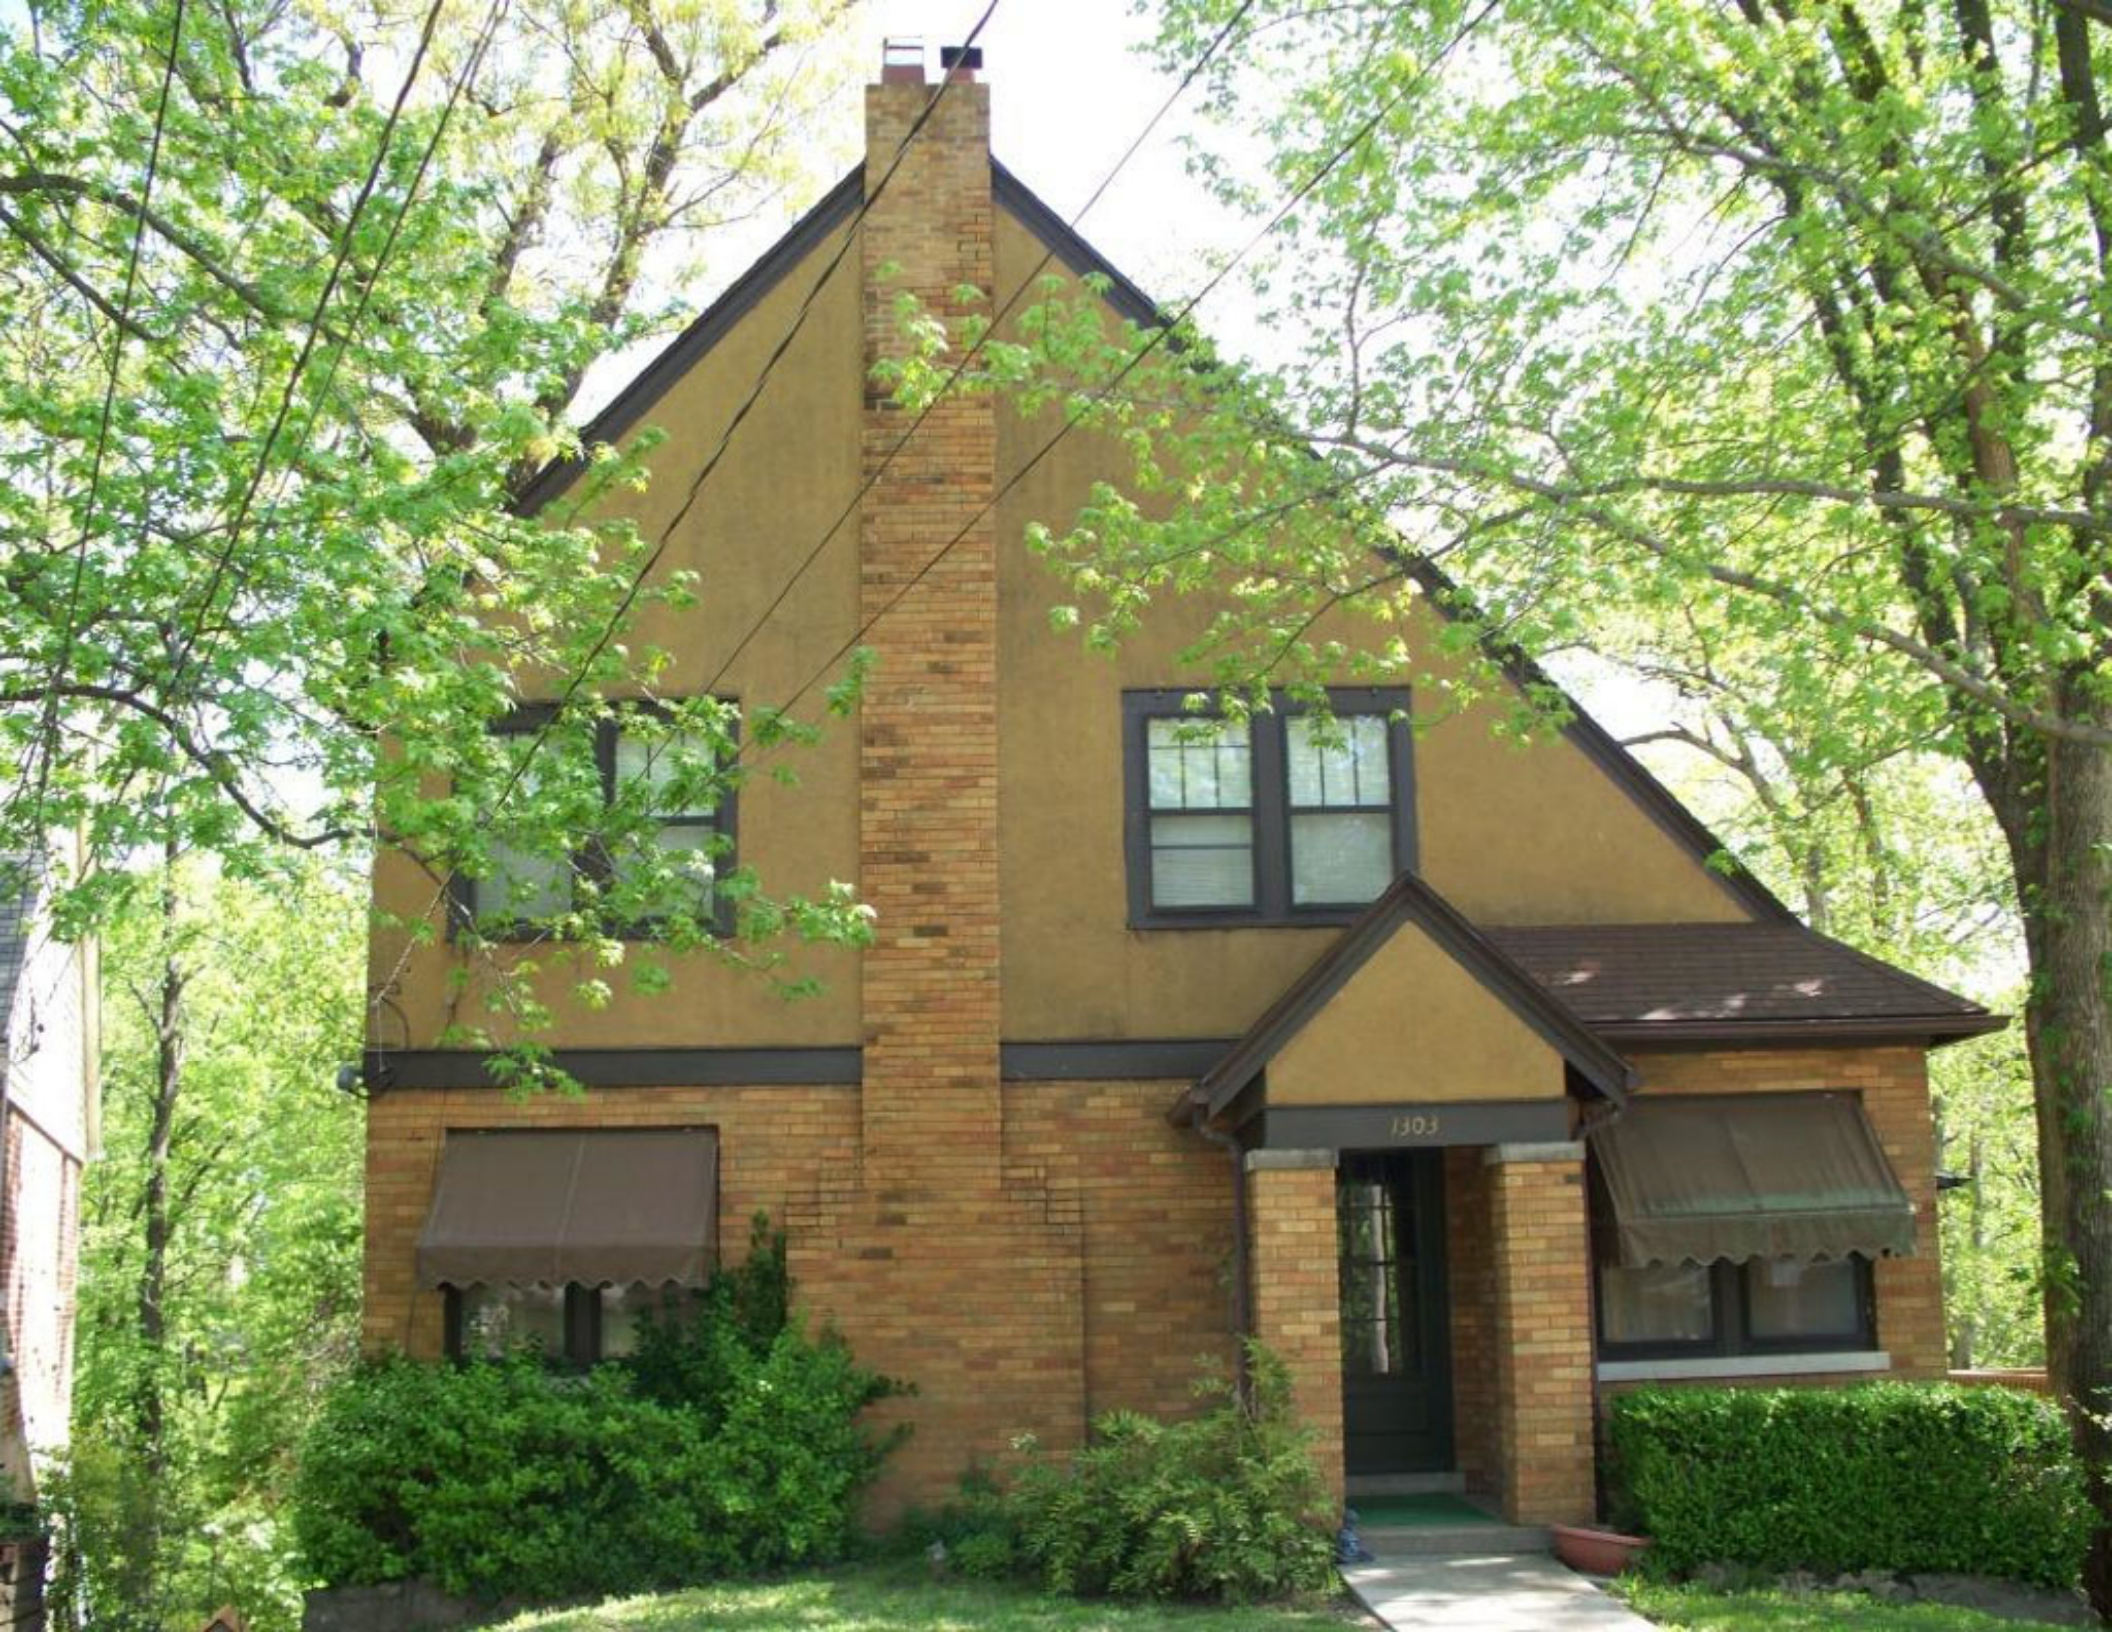
This two story home has a front gable roof and is clad in stucco on the upper half and brick on the lower. The upper floor has two paired historic 3/1 windows that are separated by the exterior of the centered chimney. The left bay on the lower floor has paired windows with a cloth awning (division obscured). On the other side of the chimney is the entrance which is covered by a gabled portico (stucco on brick piers). This bay and the next projects from the property. The right bay has a shed roof and paired windows covered by a cloth awning.

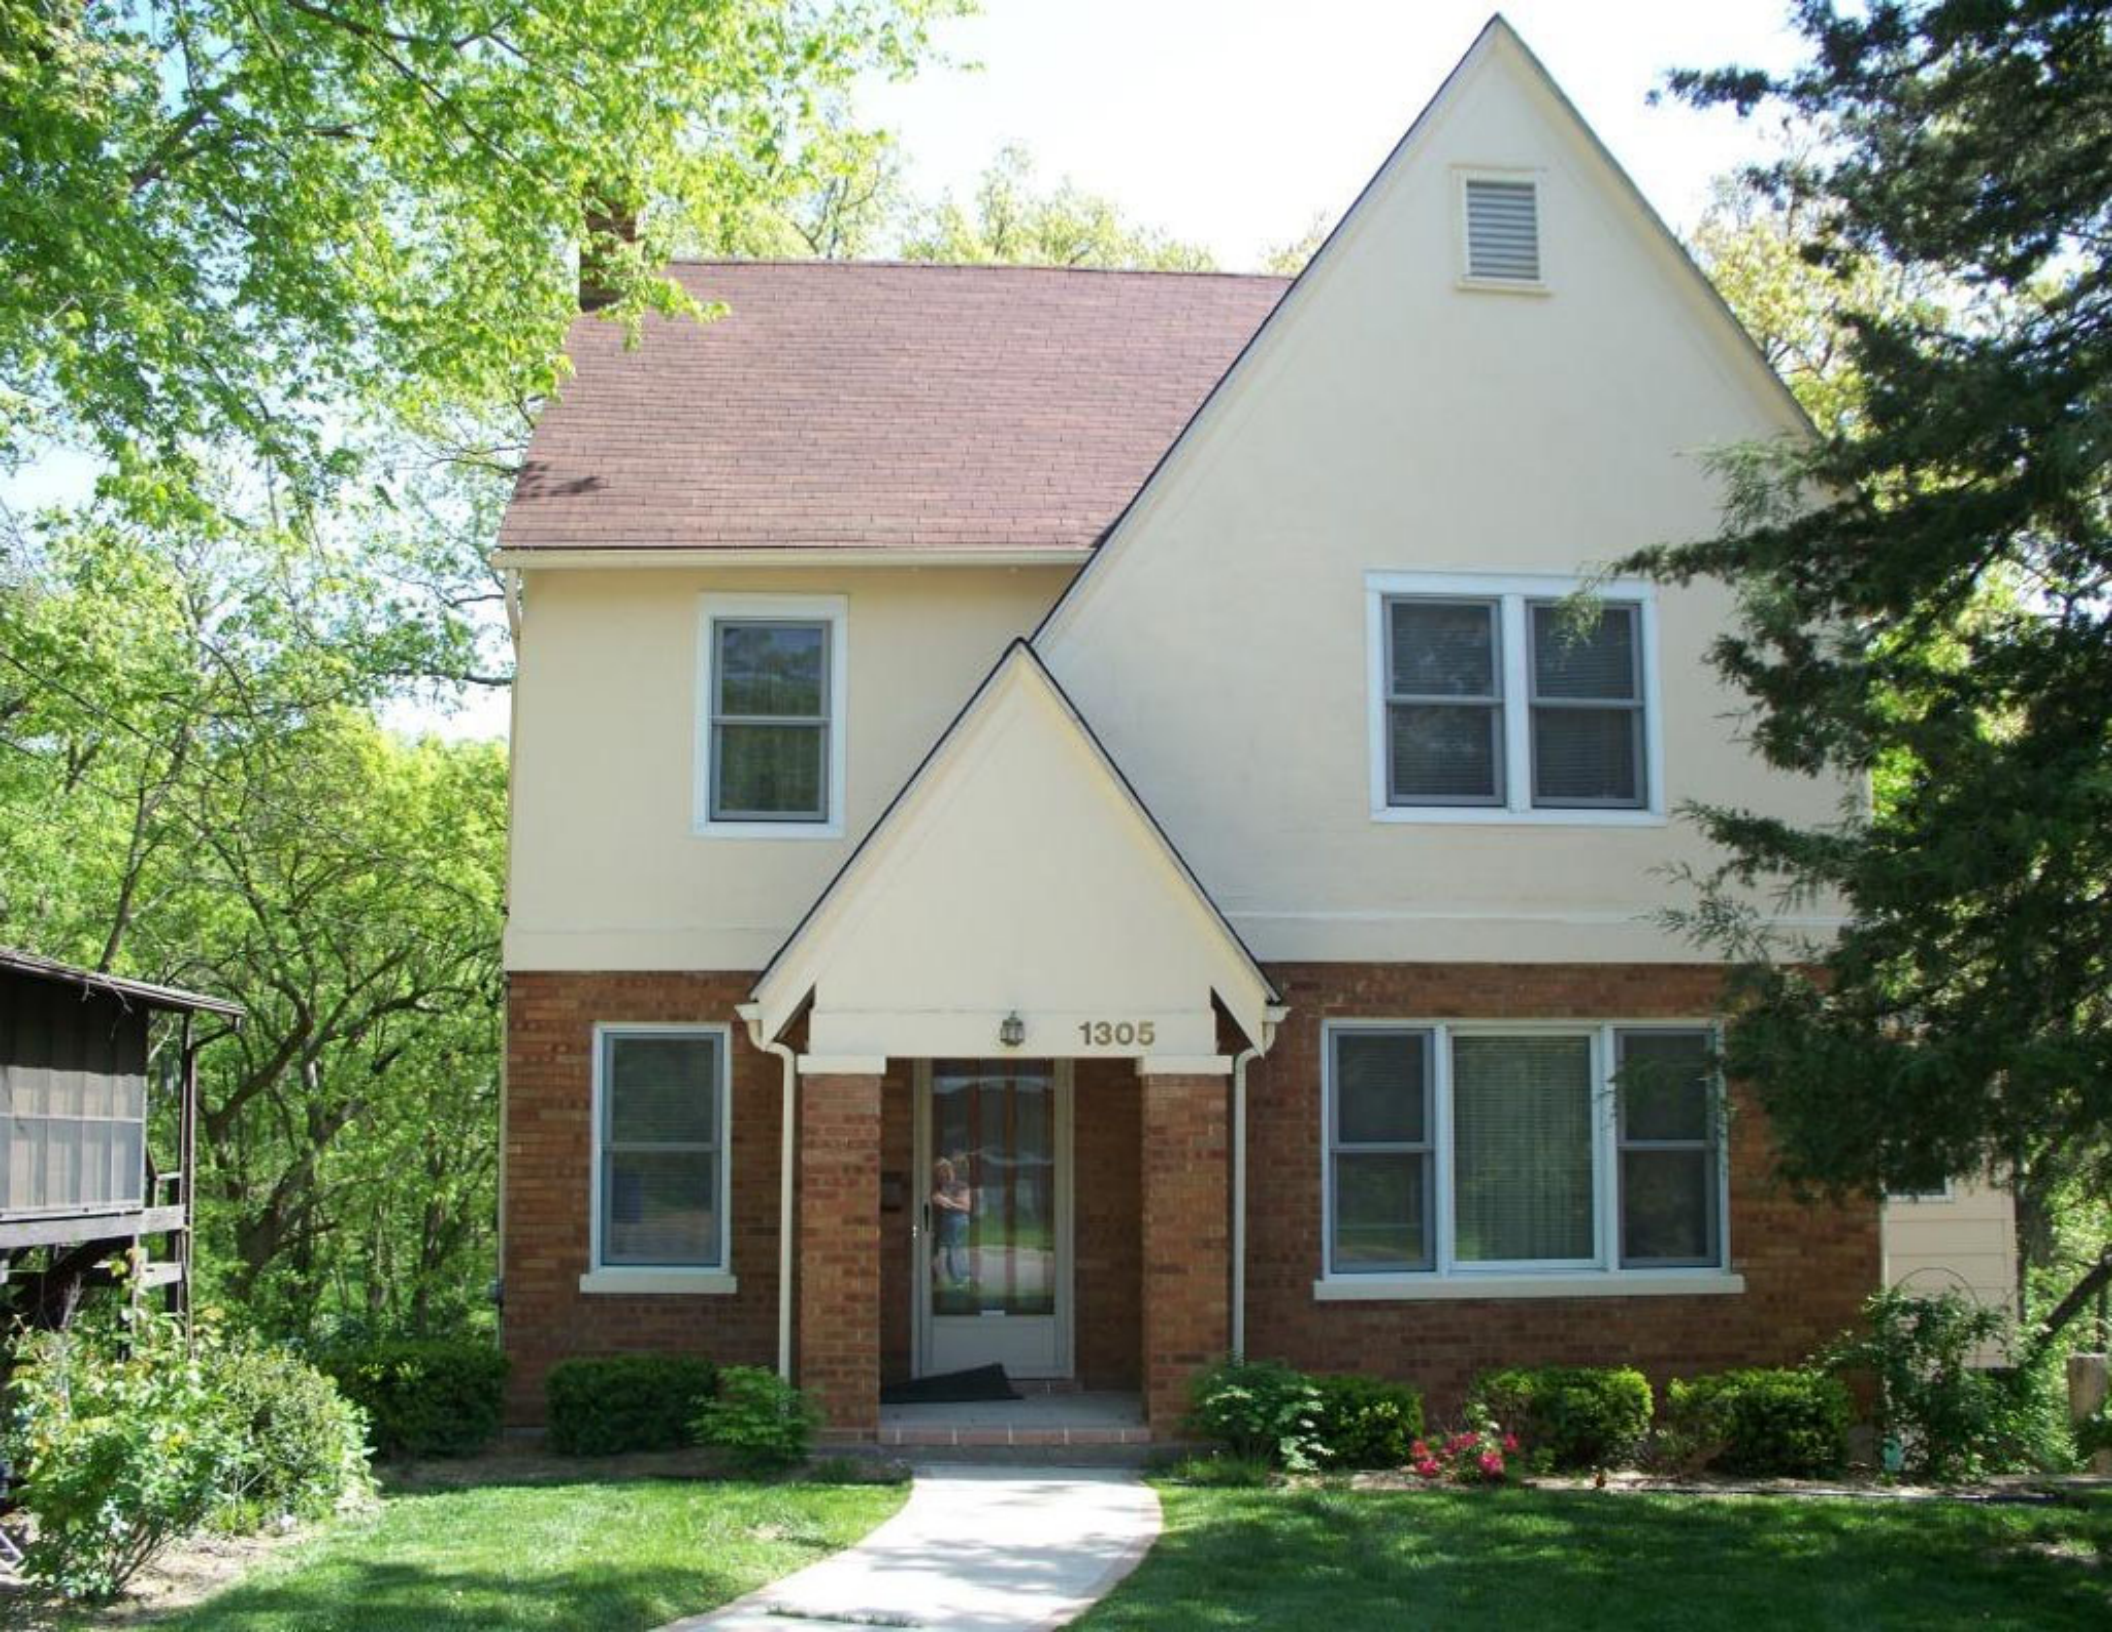
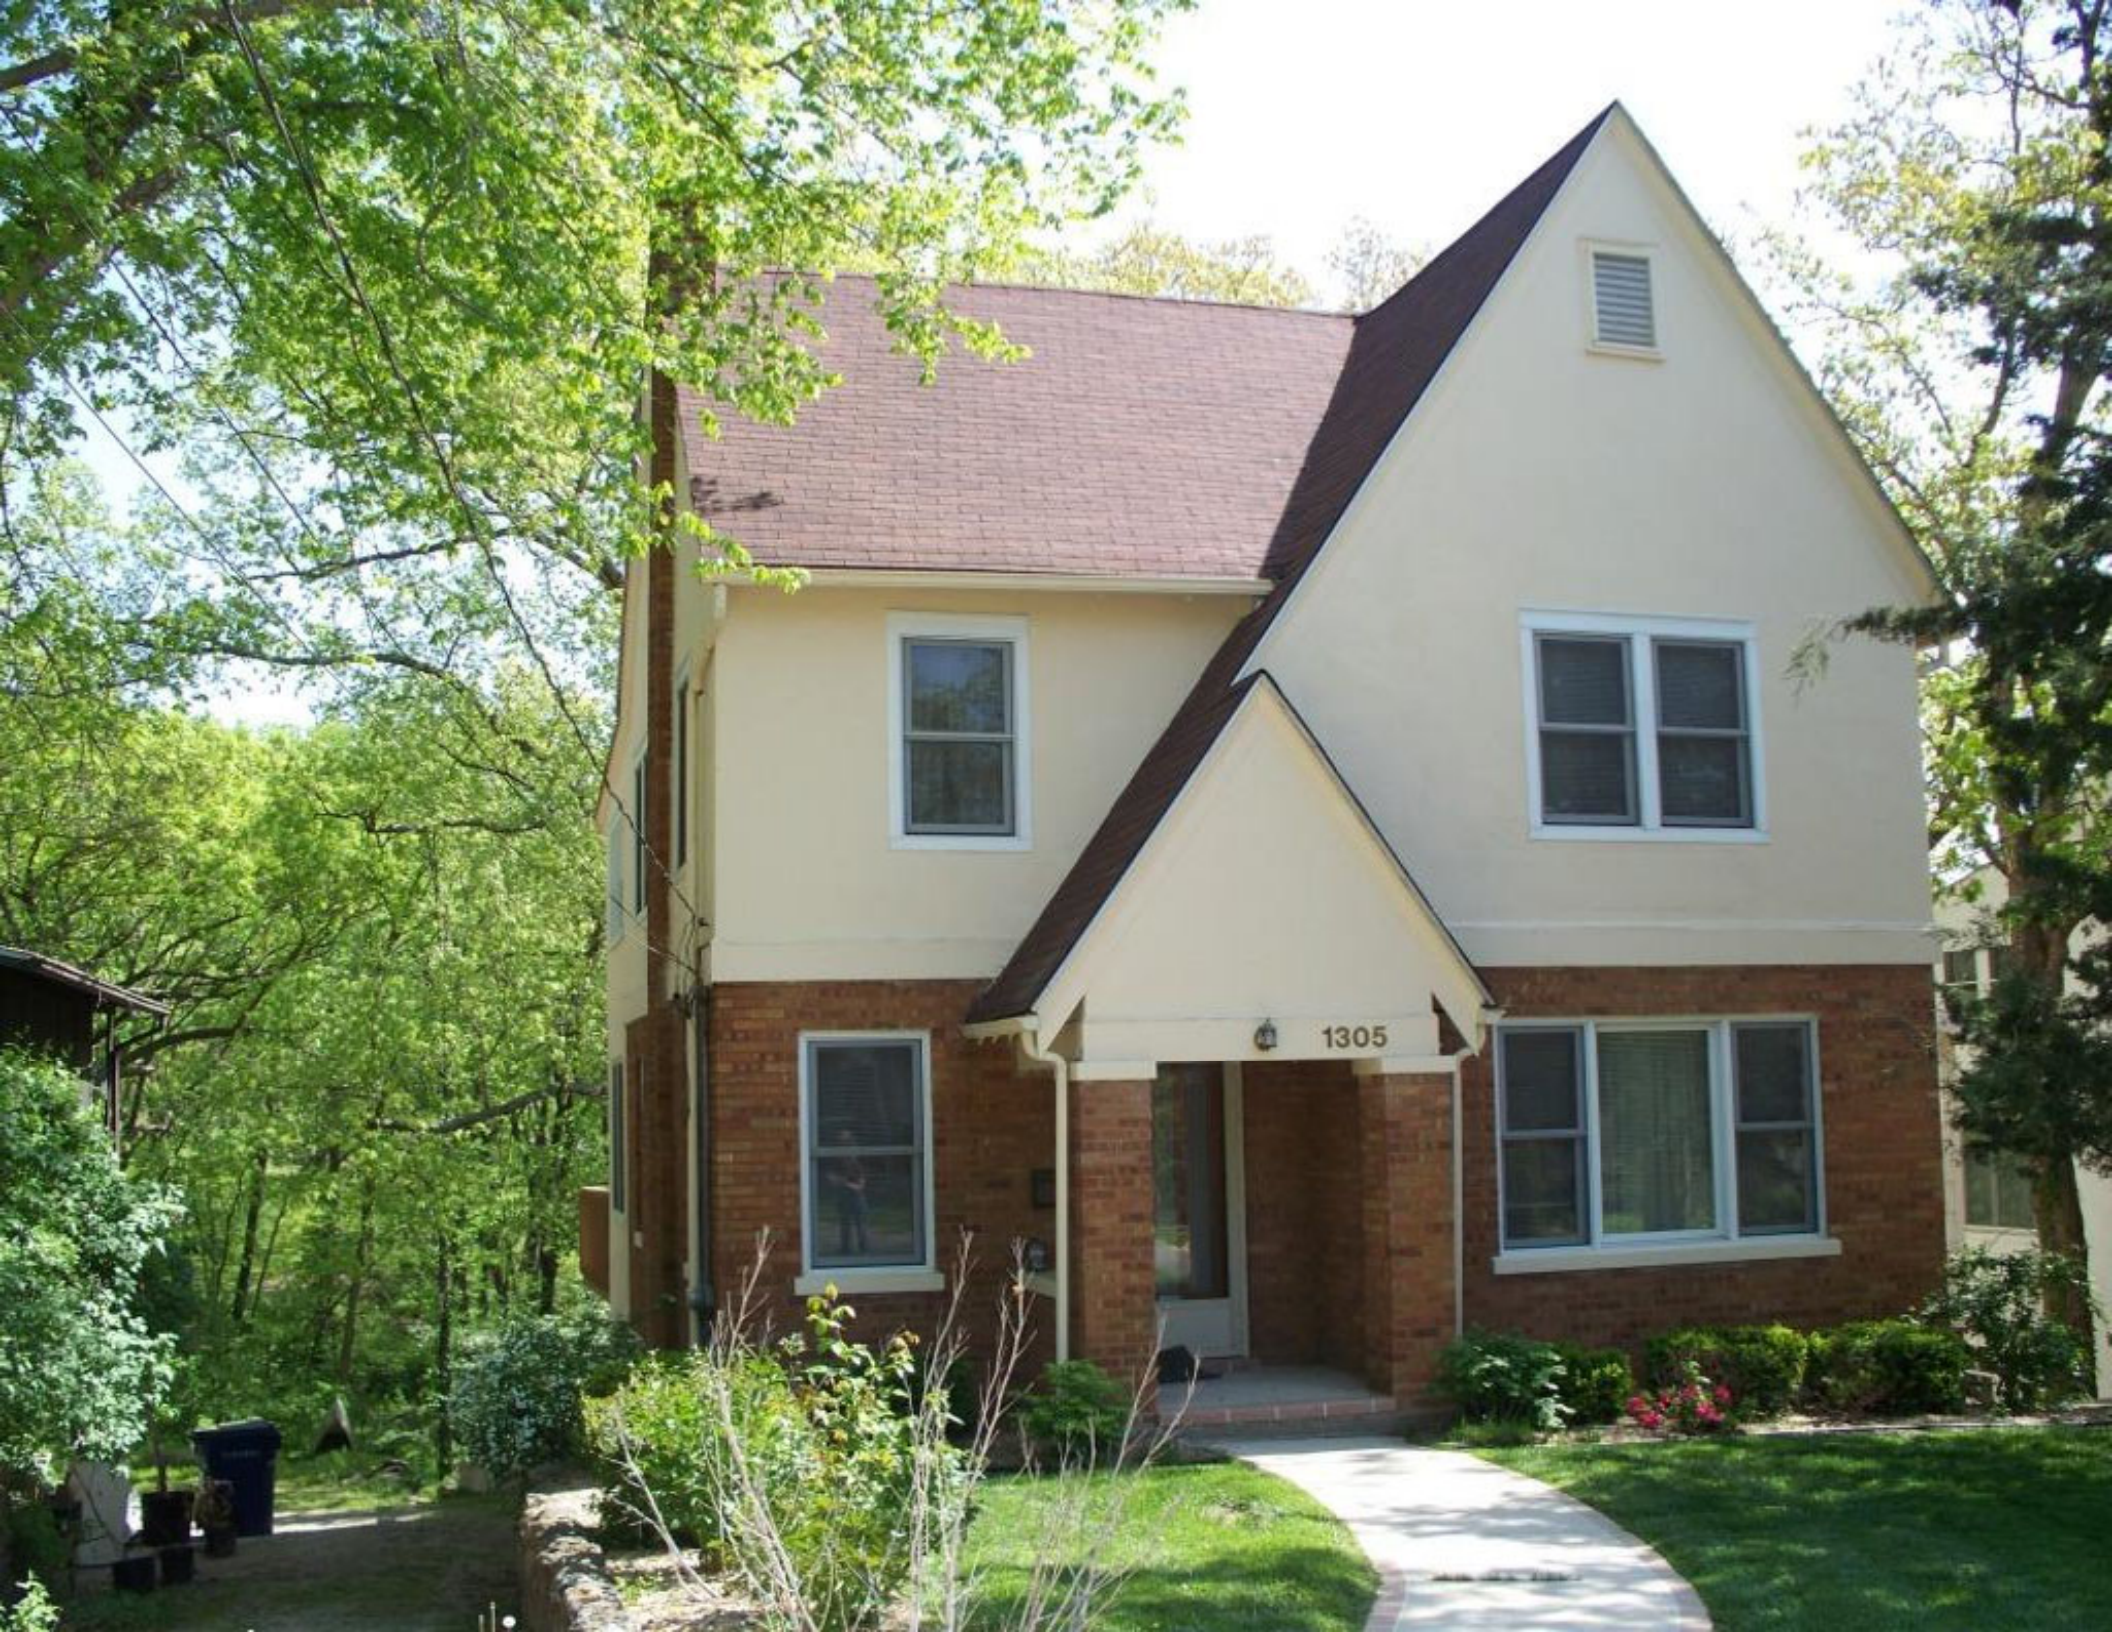
This two story home has a cross gable roof and is clad in stucco on the upper half and brick on the lower. The upper floor has a single 1/1 window in the left bay, which has a side-gabled roof. The right bay has a slightly projecting front gable that rises well over the side gable portion of the roof and slopes down to the left. A vent is in the peak of this gable and paired 1/1 windows are beneath it. All windows in the property are modern replacement. On the lower floor in the left bay is a single 1/1 window. The center bay contains the entrance, which has a projecting gabled portico (stucco in the gable on brick piers). The right bay has a modern tri-part window.
