ARCHITECTURAL/HISTORIC INVENTORY FORM

1. Survey No. CO-AS-005-001		2. Survey name: Moreau Drive Neighborhood Survey	
3. County: Cole		4. Address: 1202 Elmerine Ave.	
5. City: Jefferson City	Vicinity: <input type="checkbox"/>	6. UTM: / /	7. Township/Range/Section: T: R: S:
8. Historic name (if known):		9. Present/other name (if known):	
10. Ownership: <input checked="" type="checkbox"/> Private <input type="checkbox"/> Public		11. Historic use (if known): Residential	11. Current use: Residential

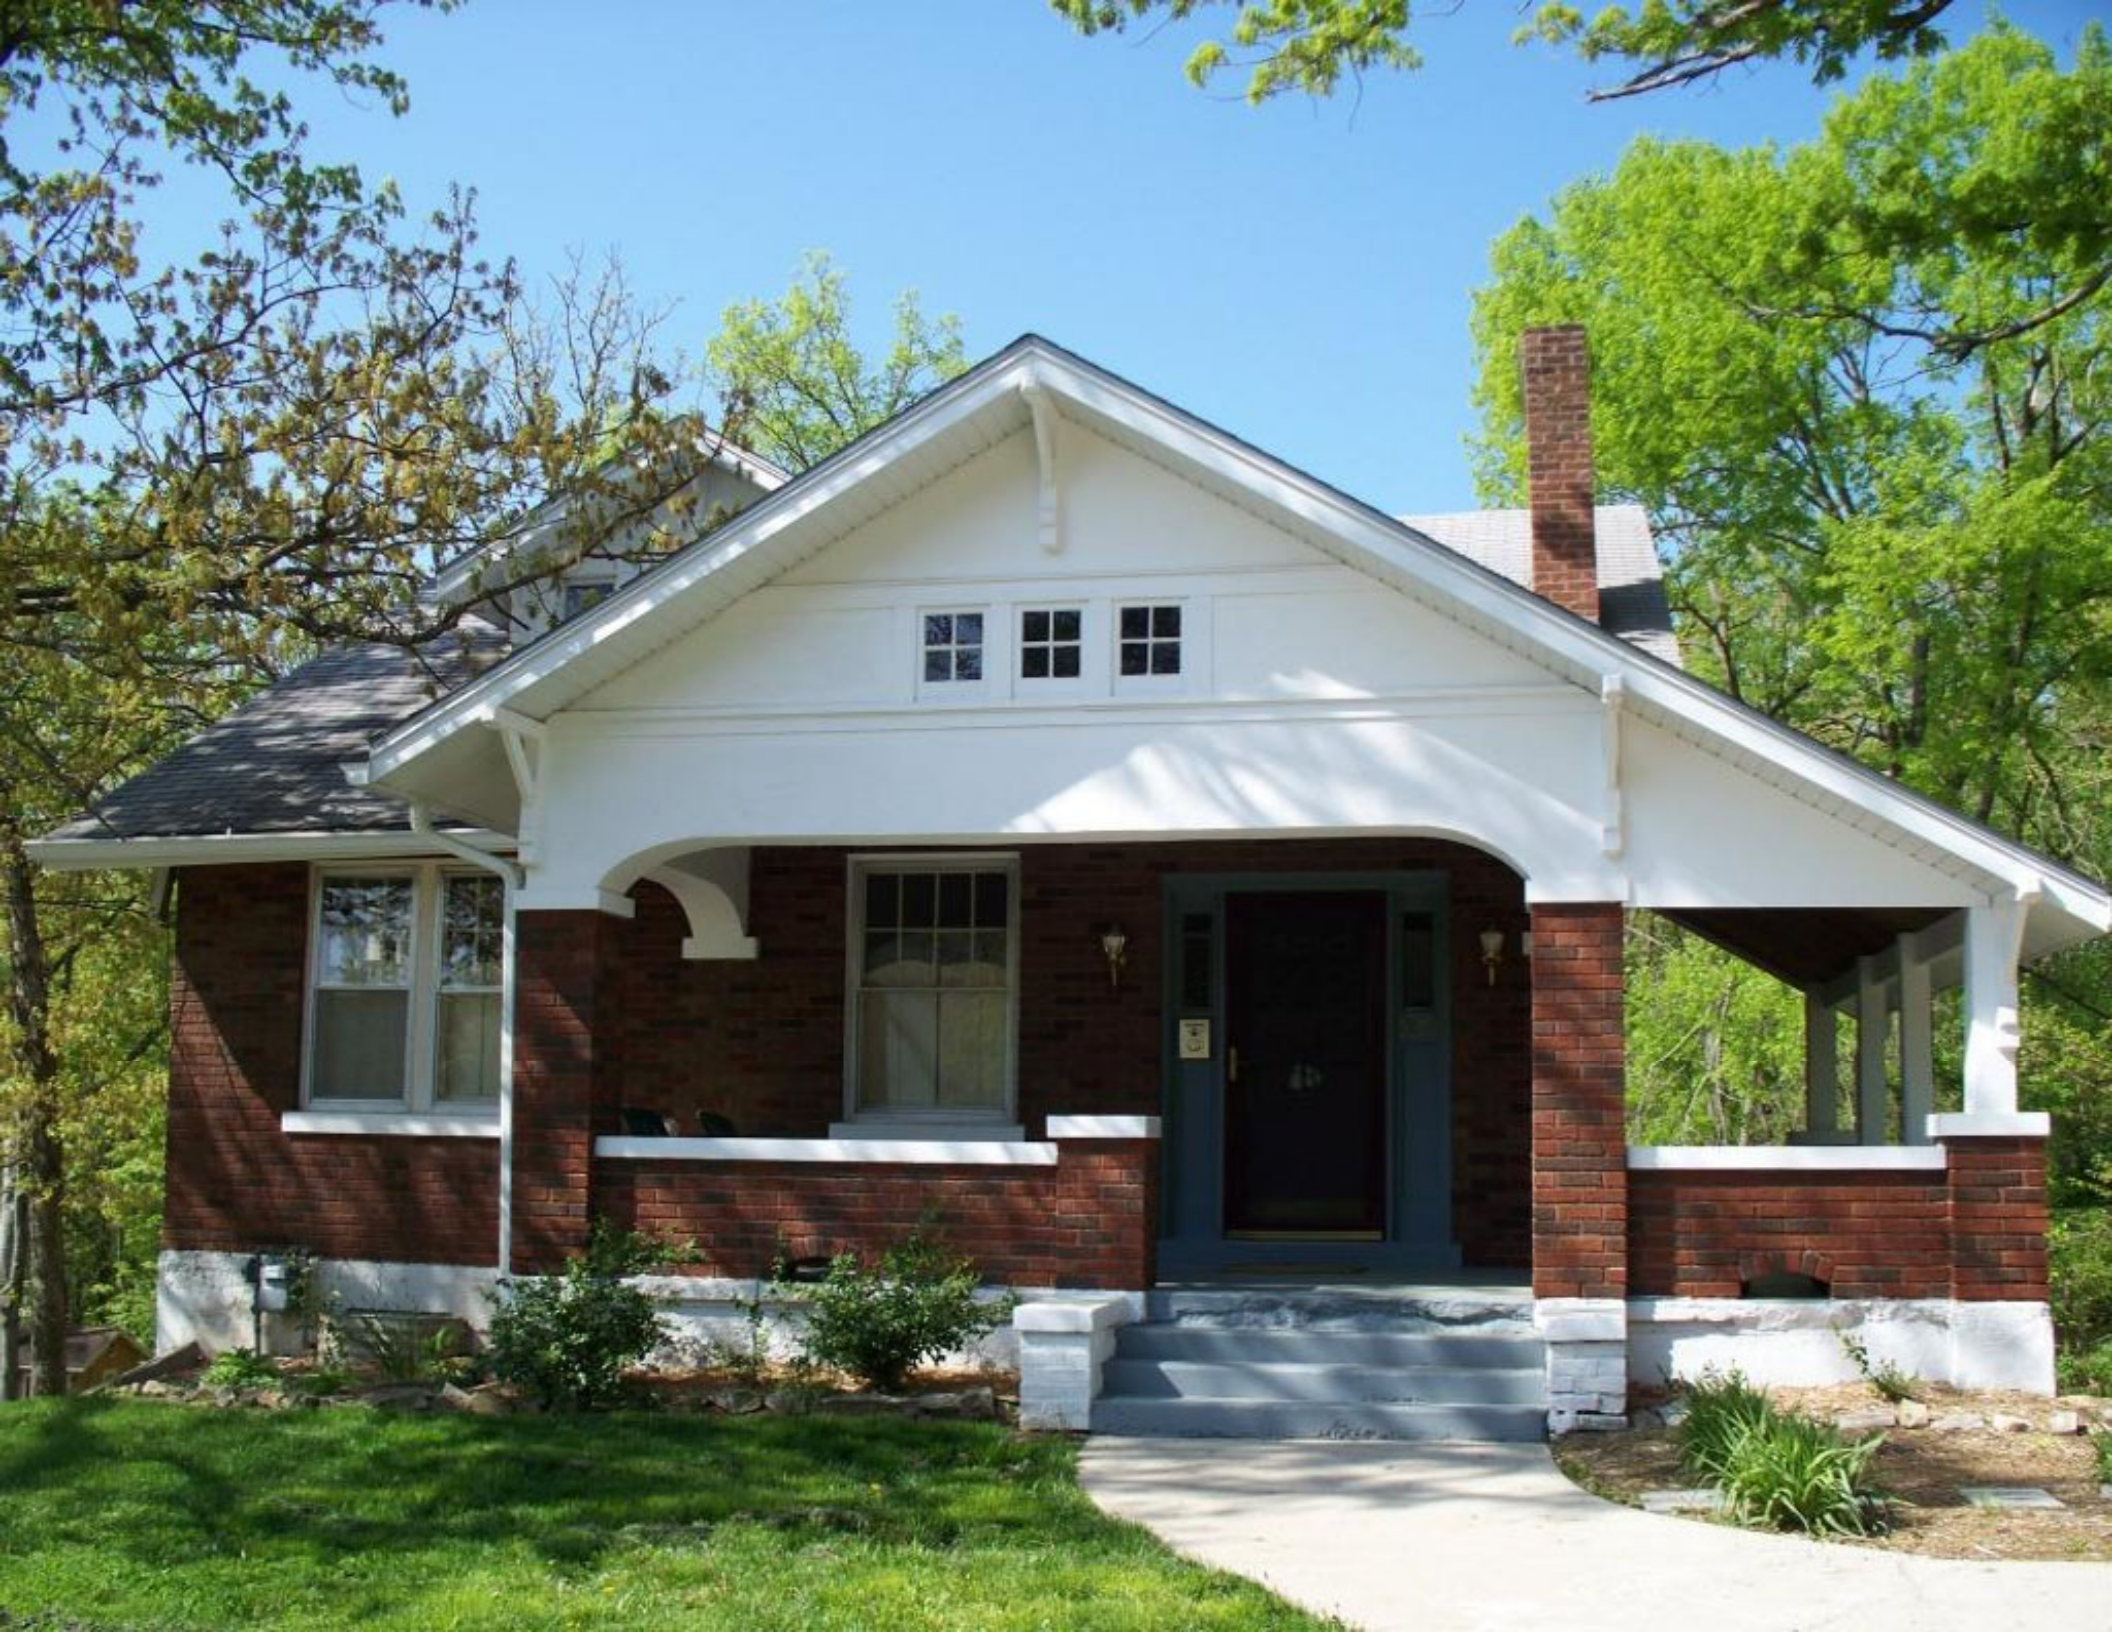
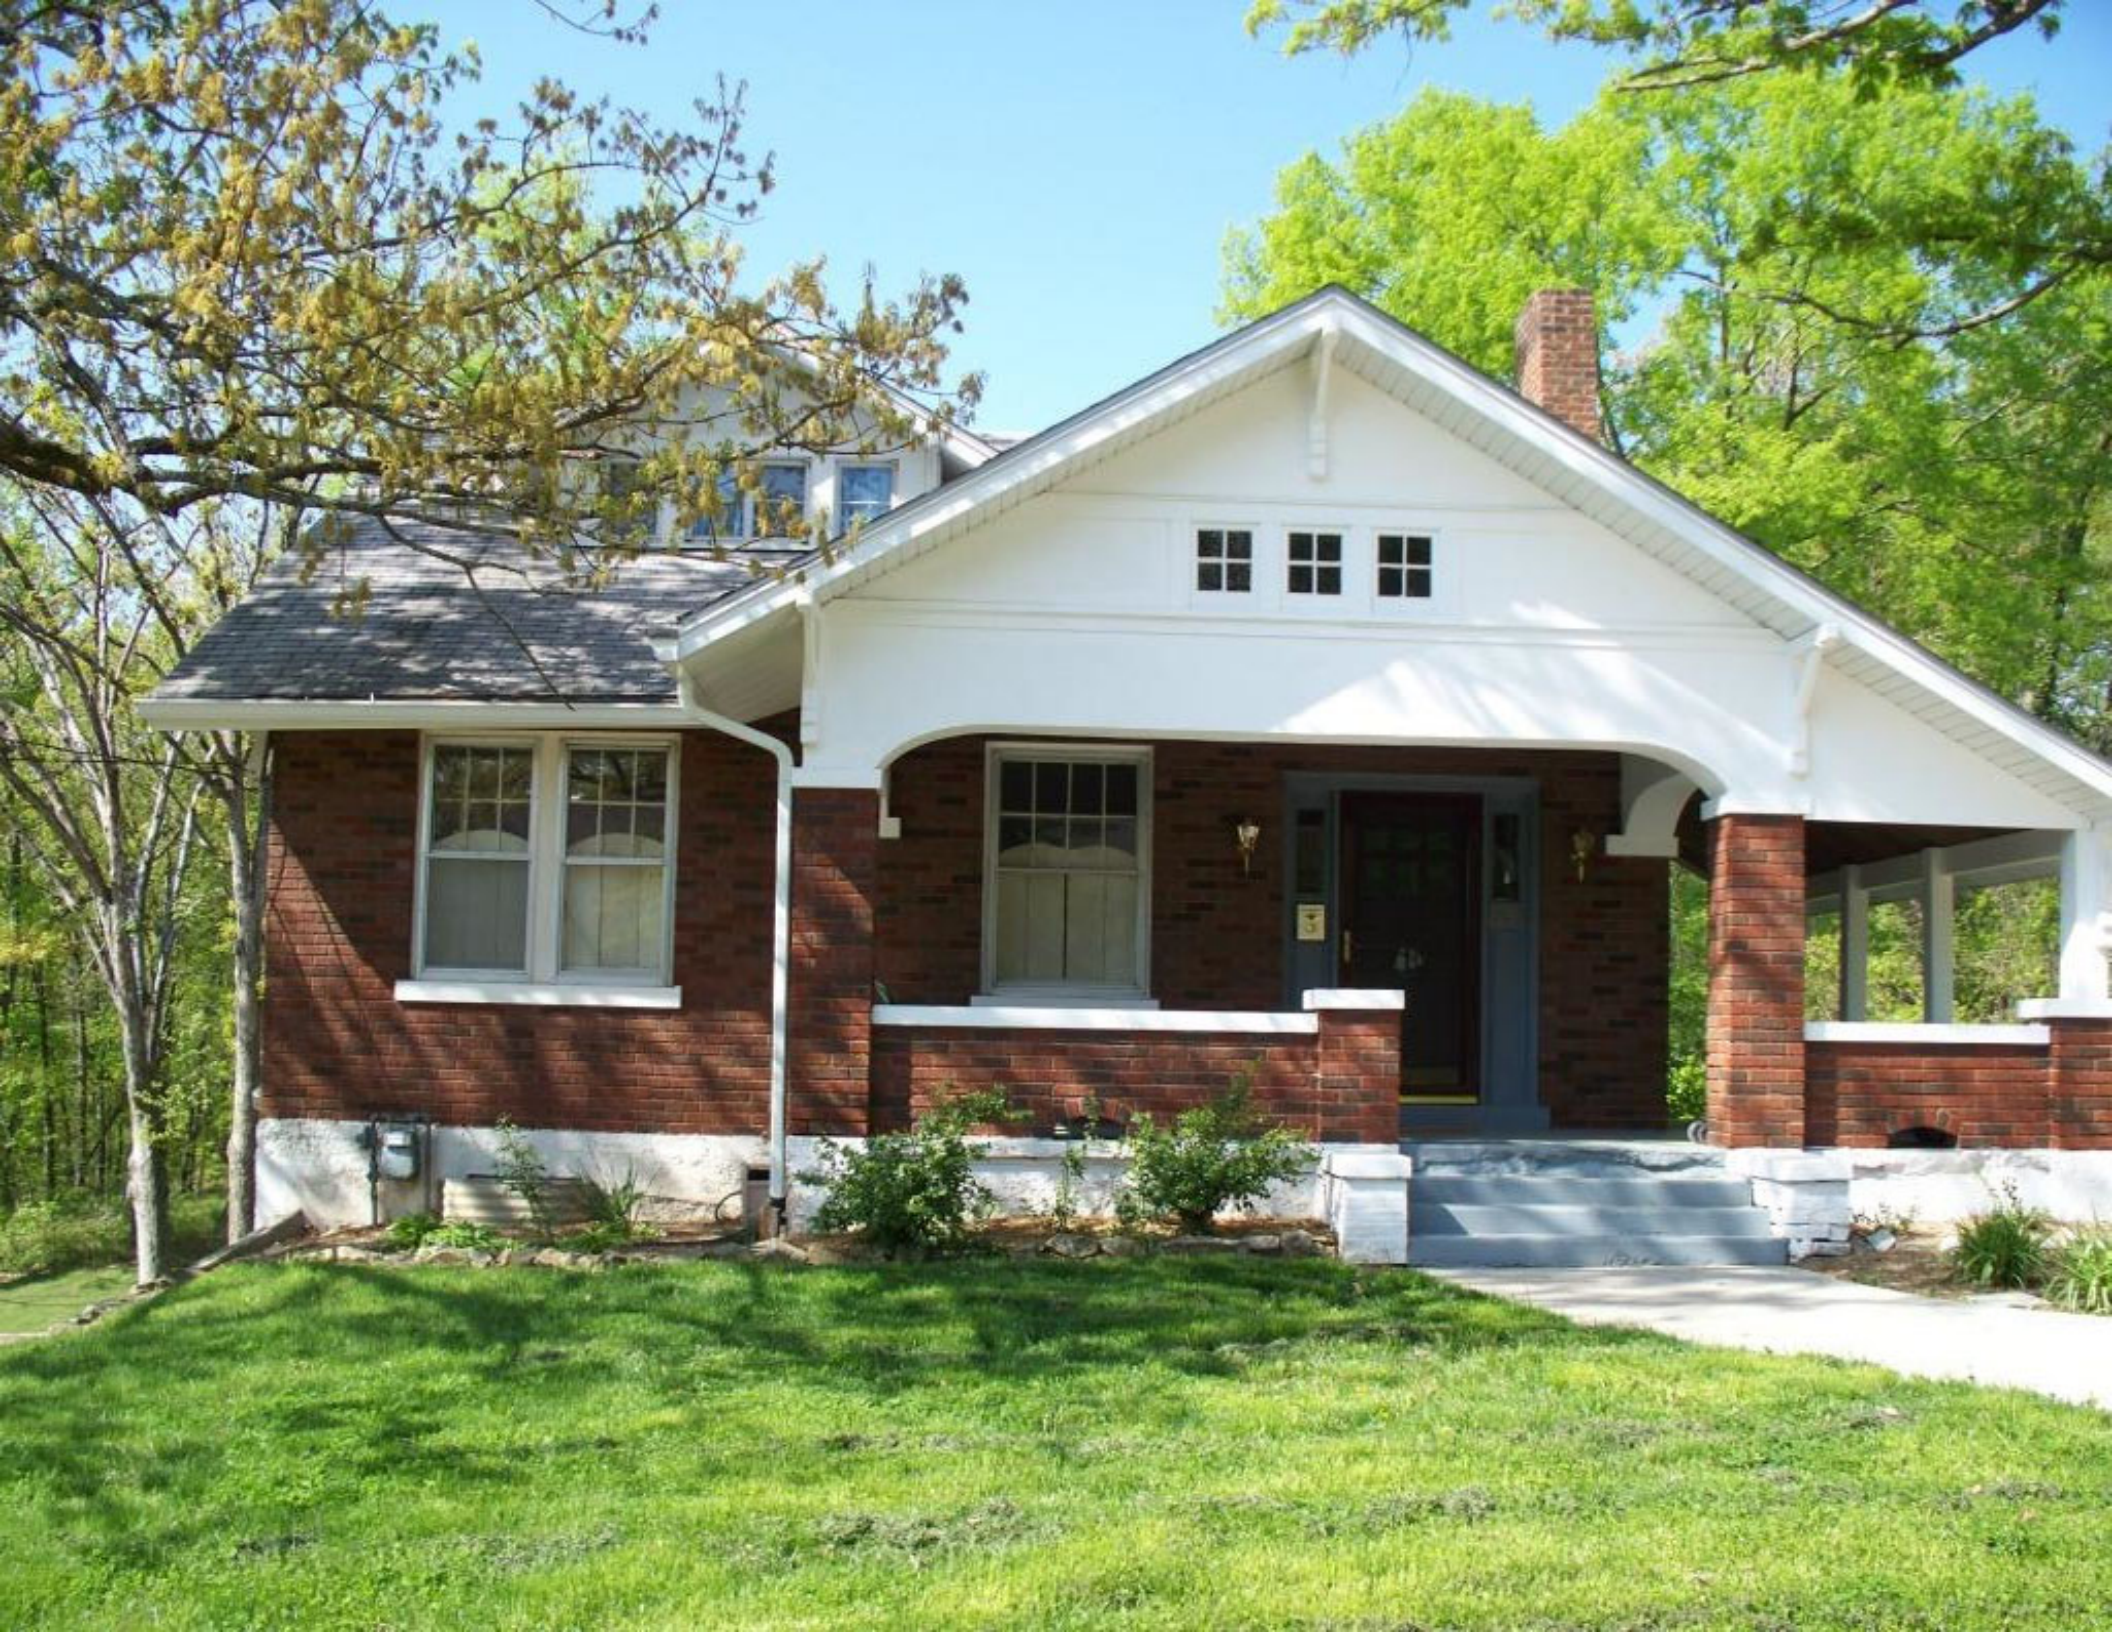
This 1 ½ story brick bungalow has a side gable roof and a gable dormer in the left bay. On the first floor in this bay is a paired 6/1 window. A large front gable projects over the center and right bay and acts as the porch roof. It slopes deeply at the right to cover the wrap around porch on the right side of the property. The gable is clad in plaster and features brackets and three small fixed, four-paned square windows in the peak. A row of molding is above and below the windows. The porch has a basket handle opening which rests on brick piers capped in concrete on the front and the left side. The central bay of the home has an 8/1 historic window and the right bay contains the entrance with a wooden door surround and sidelights. The porch has brick half walls, on the right side of the property the porch roof is supported by wooden square posts. A set of concrete stairs leads up to the entrance.

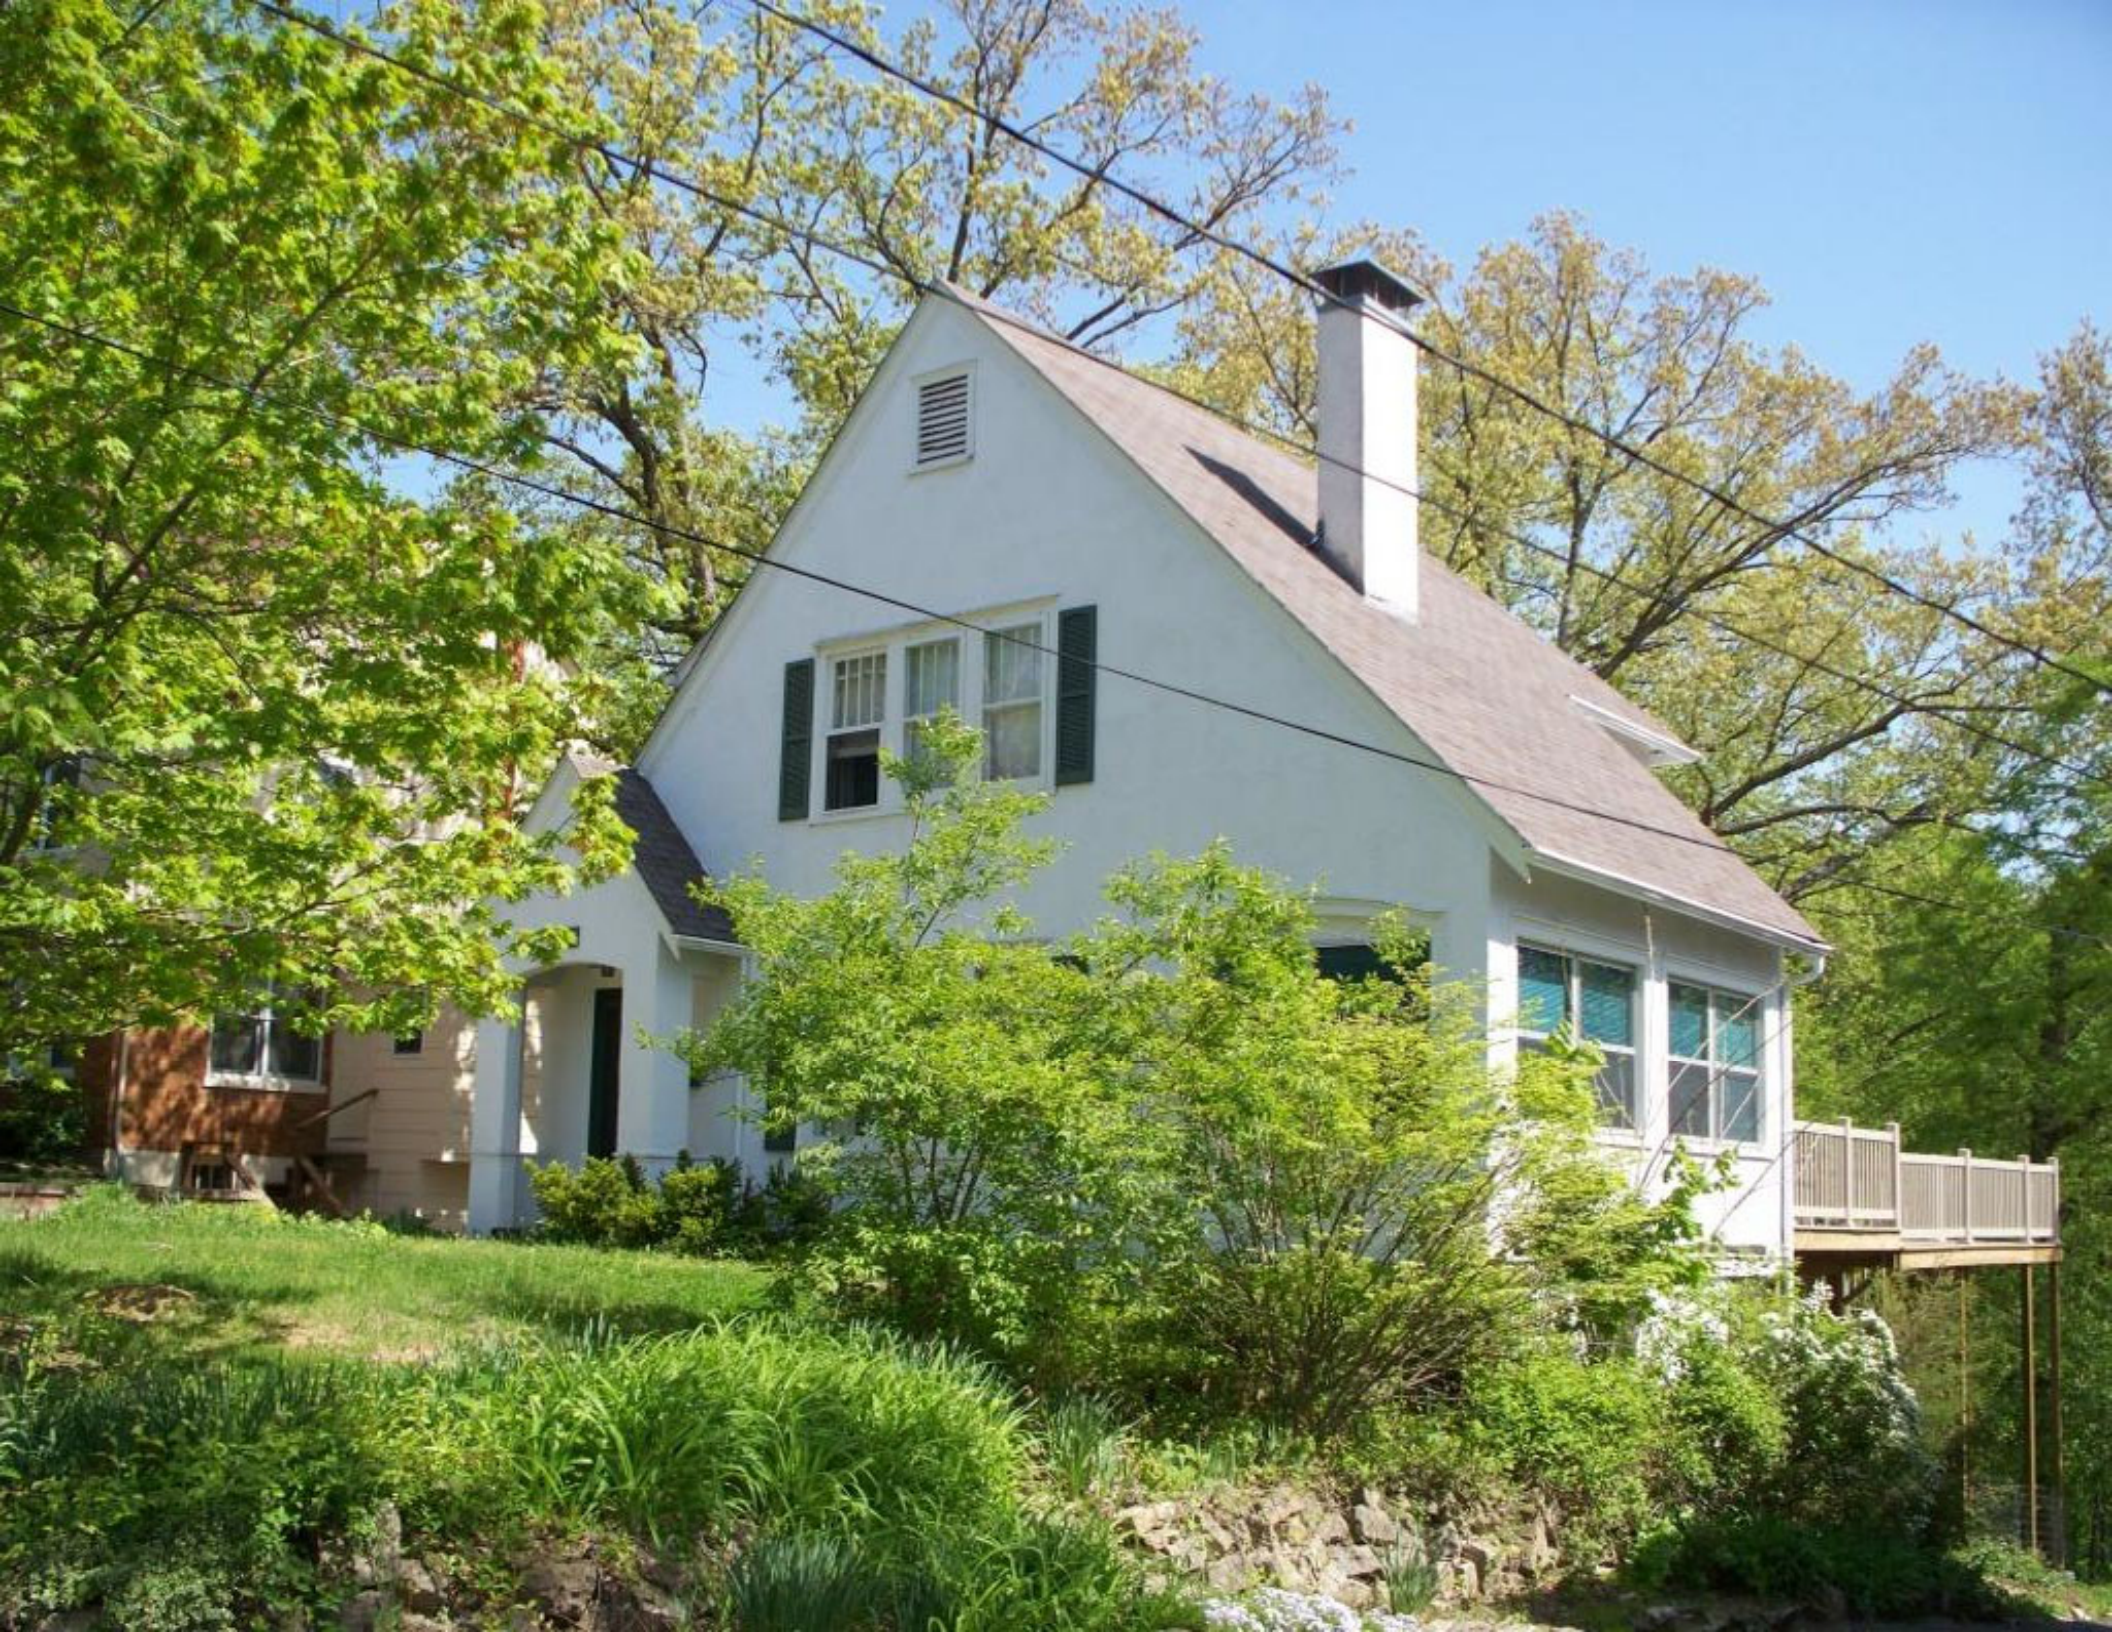
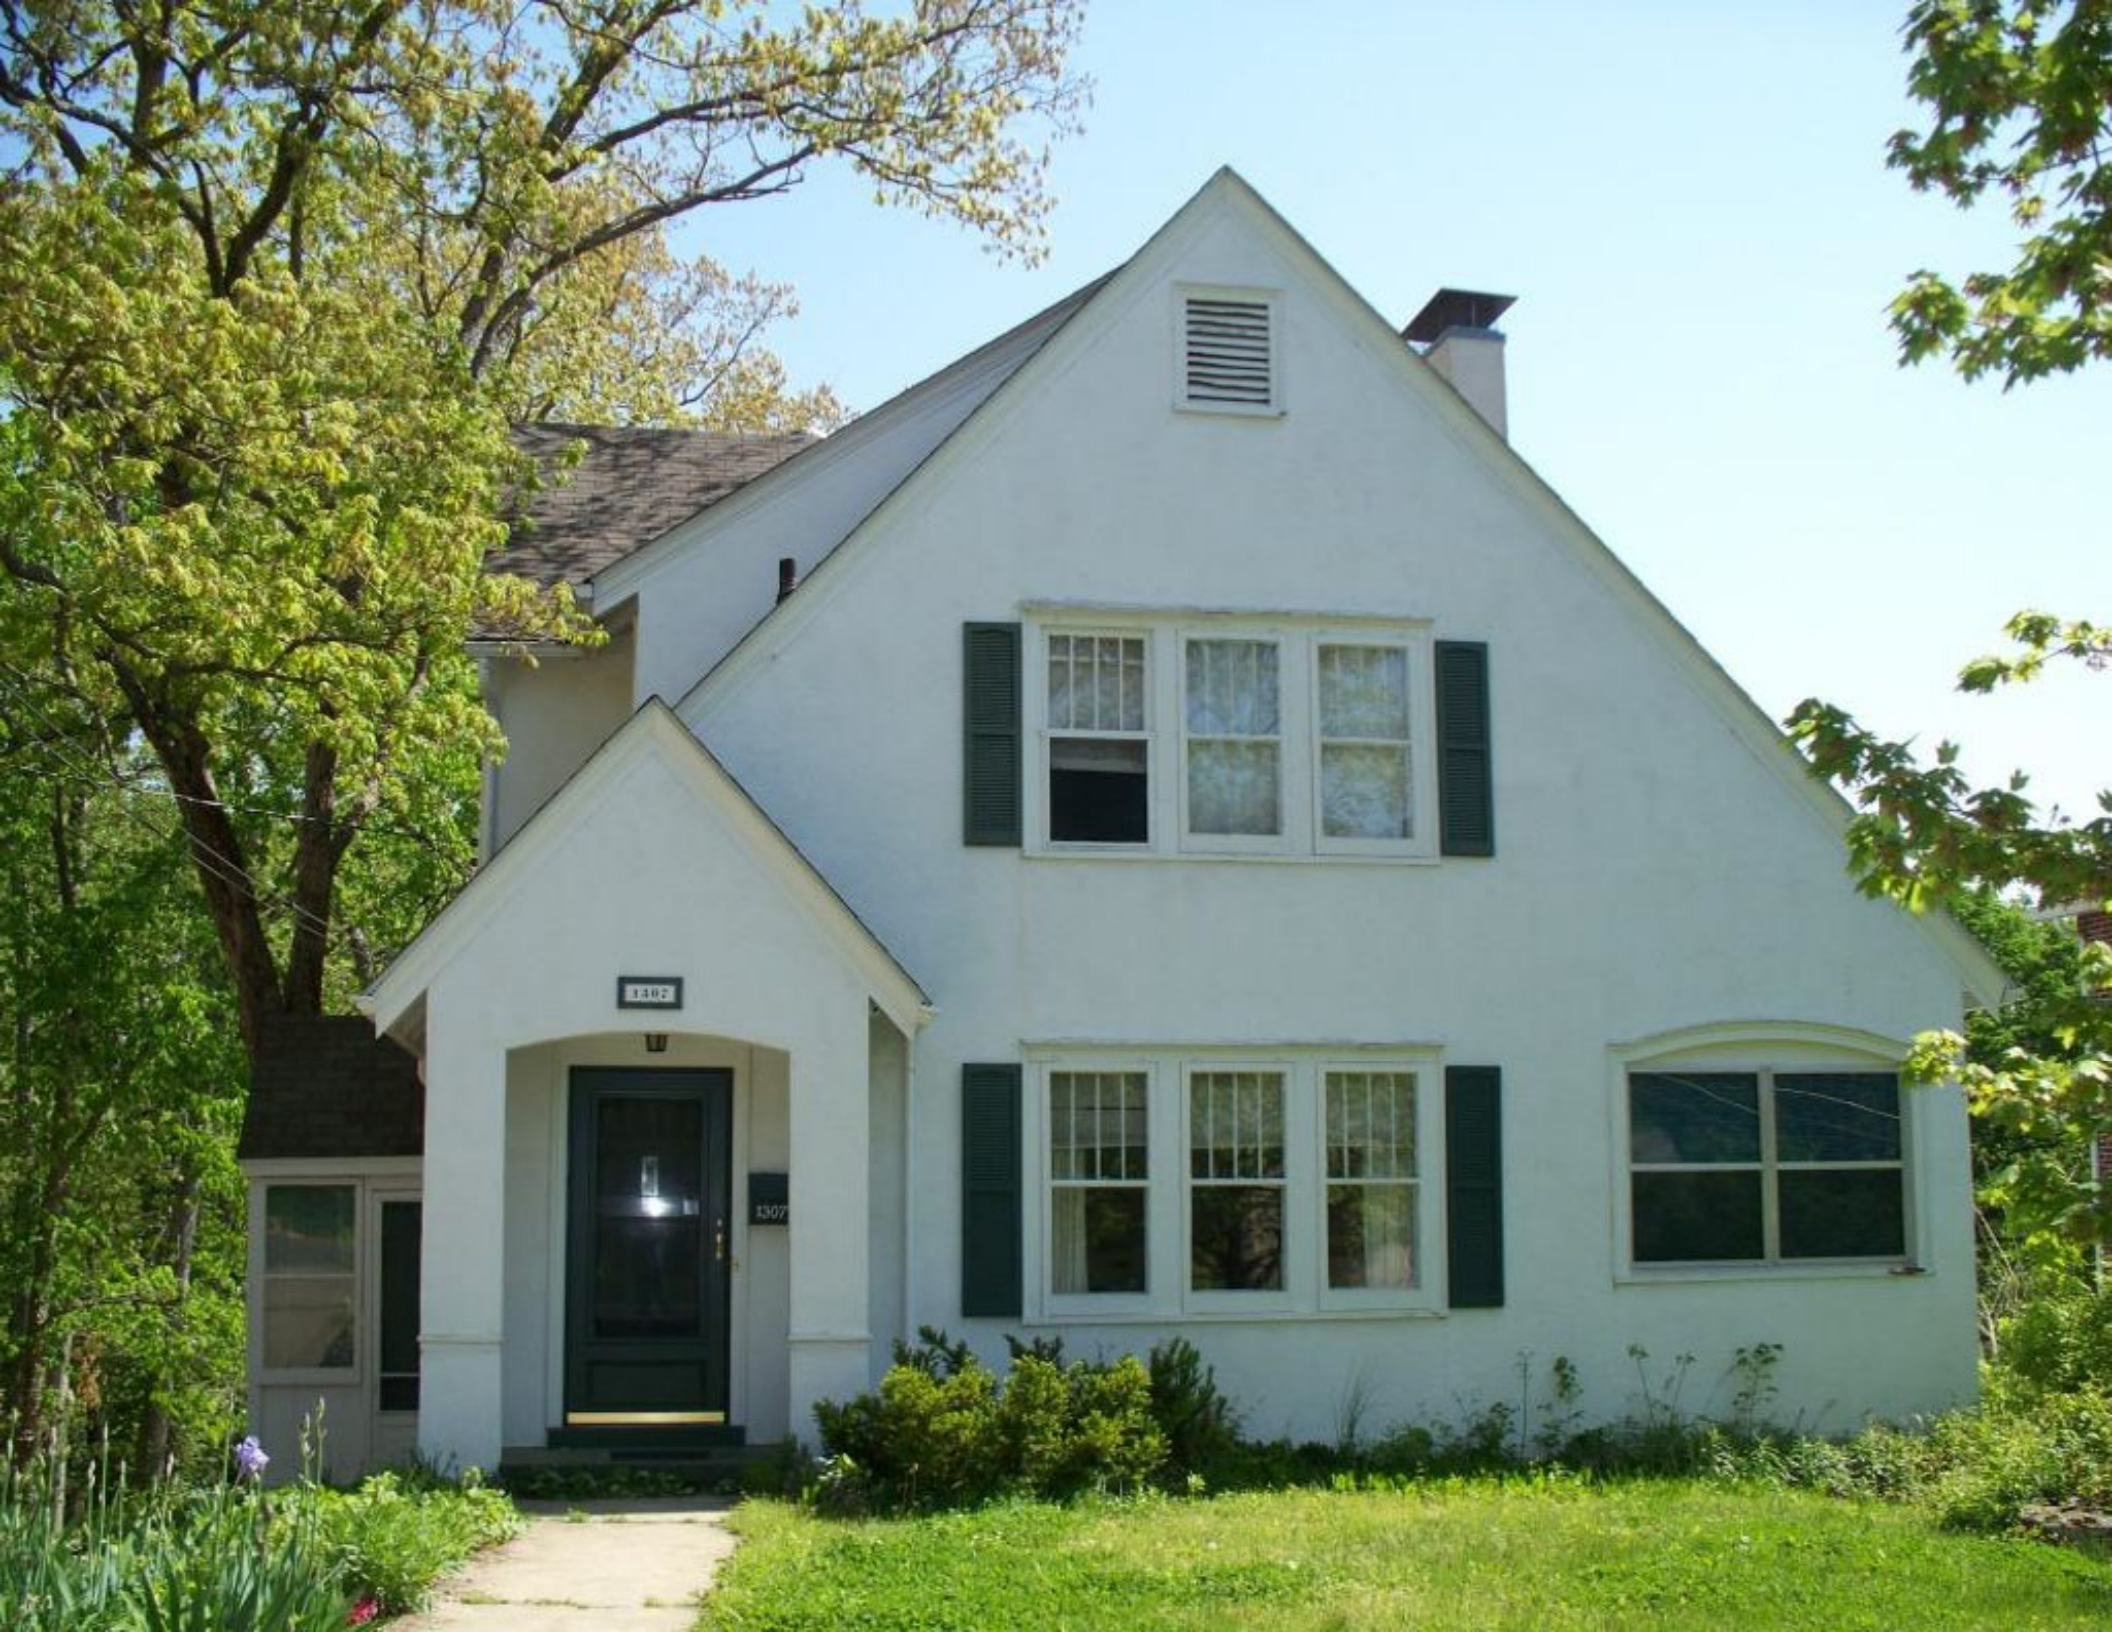
This 1 ½ - 2 story stucco home has a gable roof with an additional shed and gable dormer off of the side of the left slope. There is a vent in the peak of the gable roof. The upper floor has a row of three 4/1 historic windows with shutters. On the first floor the left bay contains the entrance and a projecting gabled portico with a segmental arched opening. The center bay has a row of three historic 4/1 windows with shutters. The right bay has a segmental arched opening that has been in-filled with paired replacement 1/1 aluminum windows. It's possible this was once an open porch. An additional side-gabled bay is set back and projects from the left side of the home and contains an additional entrance and 1/1 window.

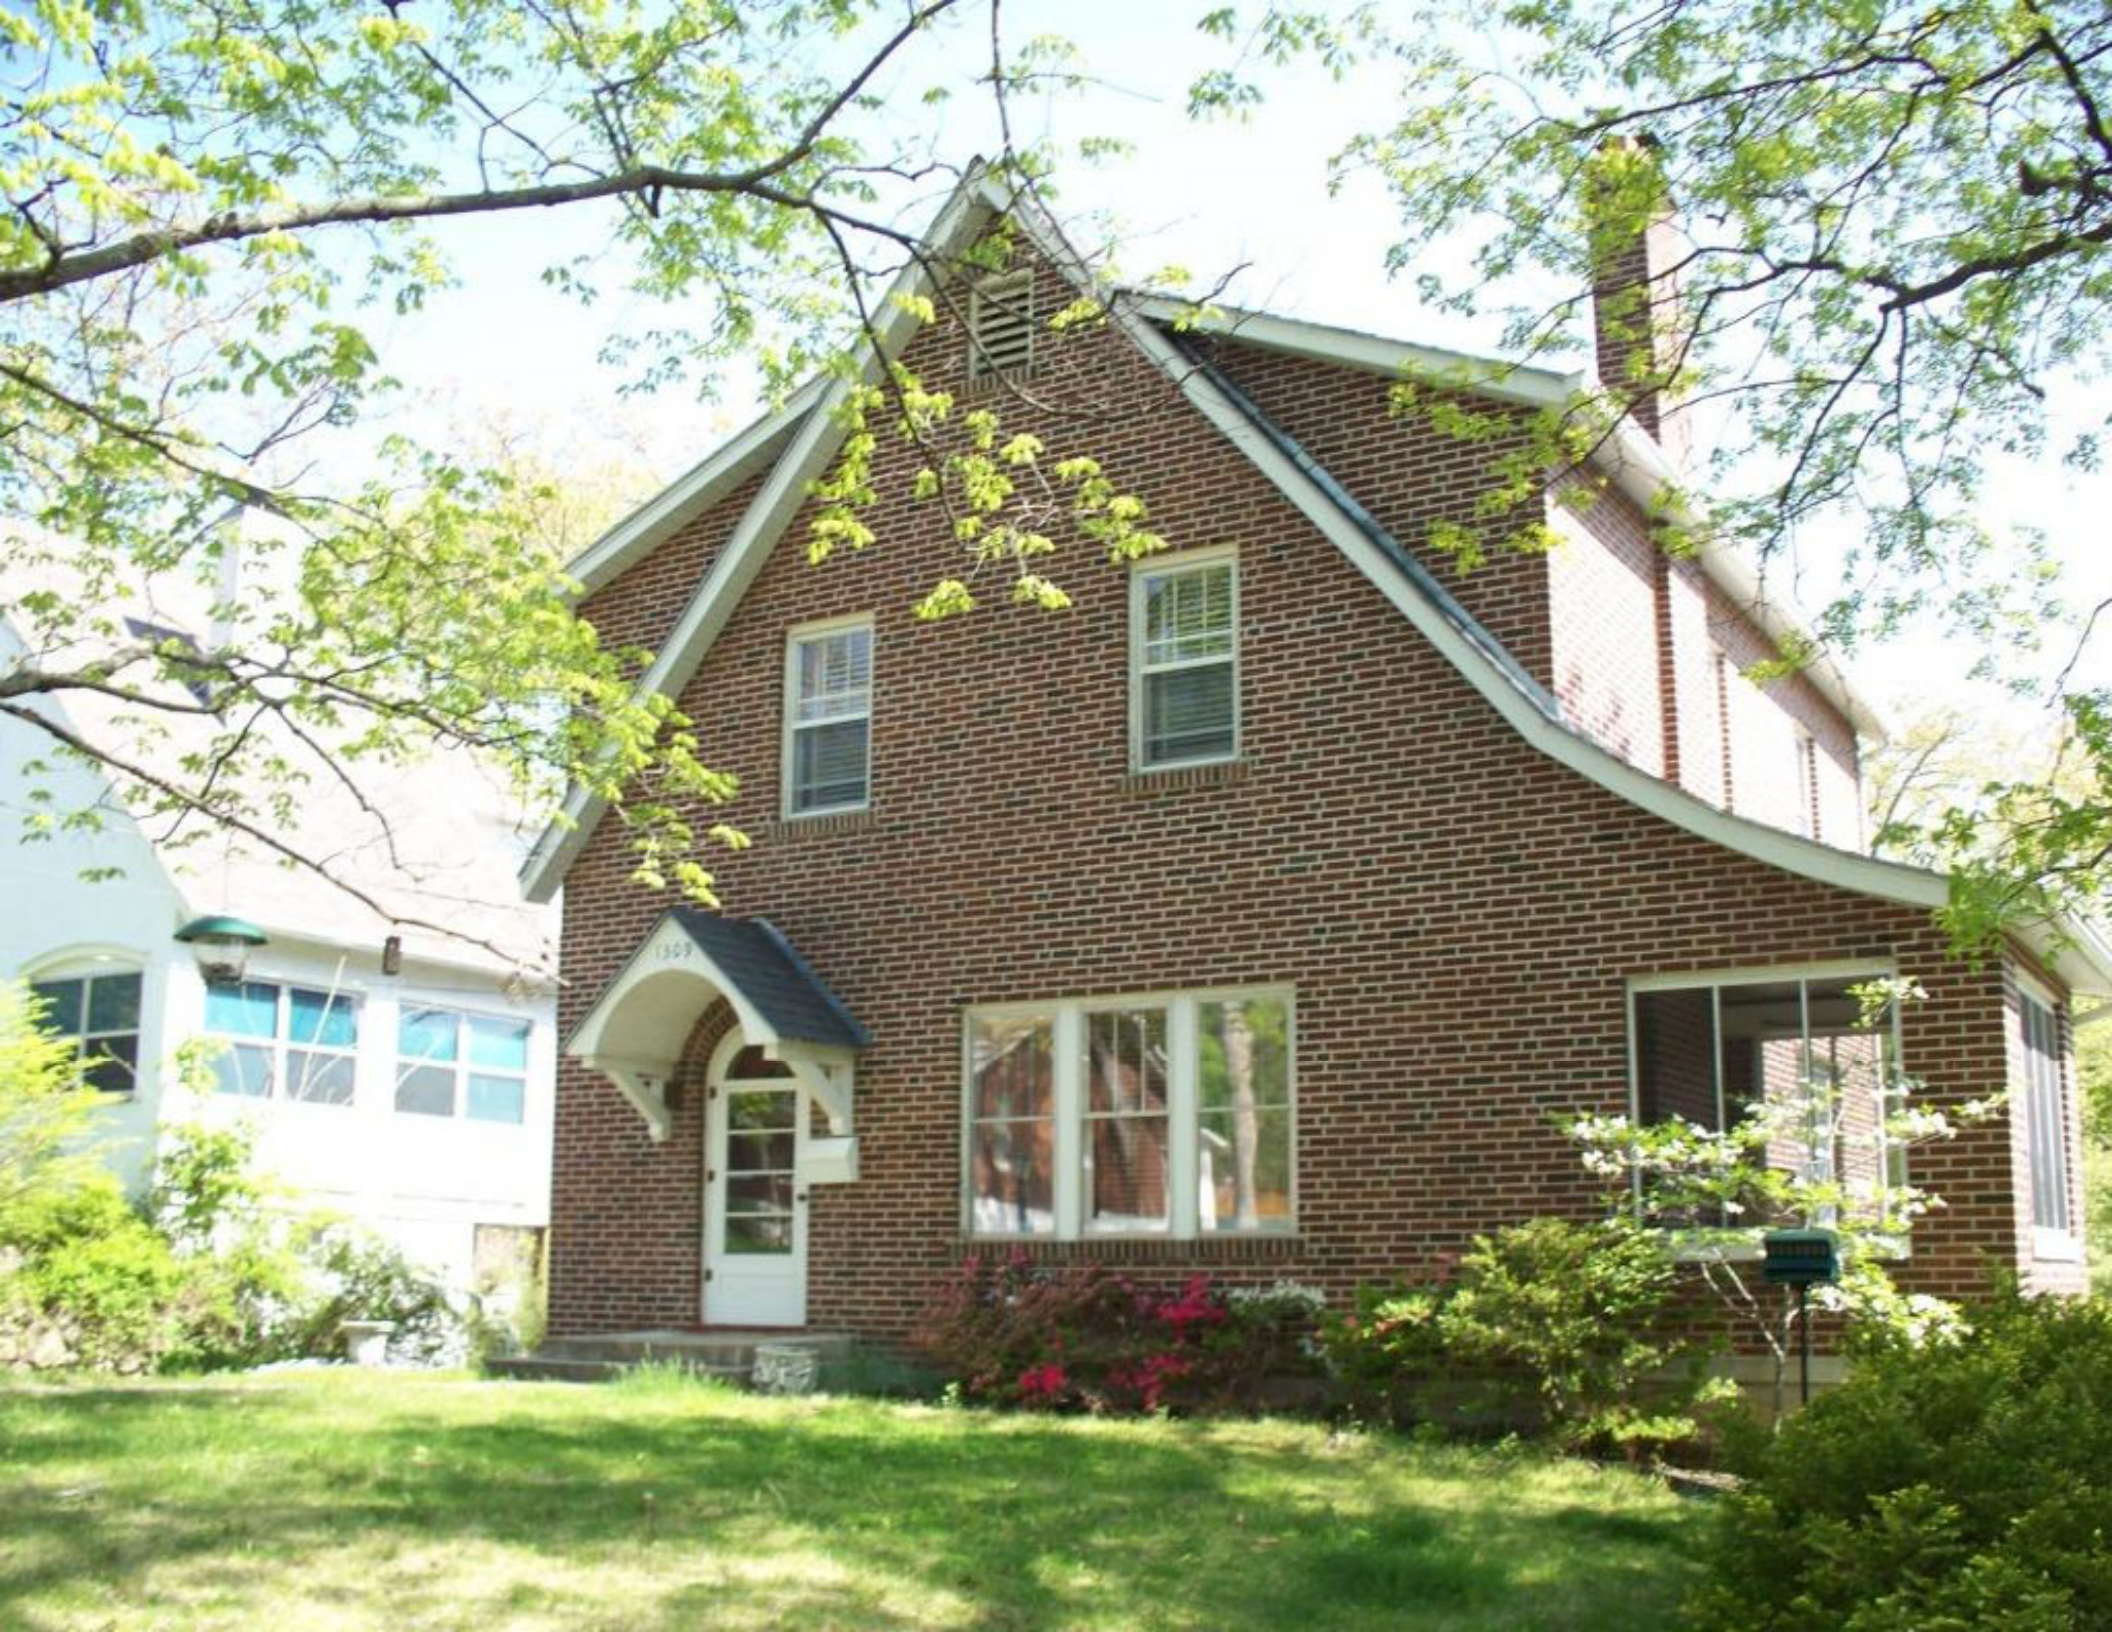
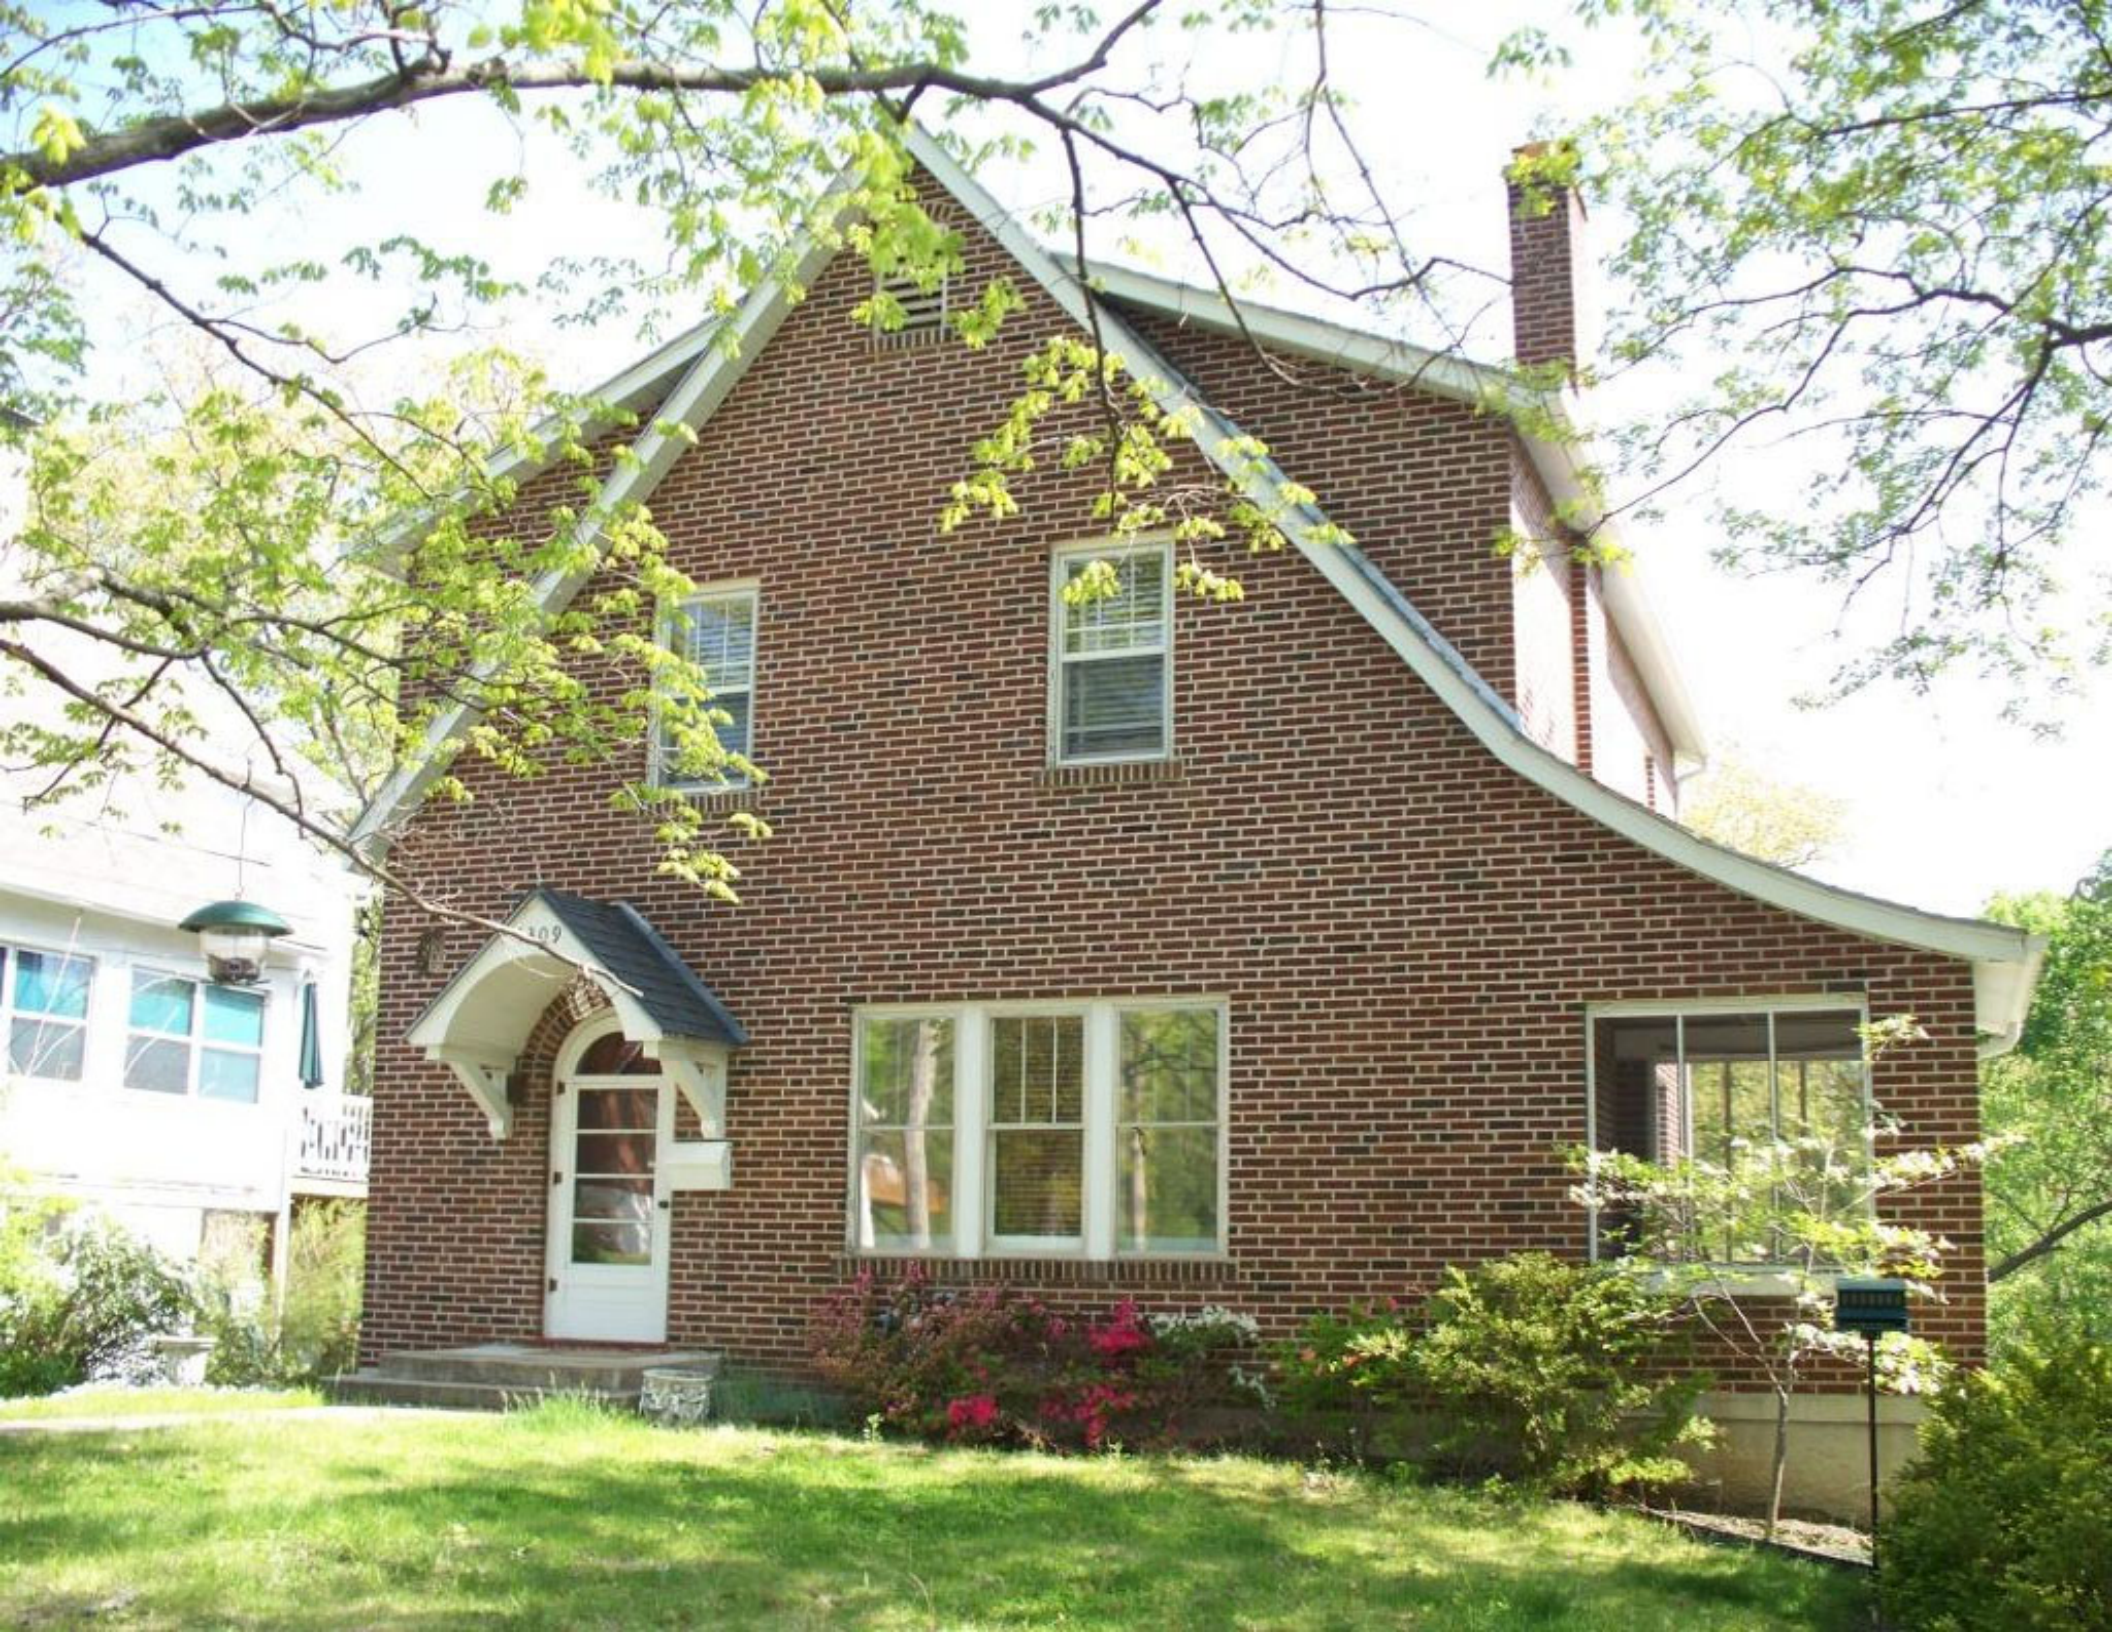
This 1 ½ - 2 story brick home has a gable roof with an additional steeply pitched gable overhang projecting slightly under the initial gable. The steeply pitched gable sweeps lower to the right and flares over an enclosed sun porch, which gives the property its Tudor look. There are two historic 3/1 windows in the upper floor. The lower floor has an arched entryway and door in the left bay that is covered by a gable hood with knee braces and an arched entablature. There is also a concrete stoop and step in this bay. The center bay has a row of historic 3/1 windows. The final bay to the right appears to have once been an open porch with brick piers but is currently enclosed with large 3-light panes of glass.
