ARCHITECTURAL/HISTORIC INVENTORY FORM

1. Survey No. CO-AS-005-001		2. Survey name: Moreau Drive Neighborhood Survey	
3. County: Cole		4. Address: 1202 Elmerine Ave.	
5. City: Jefferson City	Vicinity: <input type="checkbox"/>	6. UTM: / /	7. Township/Range/Section: T: R: S:
8. Historic name (if known):		9. Present/other name (if known):	
10. Ownership: <input checked="" type="checkbox"/> Private <input type="checkbox"/> Public		11. Historic use (if known): Residential	11. Current use: Residential

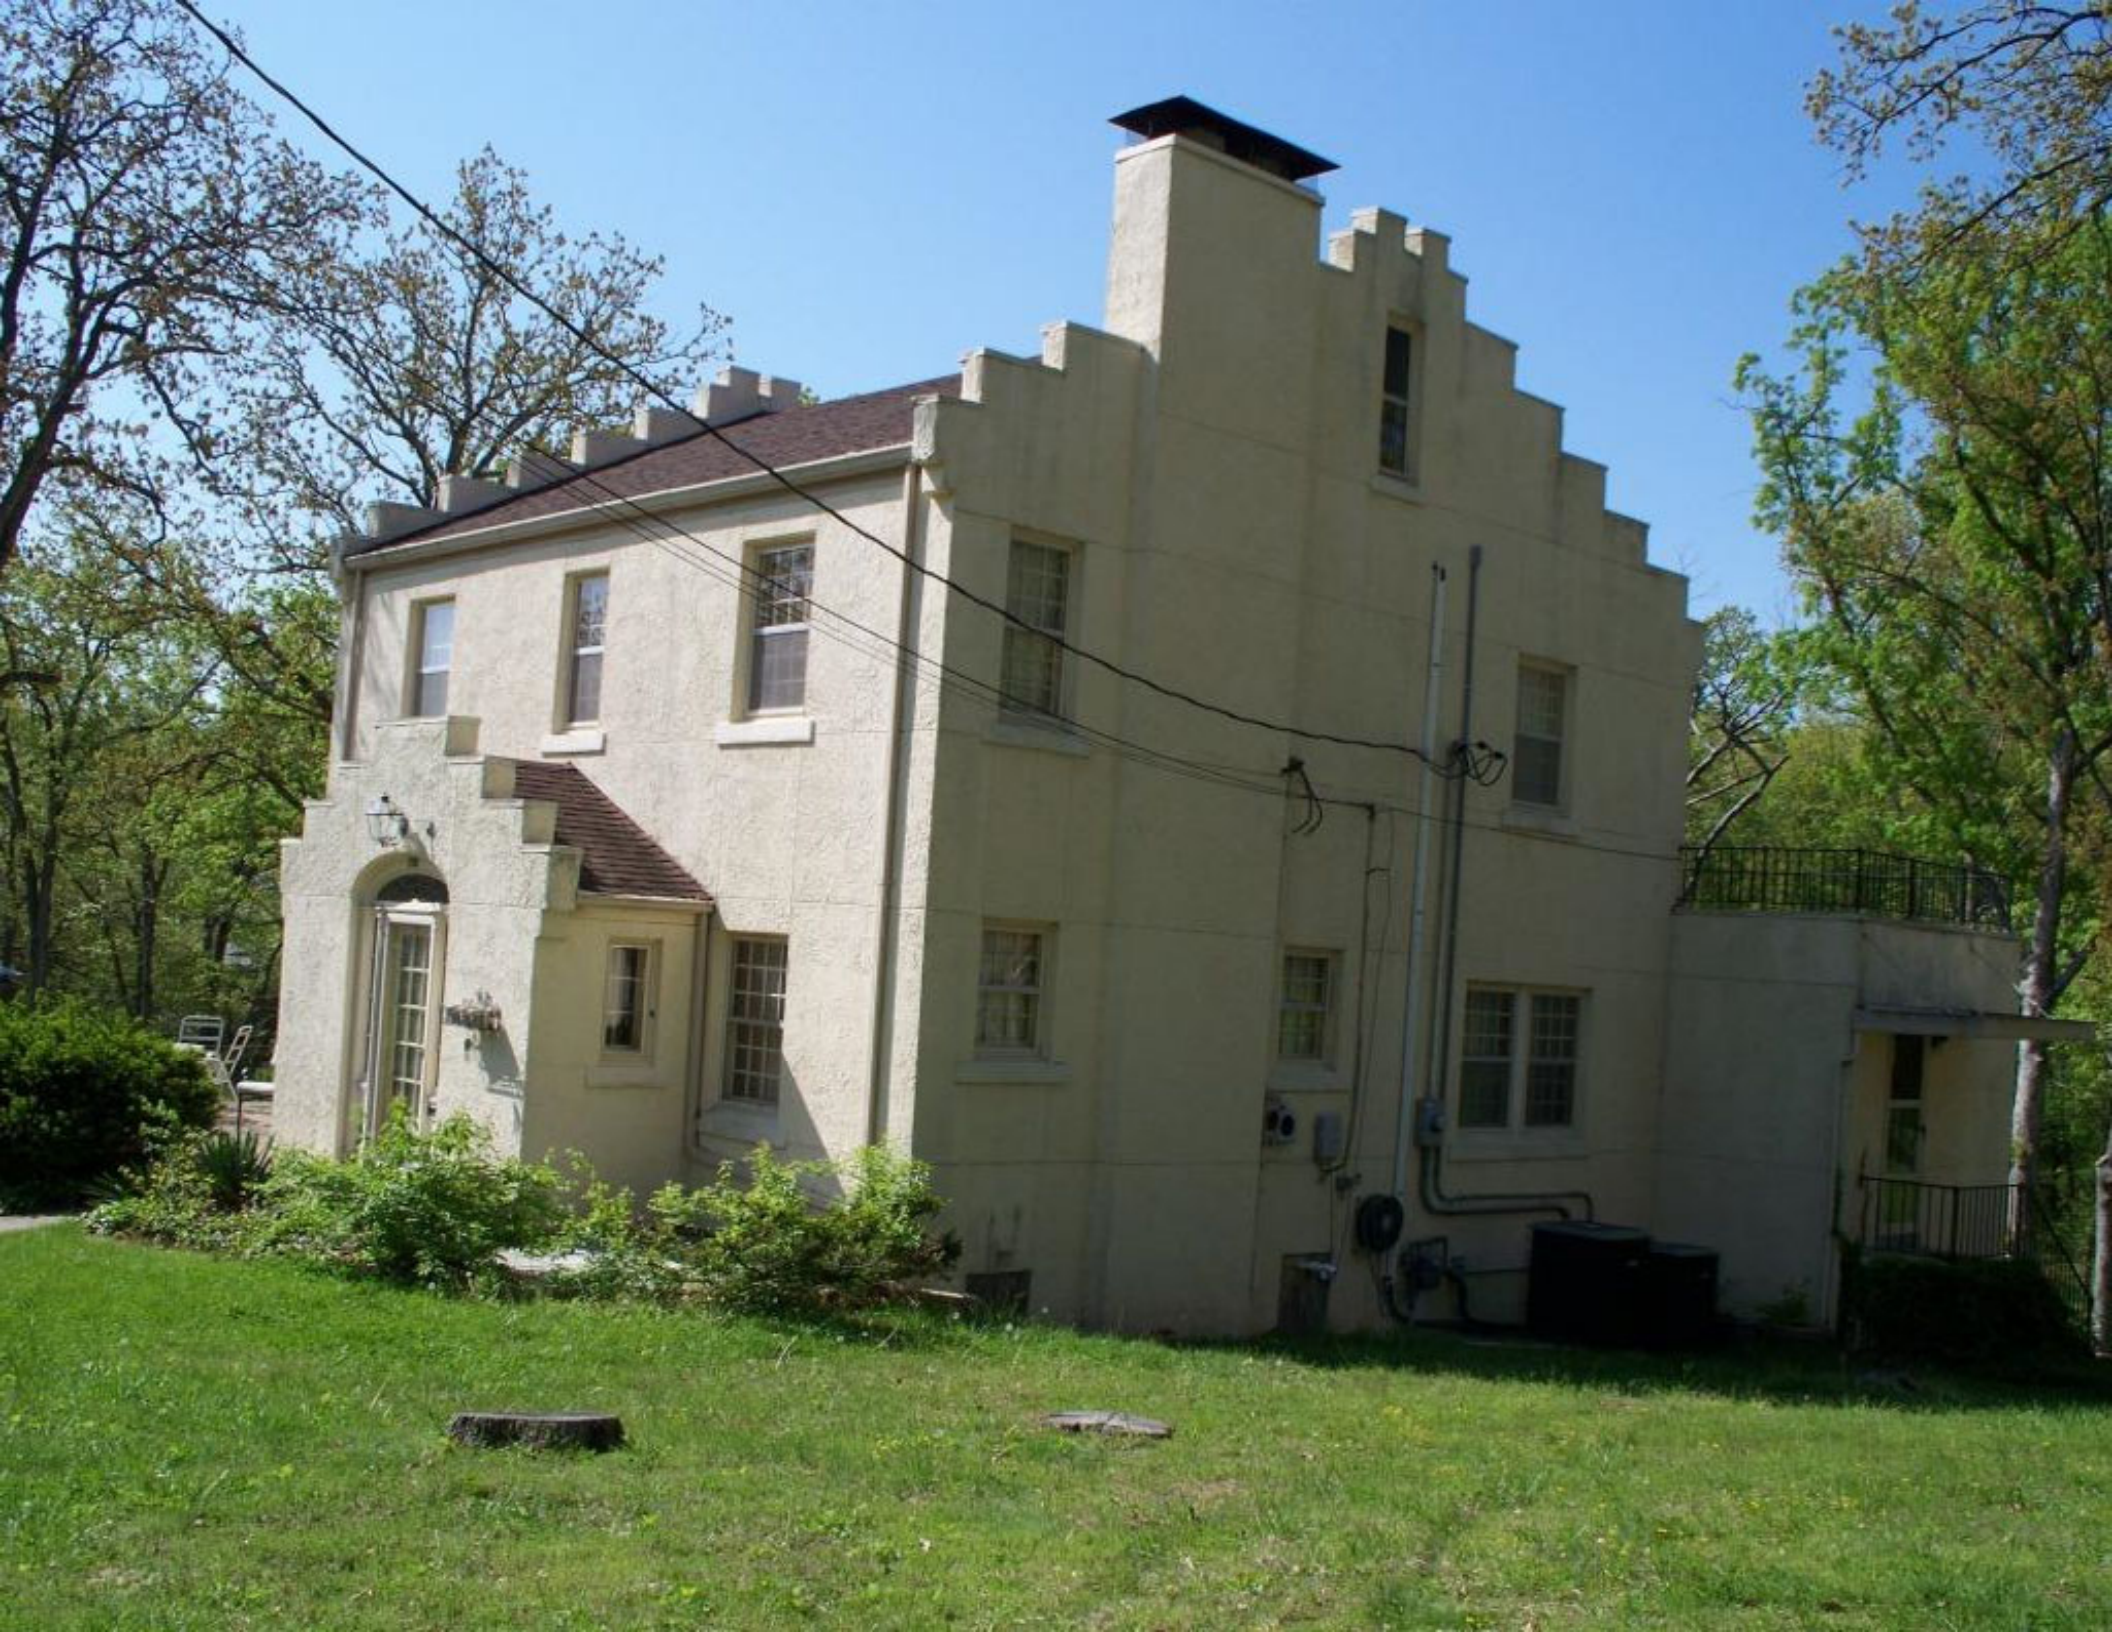
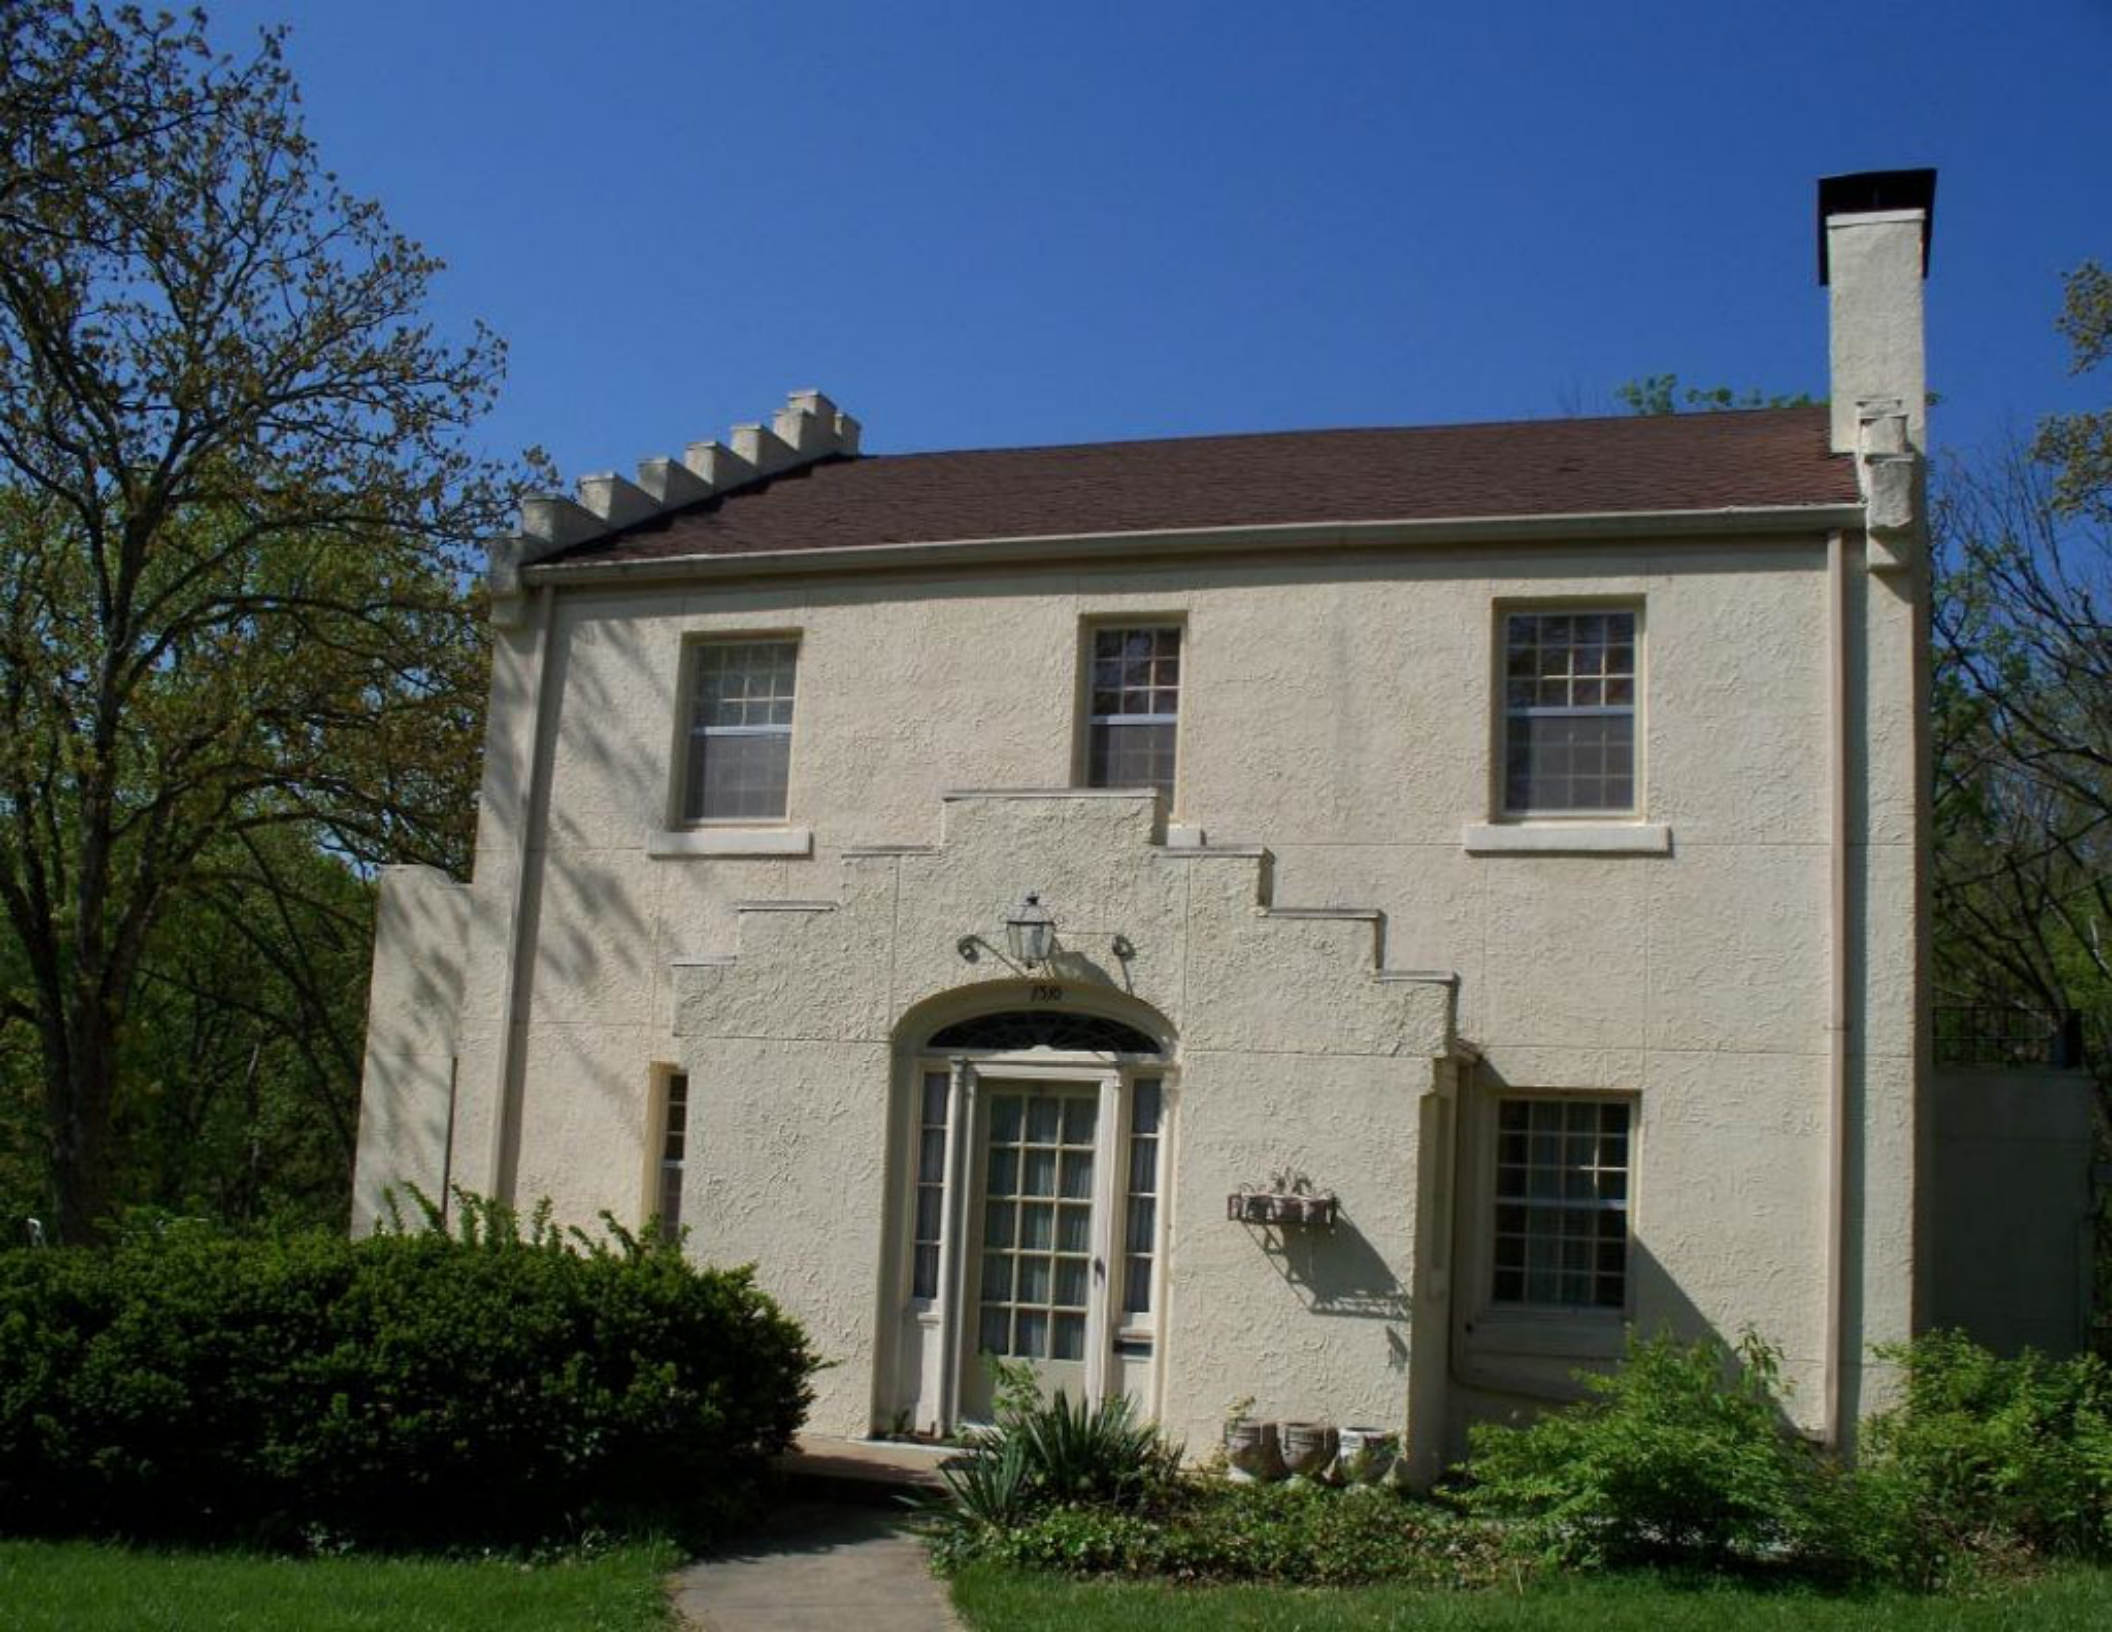
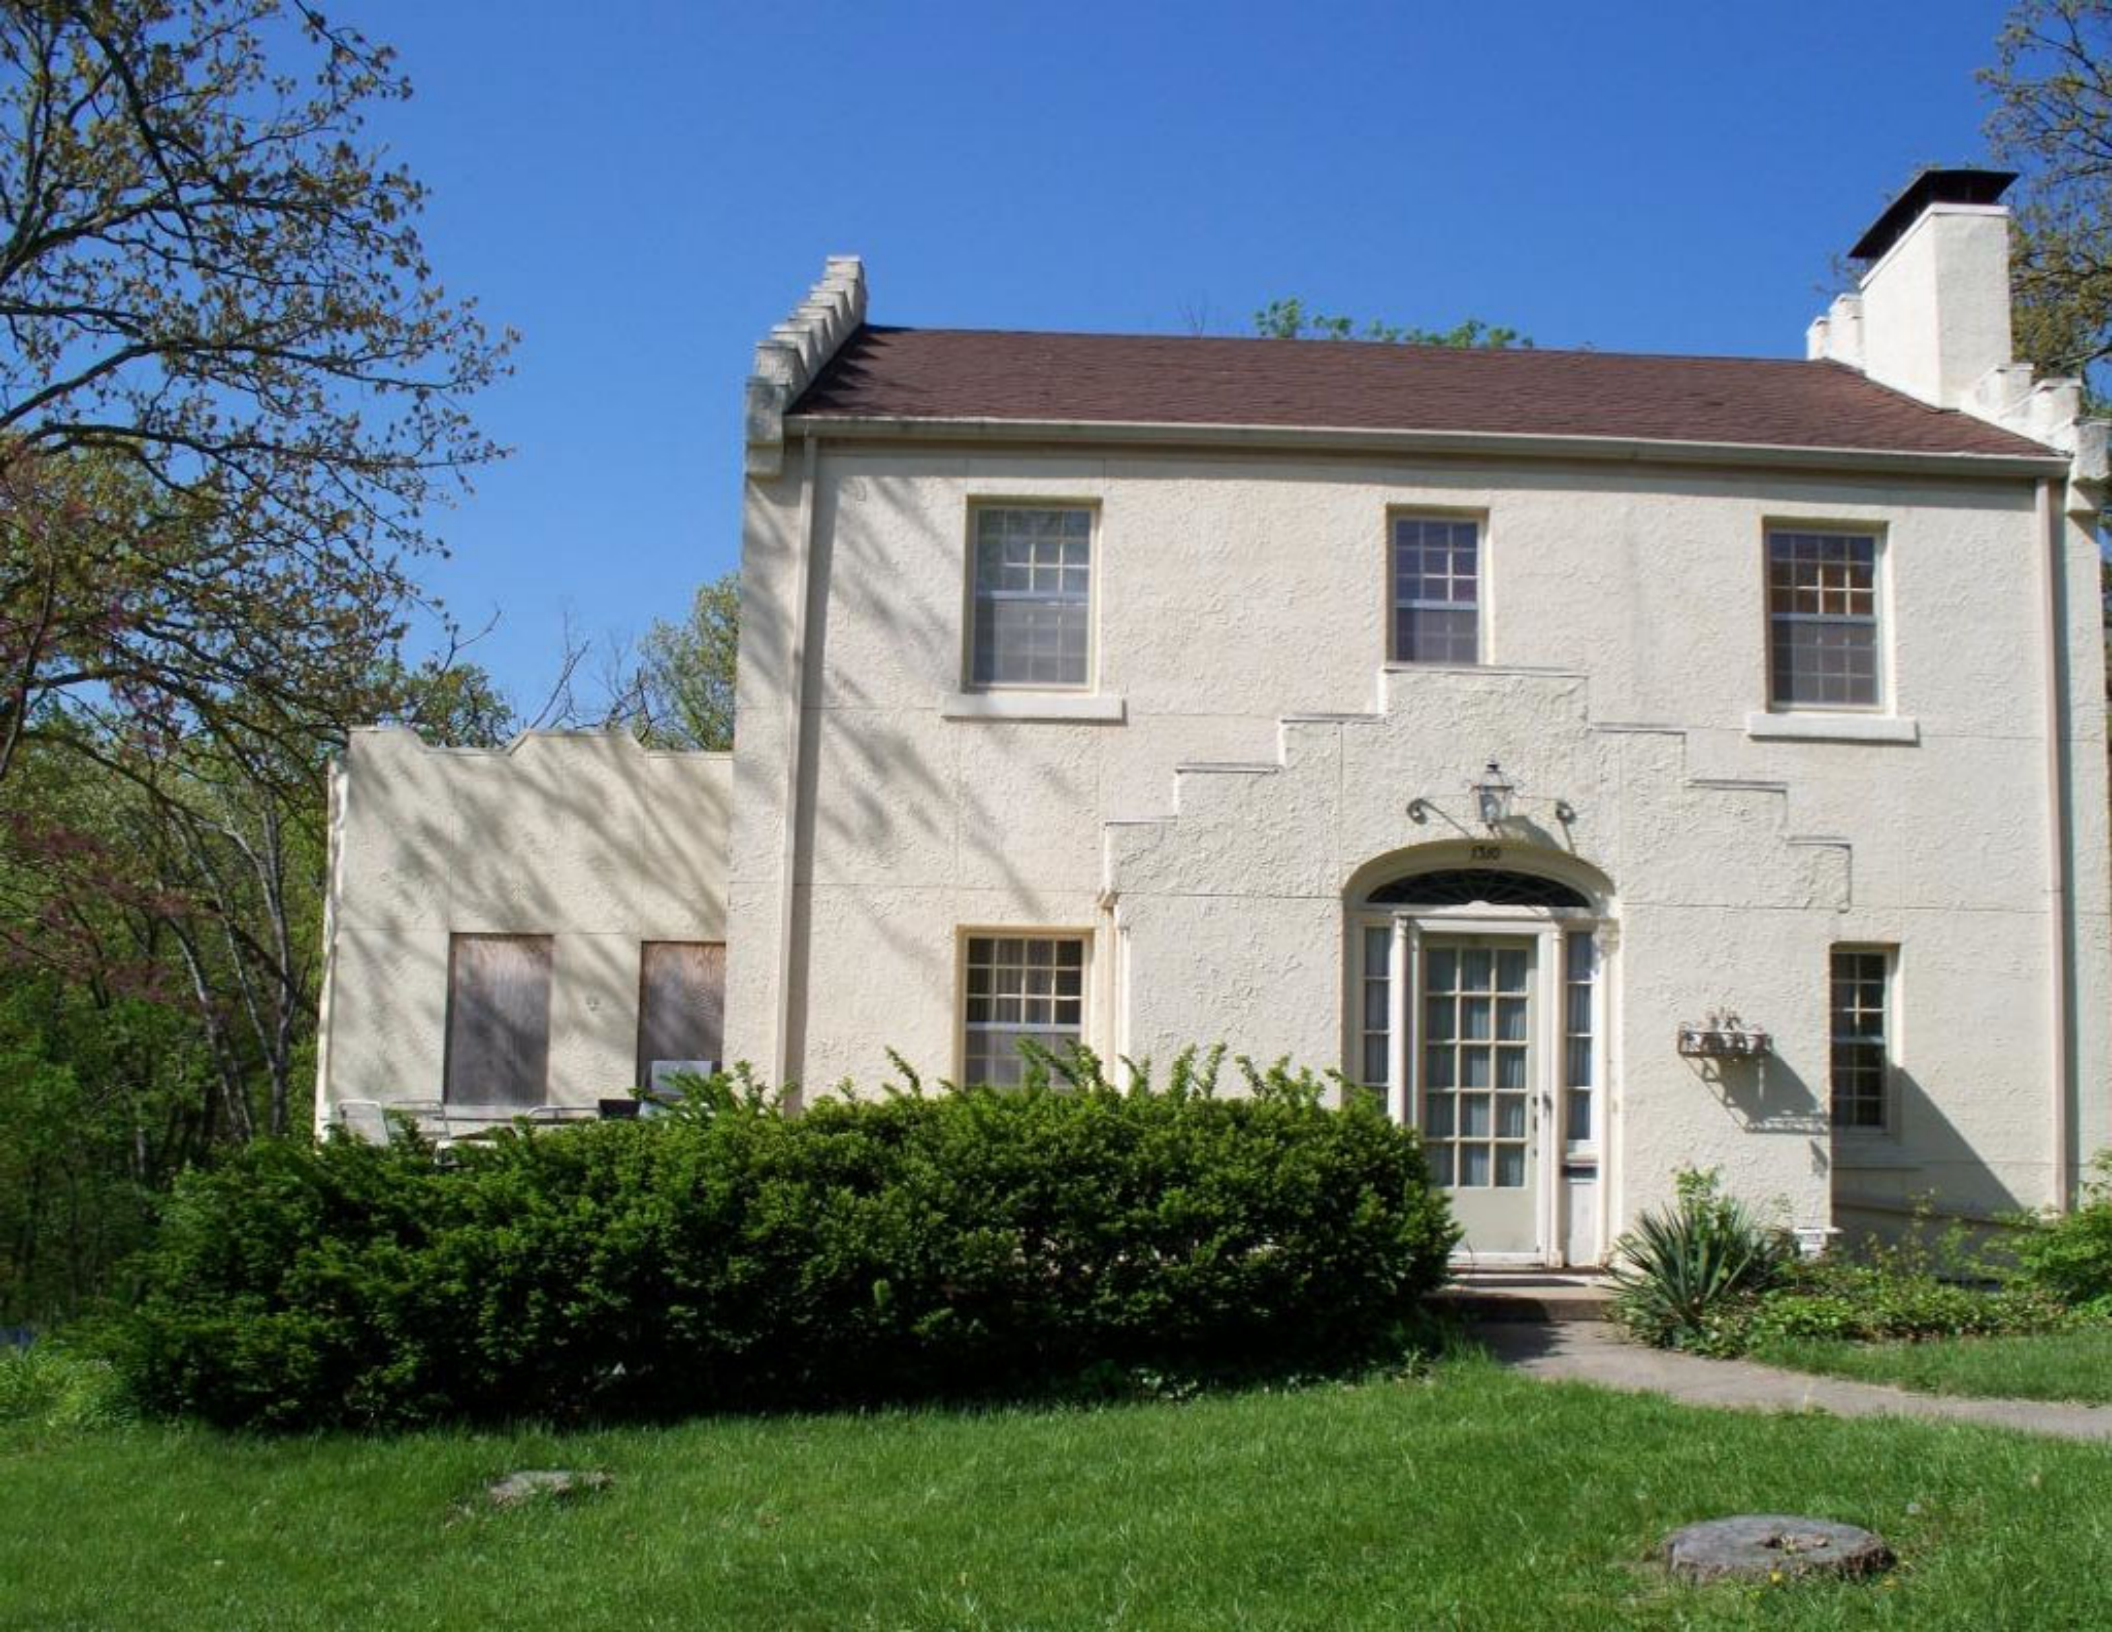
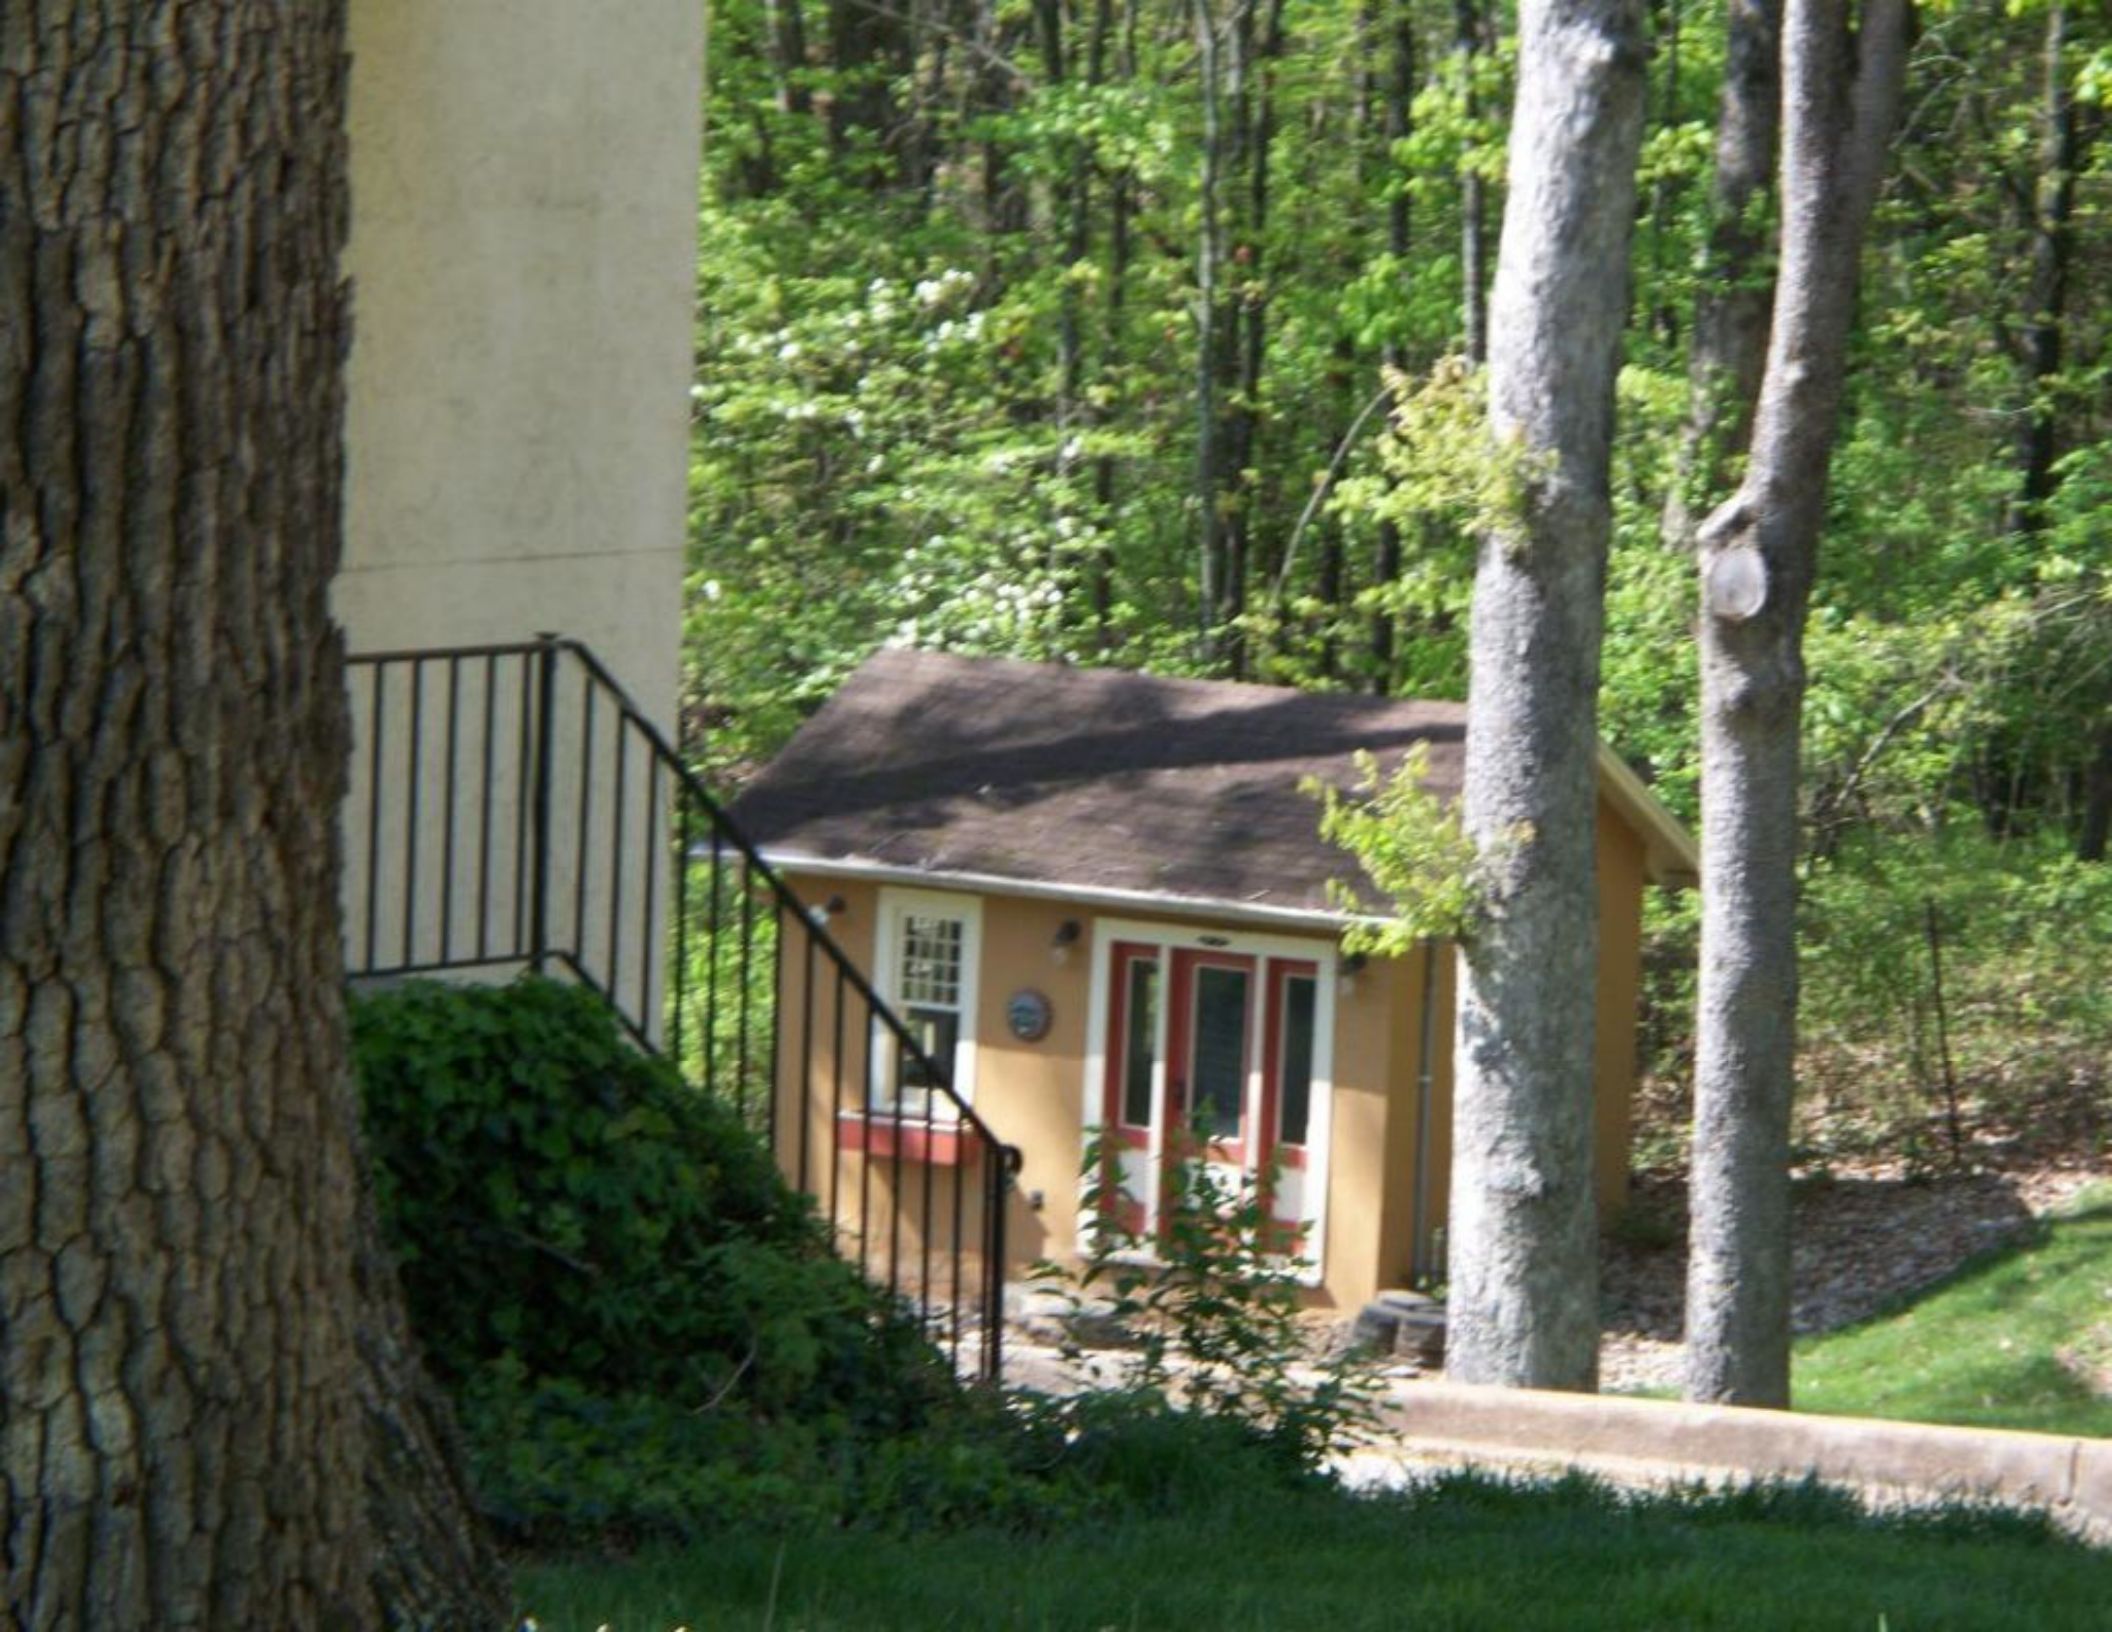
40. (cont.) Description of environment and outbuildings. Expand box as necessary, or add continuation pages.
There is a non-historic children's play house at the back of the property.

41. (cont.)
This is an interesting home. This two-story home has been clad in Dryvit or scored stucco. Its most prominent features are the stepped parapets that rise over the sides of the side gabled roof and frame the one story center projection. The second story has three multi-paned modern windows (two larger flanking a smaller center window). The first floor has two multi-paned modern windows flanking the centered entrance. The center bay projects and has a stepped parapet and contains the entrance which features a fan transom and sidelights (a Colonial Revival feature). An additional bay with two windows (boarded) is set back on the left side of the property. It also has a shaped parapet. The parapets and stucco suggest a Mission style influence. This may have originally been a Colonial Revival considering the entrance. When the exterior cladding was applied will determine the contributing status of this property. However, for the purposes of this survey it is considered contributing.

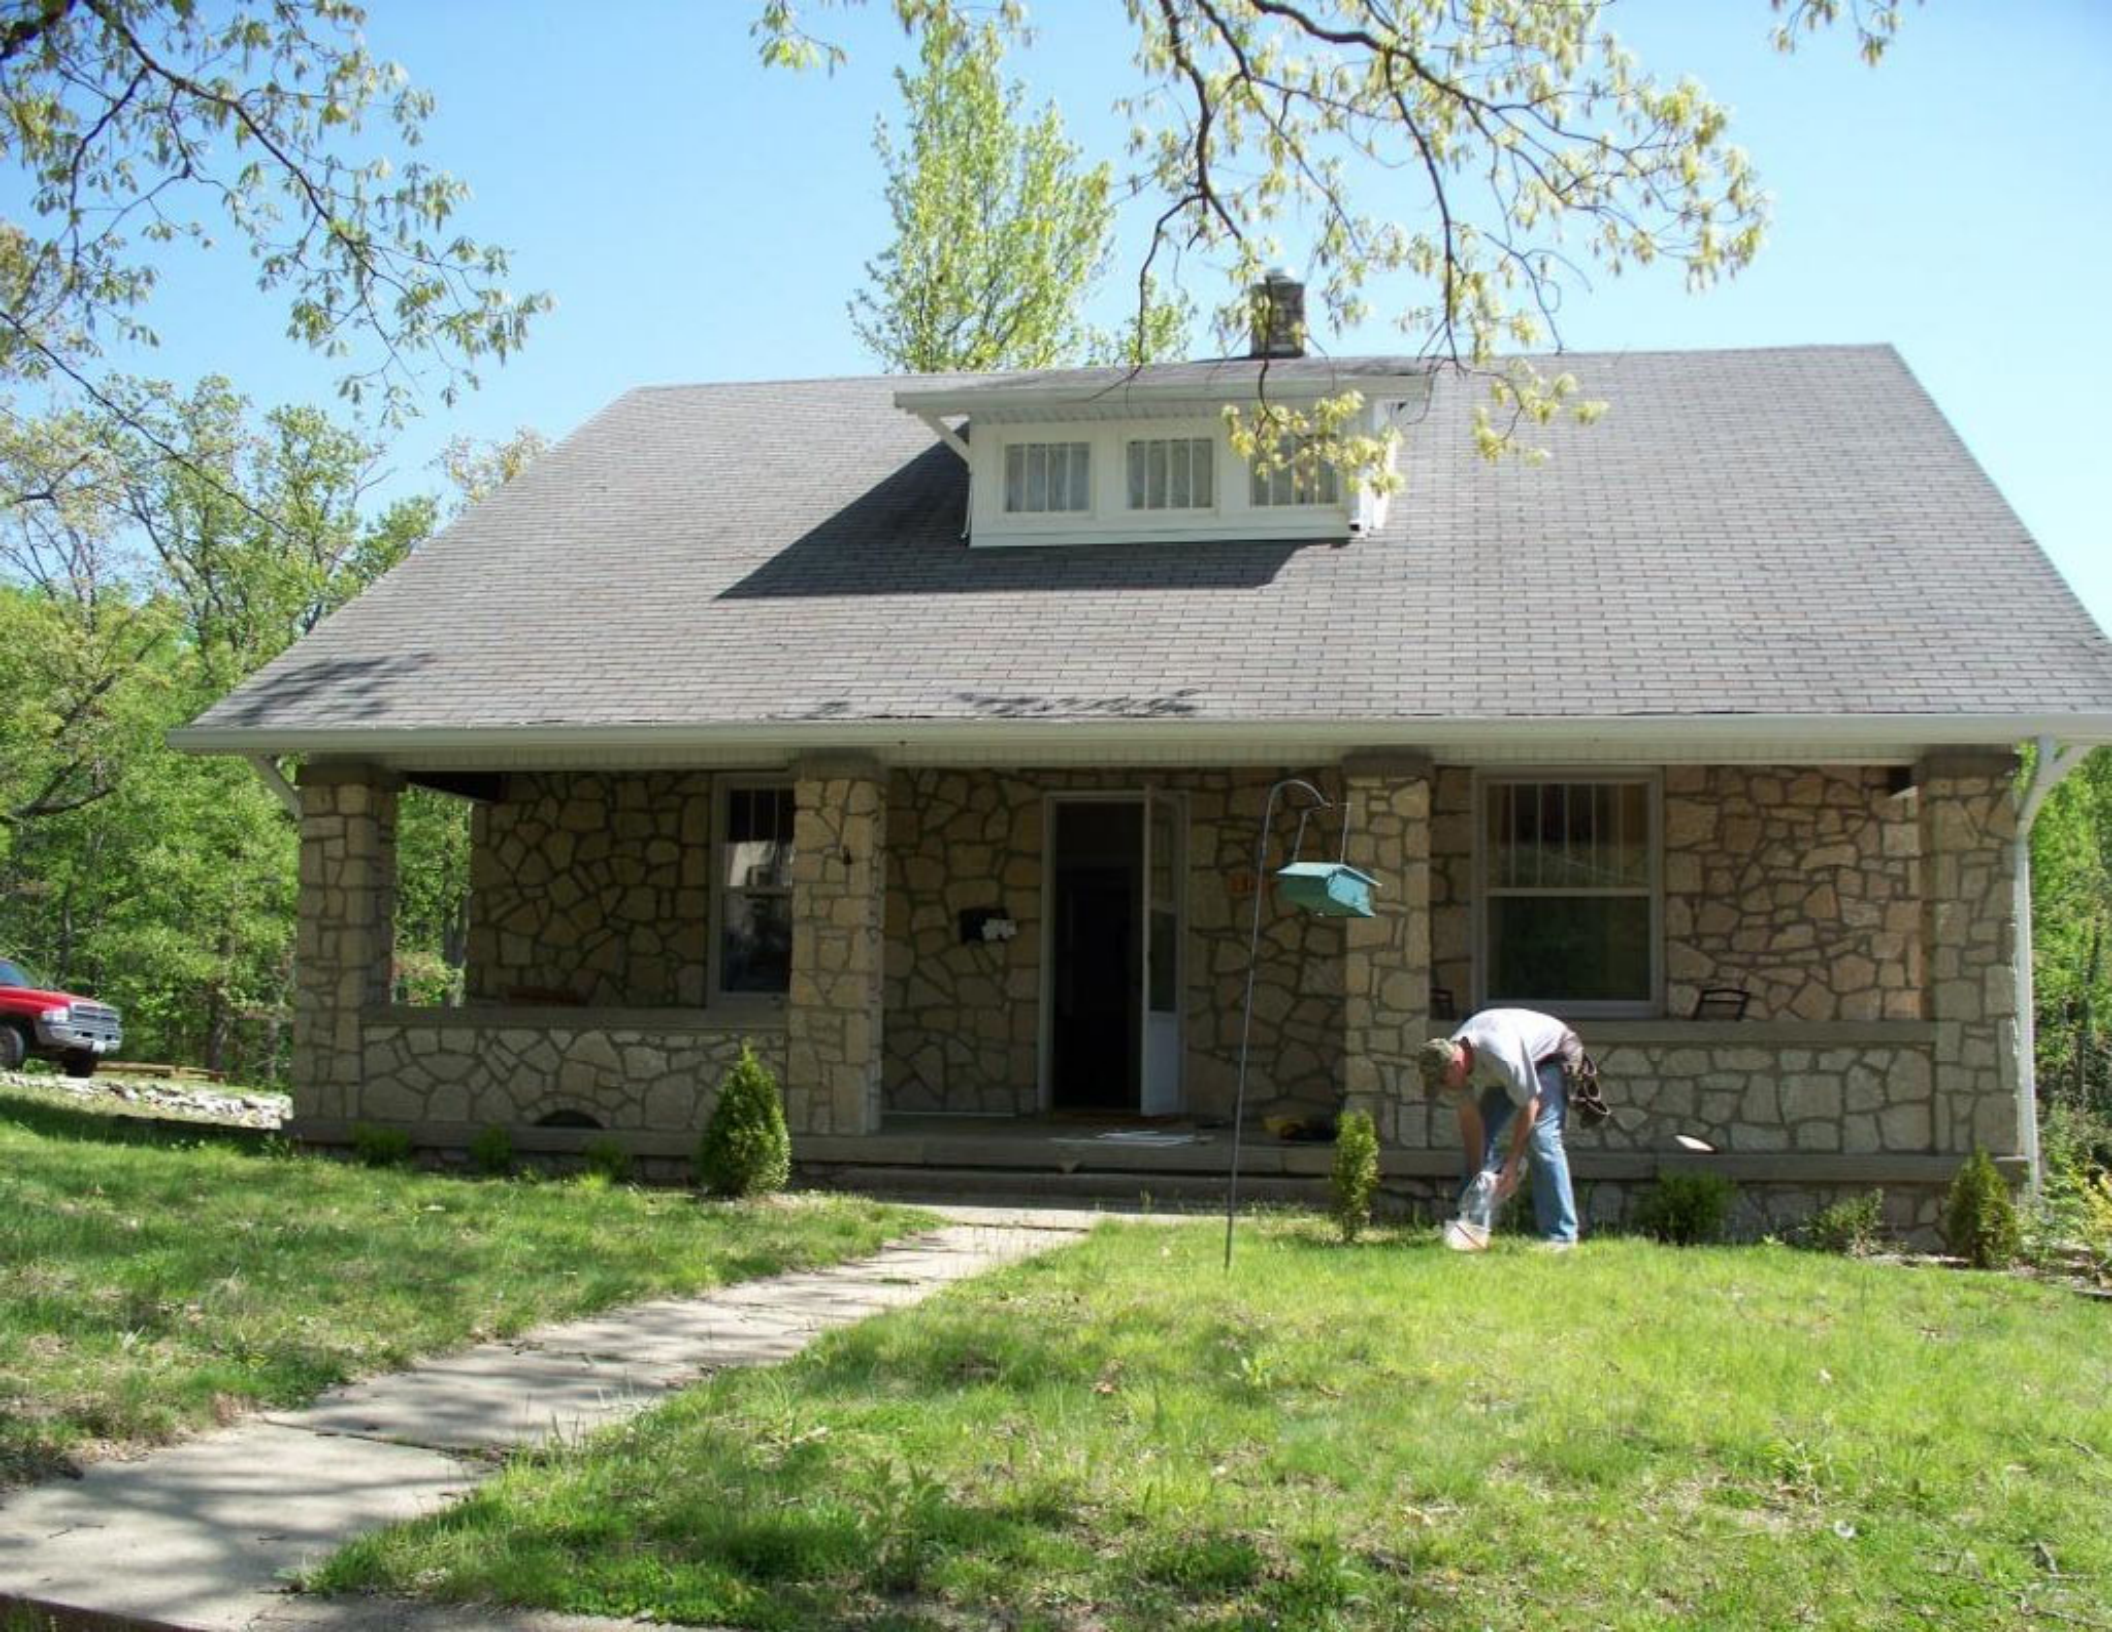
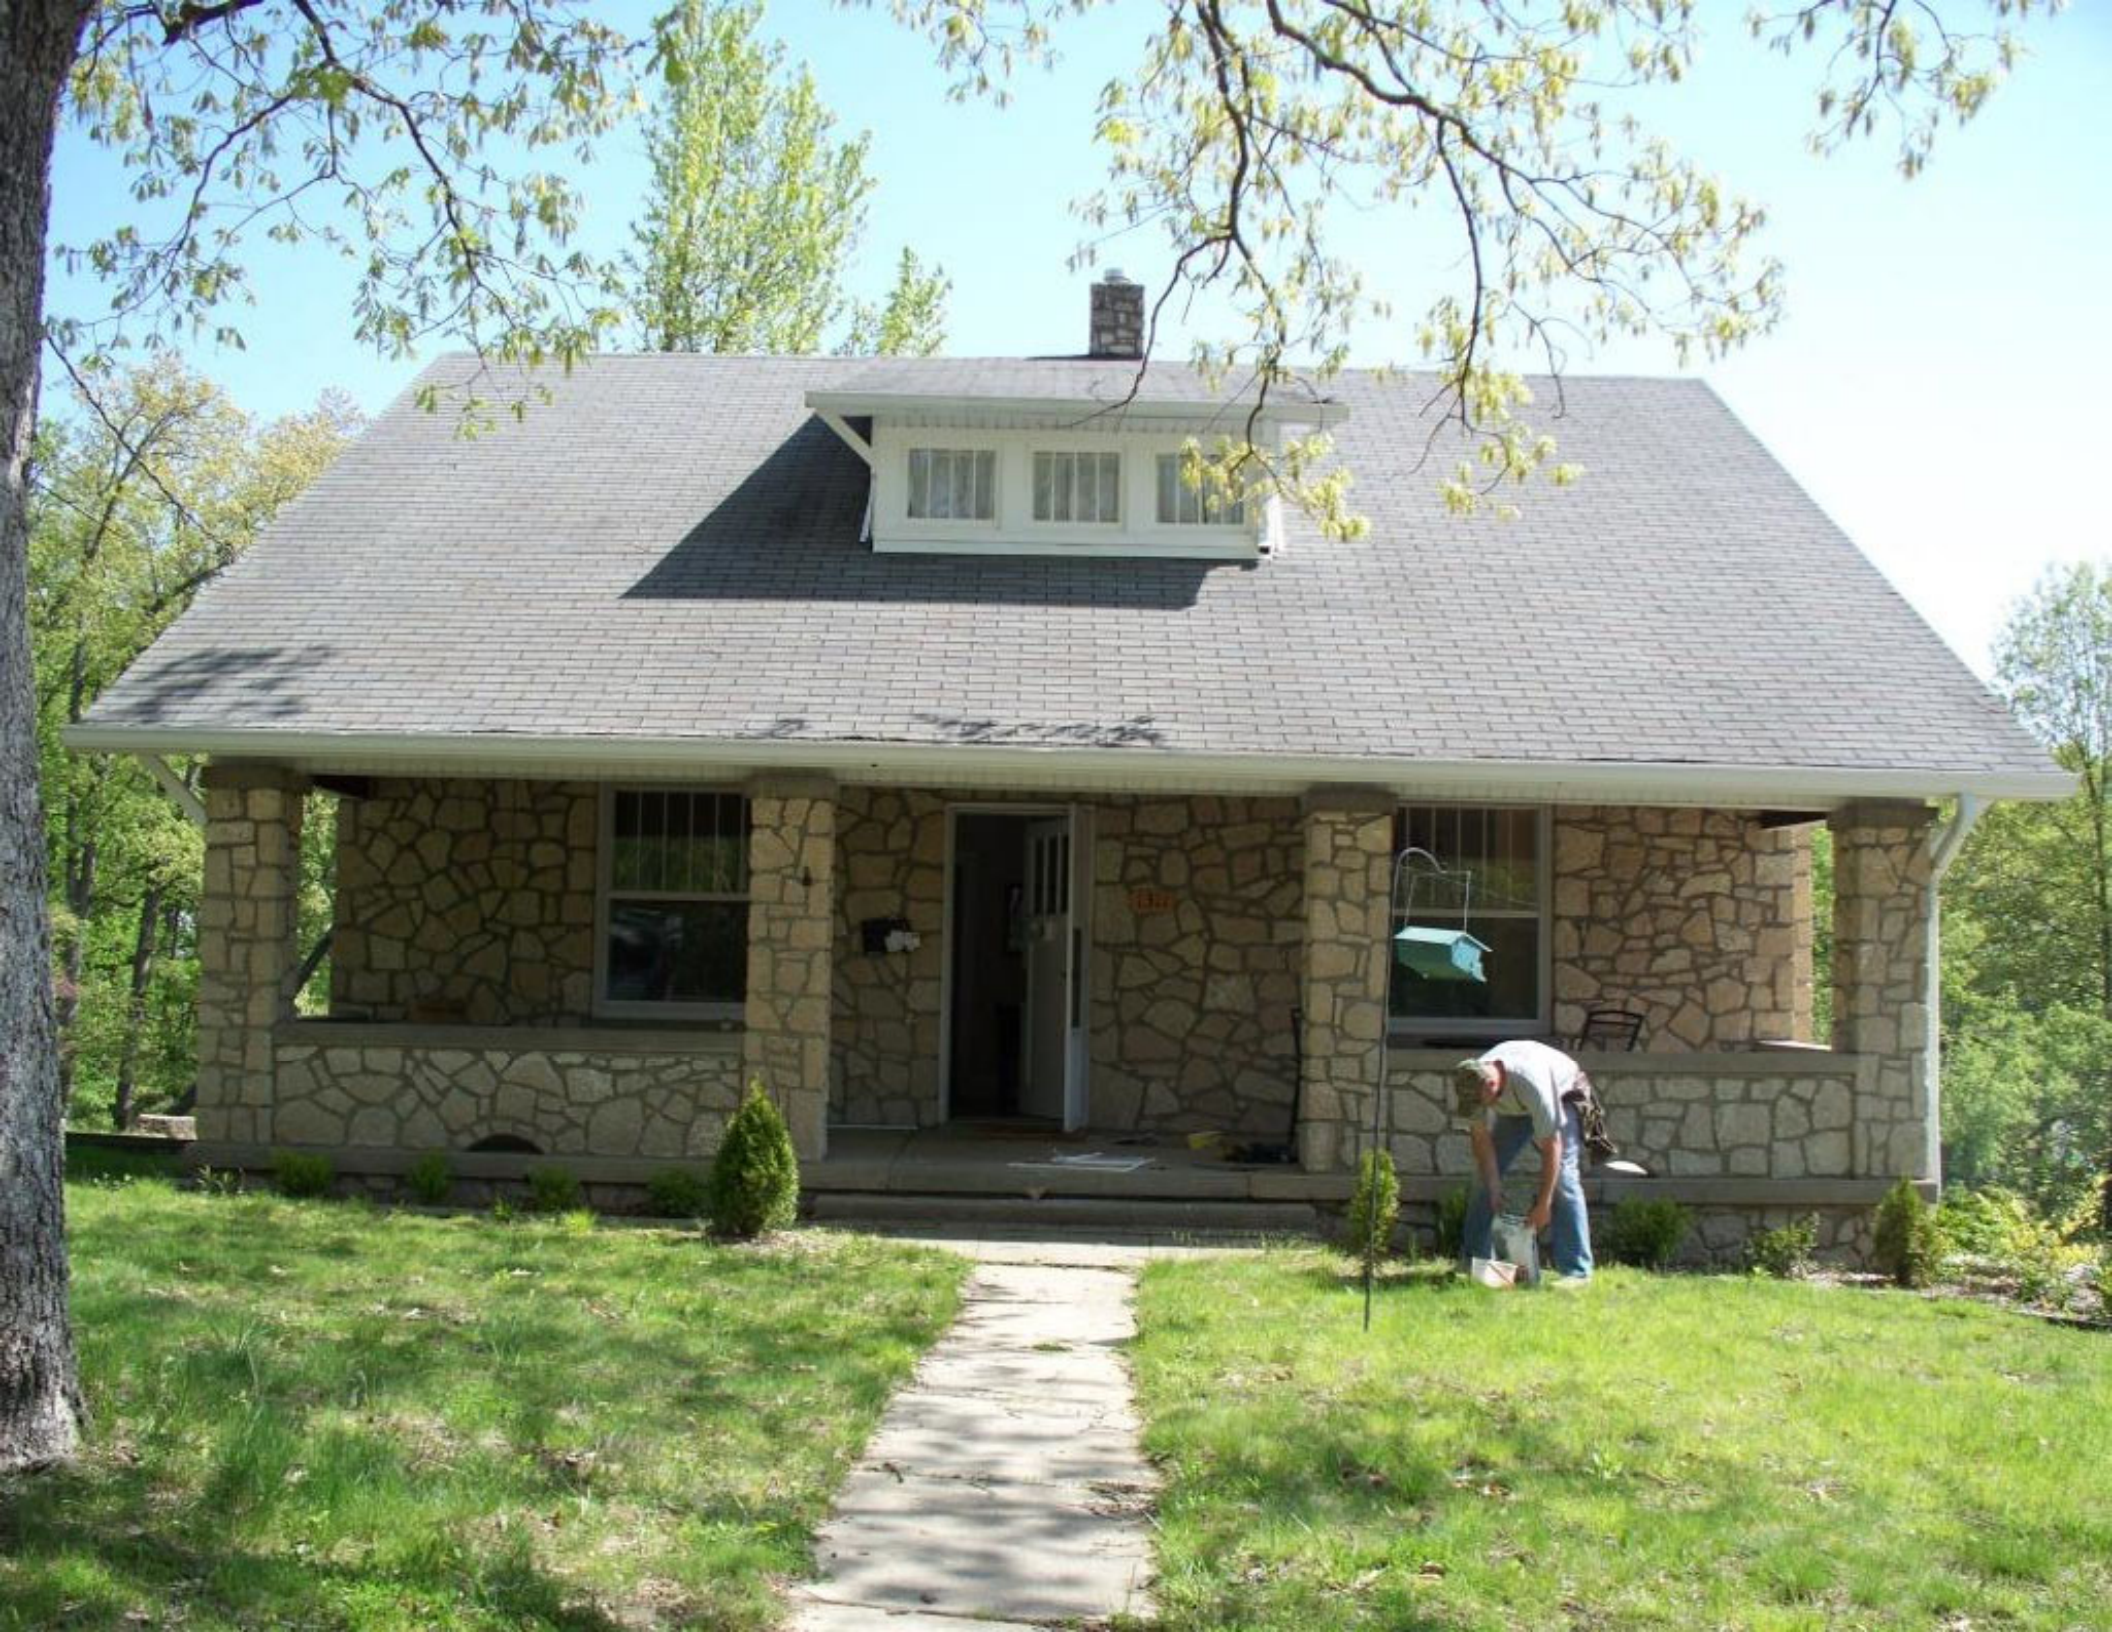
This 1 ½ story stone bungalow has a deeply sloped side gabled roof with a central shed dormer with three 4-light historic casement windows. The first floor has two large 6/1 historic windows flanking the centered entrance. There is a full width porch consisting of stone piers and half walls capped in either limestone or concrete. Centered at the bottom of each half wall is an eyebrow opening.
