ARCHITECTURAL/HISTORIC INVENTORY FORM

1. Survey No. CO-AS-005-001		2. Survey name: Moreau Drive Neighborhood Survey	
3. County: Cole		4. Address: 1202 Elmerine Ave.	
5. City: Jefferson City	Vicinity: <input type="checkbox"/>	6. UTM: / /	7. Township/Range/Section: T: R: S:
8. Historic name (if known):		9. Present/other name (if known):	
10. Ownership: <input checked="" type="checkbox"/> Private <input type="checkbox"/> Public		11. Historic use (if known): Residential	11. Current use: Residential

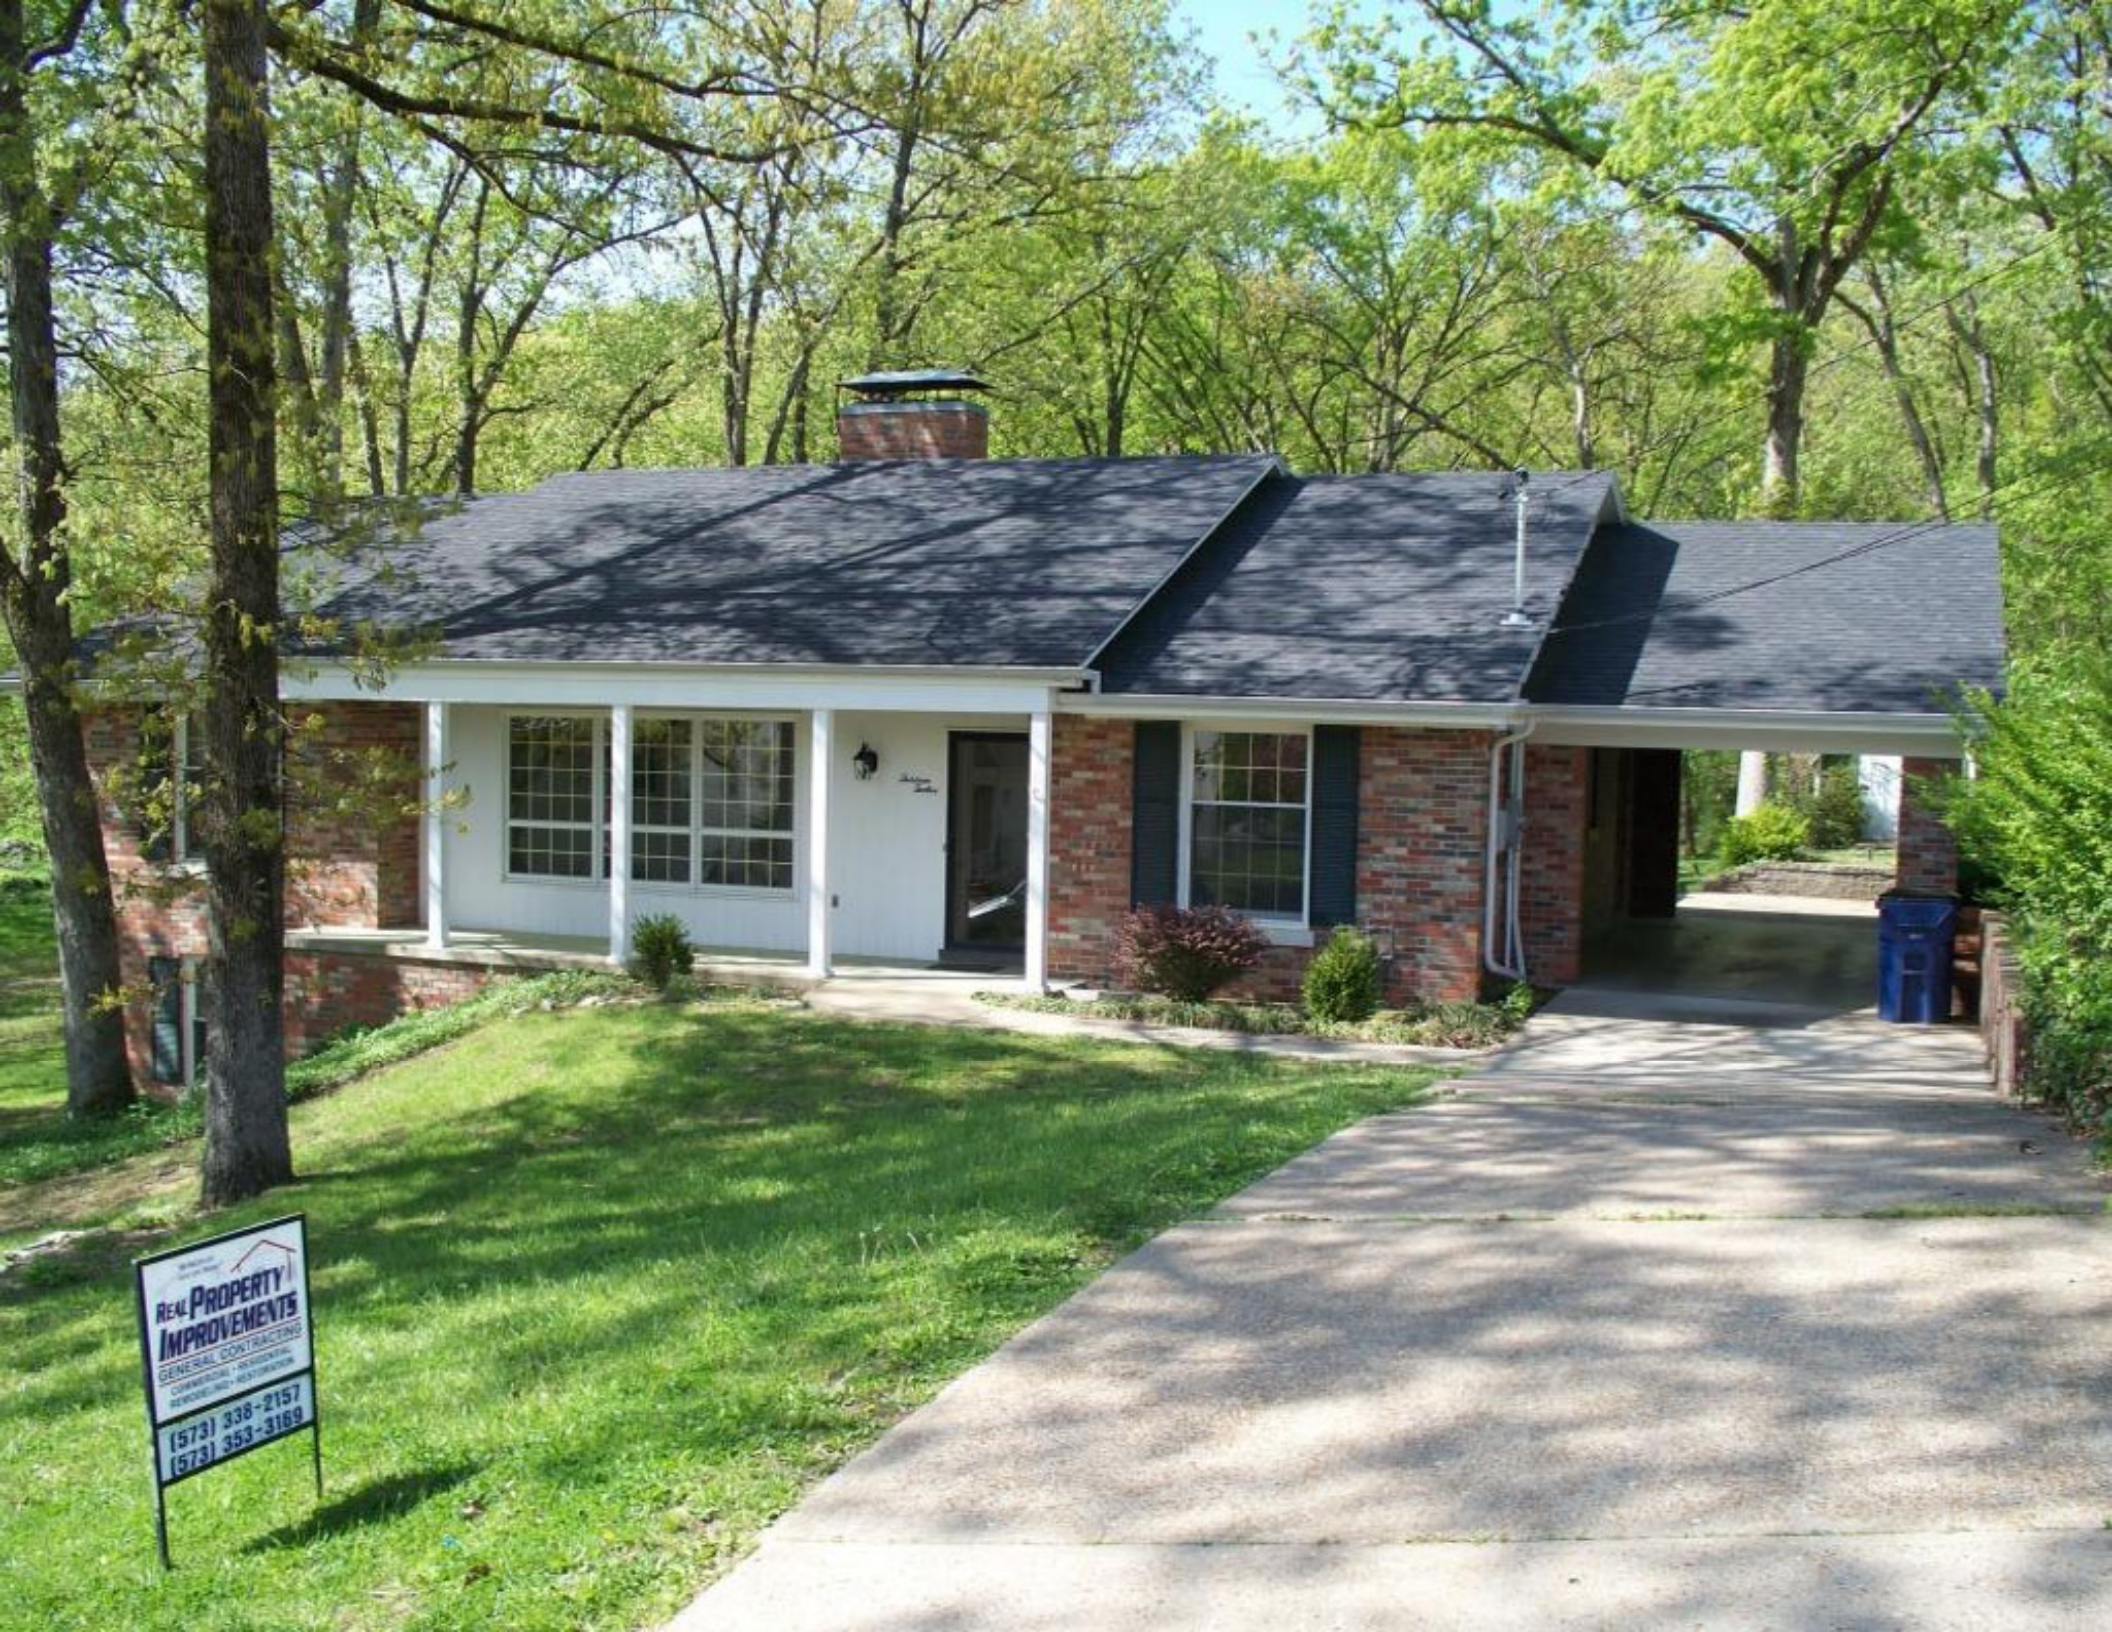
This one story brick ranch has a side gable roof and an attached brick carport on the right side of the property. Two large windows with shutters are on the far right and left bay. They flank the center two bays that are recessed and clad in painted wood or vinyl siding. A large three-part multi-pane (likely snap in muttons) picture window is in the left side and the entrance in the right. The porch is supported by thin square posts. It is outside the period of significance and is considered non-contributing.

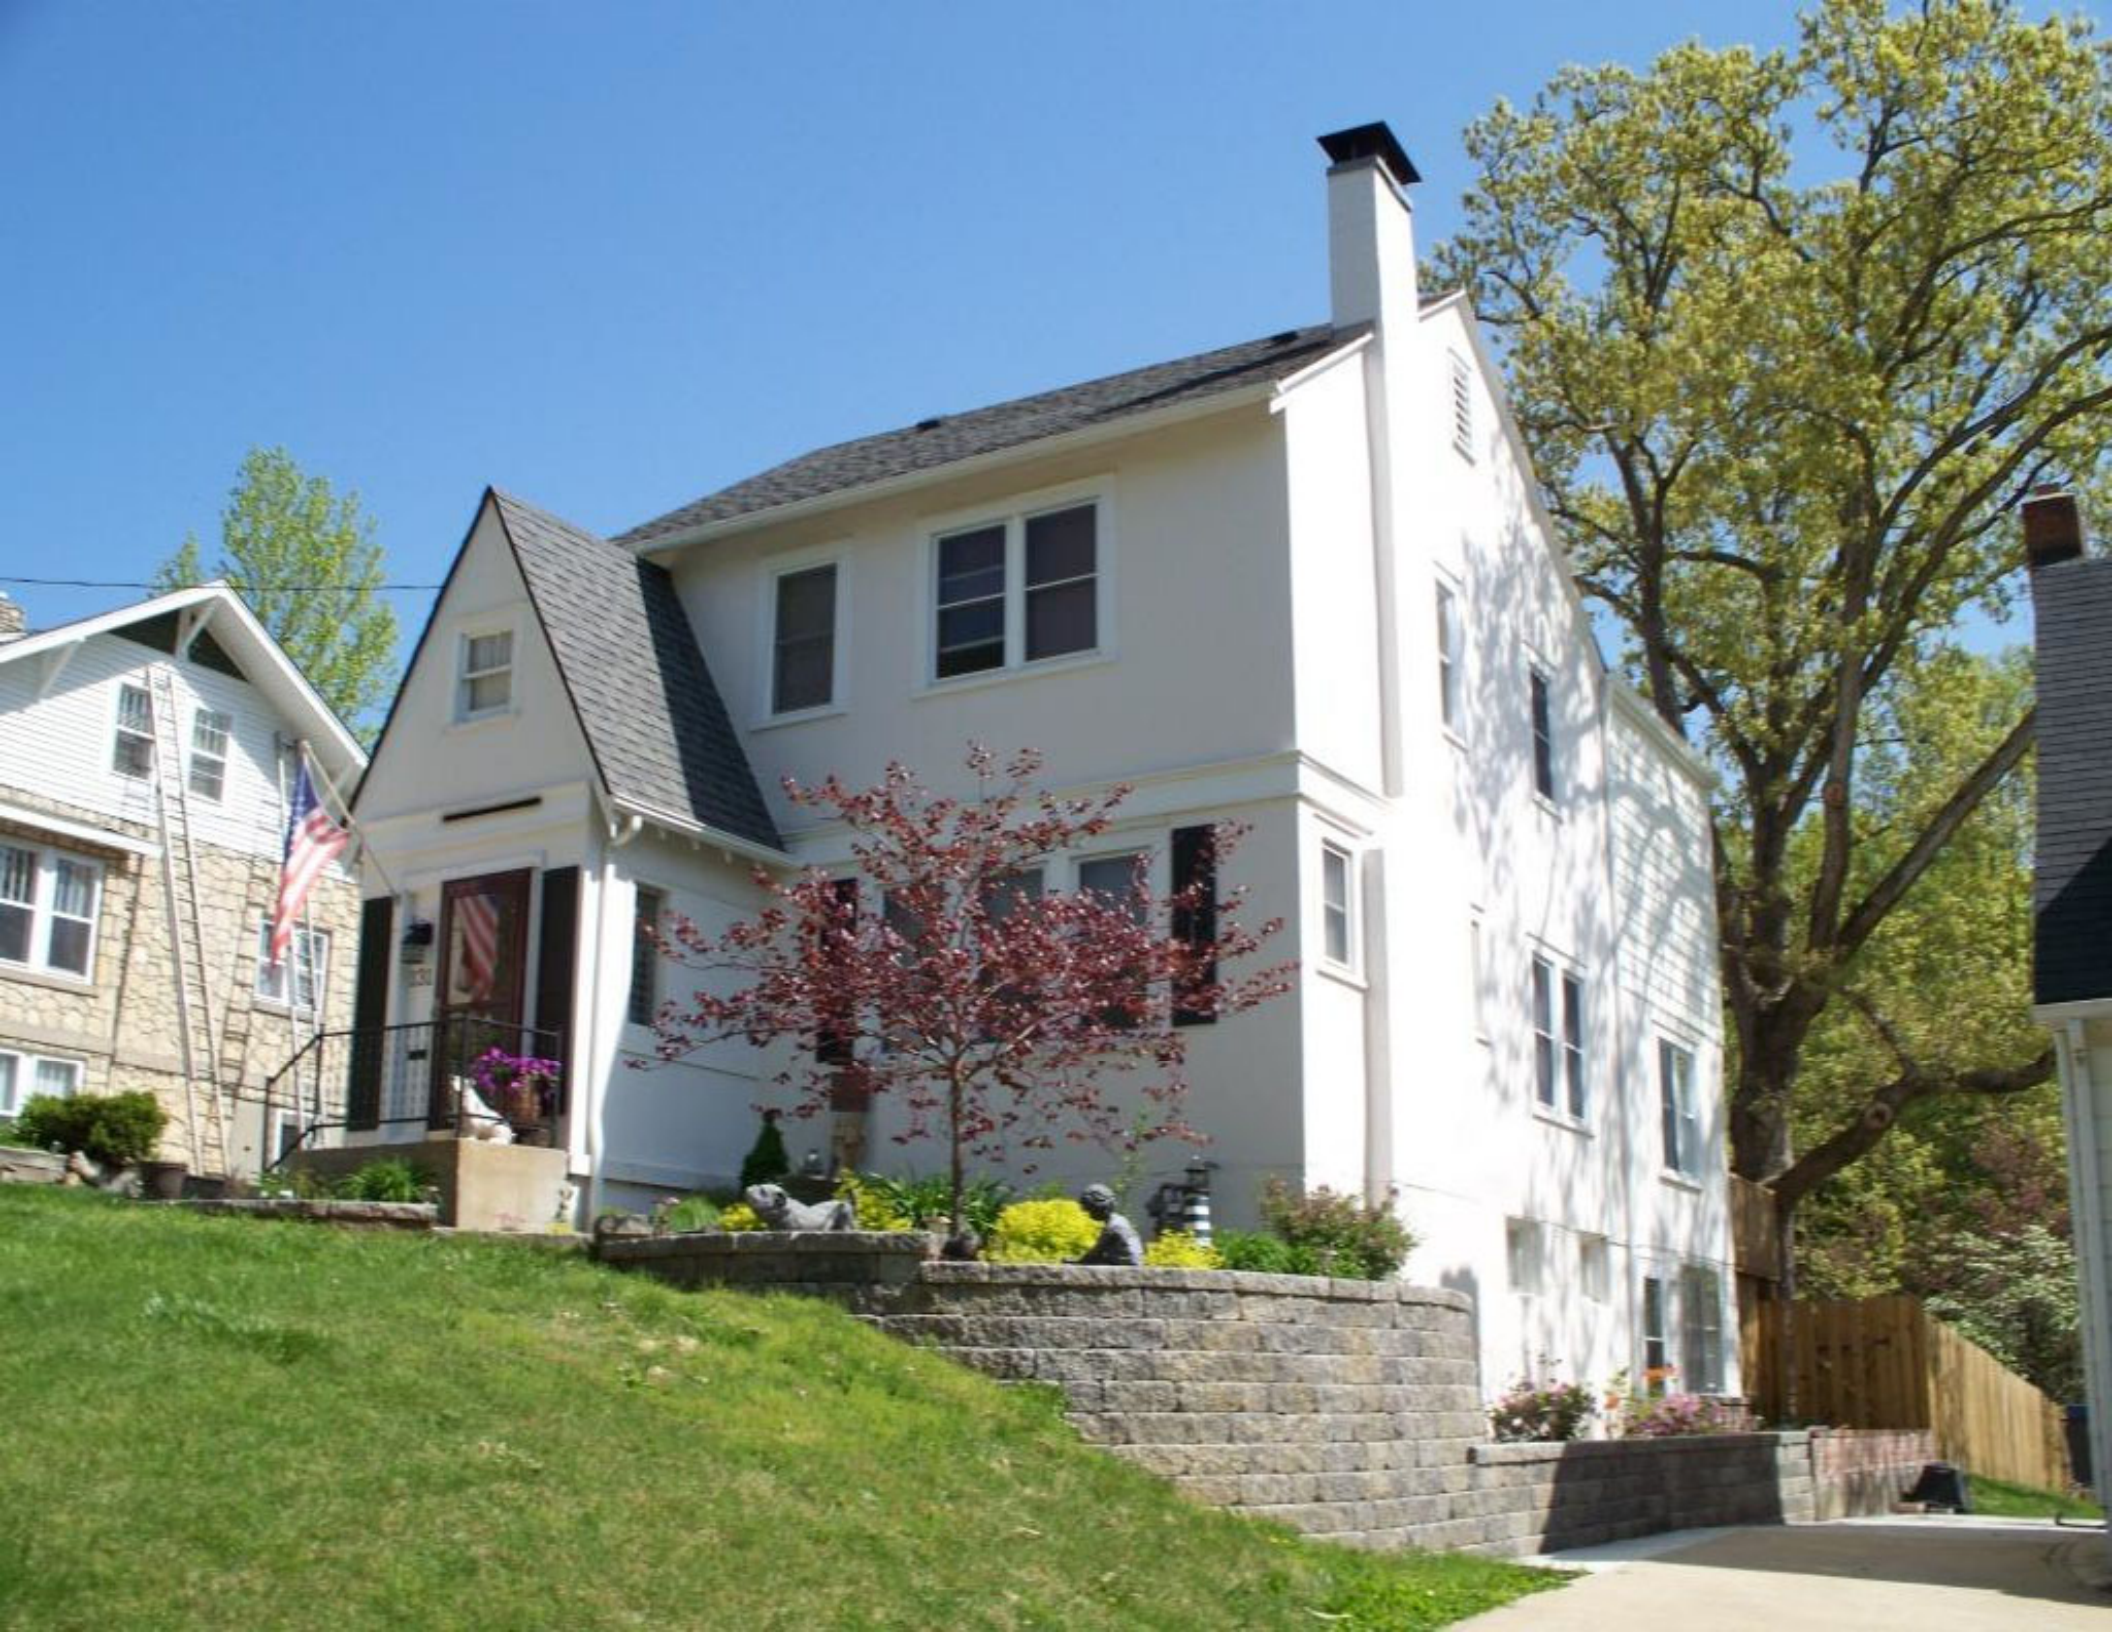
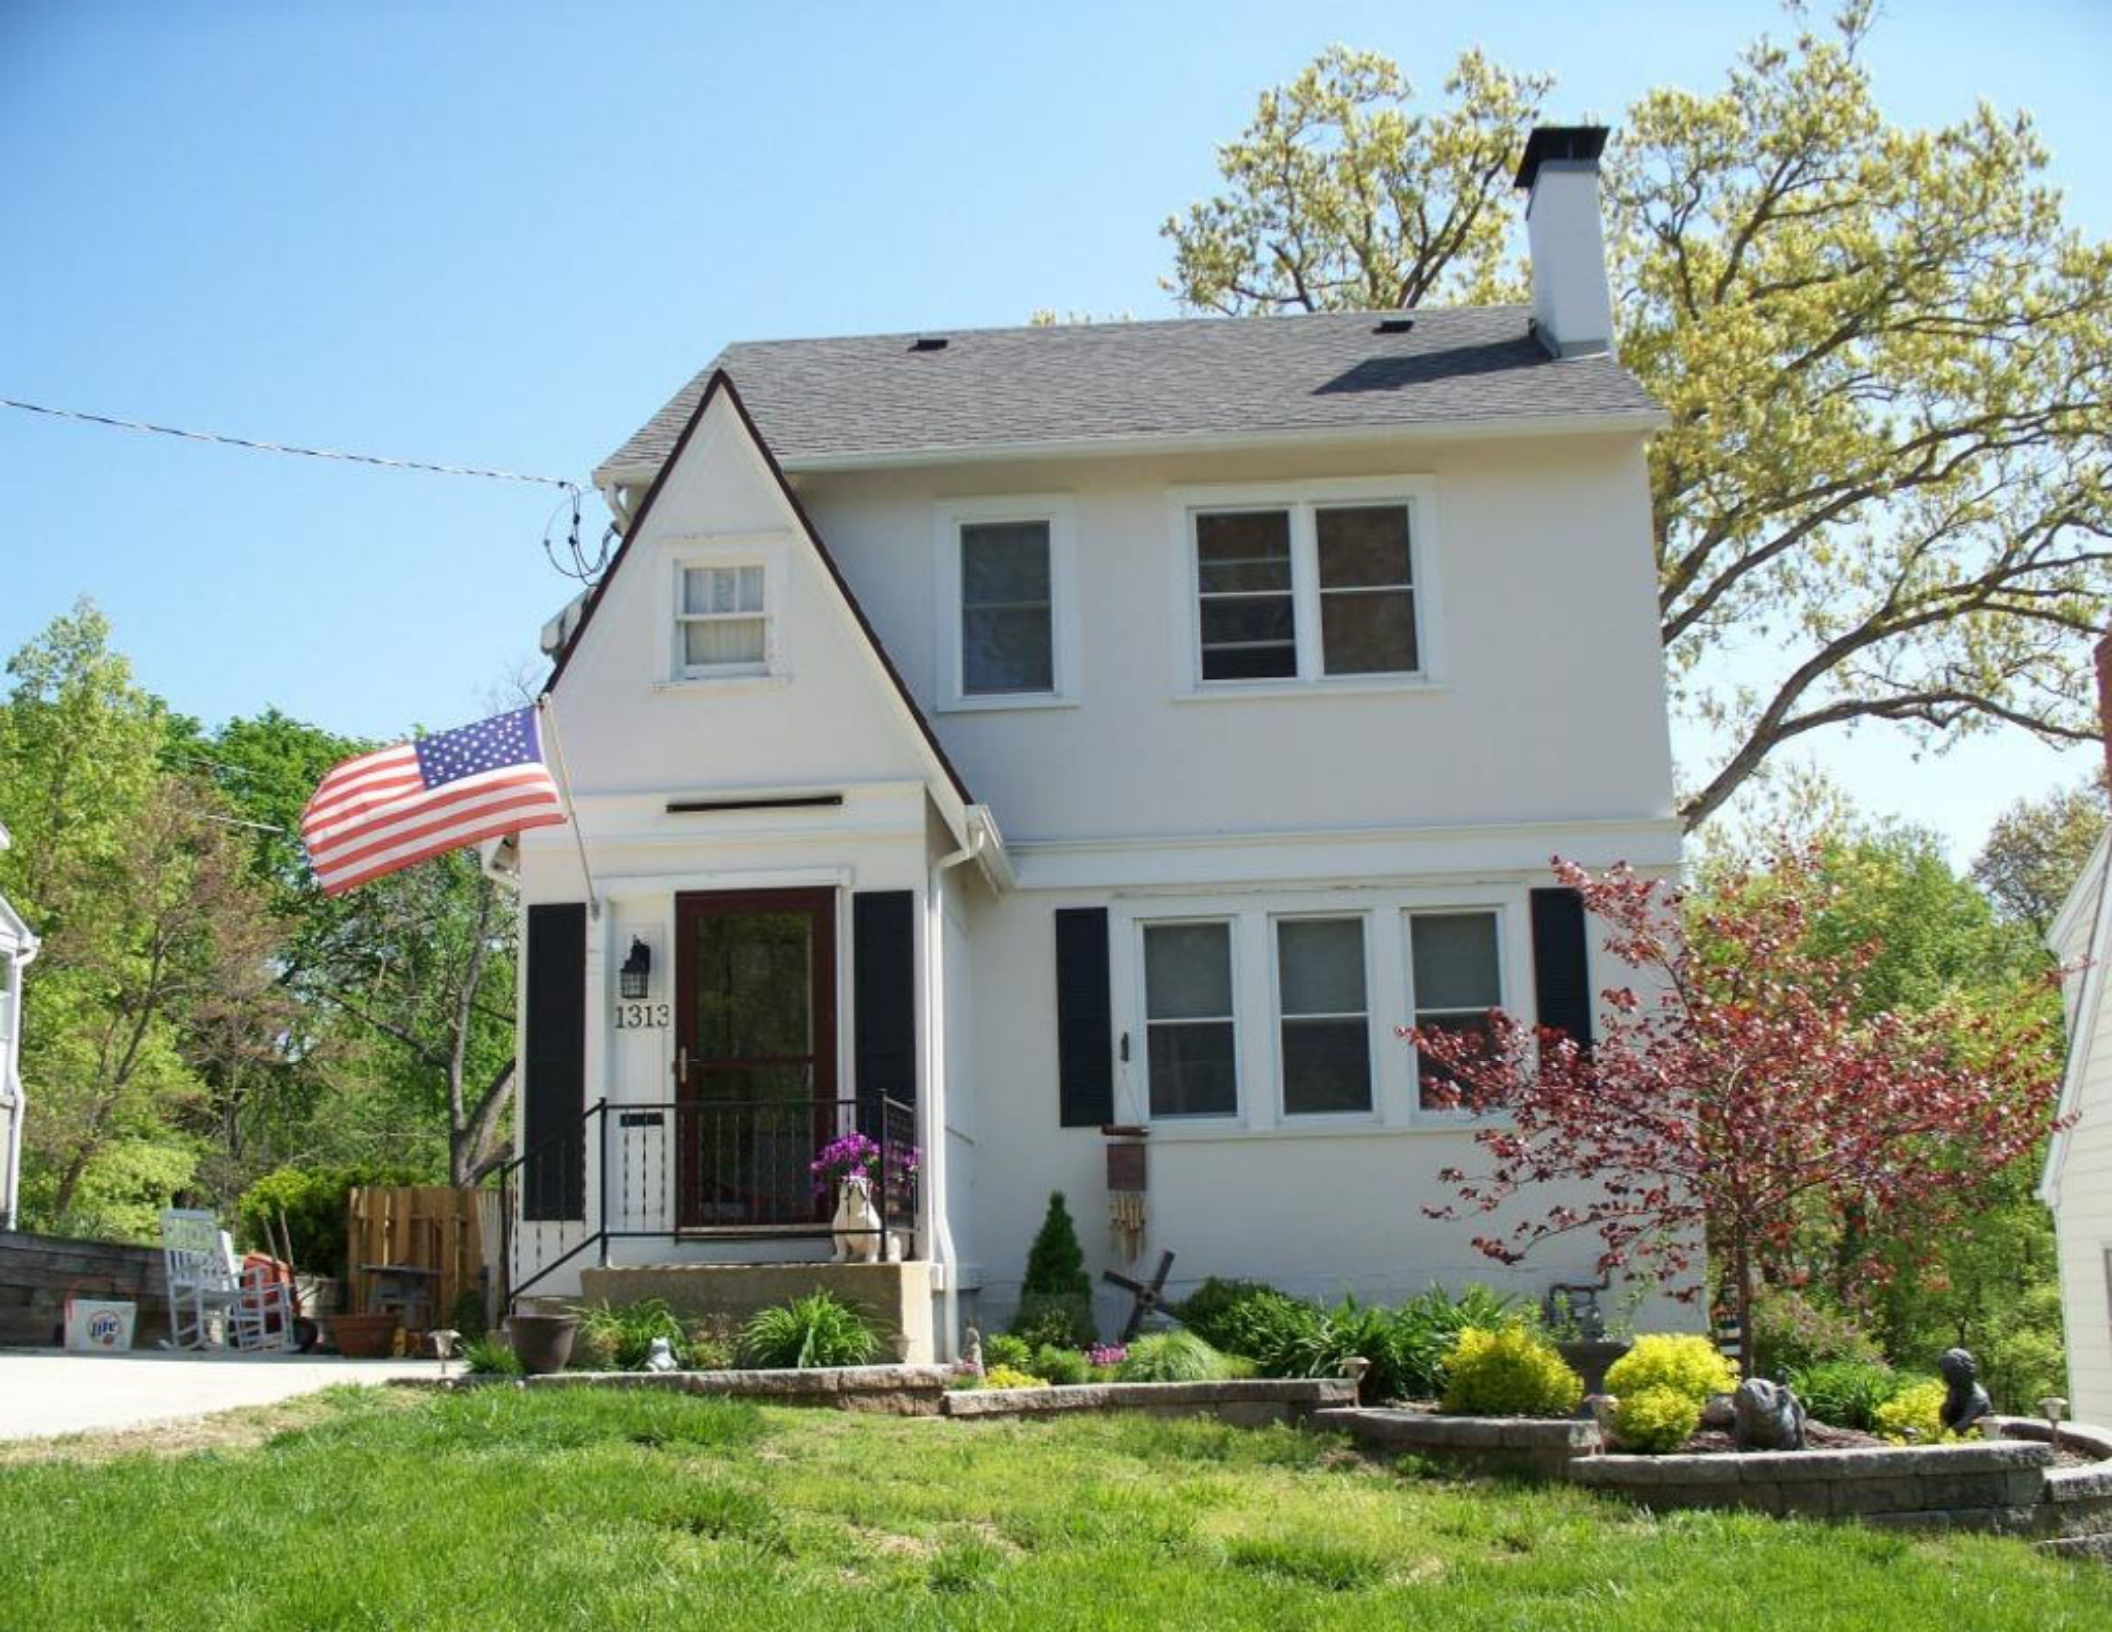
This two story home has a side gable roof and is clad in plaster or stucco. On the second story in the center and right bay is a single 1/1 replacement windows and paired 1/1 replacement windows. The left bay projects and has a steeply pitched gable roof with rafter tails that sits slightly below the eave of the side gable roof. This bay has an historic 3/1 window in its peak. It also contains the entrance which is framed with long shutters. The door is reached by a set of concrete stairs and stoop with concrete railing that is accessed from the driveway (to the left). Molding divides the upper and lower floors.

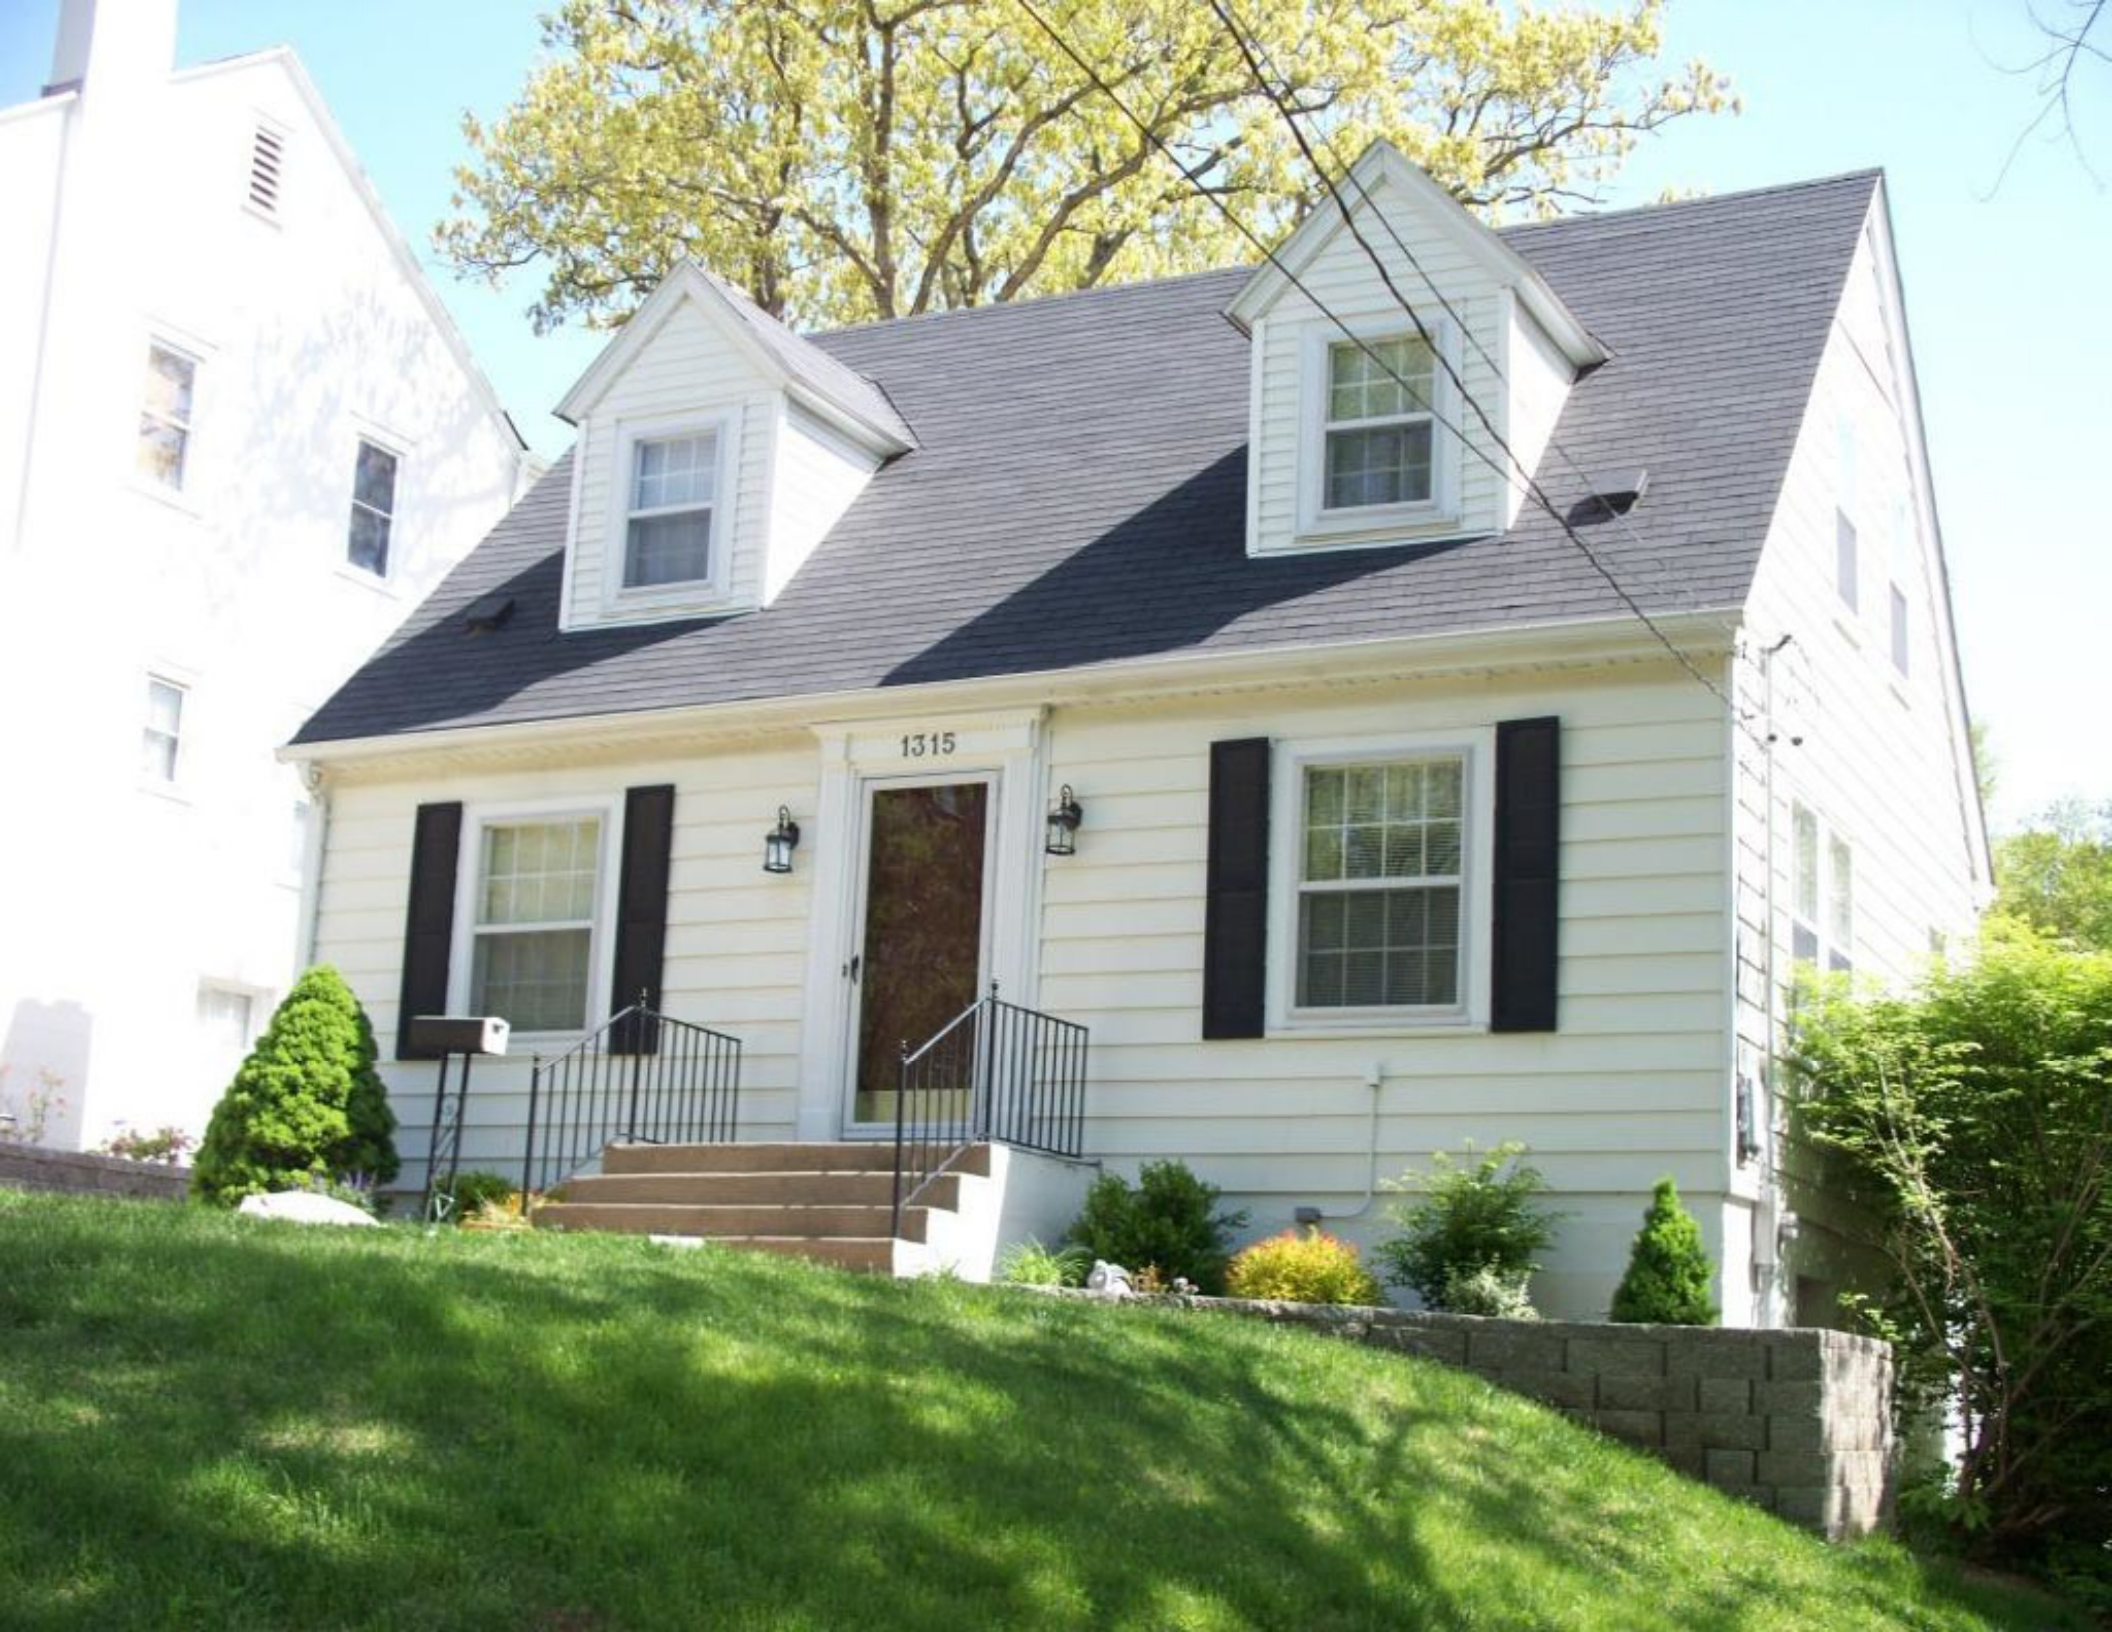
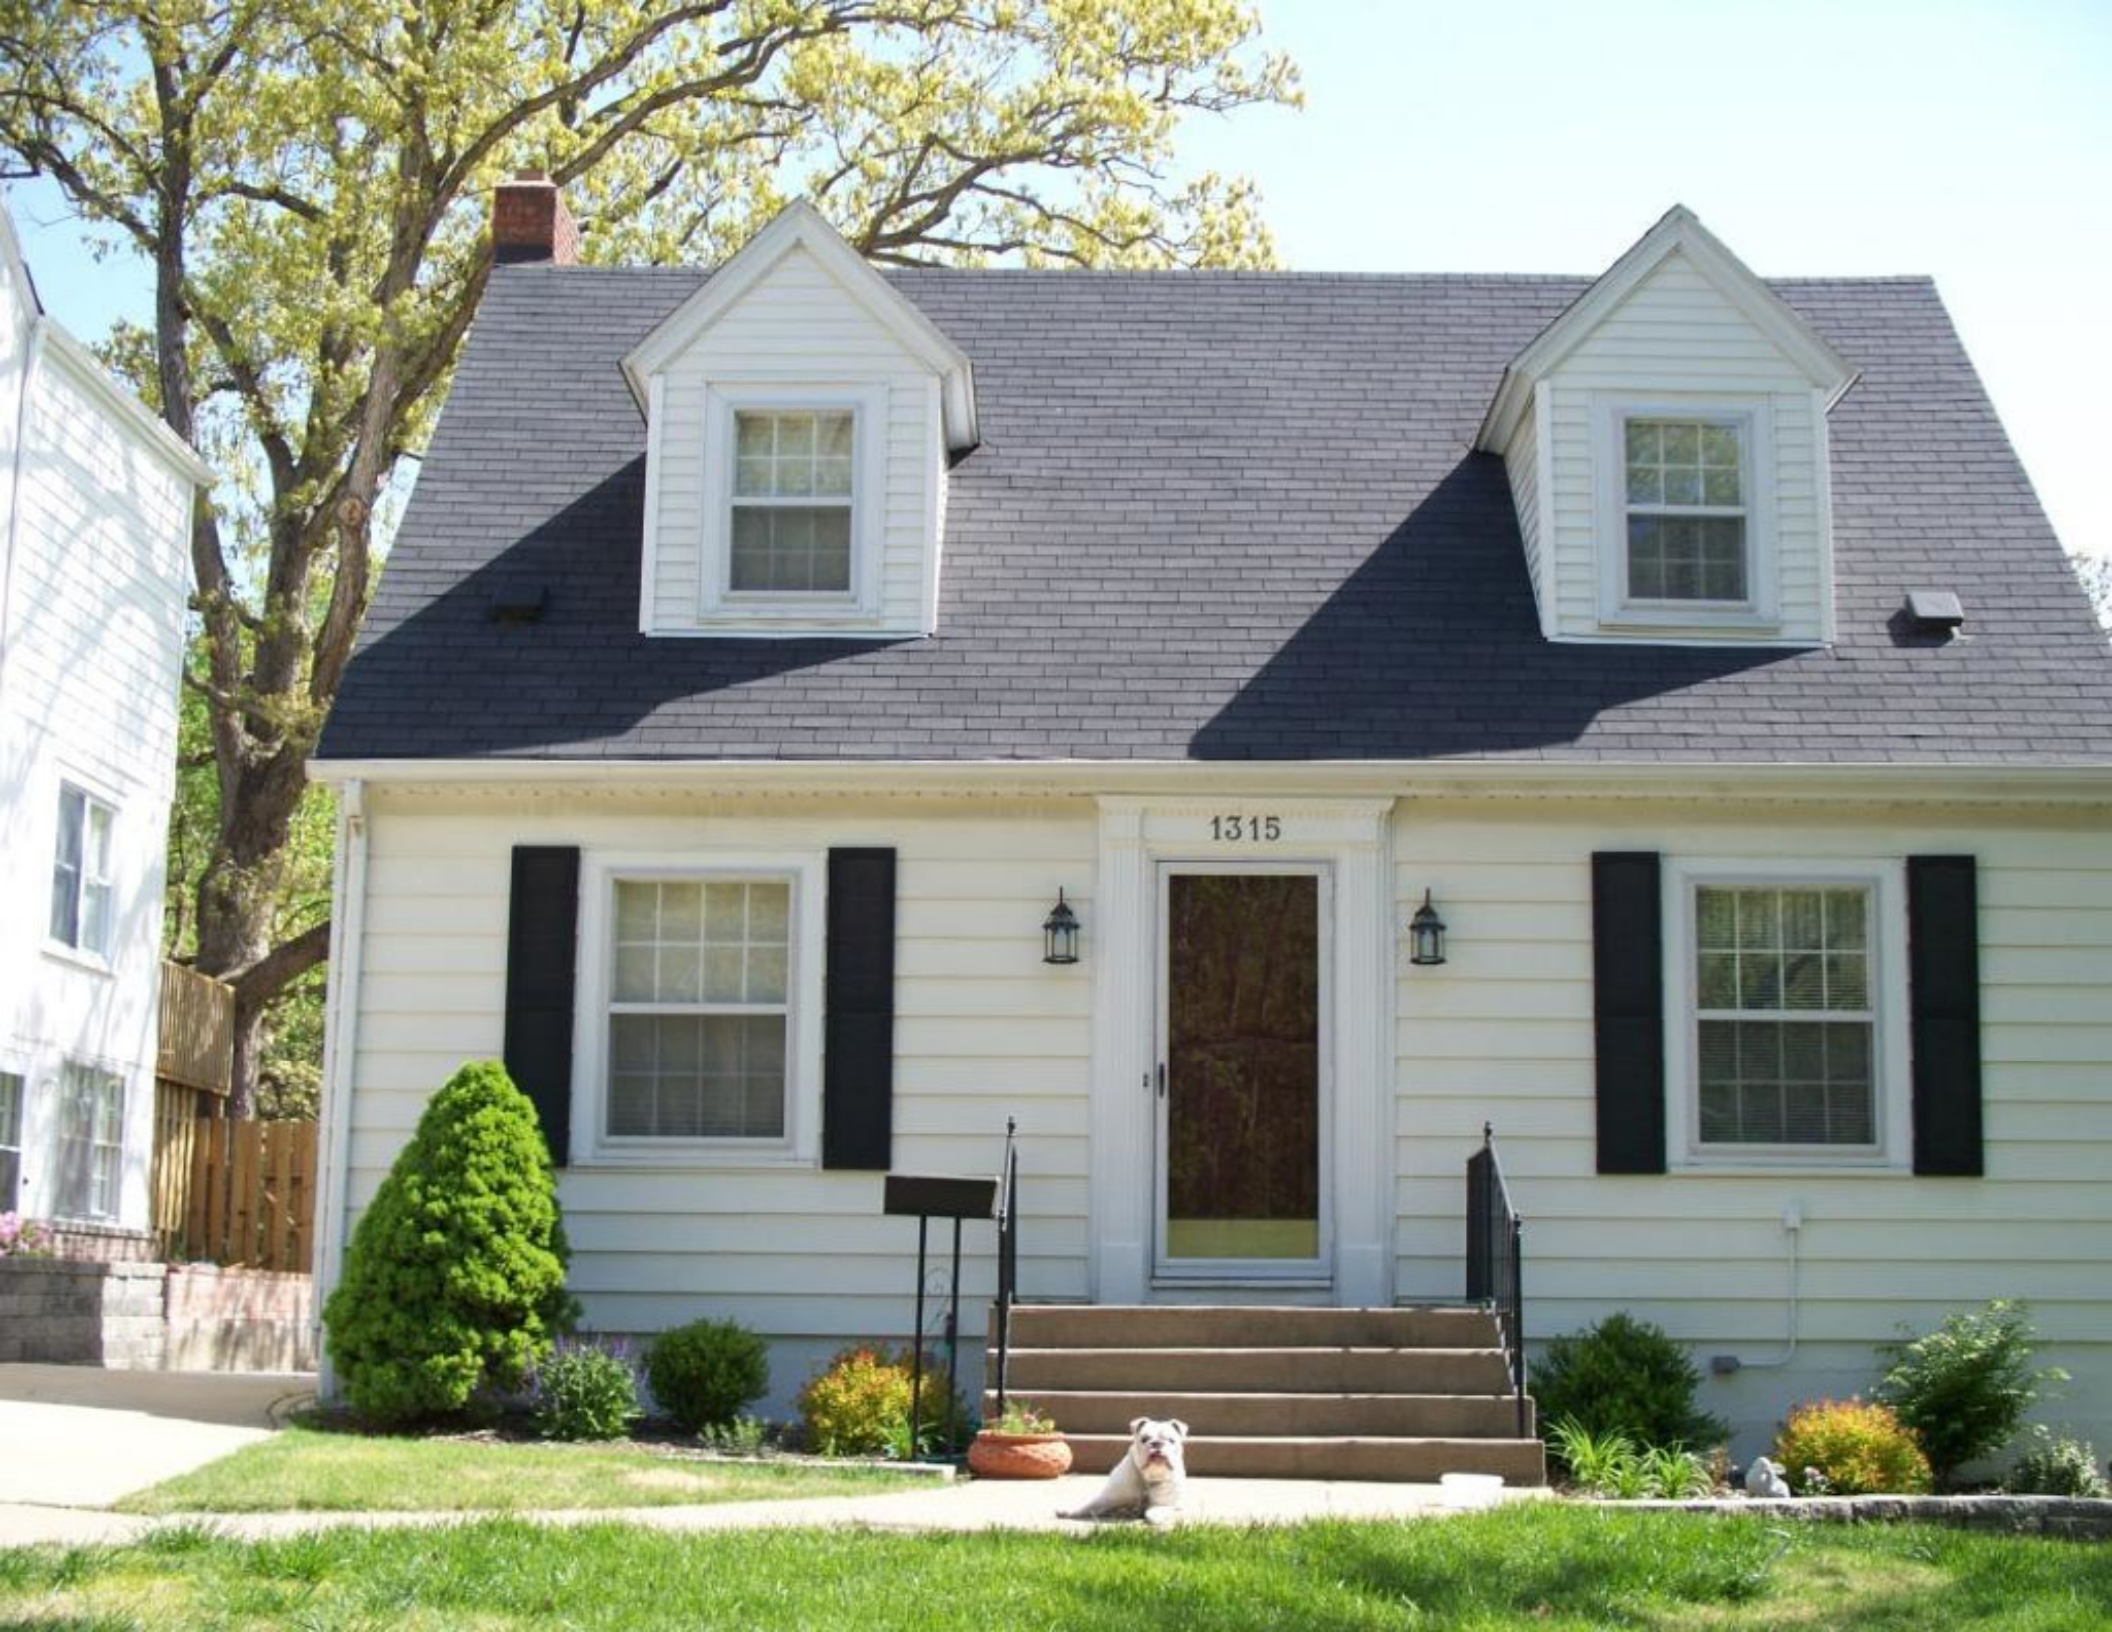
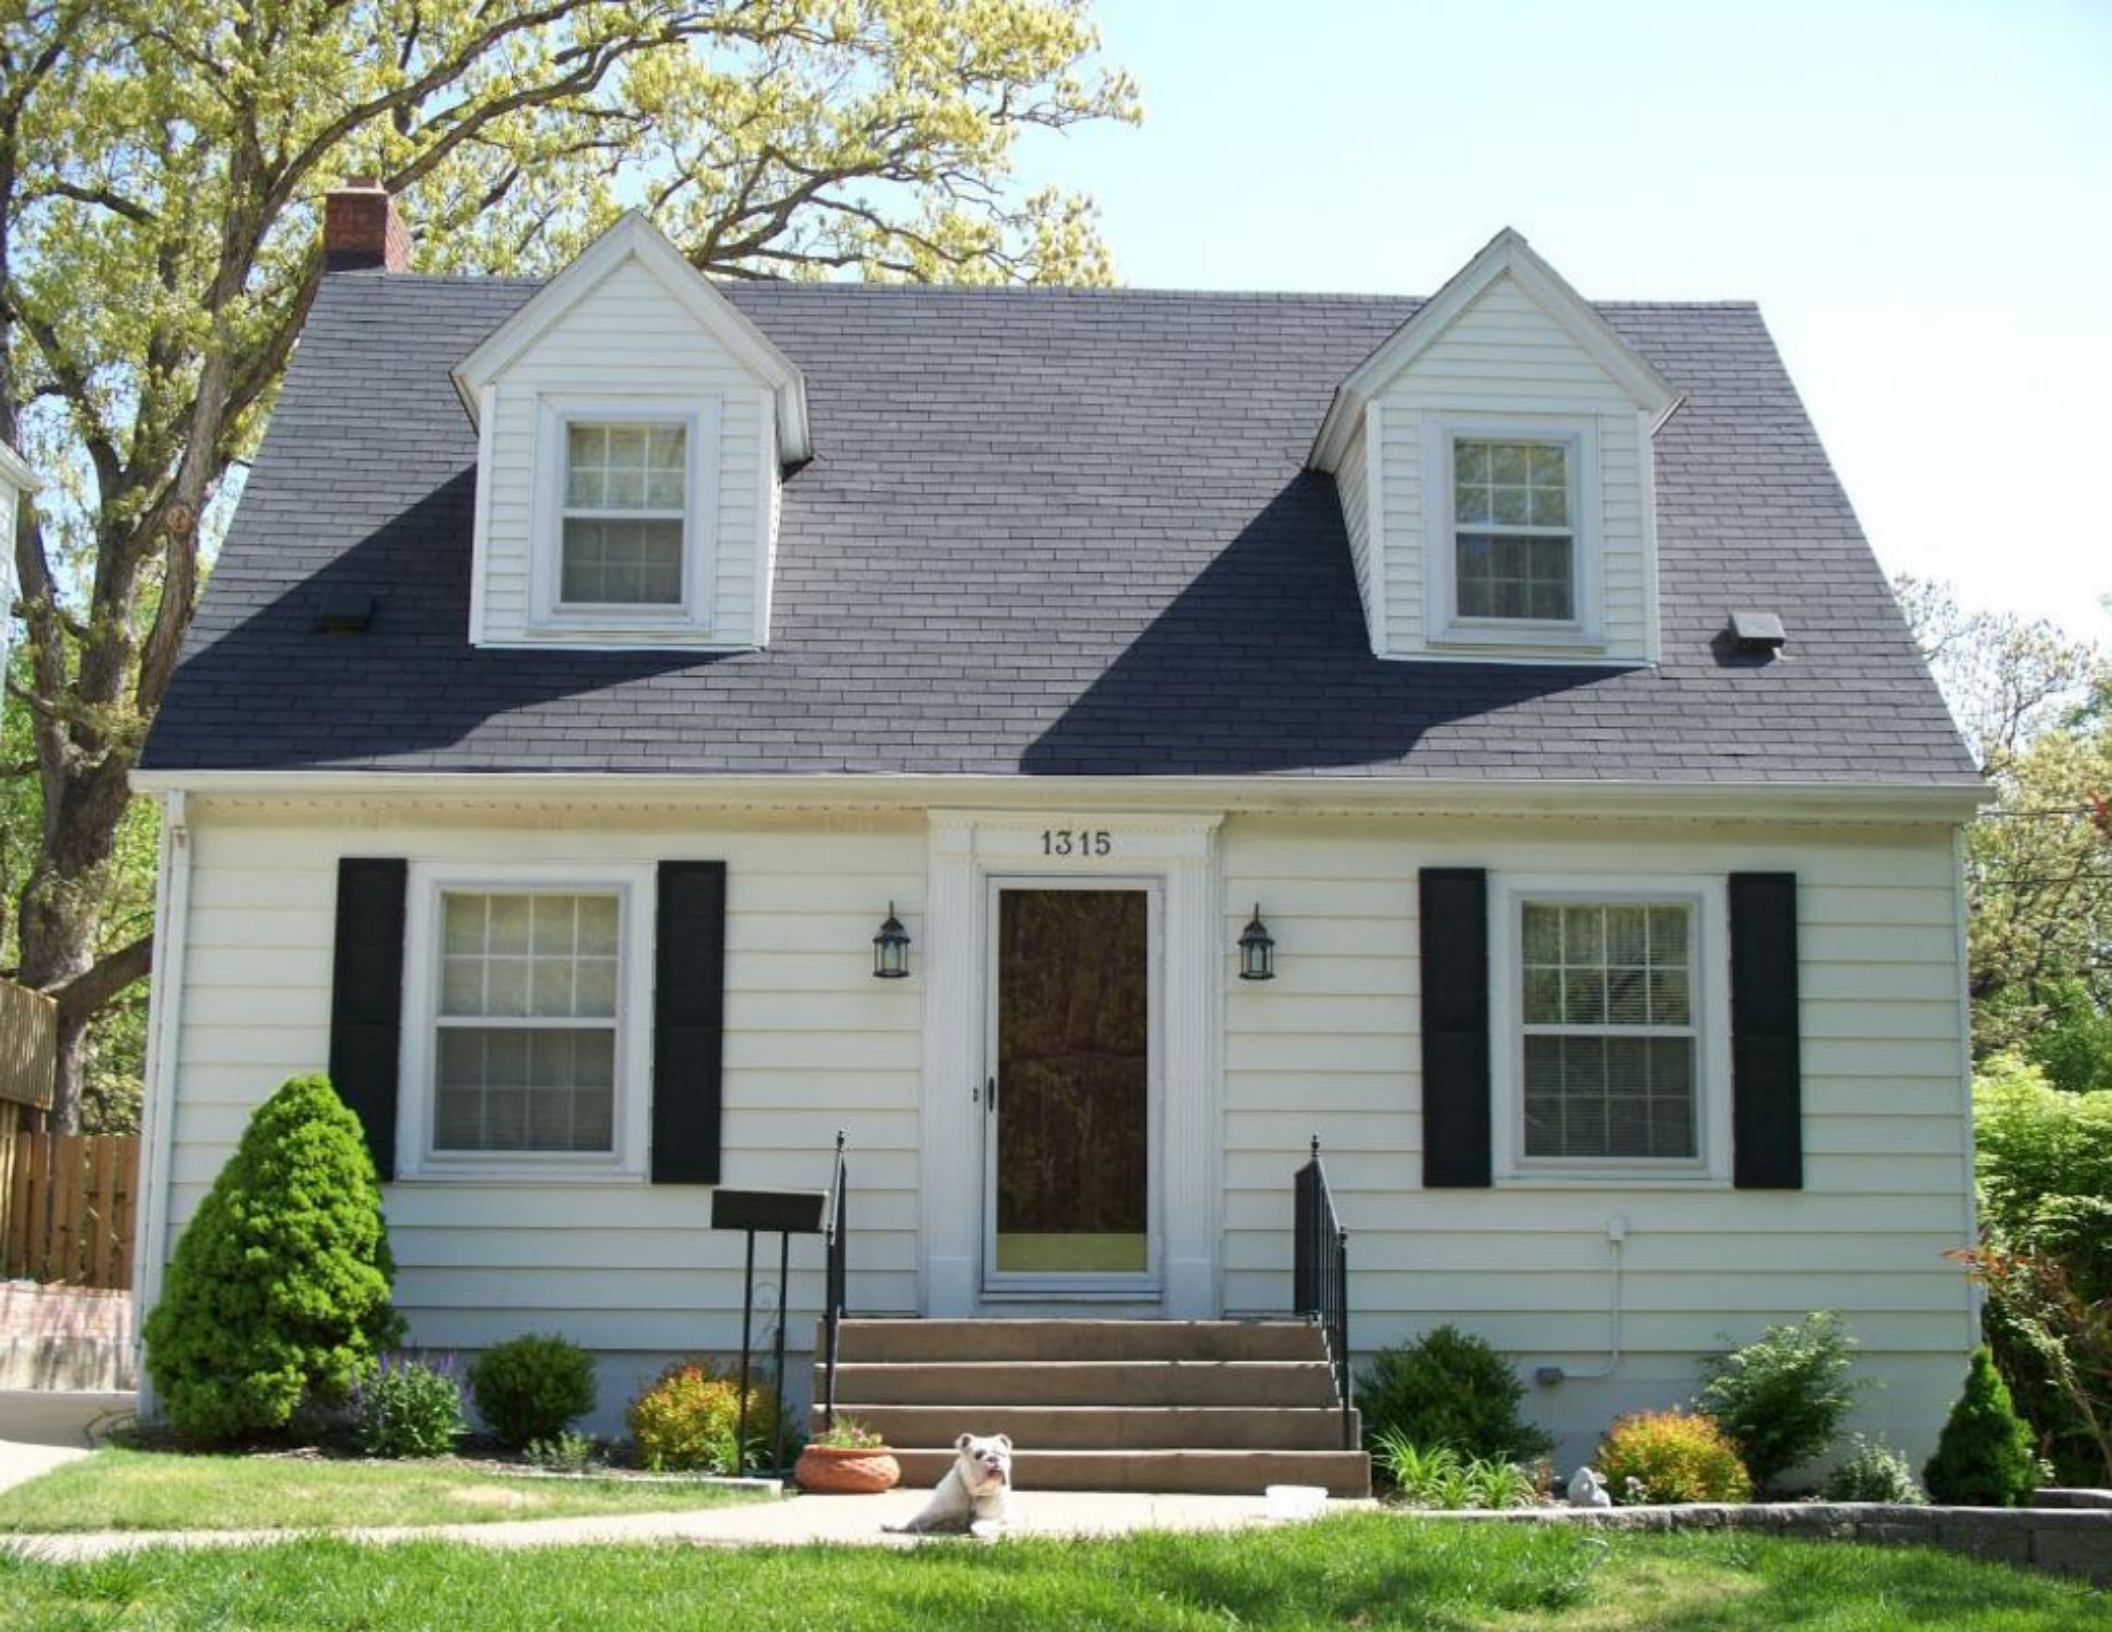
1315

This two story brick home has a side gable roof and two 6/6 windows with shutters on the first floor and two identical windows on the first. The central bay contains the entrance and has an ornate door surround. A simple concrete pad acts as the stoop. It's difficult to tell from the photos but the windows may be modern replacements. All of the windows have brick sills.
