ARCHITECTURAL/HISTORIC INVENTORY FORM

1. Survey No. CO-AS-005-001		2. Survey name: Moreau Drive Neighborhood Survey	
3. County: Cole		4. Address: 1202 Elmerine Ave.	
5. City: Jefferson City	Vicinity: <input type="checkbox"/>	6. UTM: / /	7. Township/Range/Section: T: R: S:
8. Historic name (if known):		9. Present/other name (if known):	
10. Ownership: <input checked="" type="checkbox"/> Private <input type="checkbox"/> Public		11. Historic use (if known): Residential	11. Current use: Residential

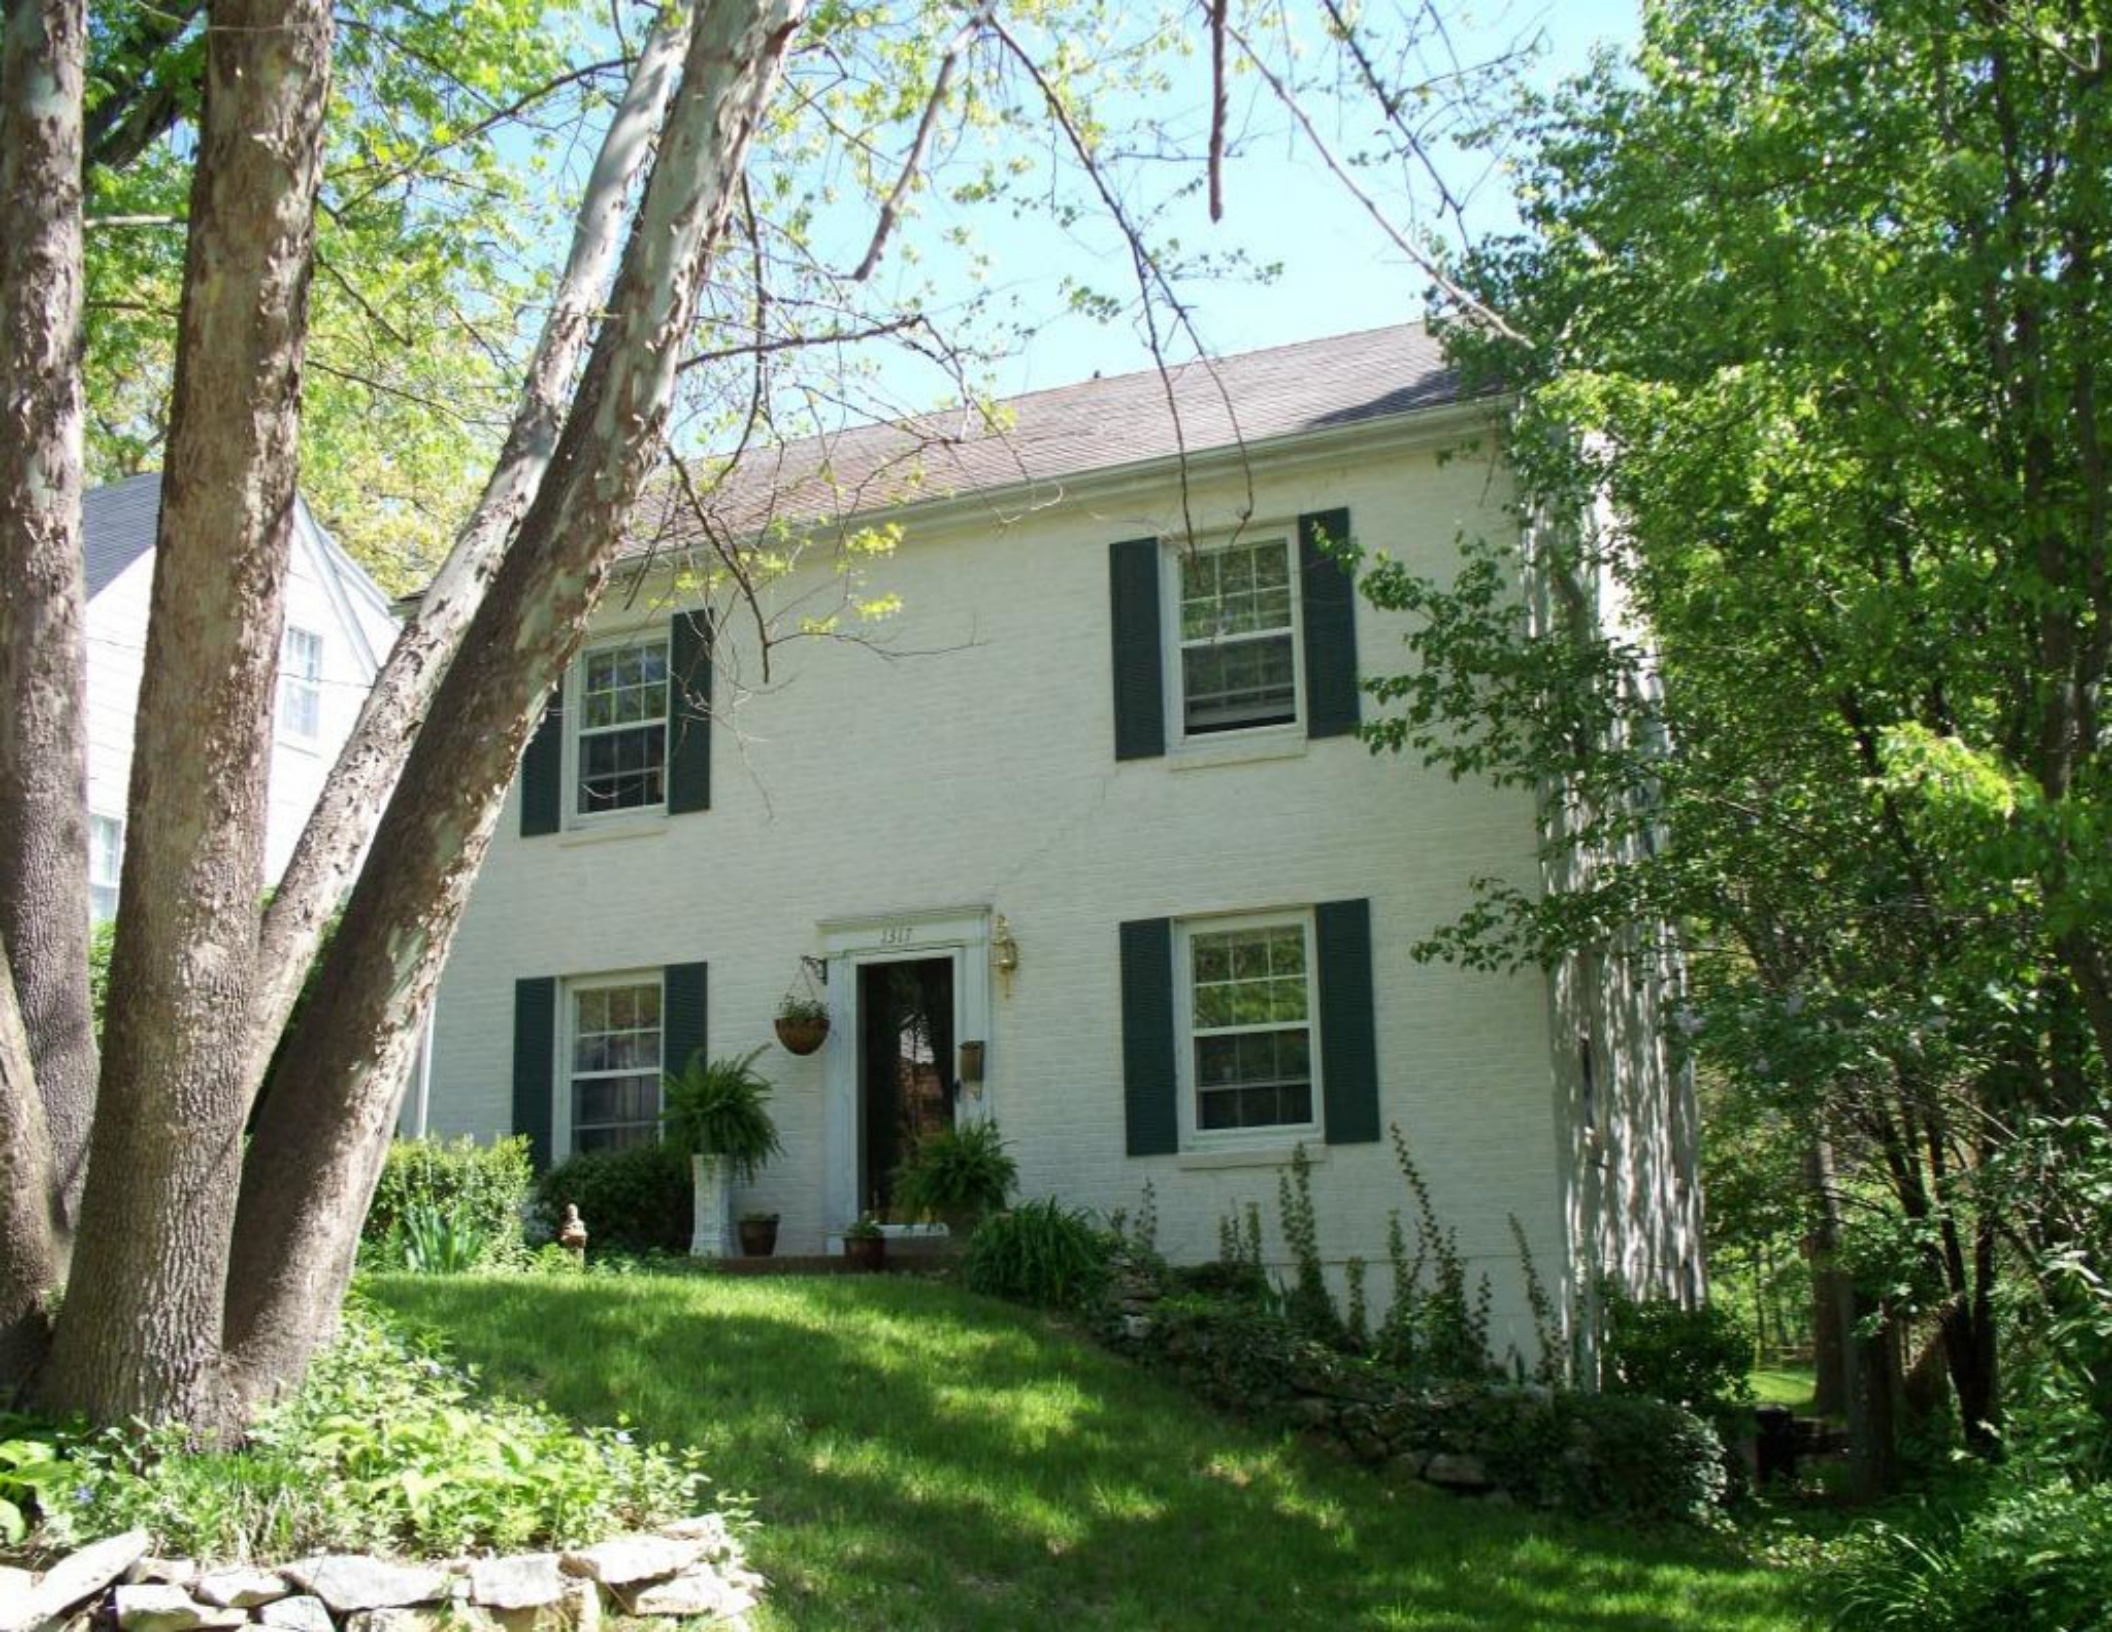
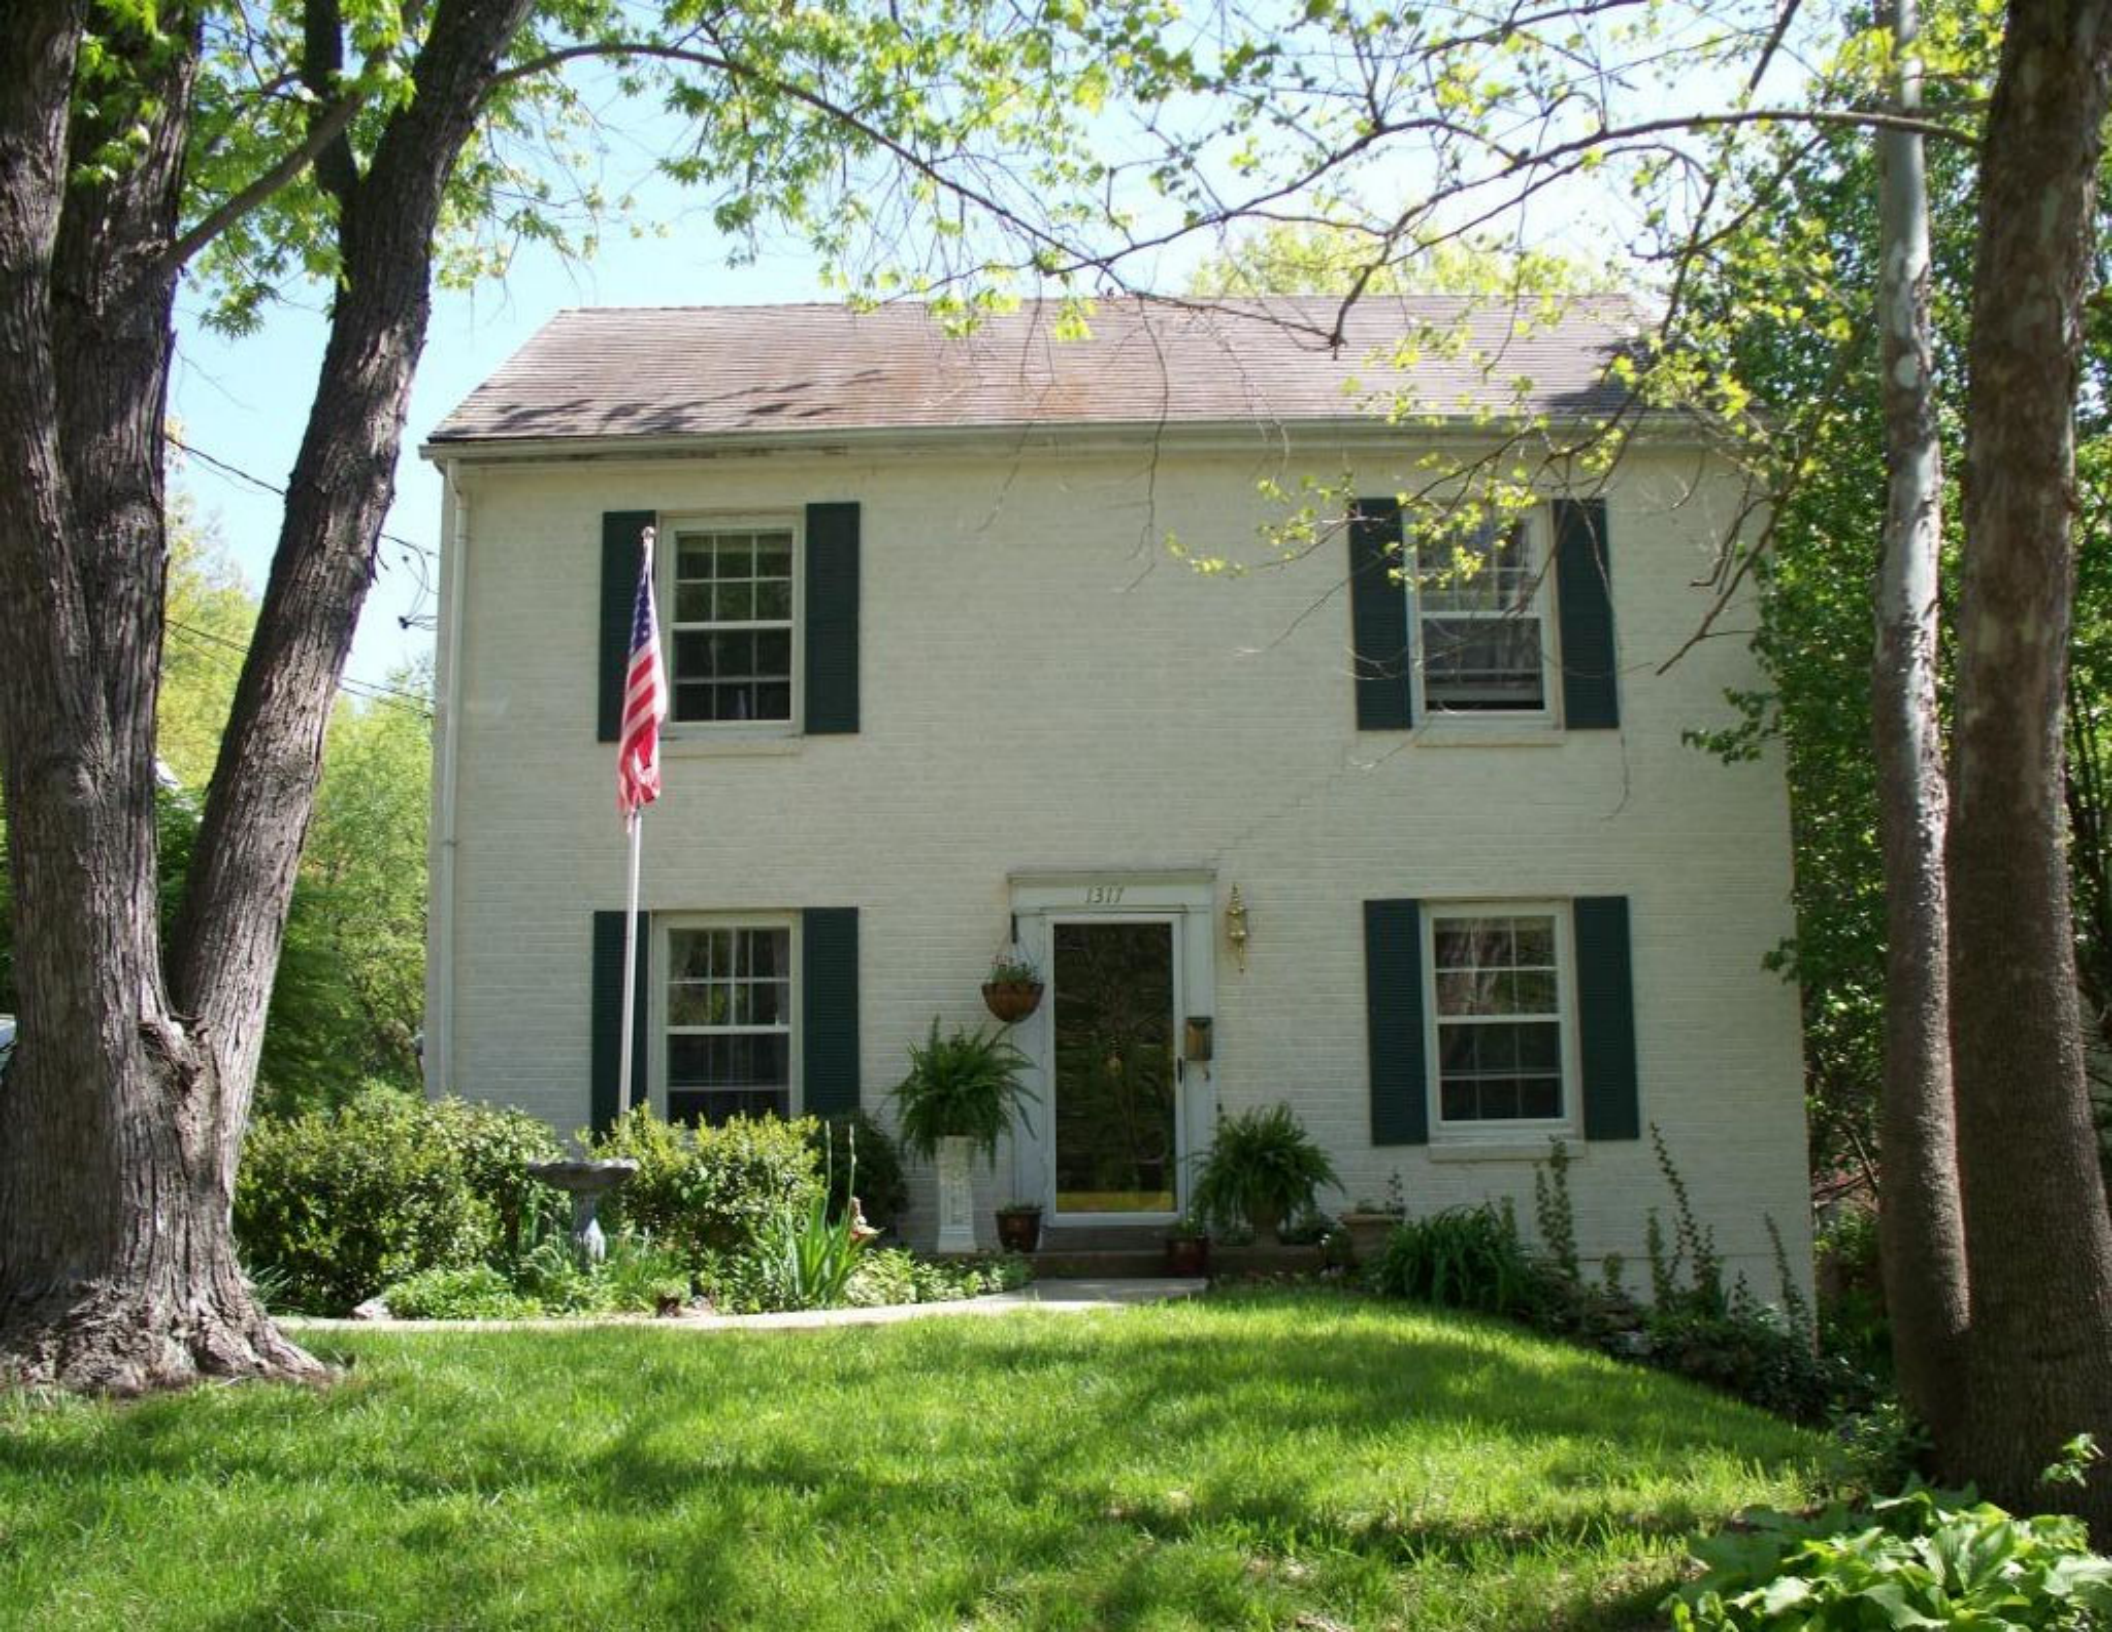
This two story brick home has a side gable roof and two 6/6 windows with shutters on the first floor and two identical windows on the first. The central bay contains the entrance and has an ornate door surround. A simple concrete pad acts as the stoop. It's difficult to tell from the photos but the windows may be modern replacements. All of the windows have brick sills.

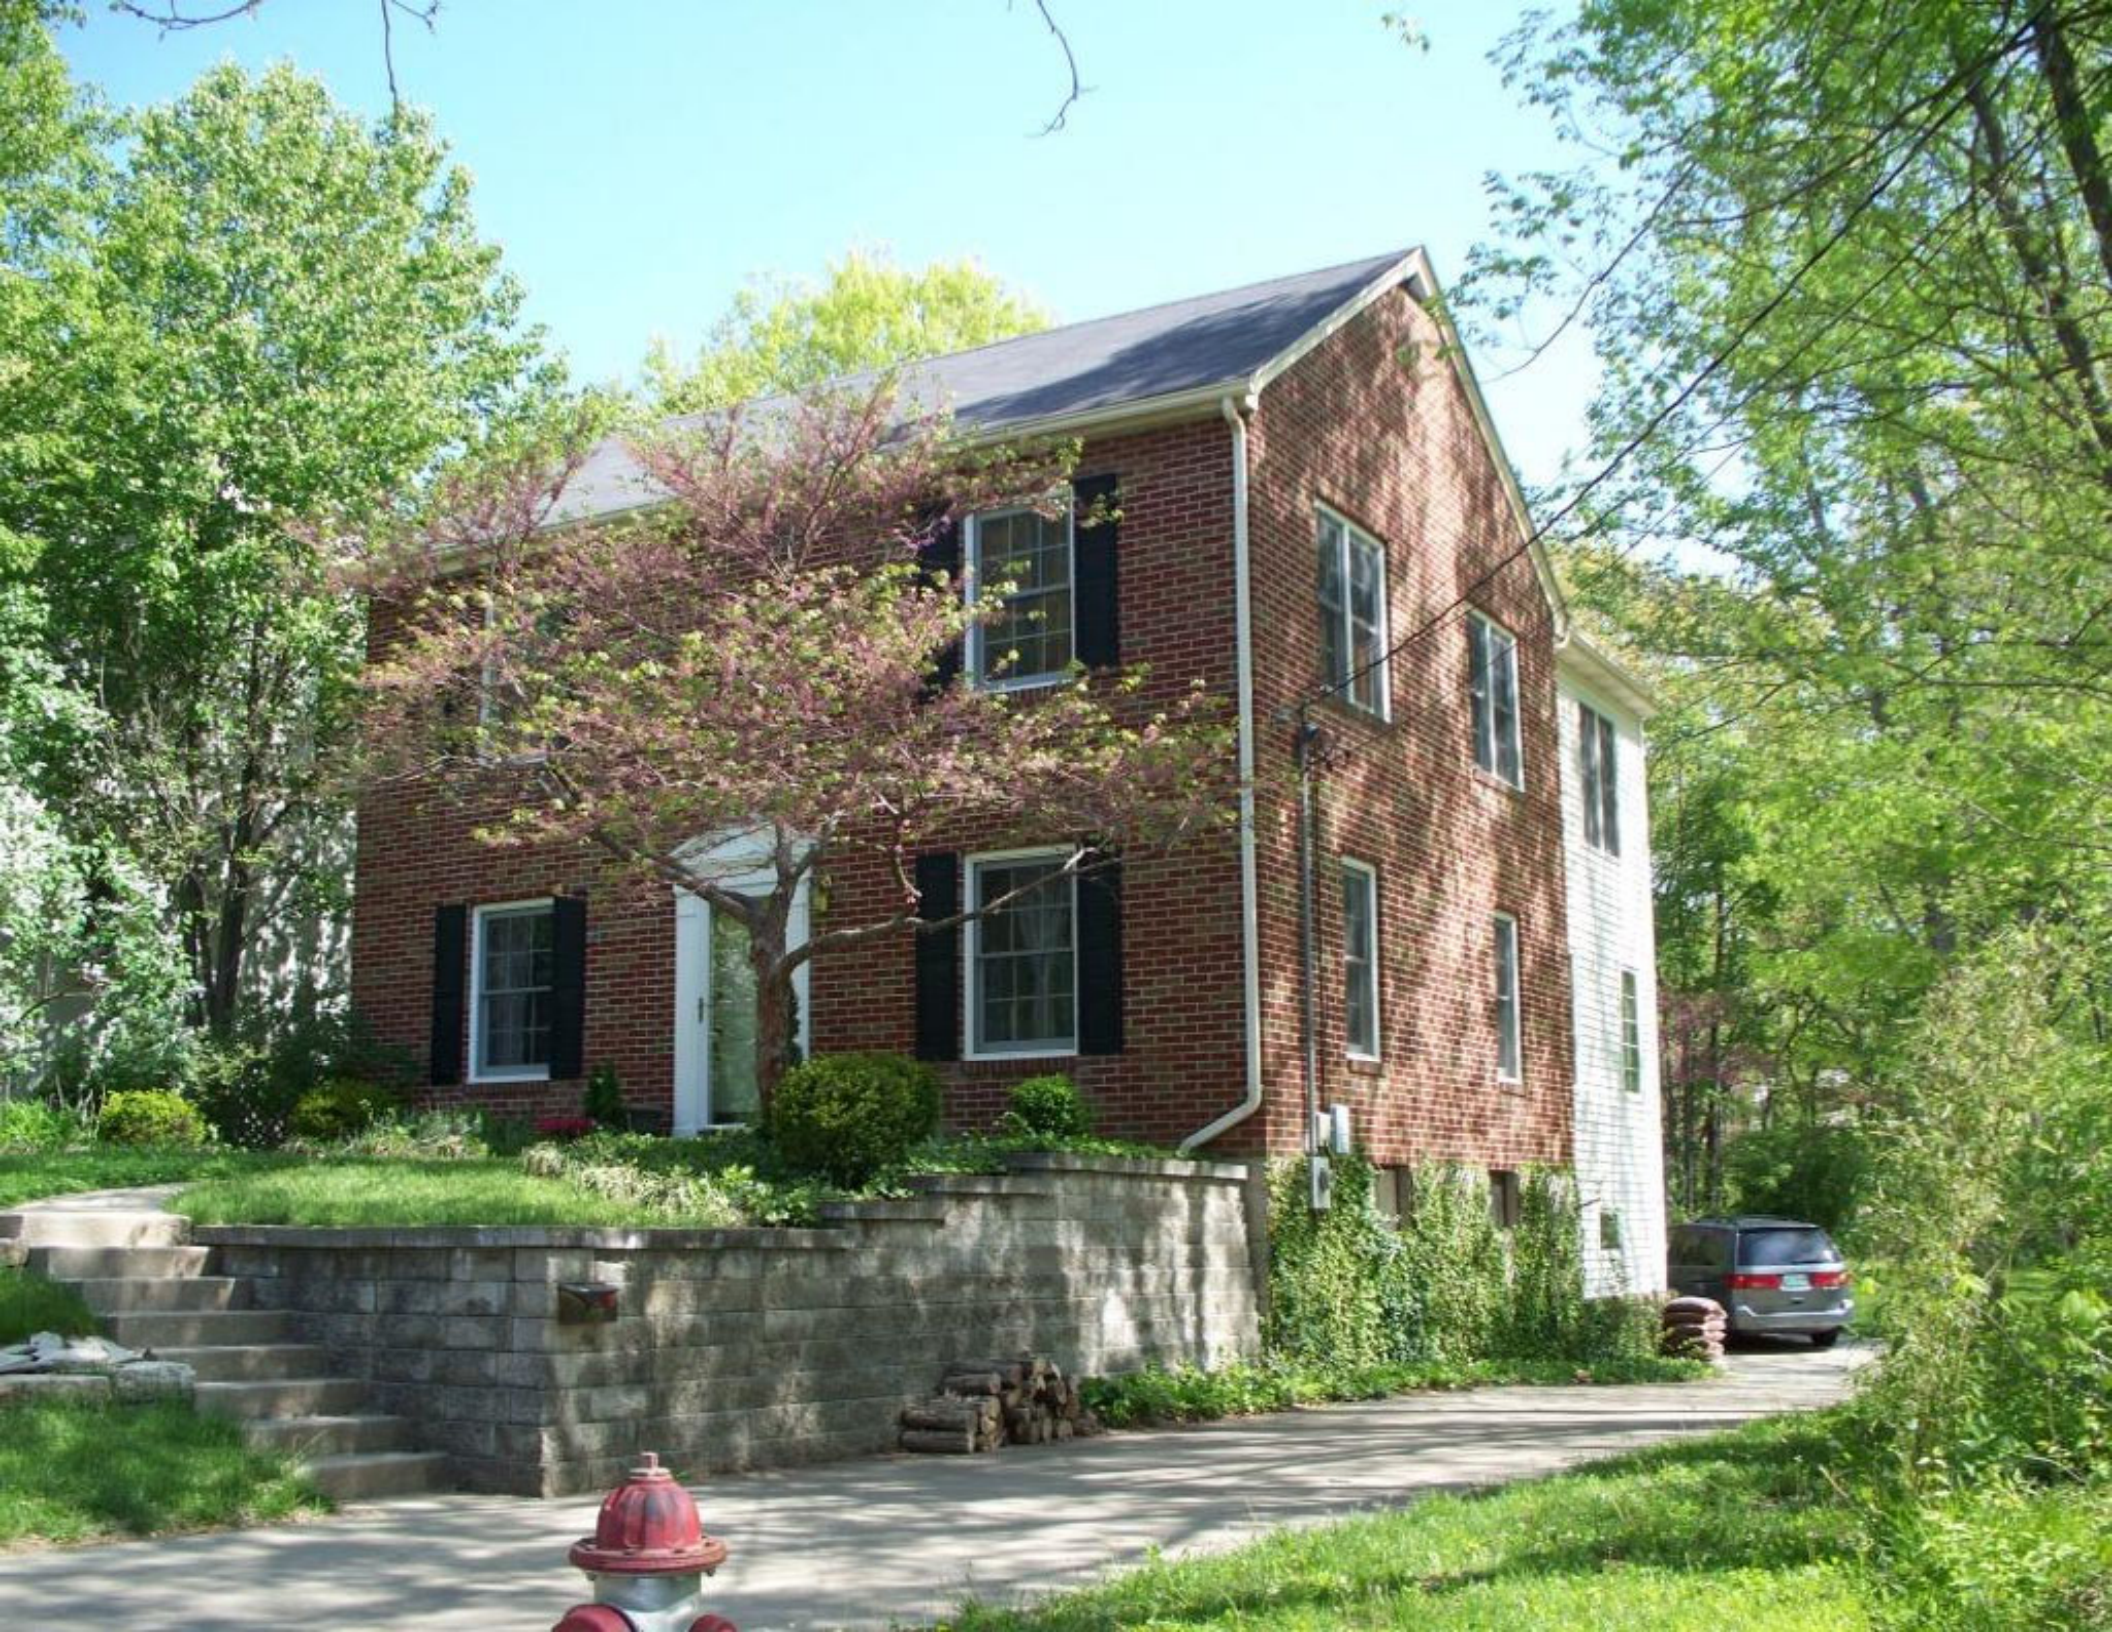
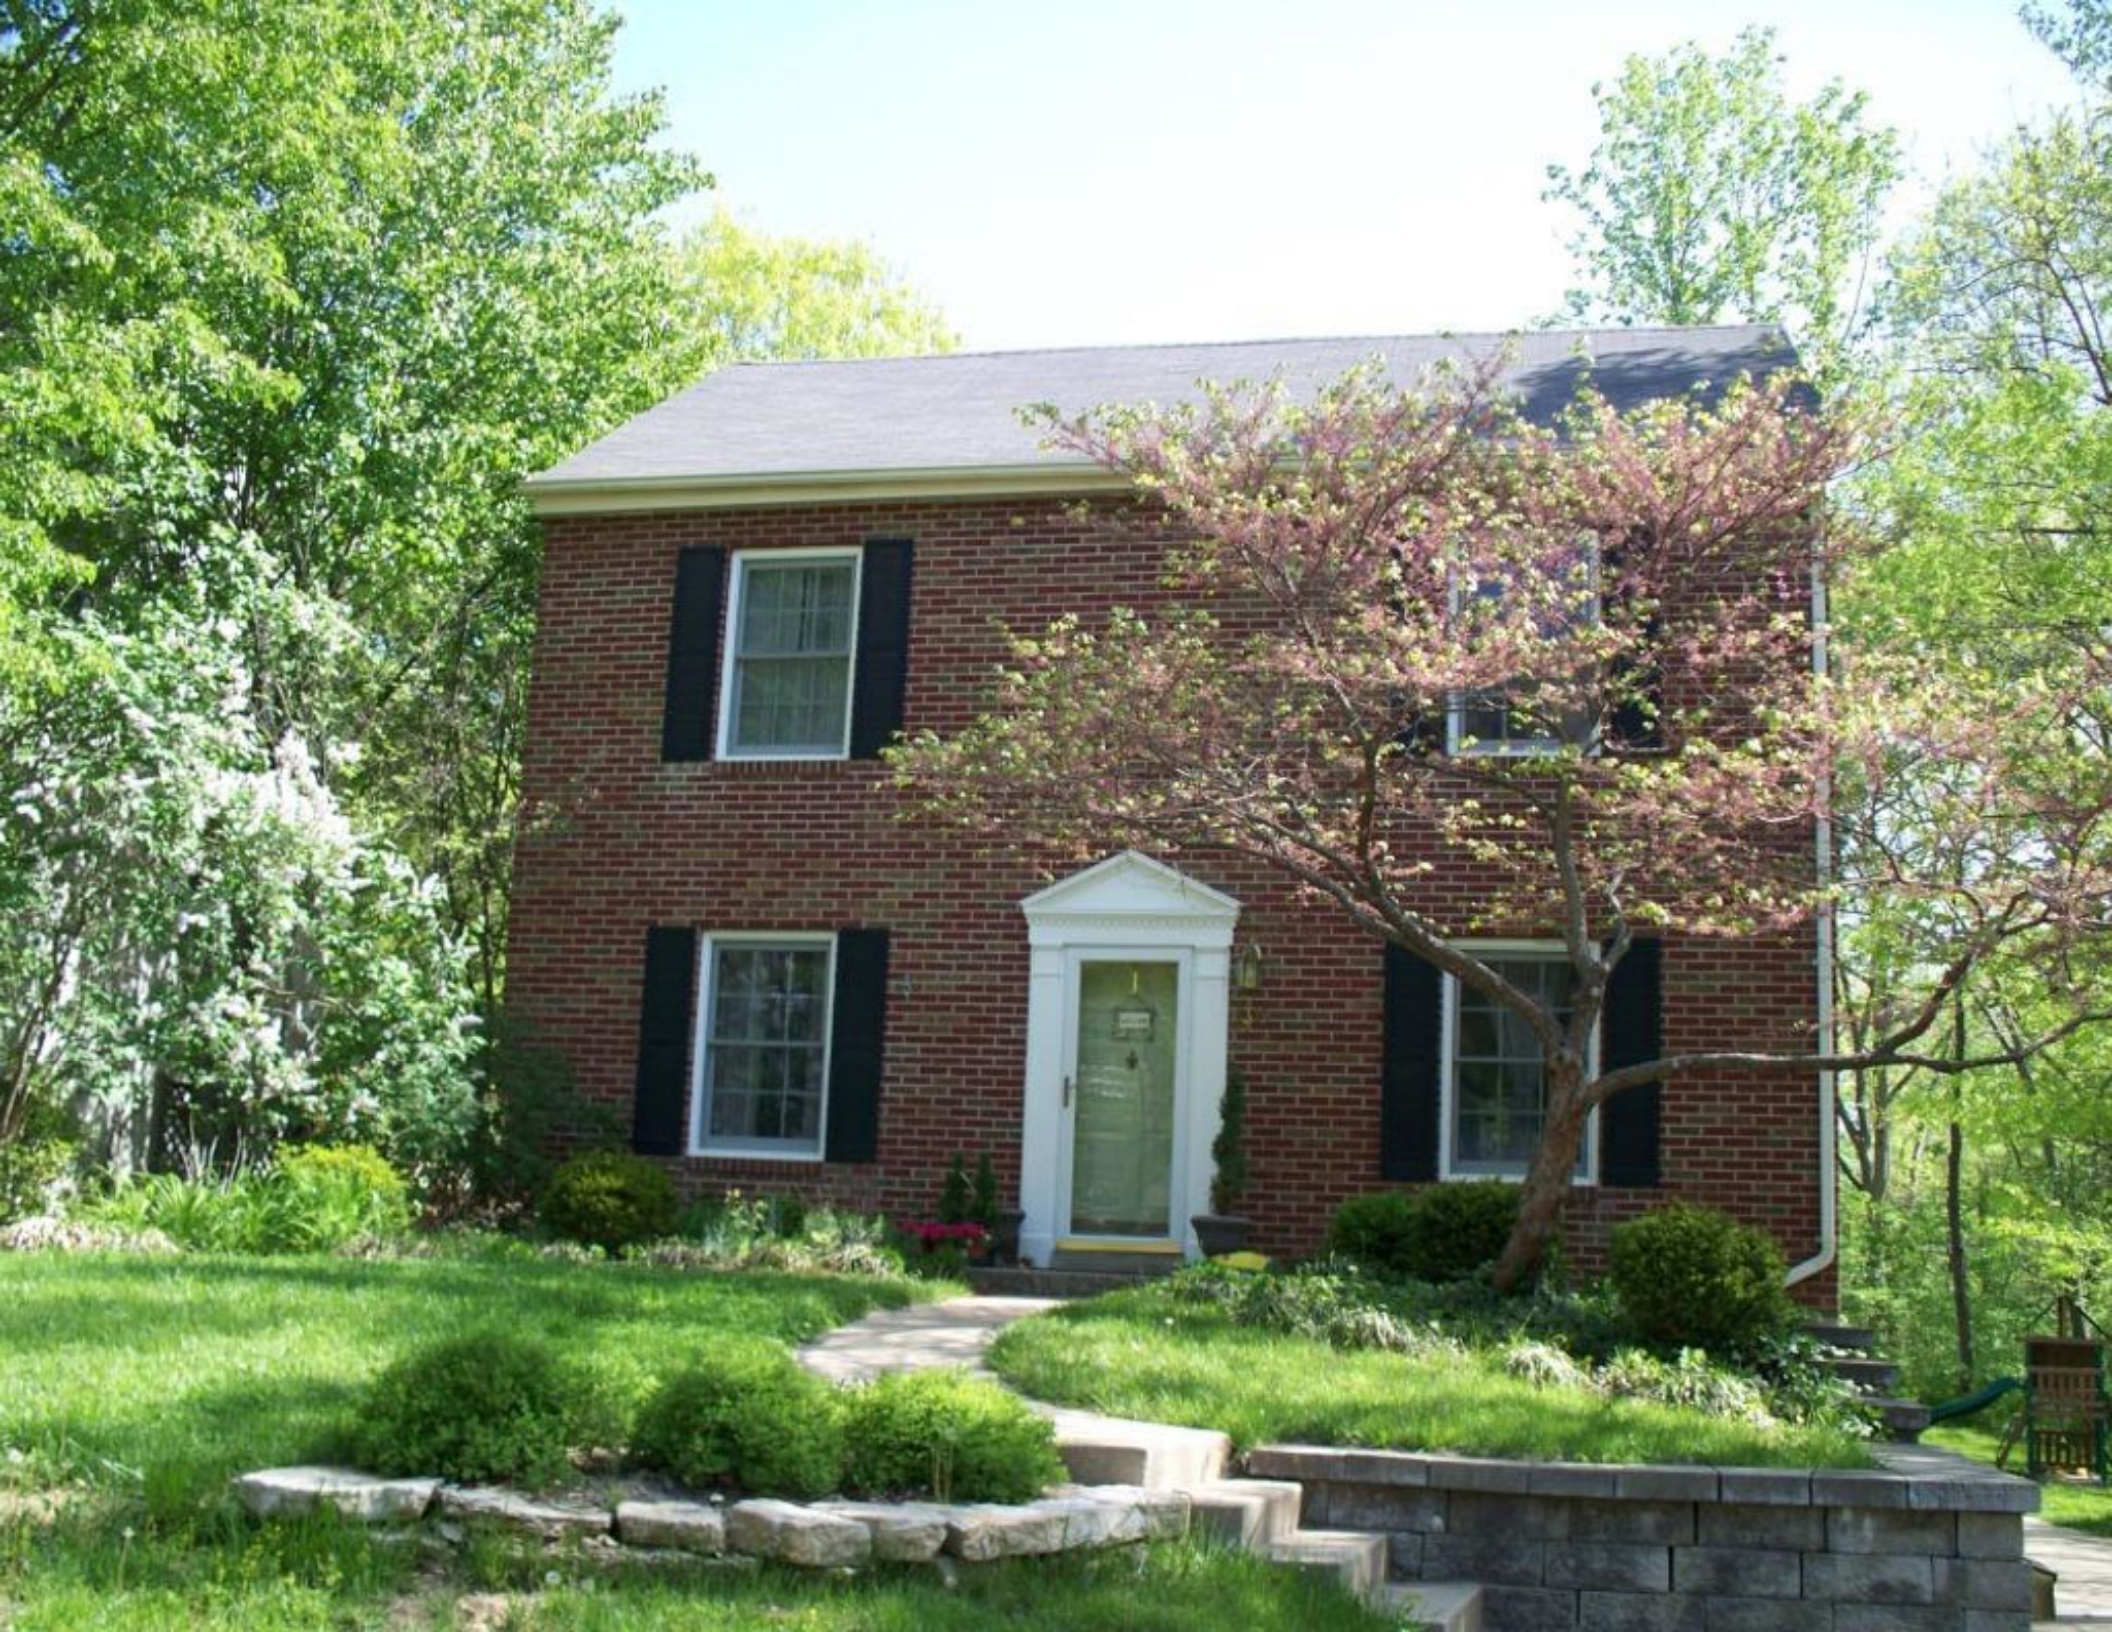
This two story brick home has a side gable roof and two 6/6 windows with shutters on the first floor and two identical windows on the first. The central bay contains the entrance and has a pedimented door surround. A simple concrete pad acts as the stoop. It's difficult to tell from the photos but the windows may be modern replacements.

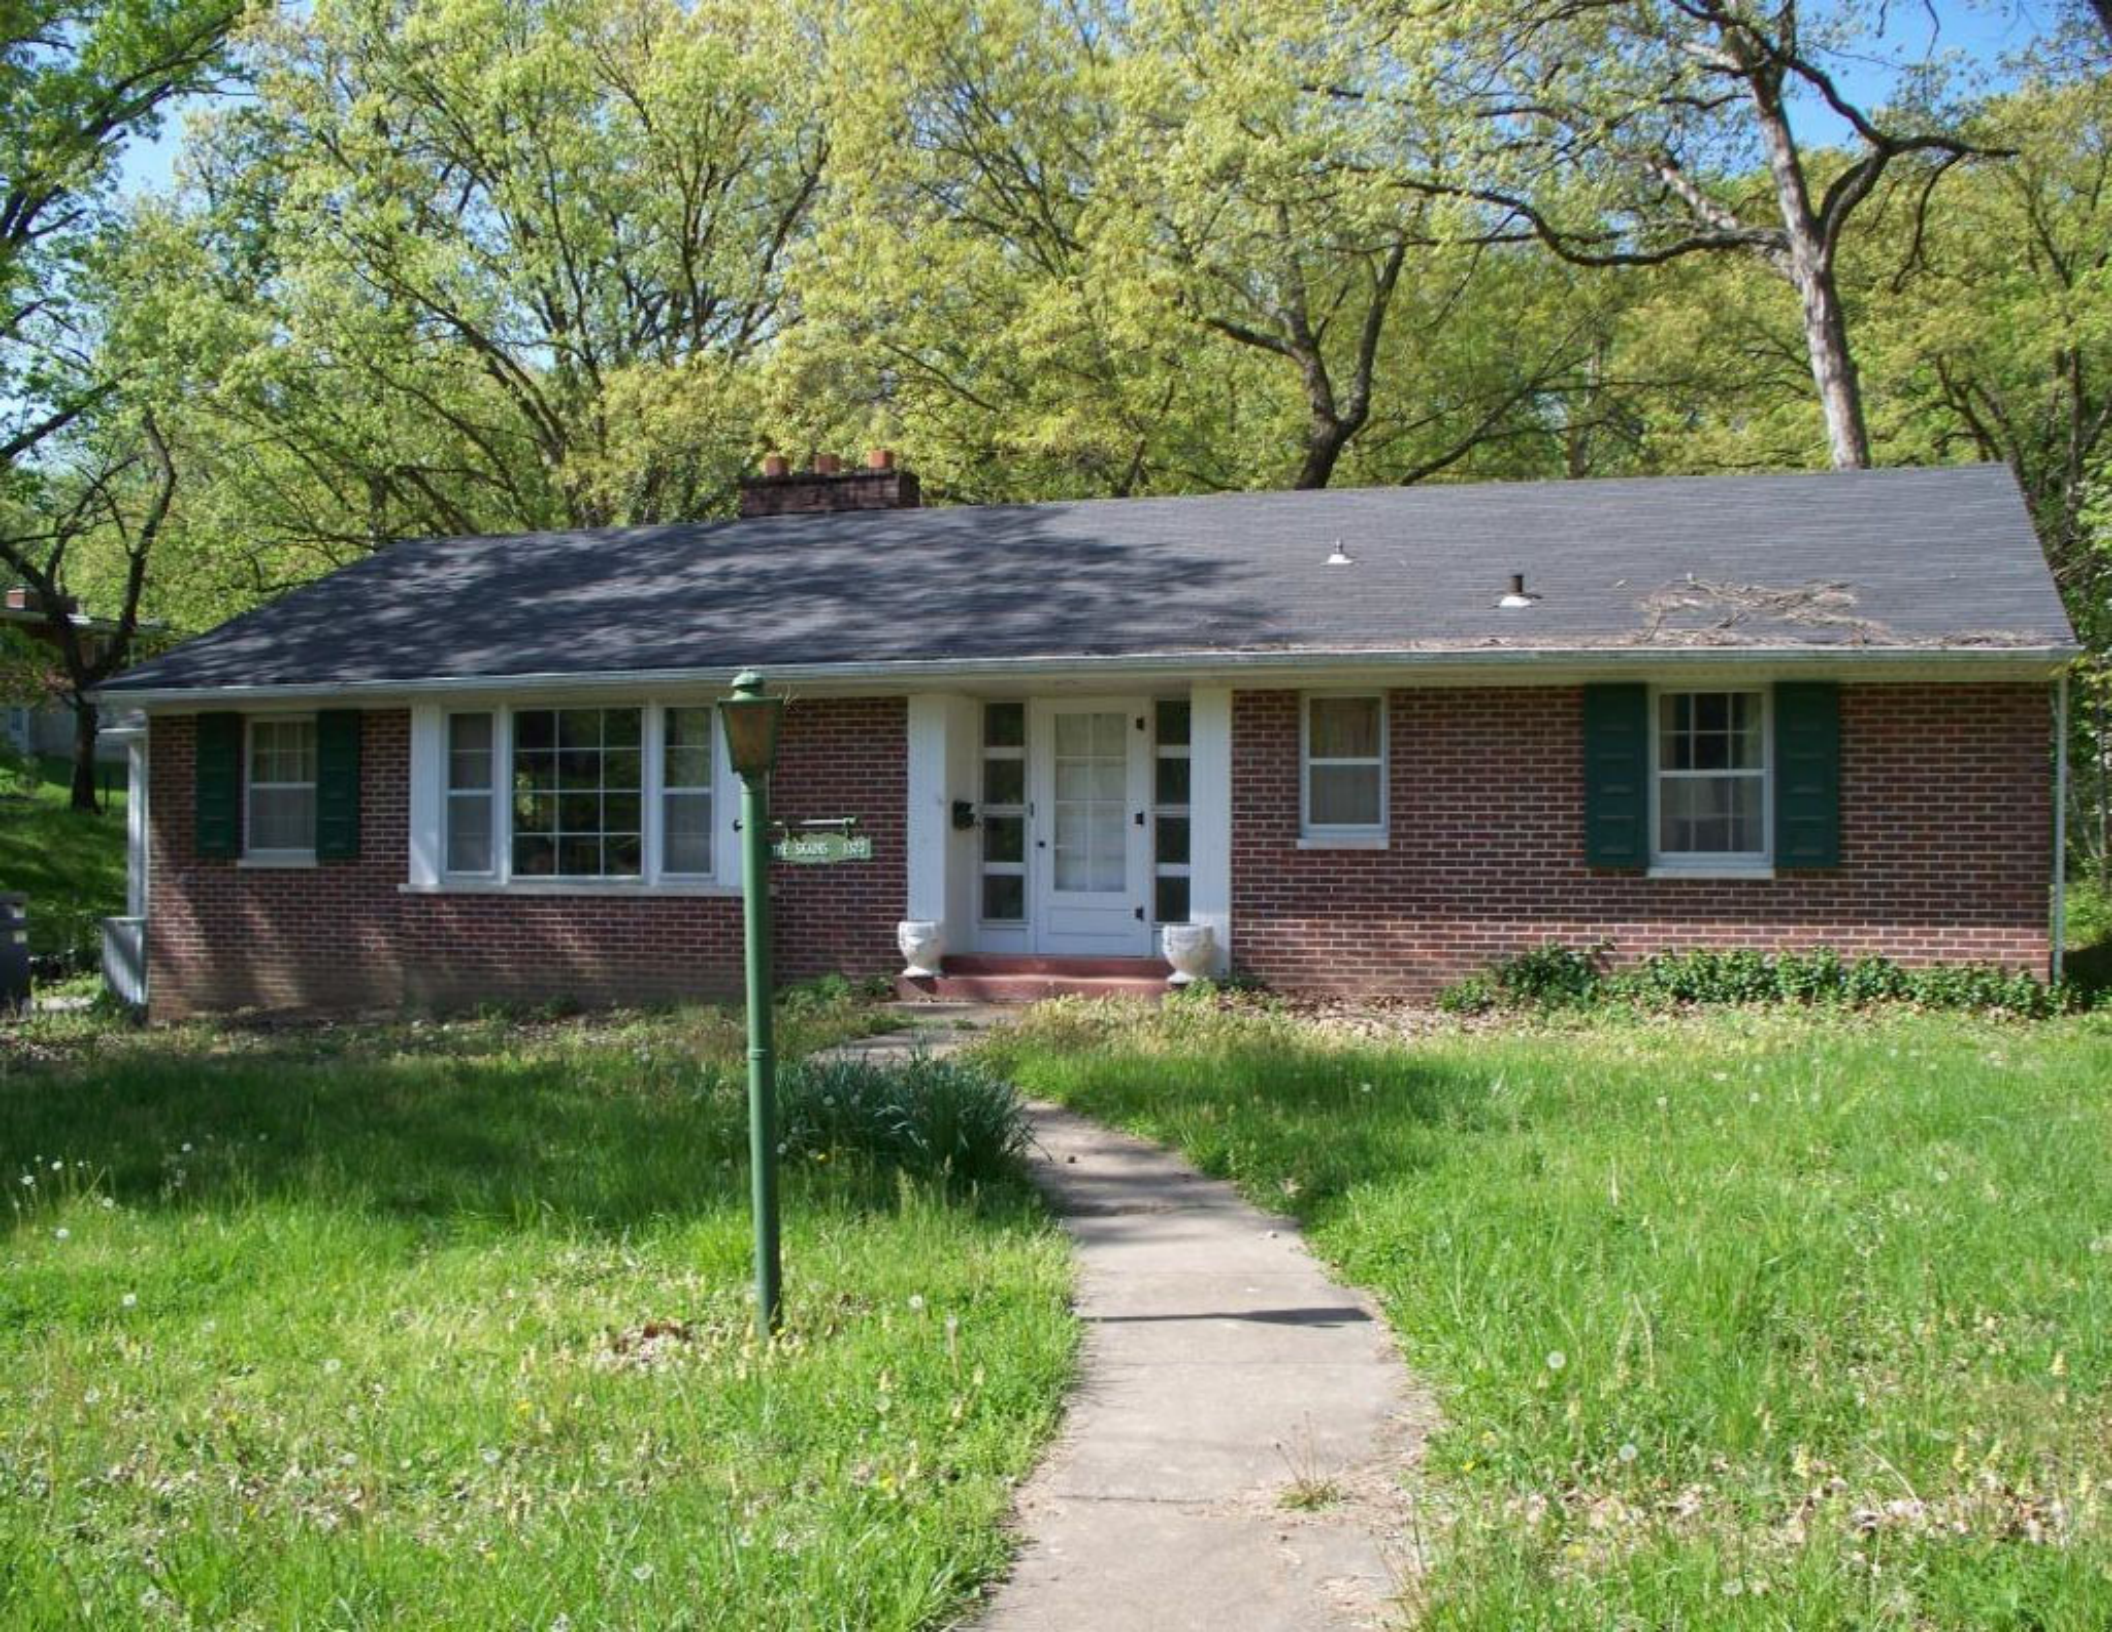
This one story brick ranch has a side gable roof. From the right it has a 6/6 window with shutters, a smaller 1/1 window, a recessed entrance with large multi-paned sidelights and a multi-paned door. A large multi-light picture window with sidelights and finally another 6/6 window with shutters. Due to the construction date it is currently considered outside the period of significance, however it would contribute if the period of significance was extended.
