ARCHITECTURAL/HISTORIC INVENTORY FORM

1. Survey No. CO-AS-005-001		2. Survey name: Moreau Drive Neighborhood Survey	
3. County: Cole		4. Address: 1202 Elmerine Ave.	
5. City: Jefferson City	Vicinity: <input type="checkbox"/>	6. UTM: / /	7. Township/Range/Section: T: R: S:
8. Historic name (if known):		9. Present/other name (if known):	
10. Ownership: <input checked="" type="checkbox"/> Private <input type="checkbox"/> Public		11. Historic use (if known): Residential	11. Current use: Residential

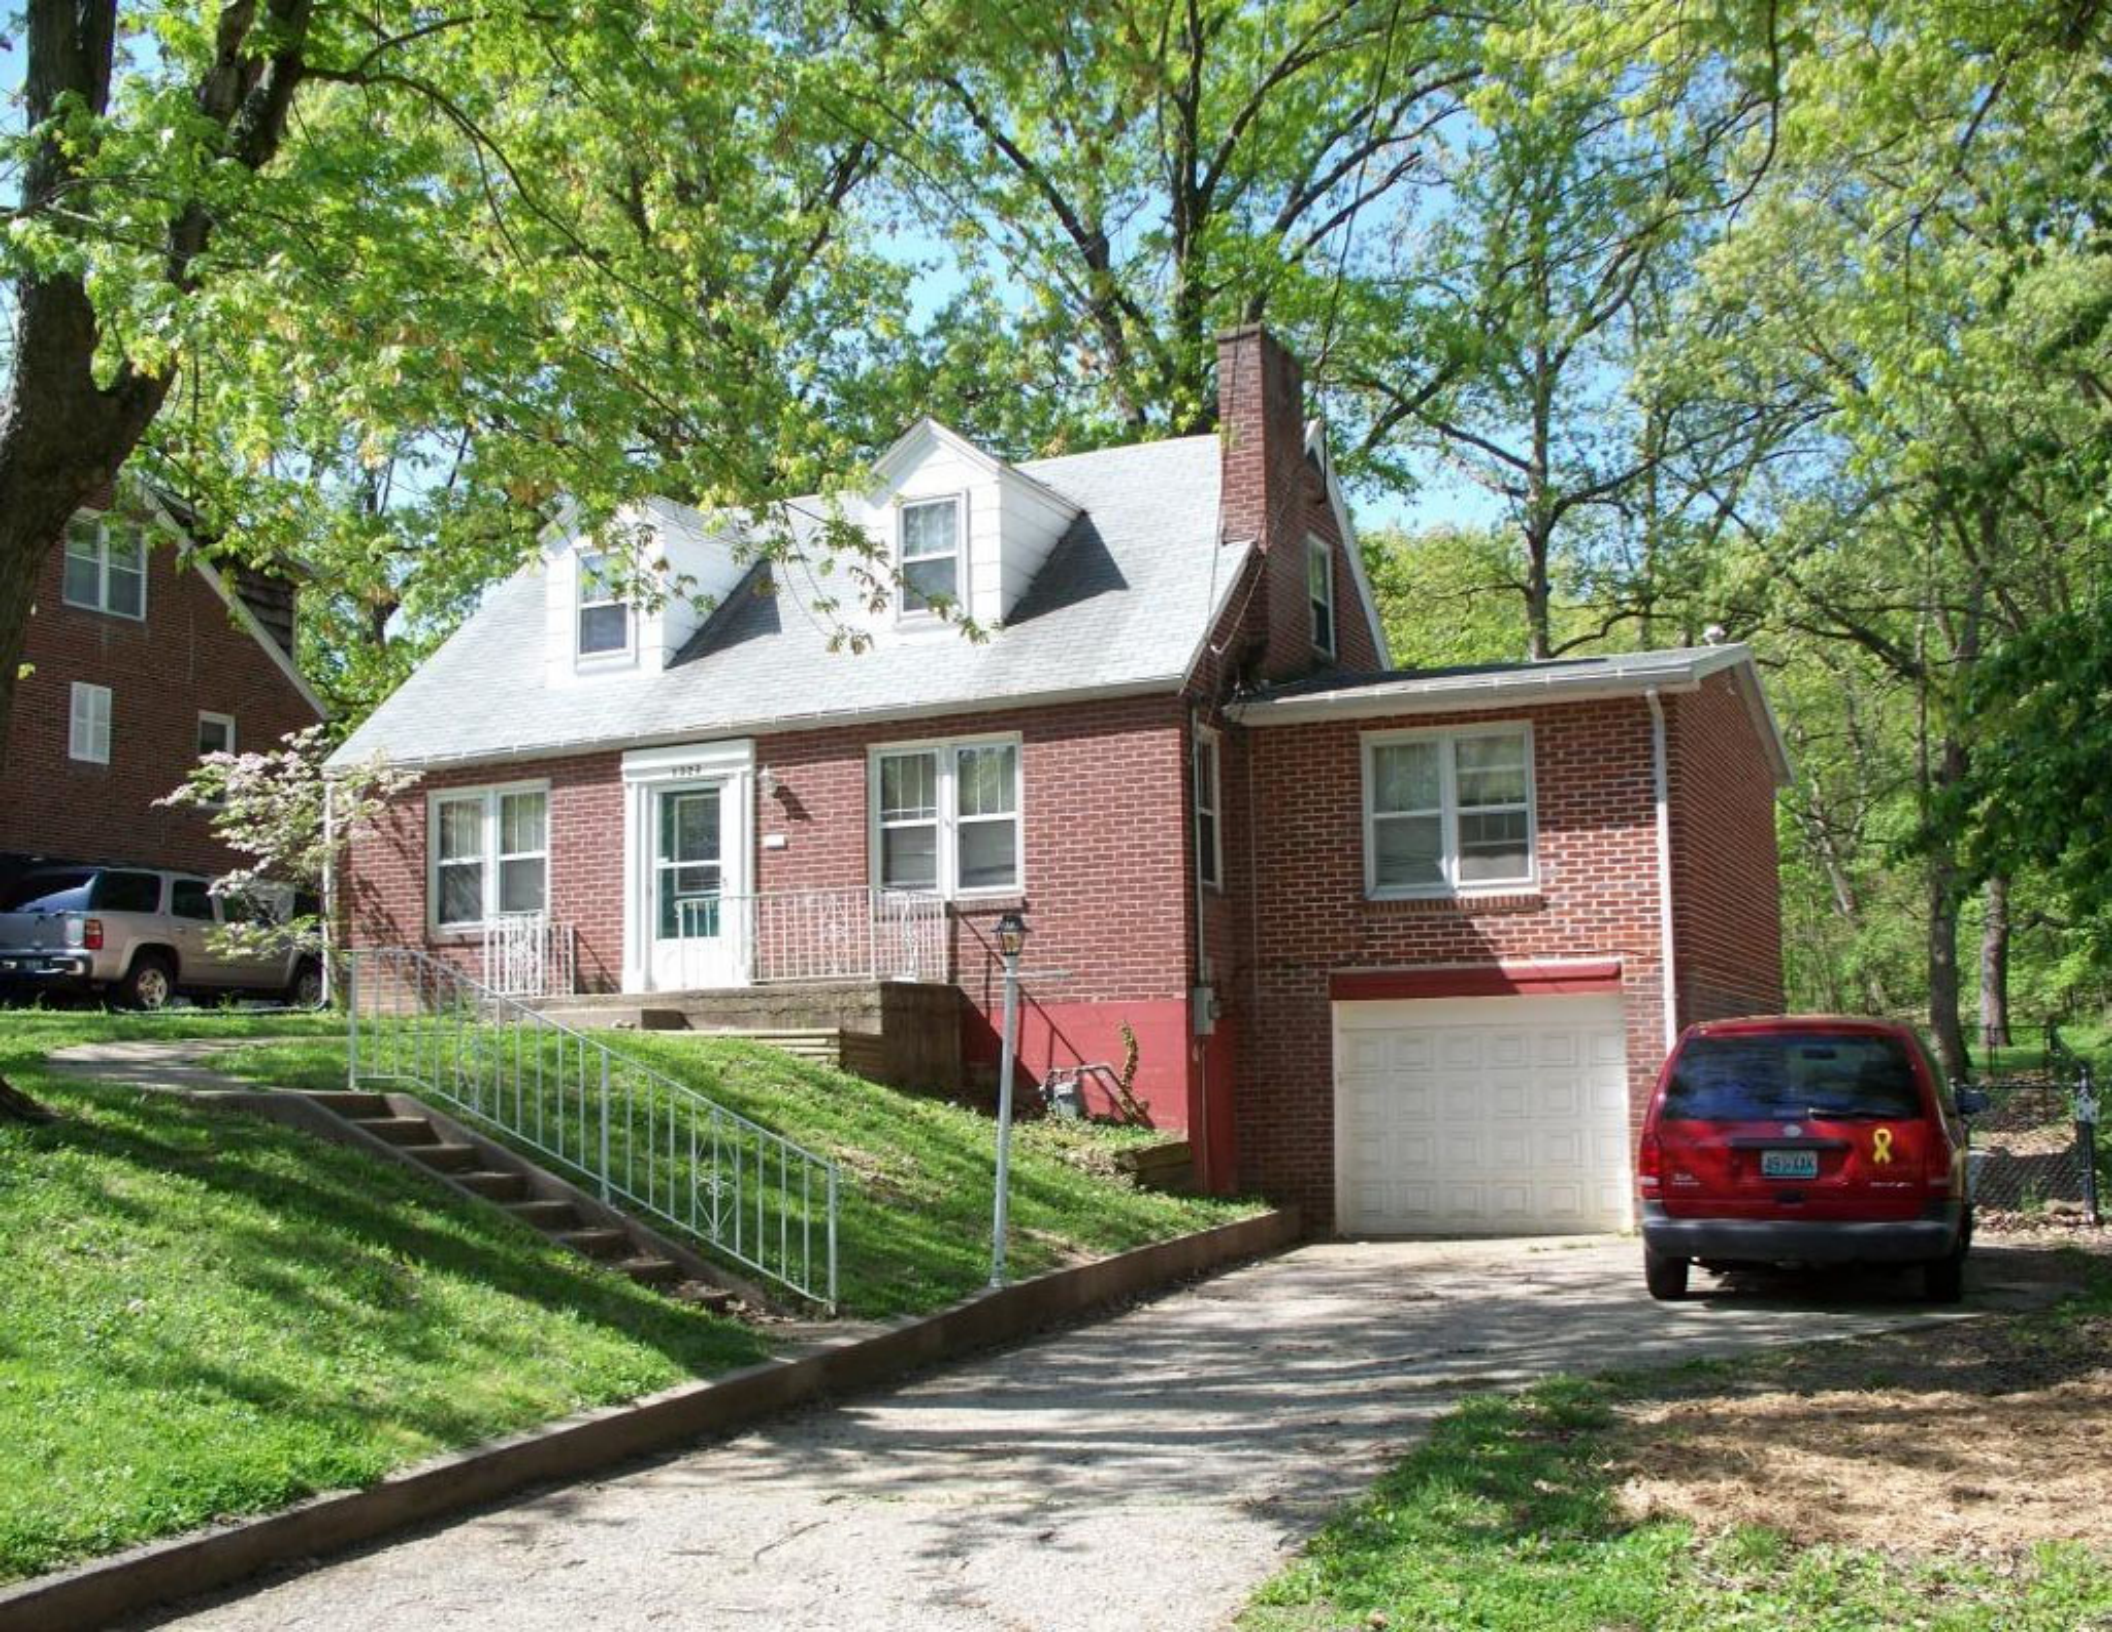
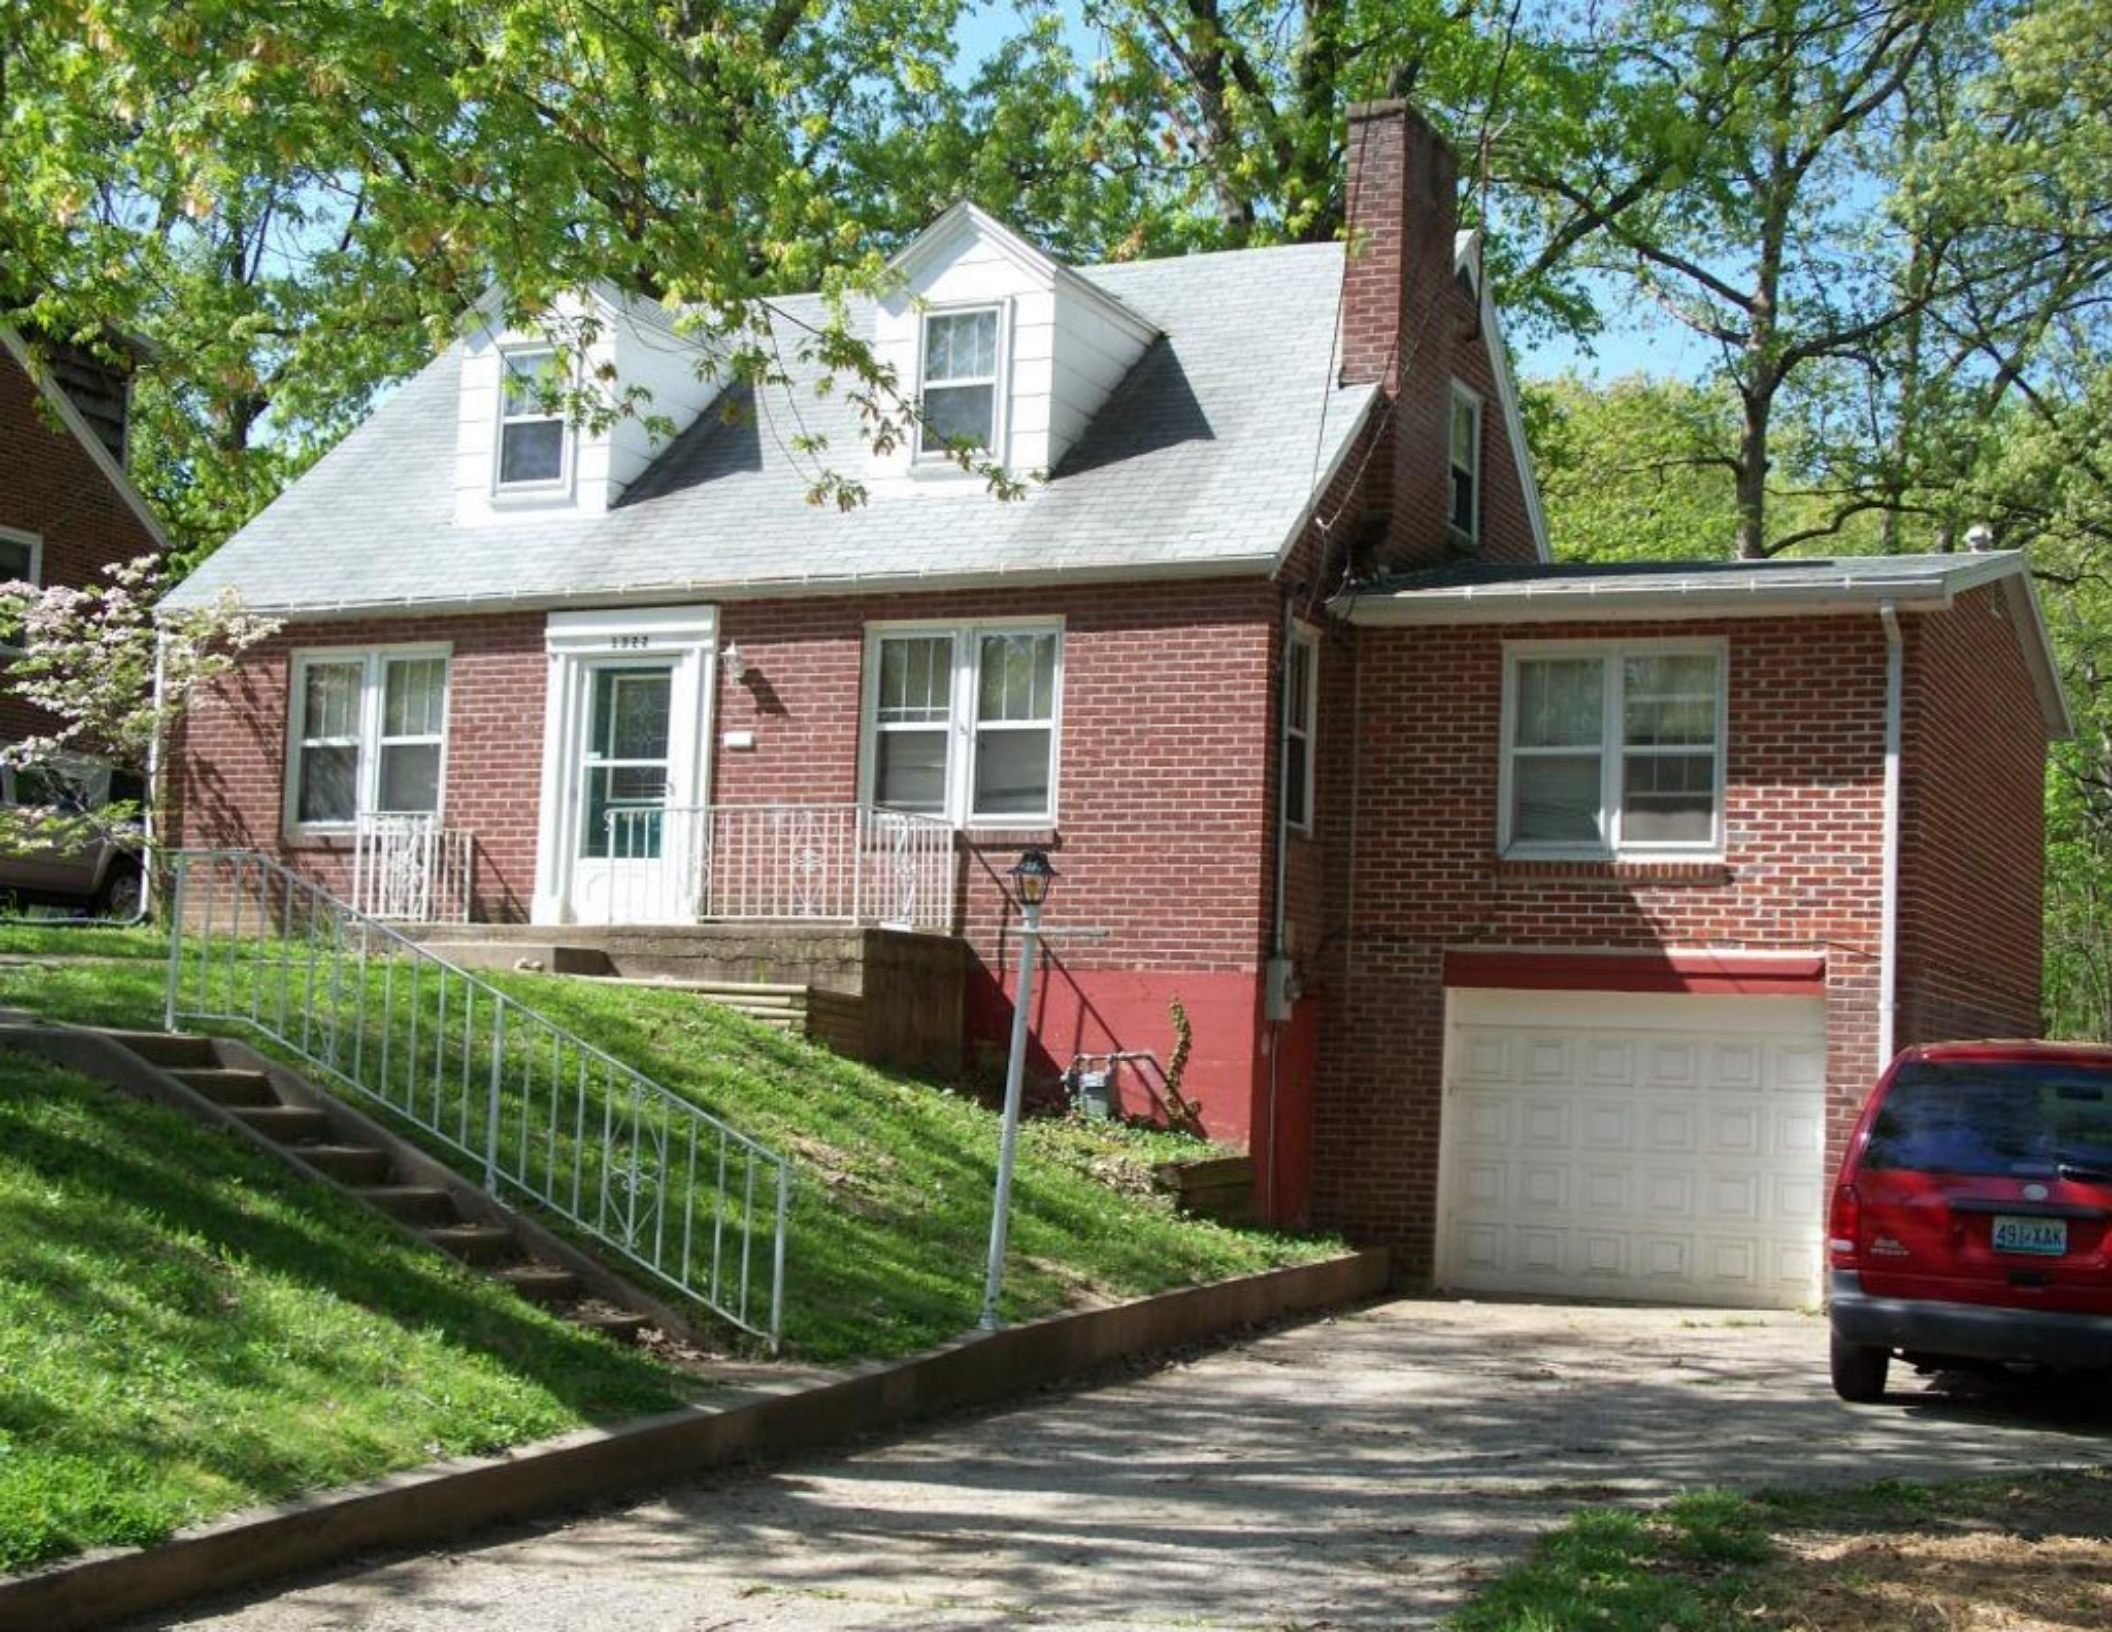
This 1 ½ story brick Cape Cod has a side gable roof and two gabled dormers that have historic 3/1 windows. The first floor has paired 3/1 windows flanking the centered entrance, which features a door surround. Set back on the left side is an additional bay, beneath which is a one-car garage (beneath grade). As the property was built after 1950 it would be N/C however this is a good example of a Cape Cod and would contribute if the significance was extended.

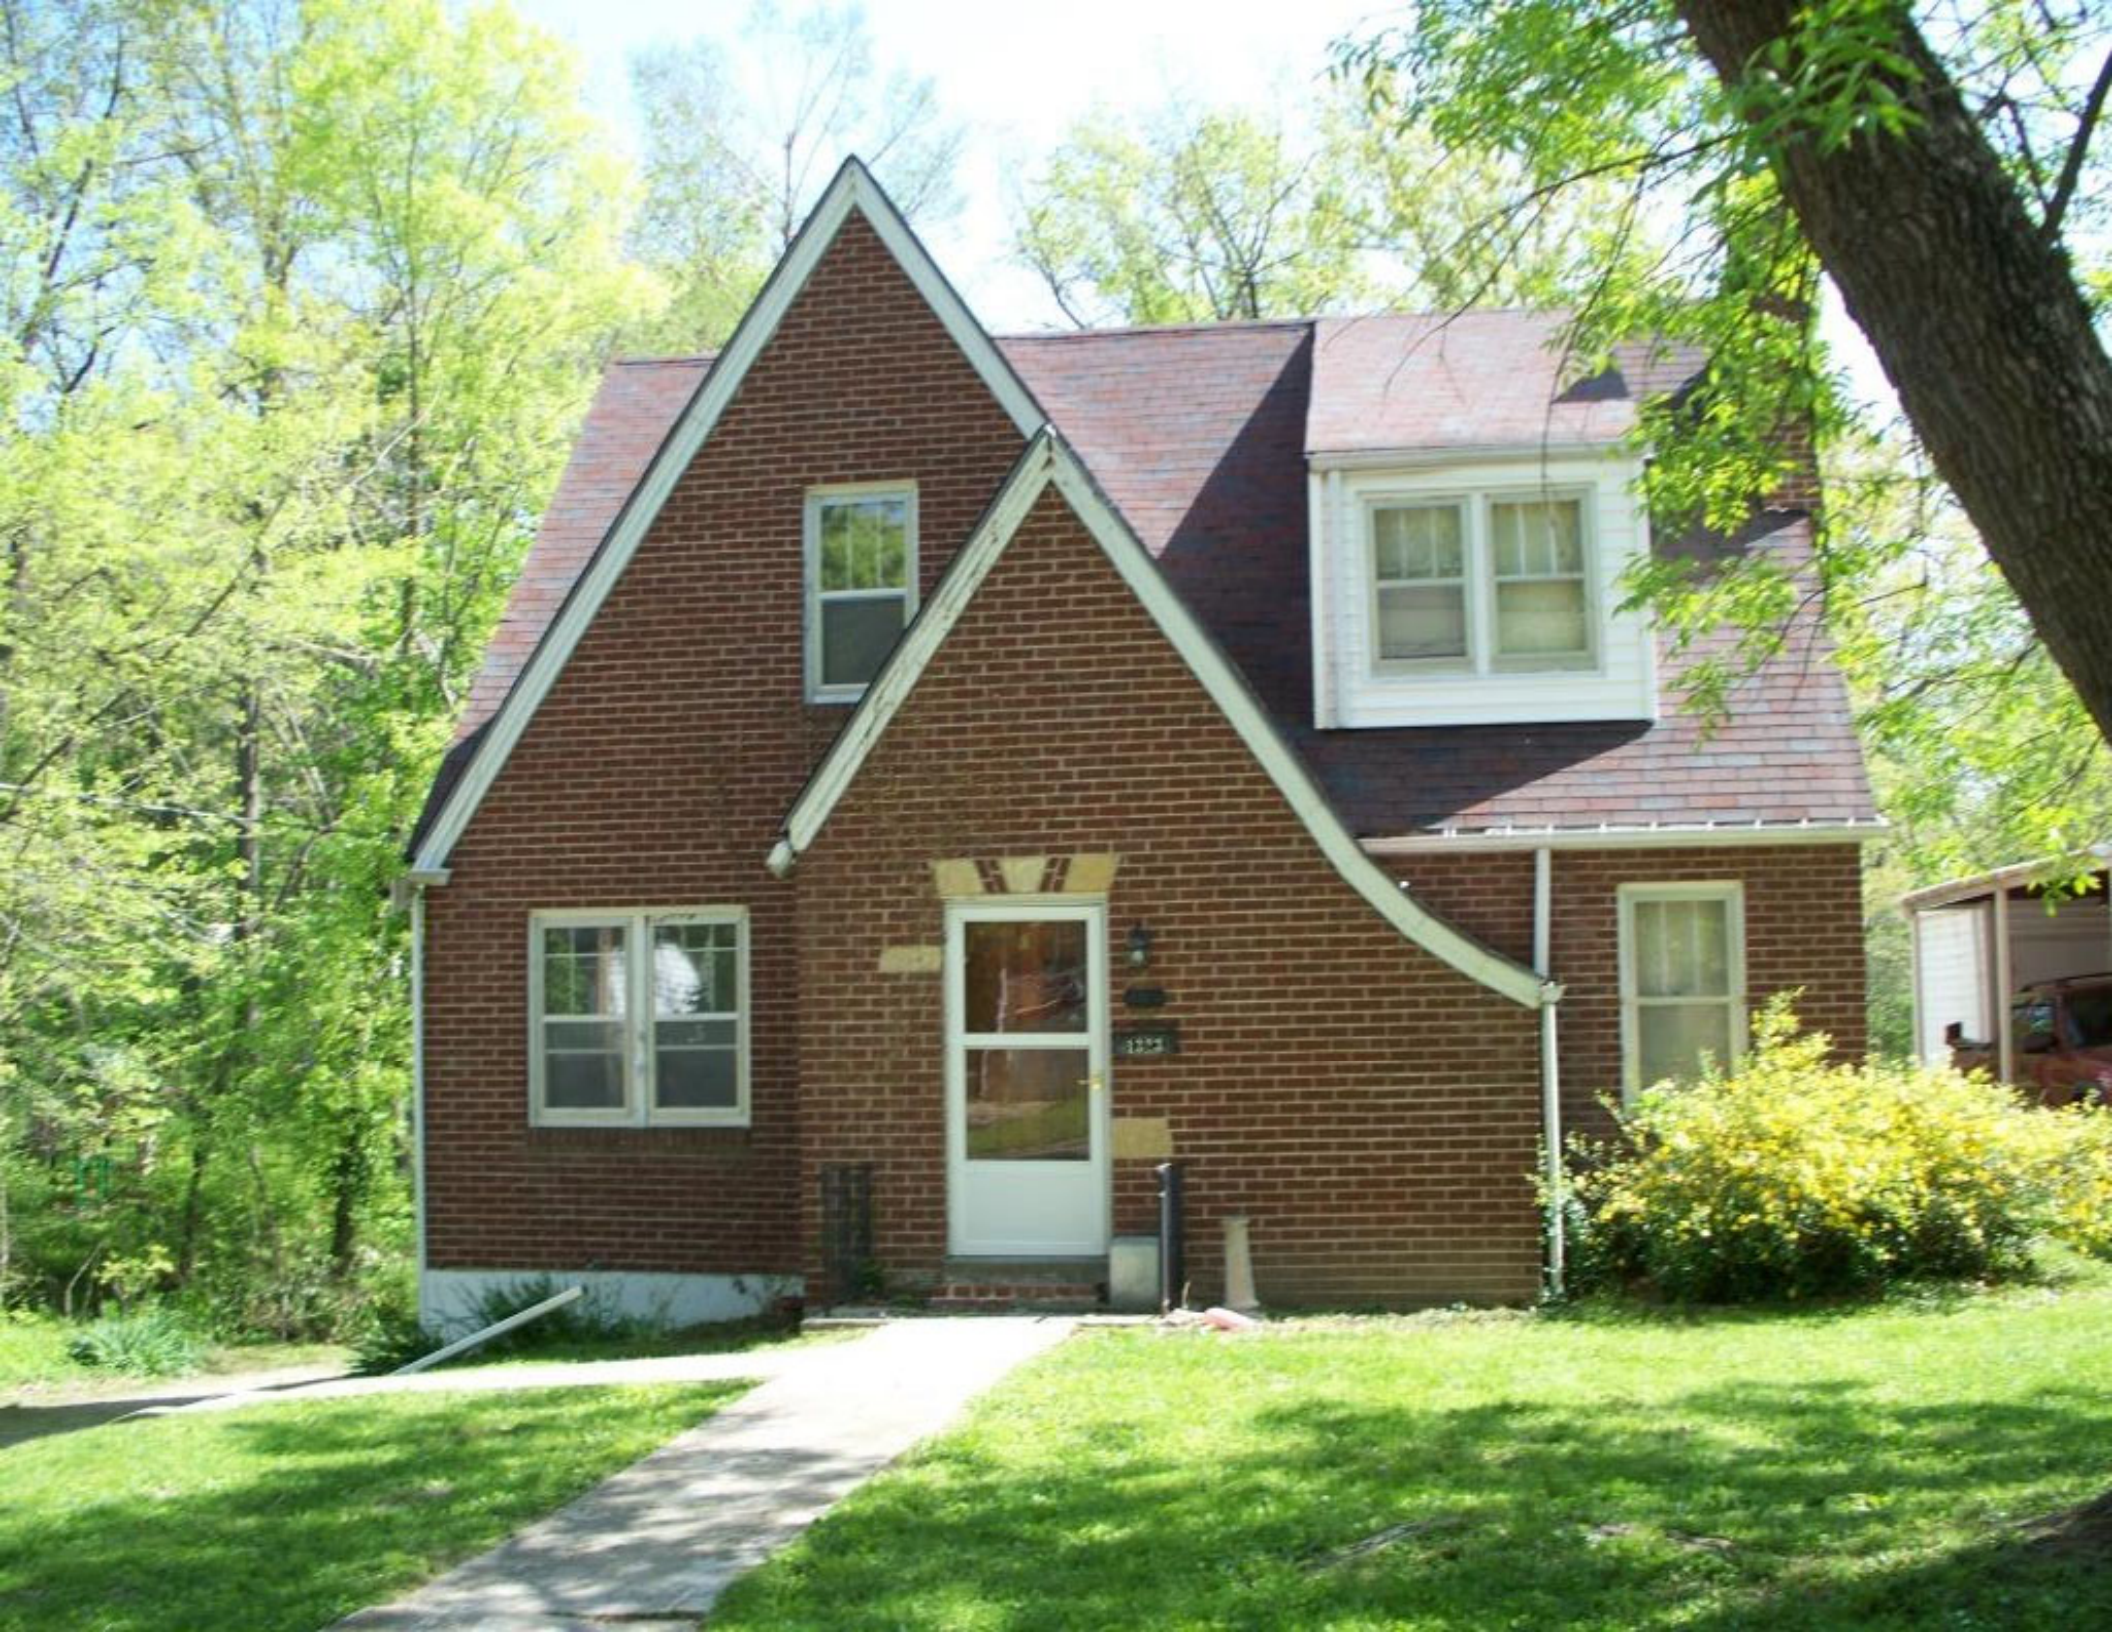
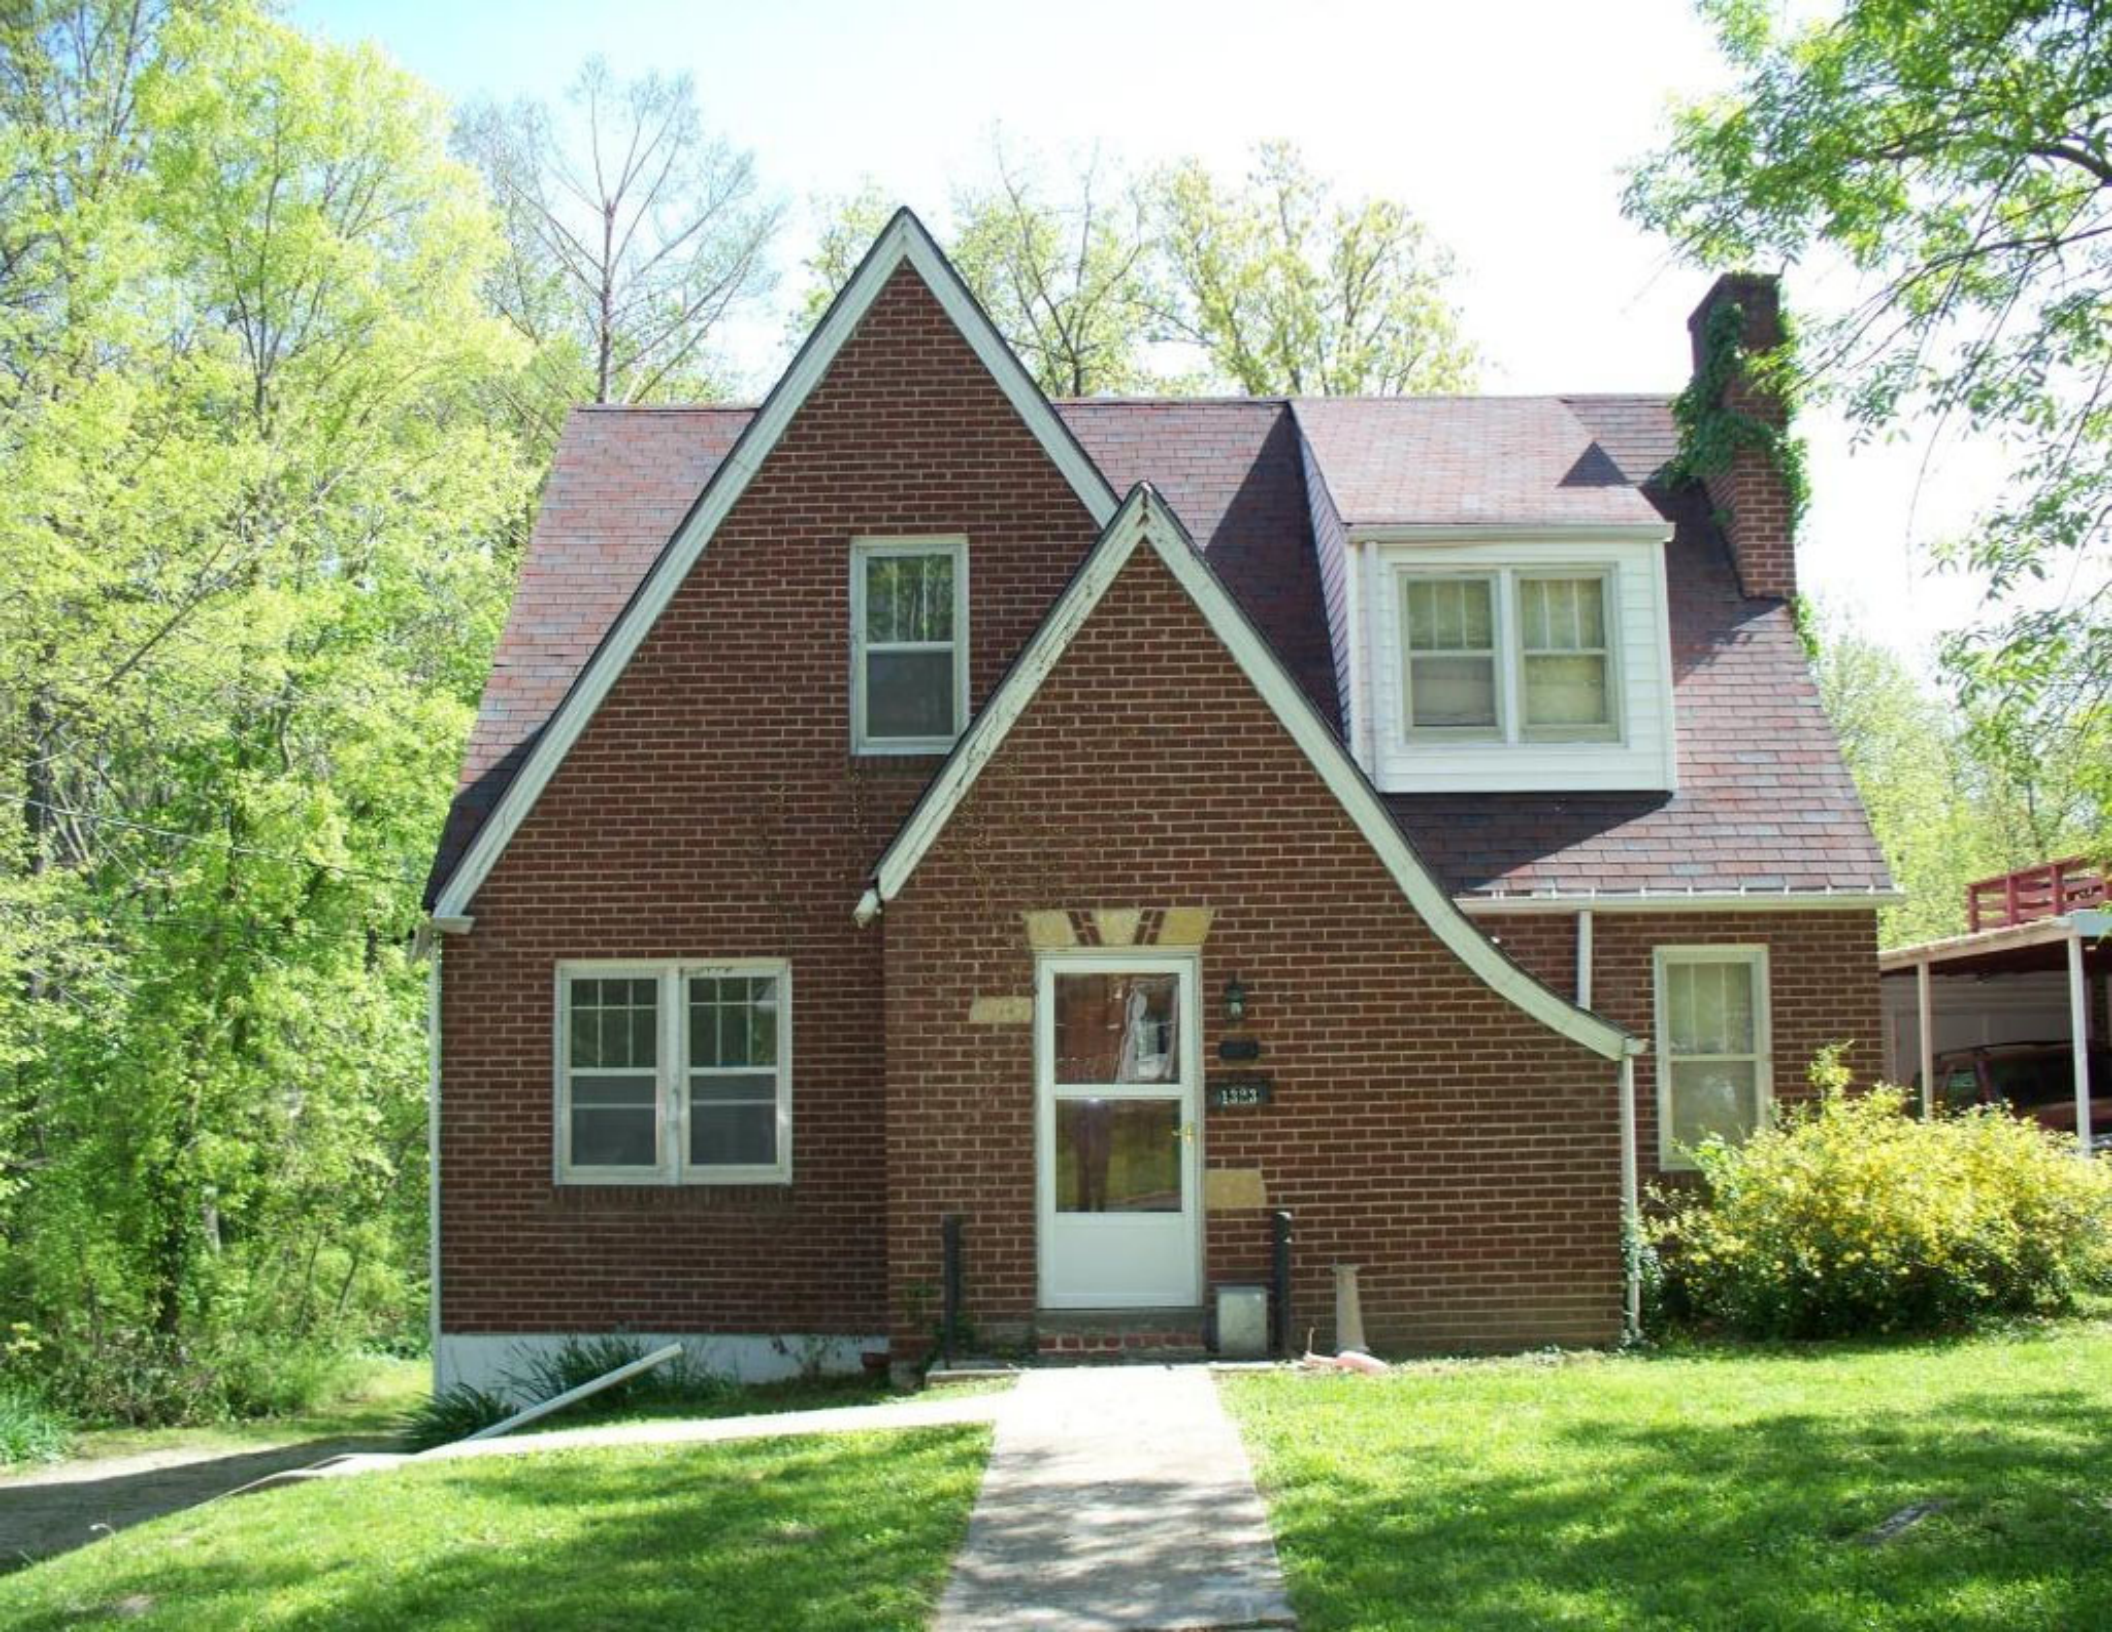
This brick 1 ½ story Tudor home has a cross gable roof with a steeply pitched front gable in the left bay with a single 3/1 window. In the left bay on the first floor is paired 3/1 windows. A second smaller steeply pitched gable projects from the home in the center bay with the right side of the gable extending and flaring closer to the ground. This bay contains the entrance, which has a decorative French arch made of alternating brick and stone. A couple more pieces of stone are on either side of the door. The entrance is reached by a shallow brick stoop with metal railing. The right bay contains a single 3/1 window. Above this on the second side gable story of the house is a shed dormer clad in vinyl with two 3/1 windows. All of the windows are historic.

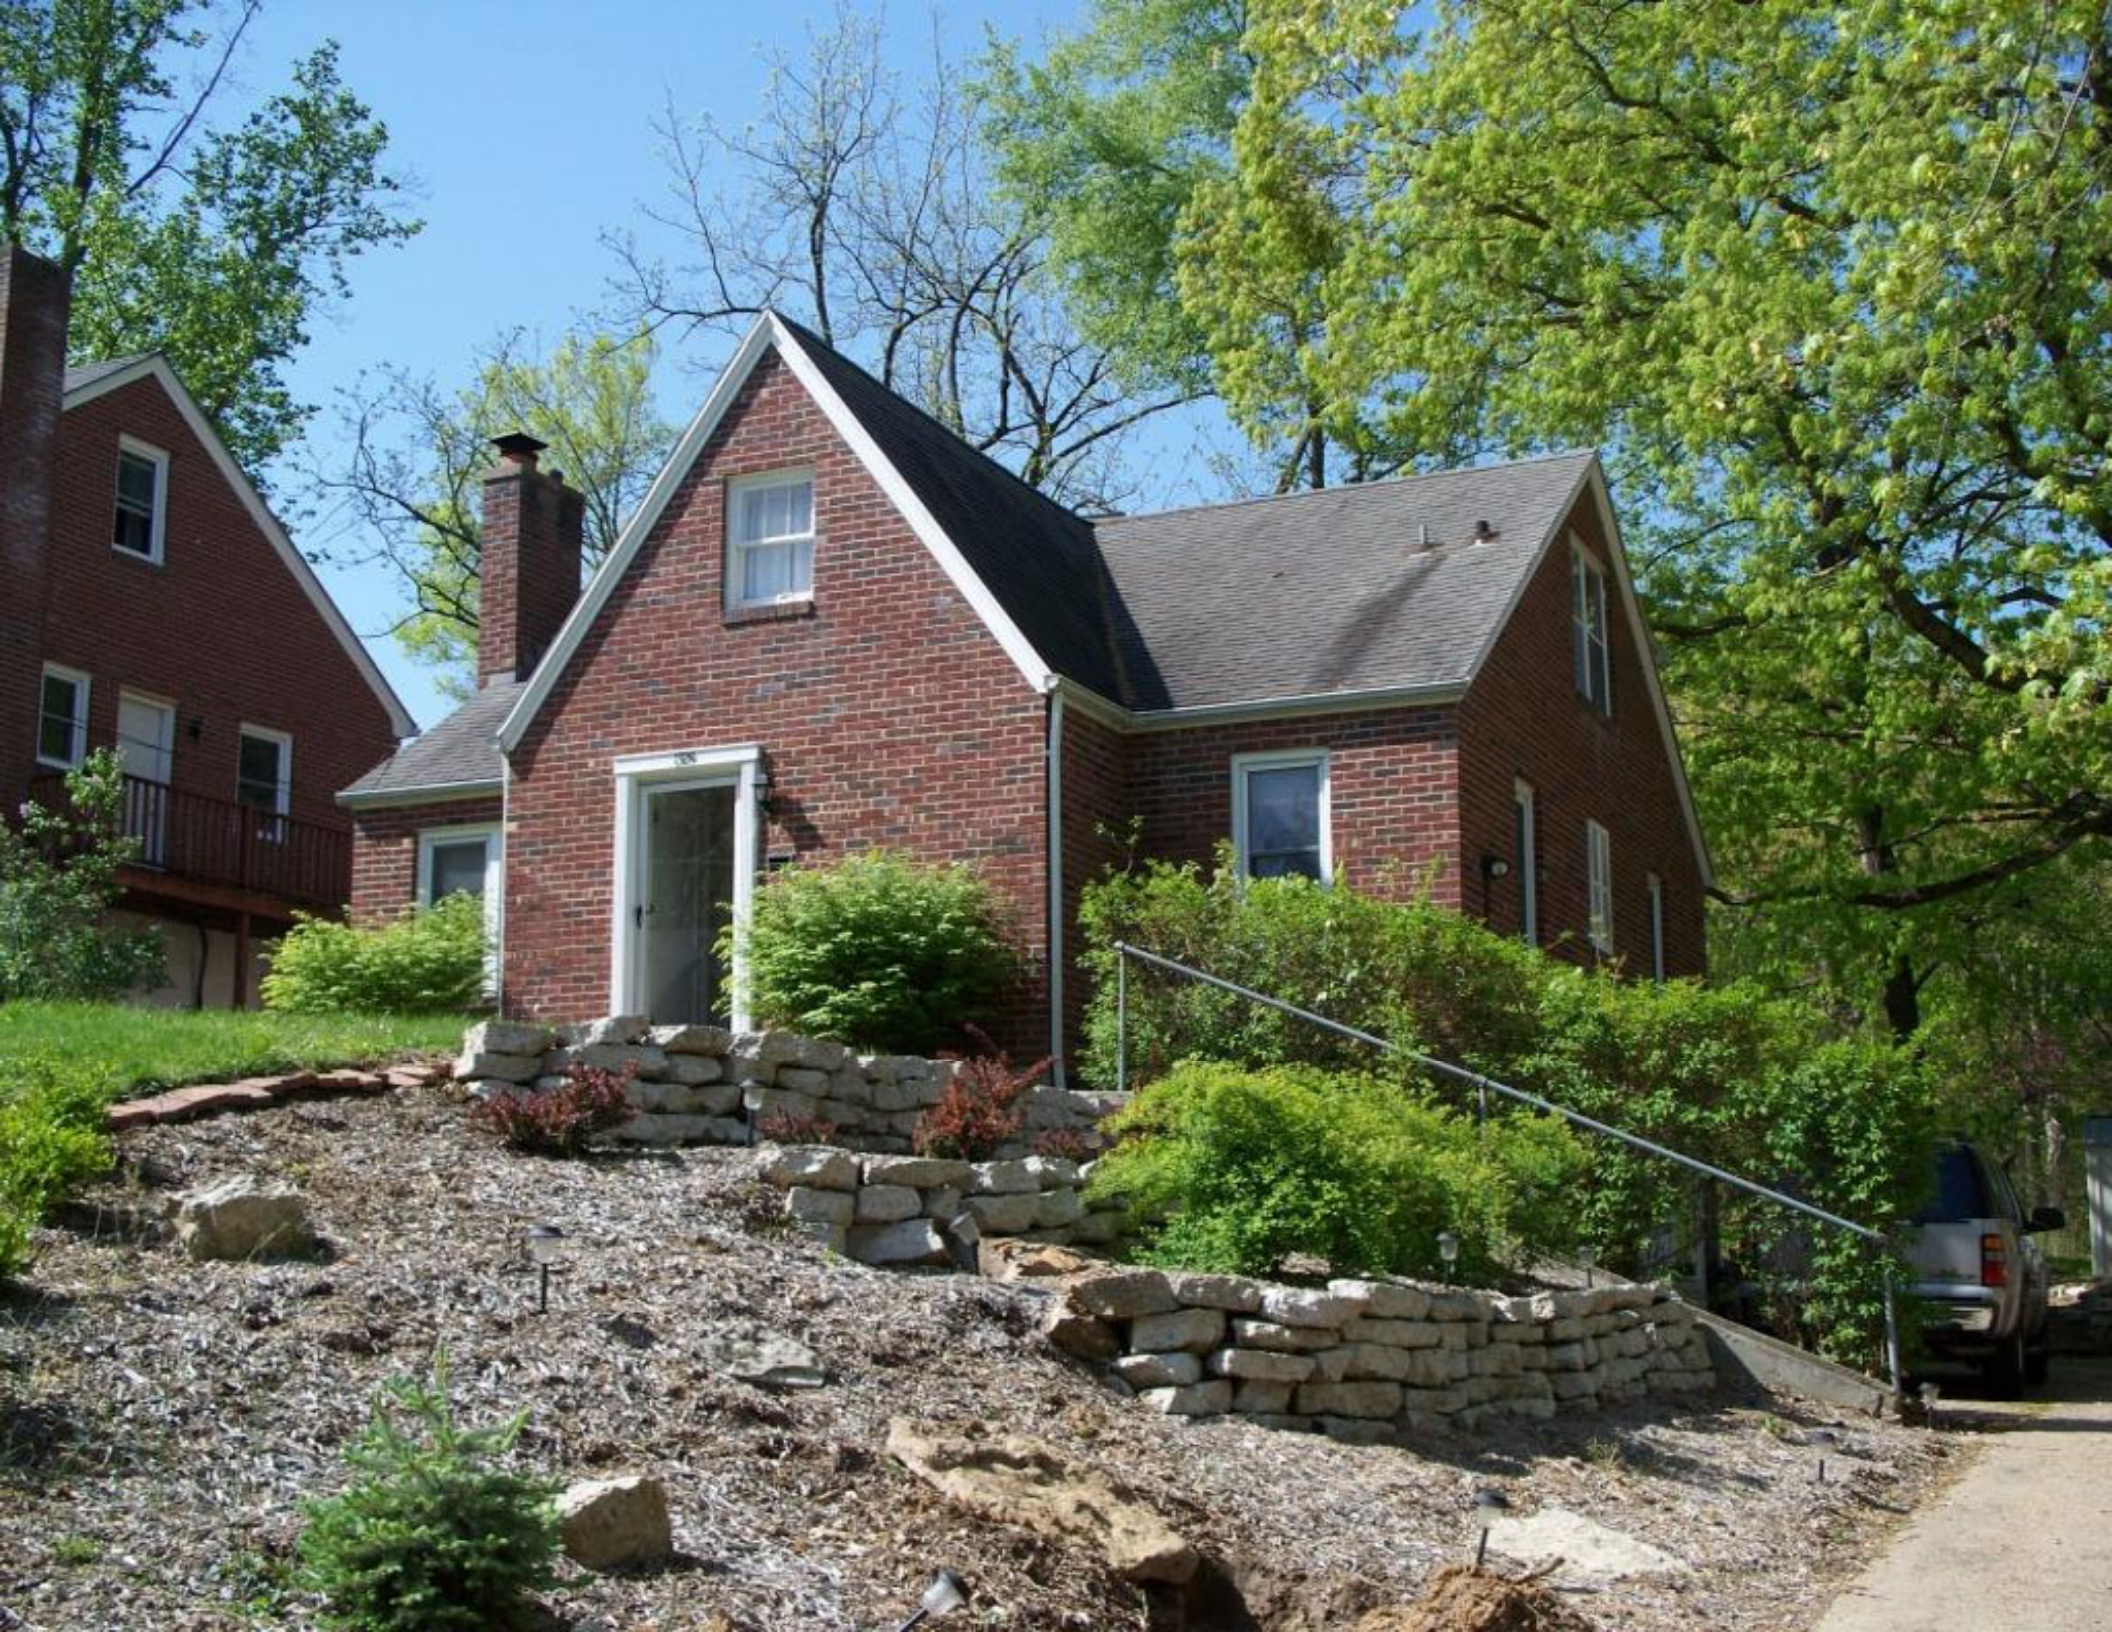
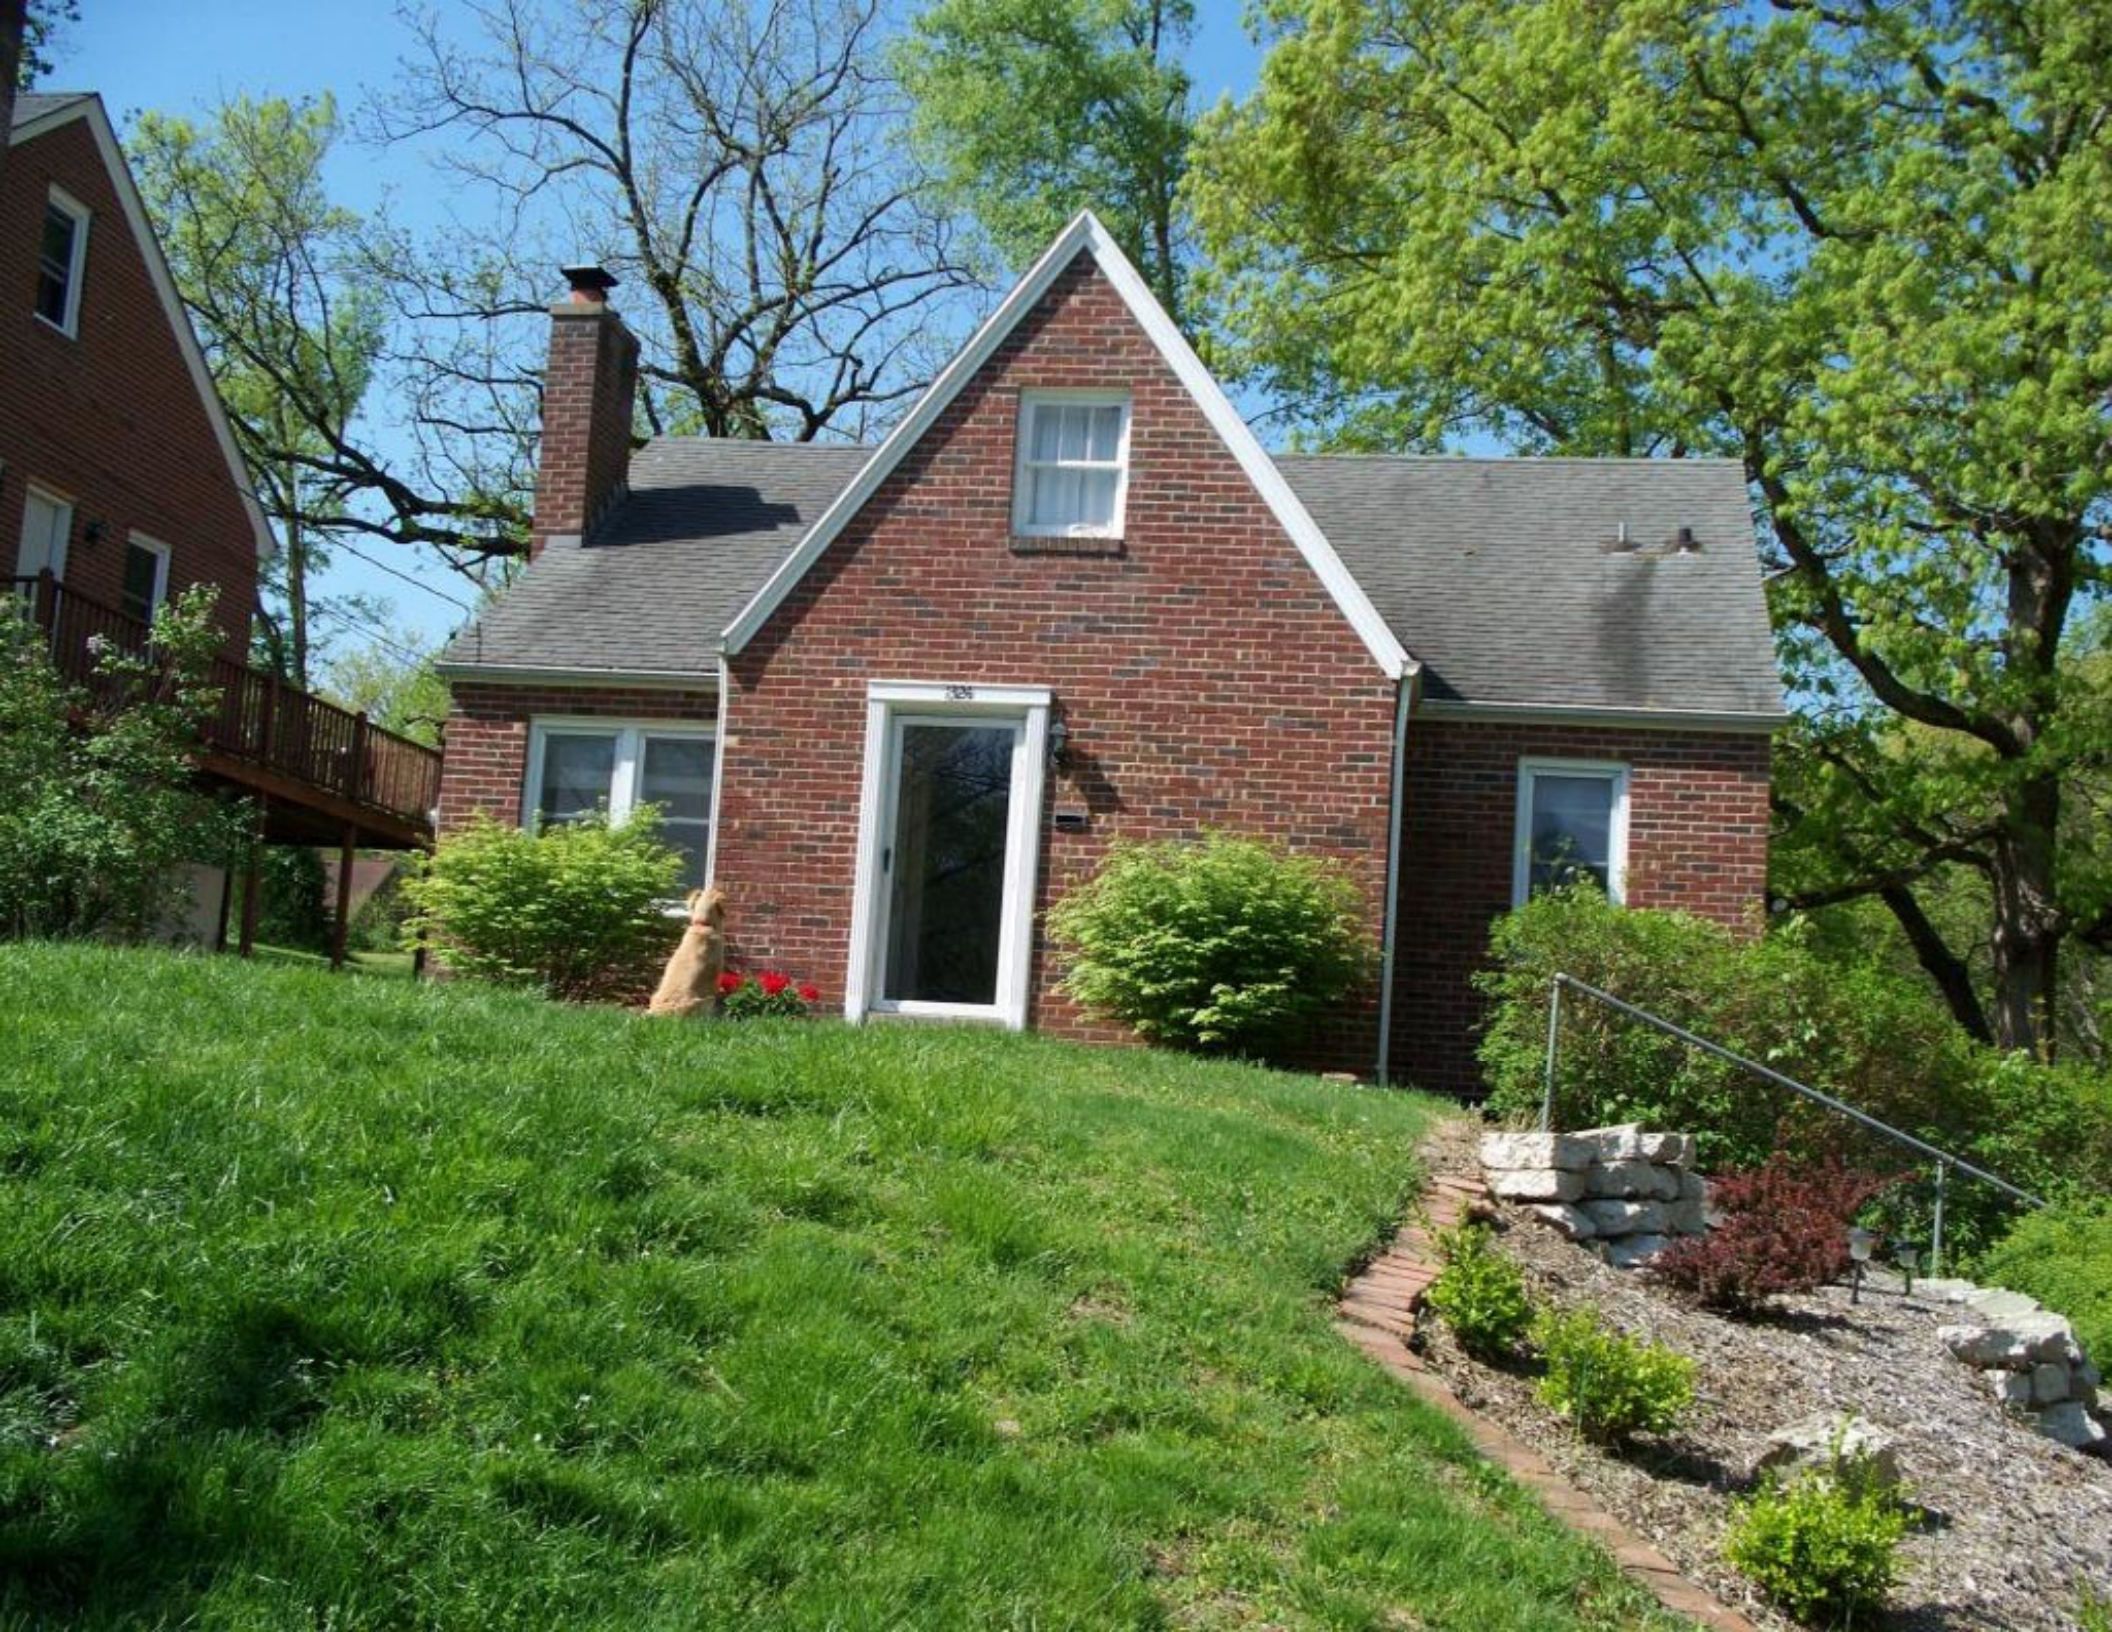
This 1 ½ story brick home has a steeply pitched center gable that projects from the rest of the side galbed property. It is this feature that gives the home a slight Tudor appearance. In the peak of the front gable is a small historic 3/1 window. The entrance is slightly off-centered to the left and has a simple door surround. The right bay has a single 1/1 replacement window. The left bay has paired 1/1 replacement windows.
