ARCHITECTURAL/HISTORIC INVENTORY FORM

1. Survey No. CO-AS-005-001		2. Survey name: Moreau Drive Neighborhood Survey	
3. County: Cole		4. Address: 1202 Elmerine Ave.	
5. City: Jefferson City	Vicinity: <input type="checkbox"/>	6. UTM: / /	7. Township/Range/Section: T: R: S:
8. Historic name (if known):		9. Present/other name (if known):	
10. Ownership: <input checked="" type="checkbox"/> Private <input type="checkbox"/> Public		11. Historic use (if known): Residential	11. Current use: Residential

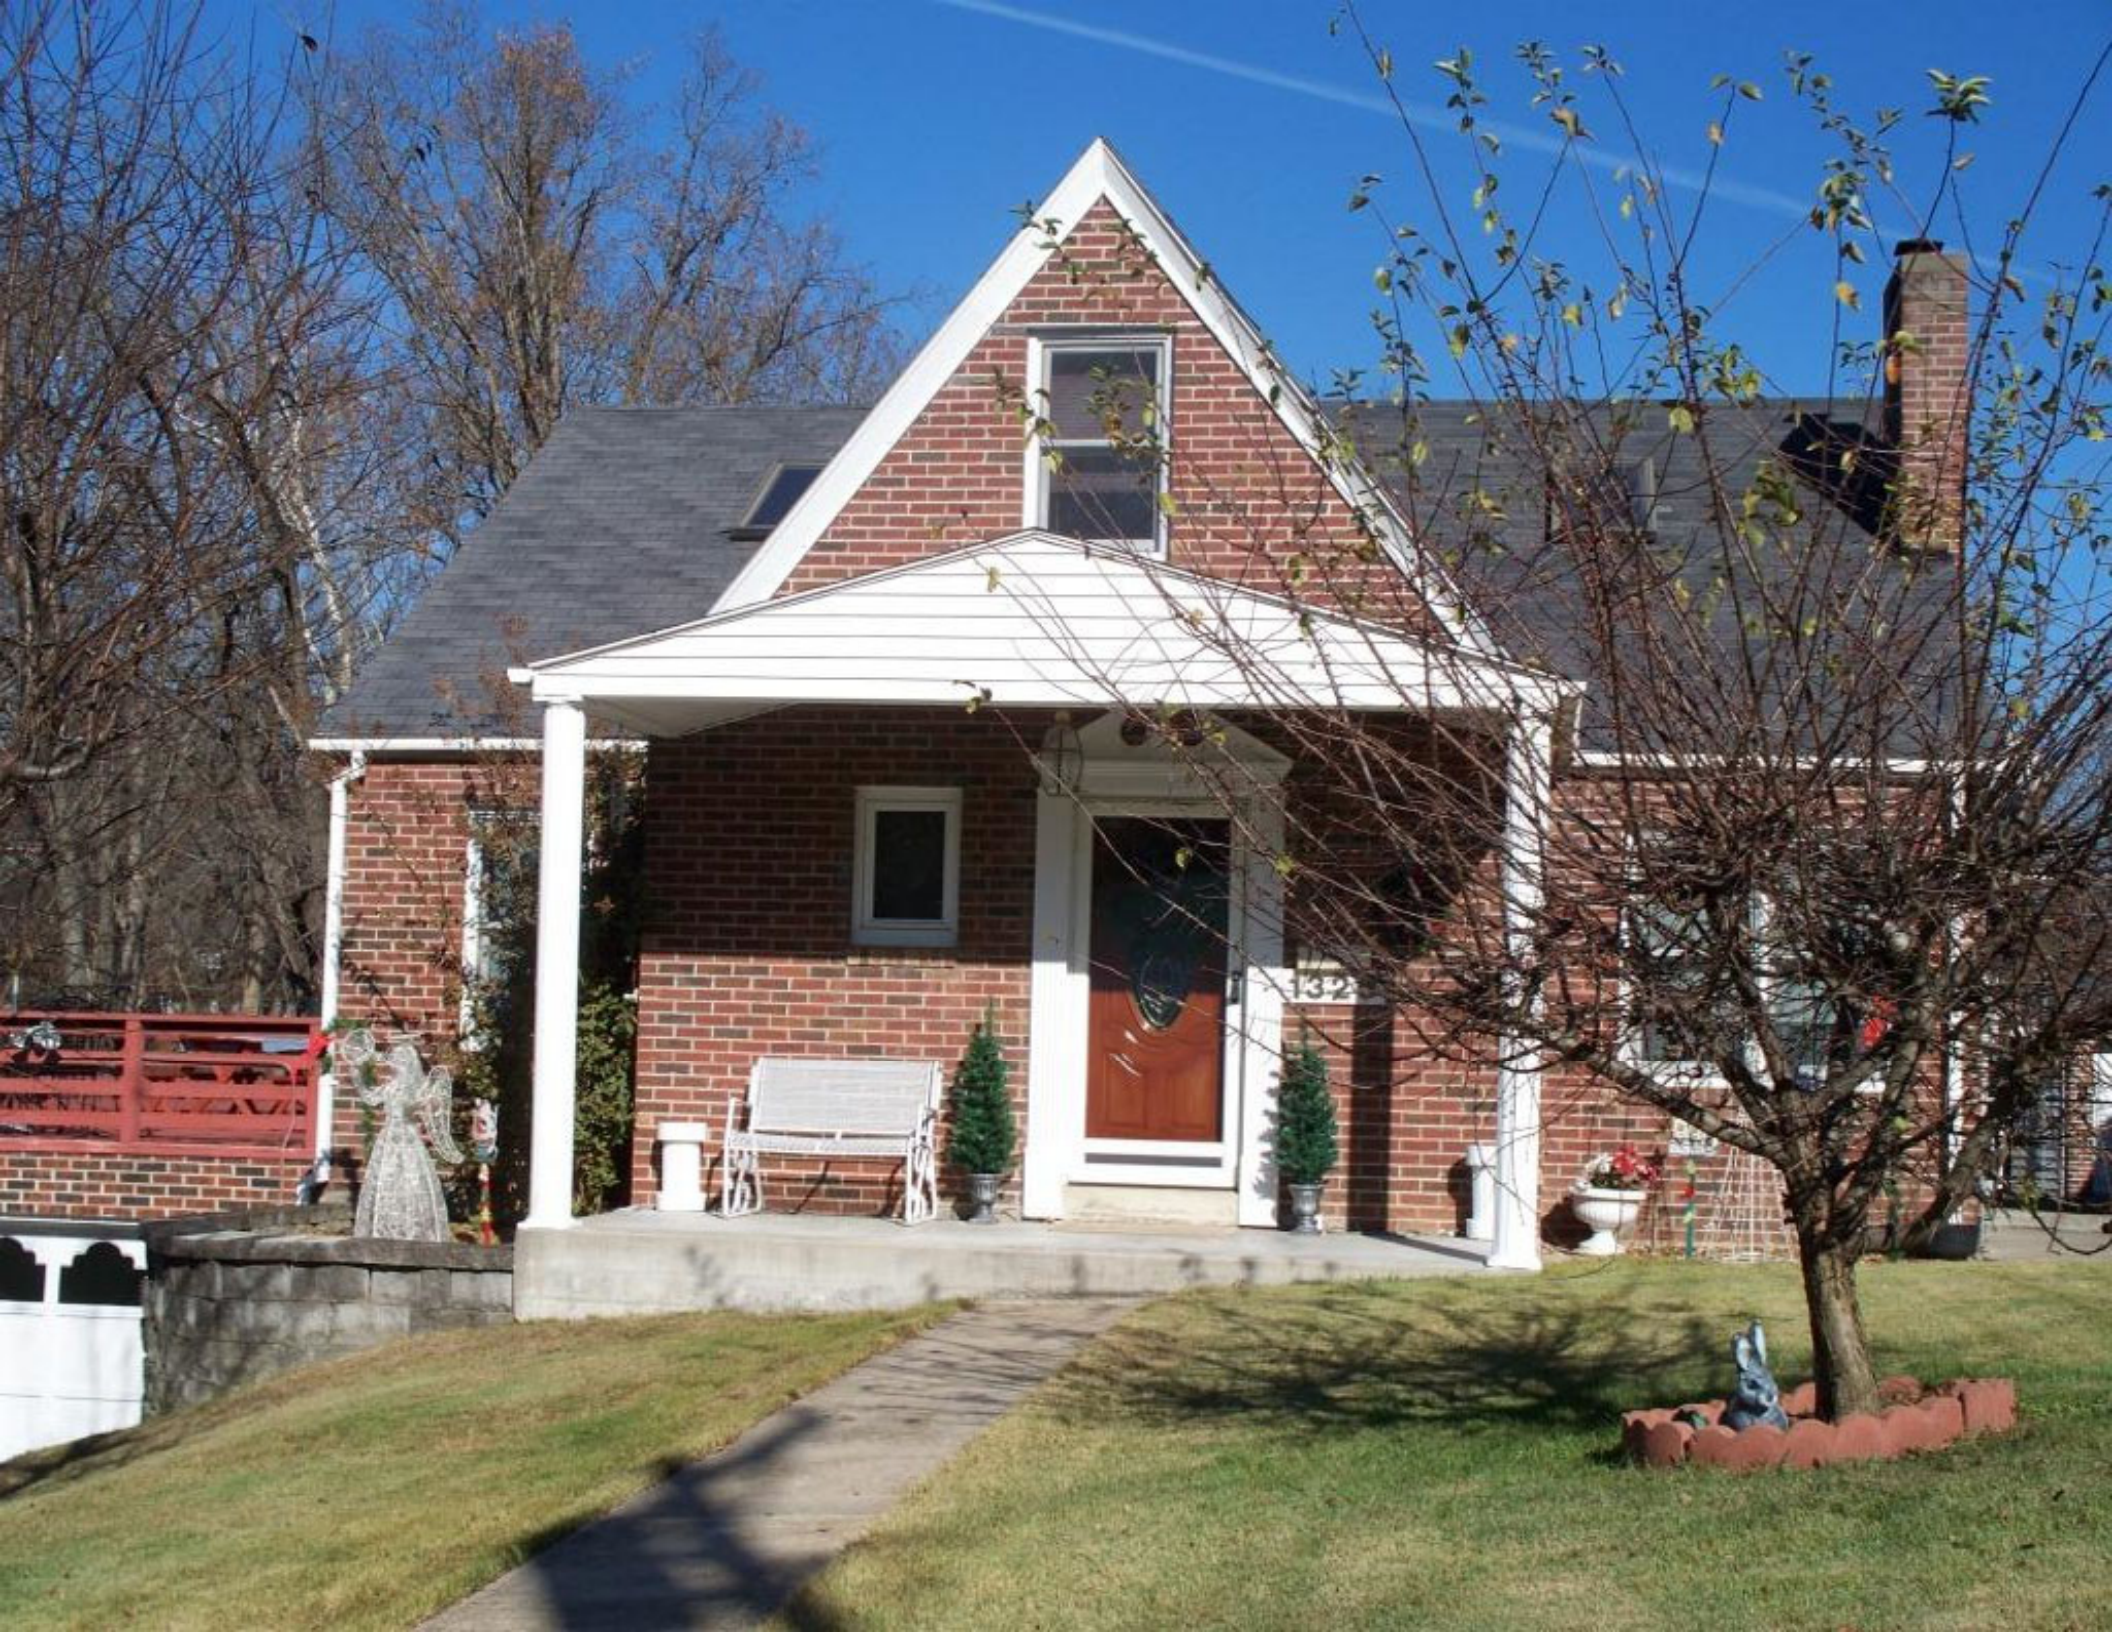
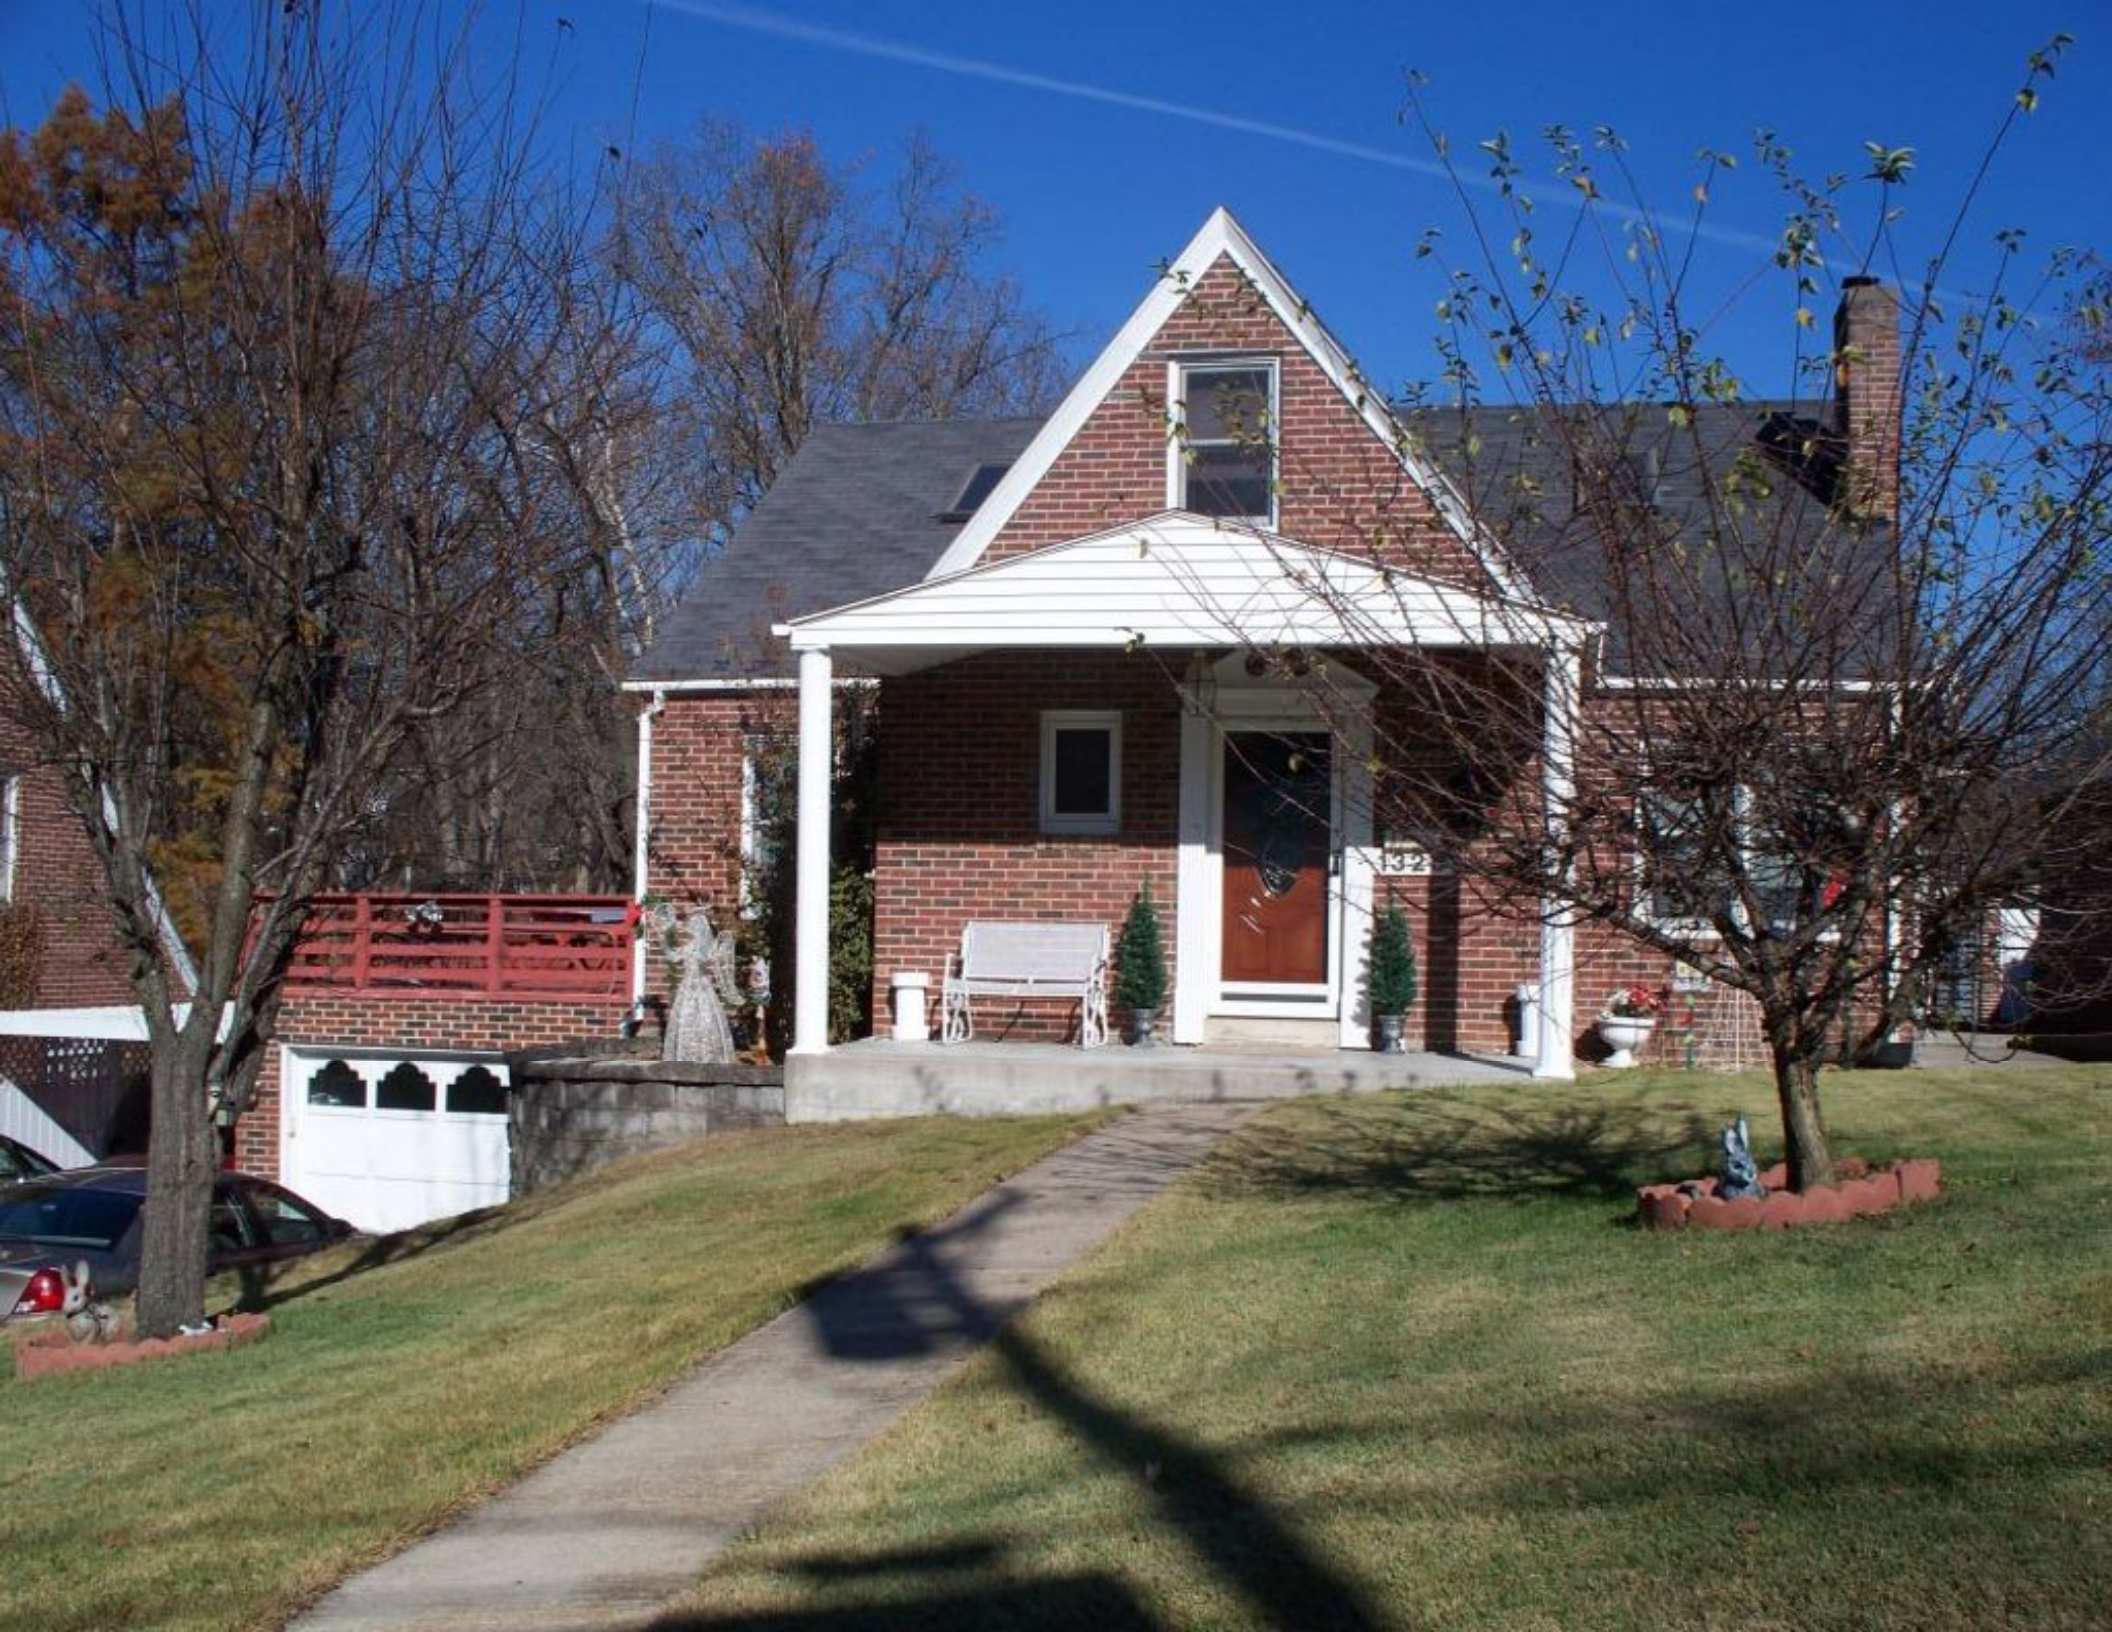
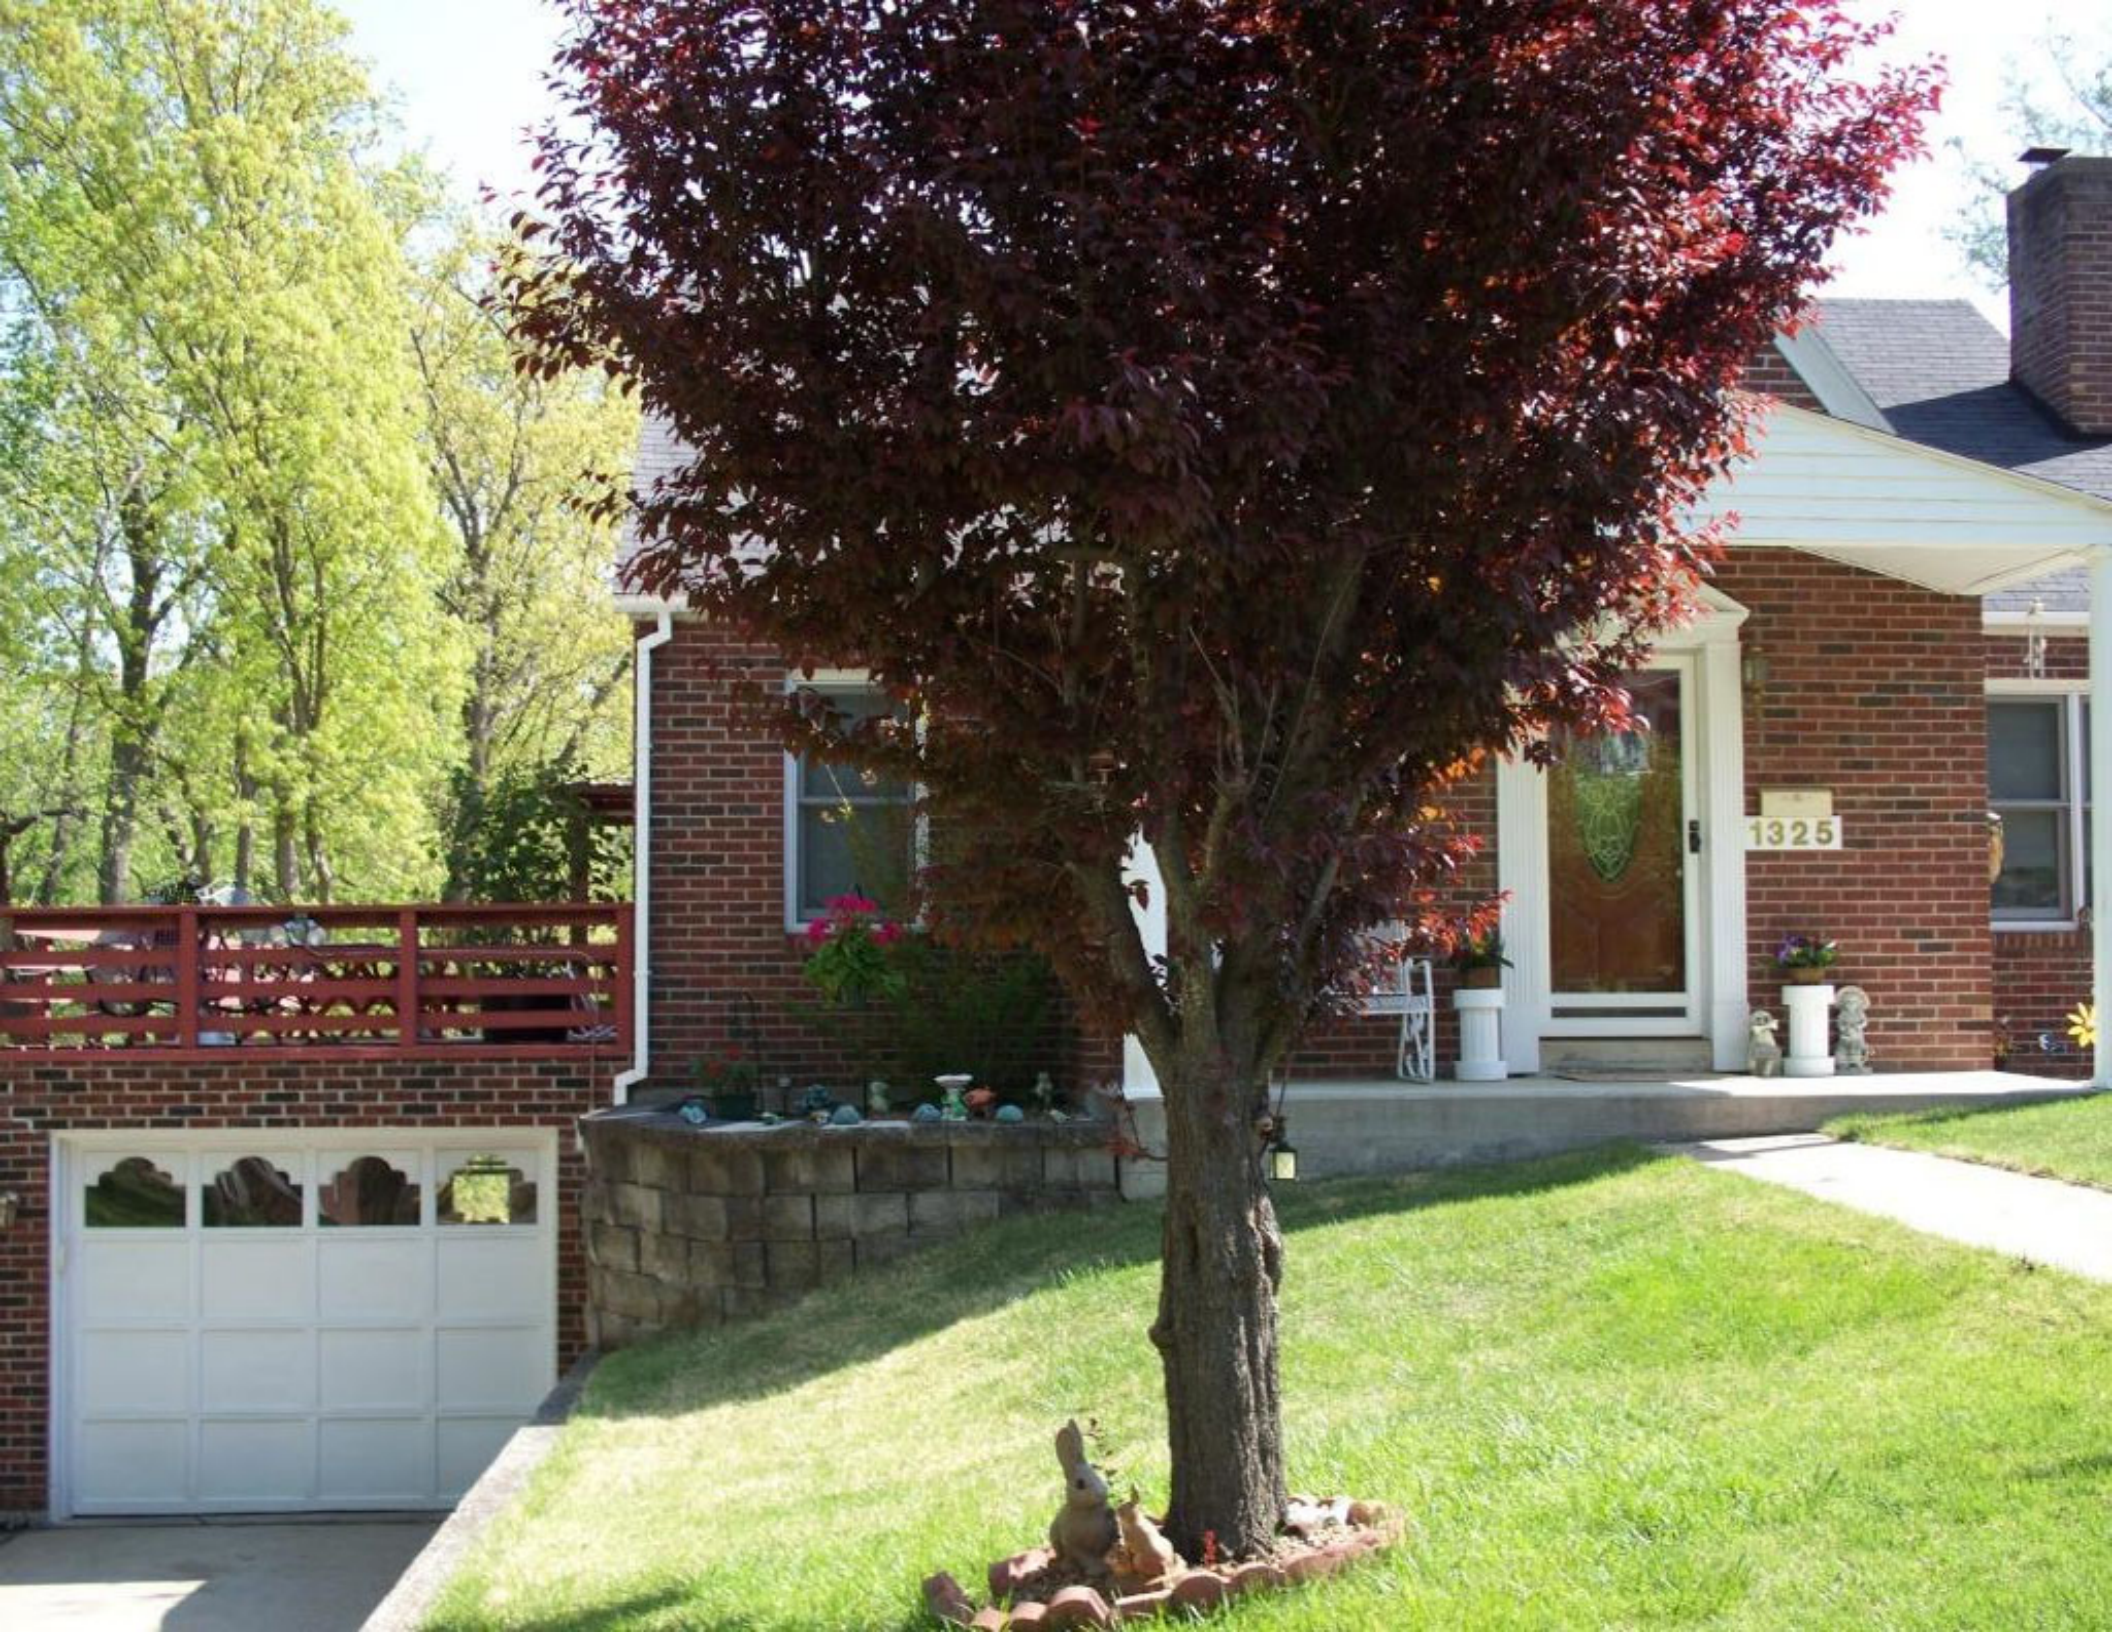
This brick cross gable home has a steeply pitched front gable that has a 1/1 window in the peak. Below is a small single paned fixed window with wooden trim in the left bay and the entrance (replacement door) with a broken pediment door surround. The left bay has a side gable roof and contains paired 1/1 windows (all of the windows are likely replacement). An additional bay is set back on the left and contains another 1/1 window. Attached to this and below grade is a one car brick garage (likely original) and attached wooden car port (not historic). The roof of the garage is utilized as a porch and features non-historic wood railing. A modern gabled vinyl or metal porch with fluted pillars has been added and is also not historic. Because of these changes the property may be non-contributing under further scrutiny however for the purposes of this survey it's considered contributing.

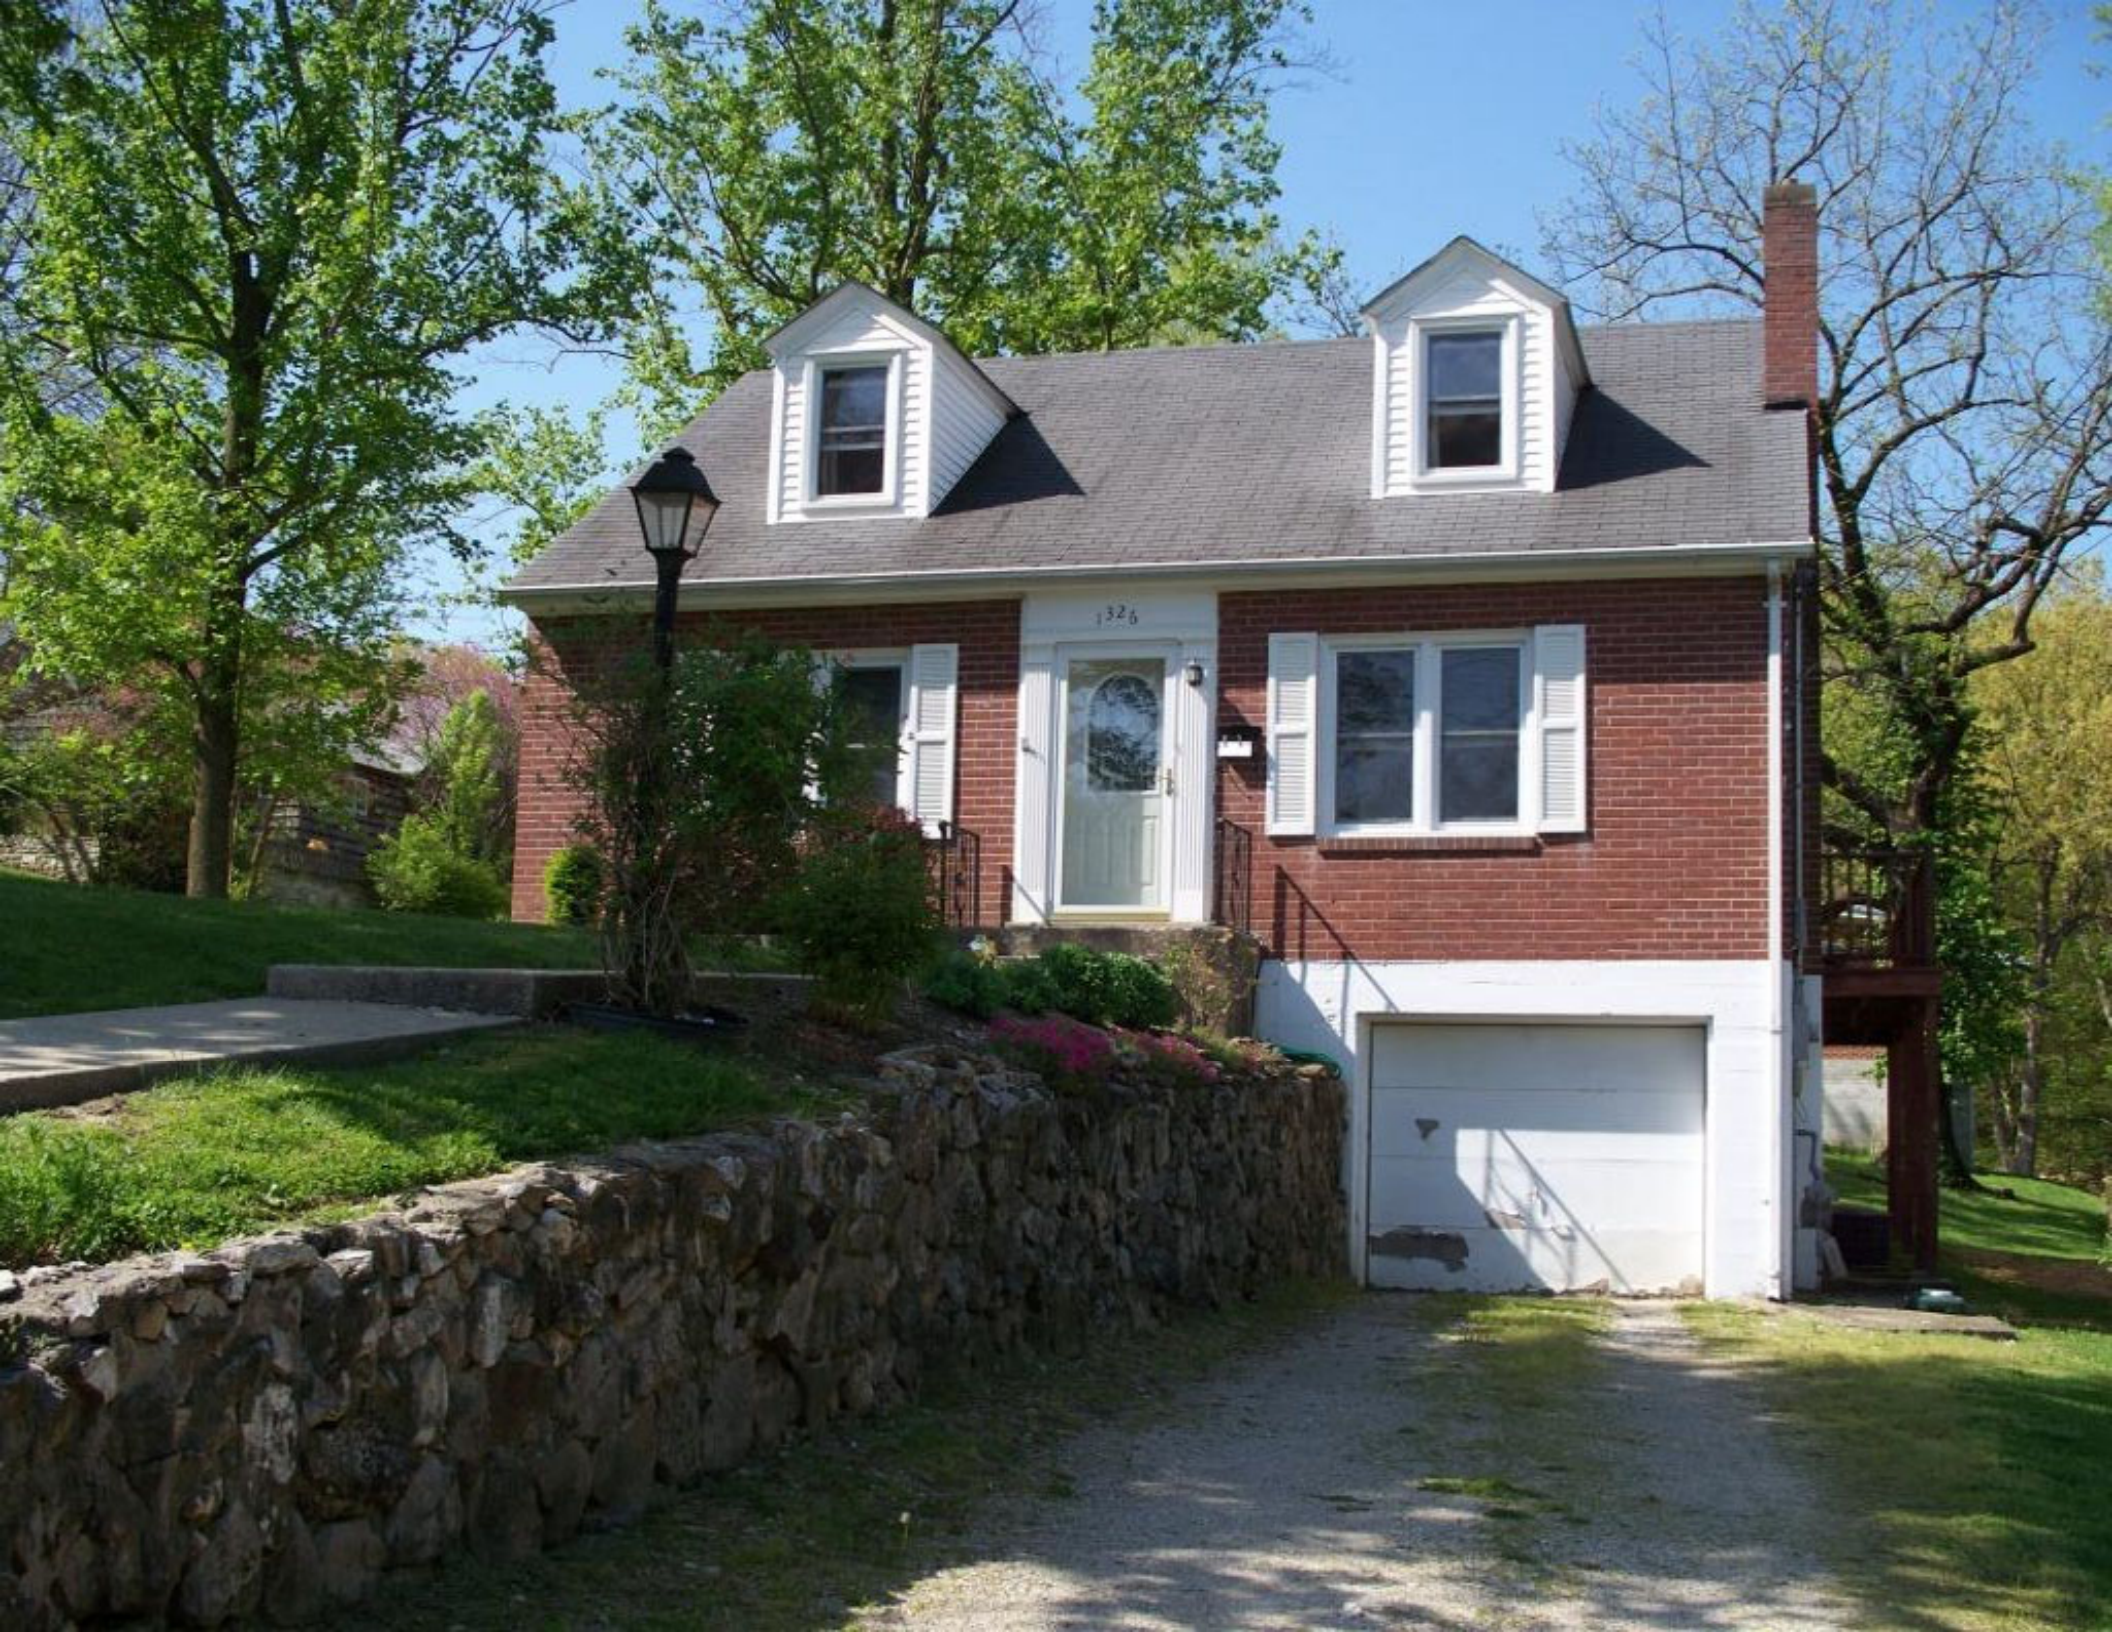
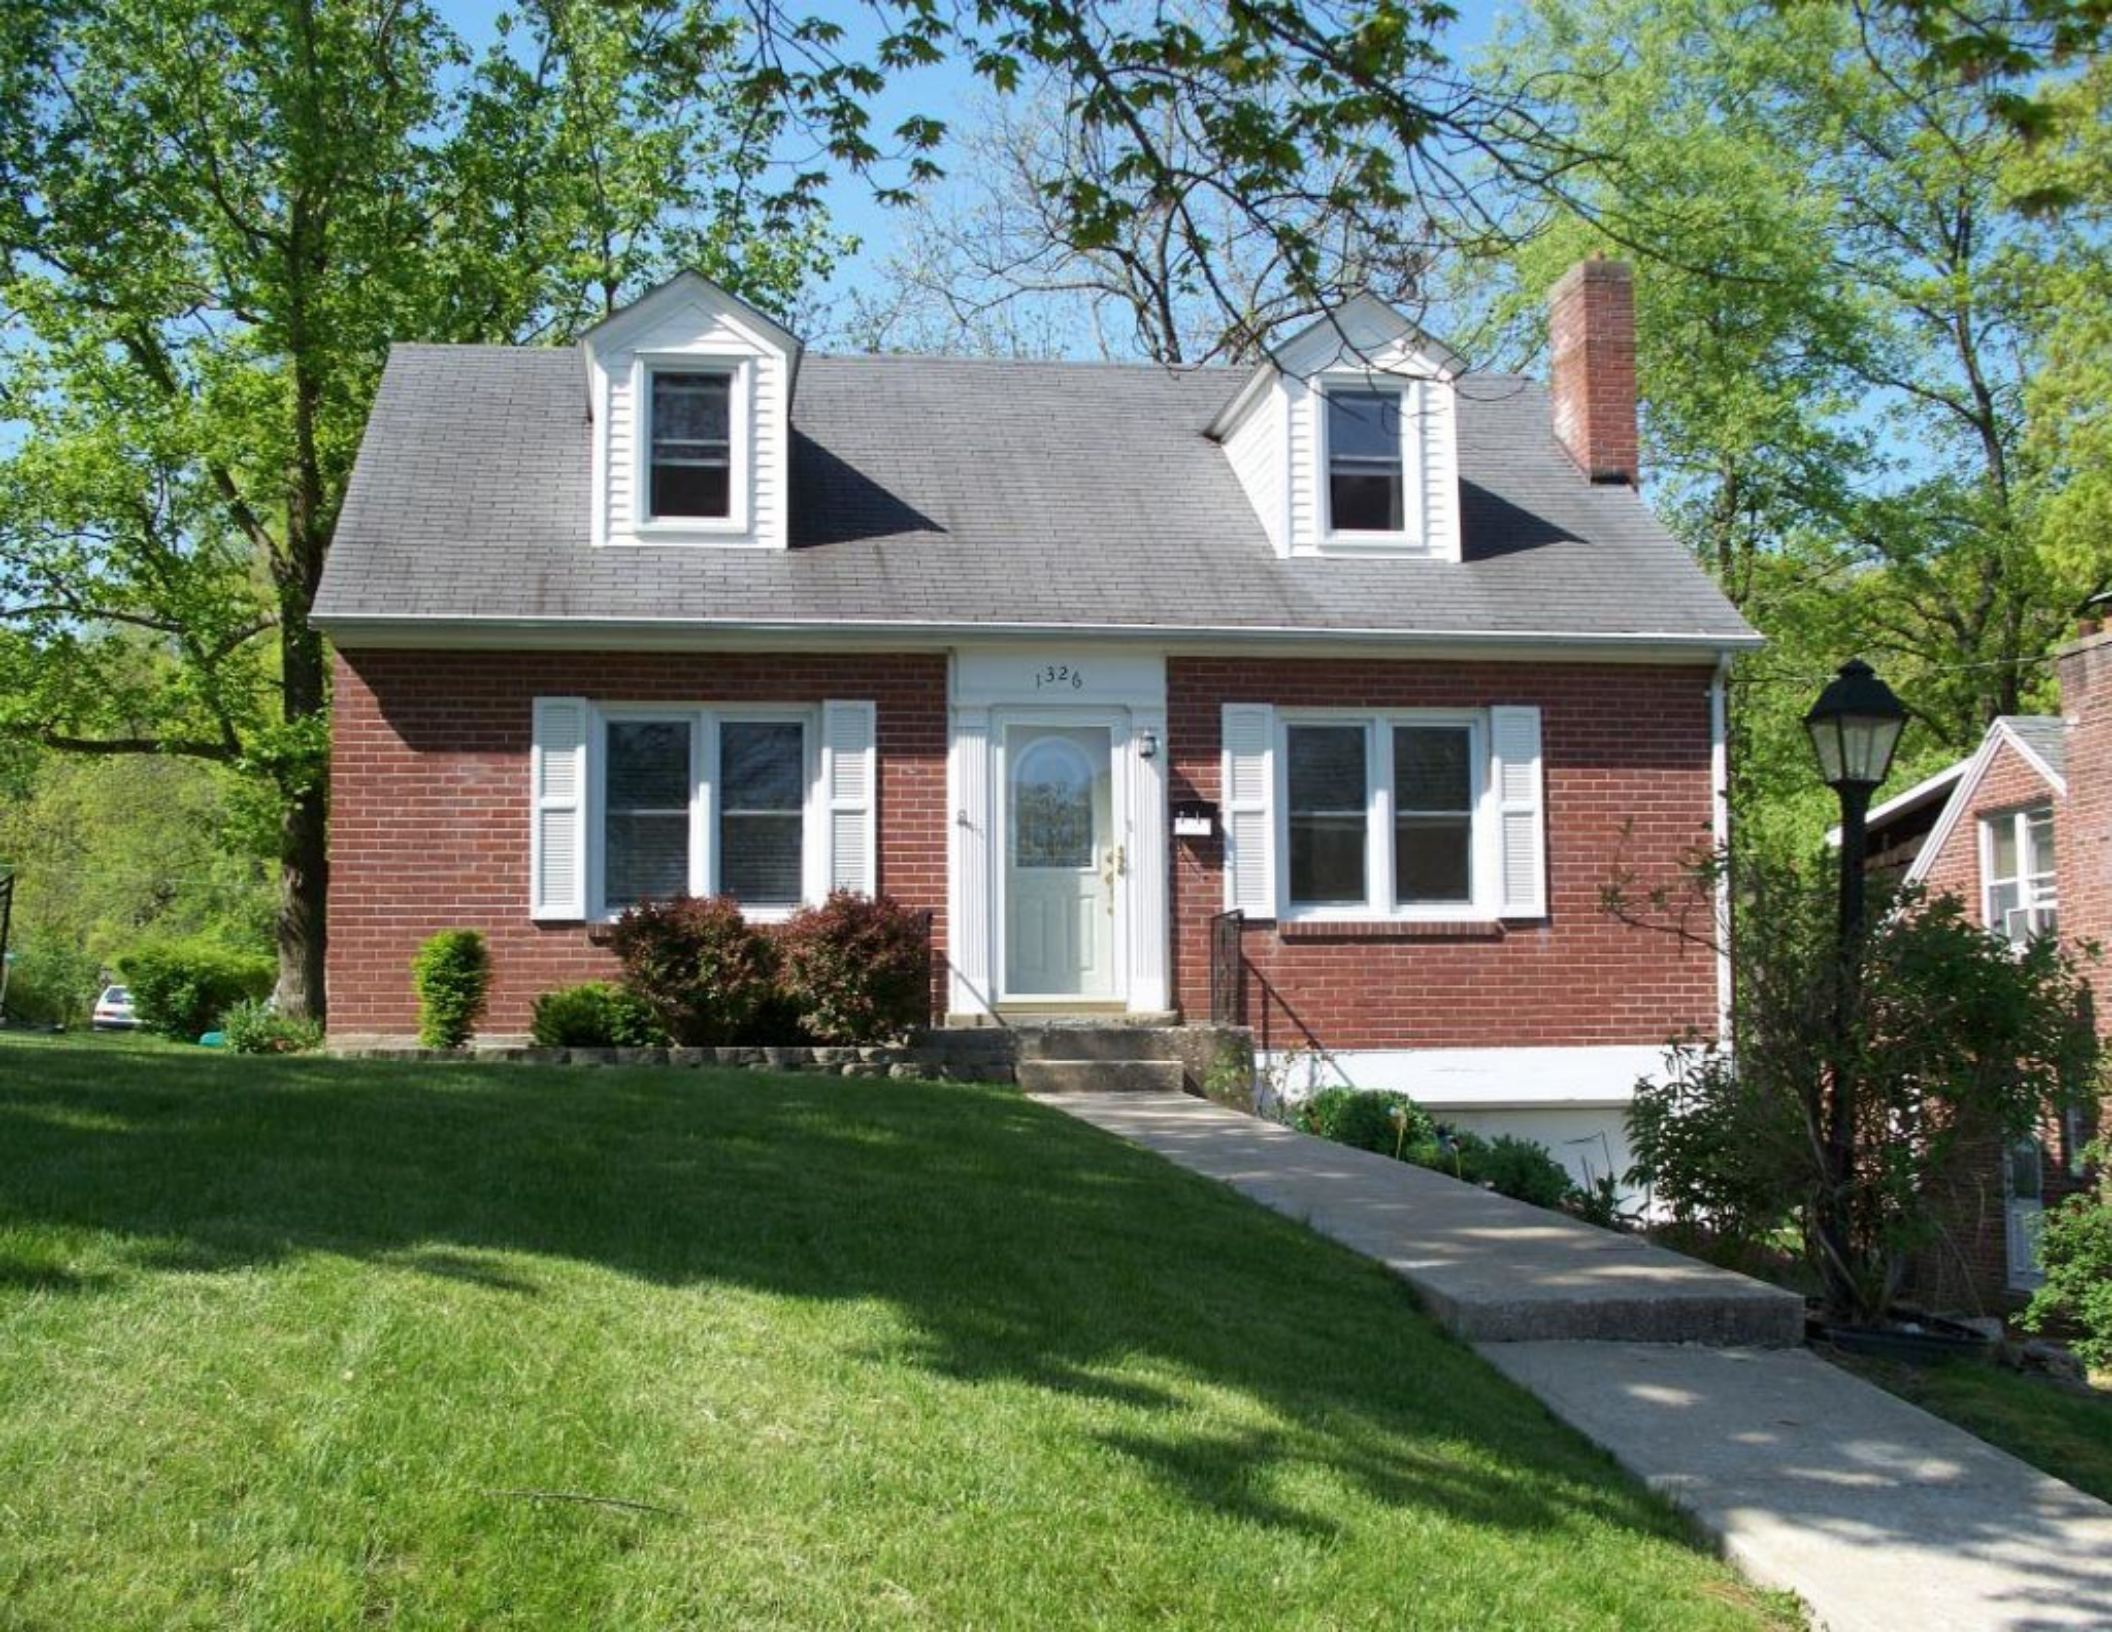
This 1 ½ story brick Cape Cod has a side gable roof and two gabled dormers clad in vinyl. They each have a 1/1 window. The first floor has paired 1/1 windows with shutters flanking the centered entrance with an ornate door surround. A concrete pad with metal railing serves as the stoop. Below grade in the right bay is a one-car garage.
