ARCHITECTURAL/HISTORIC INVENTORY FORM

1. Survey No. CO-AS-005-001		2. Survey name: Moreau Drive Neighborhood Survey	
3. County: Cole		4. Address: 1202 Elmerine Ave.	
5. City: Jefferson City	Vicinity: <input type="checkbox"/>	6. UTM: / /	7. Township/Range/Section: T: R: S:
8. Historic name (if known):		9. Present/other name (if known):	
10. Ownership: <input checked="" type="checkbox"/> Private <input type="checkbox"/> Public		11. Historic use (if known): Residential	11. Current use: Residential

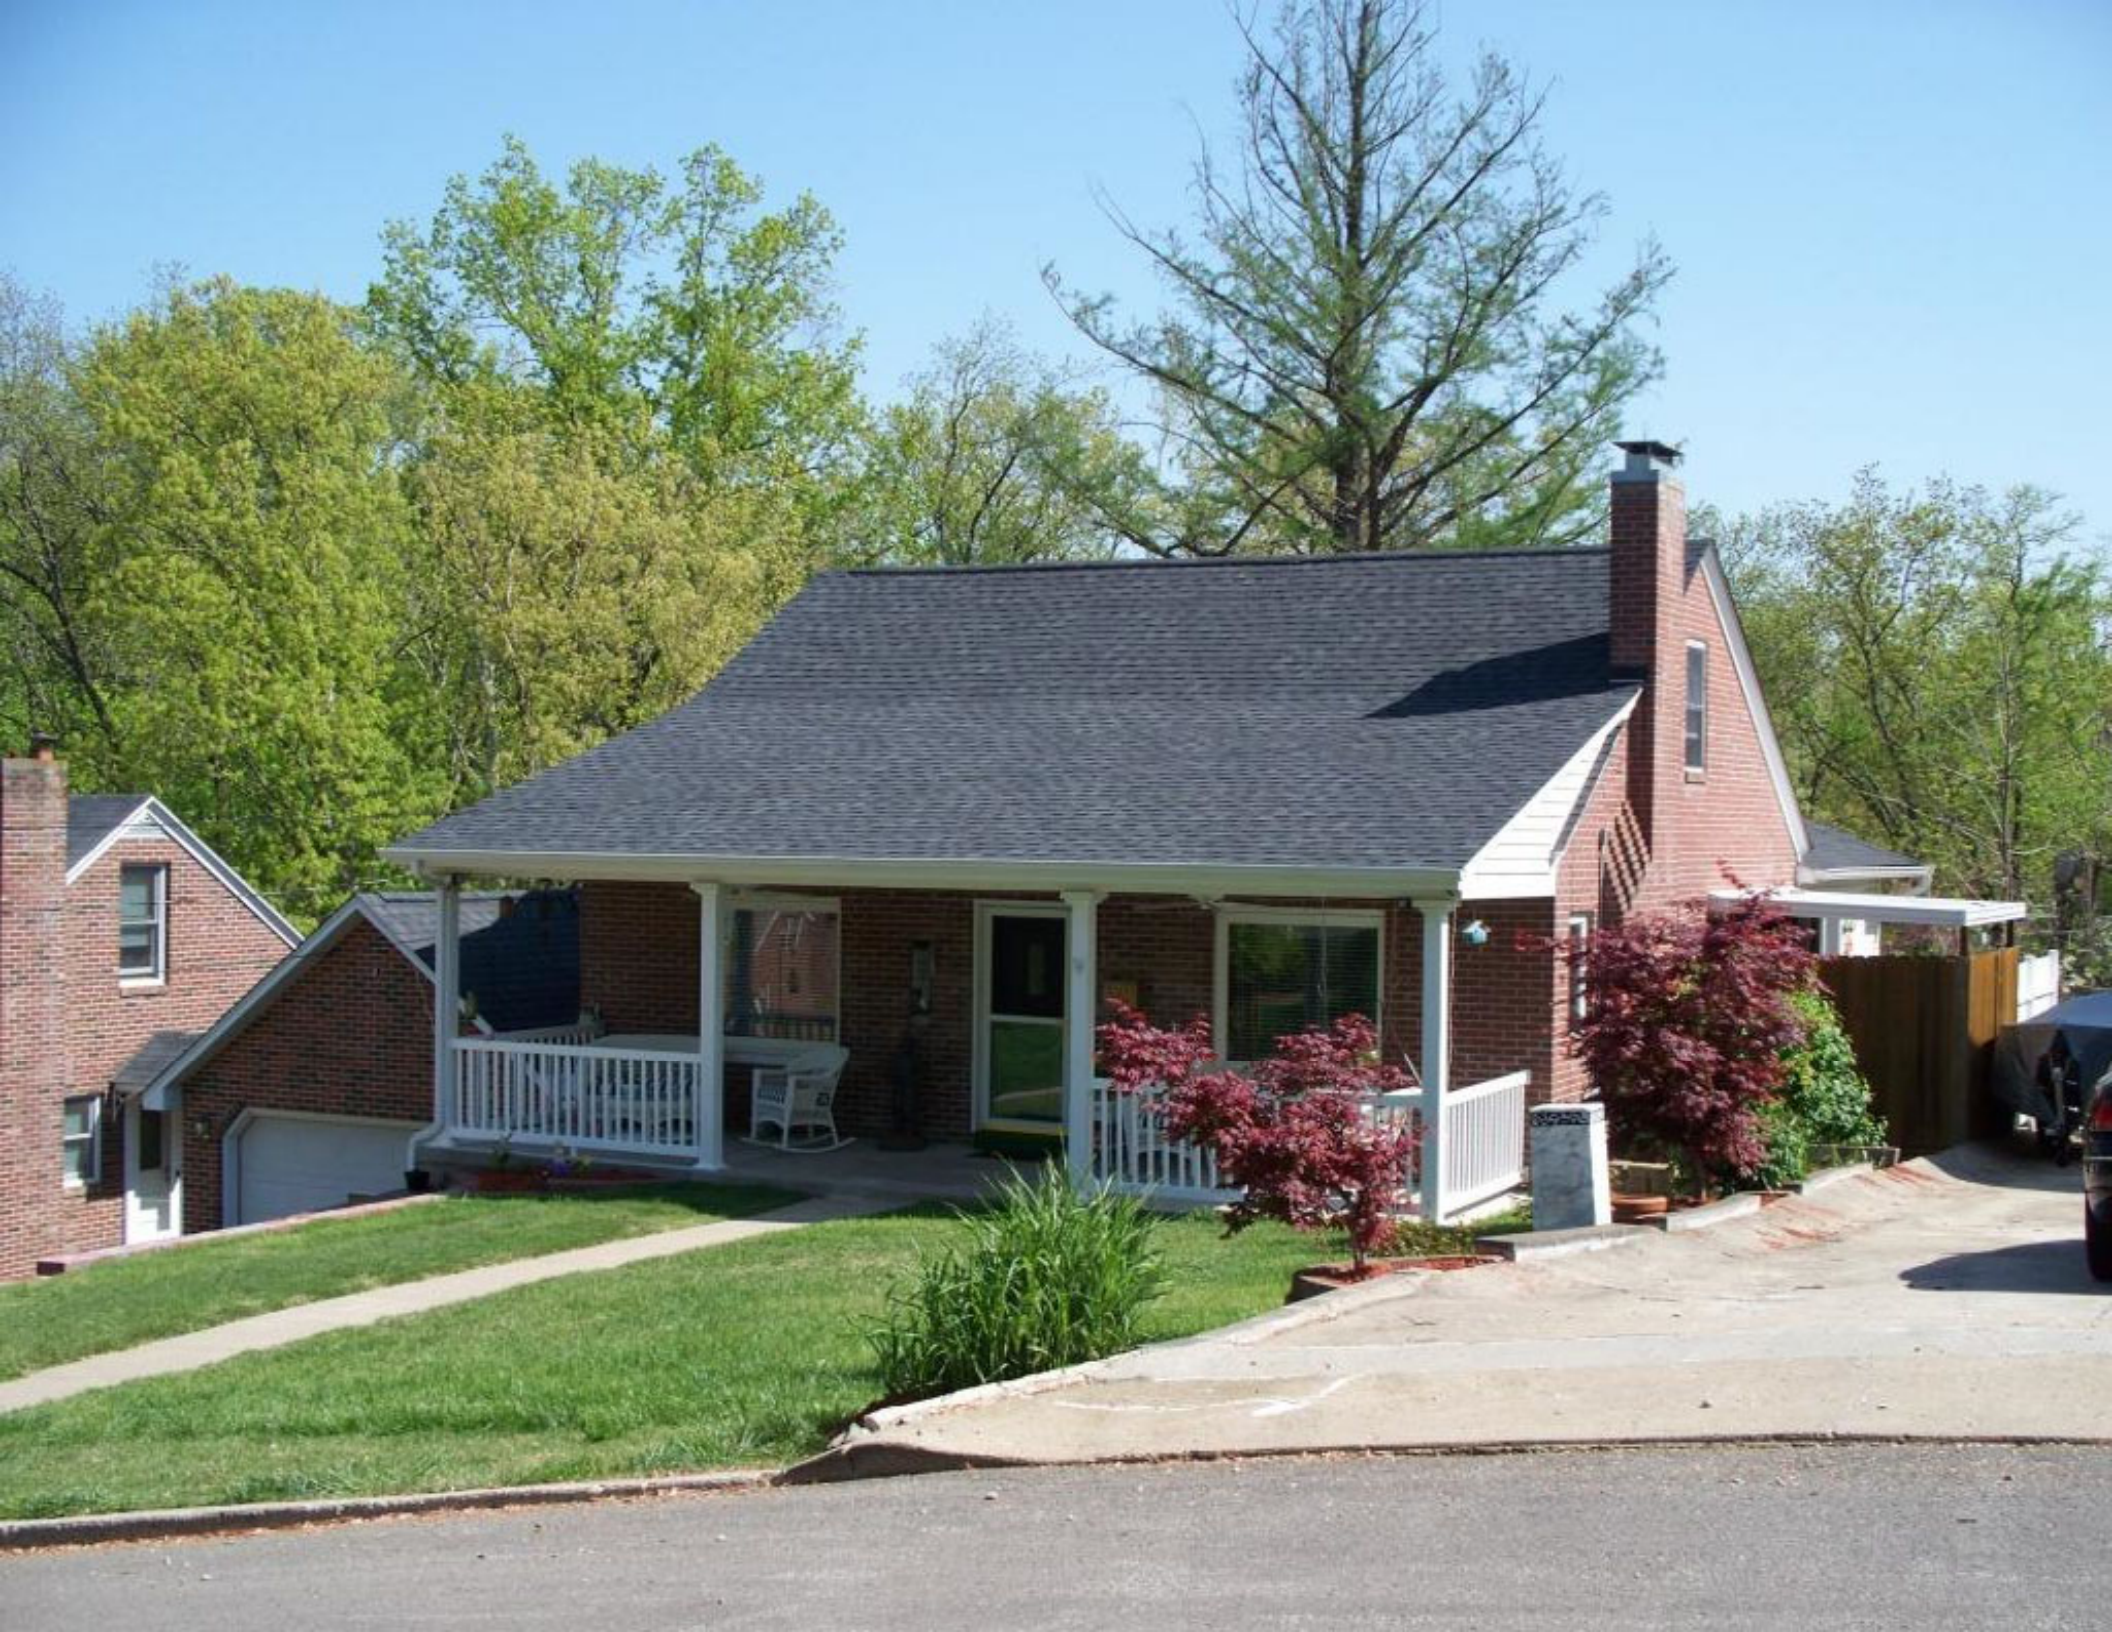
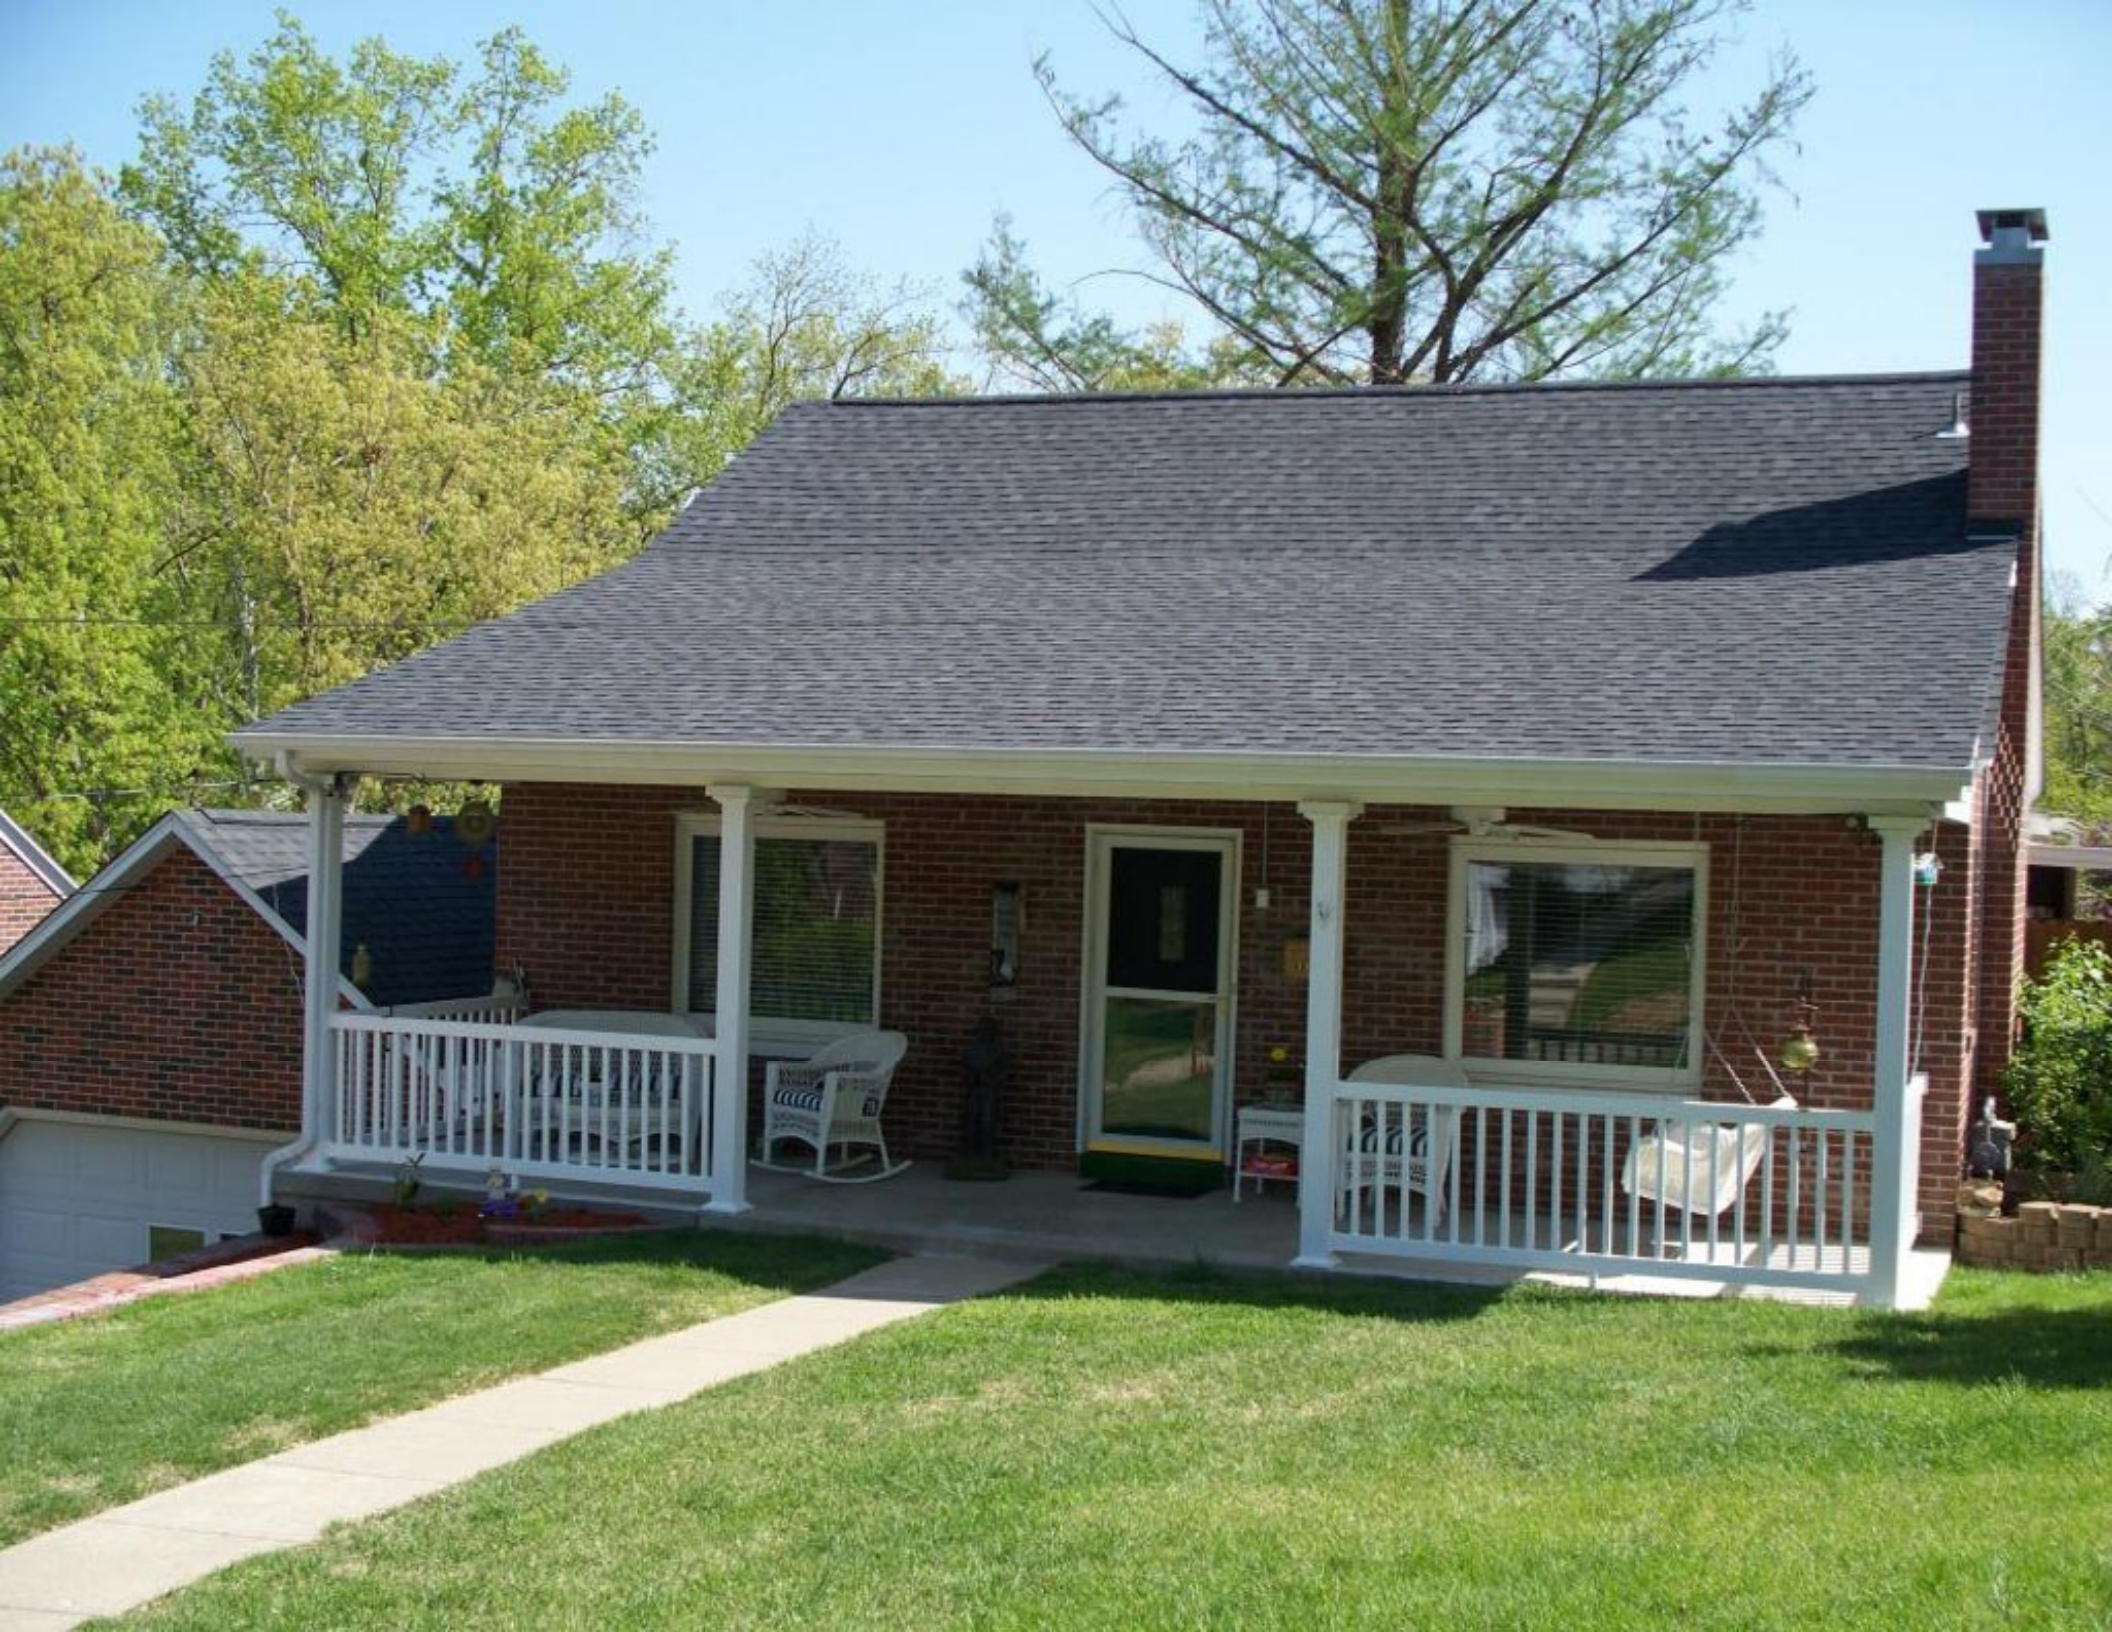
This brick side gabled home is one to one and a half stories (likely a room on upper floor). The roof is deeply pitched flaring over porch, which has wooden railing and posts. There are two large single pane picture windows flanking the centered entrance. Attached to the left and below grade is a large gabled two car garage. Due to the build date it is considered outside the period of significance and would be n/c.

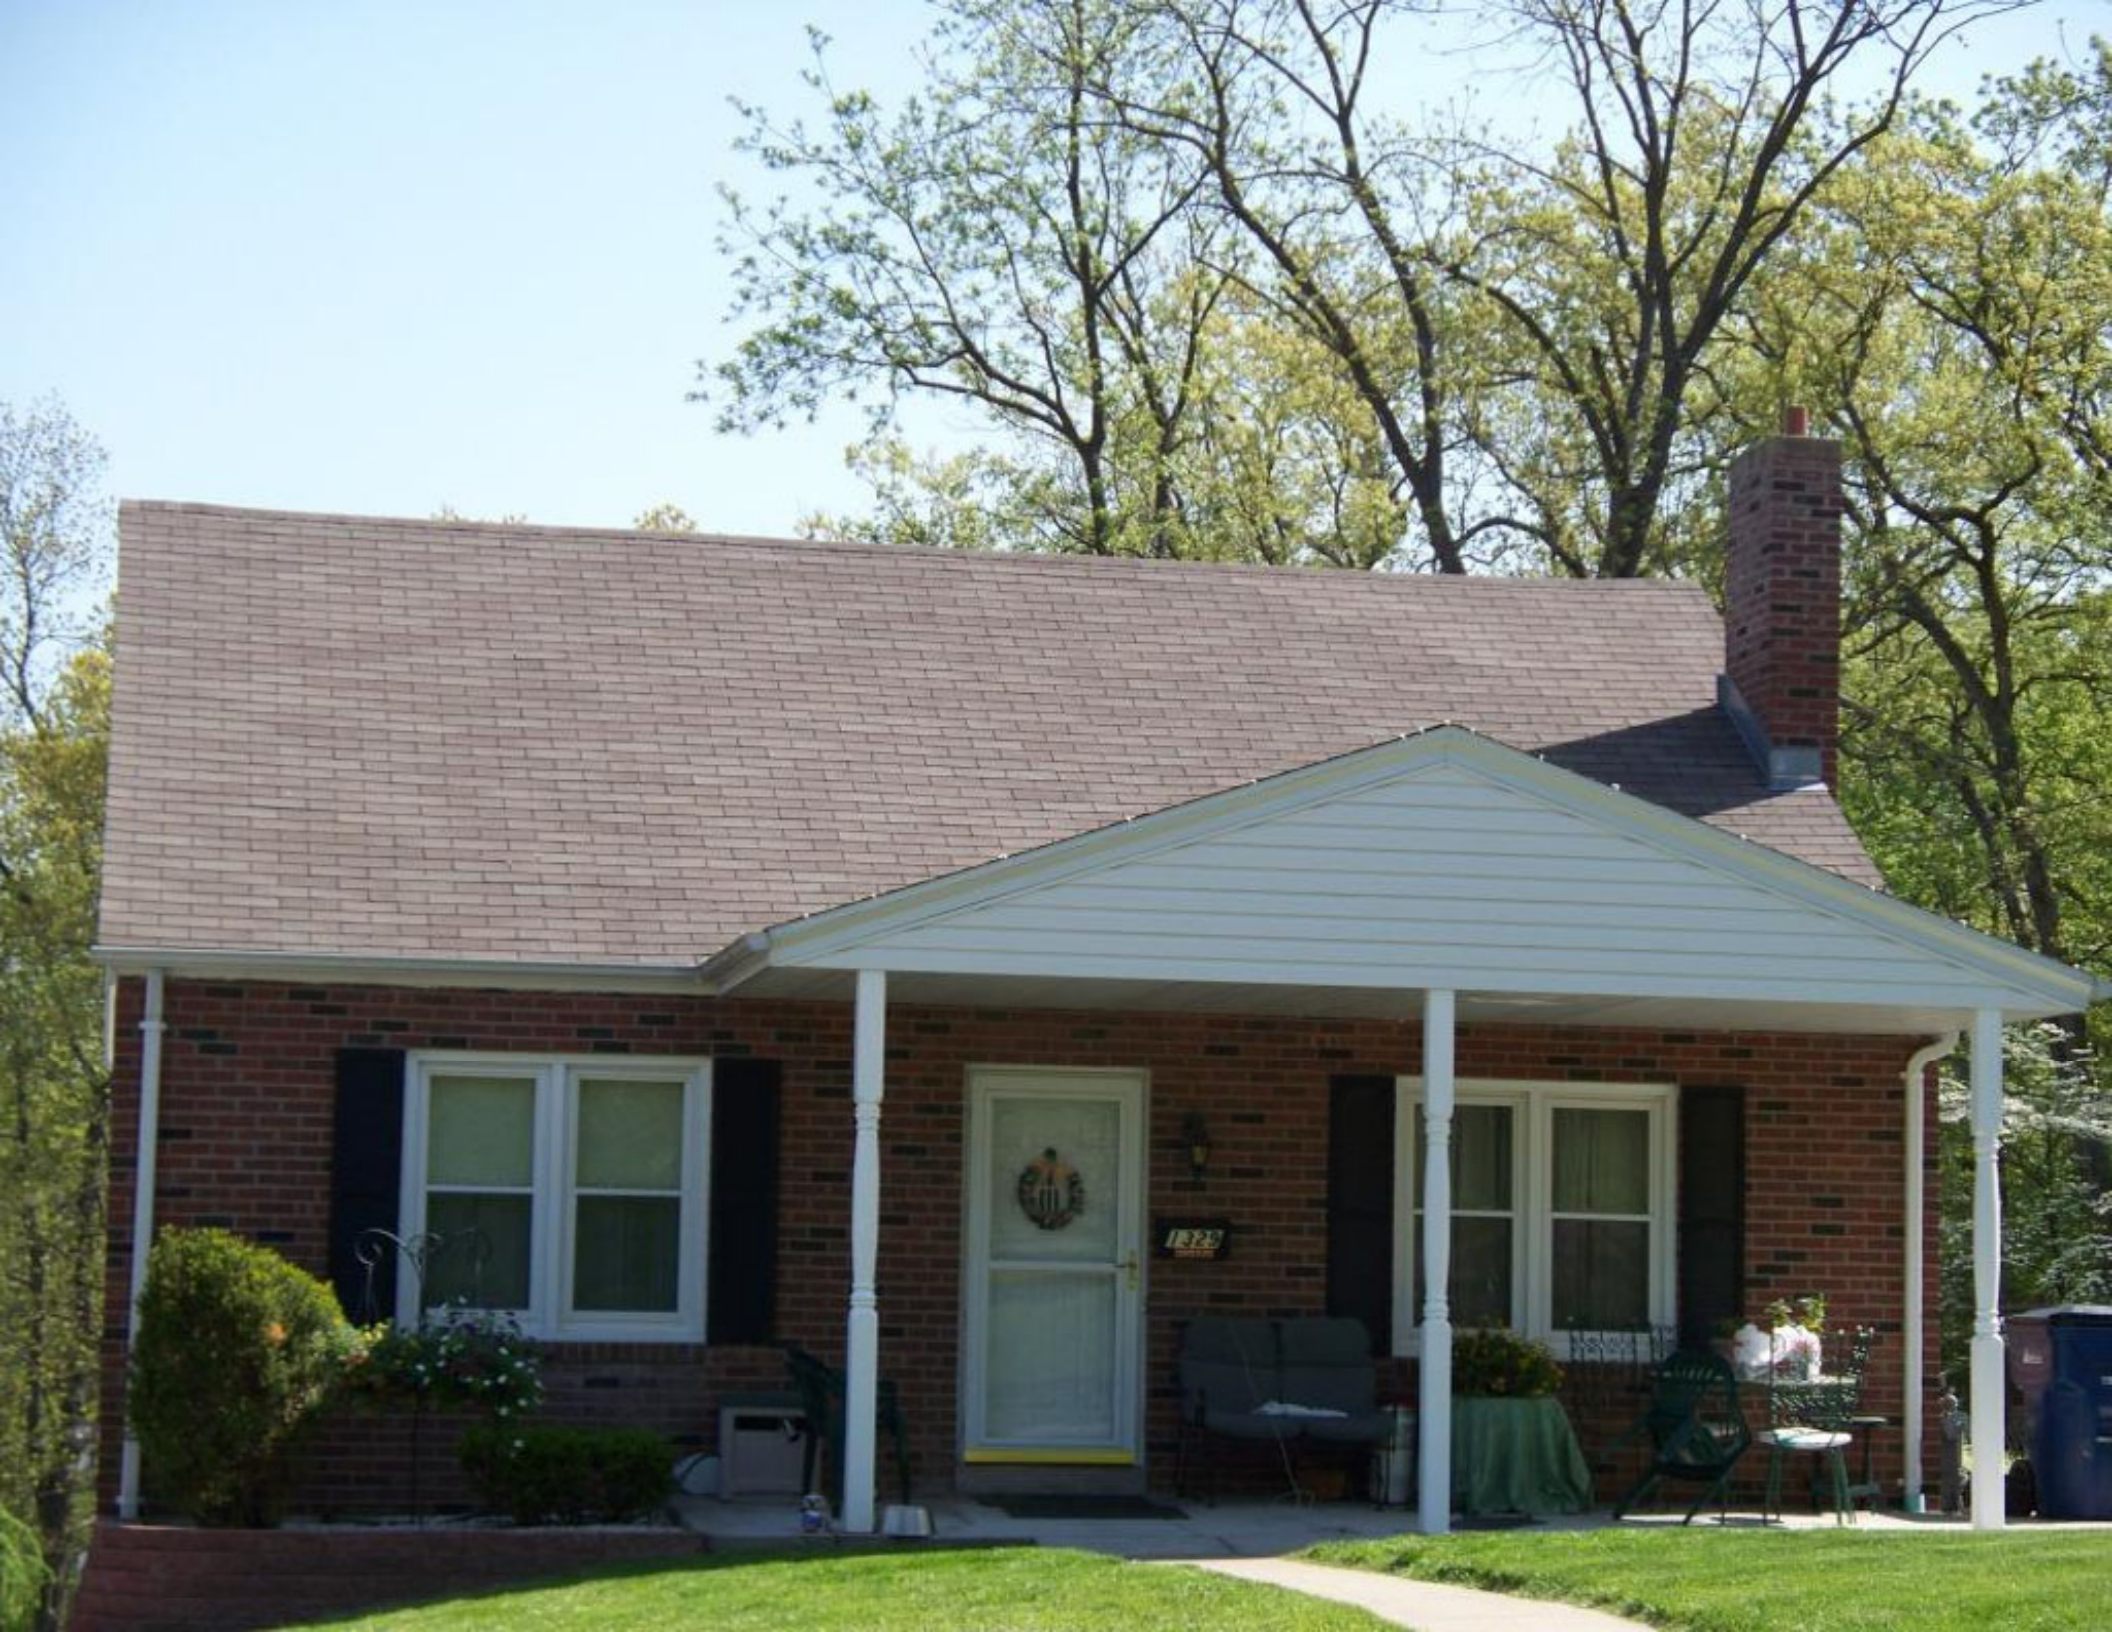
41. (cont.)
This 1 story side gable brick home has paired replacement 1/1 windows with shutters flanking the centered entrance. A large modern gabled porch was added with turned wooden posts over the center and right bays. Because of the build date it is currently considered non-contributing to a potential historic district.

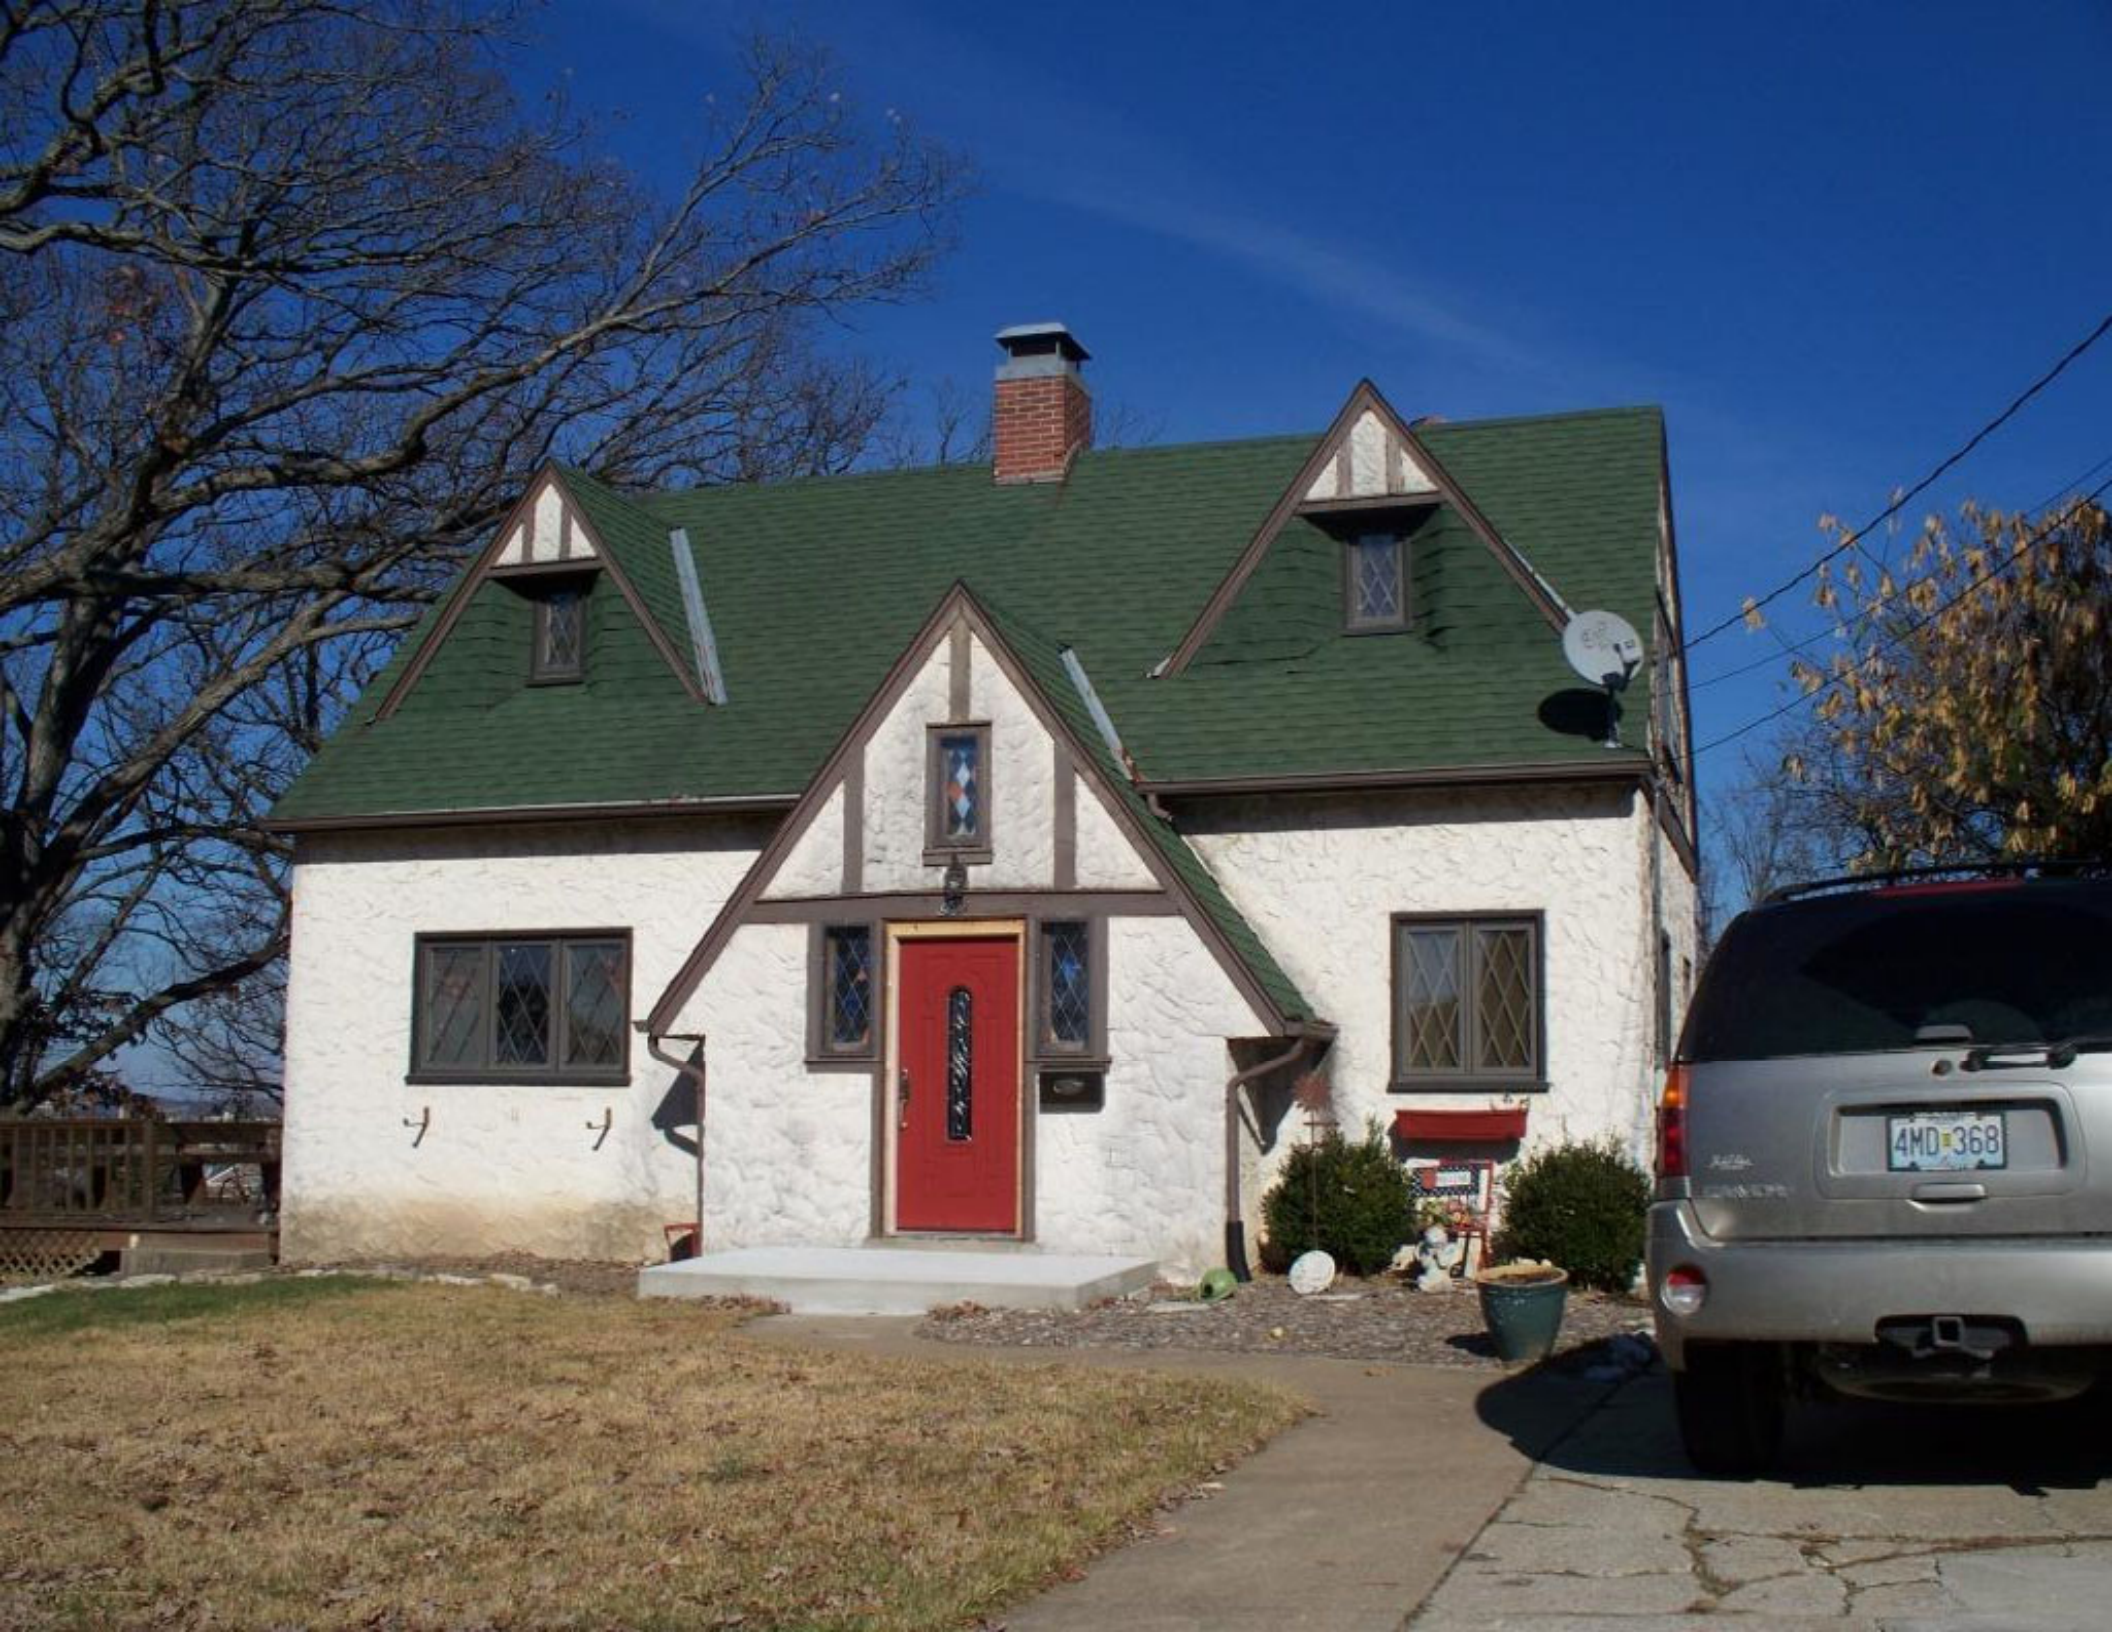
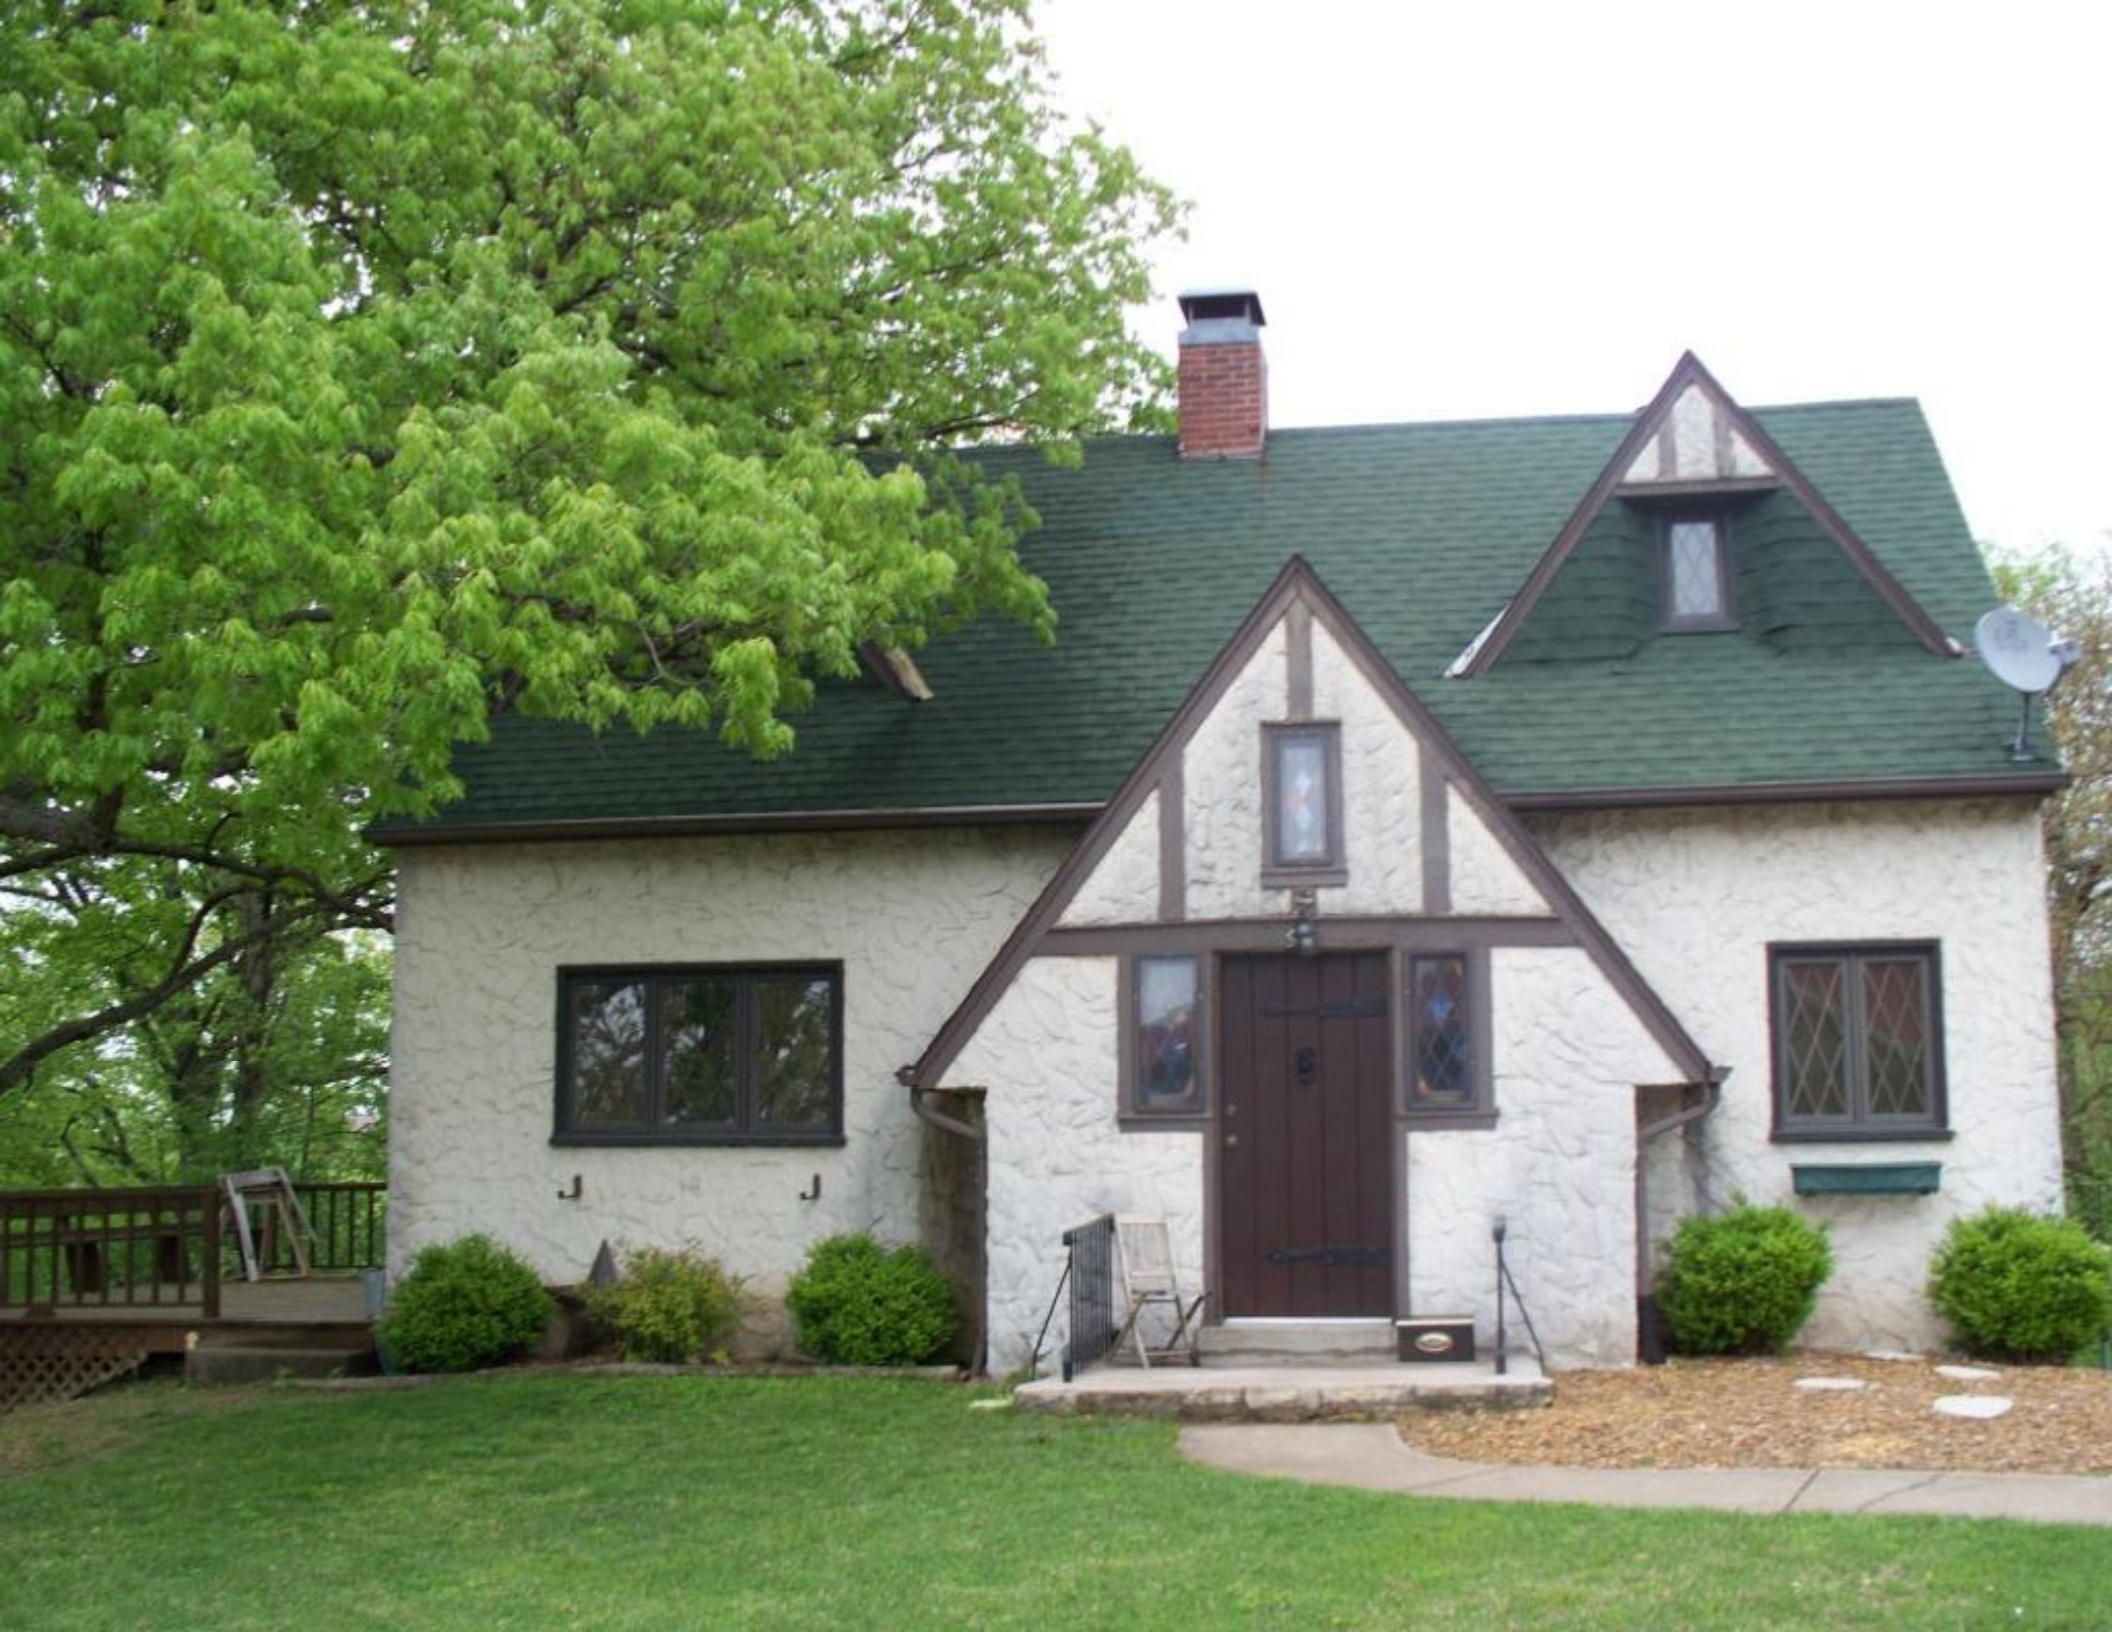
This 1 ½ story Tudor Revival is clad in textured stucco and has a side gable roof with two triangle dormers that are clad in asphalt shingle and plaster and half-timbering in the peak. Each dormer contains a narrow casement window made of art glass. The first floor has a row of three casement art glass windows in the left bay. The center bay projects and has a gable roof with half timbering and three casement art glass windows. At the time of this survey the home retained the original wooden door but was recently replaced with an unsympathetic door. The right bay has two art glass casement windows. Despite the door changing this property is an excellent example of a Tudor Revival home.
