ARCHITECTURAL/HISTORIC INVENTORY FORM

1. Survey No. CO-AS-005-001		2. Survey name: Moreau Drive Neighborhood Survey	
3. County: Cole		4. Address: 1202 Elmerine Ave.	
5. City: Jefferson City	Vicinity: <input type="checkbox"/>	6. UTM: / /	7. Township/Range/Section: T: R: S:
8. Historic name (if known):		9. Present/other name (if known):	
10. Ownership: <input checked="" type="checkbox"/> Private <input type="checkbox"/> Public		11. Historic use (if known): Residential	11. Current use: Residential

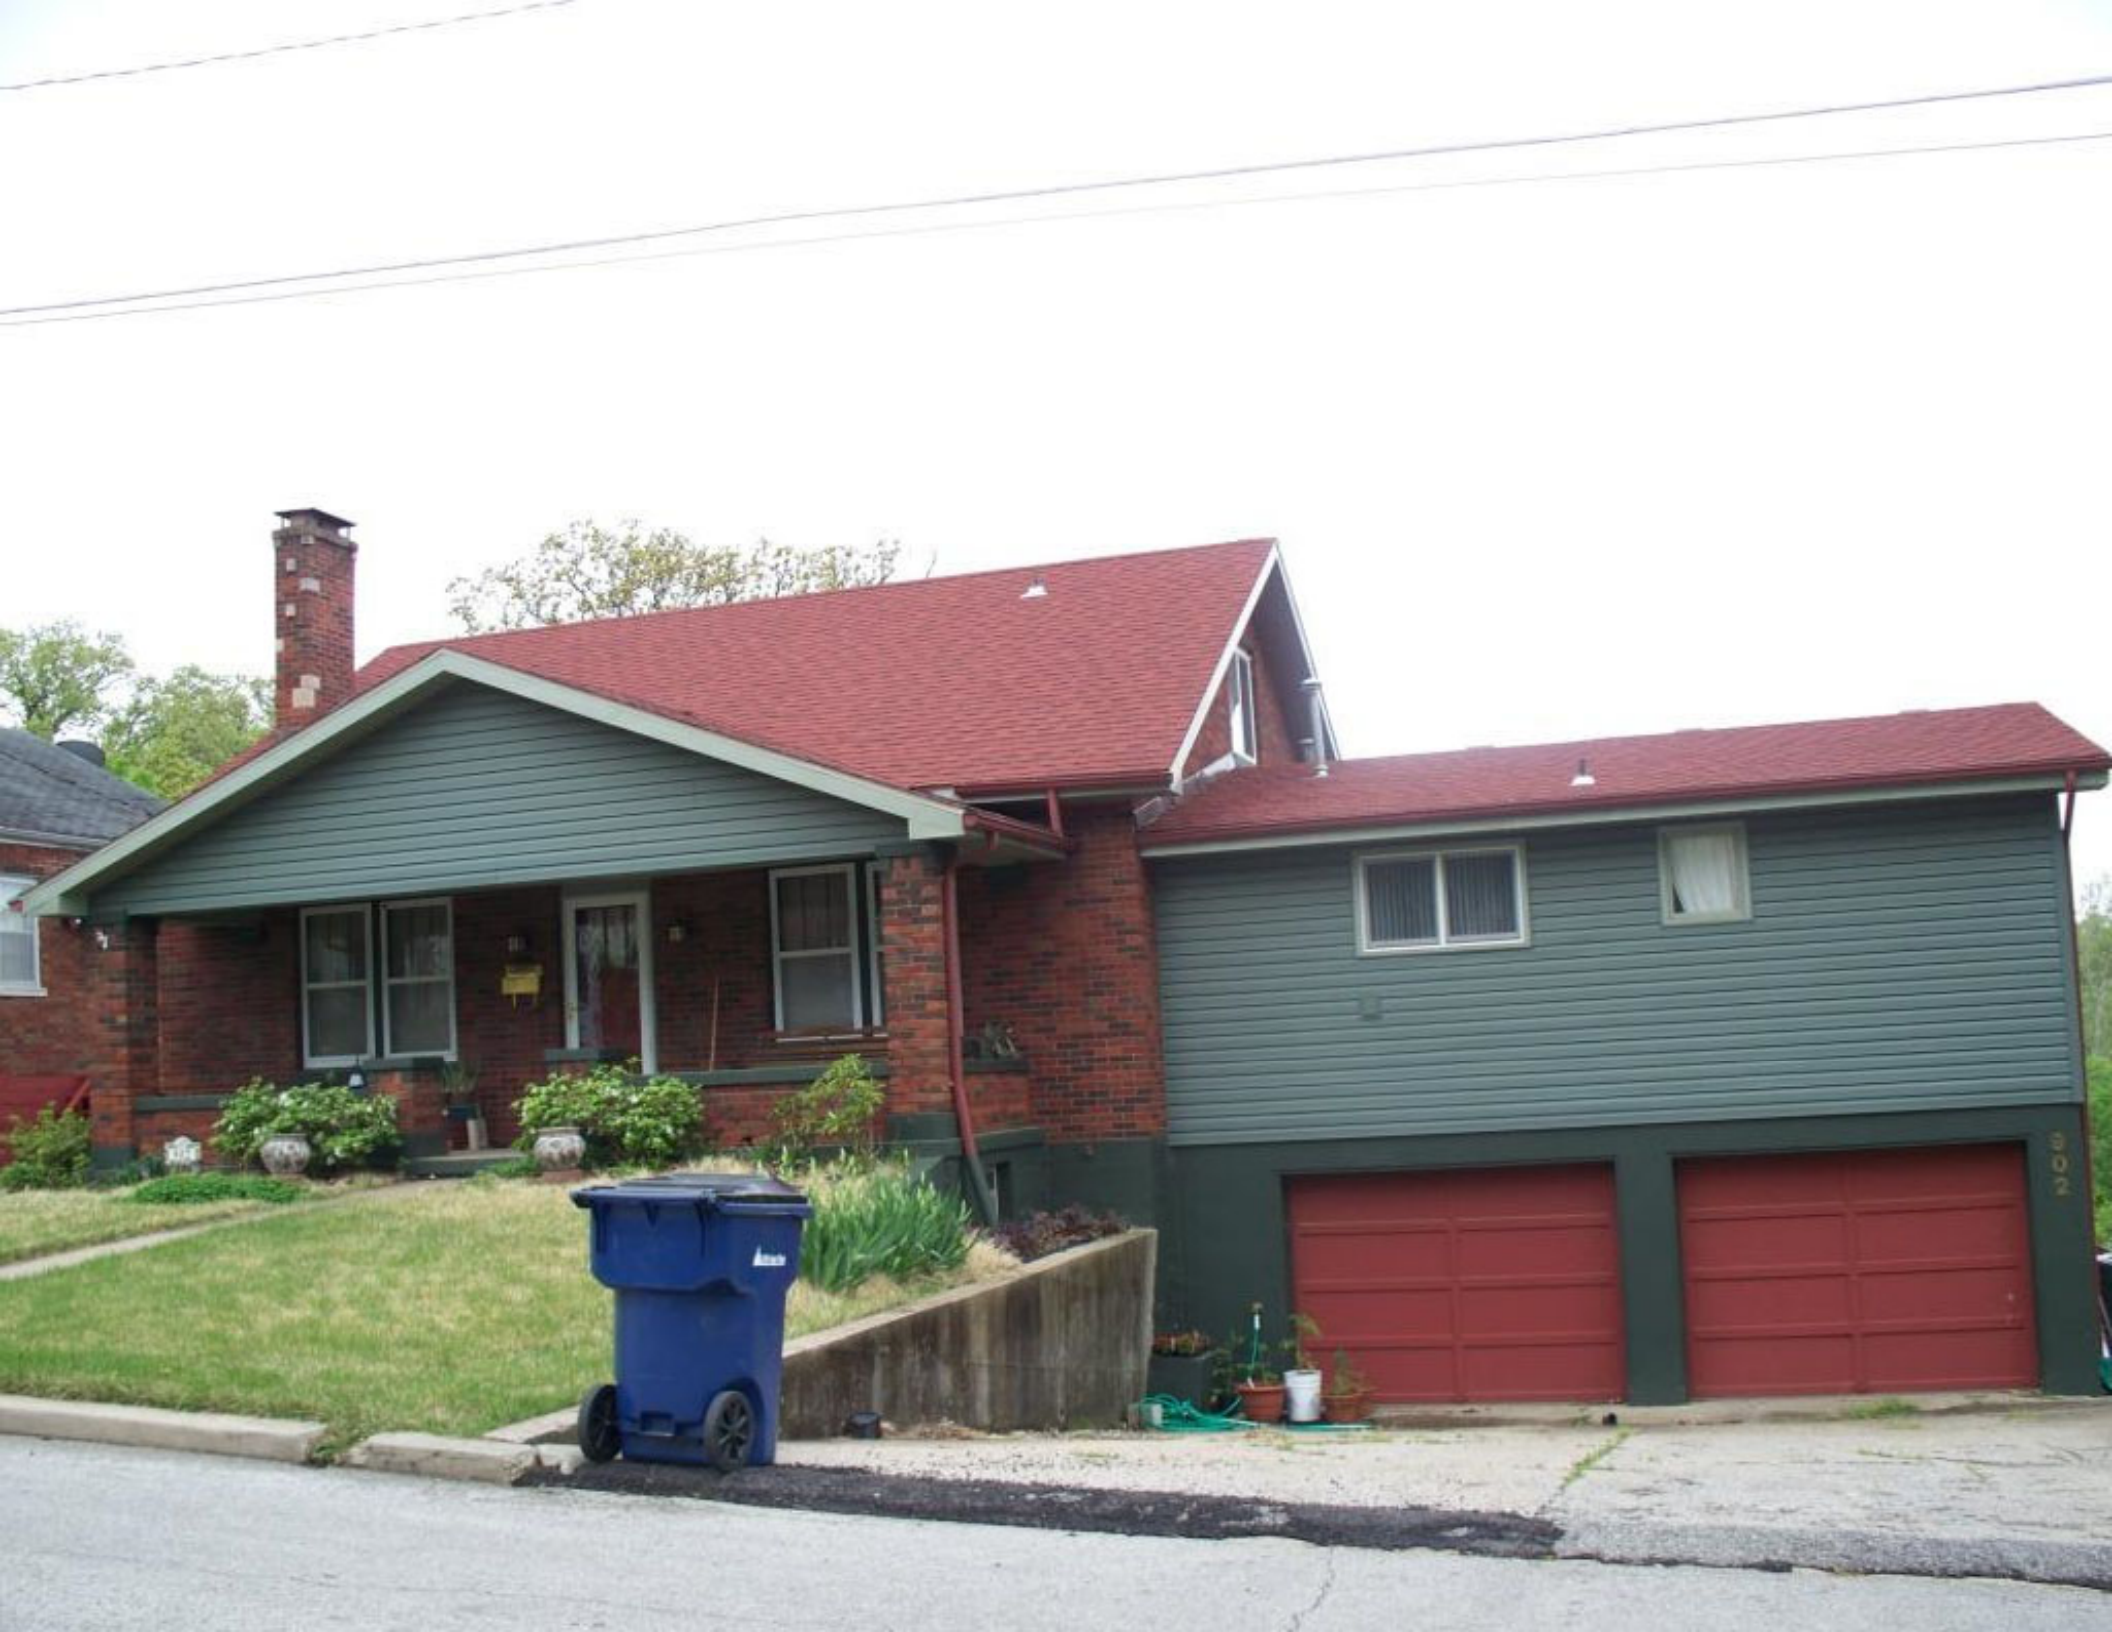
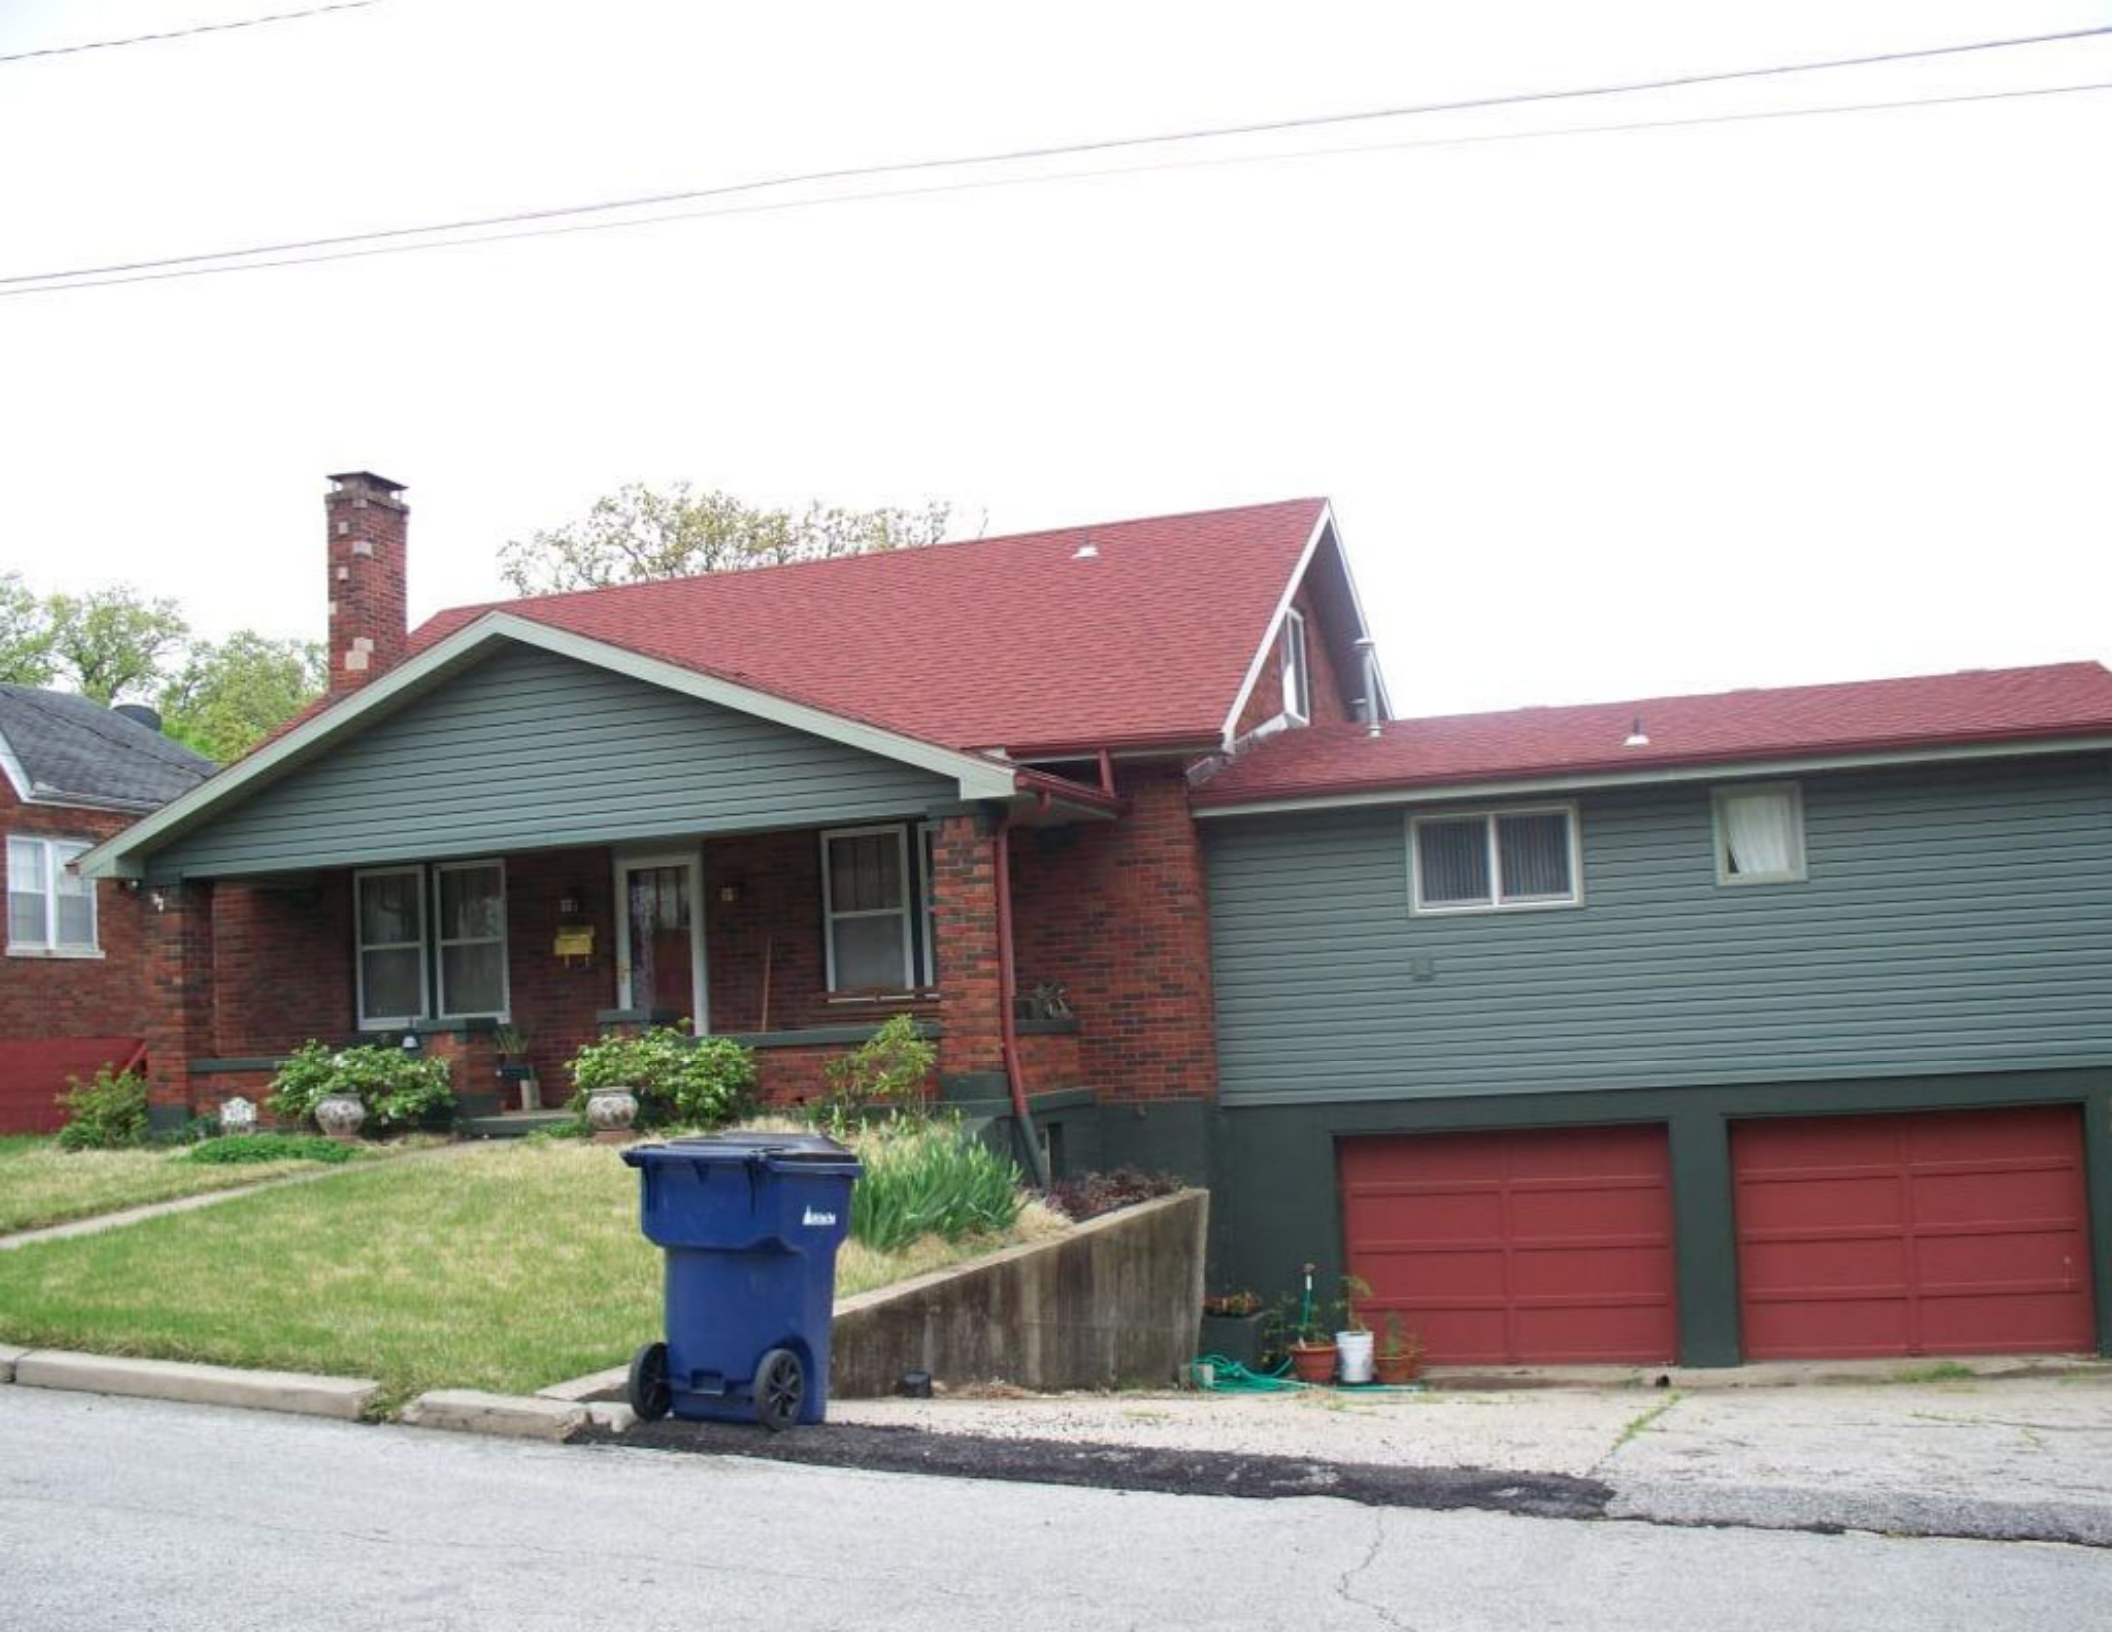
This 1 ½ story brick bungalow has a side gable roof. The porch has a large front gable roof clad in vinyl that is supported by brick piers and half walls capped in limestone or concrete. Paired 3/1 windows flank the entrance, which retains its historic wooden door with three lights. A two-story two-car garage addition has been added to the right side of the property. Three casement windows are on the second floor which is clad in vinyl. The lower floor contains two garage doors. Because this addition has doubled the footprint of the property it's considered non-contributing to the district.

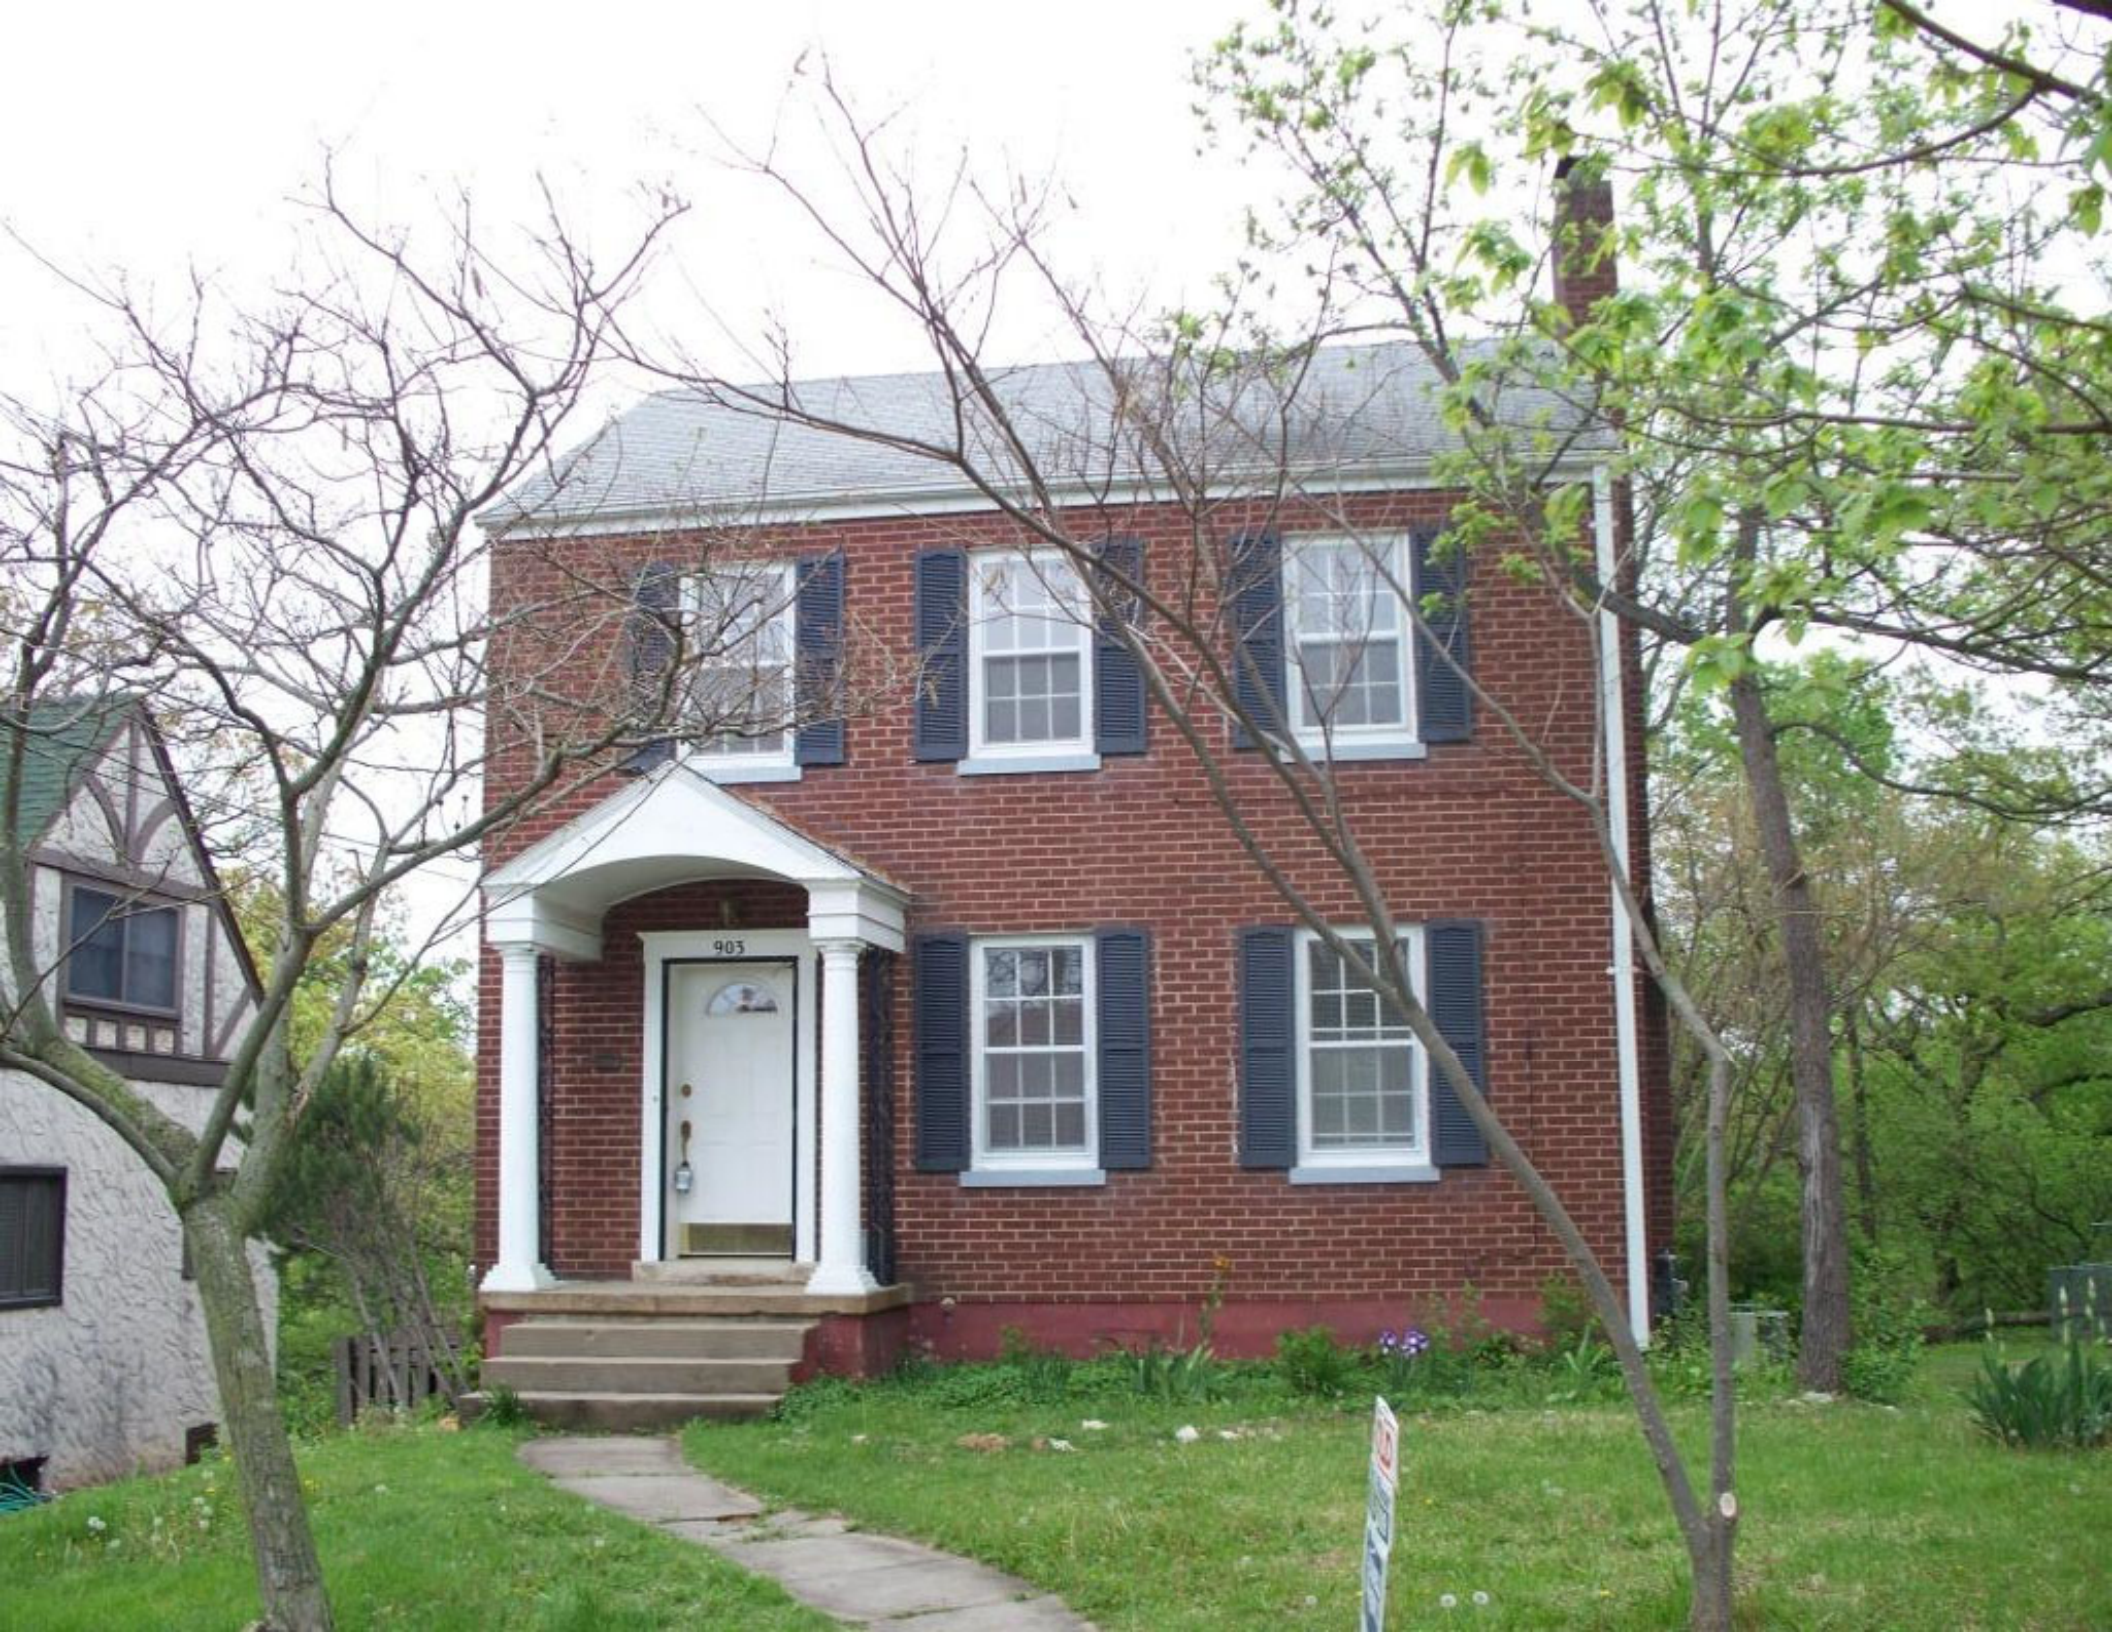
This two story brick Colonial Revival has a side gable roof. There are three 6/6 windows with shutters on the second floor. The first floor has two more 6/6 windows in the center and right bay, also with shutters. The entrance is in the left bay and has a projecting gabled portico with a basket handle arch and Ionic pillars and decorative metal railing.

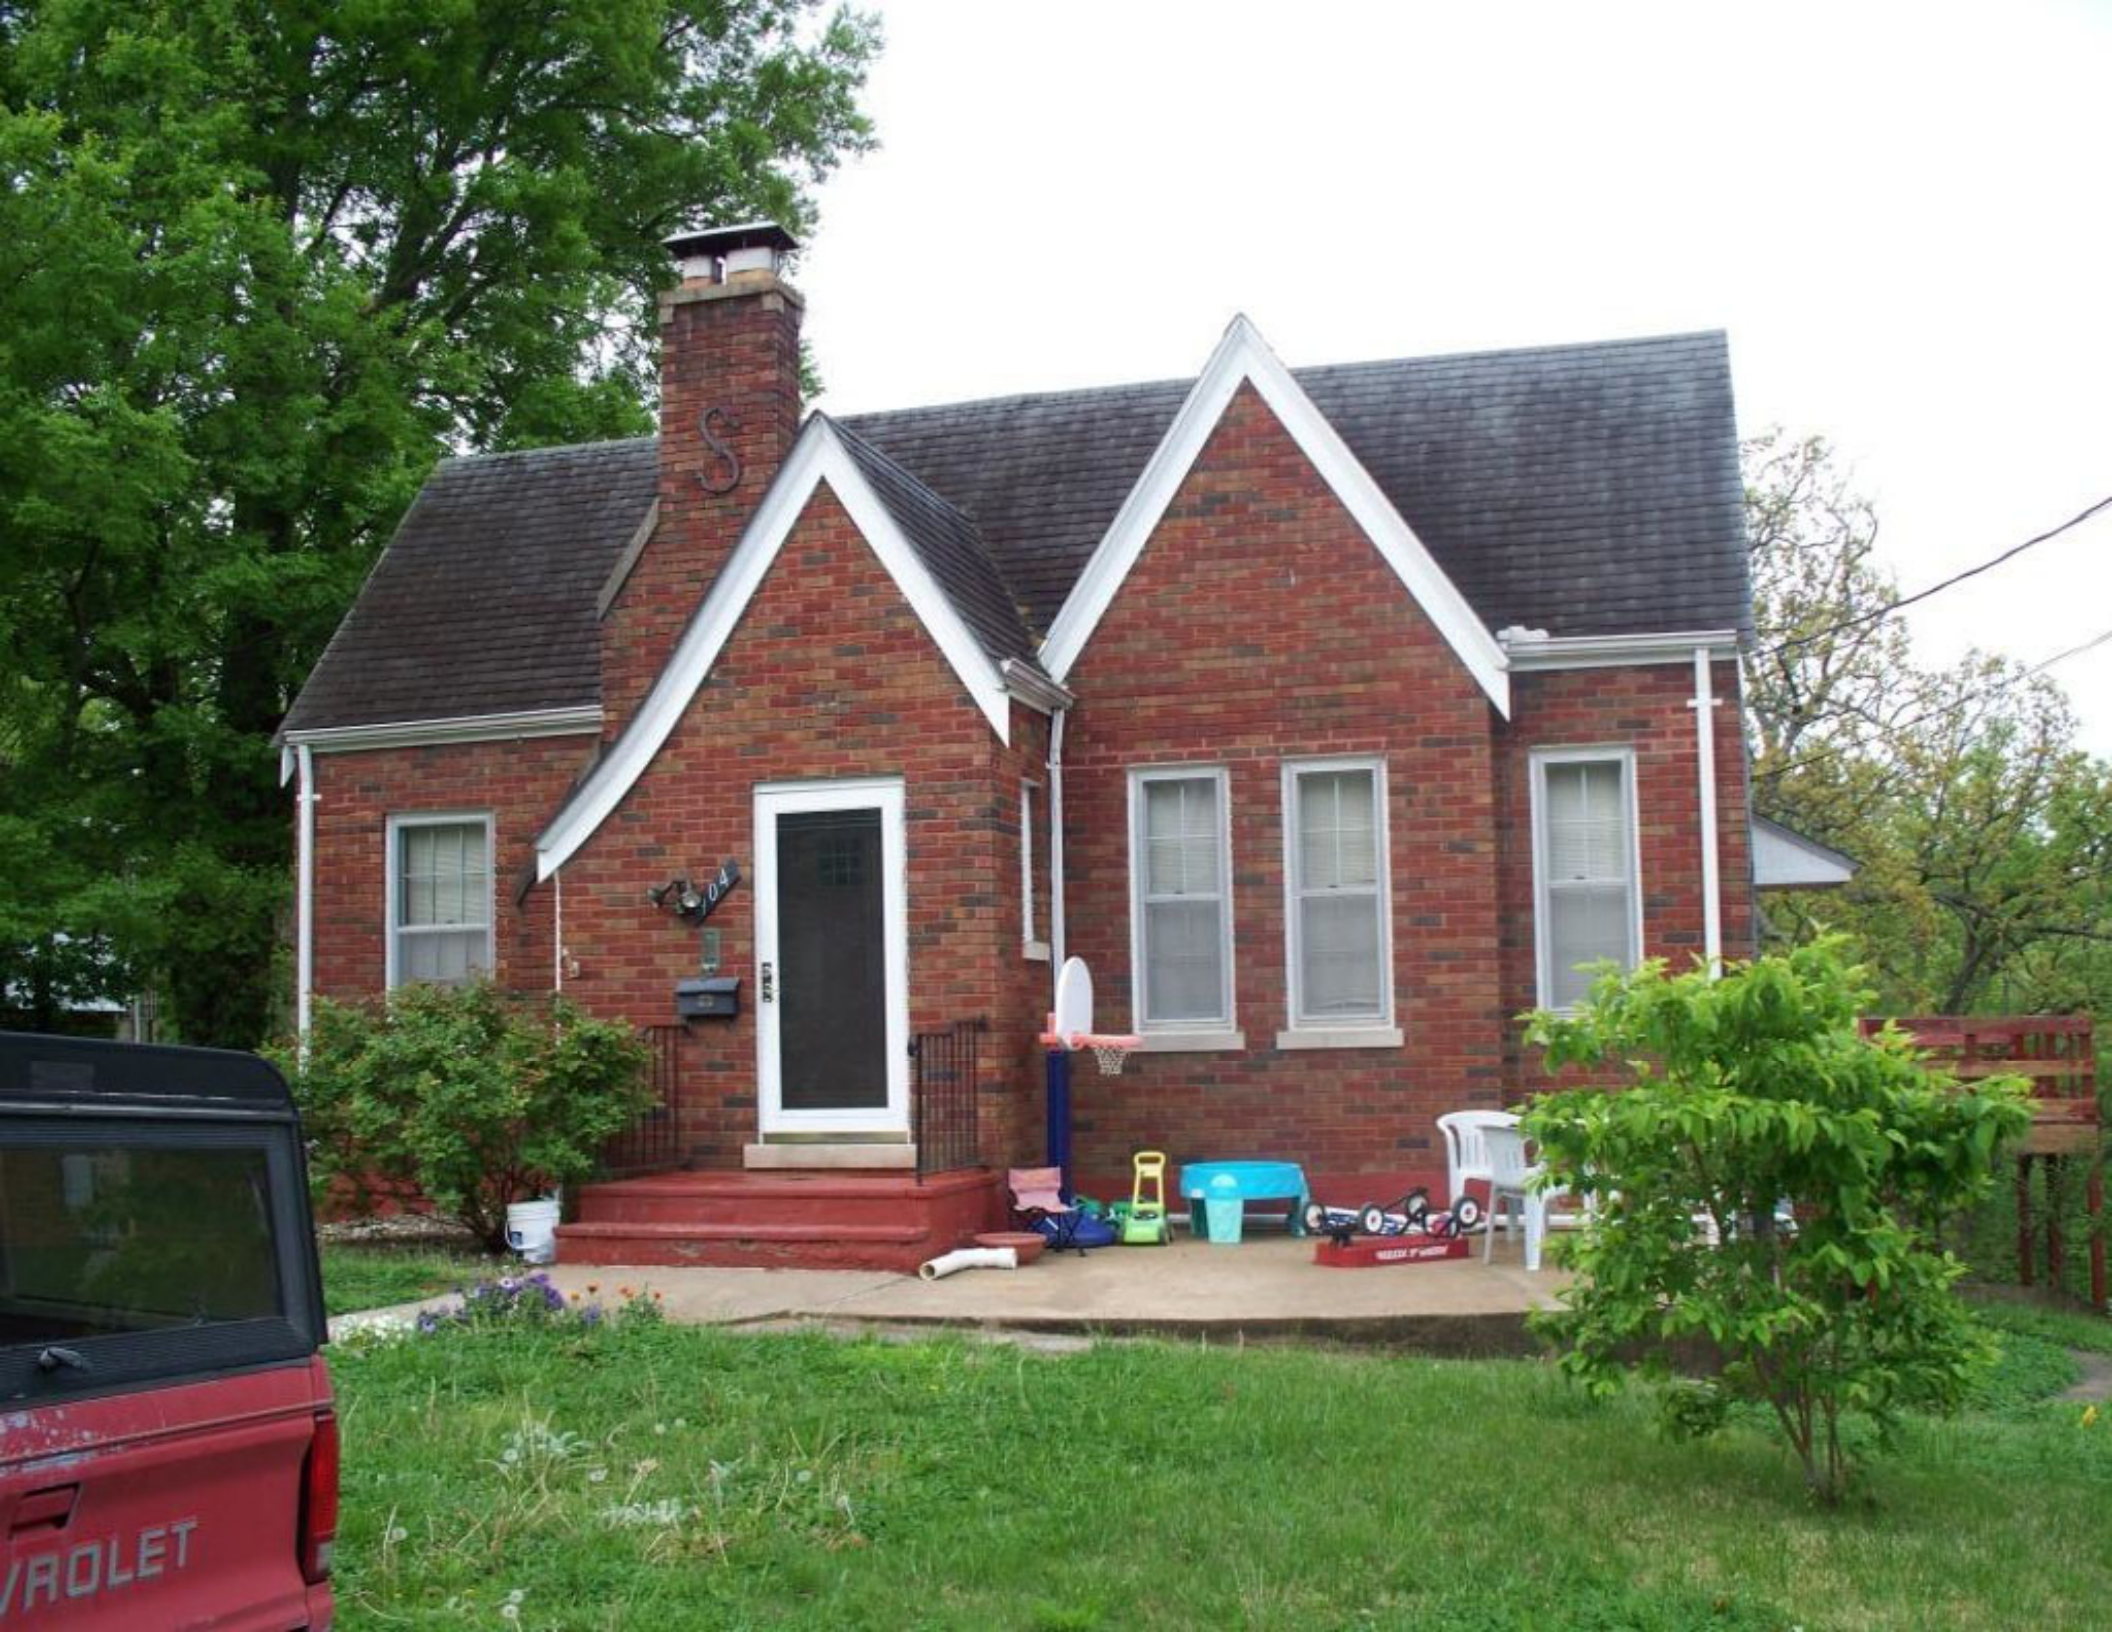
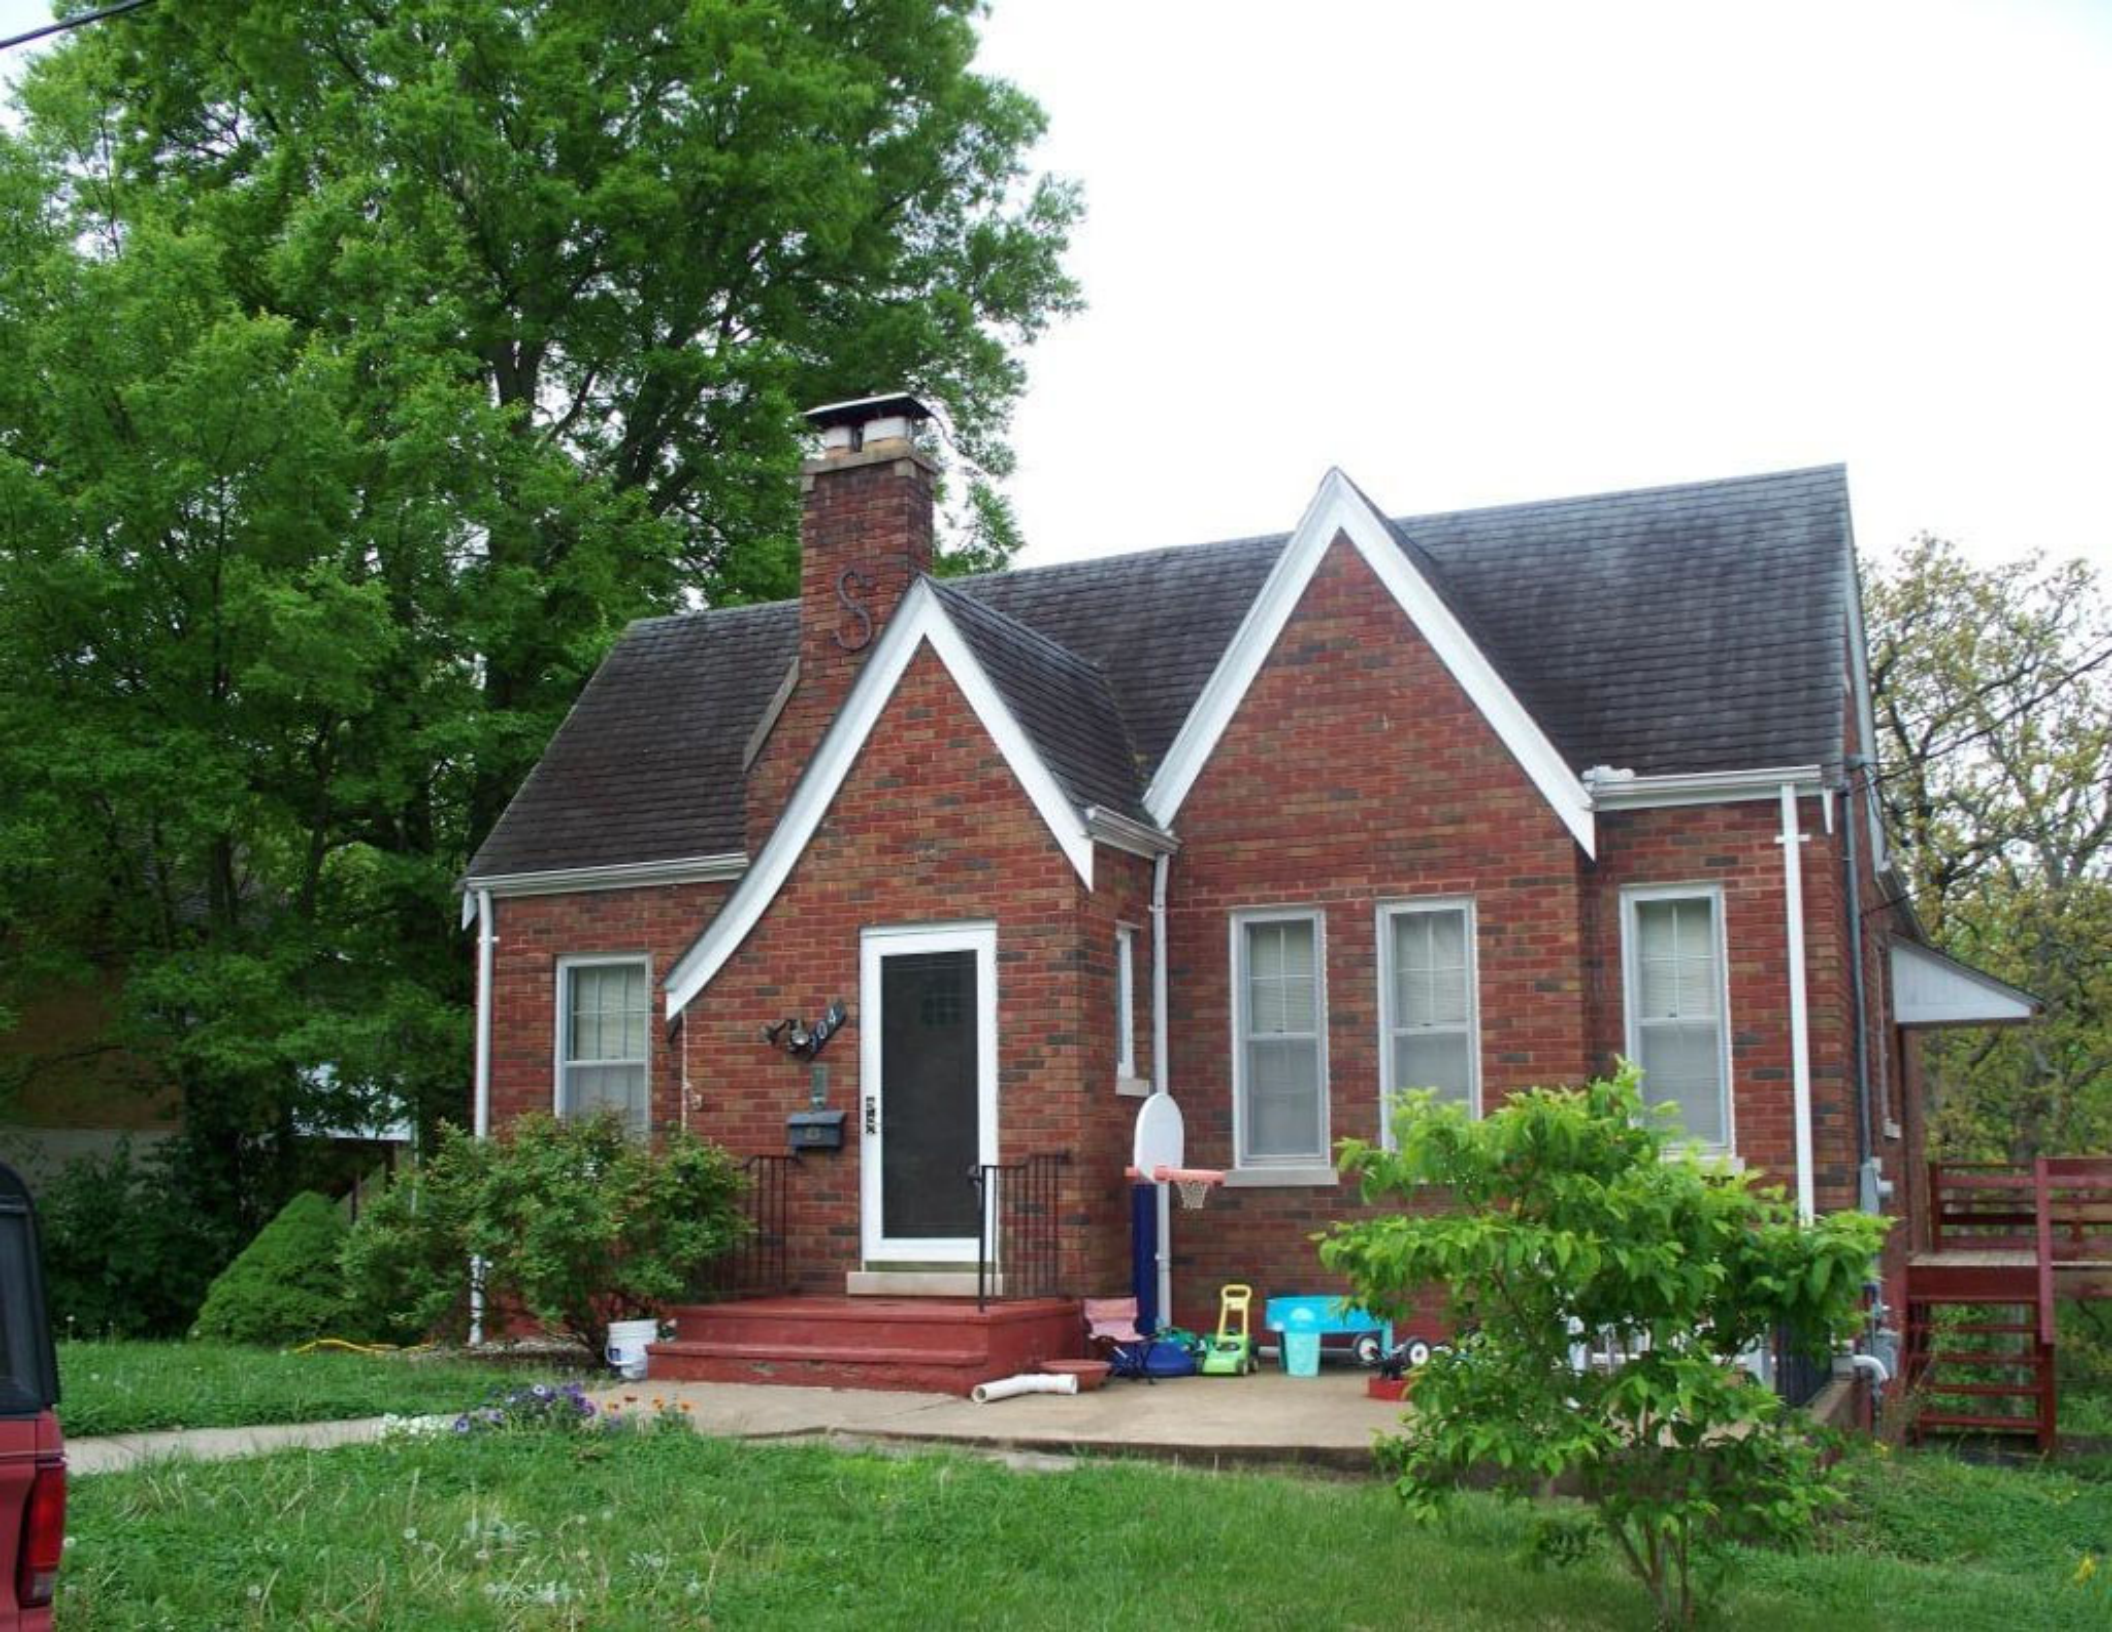
This one story brick Tudor Revival has a side gable roof with two intersecting front gables extending from the center of the property. The left bay has a 6/6 window. The next bay (to the right) projects with a steeply pitched gable that slopes to the left and has a chimney extending from it and contains the entrance, which appears to retain its historic wooden door. A concrete or limestone stoop with metal railing leads to the door. The next bay is set back has a steeply pitched gable and two narrow historic 4/4 windows. The final bay is set back (appears to be flush with the first bay) and contains a narrow single 4/4 window. All of the windows appear historic.
