ARCHITECTURAL/HISTORIC INVENTORY FORM

1. Survey No. CO-AS-005-001		2. Survey name: Moreau Drive Neighborhood Survey	
3. County: Cole		4. Address: 1202 Elmerine Ave.	
5. City: Jefferson City	Vicinity: <input type="checkbox"/>	6. UTM: / /	7. Township/Range/Section: T: R: S:
8. Historic name (if known):		9. Present/other name (if known):	
10. Ownership: <input checked="" type="checkbox"/> Private <input type="checkbox"/> Public		11. Historic use (if known): Residential	11. Current use: Residential

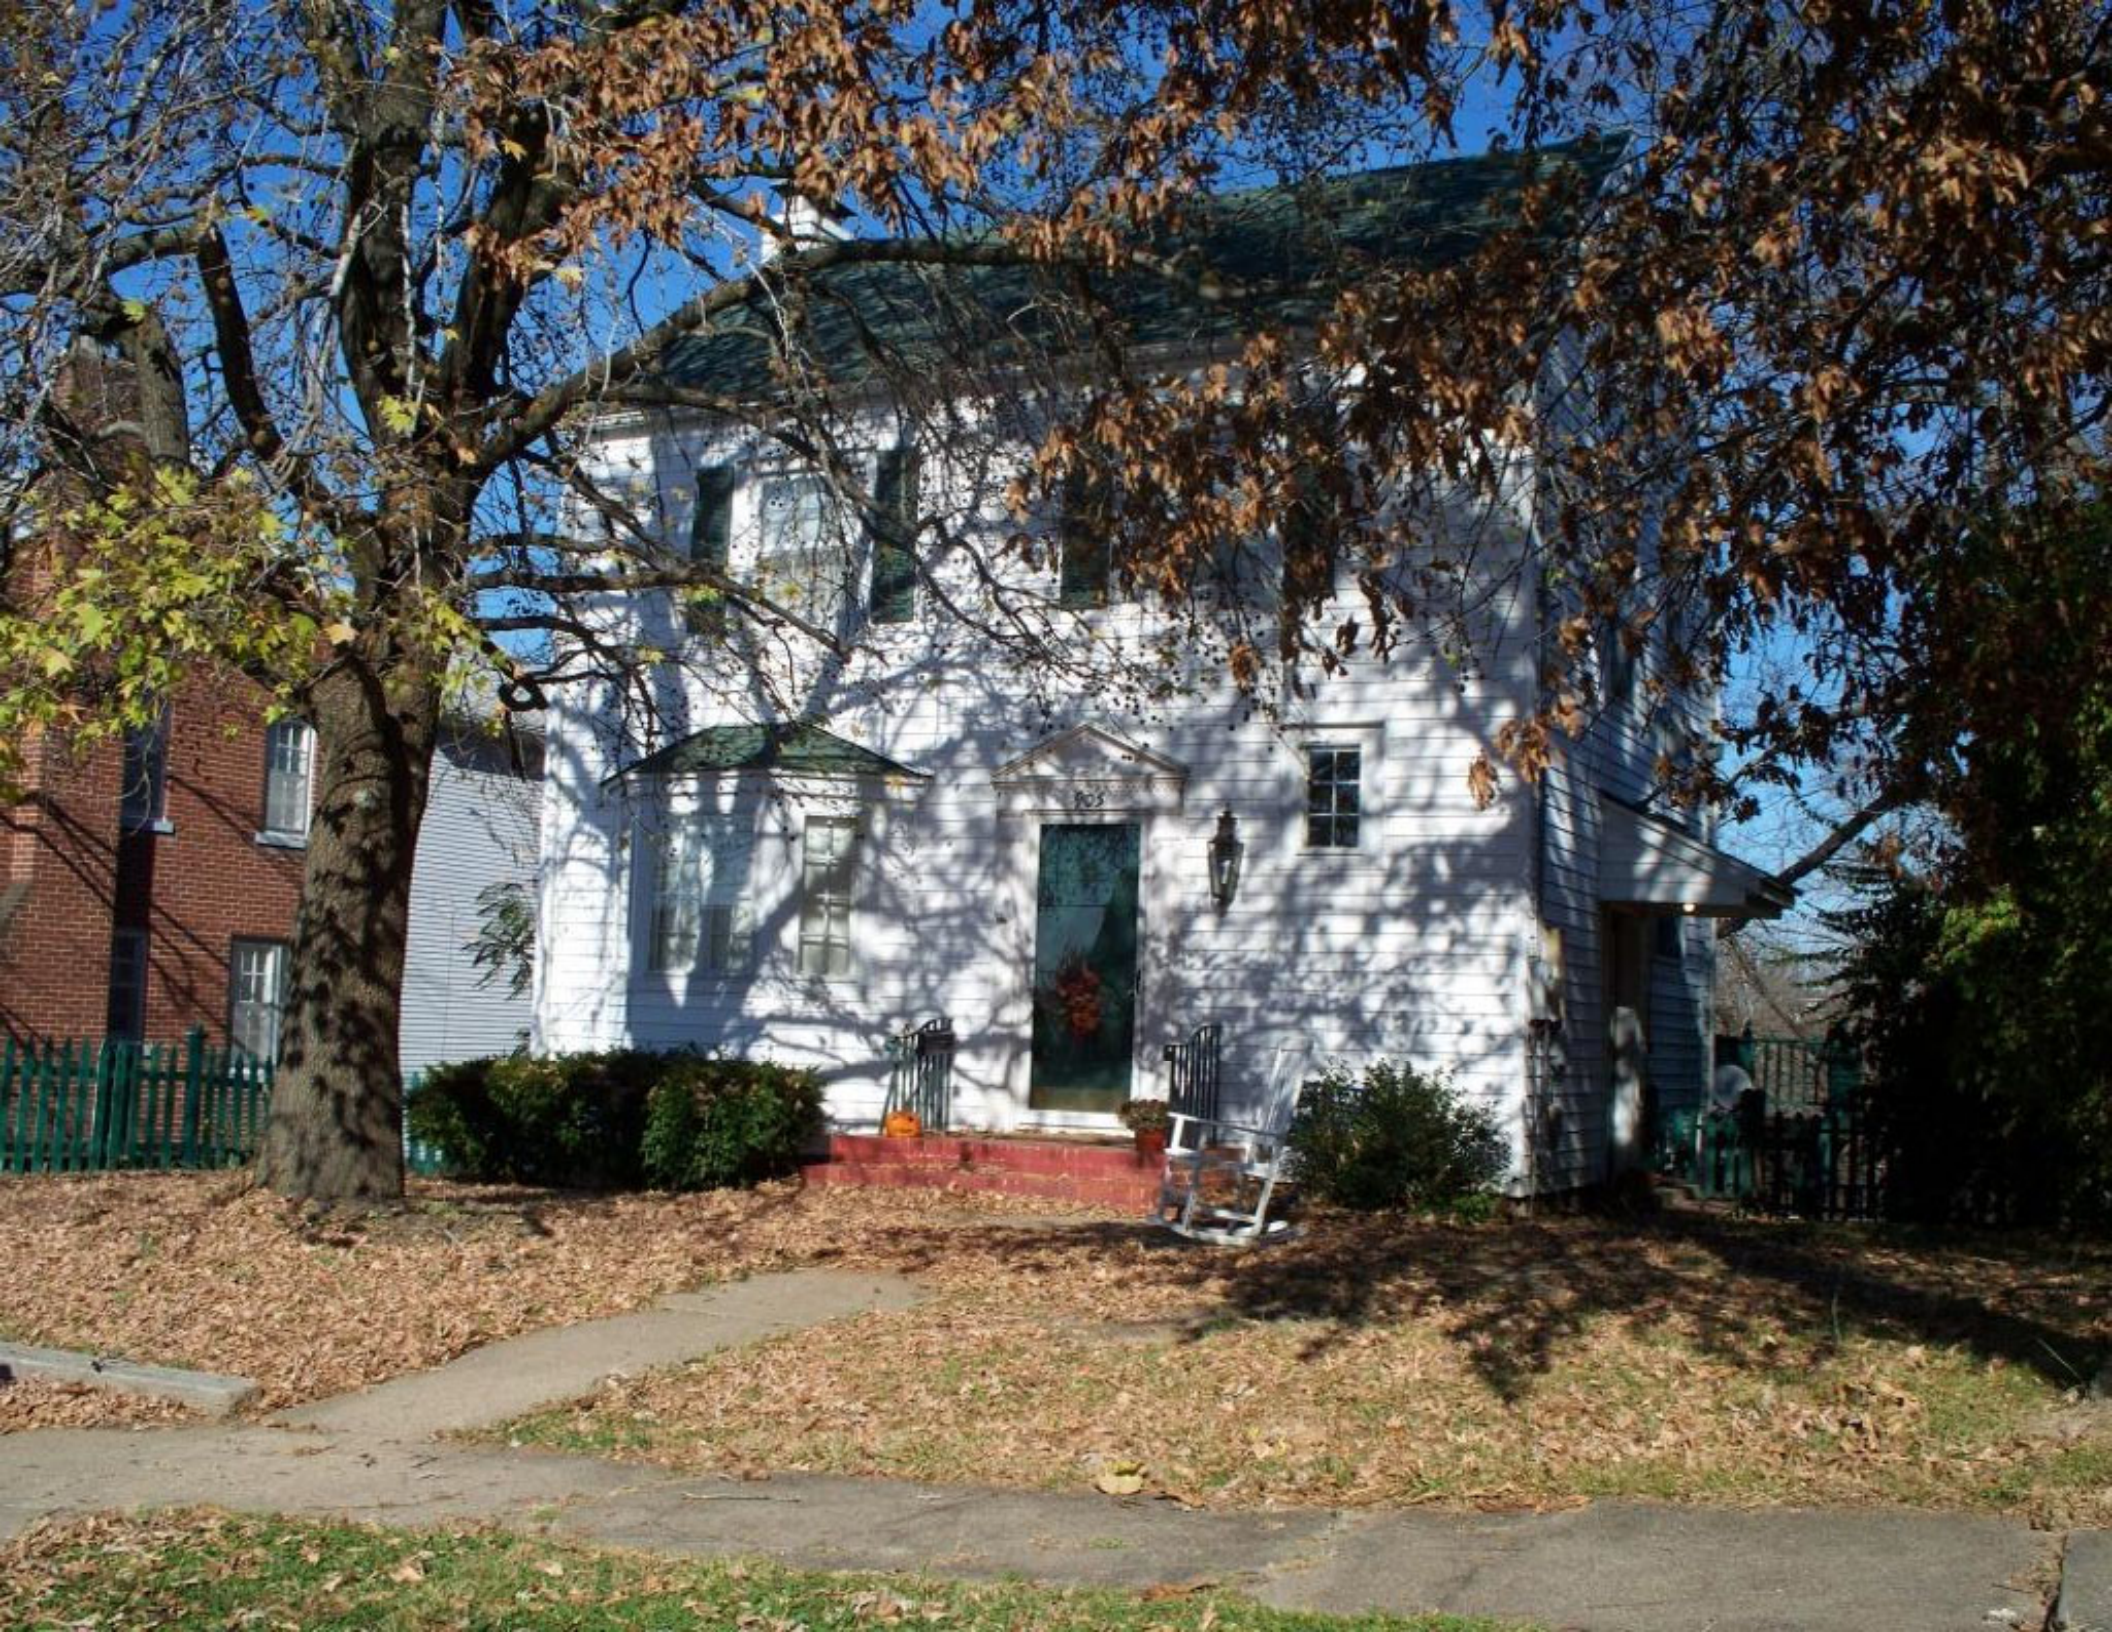
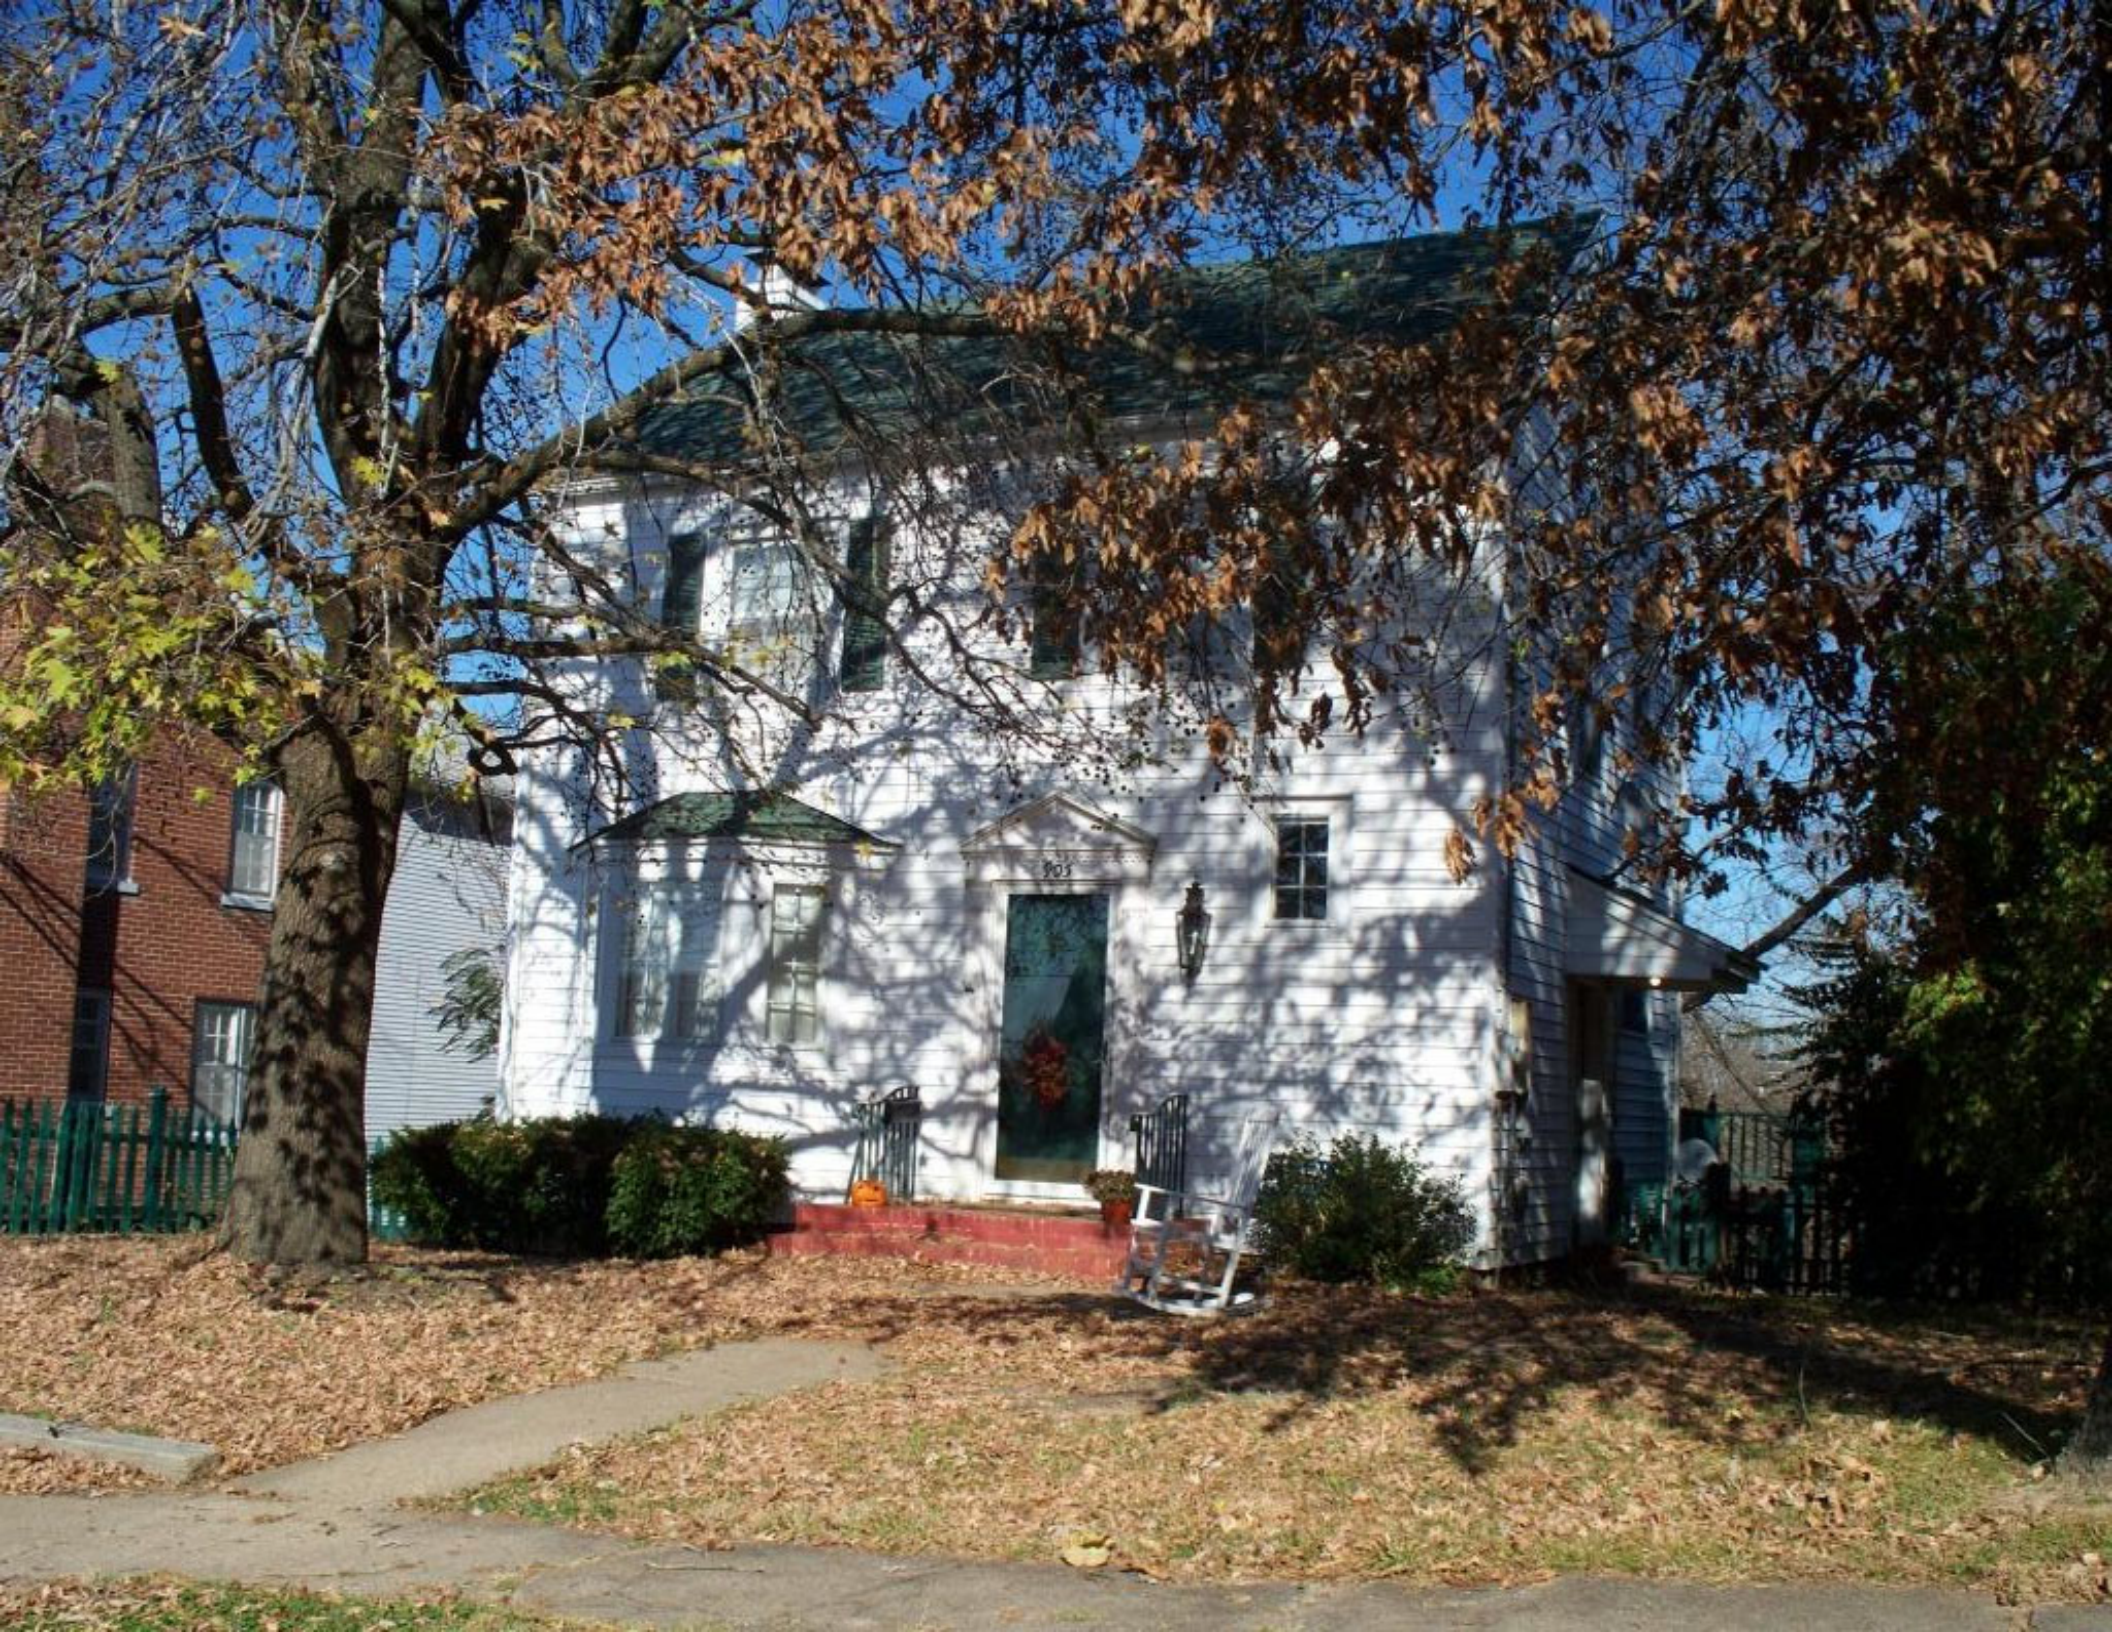
This two story Colonial Revival has a side gable roof and is clad in vinyl. The second floor has two 6/6 windows with shutters. The lower floor has a bay window with multi-light panes in the left bay. The center bay contains the entrance and has a pedimented door surround. The right bay has a small six-light casement window. The entrance has a brick stoop with metal rails. If the windows are not historic this property probably lacks integrity and would not be contributing to the district. More research is necessary.

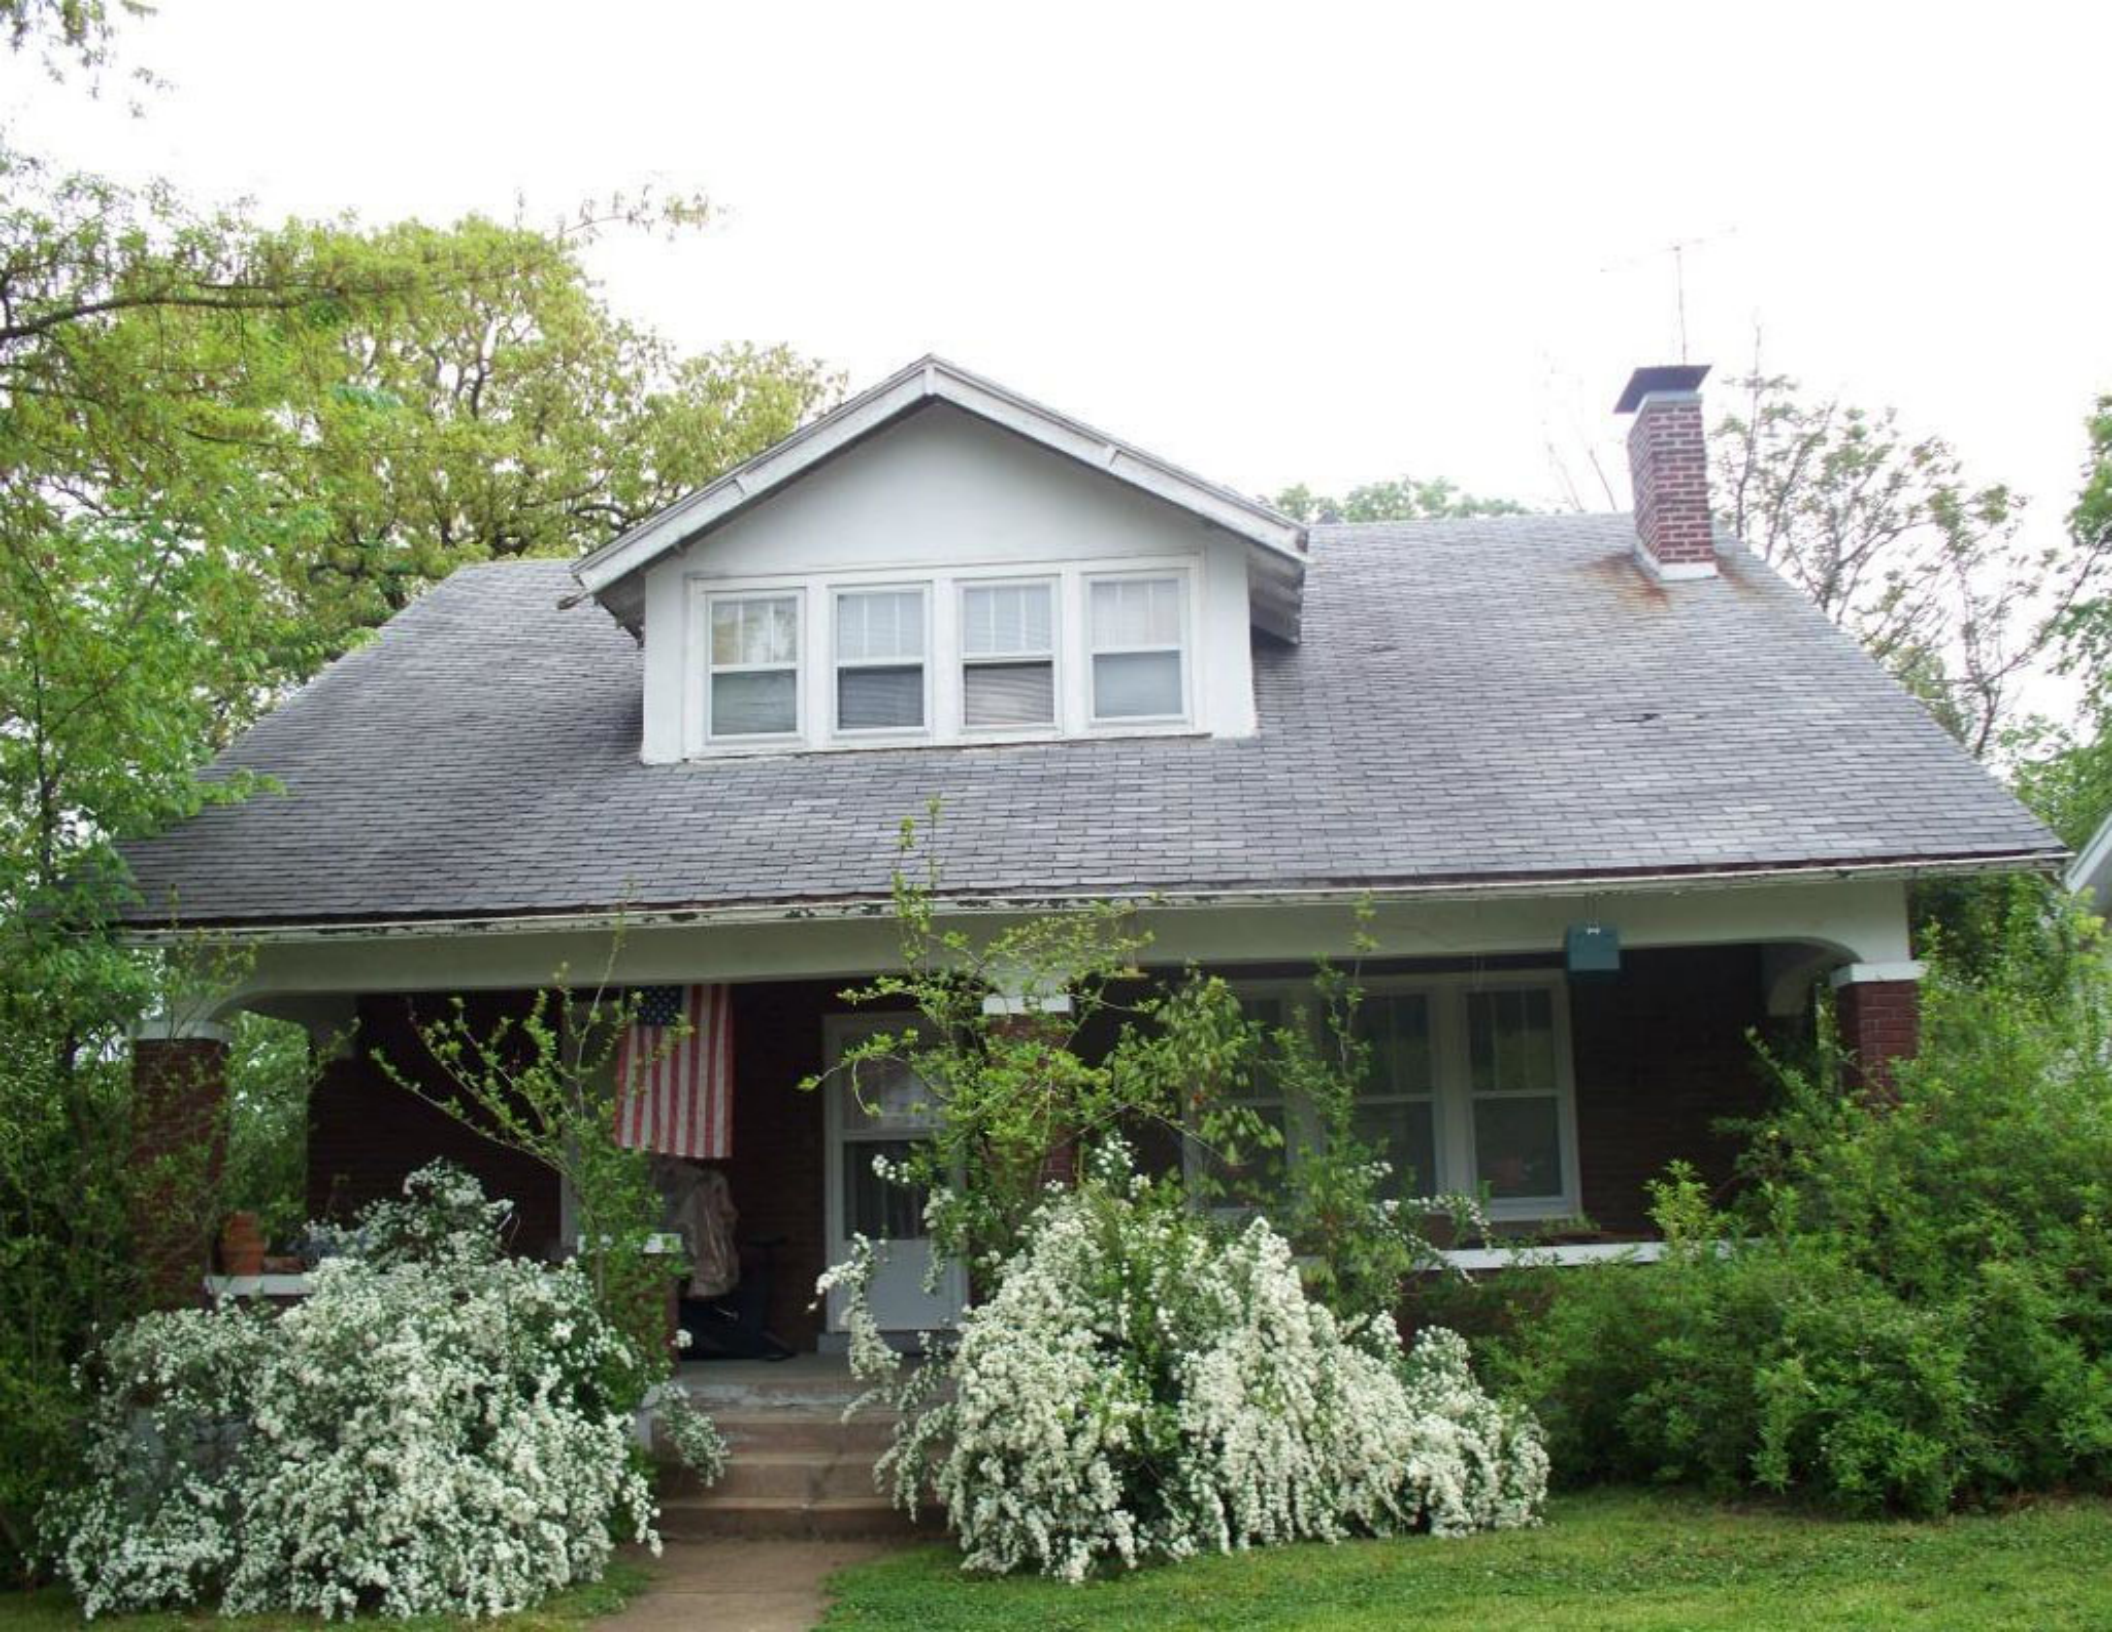
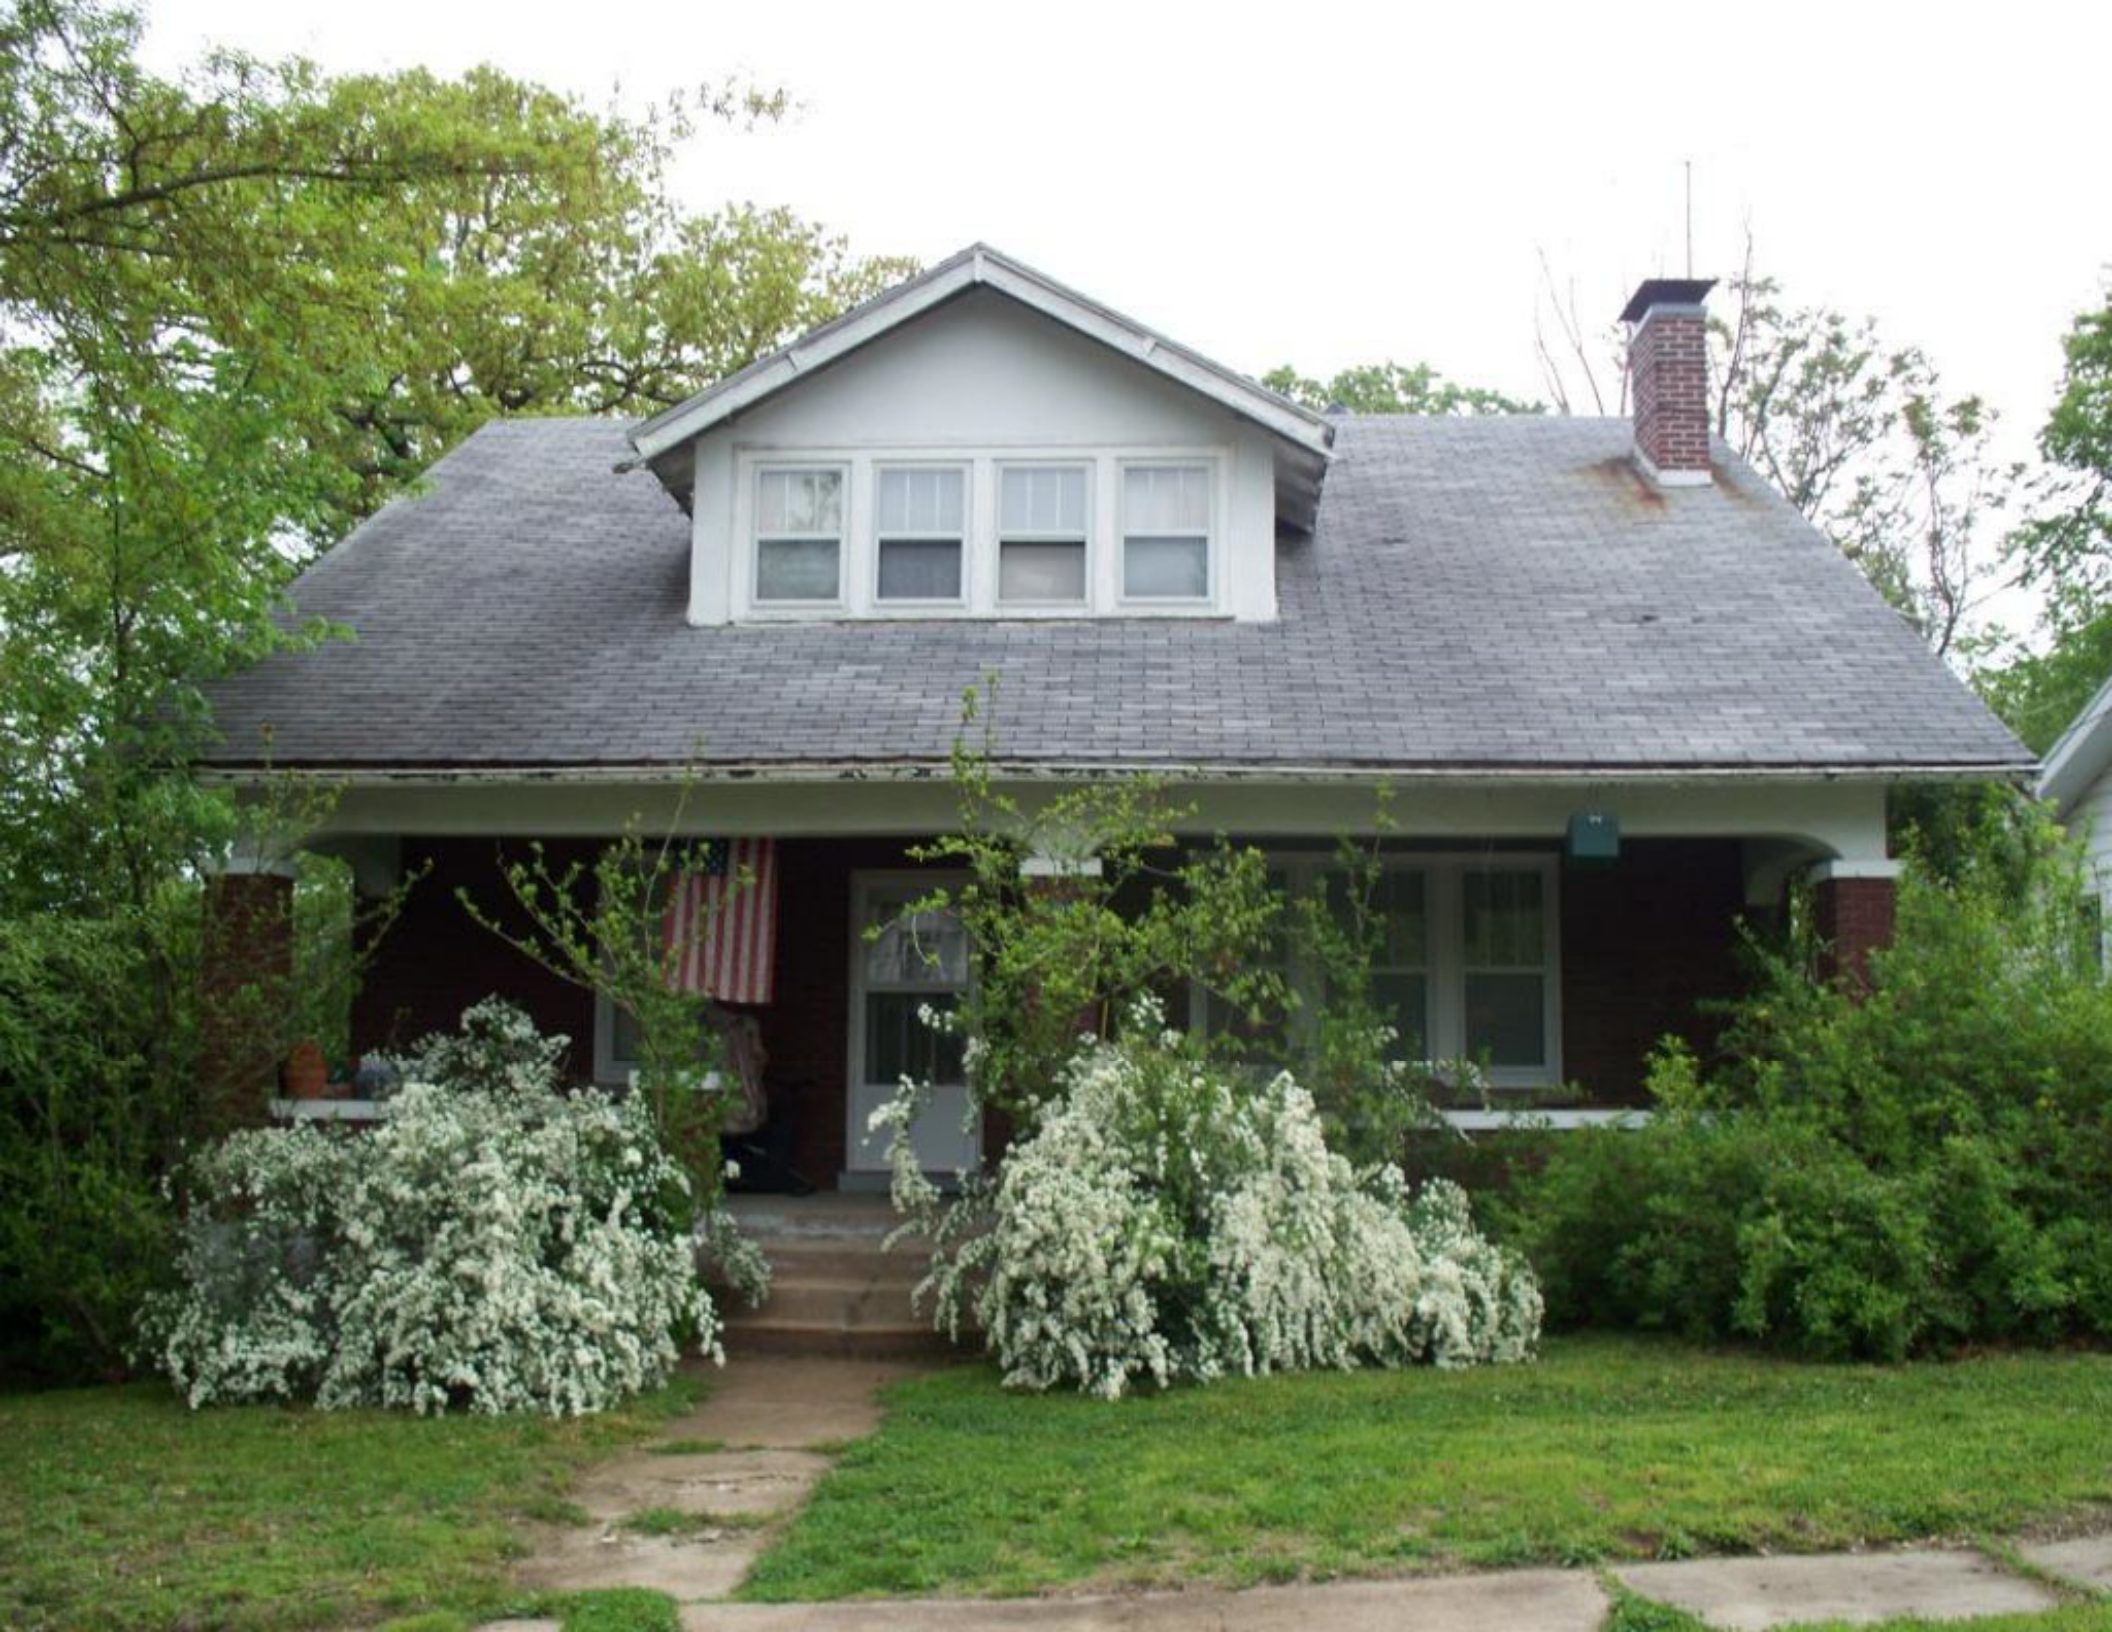
This 1 ½ story brick bungalow has a side gable roof with a central gabled dormer with rafter tails clad in plaster with four 3/1 historic windows. In the left bay is a single window and in the center bay is the entrance. Finally the right bay has a row of three historic 3/1 windows. The property has a full width porch with brick half walls and piers capped in concrete.

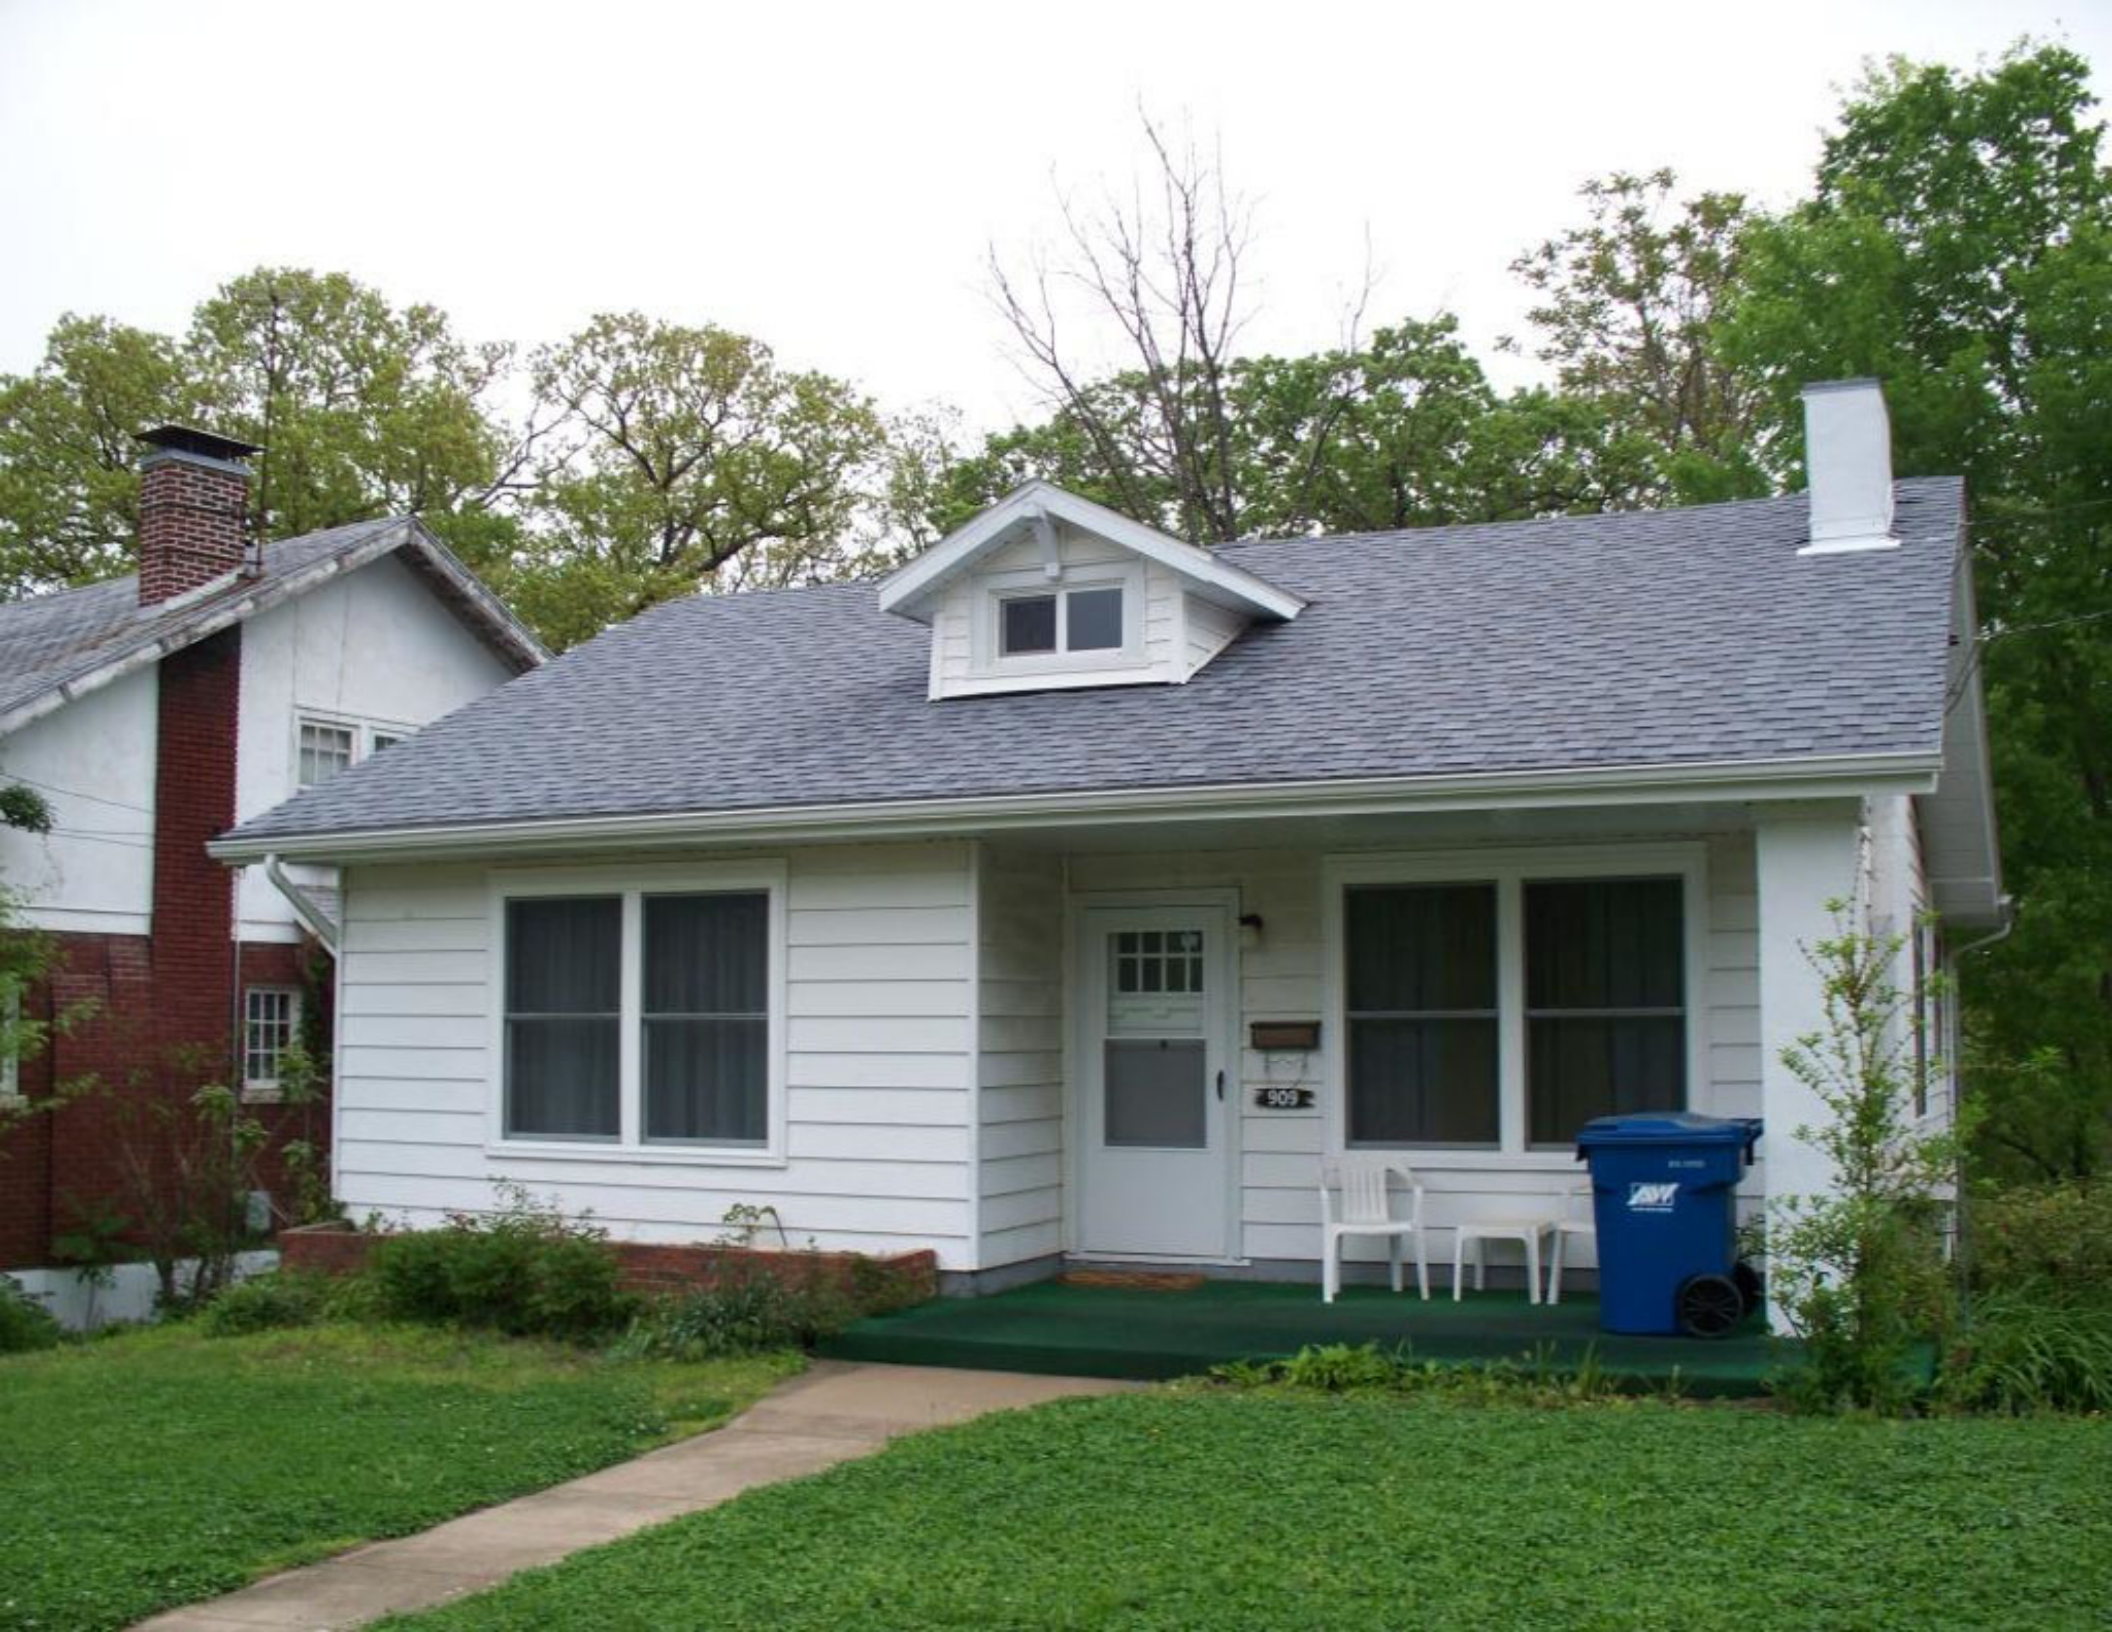
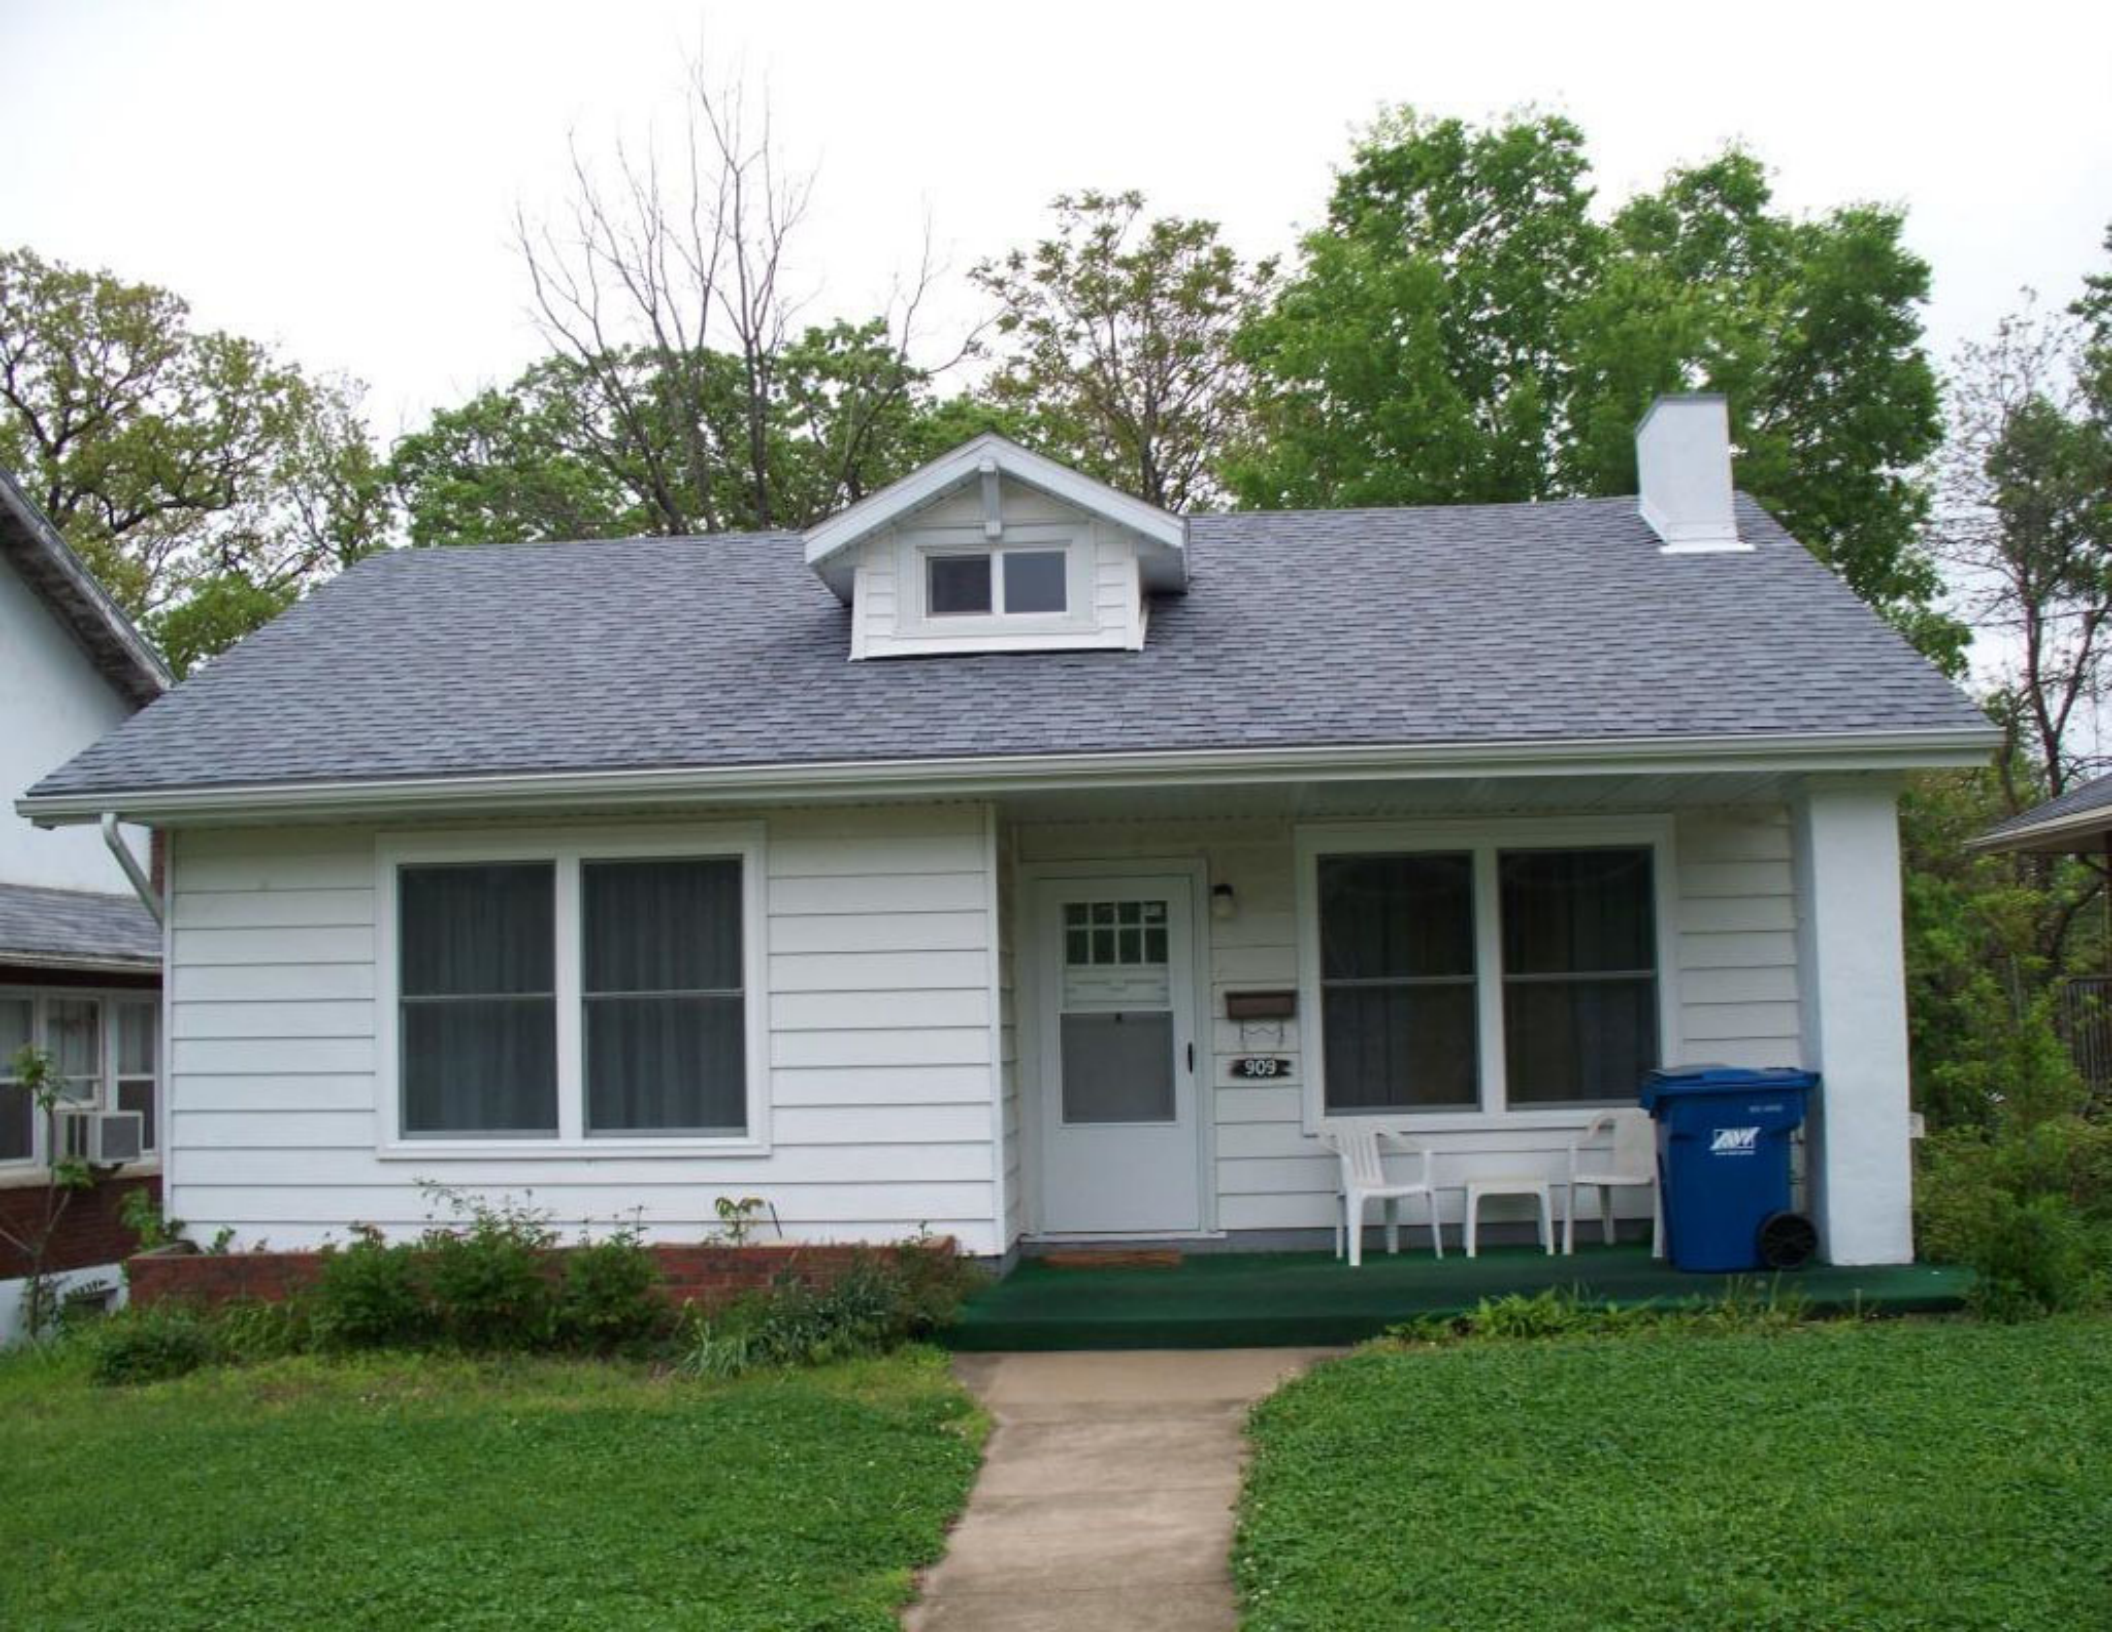
This 1 ½ story side gable roof has been clad in vinyl. There is a gabled dormer with bracket and two-paned fixed casement window. The left bay has paired 1/1 replacement windows. The center and right bay are recessed and contain a door and paired 1/1 replacement windows. Because of the vinyl siding and replacement windows the property does not have sufficient integrity to be contributing to the district.
