ARCHITECTURAL/HISTORIC INVENTORY FORM

1. Survey No. CO-AS-005-001		2. Survey name: Moreau Drive Neighborhood Survey	
3. County: Cole		4. Address: 1202 Elmerine Ave.	
5. City: Jefferson City	Vicinity: <input type="checkbox"/>	6. UTM: / /	7. Township/Range/Section: T: R: S:
8. Historic name (if known):		9. Present/other name (if known):	
10. Ownership: <input checked="" type="checkbox"/> Private <input type="checkbox"/> Public		11. Historic use (if known): Residential	11. Current use: Residential

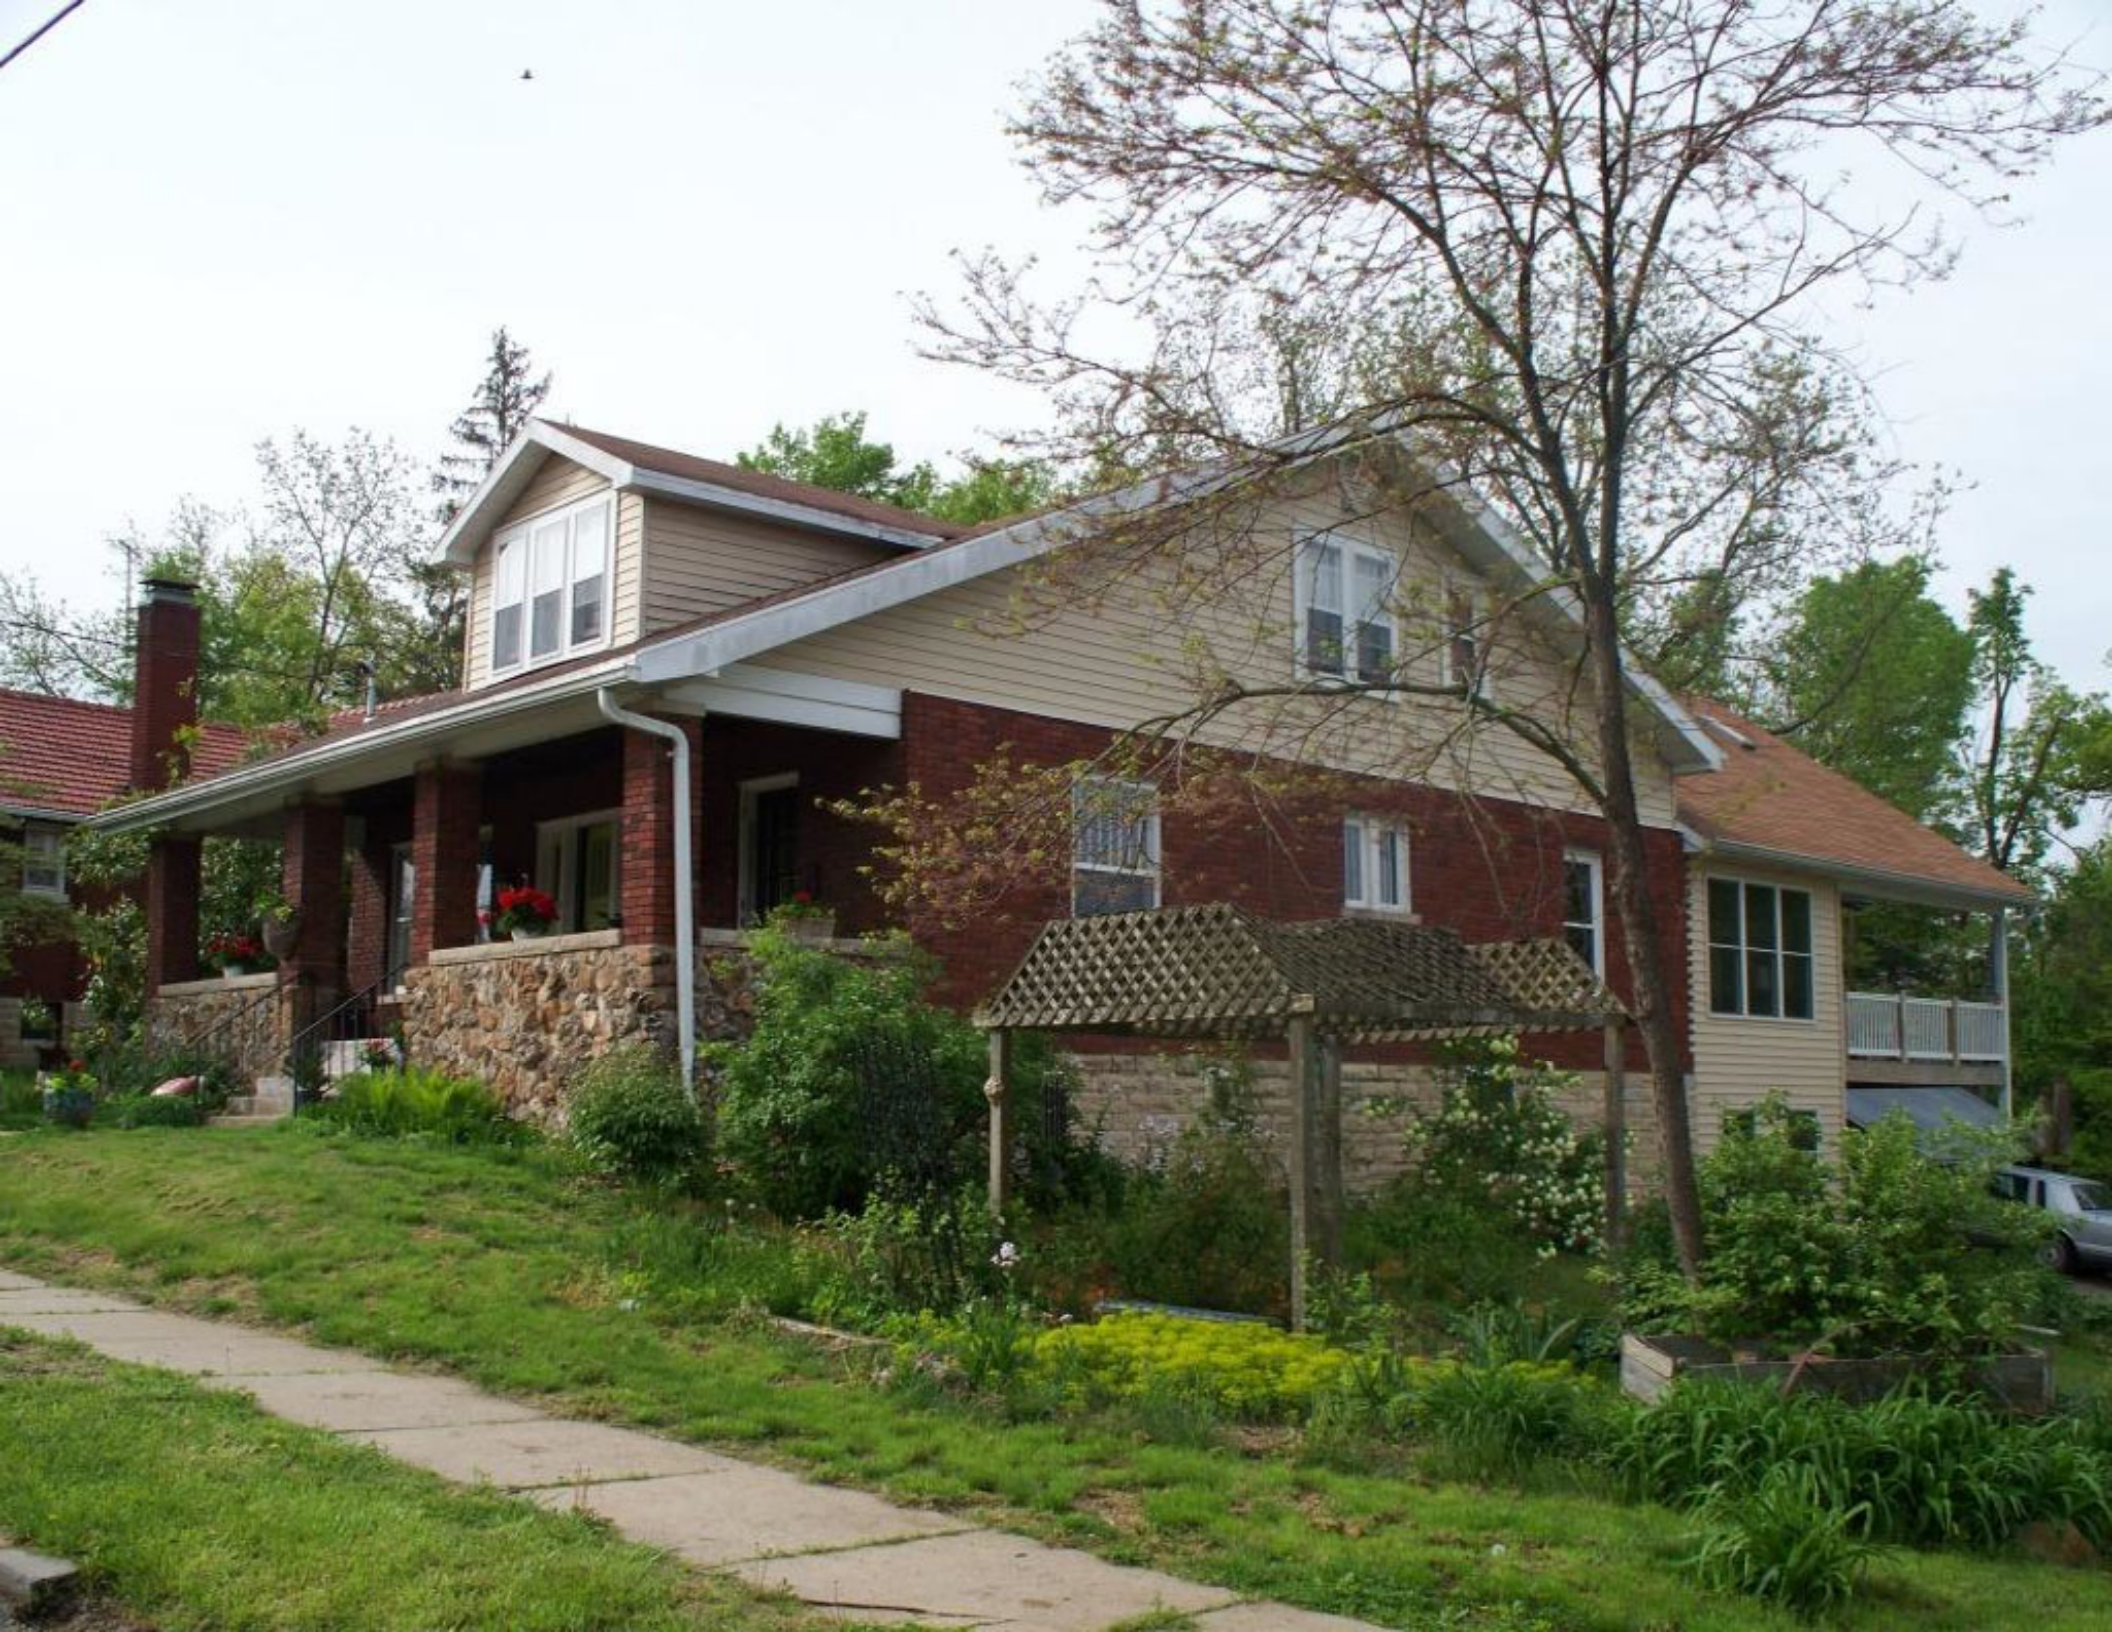
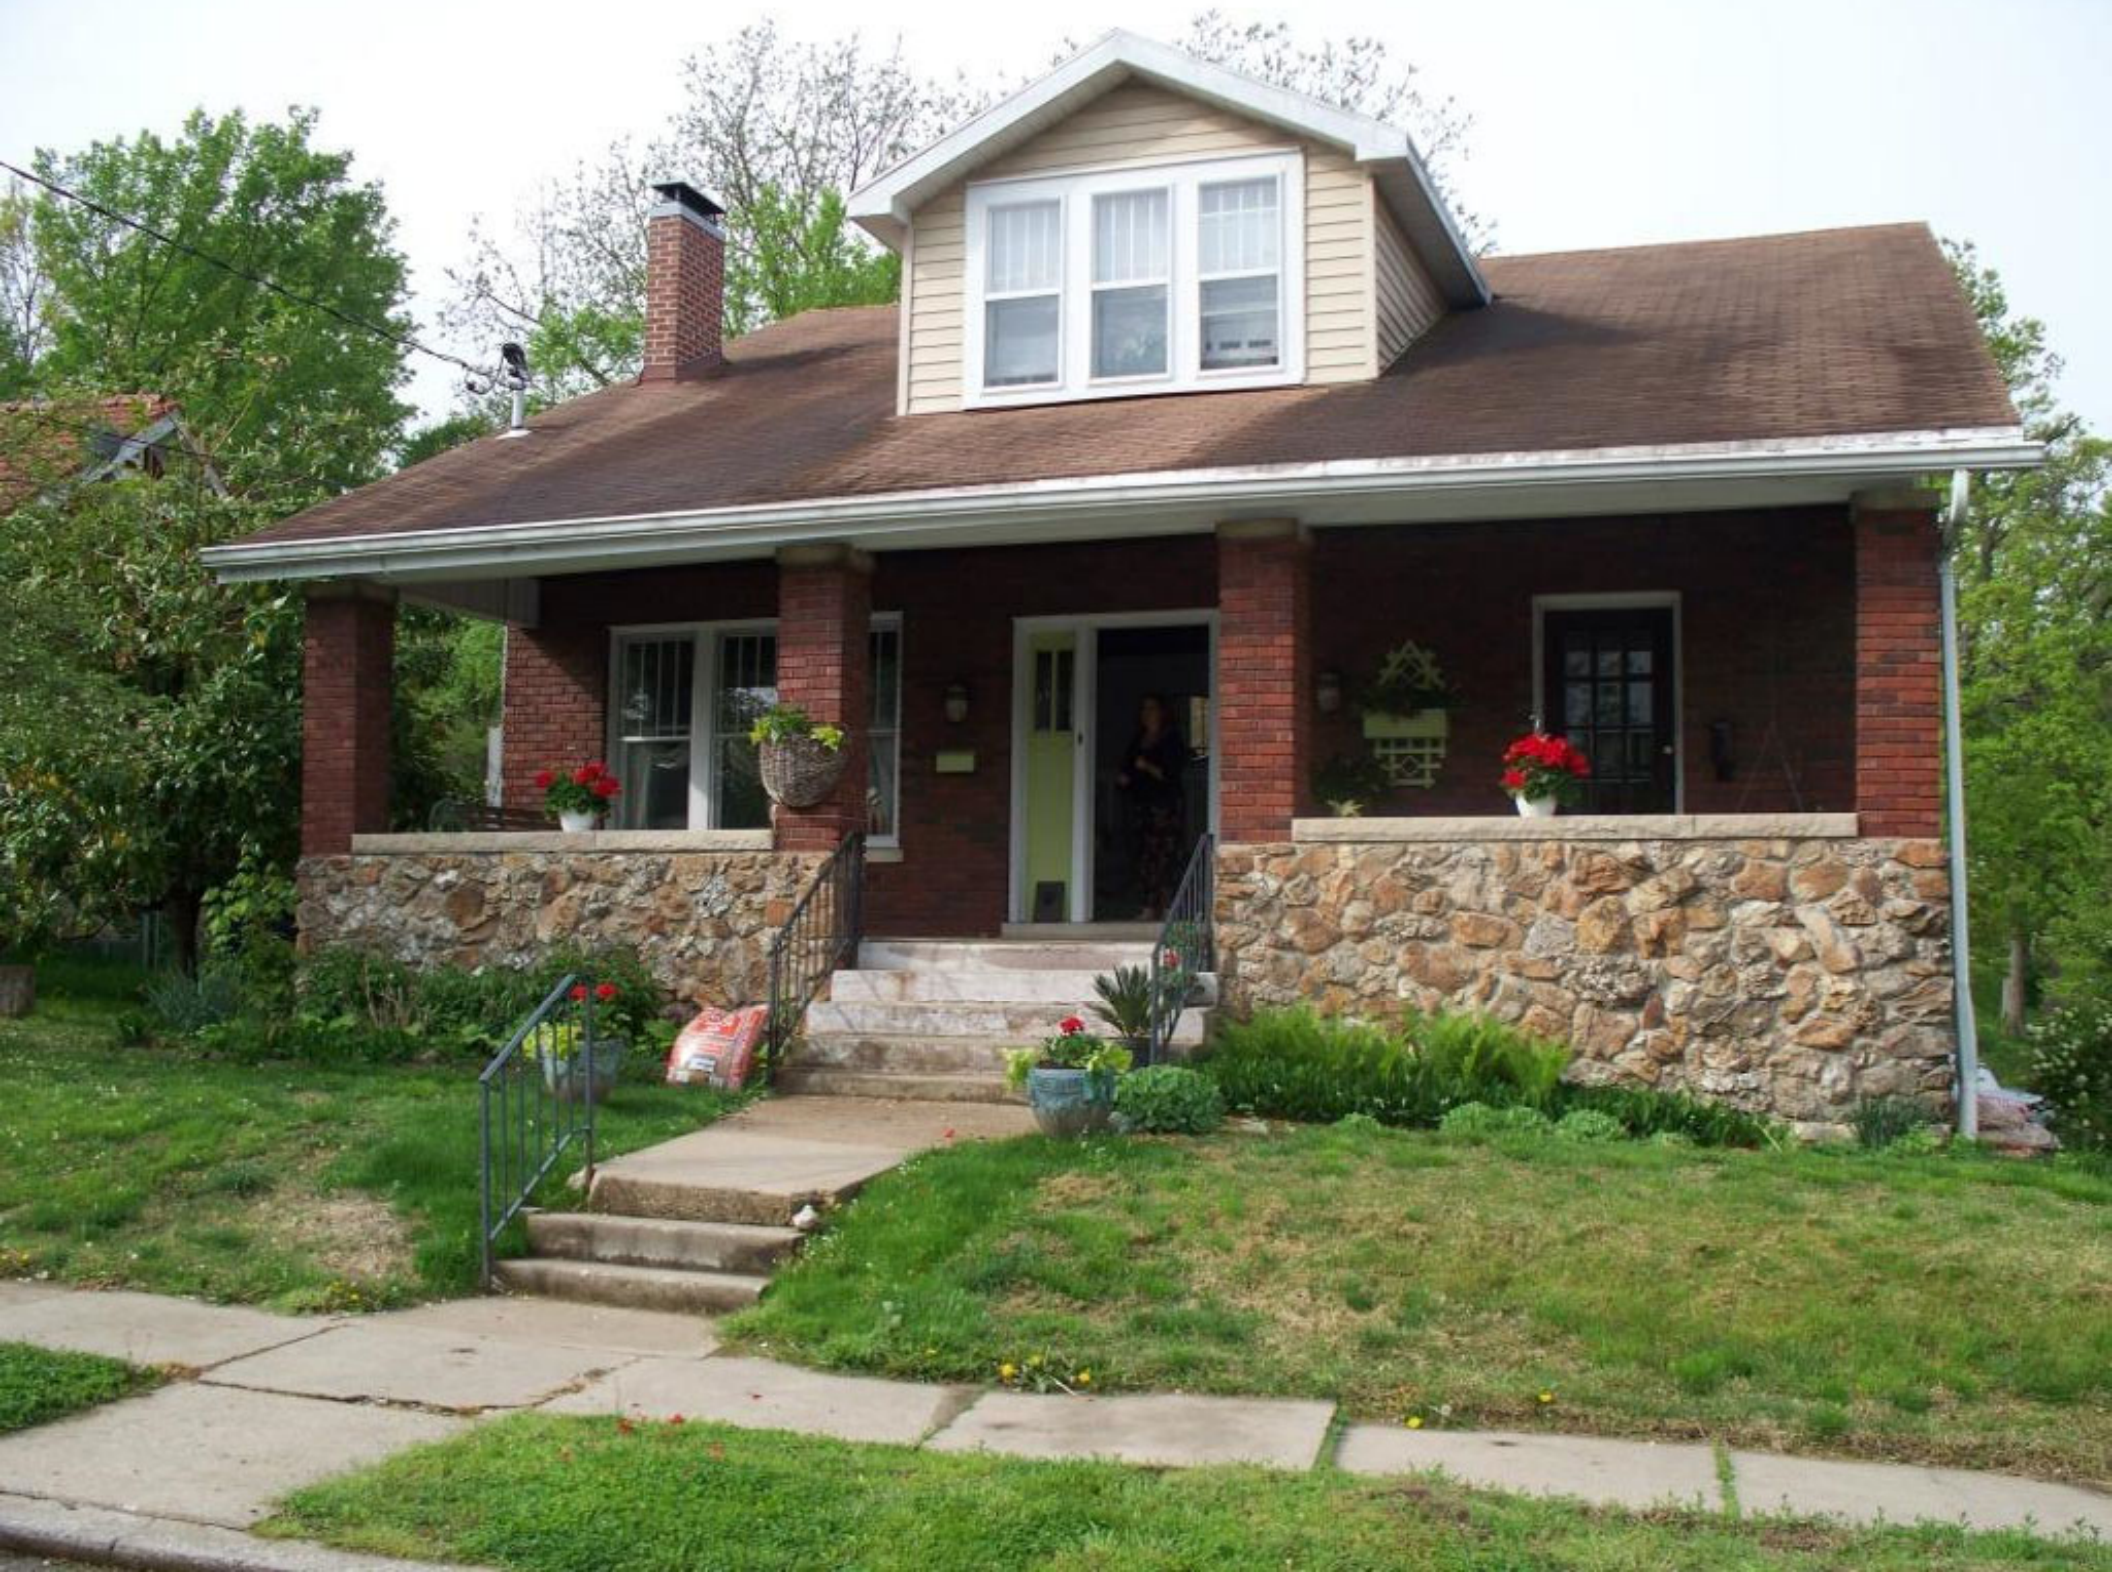
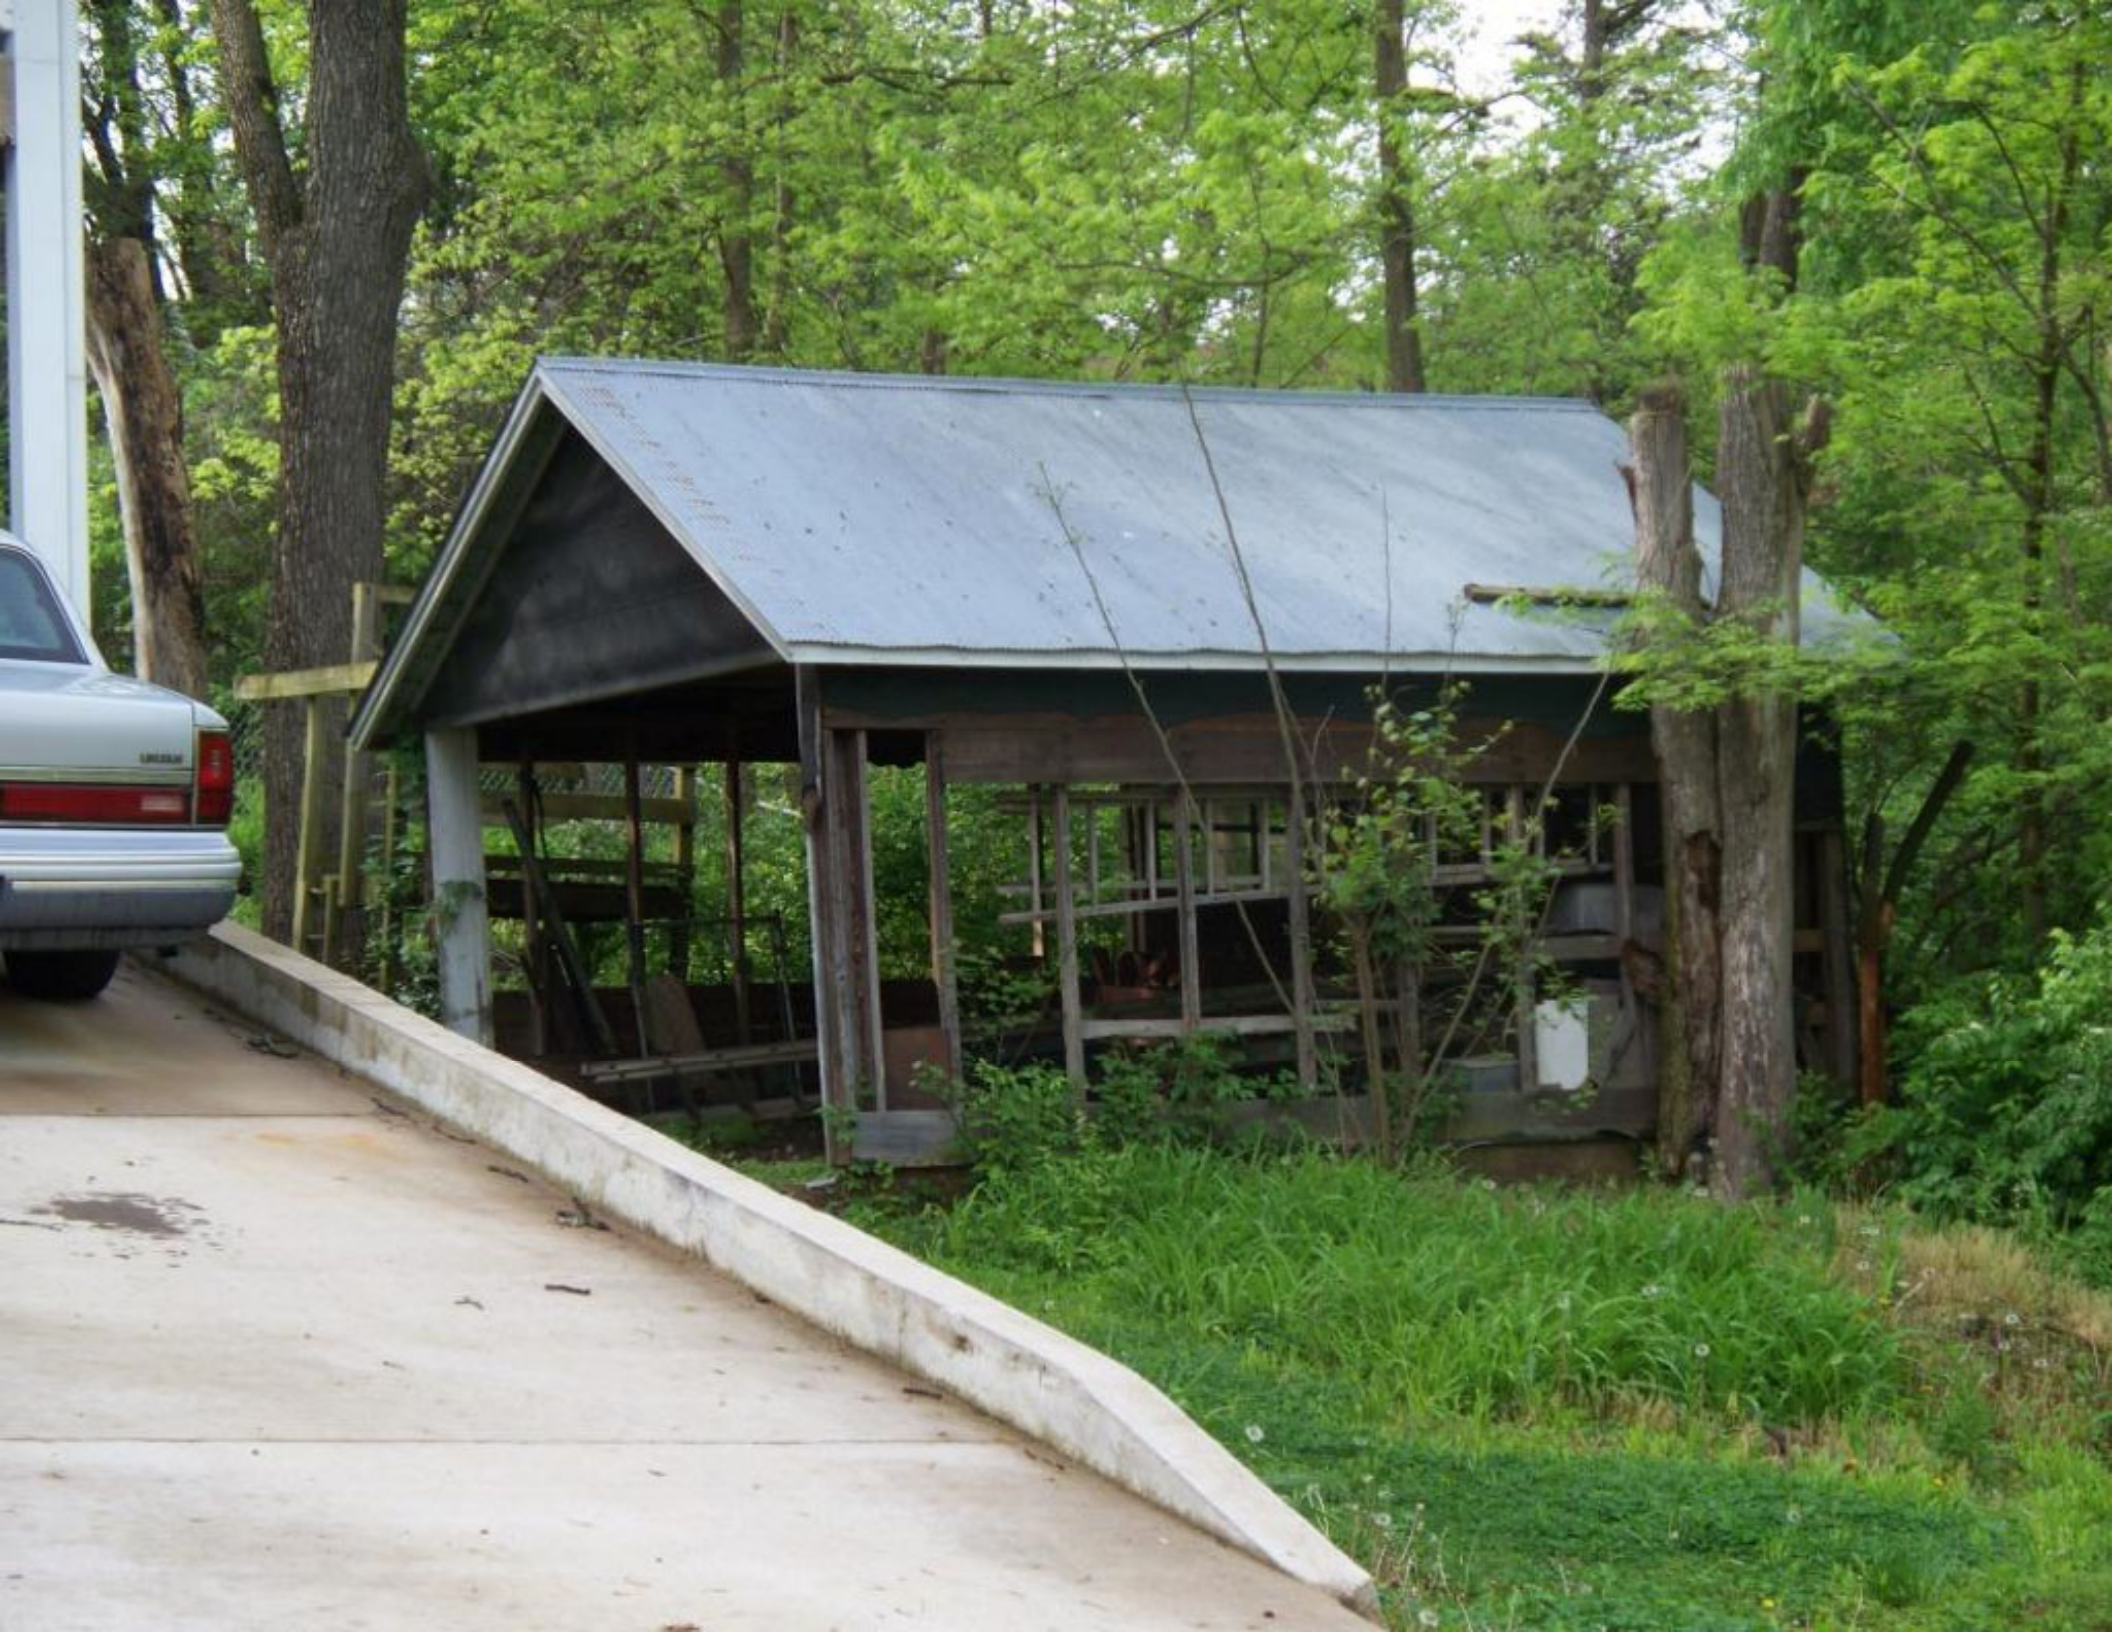
40. (cont.) Description of environment and outbuildings. Expand box as necessary, or add continuation pages.
There is an old wooden garage/shed that has a gable tin roof at the side of the house. It's in poor condition (walls are falling in) but as of the survey date would probably still contribute.

41. (cont.)
This 1 ½ story brick bungalow has a side gable roof with a central gabled dormer clad in vinyl with three historic 4/1 windows. On the first floor the left bay has three historic 4/1 windows. The center bay contains the entrance, which appears to retain its original door and sidelights. The right bay contains a secondary entrance with a multi-light door. This property has a full width porch with brick piers and rubble stone walls.

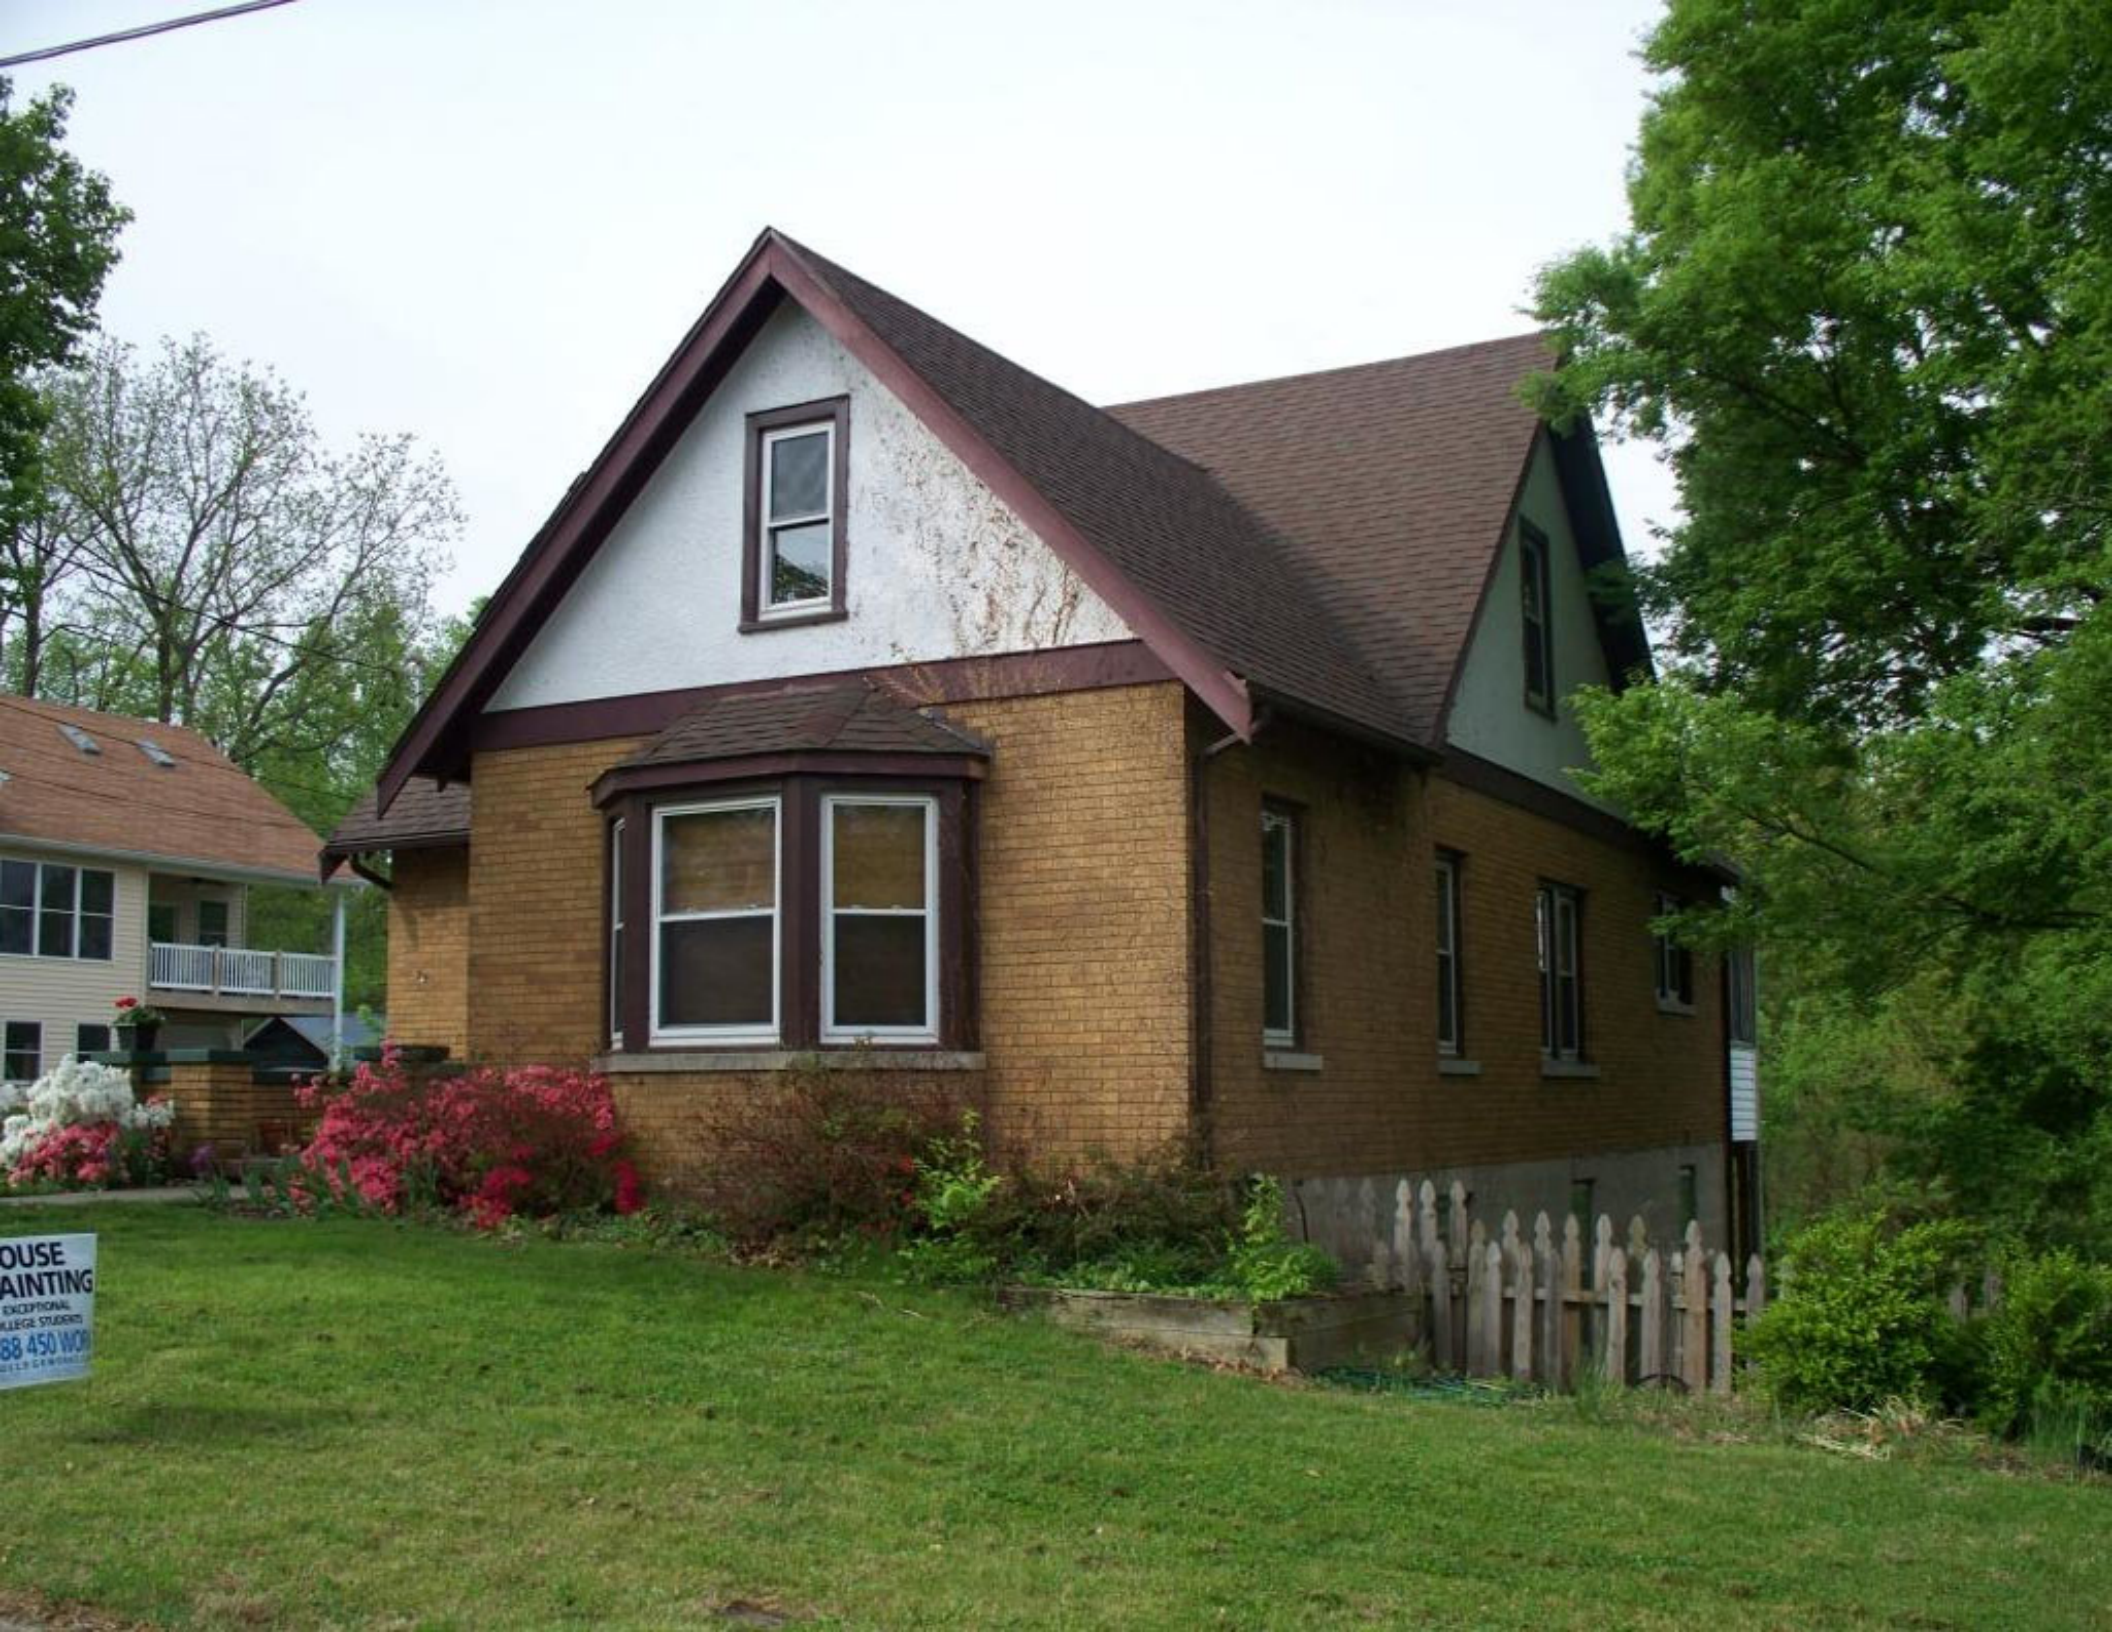
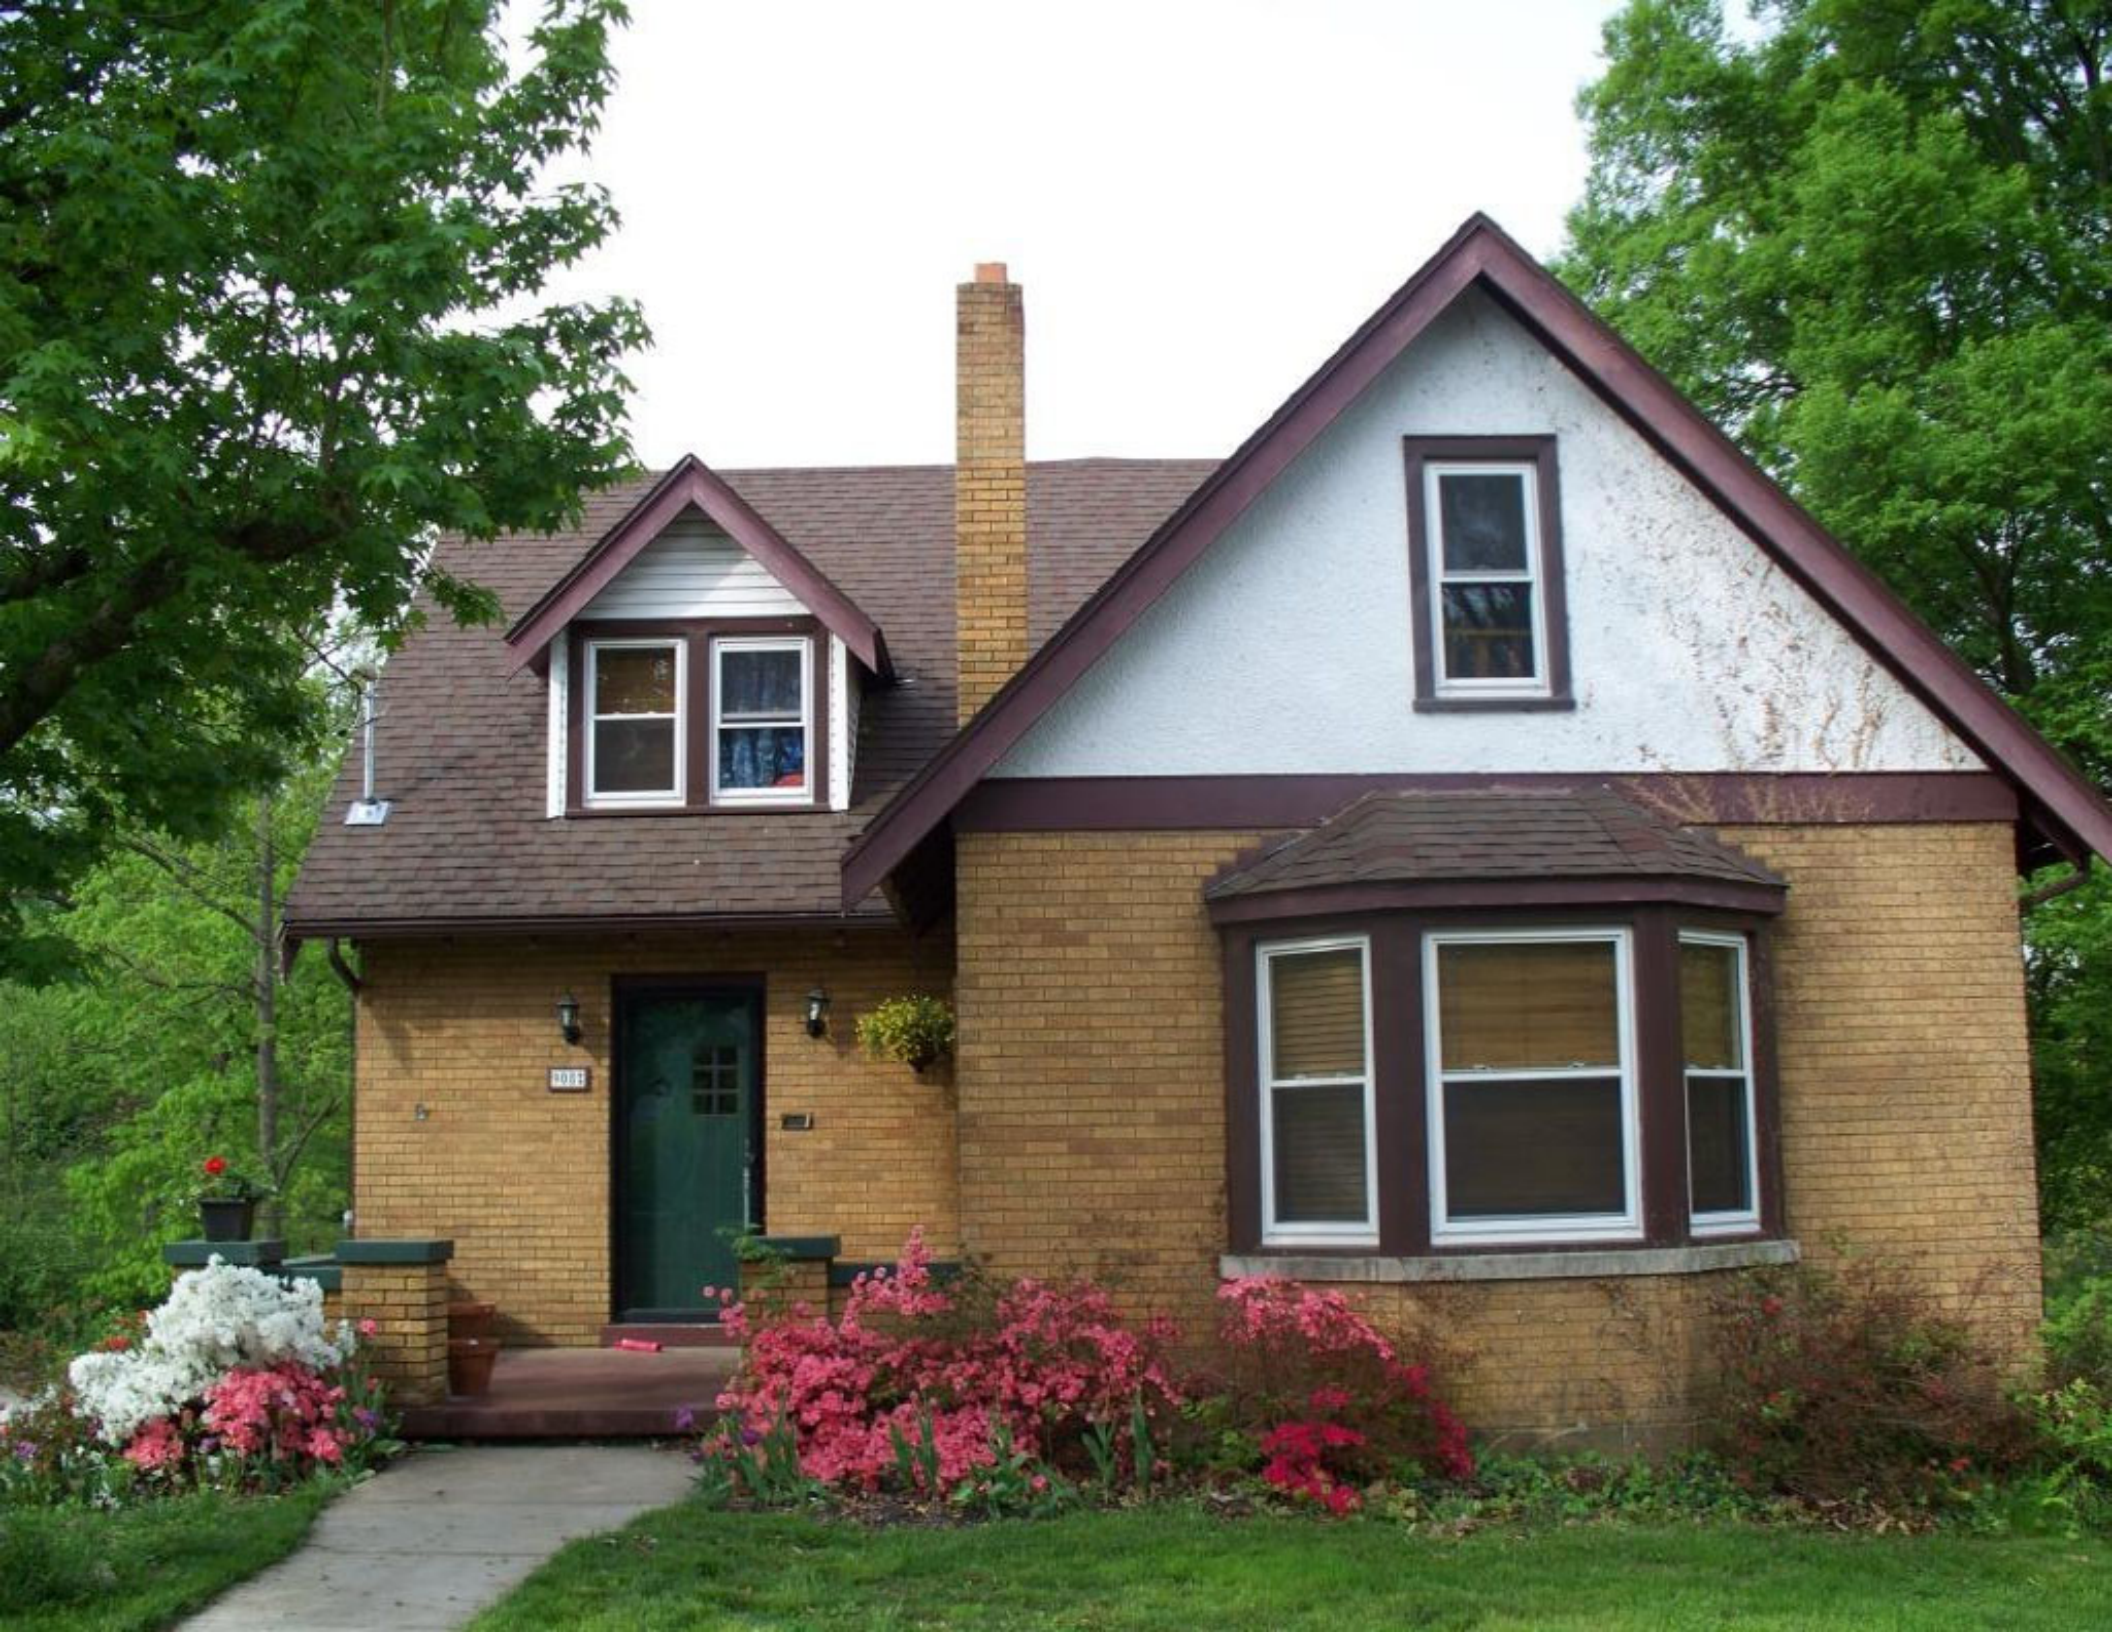
This 1 ½ story brick Tudor has a cross gable roof and a gable dormer clad in vinyl in the left side (side gable portion) of the home with two 1/1 replacement windows. Beneath this is the entrance, which appears to retain its wooden door with multi-lights at the top. This bay also contains a platform porch with brick piers and half walls. The right bay has a large gable roof that is clad in stucco and contains a 1/1 replacement window. Below this is a bay window with a hipped roof and three 1/1 windows. The chimney extends from the left side of this bay.
