ARCHITECTURAL/HISTORIC INVENTORY FORM

1. Survey No. CO-AS-005-001		2. Survey name: Moreau Drive Neighborhood Survey	
3. County: Cole		4. Address: 1202 Elmerine Ave.	
5. City: Jefferson City	Vicinity: <input type="checkbox"/>	6. UTM: / /	7. Township/Range/Section: T: R: S:
8. Historic name (if known):		9. Present/other name (if known):	
10. Ownership: <input checked="" type="checkbox"/> Private <input type="checkbox"/> Public		11. Historic use (if known): Residential	11. Current use: Residential

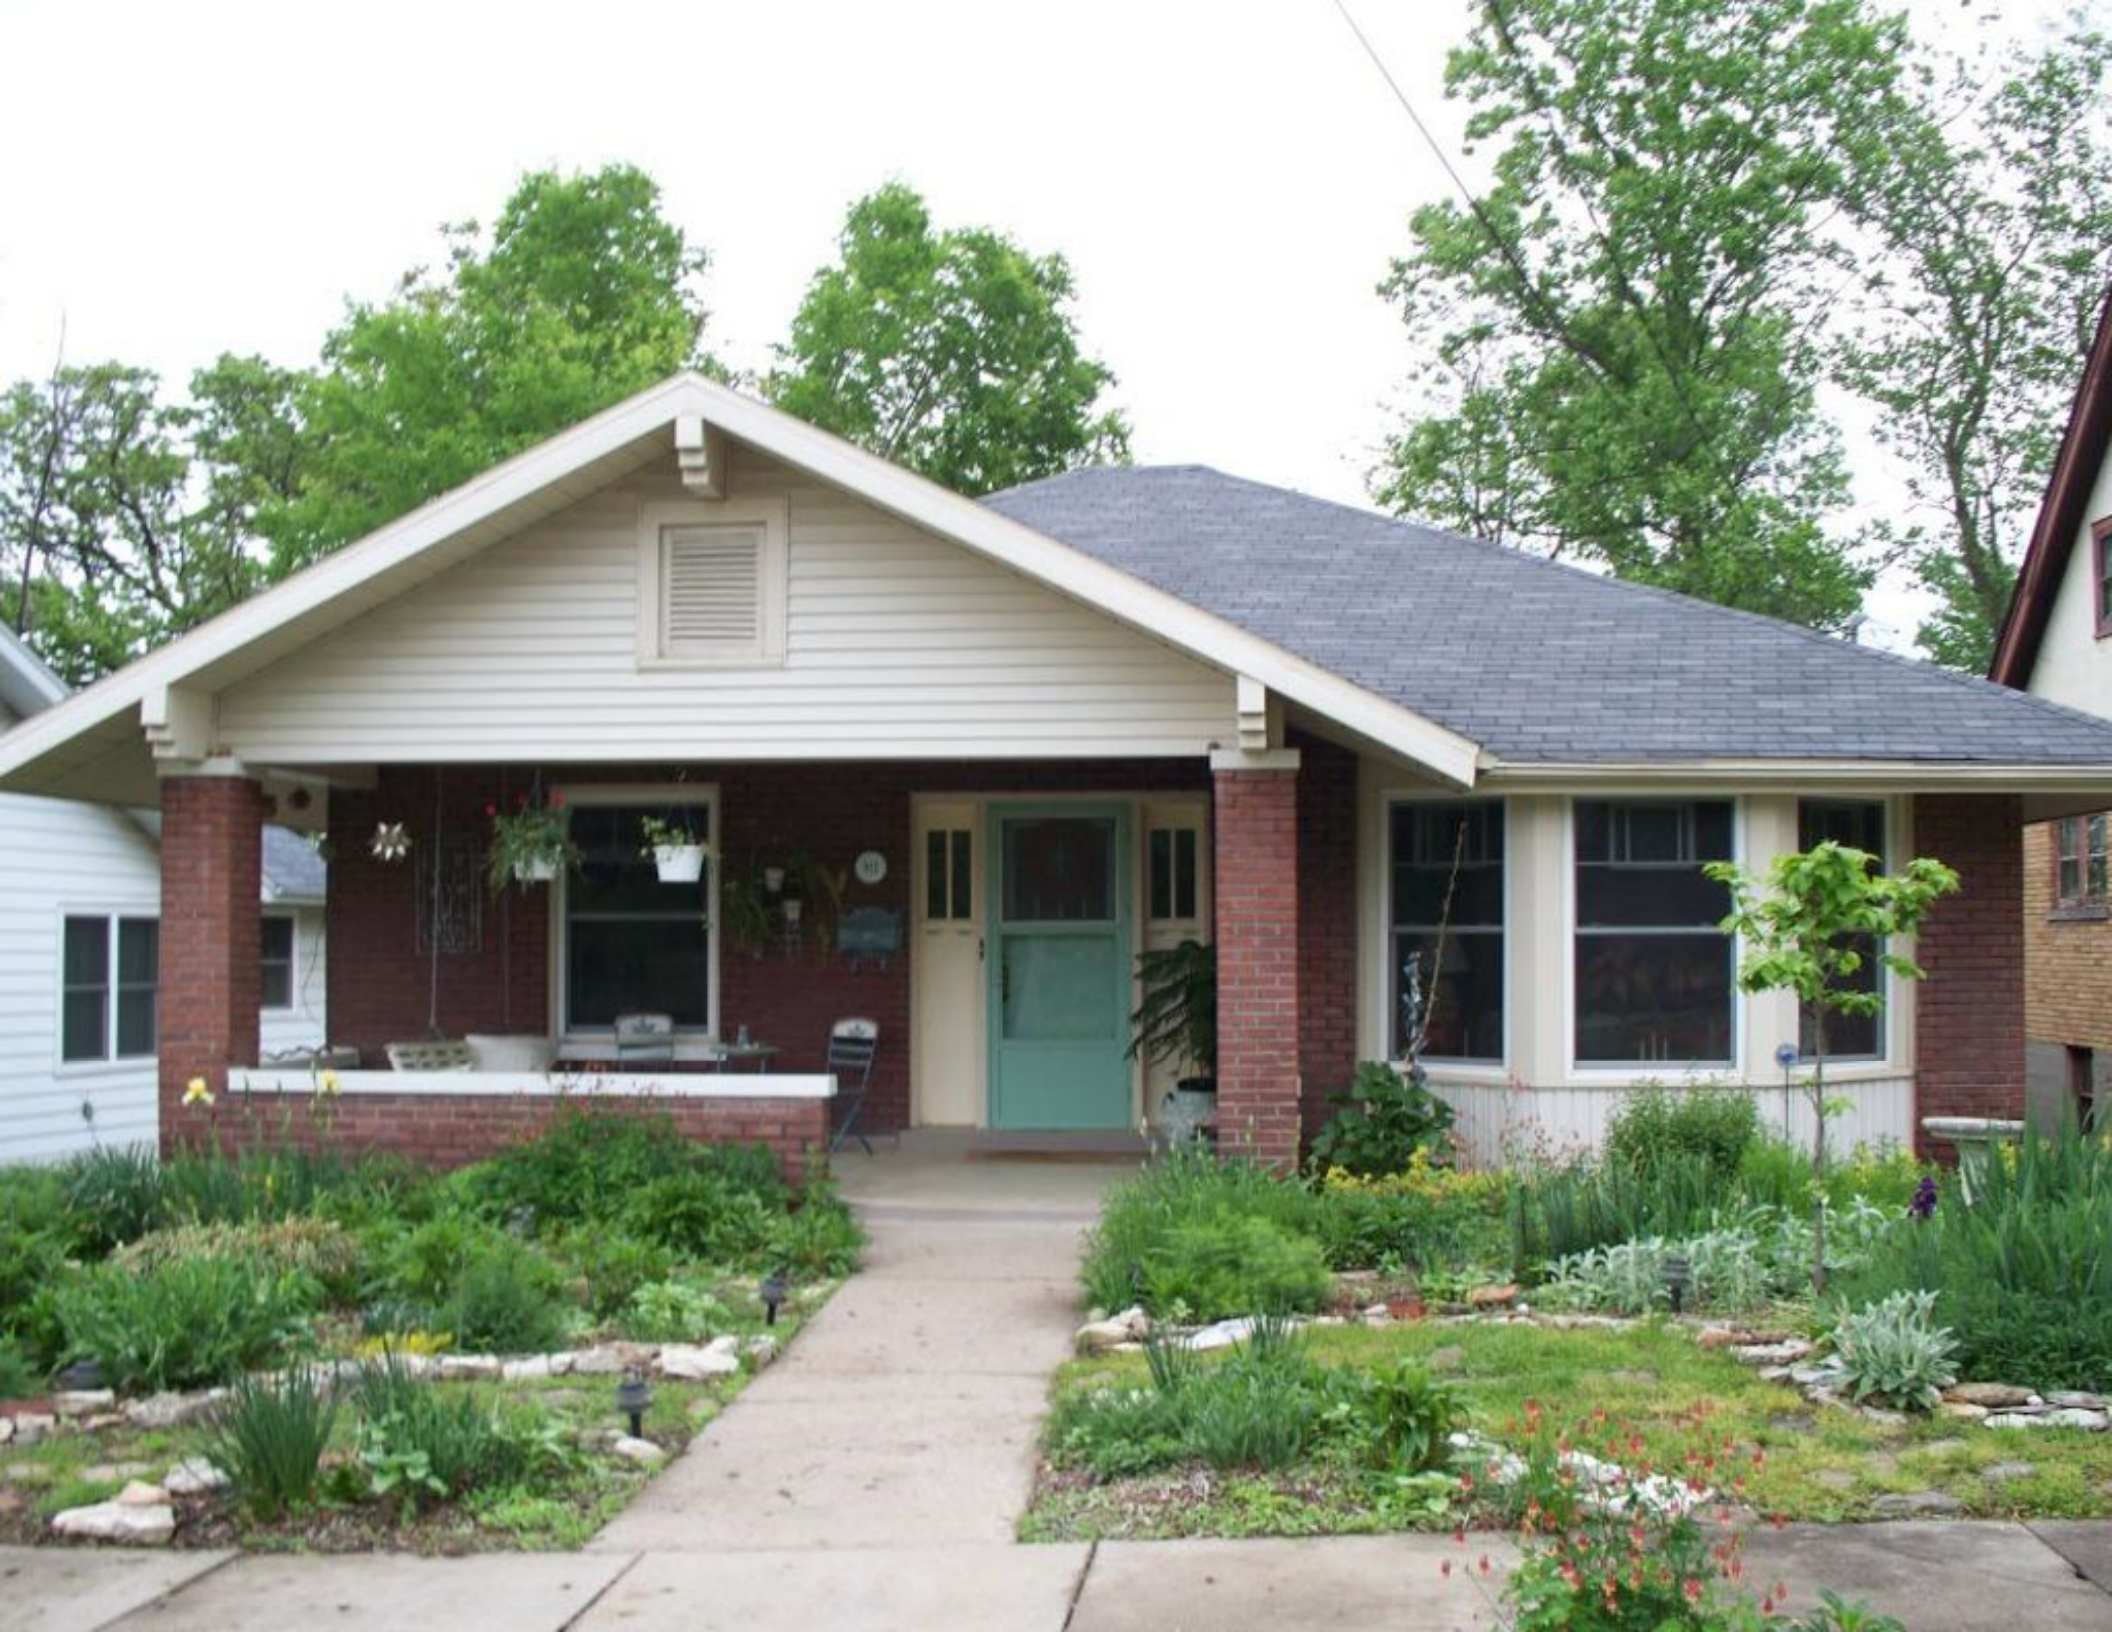
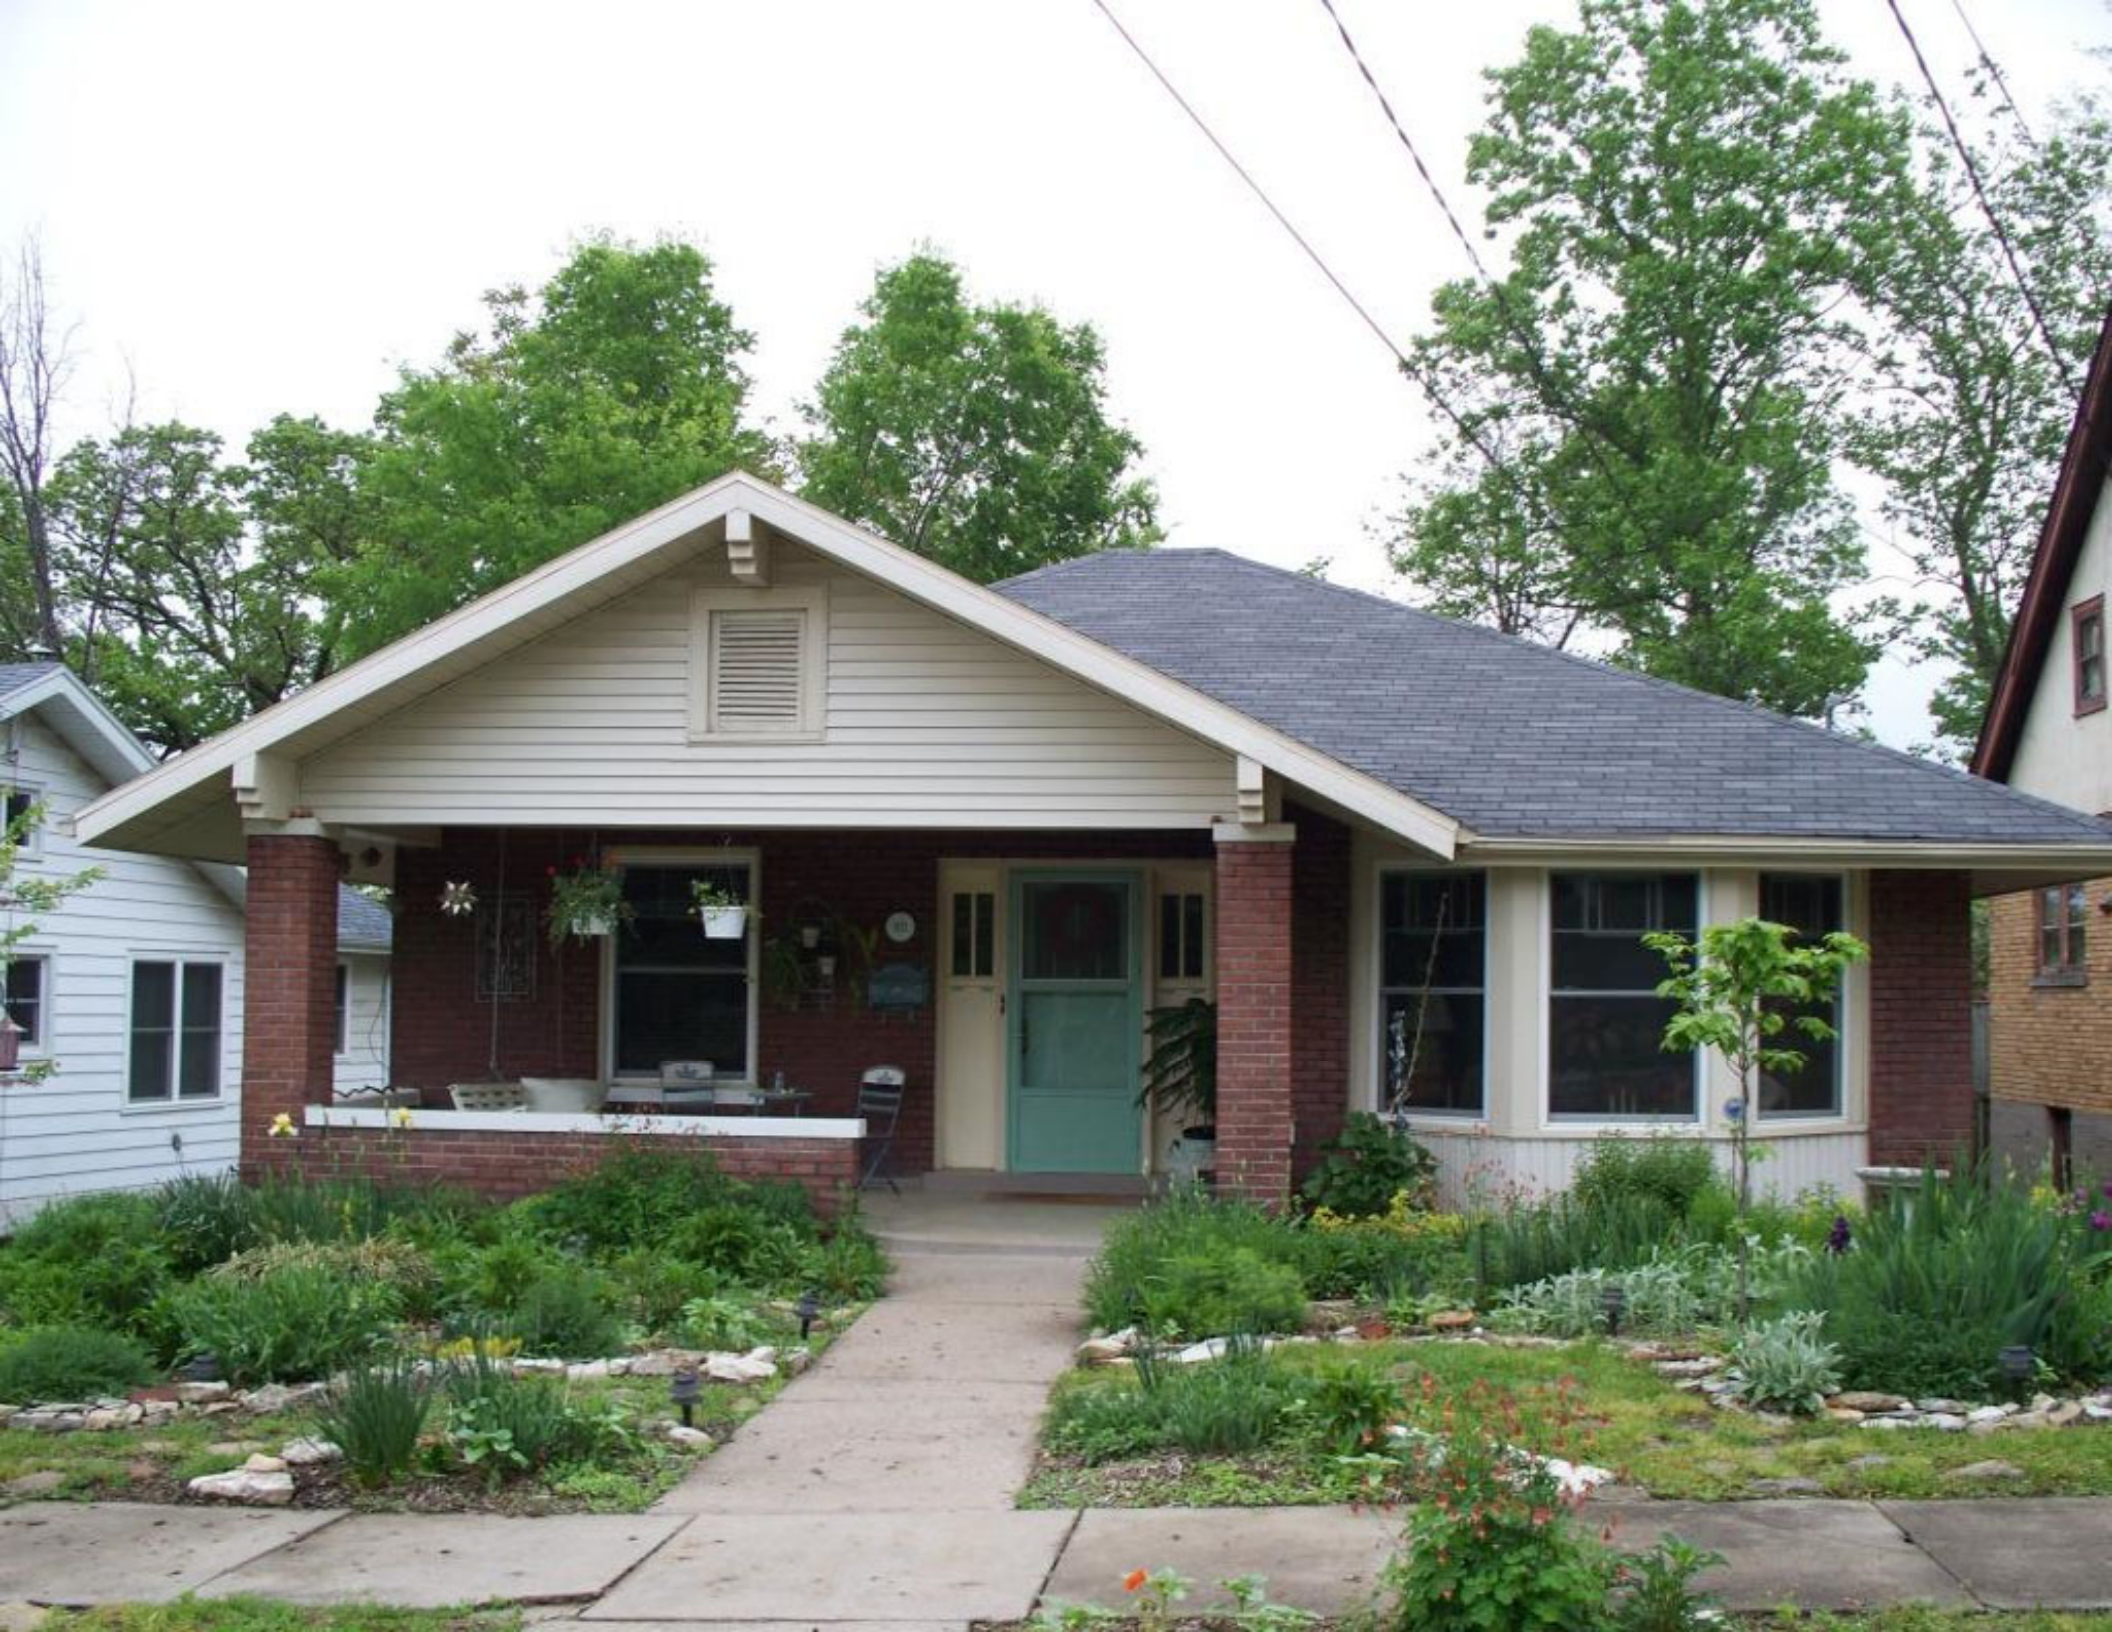
This one story brick bungalow has a hipped roof with a large gable porch roof on the left half of the property. The gable end is clad in vinyl and has jigsaw brackets and a vent in the peak. The porch consists of brick piers and half-walls capped in concrete. The porch covers the left and center bay and contains a 1/1 window and a four-light door with sidelights that appear historic. The right bay has what appears to be a non-historic bay window clad in synthetic siding with three replacement windows.

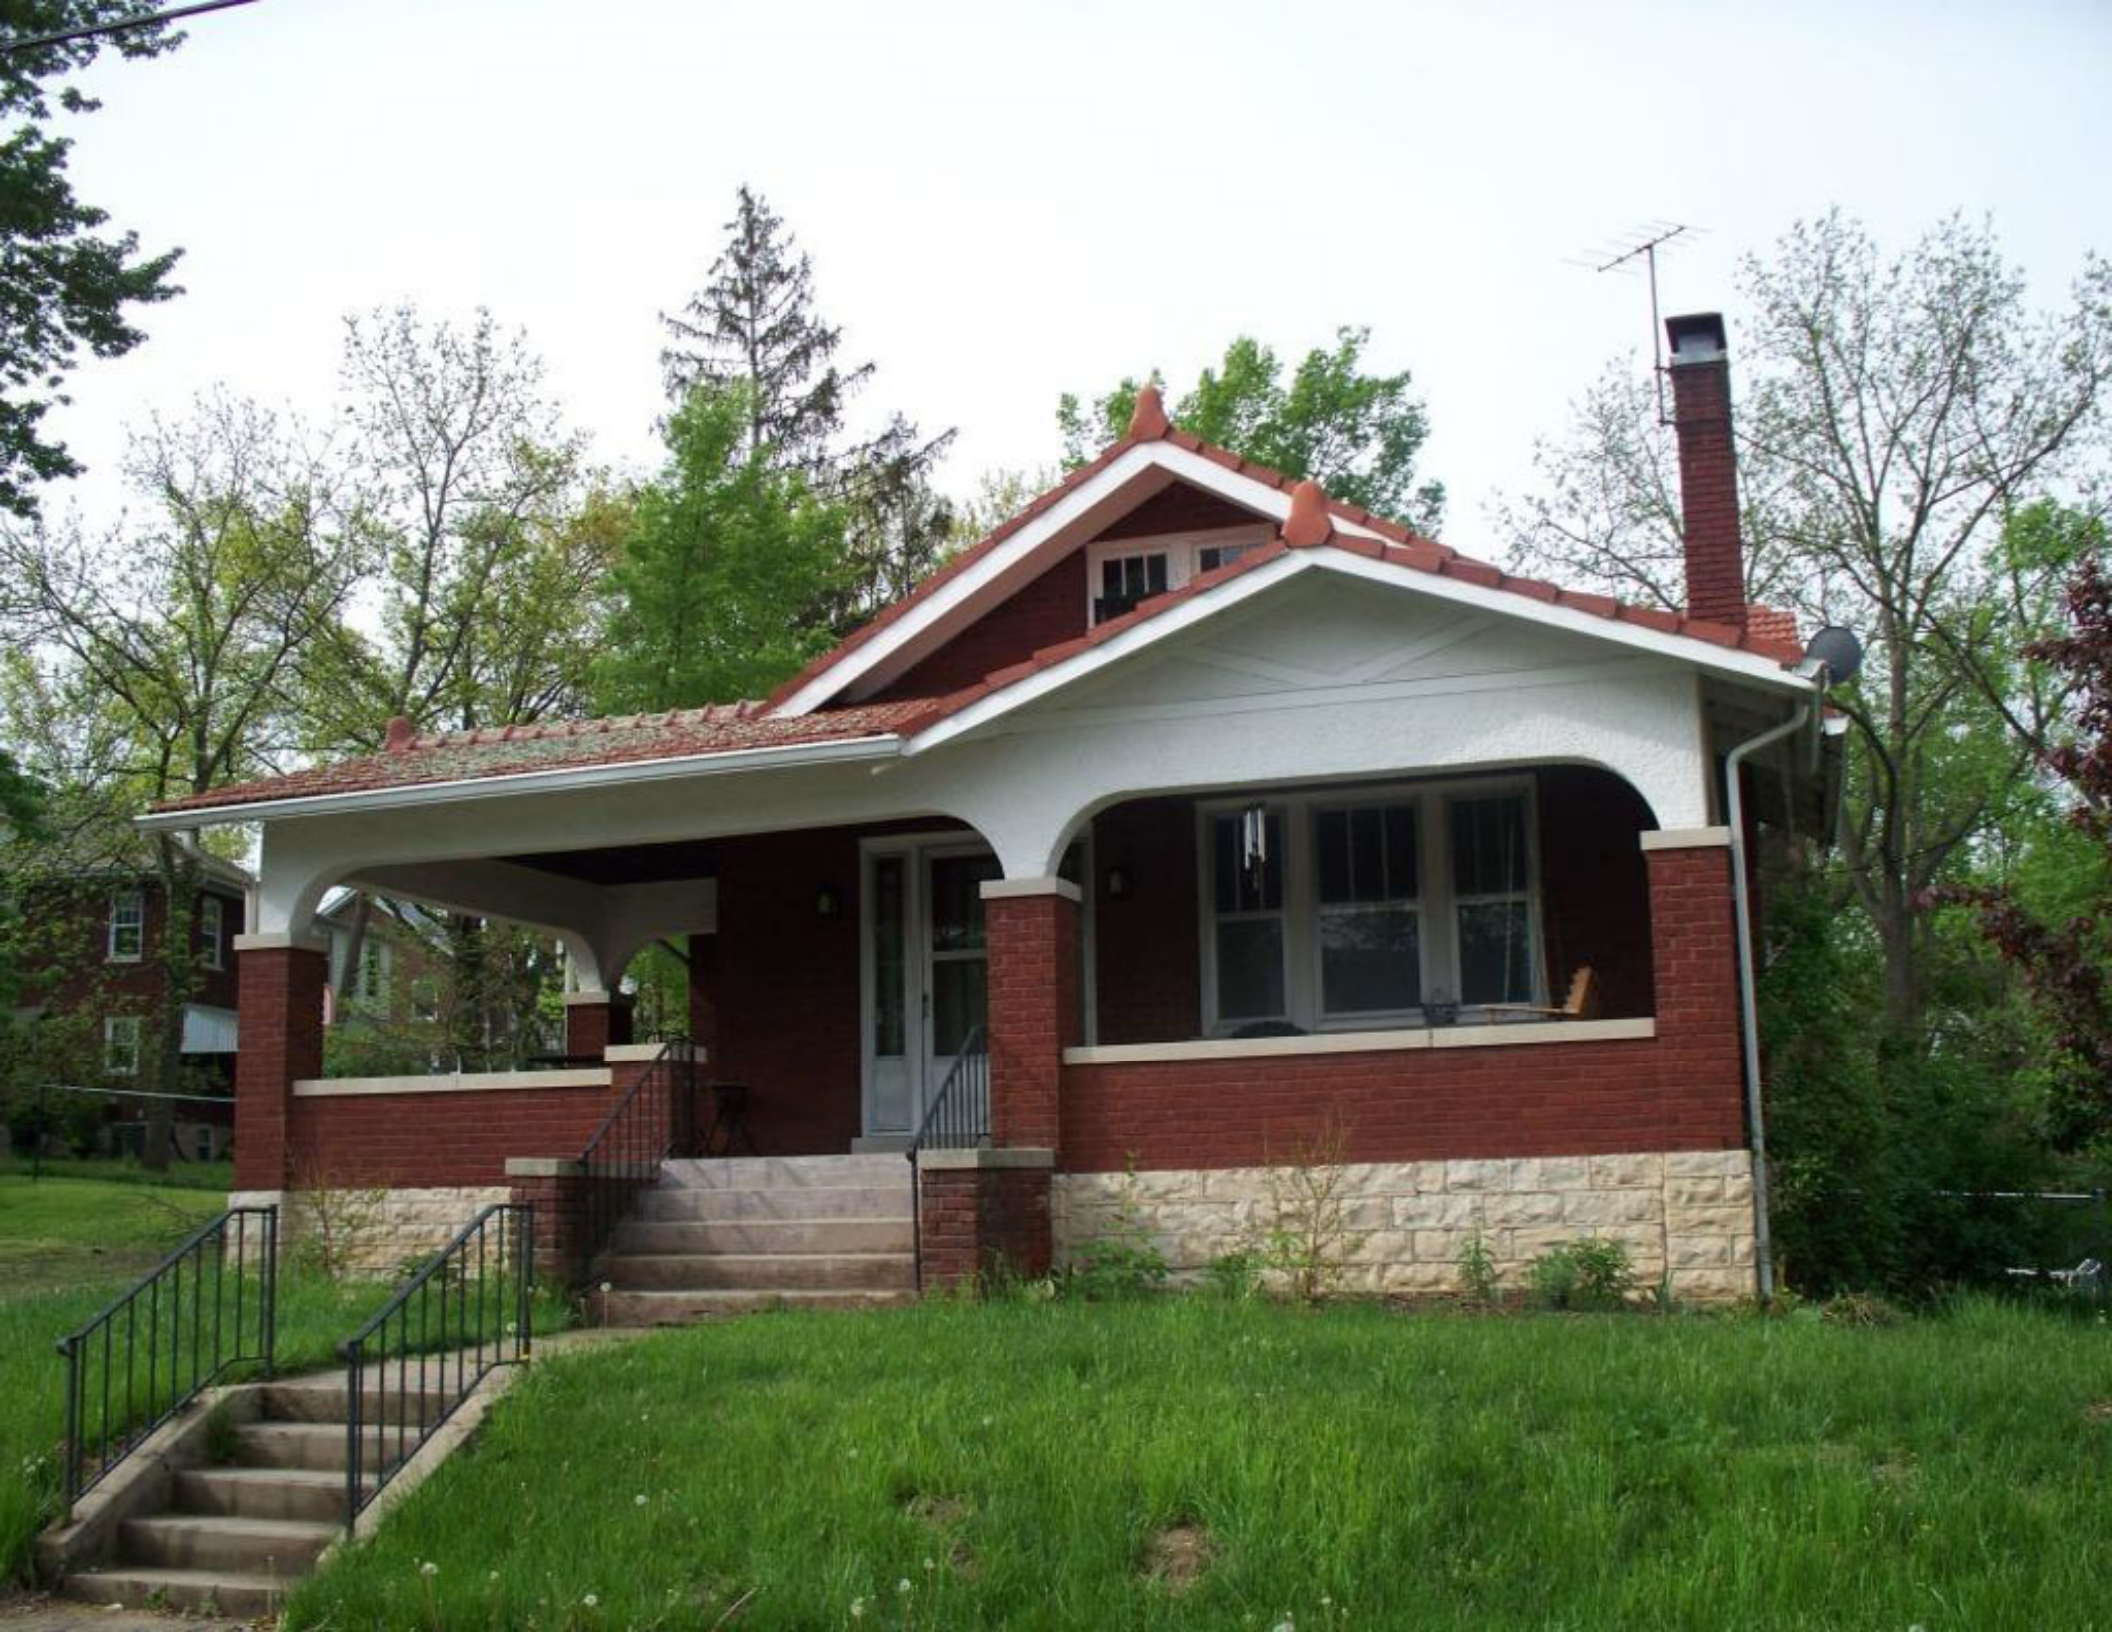
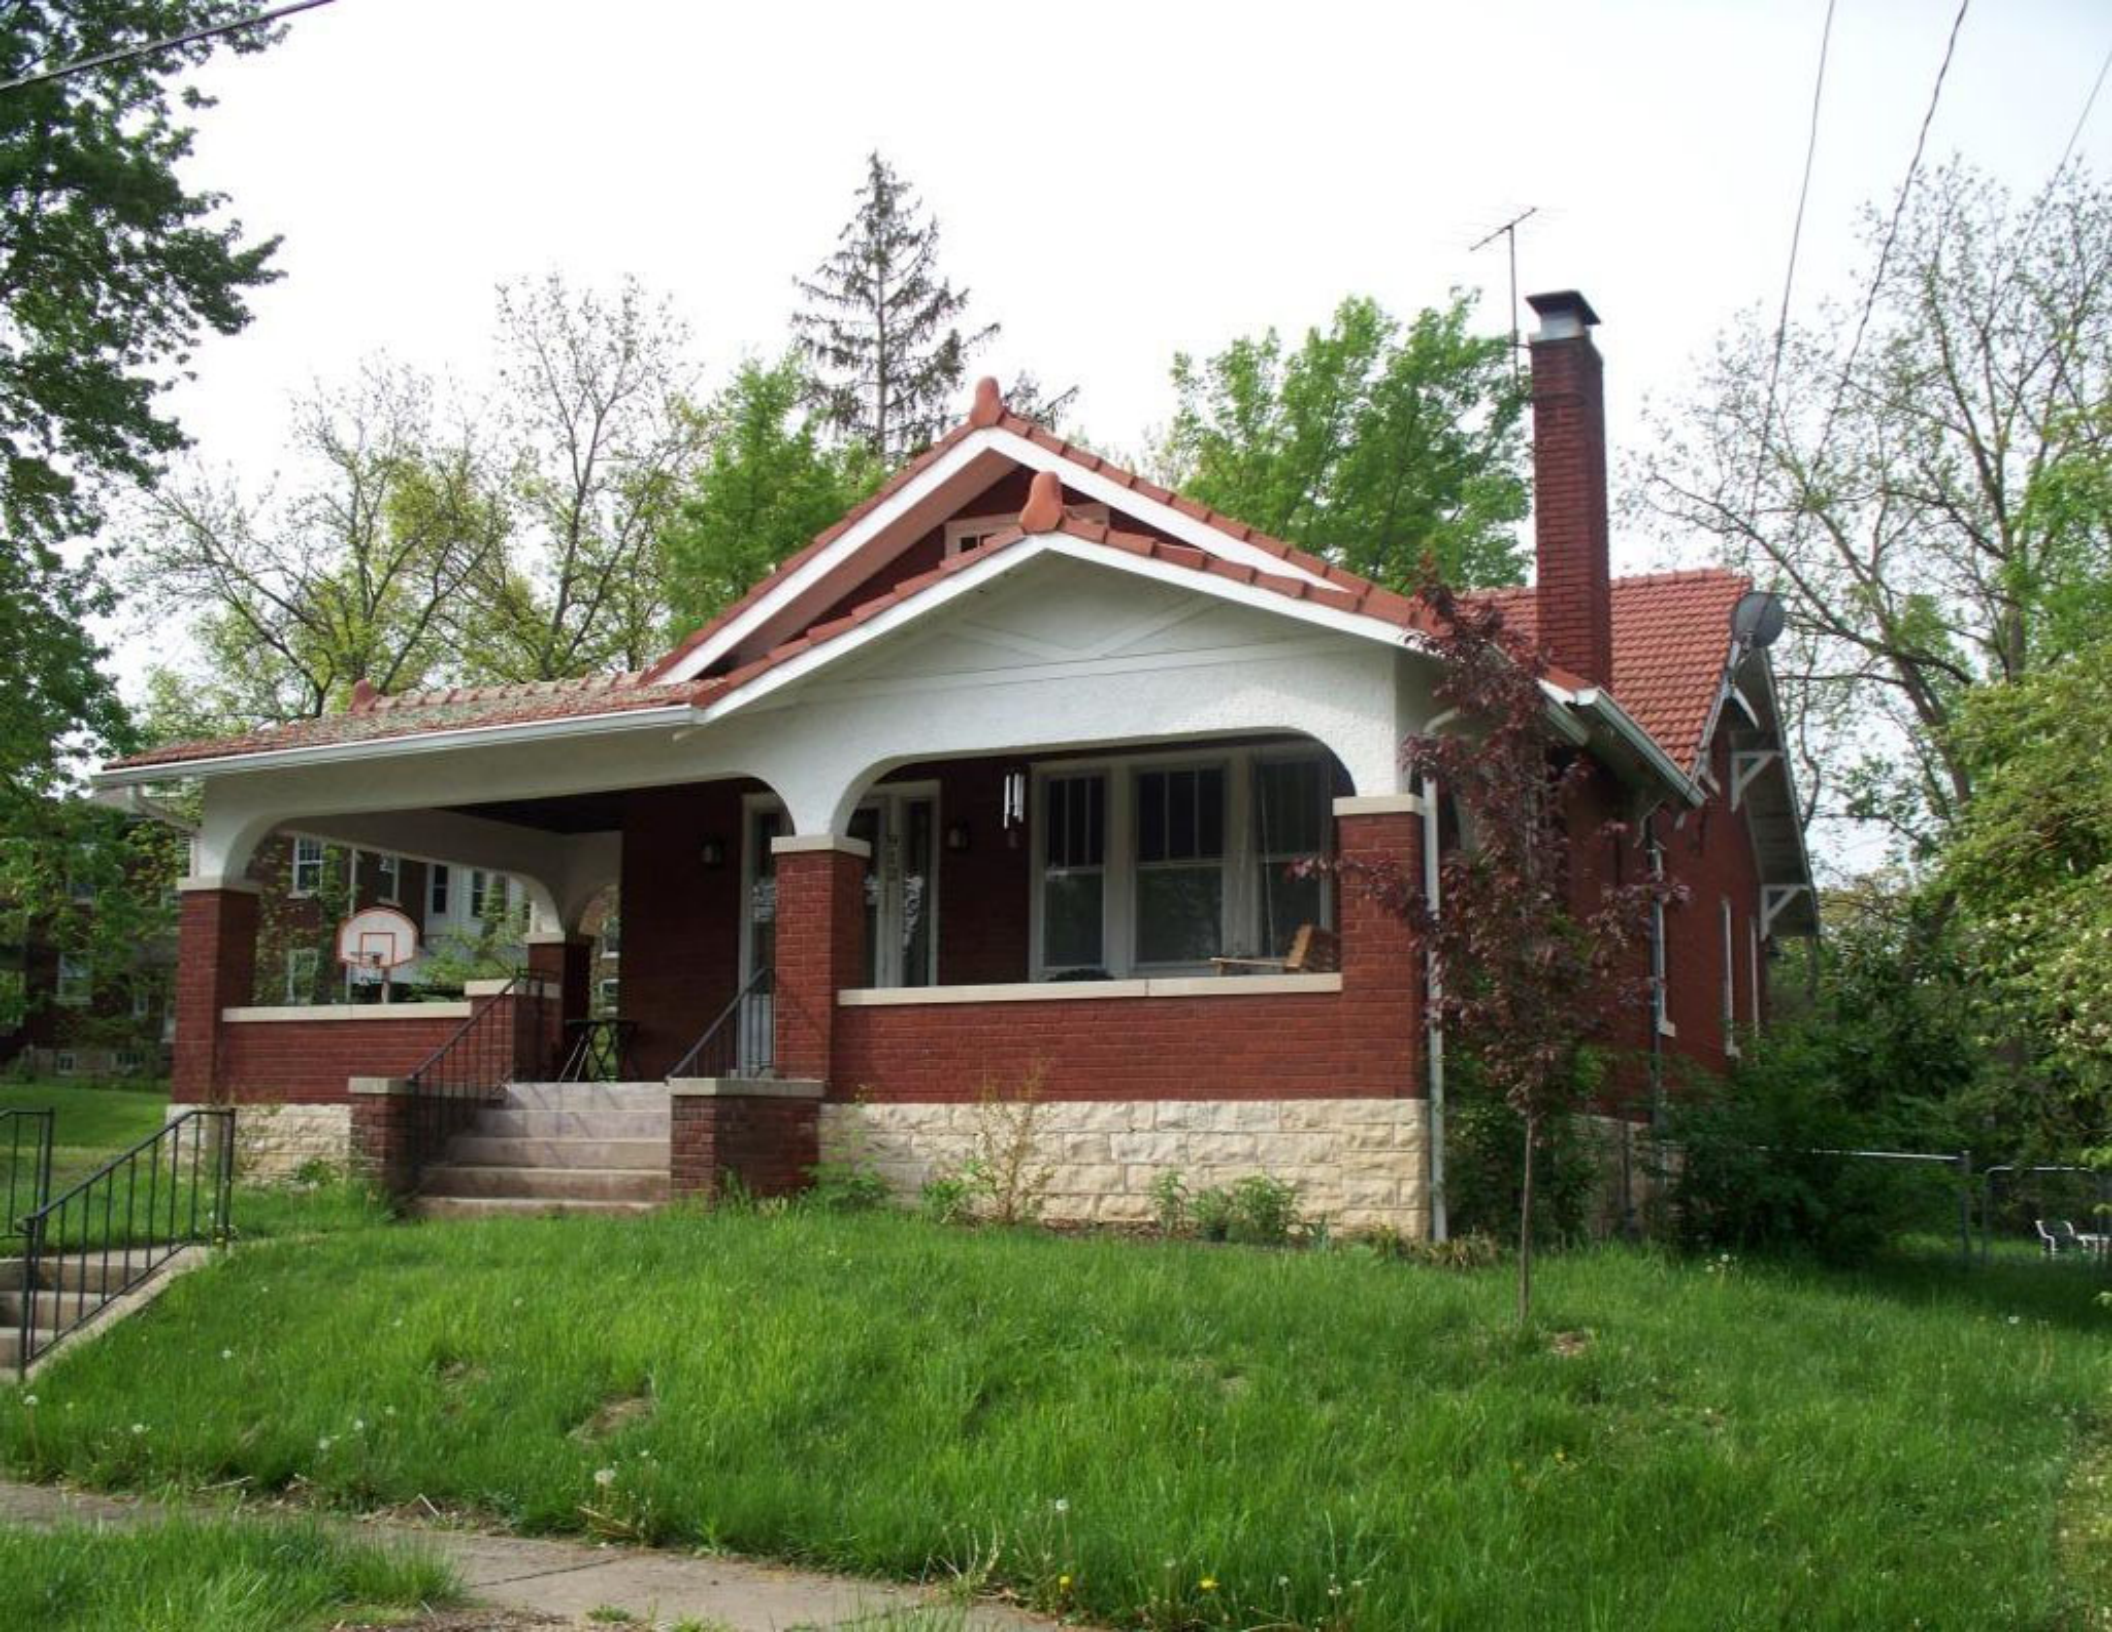
This 1 ½ story brick bungalow has a cross gable red tile roof. The front gable has paired 3/1 historic windows. This portion is divided by the porch roof, which is also clad in tile and has a gable clad in stucco and half timbering over the right bay but extends and wraps around the left side of the property. The gables are capped with tile finials. The left bay contains the entrance, which appears to retain its original wooden door and sidelights. The right bay has a tri-part historic window (3/1 flanking 4/1). The porch consists of brick piers and half walls capped in limestone or concrete. The lower half of the walls are clad in stone.

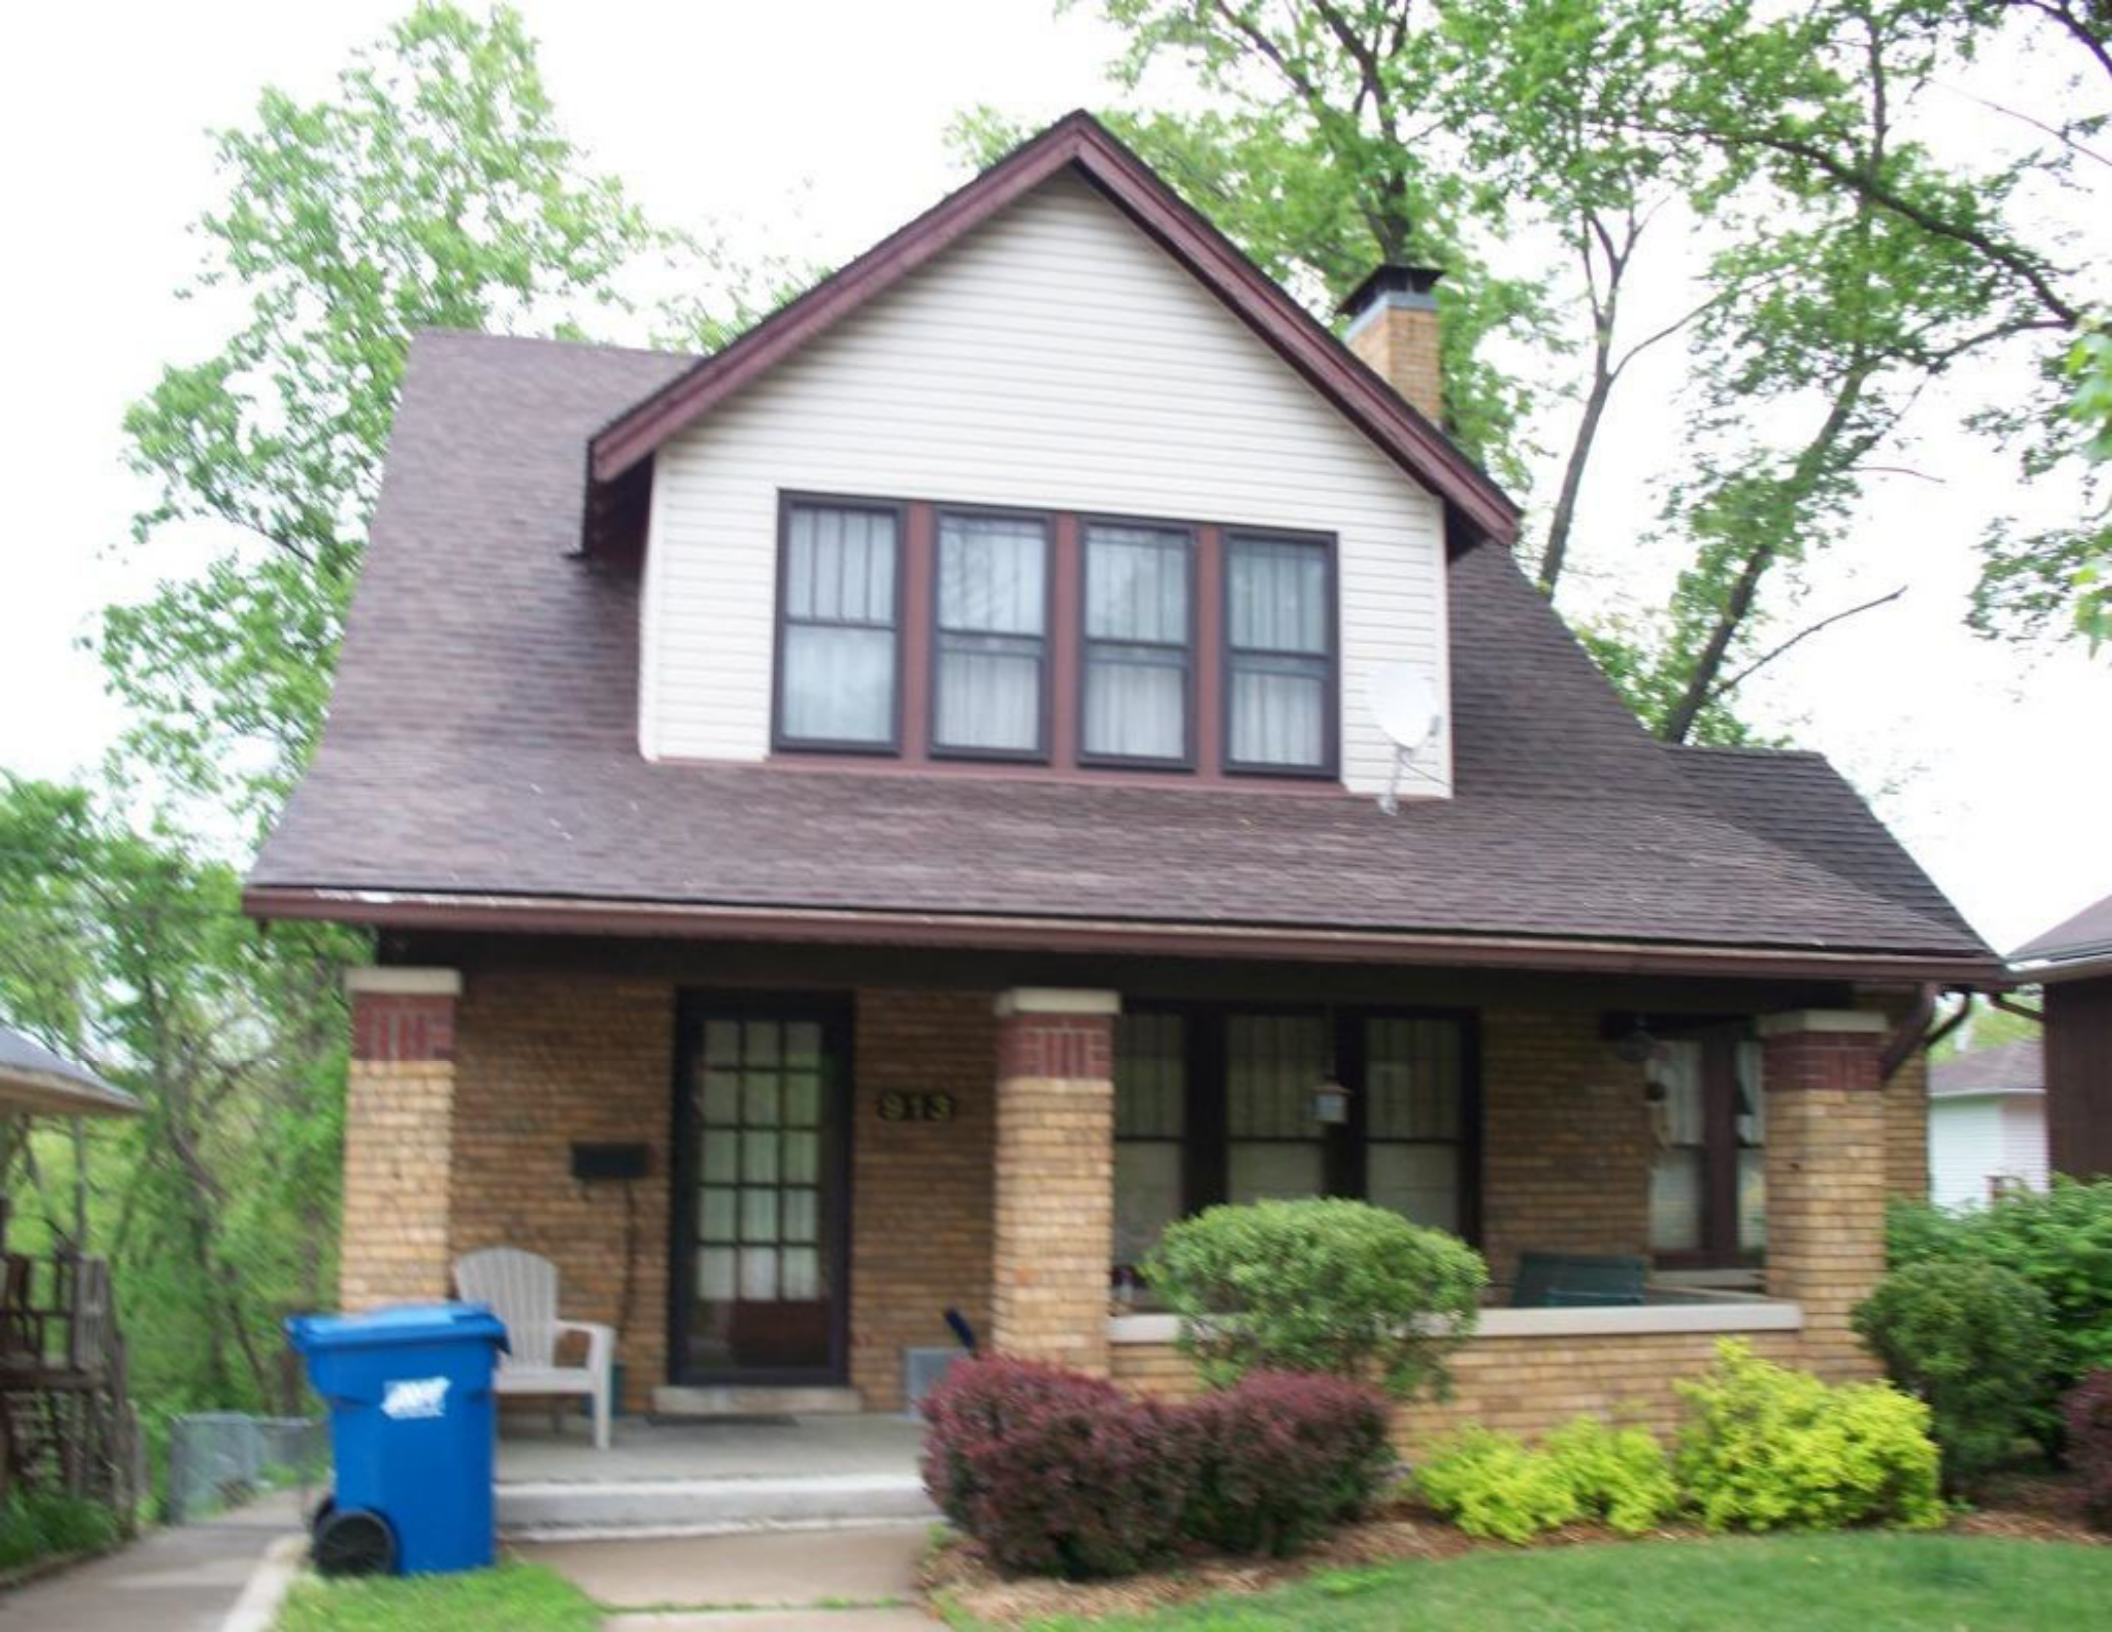
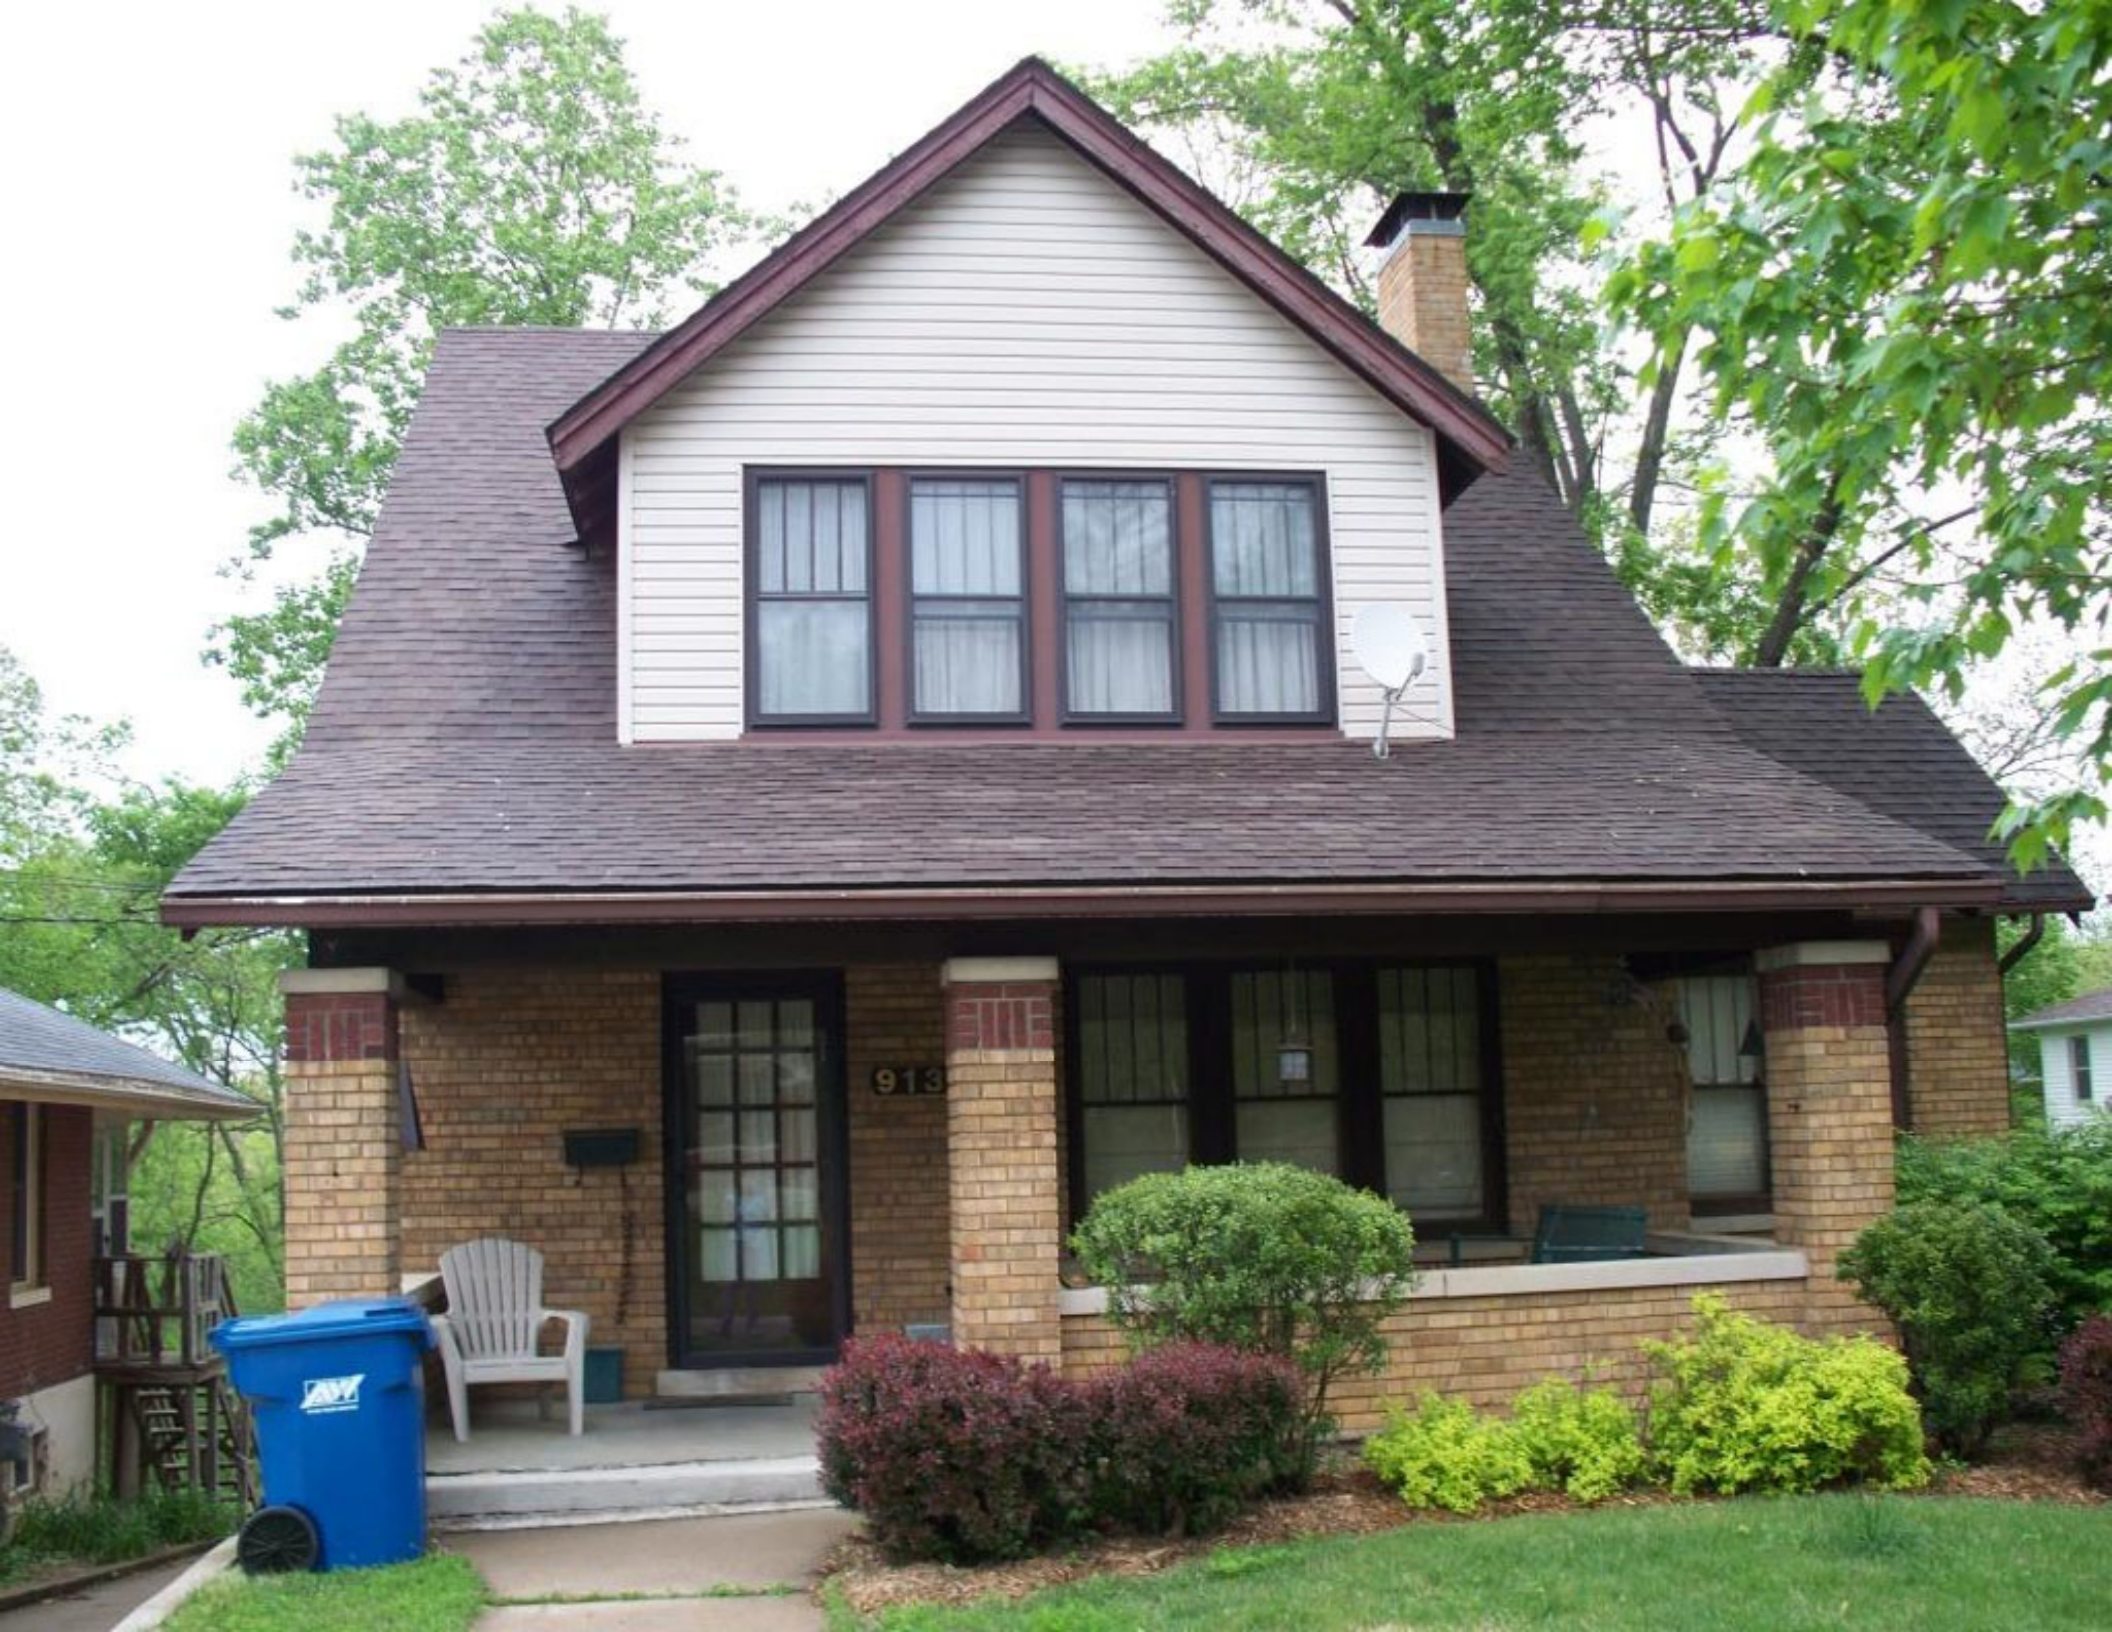
This 1 ½ story brick bungalow has a high side gable roof with a large gabled dormer clad in vinyl with four historic 4/1 windows. The side gable roof flares over the front porch, which consists of brick half walls and piers capped in concrete. The piers have red decorative bricks at their tops. The left bay contains the entrance which has a wooden multi-paned historic door. The right bay has a row of three historic 4/1 windows. Off the right side of the house and slightly set back is a one-story sunroom with a side gable roof and two 4/1 historic windows.
