ARCHITECTURAL/HISTORIC INVENTORY FORM

1. Survey No. CO-AS-005-001		2. Survey name: Moreau Drive Neighborhood Survey	
3. County: Cole		4. Address: 1202 Elmerine Ave.	
5. City: Jefferson City	Vicinity: <input type="checkbox"/>	6. UTM: / /	7. Township/Range/Section: T: R: S:
8. Historic name (if known):		9. Present/other name (if known):	
10. Ownership: <input checked="" type="checkbox"/> Private <input type="checkbox"/> Public		11. Historic use (if known): Residential	11. Current use: Residential

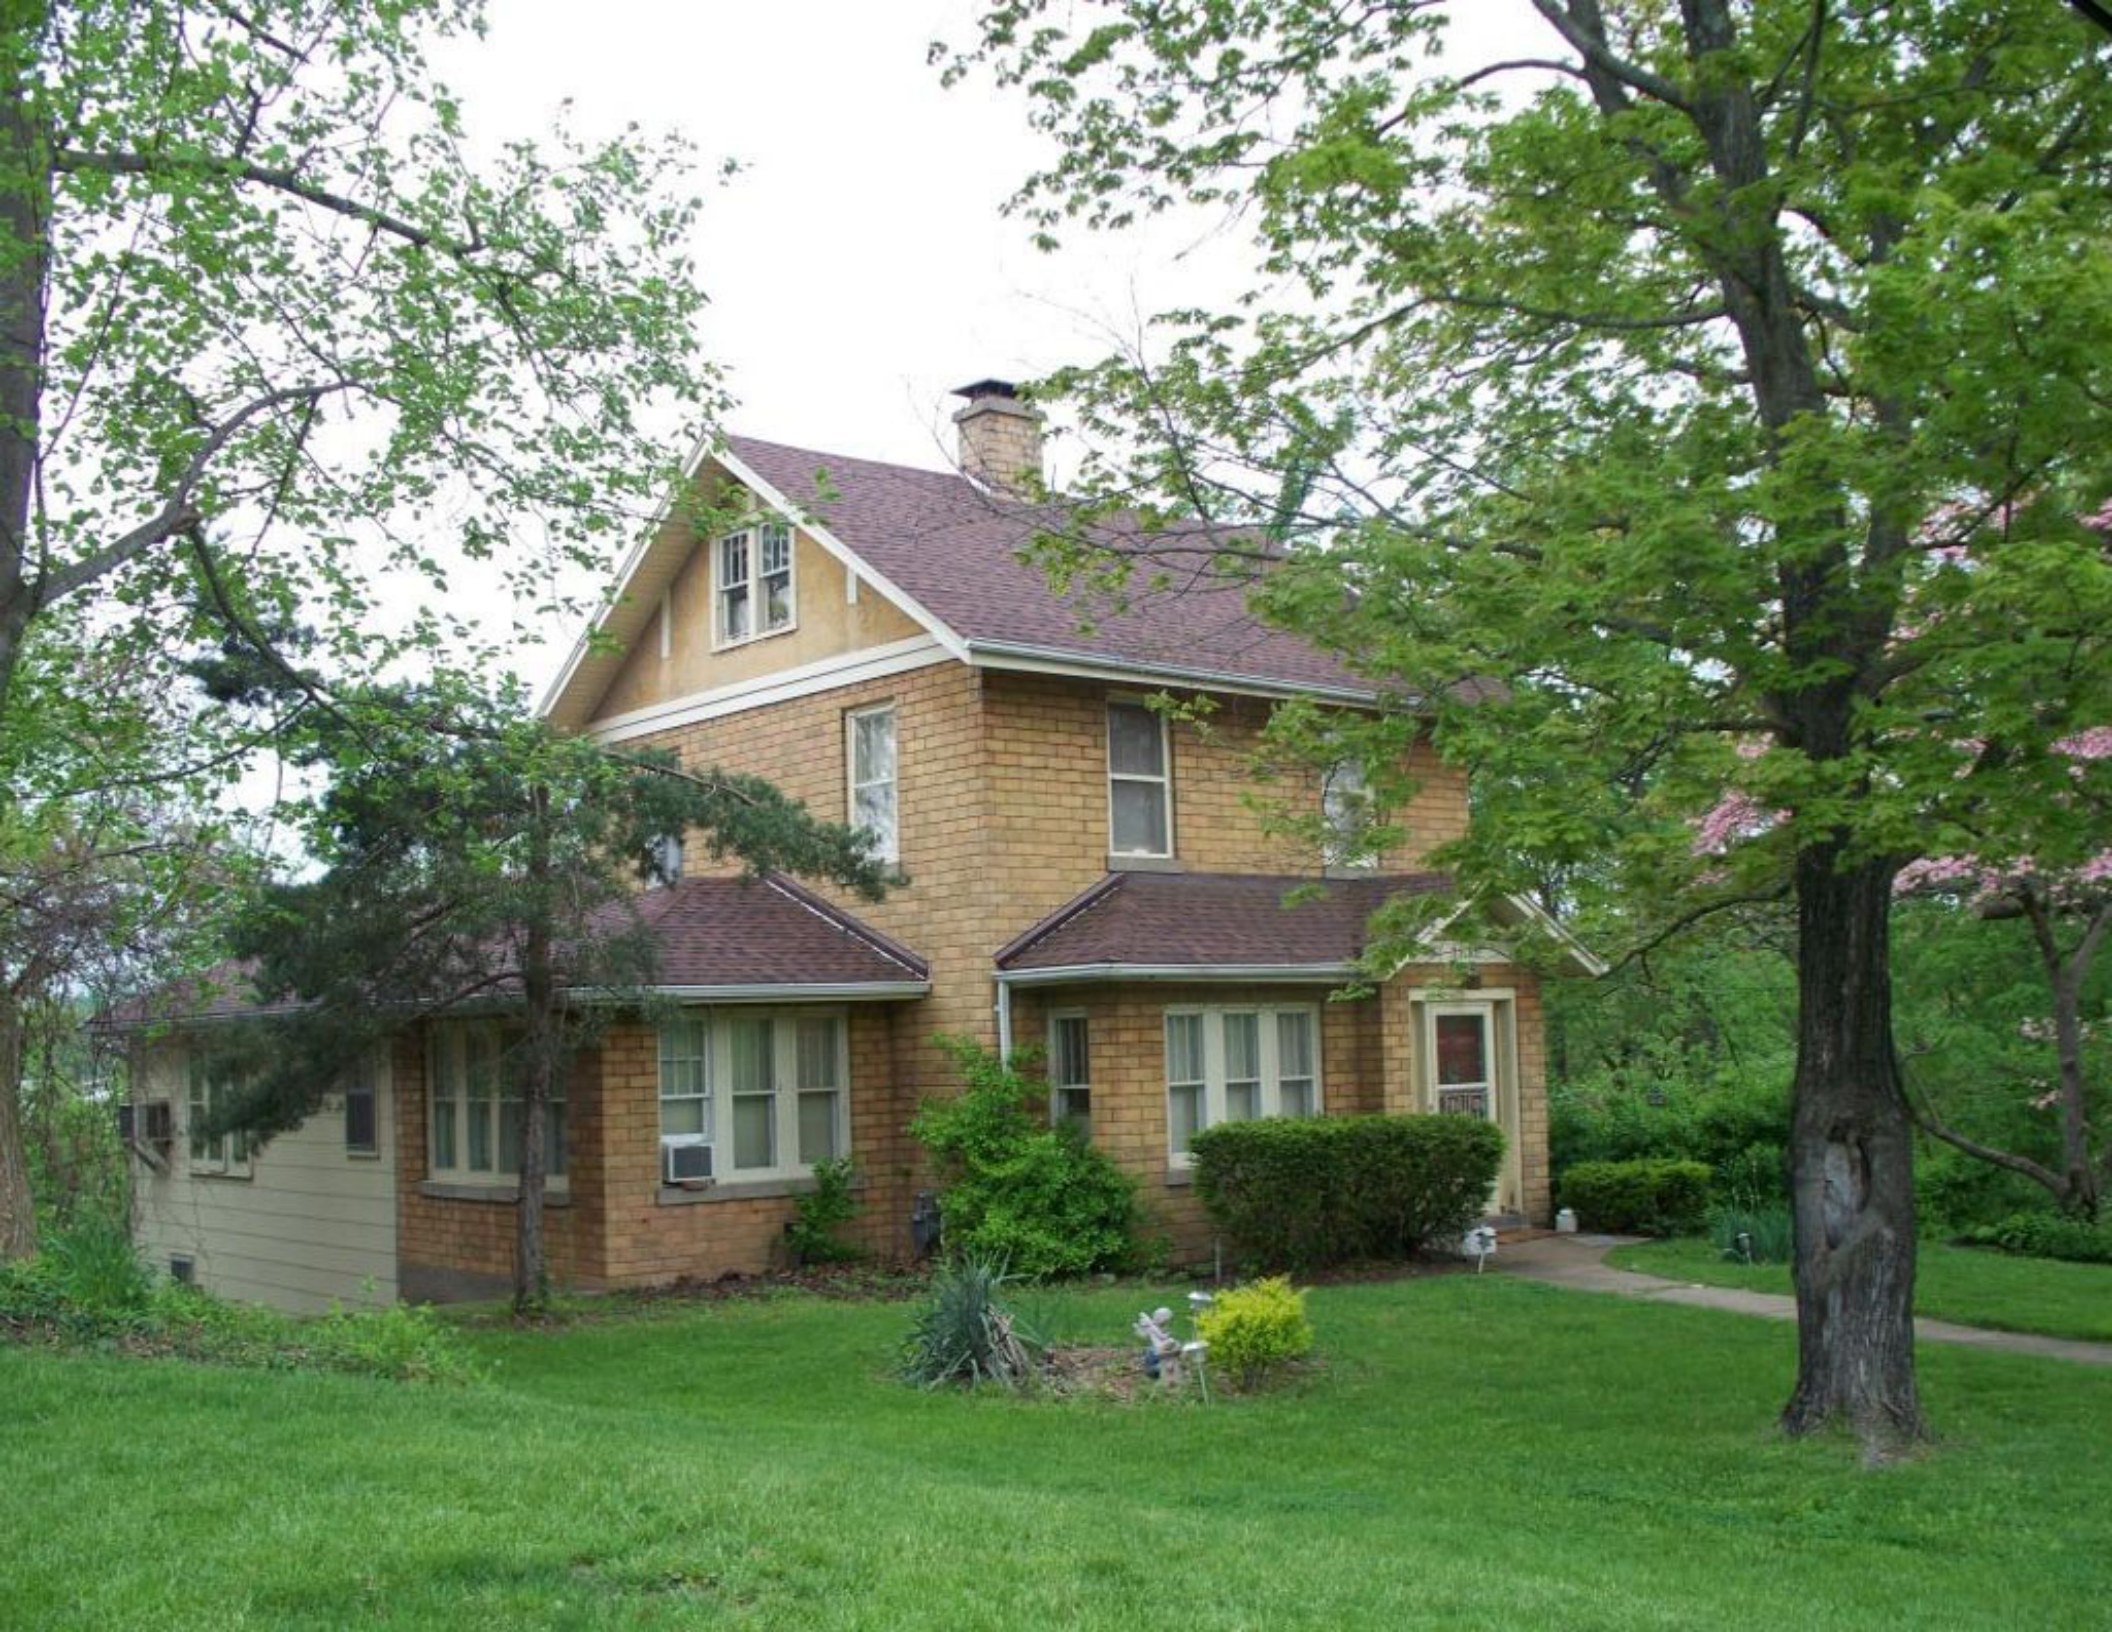
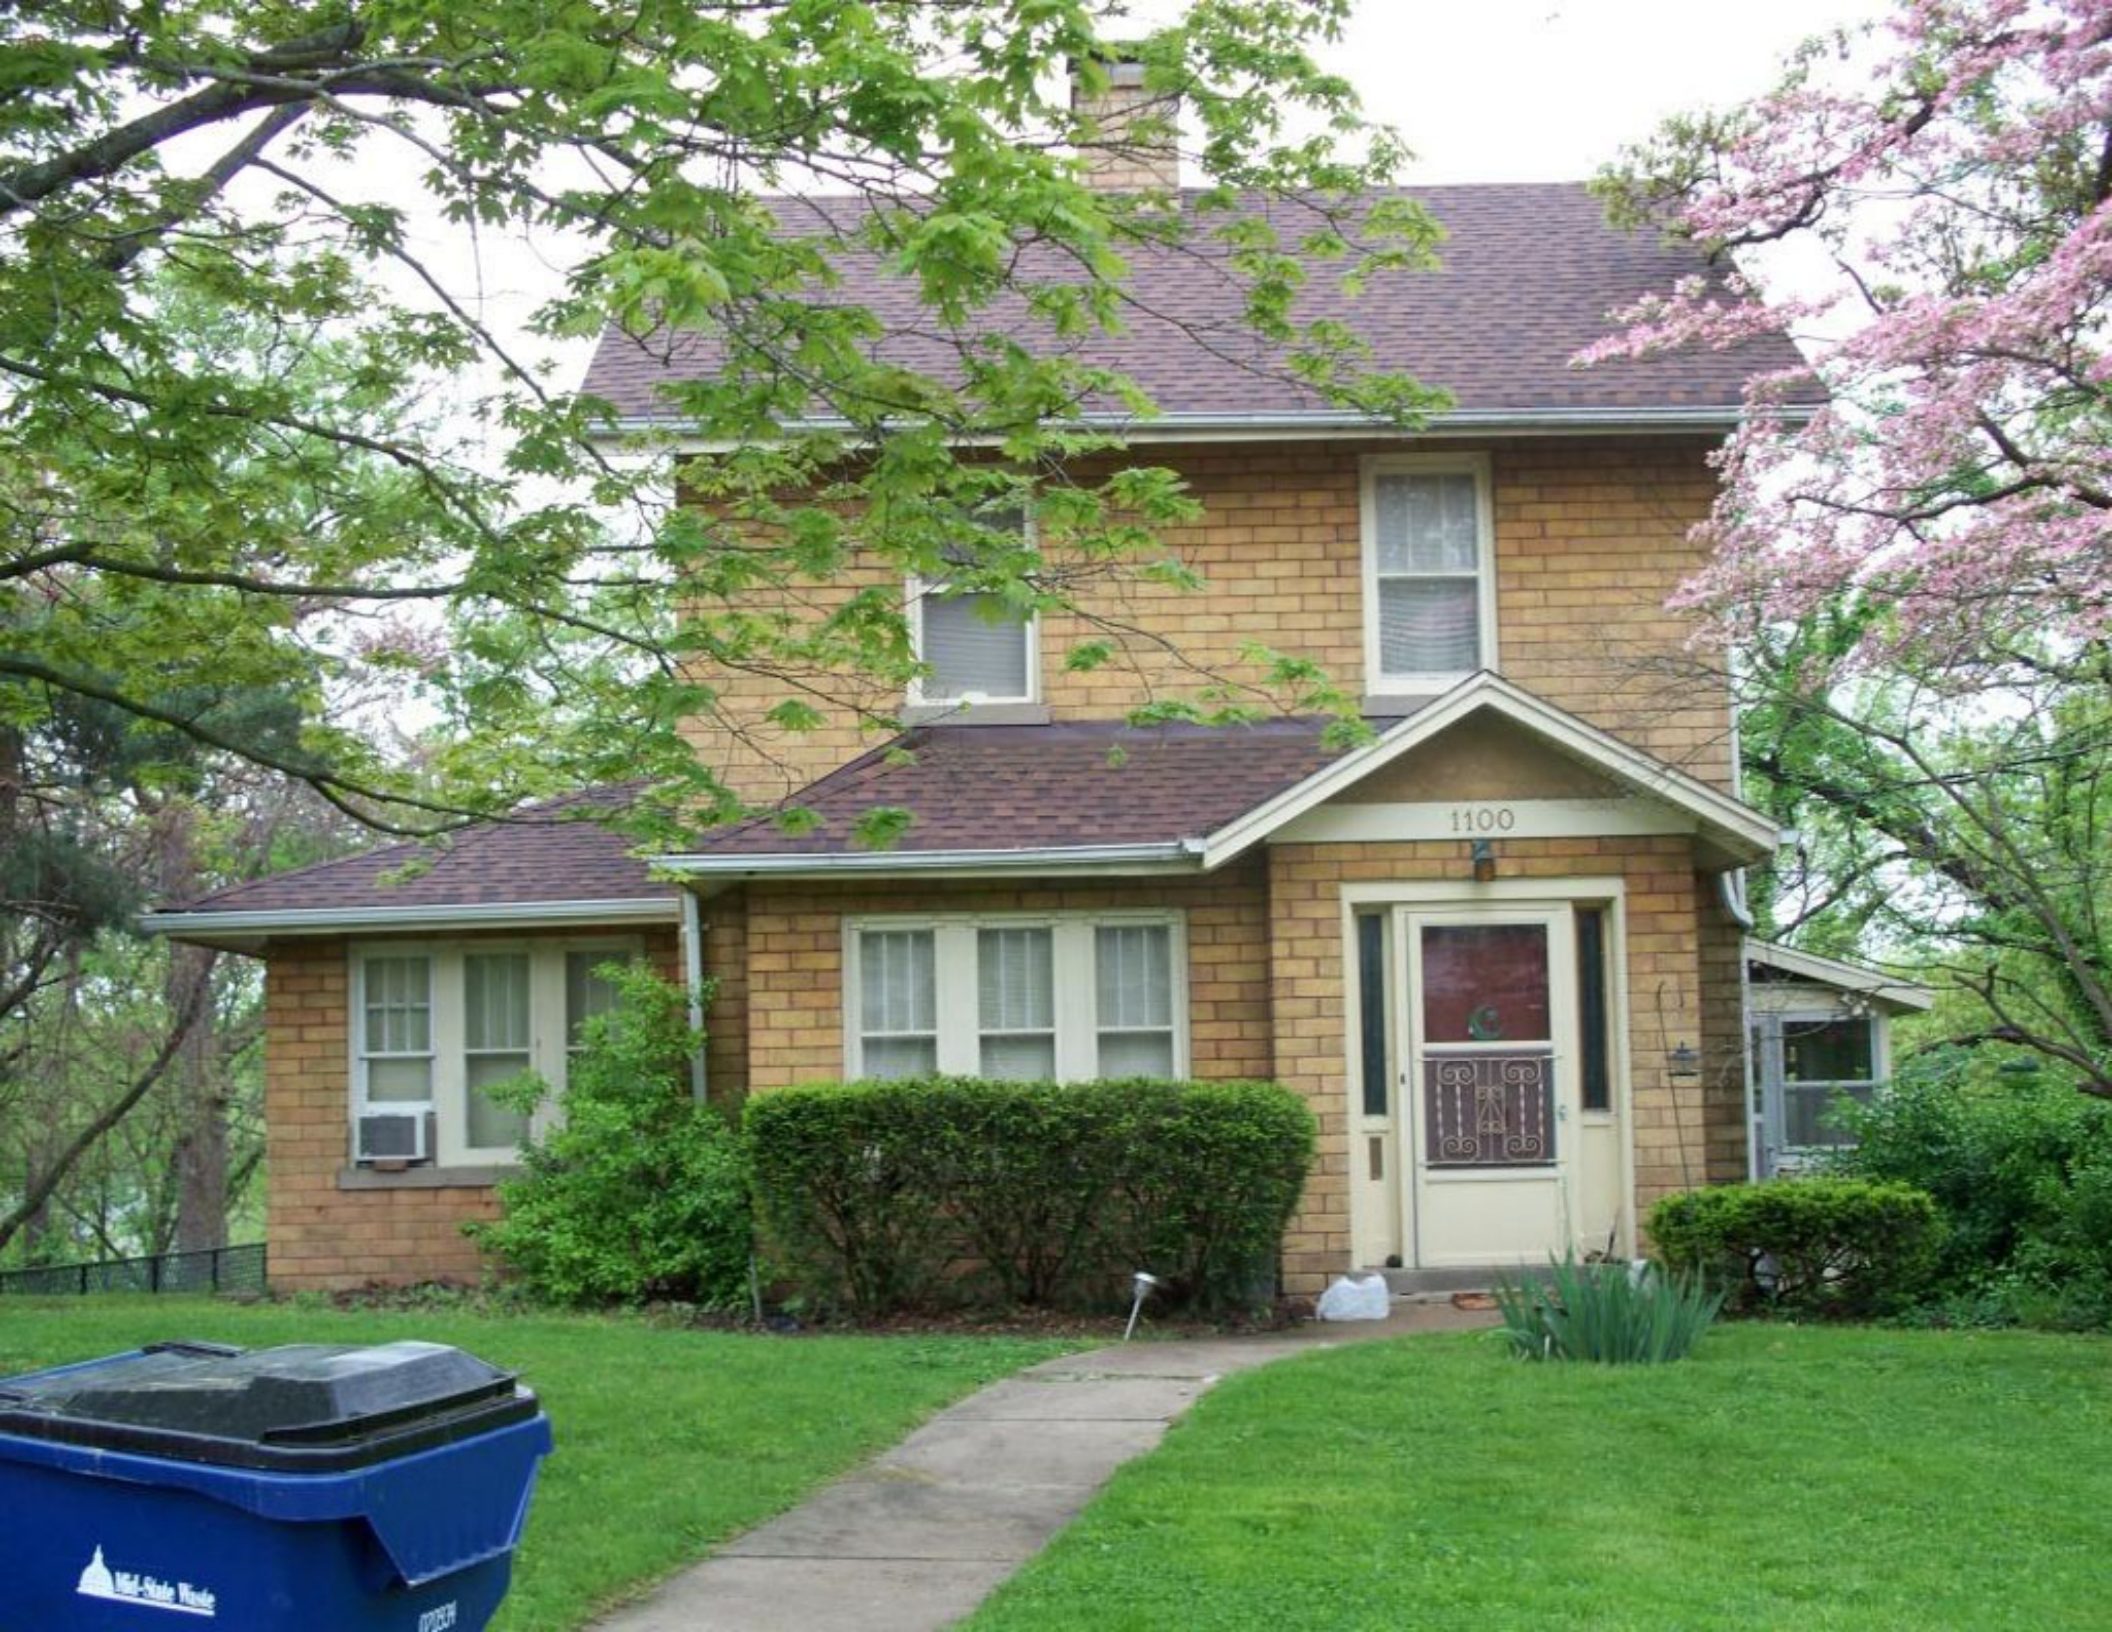
This two story brick home has a side gable roof that extends several feet over each side of the home and has a deep overhang. The second floor has two historic 3/1 windows with concrete sills. The first floor has a full width hipped roof with gable over the right bay. These bays project from $\frac{3}{4}$ of the façade and feature a row of three historic 3/1 windows with concrete sills. The right bay projects slightly and is capped by the gable which is clad in stucco with a wide wood band over the entrance. The historic sidelights have been retained but the door may or may not be original. Slightly set back on the left side of the property is a one story sun room with a hipped roof. It has a row of three historic 3/1 windows. Off the back of the right side of the home is another one story sun room with a shed roof clad in either wide vinyl or weatherboard. It has aluminum 1/1 windows and an additional door.

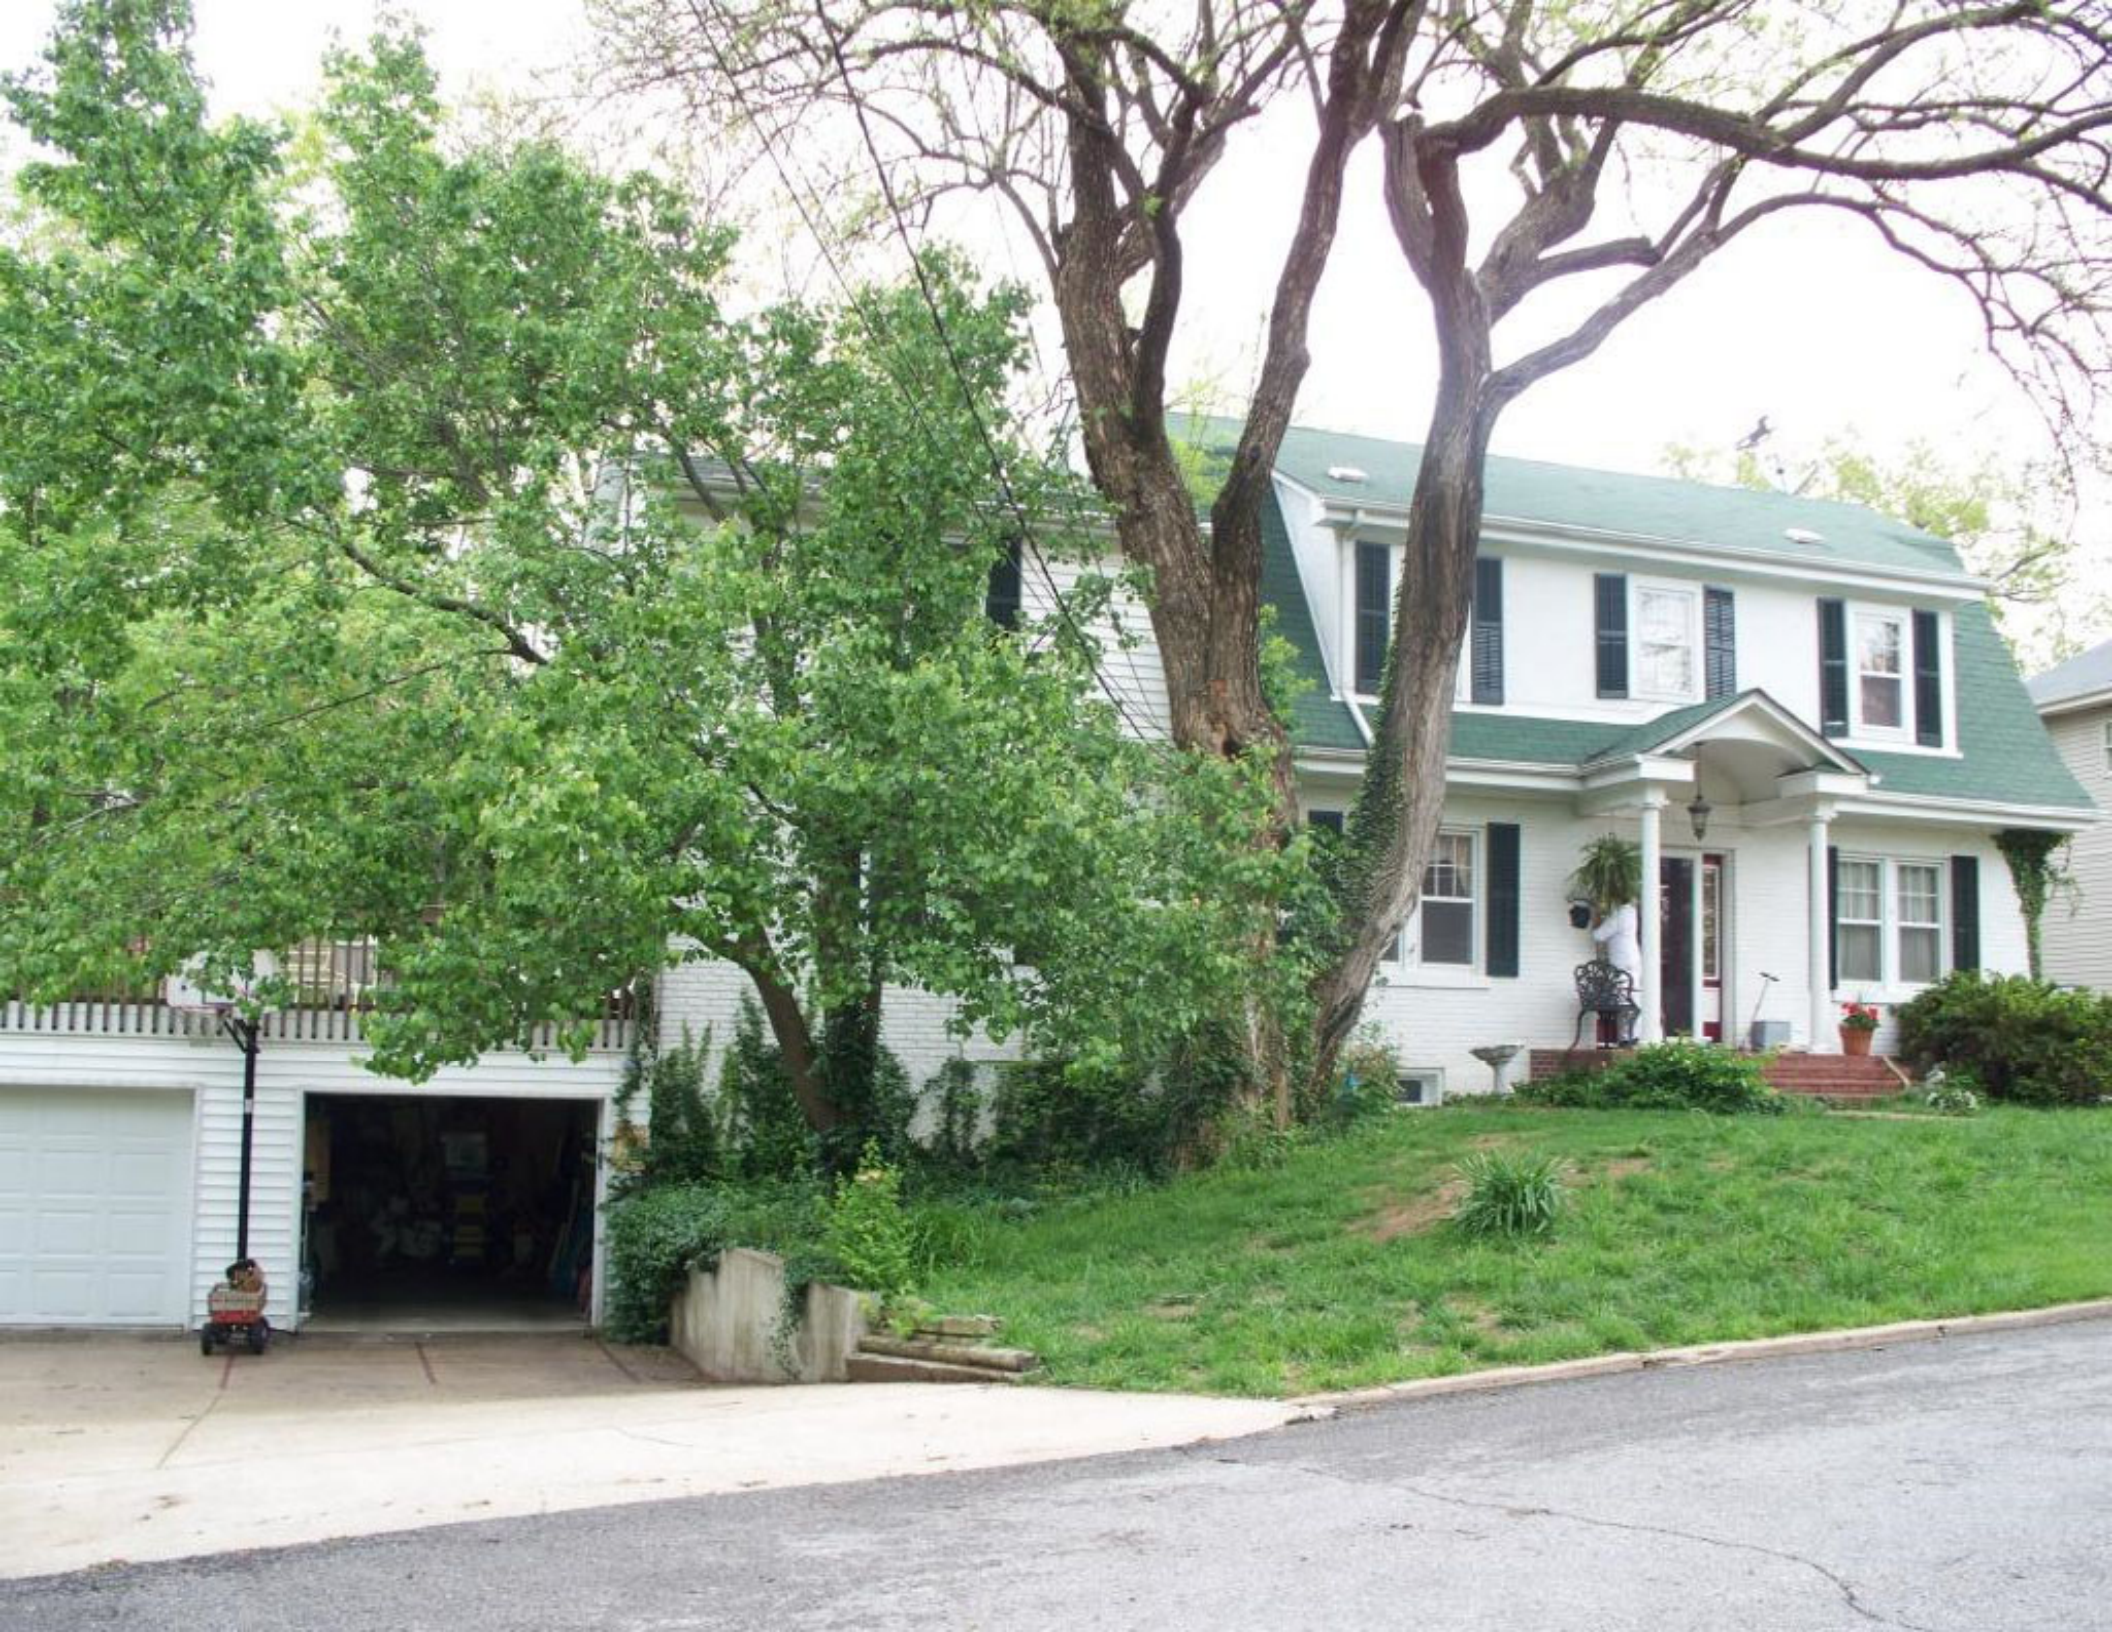
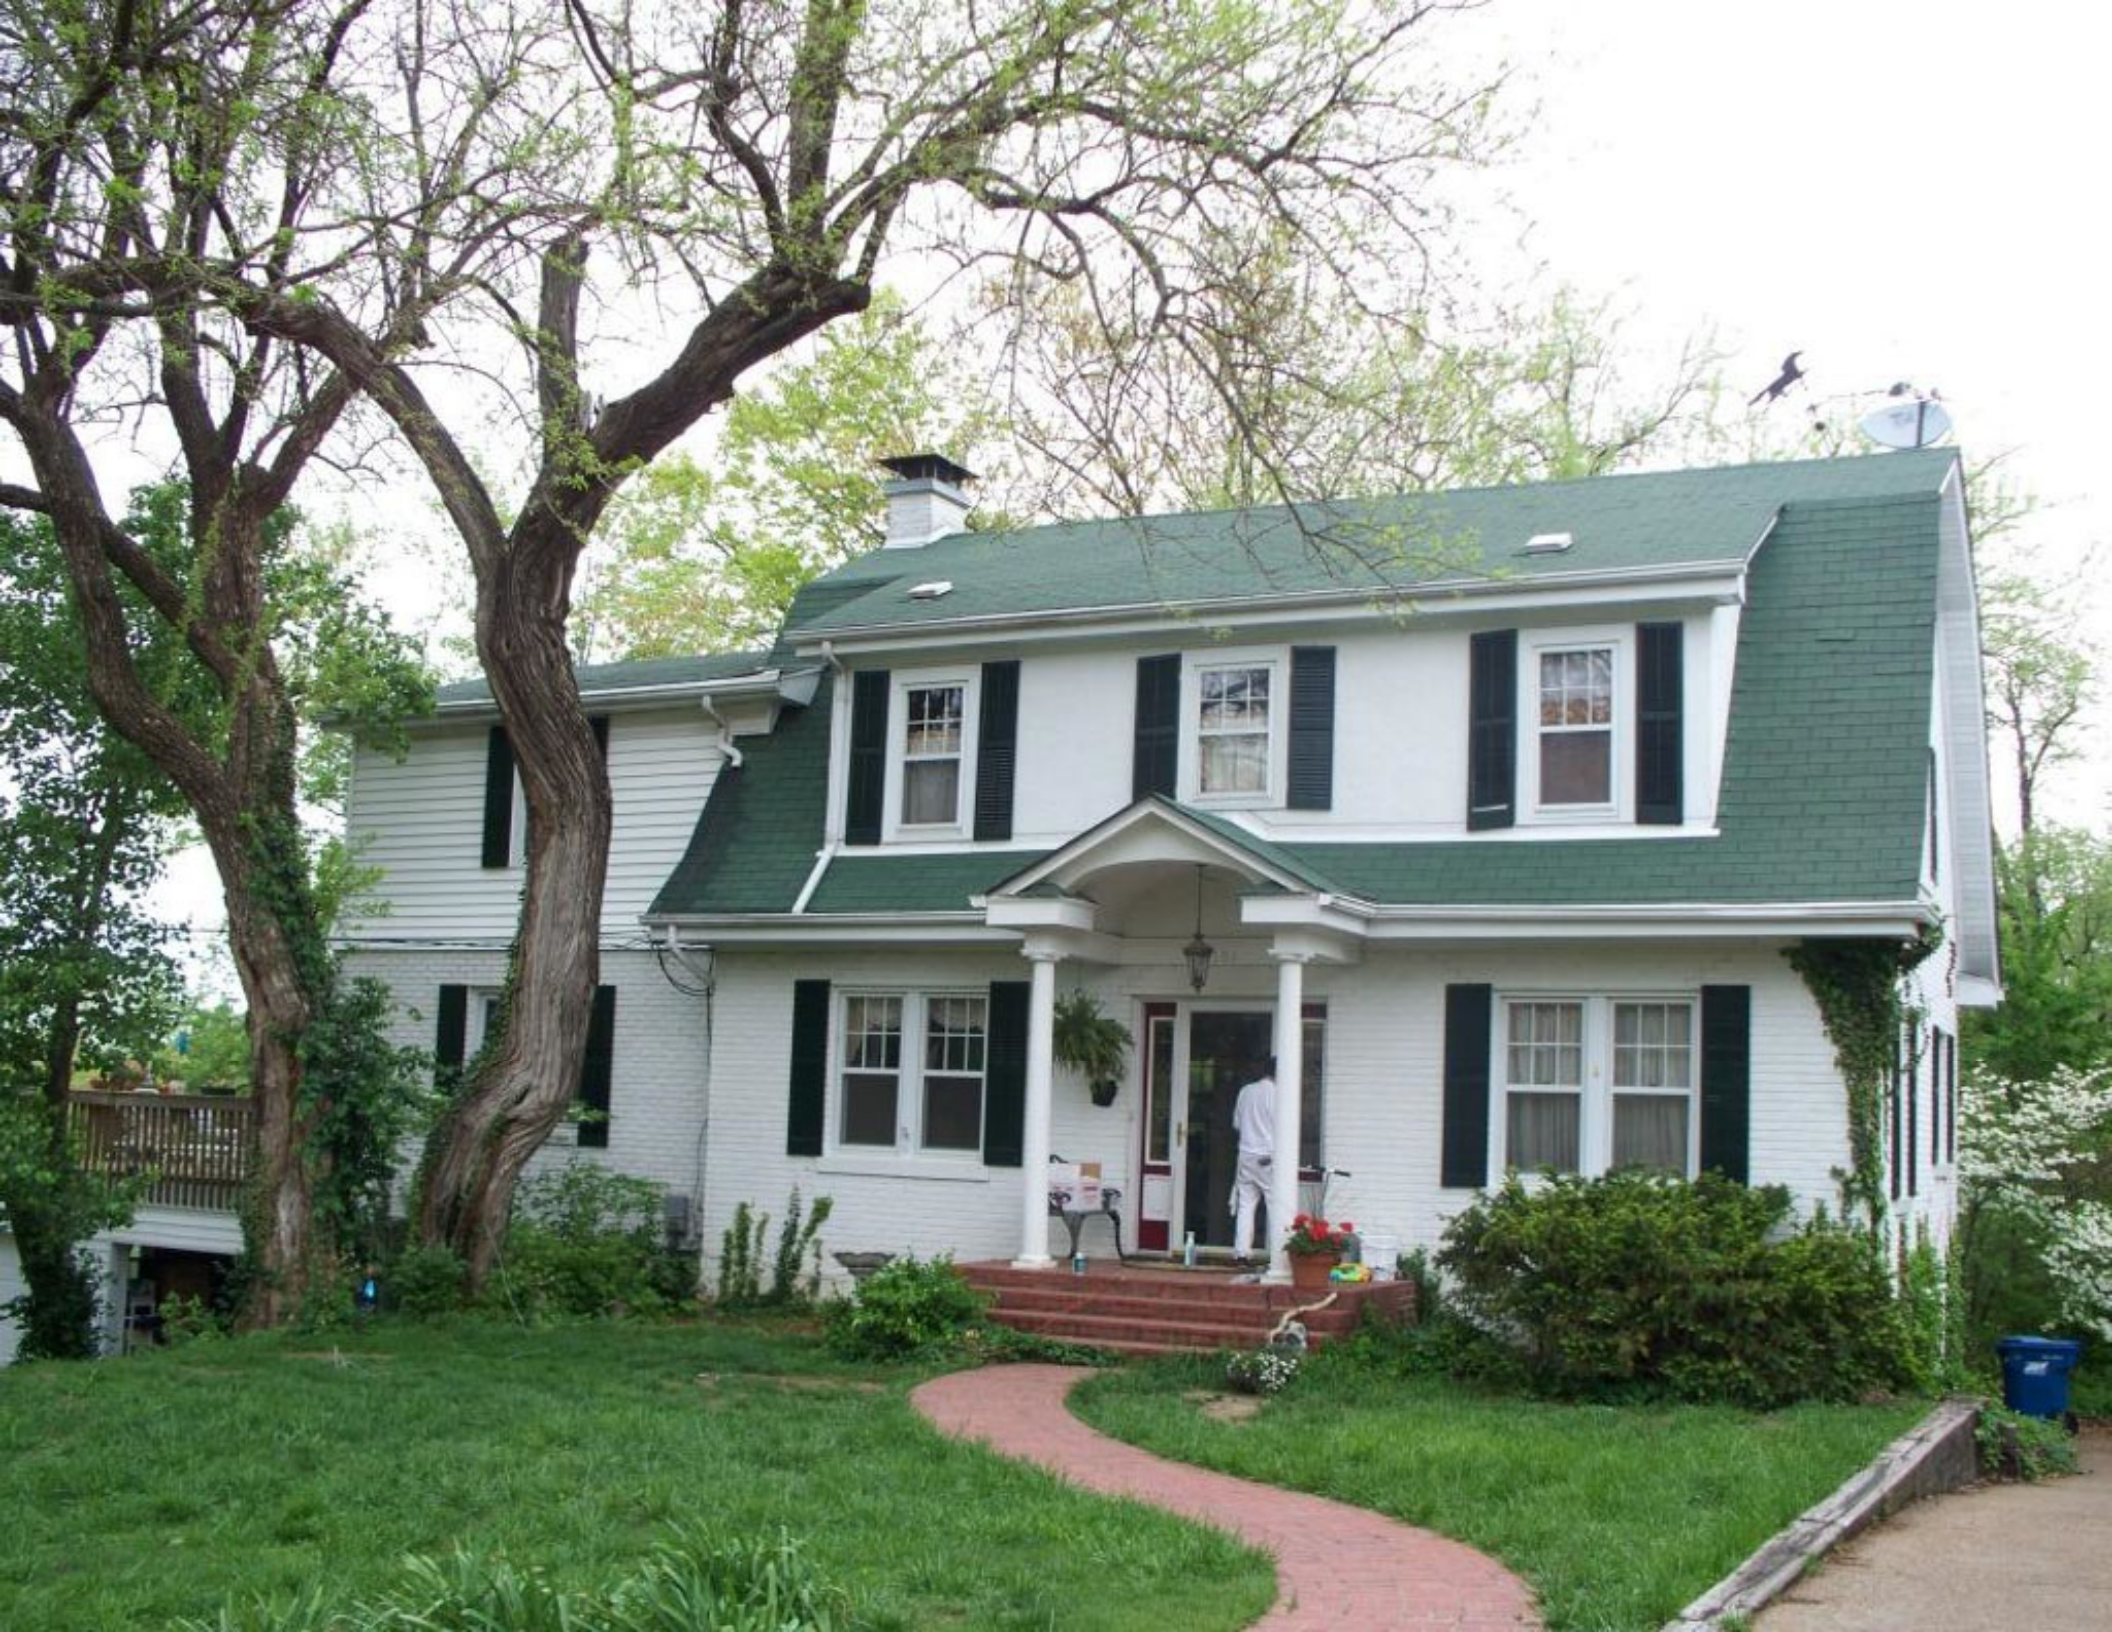
This two story brick Dutch Colonial has a side gambrel roof with a large center shed dormer with three 6/1 windows with shutters. The first floor has paired 6/1 windows flanking the centered entrance which has sidelights. The windows on this property may or may not be modern replacements. The sidelights may also be replacement. The entrance is covered by a gable with returns that projects from the roof. It is supported by two fluted columns with entablature and rests on a brick stoop with stairs. Set back on the left side is a two story wing. The lower portion is clad in brick and contains a window (obscured by vegetation) with shutters. The upper portion may be an addition and is clad in vinyl and also contains a window with shutters. Extending from this wing and below grade is a two car garage addition clad in vinyl. It has a flat roof that has been utilized as a porch with wood railing. Since the garage addition is set below grade and is set back it could possibly be argued that the house retains integrity. However, the footprint has nearly doubled and if the windows are replacement and a second story addition was added to the brick wing it seriously affects the integrity. For the purposes of this survey it is considered non-contributing.

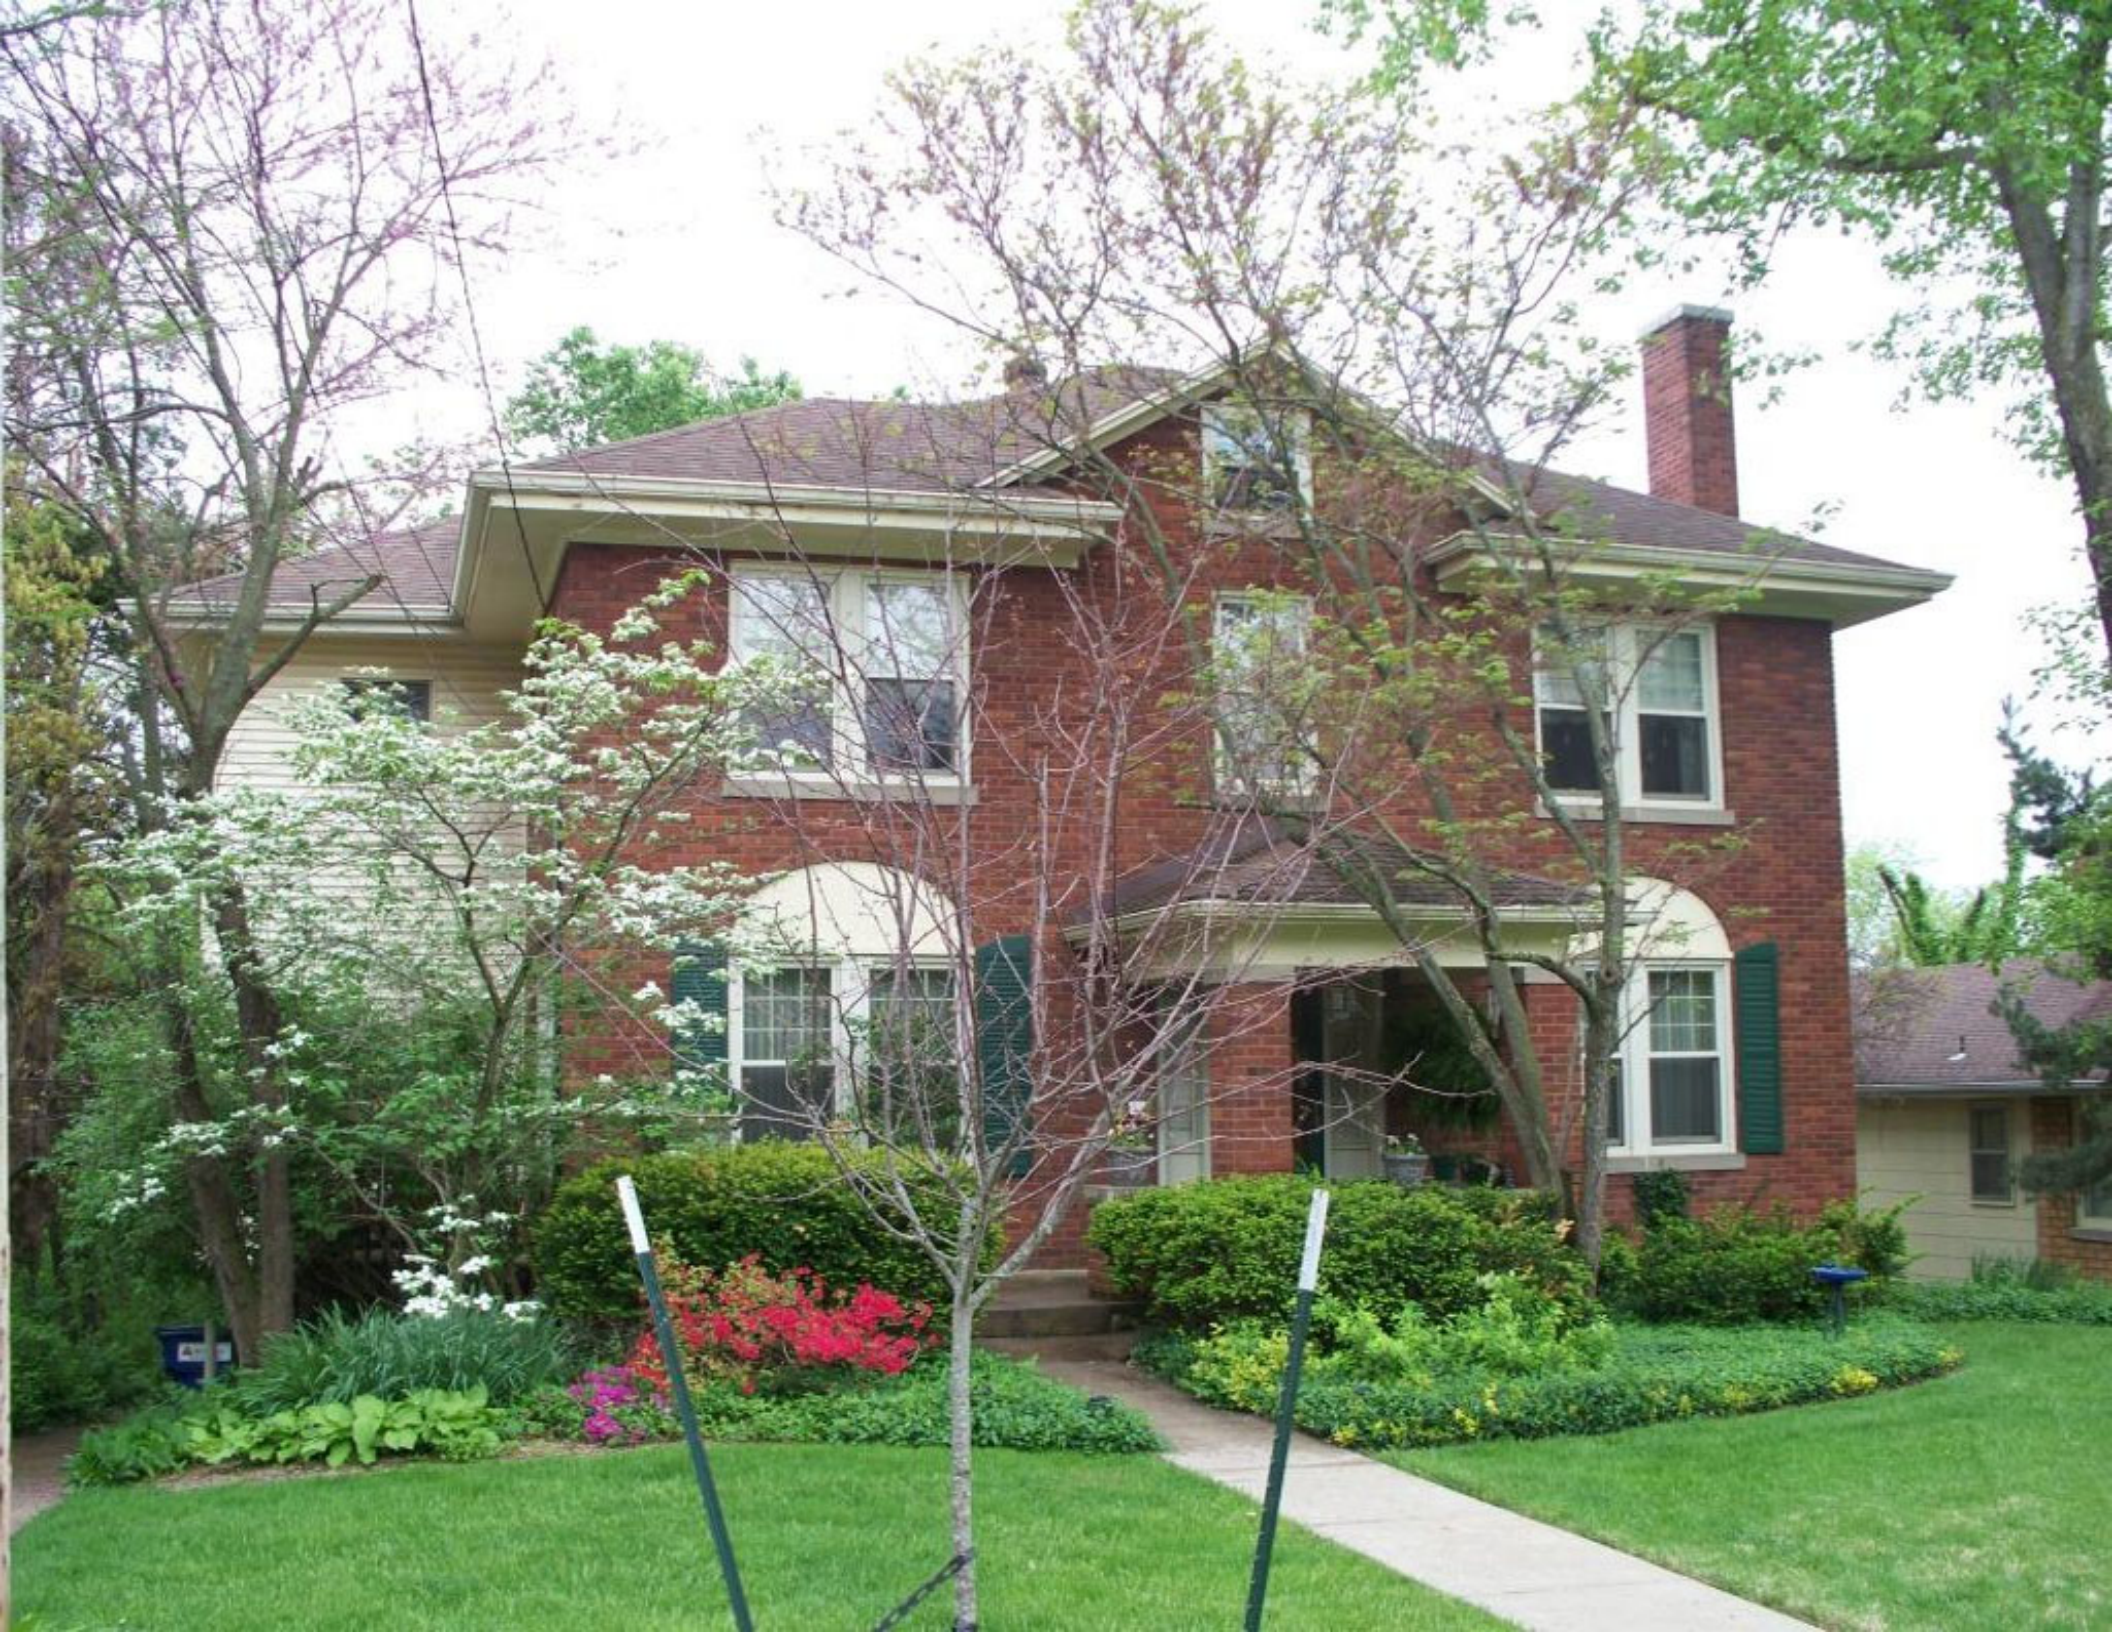
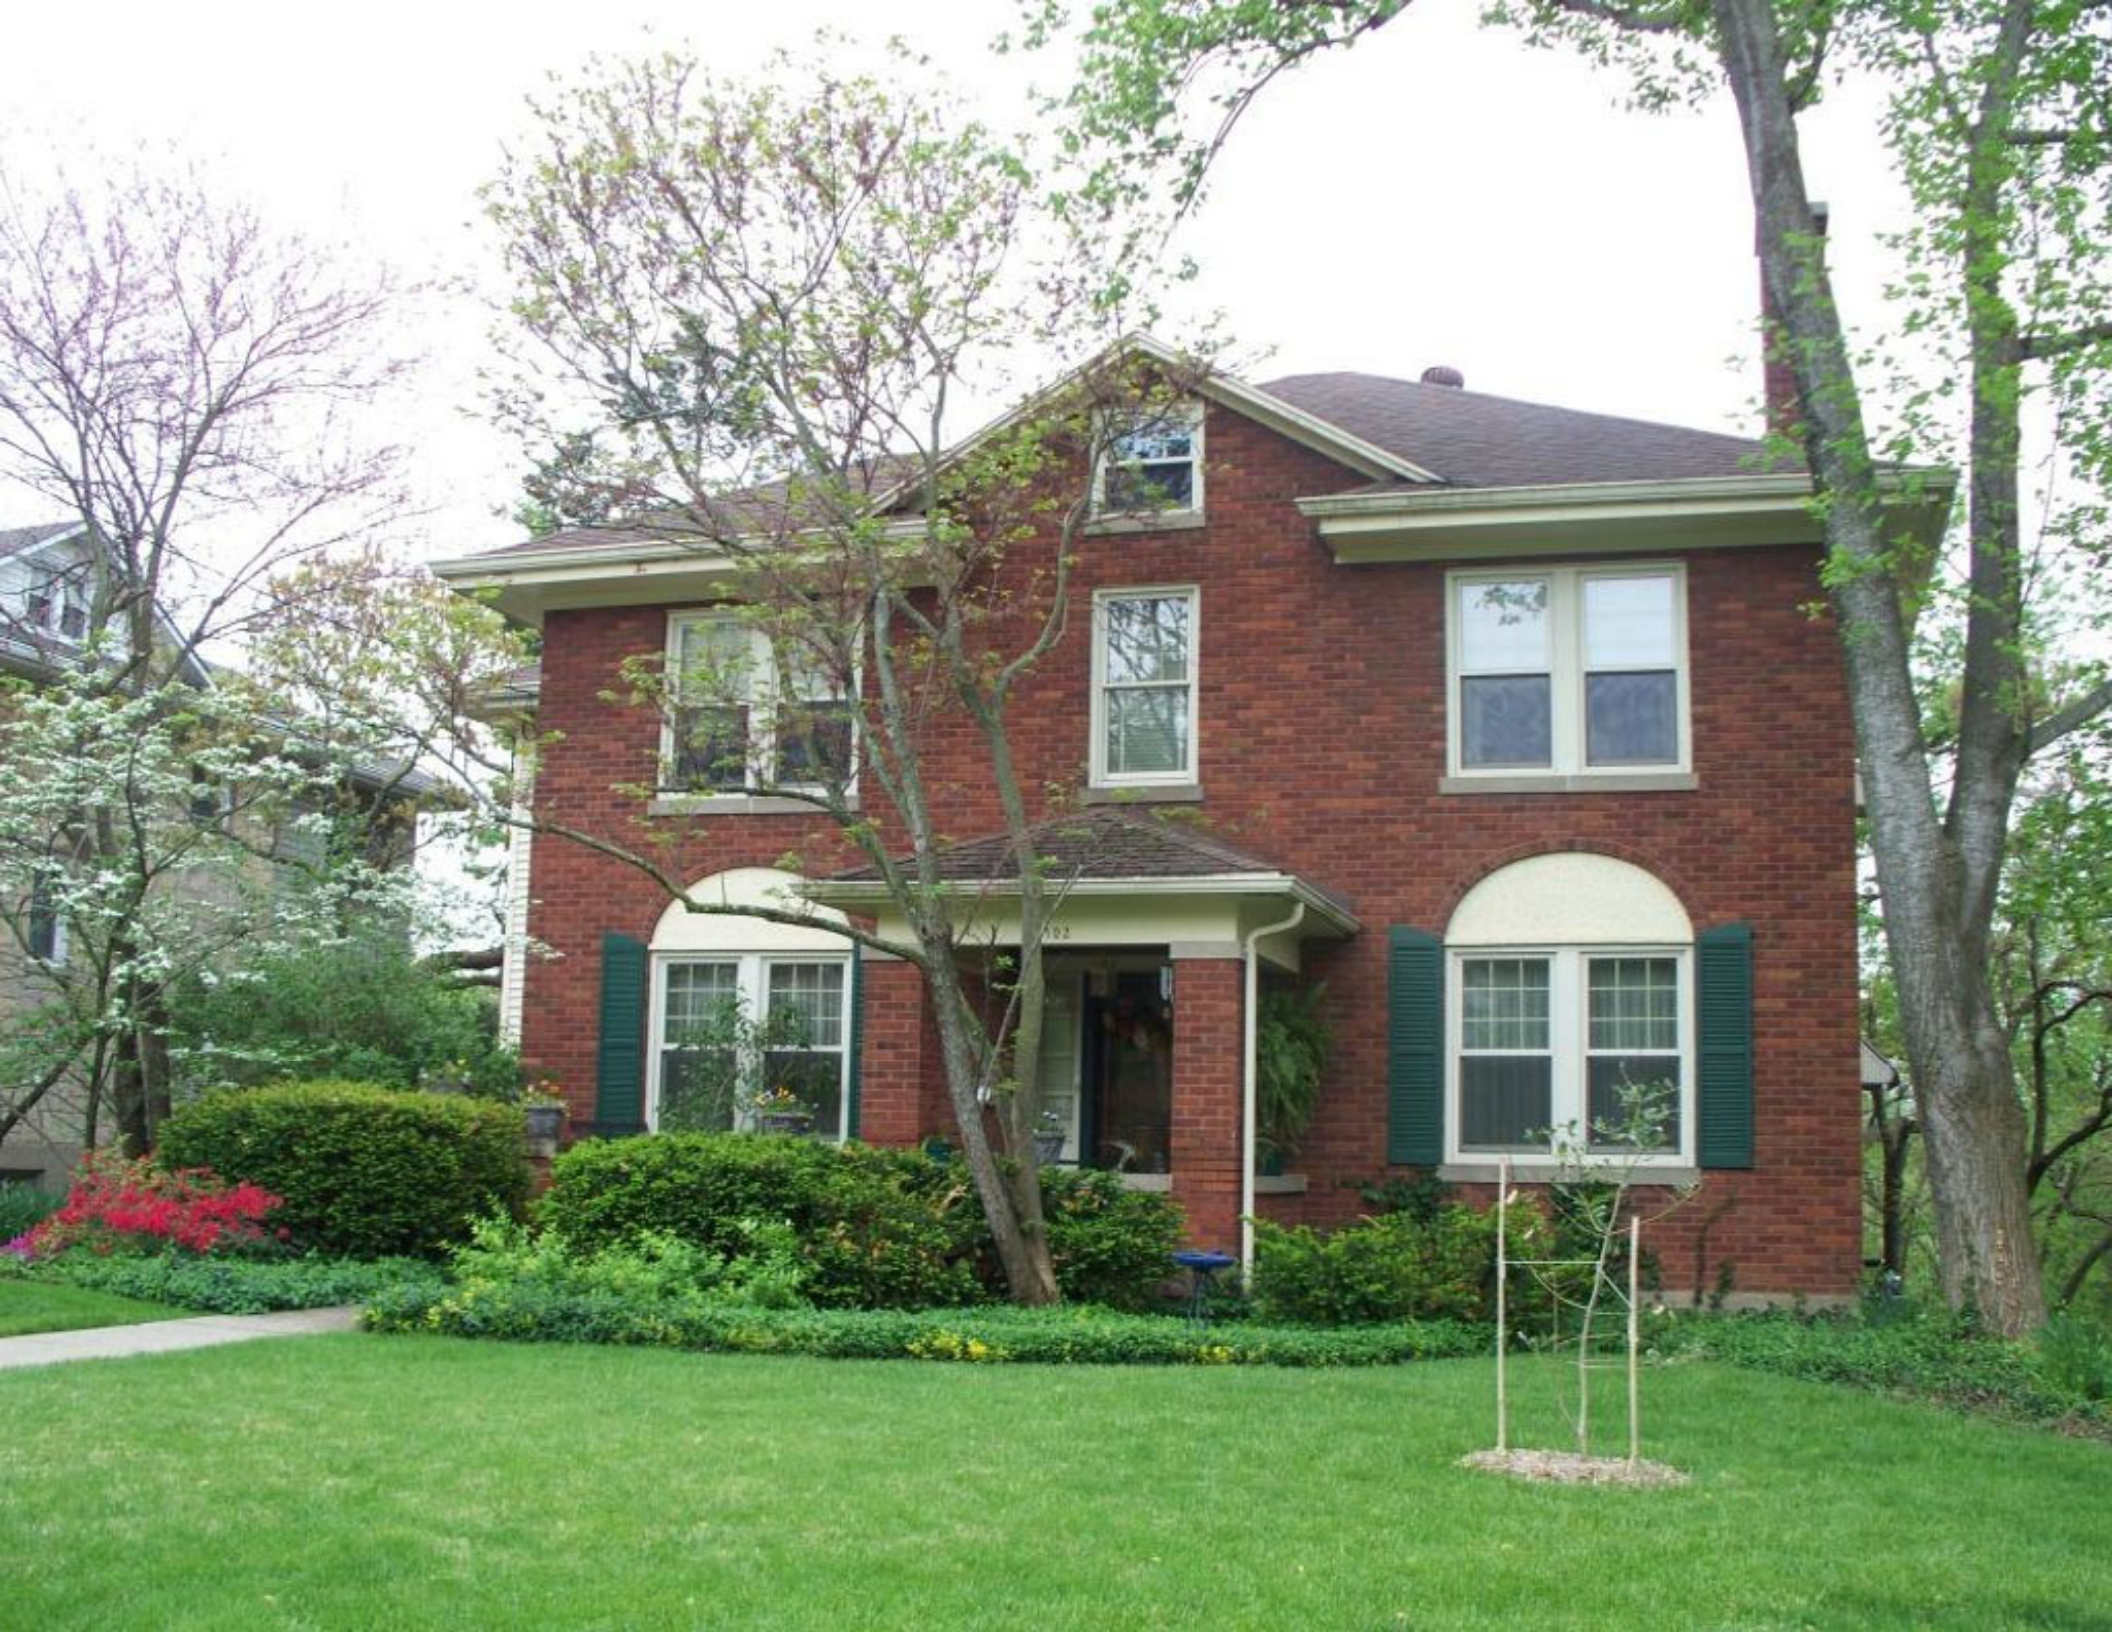
This 2 ½ story brick Colonial Revival has a hipped roof with wide eaves with entablatures and a smaller center gable with returns (created by the eaves of the hipped roof) that contain a small historic 3/1 window. The second floor has paired modern 9/1 windows flanking a single 9/1 window. The first floor has two large paired 9/1 flat arched windows with shutters that have round arch brick work around a filled-in fan lights flanking the center entrance. The entrance appears to retain its historic wooden door and sidelights. It is covered by a projecting portico with a hipped roof and entablature with brick piers and half walls capped in concreted. All of the windows have concrete sills. Set off the back of the left side of the property is a two story bay that is clad in vinyl and contains a window on the second story (the rest was obscured by vegetation).
