ARCHITECTURAL/HISTORIC INVENTORY FORM

1. Survey No. CO-AS-005-001		2. Survey name: Moreau Drive Neighborhood Survey	
3. County: Cole		4. Address: 1202 Elmerine Ave.	
5. City: Jefferson City	Vicinity: <input type="checkbox"/>	6. UTM: / /	7. Township/Range/Section: T: R: S:
8. Historic name (if known):		9. Present/other name (if known):	
10. Ownership: <input checked="" type="checkbox"/> Private <input type="checkbox"/> Public		11. Historic use (if known): Residential	11. Current use: Residential

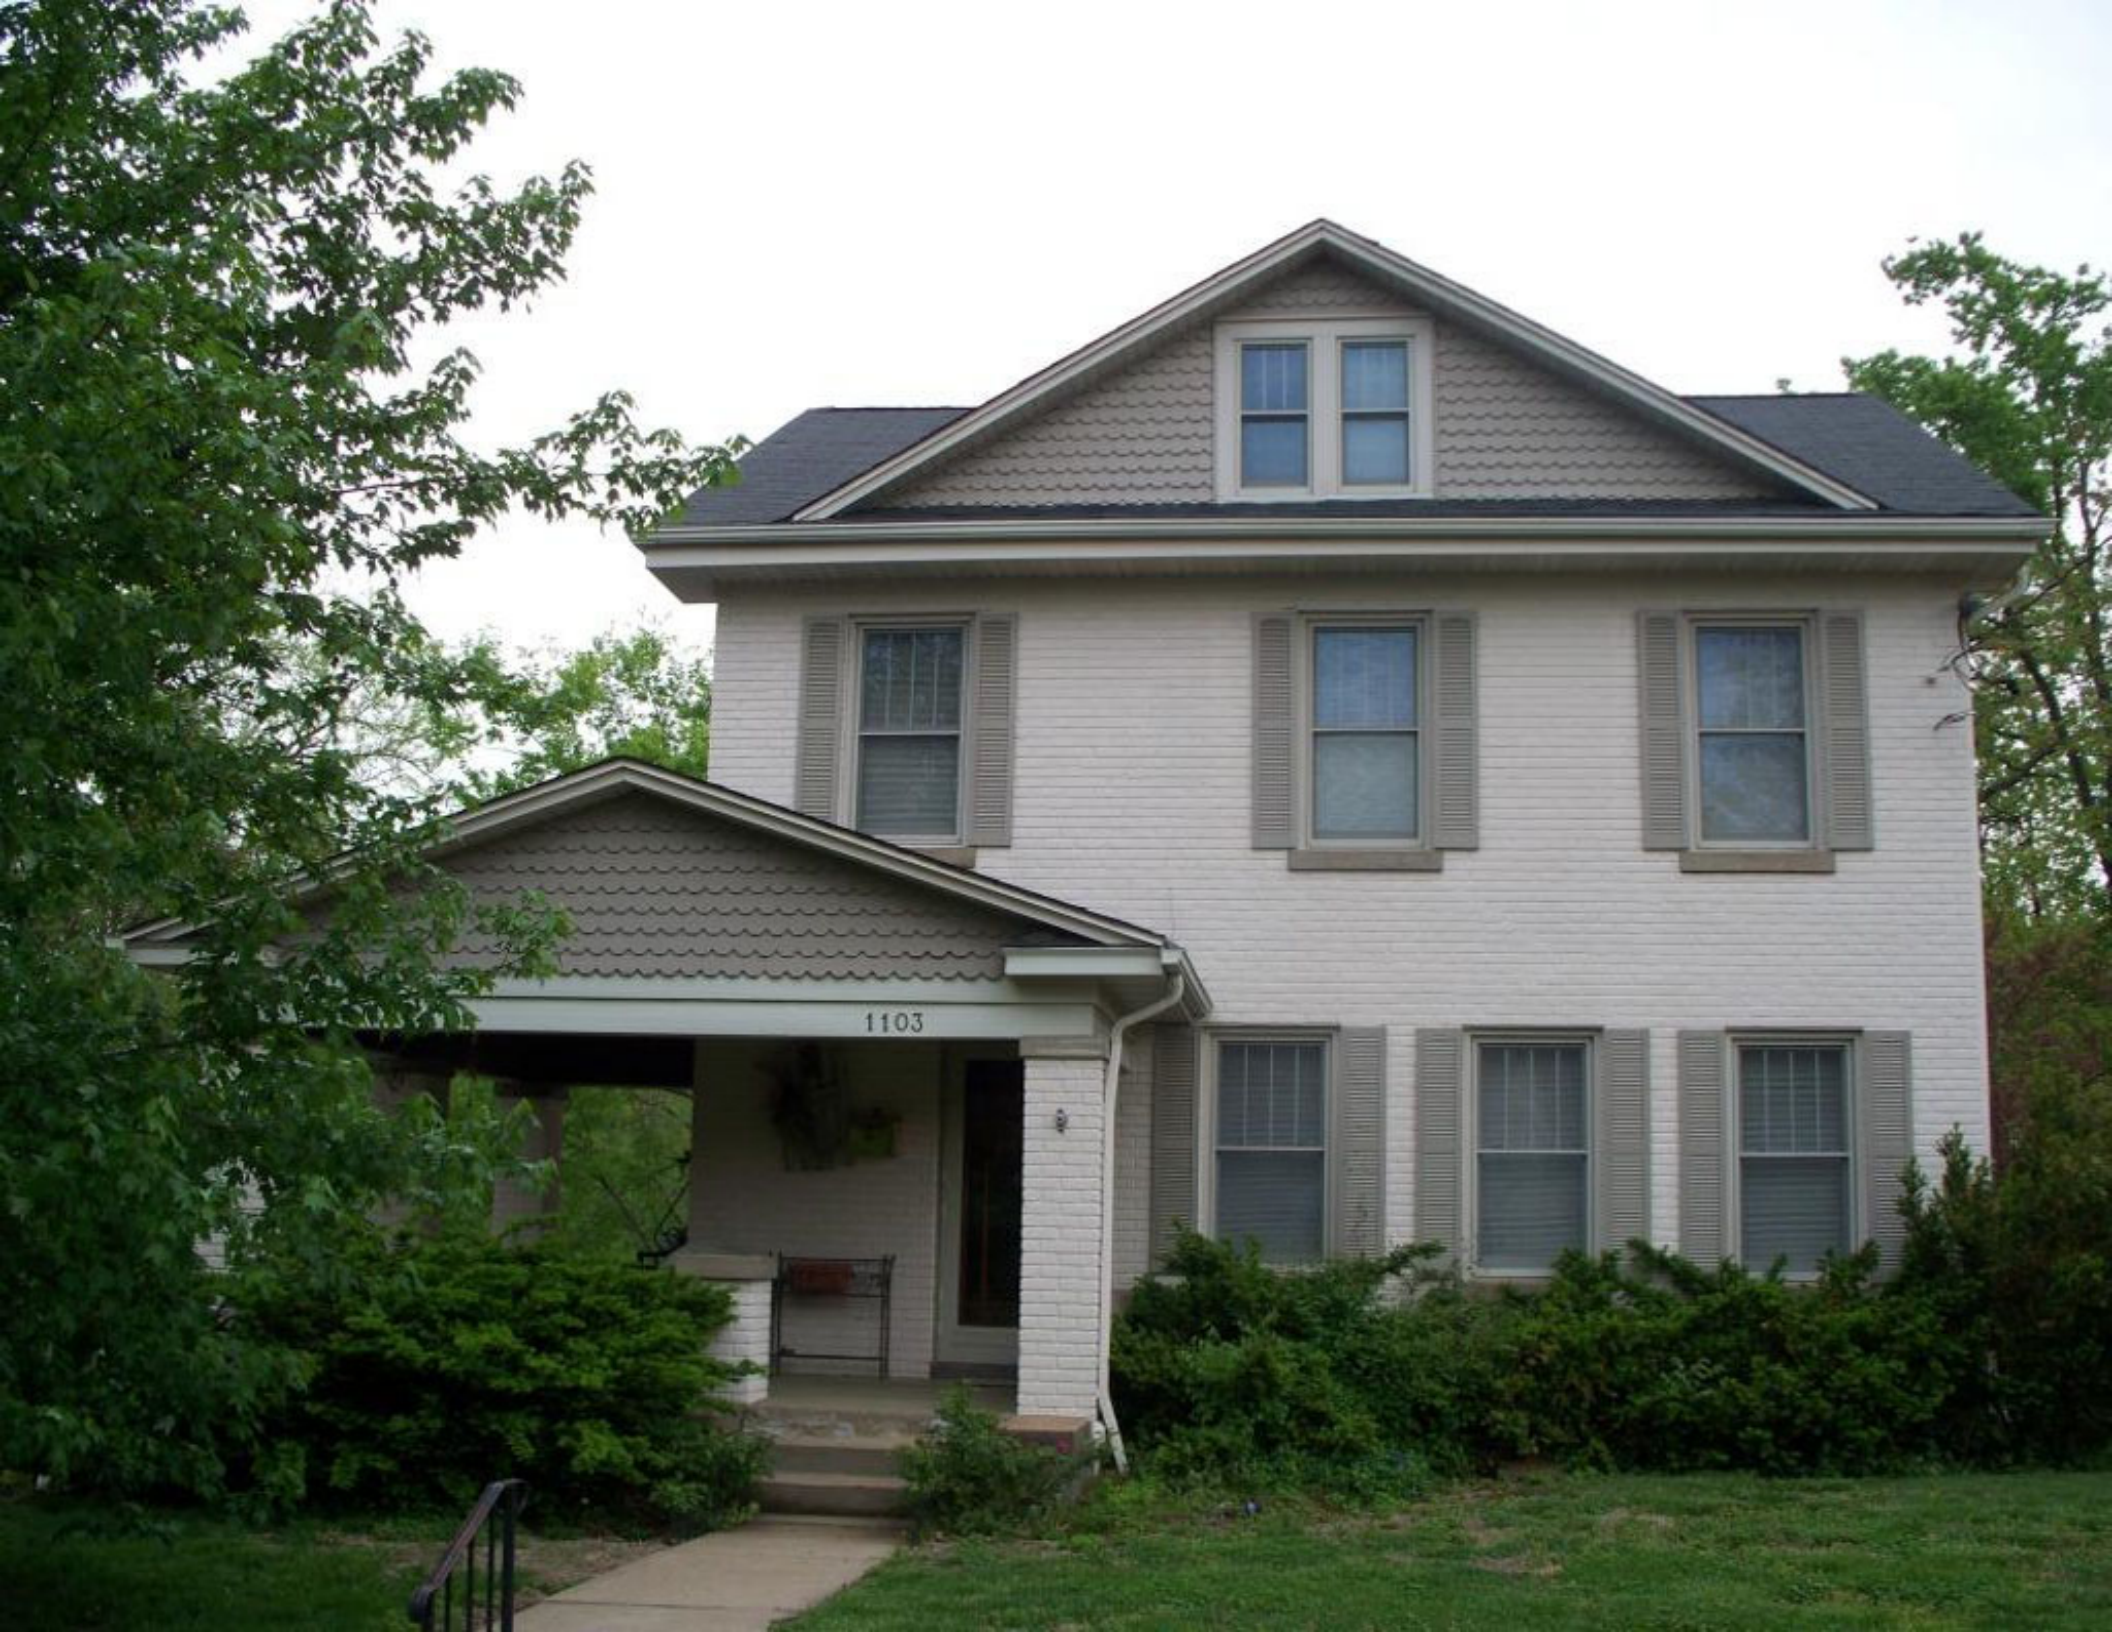
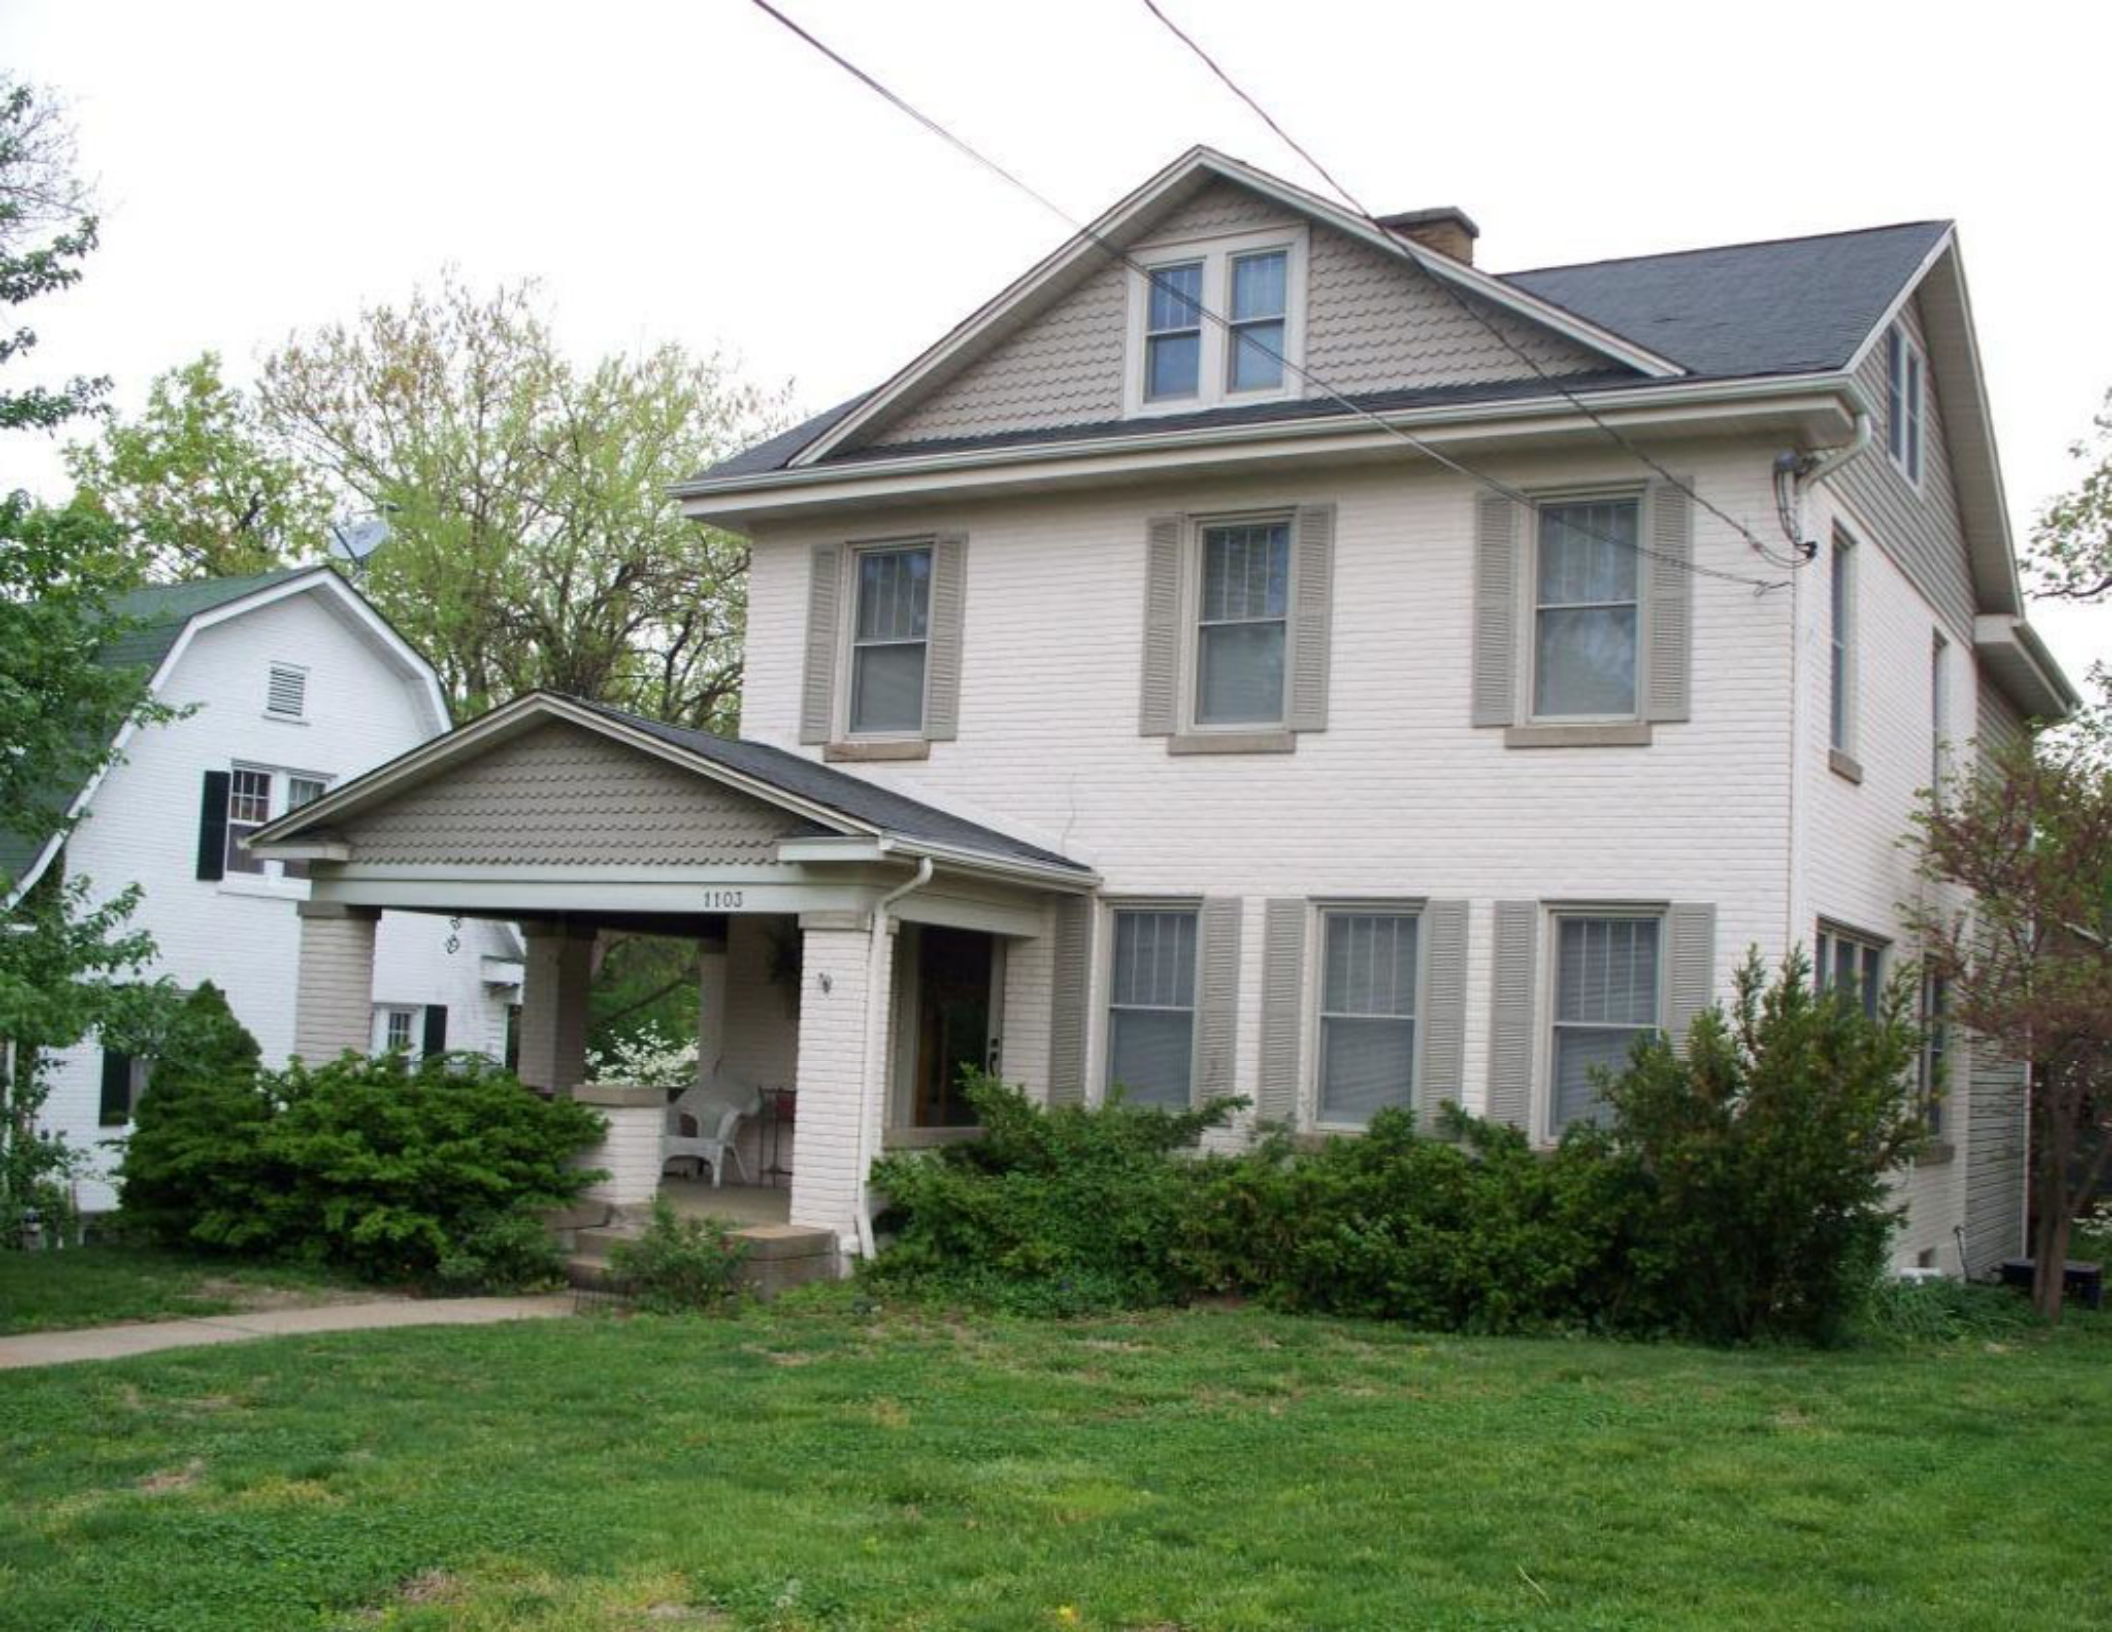
This 2 ½ story brick property has a side gable roof with a front cross gable or a very large gabled dormer. The gable has been clad in what appears to be some sort of synthetic material made to look like shingles. There are paired 3/1 historic windows in this gable. The second floor has historic 4/1 windows with shutters. The first floor has three 4/1 windows with shutters. All of the windows have concrete sills. In the left bay on this floor is the entrance. Covering it is a projecting gable roof with returns that is offset to the left of the property. It features the same synthetic shingles as in the dormer/gable on the uppermost floor. It is supported by brick piers and half walls capped in concrete, which wraps around the left side of the building.

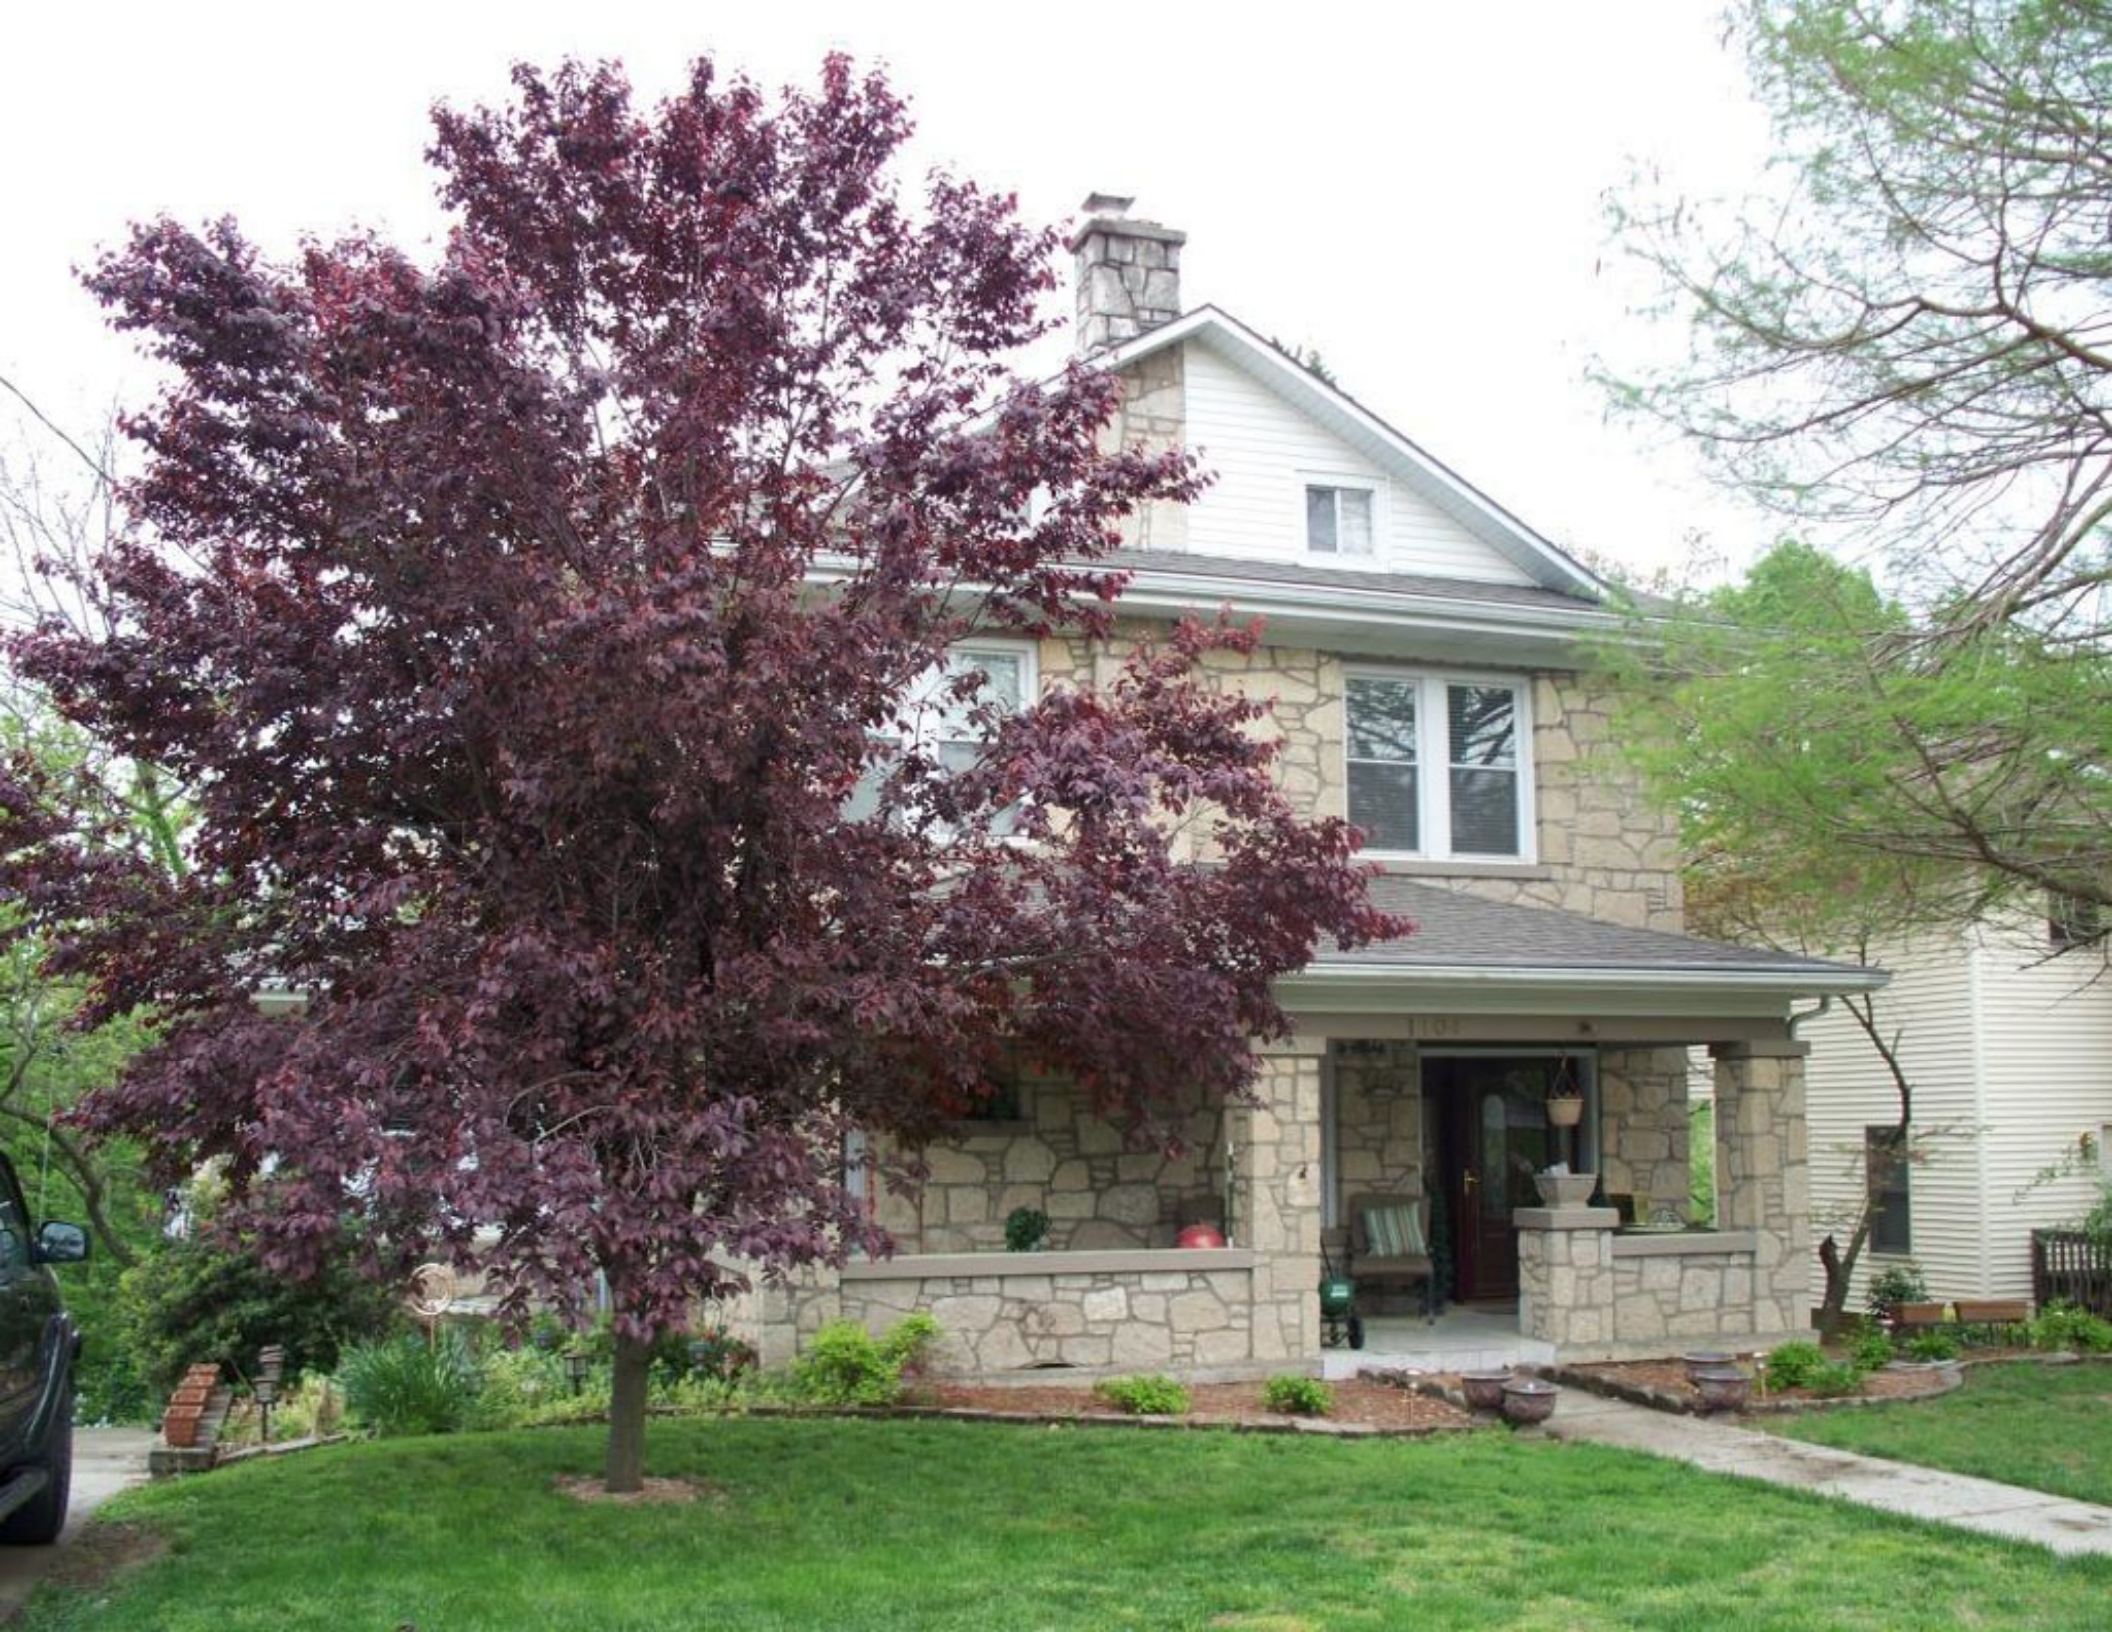
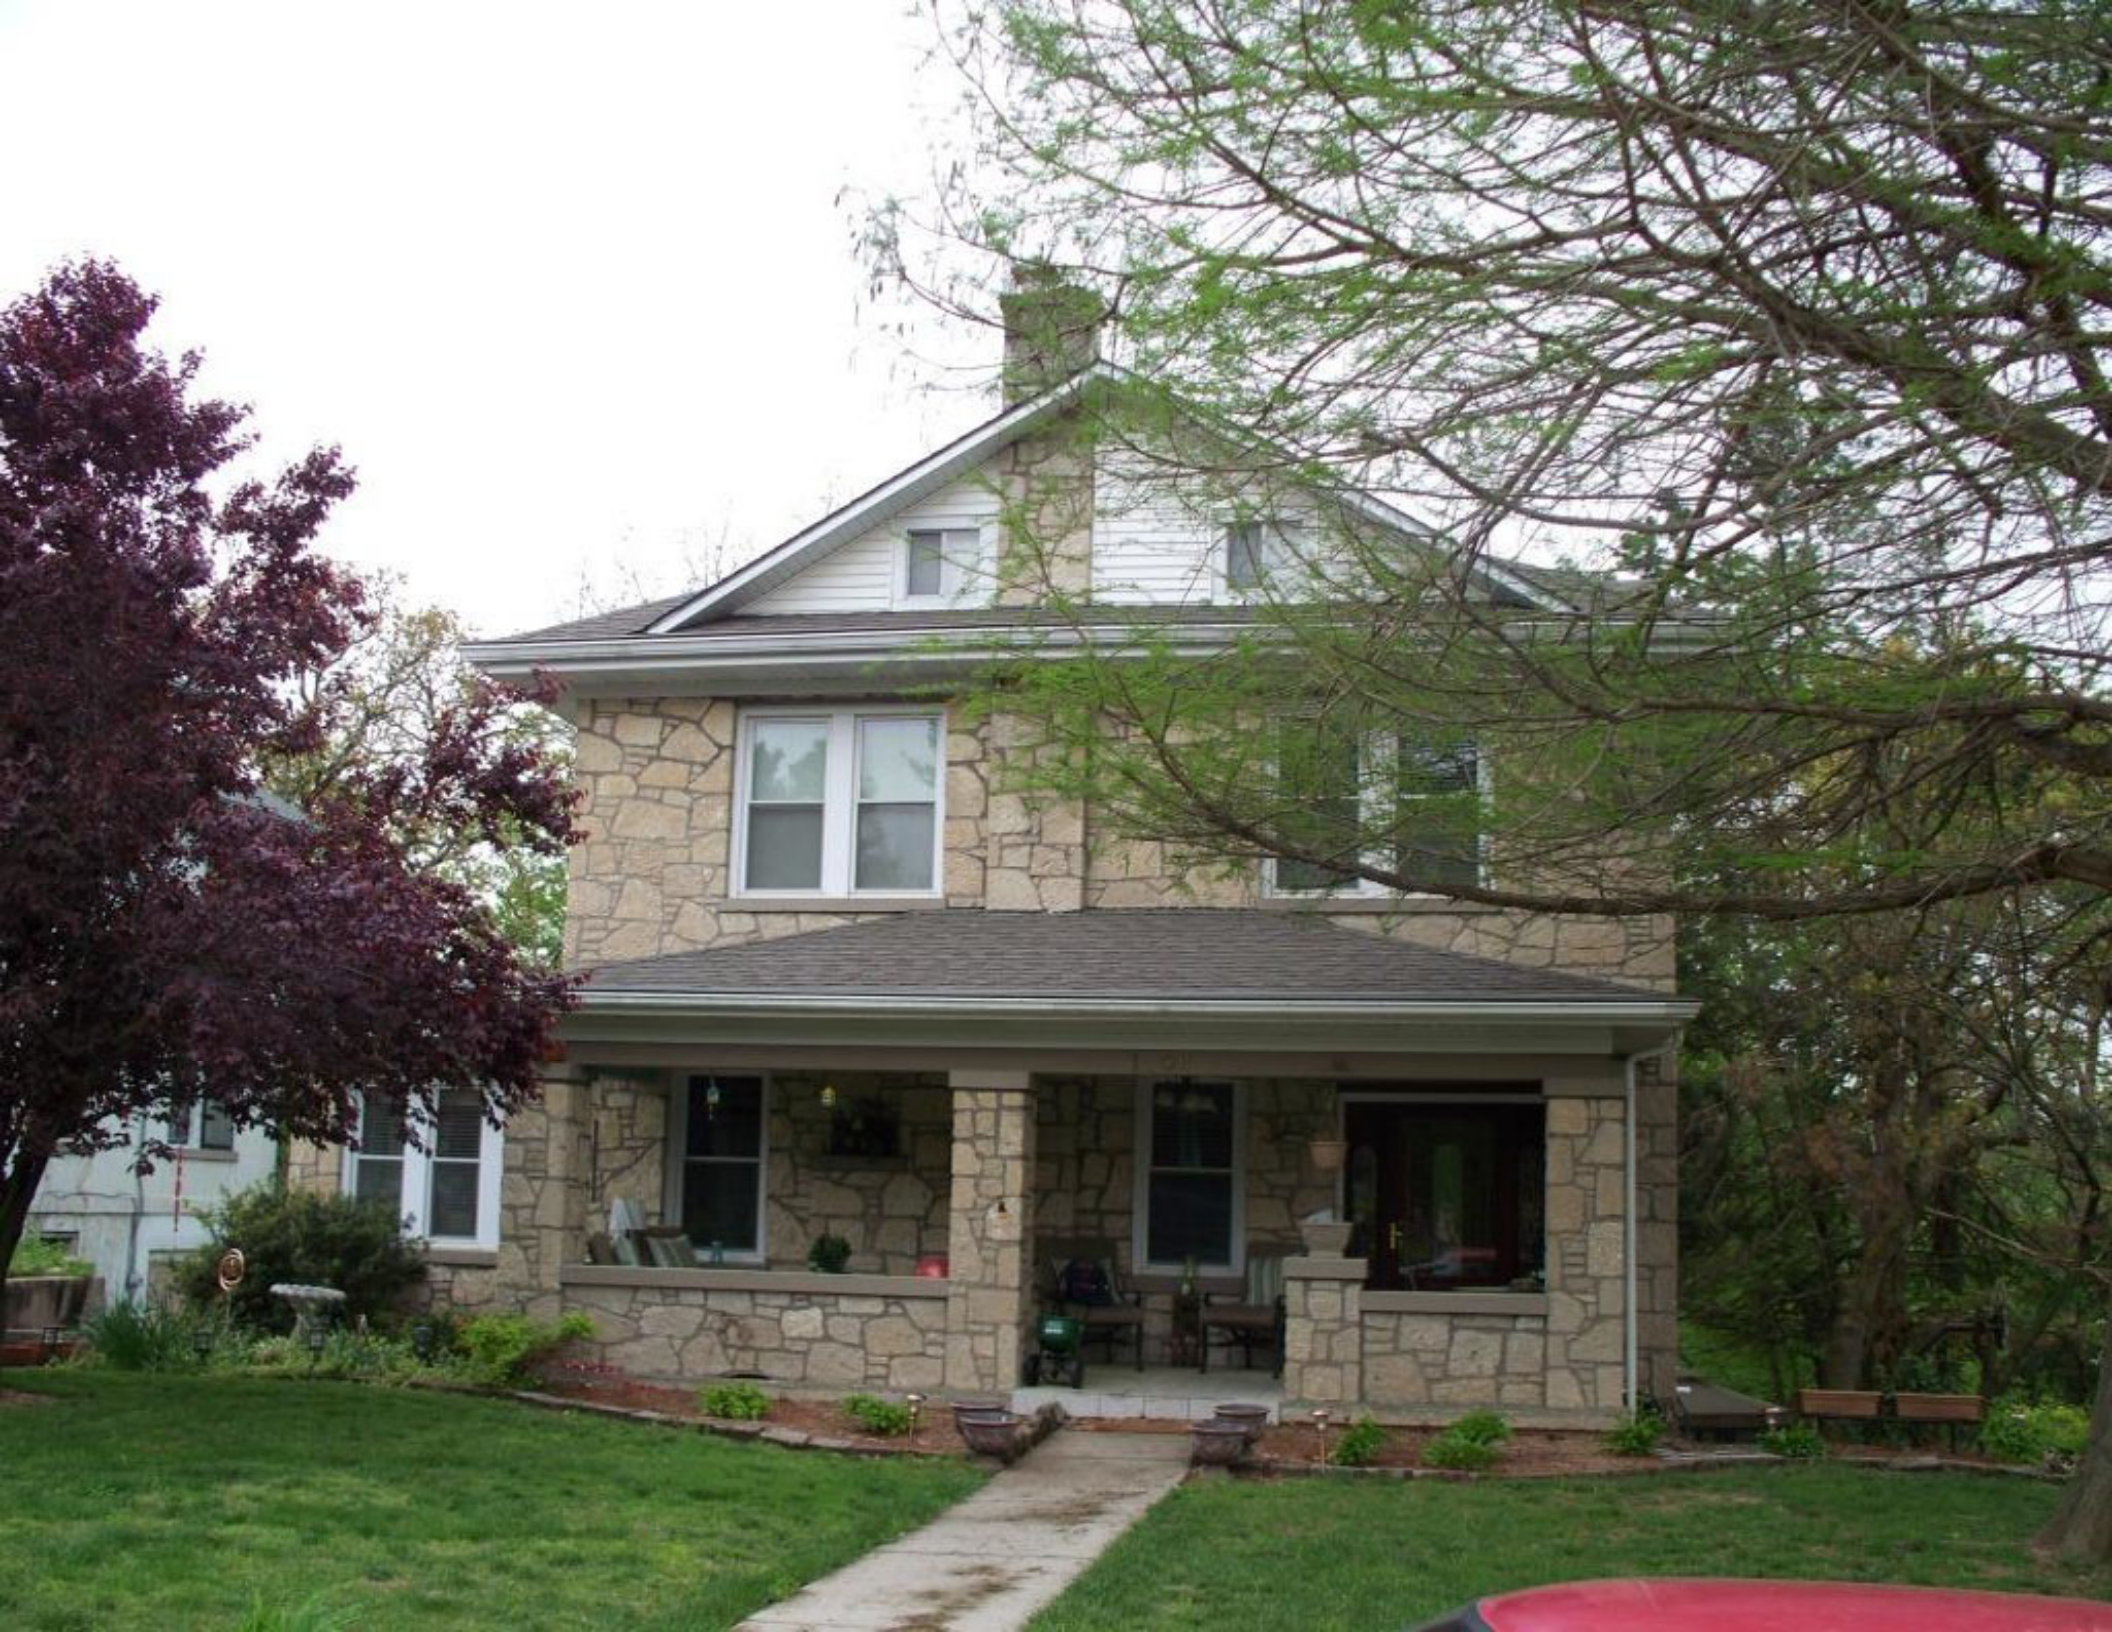
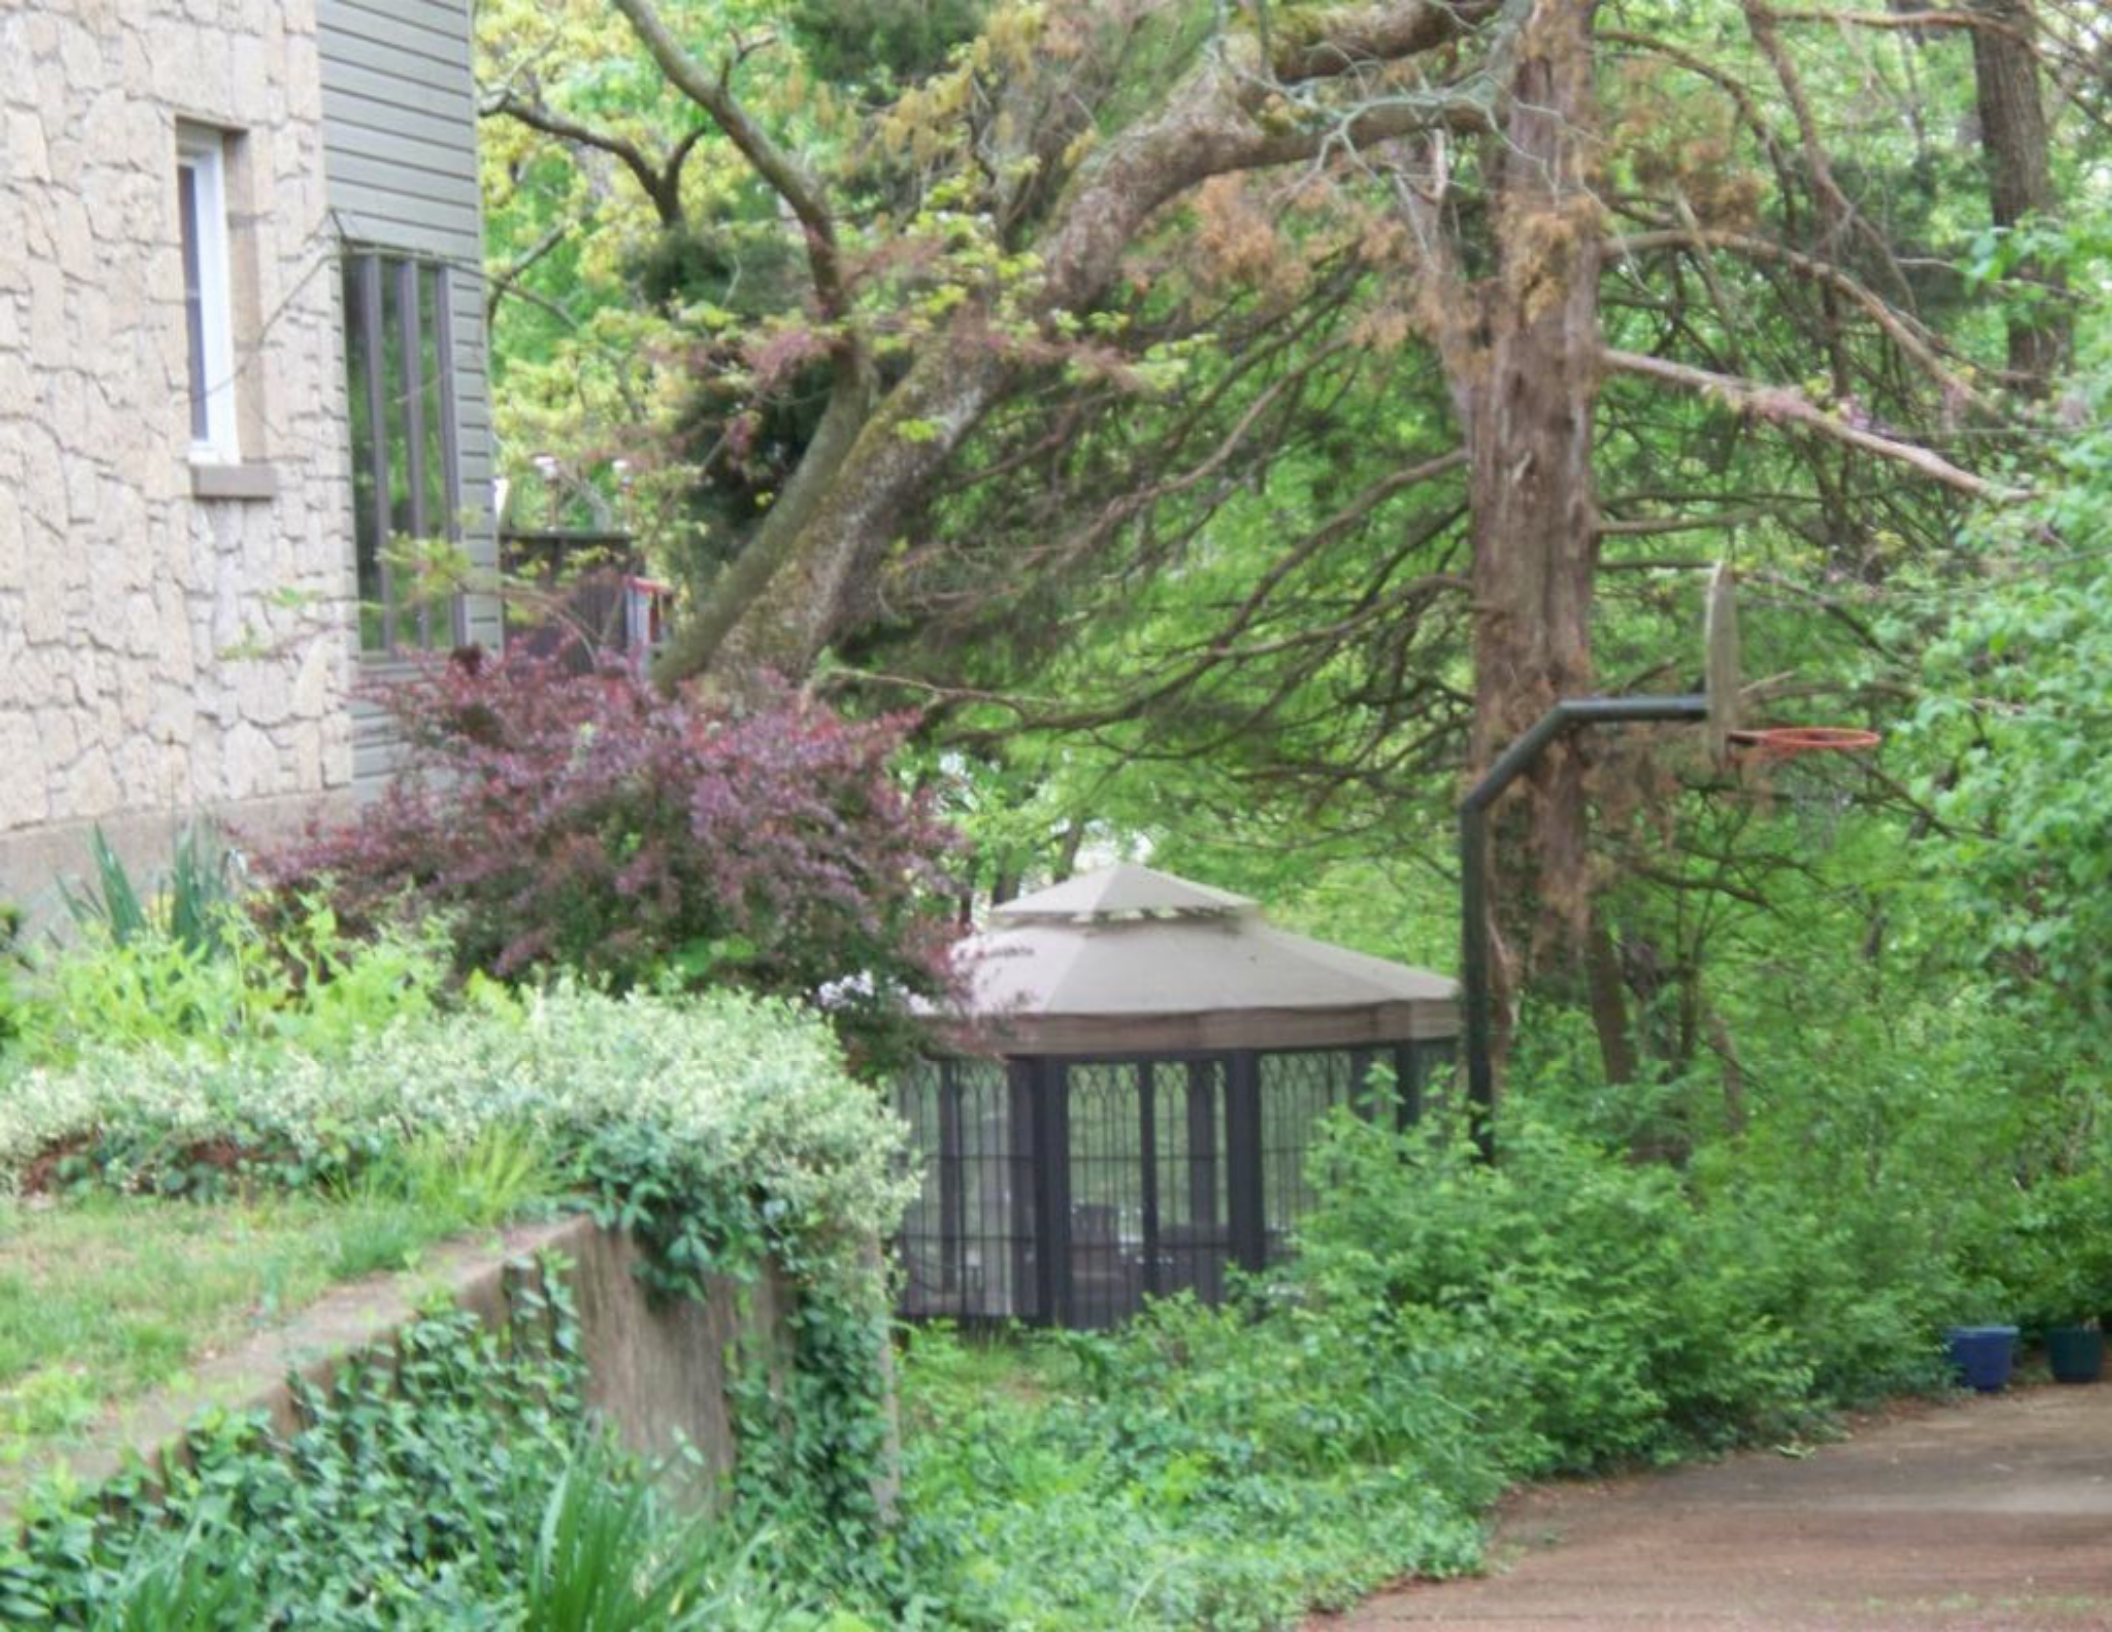
40. (cont.) Description of environment and outbuildings. Expand box as necessary, or add continuation pages.
There is a modern gazebo set back on the right side of the property. It is considered non-contributing.

41. (cont.)
This 2 ½ story stone home has a gable on hip roof. The center front gable is clad in vinyl and contains part of the stone chimney and two 1 by 1 casement windows that appear modern. It's possible the gable was a later addition. The second floor has two paired 1/1 replacement windows. The porch has a hipped roof with wide eaves supported by an entablature and stone piers capped in concrete. The porch features stone half walls also capped in concrete. The opening is in the center bay with a full pier on the left and a half pier on the right. The first floor has a 1/1 replacement window in the left and center bays. The entrance is in the right and appears to retain its historic sidelights and wooden door. A one story sun room is on the left side of the property and has paired 1/1 replacement windows.
