ARCHITECTURAL/HISTORIC INVENTORY FORM

1. Survey No. CO-AS-005-001		2. Survey name: Moreau Drive Neighborhood Survey	
3. County: Cole		4. Address: 1202 Elmerine Ave.	
5. City: Jefferson City	Vicinity: <input type="checkbox"/>	6. UTM: / /	7. Township/Range/Section: T: R: S:
8. Historic name (if known):		9. Present/other name (if known):	
10. Ownership: <input checked="" type="checkbox"/> Private <input type="checkbox"/> Public		11. Historic use (if known): Residential	11. Current use: Residential

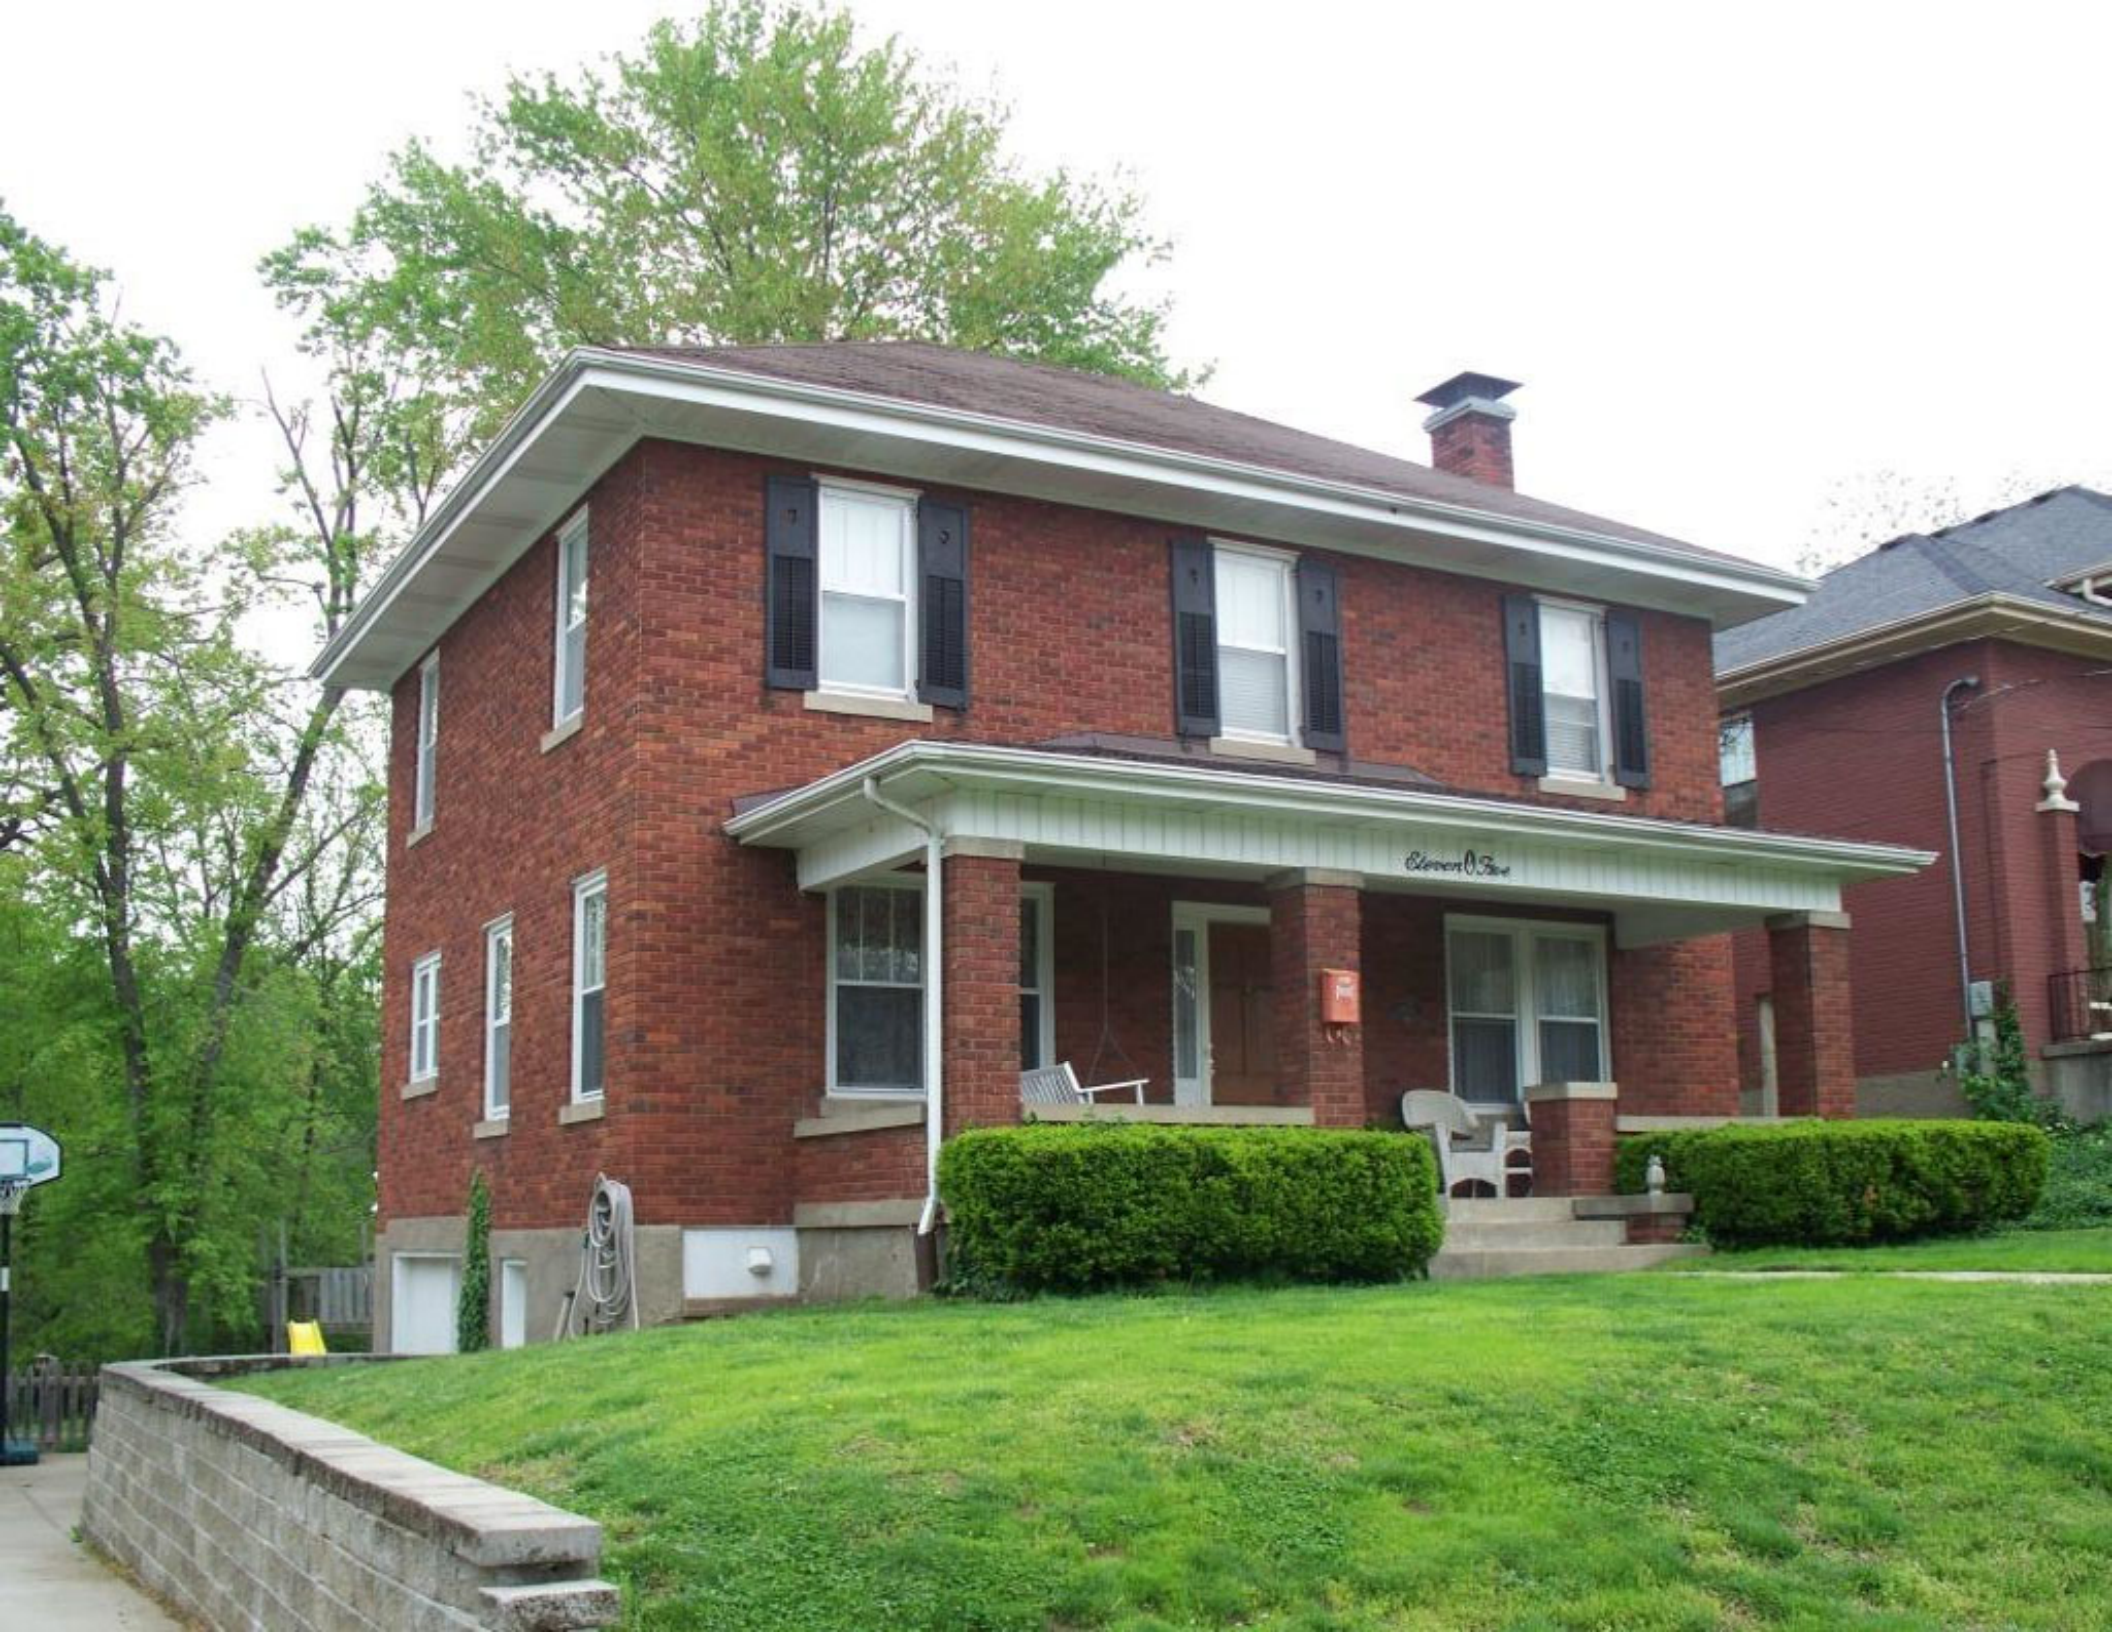
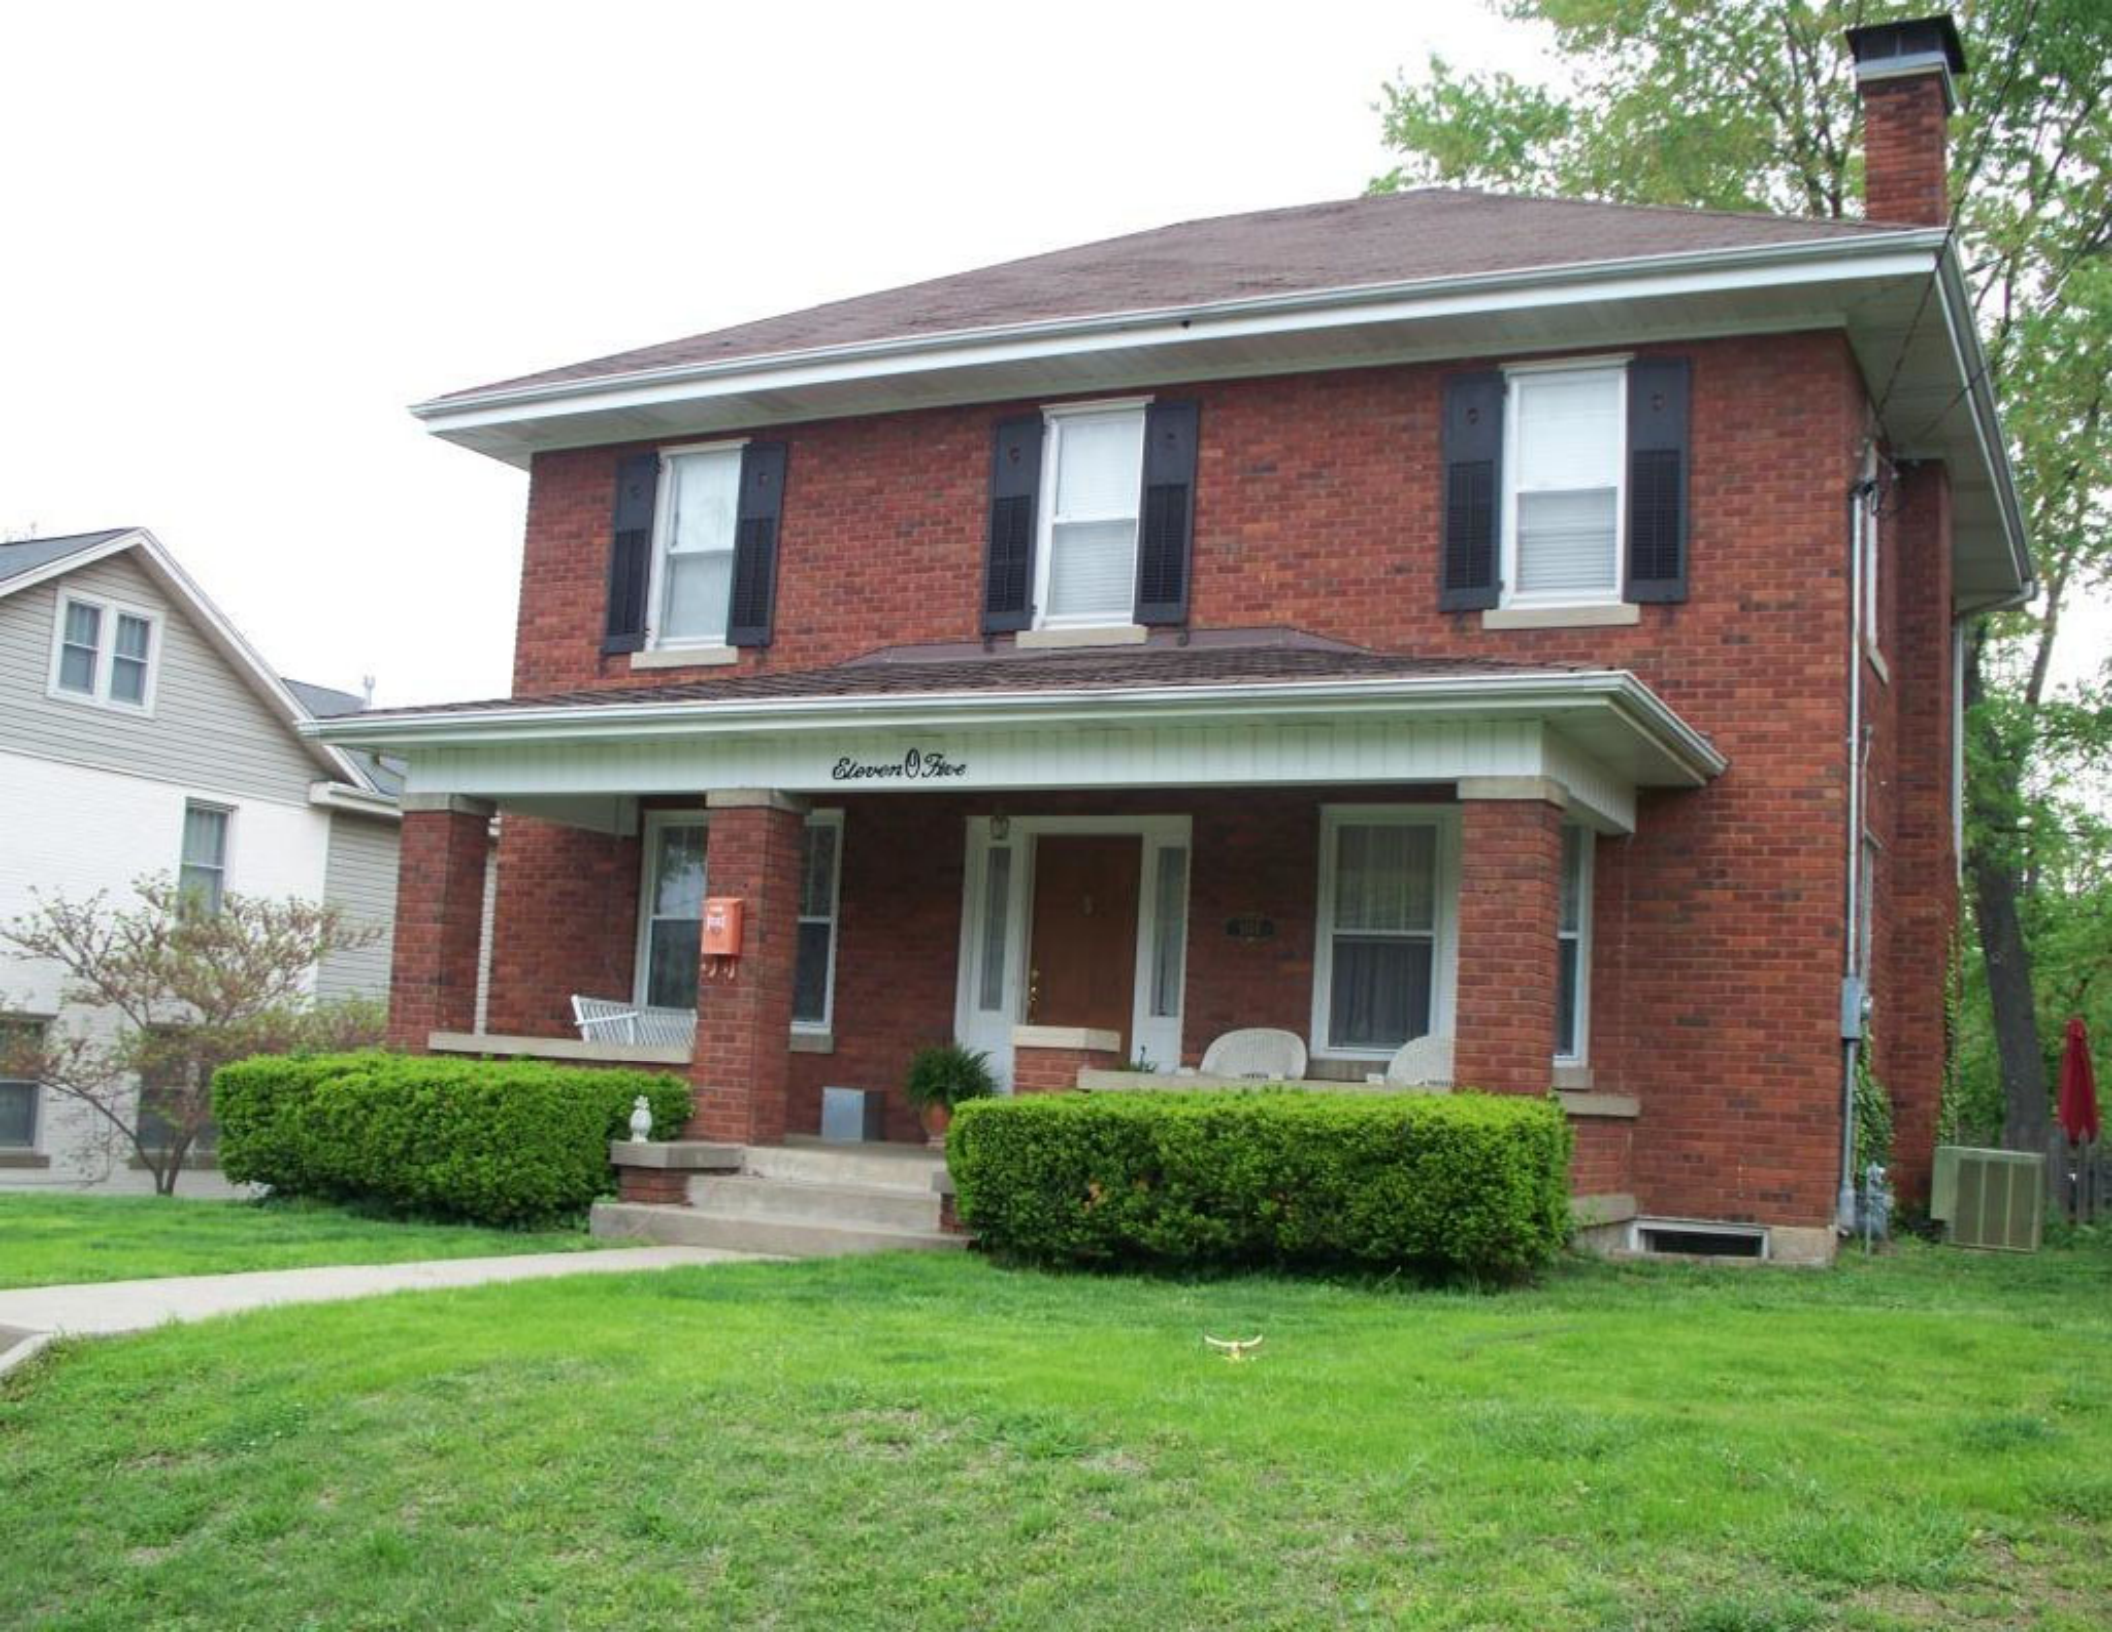
This two story brick property has a hipped roof with wide eaves. There are three 3/1 historic windows on the second floor with shutters with a decorative acorn or shield motif cut-out. The first floor has two pairs of paired 3/1 windows flanking the entrance. All of the windows have concrete sills. The entrance has a wooden door that may be replacement and features sidelights. A shallow hipped roof flares out to almost flat with wide eaves on the first floor and sits on a vinyl-clad entablature supported by brick piers capped in concrete. Brick half walls also capped in concrete make up the rest of the porch, which spans out over $\frac{3}{4}$ of the façade. The porch is entered through a small set of concrete steps with brick knee walls capped in concrete. The wide eaves of the porch and roof plus the horizontal use of the windows suggest a Prairie influence, however the symmetrical setting of the windows and shutters suggest Colonial Revival. This is one of those properties that sits somewhere in between the two.

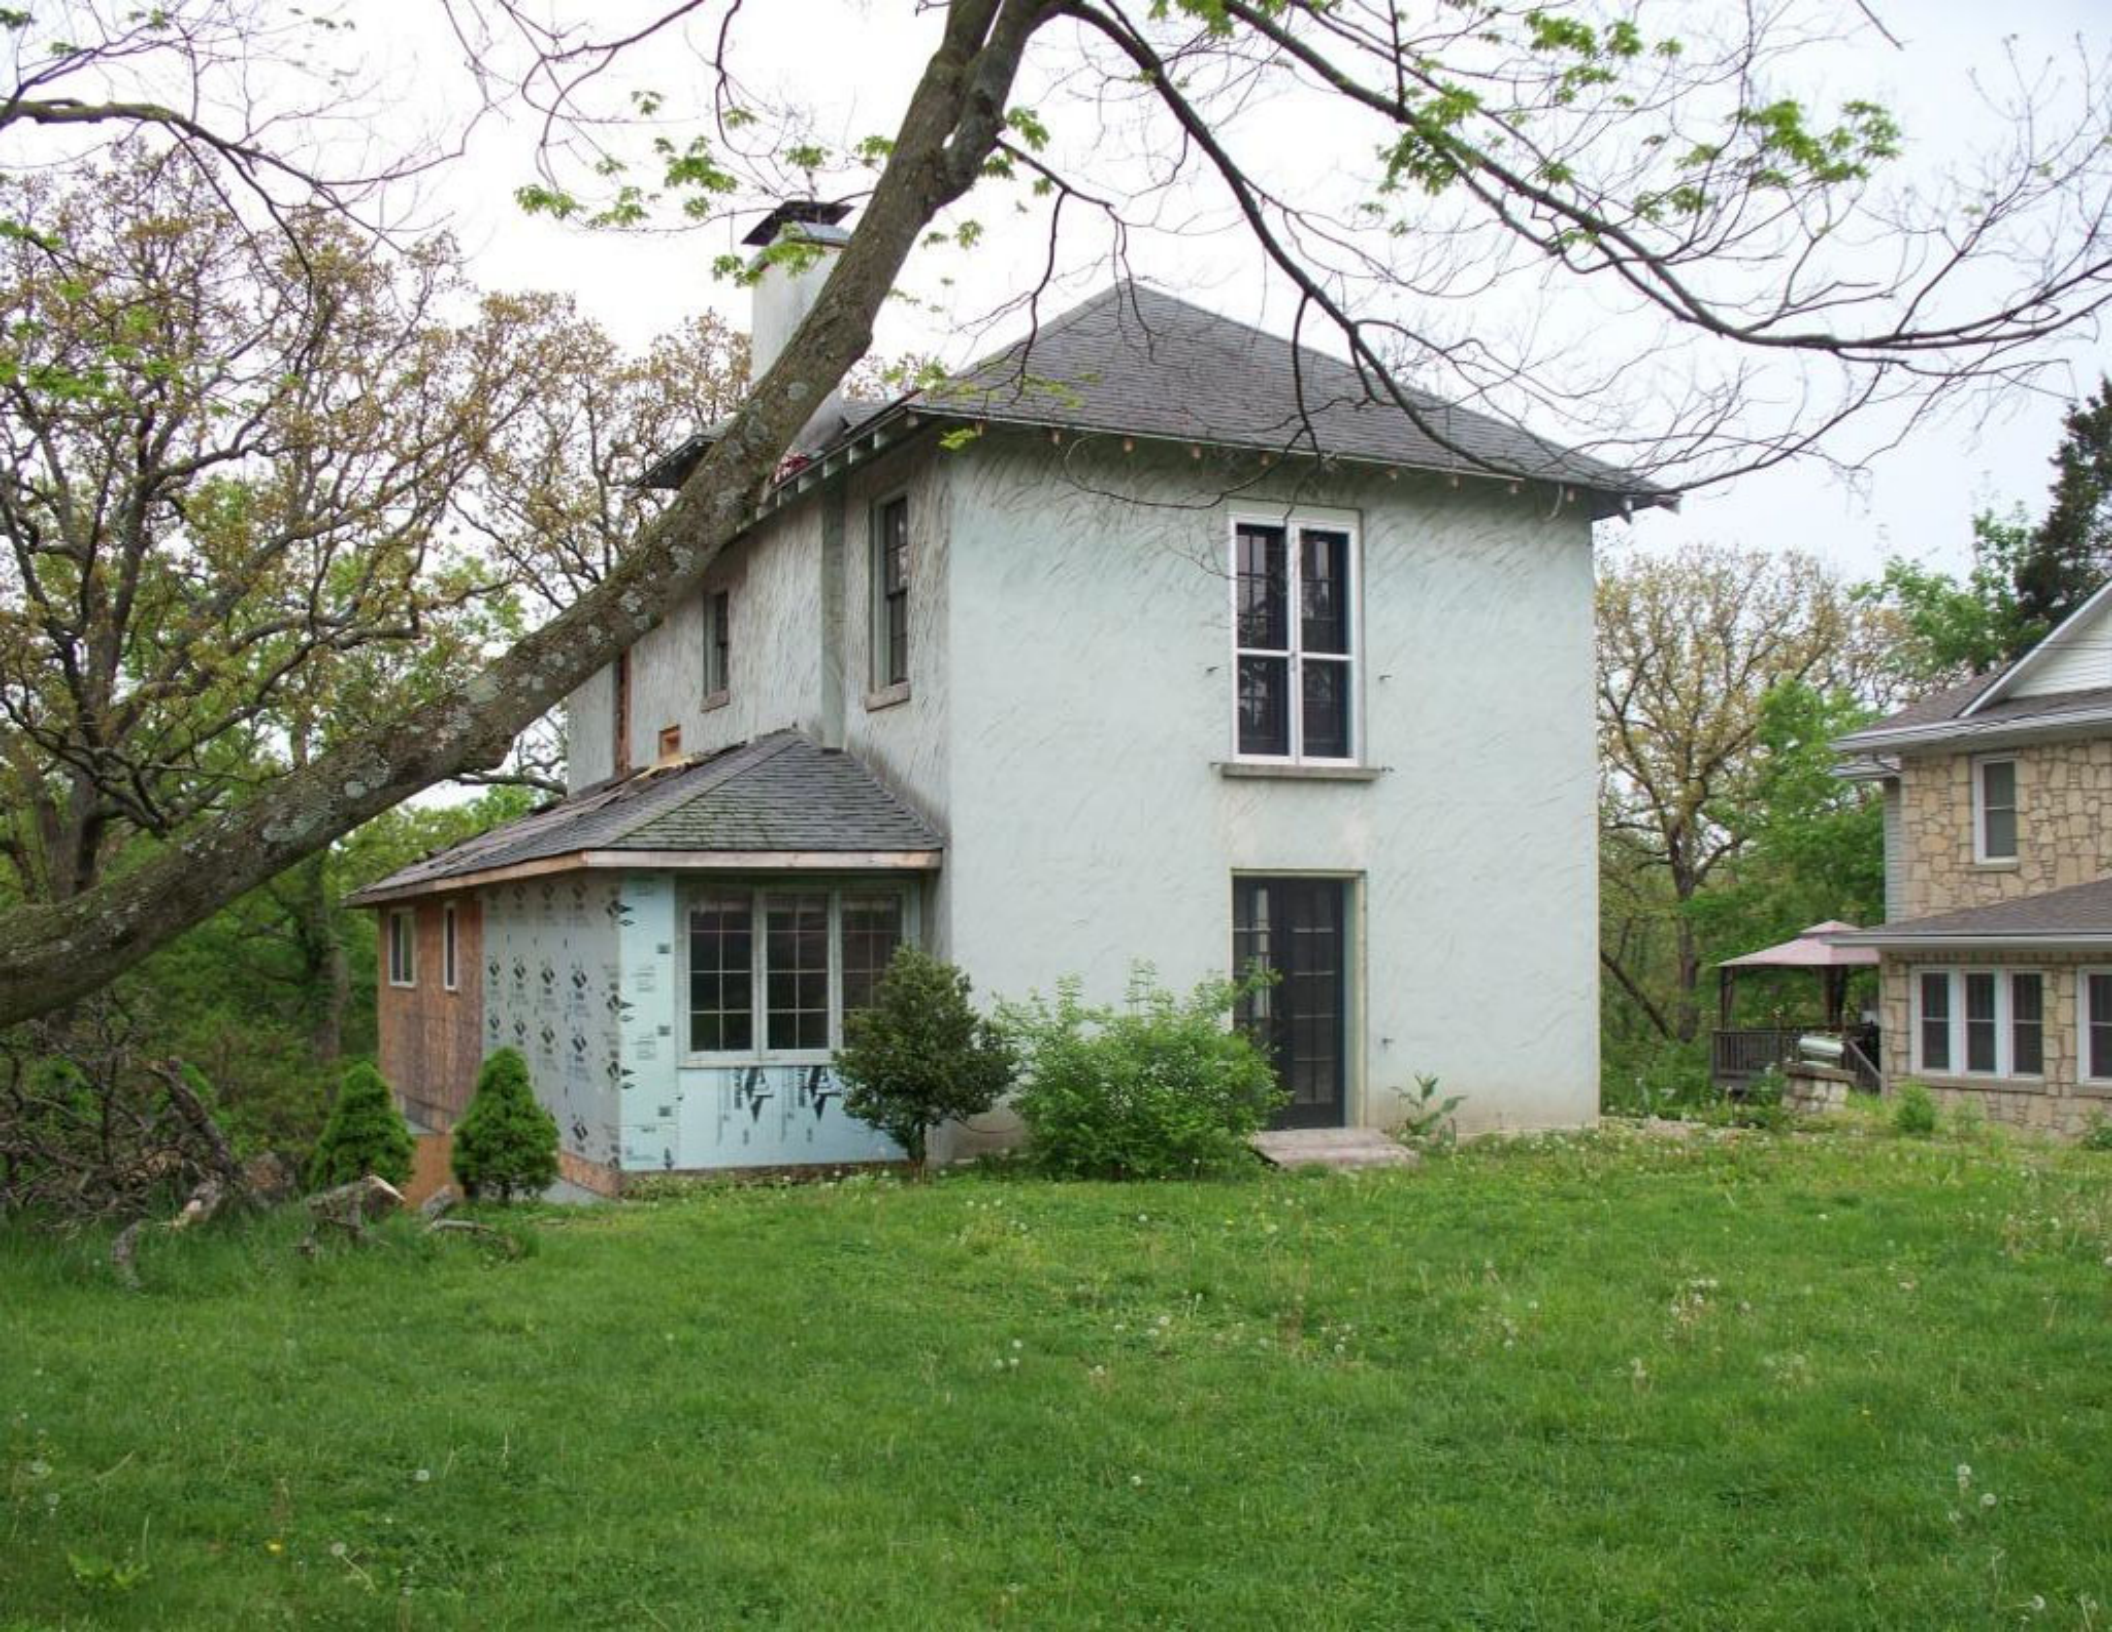
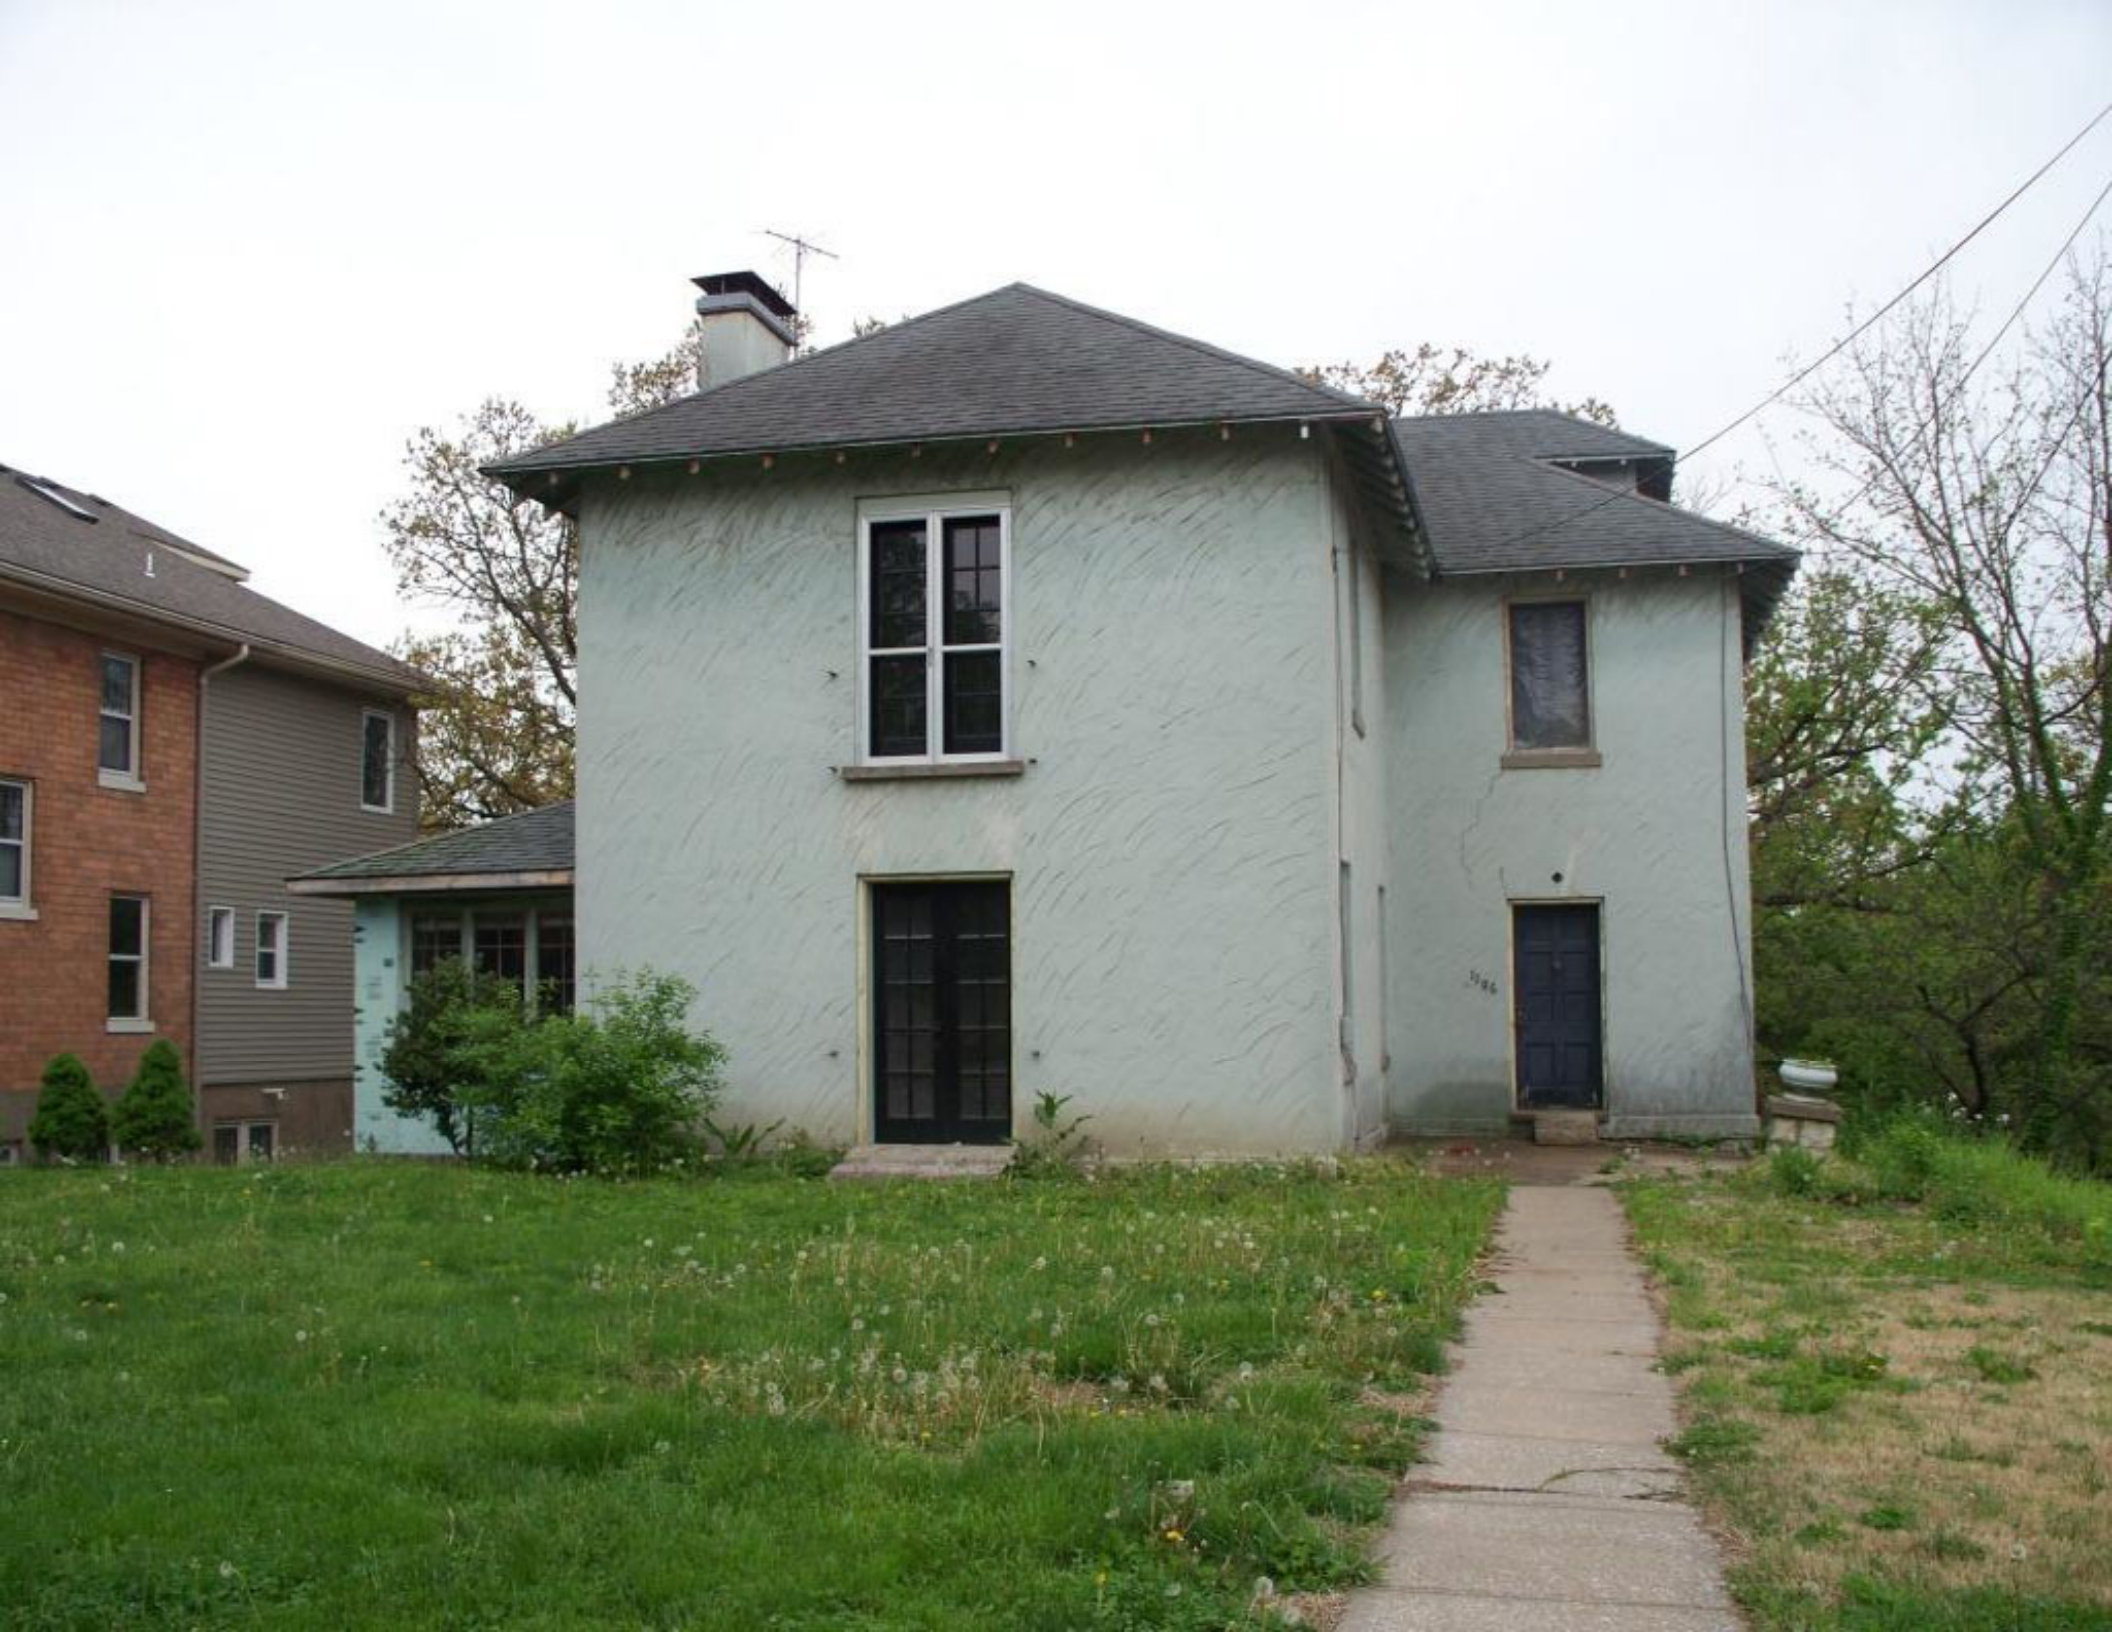
At the time of this survey the property appeared to be in the middle of repair from fire damage. The two story property is clad in textured stucco and has a cross hipped roof with exposed rafter tails. The central portion of this house is one bay wide with multi-light French doors (possibly historic) with modern storms on the second floor with a concrete or stone sill. Below it on the first floor are identical French doors. Set two bays back on the right side is the entrance. The door is paneled and may or may not be historic, above it is a single window that was obscured by plastic sheeting. A side hipped roof extends over this portion of the home. A one story sun room with a hipped roof is slightly set back from the façade on the left side of the property. It has a row of three modern windows. This appears to be an addition as it does not appear on the Sanborn maps. Depending on when the stucco was applied the property is currently considered non-contributing to a potential historic district.

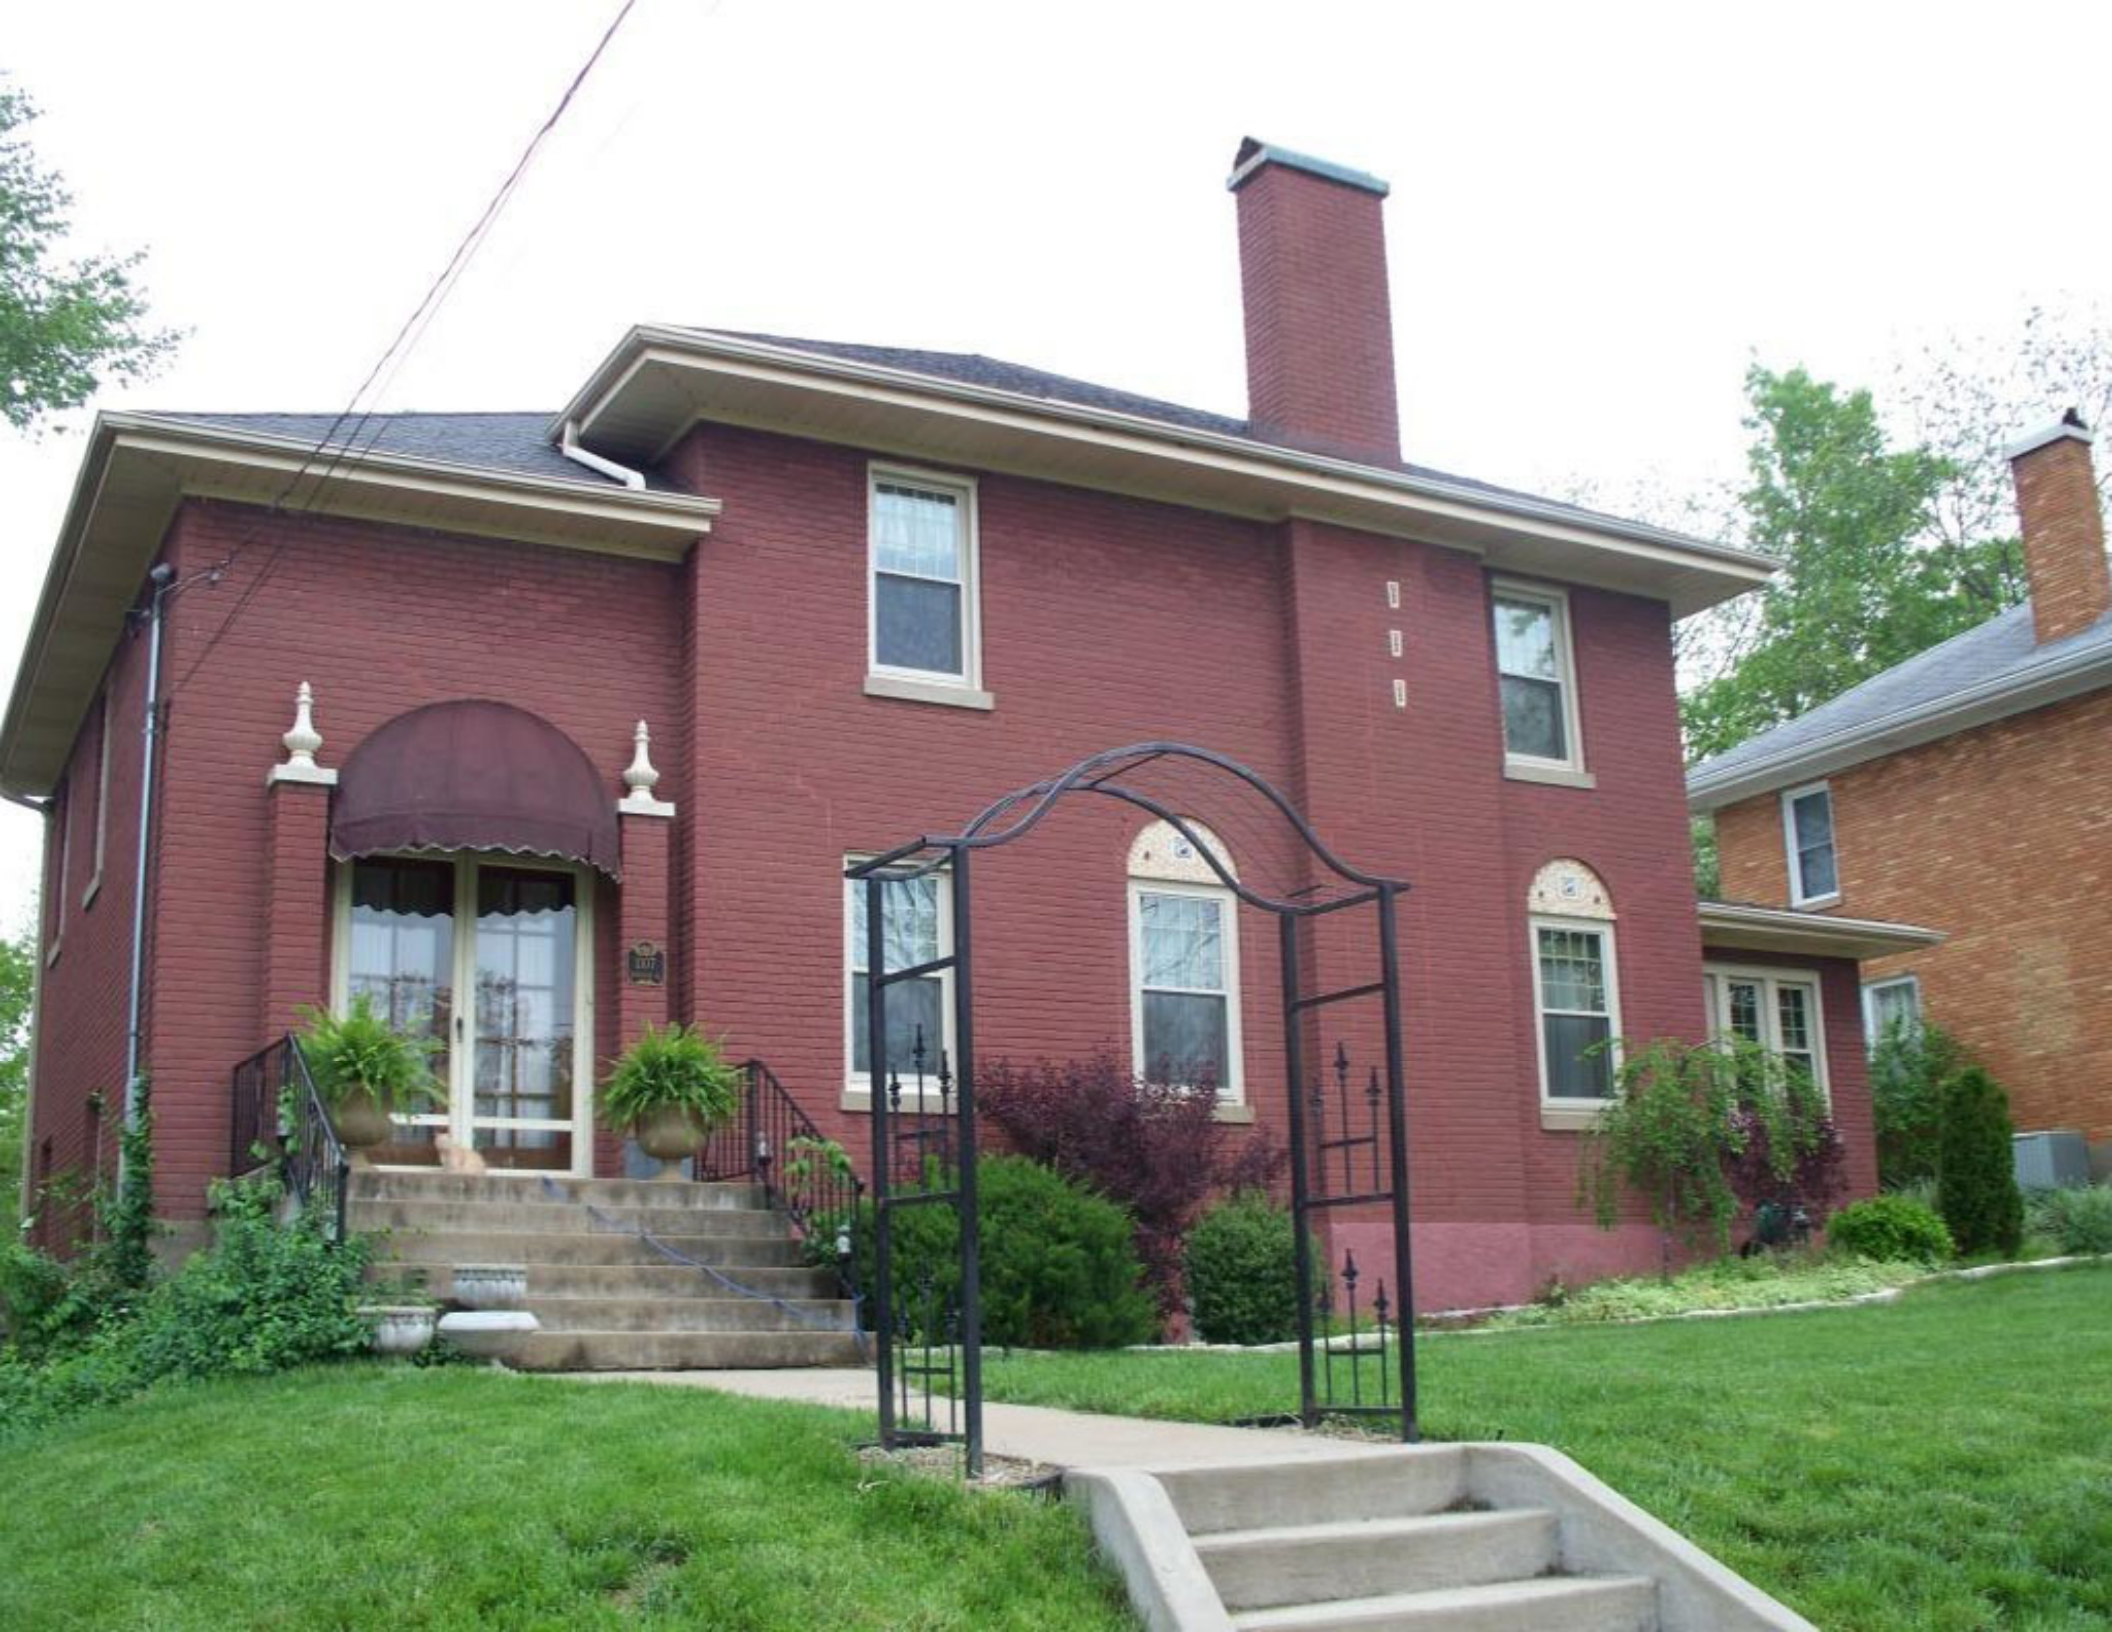
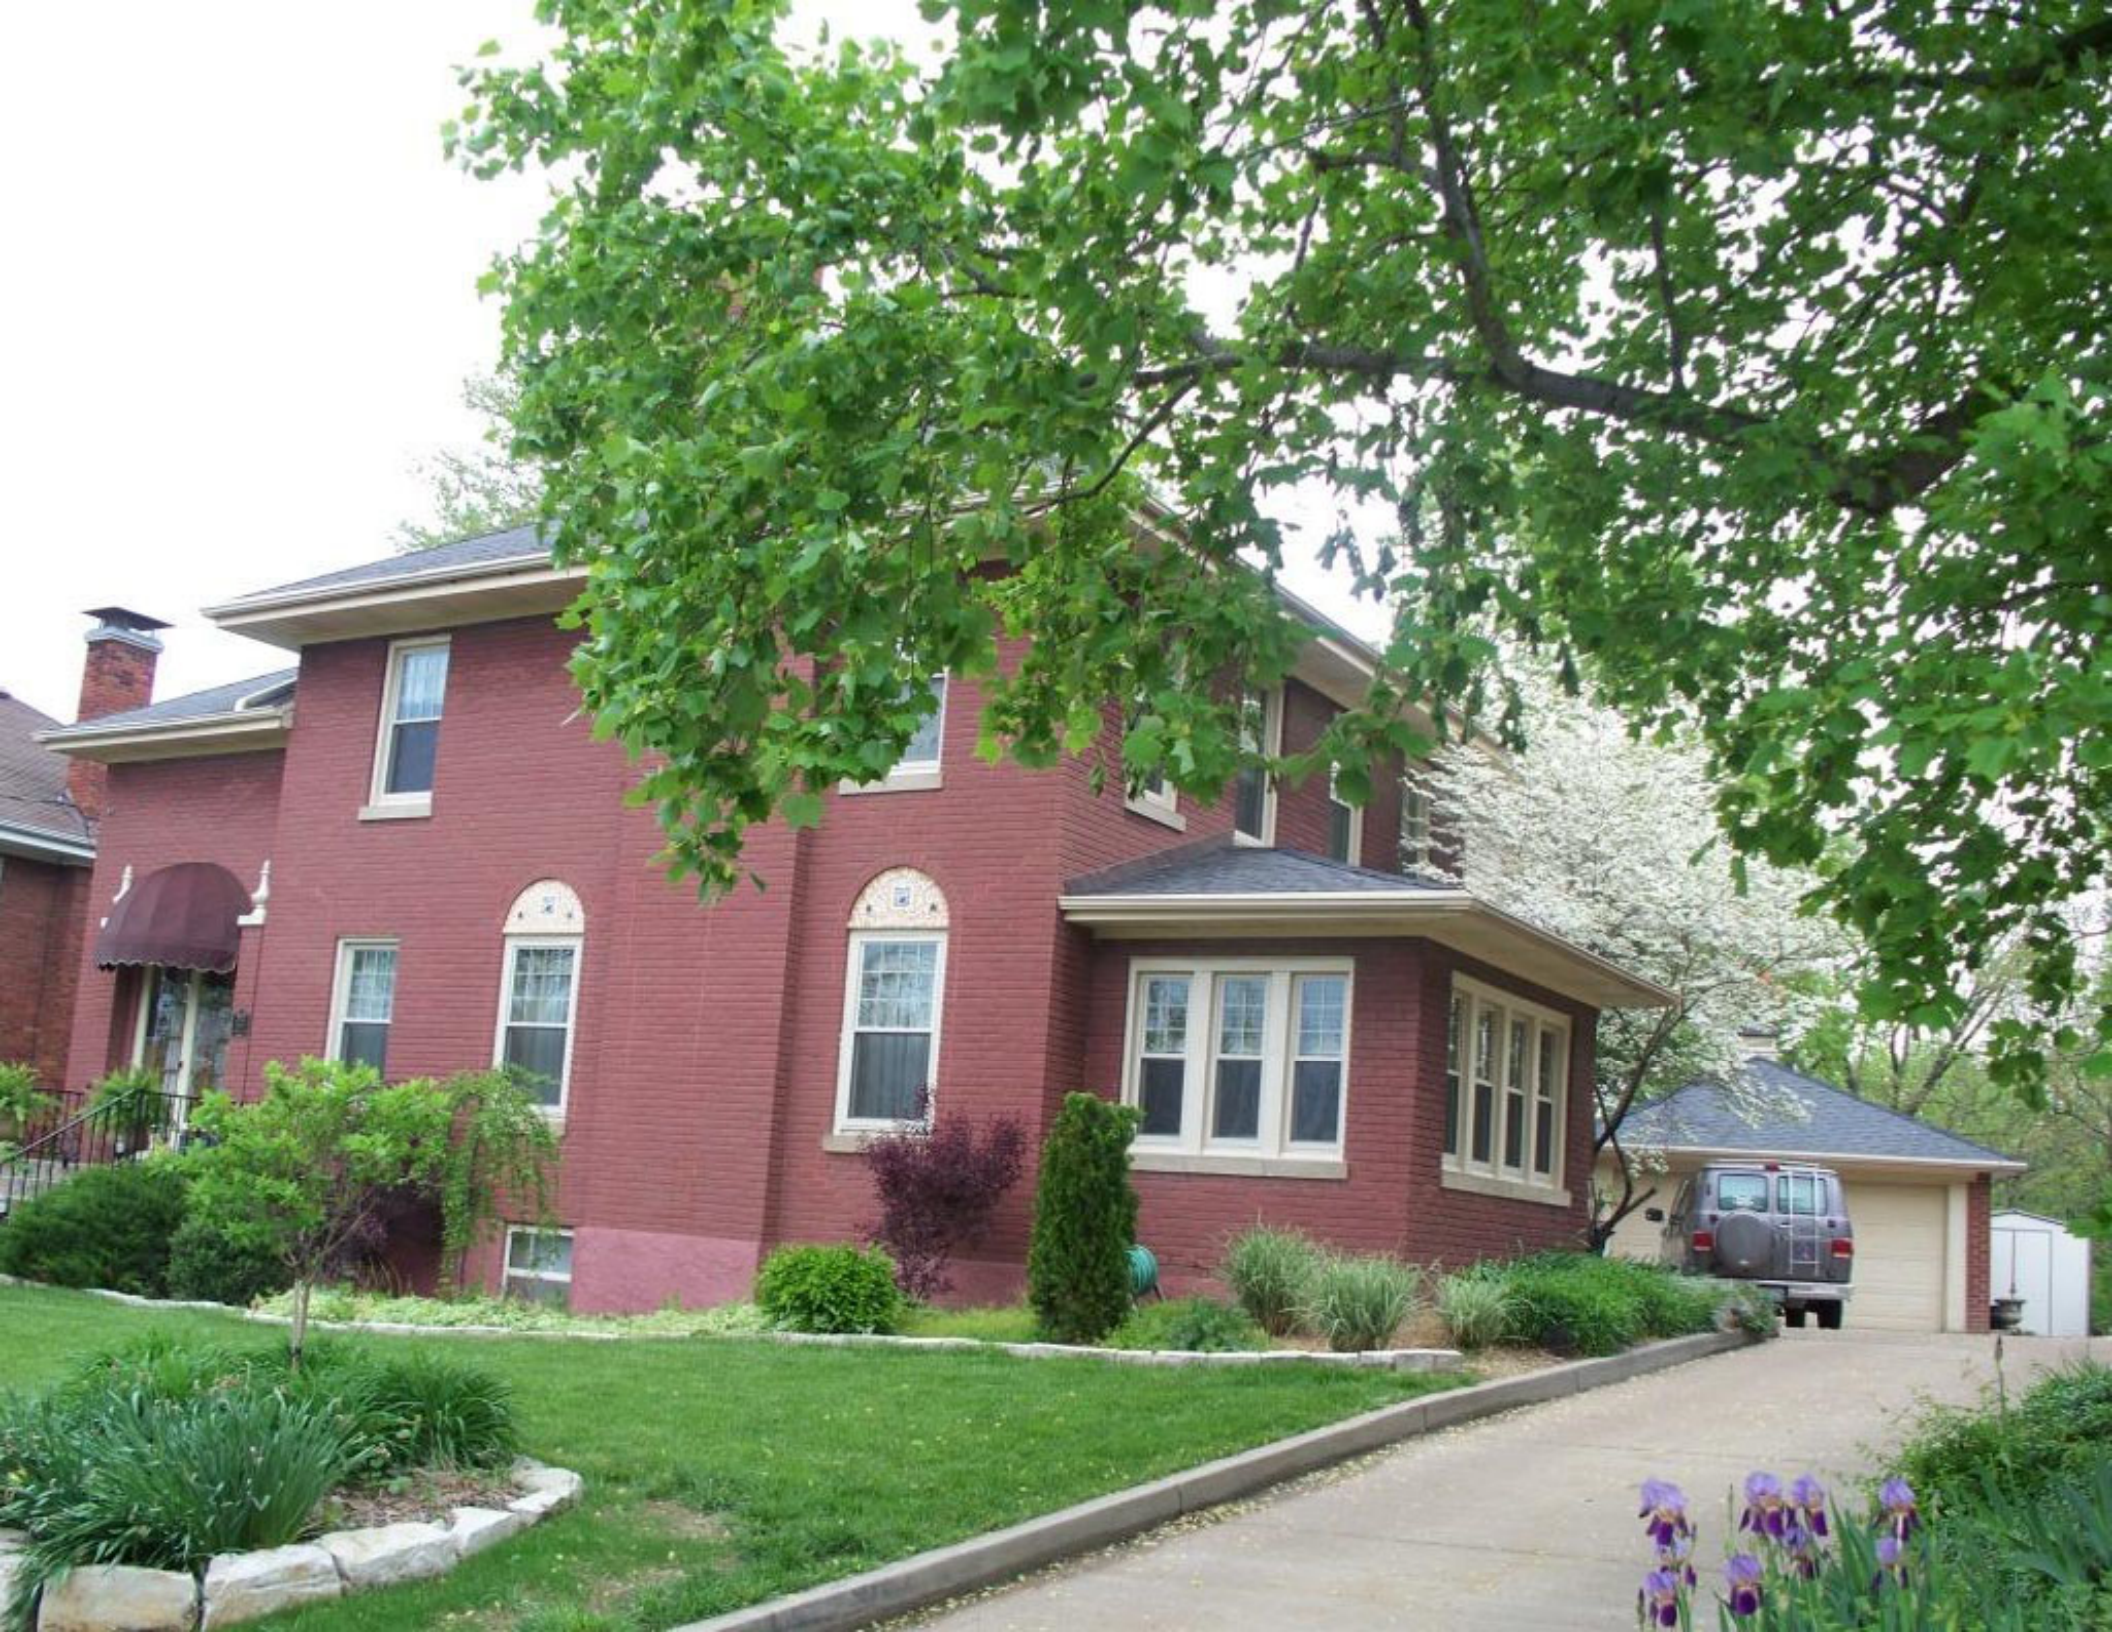
40. (cont.) Description of environment and outbuildings. Expand box as necessary, or add continuation pages.
There is a two-car brick garage with a pyramidal roof behind the property. It has one large door and possibly a cupola (obscured by vegetation).
Although it does not appear on the Sanborn maps it may be within the period of significance. More research is necessary.

41. (cont.)
This two story brick property has a tiered hipped roof with wide eaves. The left bay sits slightly lower and back. The upper story of this bay is blind but the first floor contains the entrance, which consists of multi-light paired French doors (may be historic) that are bracketed by two projecting piers capped with decorative finals. Over the entrance is a domed cloth awning. A set of concrete stairs with metal railing leads up to the entrance. The main portion of the house (center and right bays) has asymmetrical fenestration and, as noted before, projects and is slightly higher than the left bay. From the left, the upper story has two 12/1 windows with concrete sills set far from each other. They are divided by the chimney, which is offset to the right. The lower floor has a single 12/1 window (all windows appear to be replacements) with concrete sill, the next bay has an arched brick opening that has been partially in-filled with a decorative mosaic and flat 12/1 window with concrete sill. A similar window is on the other side of the chimney in the fourth bay. Set back on the left of the home is a one story sun room with wide eaves and bands of 6/1 windows. The wide eaves of the property suggest a Prairie Influence, but otherwise this property is difficult to type.
