ARCHITECTURAL/HISTORIC INVENTORY FORM

1. Survey No. CO-AS-005-001		2. Survey name: Moreau Drive Neighborhood Survey	
3. County: Cole		4. Address: 1202 Elmerine Ave.	
5. City: Jefferson City	Vicinity: <input type="checkbox"/>	6. UTM: / /	7. Township/Range/Section: T: R: S:
8. Historic name (if known):		9. Present/other name (if known):	
10. Ownership: <input checked="" type="checkbox"/> Private <input type="checkbox"/> Public		11. Historic use (if known): Residential	11. Current use: Residential

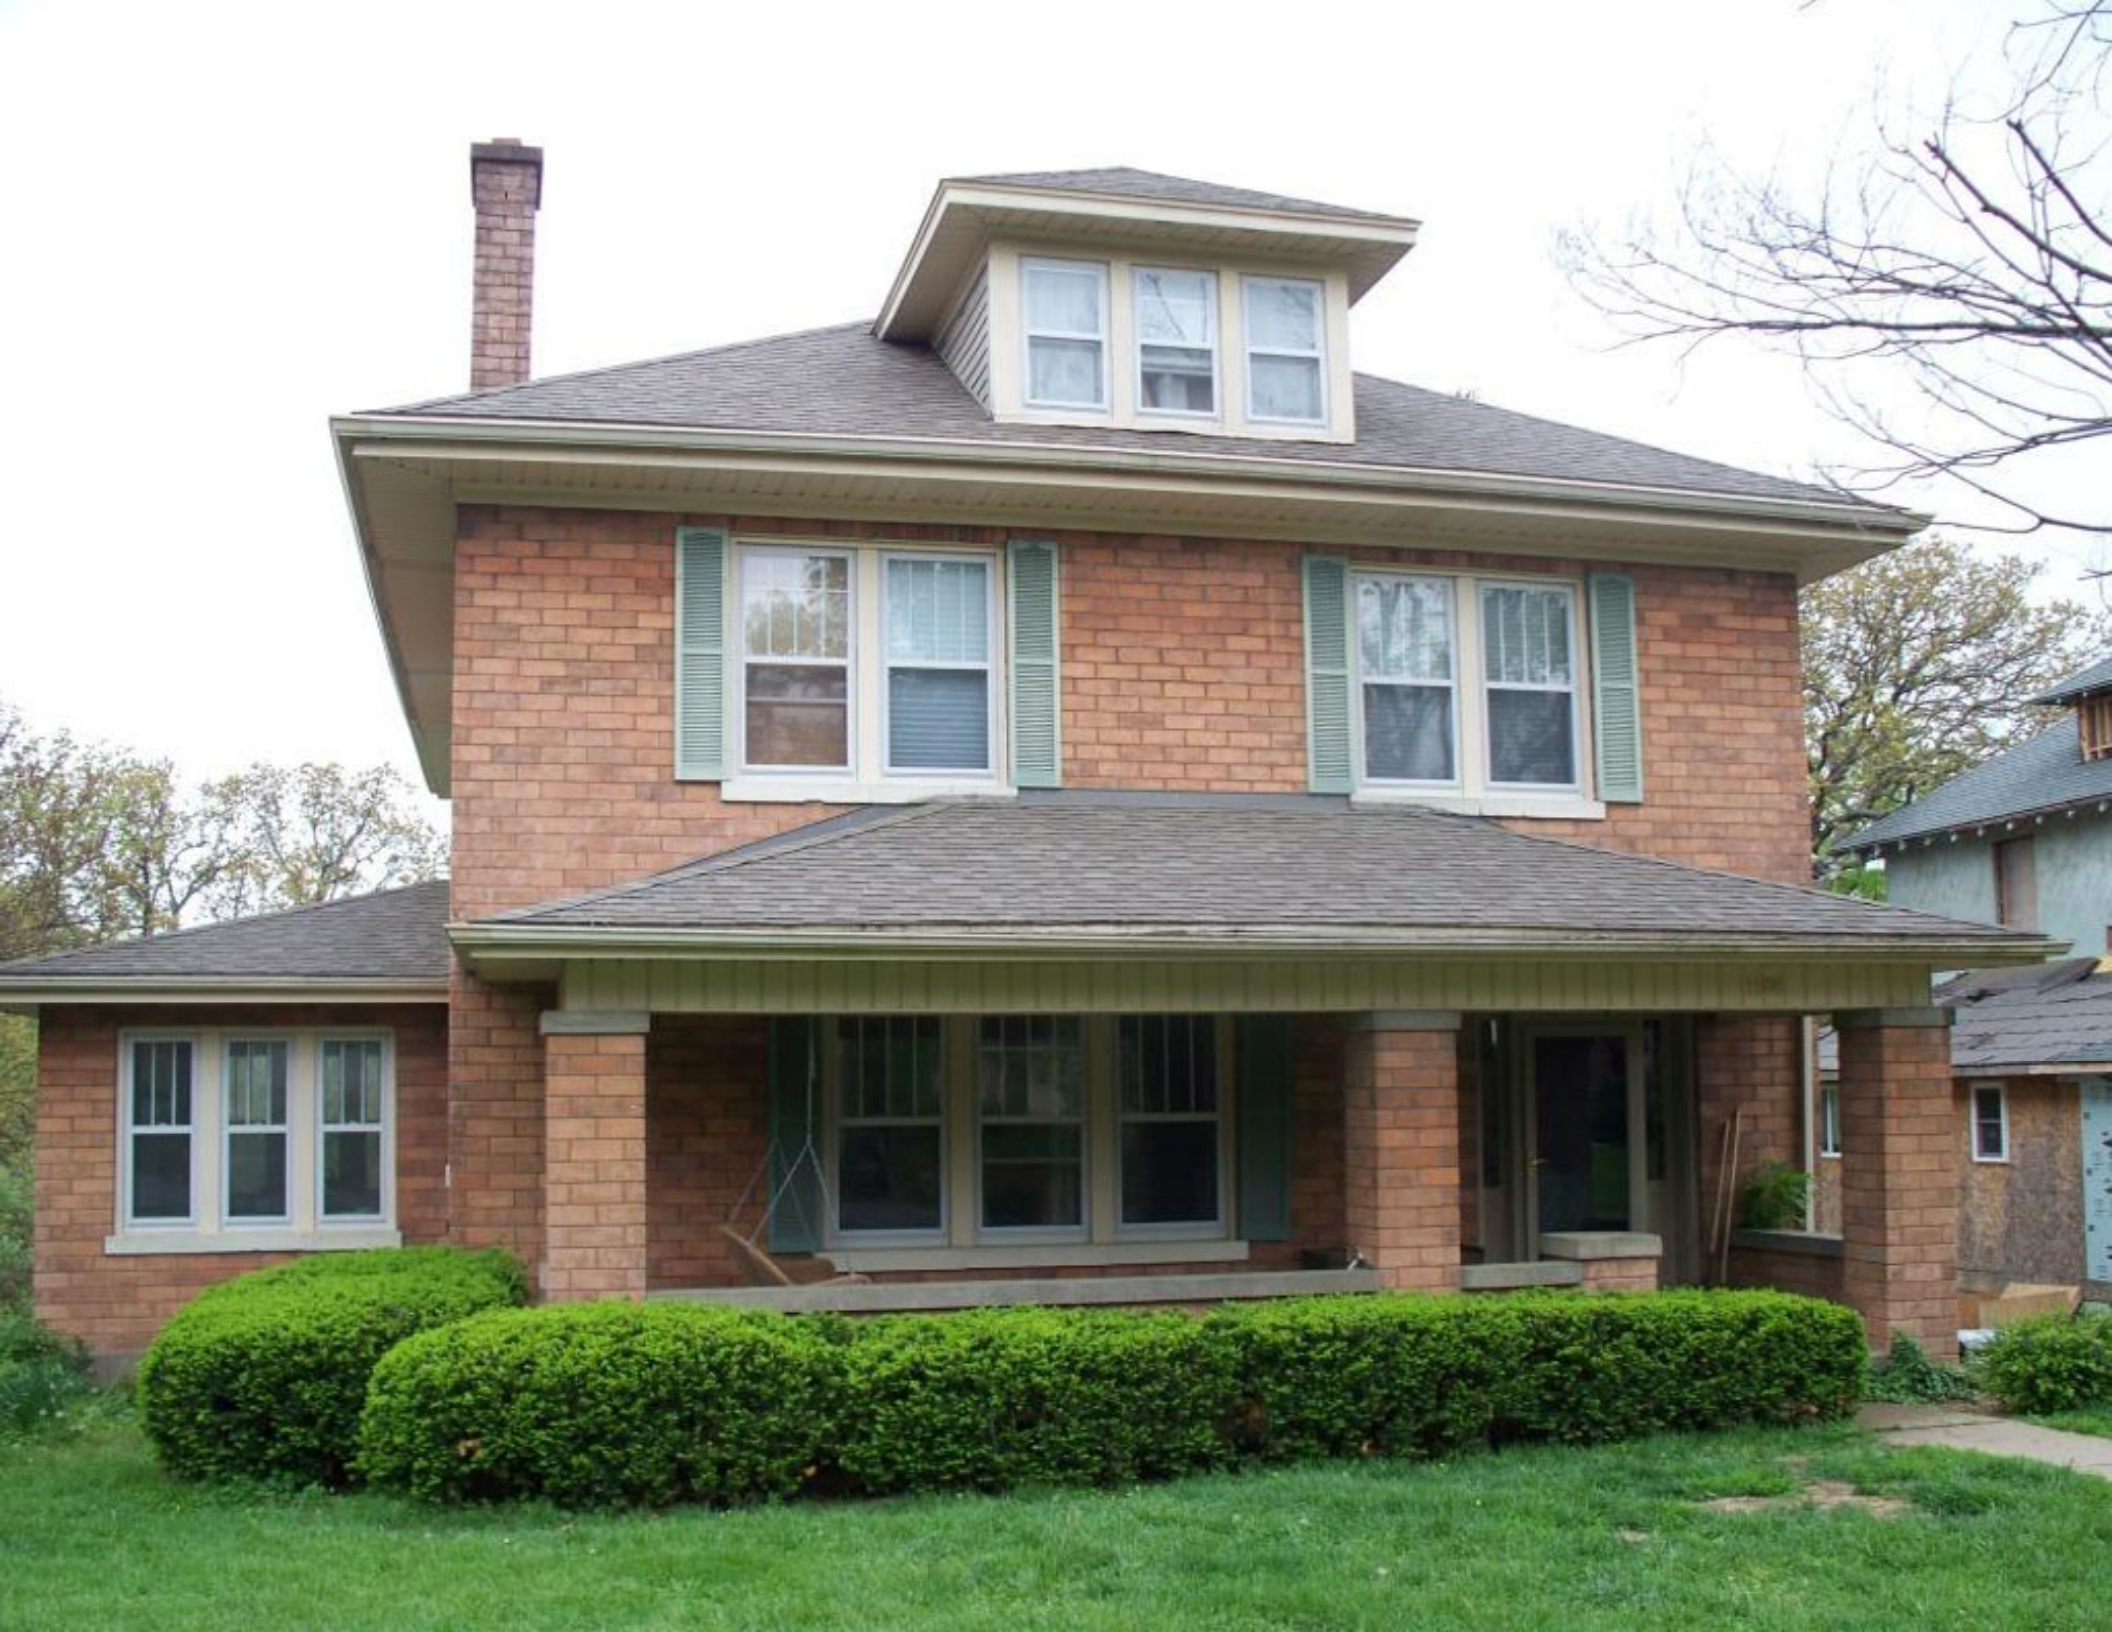
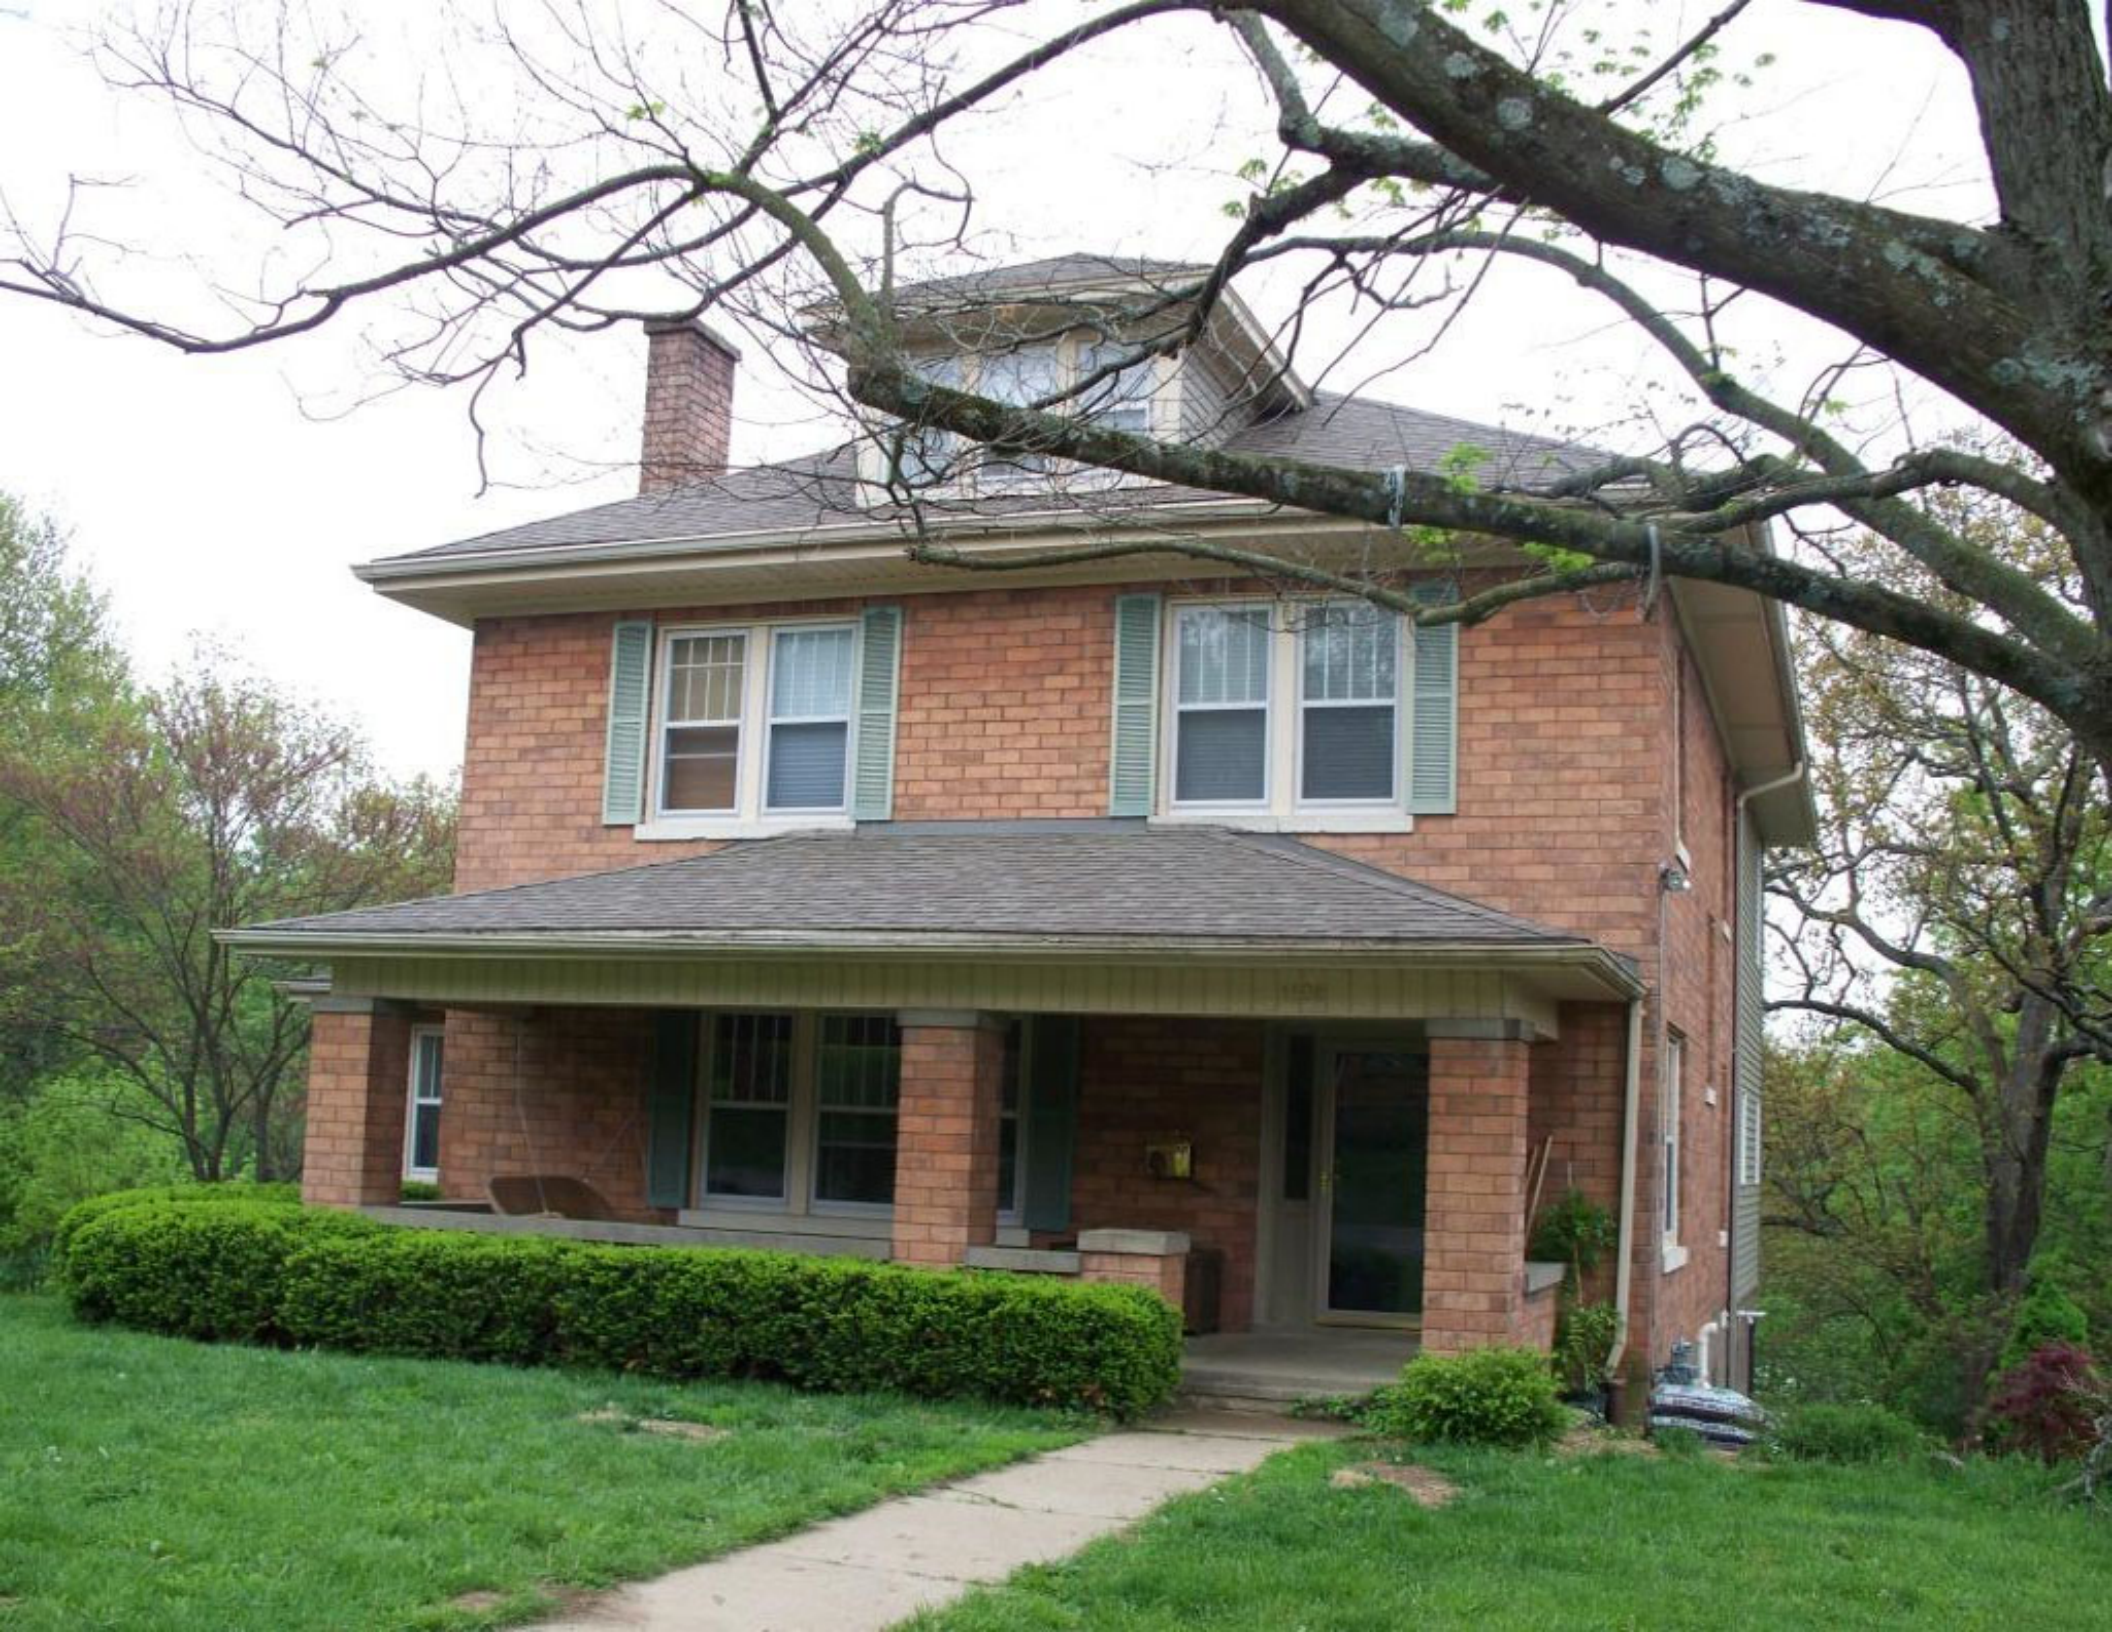
This 2 ½ story Colonial Revival has a hipped roof with wide eaves with a centered hipped gable with a row of three historic 3/1 windows with storms. There are two paired historic 4/1 windows with shutters on the second floor. A full width shed roof with wide eaves covers the porch on the first floor. It sits on what appears to be a wide wood entablature that is supported by brick piers with concrete caps. The porch consists of half walls also capped in concrete with an opening in the right bay in front of the door (obscured by glass storm door), which has historic sidelights. The left bay has a row of three 4/1 historic windows with shutters. There is an additional one story bay set back on the left side of the property that has a hipped roof and a row of three narrow historic 3/1 windows with shutters. All of the windows have concrete sills. Due to the shutters and windows this appears to be more of a Colonial Revival however the wide eaves of the roof and porch roof suggest a Prairie Influence.

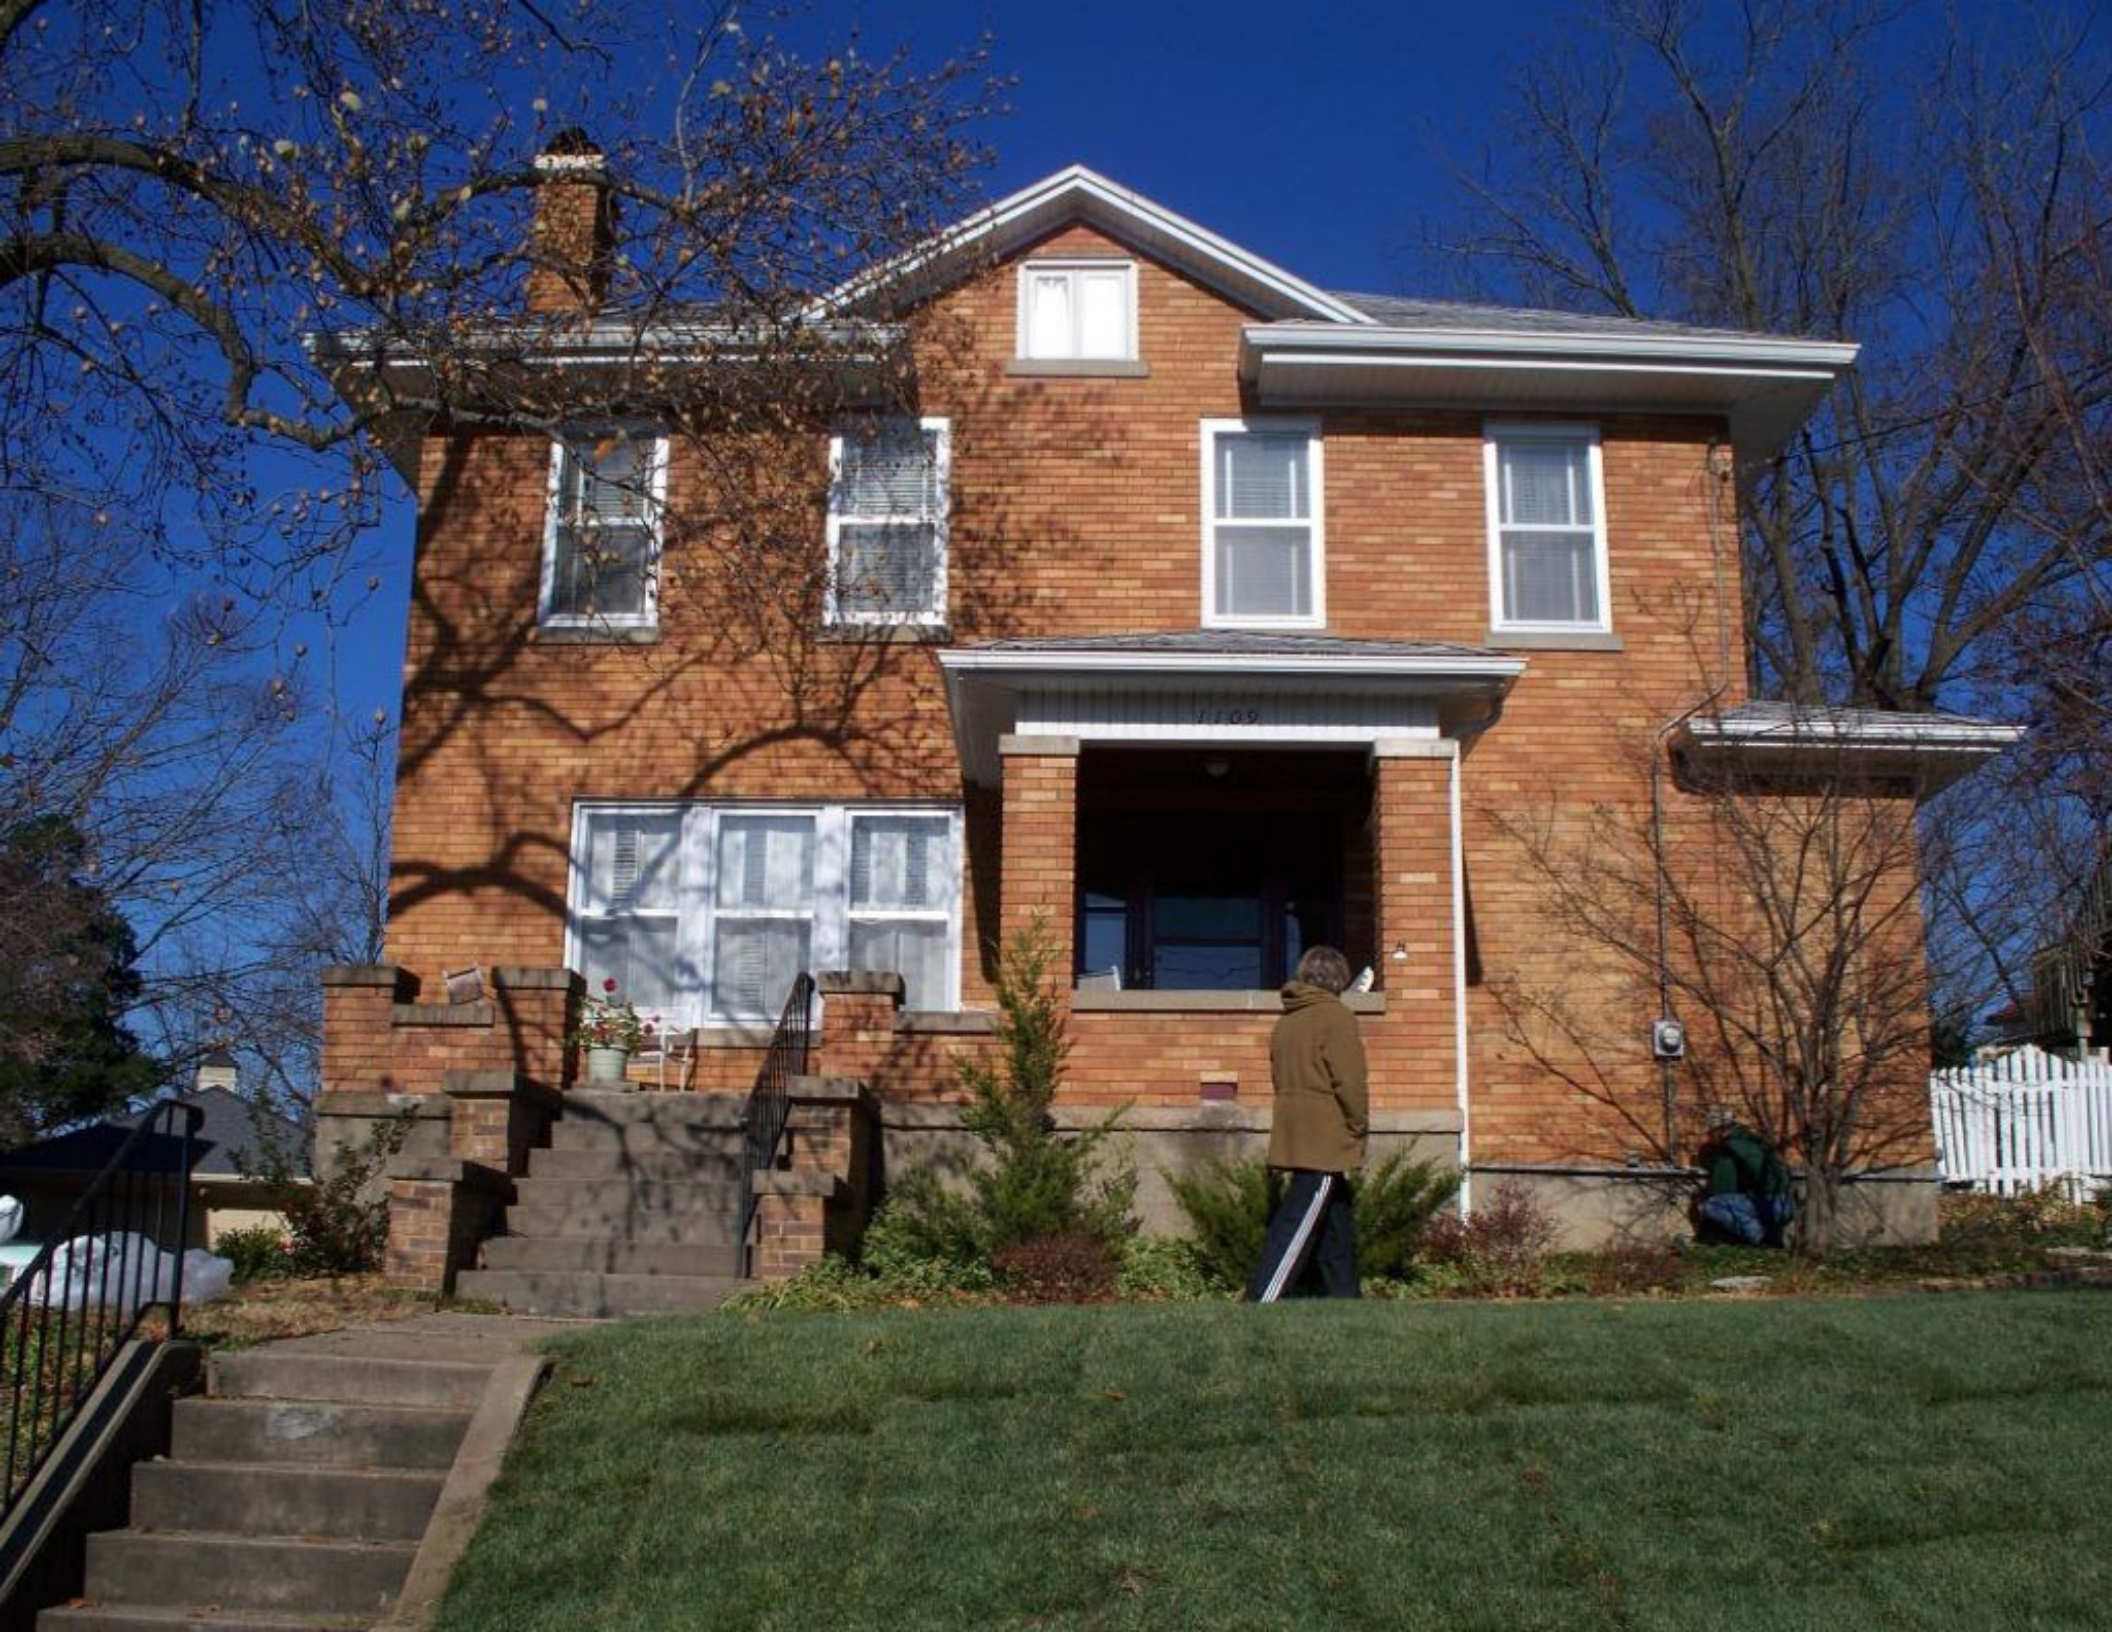
This 2 ½ story brick property has a hipped roof with wide eaves with a gablet with returns on the center of the façade. In this gablet is a one by one casement window. The second floor has four 1/1 vinyl windows. The first floor has a row of three 1/1 windows in the left bay. All of the windows on the home have concrete sills and all appear to be modern replacements. The center bay contains the entrance that appears to retain its original sidelights. A portico with a hipped roof and brick piers projects over the center bay. It connects to brick half walls capped in concrete that extend over to the left bay (no roof over this portion). There is an offset opening and concrete stairs that are flanked with brick knee walls capped in concrete. A metal railing has been added to the right side of the stairs. The right bay is on the first floor is currently blind but it appears there were originally two window openings that were bricked up. This bay extends slightly out to the right (only one story) and has a partial flared roof that wraps around the corner of the home, suggesting this may have once been a sun room. The concrete foundation extends up to the porch level, creating a high water table. This home has the symmetrical characteristics (at least on the second floor) that suggest Colonial Revival influence. It also features the wide eaves of the Prairie style.

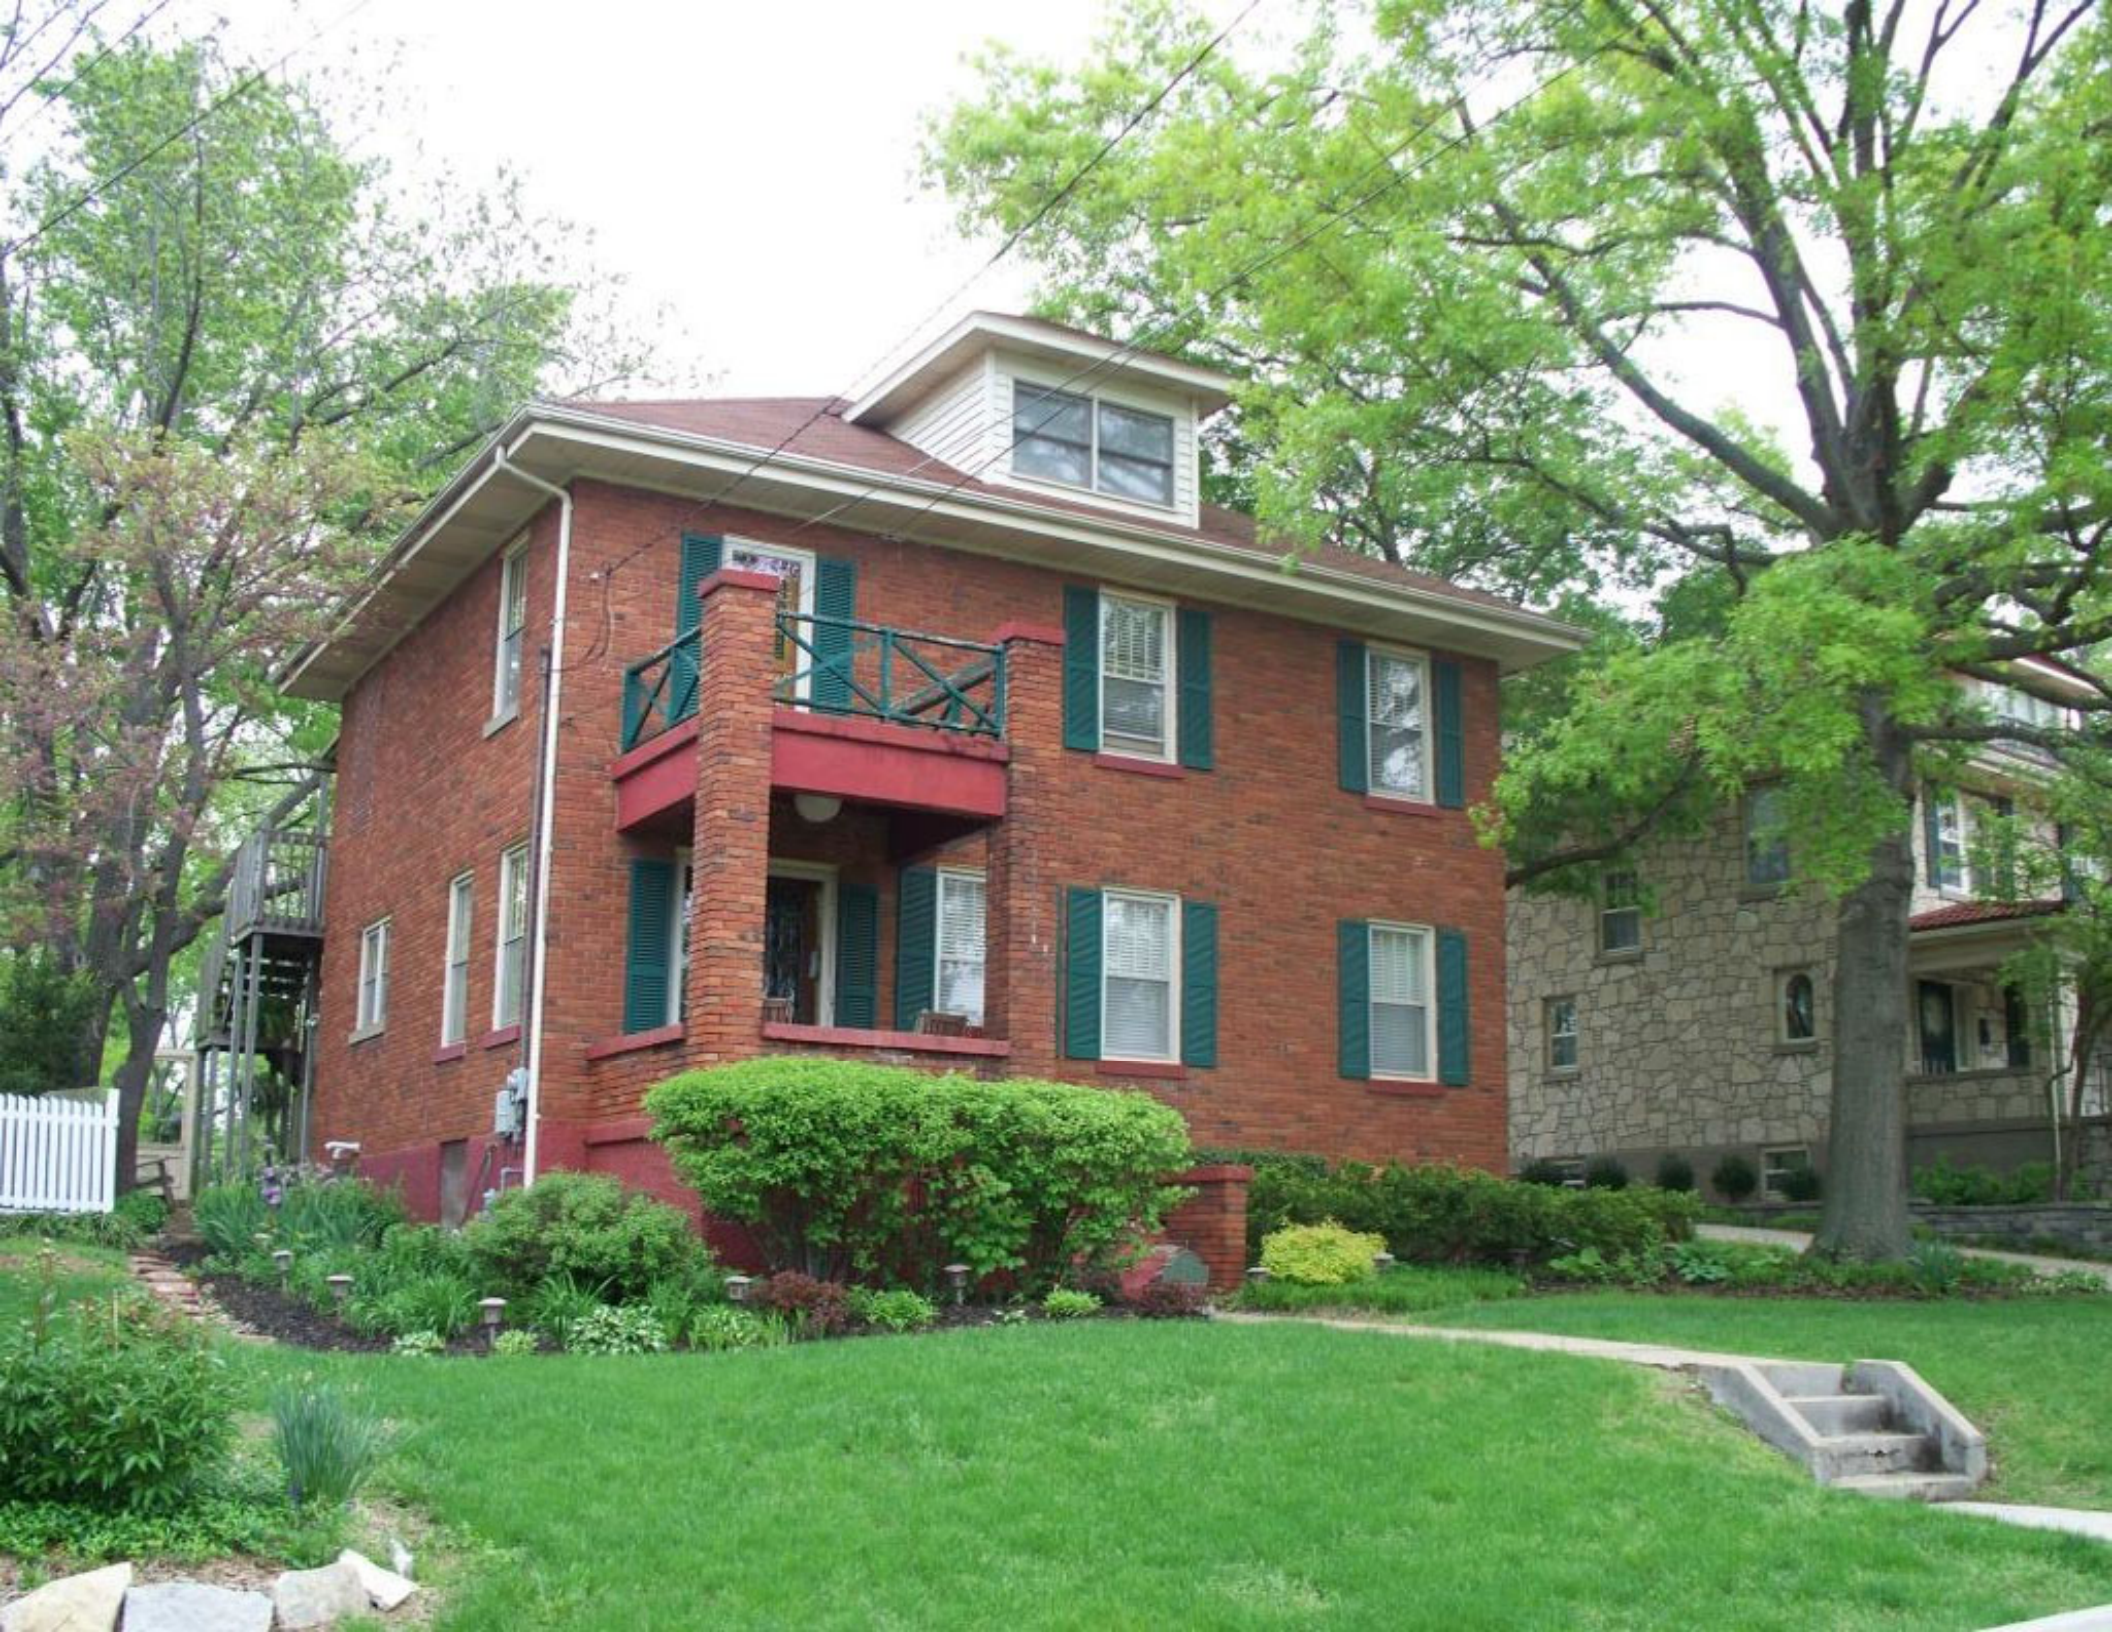
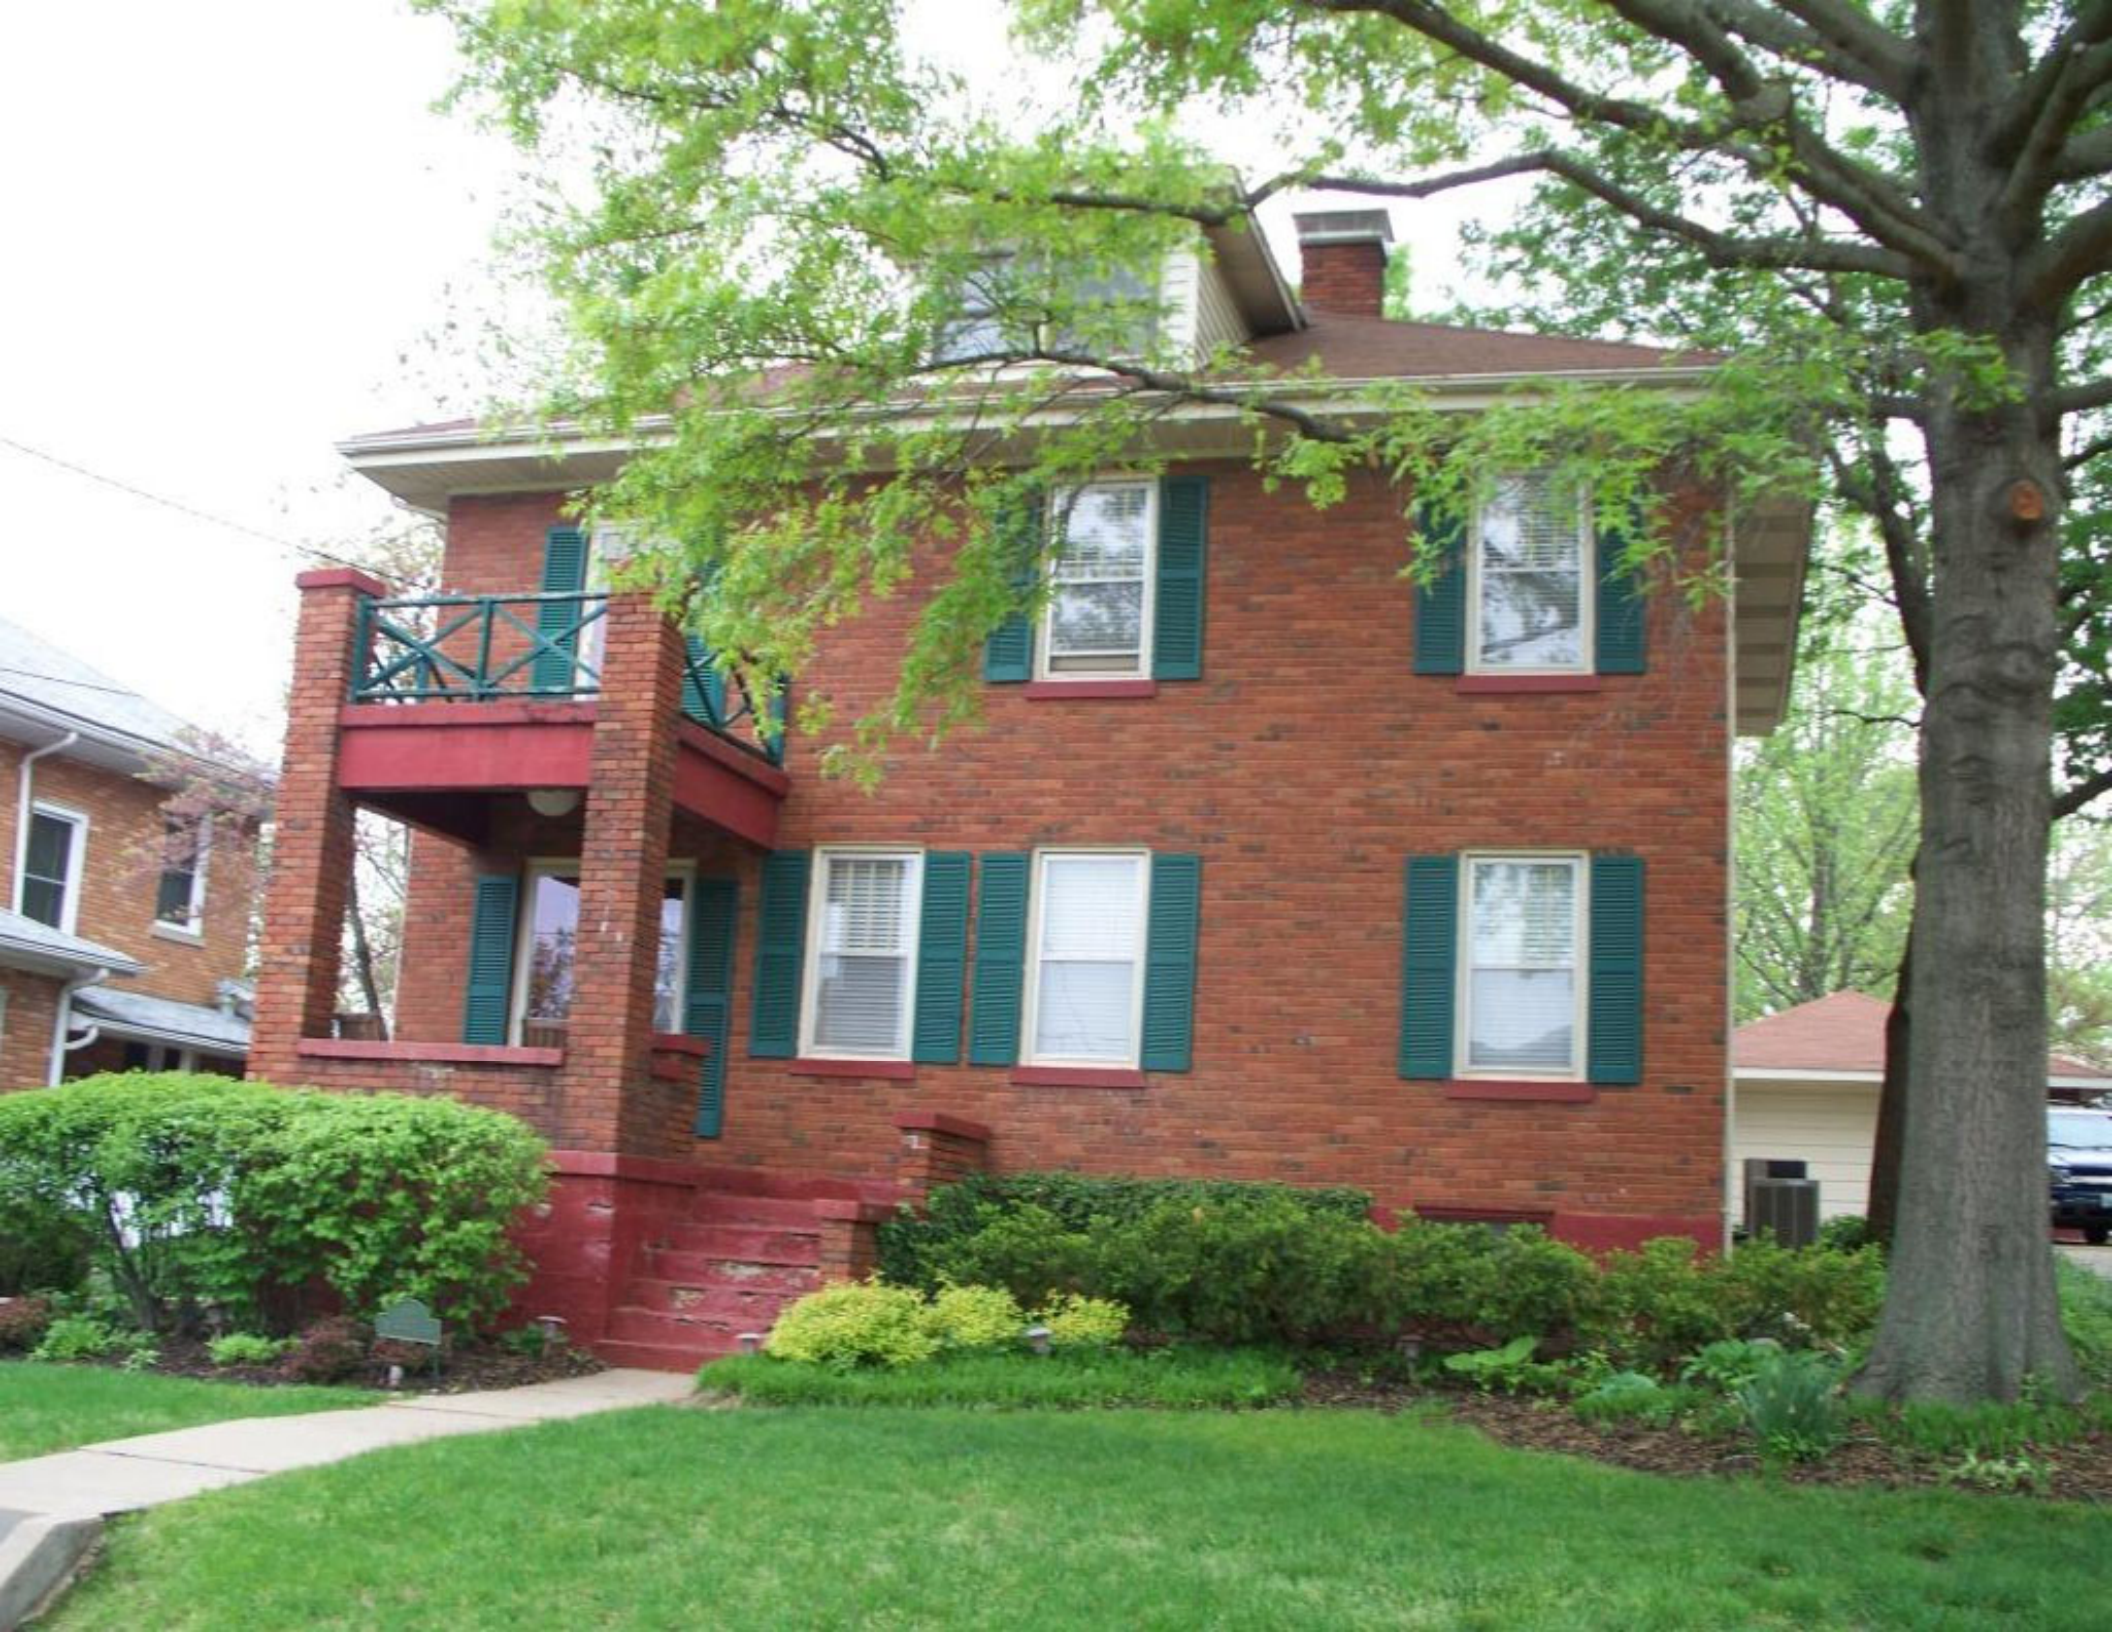
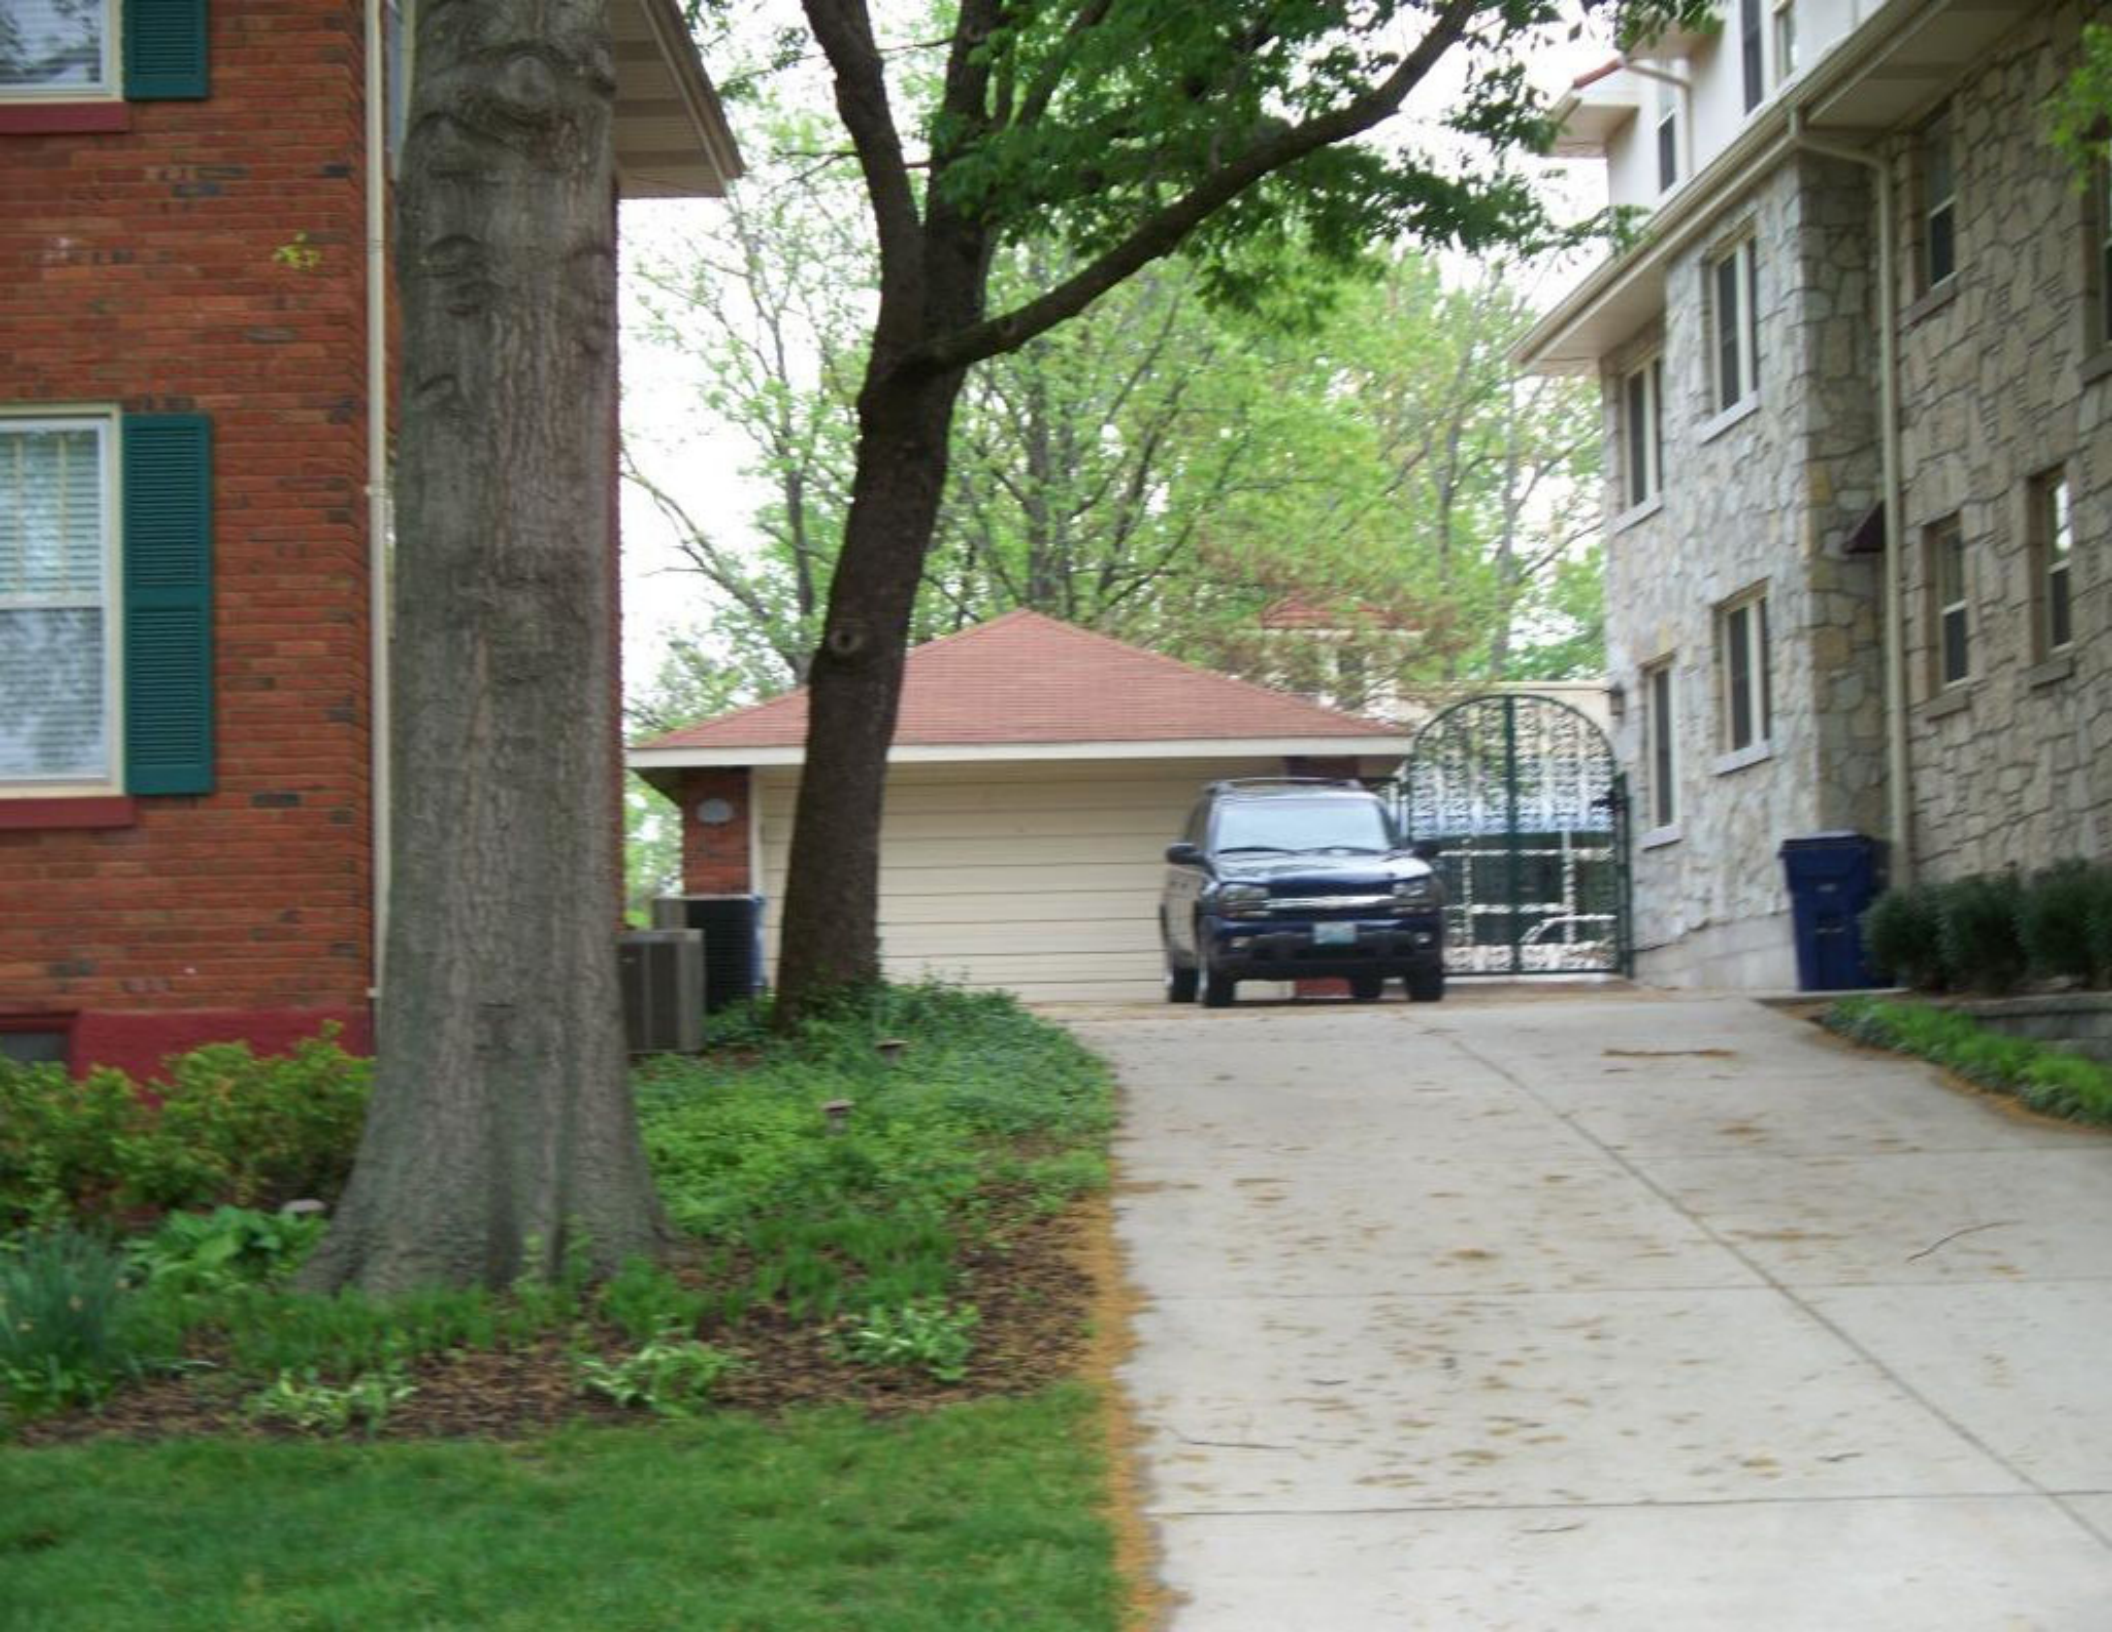
41. (cont.)
This 2 ½ story brick Colonial Revival has a hipped roof with wide eaves and a hipped centered dormer clad in vinyl that contains two 1/1 replacement windows. The second floor has a door with shutters on the left bay that leads out to a small porch that connects to the portico in the left bay on the first floor. It has wood railing that is anchored by two brick piers that extend from the first floor and are capped in concrete. The center and right bay on the second floor have historic 4/1 windows with shutters. The first floor has the entrance in the left bay that appears to retain its historic door. It has shutters as does the three historic 4/1 windows in the remaining bays. All of the windows have concrete sills. A brick portico in the left bay is accessed from the side via a set of concrete or limestone steps that connect to brick knee walls. The portico has a brick half wall in the front capped in concrete. Two brick piers extend up to the second story. A flat boxed wooden roof serves as the floor to the second story porch.

40. (cont.) Description of environment and outbuildings. Expand box as necessary, or add continuation pages.
There is a two car brick garage accessed by one large door with a pyramidal roof. A garage does appear on the Sanborn map but it was much longer and may have been shared with 1113 Vineyard. This is much shorter and is likely a replacement. More research is necessary to determine the build date and contributing status.
