ARCHITECTURAL/HISTORIC INVENTORY FORM

1. Survey No. CO-AS-005-001		2. Survey name: Moreau Drive Neighborhood Survey	
3. County: Cole		4. Address: 1202 Elmerine Ave.	
5. City: Jefferson City	Vicinity: <input type="checkbox"/>	6. UTM: / /	7. Township/Range/Section: T: R: S:
8. Historic name (if known):		9. Present/other name (if known):	
10. Ownership: <input checked="" type="checkbox"/> Private <input type="checkbox"/> Public		11. Historic use (if known): Residential	11. Current use: Residential

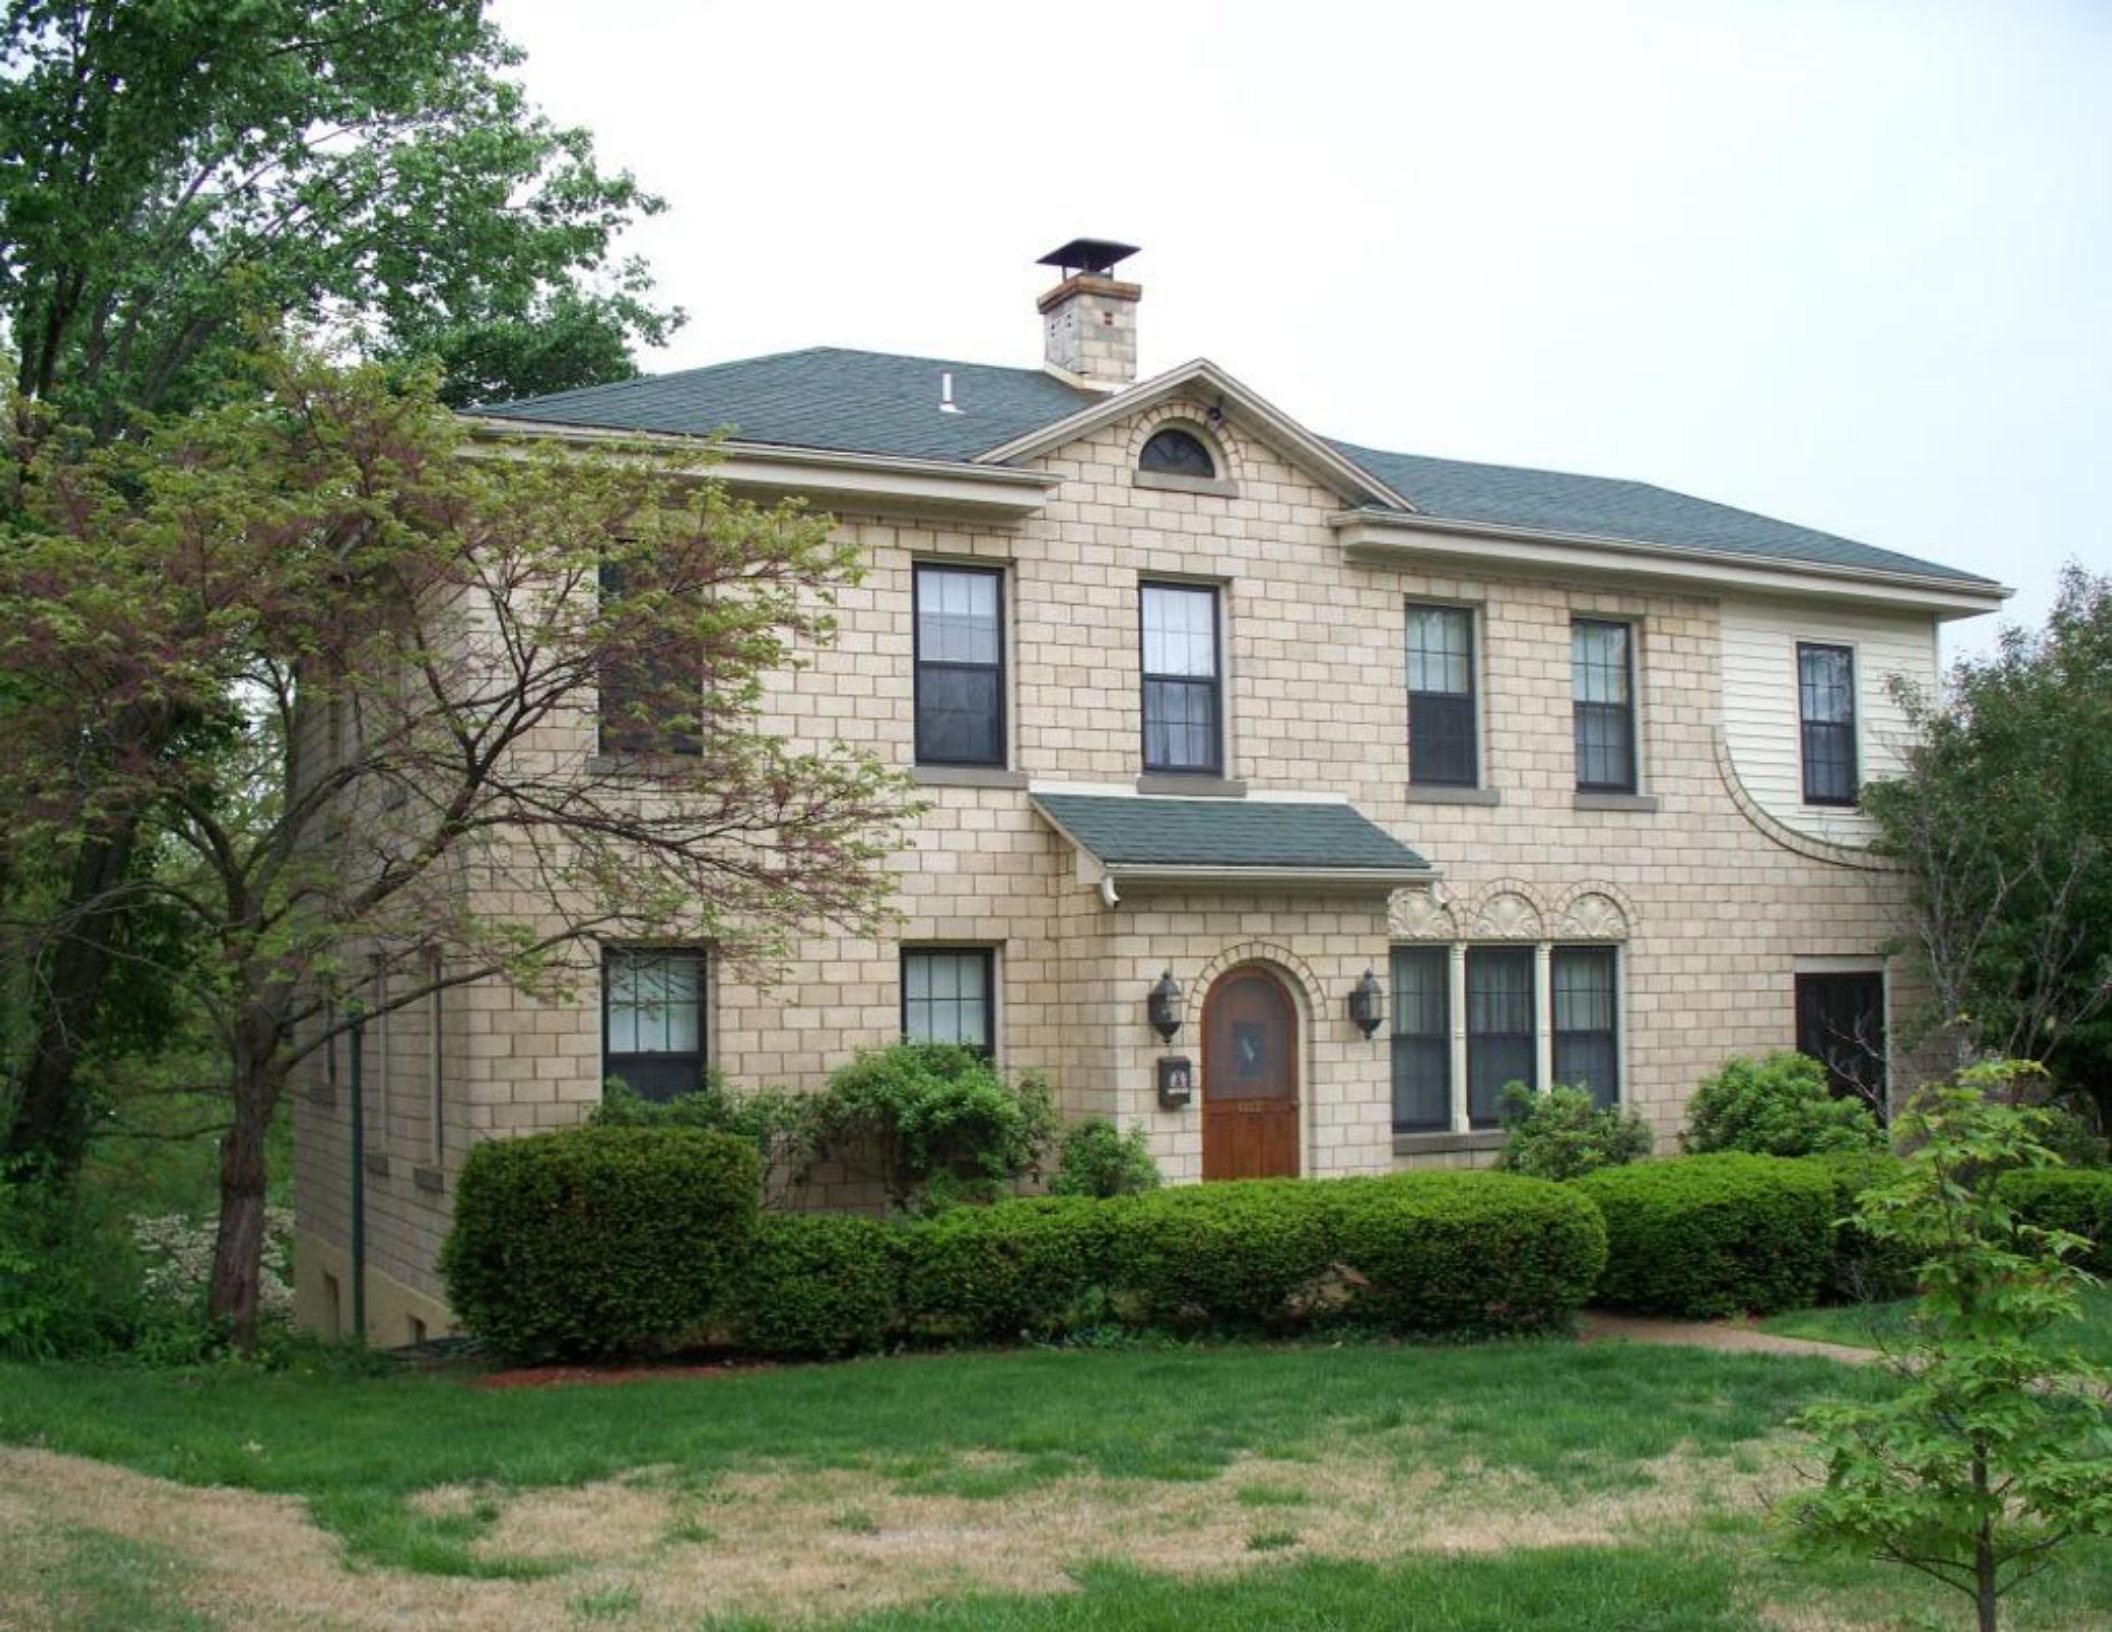
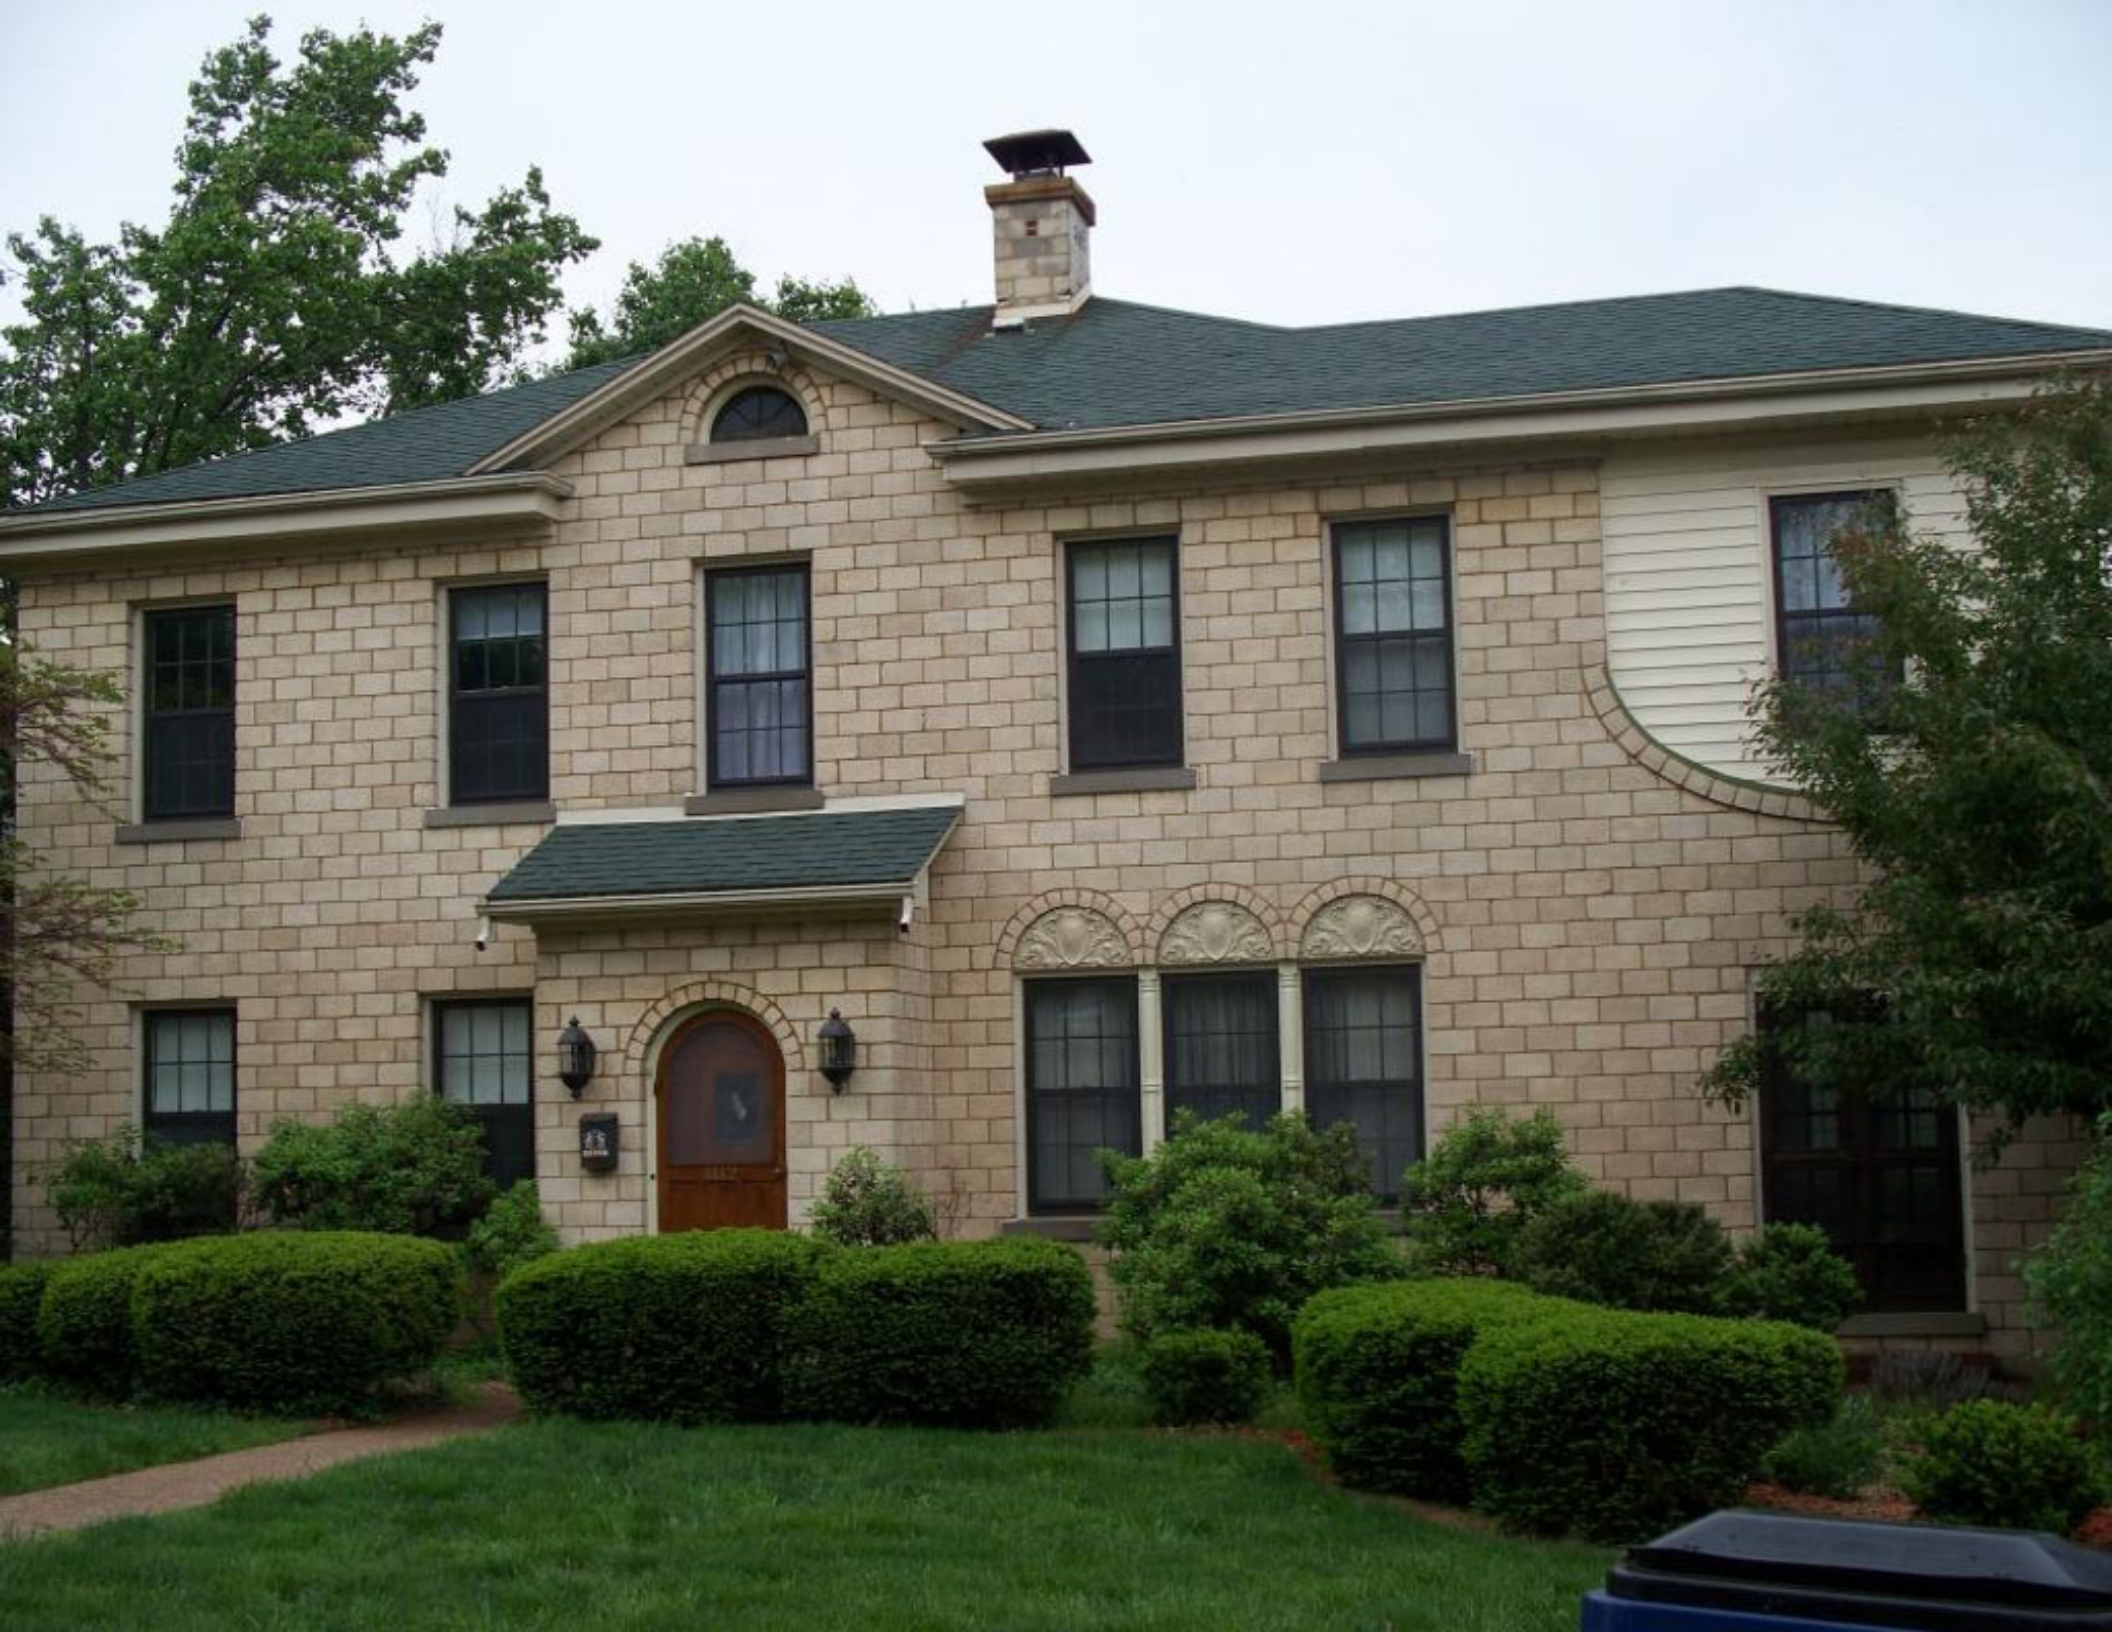
This two story Colonial Revival has a hipped roof with a center gable and wide eaves with entablature. A fanlight is in the peak of the gable. The home is clad in smooth square cut stone that may not be original. There are six 6/6 windows in the upper floor that may or may not be historic. The final window is clad in vinyl (likely an addition) as the stone slopes under it to the edge of the building. From the left on the lower floor are two 6/6 windows. The entrance bay projects and has a shed roof and an arched opening. It appears to have retained its original arched wooden door with art glass. The next bay has a row of three 6/6 windows, over each is a curved shield bas-relief. Ornate molding frames the center window. The final bay on the right has multi-paned French doors. All of the openings, save the one set in vinyl, has limestone or concrete sills. If the stone façade is historic the property would certainly contribute to a district, if not it would likely be n/c. More research is necessary.

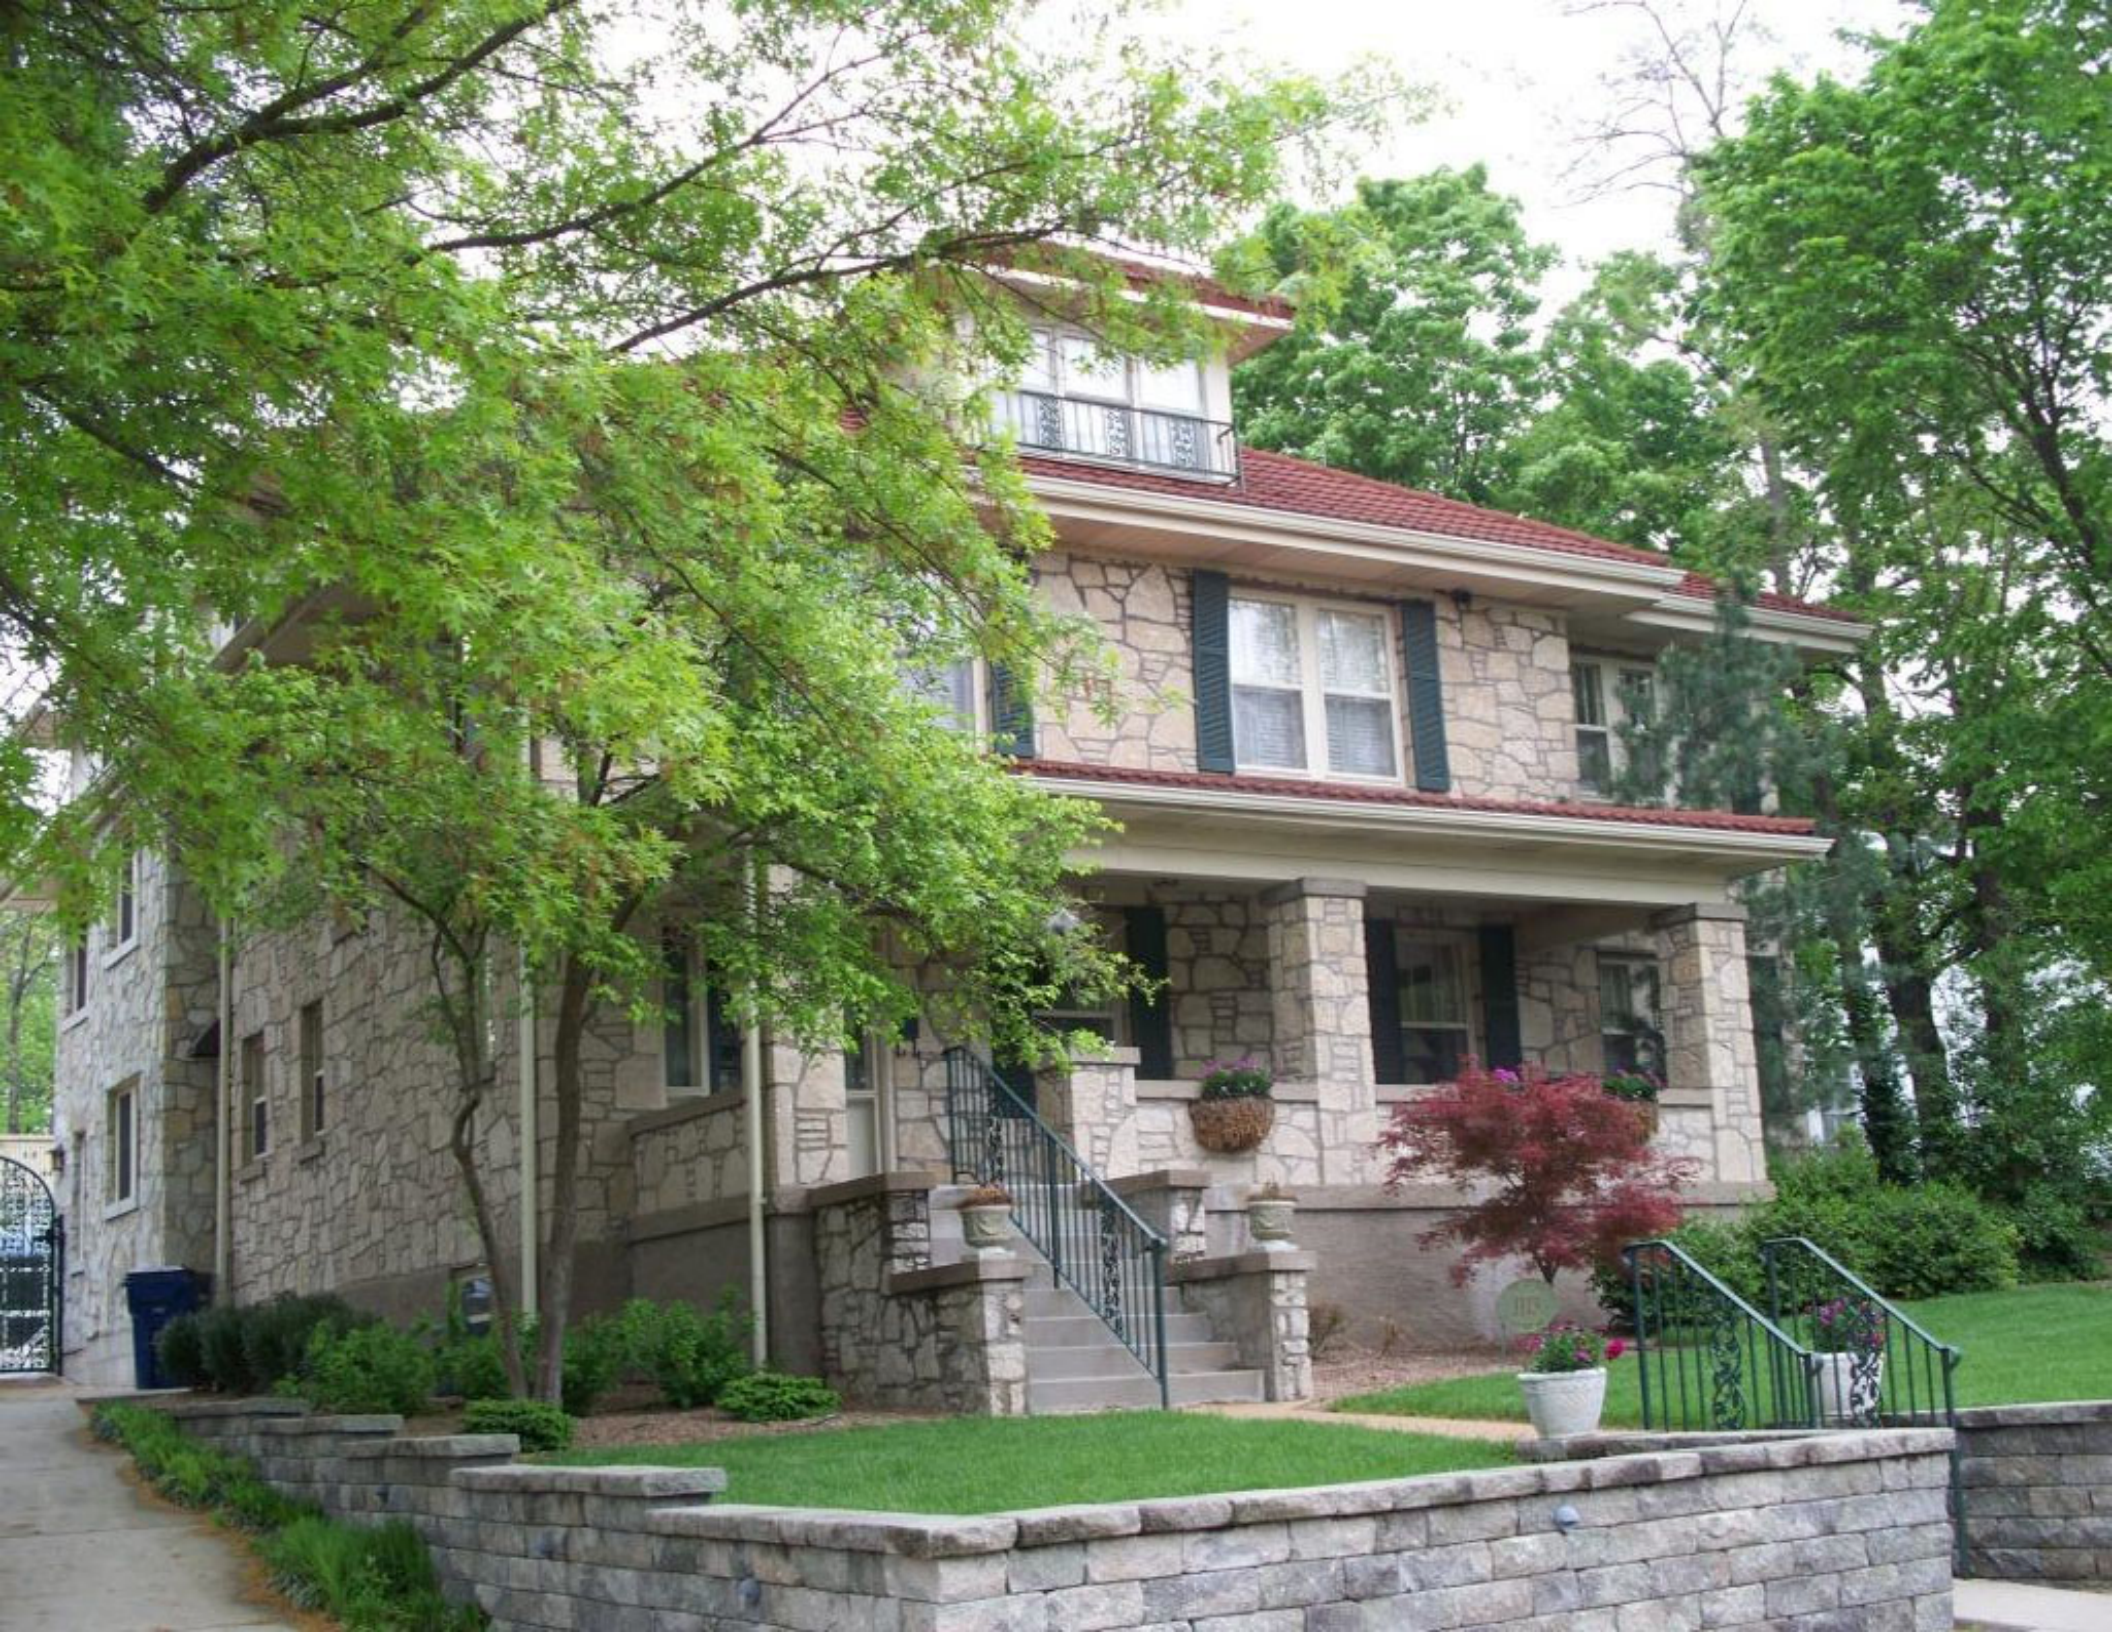
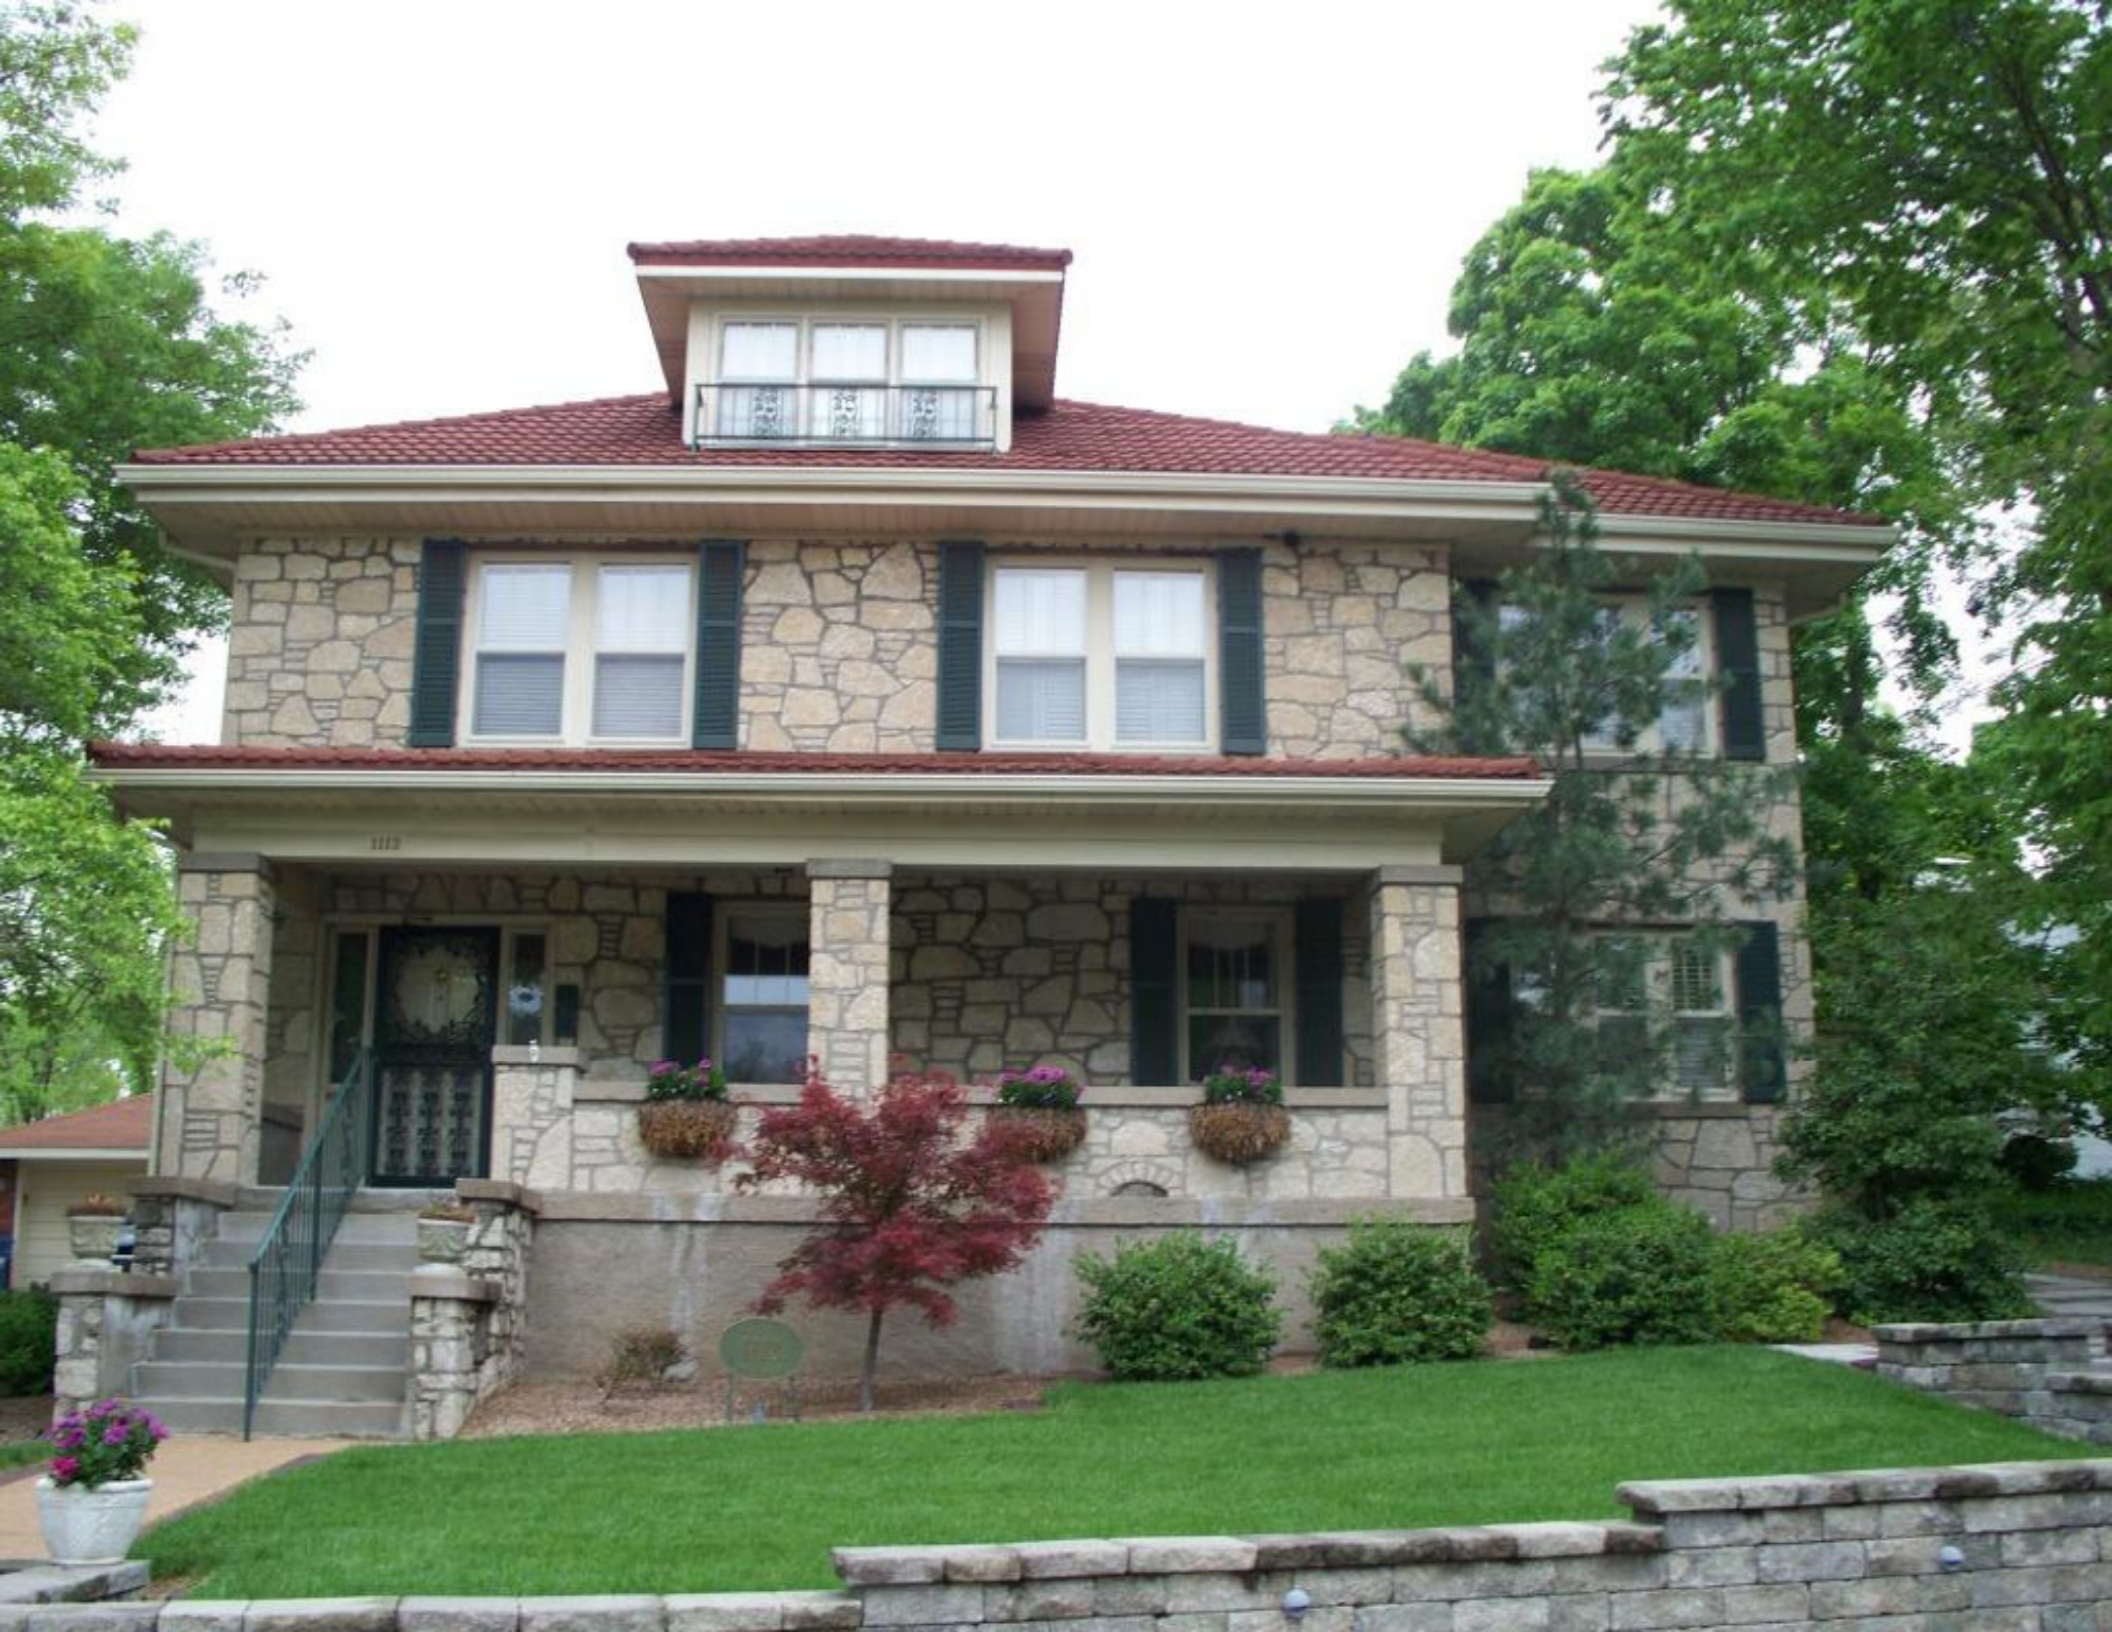
This 2 ½ story property is clad in dressed stone and features a hipped tile roof with a central hipped tile dormer with three historic 3/1 windows. A decorative metal grill/railing has been added in front of the lower portion of these windows. The second floor has two paired historic 3/1 windows with shutters. The lower floor has two historic 3/1 windows with shutters in the center and right bays. The left bay contains the entrance which appears to retain its historic side lights. The door is obscured by a decorative metal storm door. A full width shed tile roof porch has a wooden or vinyl entablature that sits on stone piers that connect to stone half walls. There is an eyebrow vent in the bottom of the porch wall. The piers and walls are capped in concrete. The concrete foundation continues to the porch level (accessed by a set of concrete stairs flanked with stone half walls) creating a high water table. A two story bay is slightly set back on the right side and has a hipped roof (continues from the main roof). Each floor has a row of three historic 3/1 windows with shutters.

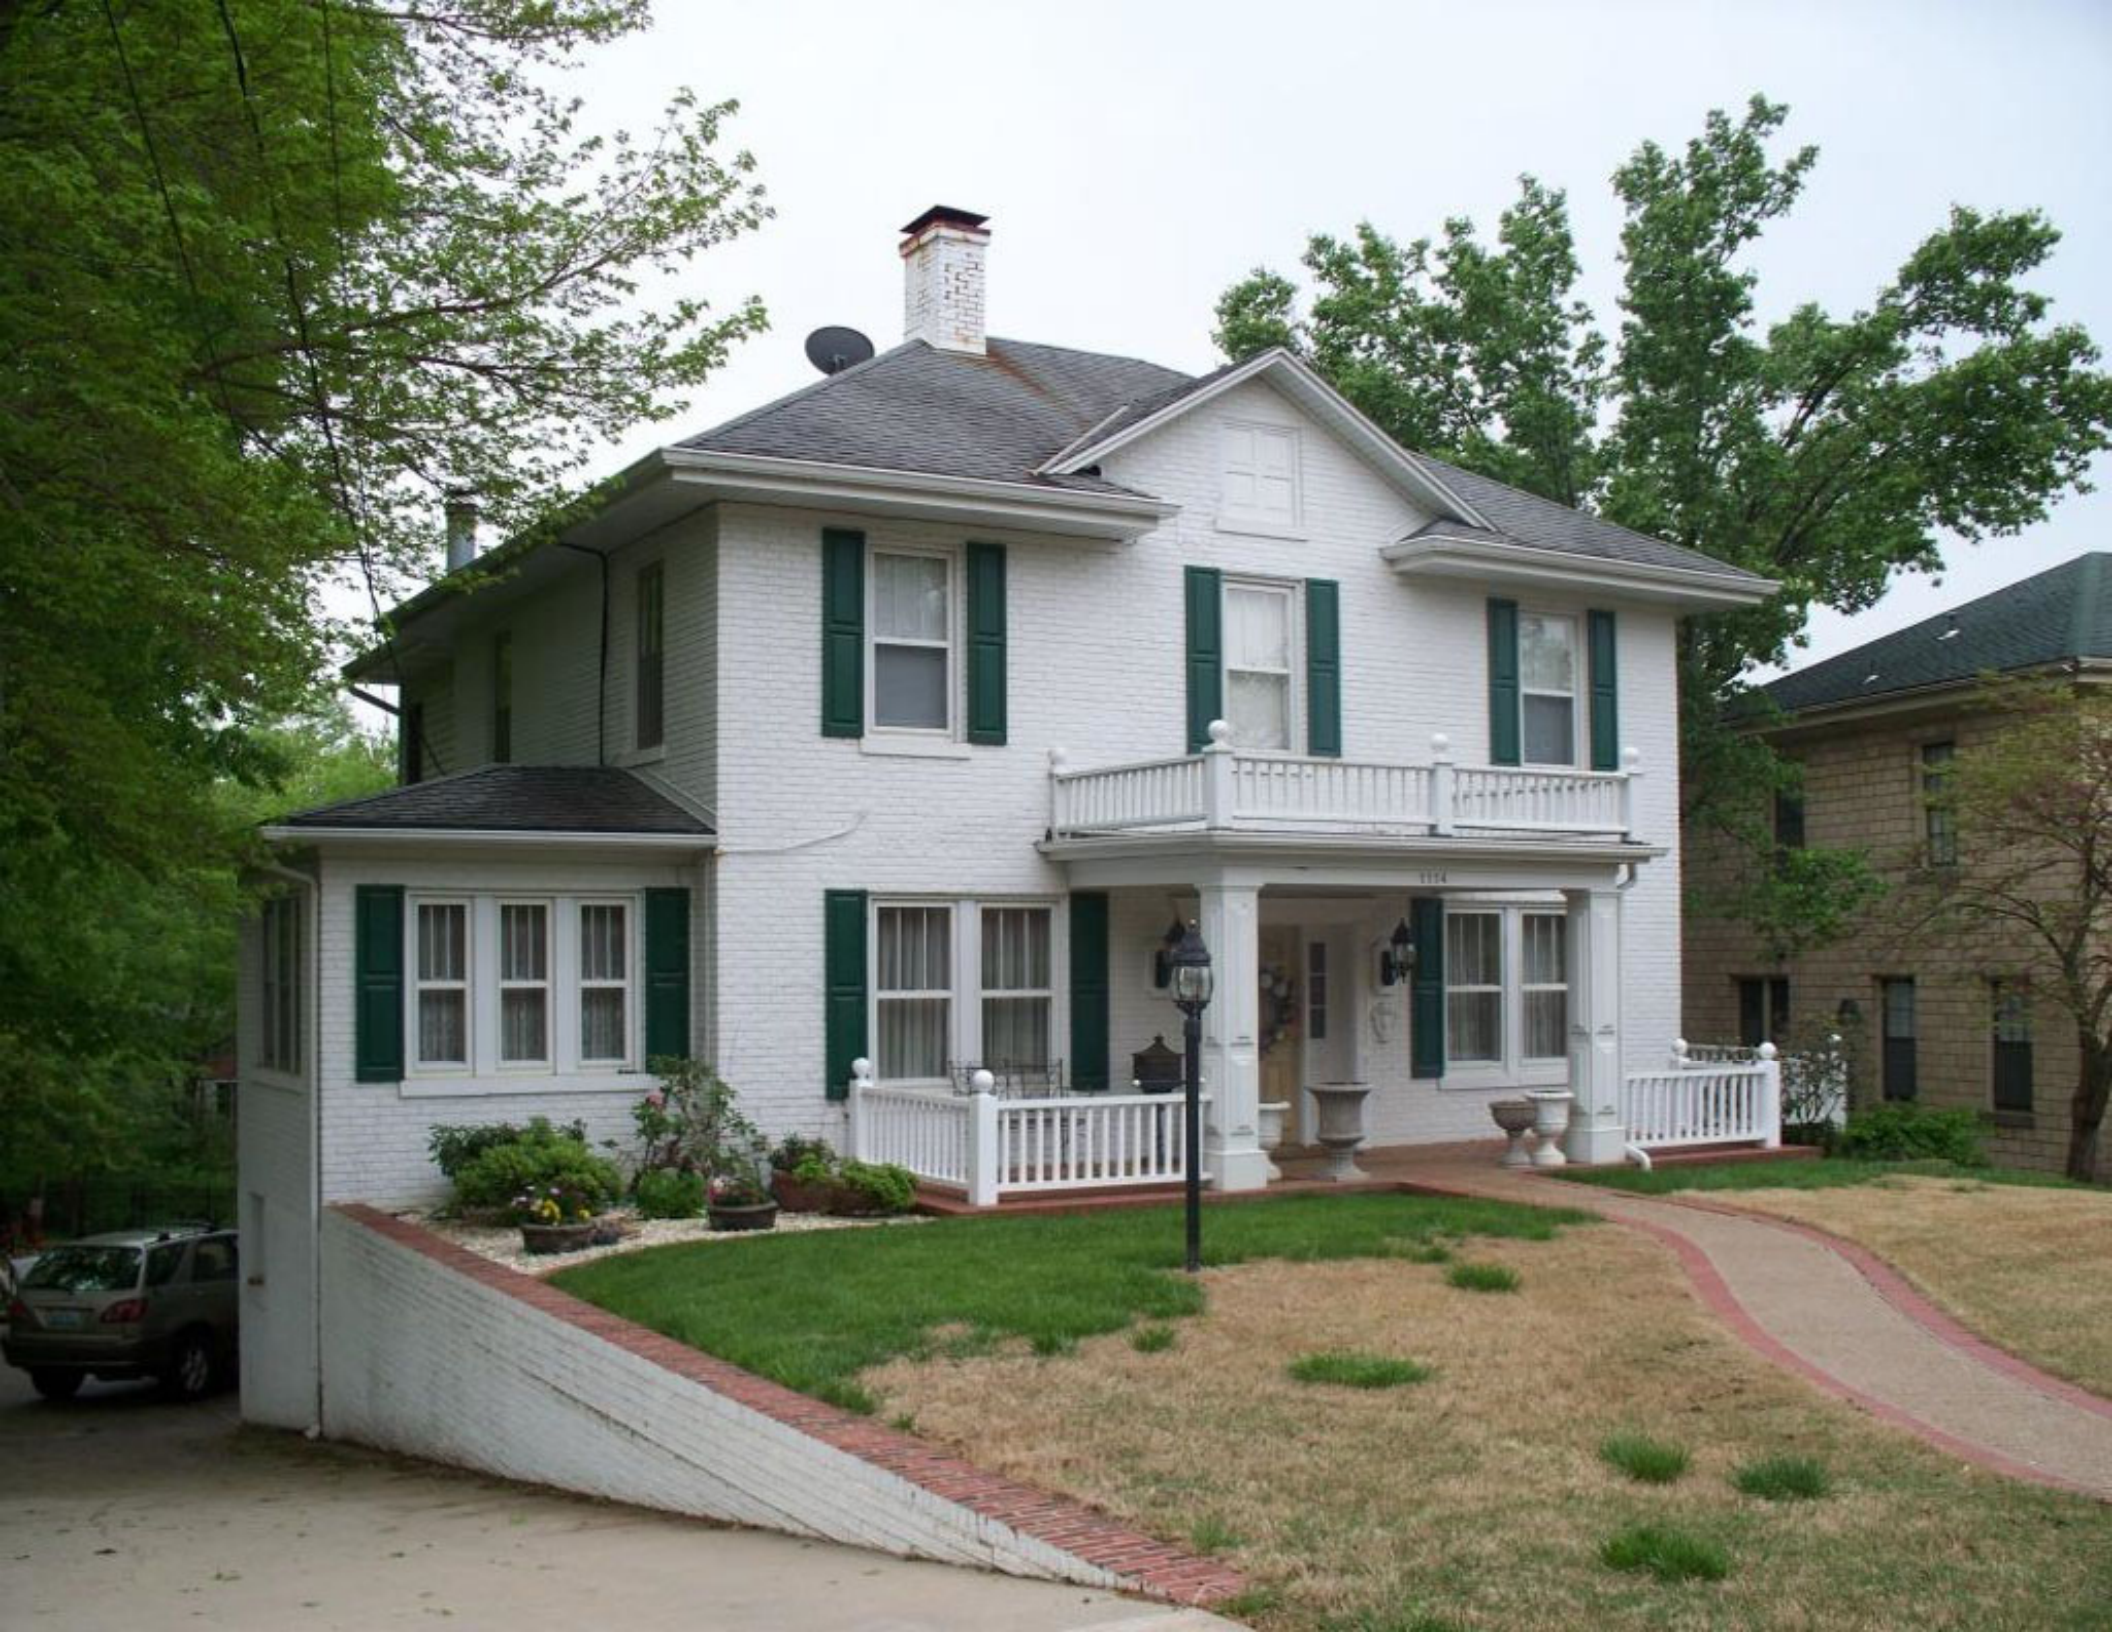
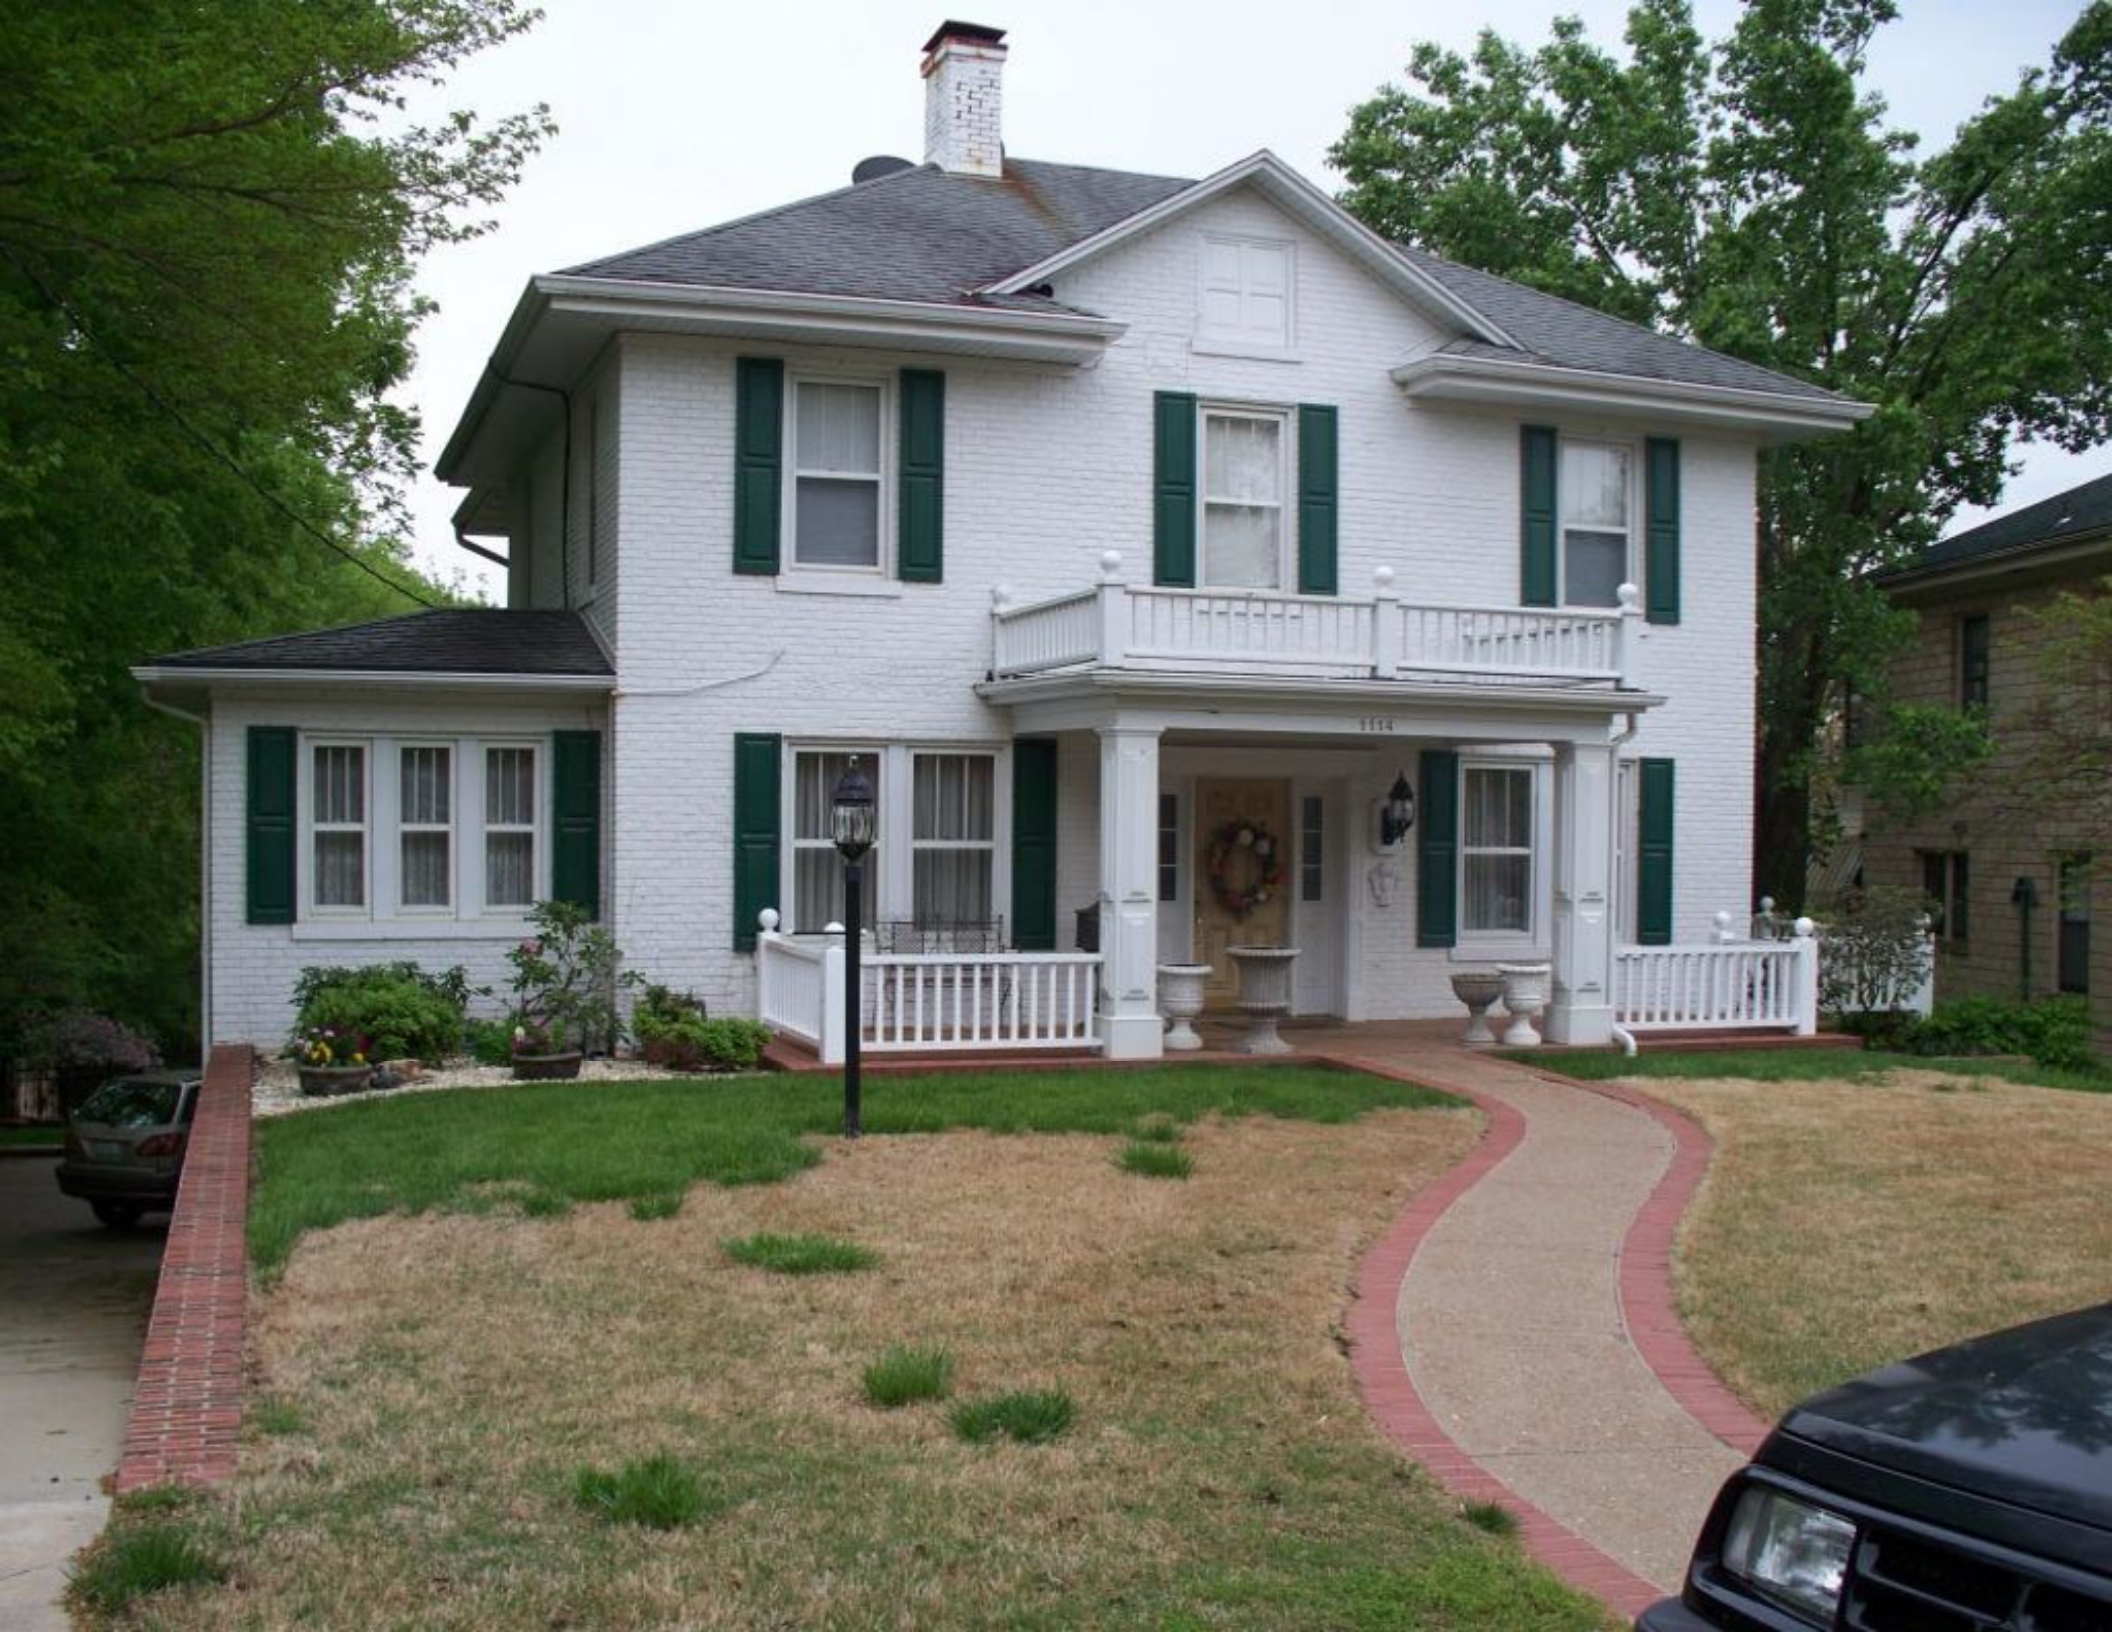
This two story brick Colonial Revival has a hipped roof with a center gable and wide eaves. A panel is in the peak of the gable that may be covering a vent or a window. The second floor has three historic 3/1 windows with shutters. The lower floor has two paired 3/1 windows with shutters flanking the entrance. The door appears to be a replacement but the entrance has retained its historic sidelights. A porch with wooden railing covers most of the main façade and wraps partially around the right side. Two square posts support the flat roof porch that has additional railing with finials on the top. Slightly set back on the right side is a one story sun room with a hipped roof and a row of three historic 3/1 windows with shutters.
