# ARCHITECTURAL/HISTORIC INVENTORY FORM

1. Survey No. <b>CGSEA002-051</b>		2. Survey name: <b>N. Sprigg-N. Middle Survey</b>	
3. County: <b>Cape</b>		4. Address: <b>419 Bellevue Street</b>	
5. City: <b>Cape Girardeau</b>	Vicinity: <input type="checkbox"/>	6. UTM: <b>16/276414/4131995</b>	7. Township/Range/Section: <b>T: 30 R: 14 S: 5</b>
8. Historic name (if known): <b>Bellevue Apartments</b>		9. Present/other name (if known): <b>Bellevue Apartments</b>	
10. Ownership: <input checked="" type="checkbox"/> Private <input type="checkbox"/> Public		11. Historic use (if known): <b>Domestic: Multiple Dwelling</b>	
		11. Current use: <b>Domestic: Multiple Dwelling</b>

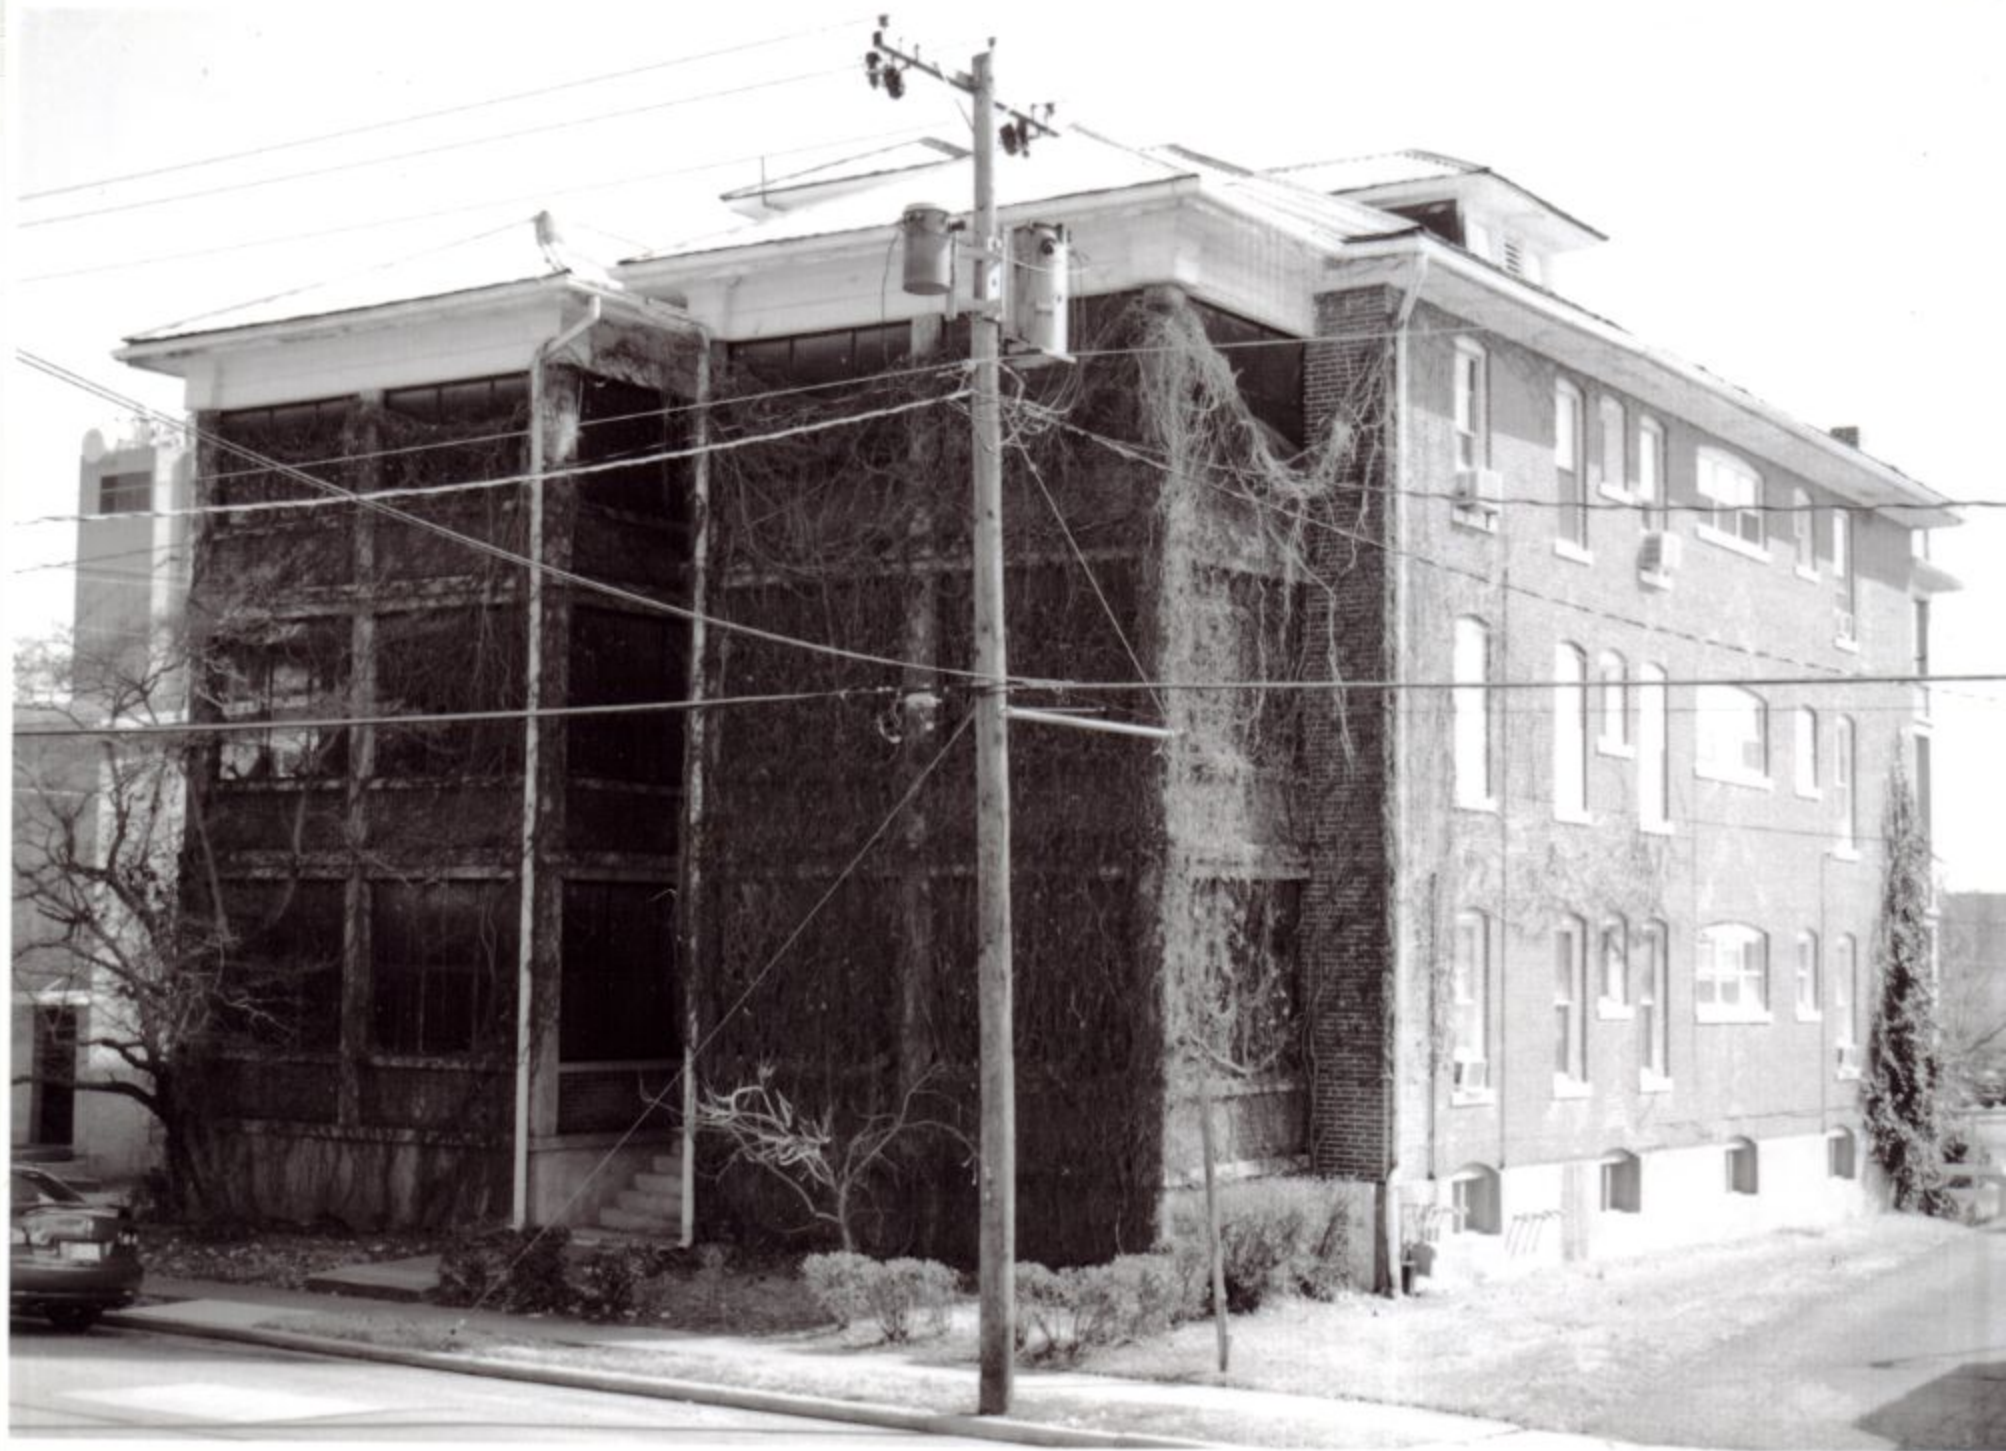
This three-story, U-shaped apartment complex is constructed in brick on a concrete foundation and has colonial revival elements to its design. The low hipped roof with wide, overhanging eaves is covered in sheet metal and has four dormers, one facing each elevation. A wide, pressed metal cornice dominates the roofline of the façade. The façade has five bays, with the original front door with sidelights and transom in the center flanked by two protruding, three-level screened in porches. The condition of the porches is hard to determine, due to thick vines growing all over the façade. The majority of the windows are vinyl one-over-one double-hung, sash windows, appearing to have been replaced at some point. The rear of the building has wooden stairs with decks on each level.

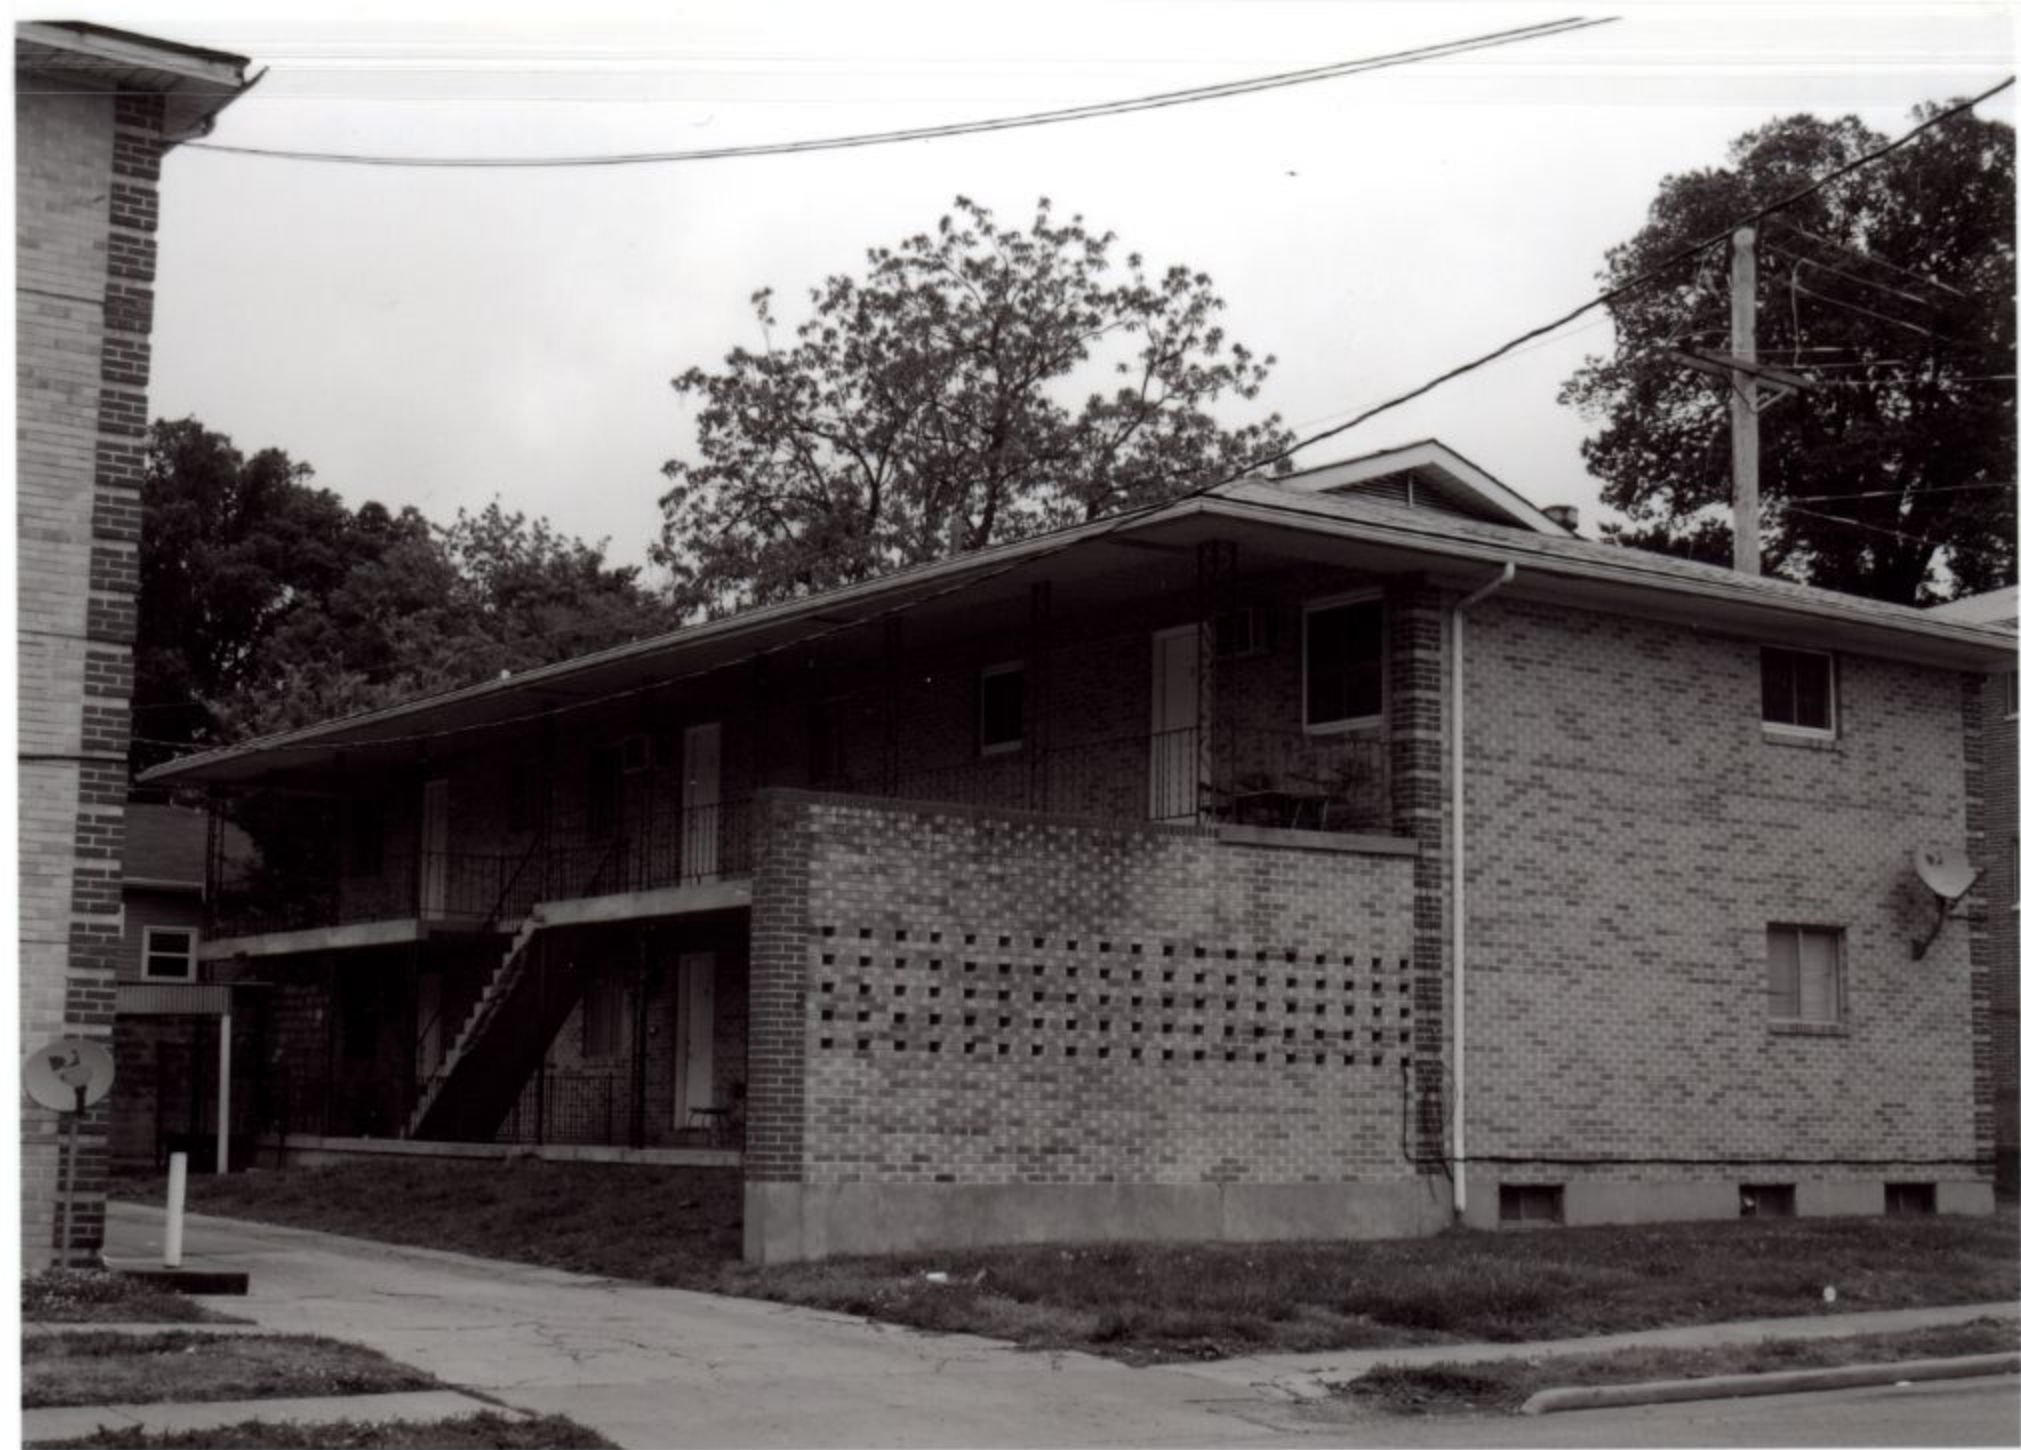
Building is situated near Southeast Missouri State University and downtown Cape Girardeau, MO. The garage was built with a concrete foundation, aluminum walls and a gable roof made of sheet metal. Garage was built in the 1960s, is 3 bays wide, is attached to the main building by a wall extension, and sits hidden immediately beside the apartment complex creating a cement courtyard with 426 Bellevue.

Two story apartment building clad in blond brick with red brick quoining on all corners. Sits on a concrete foundation. Side gable roof is wrapped in a shallow pitched hipped addition with wide, bare, overhanging eaves. Main façade faces west and is hidden from street by brick wall extension with brick grill work. Veranda porch covers cantilevered concrete second floor, accessible by centrally place concrete stairs decorated with wrought iron railings. Apartment doors and windows are symmetrically set with nine bays on each level.

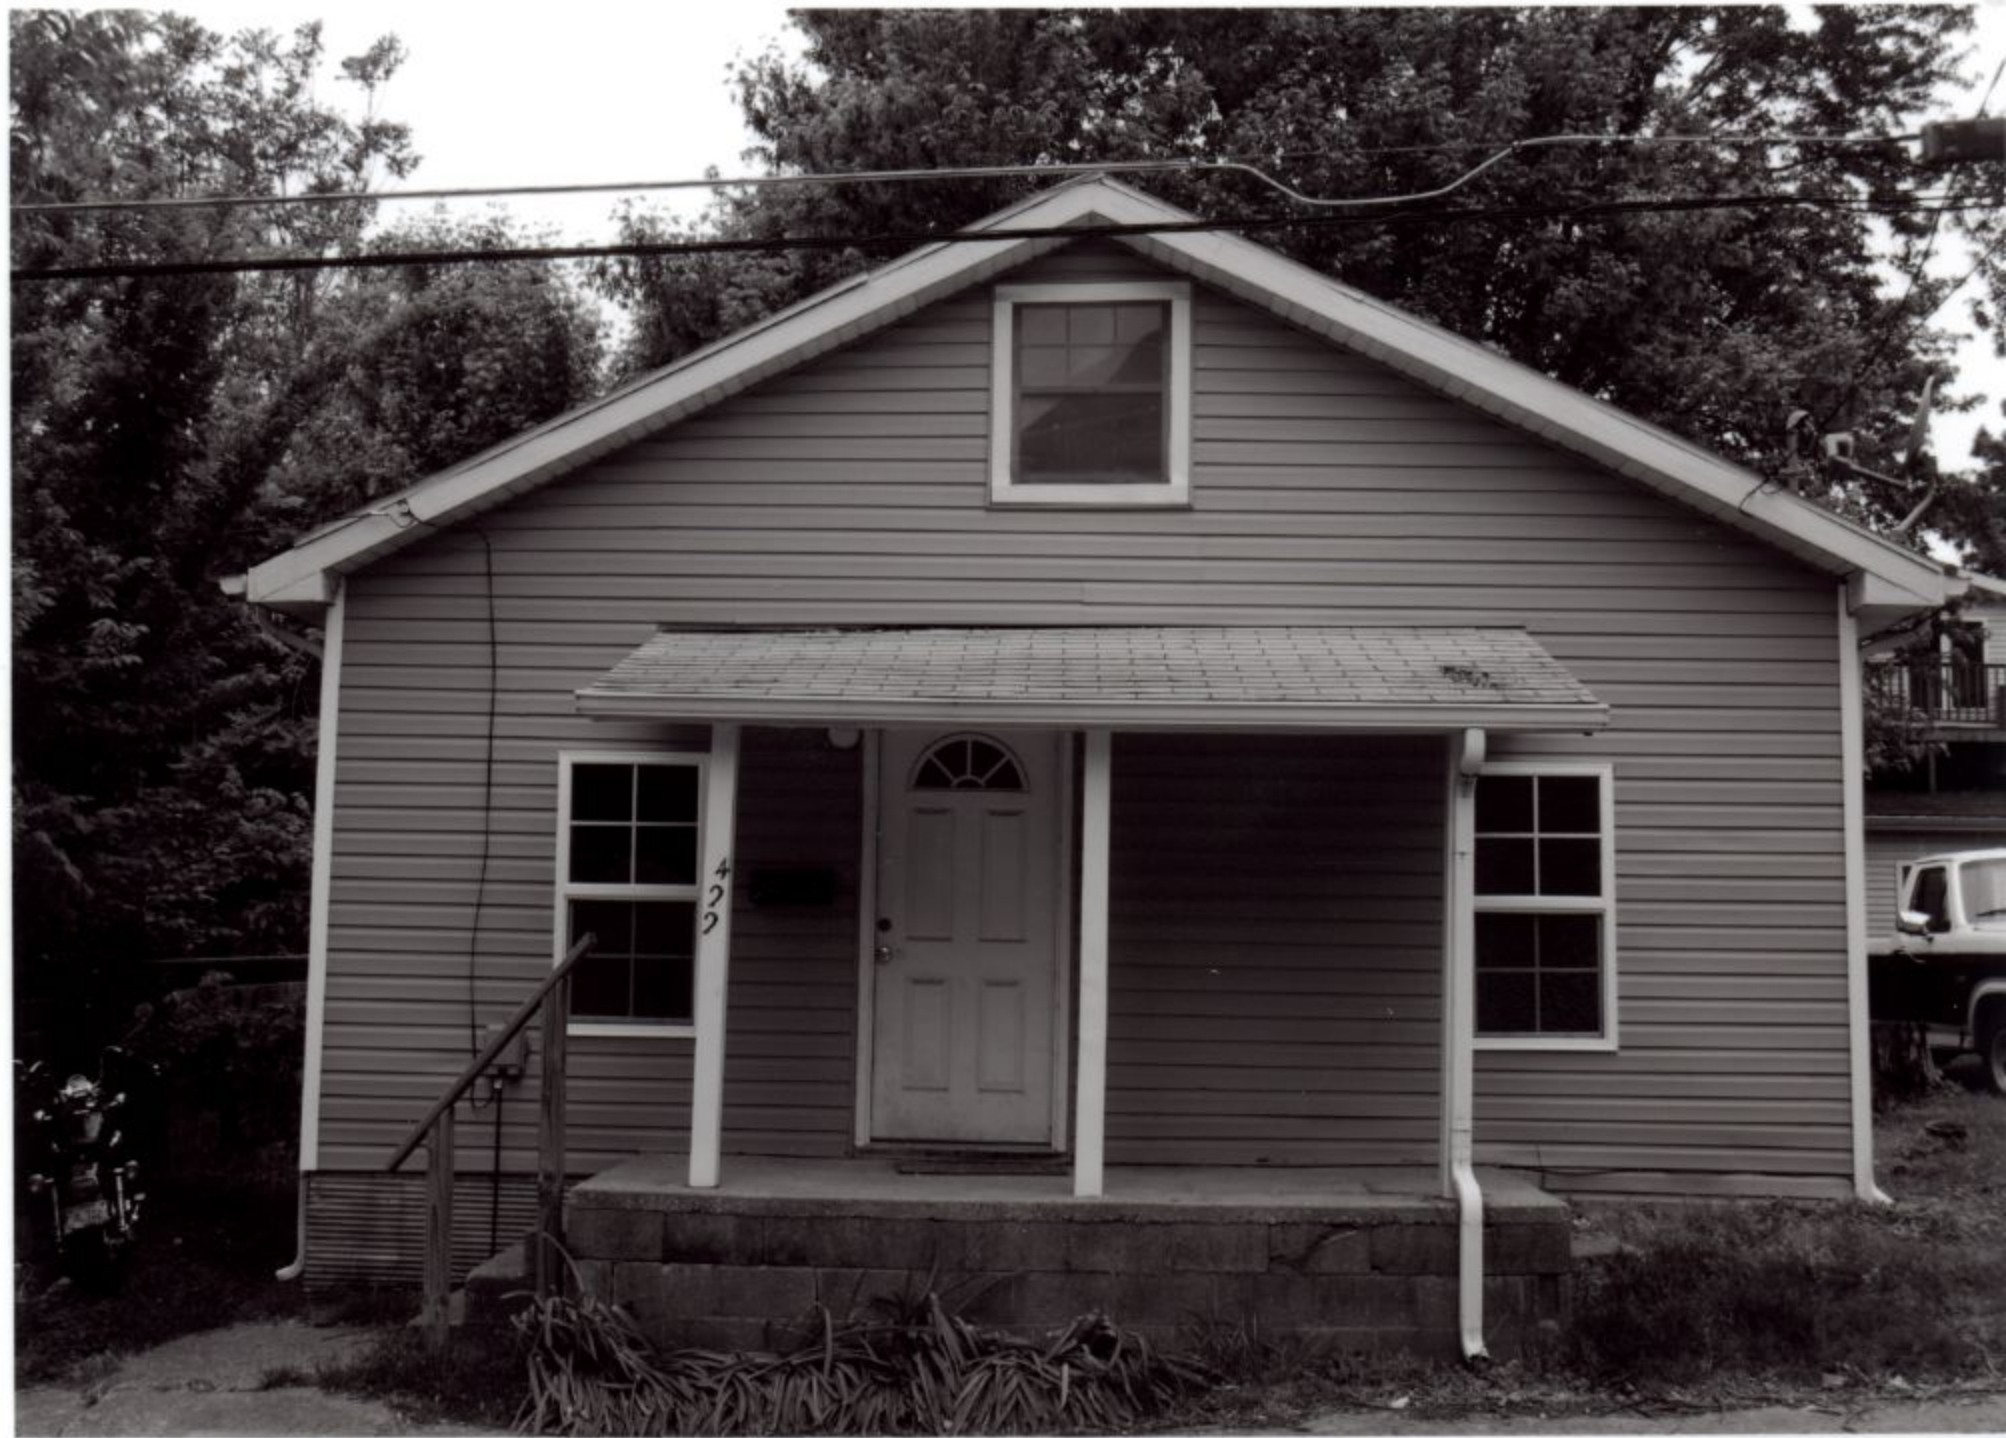
One story building sits on a piers and stone foundation. Sided in aluminum. Front gable roof is covered in sheet metal. Separate roof section covers an open porch. Three wooden columns sits on concrete blocks. Facade is three bays deep with an asymmetrically placed door. Vinyl windows are new four-over-four sash.

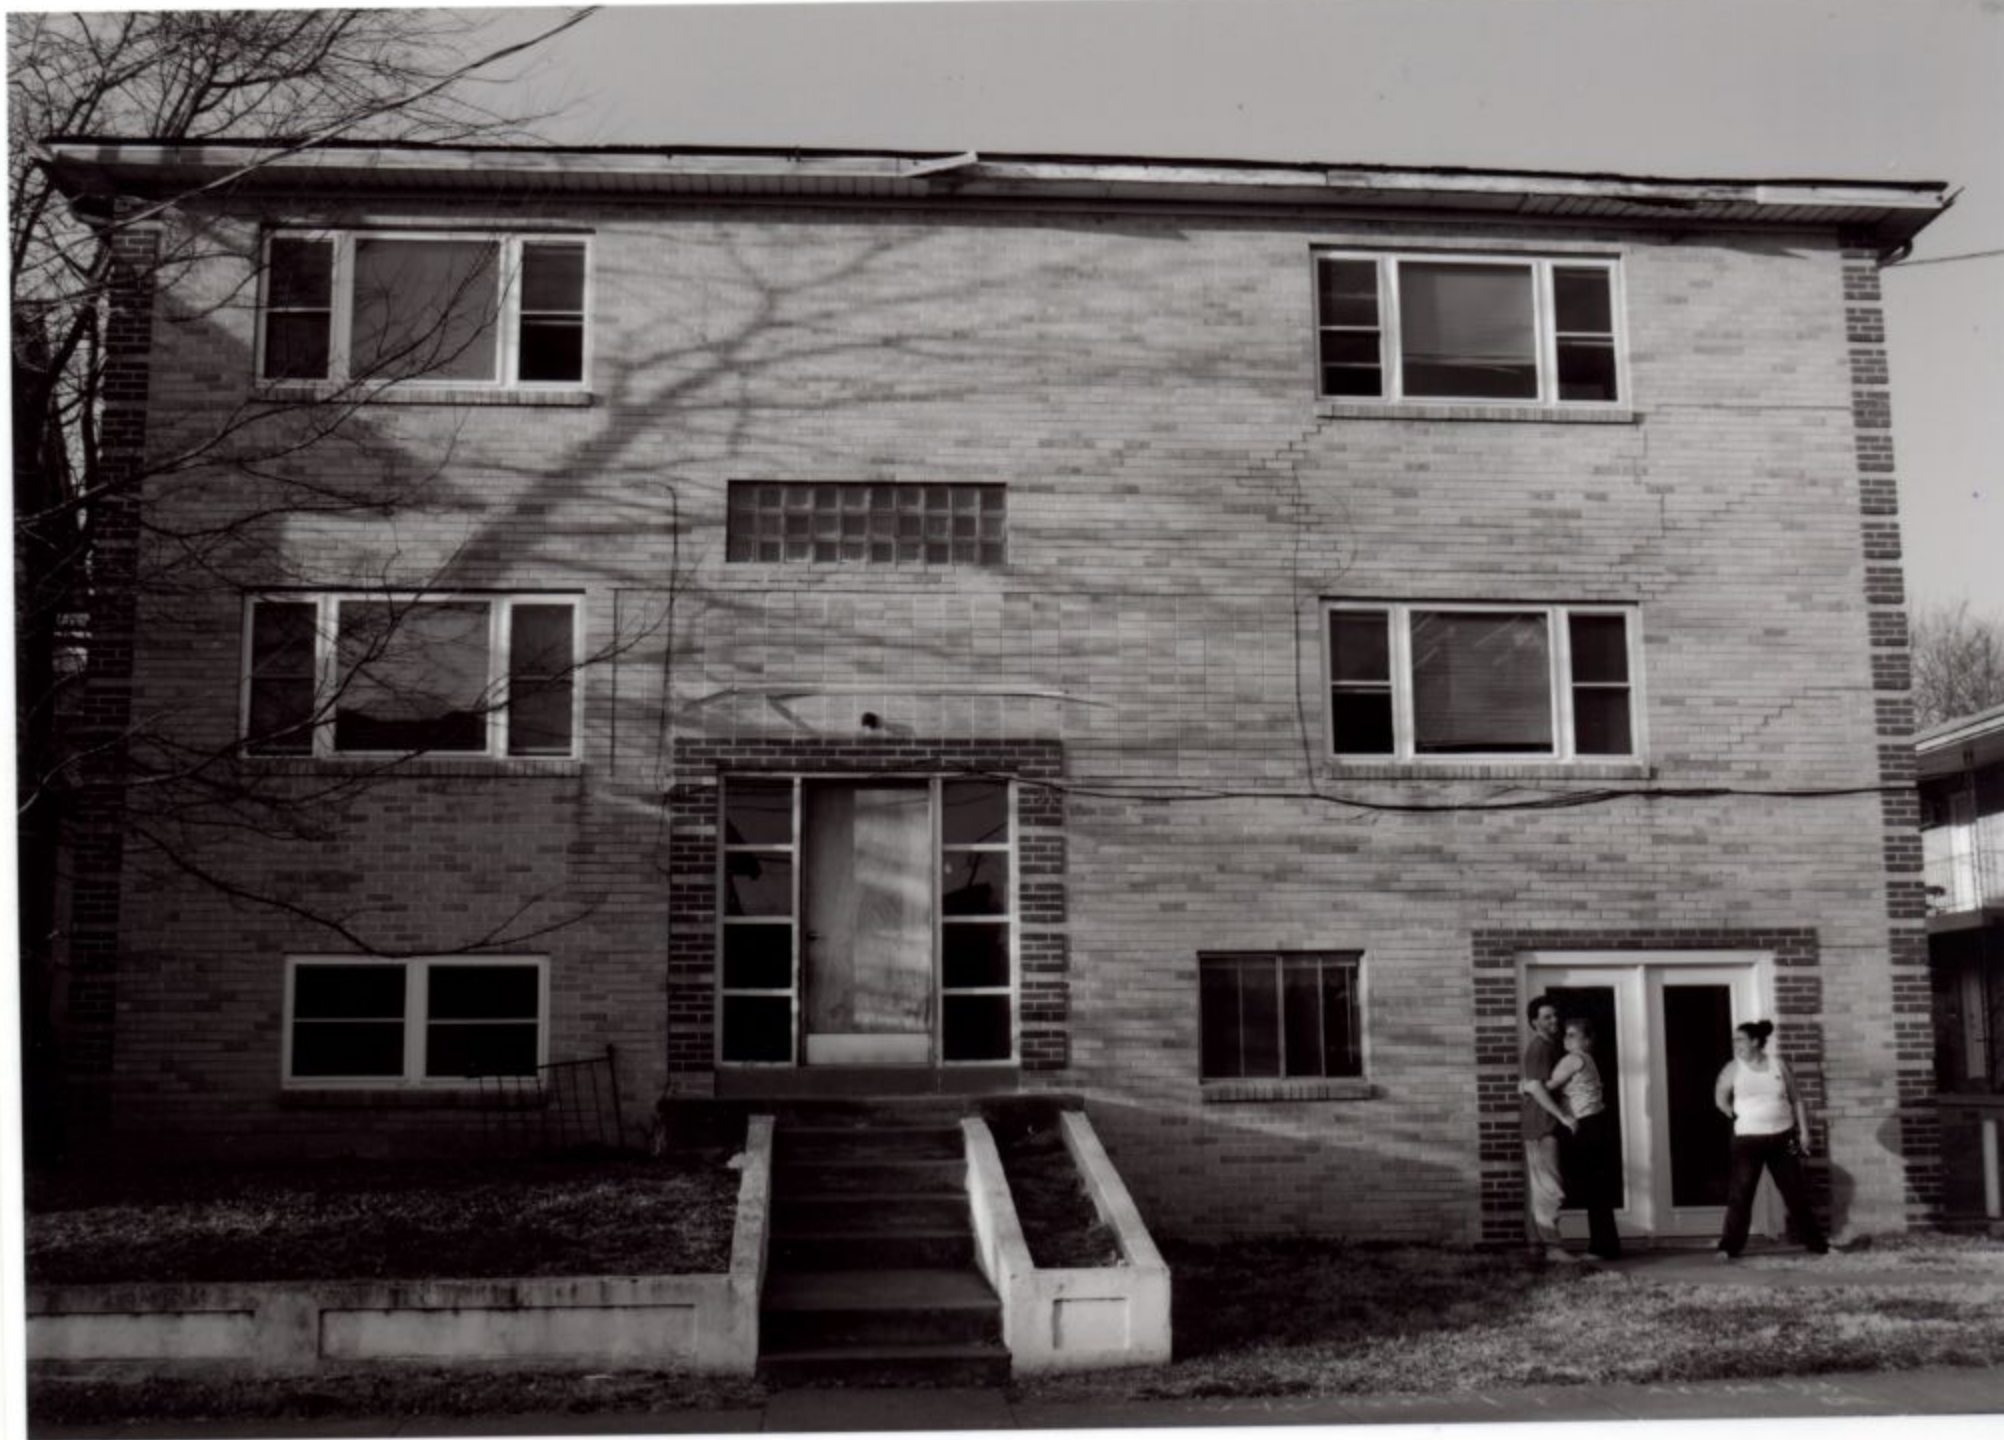
Building is situated near Southeast Missouri State University and downtown Cape Girardeau, MO. The garage was built with a concrete foundation, aluminum walls and a gable roof made of sheet metal. Garage was built in the 1960s, is 6 bays wide, and sits hidden immediately behind apartment complex creating a cement courtyard with 422 Bellevue.

Three story apartment complex clad in blonde brickwork. Sits on a split level concrete foundation. West side and entrance sit at a higher level than the southern half. Hipped roof has shallow pitch and asphalt shingles. Wide overhanging eaves are bare aluminum. Front door had large square transom lights along side and doorway is outlined with patterned red brick. Building also has red brick quoin work along the front facades edges. Second and Third floor windows are tripartite. First floor windows differ, one is casement and one is one over one double hung. Front façade also had a sliding door to the south of main entrance on the lower elevation.

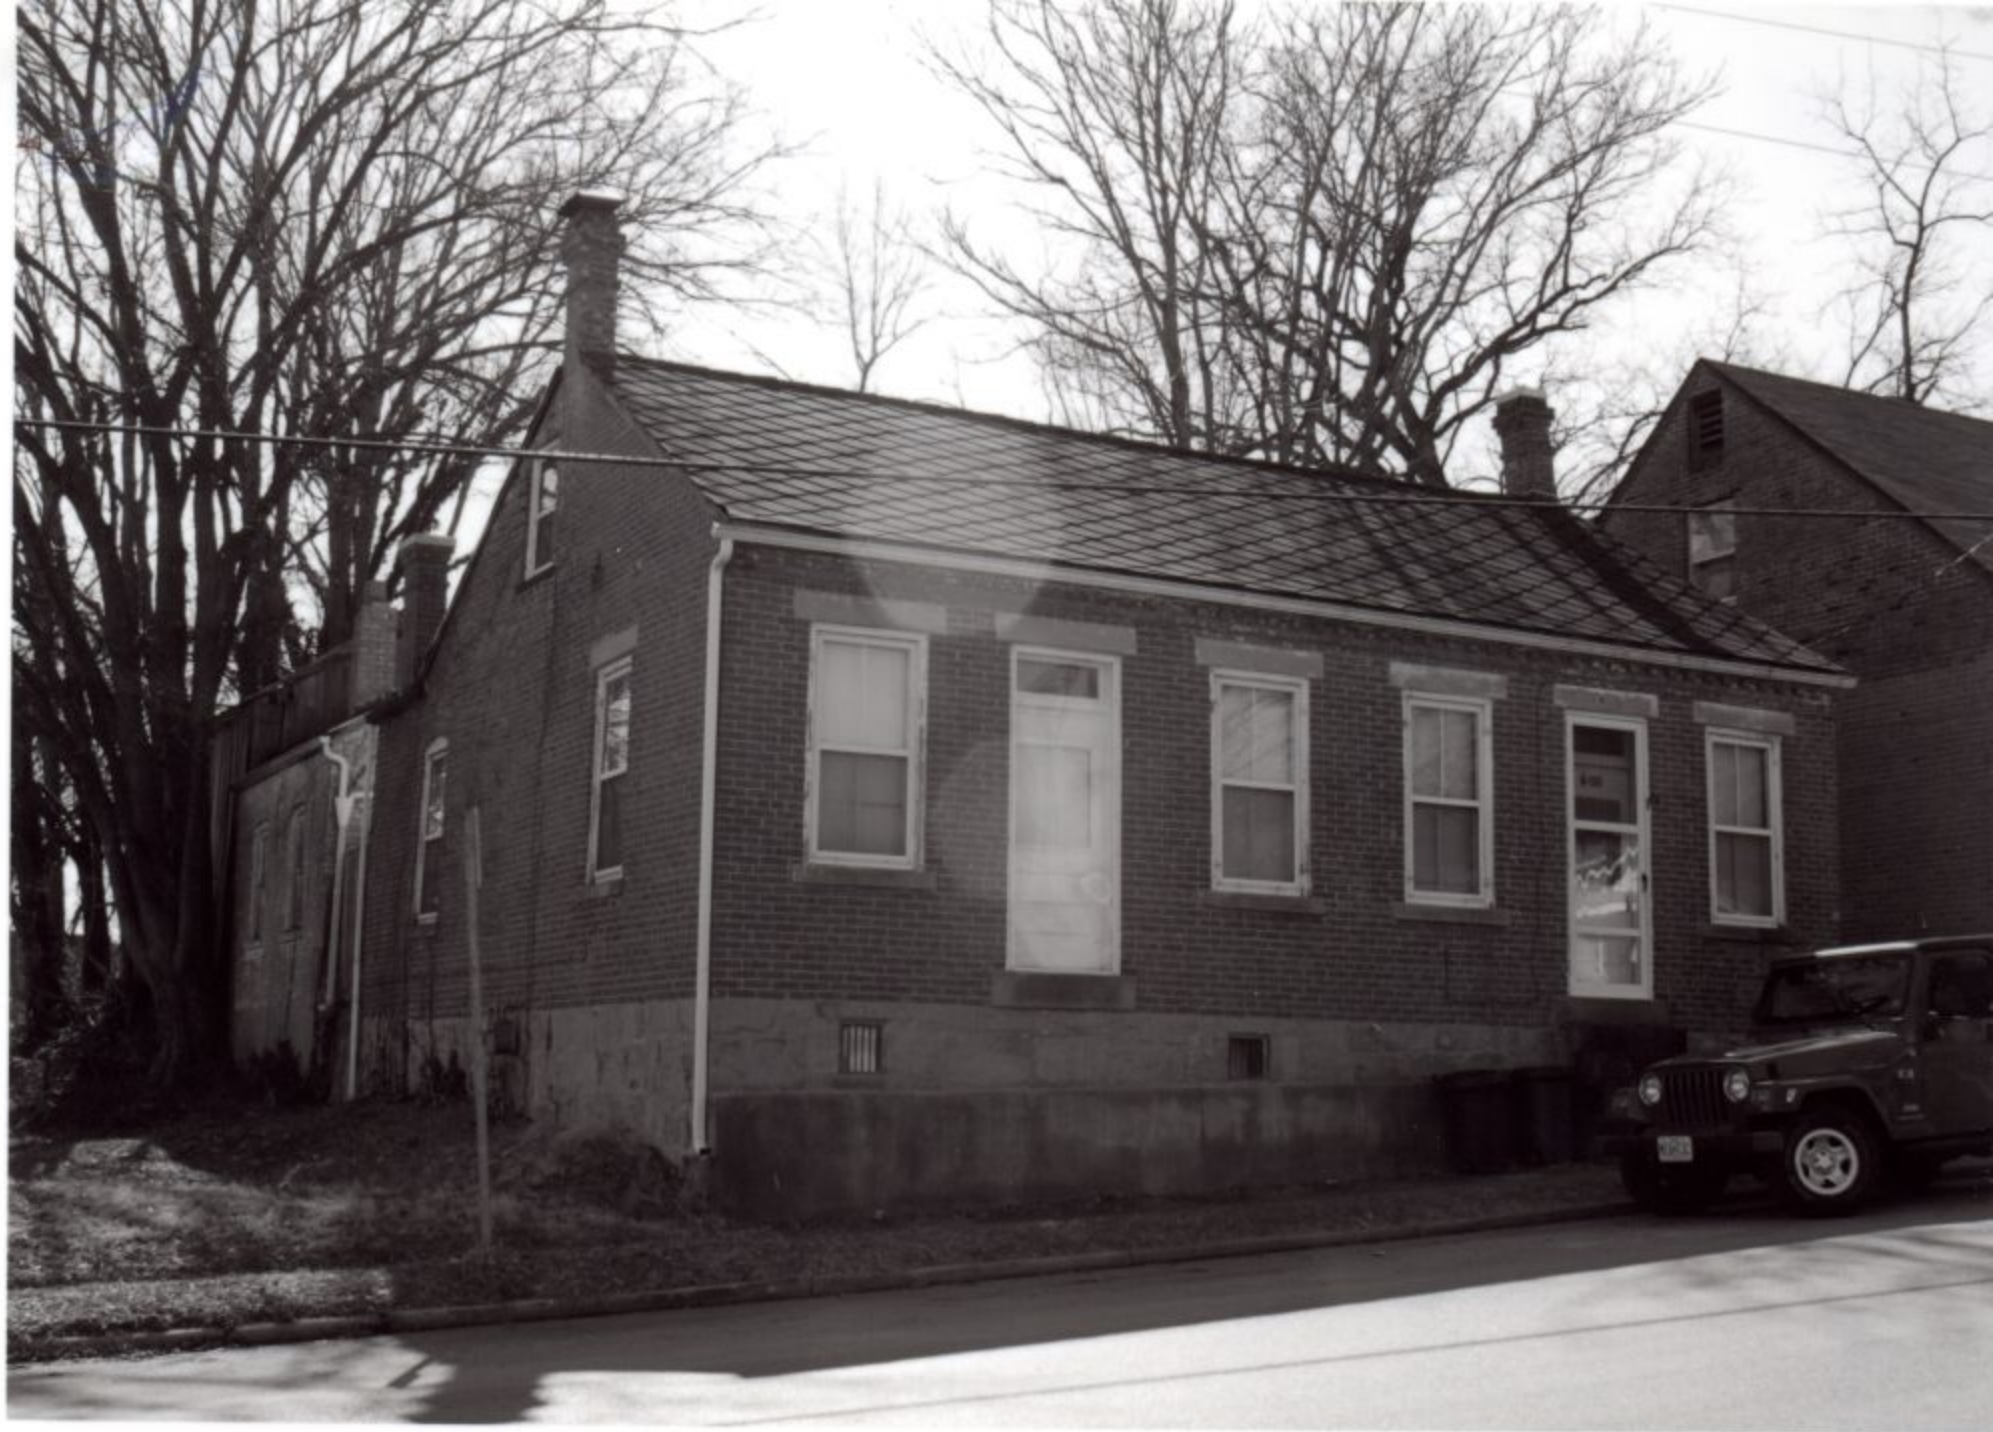
The single story brick Missouri German vernacular house is constructed of brick and sits very close to the road. The building is side gabled and has a dental design in the brick along the roofline of the façade. There are three chimneys; two central end ones and one that is on a small extension to the back left of the house. There are six evenly spaced bays on the front façade, all with concrete sills above them; the two ends are windows, the next two in are doors, and the middle two are windows. There is a stone foundations with a concrete half wall and steps leading to the door on the façade.

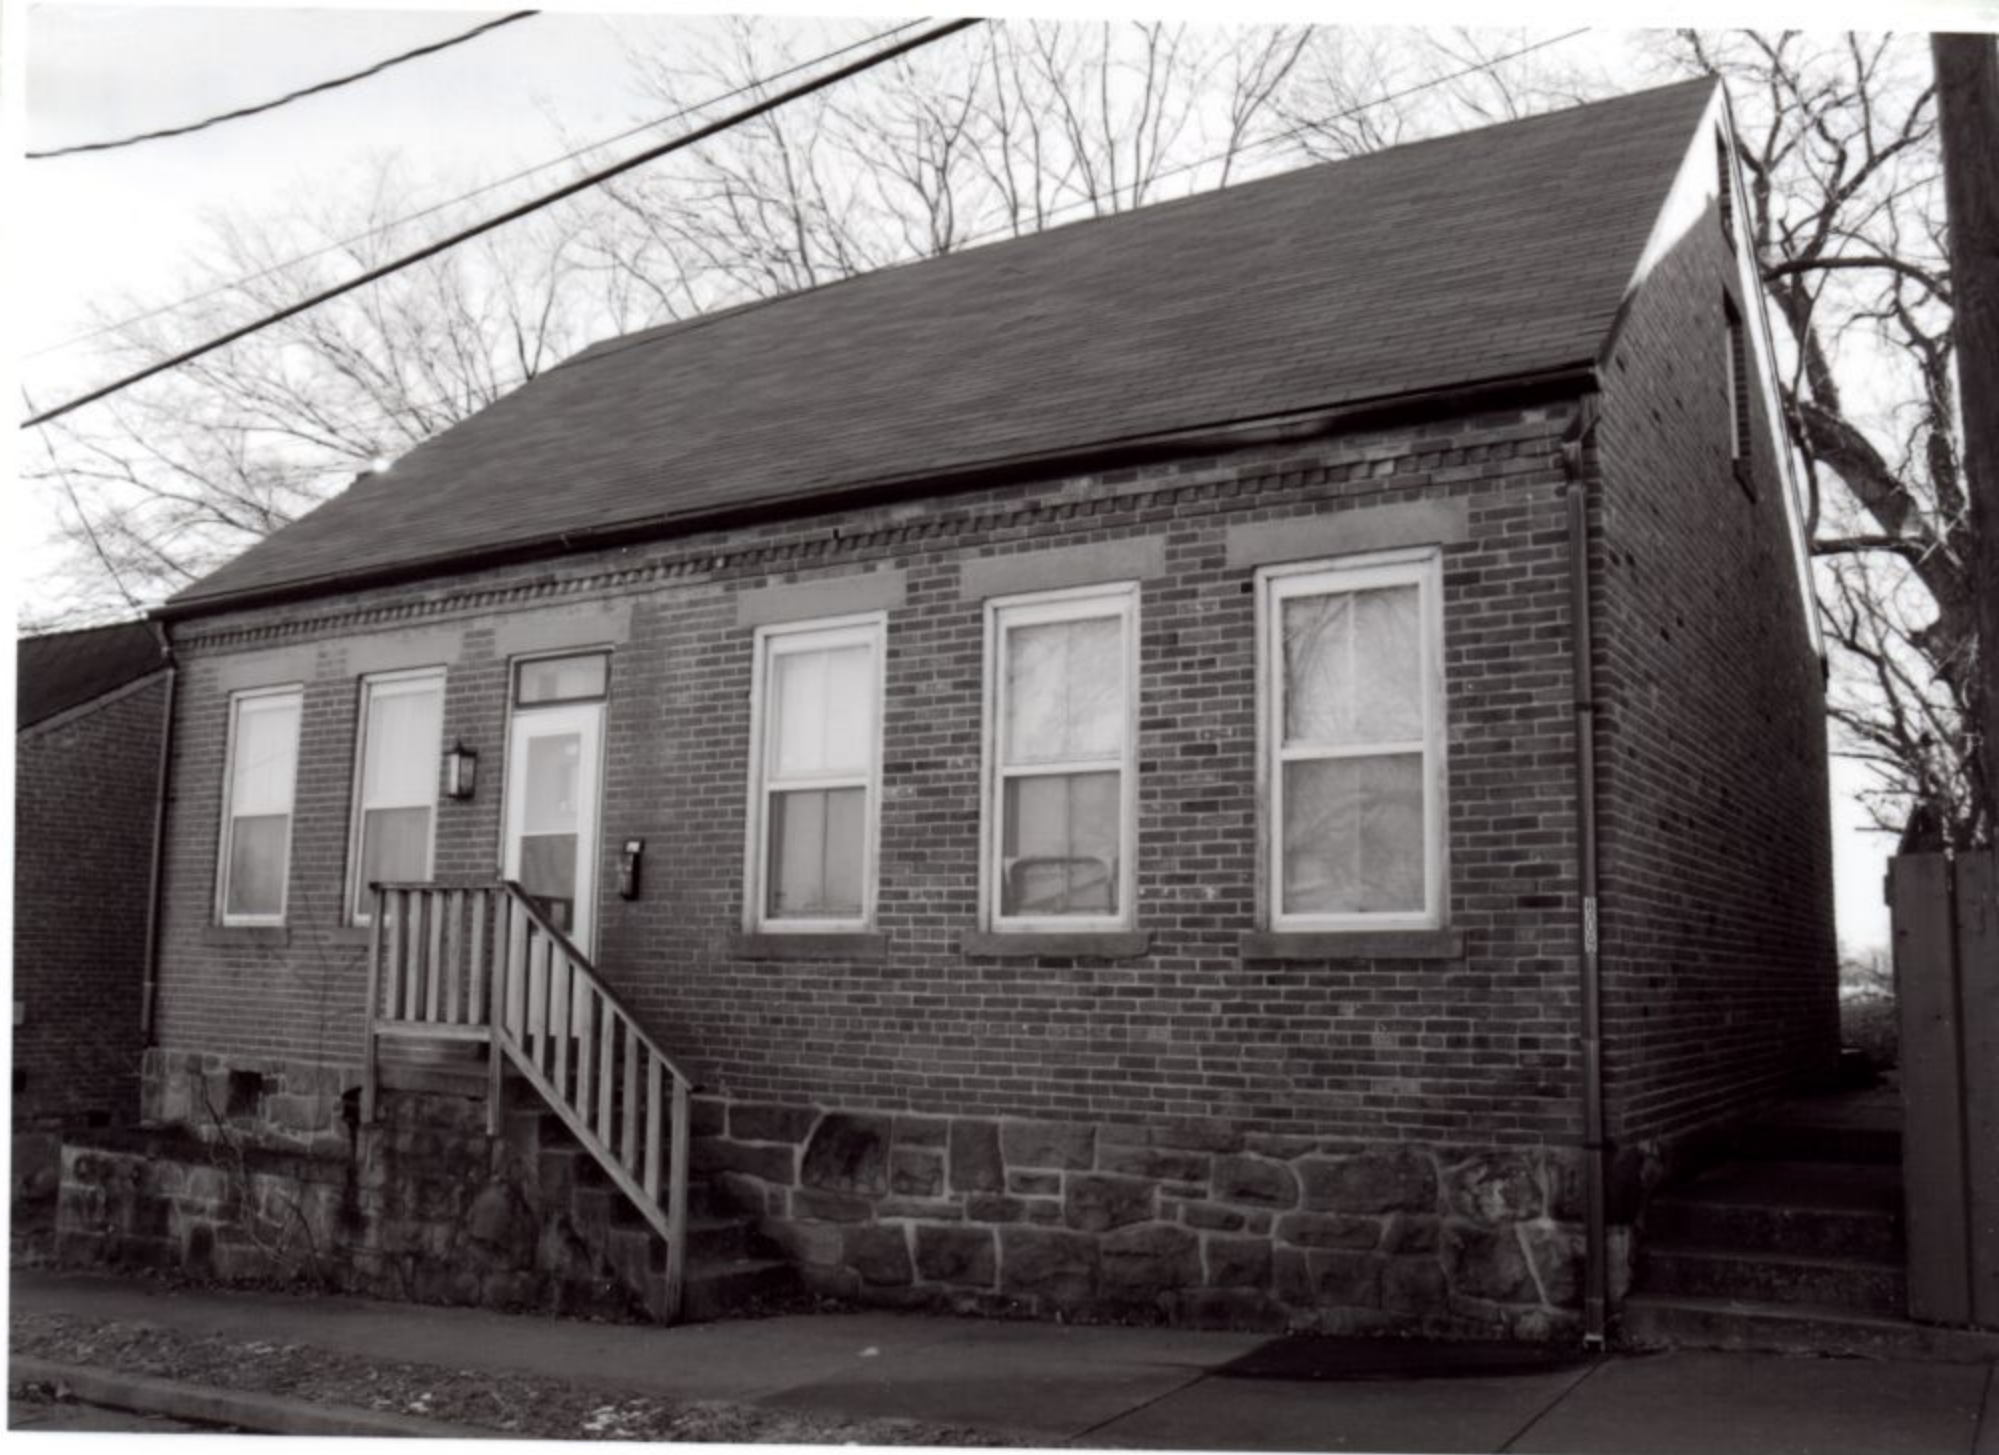
This one and one-half story building is of German Vernacular style with a side gable roof covered likely with cedar shake shingles. Brick chimneys rest on each gable end and one on the southeast corner. The building is made of brick with a stone foundation. The façade has sash windows and two entry panel doors. Dental runs along the cornice line.

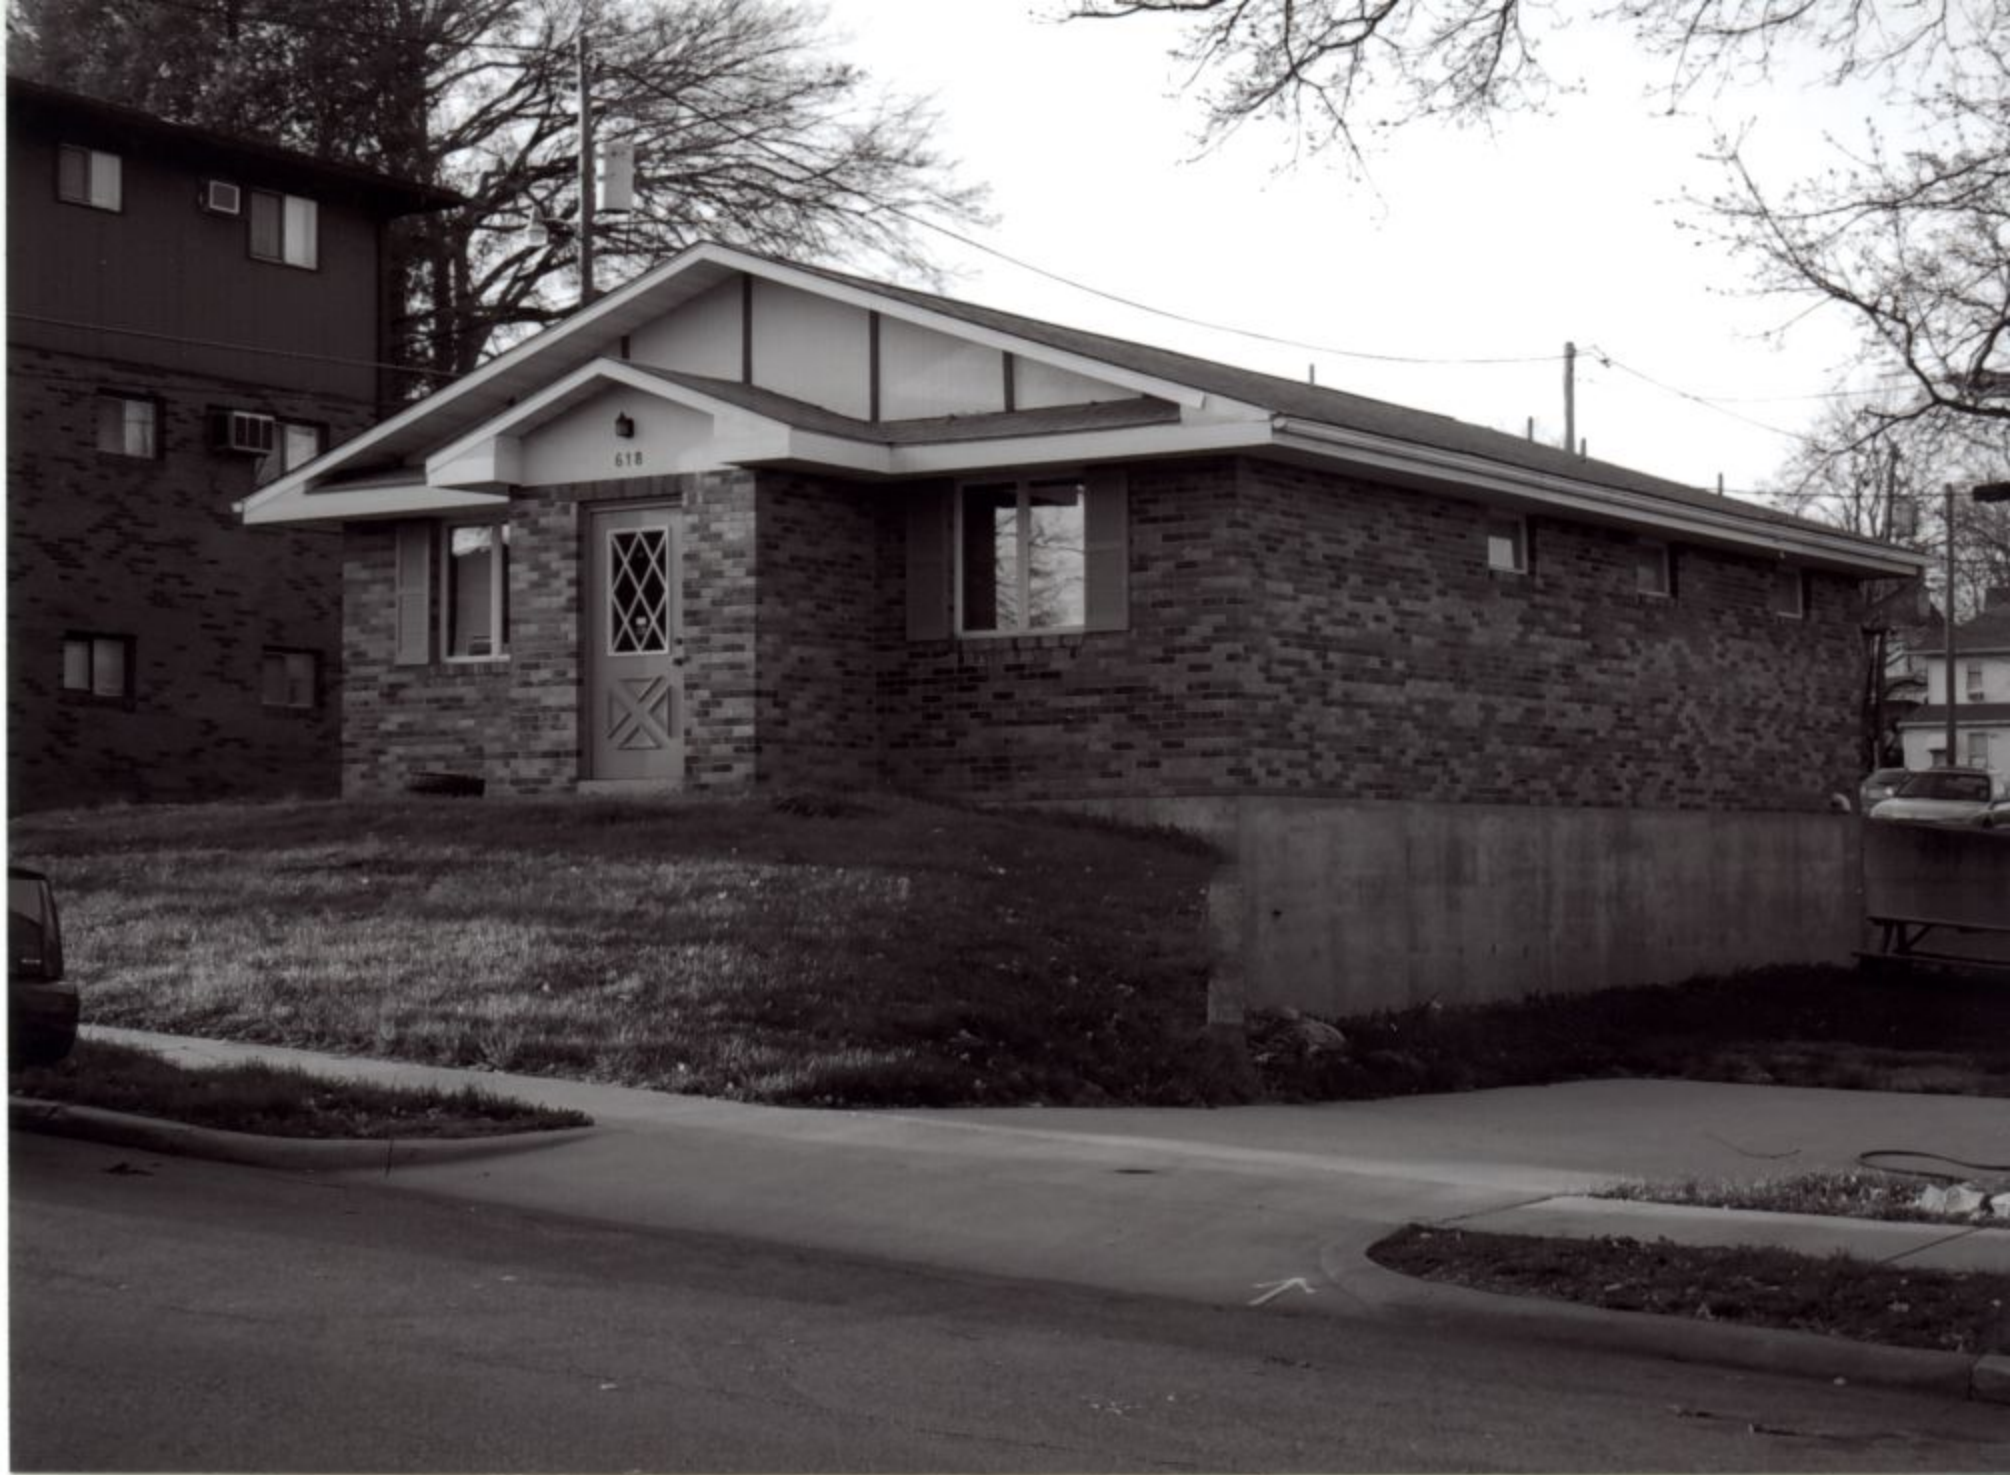
One story with poured concrete foundation. Low pitched, end gabled roof with asphalt shingles. Small single bay business building with entrance and small concrete stoop on south facade. Faced with red brick on the south facade.
