# ARCHITECTURAL/HISTORIC INVENTORY FORM

1. Survey No. <b>CGSEA002-051</b>		2. Survey name: <b>N. Sprigg-N. Middle Survey</b>	
3. County: <b>Cape</b>		4. Address: <b>419 Bellevue Street</b>	
5. City: <b>Cape Girardeau</b>	Vicinity: <input type="checkbox"/>	6. UTM: <b>16/276414/4131995</b>	7. Township/Range/Section: <b>T: 30 R: 14 S: 5</b>
8. Historic name (if known): <b>Bellevue Apartments</b>		9. Present/other name (if known): <b>Bellevue Apartments</b>	
10. Ownership: <input checked="" type="checkbox"/> Private <input type="checkbox"/> Public		11. Historic use (if known): <b>Domestic: Multiple Dwelling</b>	
		11. Current use: <b>Domestic: Multiple Dwelling</b>

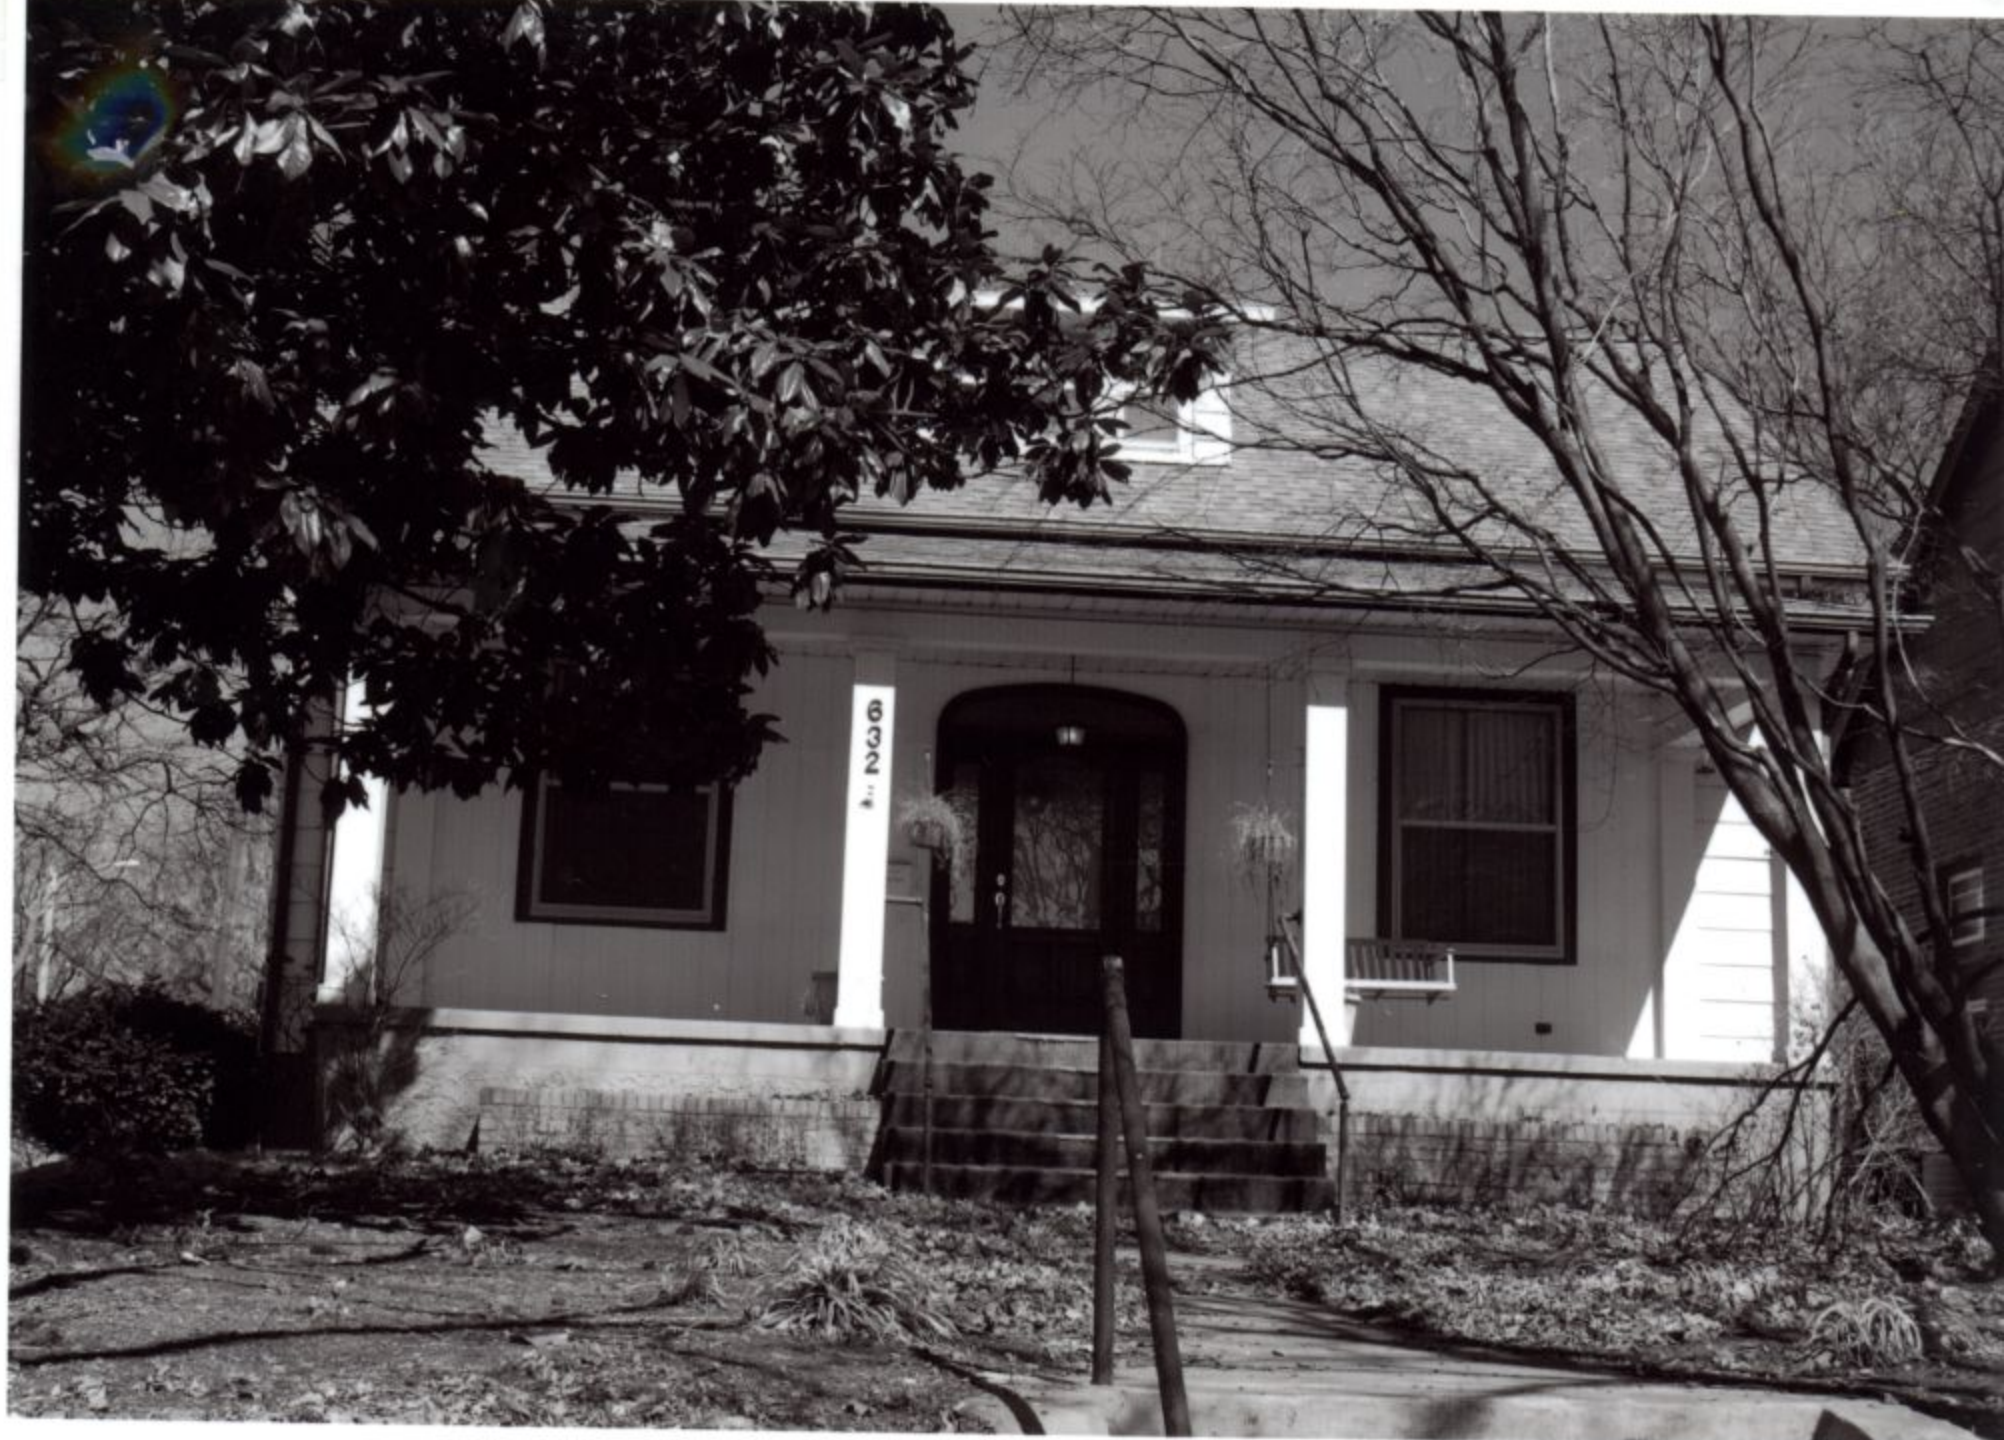
Large central wooden door with side lights and an arched transom of leaded glass. Side gabled roof with asphalt shingles and a large central dormer. Full width porch with four square columns evenly spaced. Aluminum replacement windows on either side of front doorway.

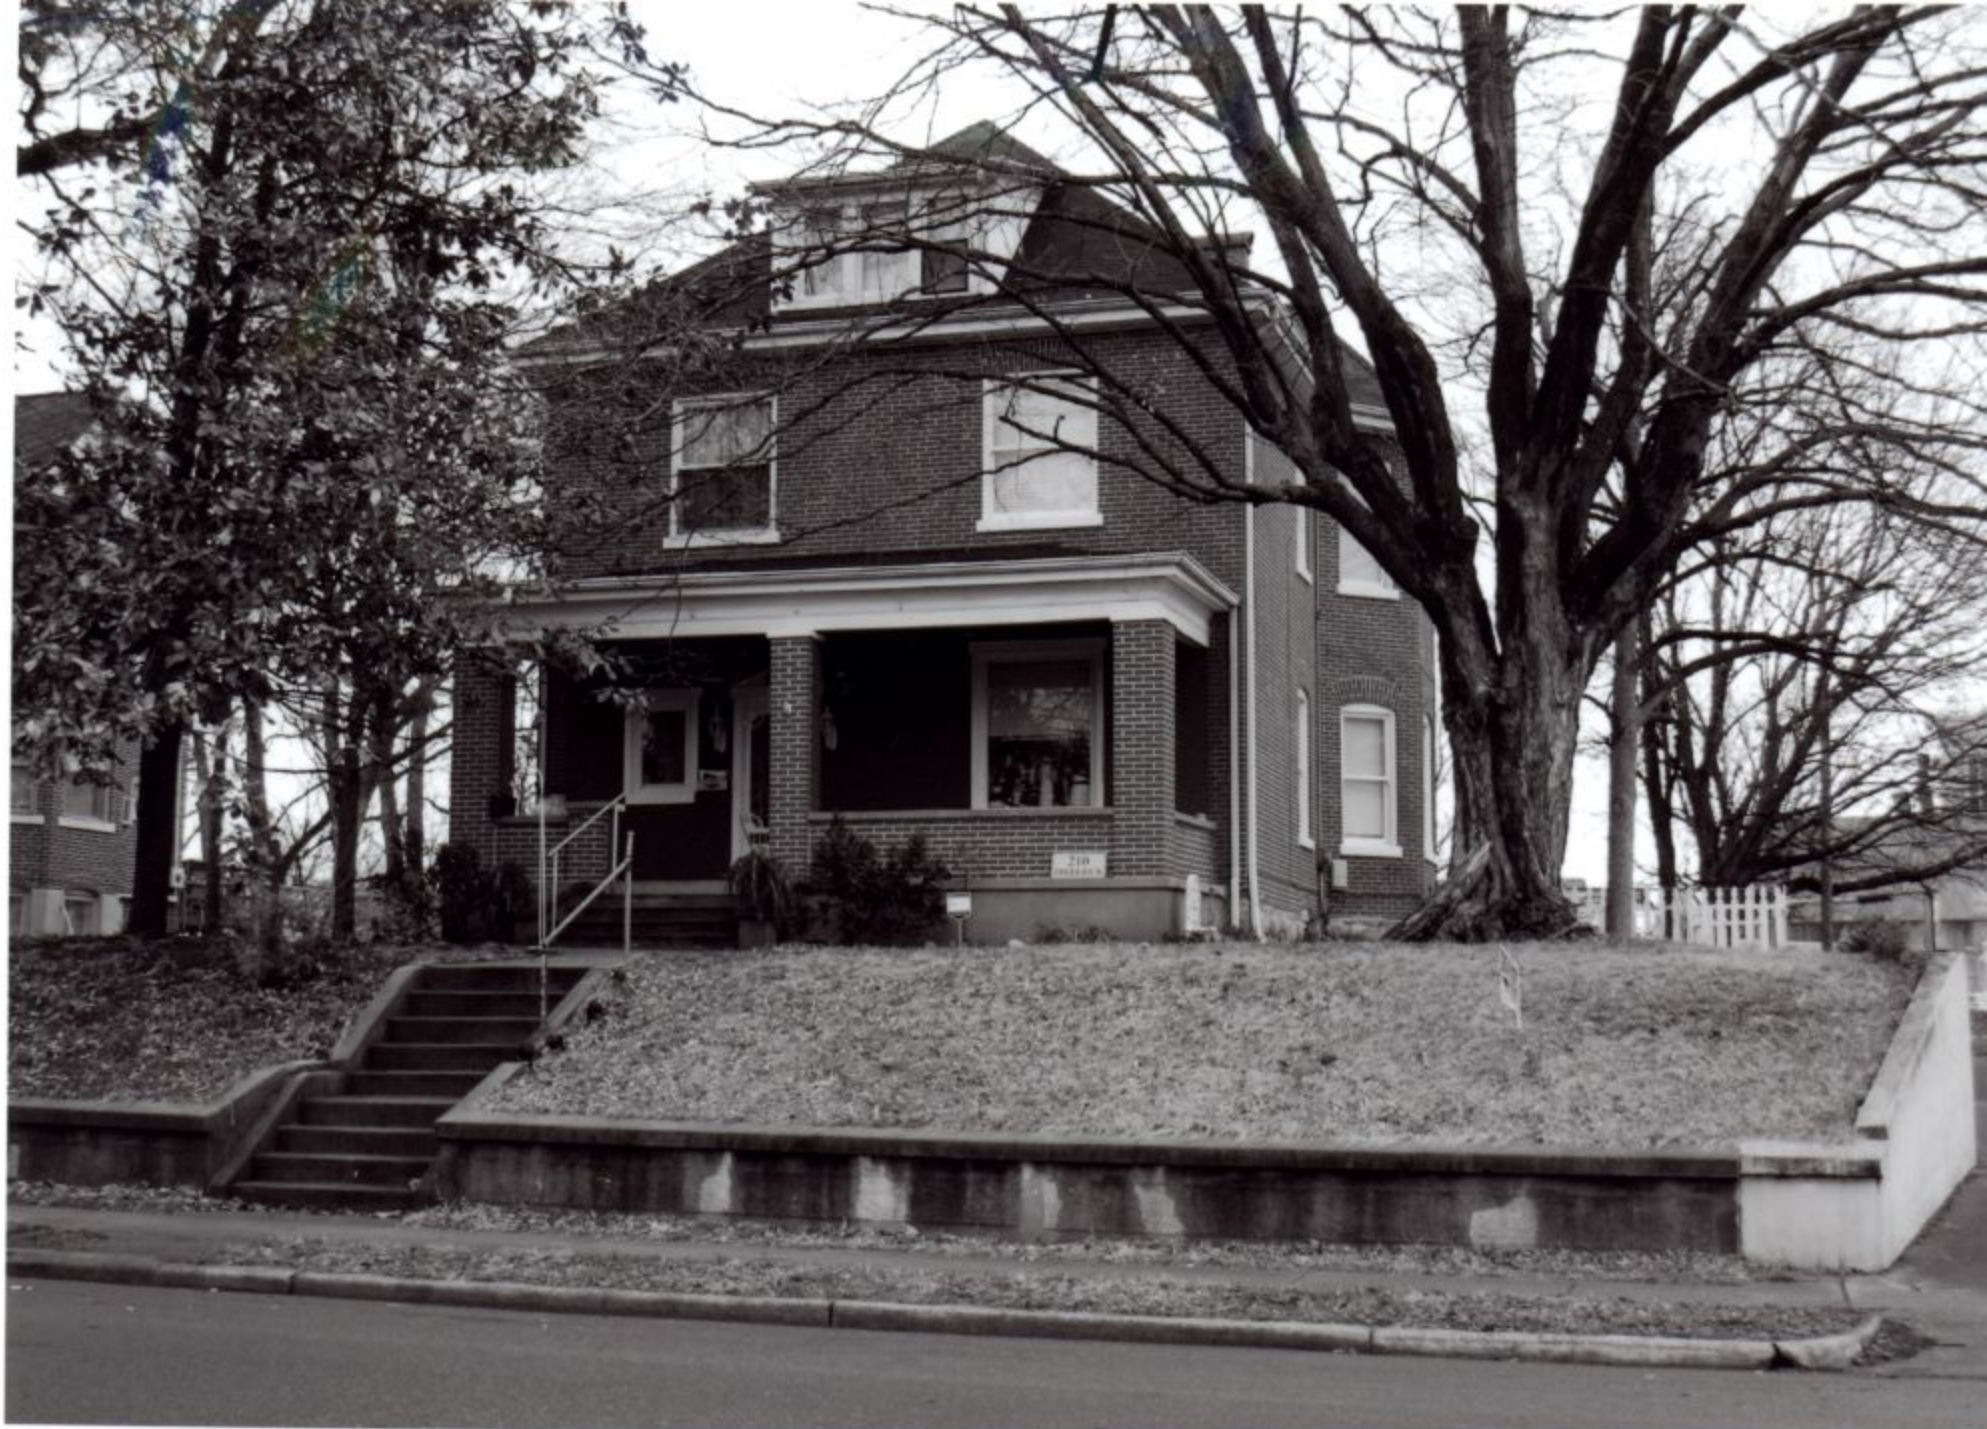
2 1/2 story brick, medium hipped roof, centralized dormer with three windows, one story porch held up by three brick posts. Front door offset to left, broken pediment, and flanked by light fixtures, mailbox and small window to left. Large window on right side. Second story has two large windows equidistance apart with brick lintel. Projecting two-story bay on right side of house.

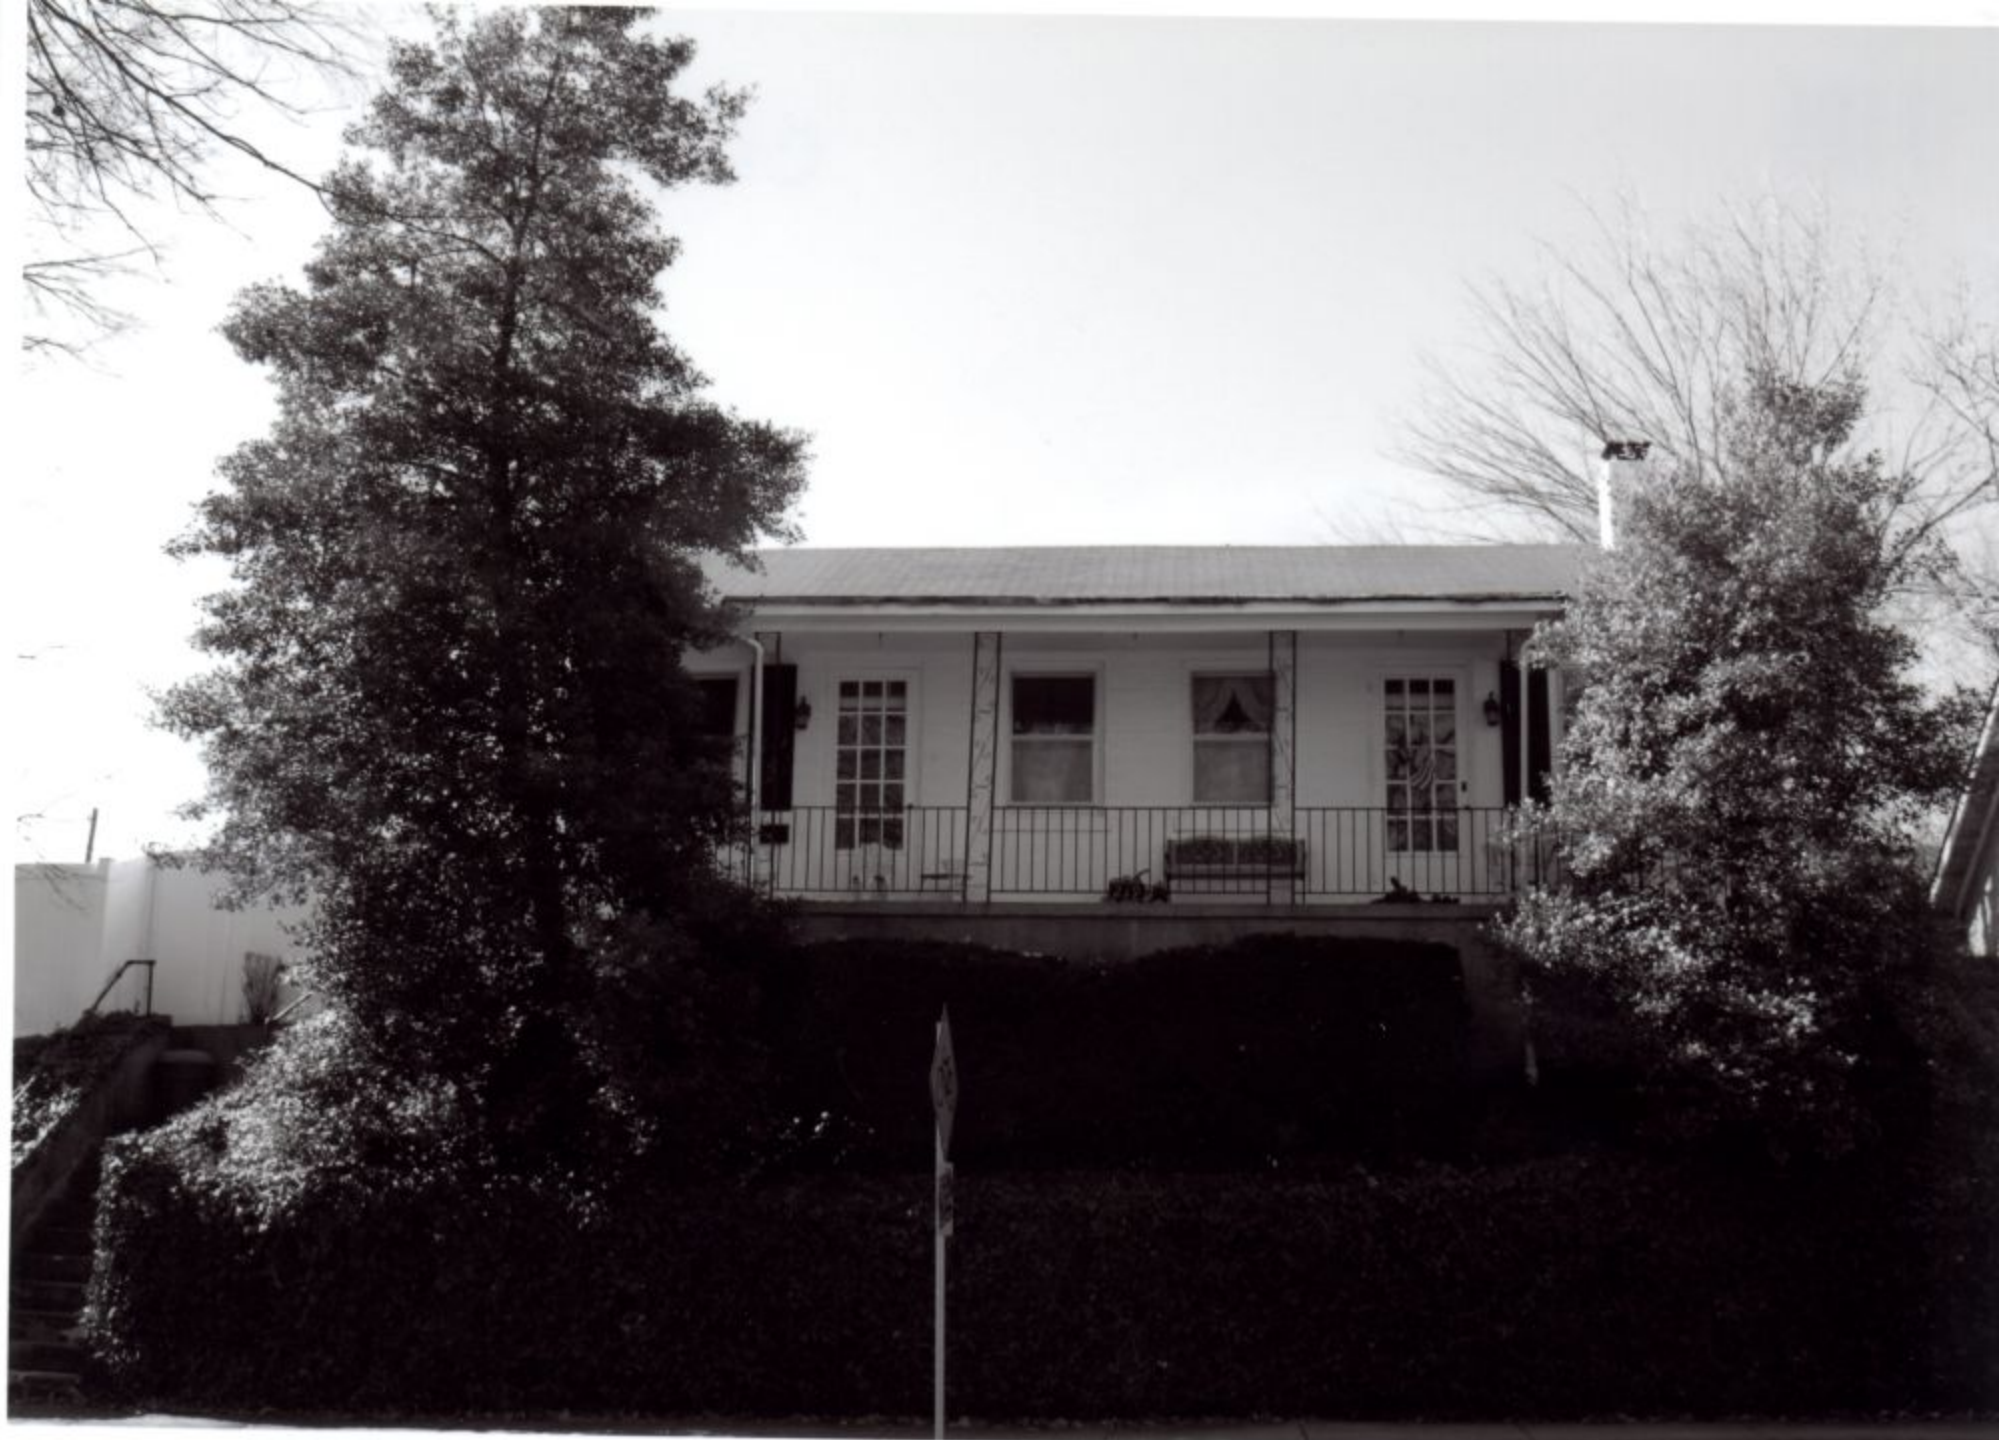
This single story house has distinctive features of a Missouri German Vernacular house, because of the single story, having two doors, and sitting almost right along the road. The roof is side gabled which extends past the façade to create a gallery, and that has a central right end chimney. There are six evenly spaced bays on the front façade; the outside two are windows with shutters, the next two in are doors, and the middle two are windows. The doors have been replaced with 15 light doors.

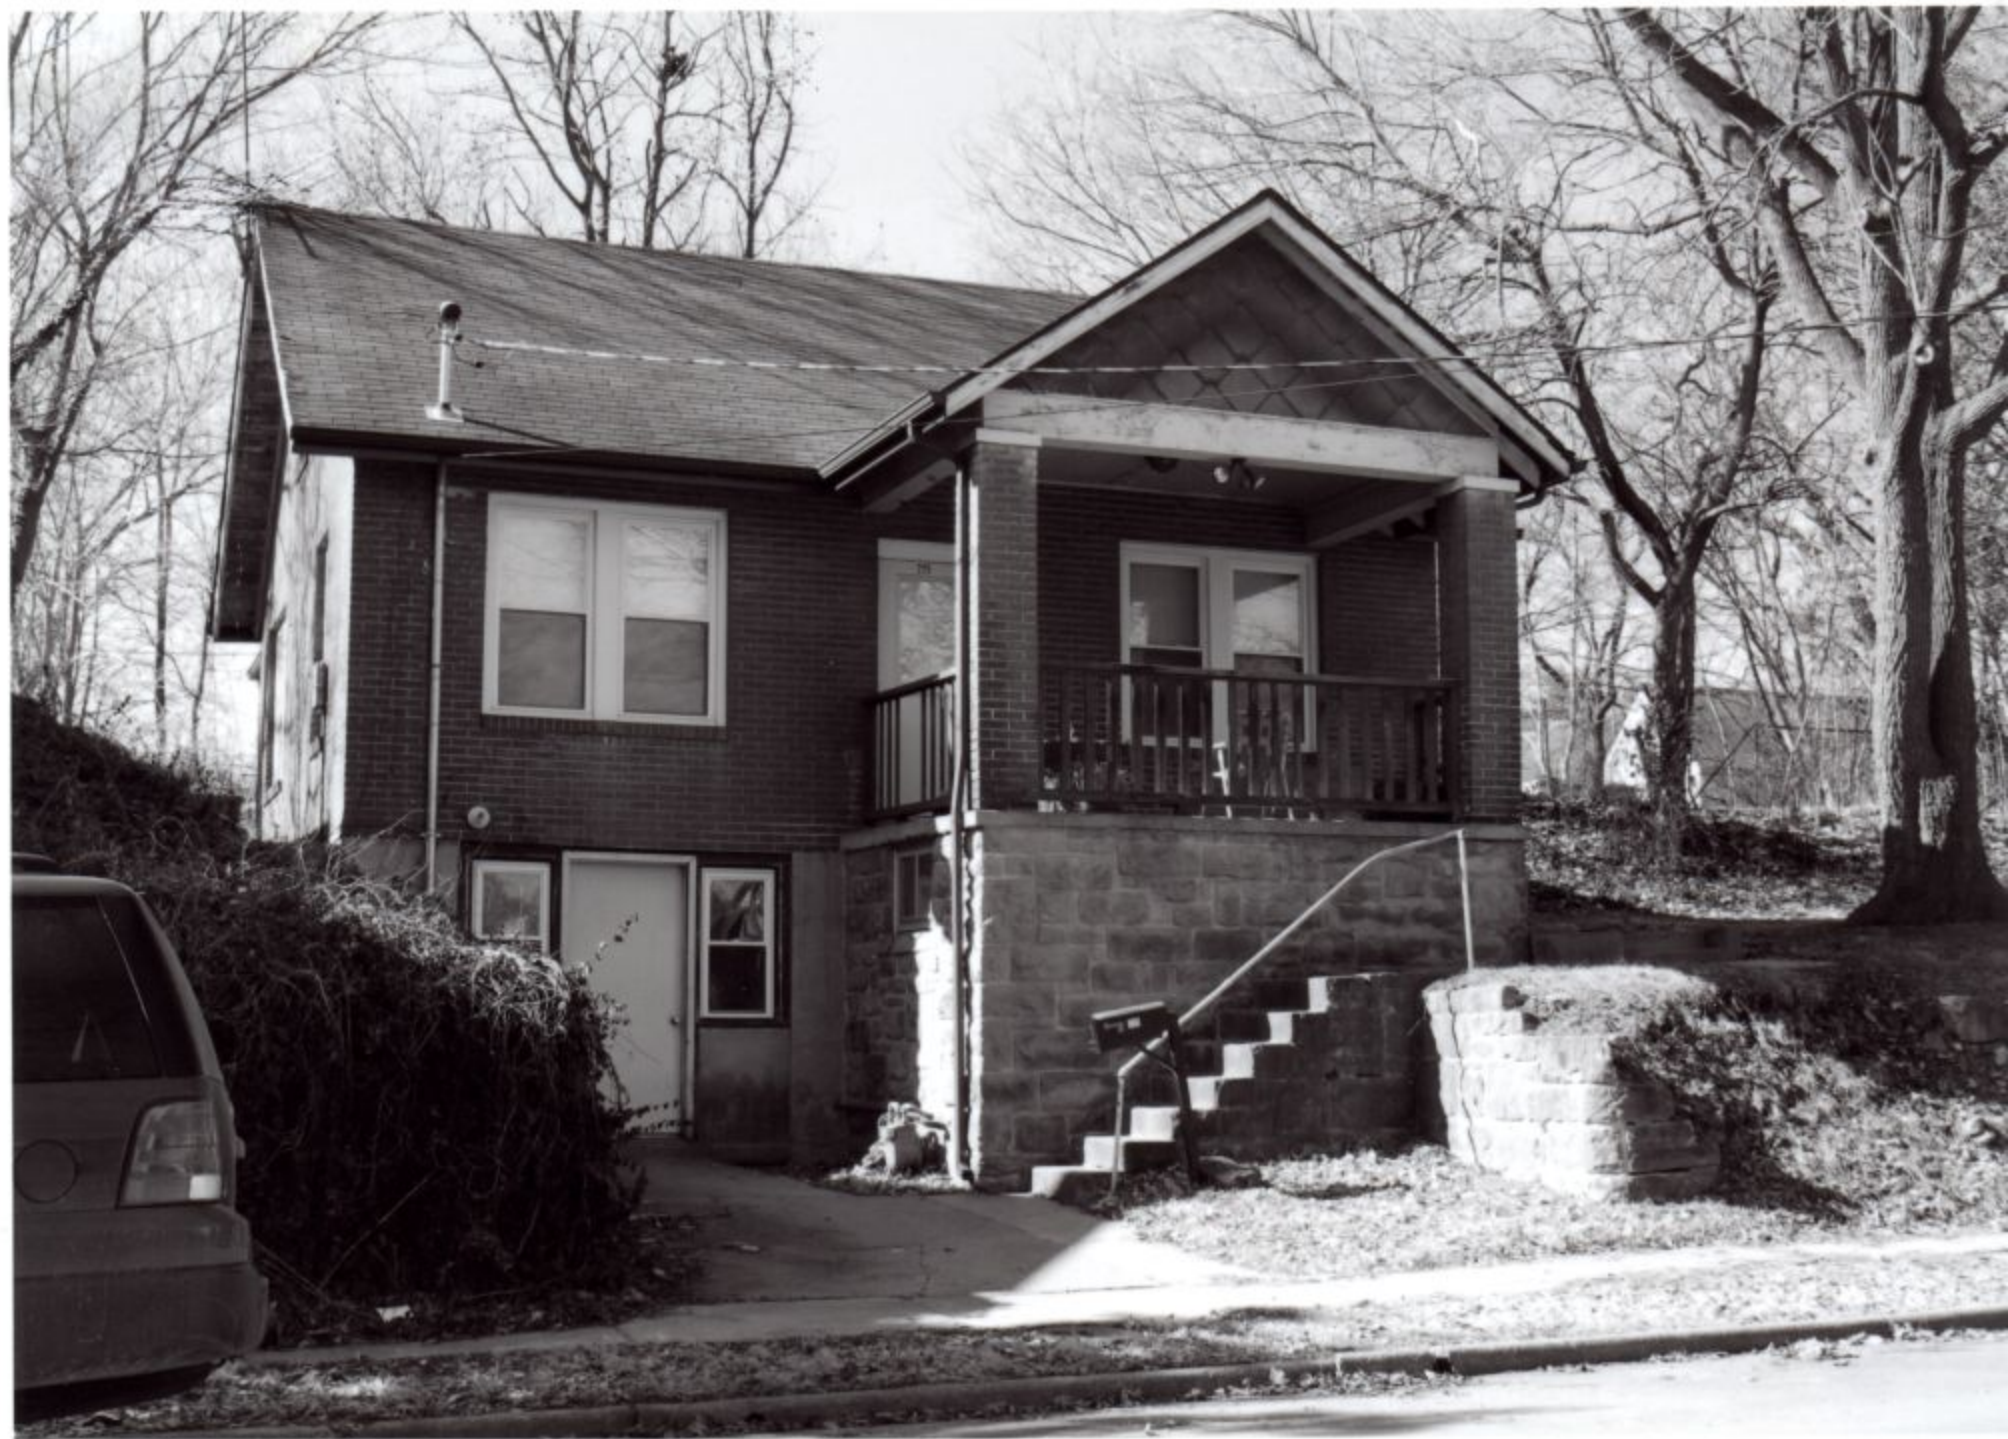
The one and one-half story building is constructed of brick with a stone foundation. The roof is side gabled with asphalt shingle covering. The porch is open form with brick posts and a gable façade covered with fish scale shingles possibly of cedar and a stone foundation. The façade has double sash windows and a single entry. The basement has a single entry with sash windows on each of its sides.

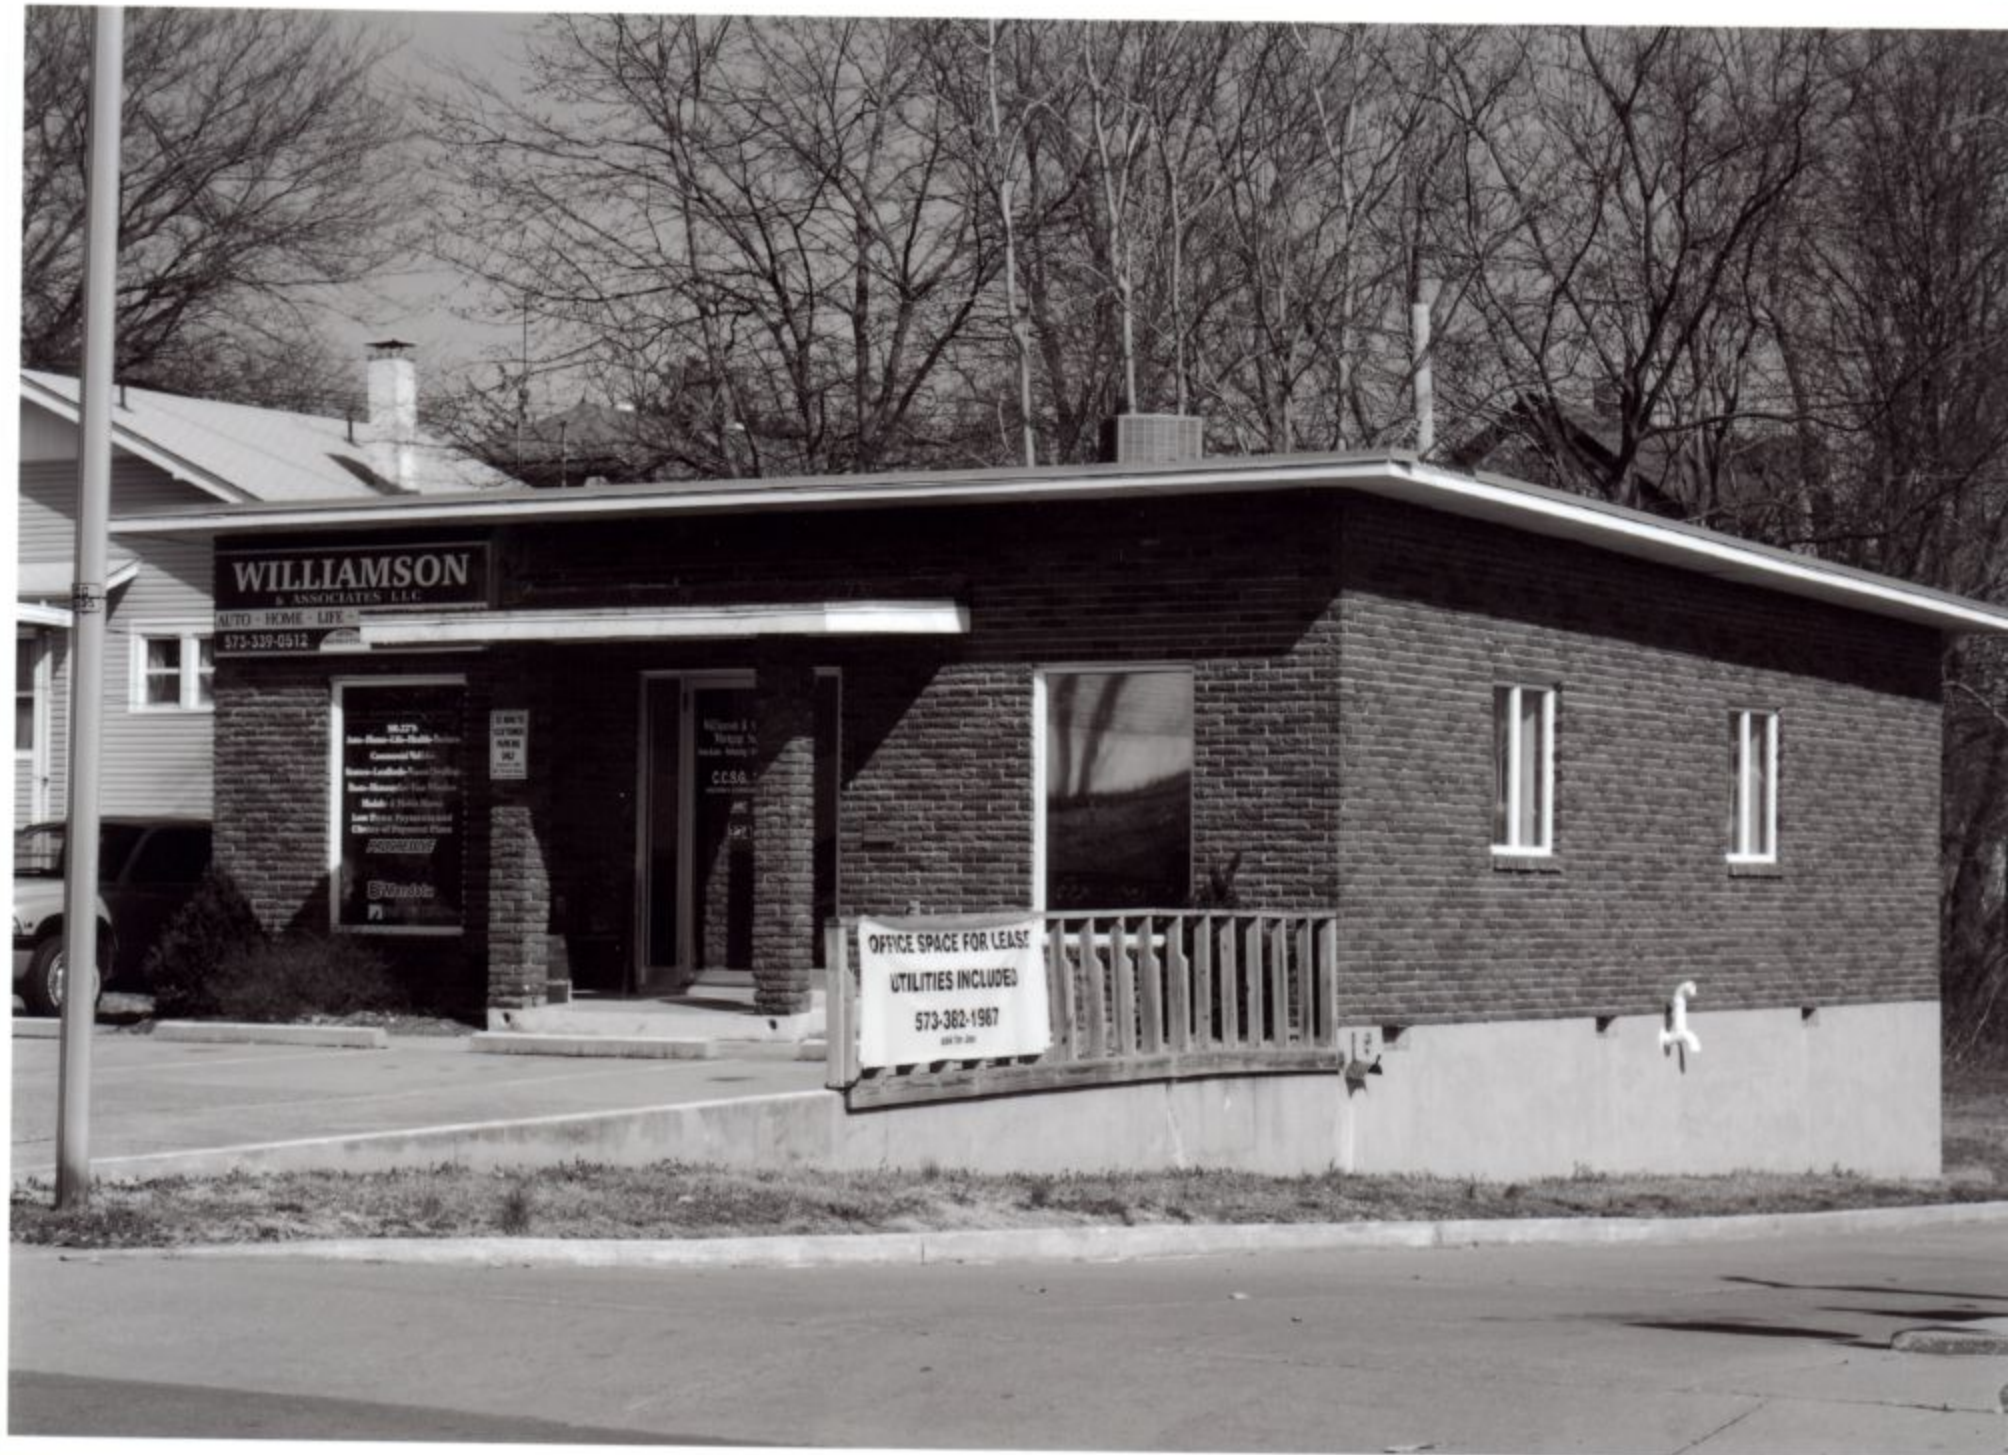
This small, one-story, modern style building sits on a raised, poured concrete foundation and is constructed out of brick. It has a flat, tar and gravel roof with wide overhanging eaves. The façade has three bays, made up of a single-pane glass front door flanked by two large single-pane windows. It has a slab porch with two plain, brick pillars connecting it to a small slab overhang. The north and south elevations have newer vinyl, casement type windows. In the rear of the building is a back door and another slab porch.

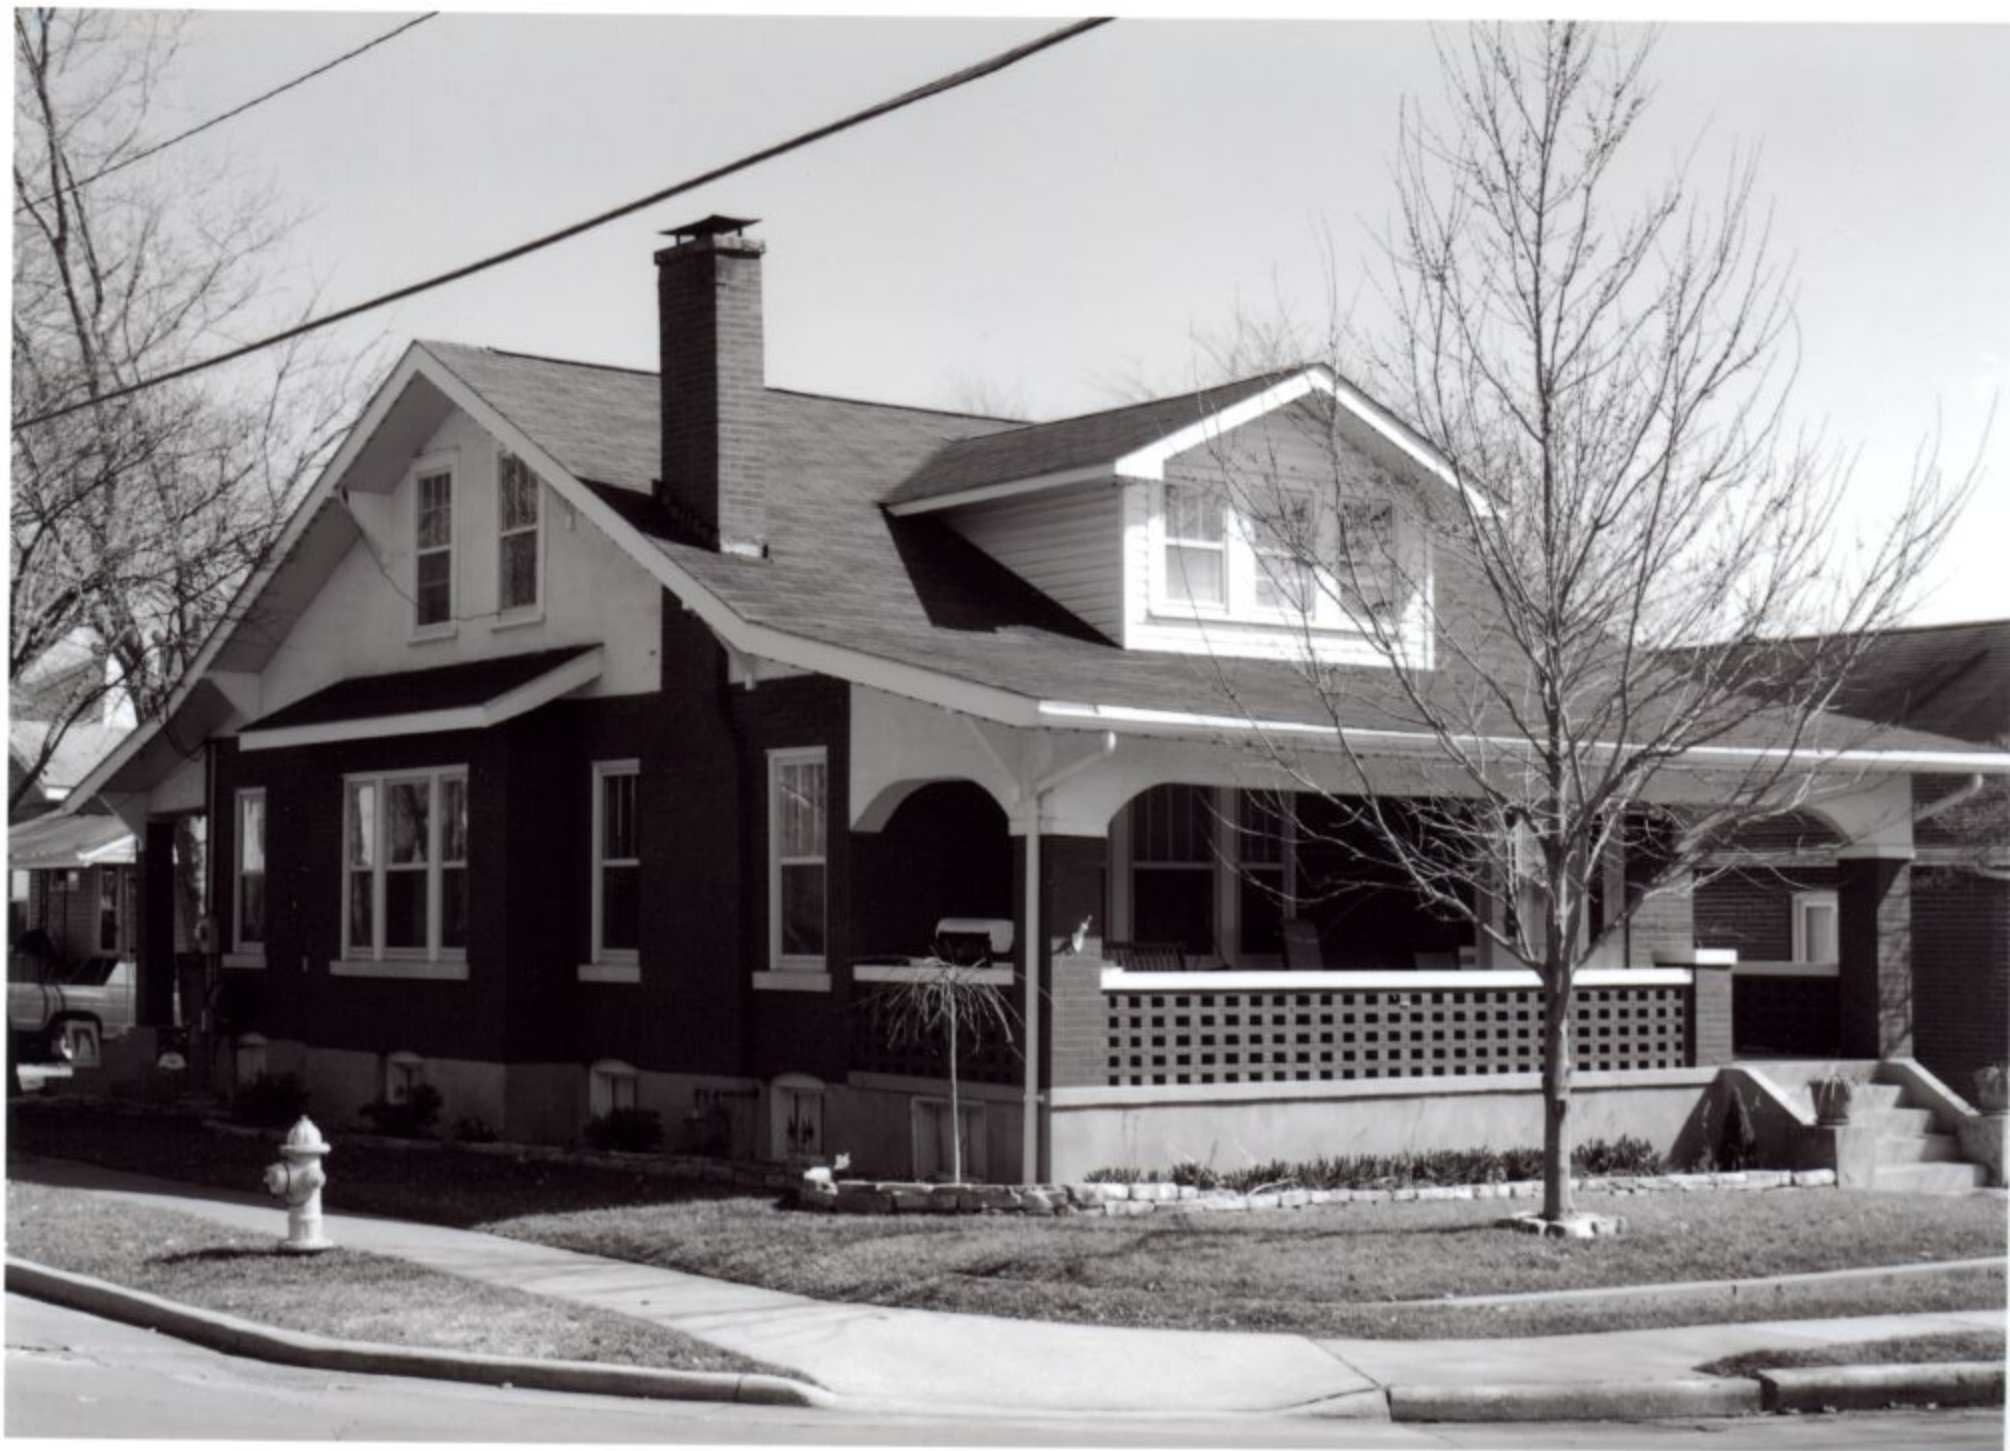
This one-and-a-half-story craftsman bungalow is constructed out of brick over a wood frame on a poured concrete foundation. The side gabled, dual-pitched roof has asphalt shingles, wide overhanging eaves with wooden brackets underneath, and a large central gable dormer with three windows and vinyl siding. The gable ends have a stucco finish. A tall, exterior brick chimney extends through the roofline on the north elevation. The open verandah porch extends the full width of the façade and has two full height brick pillars on the outsides, and one half pillar on one side of the stairs, which are offset to the right. Brick "lattice" work wraps around the porch. The façade has two bays, with the front door also offset to the right, and a large bay window on the left. There is also a bay window on the north elevation. The door has a large, single-pane window in it, and sidelights. All of the windows appear to be vinyl three-over-one double hung, sash windows, with the exception of the center part of the two bay windows, which have a four-over-one pattern.

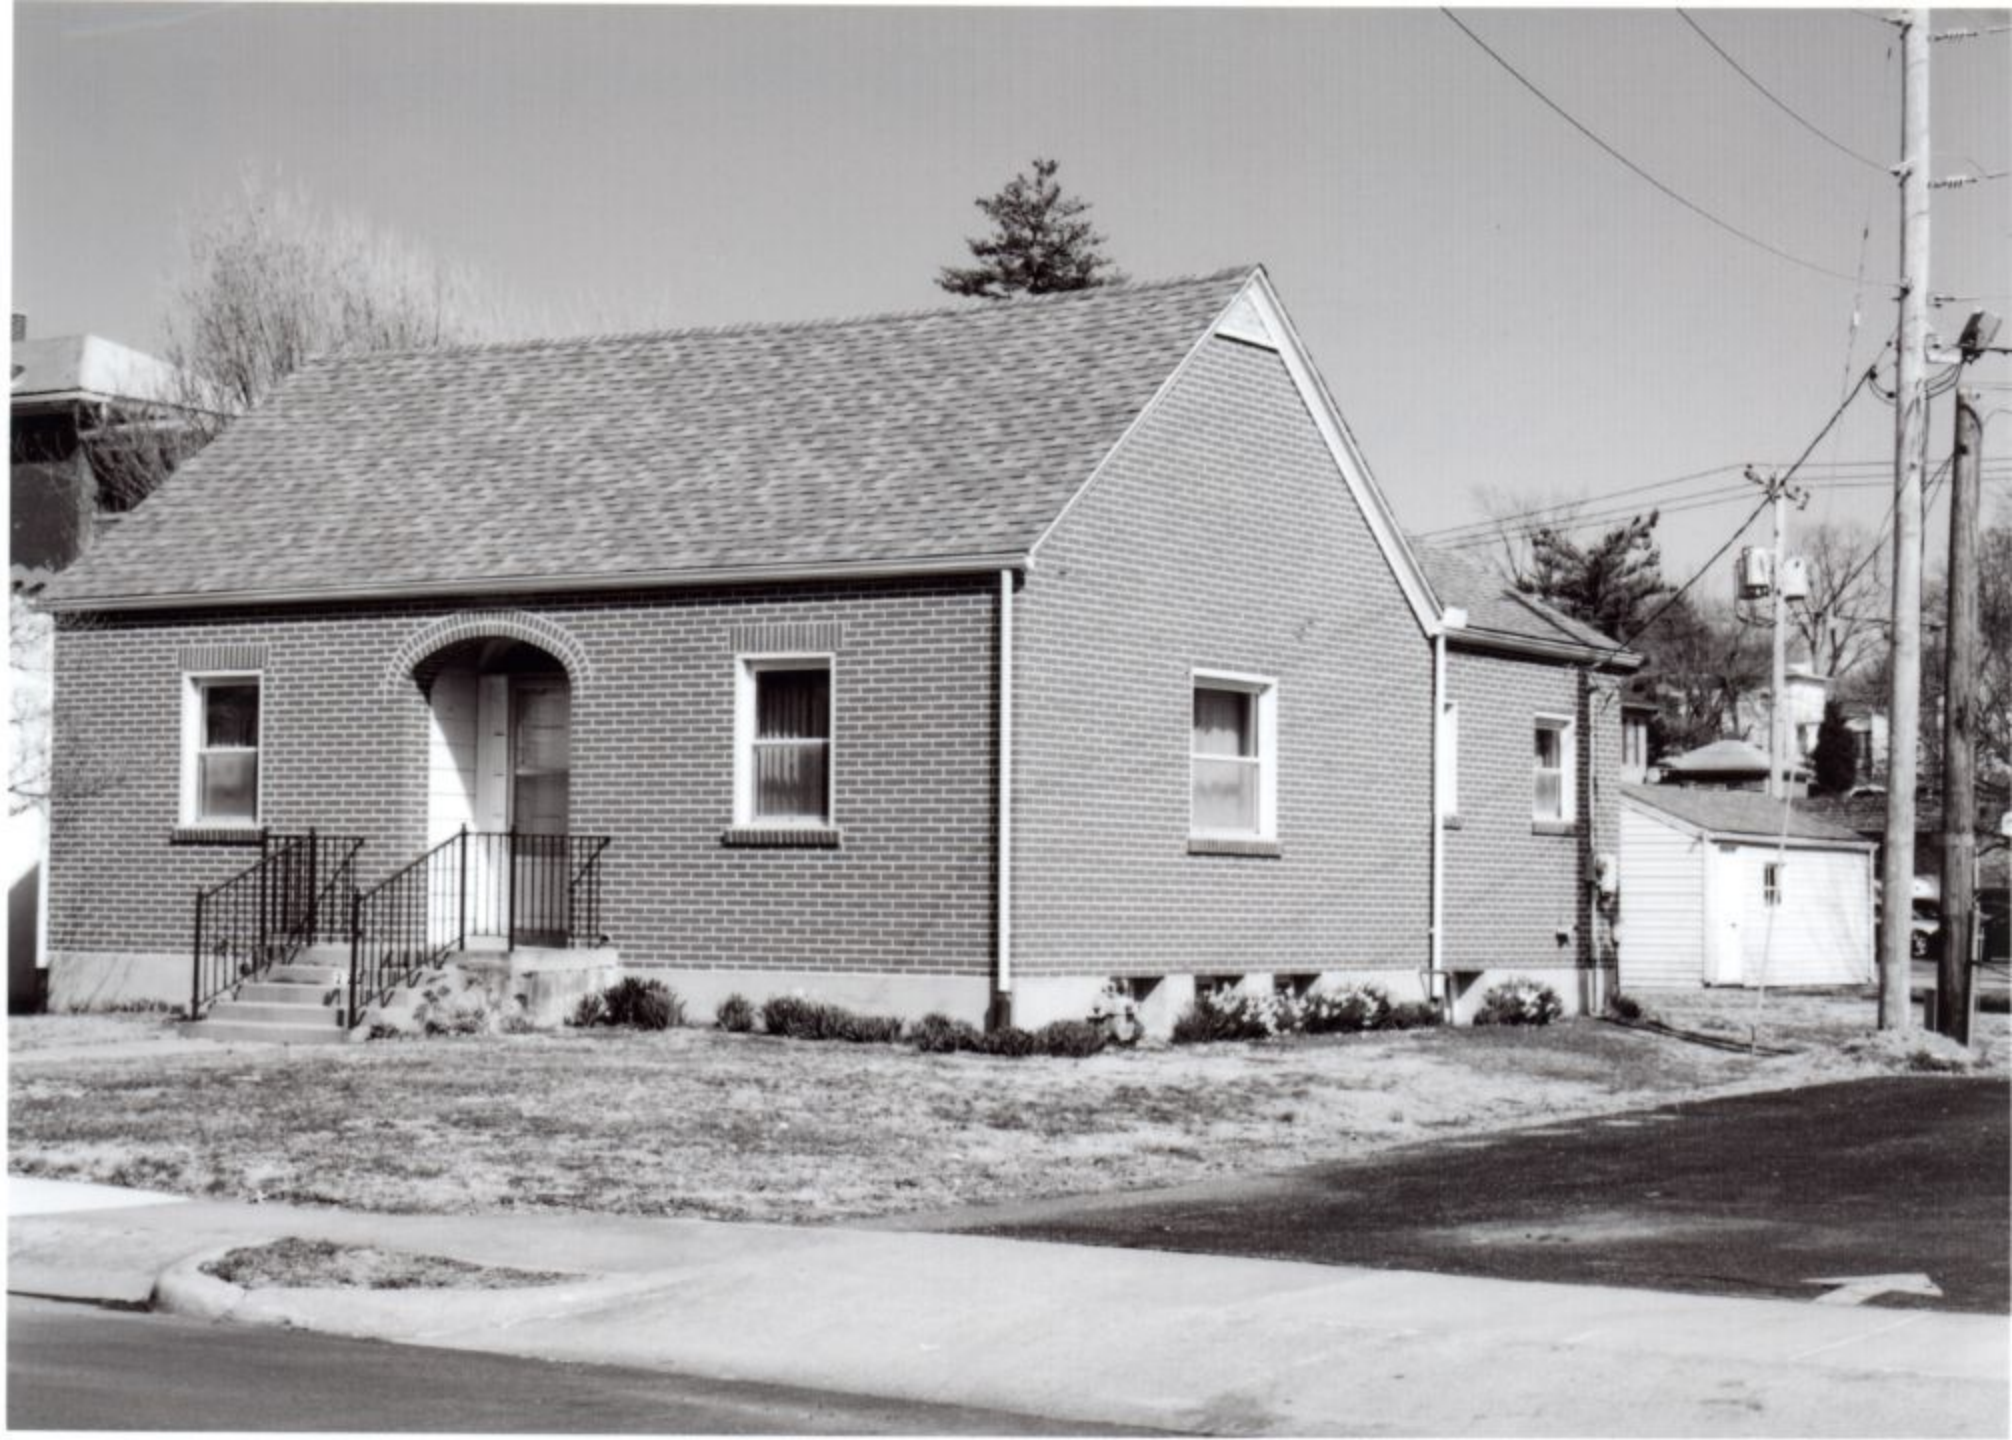
This one-story, Cape Cod style building is constructed out of brick on a slab concrete foundation. The roof is fairly steeply pitched, with a side gable and asphalt shingles. The façade is comprised of three bays, with the recessed, arched door (with arched lintel) in the center, flanked by windows on either side. The windows, including the two on the north and south elevations and the back of the building, are vinyl one-over-one double hung sash windows. The building has a slab porch with wrought iron railings.
