# ARCHITECTURAL/HISTORIC INVENTORY FORM

1. Survey No. <b>CGSEA002-051</b>		2. Survey name: <b>N. Sprigg-N. Middle Survey</b>	
3. County: <b>Cape</b>		4. Address: <b>419 Bellevue Street</b>	
5. City: <b>Cape Girardeau</b>	Vicinity: <input type="checkbox"/>	6. UTM: <b>16/276414/4131995</b>	7. Township/Range/Section: <b>T: 30 R: 14 S: 5</b>
8. Historic name (if known): <b>Bellevue Apartments</b>		9. Present/other name (if known): <b>Bellevue Apartments</b>	
10. Ownership: <input checked="" type="checkbox"/> Private <input type="checkbox"/> Public		11. Historic use (if known): <b>Domestic: Multiple Dwelling</b>	
		11. Current use: <b>Domestic: Multiple Dwelling</b>

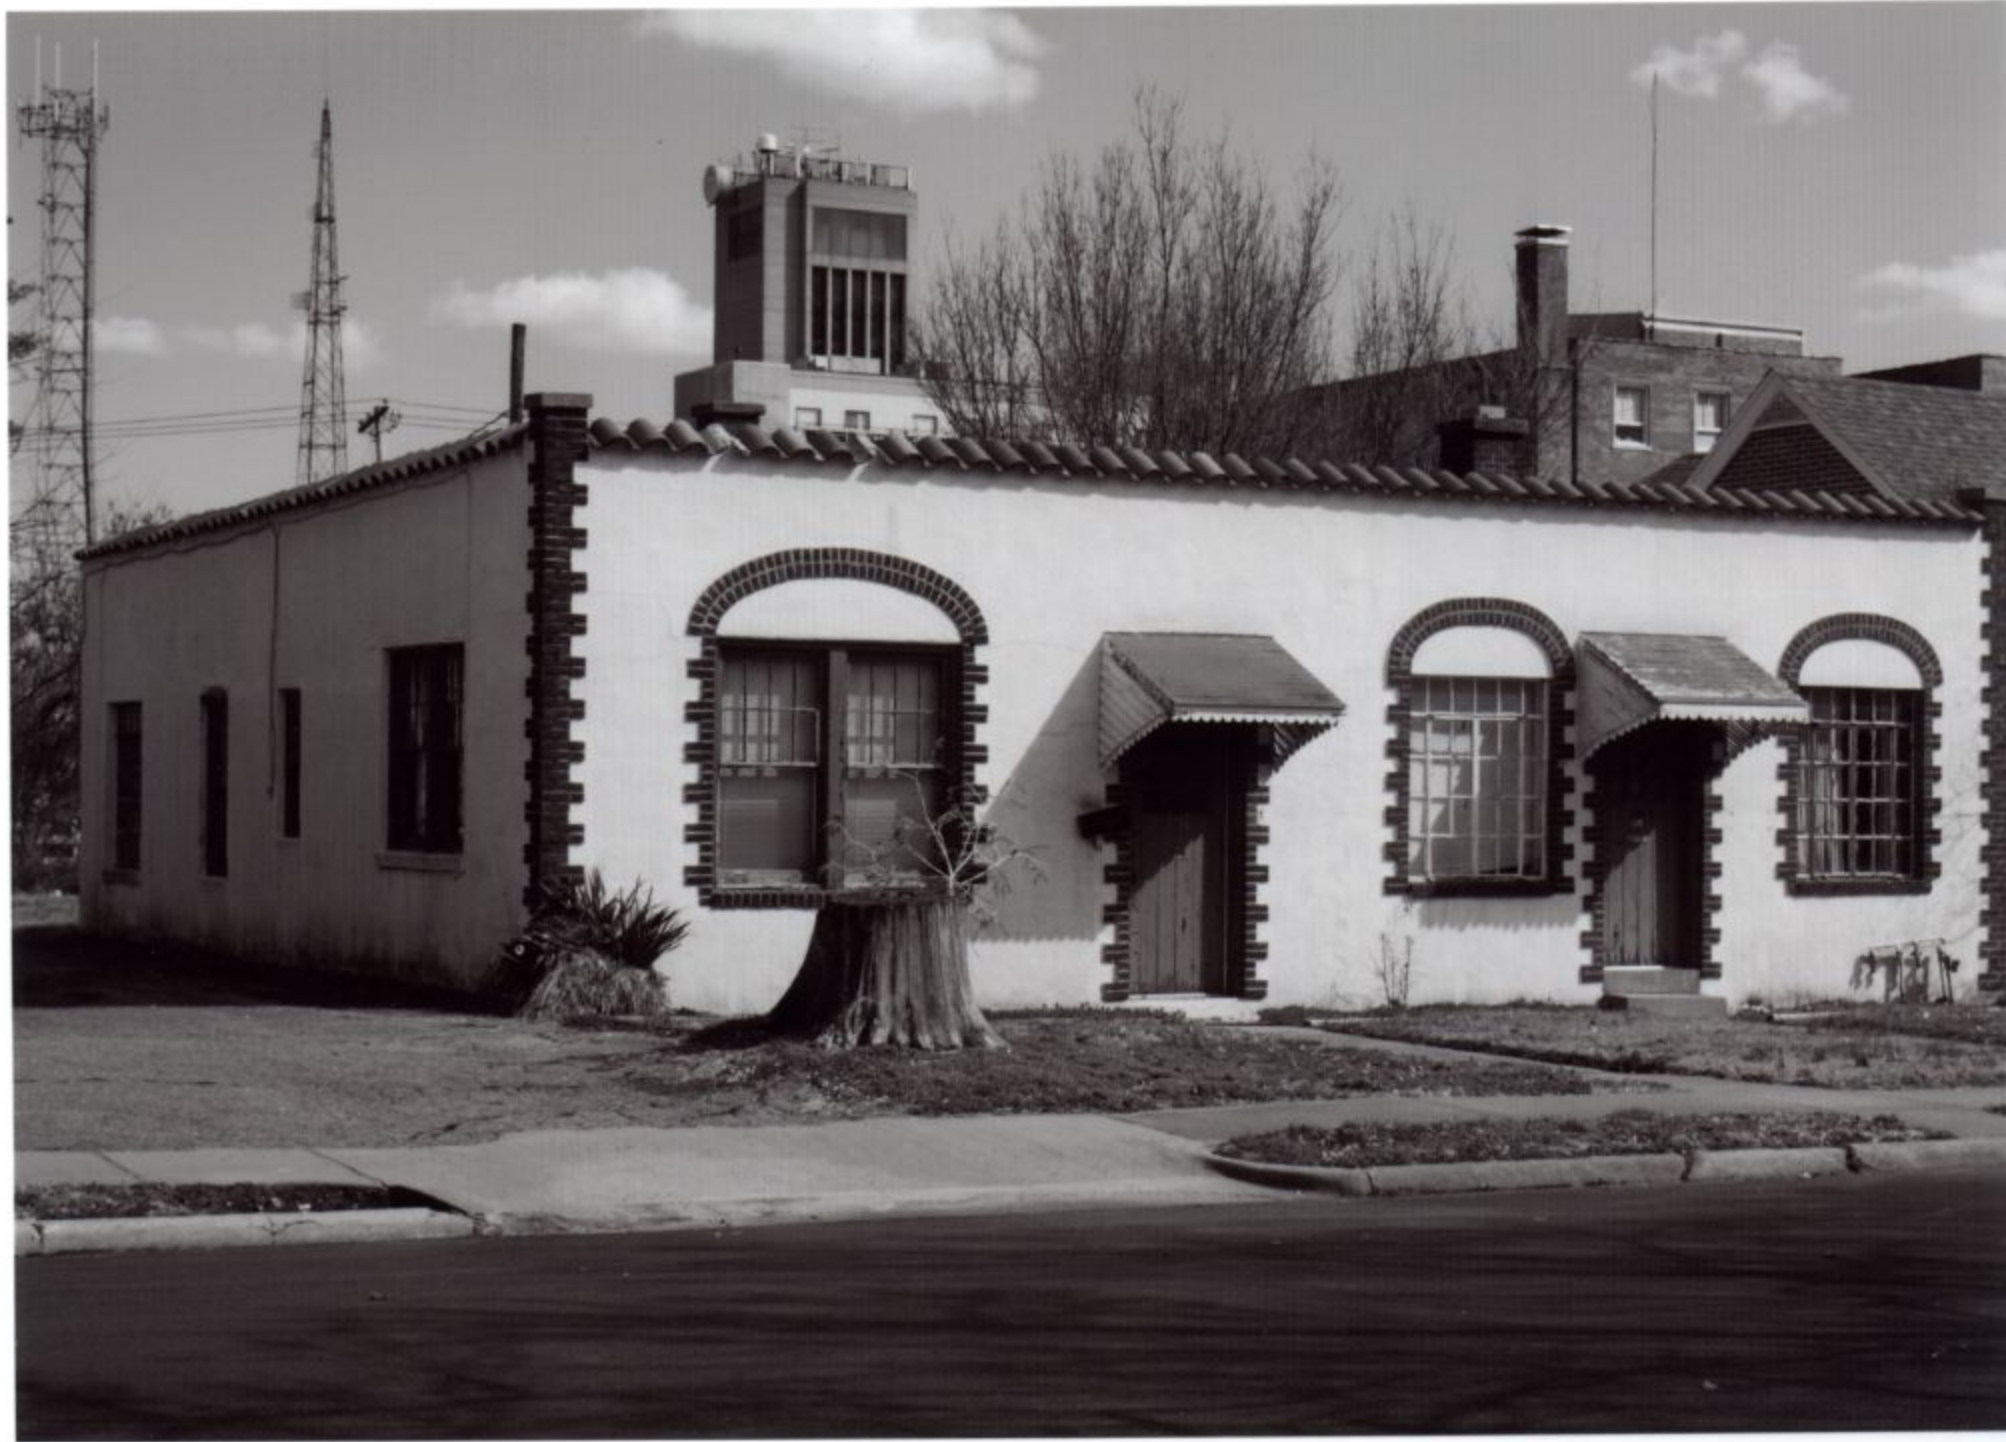
This one-story, brick building has a white stucco finish and sits on a concrete foundation. The Mission/Spanish Colonial Revival style building has a flat roof bordered with parapet walls with clay tiles along the tops. There are two entrances on the façade, with windows in between and on the sides. The plain wooden doors are slightly recessed and have awnings over the tops, while the windows have arched, brick lintels over them. Some of the windows are double hung, sash windows with a multi-pane over single pane pattern, while a few others appear to be casement type windows. All of the windows are wood, suggesting they are original. Quoining adorns the corners of the building, as well as the edges of the doors and windows. The right entrance has a stoop type porch, while the other has no porch at all. Small chimneys can barely be seen in the rear part of the building over the top of the parapet walls.

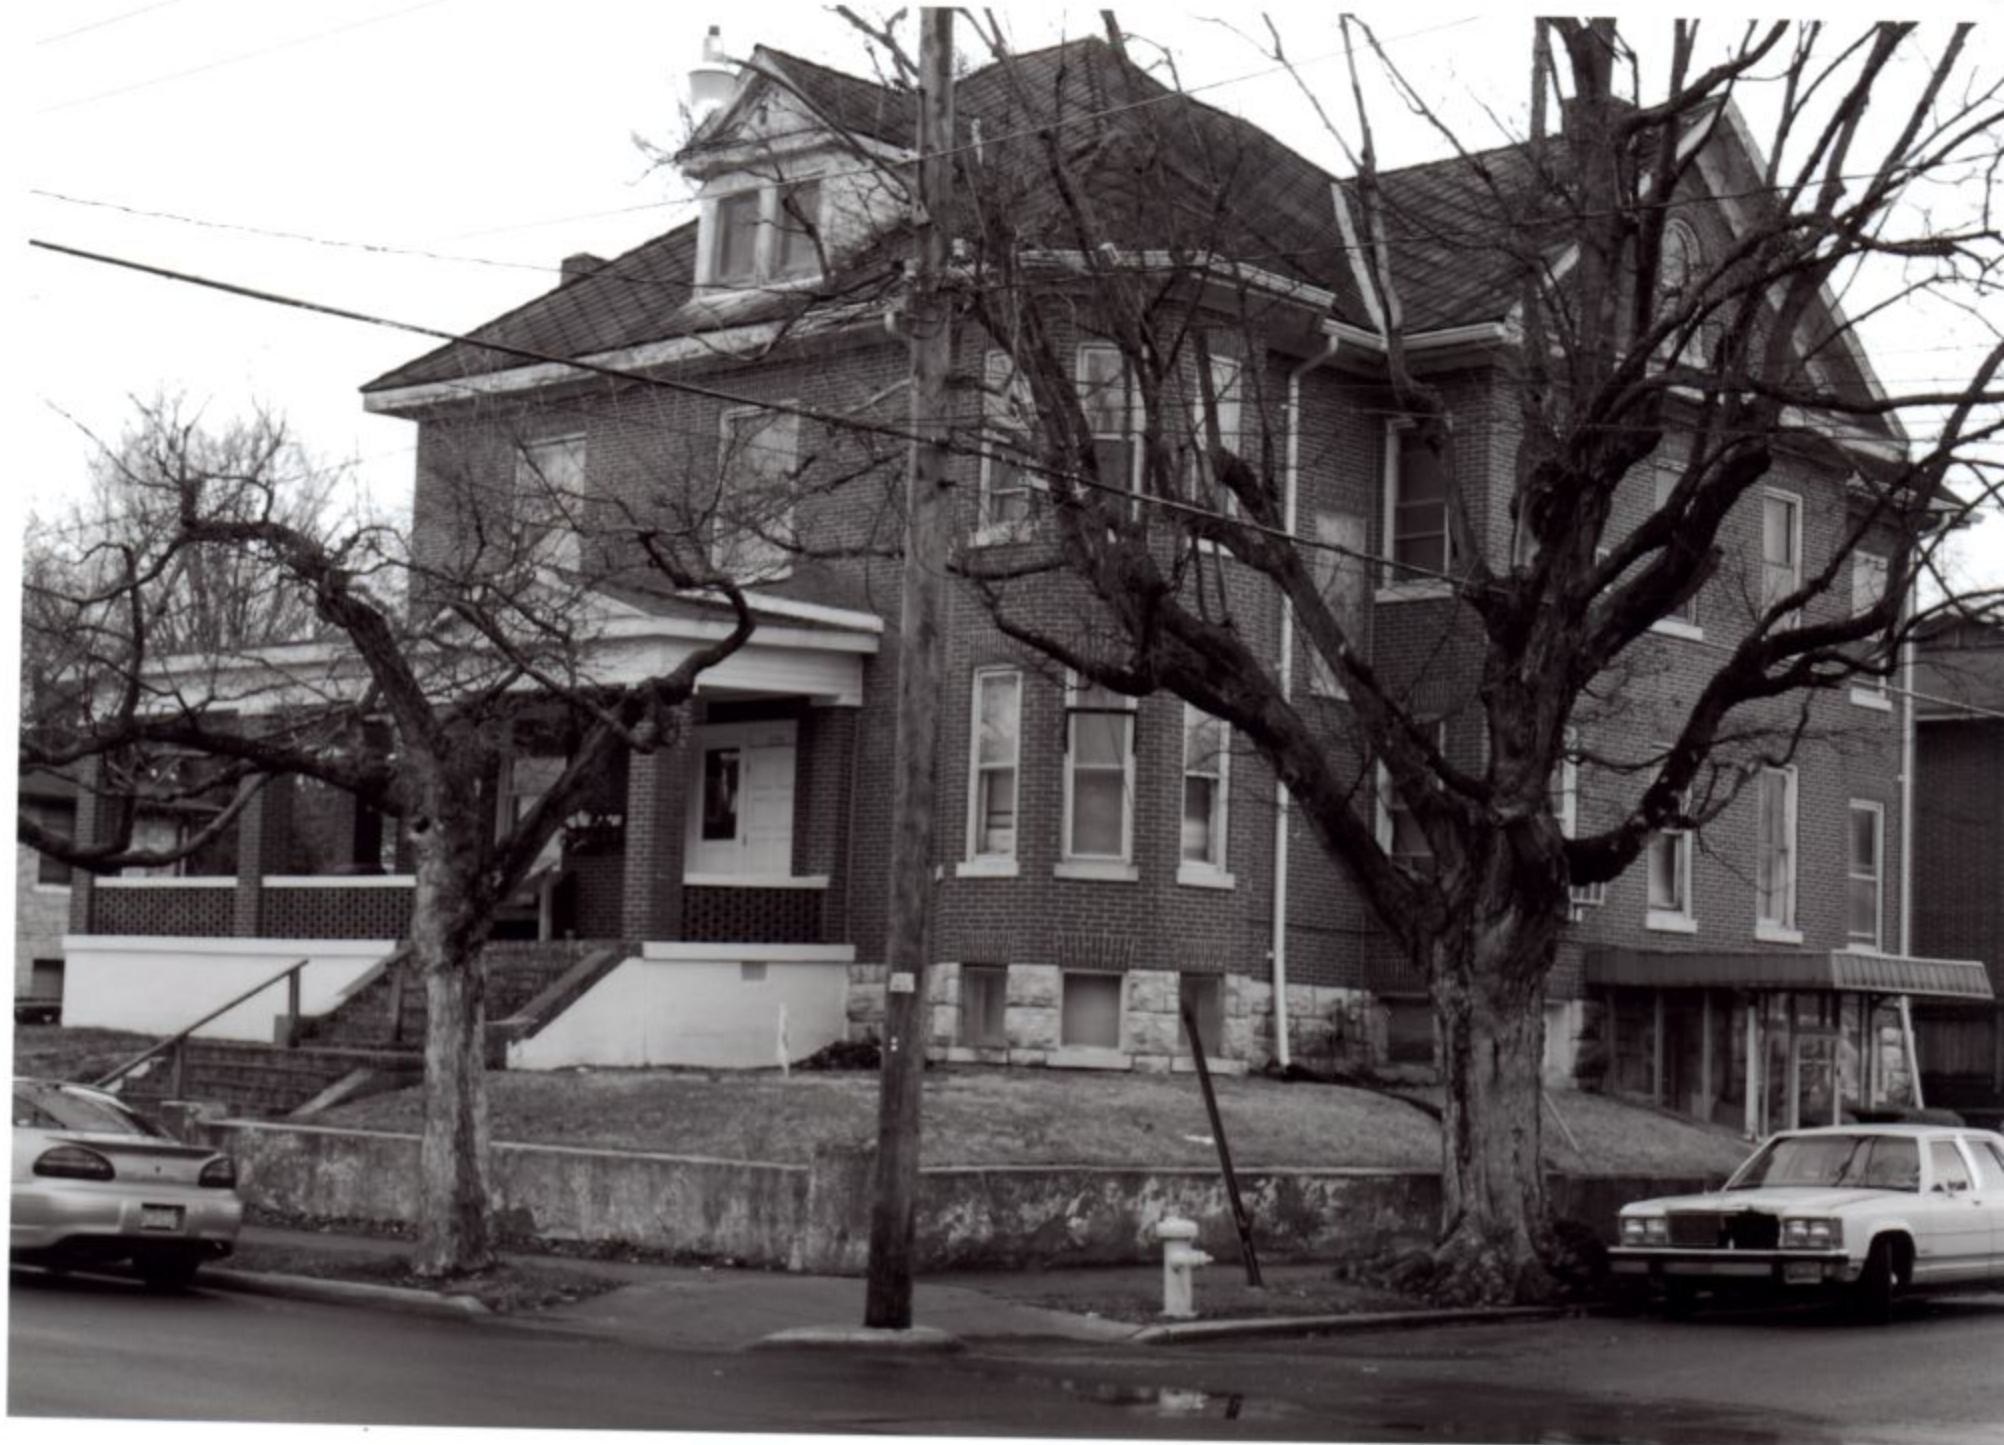
A three-story Queen Anne dwelling of brick construction and it sits on a concrete block foundation. The building has a full basement. The entrance on the façade has a one-story open porch with four evenly spaced brick columns and a triangular pediment directly above the entryway. A central staircase leads up to the entrance. The building has a high hip roof made of asphalt shingle with a dormer on the façade and a cross gable on both the left and right elevations. The chimney is offset left of the façade. There is a modern entrance on the bottom of the right elevation. Windows are double hung one-over-one and may be replacements. The building exterior has not been extensively altered but the interior has been converted into a multiple dwelling from a single dwelling.

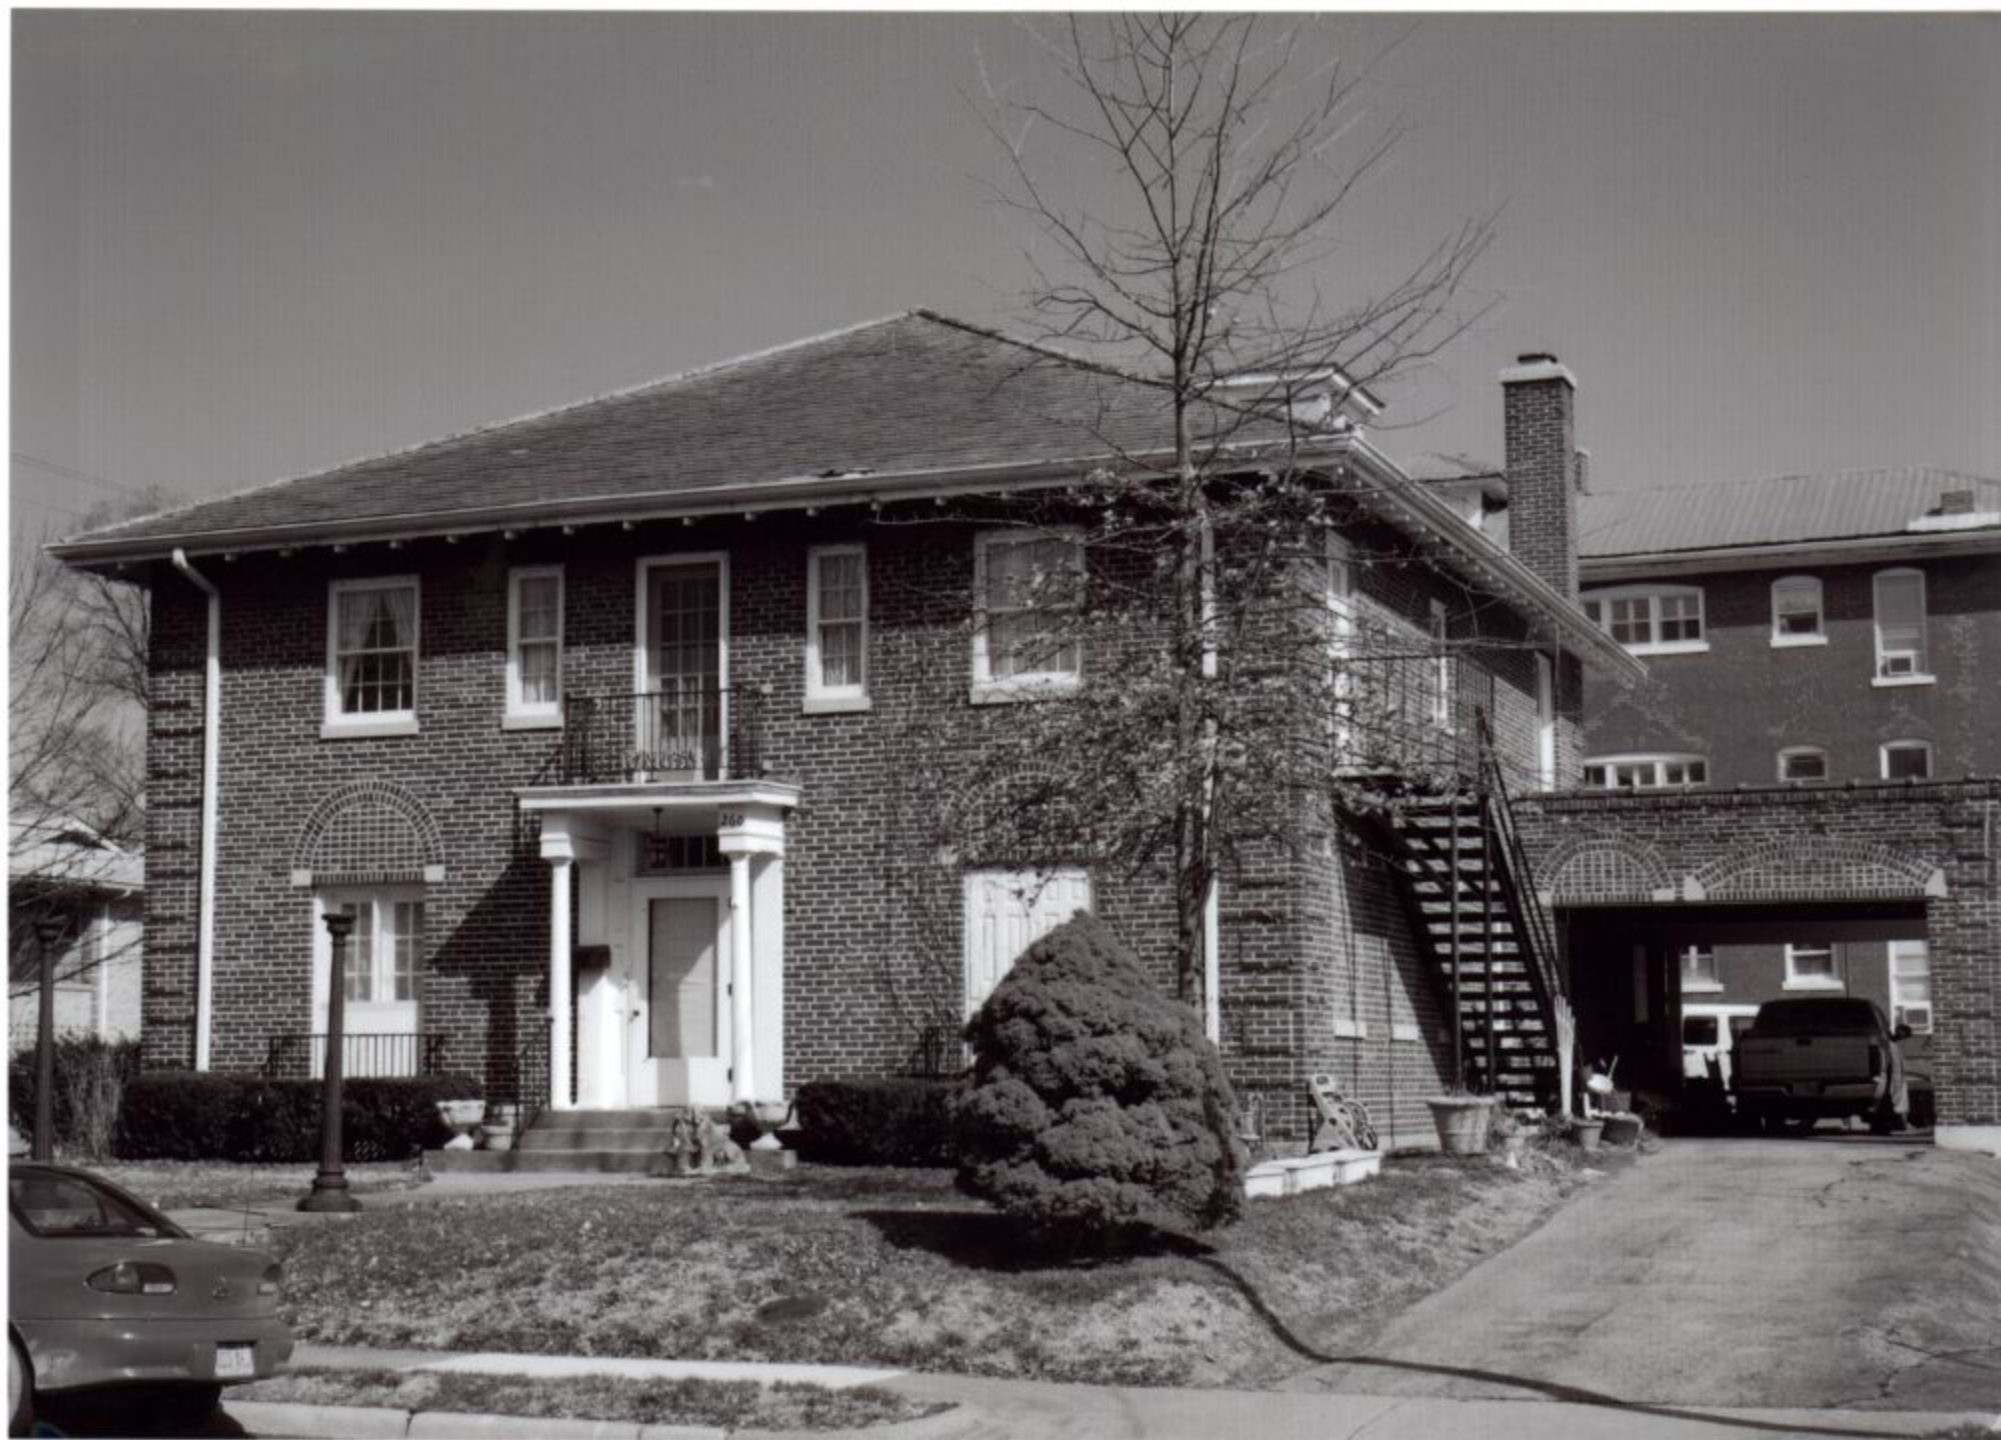
This two-story, Colonial Revival building is constructed out of brick on a concrete foundation. The low-pitched, hipped roof has asphalt shingles, wide overhanging eaves with brackets underneath, and a shed dormer on the southern elevation. The first floor of the façade has three bays, with the front door (with transom) in the center, flanked by a window on the left side and a fake door (which was put in place of a window) on the right. The window on the right is probably a replacement as well, having only the top half as a window. It looks like both were originally designed to be windows that extended all the way to the base of the building. Most of the windows are vinyl double hung, sash windows with a multi-pane over multi-pane design. Some windows on the southern elevation have been bricked in as well. Other architectural features include a tall chimney in the rear, right corner of the building, an extended car port on the southern elevation, quoining on the corners of the building, and a set of wrought iron stairs on the southern elevation that lead to a door on the second floor.

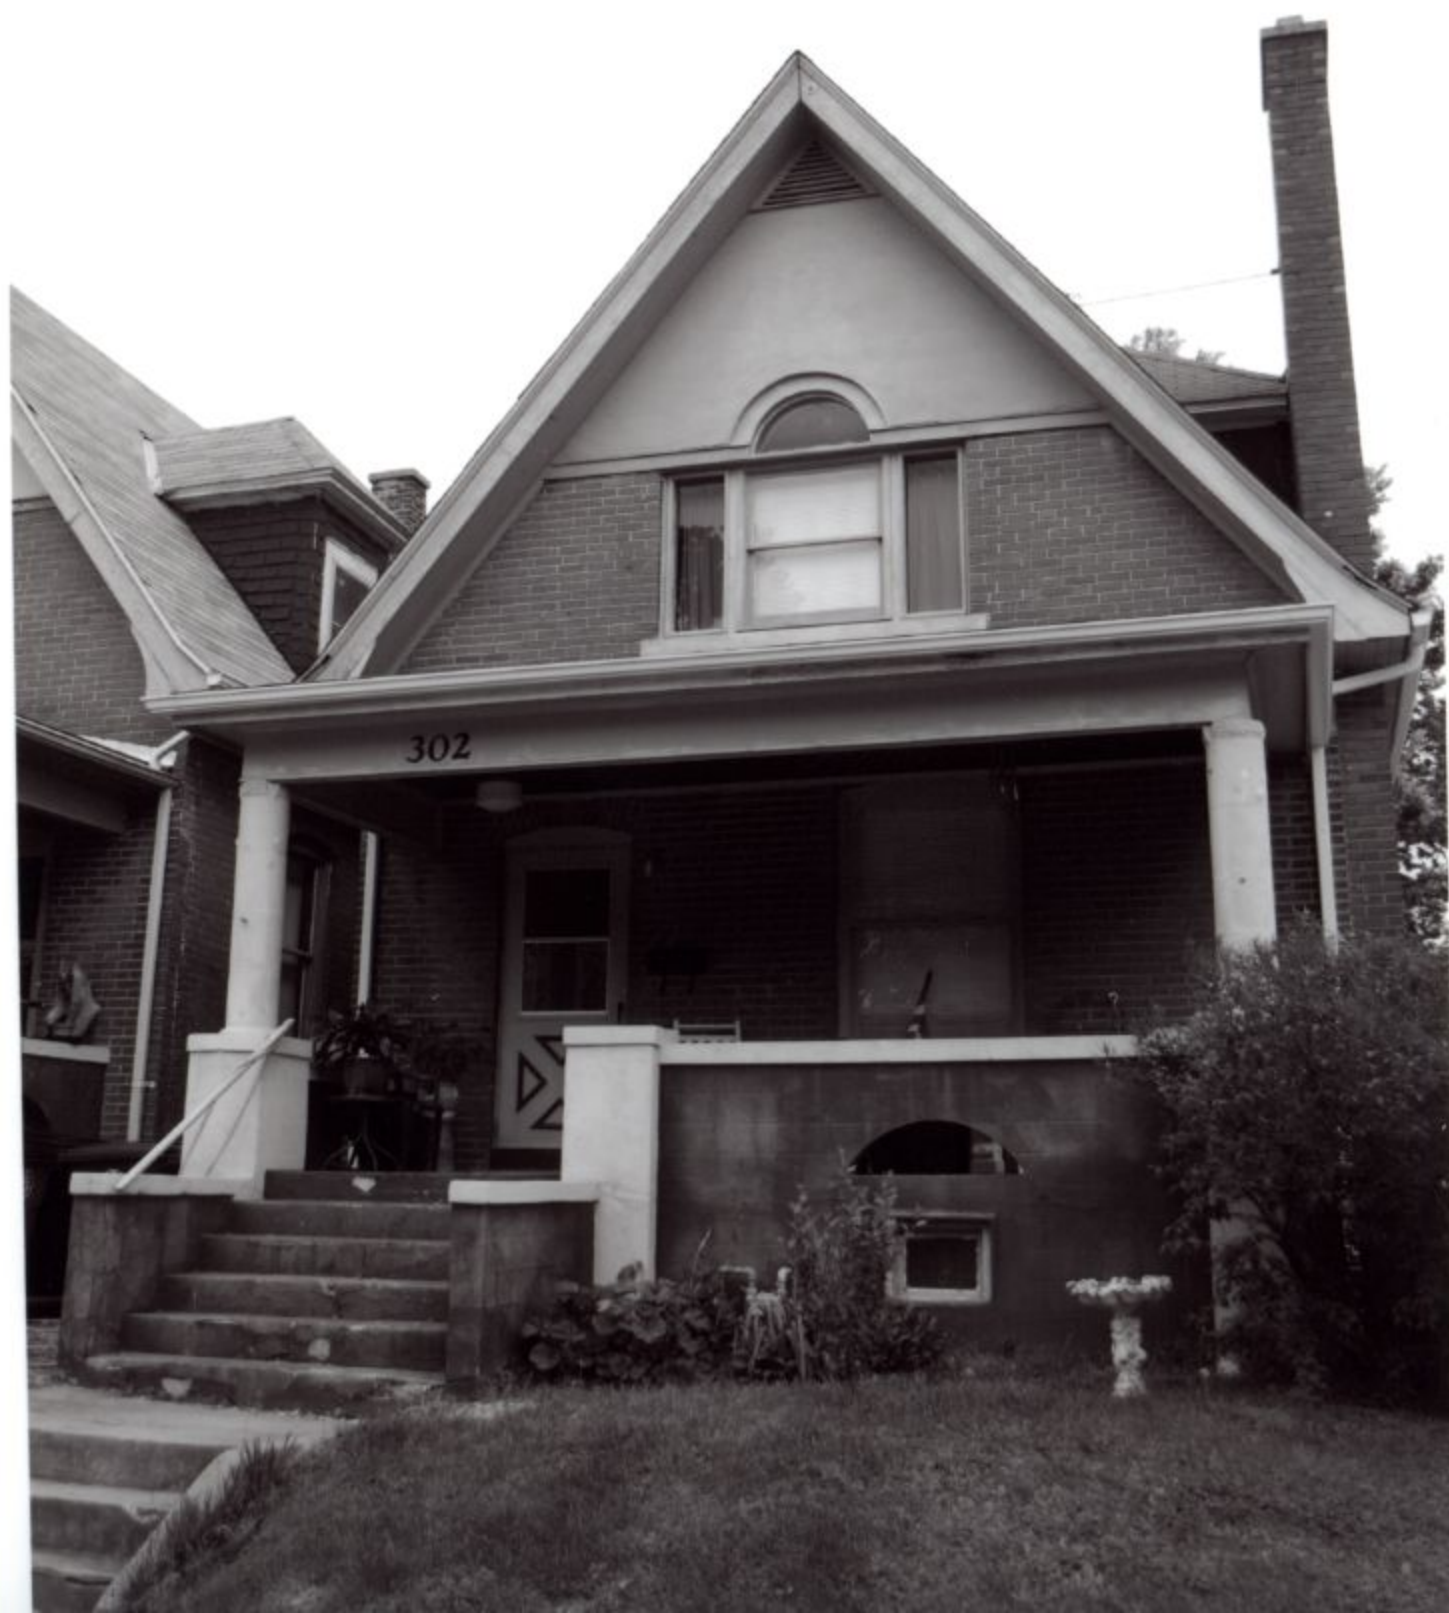
One and a half story brick Craftsman Bungalow. Sits on a concrete foundation. Steeply pitched roof is front gable with hipped dormers on north and south elevations. Dormers are shingled. Tall chimney is offset over north dormer. Facade features formed concrete appliqué above Palladian window. Open porch with pedestal support pillars resting on concrete.

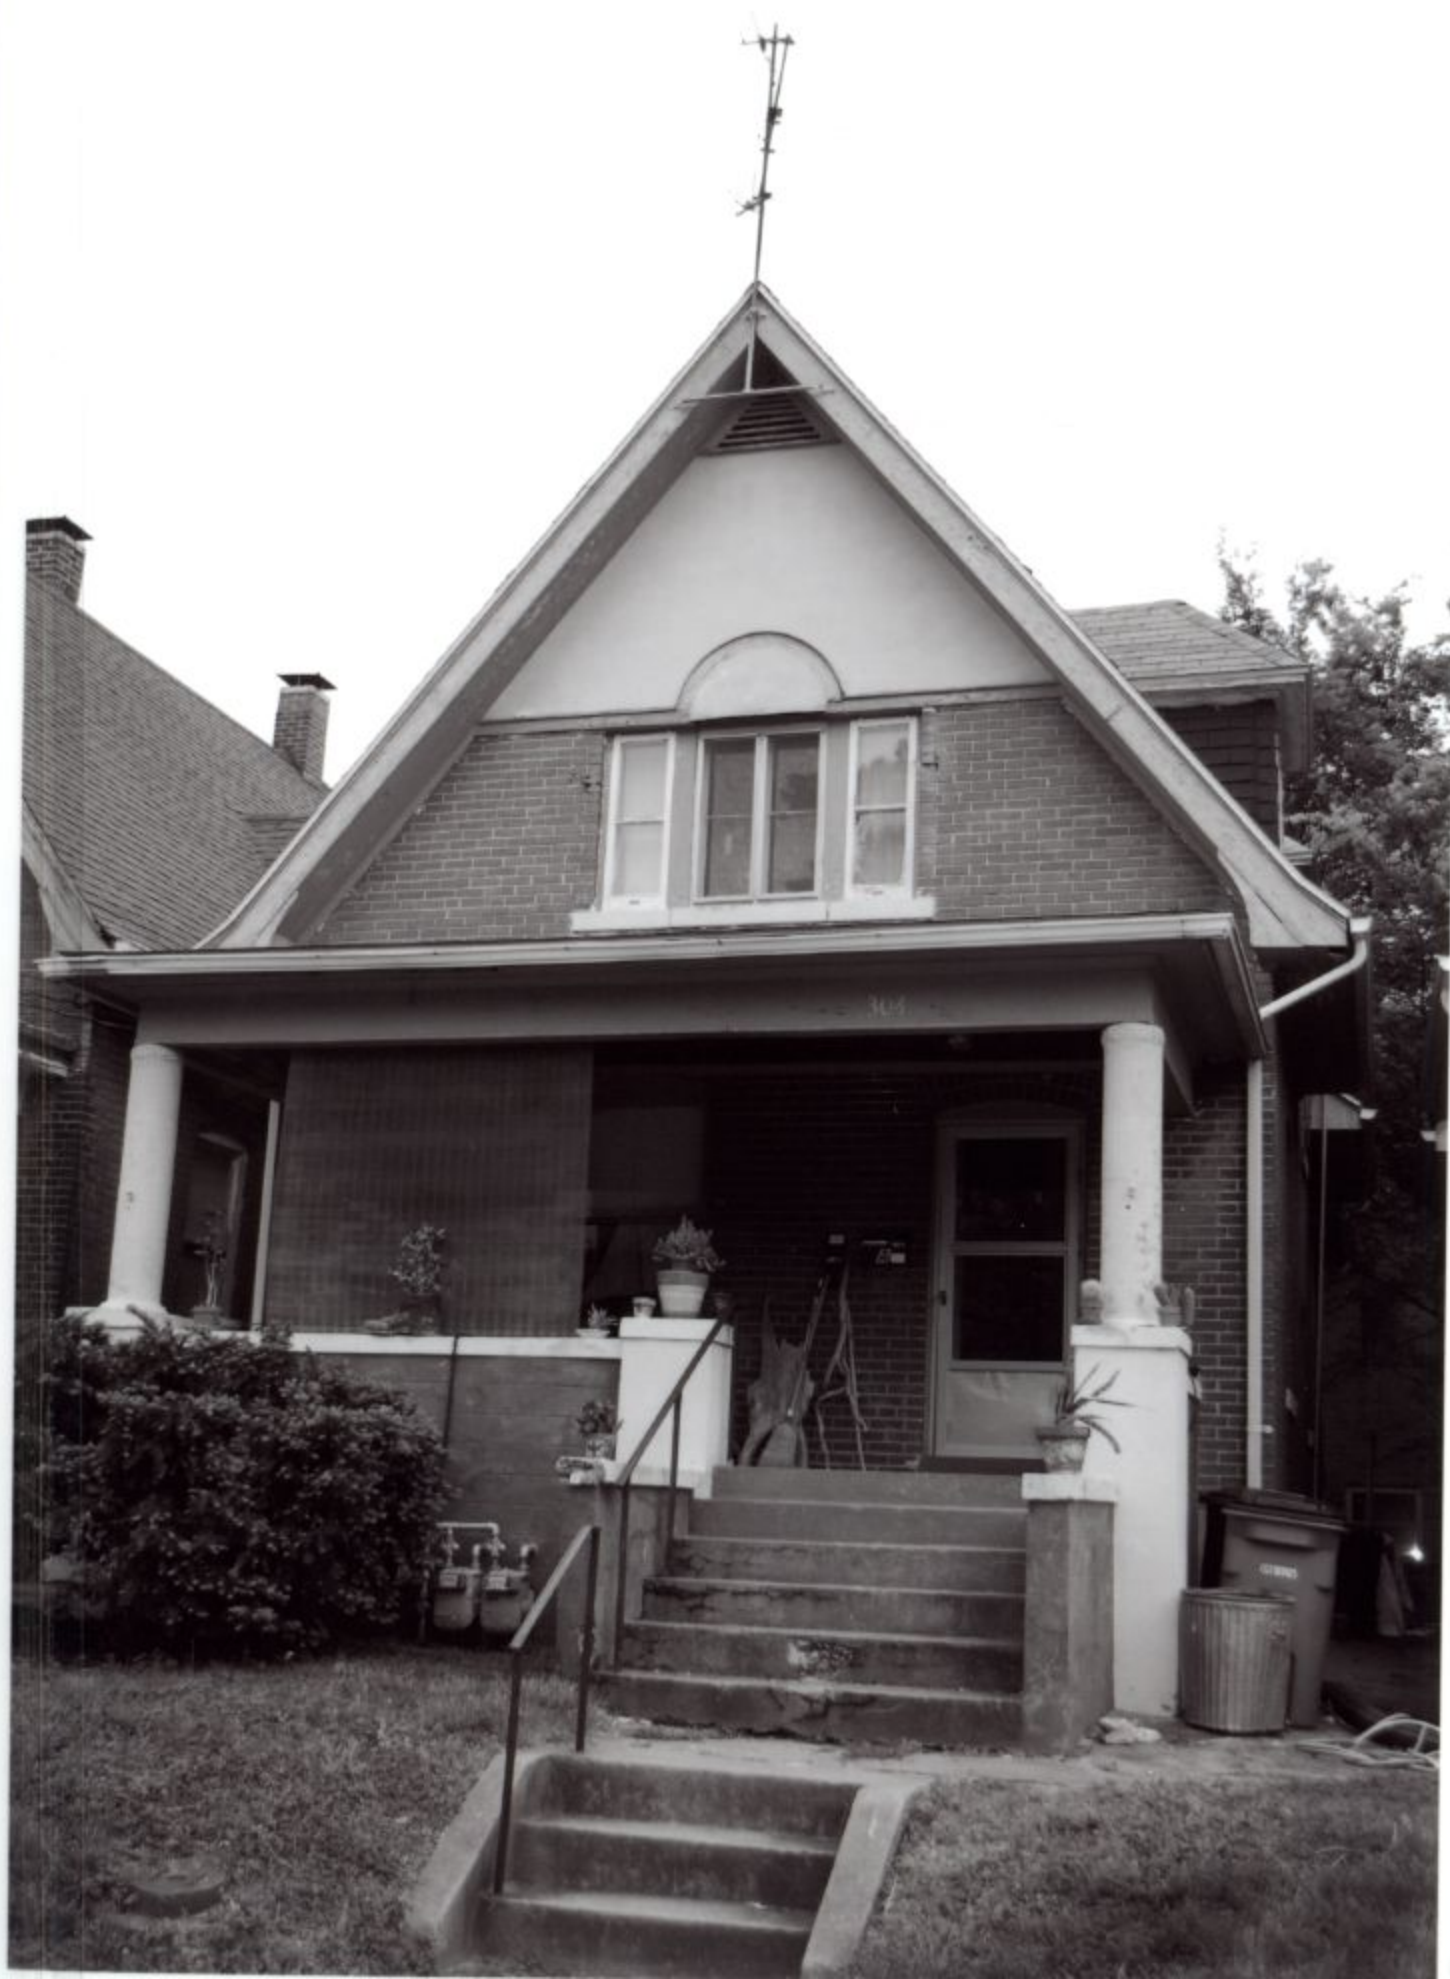
One and a half story brick Craftsman Bungalow. Sits on a concrete foundation. Steeply pitched roof is front gable with hipped dormers on north and south elevations. Dormers are shingled. Tall chimney is offset over north dormer. Facade features formed concrete appliqué above Palladian window. Open porch with pedestal support pillars resting on concrete.

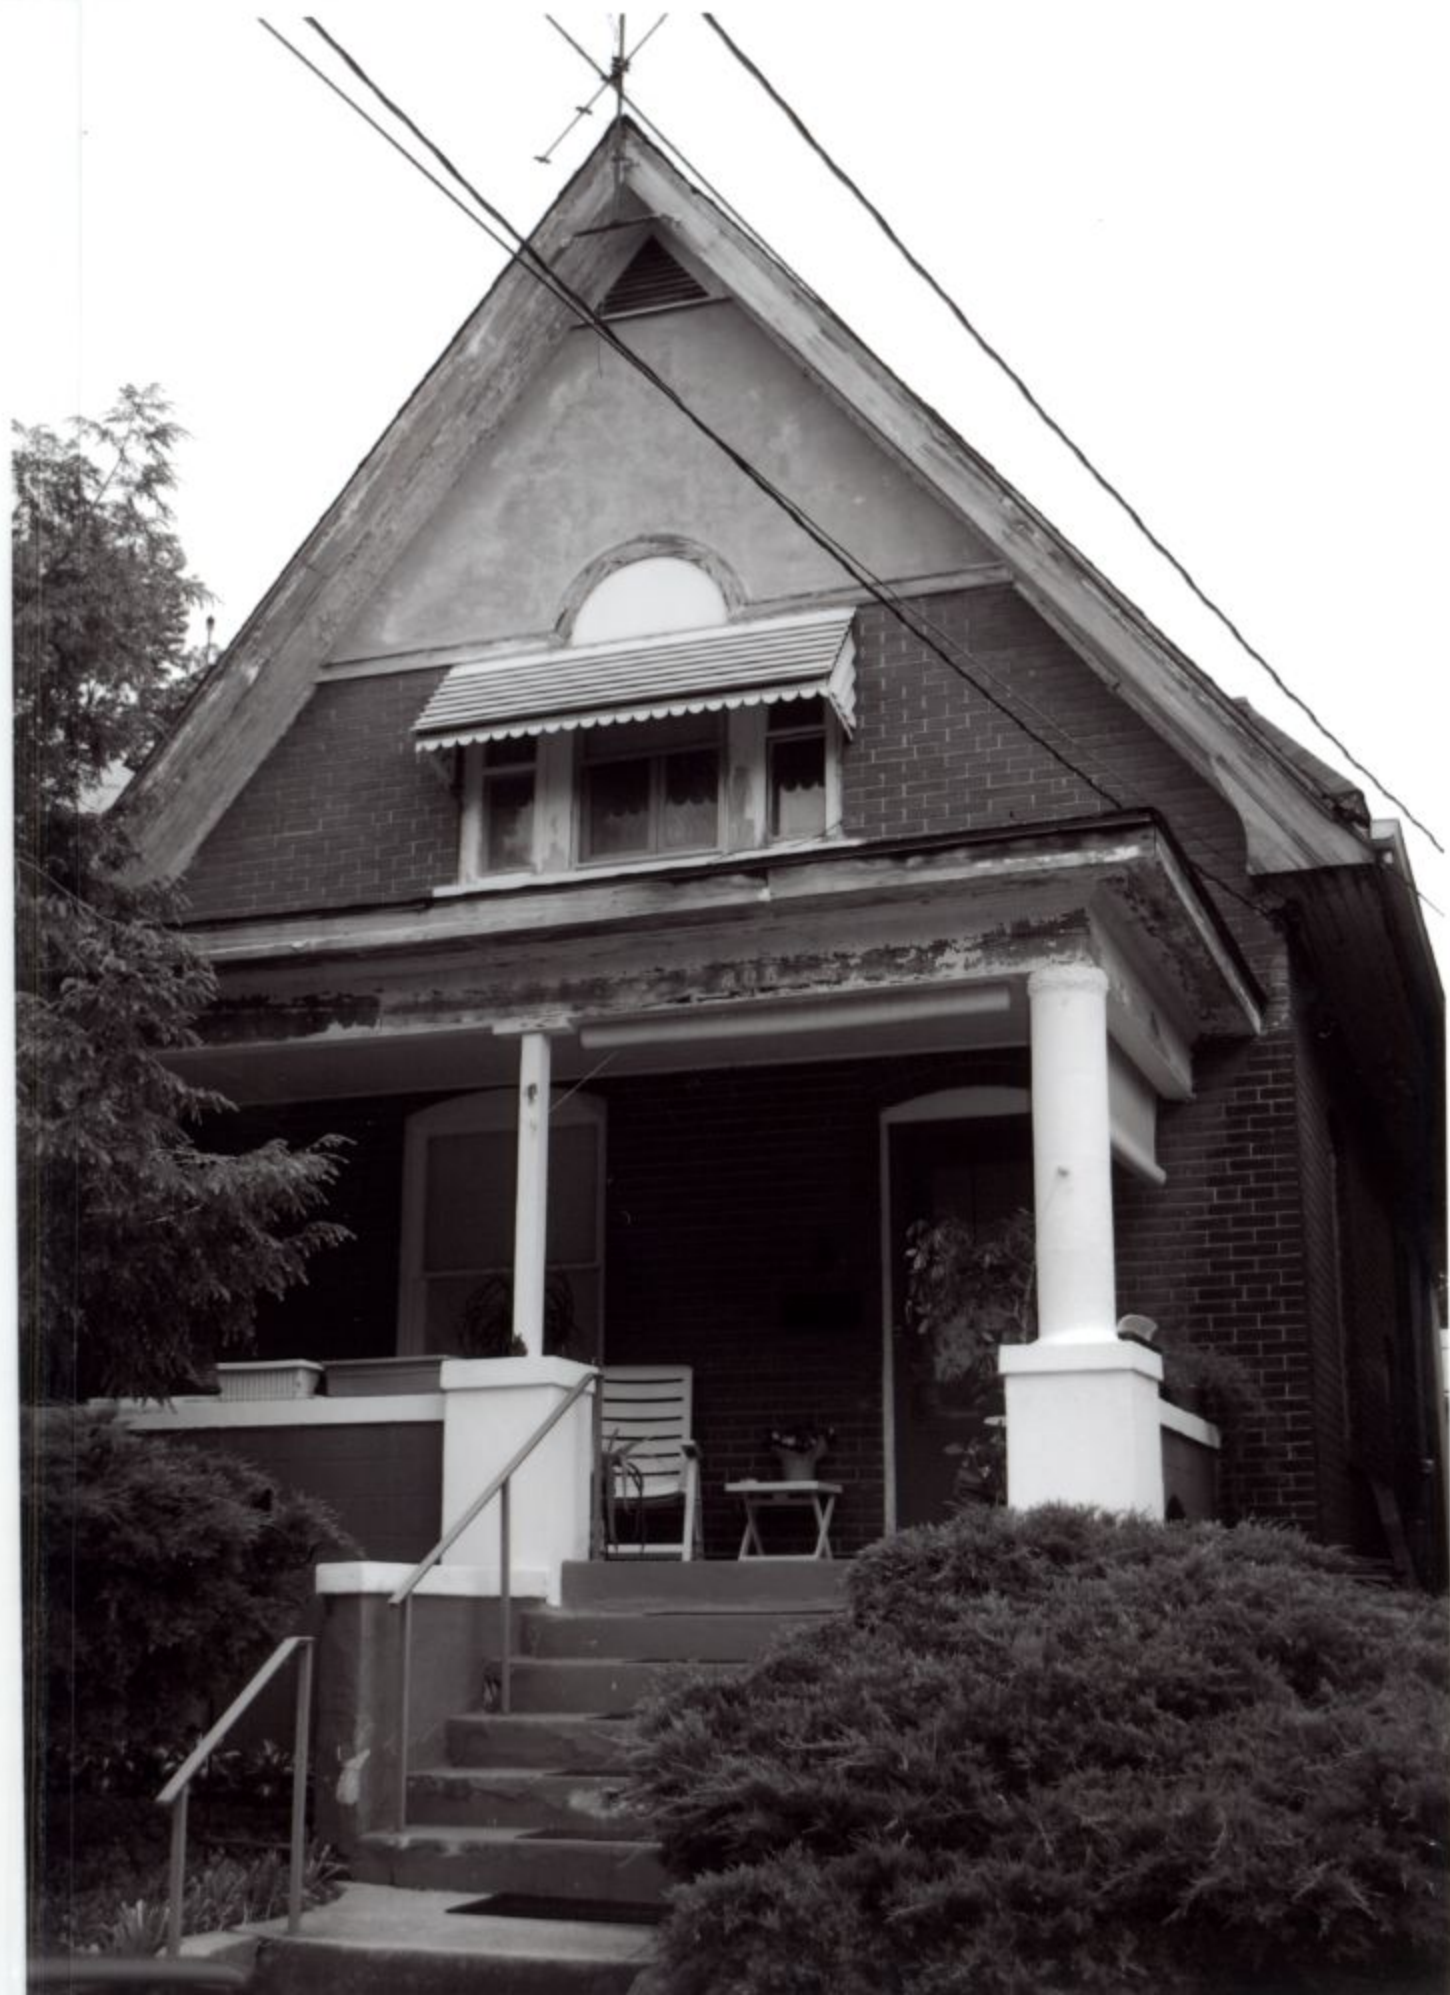
One and a half story brick Craftsman Bungalow. Sits on a concrete foundation. Steeply pitched roof is front gable with hipped dormers on north and south elevations. Dormers are shingled. Tall chimney is offset over north dormer. Facade features formed concrete appliqué above Palladian window. Open porch with pedestal support pillars resting on concrete.

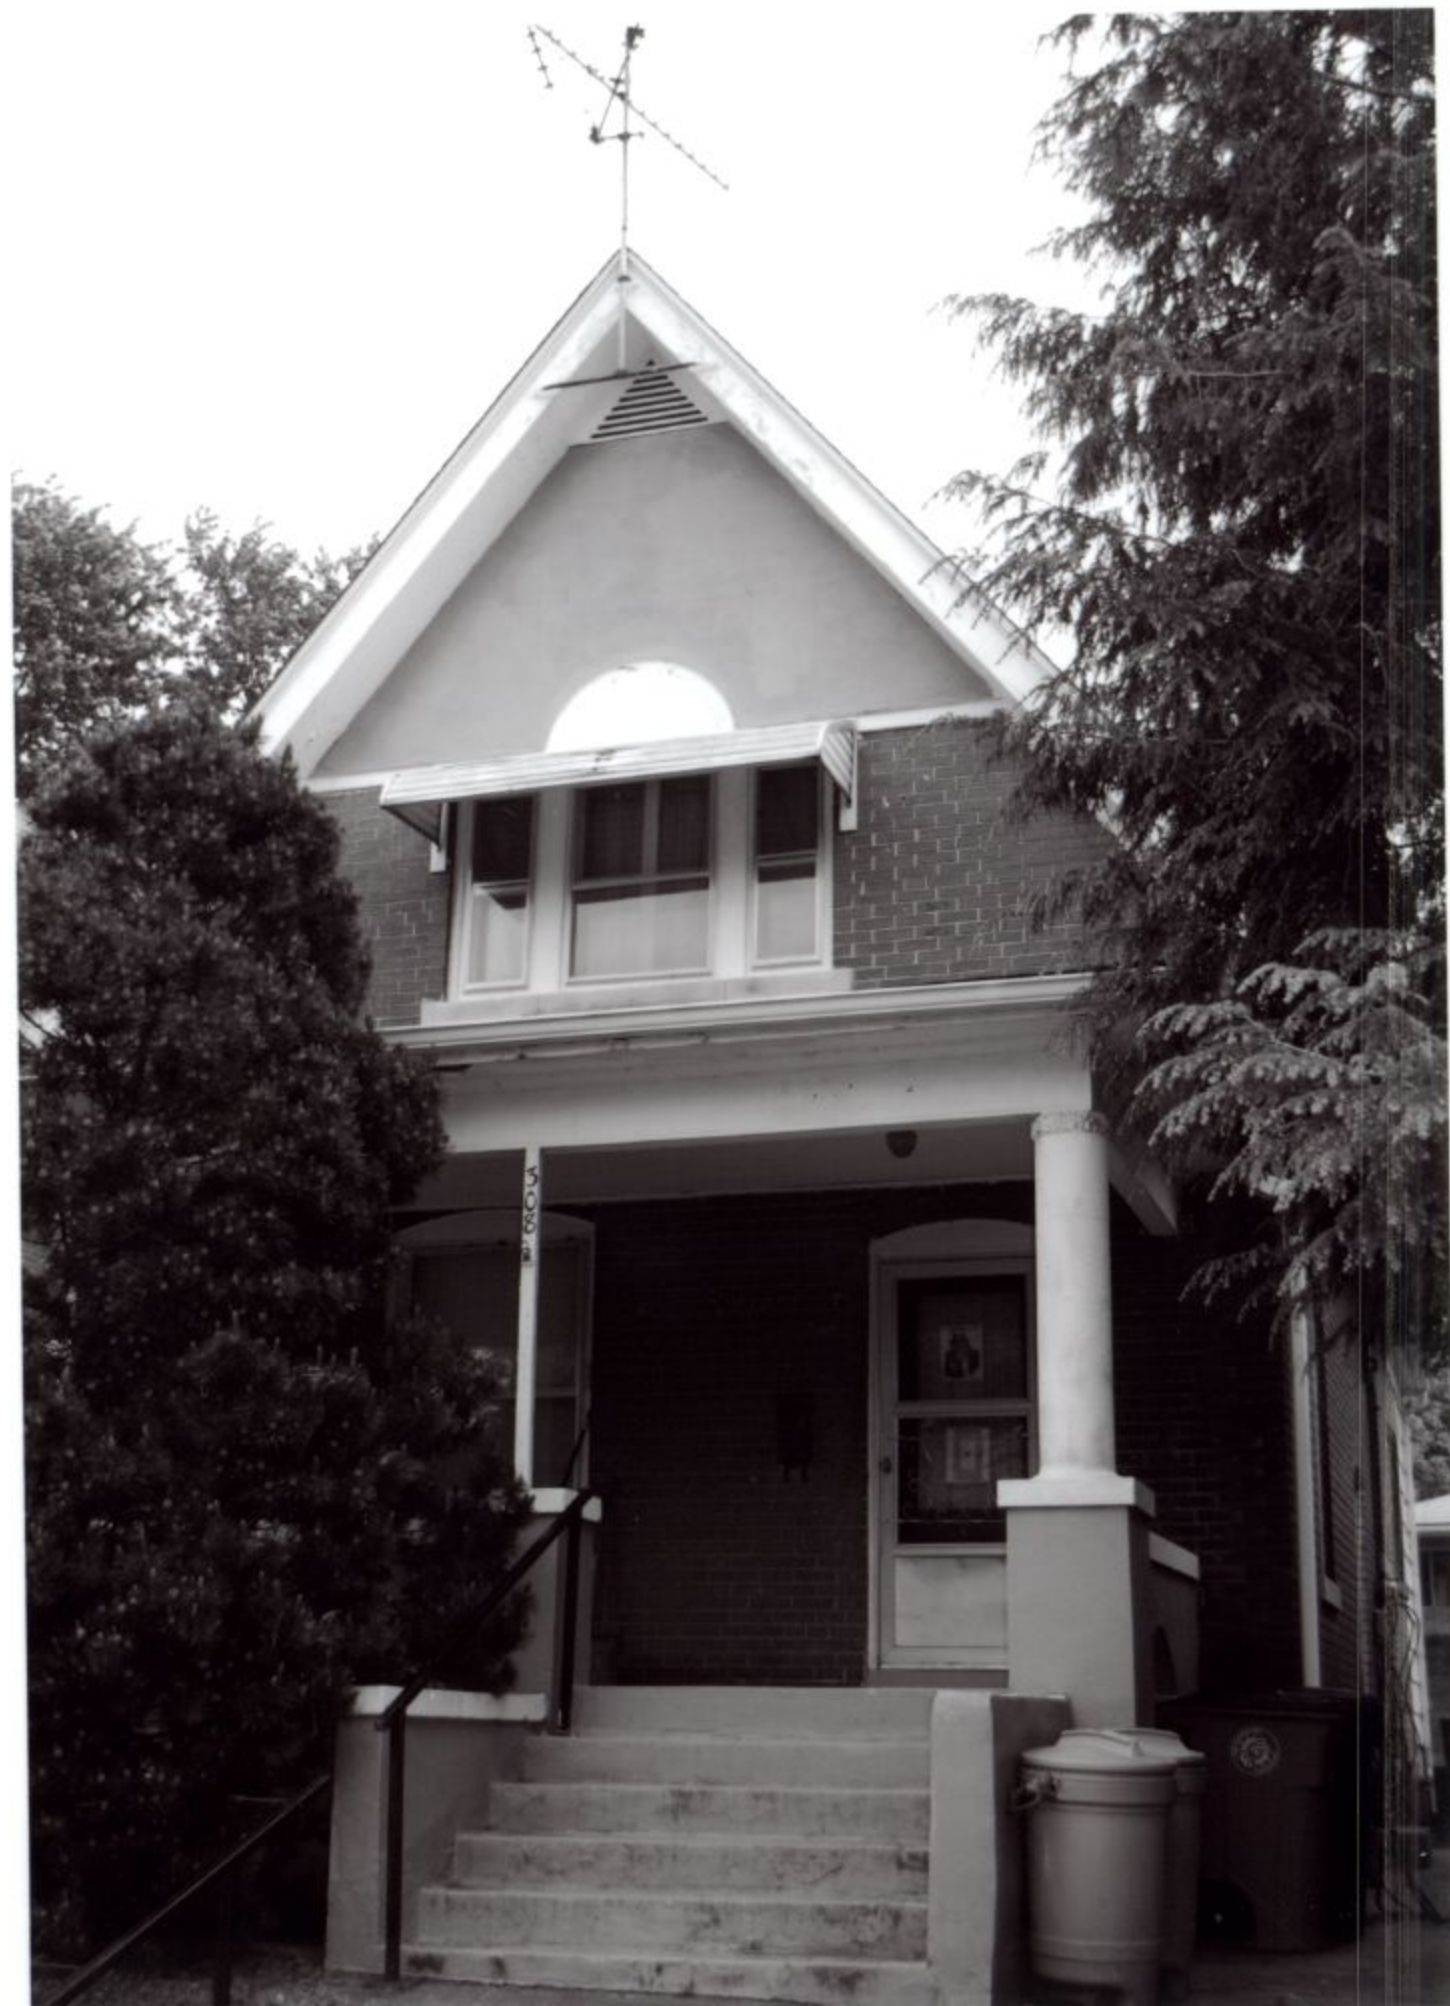
One and a half story brick Craftsman Bungalow. Sits on a concrete foundation. Steeply pitched roof is front gable with hipped dormers on north and south elevations. Dormers are shingled. Tall chimney is offset over north dormer. Facade features formed concrete appliqué above Palladian window. Open porch with pedestal support pillars resting on concrete.
