# ARCHITECTURAL/HISTORIC INVENTORY FORM

1. Survey No. <b>CGSEA002-051</b>		2. Survey name: <b>N. Sprigg-N. Middle Survey</b>	
3. County: <b>Cape</b>		4. Address: <b>419 Bellevue Street</b>	
5. City: <b>Cape Girardeau</b>	Vicinity: <input type="checkbox"/>	6. UTM: <b>16/276414/4131995</b>	7. Township/Range/Section: <b>T: 30 R: 14 S: 5</b>
8. Historic name (if known): <b>Bellevue Apartments</b>		9. Present/other name (if known): <b>Bellevue Apartments</b>	
10. Ownership: <input checked="" type="checkbox"/> Private <input type="checkbox"/> Public		11. Historic use (if known): <b>Domestic: Multiple Dwelling</b>	
		11. Current use: <b>Domestic: Multiple Dwelling</b>

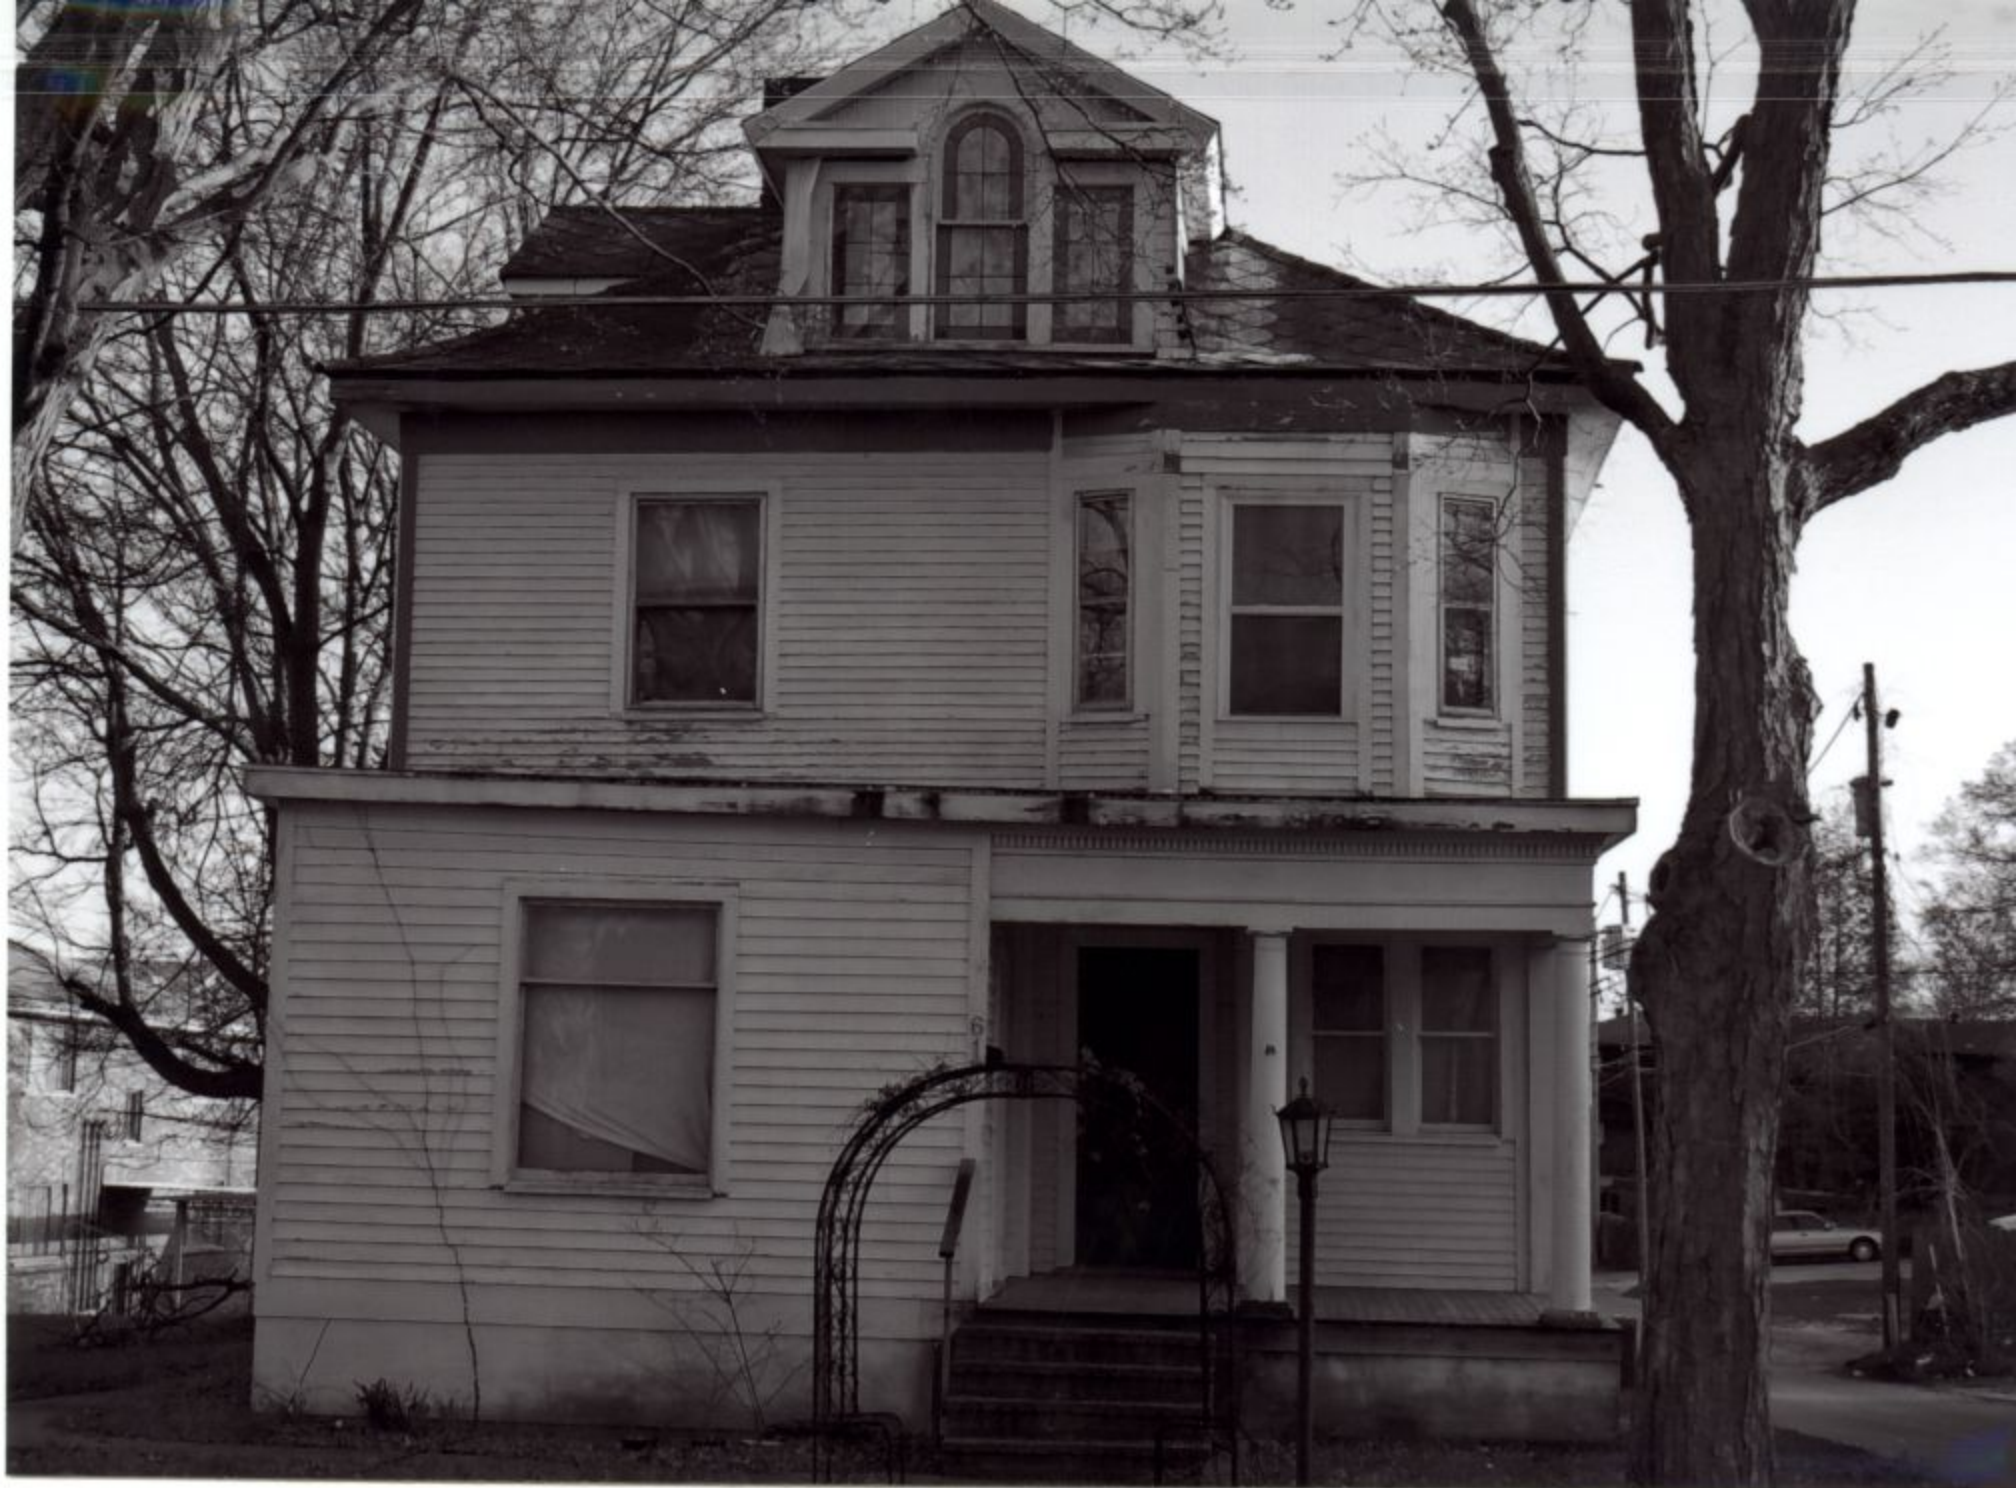
28. (cont.) Further description of important architectural features.  
American Four Square with Classical Revival details. Wood frame construction covered with clapboard siding. About half of windows replaced with modern vinyl frame windows. Heavily modified over it's lifetime. Currently cut into several apartments, with half of the front porch enclosed. North elevation is facade. Large Gable dormers on north and east roof elevations with paladian windows. Bay window on north elevation of second floor.

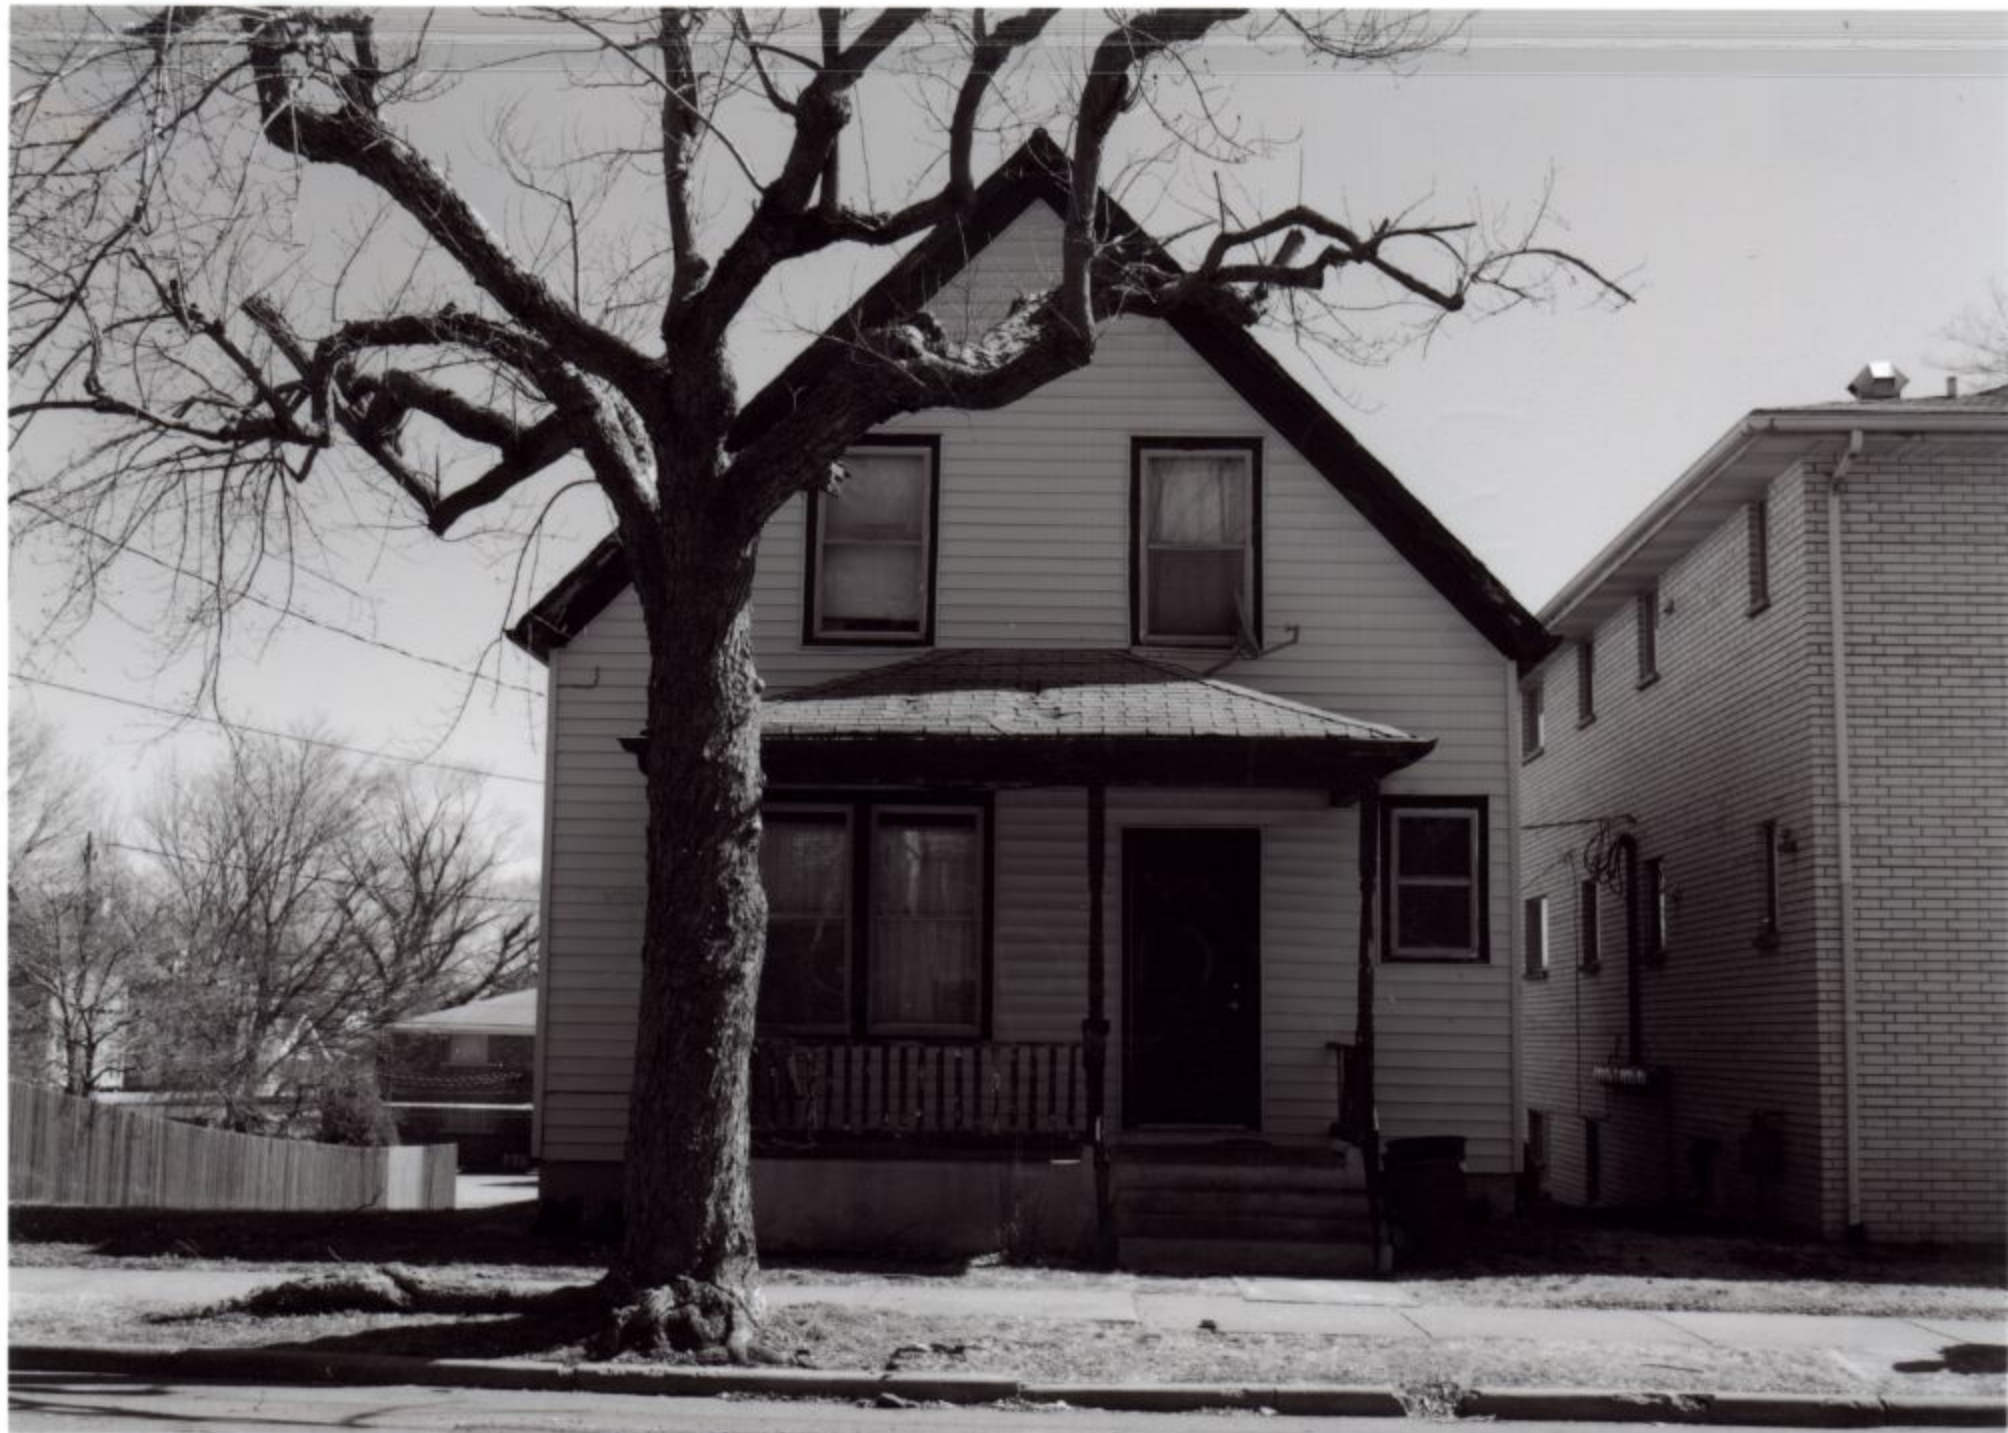
Steeply pitched front gabled roof. Small front porch with three wooden turned posts with steps on the right front of the porch. There is a small window to the right of the porch with all windows being aluminum replacements.

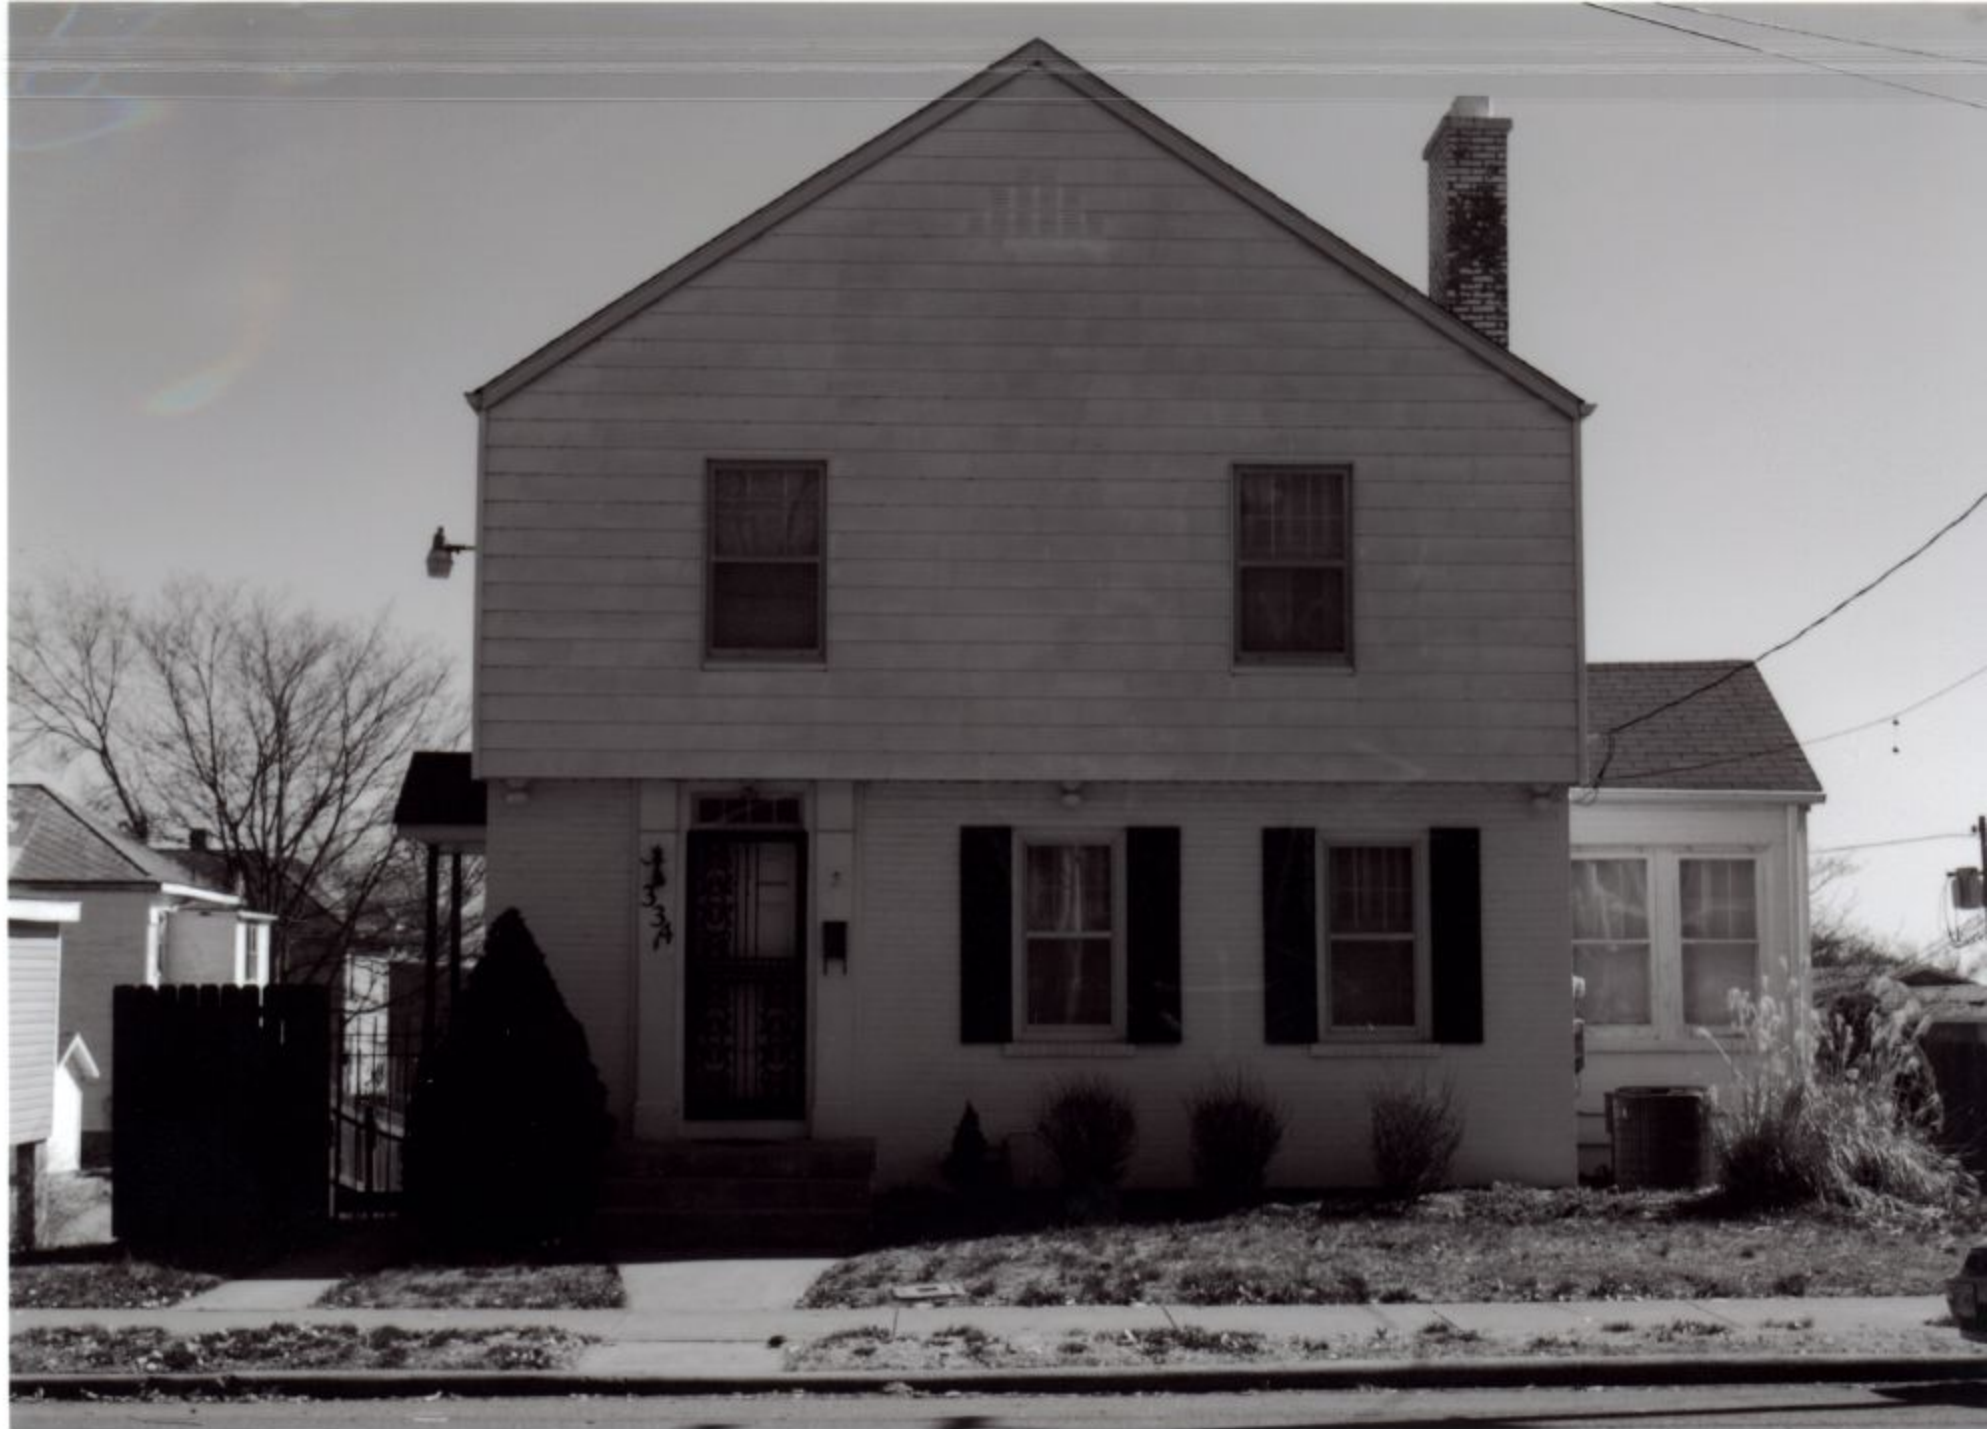
Front gable home with tall brick chimney on the south side of the building. Top floor is wood framed with wooden siding and jettys over the first floor which is of brick construction. Has three ornamental drops evenly spaced underneath the jetty. Has aluminum replacement windows throughout.

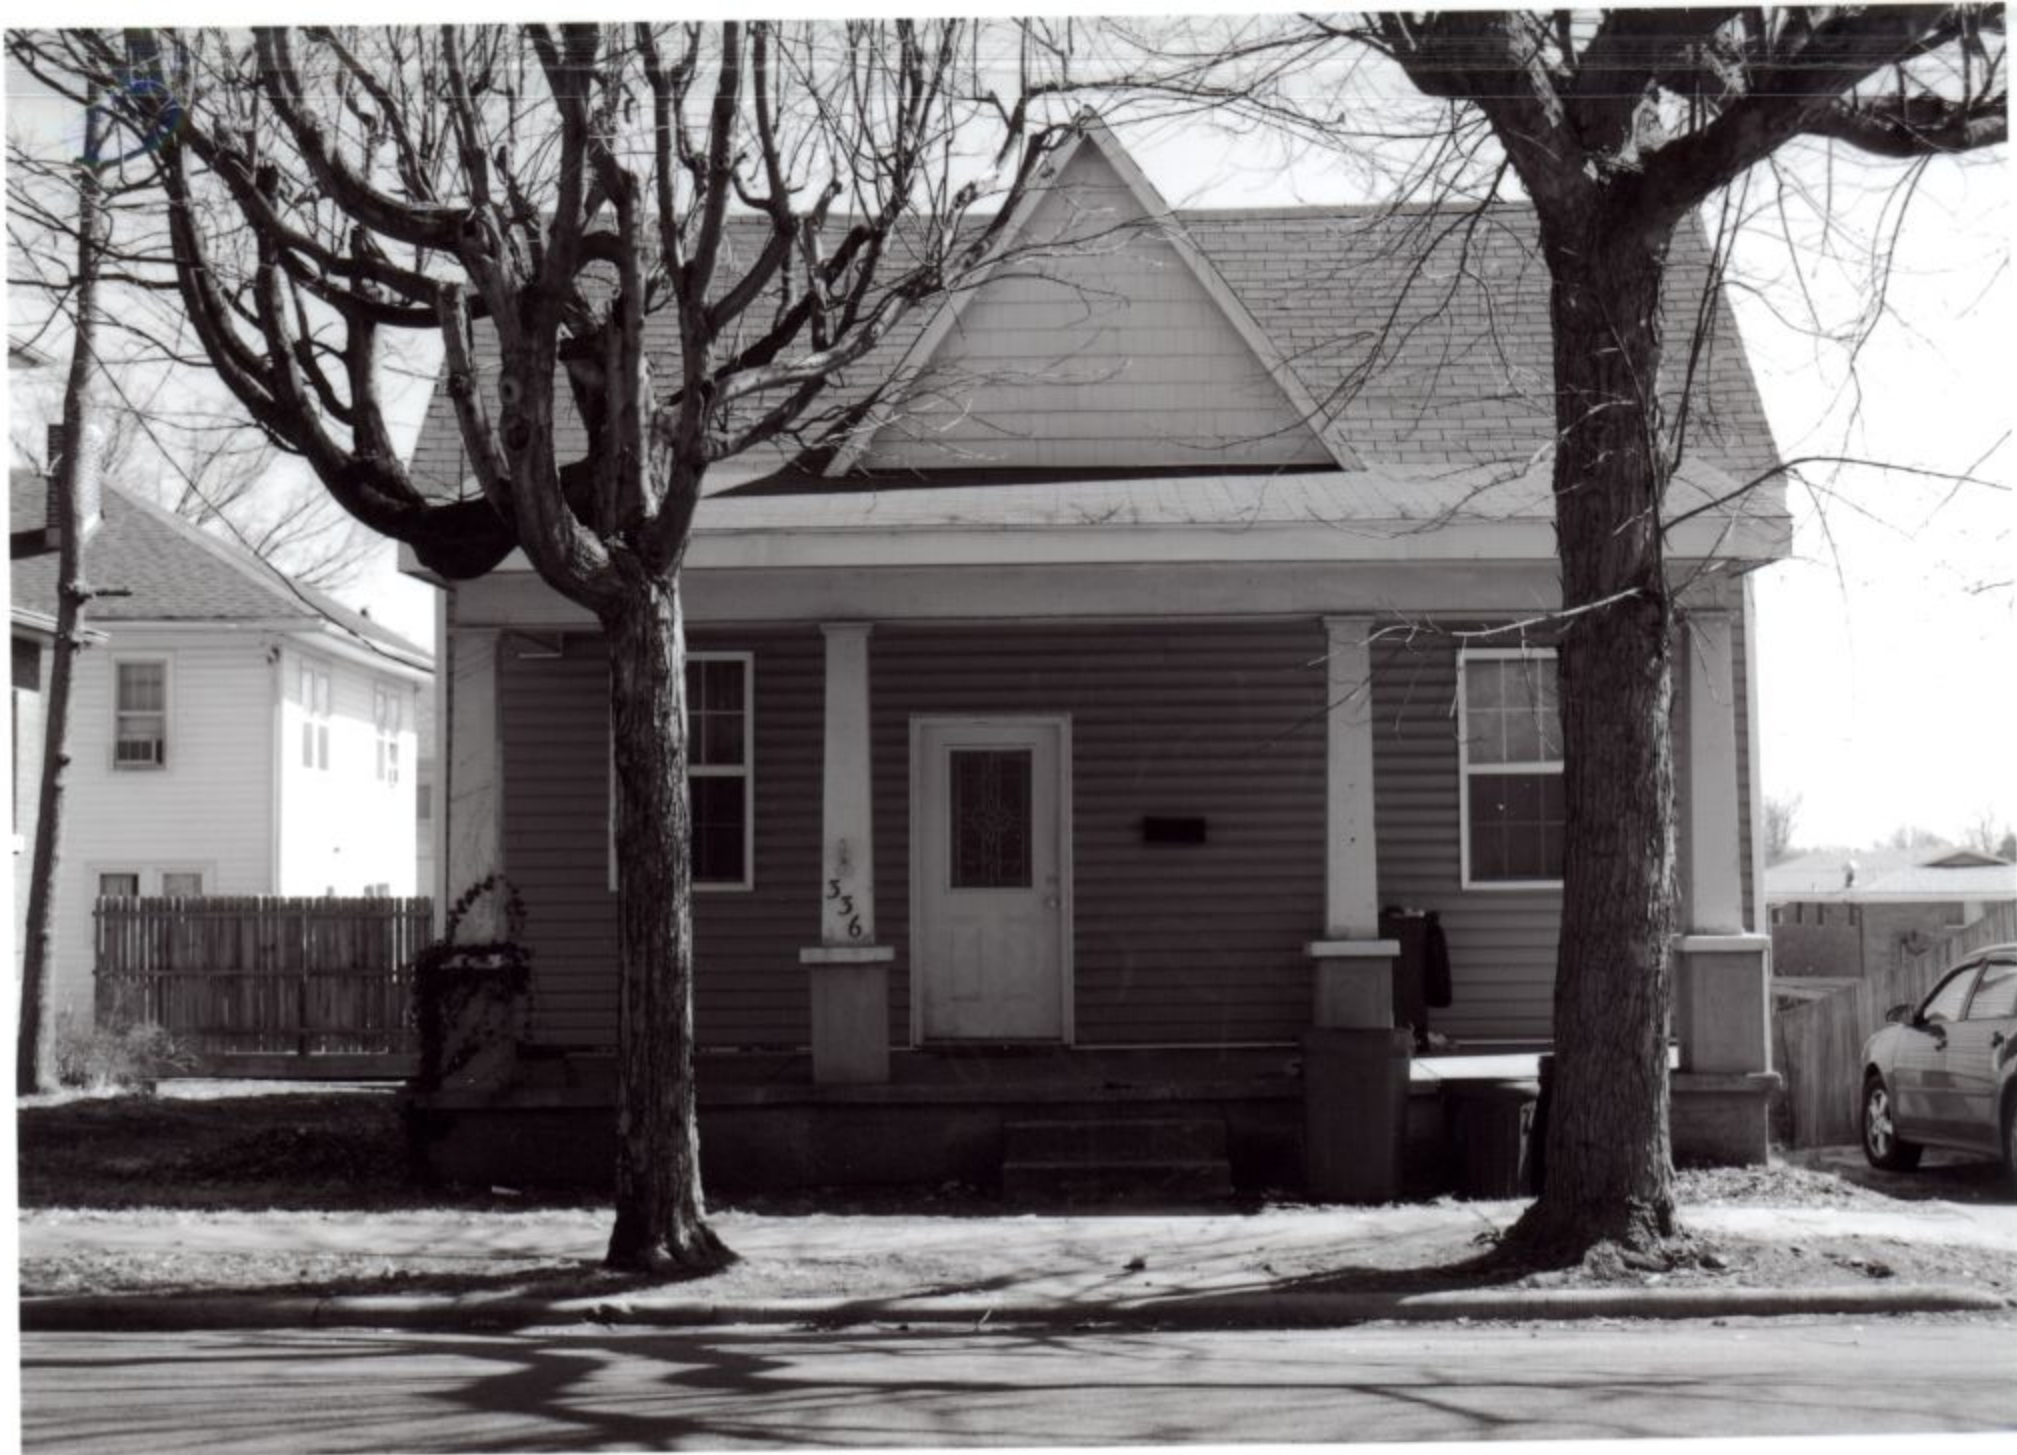
Side Gabled roof with asphalt shingle and a large steeply pitched front gabled section. Full width porch with  $\frac{3}{4}$  length wooden columns on top of concrete piers. Doorway slightly offset to the left of the home with vinyl replacement windows throughout.
