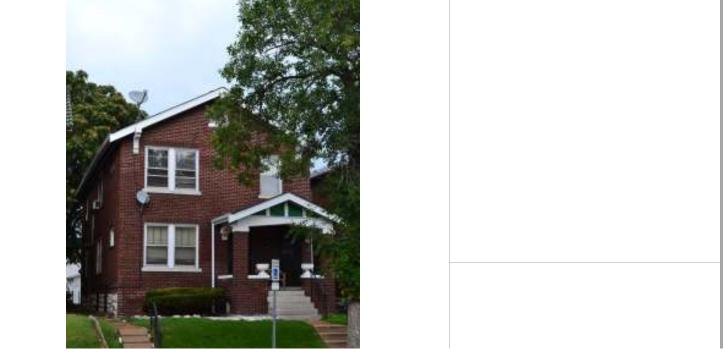
Photos			Detail 1

ID 587				
Street Numb	er <b>4135</b>	Street Name	San Francisco Avenue	
Historic Use	Multiple Dwelling: 2-Family Flat	Ţ		
Current Use	Multiple Dwelling: 2-Family Flat	:		
Construction	Date 1926			
Architect Sm	ith, G.E.		Builder C. Wilcox Con. Co.	
Style	Late 19th & Early 20th C. Americ	can Movement	S	
Number of St	torie 2	Roof Shape F	ront Gabled	
Wall Materia	Brick	Foundation	-	
Contributing	? Yes			
Description				
This two story variegated brick building stands two bays wide. It has a bracketed front-gabled roof with vergeboards. The right first story bay has a raised, front-gabled porch with vergeboards over two transomed entrances, both which retain their original wood and vision paneled doors. The porch has squared brick piers, a shaped wooden entablature, a solid brick bulkhead capped in limestone, and timbering in the gable front. The first and second story left bays have paired windows with original 3/1 sashes, limestone lug sills, and soldier course lintels. The right second story bay has a single window with 3/1 sashes, a limestone lug sill, and soldier course lintel. A segmental arched louvered window with limestone sill sits below the roof peak.
