NATIONAL REGISTER OF HISTORIC PLACES
REGISTRATION FORM

historic name Poplar Bluff Commercial Historic District

state Missouri code MO county Butler code 023 zip code 63901

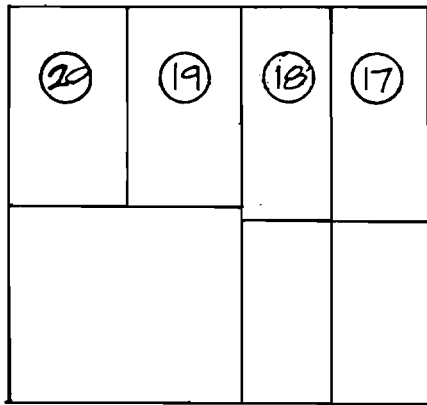
Poplar Bluff Commercial Historic District
Butler Co., MO

The boundary for the Poplar Bluff Commercial Historic District is shown as the heavy broken line on the accompanying map, "Poplar Bluff Commercial Historic District, Butler Co., MO," drawn to a scale of 1"=100'.
