Victorian Towers Historic Architectural Survey

Final Report // August 18, 2021

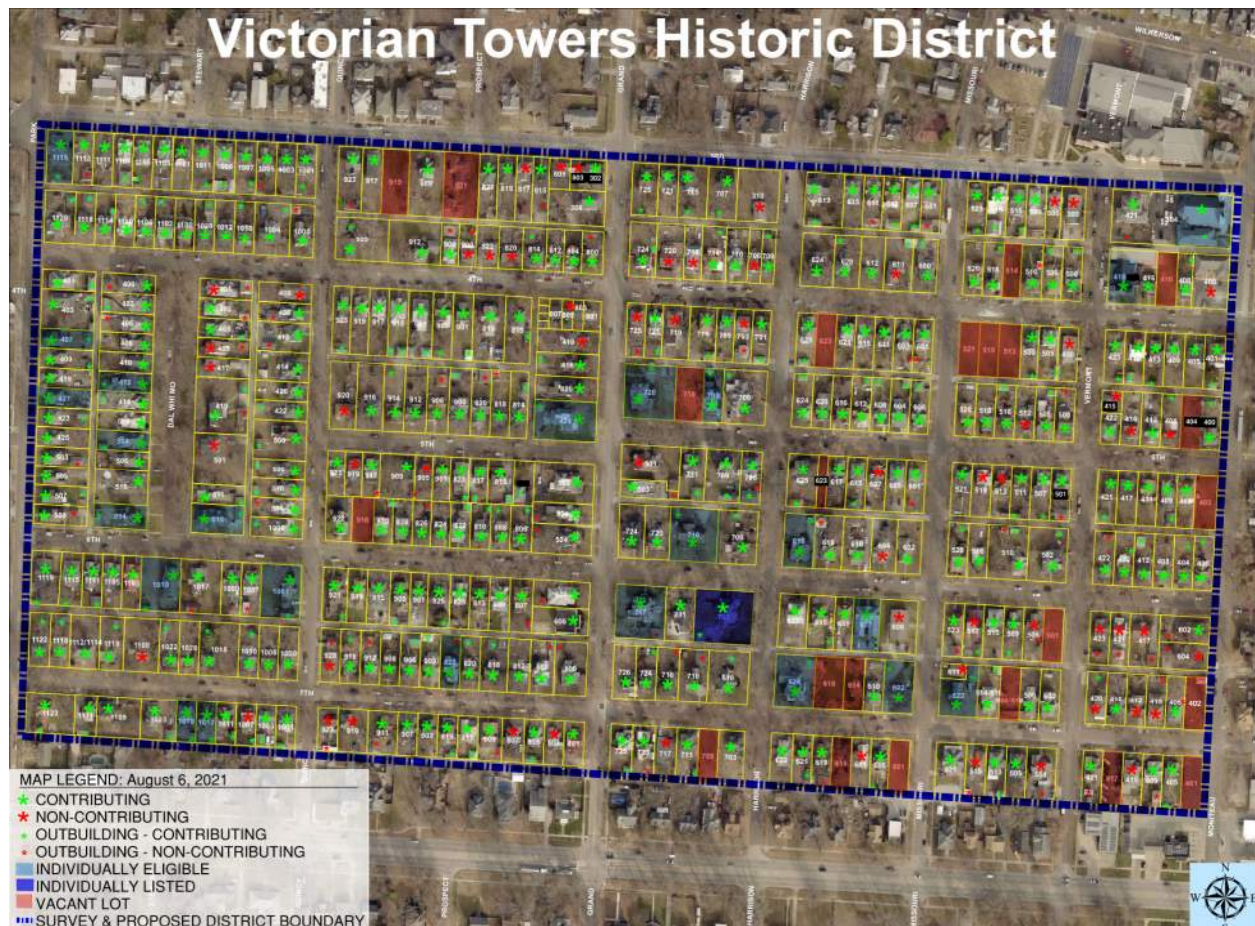
Image 1 – Victorian Towers District Survey Map (SFS Architecture, 2021)

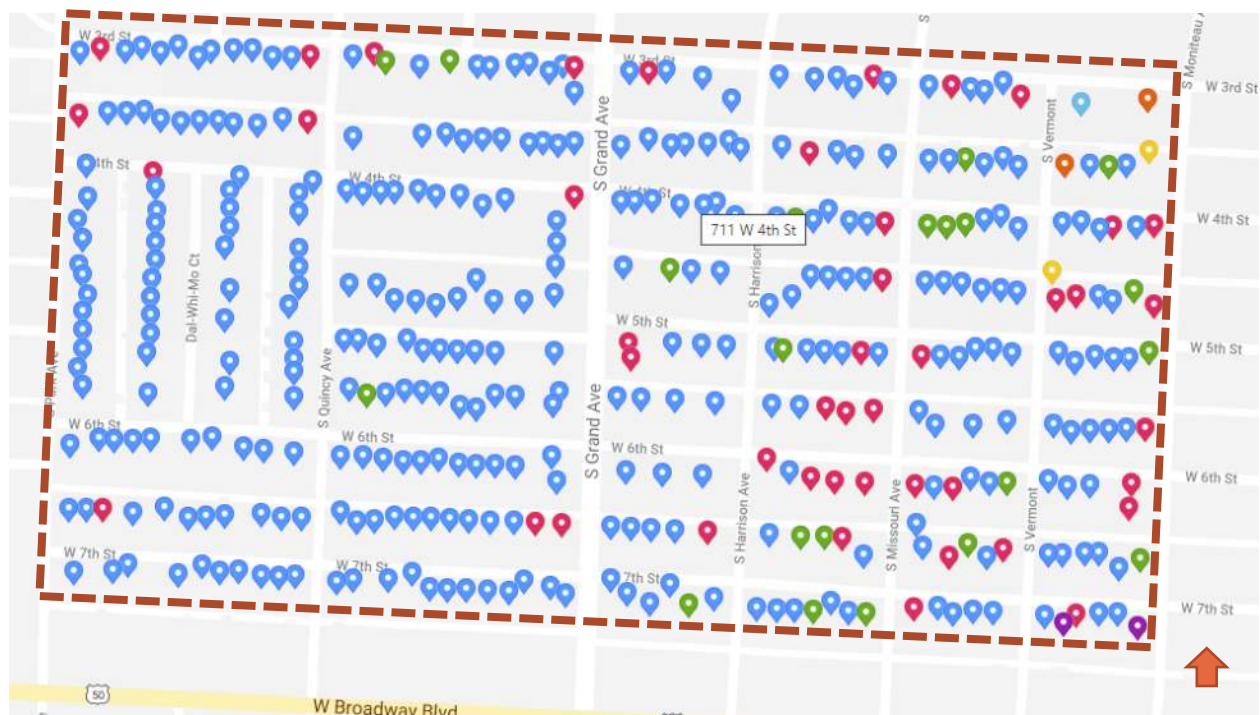
Image 12 – Property Types map of the Victorian Towers District (RuskinARC).

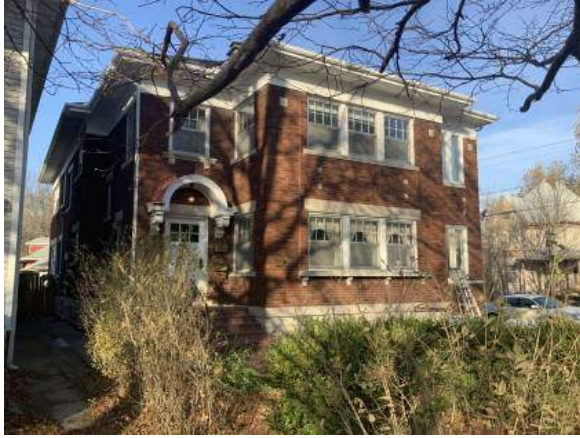
Image 15 – Prairie School apartment at 400 S. Dal Whi Mo.

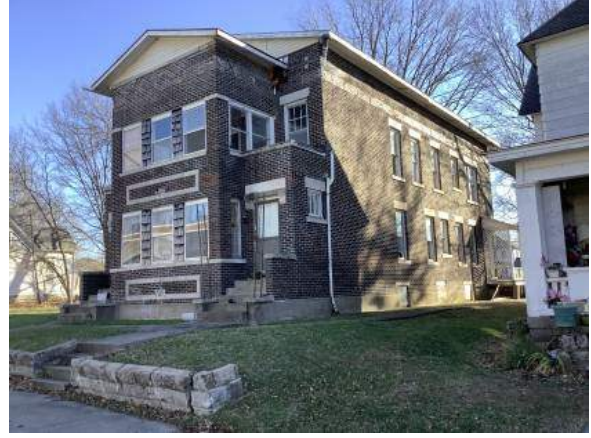
Image 16 – Colonial Revival apartment at 917 W. 3rd.

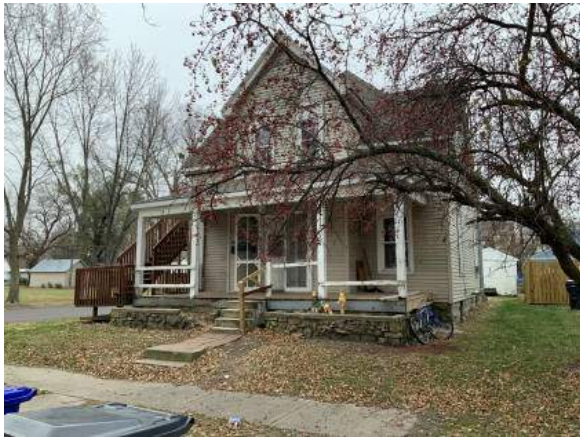
Image 17 – Queen Anne duplex at 601 W. 4th.

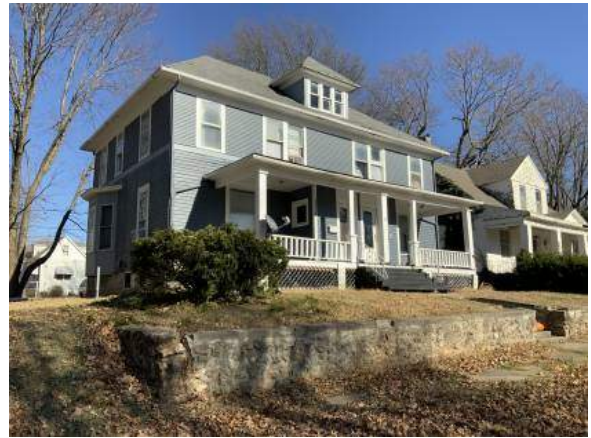
Image 18 – Colonial Revival multi-family, 1112-14 W. 7th

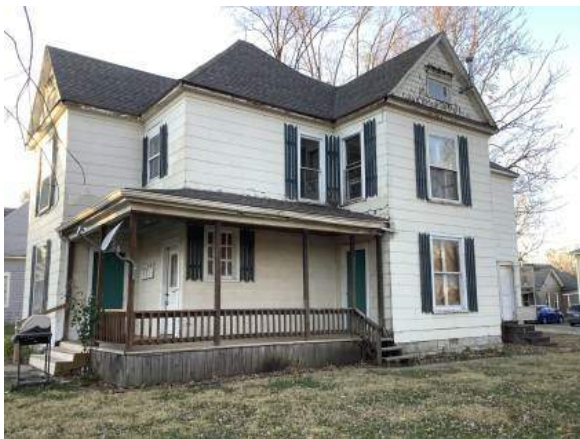
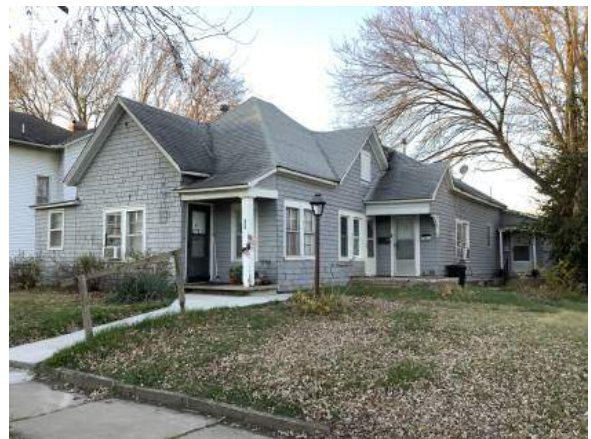
Image 19 and Image 20 – Examples of single-family residences converted into multi-family residences at 602 W 6th (left) and 604 W. 6th (right).

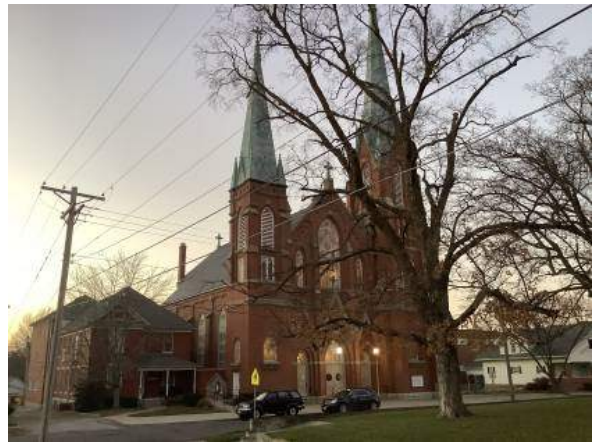
Image 22 – Sacred Heart Church

17. **304 S. Moniteau Avenue – Sacred Heart Church:** This Gothic Revival style religious structure was constructed c.1882. The church features red brick construction with stone detailing and a stone foundation, a center gable roof clad in original slate shingles, two bell towers with copper roofing, and stained glass windows.

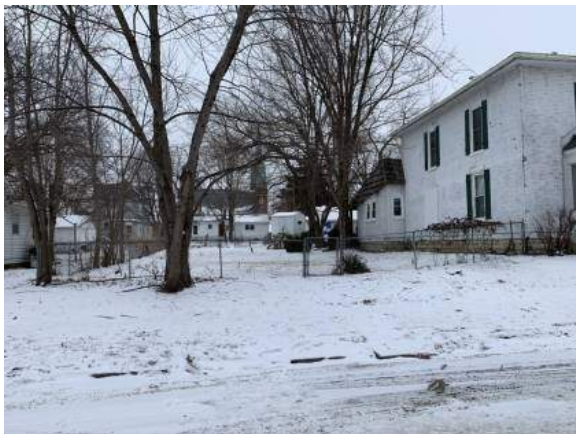
Unfortunately, there are twenty (20) vacant lots and two (2) parking lots in the district.¹⁰ The vacant lots are distributed primarily in the eastern half of the district and are a result of either having never been developed, demolition by neglect, or fire. Both parking lots are on 7th Street on the east side of the district close to Sedalia's commercial district.

Image 27 – Vacant lot at 404 W. 5th Street

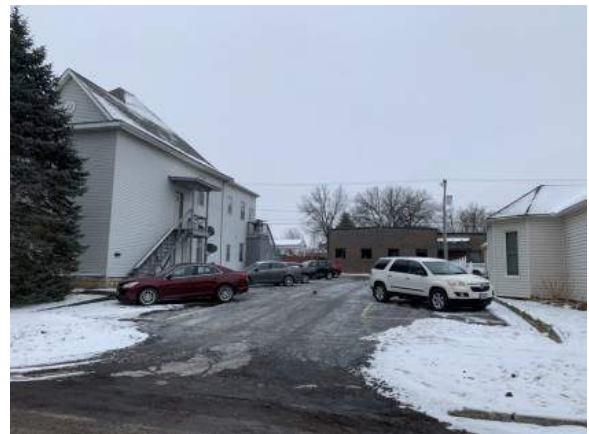
Image 28 – Parking lot at 417 W. 7th Street

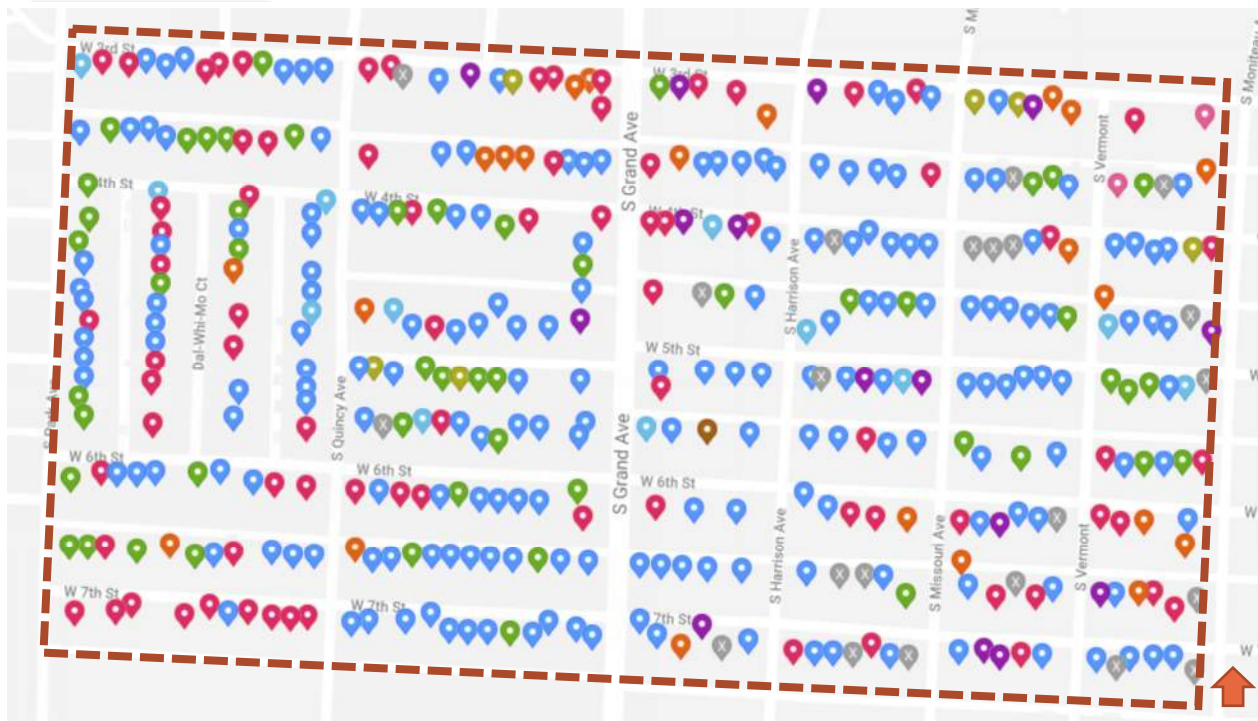
Image 29 – Architectural styles map of the Victorian Towers District (RuskinARC).

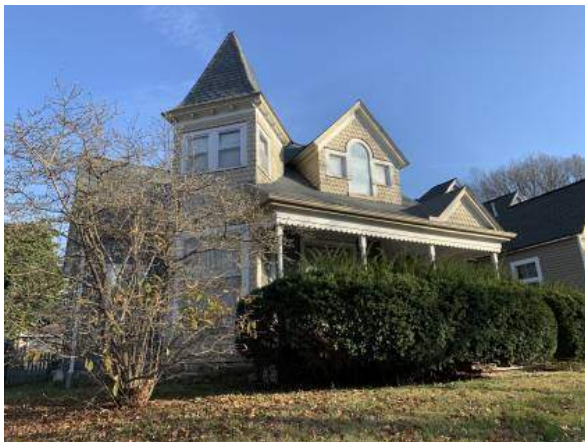
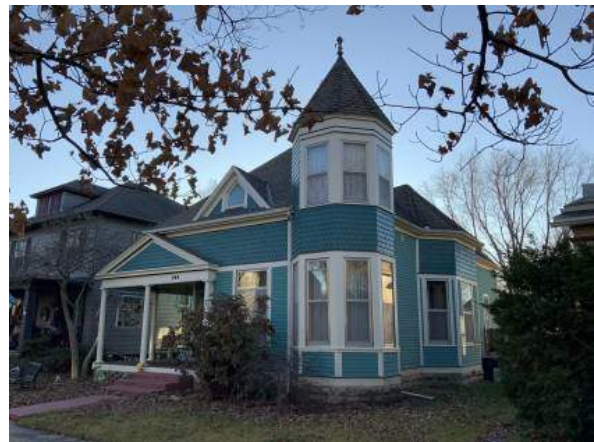
Image 30 (Left) – 1 ½ story Queen Anne with square tower and full porch with bracketed eaves. Image 31 (Right) – Another 1 ½ story Queen Anne with octagonal tower and partial porch with two front gables.

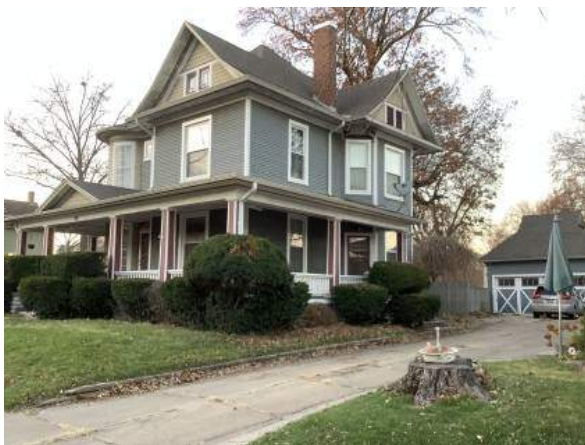
Image 32 (Left) – 2 ½ story Queen Anne with dominant front gable with bracketed eaves and round tower. Image 33 (Right) – Another 2 ½ story Queen Anne with 3-story round tower clad in wood shingles and with a partial width single-story porch.

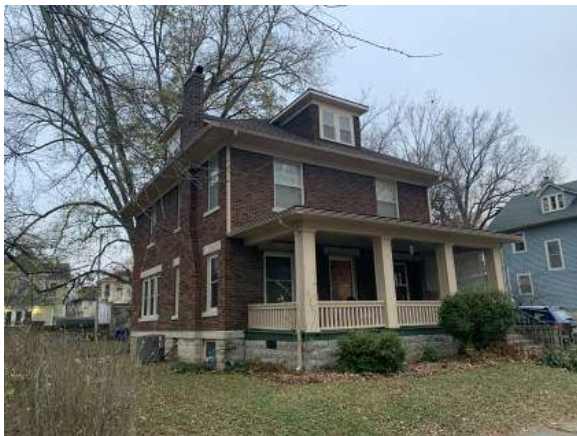
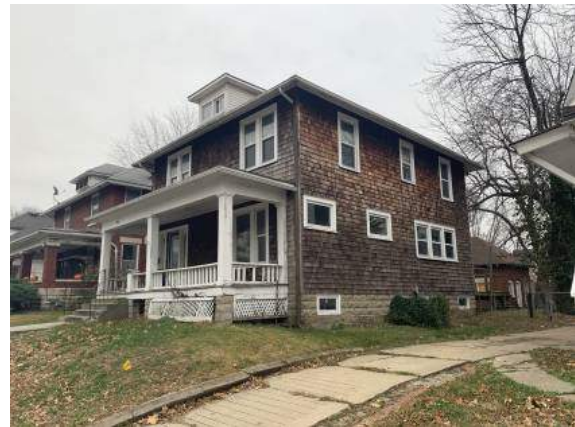
Image 34 and Image 35 – Examples of the typical hipped-roof with full-width porch subtype, constructed of brick and wood shingles. The district is filled with these types.

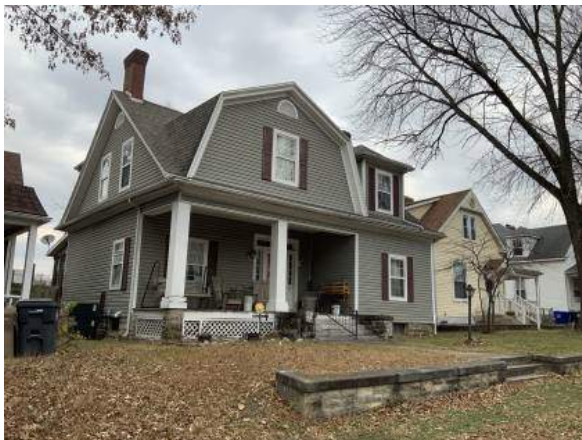
Image 36 (Left) - Dutch Colonial subtype with gambrel roof and partial-width porch. Image 37 (Right) – An excellent example of a symmetrical hipped-roof subtype with center portico supported by paired round columns. This dwelling should be individually listed for its architectural integrity.

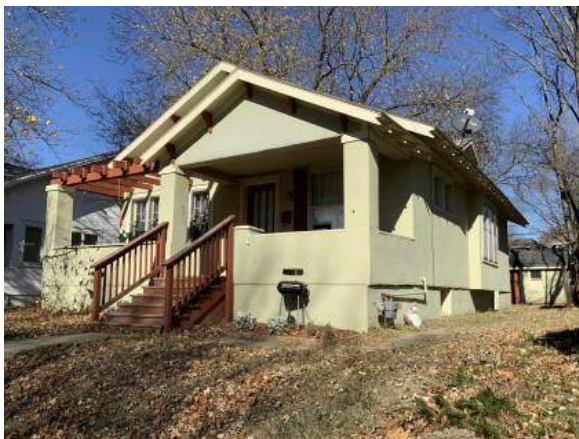
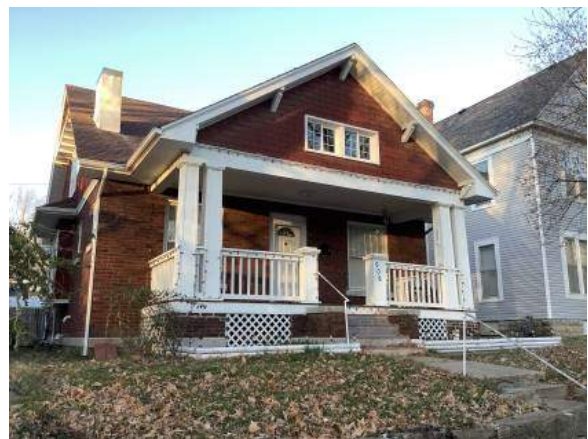
Image 38 and Image 39 – Examples of front-gabled roof Bungalows. The left example features stucco siding, whereas the right example features brick cladding with wood shingle siding in the gabled end. Both examples feature exposed decorative false beams or braces.

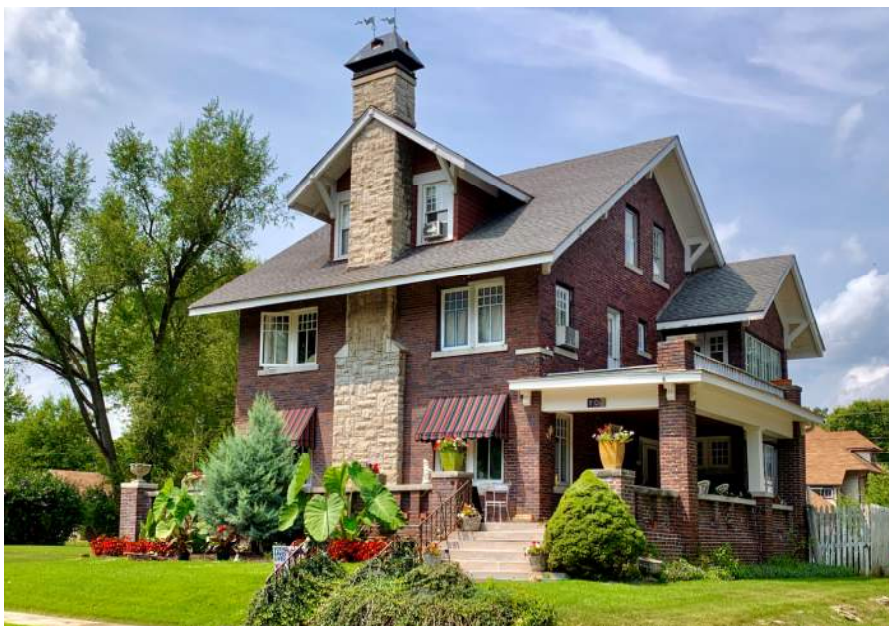
Image 40 – This dwelling on Fifth Street is the best example of the Craftsman Style in the district. It features brick cladding, an unusually centrally placed stone-clad chimney and a side gabled roof with exposed braces.

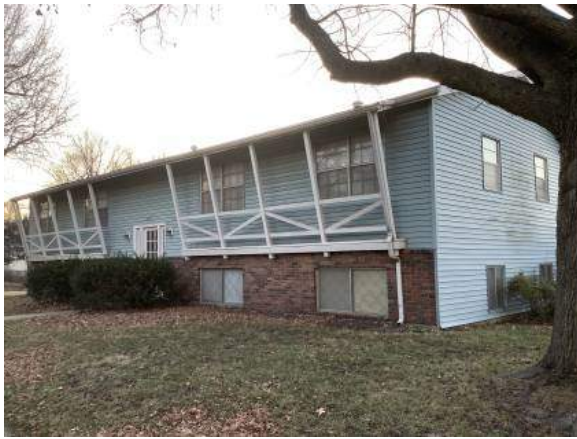
Image 41 (Left) – Contemporary Apartments at 300 S Vermont Avenue

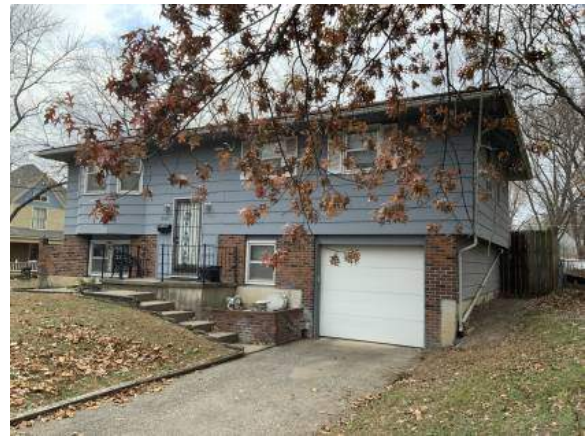
Image 42 (Right) – Split-Level at 920 W 5th Street

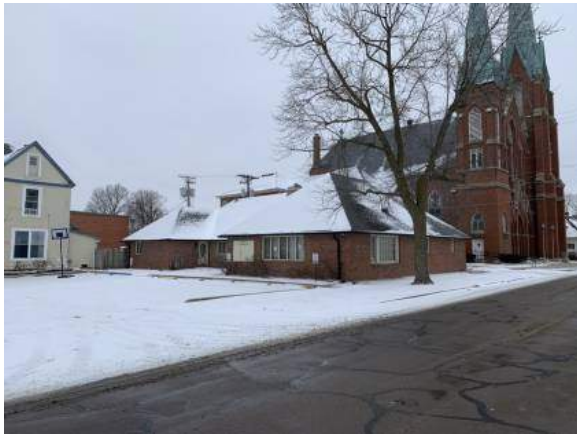
There are two (2) commercial buildings in the district. The first commercial building is a converted garage with a one-story, two-bay Modern Movement Style addition occupied by a hair salon. The second commercial building is single-story, four-bay commercial building constructed in the Modern Movement Style and built in 1963. It houses several office suites.

Image 43 (Left) – Ranch commercial building at 400 W 4th Street

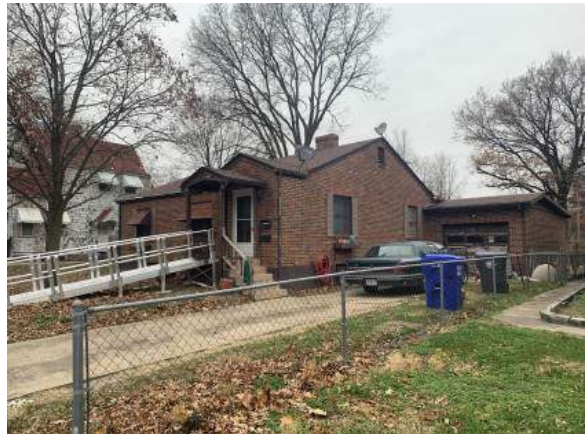
Image 44 (Right) – Minimal traditional dwelling at 720 W 4th Street

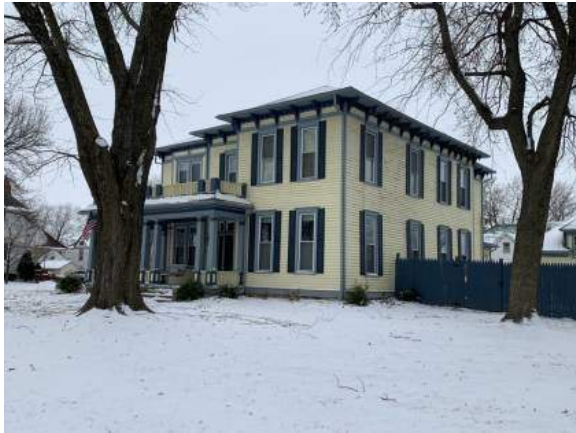
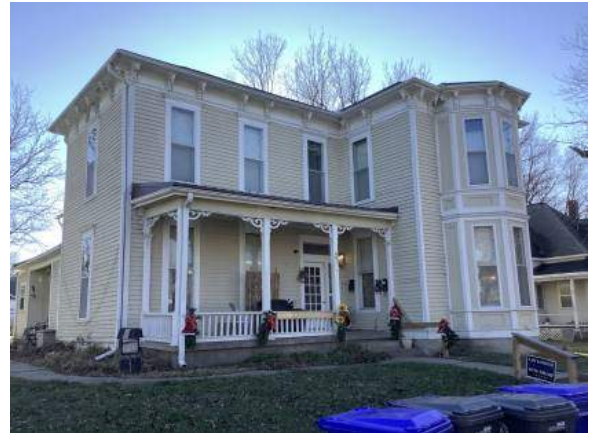
Image 45 (Left) – This is the best example of the Italianate style in the district. This dwelling on Grand Avenue features its original bracketed cornice, single-story porch, and outbuilding. It should be individually listed for its architectural integrity. Image 46 (Right) – Unfortunately, this excellent example of the Italianate style burned down during this survey during the winter of 2021.

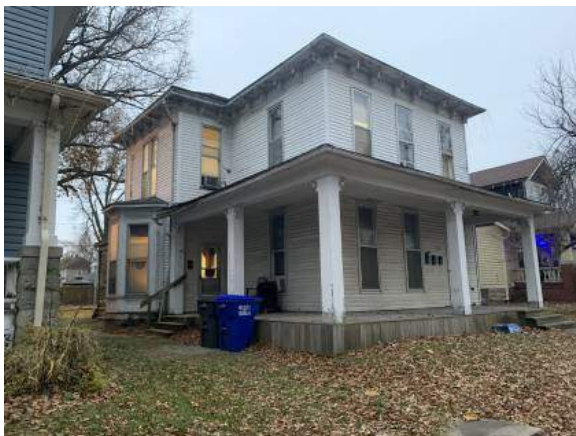
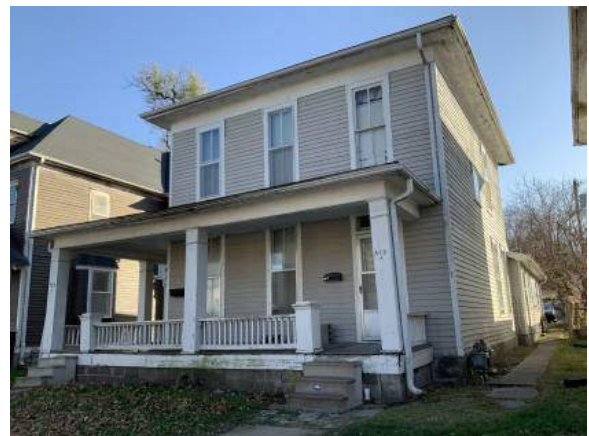
Image 47 and Image 48 – Two similar examples of the Italianate style in the district. Both dwellings feature full-width porches with square supports and rectangular windows with 2/2 sash light configurations. The left example features its original bracketed eaves.

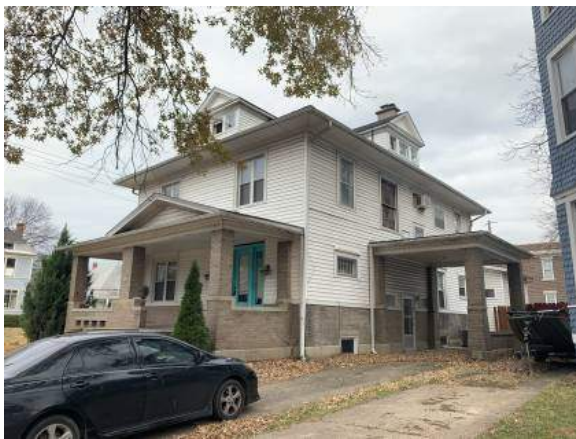
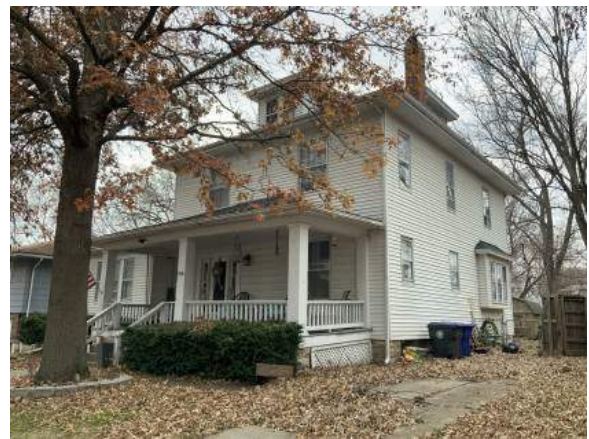
Image 49 and Image 50 – Examples of the most common vernacular form of the Prairie School style, with full-width single story porches with square porch supports, wide overhanging eaves and an emphasis on horizontality with the front porch detailing.

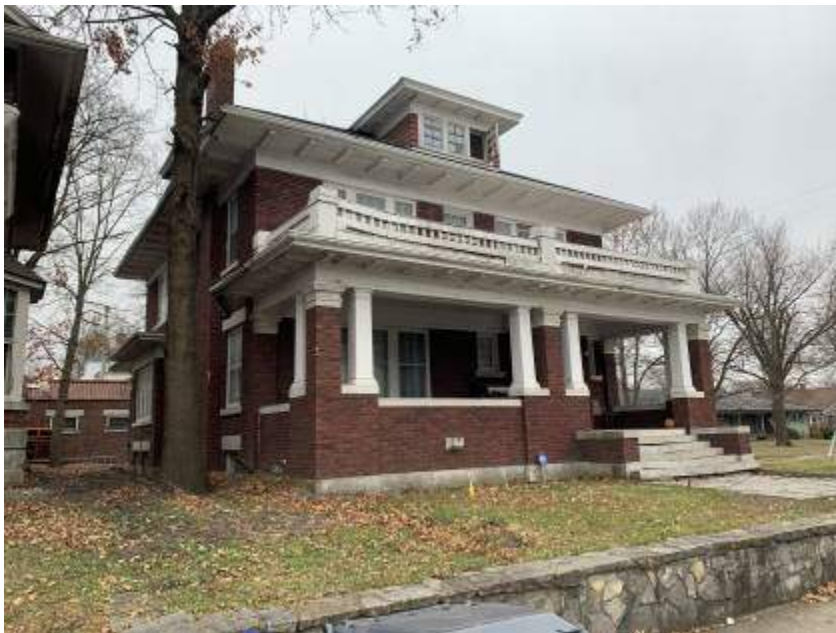
Image 51 – This example could transition as a Colonial Revival style. The Prairie School style was selected, however, due to the wide overhanging eaves and emphasis on horizontality.

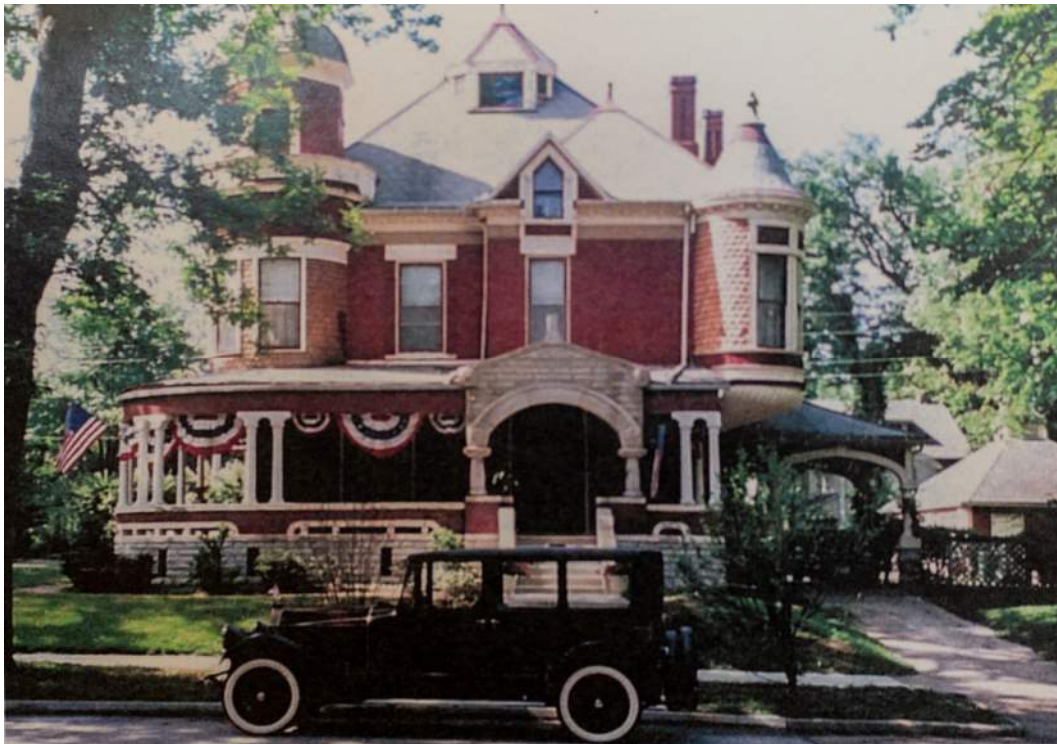
Image 56 – Harris House at 705 W 6th Street (Source: City of Sedalia, Date Unknown)

The Harris House at 705 W 6th Street is currently the only individually listed National Register property in the district. It is an exceptional example of the Queen Anne style with its three-story tower, intricate roof form, turreted oriel, side porte cochere, and rich materiality. It's architecturally intact, in excellent condition and provides an anchor to the neighborhood. The Harris House is an example of why properties should be individually listed on the National Register of Historic Places. See the nomination form for more information on the rich history of this home: <https://dnr.mo.gov/shpo/nps-nr/79001387.pdf>.

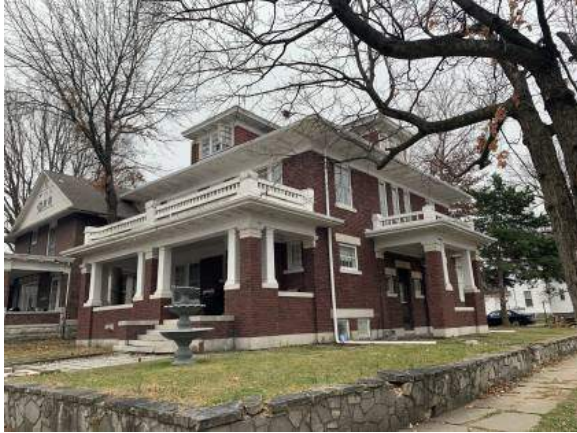
Image 57 – 1115 W. 3rd Street, c.1913

1. **1115 W 3rd Street:** This 2 ½ story, Prairie School style, single-family dwelling was constructed c.1913. The dwelling features original brick construction with a stone foundation, 9/1 and 6/1 wood double-hung windows, and a full-width porch with square brick posts.

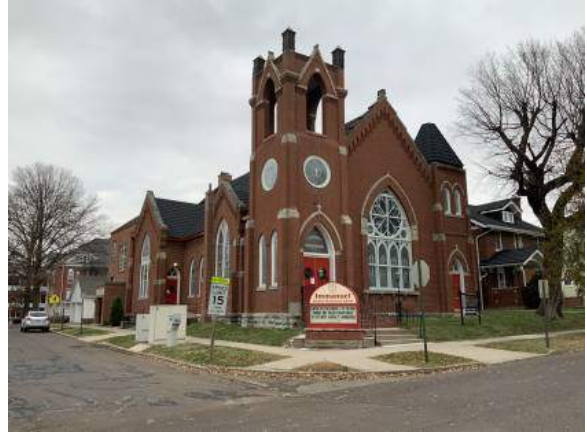
Image 58 – 418 W. 4th Street, c.1896

2. **418 W. 4th Street – Immanuel Church of Christ:** This Gothic Revival style, religious structure was constructed c.1896. The church was originally constructed as the German Immanuel Evangelical Church which was organized in 1876 when twenty percent of Sedalians were first generation German Americans.¹⁴ The church features original red brick construction with sandstone detailing, a center gable roof, stained glass windows, and bell tower.

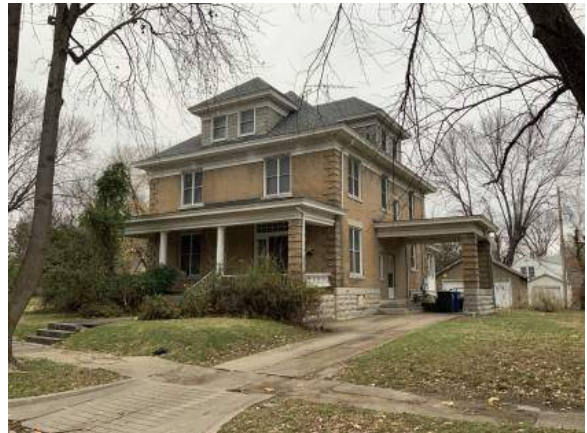
Image 60 – 720 W. 5th Street, c.1907

4. **720 W. 5th Street:** This 2 ½ story, Colonial Revival style, single-family dwelling was constructed c.1907. The home was originally built for William Jolly who was the vice president of the Beiler Grocery Company.¹⁶ The dwelling features original brick construction with slate shingle siding, stone foundation, 1/1 double-hung wood windows, wood door with sidelights, and single-story full width porch with round wood posts.

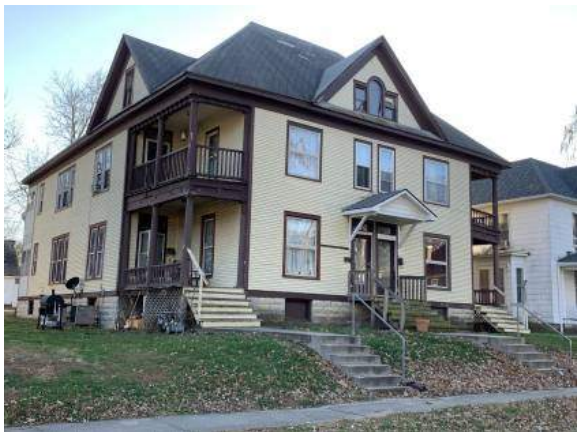
Image 61 – 607 W. 6th Street, c.1909

5. **607 W. 6th Street:** This 2 ½ story, Colonial Revival style, multi-family dwelling was constructed c. 1909. The dwelling features original wood clapboard and shingle siding, rusticated concrete block foundation, roof form with three gabled dormers, 1/1 double-hung windows, two-story corner porch integrated under the main roof with round wood posts. This is one of the few intact historic multi-family dwellings remaining in the district.

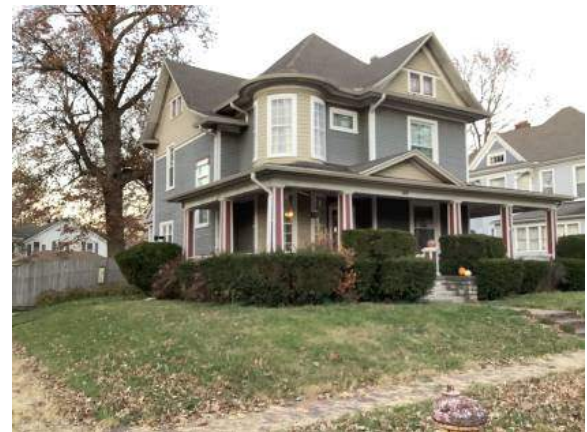
Image 62 – 618 W. 6th Street, c.1897

6. **618 W. 6th Street:** This 2 ½ story, Queen Anne style, single-family dwelling was constructed c. 1897. The dwelling features original wood clapboard and shingle siding, stone foundation, roof form with

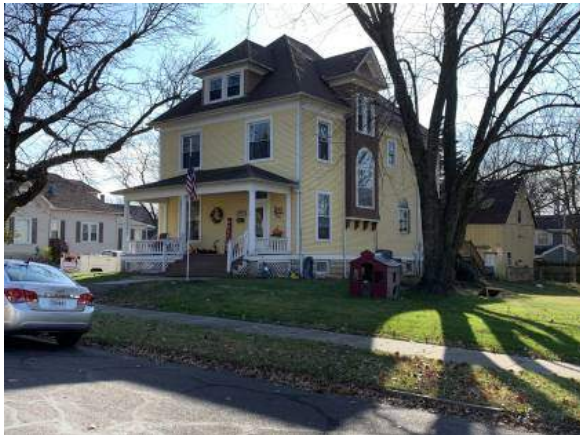
Image 65 – 1001 W. 6th Street, c.1900

9. **1001 W. 6th Street:** This 2 ½ story, Colonial Revival style, single-family dwelling was constructed c.1900. The dwelling features original wood clapboard and scalloped shingle siding, stone foundation, roof form with brick chimney, full-span porch with round wood posts on square stone piers.

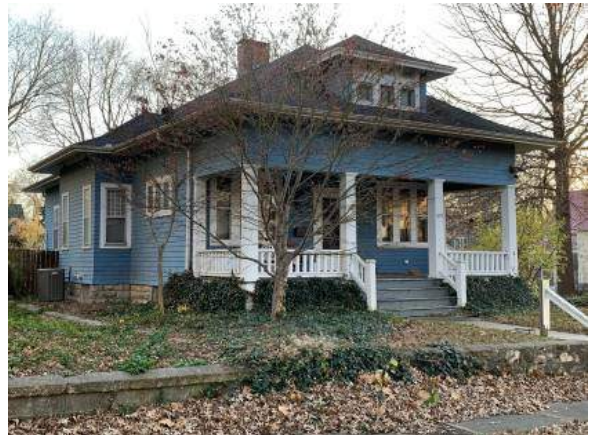
Image 66 – 1019 W. 6th Street, c.1900

10. **1019 W. 6th Street:** This 1 ½ story, Craftsman (Bungalow) style, single-family dwelling was constructed c.1900. The dwelling features its original roof form with bell cast hipped dormers, wood shingle siding, 18/1 double-hung wood windows, full-span porch integrated under the main roof with square wood posts, and stone foundation.

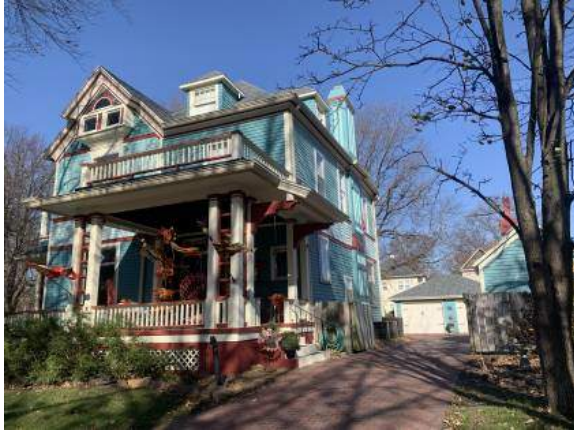
Image 69 – 624 W. 7th Street, c.1891

13. **624 W. 7th Street:** This 2 ½ story, Queen Anne style, single-family dwelling was constructed c.1891. The dwelling features original wood clapboard and shingle siding, stone foundation, roof form and chimneys, double-hung windows with stained glass, wrap-around porch with paired round columns. The dwelling appears to have been expanded since the building outline shown on the 1914 Sanborn Fire Insurance map, so additional research is required to make a final determination.

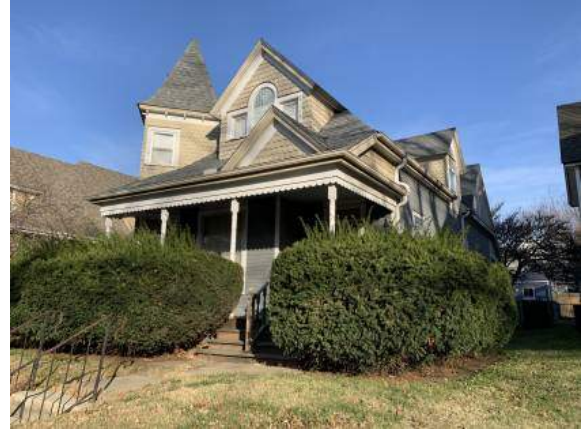
Image 70 – 822 W. 7th Street, c.1895

14. **822 W. 7th Street:** This 1 ½ story, Queen Anne style, single-family dwelling was constructed c.1895. The dwelling features original wood clapboard and scalloped shingle siding, roof form with square tower with bracketed eaves, dormer windows, and full-width porch with turned wood posts. The remainder of the windows appear to have been replaced with appropriate 1/1 aluminum windows.

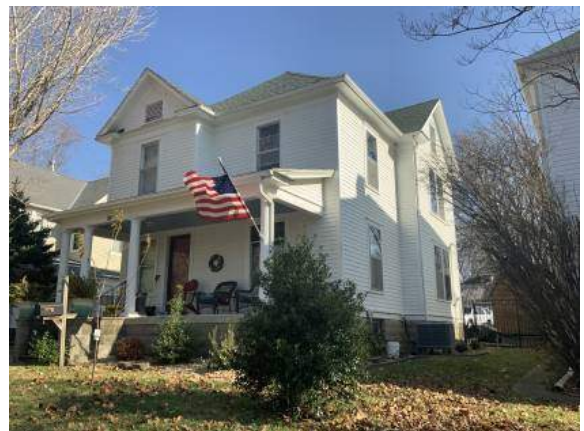
Image 80 – 421 S. Park Avenue, c.1910

24. **421 S. Park Avenue:** This 2 ½ story, Queen Anne style, single-family dwelling was constructed c.1910. The dwelling features original wood clapboard and shingle siding, rusticated concrete block foundation, 1/1 double-hung wood windows, a three-quarter front porch supported by round posts, and single light wood door.

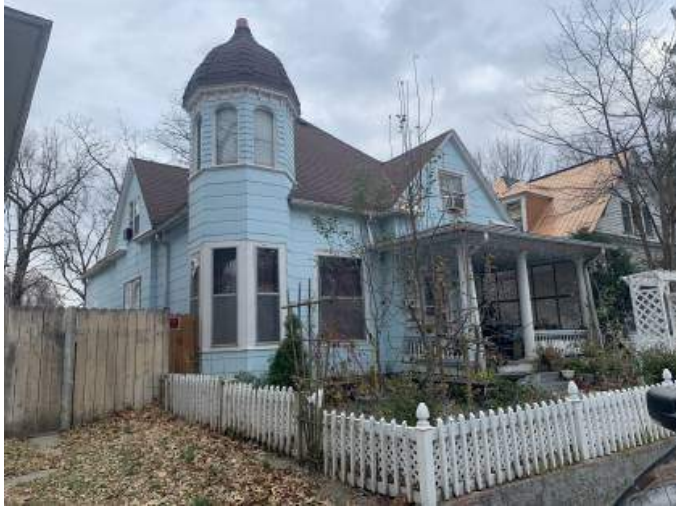
Image 81 – 812 W. 4th Street, c.1897

1. **812 W. 4th Street:** This 1 ½ story Queen Anne style, single-family dwelling was constructed c.1897. The exterior is clad in replacement asbestos siding; however, the remainder of the dwelling features original wood shingle siding, 1/1 wood double-hung windows, corner tower, and porch supported by round wood posts.

The following properties are also potentially individually eligible for listing on the National Register of Historic Places **with modifications**. They retain much of their original architectural features and finishes that characterize their architectural style; however, they exhibit features that have been replaced with incompatible features. For example, vinyl or asbestos siding covers or replaced original wood clapboard siding, or decorative metal porch supports replaced original wood posts. These properties could be considered for individual listing if these features are replaced with features matching the original features in material, size and profile.

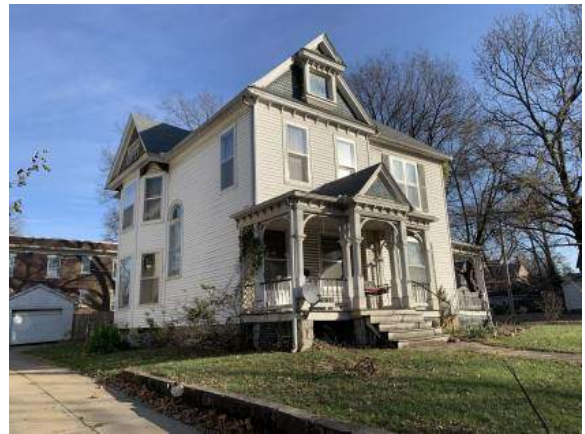
Image 82 – 416 W. 7th Street, c.1880

2. **416 W. 7th Street:** This 1 ½ story Queen Anne style, single-family dwelling was constructed c.1880. The exterior is clad in vinyl siding; however, the remainder of the dwelling features its original roof form, 1/1 double-hung wood windows with stained glass transom sash, and corner wrap-around porch with turned wood posts. This dwelling is associated with the Yost family.

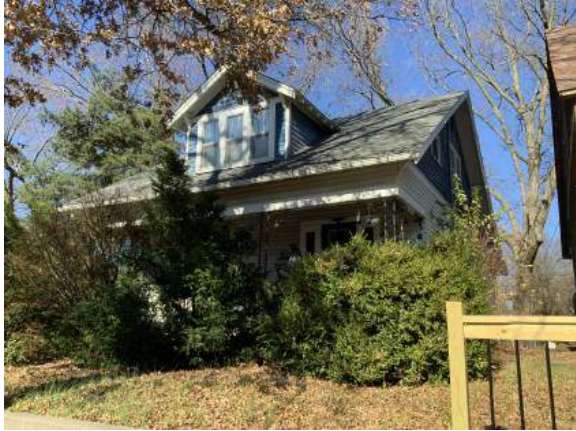
Image 85 – 1010 W. 7th Street, c.1895

5. **1010 W. 7th Street:** This 2 ½ story, Queen Anne style, single-family dwelling was constructed c.1895. The exterior is clad in vinyl siding; however, the remainder of the dwelling features its original roof form, wood shingle siding at the gable, and wrap-around porch with square wood posts. The dwelling has 1/1 replacement vinyl windows,

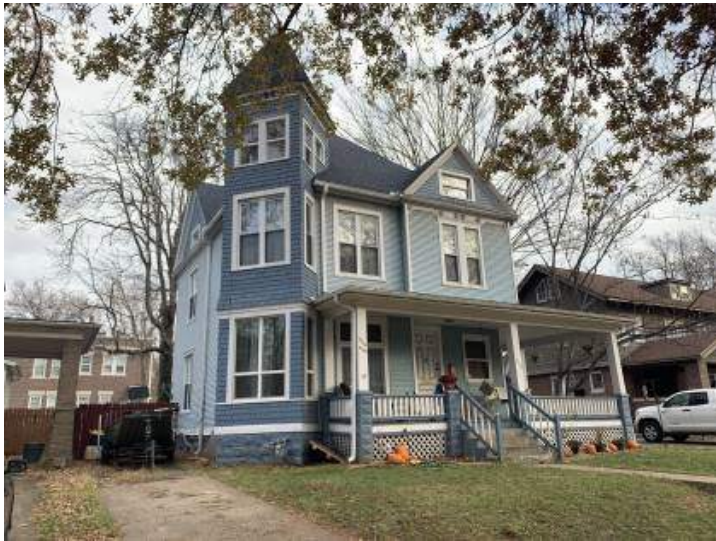
Image 88 – 720 W. 6th Street, c.1896

8. **720 W. 6th Street:** This 2 ½ story, Queen Anne style, single-family dwelling was constructed c.1896. The exterior is clad in vinyl siding; however, the remainder of the dwelling features its original roof form with corner tower, wood shingles, wrap-around porch with square wood posts and rusticated concrete block foundation.
