MISSOURI DEPARTMENT OF NATURAL RESOURCES
STATE HISTORIC PRESERVATION OFFICE, P.O. Box 176, Jefferson City, MO 65102
ARCHITECTURAL/HISTORIC INVENTORY FORM

1. SURVEY NO. BO-AS-009-0001		2. SURVEY NAME: Rocheport Historic District	
3. COUNTY: Boone		4. ADDRESS (STREET NO.)	STREET (NAME) Katy Trail
5. CITY: Rocheport	VICINITY: <input checked="" type="checkbox"/>	6. UTM: / /	LAT: LONG: T: 48W R: 15W S: 1

8. HISTORIC NAME (IF KNOWN): M.K.&T. Railroad tunnel		9. PRESENT/OTHER NAME (IF KNOWN): Katy trail tunnel	
10. OWNERSHIP: <input type="checkbox"/> PRIVATE <input checked="" type="checkbox"/> PUBLIC		11A. HISTORIC USE (IF KNOWN): railroad tunnel	11B. CURRENT USE: Katy Trail tunnel
HISTORICAL INFORMATION

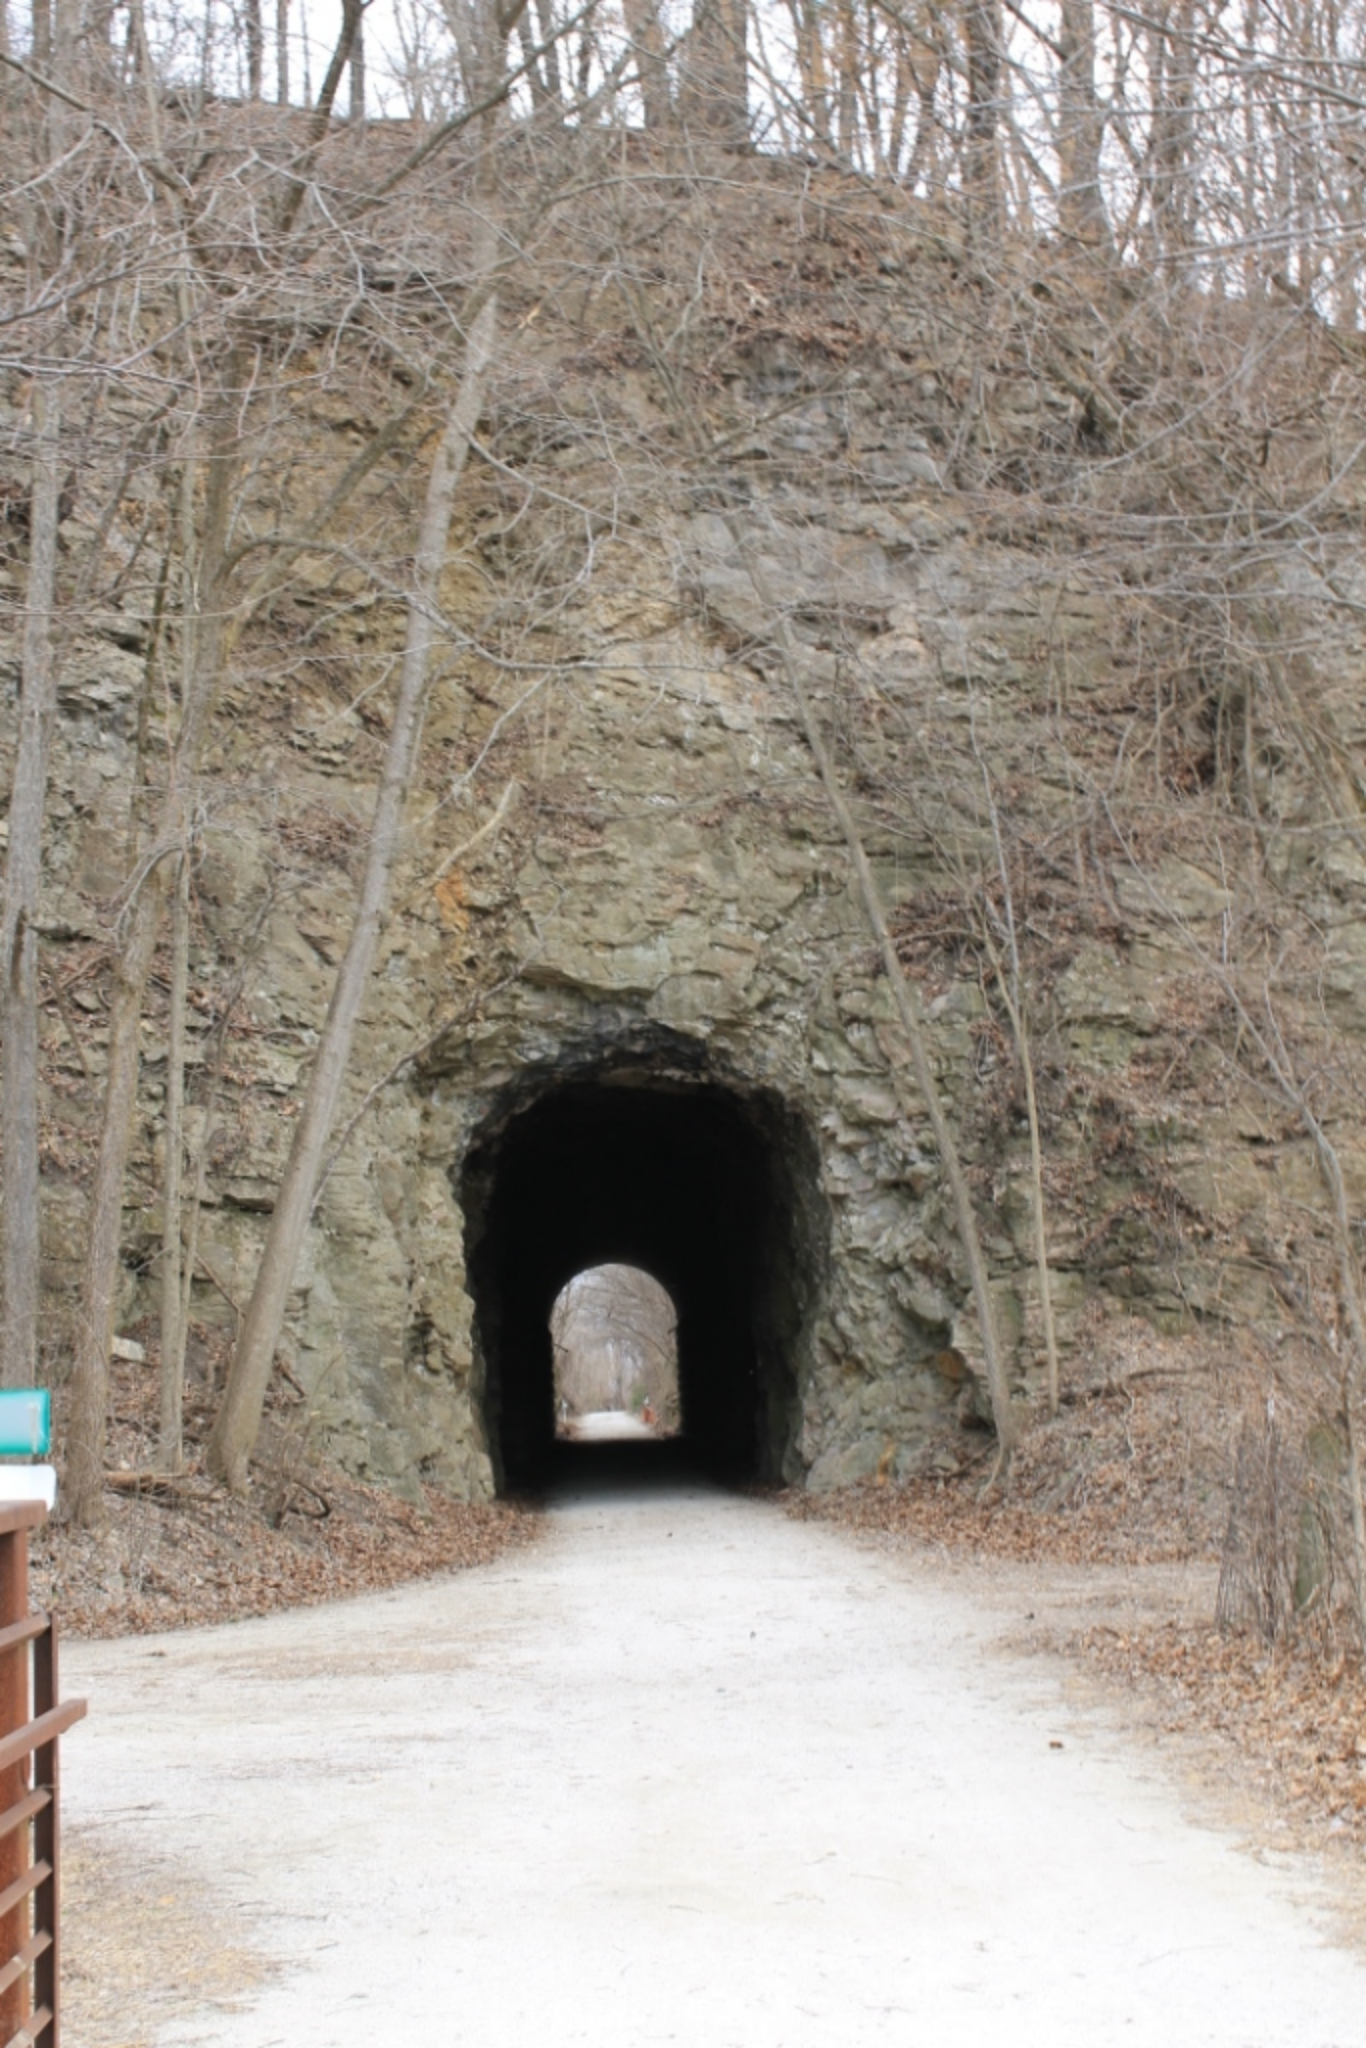
The opening of this tunnel is a round arch. The tunnel is 243 feet long, 16 feet wide, and 23 feet high. The side walls of the interior of the tunnel are lined with square stones. The top of the interior of the tunnel is a brick arch.

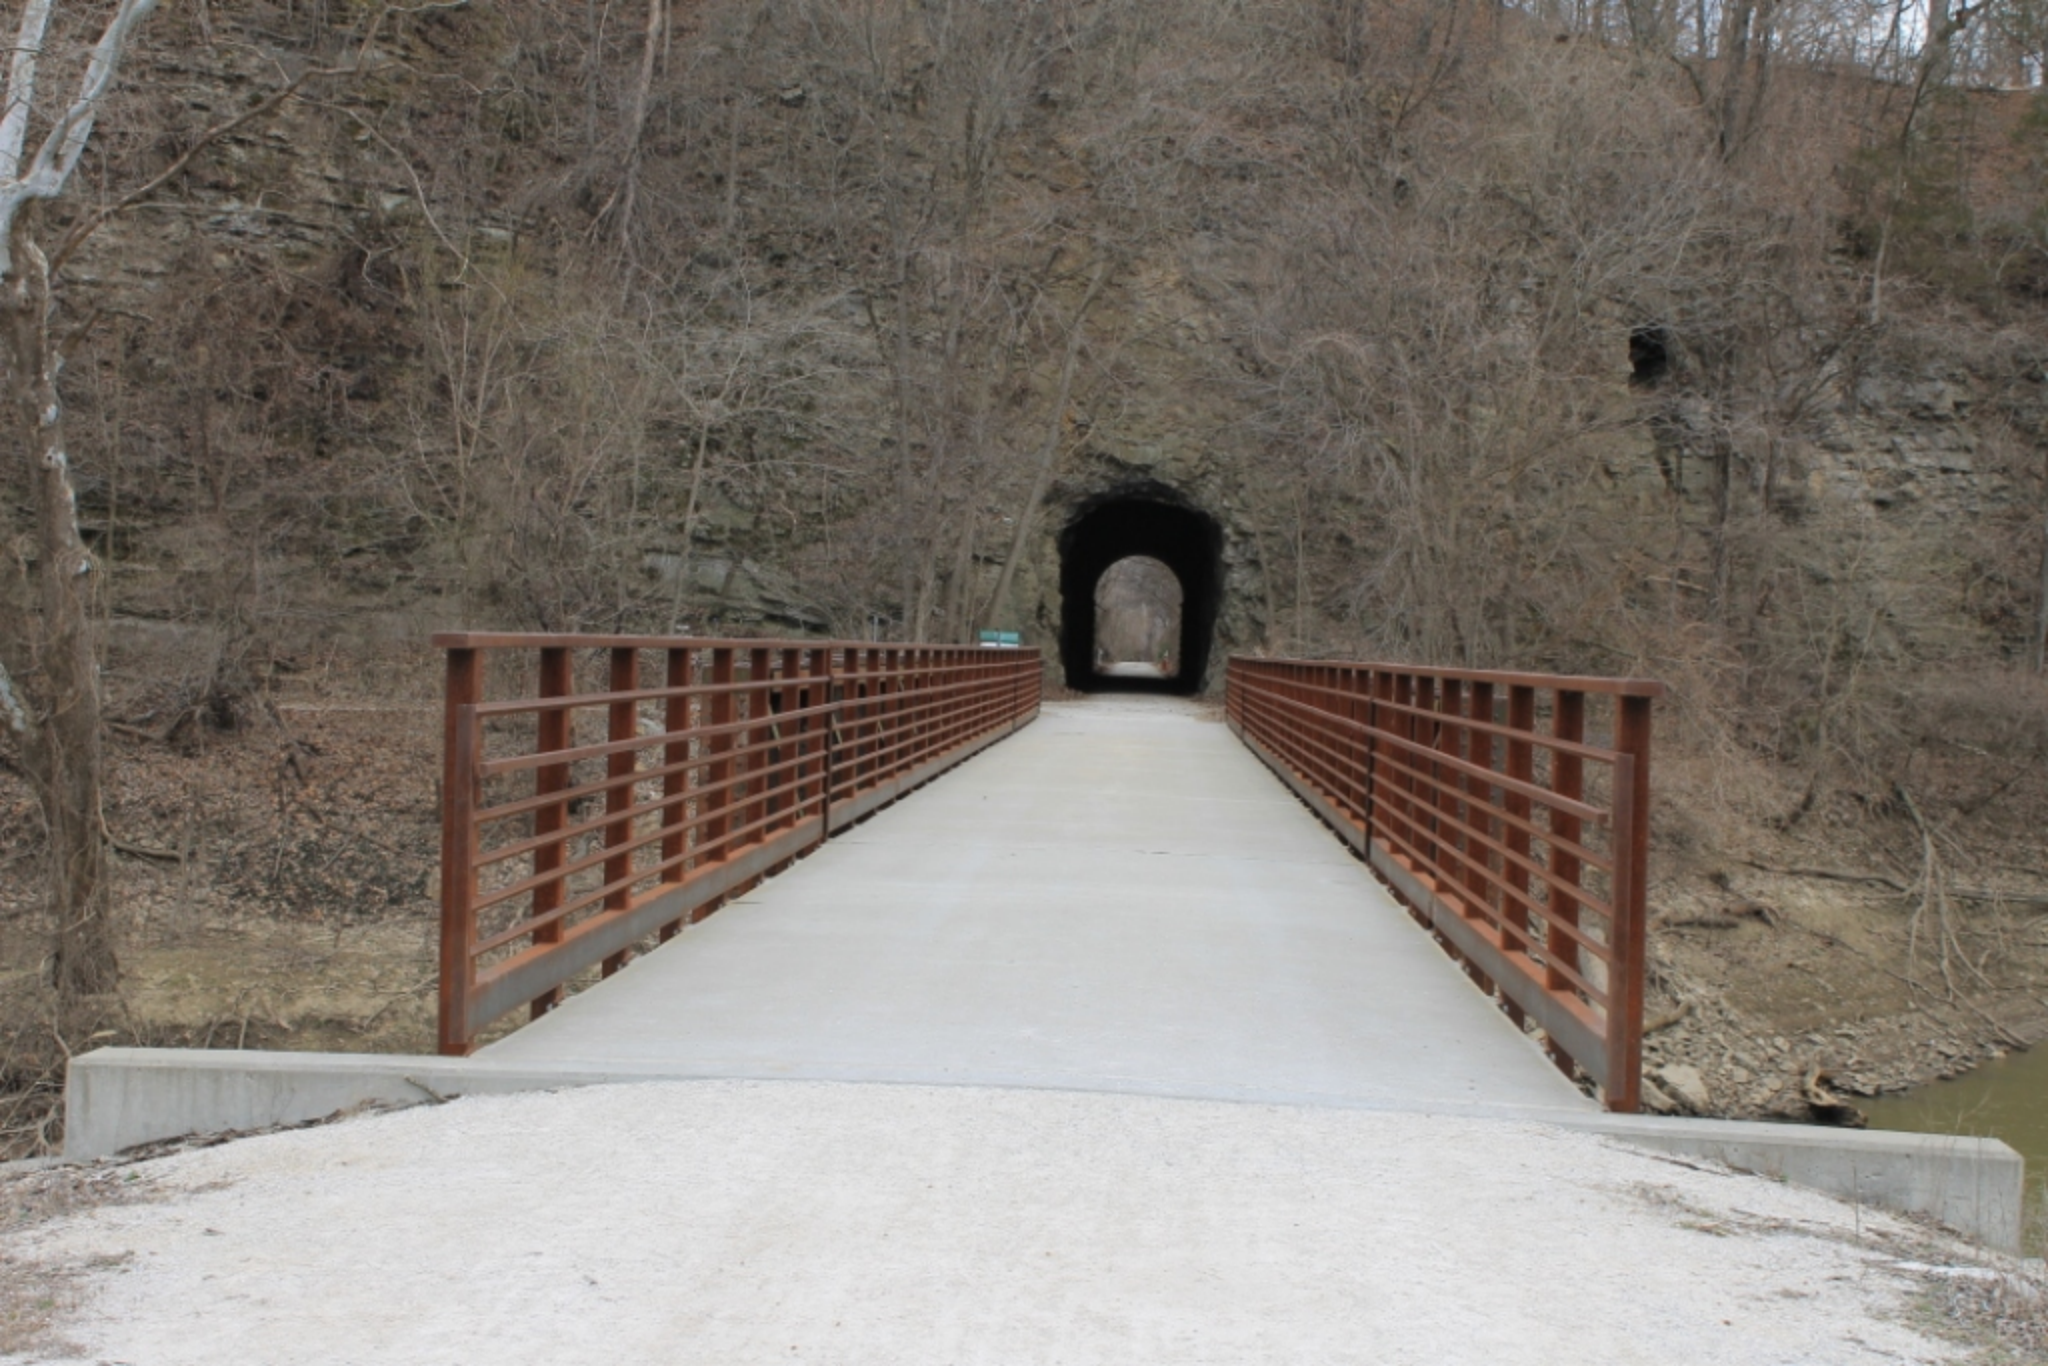
This modern bridge has a metal structure and a concrete roadbed. On either side of the roadbed are horizontal metal railings to ensure the safety of those using the Katy Trail.

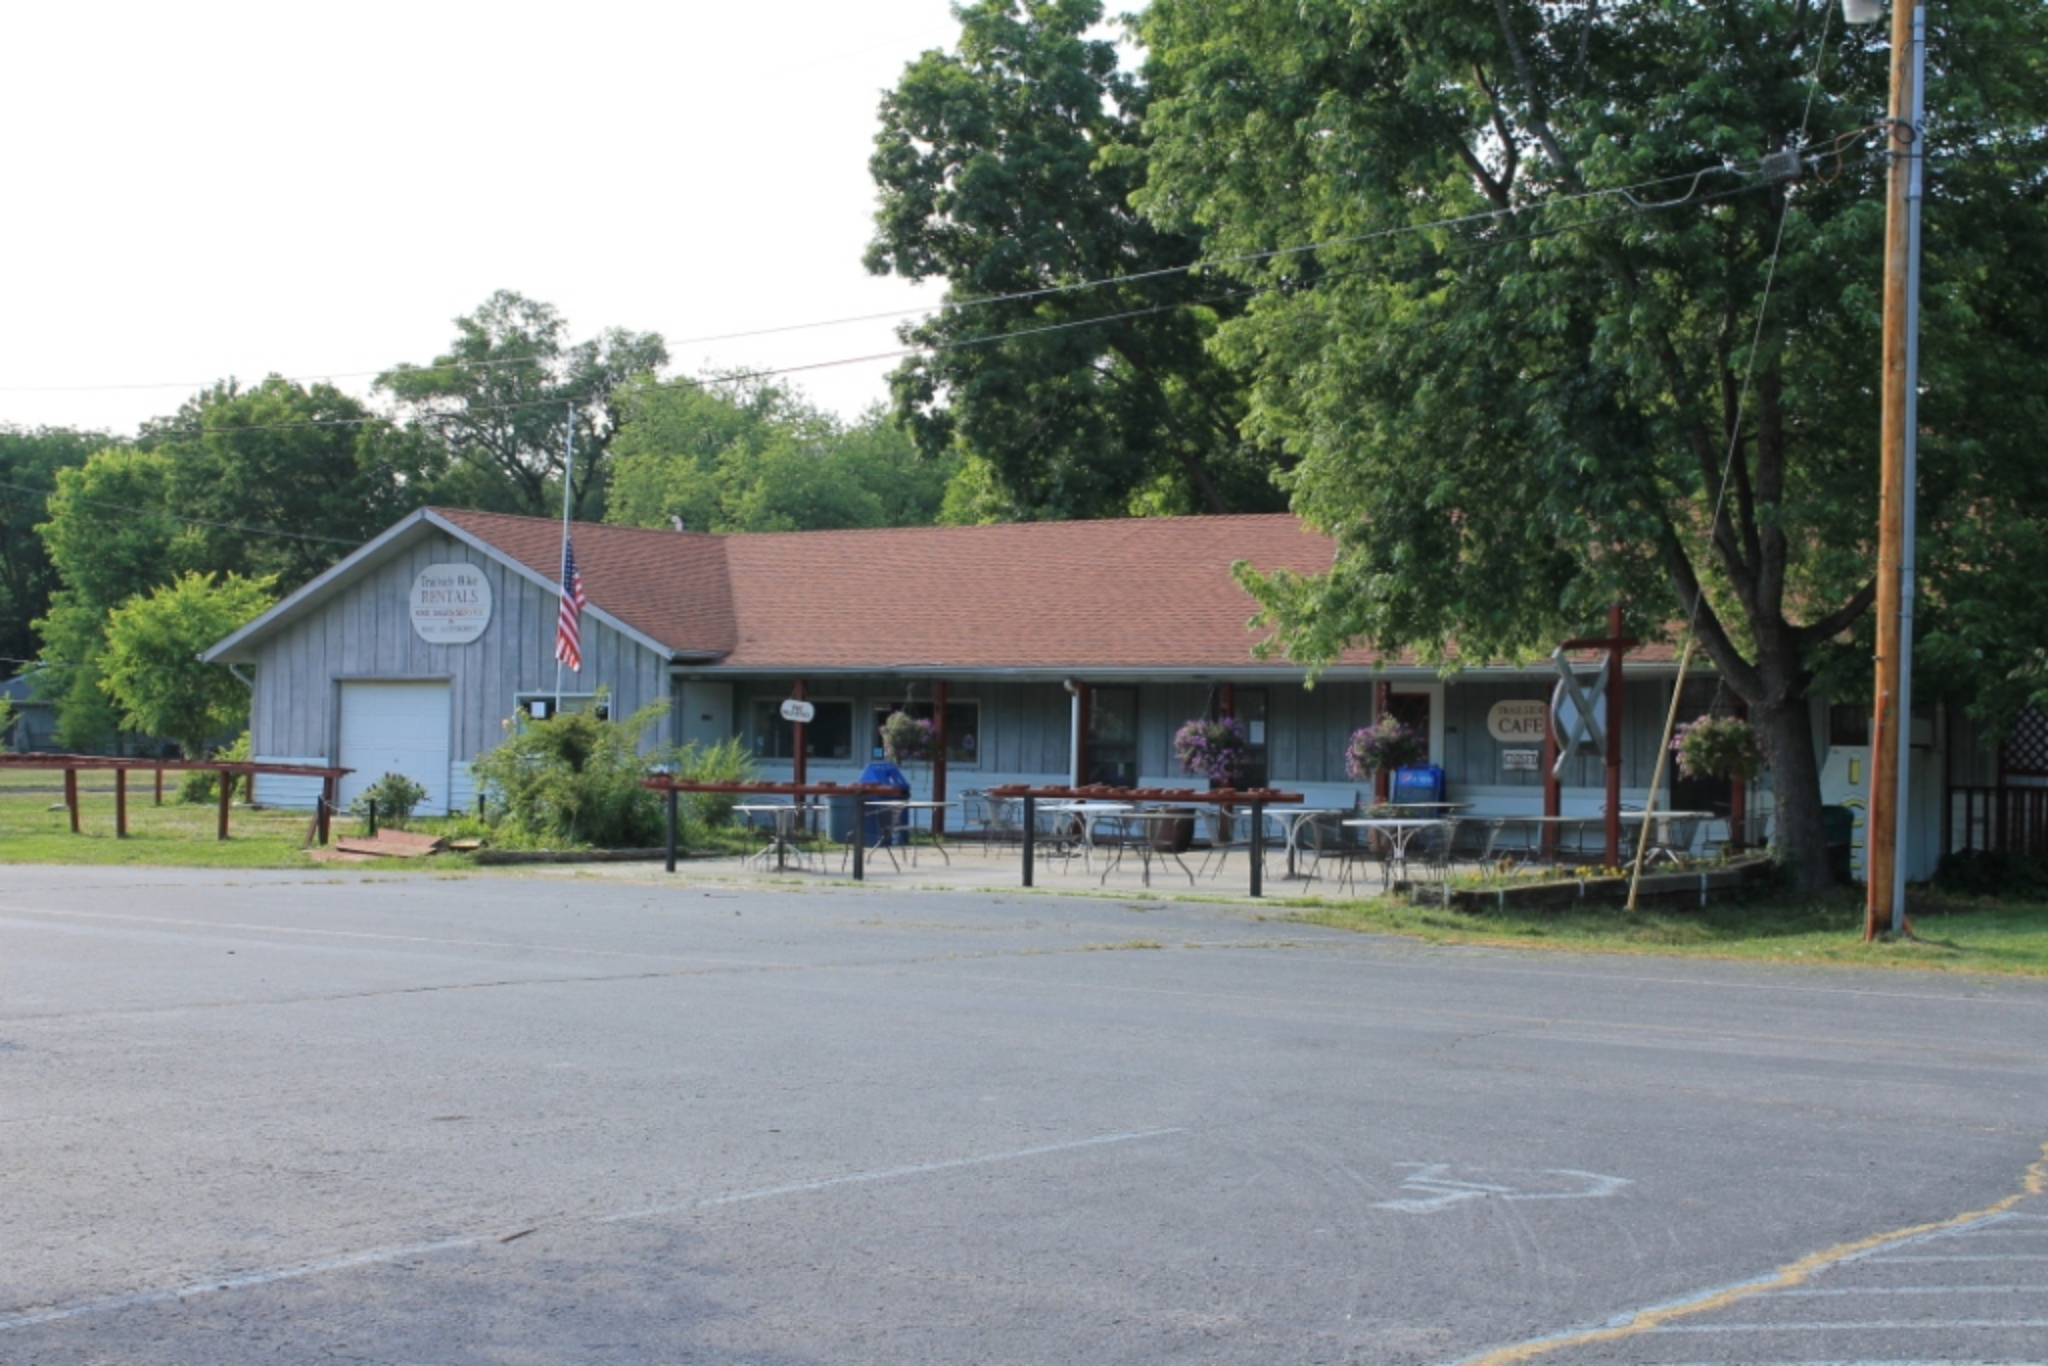
This cross gable roofed, one story, L-shaped building has two wings. The bottom portion of the walls are clad in clapboards and the top portion of the walls is clad in board and battens. The roof is covered in asphalt shingles. The west wing has a cross gable facing First Street. This wing contains a bicycle rental facility. The east wing of the building is to the right of the gable fronted wing. This wing contains a cafe. At the point where the two wings meets is an open porch that extends the length of the east wing. The building has ten bays. The leftmost bay contains an overhead door and the next bay contains a single pane stationary window. These bays are under the gable roofed wing. The next two bays, which are under the porch, each contain a fixed pane window. The next two bays, also under the porch, each contain one-over-one single hung windows. The next bay, also under the porch, contains a door with diagonal panes of glass in its upper portion. The two rightmost bays, also under the veranda, each contain a four-over-four single hung window.

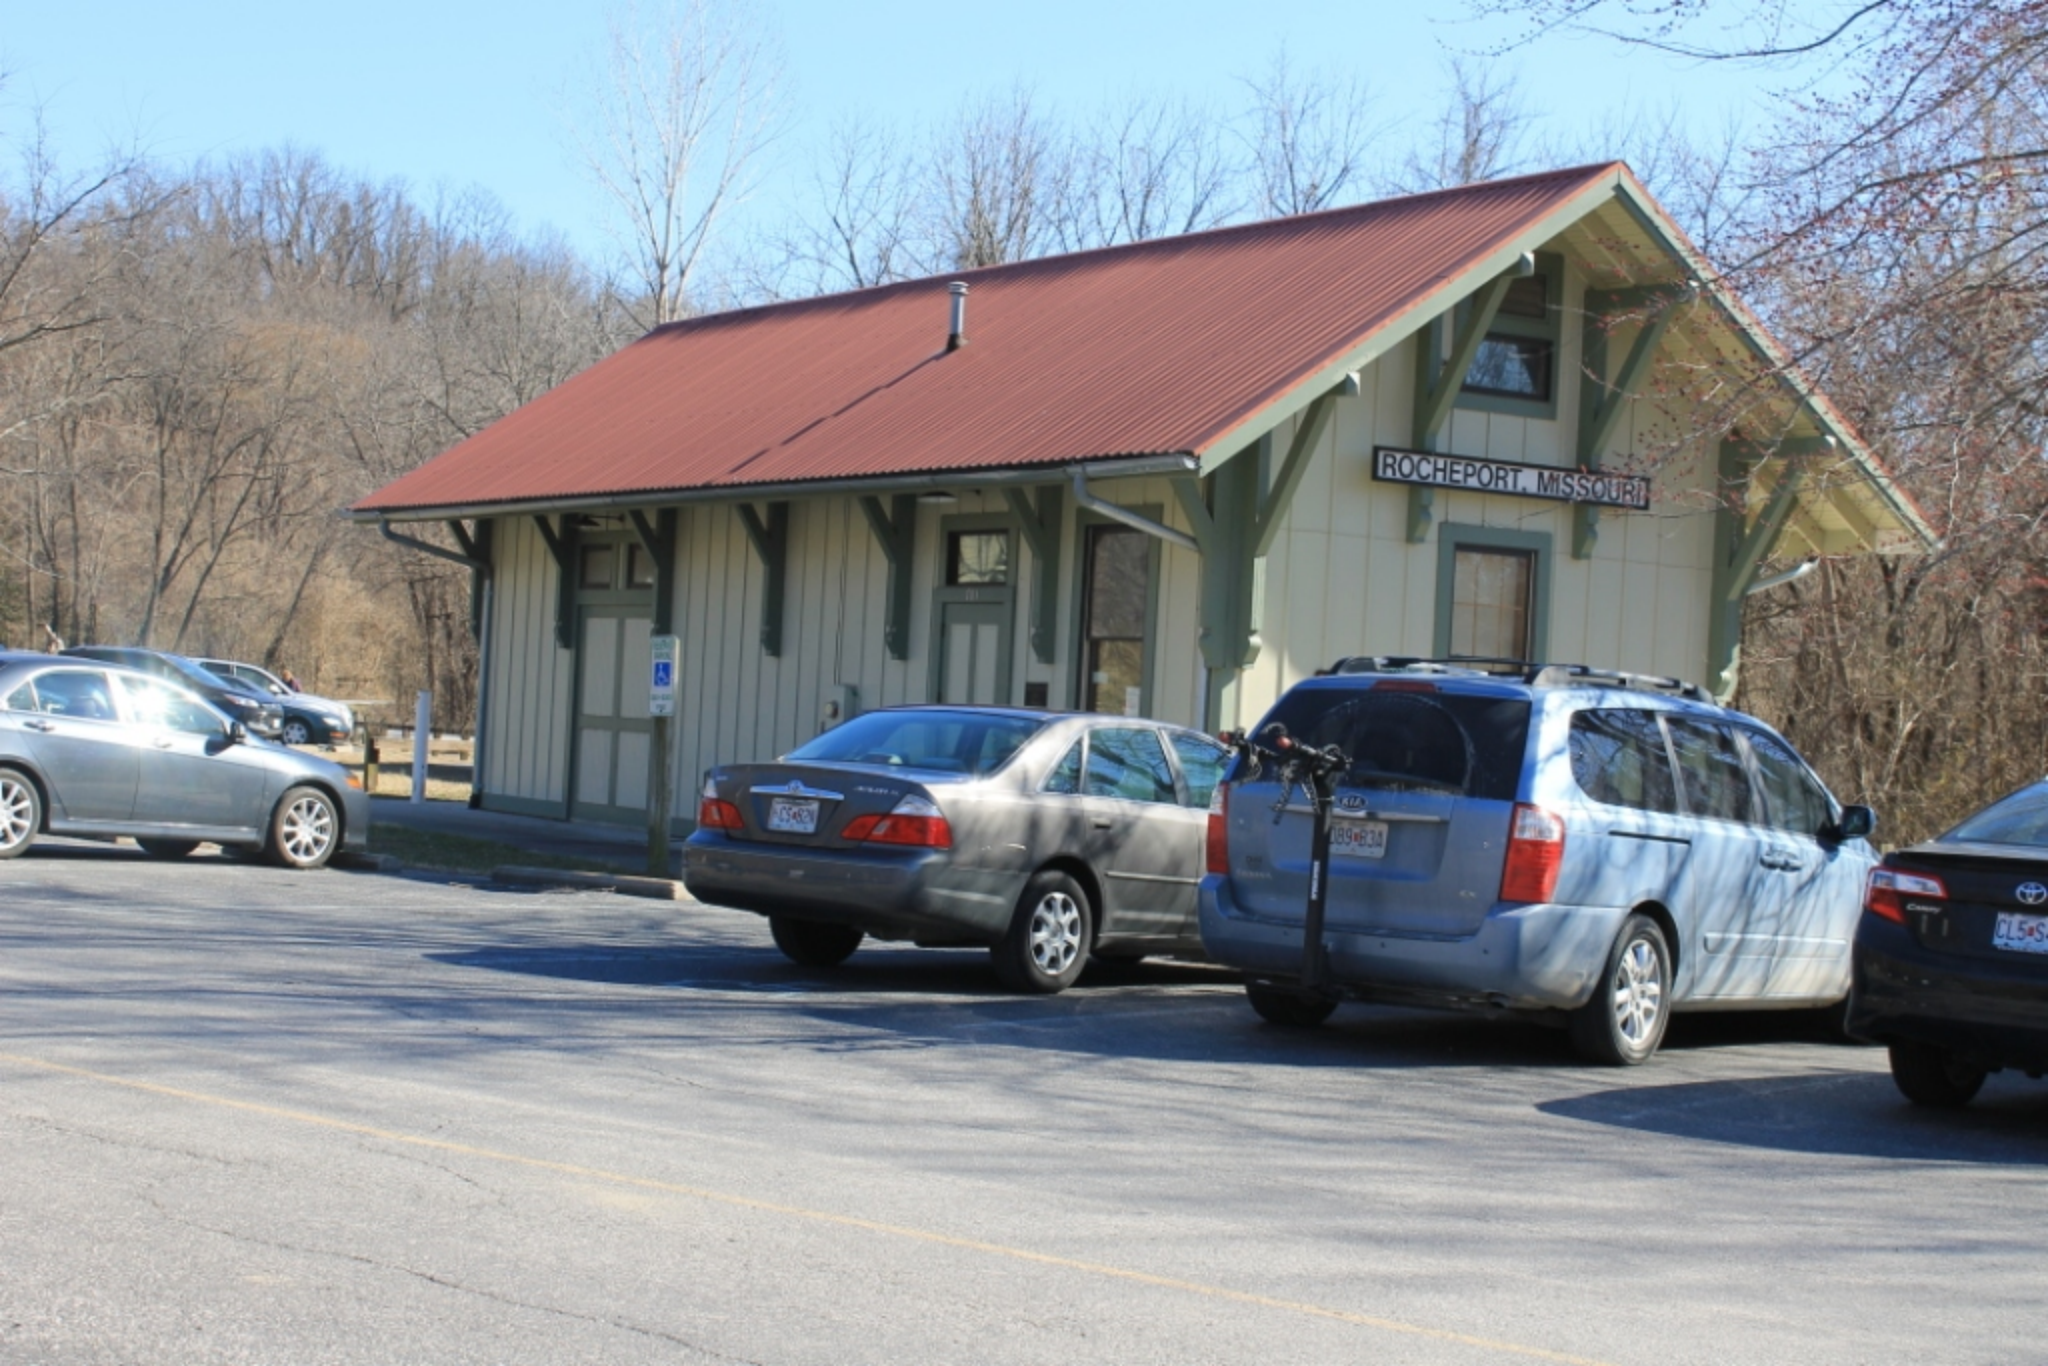
This rectangular shaped, one-story frame building is designed to resemble the original Missouri, Kansas, & Texas Railroad depot in Rocheport that was demolished in the 1950s by the M.K. & T. Railroad. This replica has board and batten siding and a medium gable roof supported by brackets and covered with asphalt shingles. The roof extends beyond the building to create a sheltered veranda on both the front and back. The front of the building has three bays. The left most bay contains a high placed pair of fixed pane windows. The next bay contains a wooden door with a single pane transom above it, and the right most bay contains a one-over-one single hung window.

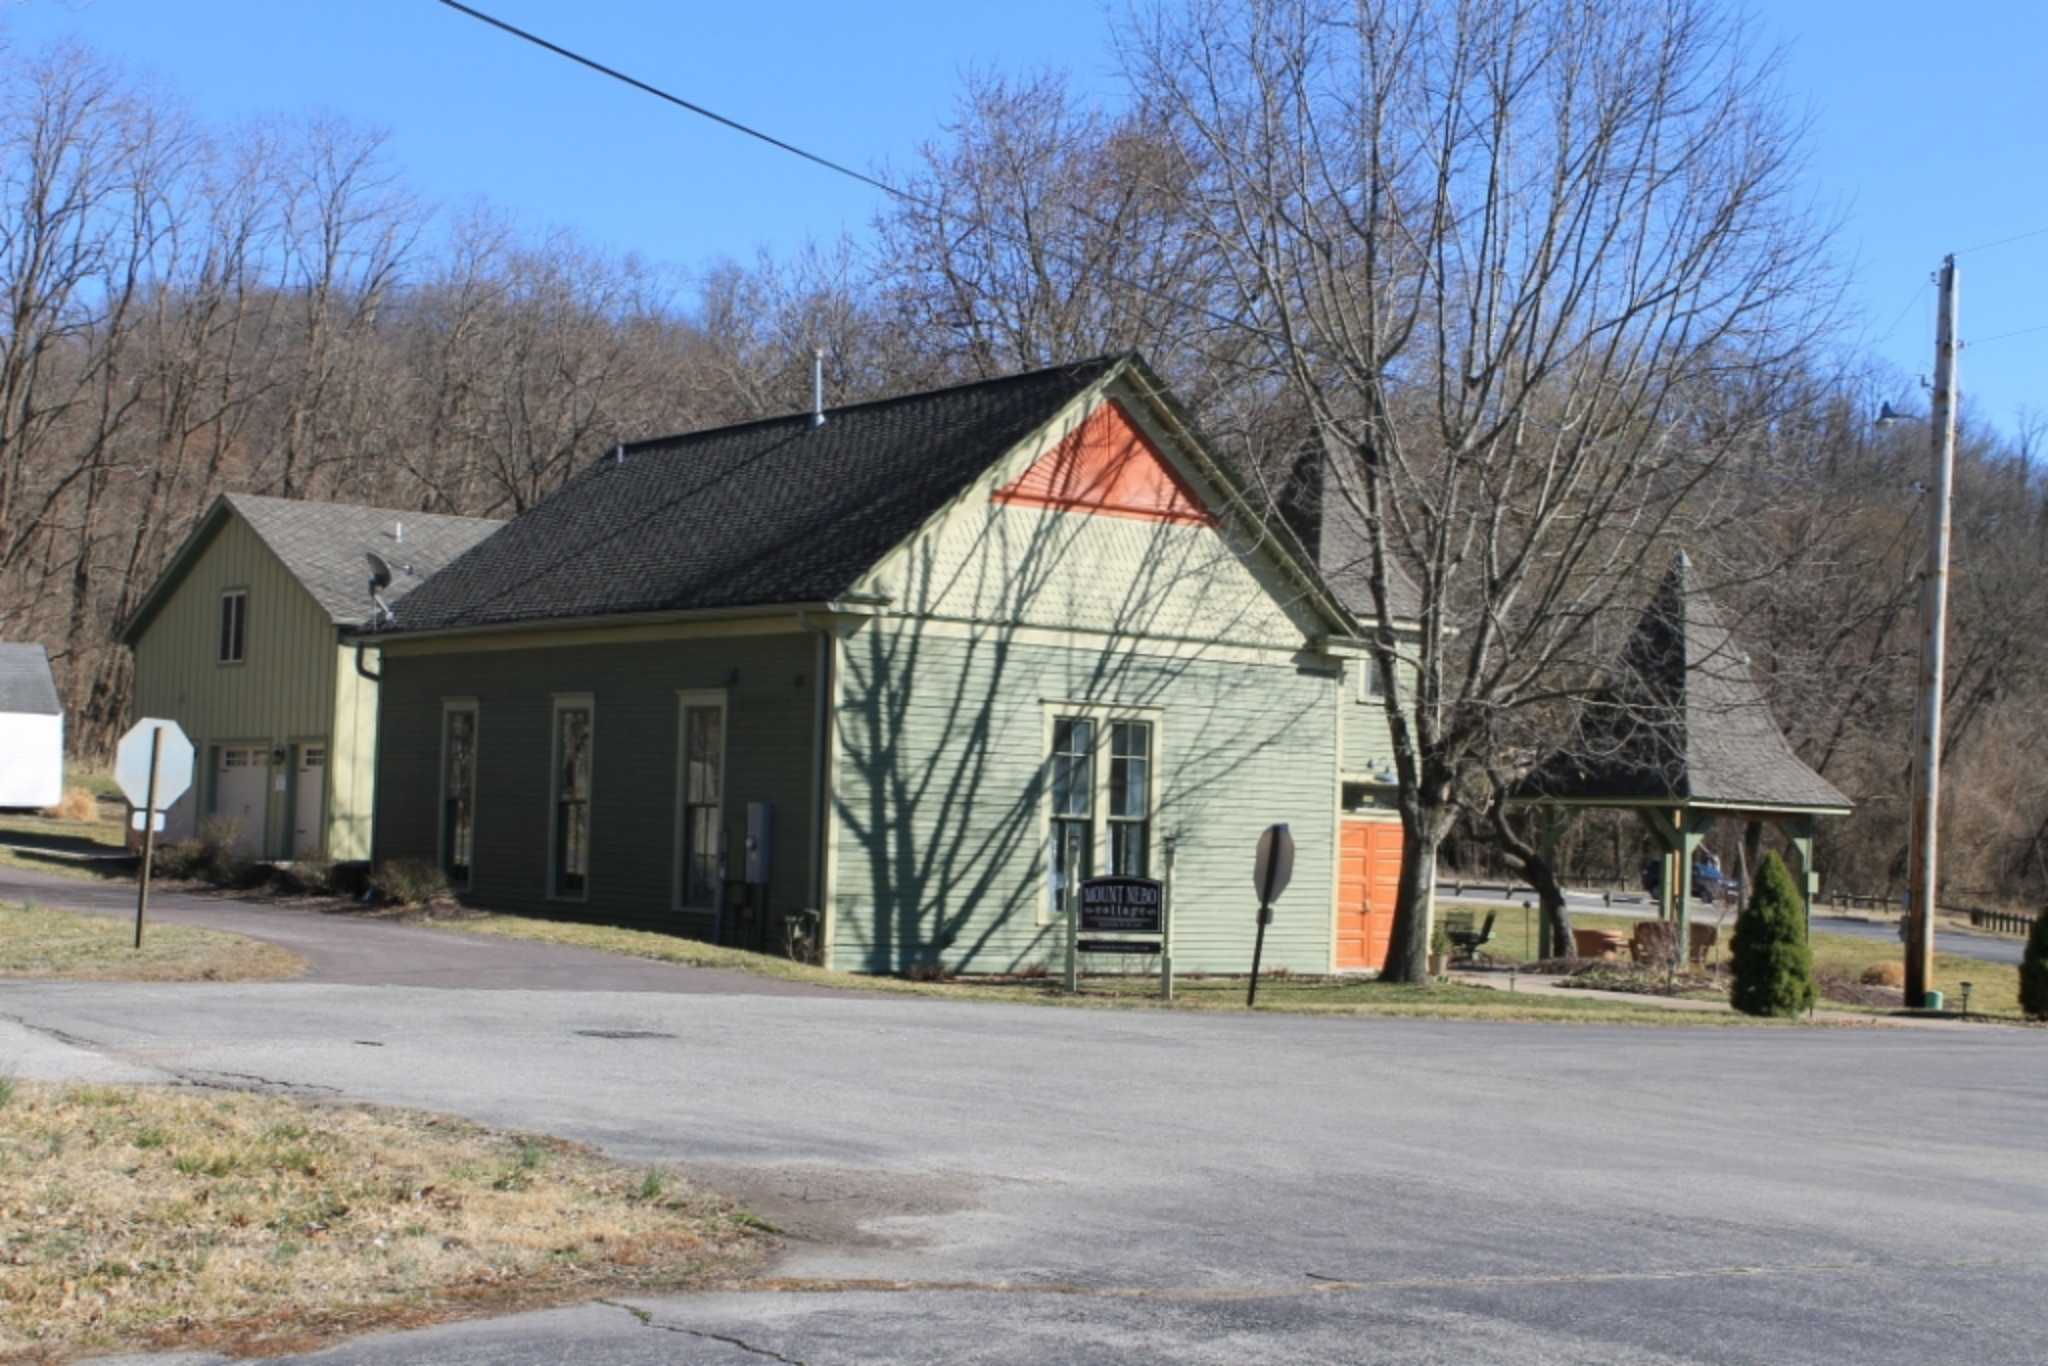
The Mt. Nebo Baptist Church is a one-story building in the front gable side steeple plan. The medium front gable roof has a pediment and gable returns. The pediment is clad in a pattern of seven rows of fishlap shingles and four rows of diamond shaped shingles beneath a sunburst motif at the peak. The building is clad in clapboards. The main block of the building has one bay on the front (west) facade; the bay contains a four-over-two wooden window. On the south side of the main block of the building is a square tower with a bell cast high hipped roof. The first story of the front facade of the tower has one bay containing two five paneled doors topped with a single fixed pane transom. Above the door is a bay containing a single fixed pane window. The north facade of the building has three bays, each containing a two-over-two wooden window.

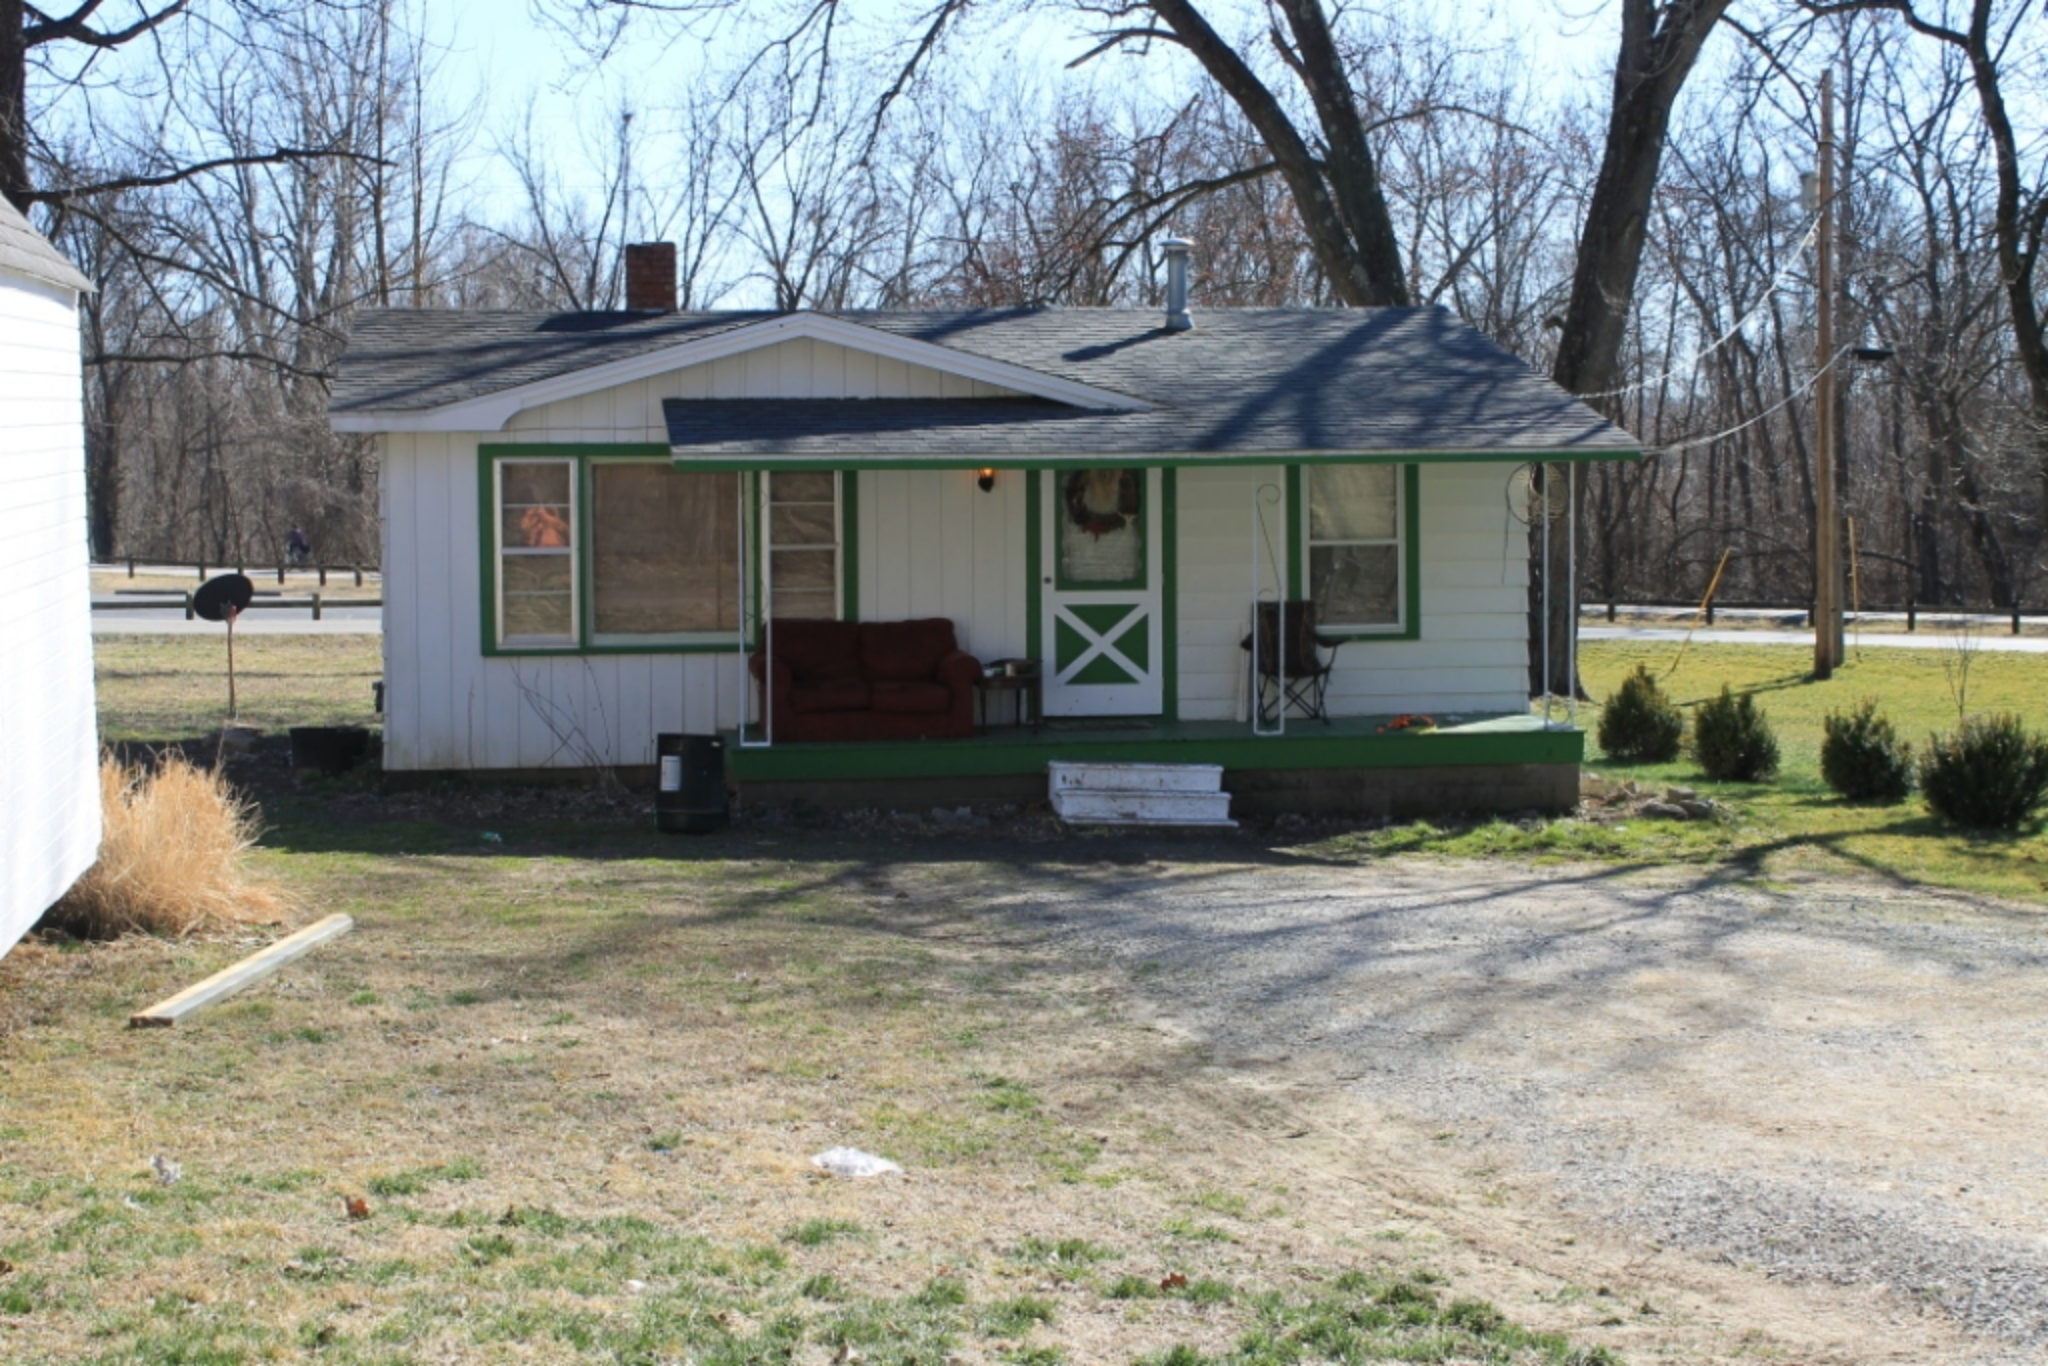
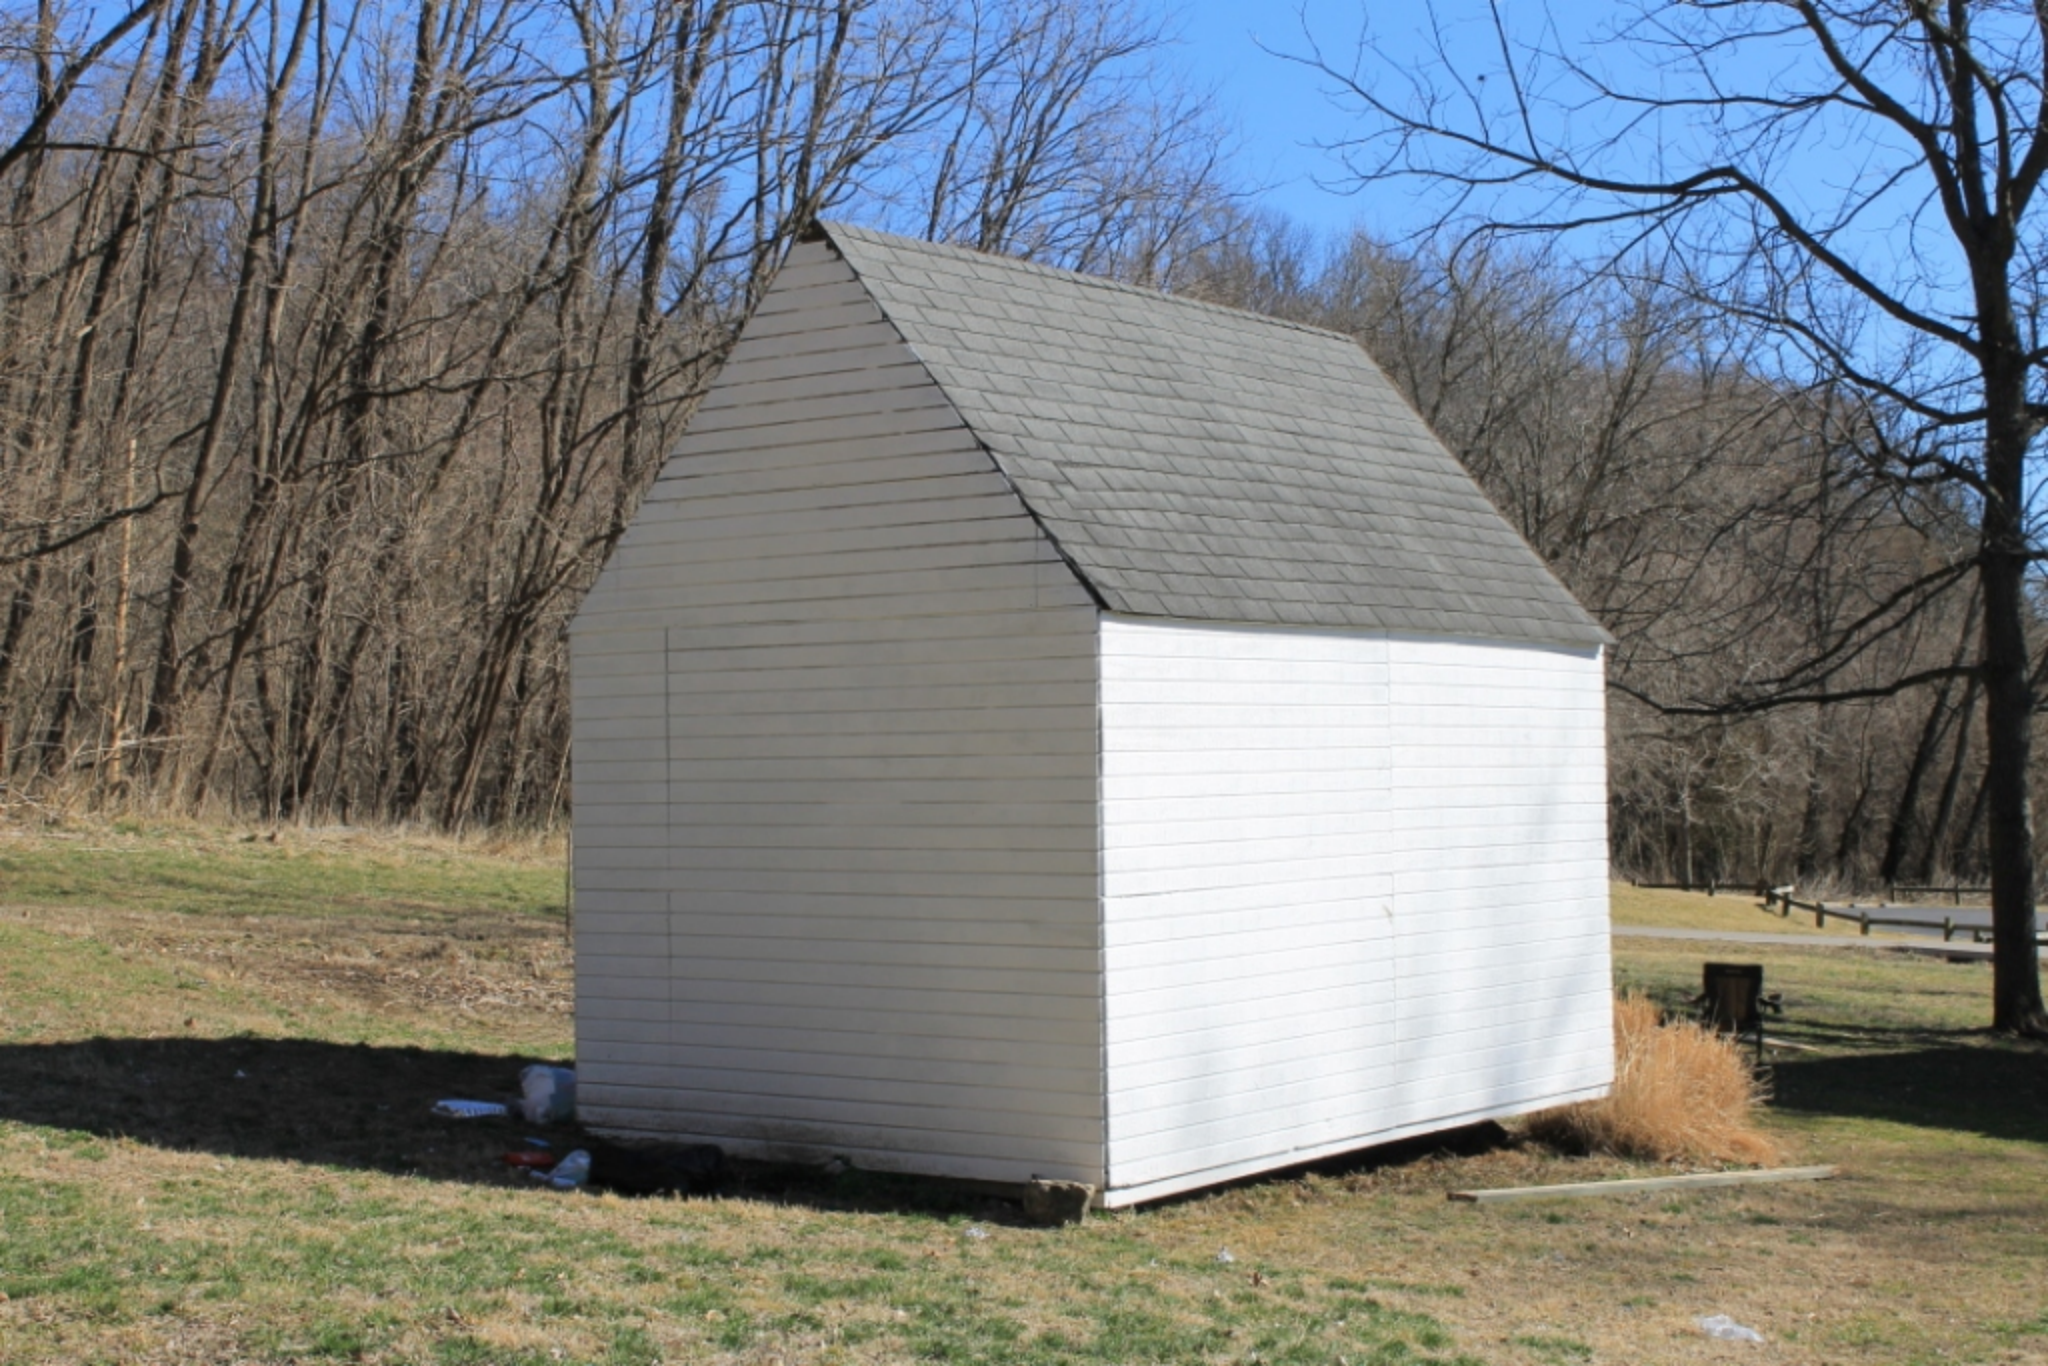
This small, one story, frame ranch house has an interesting roof configuration. The basic plan for the roof is a low pitched cross gable, but the roof of the house extends under the cross gable to form the roof of the open porch that extends across the remaining 2/3s of the front facade. The roof is covered in asphalt shingles. The front facade of the house has three bays. The center bay contains a door with a large fixed pane window covered with a modern storm door. The bay to the left of the center bay contains a fixed-pane picture window flanked on either side by one-over-one single hung windows. The bay to the right of the center bay contains a one-over-one single hung window. The house has two chimneys, a brick chimney on the rear slope of the left side of the house and a metal chimney on the front slope of the right side of the house.
