MISSOURI DEPARTMENT OF NATURAL RESOURCES
STATE HISTORIC PRESERVATION OFFICE, P.O. Box 176, Jefferson City, MO 65102
ARCHITECTURAL/HISTORIC INVENTORY FORM

1. SURVEY NO. BO-AS-009-0001		2. SURVEY NAME: Rocheport Historic District	
3. COUNTY: Boone		4. ADDRESS (STREET NO.)	STREET (NAME) Katy Trail
5. CITY: Rocheport	VICINITY: <input checked="" type="checkbox"/>	6. UTM: / /	LAT: LONG: T: 48W R: 15W S: 1

8. HISTORIC NAME (IF KNOWN): M.K.&T. Railroad tunnel		9. PRESENT/OTHER NAME (IF KNOWN): Katy trail tunnel	
10. OWNERSHIP: <input type="checkbox"/> PRIVATE <input checked="" type="checkbox"/> PUBLIC		11A. HISTORIC USE (IF KNOWN): railroad tunnel	11B. CURRENT USE: Katy Trail tunnel
HISTORICAL INFORMATION

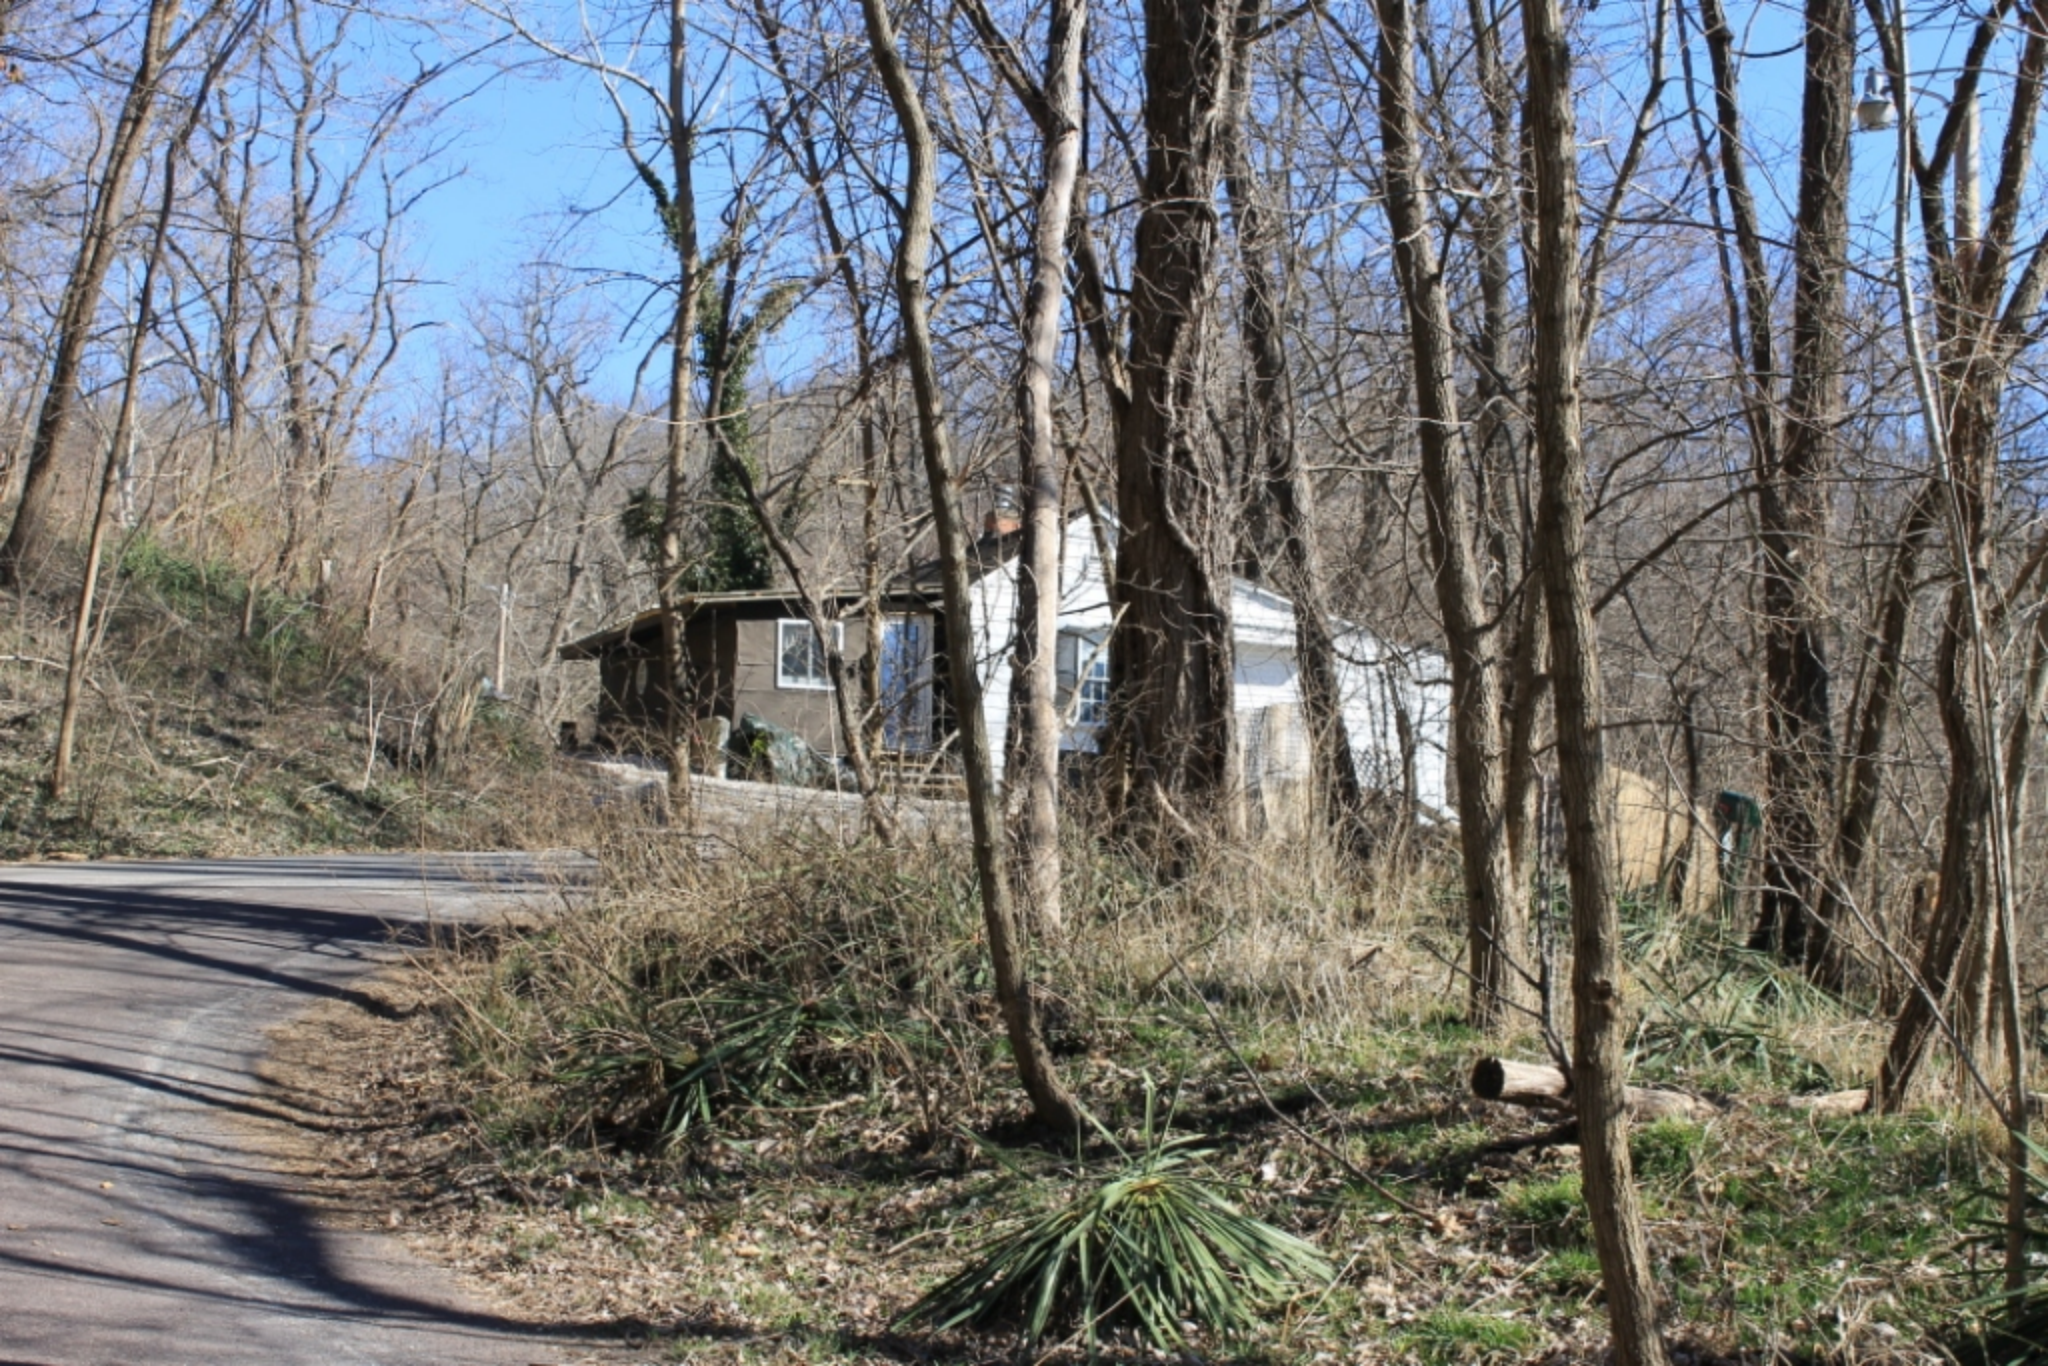
This one-story frame house has a saltbox roof on the main block of the house and a shed roof on an addition to the north of the main block of the house. The shed roofed addition is covered with tar paper. A part of the main block of the house is covered in wide clapboards; the southmost portion is covered with narrower clapboards. The west facade has three bays. The left bay is in the shed roofed addition. It contains a two pane sliding glass window. The center bay is also in the shed roofed addition. This bay contains a metal and glass door that opens onto a set of wooden steps. The third bay on the west facade is in the main block of the house. This bay contains a six-over-six single hung window. This window is accented with shutters. A chimney rises from the center ridge of the roof.

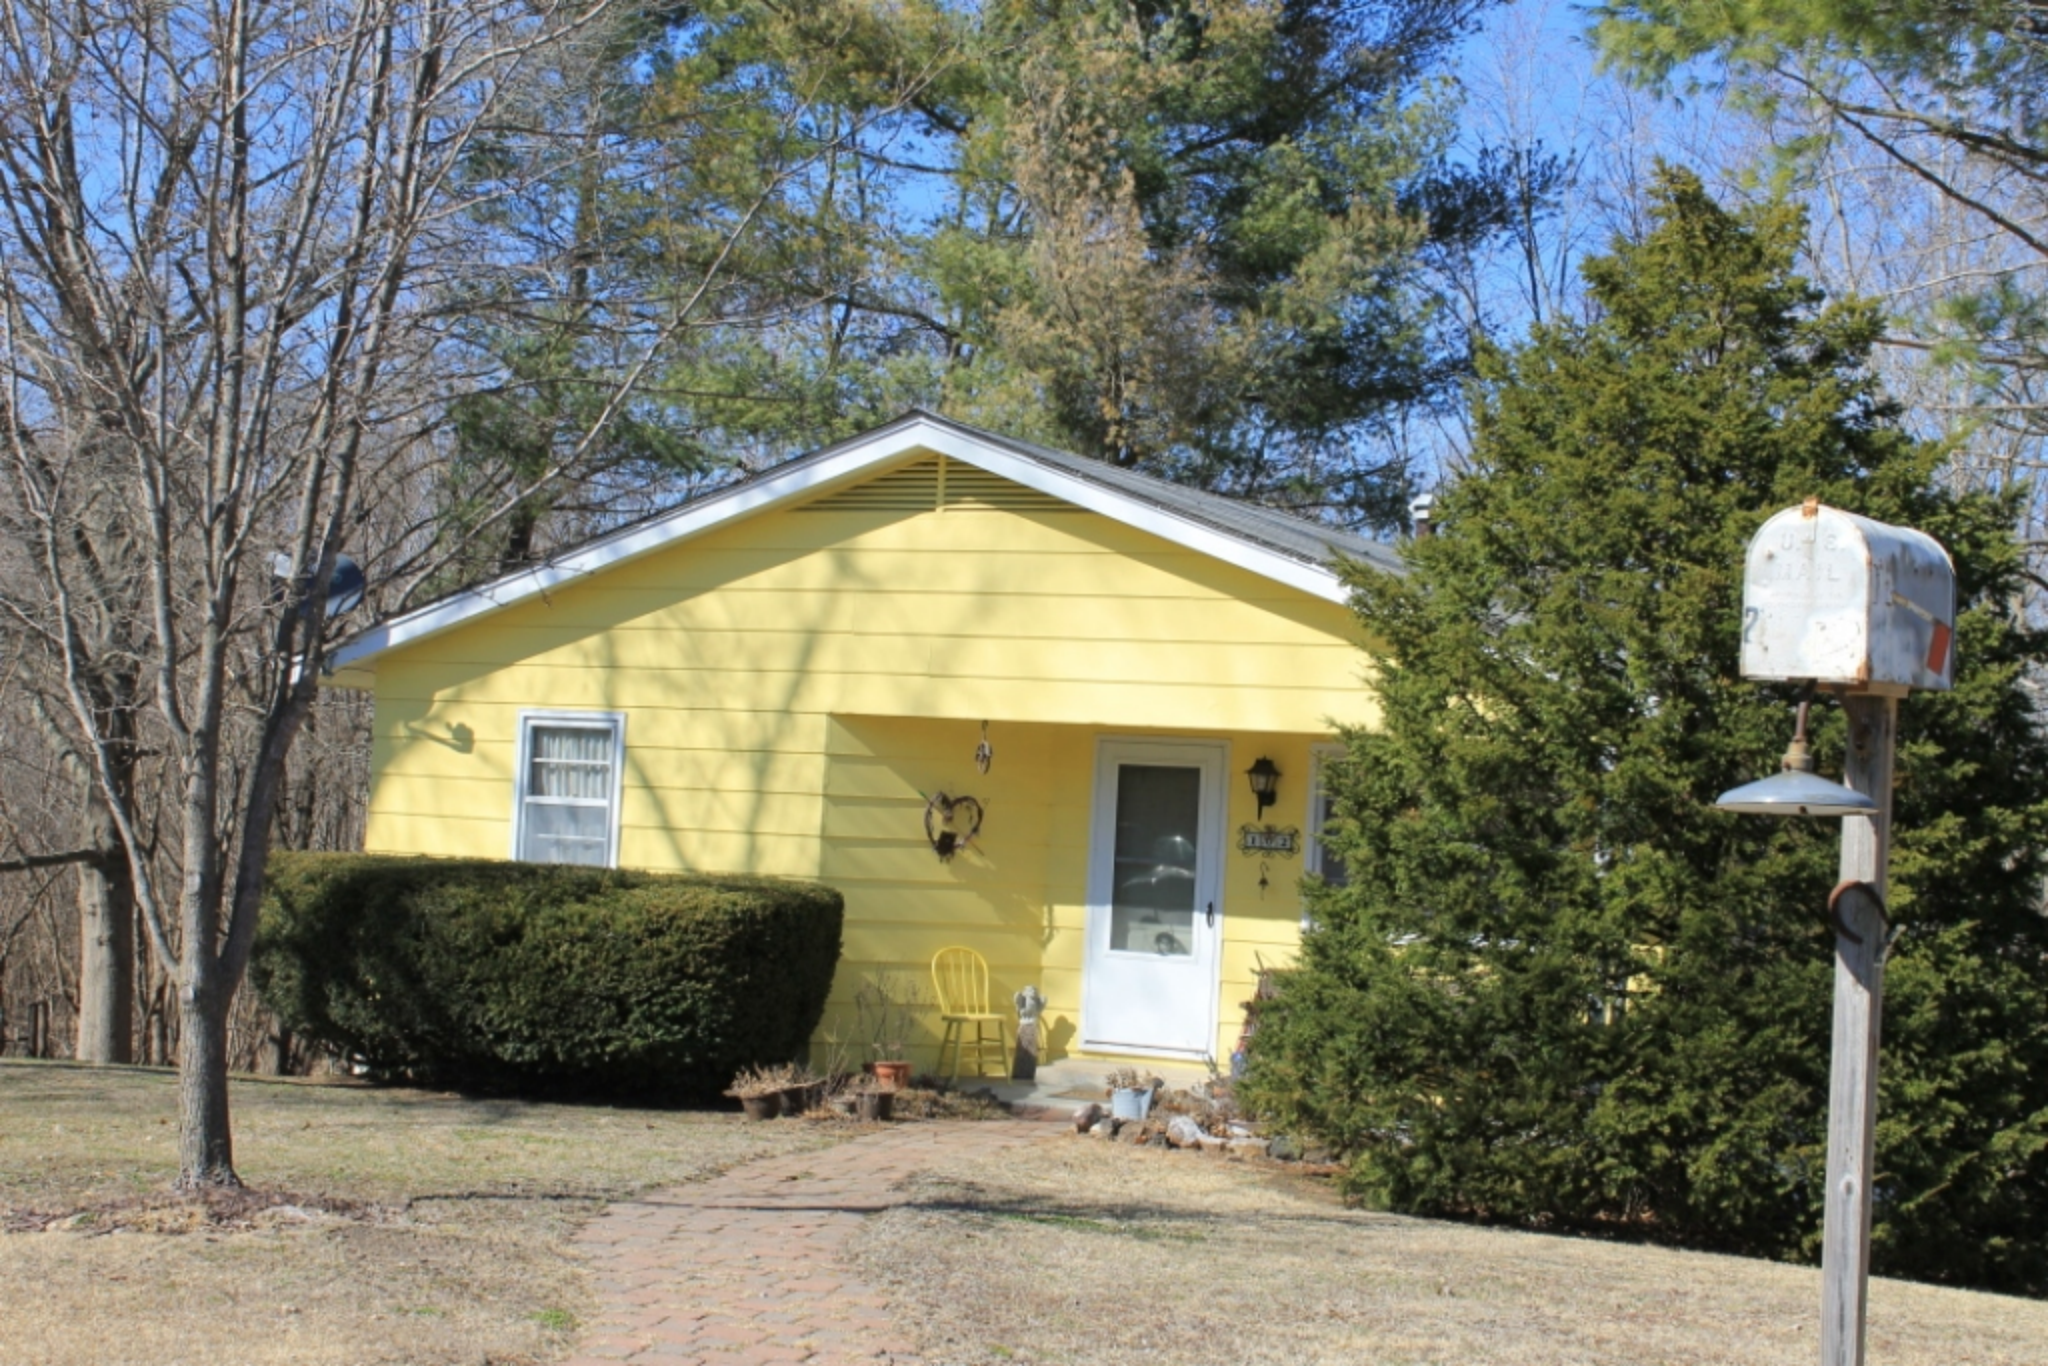
This one-story, massed plan, frame ranch house has a low front gable roof and an inset porch on the east half of the front facade. The house sits on a raised basement that is visible on the east facade. The walls are clad in clapboards and the roof is covered with asphalt shingles. The roof of the building overhangs the west portion of the front facade and an inset porch on the east portion of the the front facade. The front facade has three bays. The left bay contains a two horizontal-over-two horizontal single hung window. The center bay, which is under the porch, contains a door with a modern metal and glass storm door. The right bay, which is also under the porch, contains a pair of two horizotal-over-two horizontal windows.

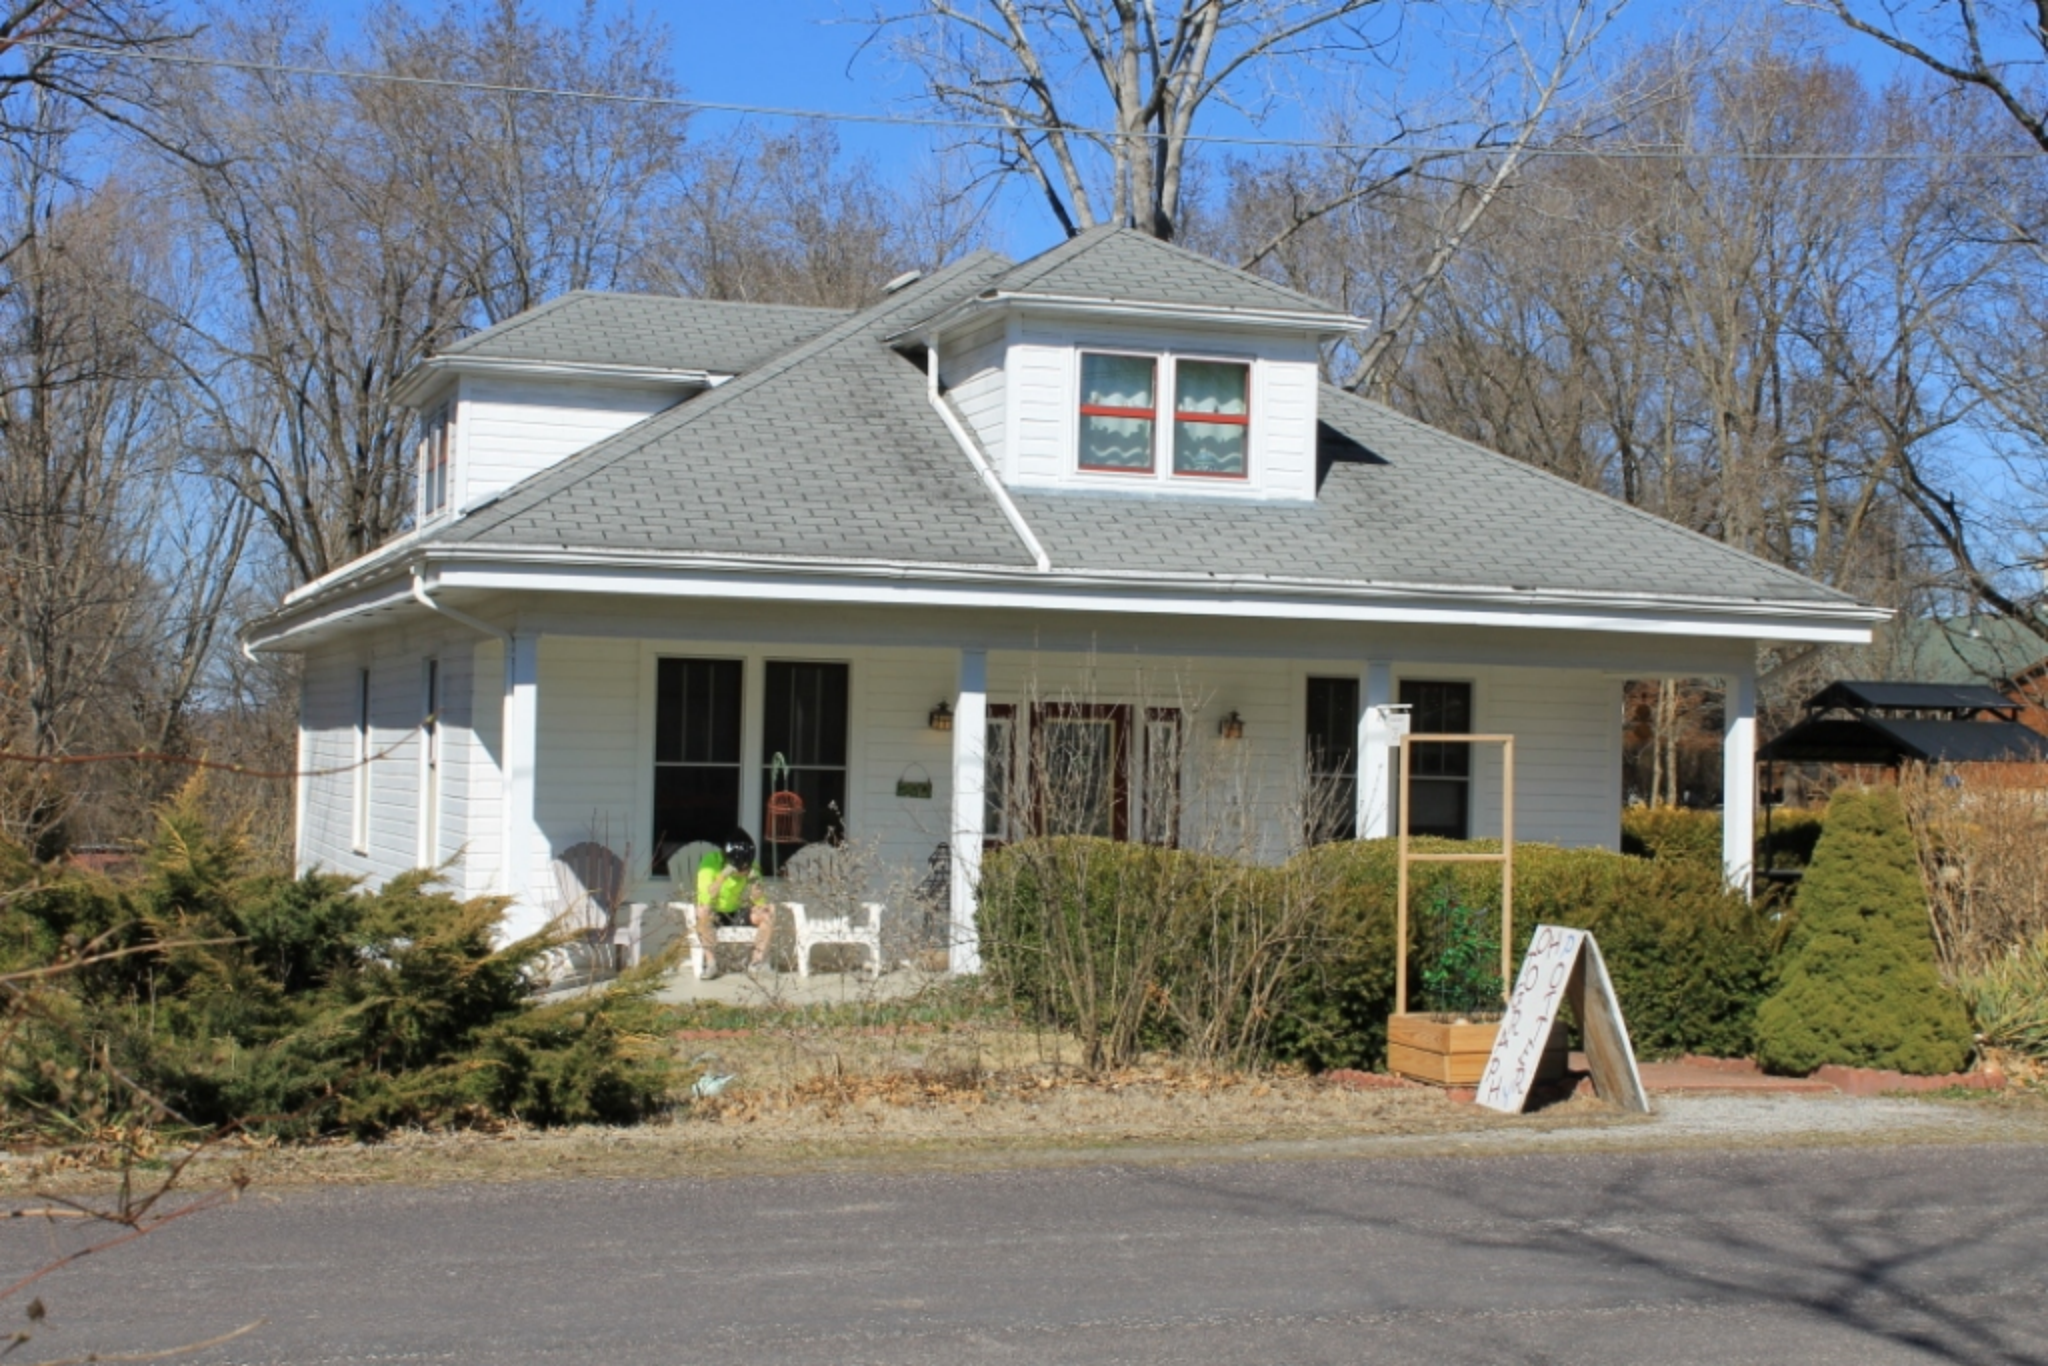
This 1 1/2 story frame house is clad in vinyl siding the same size as the original clapboards and the roof is asphalt shingles. The house has three bays on the front (south) facade. The left bay contains a pair of three vertical panes-over-one-pane single hung windows. The center bay contains a modern door with sidelights. The right bay contains a pair of three vertical panes-over-one single hung windows. The hipped roof is marked by hipped roofed dormers on the south, east, and west sides. Each dormer has one bay containing a pair of one-over-one single hung windows. An open porch extends across the front facade of the building; the roof of the house provides the roof of the porch.

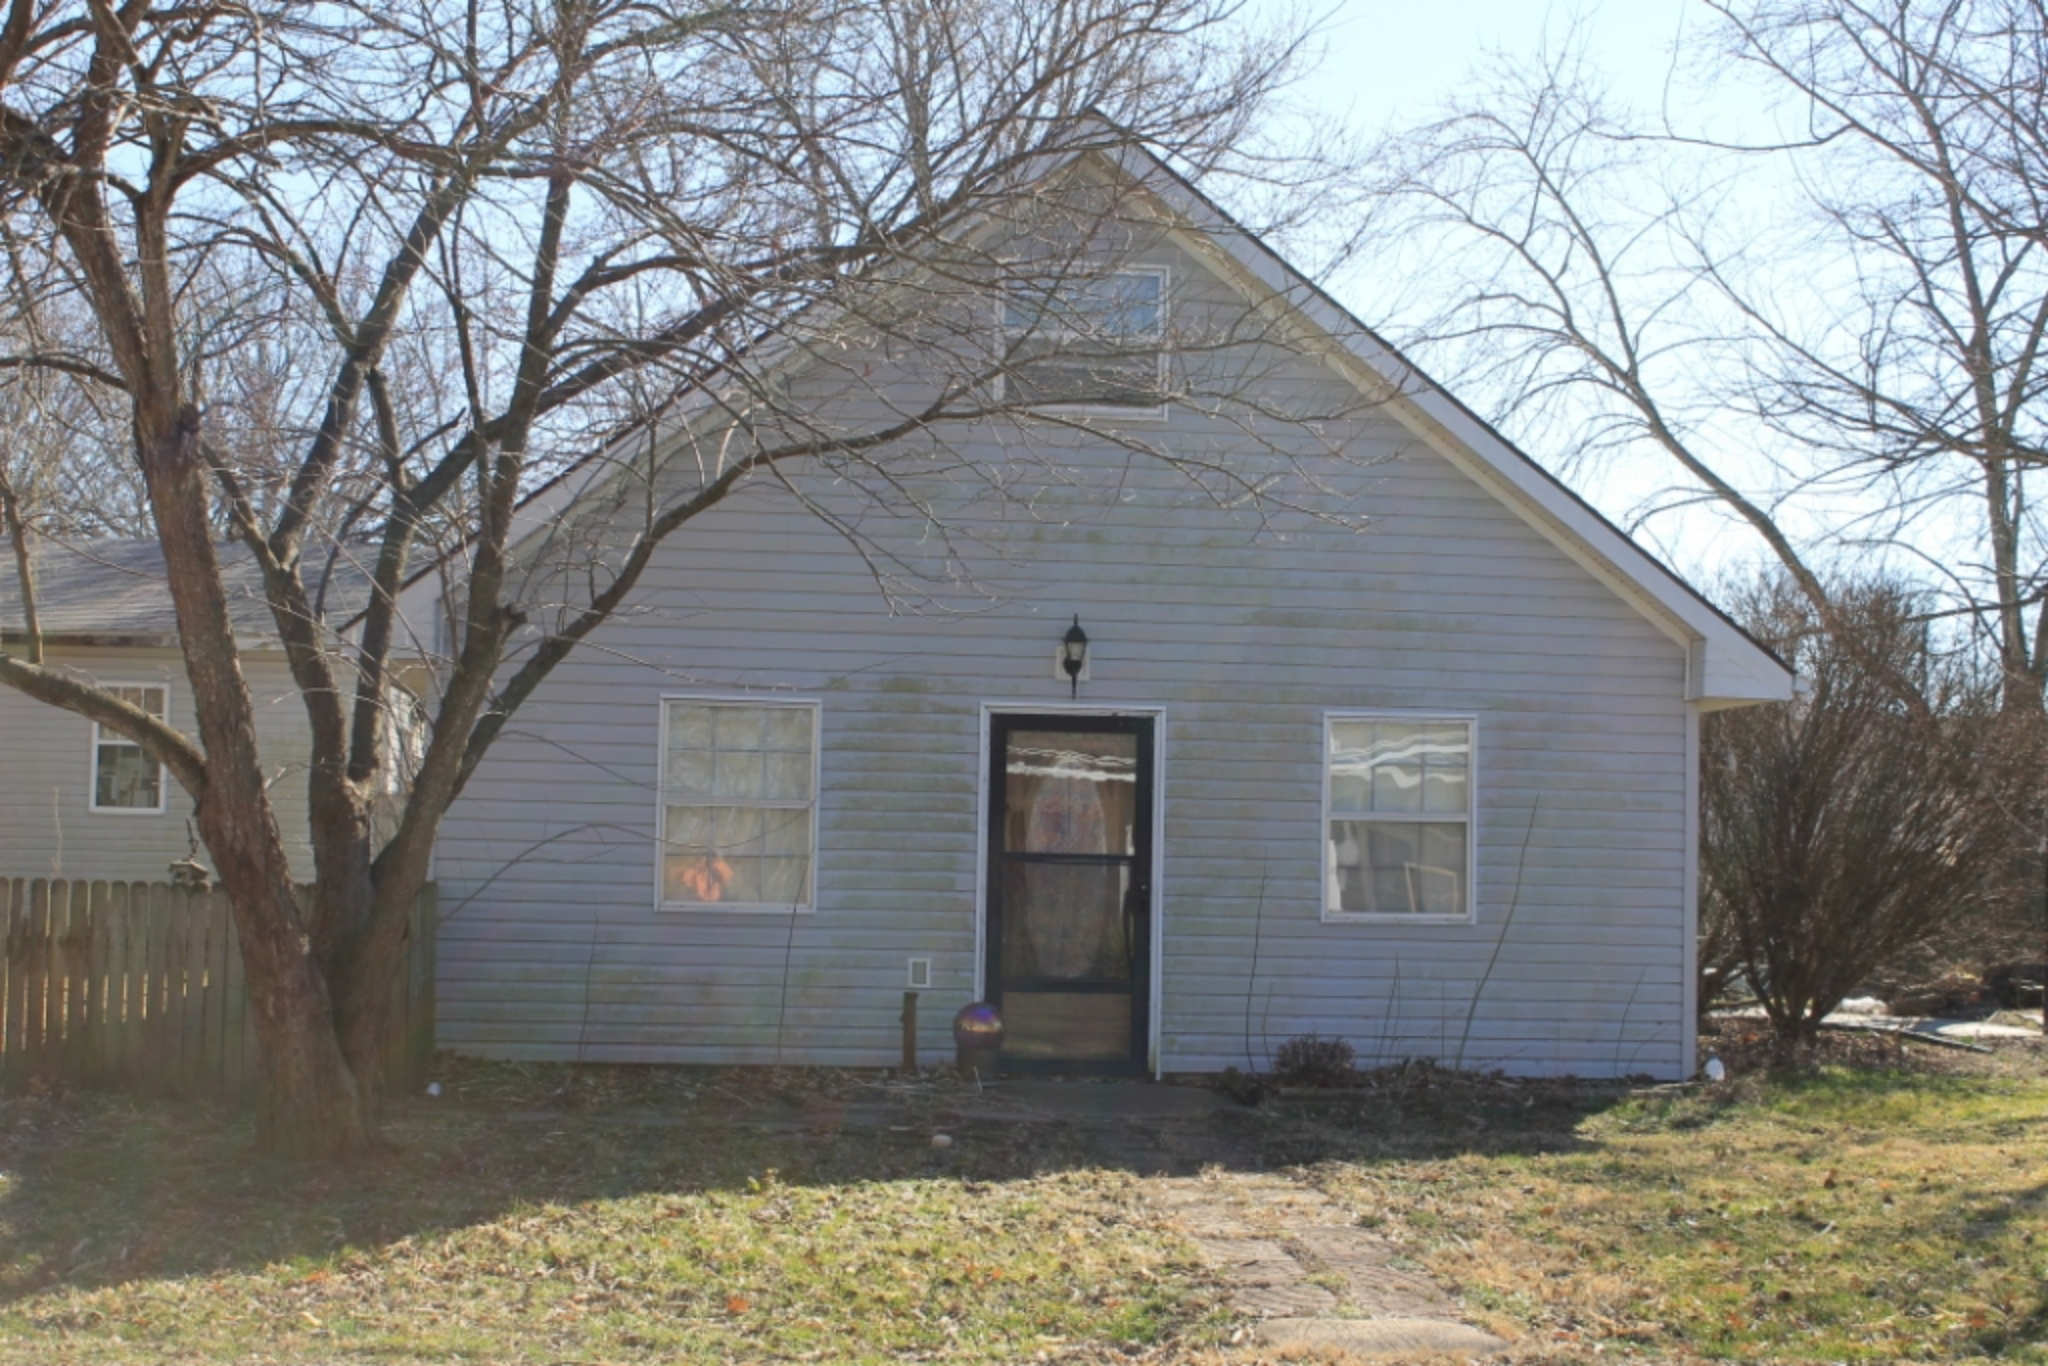
This high front gabled, 1 1/2 story, frame building sits on a concrete foundation. The exterior walls are clad in vinyl siding. The front facade of the building has three bays. The left bay contains a six-over-six vinyl window. The center bay contains a modern door with an oval shaped leaded glass panel and a modern glass and metal storm door. The right bay contains a six-over-six vinyl single hung windows. Above the door on the upper story under the gable roof is a one-over-one vinyl single hung window.

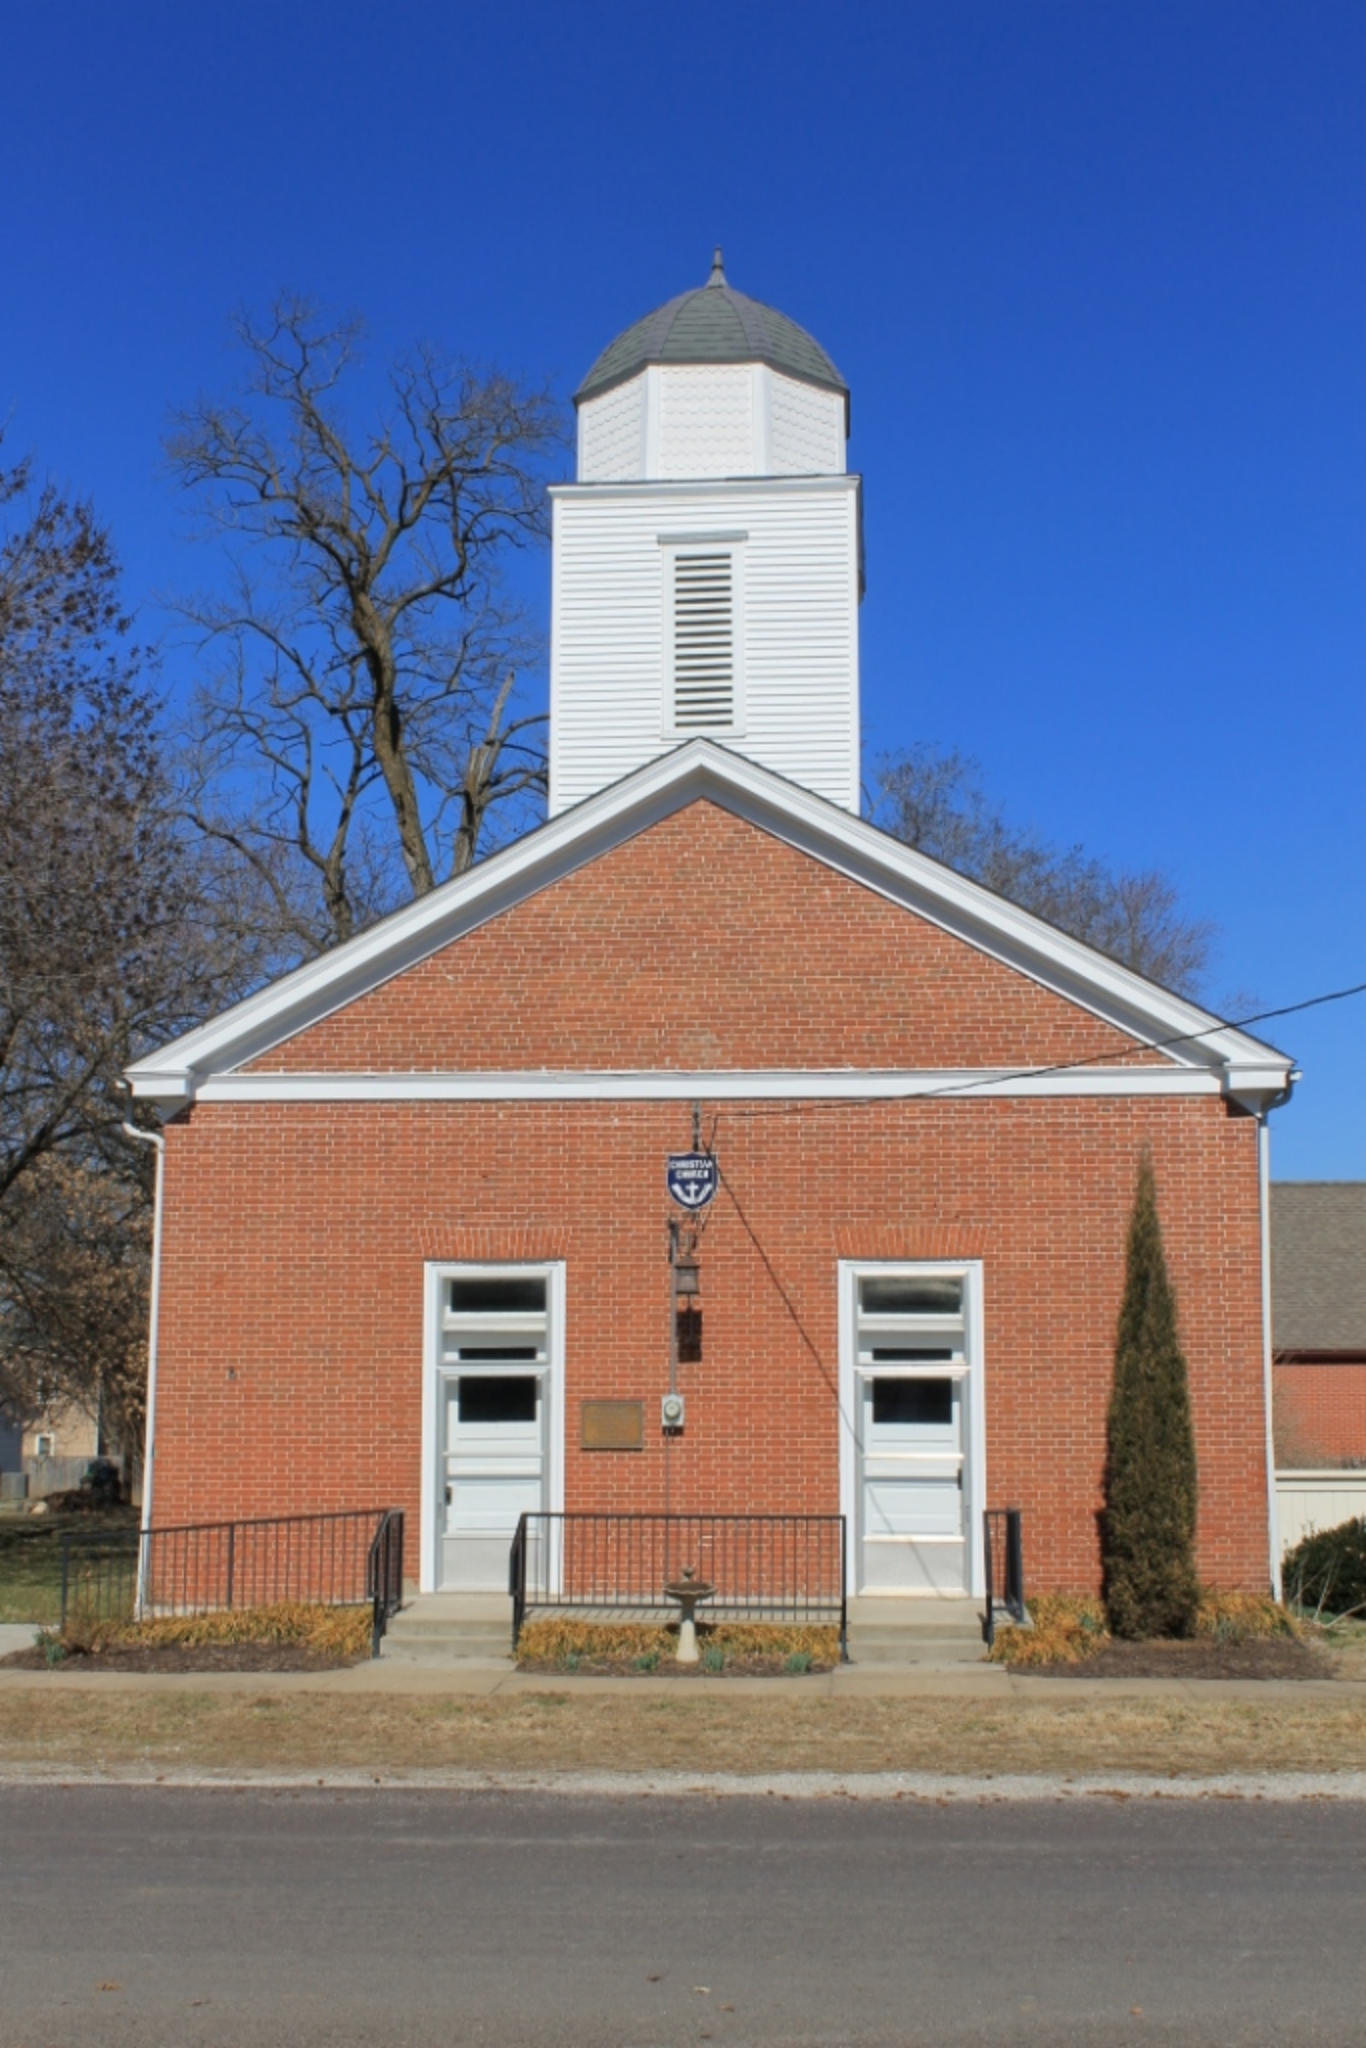
The Rocheport Church is a one-story, brick front gable plan or form building with a high pedimented gable roof. The building shows some Greek Revival influence. The gable has gable returns and a simple wooden cornice. The bricks on the front (south) facade of the building are laid in Flemish bond; the bricks on the other facades are laid in common bond. The roof is covered in asphalt shingles. The building measures 35 feet by 50 feet. The front (south) facade has a pedimented gable with a narrow cornice. The front facade has two bays, each containing a wooden door with a single window in the top of the door and a transom over the door. The doors are presently covered with metal and glass storm doors. Each door opens onto a stoop. The spire was altered in 1880, and now is a square clapboard spire with louvered panels in each side. Above the square spire is an octagonal extension topped with a rounded roof and finial. The side (west) facade of the building has four bays, each containing a pointed arch window set into a rectangular opening.

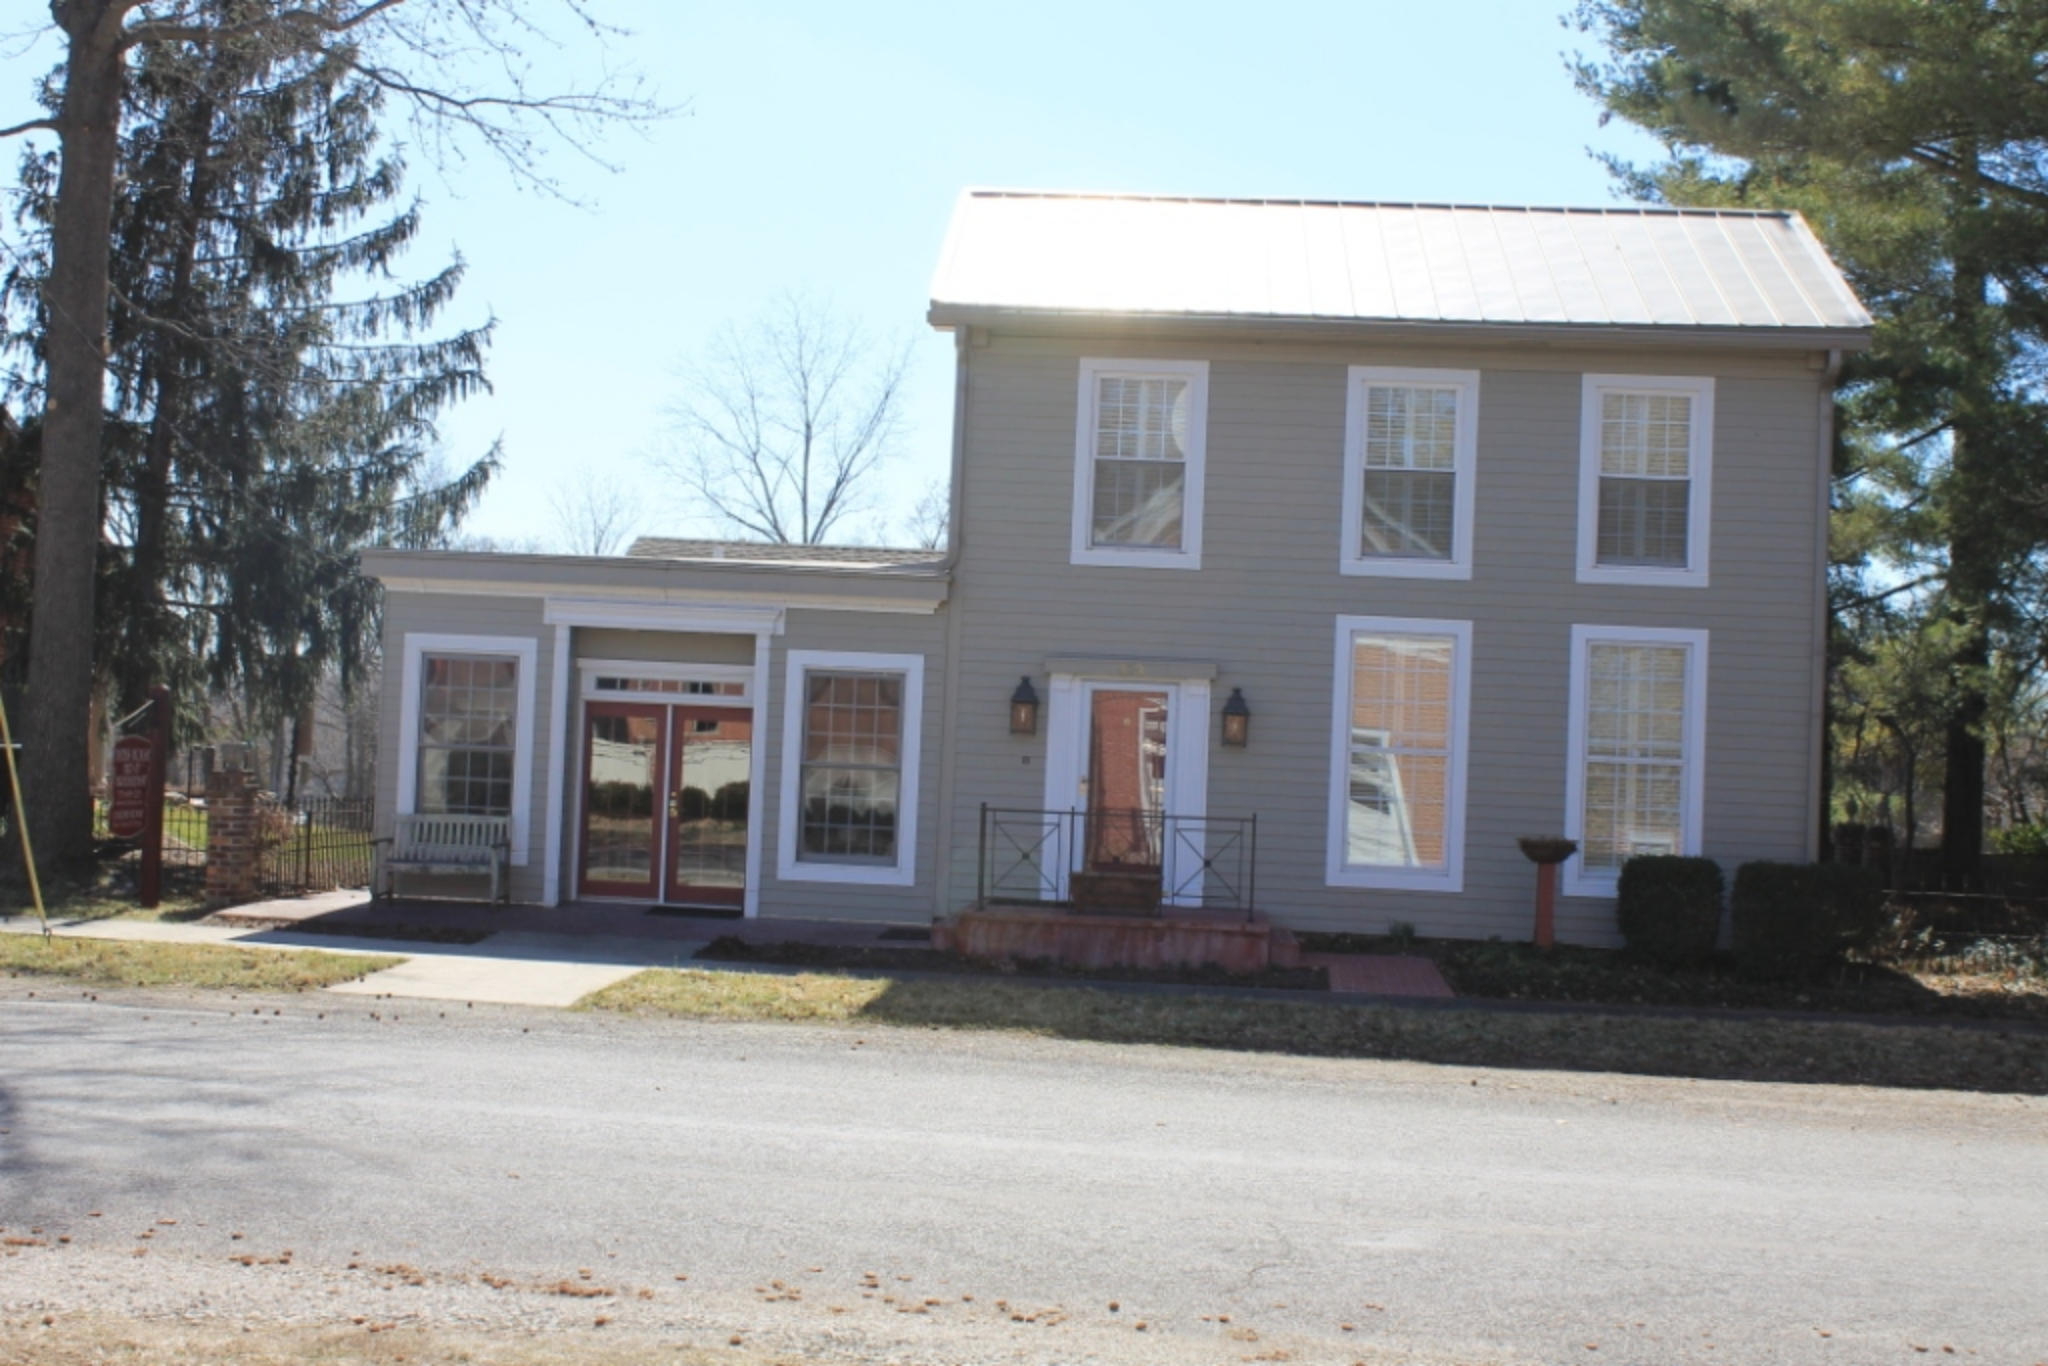
This building has three wings, the original two-story main block of the house, a one-story wing to the rear of the two story wing with an intersecting gable roof, and a modern addition on the east end of the main block of the house with a flat roof. The main block of the house is a two story, frame building with a low gable metal roof. According to a 1973 photo of the building submitted with the original Rocheport Historic District survey, the gables on the east and west of the main block of the house have gable returns. A one-story, flat roofed addition to the east end of the building was made in 1975. The first story of the front (north) facade has six bays. The left bay, which is in the 1975 addition, contains a nine-over-nine wooden window. The next bay, also in the 1975 addition, contains a double door topped with a seven pane transom and surrounded by a door surround. The next bay, also in the 1975 addition, contains a nine-over-nine wooden window. The next bay is in the original building and contains a modern glass door with a door surround consisting of pilasters topped with a prominent lintel. The two rightmost bays each contain nine-over-nine wooden single hung windows. On the second story of the original building are three bays. Each bay contains a six-over-six wooden window. The building has a tall brick chimney in the center ridge of the one-story rear wing.

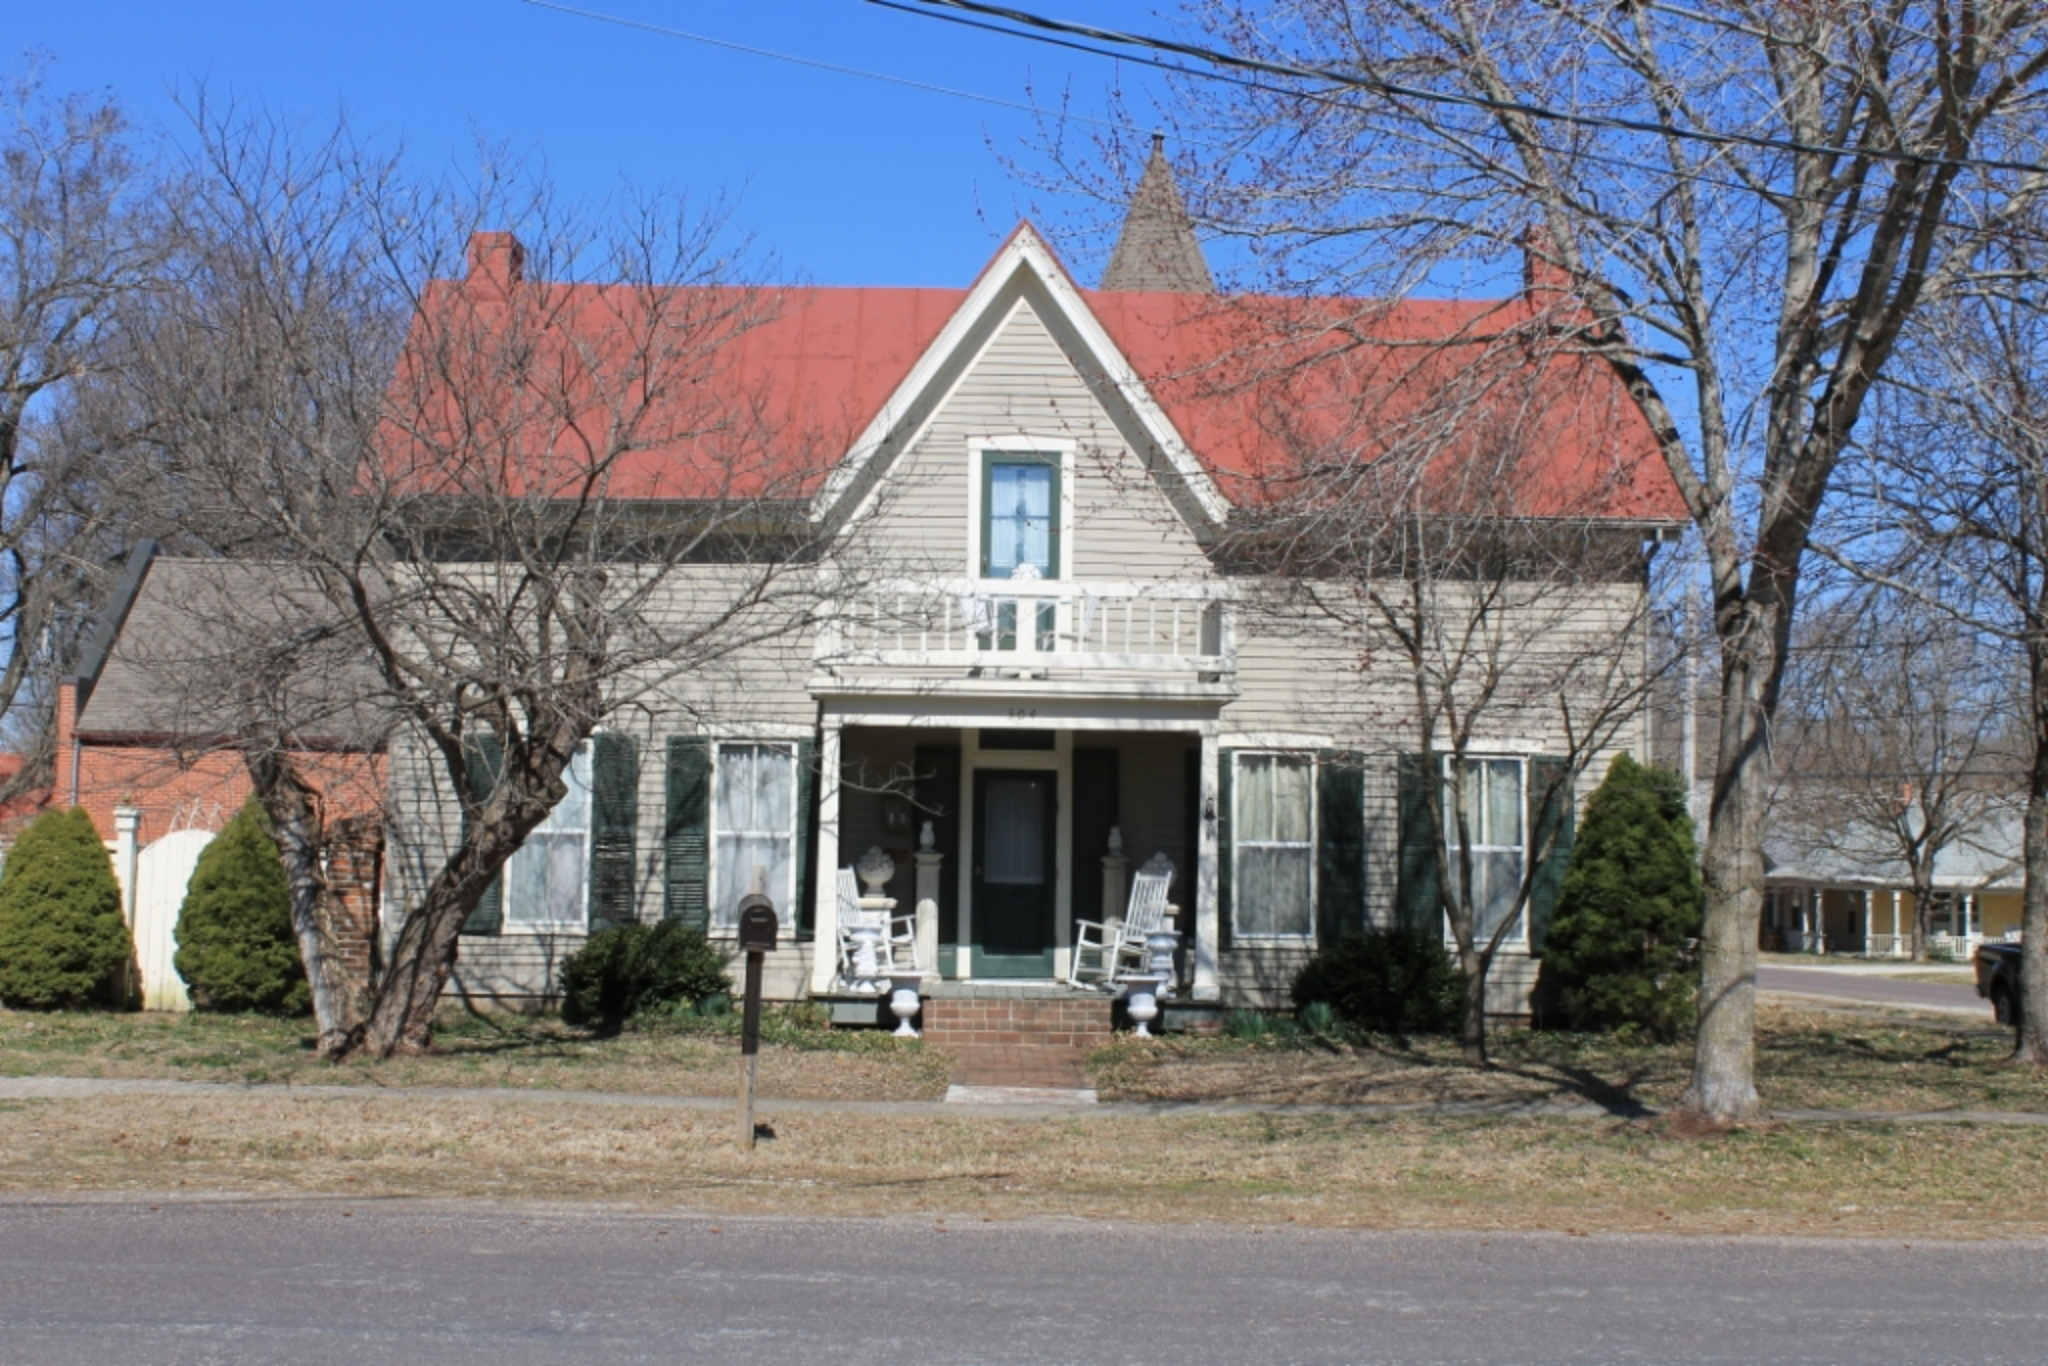
This 1 1/2 story frame Gothic Revival styled I-house has a cross gable roof. The first story of the front (south) facade has five bays. The two left bays each contain a two-over-two wooden window accented with shutters. The center bay, which is under the gable, is sheltered by a porch roof that forms a balcony on the second story. The two right bays each contain a two-over-two wooden window accented with shutters. The windows have slightly arched lintels. The second story has one bay containing a door with four panes of glass above a wooden panel; the door opens onto the balcony. The door frame has a slightly arched lintel. Chimneys rise from the interior ends of the house.
