MISSOURI DEPARTMENT OF NATURAL RESOURCES
STATE HISTORIC PRESERVATION OFFICE, P.O. Box 176, Jefferson City, MO 65102
ARCHITECTURAL/HISTORIC INVENTORY FORM

1. SURVEY NO. BO-AS-009-0001		2. SURVEY NAME: Rocheport Historic District	
3. COUNTY: Boone		4. ADDRESS (STREET NO.)	STREET (NAME) Katy Trail
5. CITY: Rocheport	VICINITY: <input checked="" type="checkbox"/>	6. UTM: / /	LAT: LONG: T: 48W R: 15W S: 1

8. HISTORIC NAME (IF KNOWN): M.K.&T. Railroad tunnel		9. PRESENT/OTHER NAME (IF KNOWN): Katy trail tunnel	
10. OWNERSHIP: <input type="checkbox"/> PRIVATE <input checked="" type="checkbox"/> PUBLIC		11A. HISTORIC USE (IF KNOWN): railroad tunnel	11B. CURRENT USE: Katy Trail tunnel
HISTORICAL INFORMATION

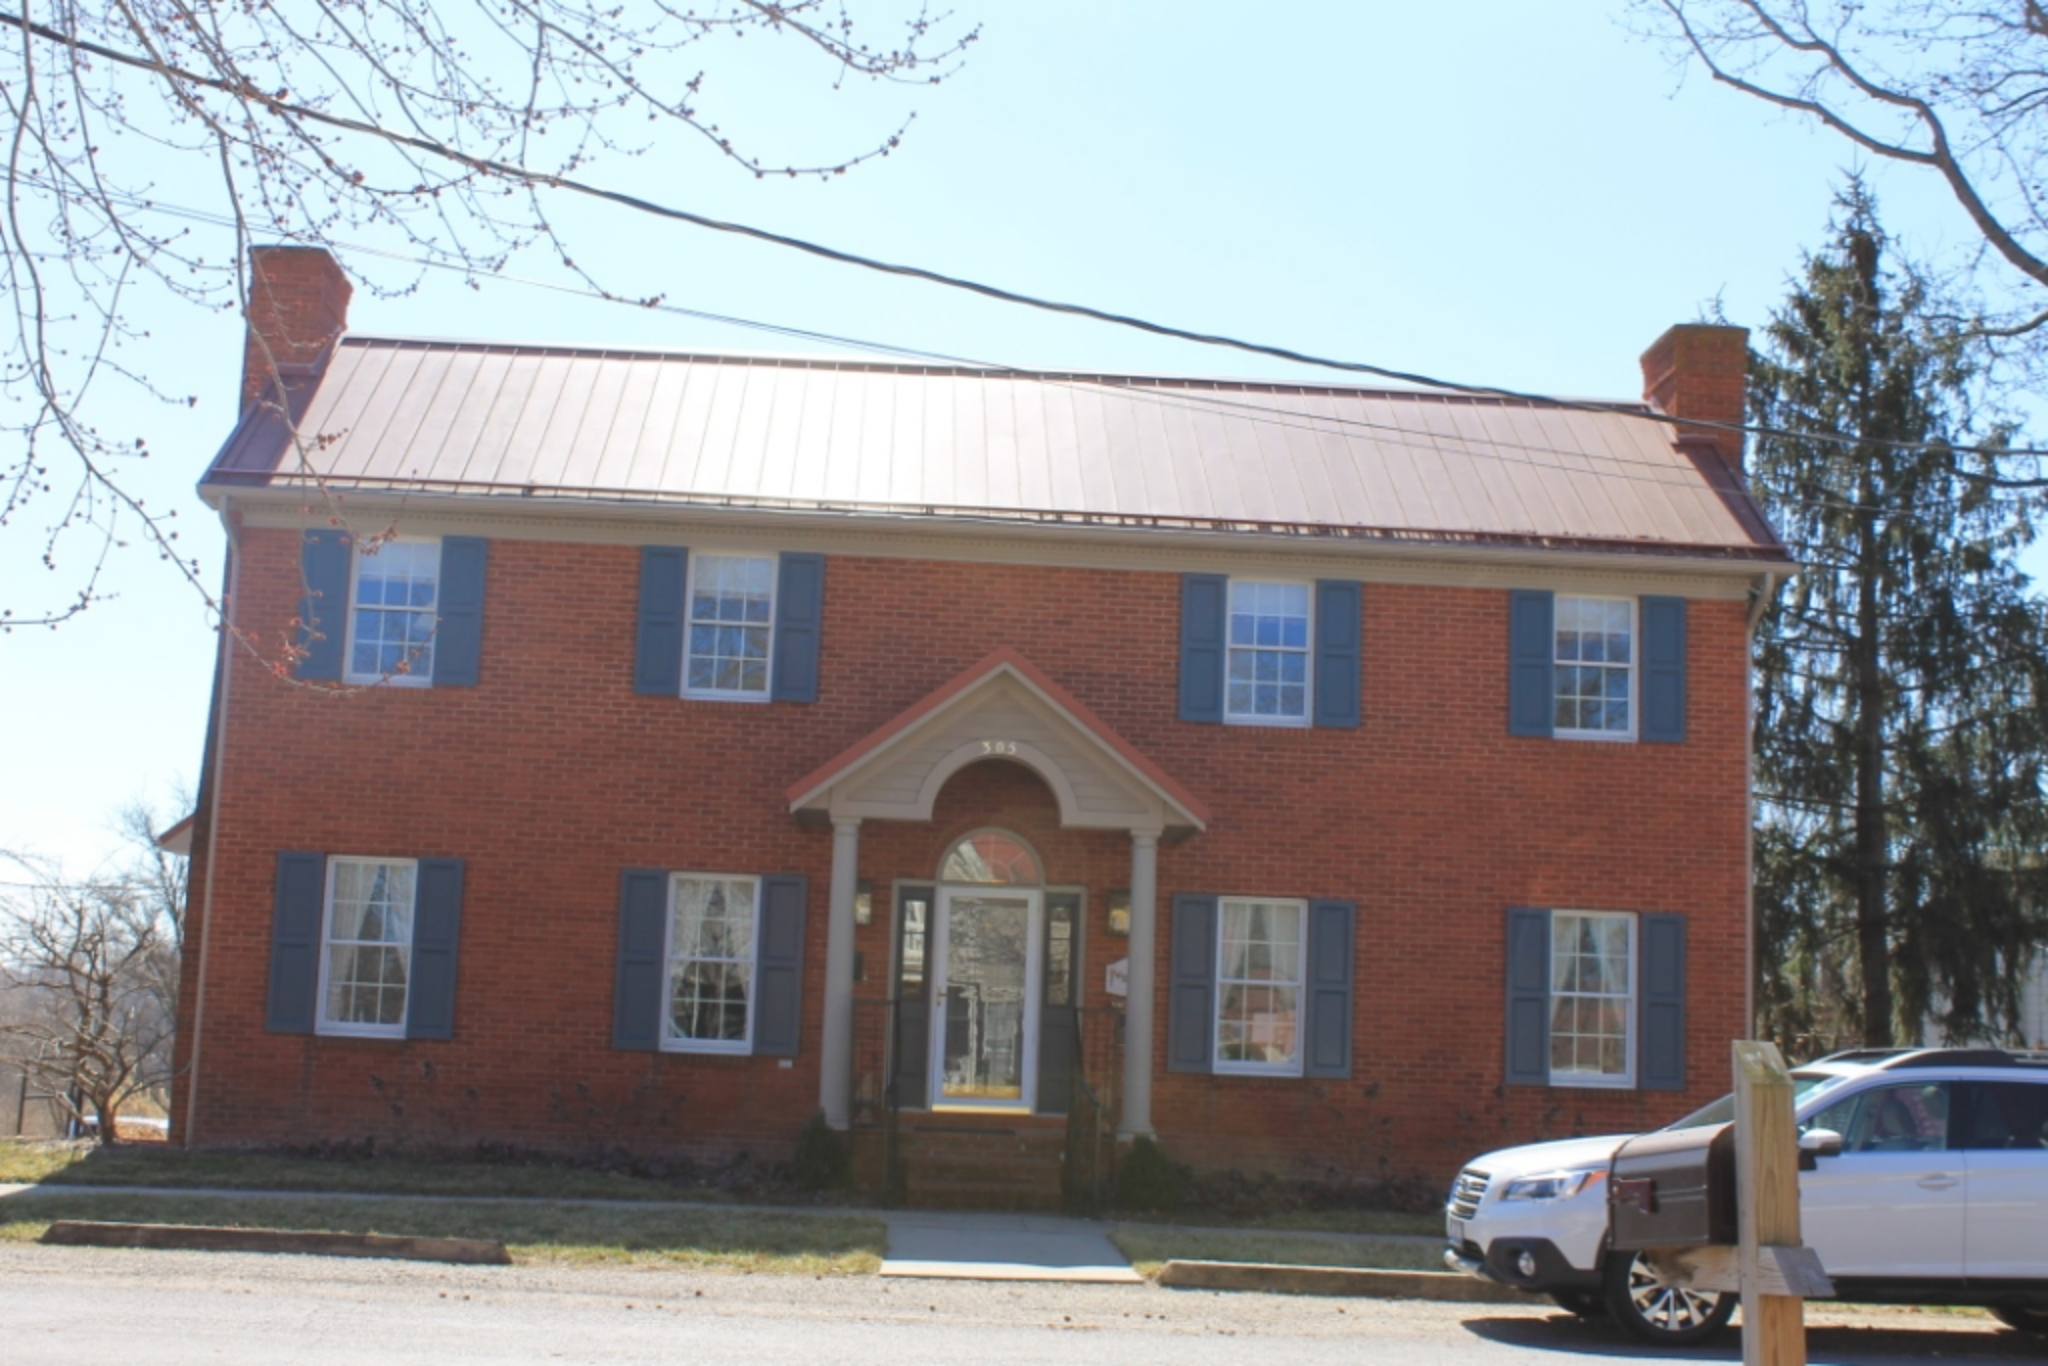
This two-story, massed plan, brick building is a New Traditional, Colonial Revival style building with Federal style features. The building has an intersecting gable roof. On the first story, the building has five bays. The two left bays each contain a six-over-six vinyl window accented with decorative shutters. The center bay contains a door with a fanlight window above it and sidelight with fixed pane glass above panels on either side. A beige painted pedimented portico with a medium gable roof is supported by round posts. The pediment has a half circle cut away above the fanlight window that accentuates the line of the window. The two right bays each contains a six-over-six vinyl window accented with shutters. On the second story are four bays, evenly spaced above the side bays on the first story. Each of these bays contains a six-over-six vinyl window. Interior chimneys rise from each end of the roof of the main block of the building.

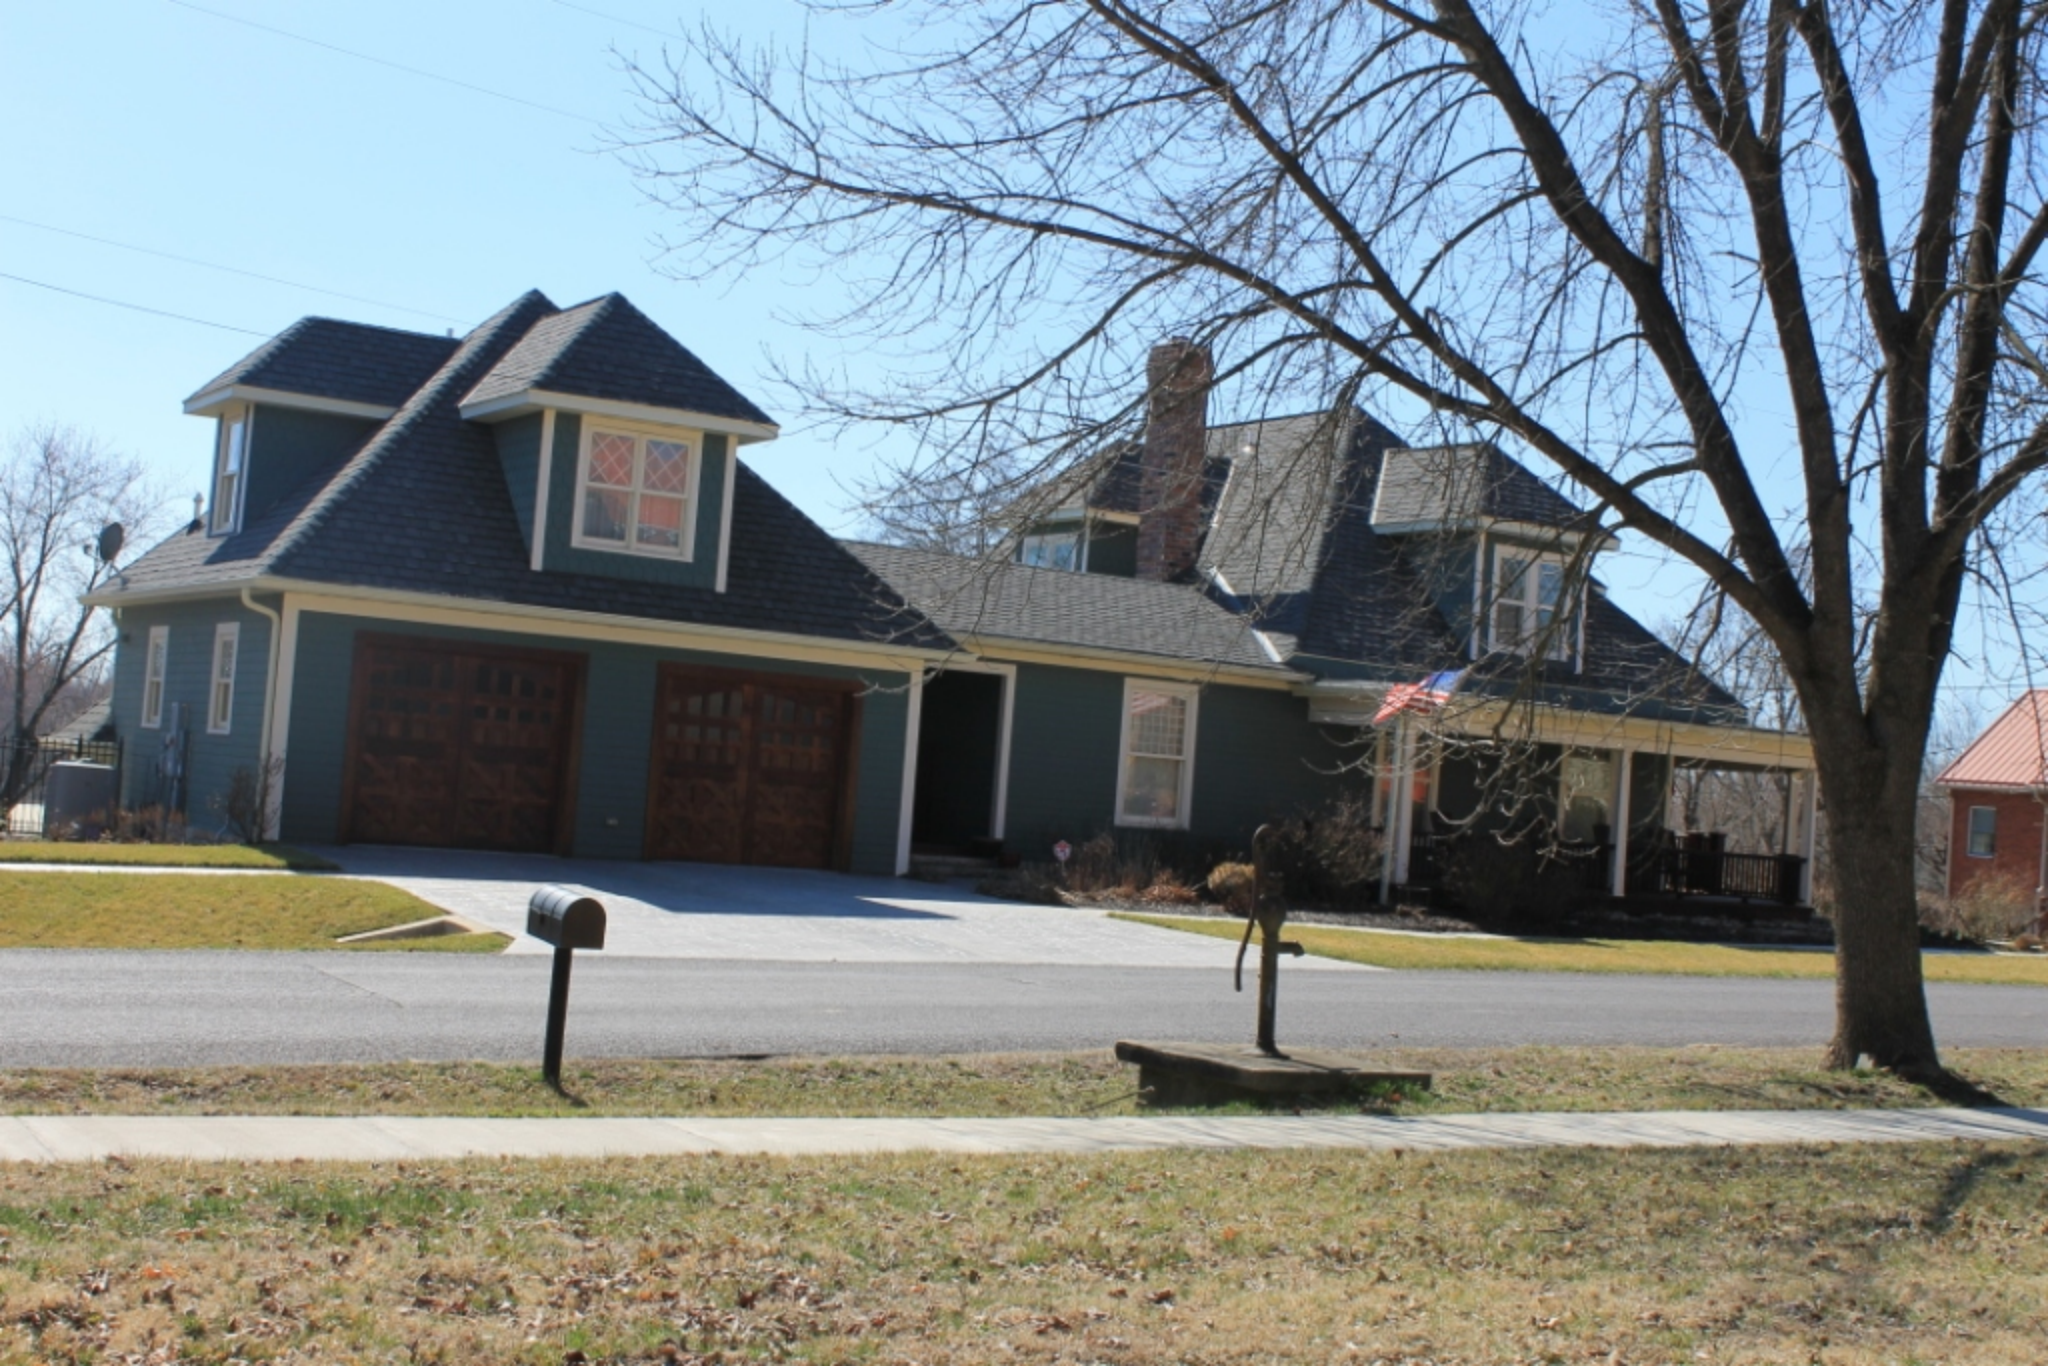
This 1 1/2 story, massed plan, pyramidal house has a high hipped roof and a hipped roof dormer on each facade of the main block of the house. Each dormer has one bay containing a pair of windows with diamond shaped panes-over-one pane. The garage, added after 1976, has two hipped roof dormers, one on the north (front) facade and one on the east facade, each containing multiple diamond paned-over-one pane window. The sides of the dormers are clad in fishlap shingles. The first story of the front of the building has seven bays. The two leftmost bays are in the modern garage; each bay contains a one-car overhead garage door. The next bay opens into a recessed entryway in the passageway between the garage and the main block of the house. The next bay, also in the passageway contains a modern forty two-over-one single hung window. The remaining bays are on the original main block of the house and include a bay containing a door, a bay containing a forty two-over-one single hung window, and a angled bay on the corner of the main block of the house that contains a door with a transom and sidelights. The second story of the main block of the house has four hipped roof gables, each having one bay. These bays contain a pair of windows with multiple diamond shaped panes-over-one pane window.

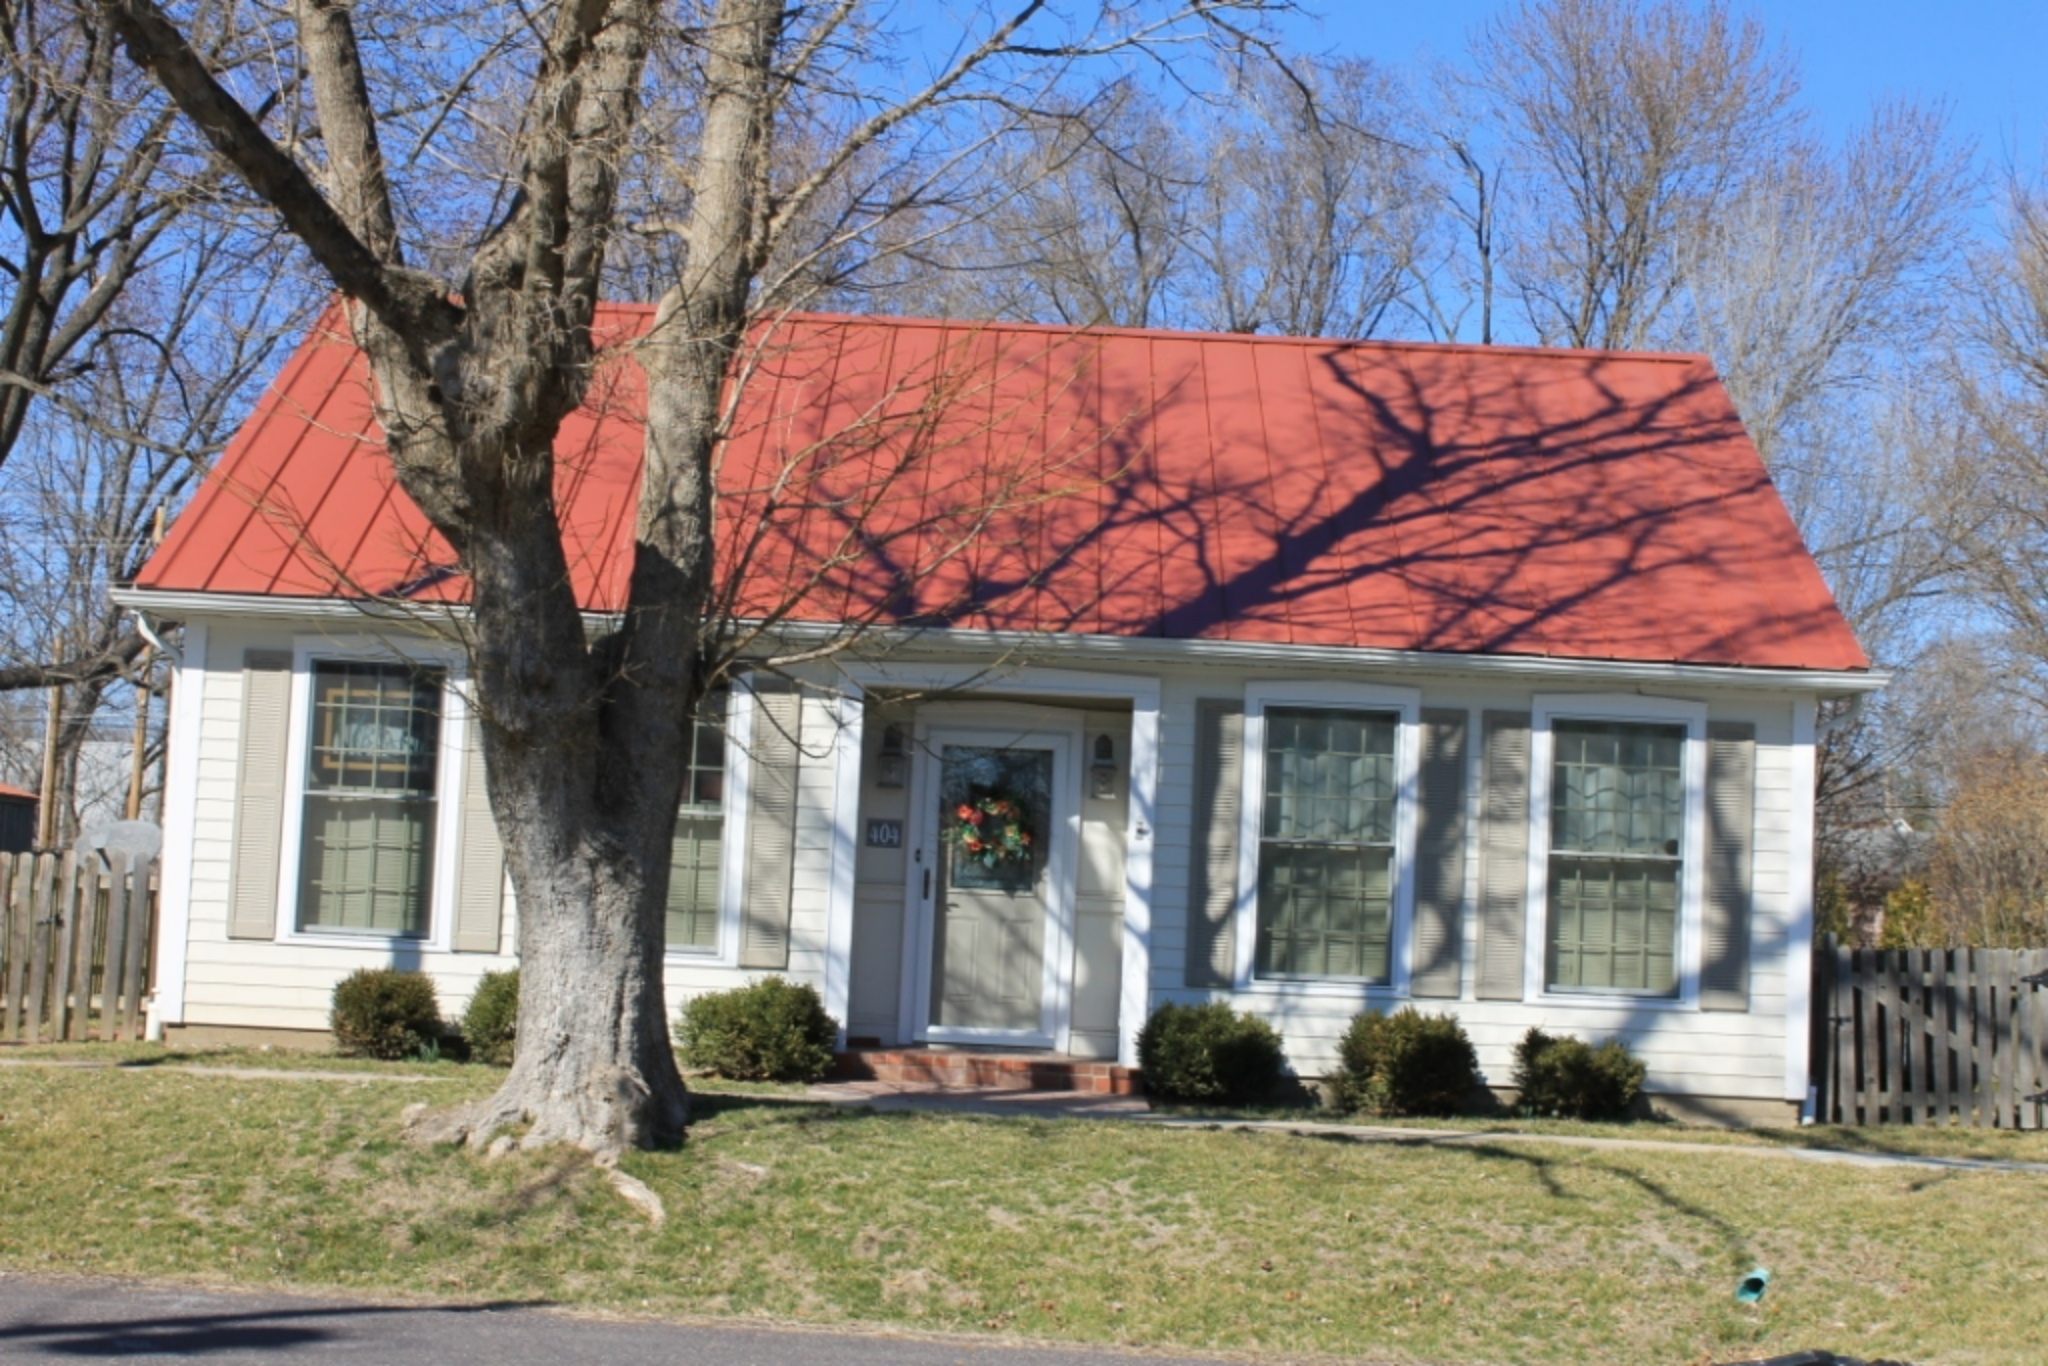
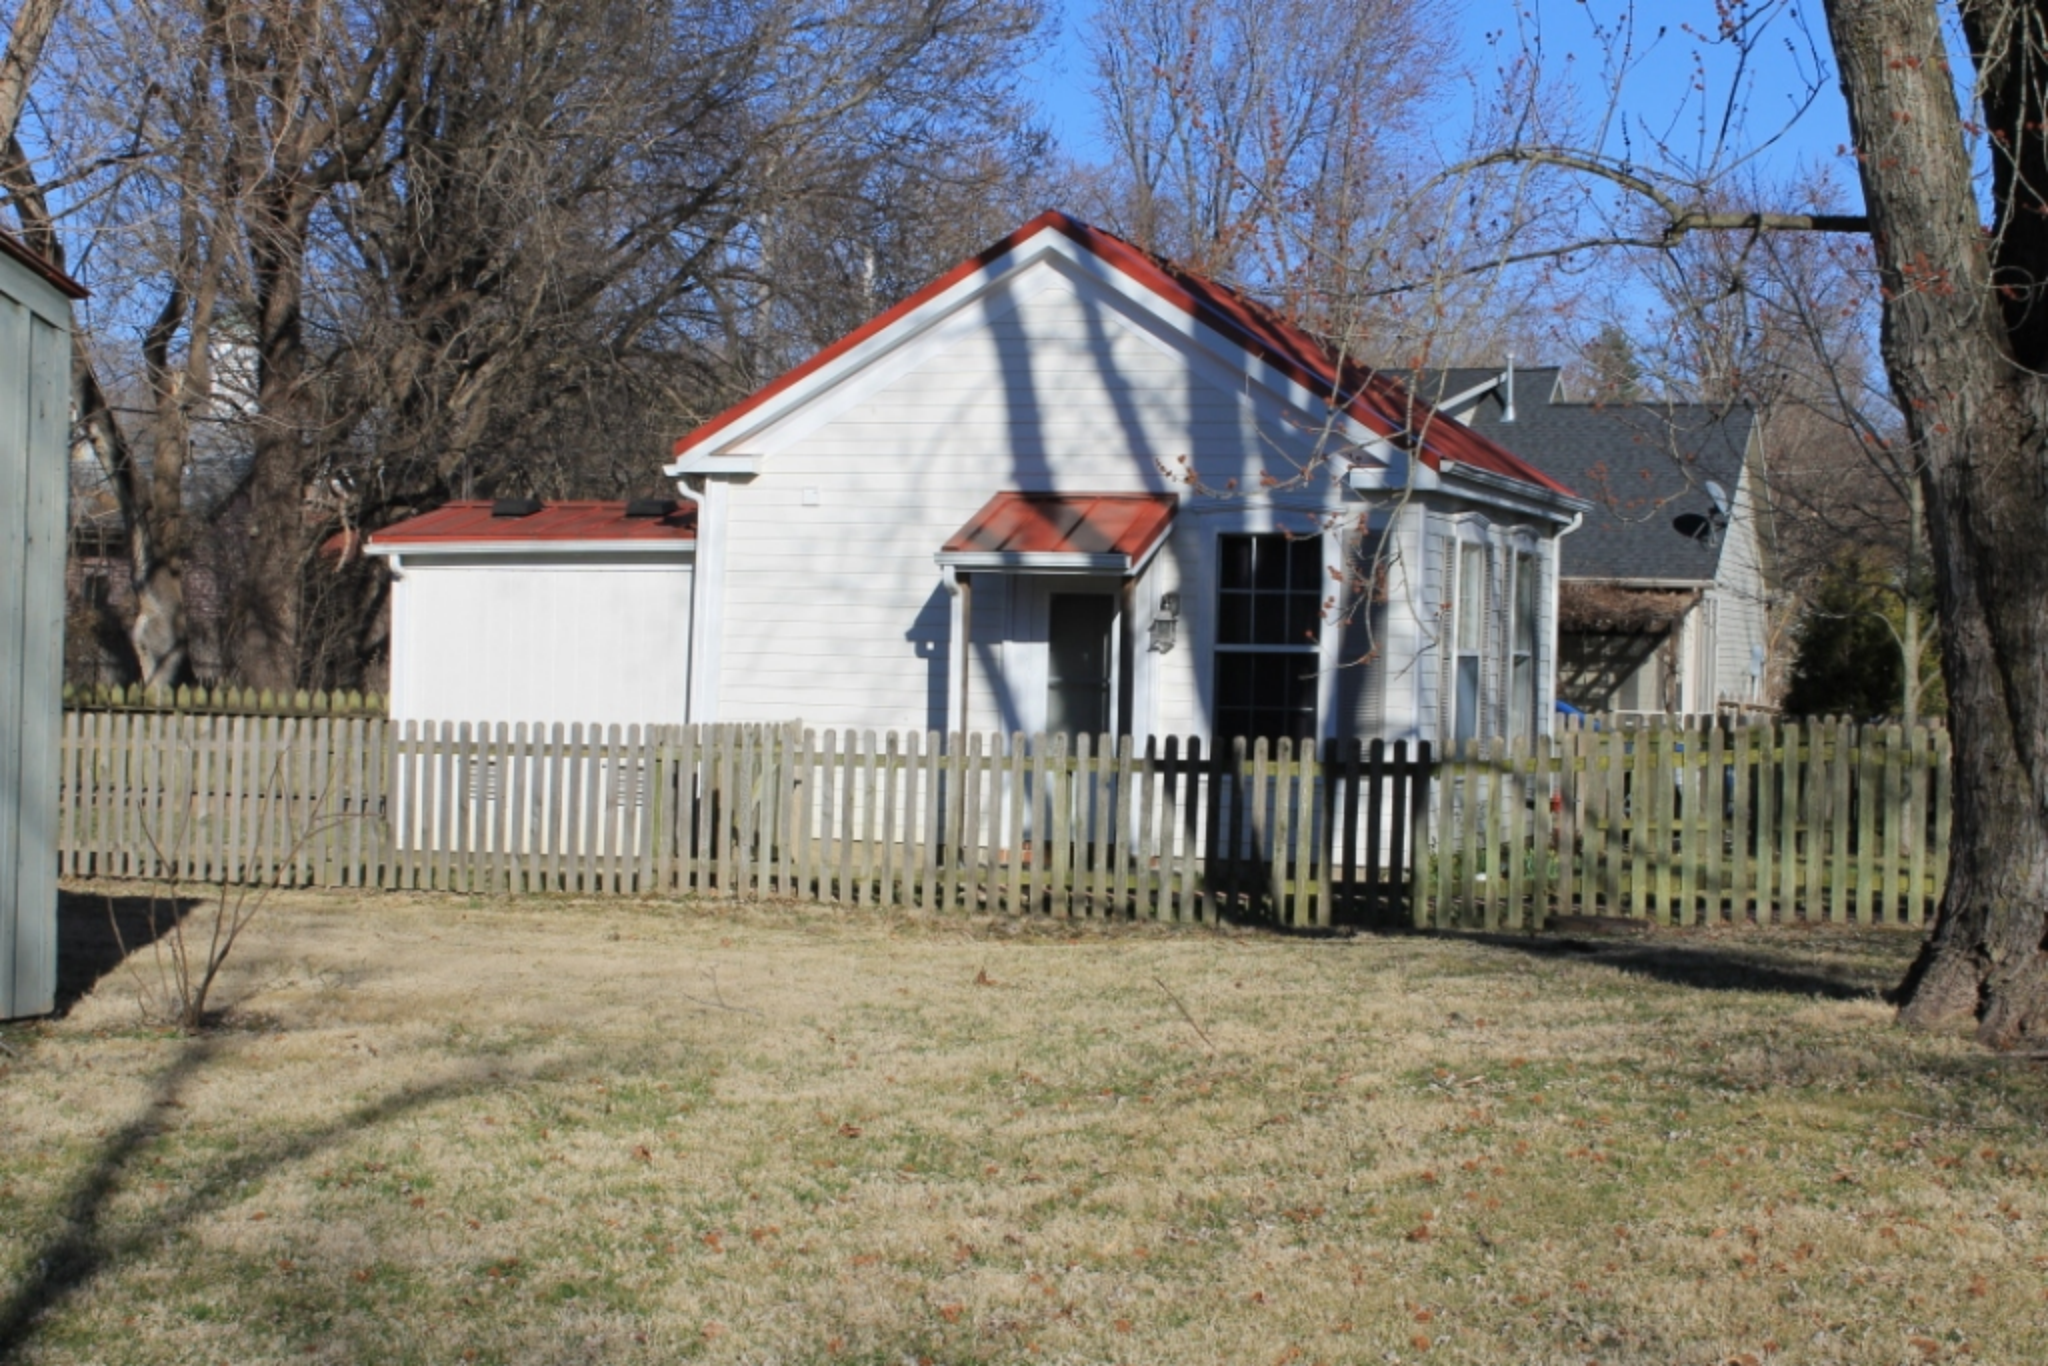
This one story, hall and parlor plan, Federal style frame house with a medium gable roof has a wing to the rear with a gable roof that faces the north. The walls are clad in clapboards and the roof is covered in metal. The front (south) facade has five bays. The two left bays each contain a twelve-over-twelve wooden single hung window. The central bay contains an inset entry that covers a small porch; the bay contains a wood paneled door covered with a modern glass storm door. The two right bays each contain a twelve-over-twelve wooden single hung window. The windows have slightly arched lintels.

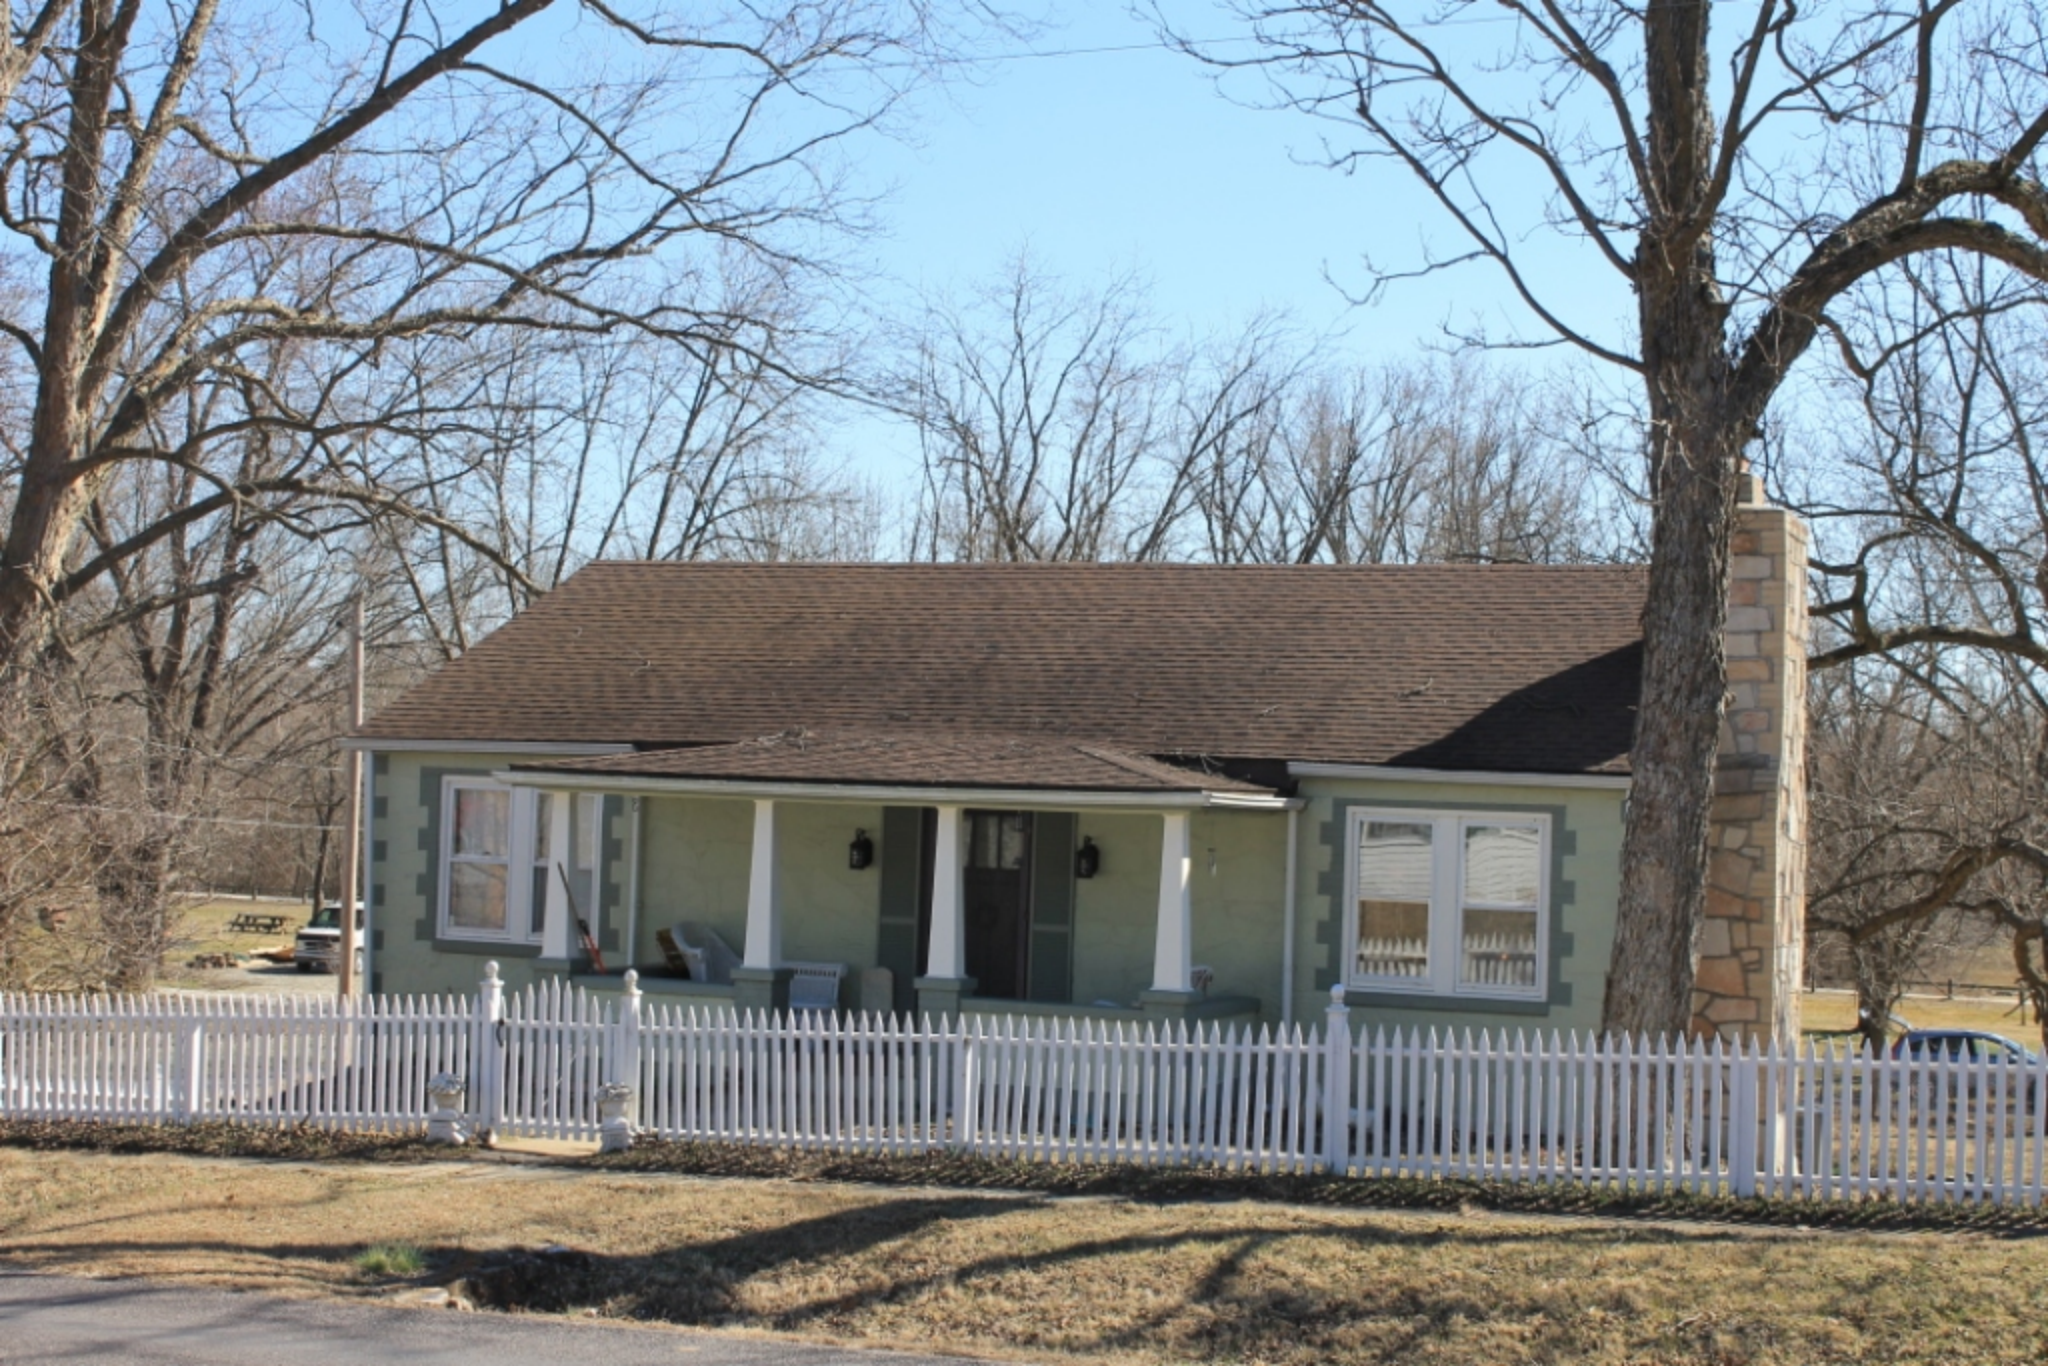
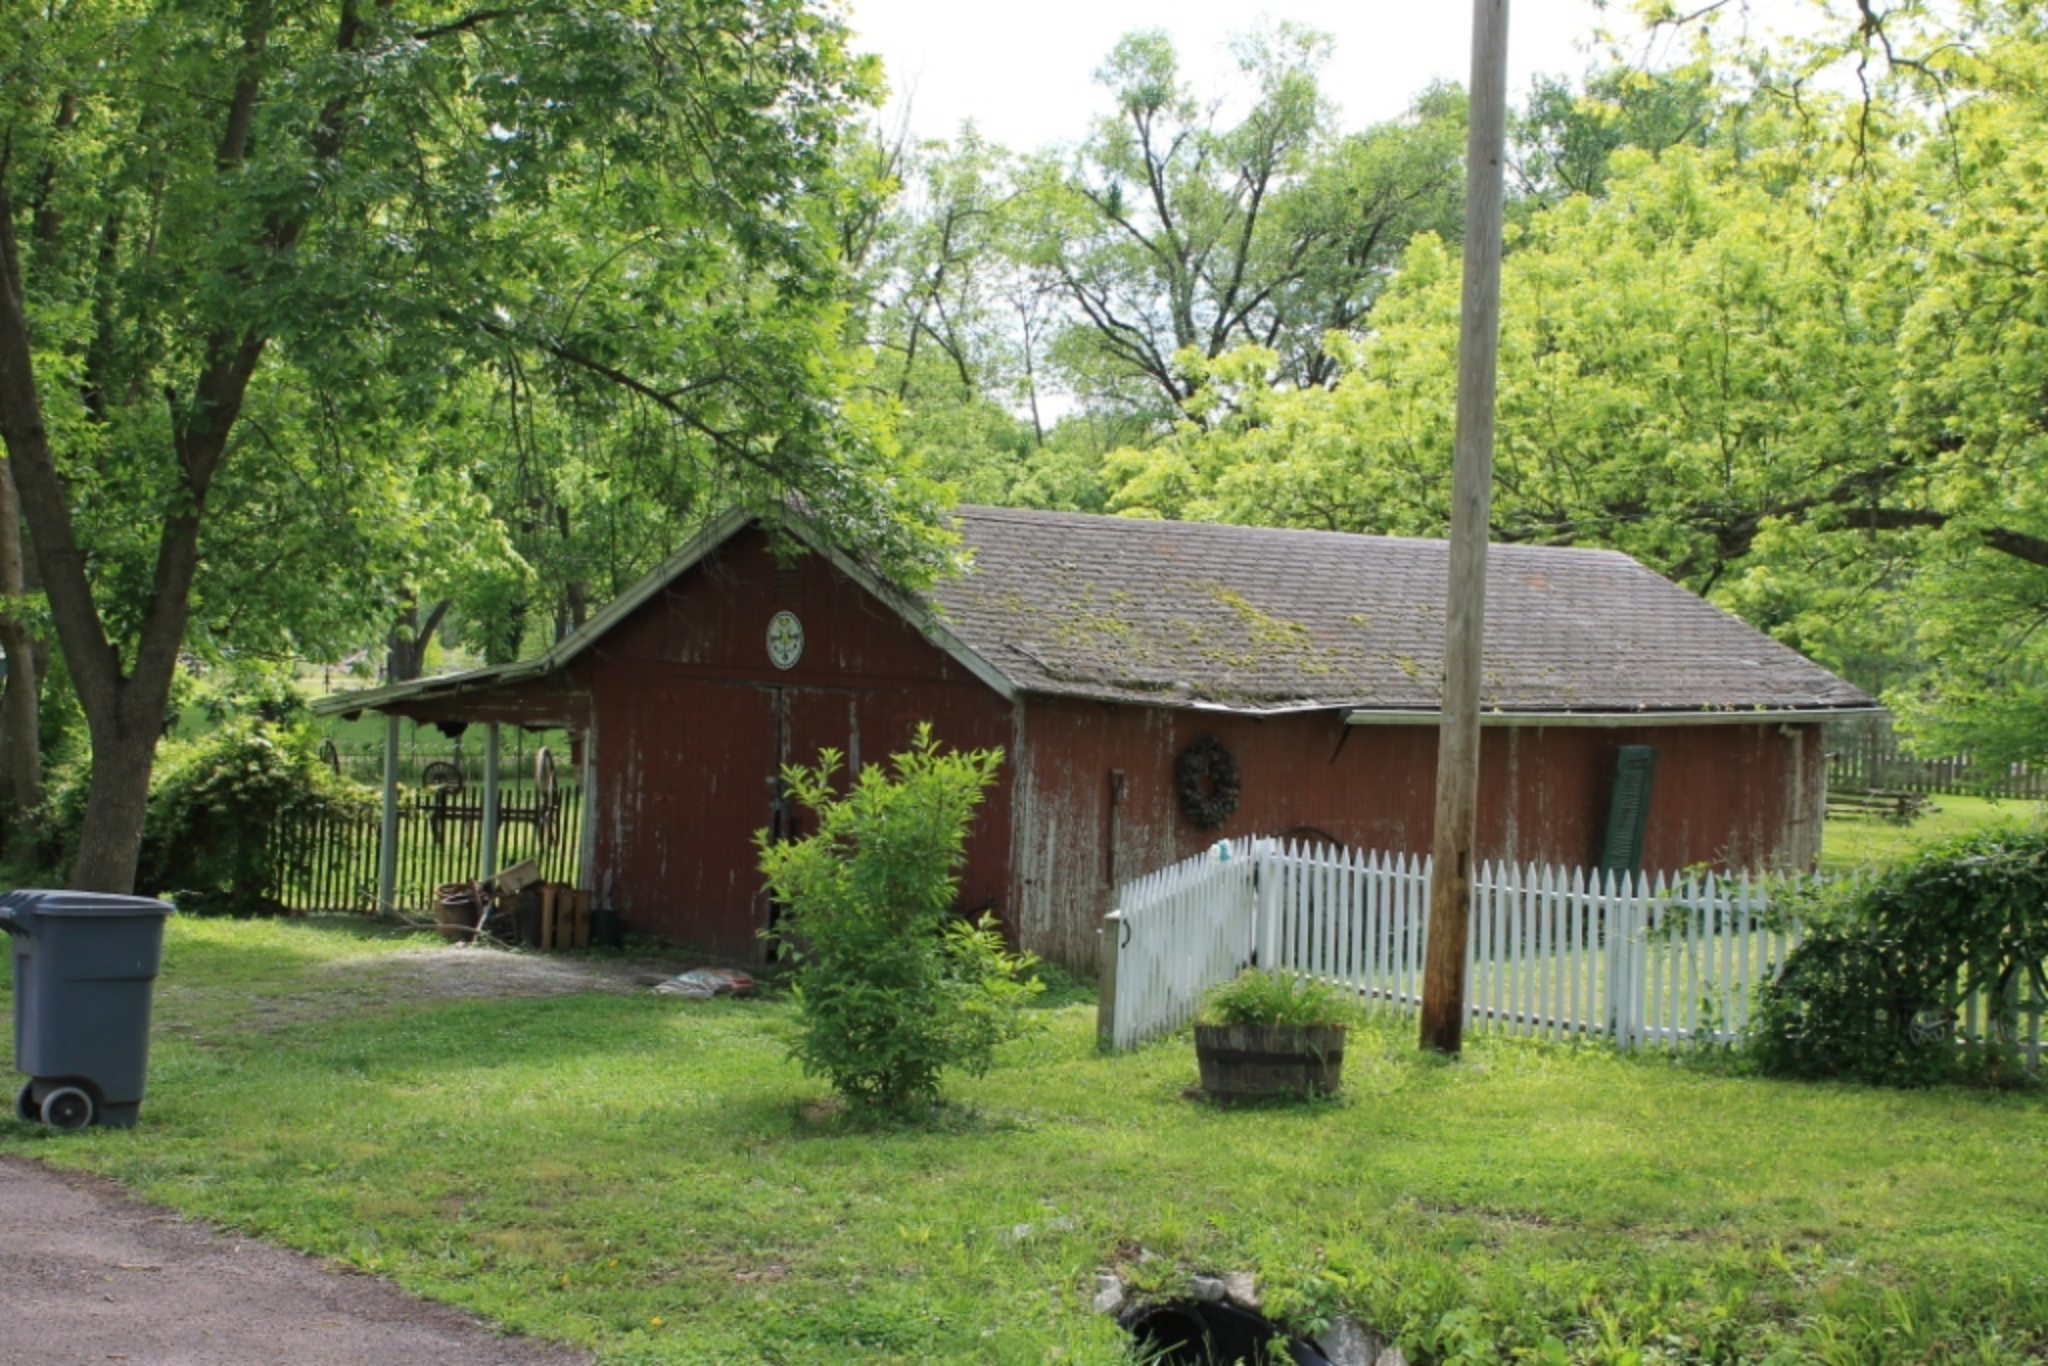
This one-story, massed plan house has a low gable roof and a hipped roof porch. The walls are stone and the roof is covered in asphalt shingles. The walls are accented with brick quoins around the windows and at the corners. The quoins are painted a darker color than the body of the house. The front facade has three bays. The left bay contains a pair of one-over-one single hung windows. The center bay contains a door with three fixed pane windows in the top. The door has decorative shutters on either side. The right bay contains a pair of one-over-one wooden windows. The hipped roof porch extends over the central doorway almost to the side bays. Four pyramidal posts resting on brick piers support the porch roof. A brick knee wall extends between the two left porch support piers and between the two right porch support piers. The roof of the house extends slightly on the right side to accommodate a slight projection of the wall to the north. A stone exterior chimney is on the right side of the building.

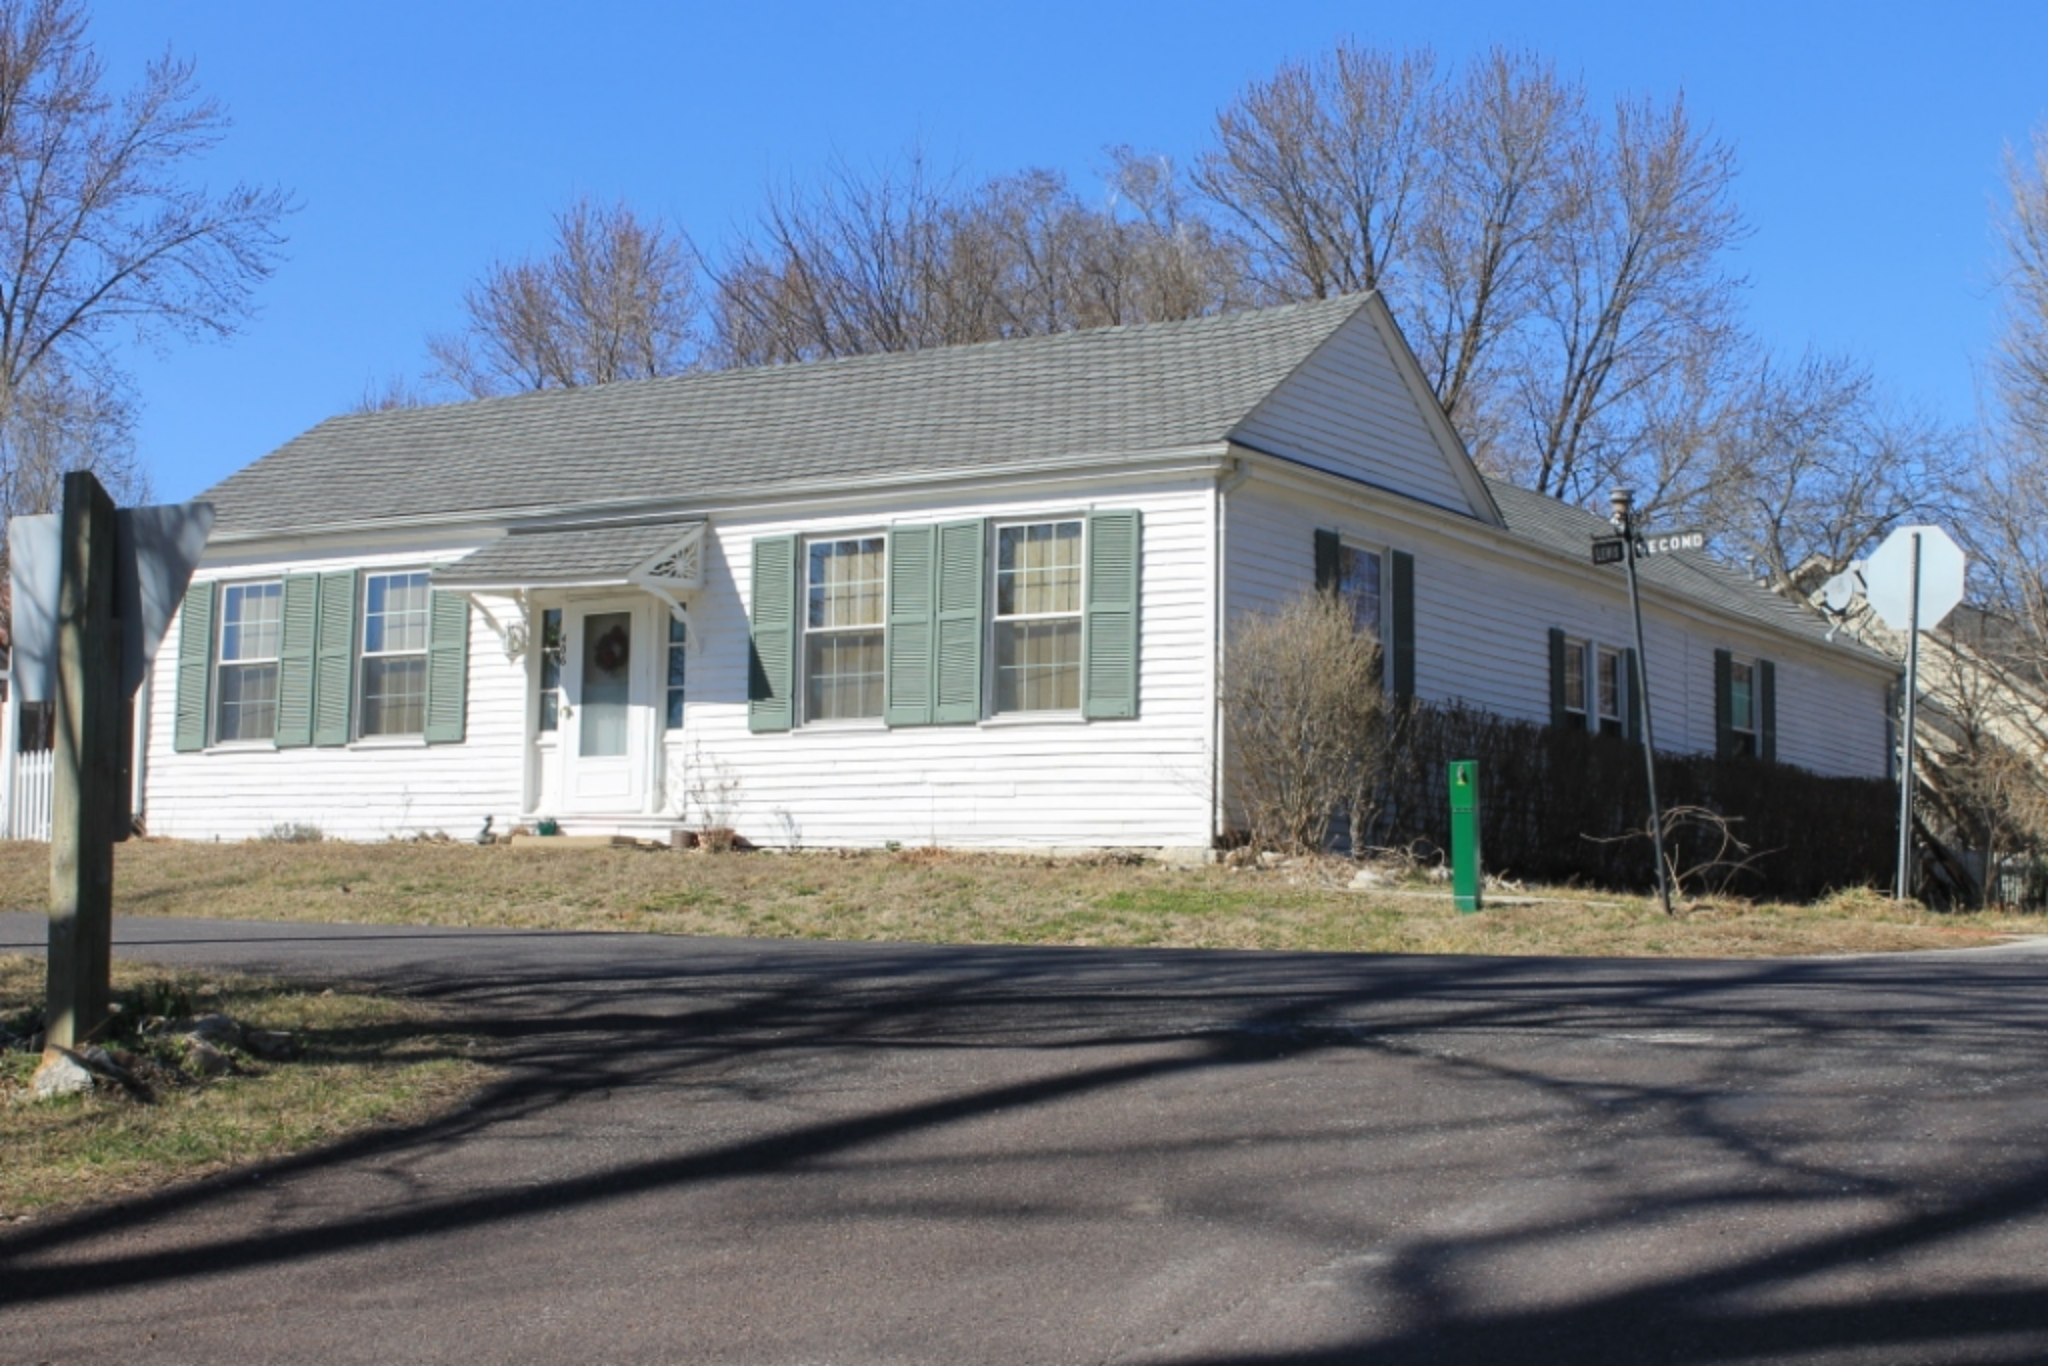
This one-story, hall and parlor plan, L-shaped, Federal style, frame house has a front wing facing south and a rear projecting wing giving the house an L shape. The walls are clad in clapboards and the roof is covered in asphalt shingles. A shed-roofed hood covers a concrete slab that serves as a porch that sits at ground level. Decorative sawn wooden brackets support the hood. The front facade of the house has five bays. The two left bays each contain six-over-six single hung windows with shutters. The center bay contains a doorway with a wooden door and sidelights with three panes above wooden panels. The two right bays each contain a six-over-six single hung windows with shutters. The rear projecting wing has a gable roof. The side (east) facade of the house has three bays. The left bay, which is located in the main block of the house, contains a six-over-six window. The next right bay, which is located in the north projecting wing, contains a pair of six-over-six single hung window. The rightmost bay contains a six over-six single hung window. The windows on the east facade also have shutters.
