MISSOURI DEPARTMENT OF NATURAL RESOURCES
STATE HISTORIC PRESERVATION OFFICE, P.O. Box 176, Jefferson City, MO 65102
ARCHITECTURAL/HISTORIC INVENTORY FORM

1. SURVEY NO. BO-AS-009-0001		2. SURVEY NAME: Rocheport Historic District	
3. COUNTY: Boone		4. ADDRESS (STREET NO.)	STREET (NAME) Katy Trail
5. CITY: Rocheport	VICINITY: <input checked="" type="checkbox"/>	6. UTM: / /	LAT: LONG: T: 48W R: 15W S: 1

8. HISTORIC NAME (IF KNOWN): M.K.&T. Railroad tunnel		9. PRESENT/OTHER NAME (IF KNOWN): Katy trail tunnel	
10. OWNERSHIP: <input type="checkbox"/> PRIVATE <input checked="" type="checkbox"/> PUBLIC		11A. HISTORIC USE (IF KNOWN): railroad tunnel	11B. CURRENT USE: Katy Trail tunnel
HISTORICAL INFORMATION

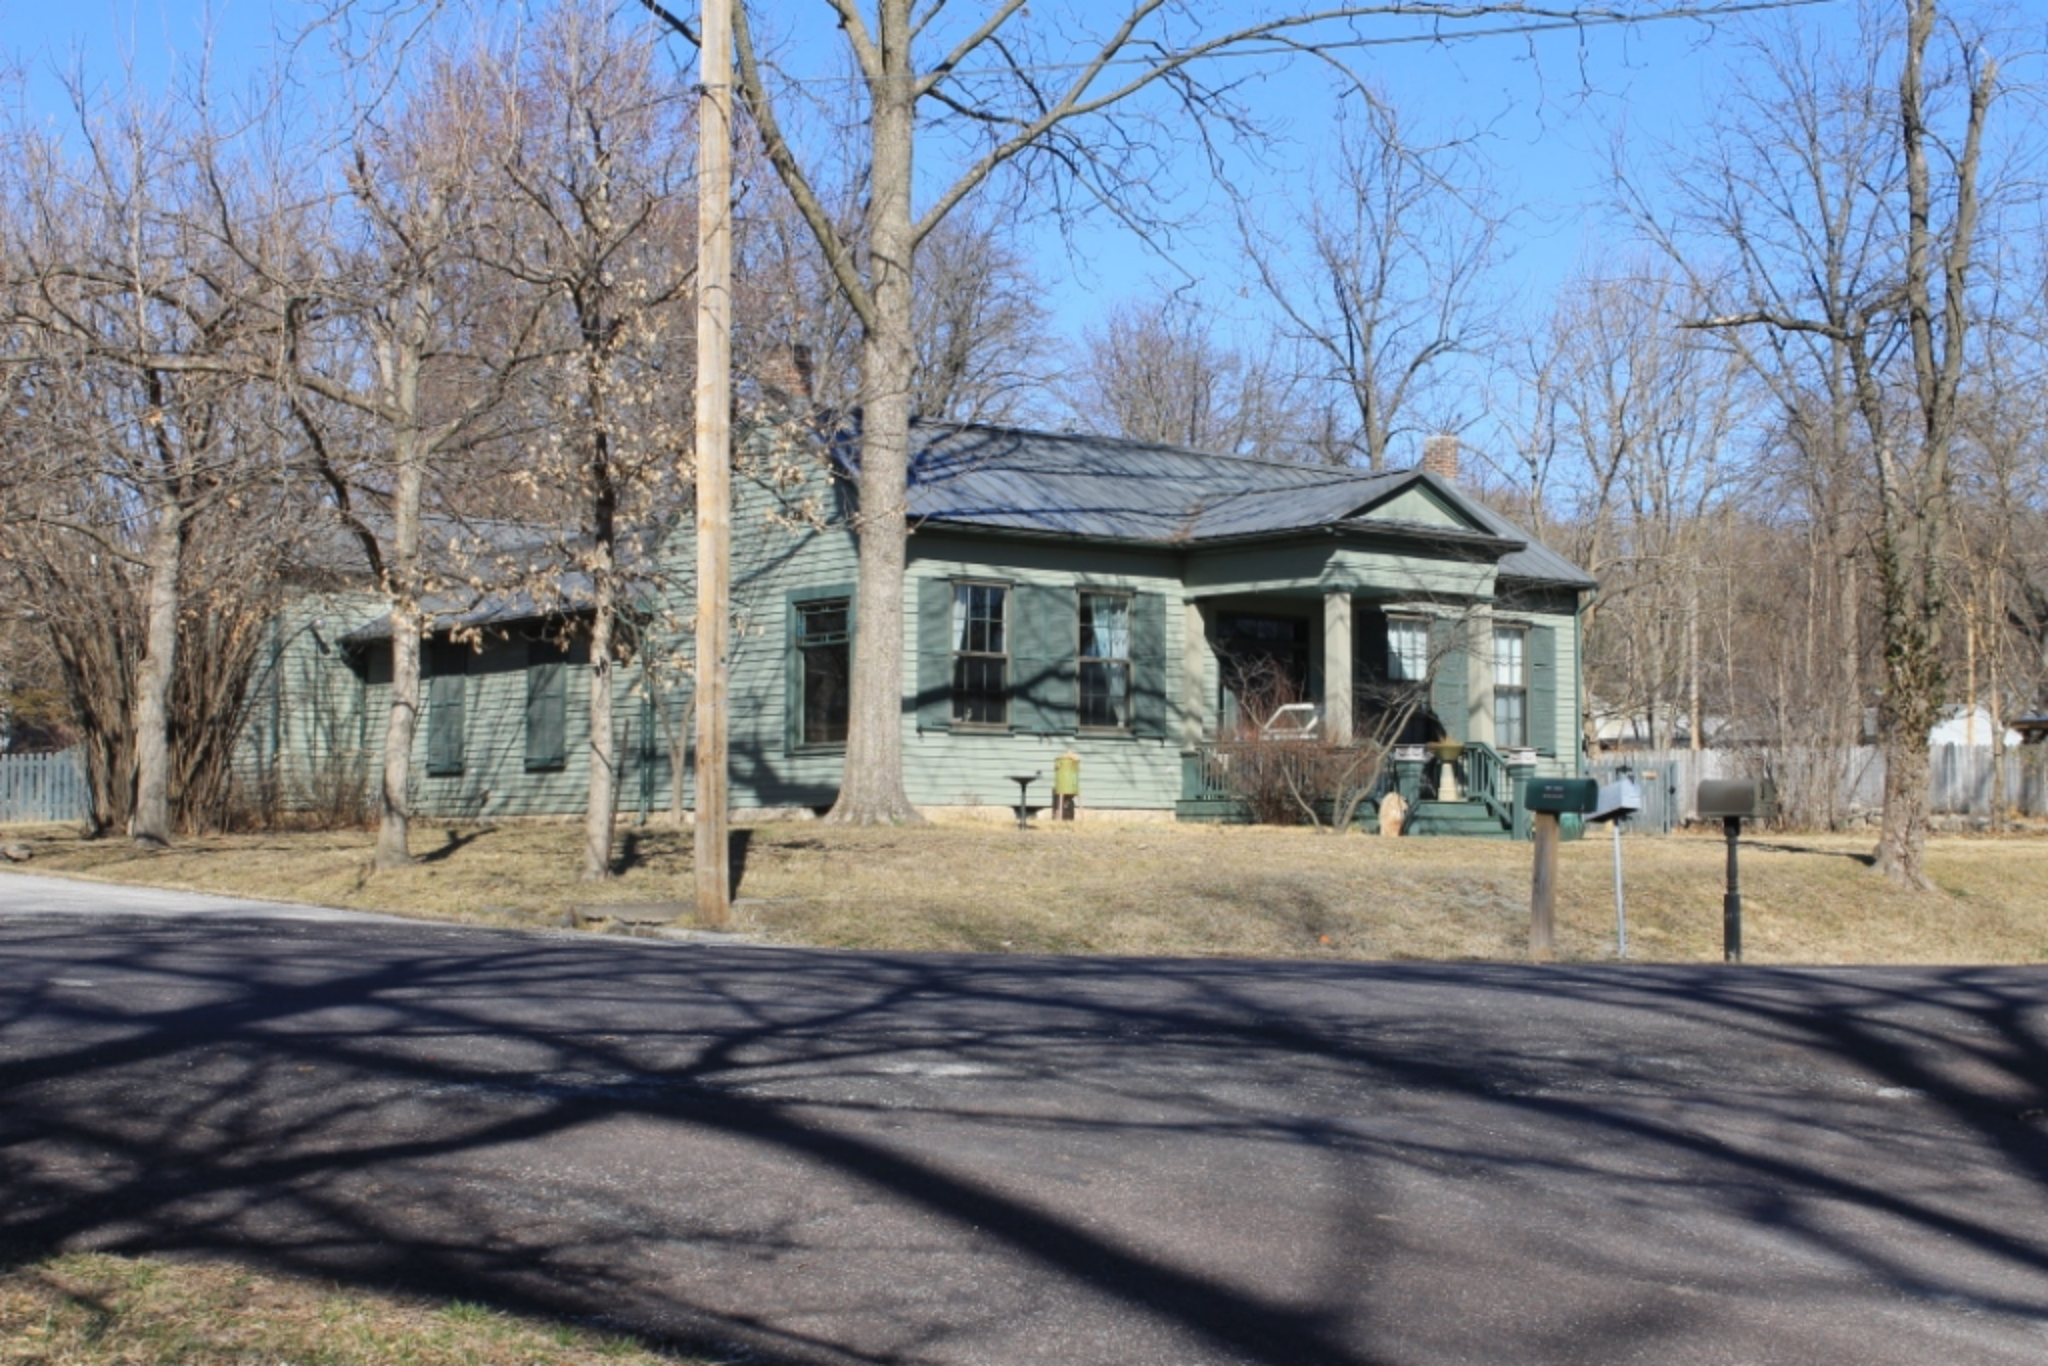
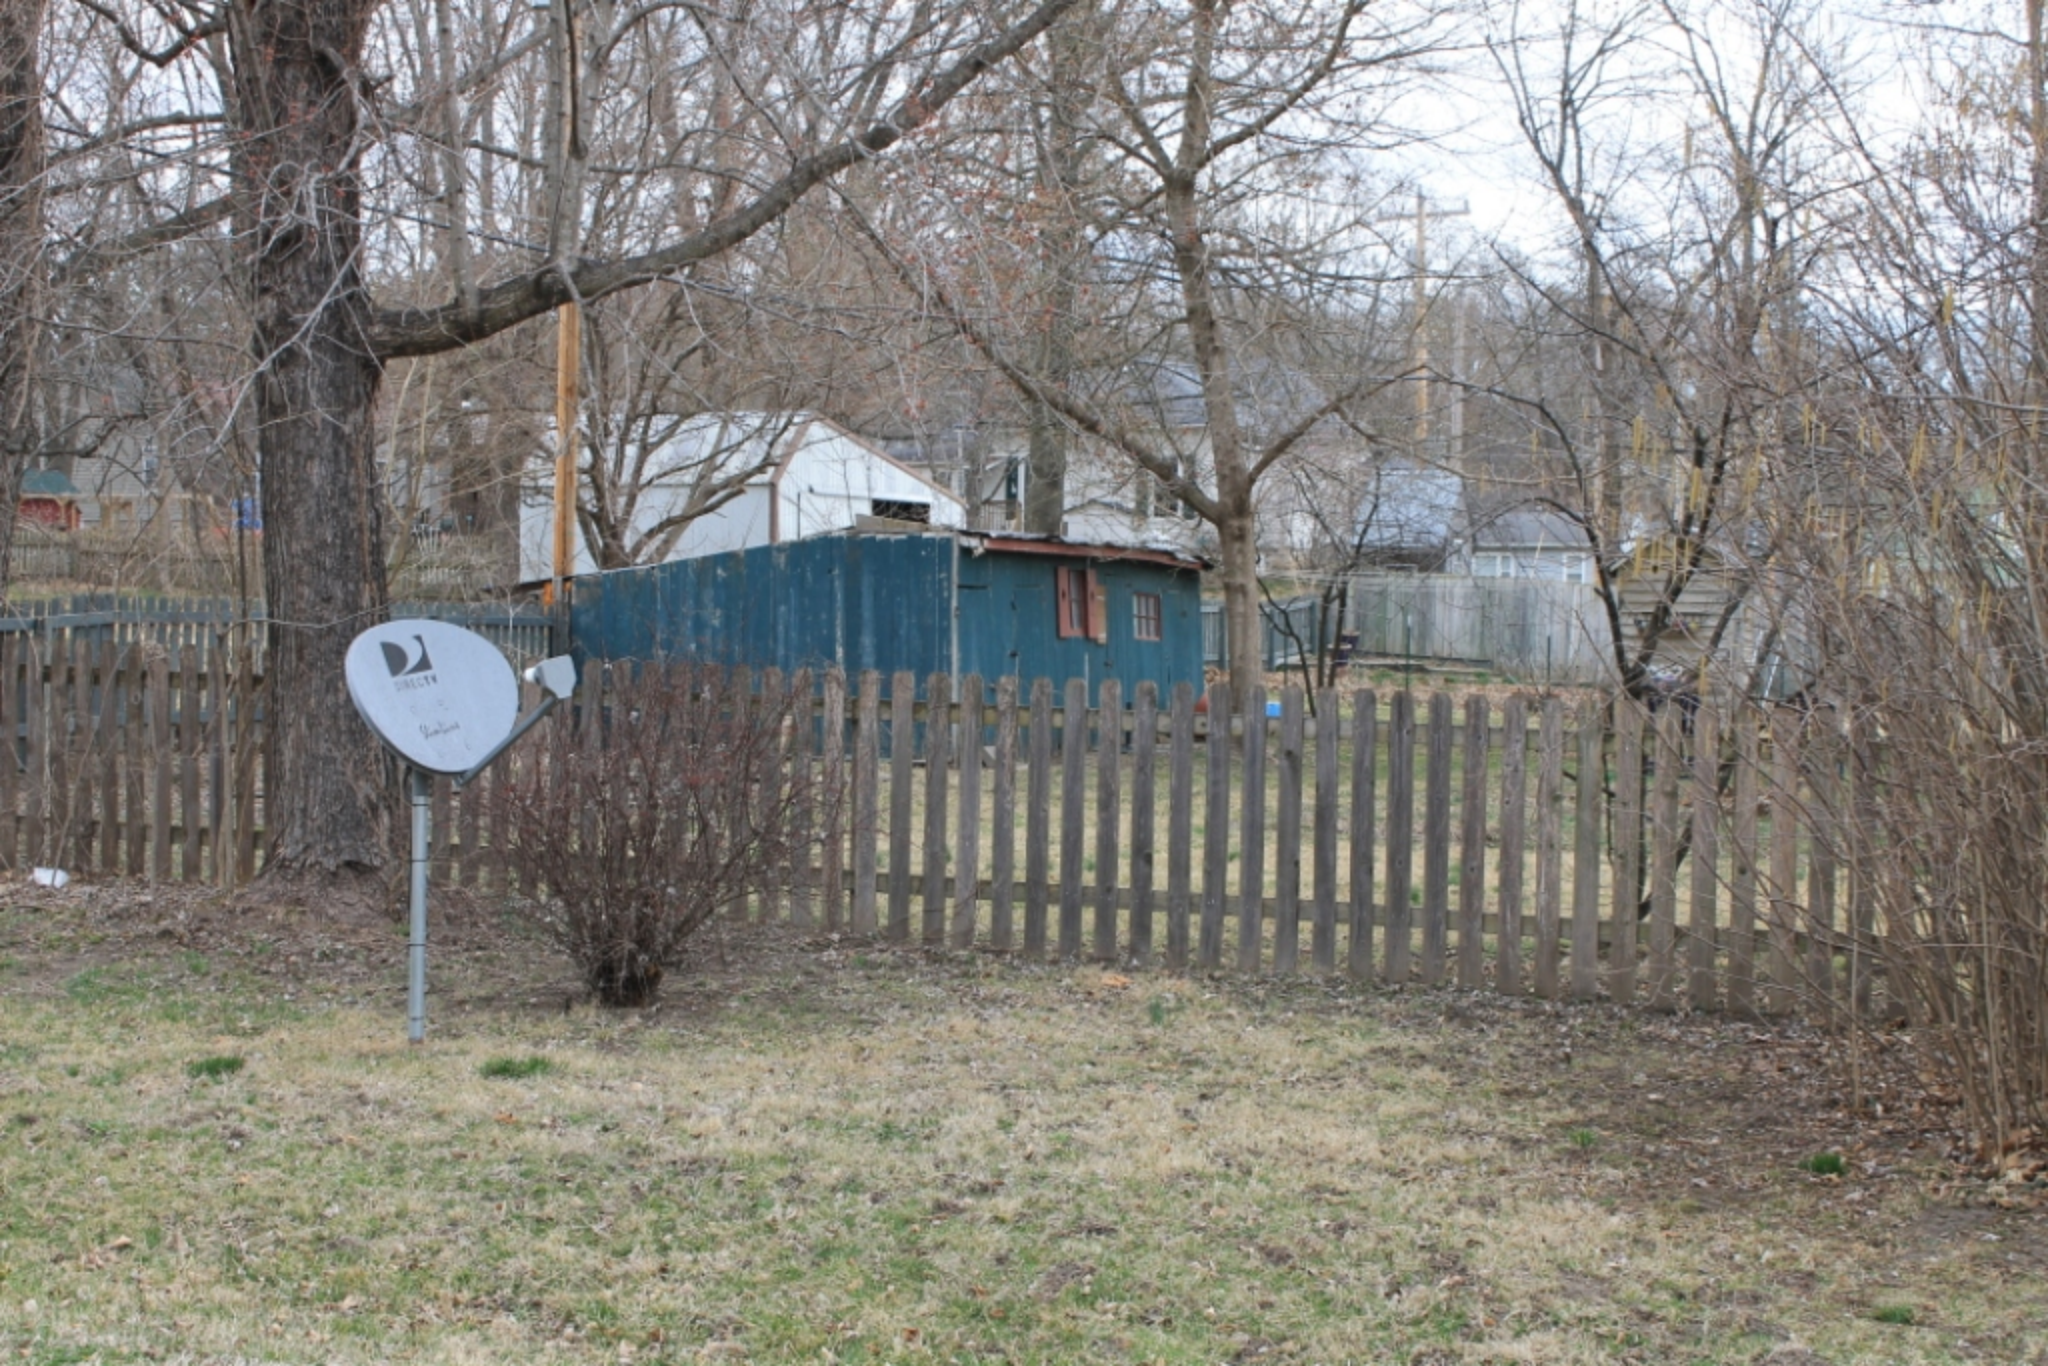
This one-story, frame, intersecting gable roof house is in the hall and parlor plan and the Greek revival style. The building is clad in clapboards and the roof is covered in metal. The front (south) facade has a pedimented portico. Under the portico is a bay containing a door that the Rocheport Historic District survey suggests is original. The front facade has five bays. The two left bays each contain a six-over-six single hung window with working shutters. The center bay under the portico contains a door with three paned sidelights and five paned transom. The two right bays each contain a six-over-six single hung window with working shutters. The side (west) facade has three bays. The left bay and the center bay contain shuttered windows. The right bay contains a one-over-one window; the bottom portion of the window is tall and the upper portion of the window consists of a clear glass pane surrounded by small colored glass panes. The house has interior end chimneys.

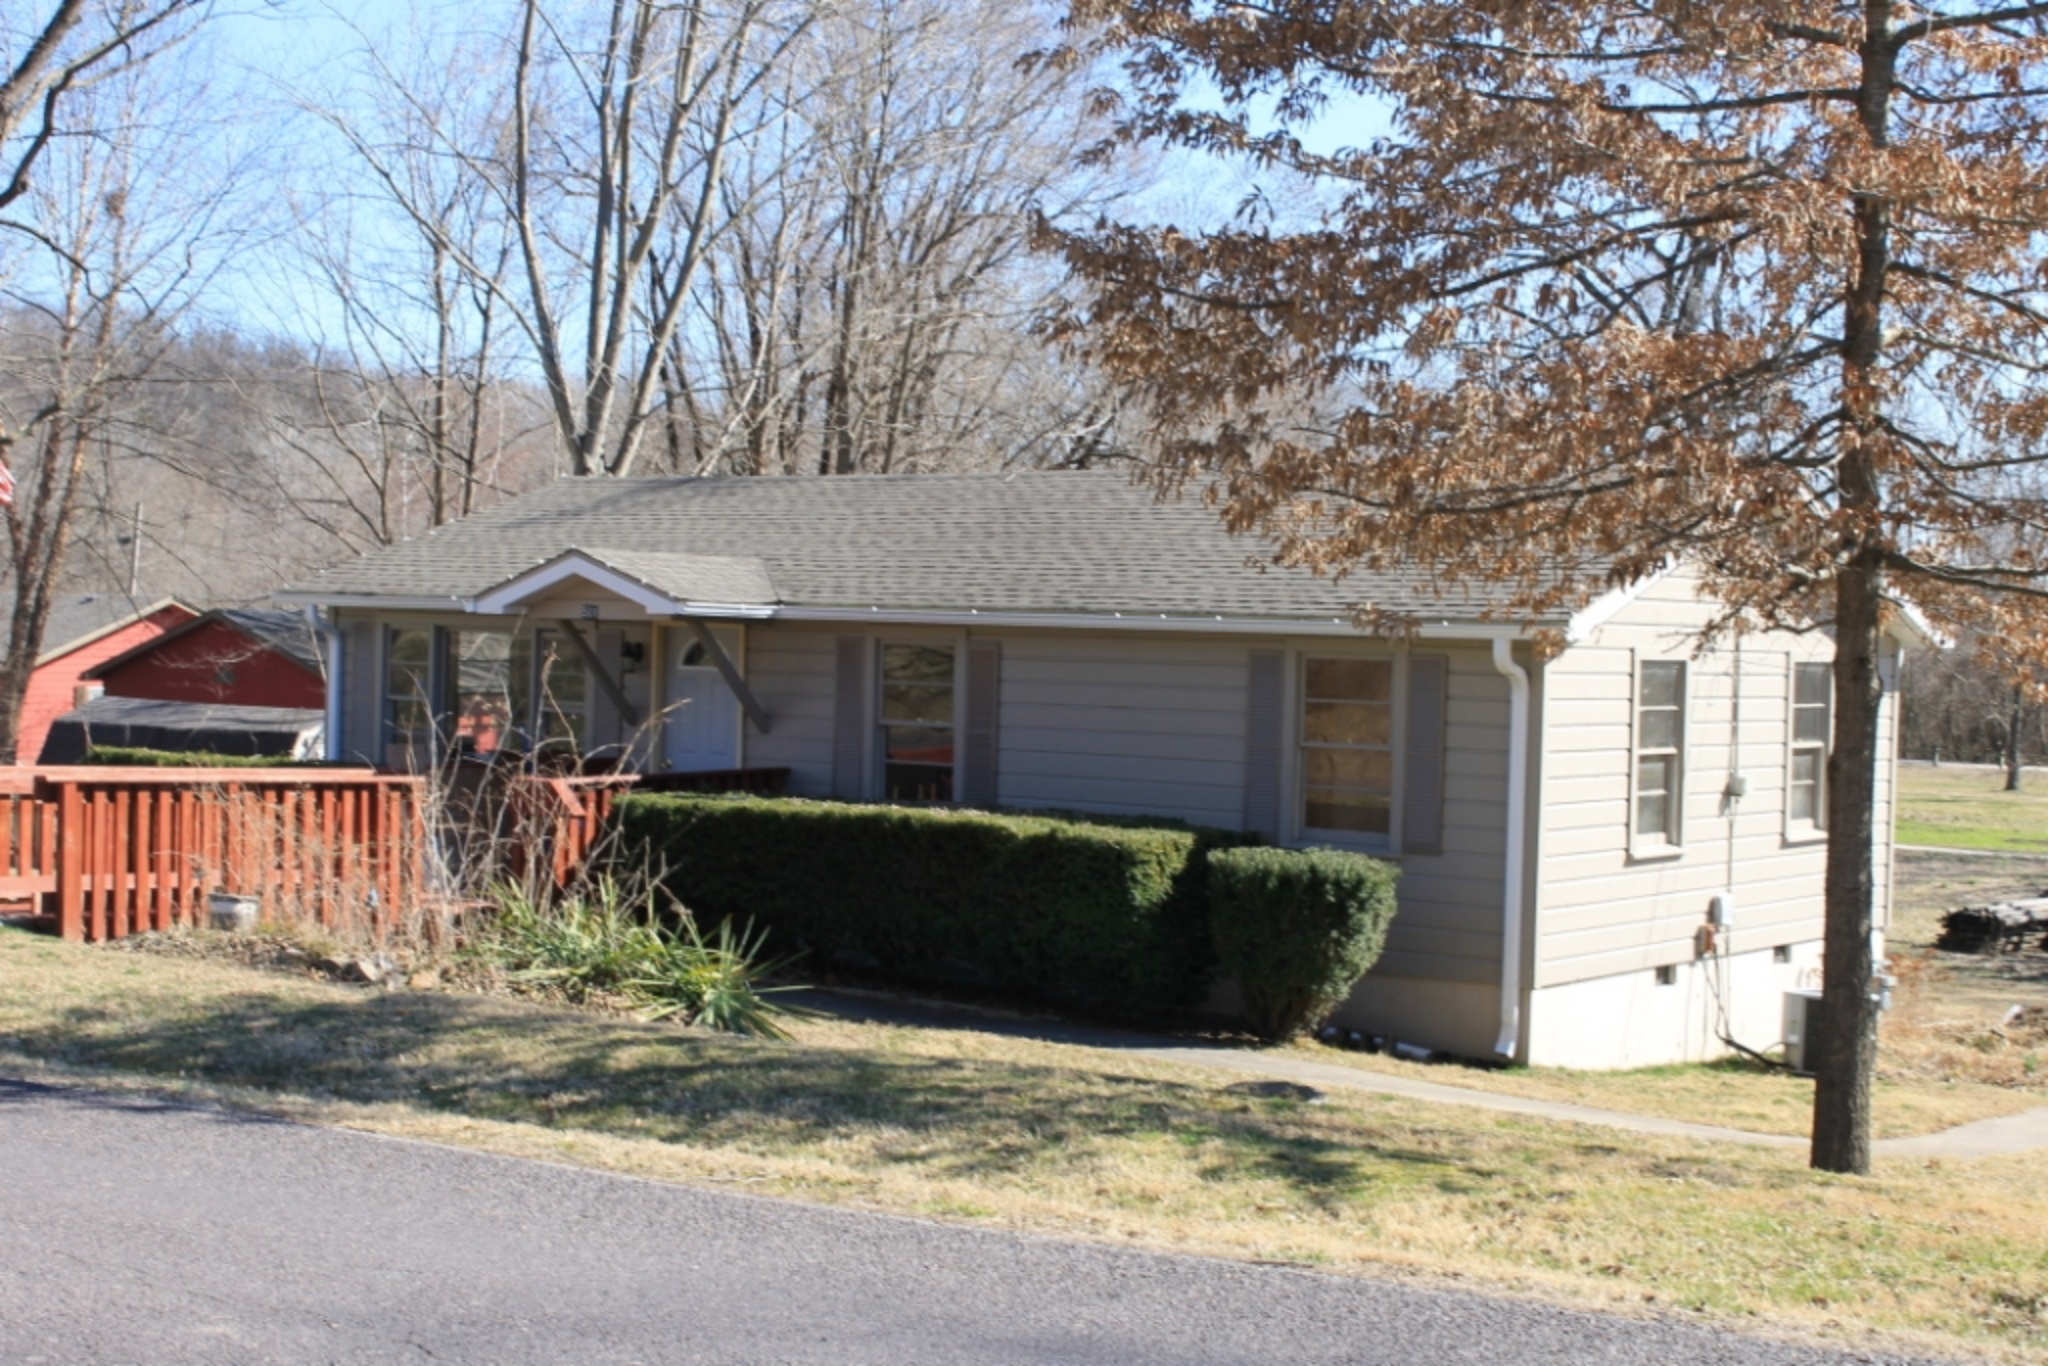
This one-story, massed plan side gable, frame ranch house is clad in clapboards. Its low gable roof is covered in asphalt shingles. The front facade of the house has four bays. The left bay contains a pair of two horizontal-over-two horizontal single hung windows. The next bay to the right contains a door with a half-round window. A front facing gable roofed hood supported by brackets shields the door which opens onto a small open porch. The two right bays each contain a two horizontal-over-two horizontal single-hung window. The windows are accented with decorative shutters. The west facade of the house has two bays, each containing a two horizontal-over-two horizontal single hung window.

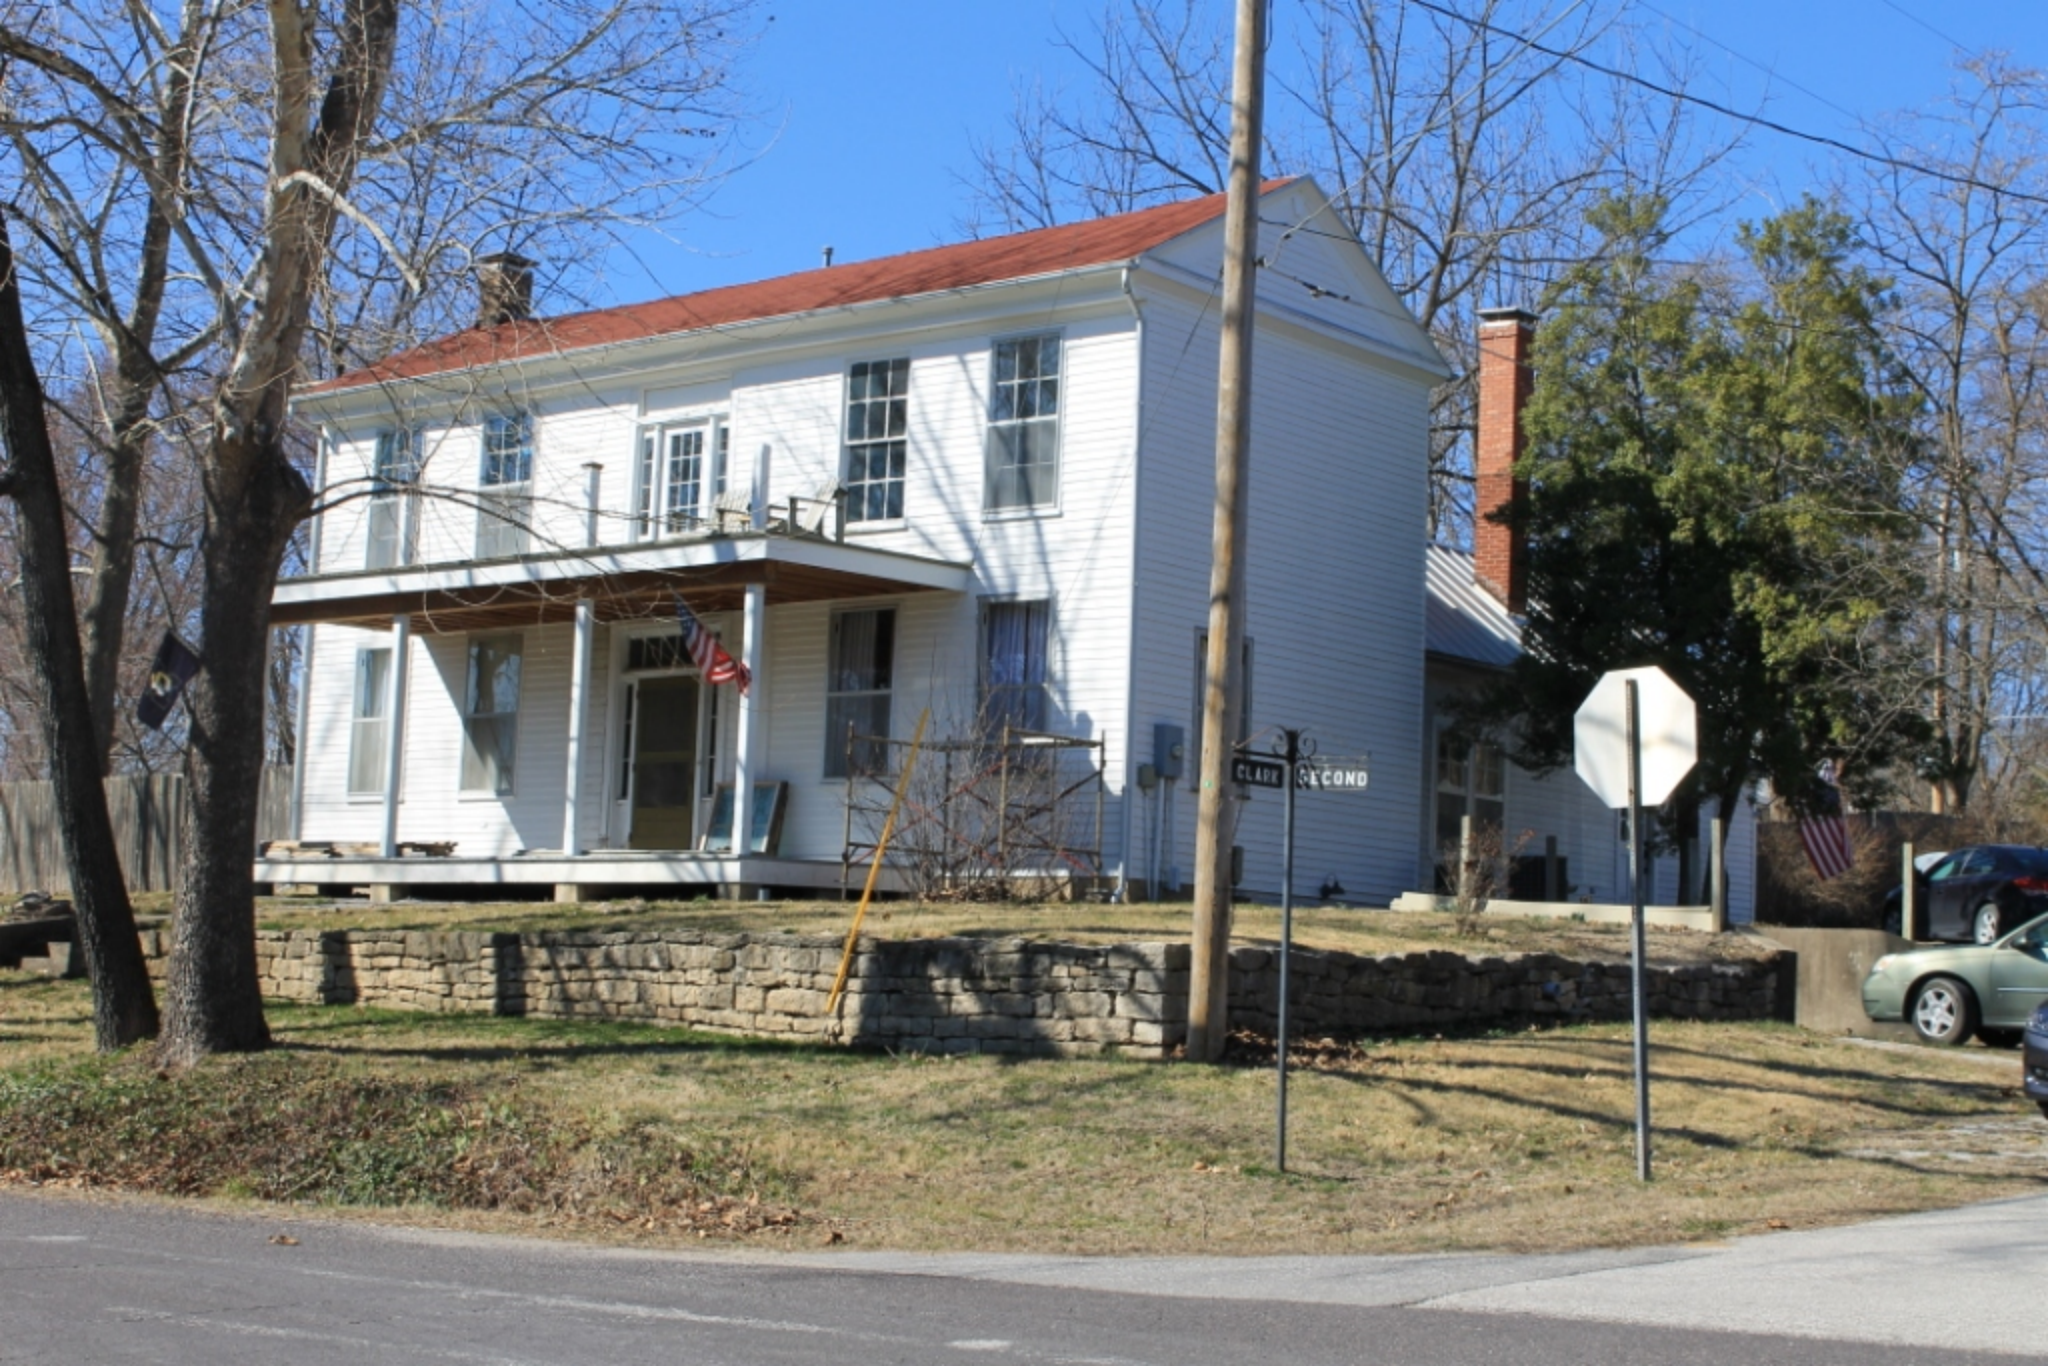
This two-story, frame, I-house with Federal details is clad in clapboards. The low side gable roof is covered in metal. The front (south) facade has a two story porch that extend along part of the front of the house. The first story porch is supported by wooden posts. The second story balcony is being restored with a railing and balusters. The front facade has five bays. The two left bays each contain a six-over-six single hung wooden window. The center bay contains a door with a six fixed paned transom and three panes above wooden panels sidelights. The door has a wooden screen door. The two right bays each contain a six-over-six single hung wooden window. The second story of the front facade has five bays. The two left bays each contain a six-over-six single hung window. The center bay contains a door with twelve fixed panes. Above the door is a single fixed pane transom now filled in with wood. On each side of the door is a four fixed pane sidelight. The two right bays each contain a six-over-six single hung wooden window. The rear wing of the house has a tall center front brick chimney. According to the Rocheport Historic District survey the house once had cornice moldings but these have been covered. The original survey photograph showed a pair of windows in the center bay of the second story and a hipped roof porch that also covered a front facing garage. The house is undergoing restoration and the garage has been removed and the roof of the porch changed to allow for the creation of the balcony. The building has an interior end brick chimney.

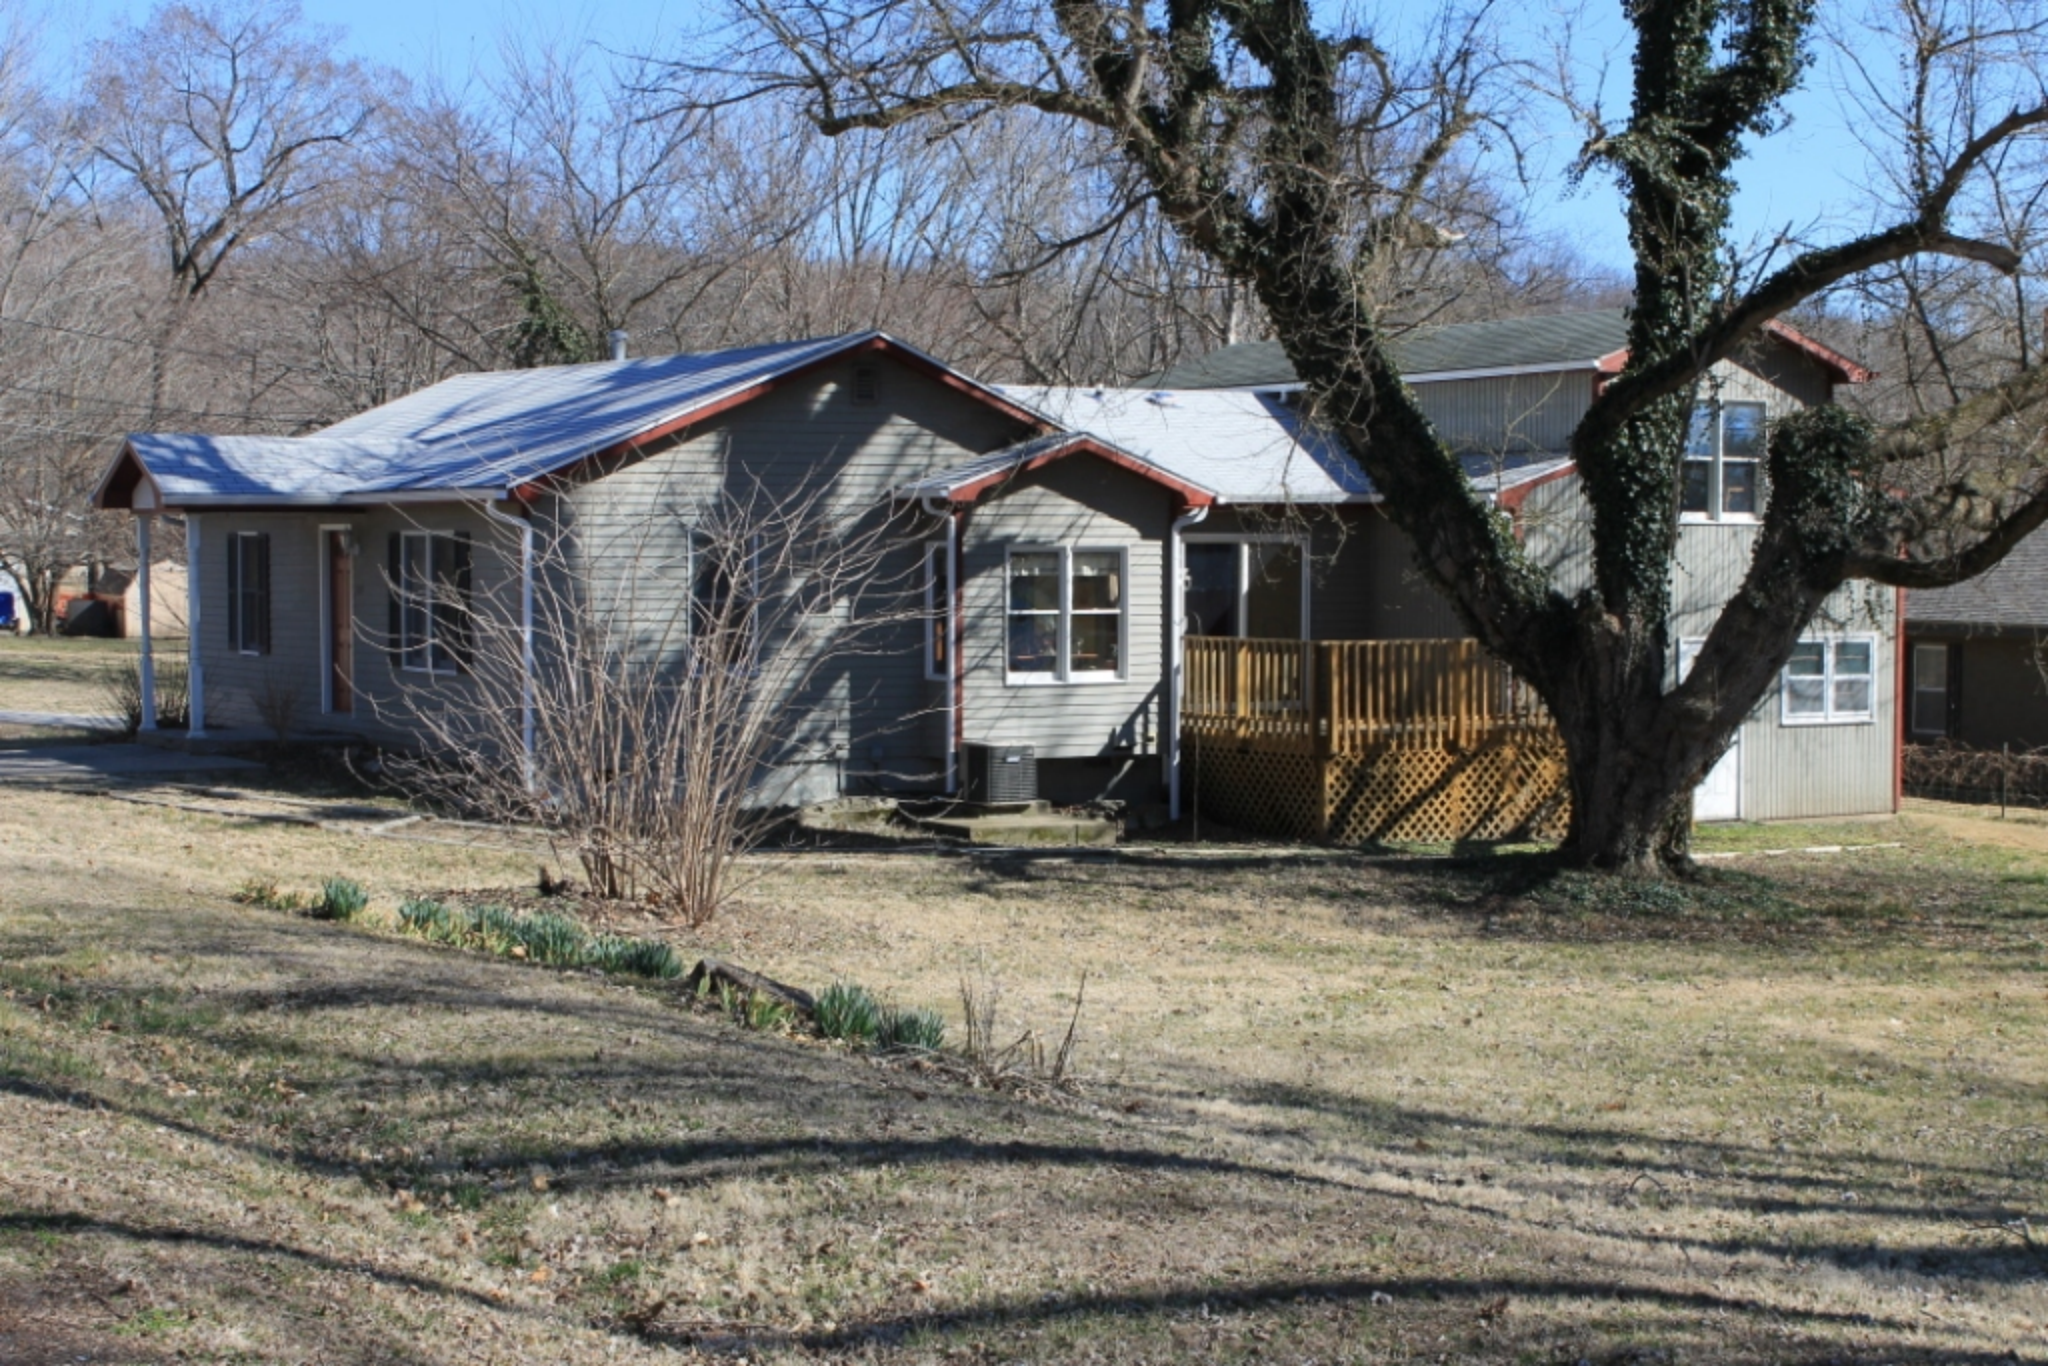
This irregular shaped house has three wings. Behind the low gable roofed main block of the house is a gable roofed wing that connects the main wing of the building to a two story wing housing a garage on the ground floor and rooms on the second floor. This wing has a low gable roof. The central connecting wing has a deck extending off the west side. The house is clad in clapboards and the roof is covered in asphalt shingles. The main block of the house has a low side gable roof and a small gable roofed porch in the center. The pediment of the porch has a sunburst decoration. The front facade has three bays. The left bay contains a one-over-one single hung window. The center bay under the porch contains a door. The right bay contains a pair of one-over-one single hung windows.

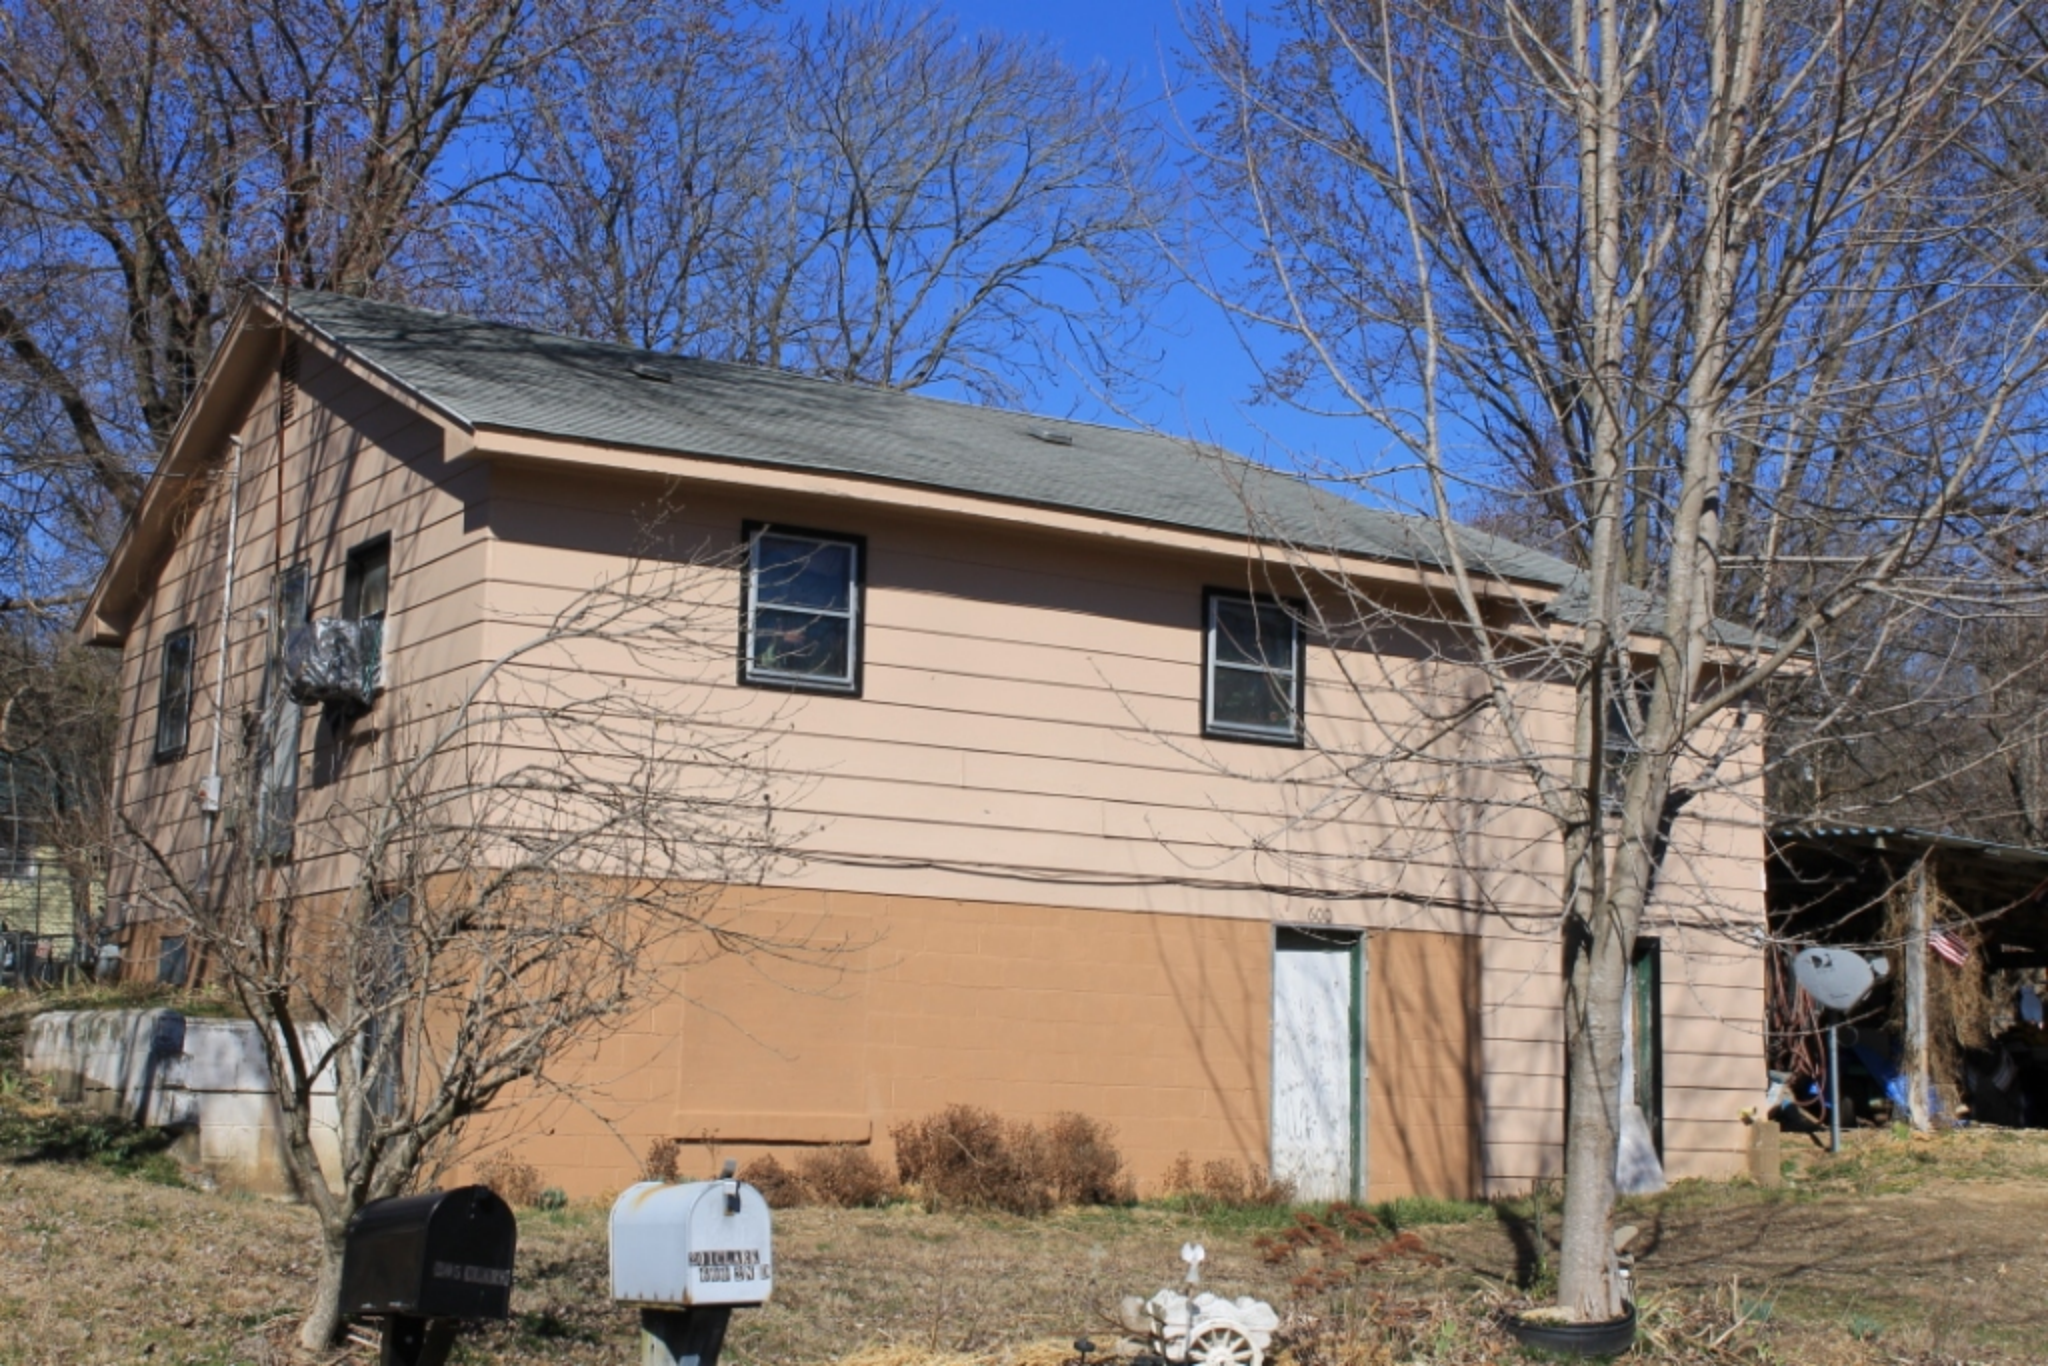
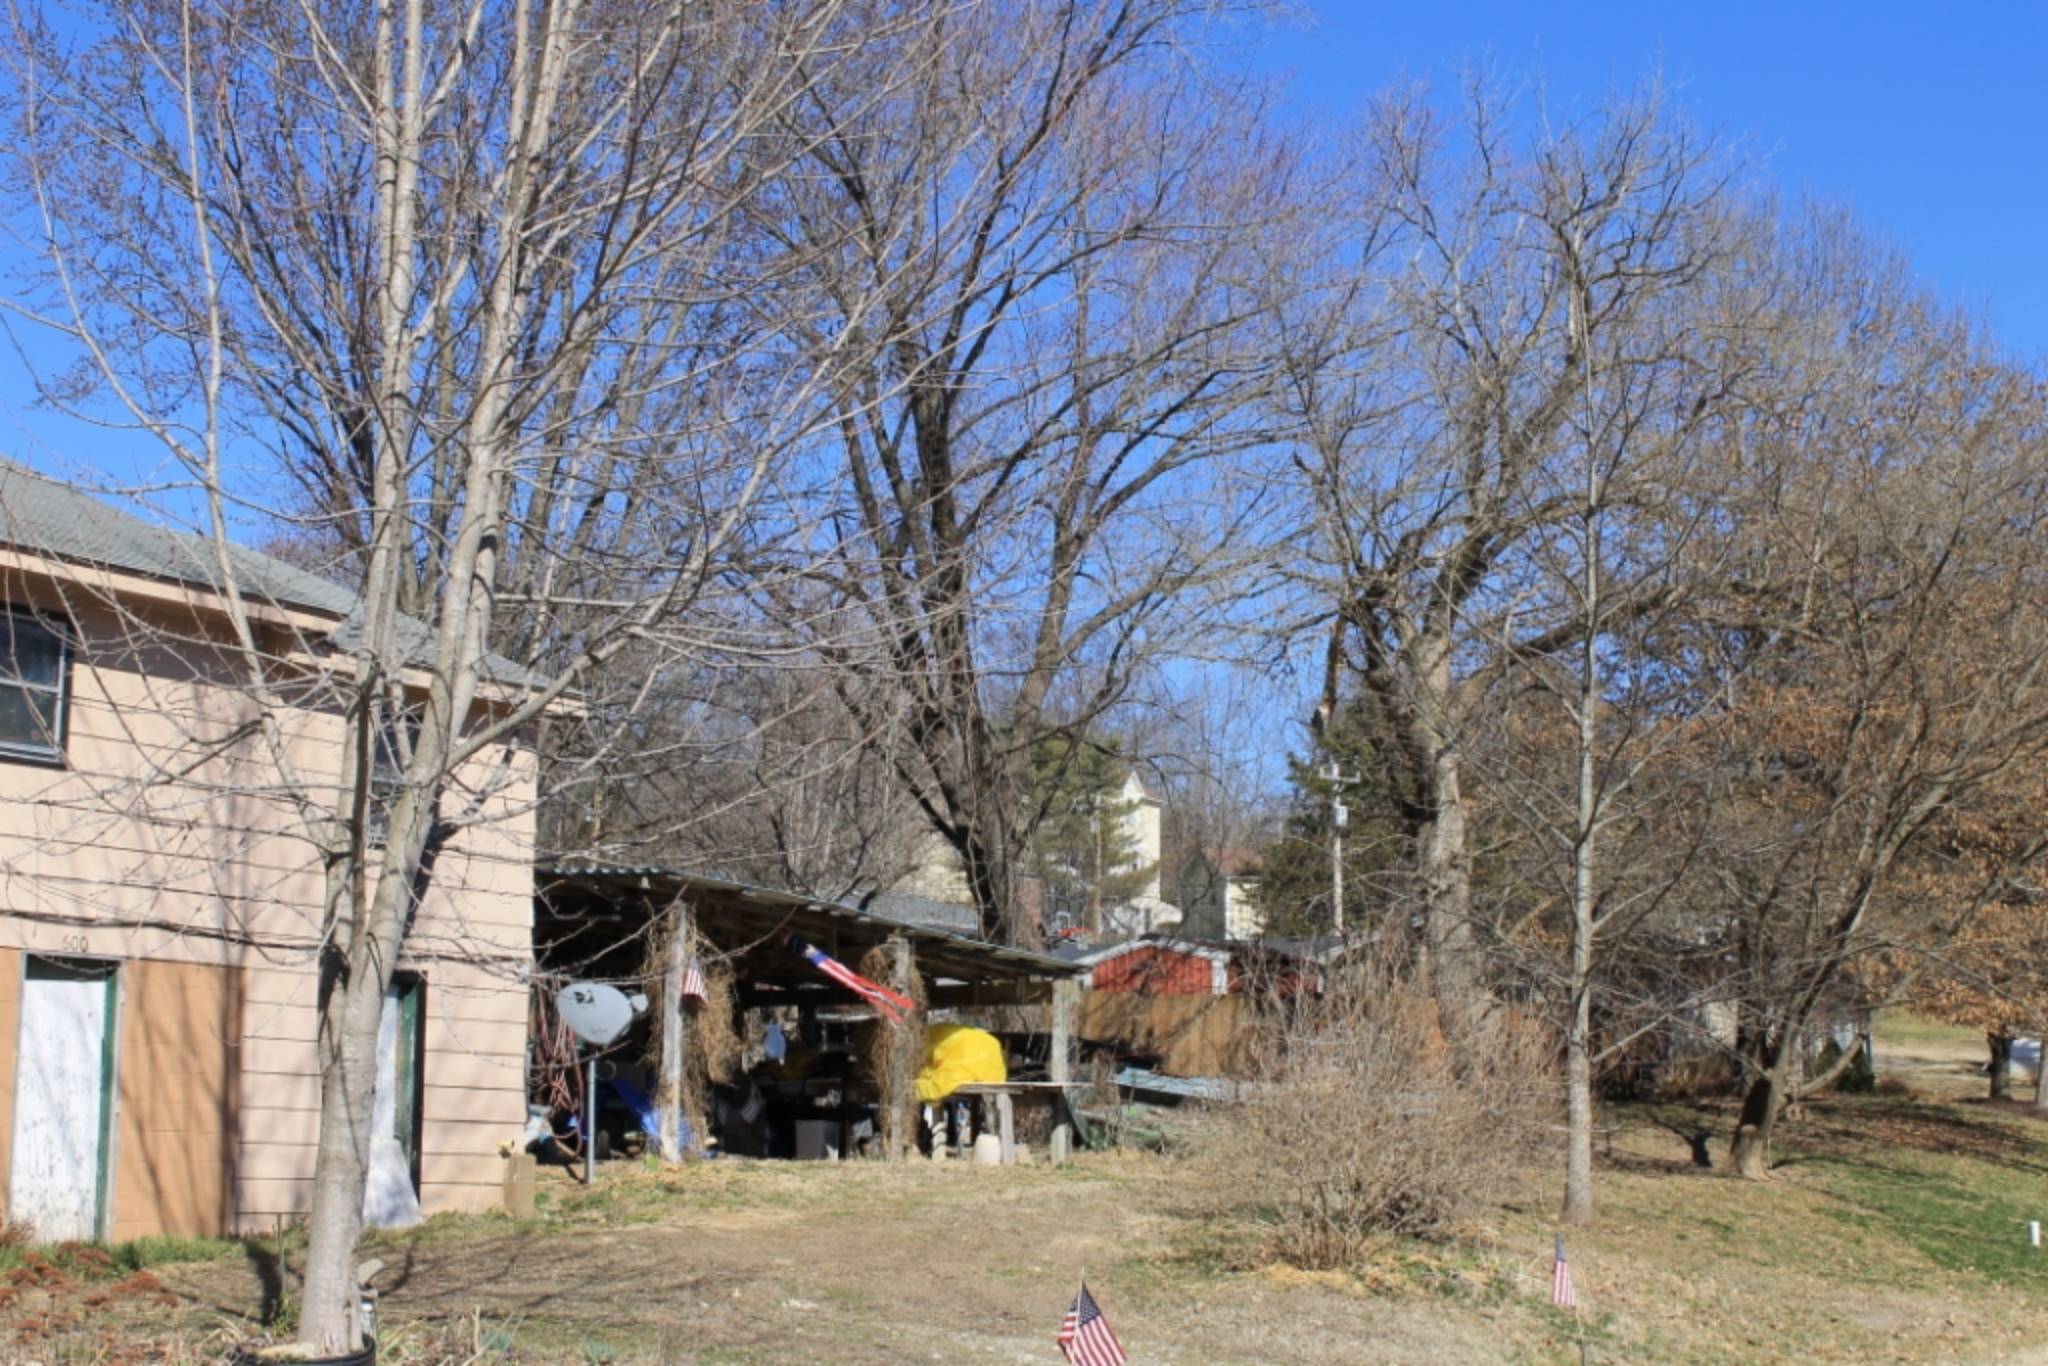
This two-story, massed plan side gable, frame ranch building is clad in partly in clapboards and partly in concrete blocks. The roof is covered with asphalt shingles. The first story, which is made of concrete block on the north and west walls and covered in wide clapboards on the east northeast corner and east side, has two bays, each containing a door. The second story, all of which is covered in wide clapboards, has three bays, each containing a one-over-one single hung window.
