MISSOURI DEPARTMENT OF NATURAL RESOURCES
STATE HISTORIC PRESERVATION OFFICE, P.O. Box 176, Jefferson City, MO 65102
ARCHITECTURAL/HISTORIC INVENTORY FORM

1. SURVEY NO. BO-AS-009-0001		2. SURVEY NAME: Rocheport Historic District	
3. COUNTY: Boone		4. ADDRESS (STREET NO.)	STREET (NAME) Katy Trail
5. CITY: Rocheport	VICINITY: <input checked="" type="checkbox"/>	6. UTM: / /	LAT: LONG: T: 48W R: 15W S: 1

8. HISTORIC NAME (IF KNOWN): M.K.&T. Railroad tunnel		9. PRESENT/OTHER NAME (IF KNOWN): Katy trail tunnel	
10. OWNERSHIP: <input type="checkbox"/> PRIVATE <input checked="" type="checkbox"/> PUBLIC		11A. HISTORIC USE (IF KNOWN): railroad tunnel	11B. CURRENT USE: Katy Trail tunnel
HISTORICAL INFORMATION

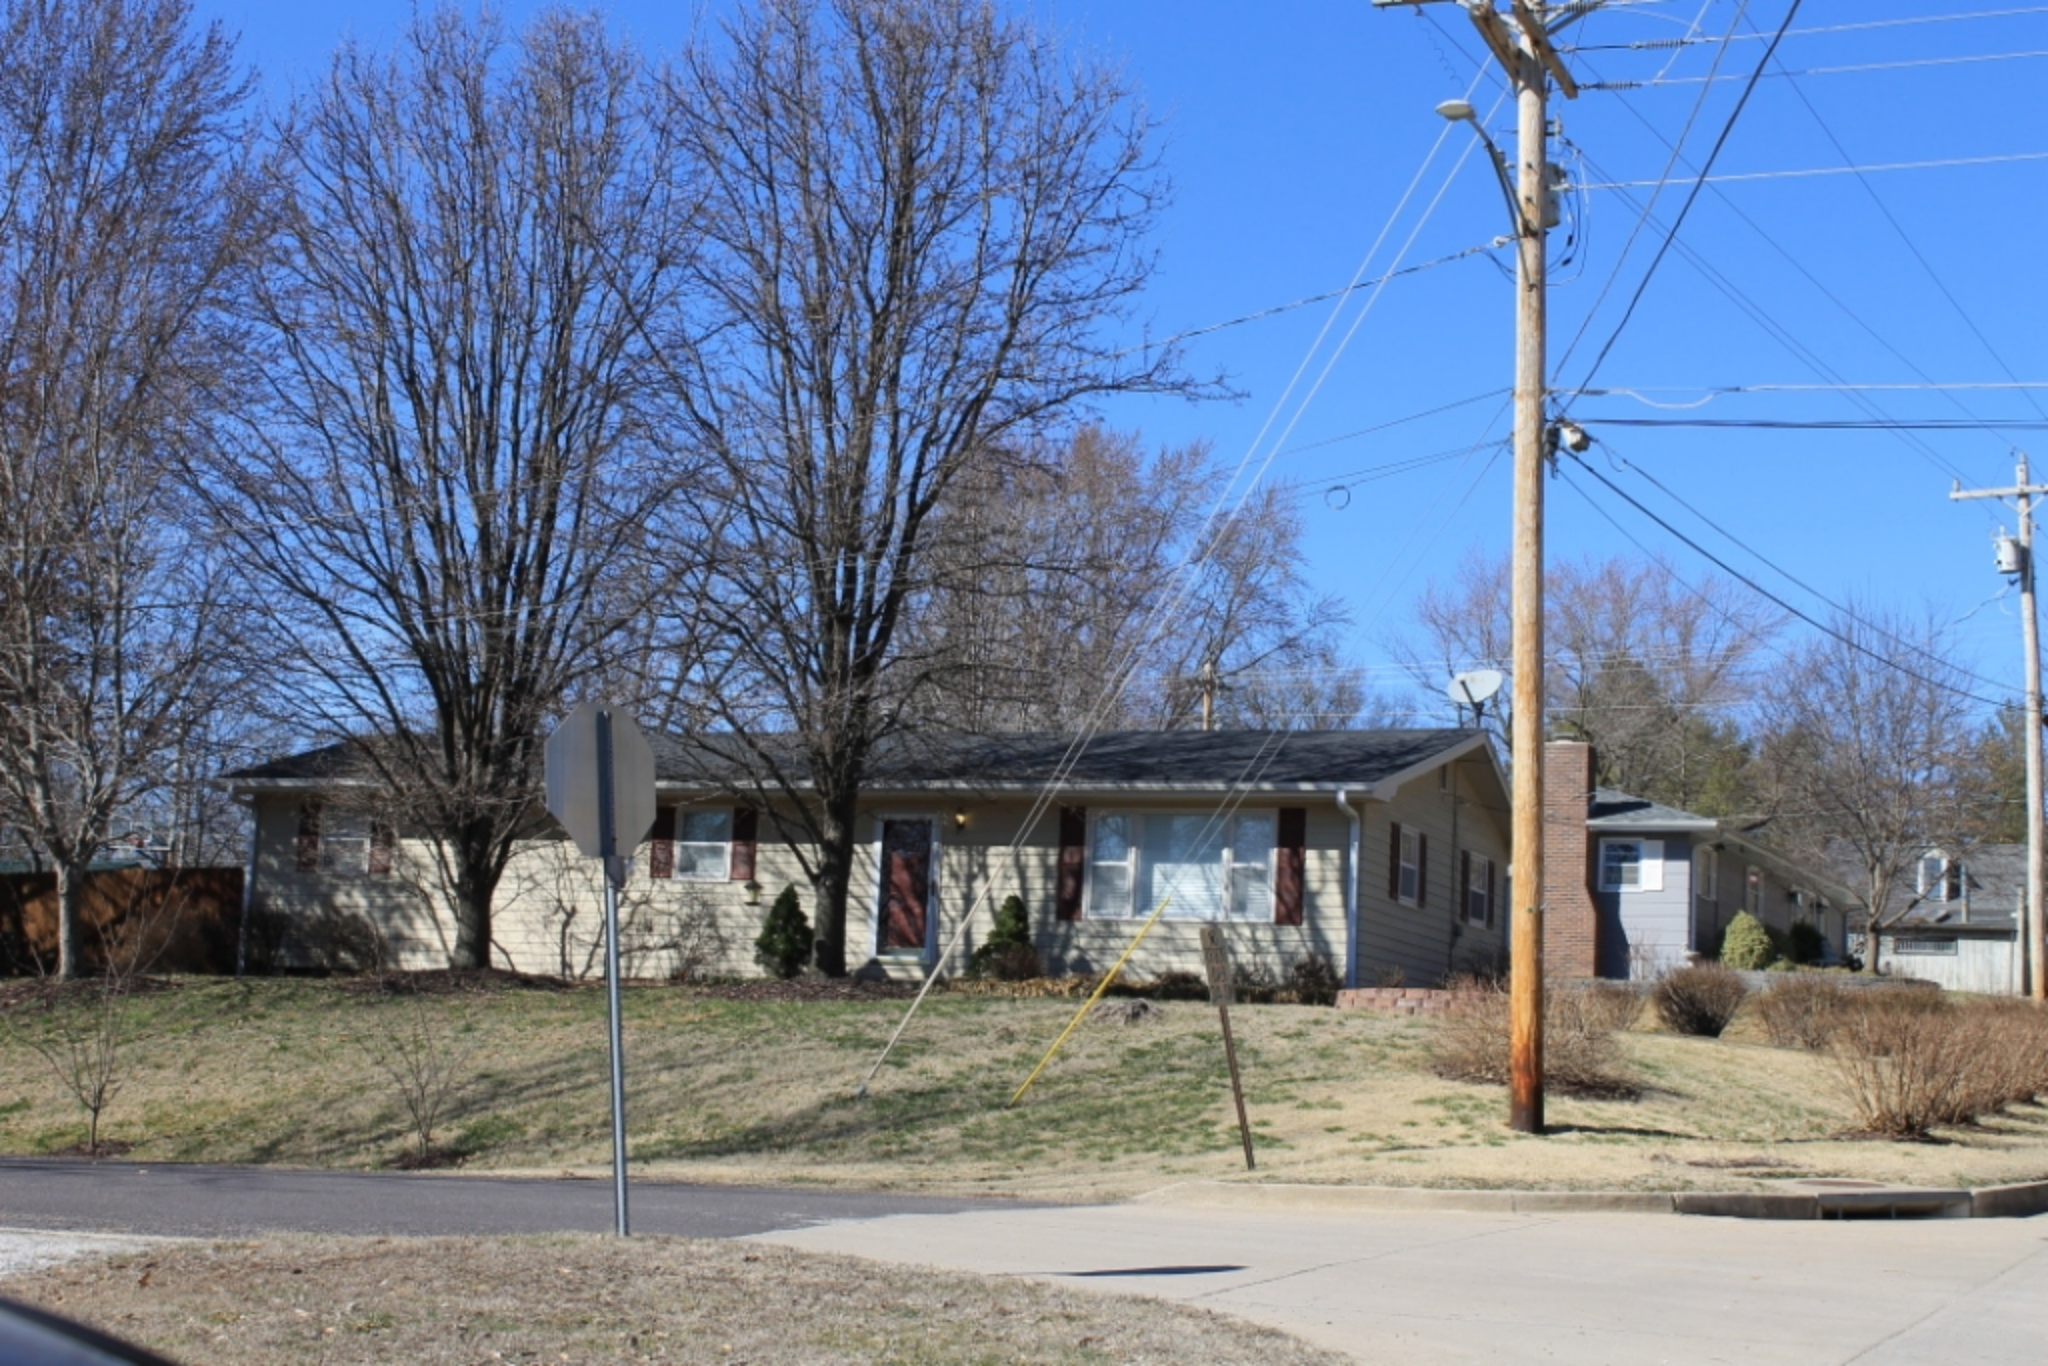
This one-story, massed plan side gable, frame ranch house has a low gable roof. The house is clad in clapboards and its roof is covered in asphalt shingles. The front (south) facade has four bays. The left bay contains a one-over-one single hung window. The next bay also contains a one-over-one single hung window. The next bay contains a door with a modern metal and glass storm door. The door opens onto a stoop. The rightmost bay contains a large fixed glass picture window flanked on either side by a one-over-one single hung window. The windows have decorative shutters.

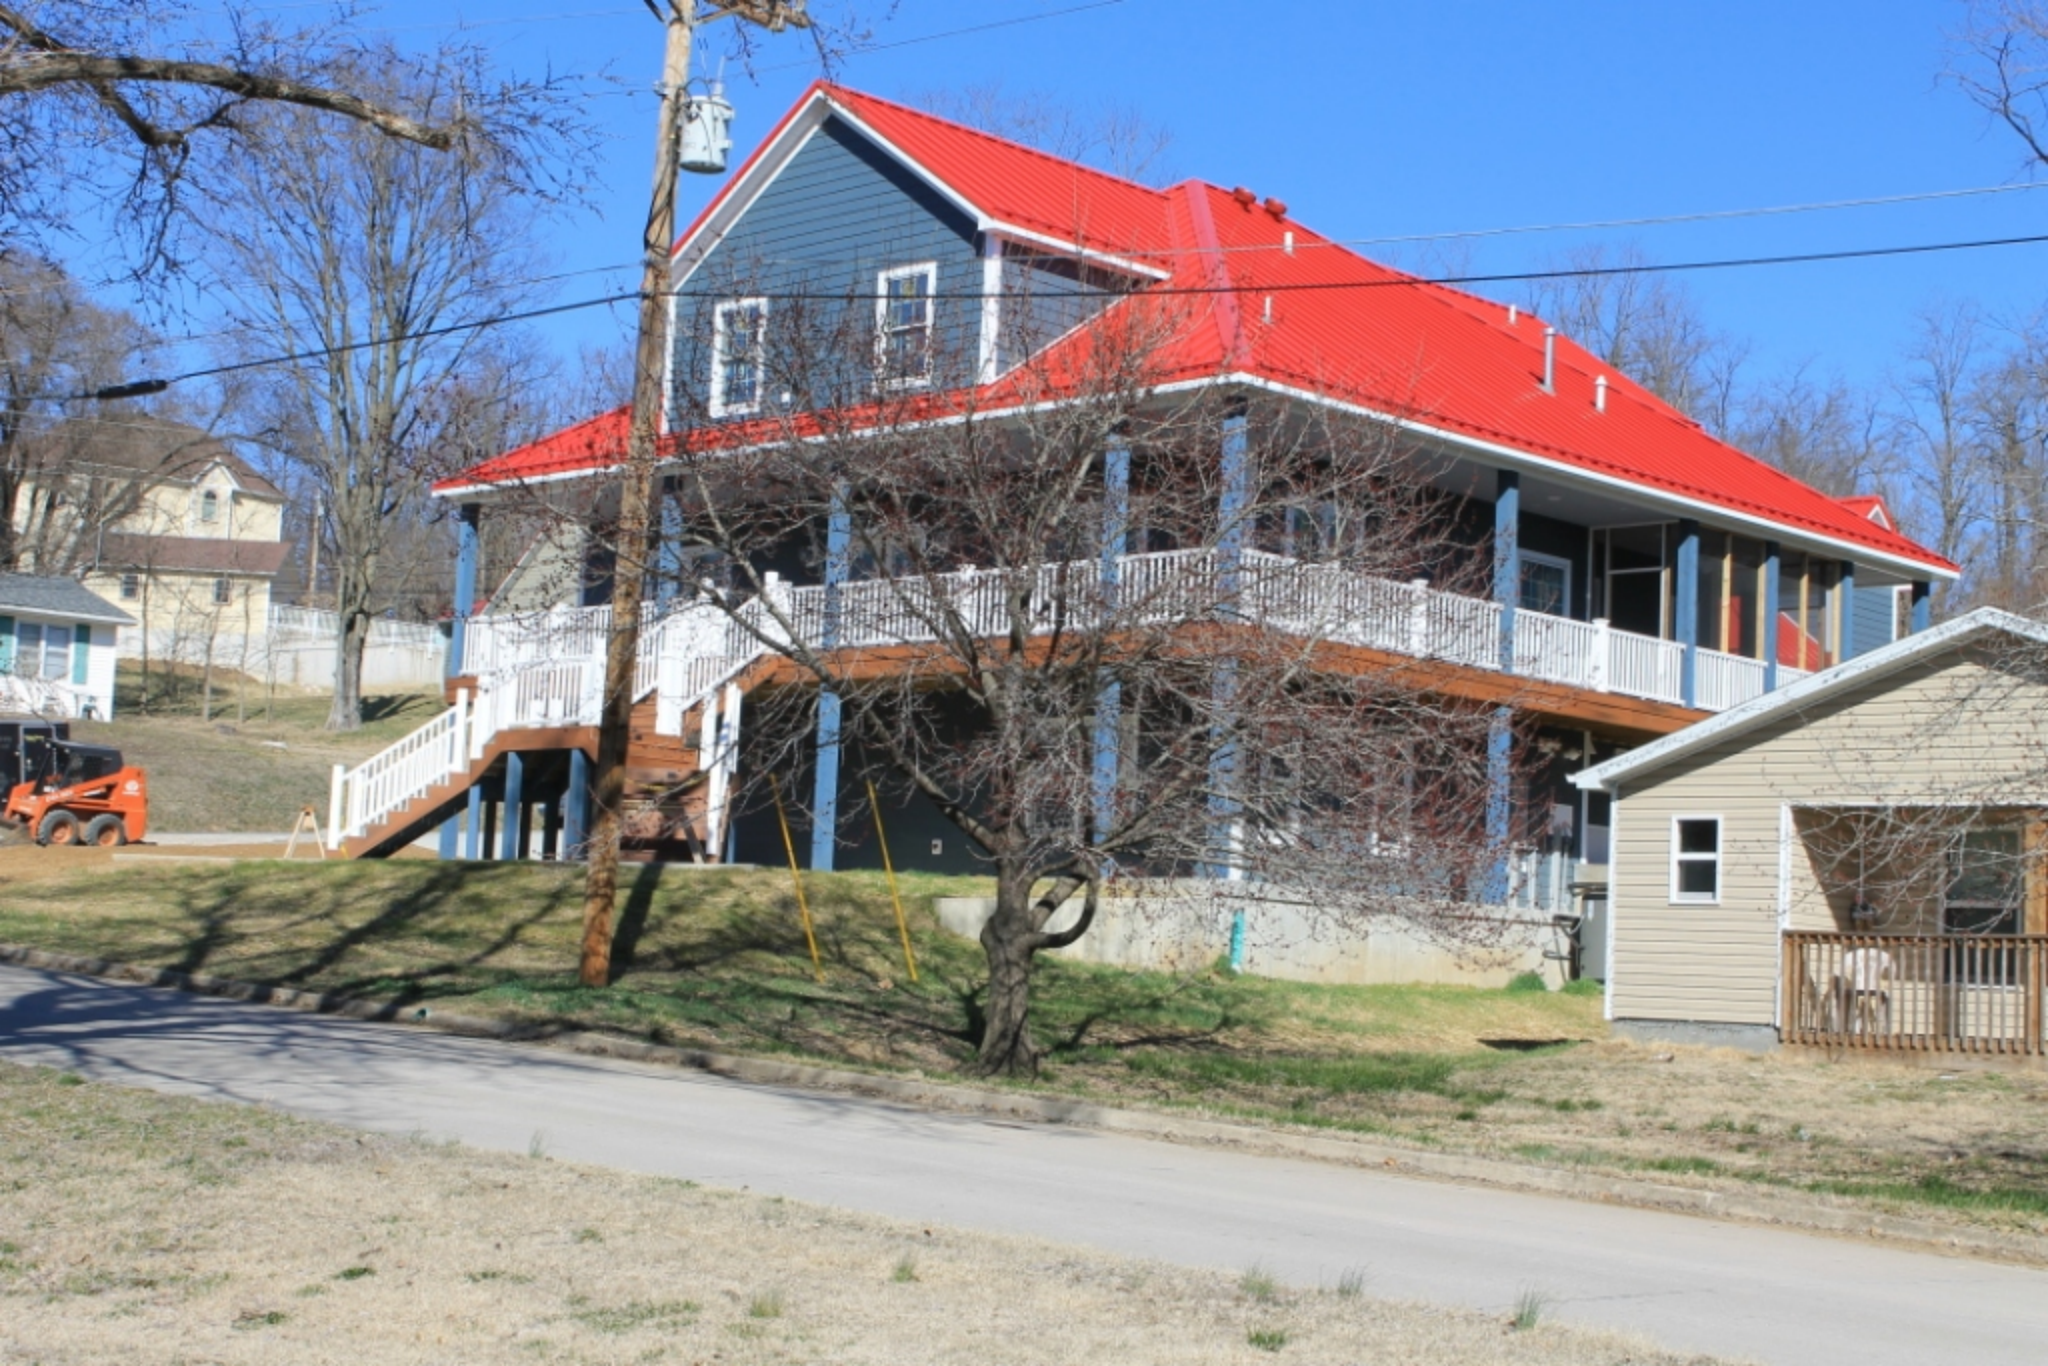
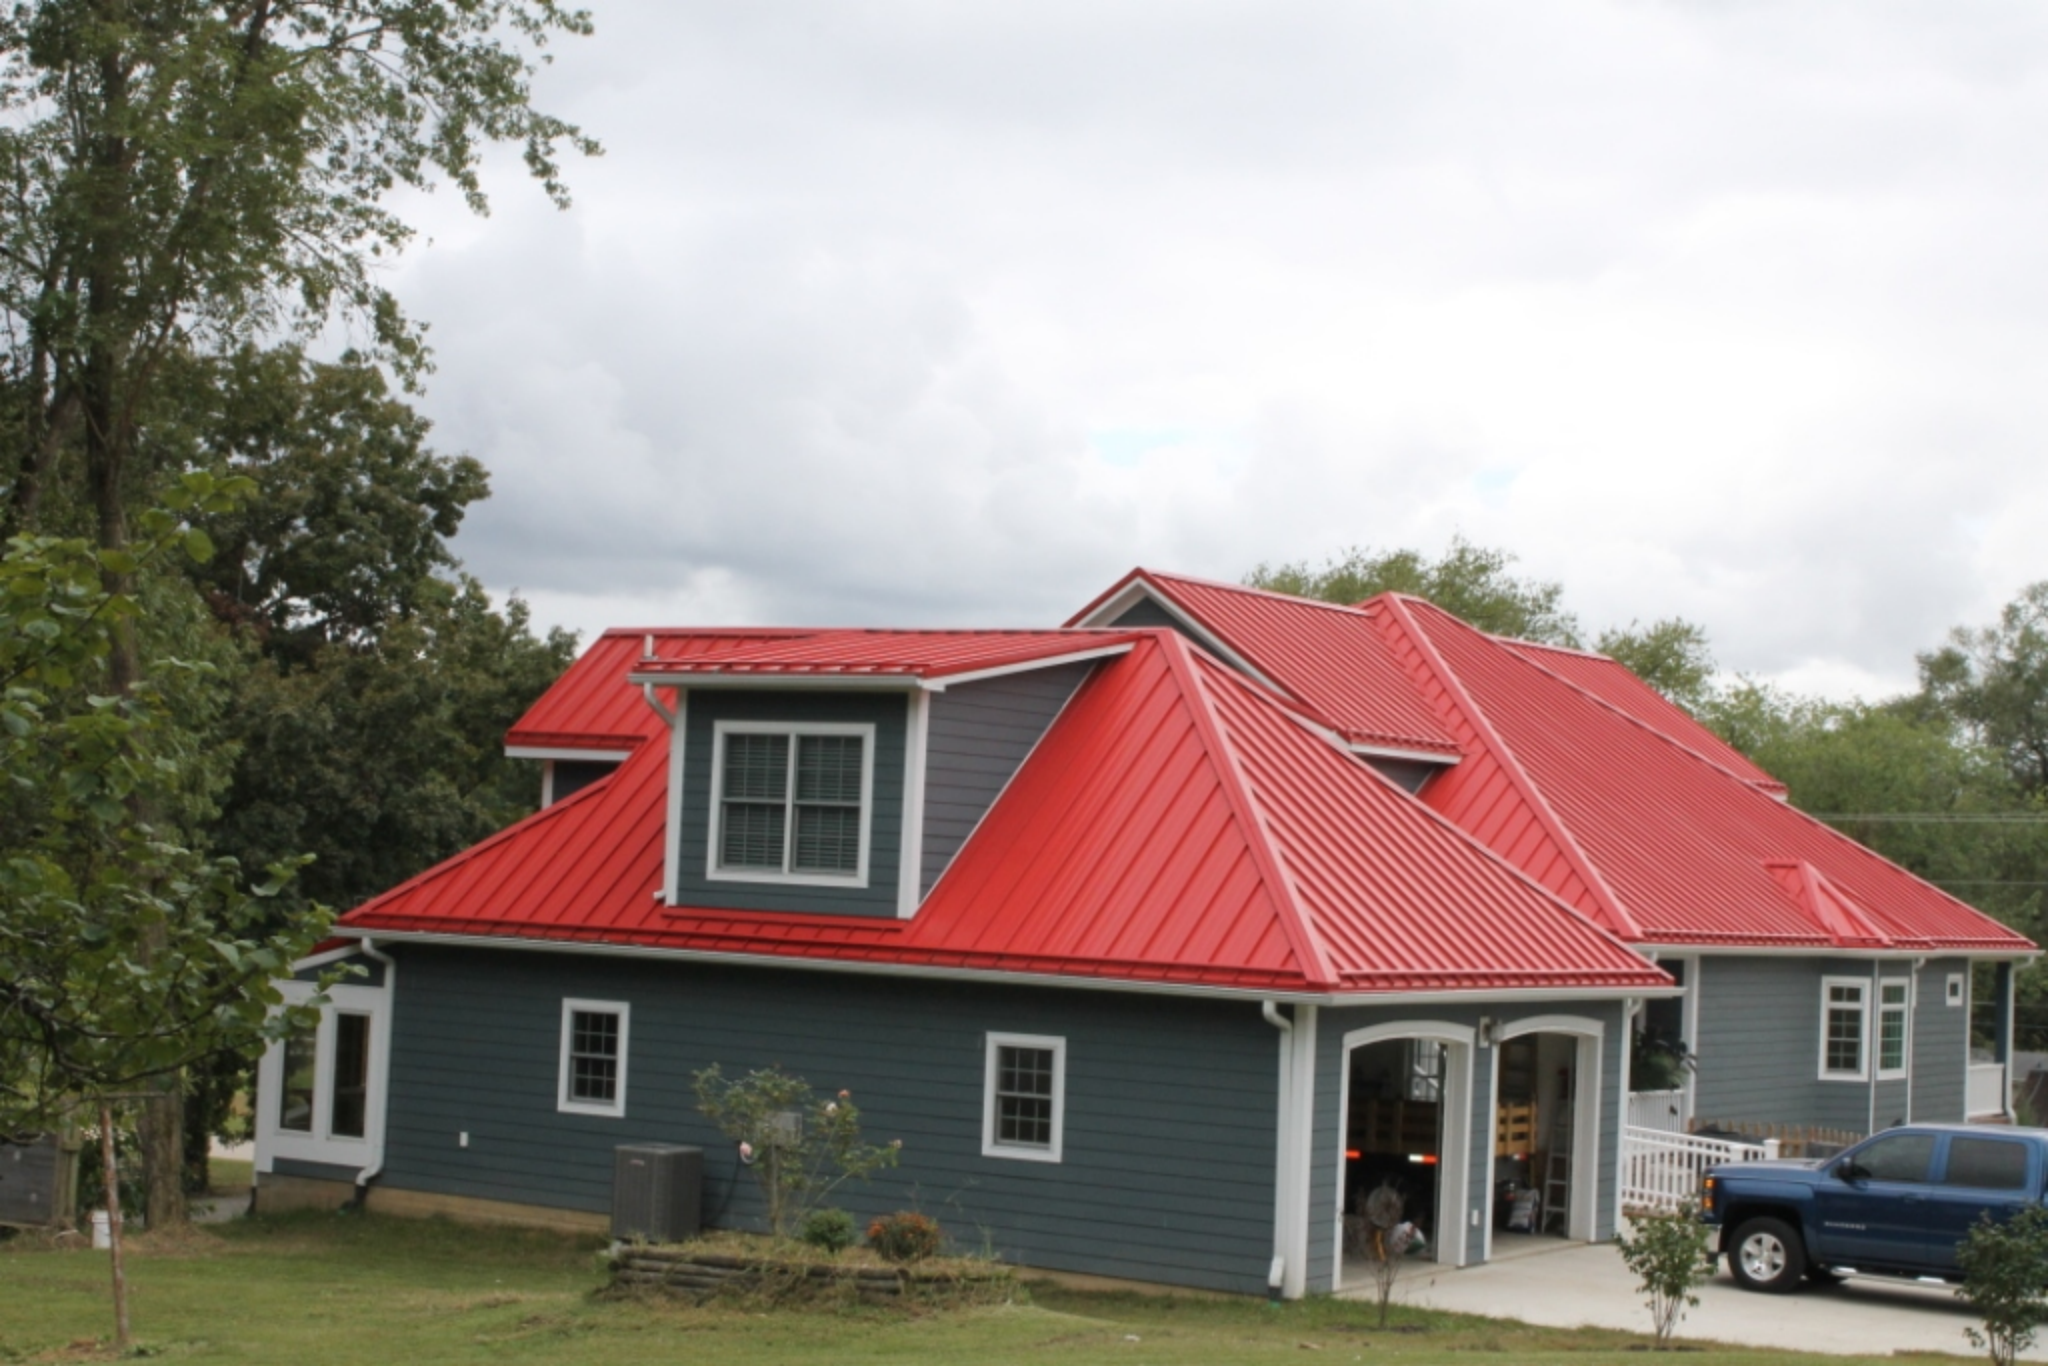
This 2 1/2 story, massed plan pyramidal house is clad in vinyl siding and the high hipped roof is covered in metal. According to McAlester, its style is American Vernacular. The most dominant feature of this house is the exterior stairway that leads to a second story wrap around porch and the main entrance of the house. Stairs rise from each side of the yard, then join in a single stairway that leads to the porch. The ground level of the house has a concrete floored porch without a balustrade or railing. The front (west) facade of this level has two bays, each containing a pair of four-over-four vinyl windows. The front (west) facade of the main level of the house has three bays. The left bay contains a pair of six-over-six vinyl windows. The center bay contains a door. The right bay contains a pair of six-over-six vinyl windows. The front (west) facade of the gable on the upper story has two bays, each containing a six-over-six vinyl window.

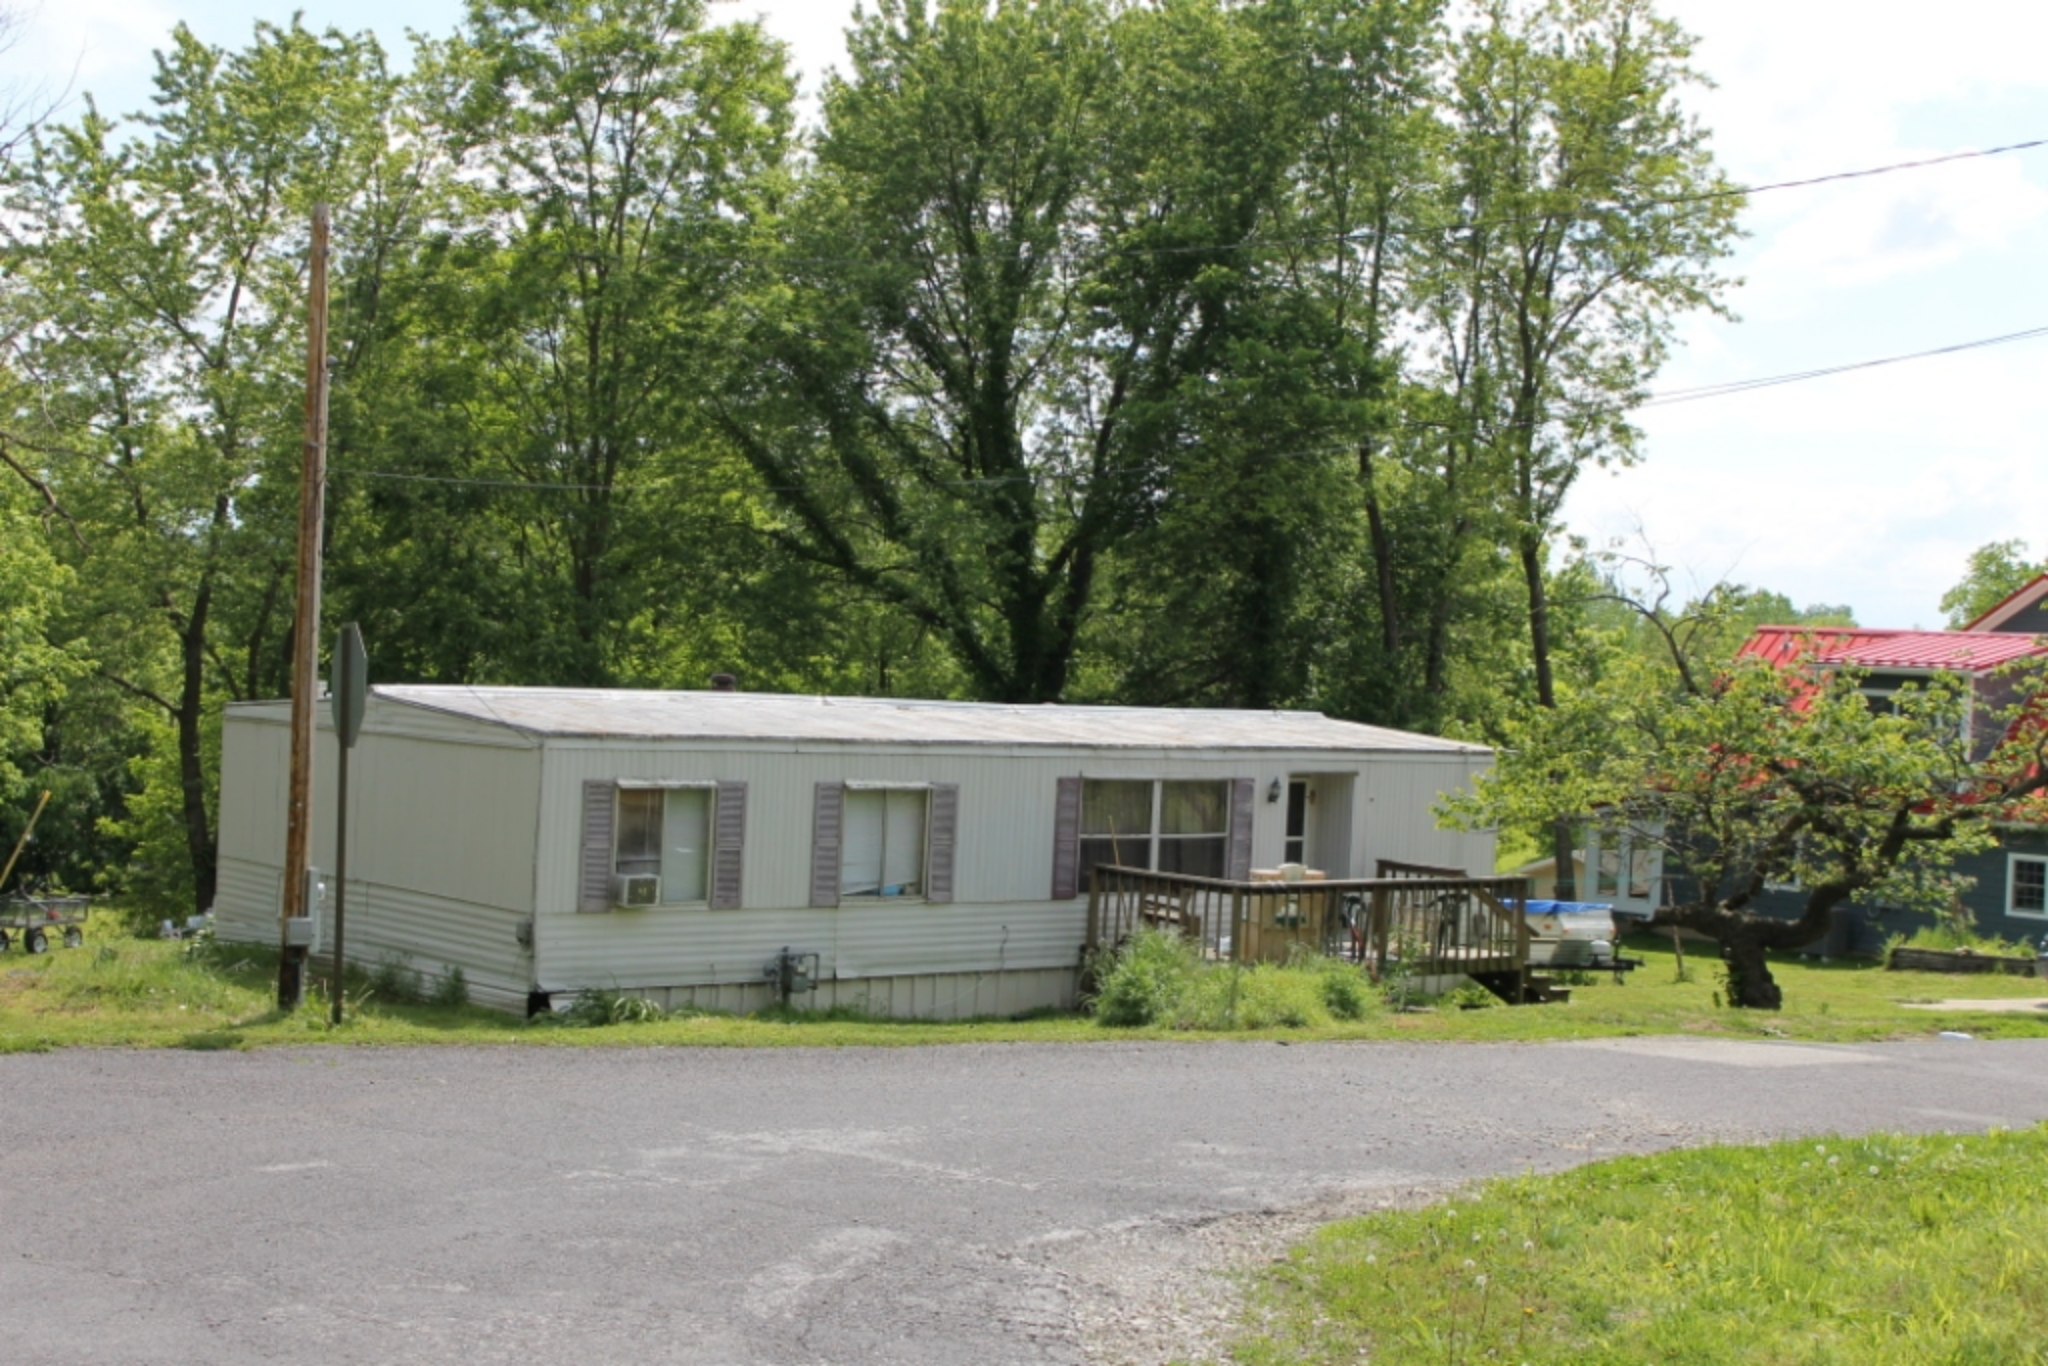
This one-story double wide mobile home is clad in metal siding and its very low gable roof is covered in metal. The mobile home has four bays. The leftmost bay contains a pair of windows. The next bay contains a pair of windows. The third bay contains a pair of wider windows. The right bay contains an inset doorway that opens onto a deck.

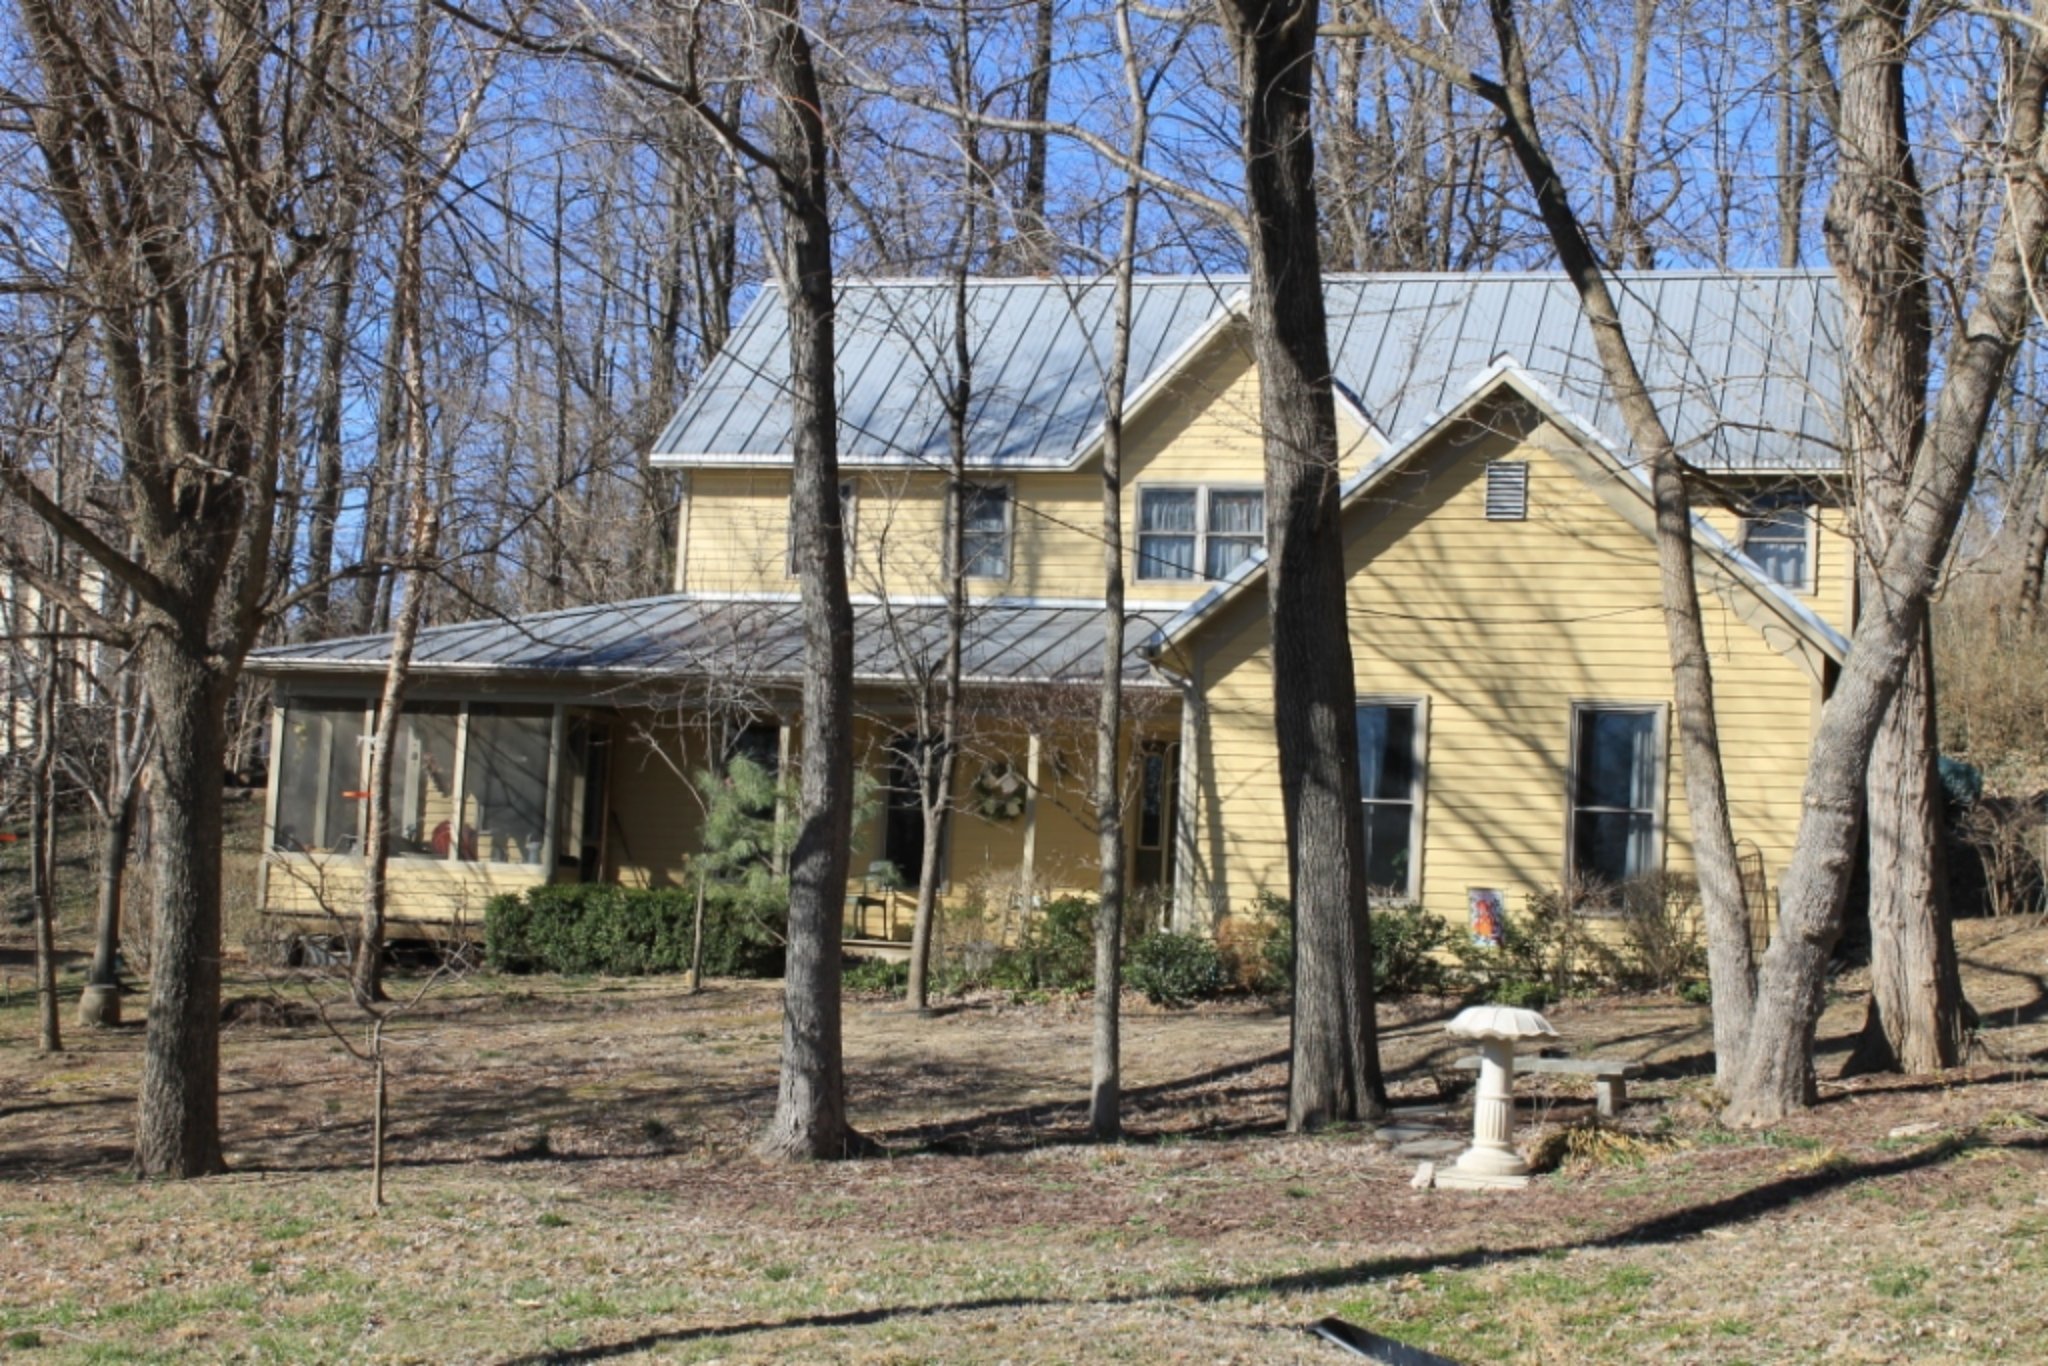
This massed plan, frame house is clad in vinyl siding and the roof is covered with metal. The house is in the New Traditional-Farmhouse style and has several wings. The main block of this building is a two-story rectangular wing with a center gable. At the right end of the main block of the building is a one-story gable-fronted wing that extends to the south. At the point where the two wings meet a hipped roof porch extends along the front facade of the main block of the house and wraps around the west side of the house. A portion of the porch is screened. The rear part of the area under the porch roof is enclosed as a room. The first story of the front facade of the house has five bays. The two left bays each contain a window. The next bay, located near the point where the gable-fronted wing meets the main block of the house, contains a door. The two right bays are located in the gable-roofed wing; each bay contains a one-over-one single hung window. The second story of the house contains four bays. The two left bays each contain a one-over-one single hung window. The center bay, which is located under the center gable, contains a trio of one-over-one single hung windows. The right bay contains a one-over-one single hung window.
