MISSOURI DEPARTMENT OF NATURAL RESOURCES
STATE HISTORIC PRESERVATION OFFICE, P.O. Box 176, Jefferson City, MO 65102
ARCHITECTURAL/HISTORIC INVENTORY FORM

1. SURVEY NO. BO-AS-009-0001		2. SURVEY NAME: Rocheport Historic District	
3. COUNTY: Boone		4. ADDRESS (STREET NO.)	STREET (NAME) Katy Trail
5. CITY: Rocheport	VICINITY: <input checked="" type="checkbox"/>	6. UTM: / /	LAT: LONG: T: 48W R: 15W S: 1

8. HISTORIC NAME (IF KNOWN): M.K.&T. Railroad tunnel		9. PRESENT/OTHER NAME (IF KNOWN): Katy trail tunnel	
10. OWNERSHIP: <input type="checkbox"/> PRIVATE <input checked="" type="checkbox"/> PUBLIC		11A. HISTORIC USE (IF KNOWN): railroad tunnel	11B. CURRENT USE: Katy Trail tunnel
HISTORICAL INFORMATION

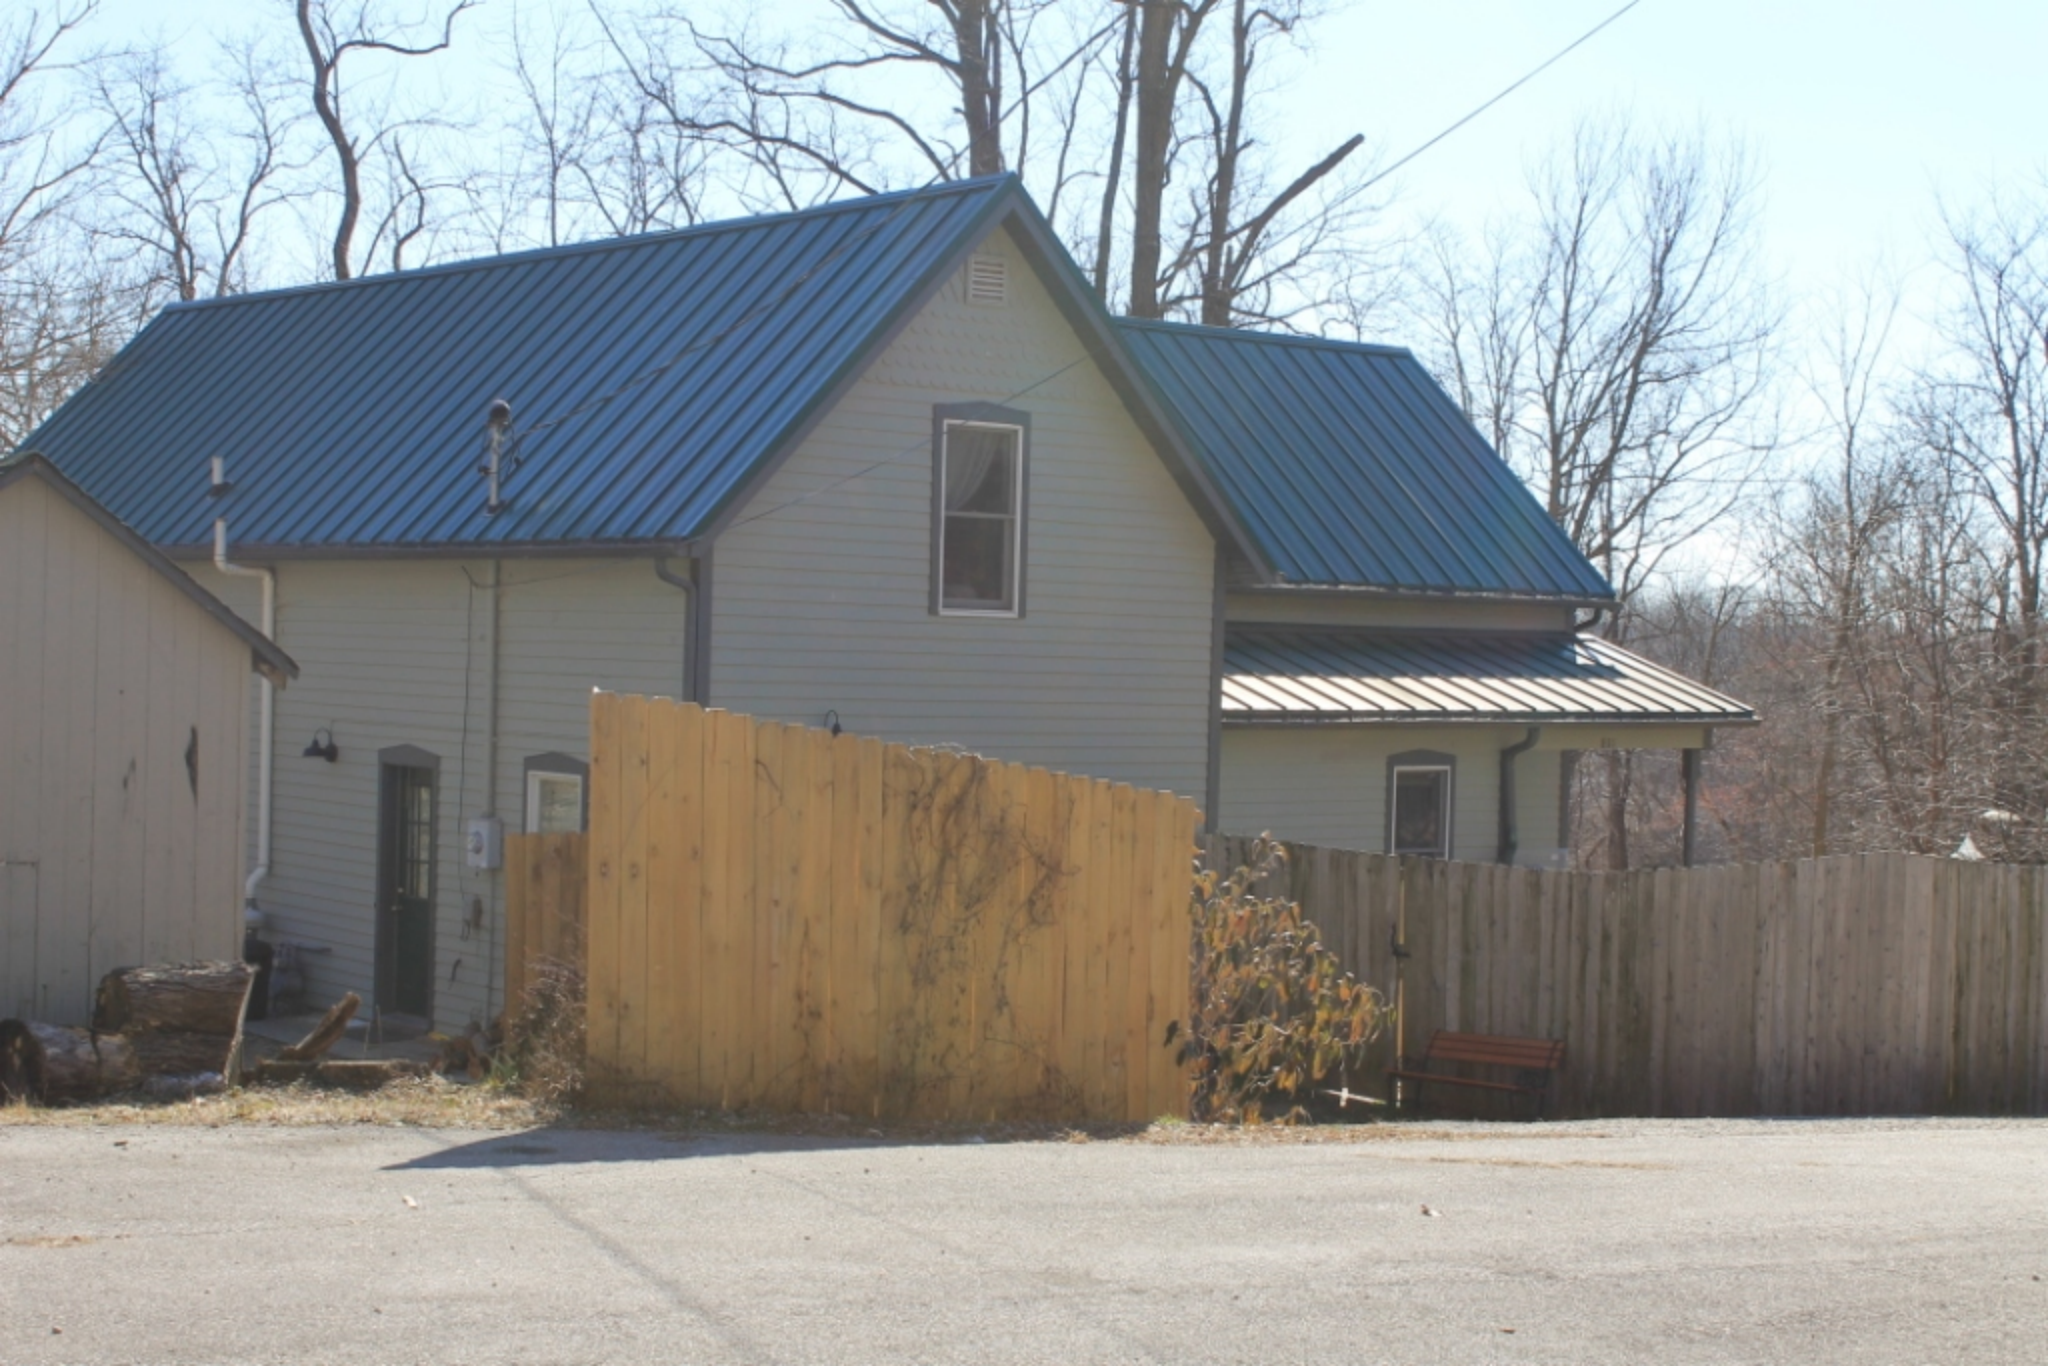
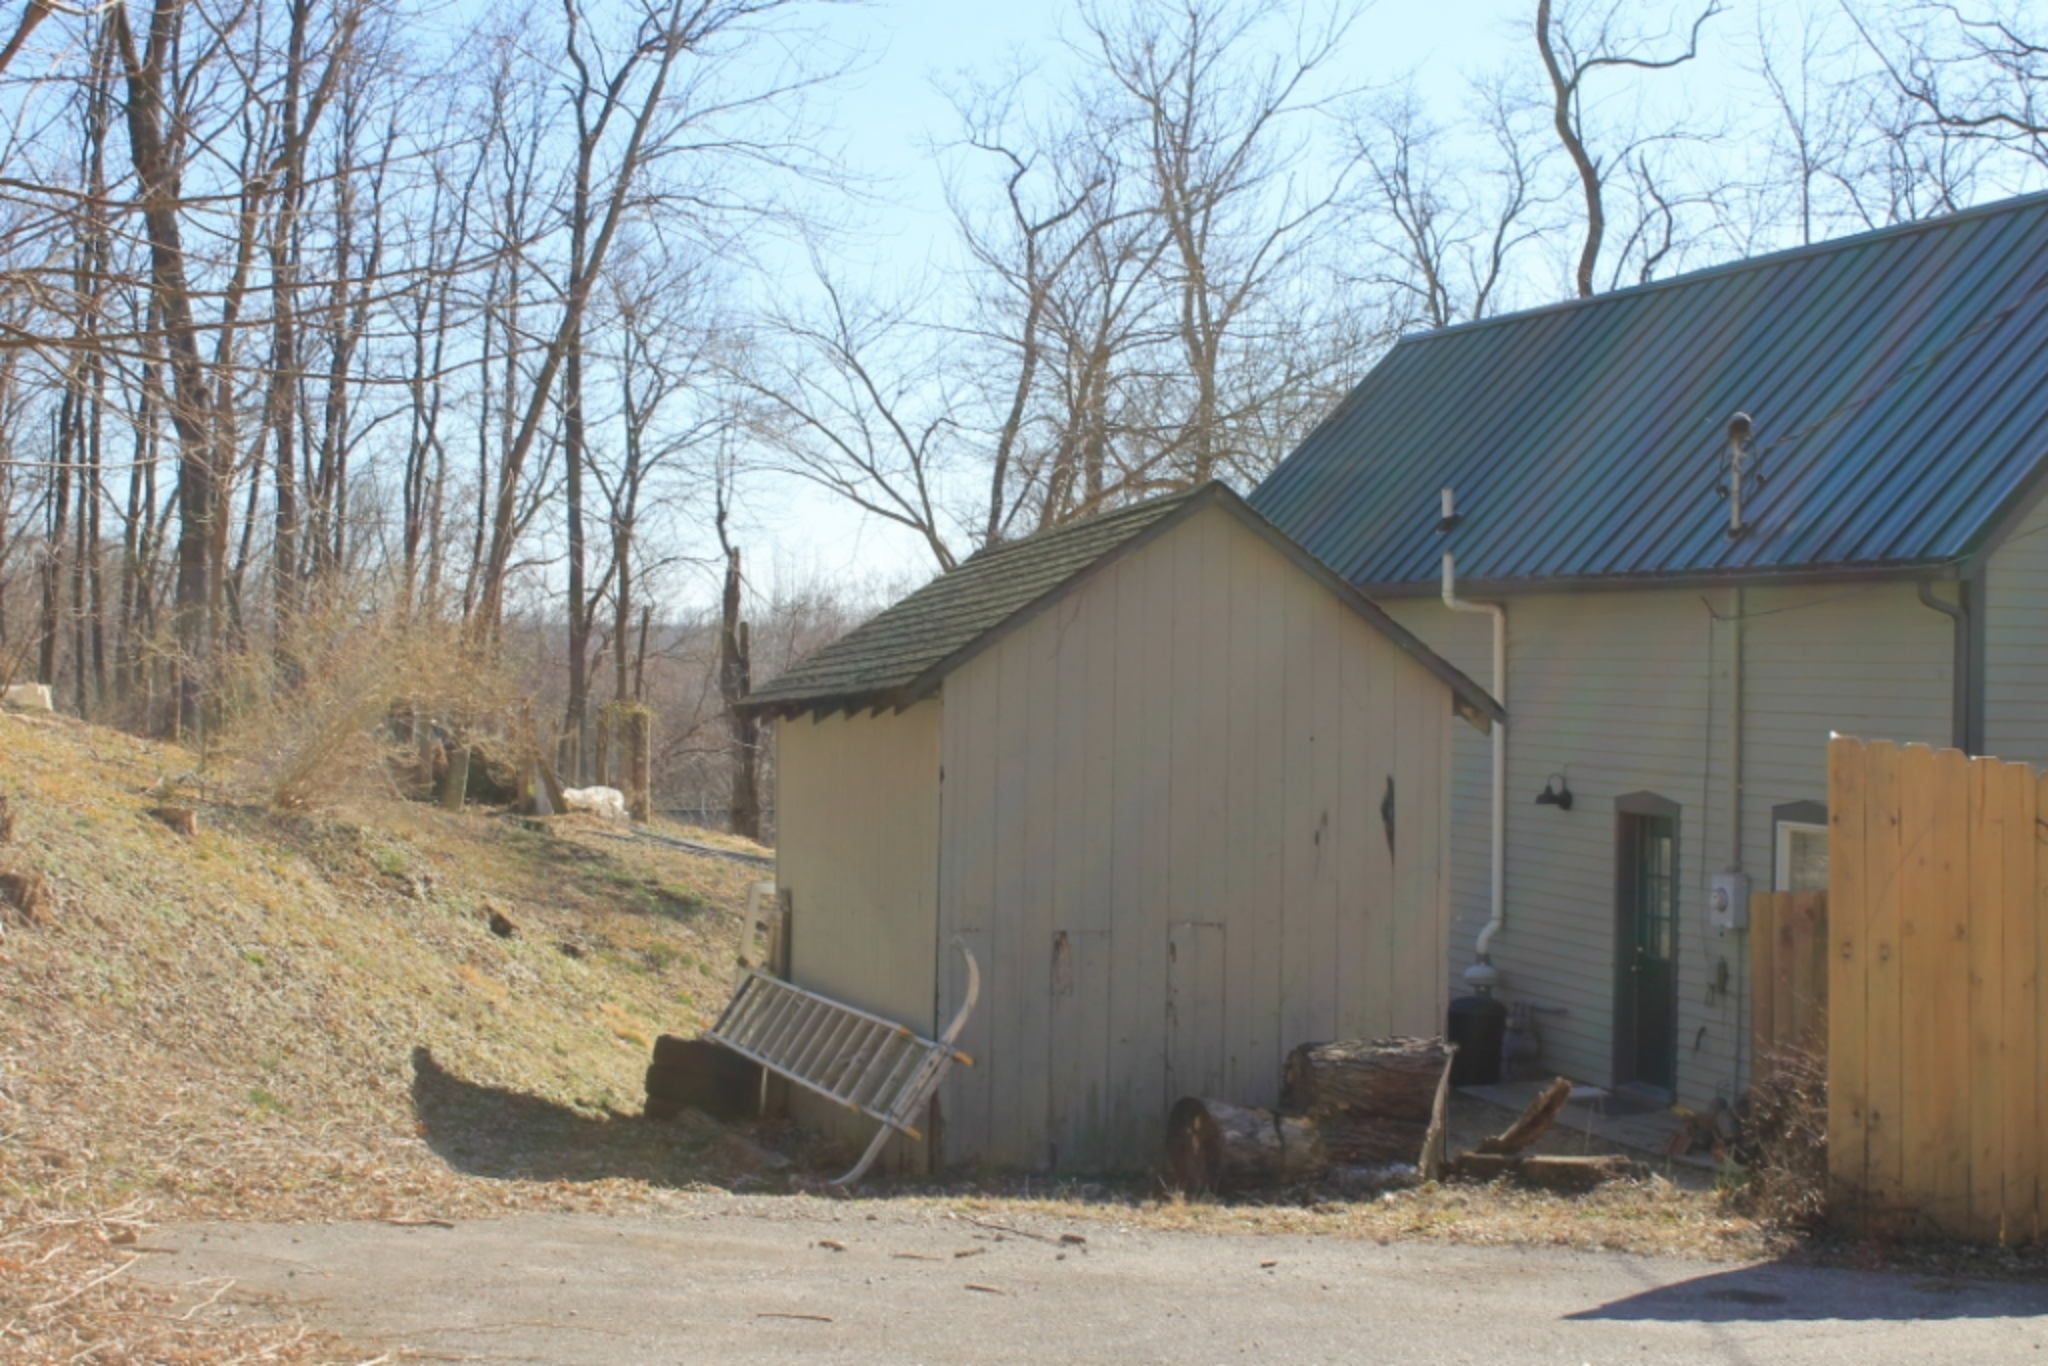
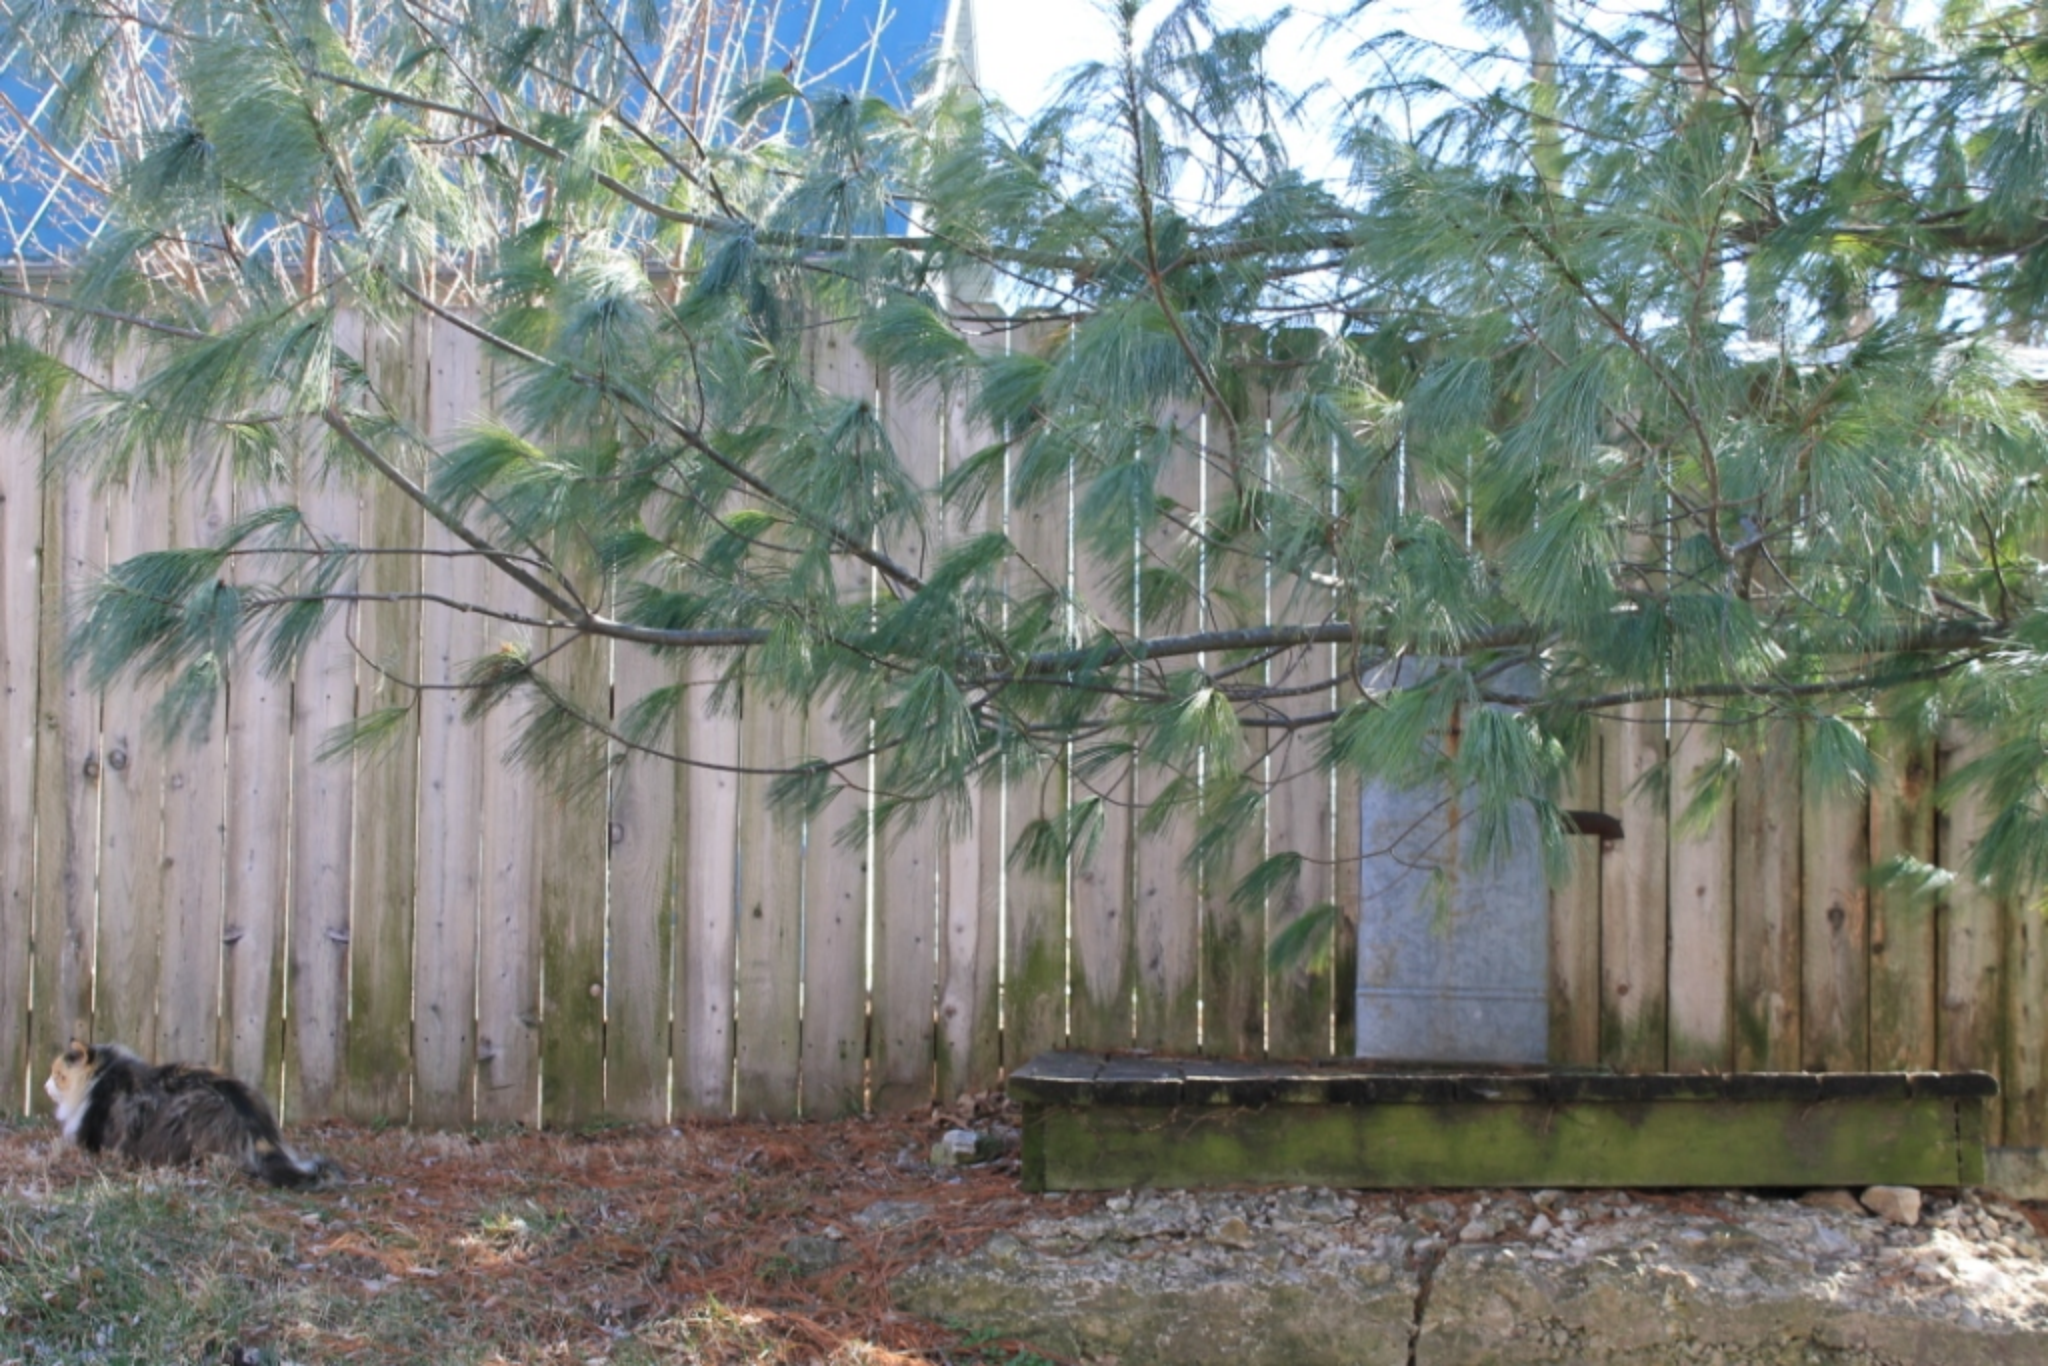
The building is a massed plan gable and wing plan, 1 1/2 story house. The house is clad in clapboards and the roof is metal. The main block of the house has a gable that faces south. The wall under the gable is clad in fishlap shingles. A lower wing extends to the west. At the point where the two wings of the building meet is a shed roofed porch with turned spindles supporting the roof. The first story of the front (south) facade has two bays. The left bay is on the main block of the house and contains a one-over-one single hung window with a slightly arched lintel. The right bay on the first story of the front facade is under the porch and contains a one-over-one single hung window with a slightly arched lintel. The second story of the main portion contains a one-over-one single hung window with a slightly arched lintel.

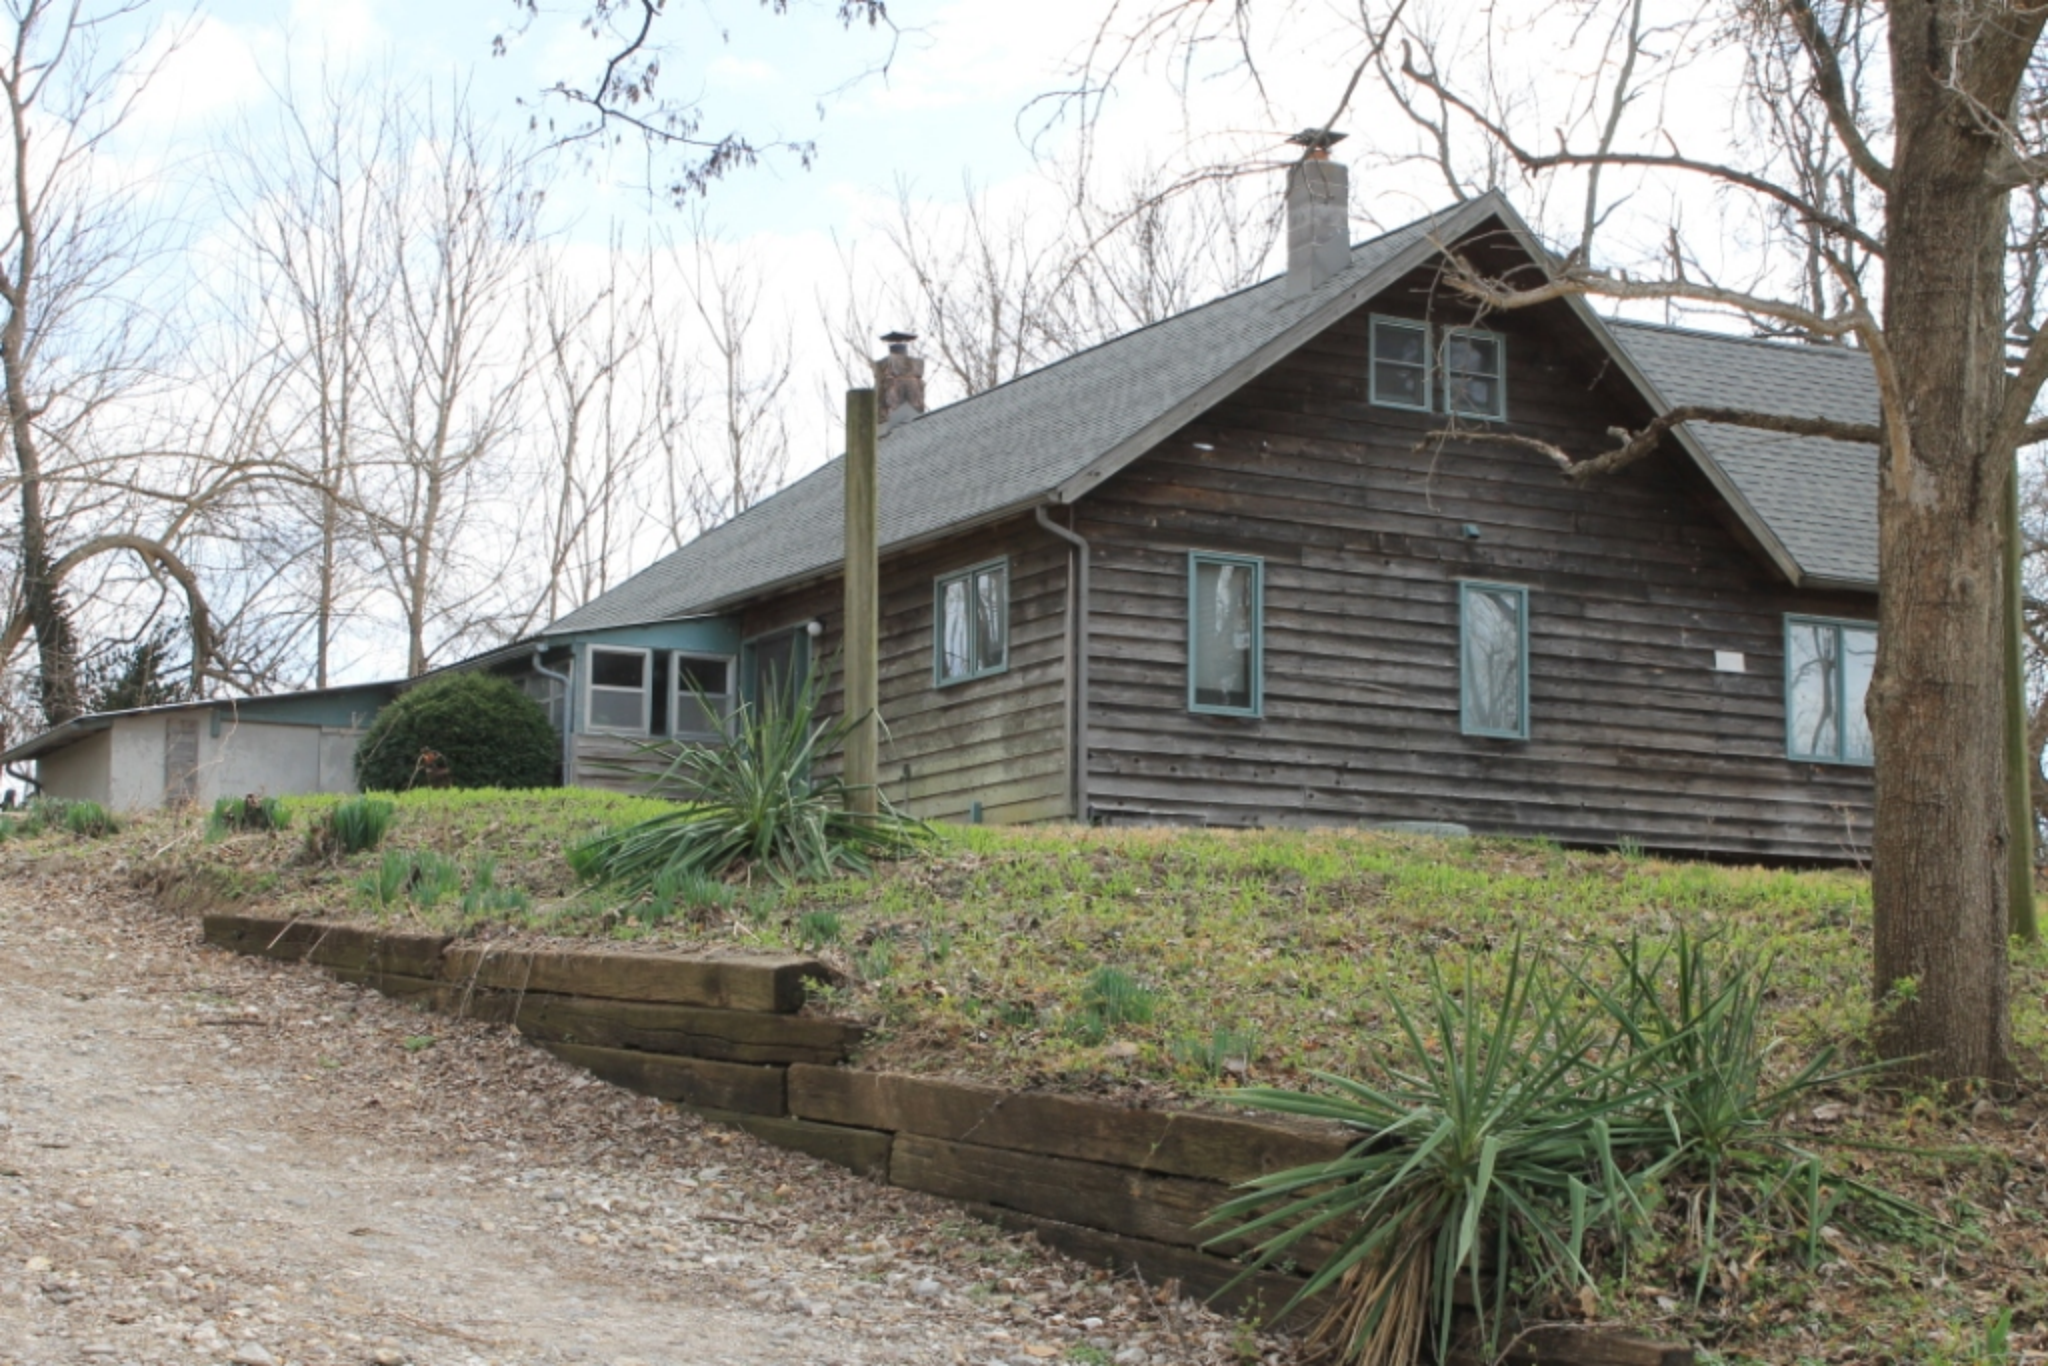
This 1 1/2 story, massed plan frame building is clad in stained clapboards and the roof is covered in asphalt shingles. The main block of the building has a medium cross gable roof. On the northeast end of the building is a modern shed roofed wing of the building that appears to have been added to the main block of the building. The front (north) facade of the addition has several bays that are partially obscured by trees and brush. The front (north) facade of the main block of the house has two bays. The left bay contains a metal and glass door with fixed pane sidelights. The right bay has a two pane sliding glass window. The first story of the east facade has three bays. The left bay contains a fixed glass window. The center bay has a fixed glass window. The right bay contains a two paned sliding glass window. The second story of the main block of the house under the gable roof has two closely spaced bays, each containing a one-over-one window. The house has two interior chimneys. The left chimney is on the ridge at the east end of the house. The right chimney is on the front slope of the west end of the house.

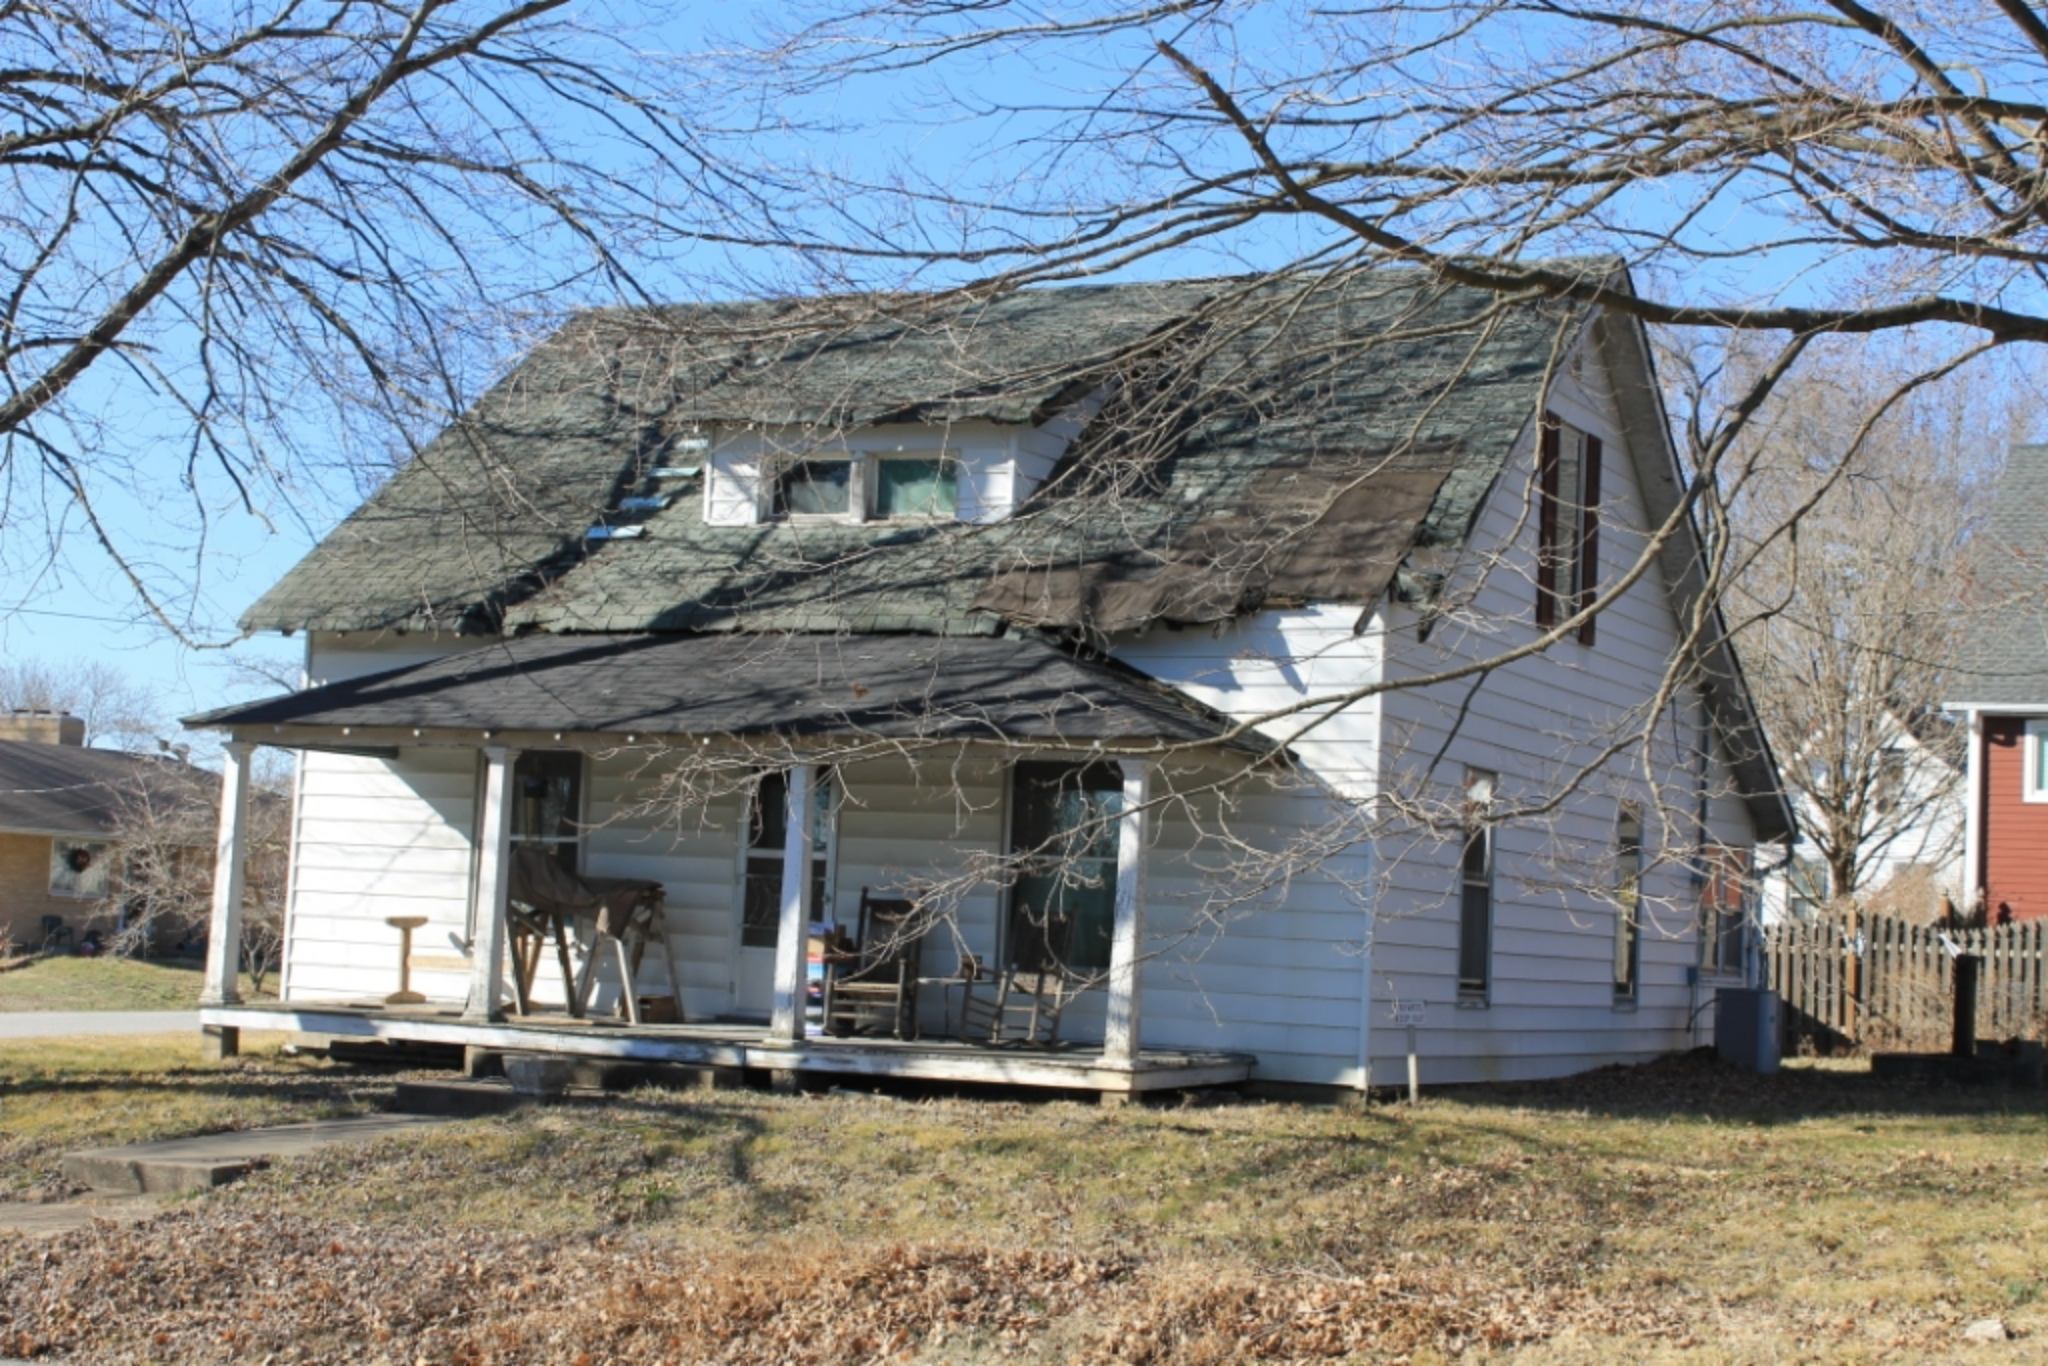
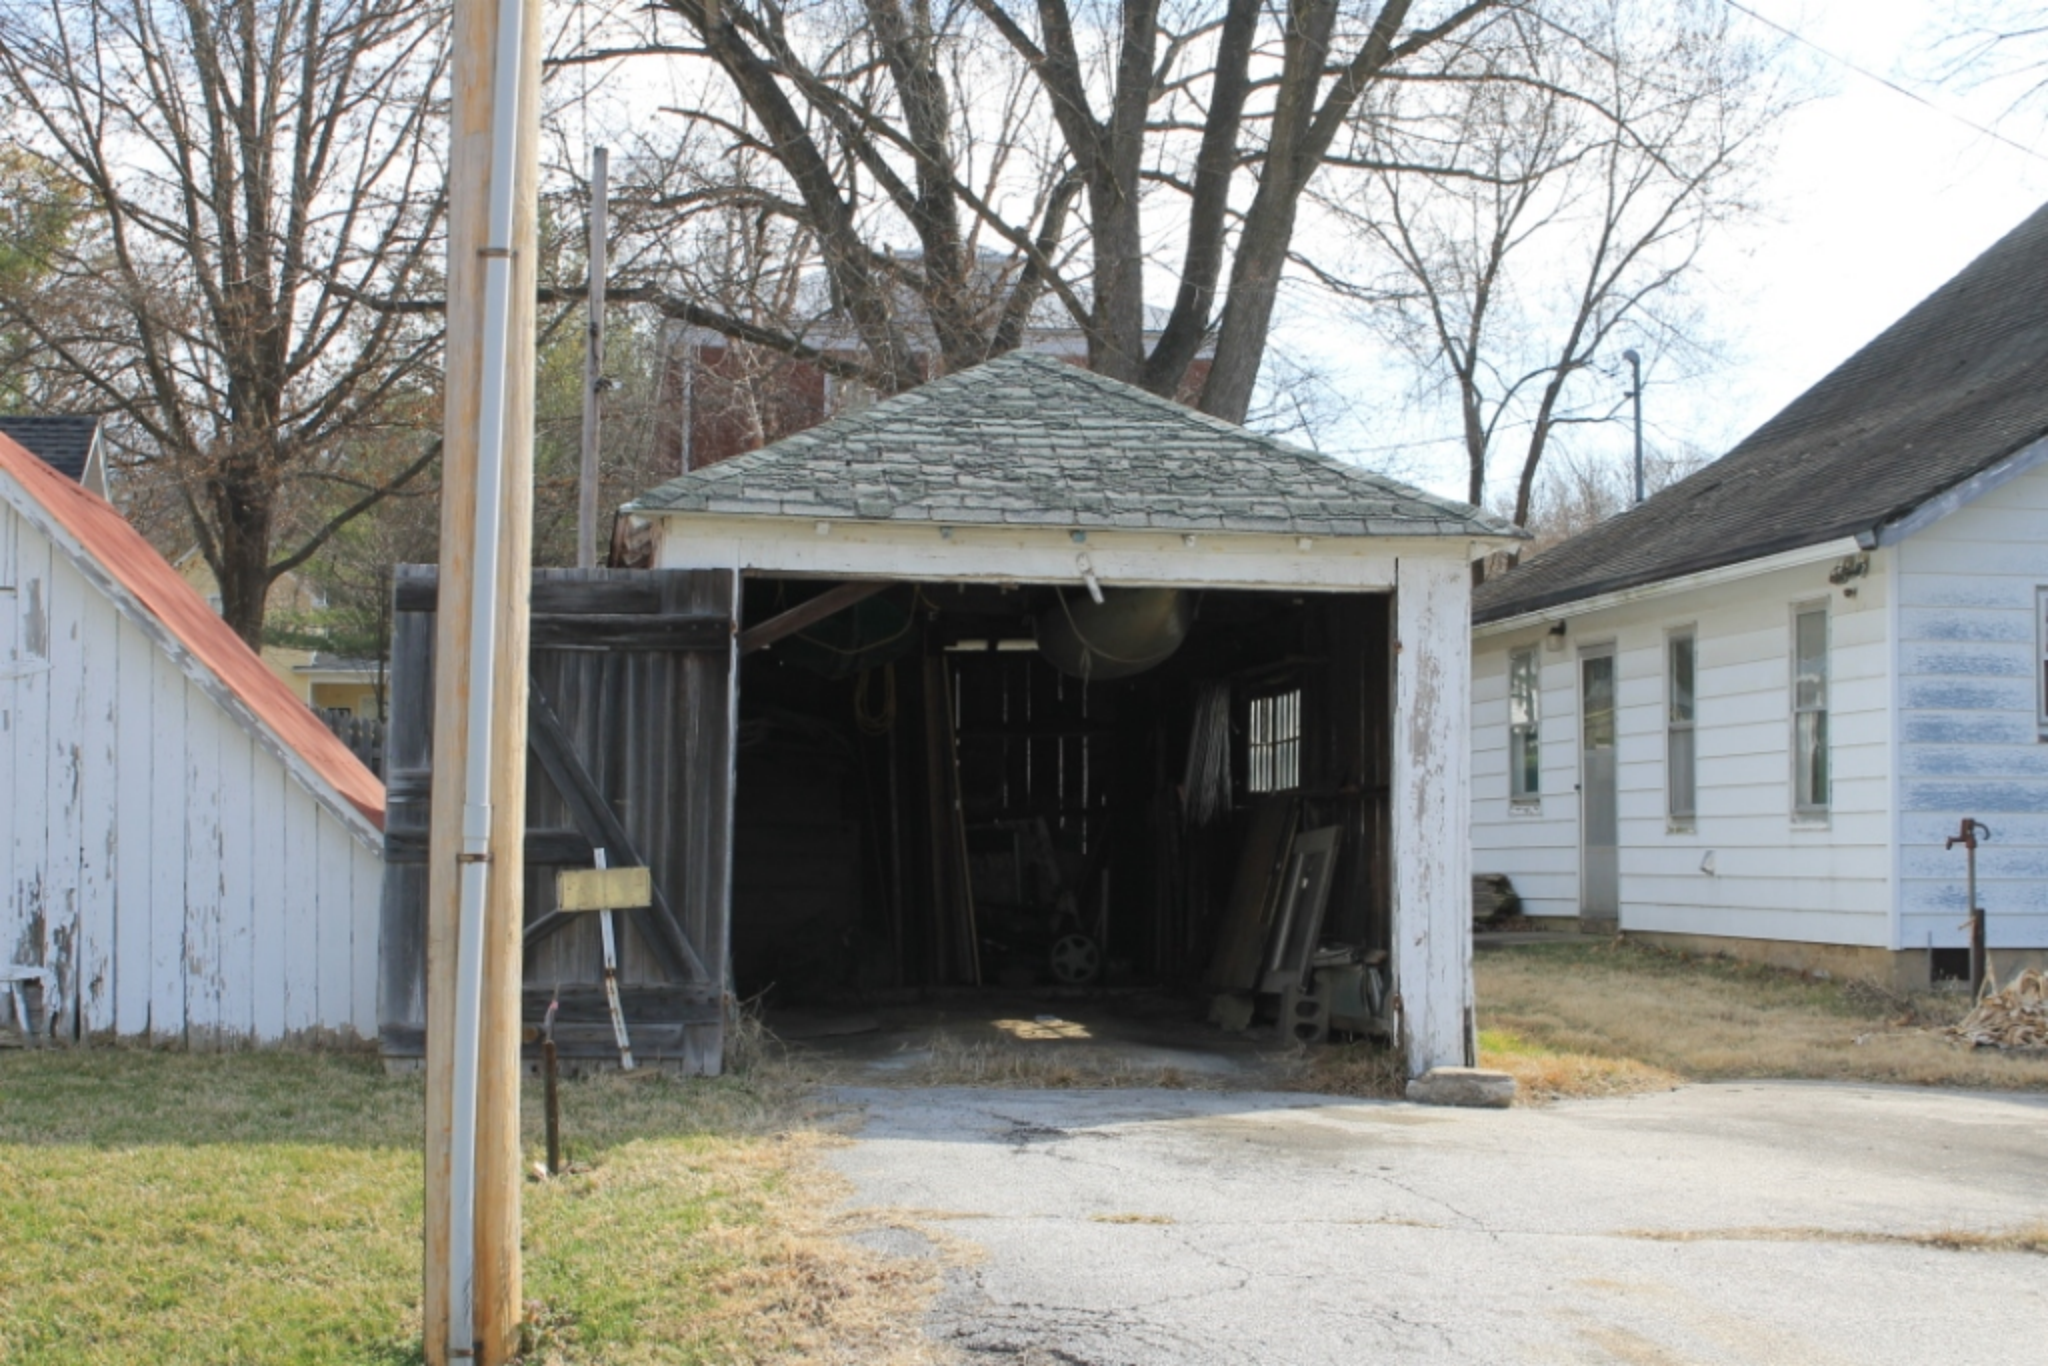
This 1 1/2 story, frame, massed plan side gable house has a saltbox roof. The building is clad in metal siding and the roof is covered in asphalt shingles. The siding was installed before 1973. The building has a front porch with a hipped roof. The porch is supported by four wooden posts. The first story of the front (south) facade has three bays, all located under the porch. The left bay contains a one-over-one wooden single hung window. The center bay contains a door with a glass and metal storm door. The right bay contains a wooden one-over-one single hung window. On the second story of the south facade is a shed-roofed dormer with two fixed pane rectangular windows. The side (east) facade has two bays on the first story; each contains a one-over-one wooden window. The second story of the east facade has one bay that contains a wooden one-over-one window. The house is in very poor condition. The asphalt shingles are badly deteriorated; part of the shingles are missing and are covered loosely with a tarp.
