MISSOURI DEPARTMENT OF NATURAL RESOURCES
STATE HISTORIC PRESERVATION OFFICE, P.O. Box 176, Jefferson City, MO 65102
ARCHITECTURAL/HISTORIC INVENTORY FORM

1. SURVEY NO. BO-AS-009-0001		2. SURVEY NAME: Rocheport Historic District	
3. COUNTY: Boone		4. ADDRESS (STREET NO.)	STREET (NAME) Katy Trail
5. CITY: Rocheport	VICINITY: <input checked="" type="checkbox"/>	6. UTM: / /	LAT: LONG: T: 48W R: 15W S: 1

8. HISTORIC NAME (IF KNOWN): M.K.&T. Railroad tunnel		9. PRESENT/OTHER NAME (IF KNOWN): Katy trail tunnel	
10. OWNERSHIP: <input type="checkbox"/> PRIVATE <input checked="" type="checkbox"/> PUBLIC		11A. HISTORIC USE (IF KNOWN): railroad tunnel	11B. CURRENT USE: Katy Trail tunnel
HISTORICAL INFORMATION

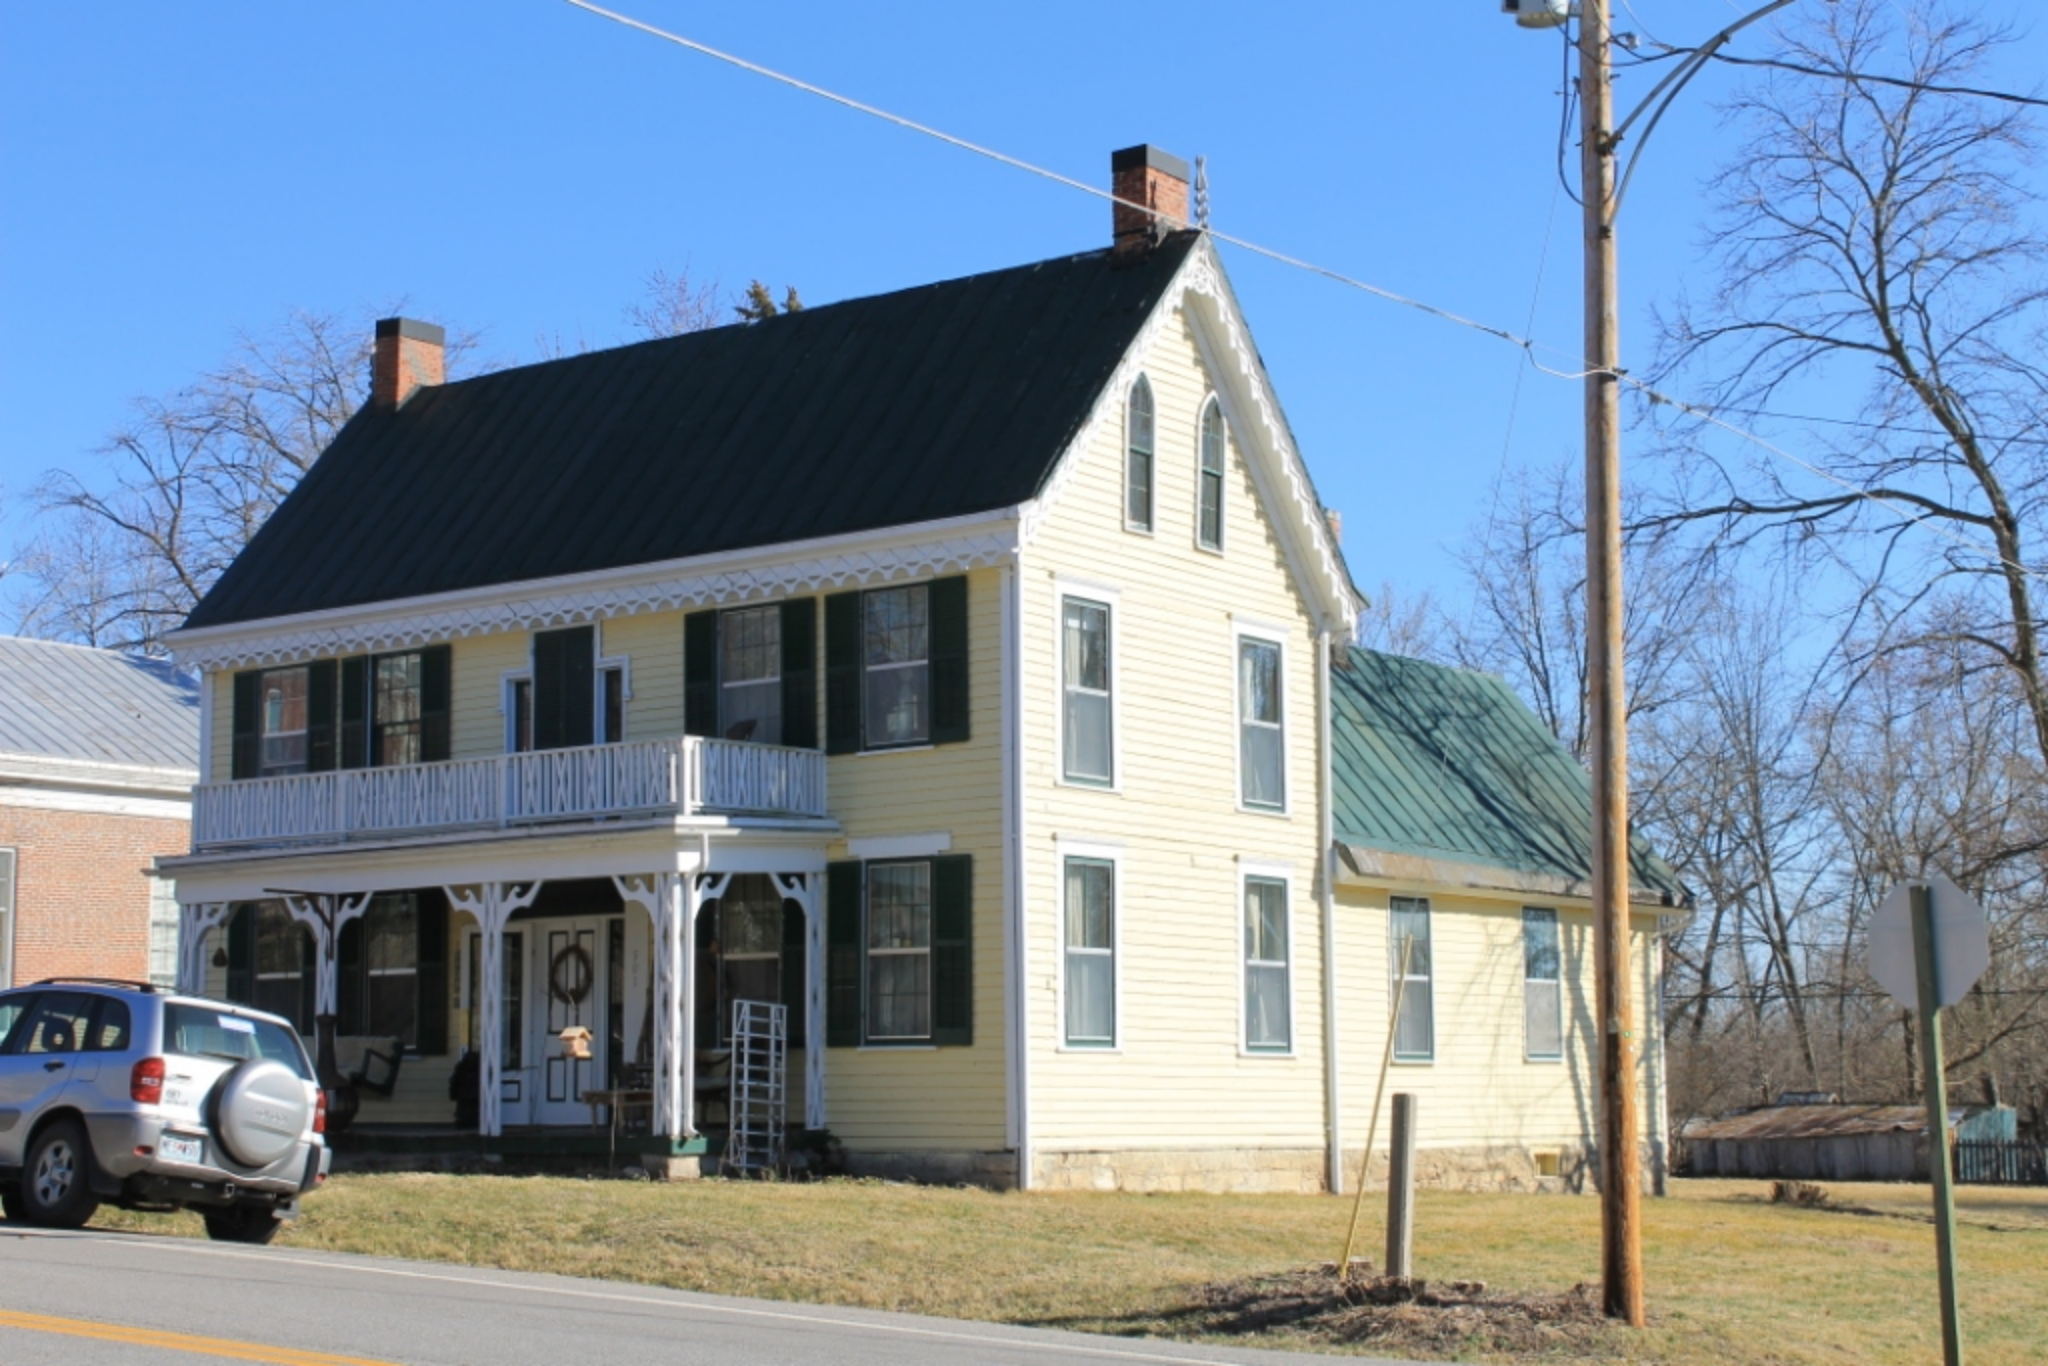
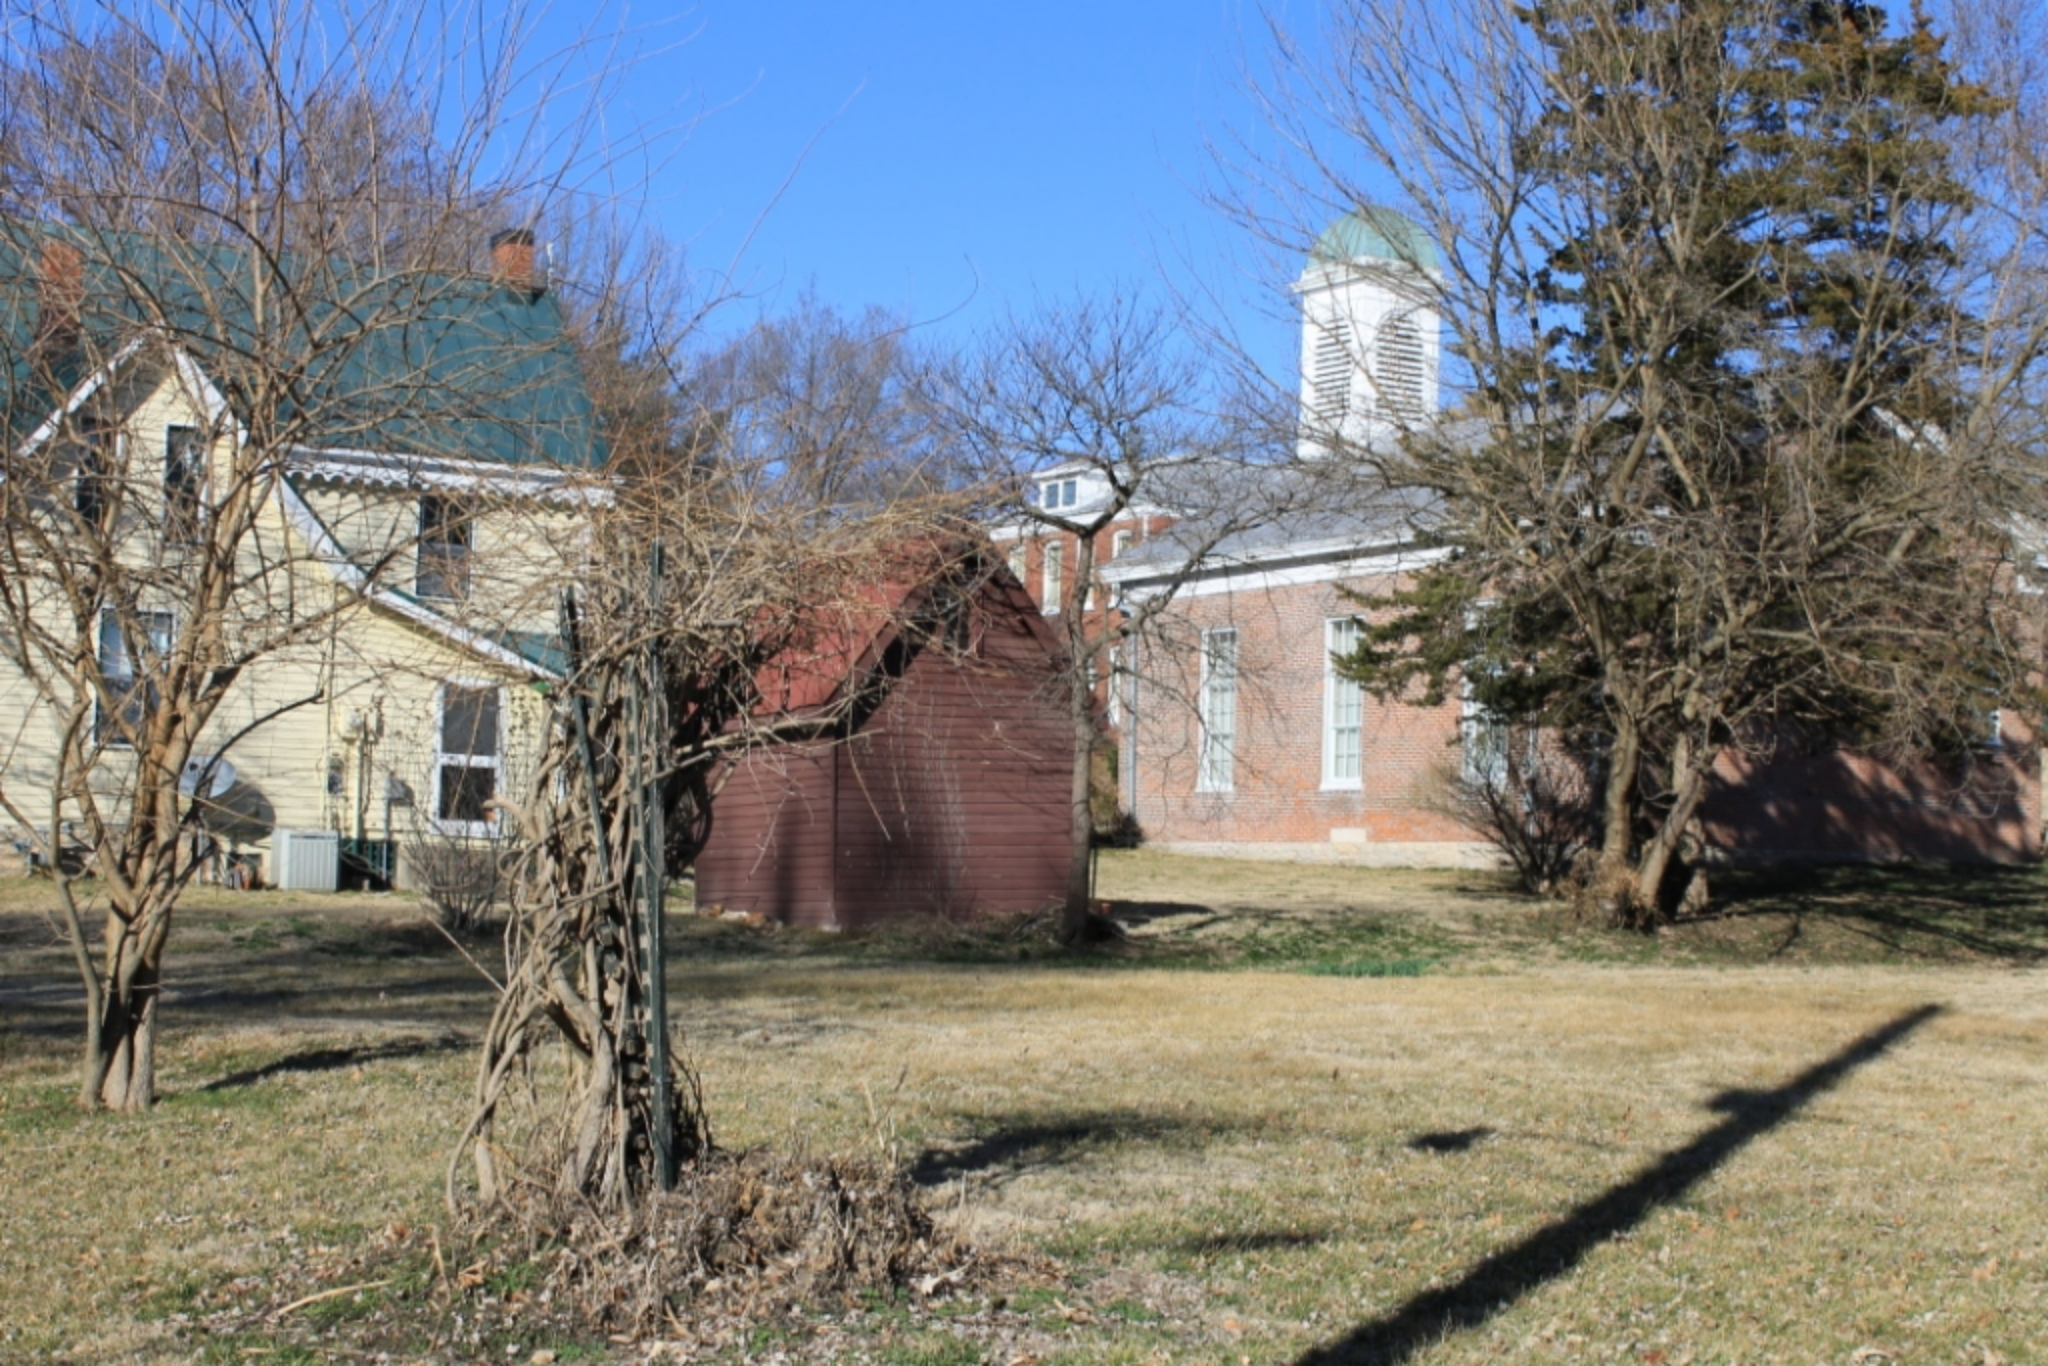
This 2 1/2 story frame I-house is clad in clapboards and the high gable roof is covered in metal. A bargeboard accents the roof line of the front and side facades of the main block of the house. A wing extends south from the main body of the house. The front (north) facade of the first story has five bays. The two left bays each contain a one-over-one single hung window. The center bay contains a central doorway with sidelights. The two right bays each contain a one-over-one single hung window. The second story of the north facade has five bays. The two left bays each contain a one-over-one window. The center bay contains a door with small sidelights that opens onto a balustraded balcony. The two right bays each contain a one-over-one window. The windows on the front facade are accented with green shutters. The side (west) facade of the house has four bays on the first story. The two left bays, which are located on the main block of the house, each contains a wooden one-over-one window. The two right bays, which are located in the south extending wing, each contains a one-over-one window. The second story of the side (west) facade has two bays with one-over-one wooden windows placed above the first story windows. Under the gable are two bays, each containing a Gothic arched, wooden four-over-four window. The east facade of the main block of the house has no bays on the first and second stories, but has two bays, each containing a Gothic arched wooden four-over-four window, under the gable. The house has interior chimneys one each end.

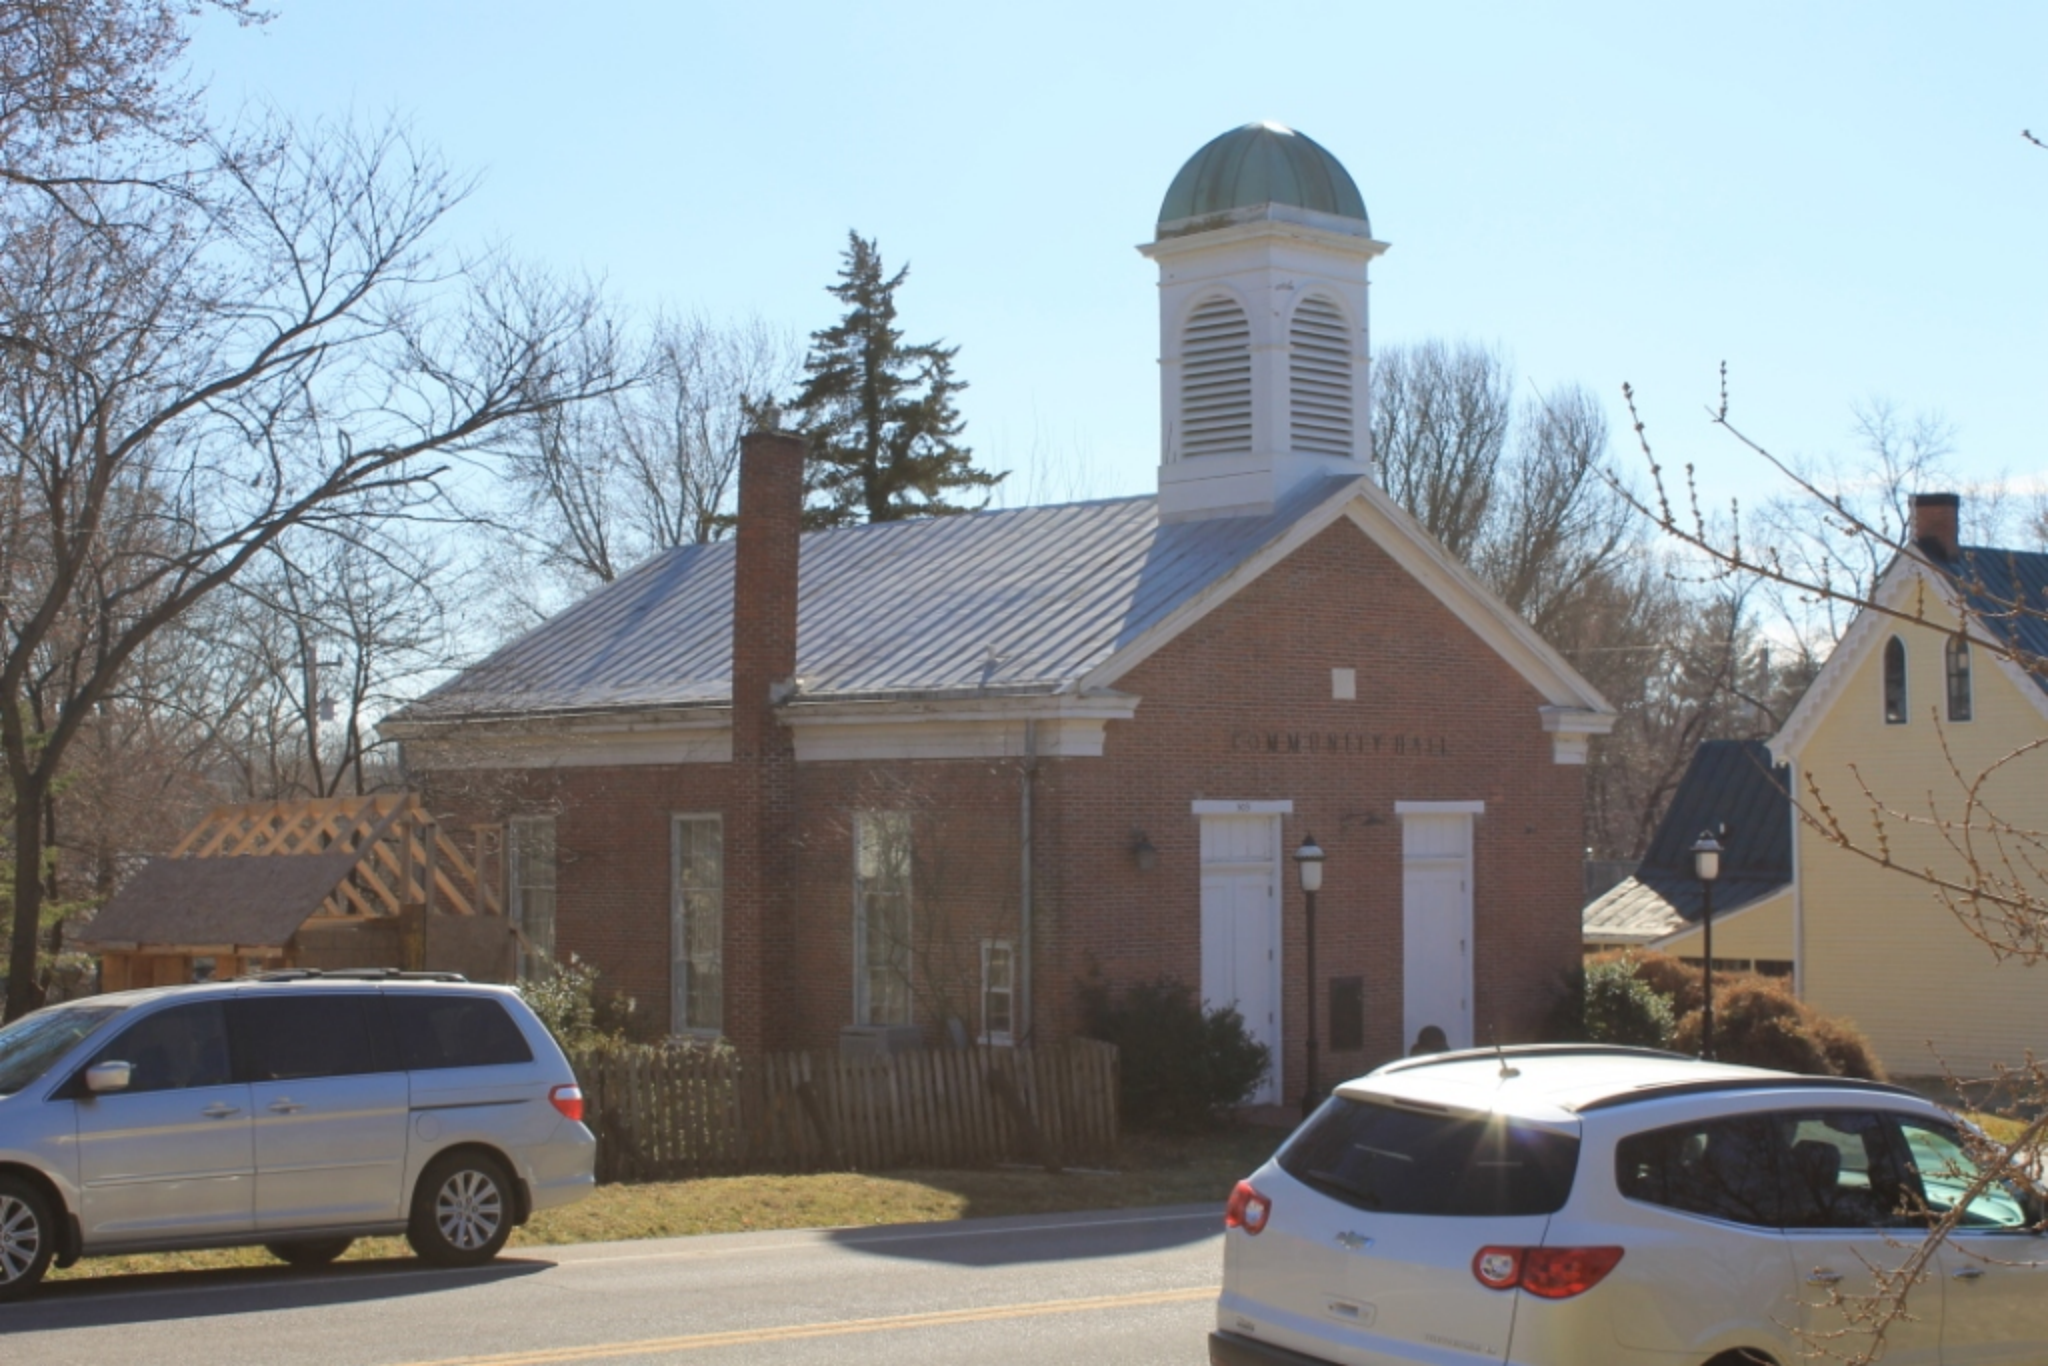
The one-story, brick building with a high gable roof with gable returns has two different types of brickwork bond patterns. The front (north) facade is done in Flemish bond and the remaining walls are done in common bond. The roof is covered in metal. The building has two bays on the north facade. Each bay on the north facade contains a door with a stone lintel. A steeple was remodeled in 1929. An early photograph shows the four sided steeple to be wider than the existing four sided steeple and with a flat roof instead of the rounded roof that tops the existing steeple. The original steeple had rectangular louvered openings on each side; the existing steeple has round topped louvered openings on each side. The east facade has three bays, each containing a large six-over-six-over-six wooden window. The building has an exterior chimney on the middle of the east wall.

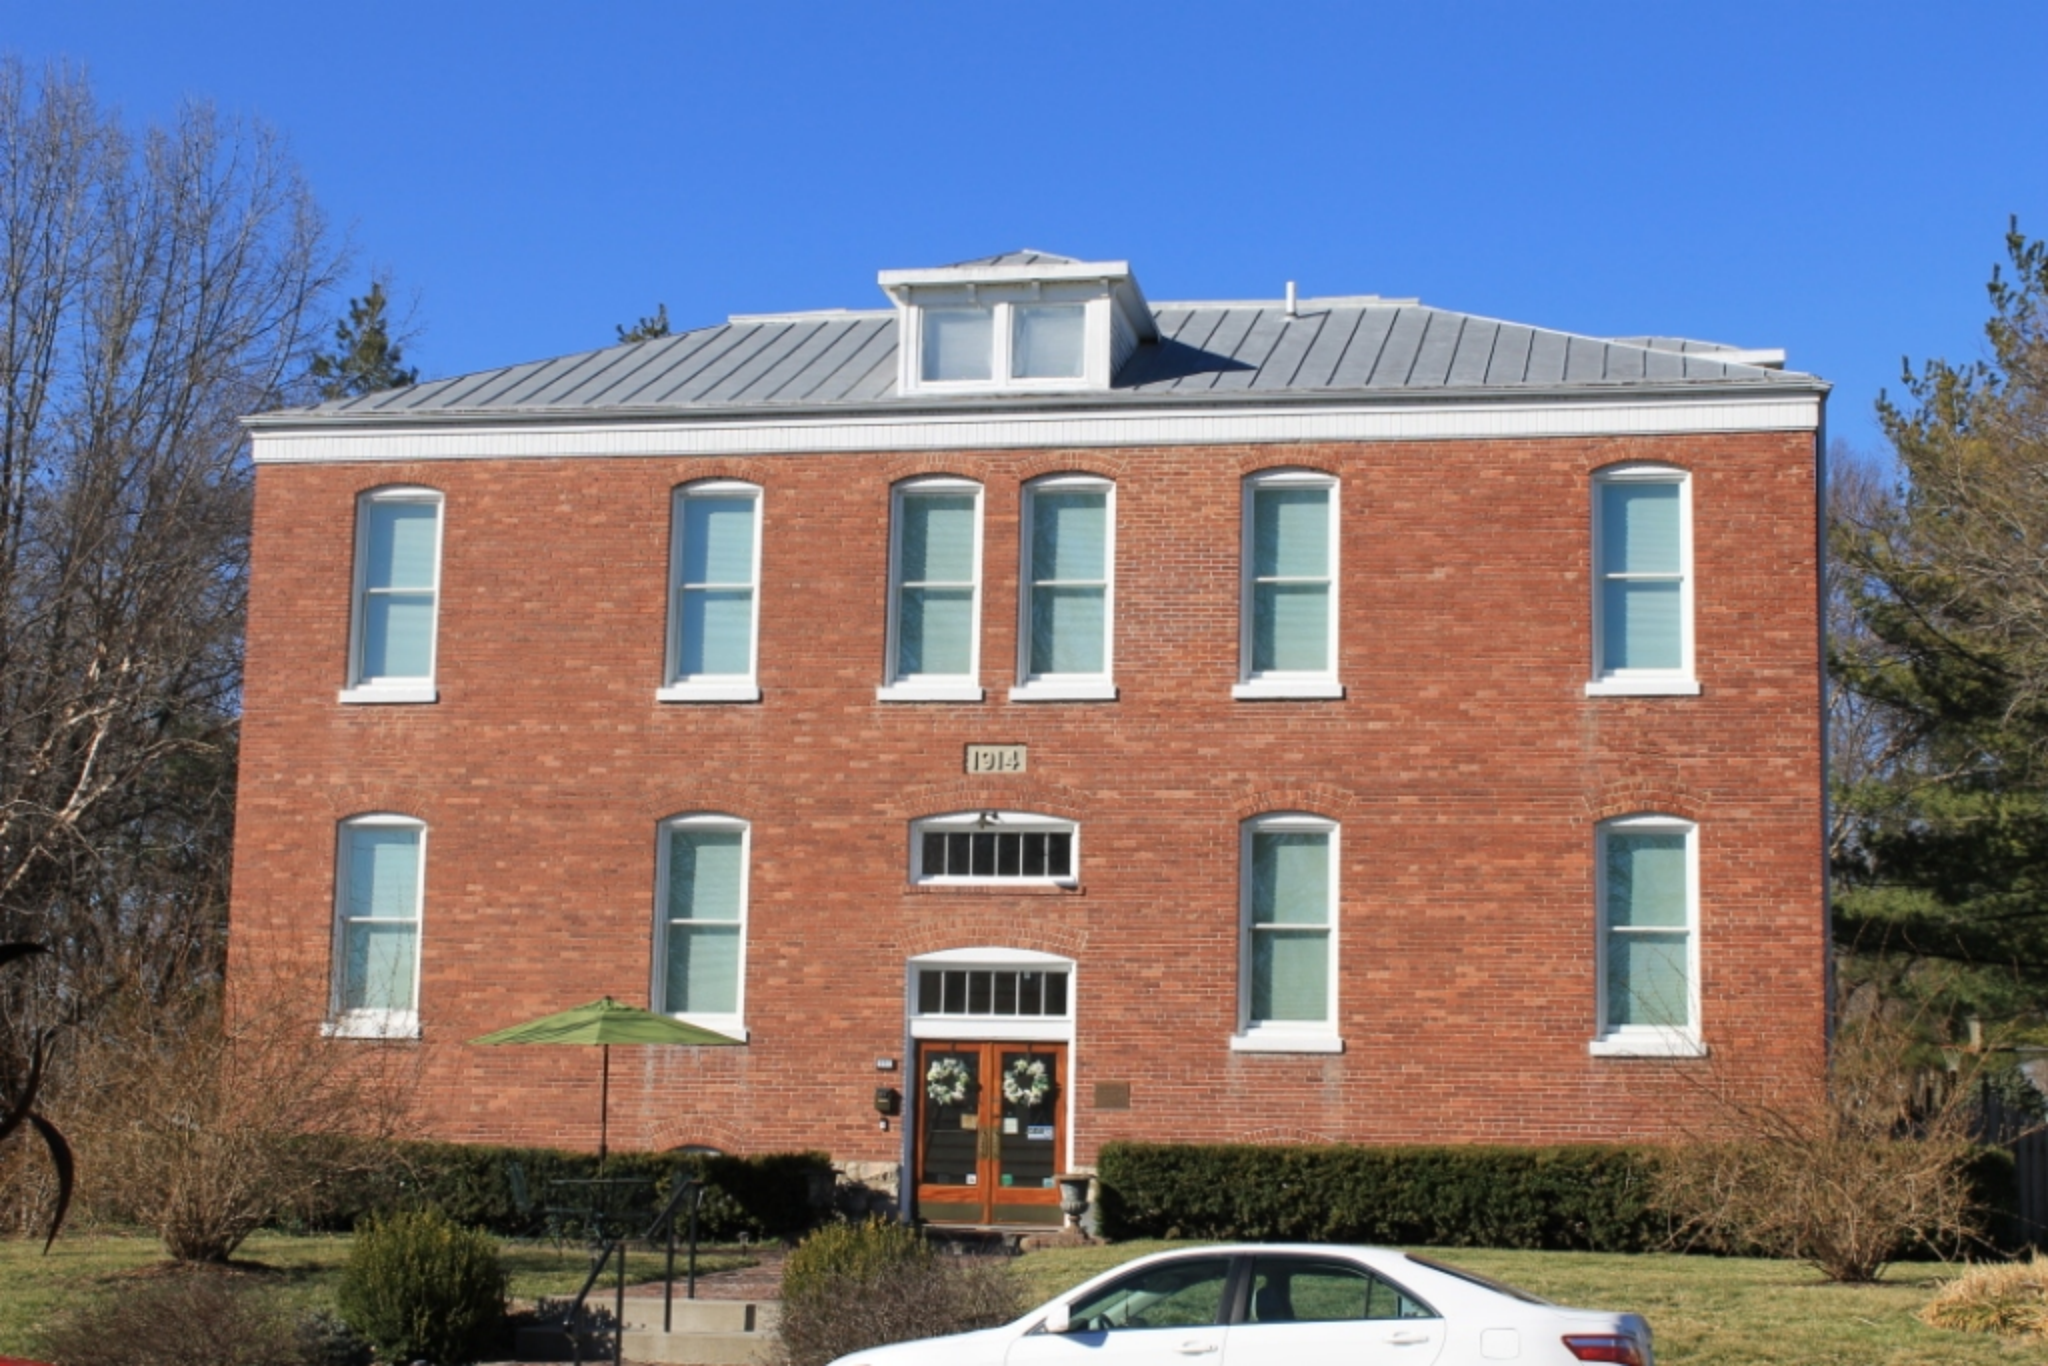
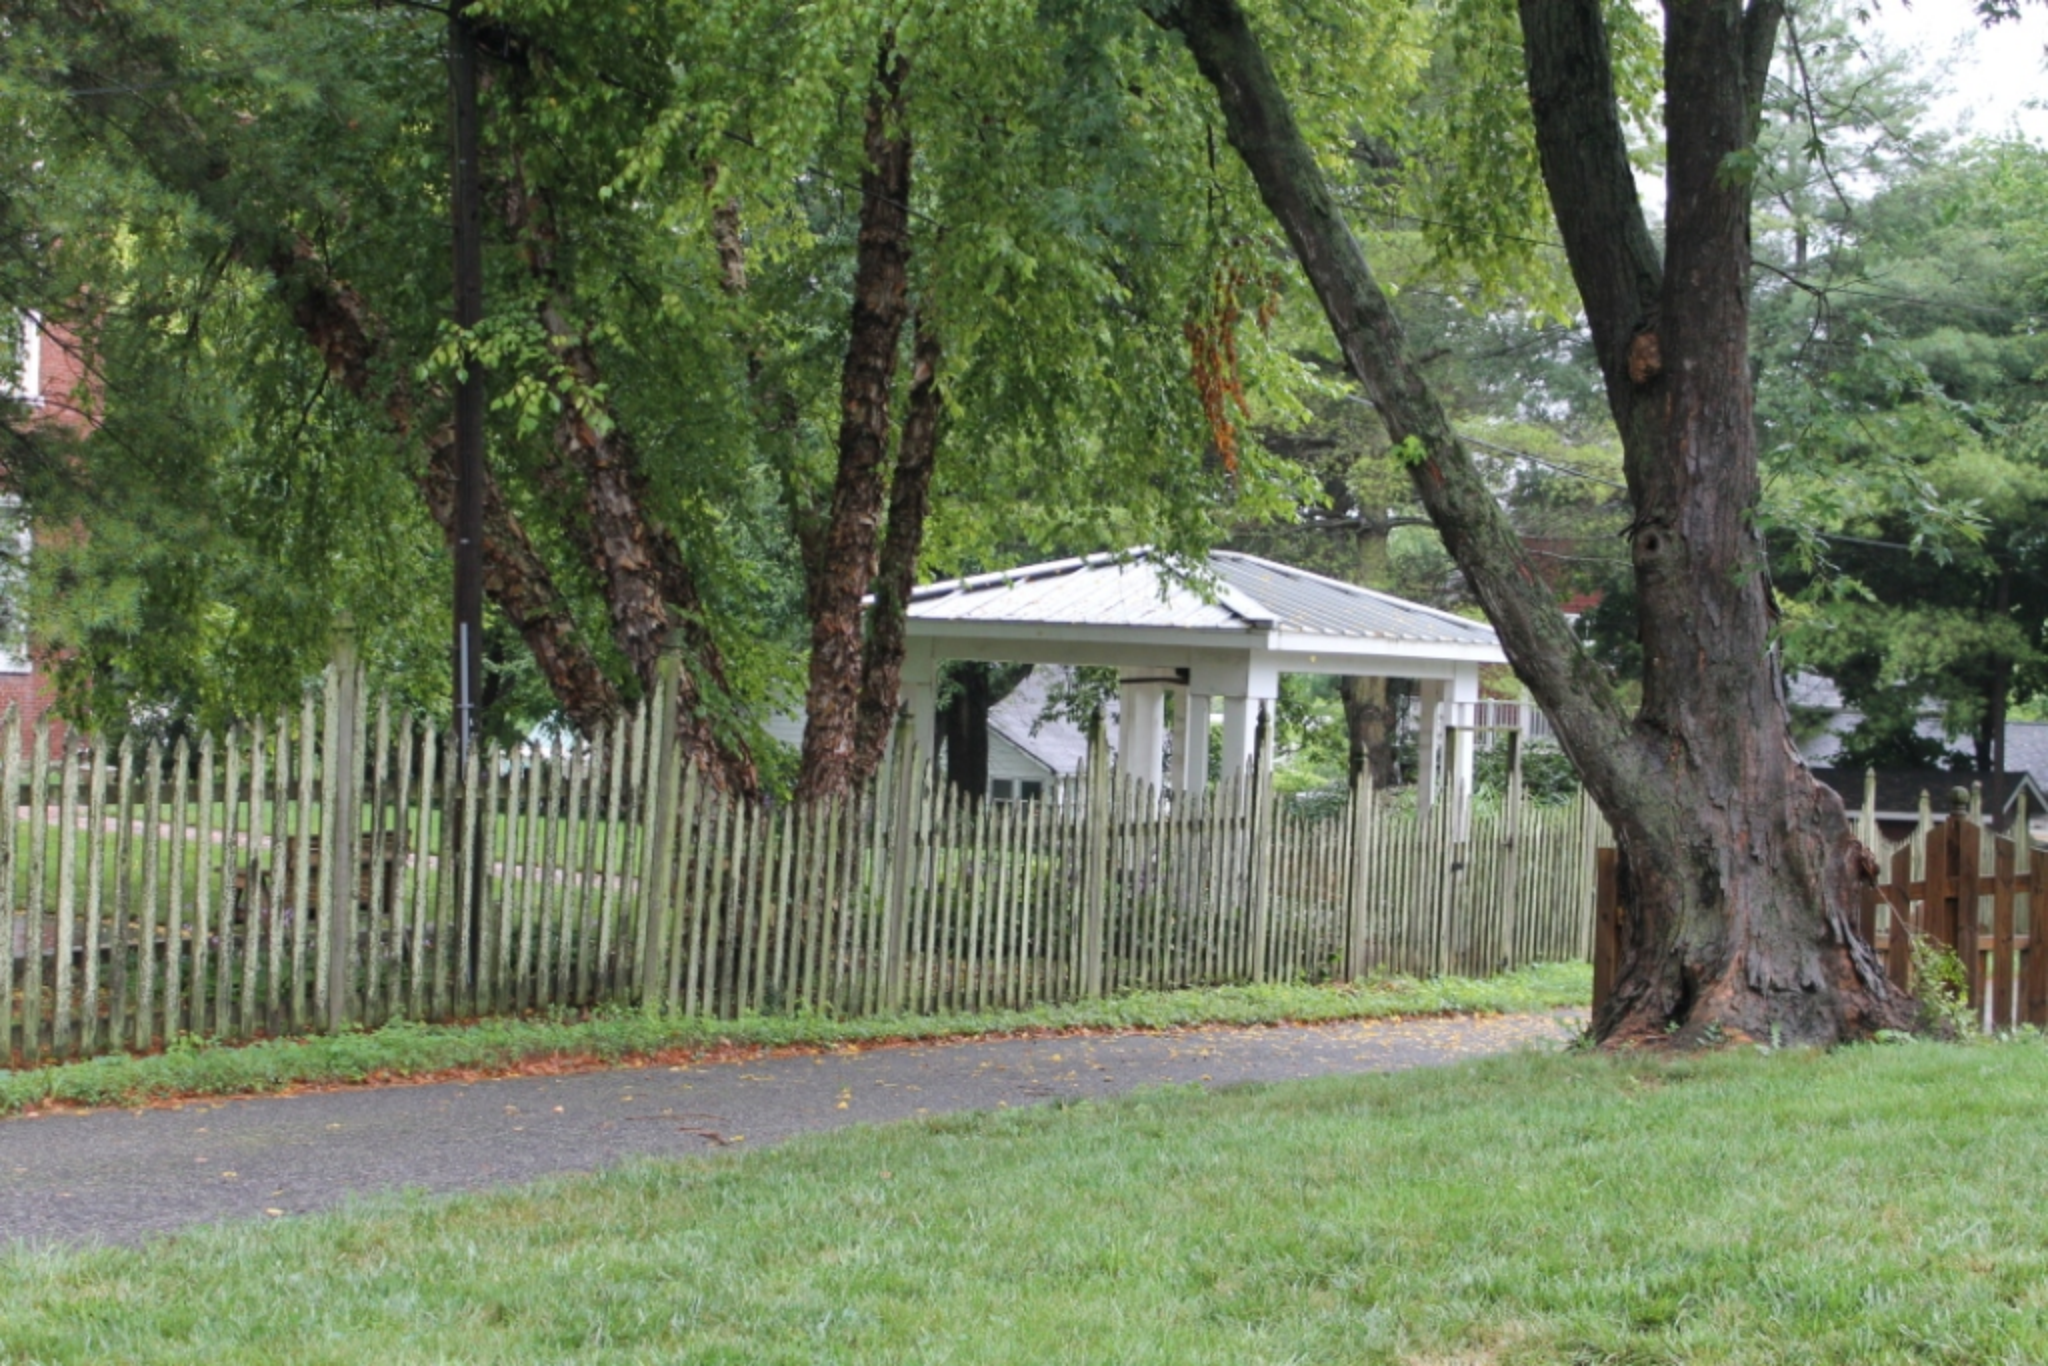
This 2 1/2 story, brick, massed plan school house building has a metal hipped roof with hipped roof gables on the the east, south, and west portions of the roof. Each gable has two bays containing a pair of fixed pane windows. The hipped roof has a rectangular shaped flat portion in the center. The windows on the first and second story are rectangular and set into segmental arched openings. The arches are accented with two rows of rowlock bricks and limestone sills. The first story of the front (south) facade has five bays. The two left bays each contain a one-over-one single hung window. The center bay contains a double door topped with a six fixed-pane transom. Approximately fifteen inches above the transom is another six fixed-pane transom-like window. The two right bays each contain a one-over-one single hung window. On the second story, the building has six bays. The two left bays each contain a one-over-one single hung window. The two center bays are close together, placed above the center bay of the first floor. Each of the center bays contains a one-over-one single hung window. The two right bays each contain a one-over-one single hung window. A simple cornice painted white is at the roof line. The building's south facade is pleasingly symmetrical.

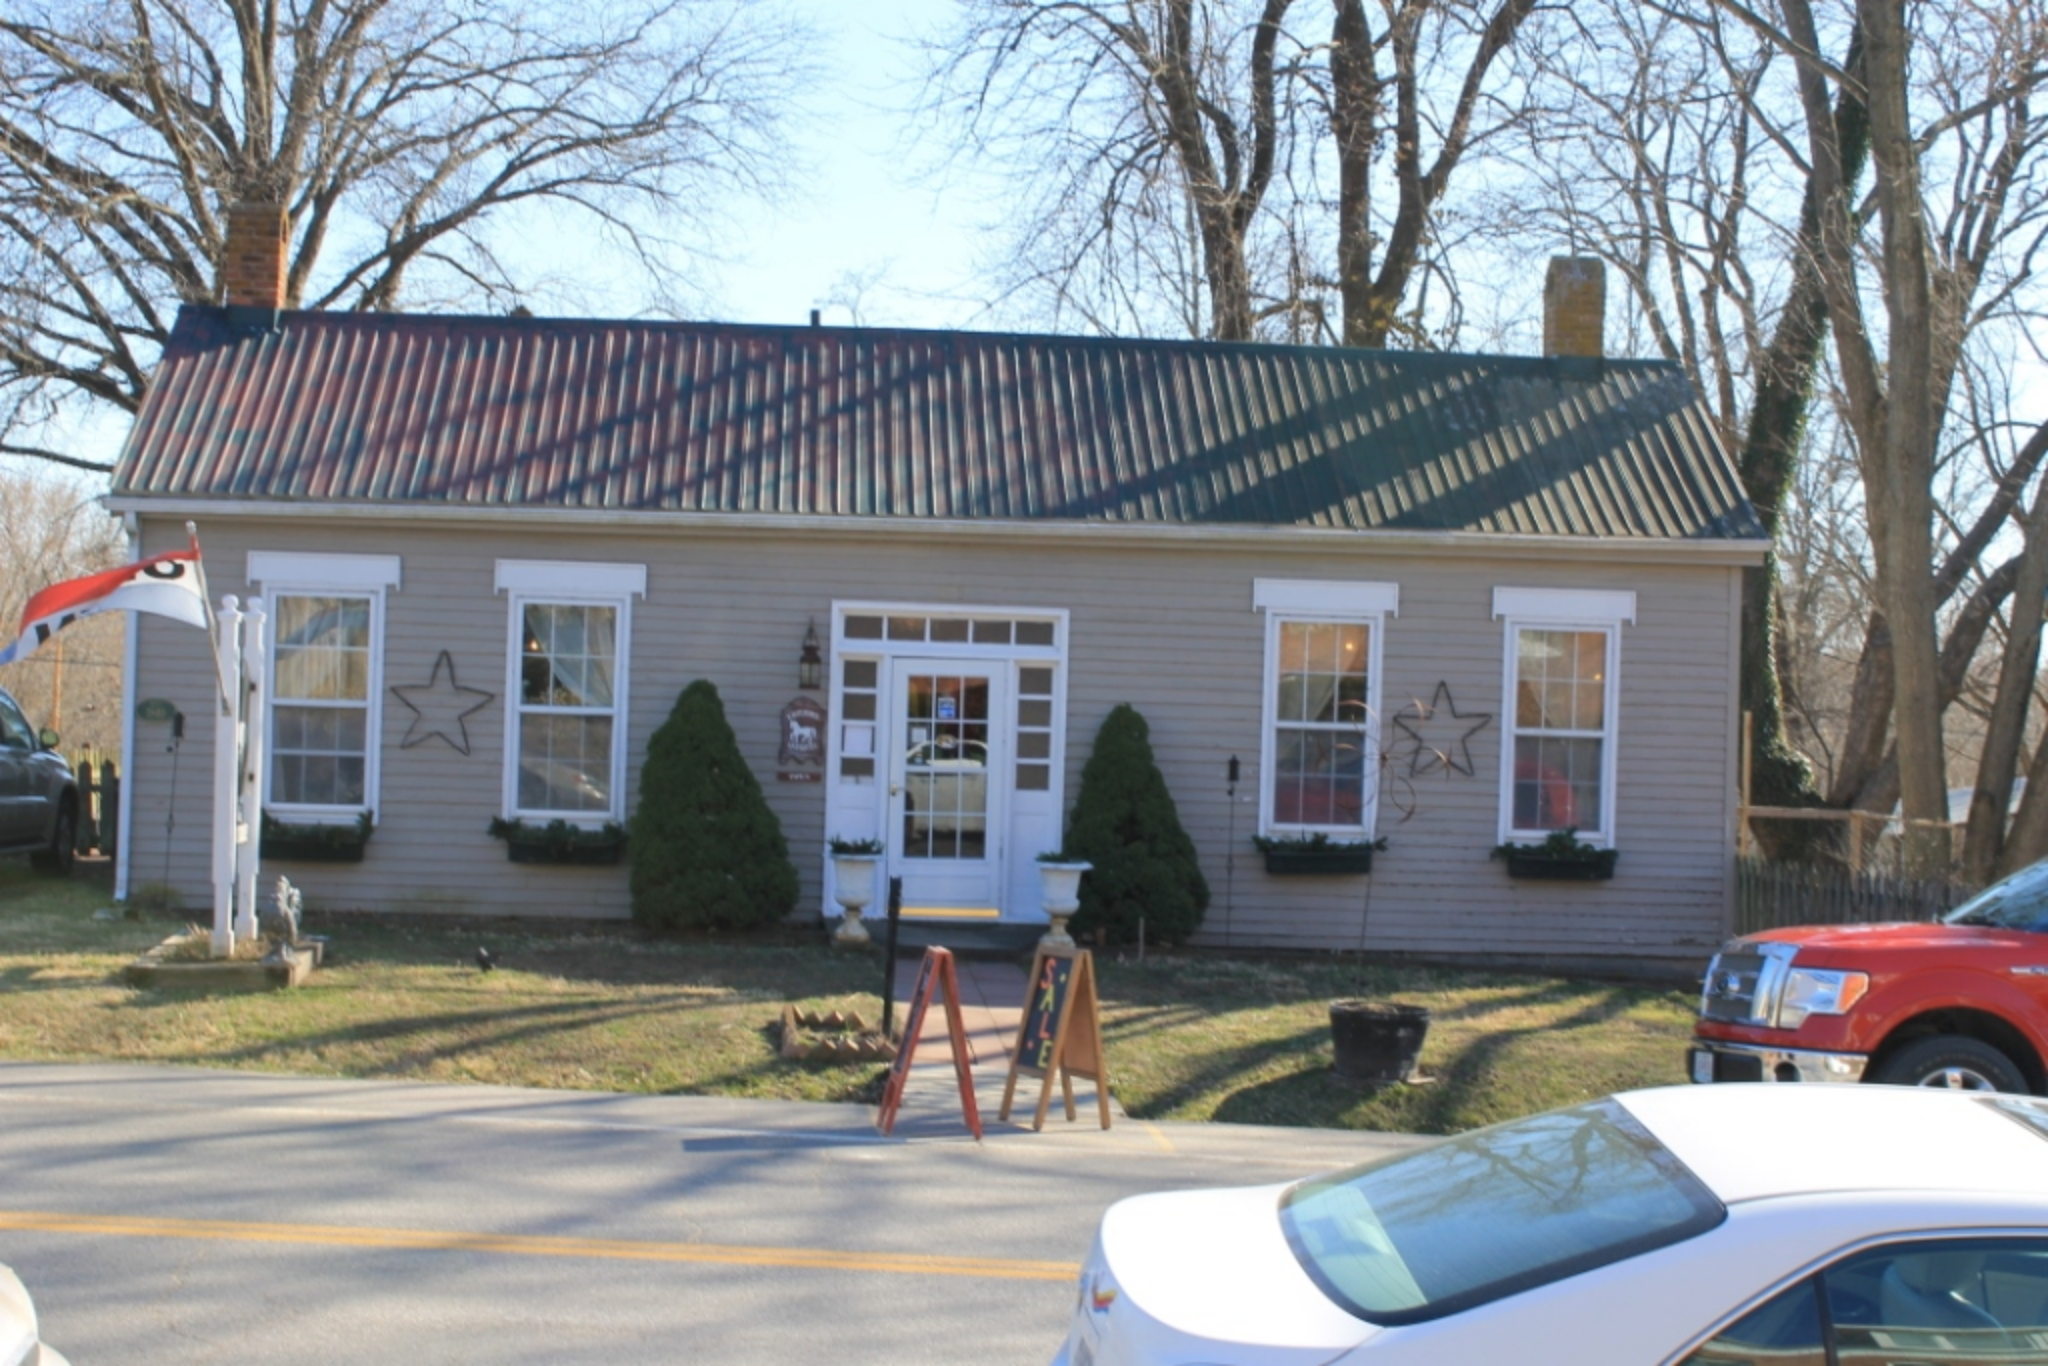
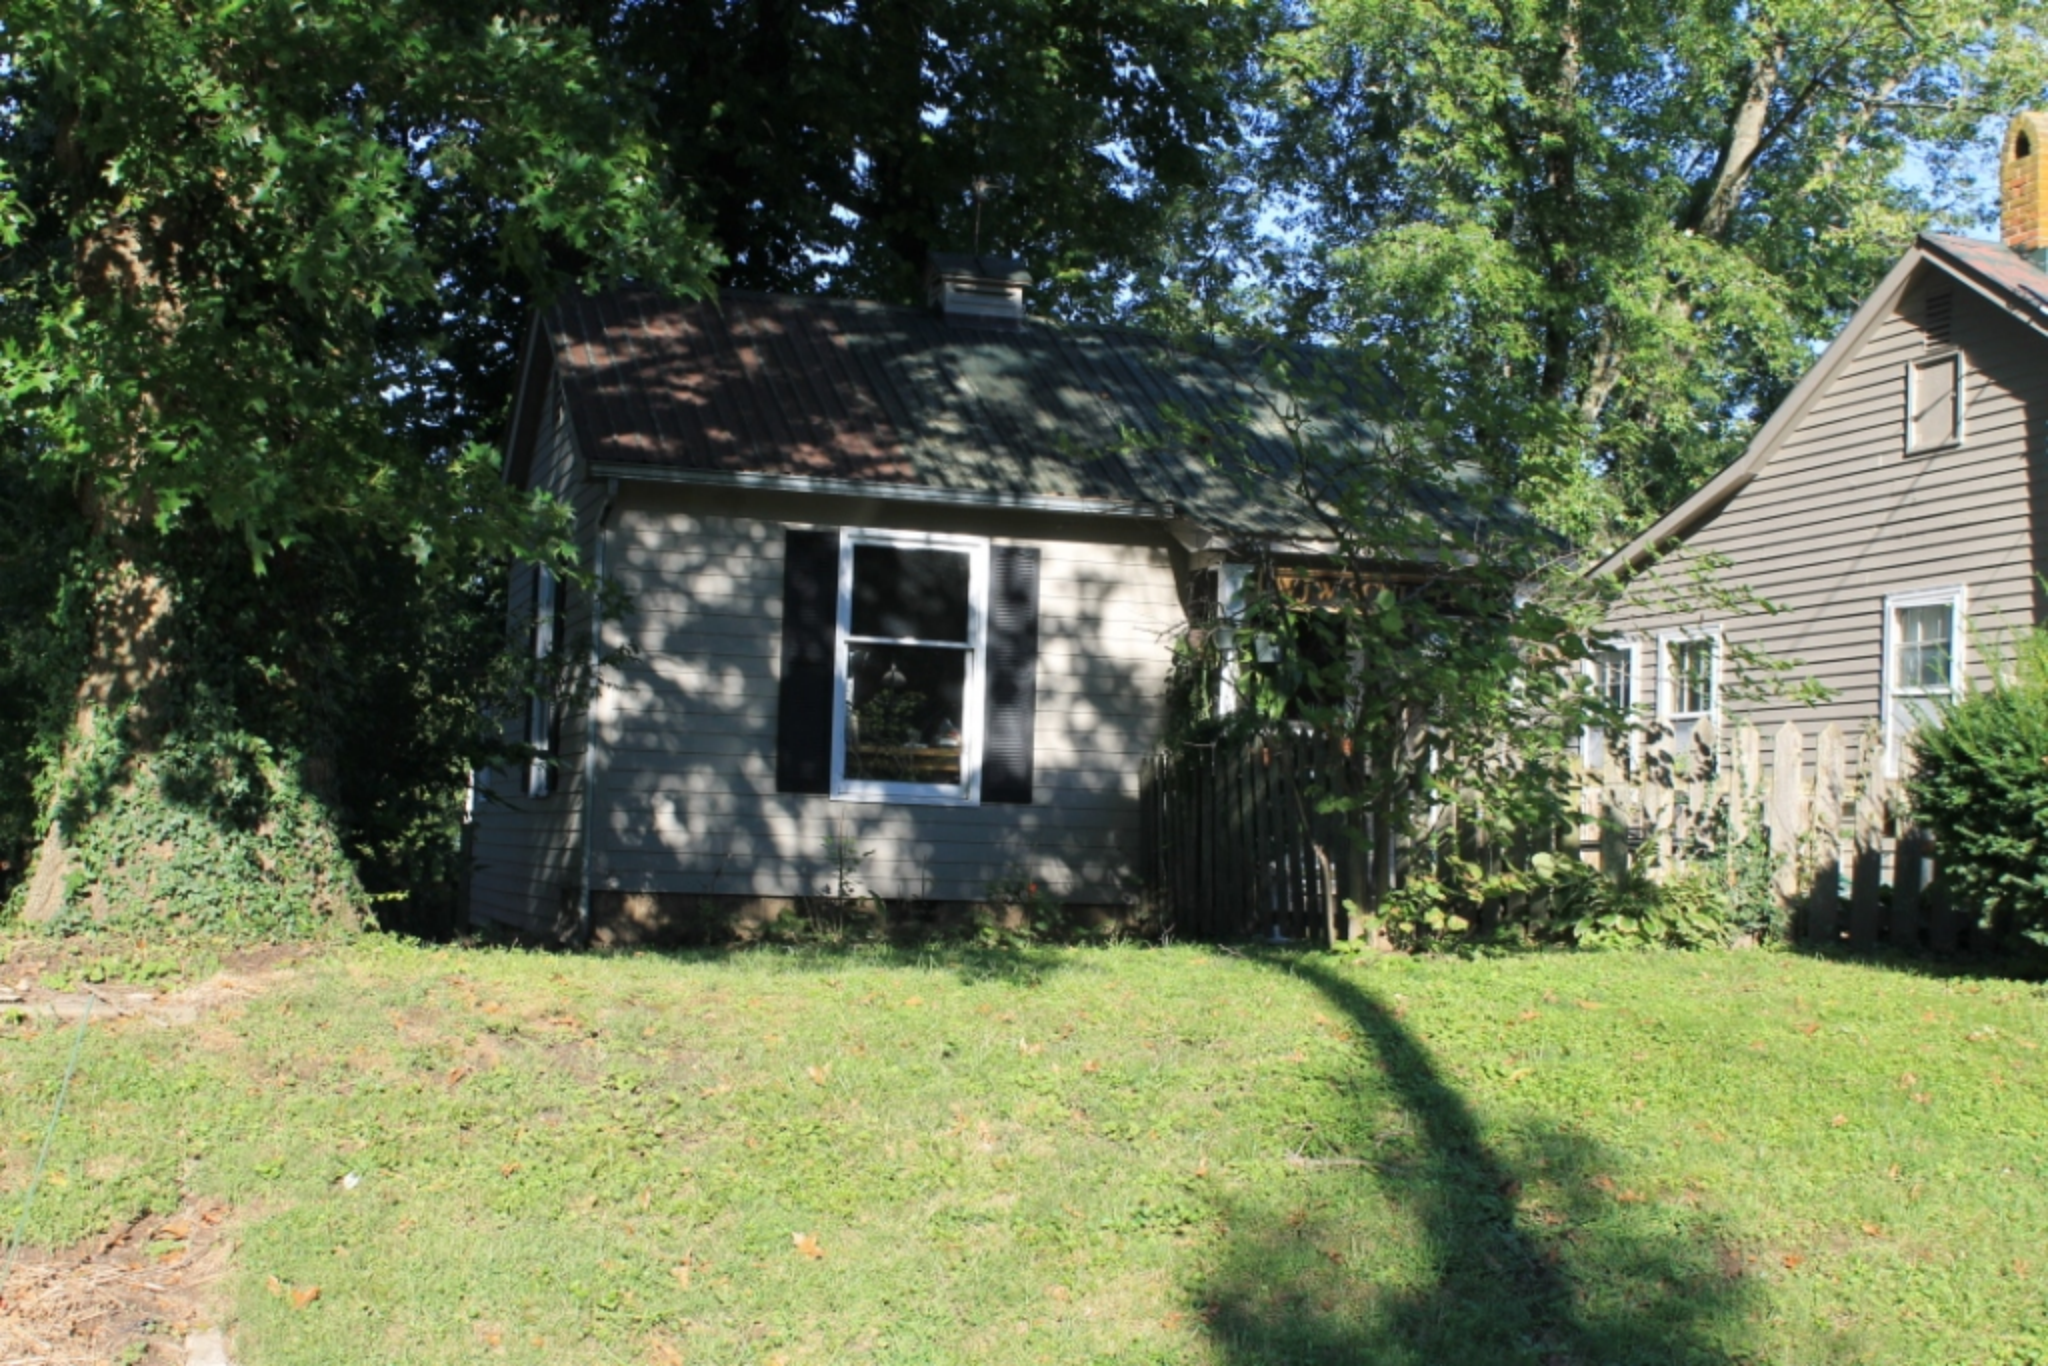
This building is a one-story, Federal style, frame house. The house is clad in clapboards and the low gable metal roof is covered in metal. The front (north) facade has five bays. The two left bays each contain a six-over-six single hung windows with a prominent lintel and drip cap molding. The center bay contains a modern door with an historic five paned transom and sidelights with four panes above wooden panels. The door has twelve panes. The door opens onto a concrete slab. The two right bays each contain a six-over-six single hung window with a prominent lintel and drip cap molding. A saltbox roofed wing extends to the south of the main block of the house. The side (east) facade of the house has three bays. The left bay contains a six-over-six single hung window. The center bay contains a door. The right bay contains a six-over-six single hung window. Brick interior chimneys rise from the rear slope on each end of the main block of the house. Another chimney rises from the rear of the ridge of the saltbox roofed addition.
