MISSOURI DEPARTMENT OF NATURAL RESOURCES
STATE HISTORIC PRESERVATION OFFICE, P.O. Box 176, Jefferson City, MO 65102
ARCHITECTURAL/HISTORIC INVENTORY FORM

1. SURVEY NO. BO-AS-009-0001		2. SURVEY NAME: Rocheport Historic District	
3. COUNTY: Boone		4. ADDRESS (STREET NO.)	STREET (NAME) Katy Trail
5. CITY: Rocheport	VICINITY: <input checked="" type="checkbox"/>	6. UTM: / /	LAT: LONG: T: 48W R: 15W S: 1

8. HISTORIC NAME (IF KNOWN): M.K.&T. Railroad tunnel		9. PRESENT/OTHER NAME (IF KNOWN): Katy trail tunnel	
10. OWNERSHIP: <input type="checkbox"/> PRIVATE <input checked="" type="checkbox"/> PUBLIC		11A. HISTORIC USE (IF KNOWN): railroad tunnel	11B. CURRENT USE: Katy Trail tunnel
HISTORICAL INFORMATION

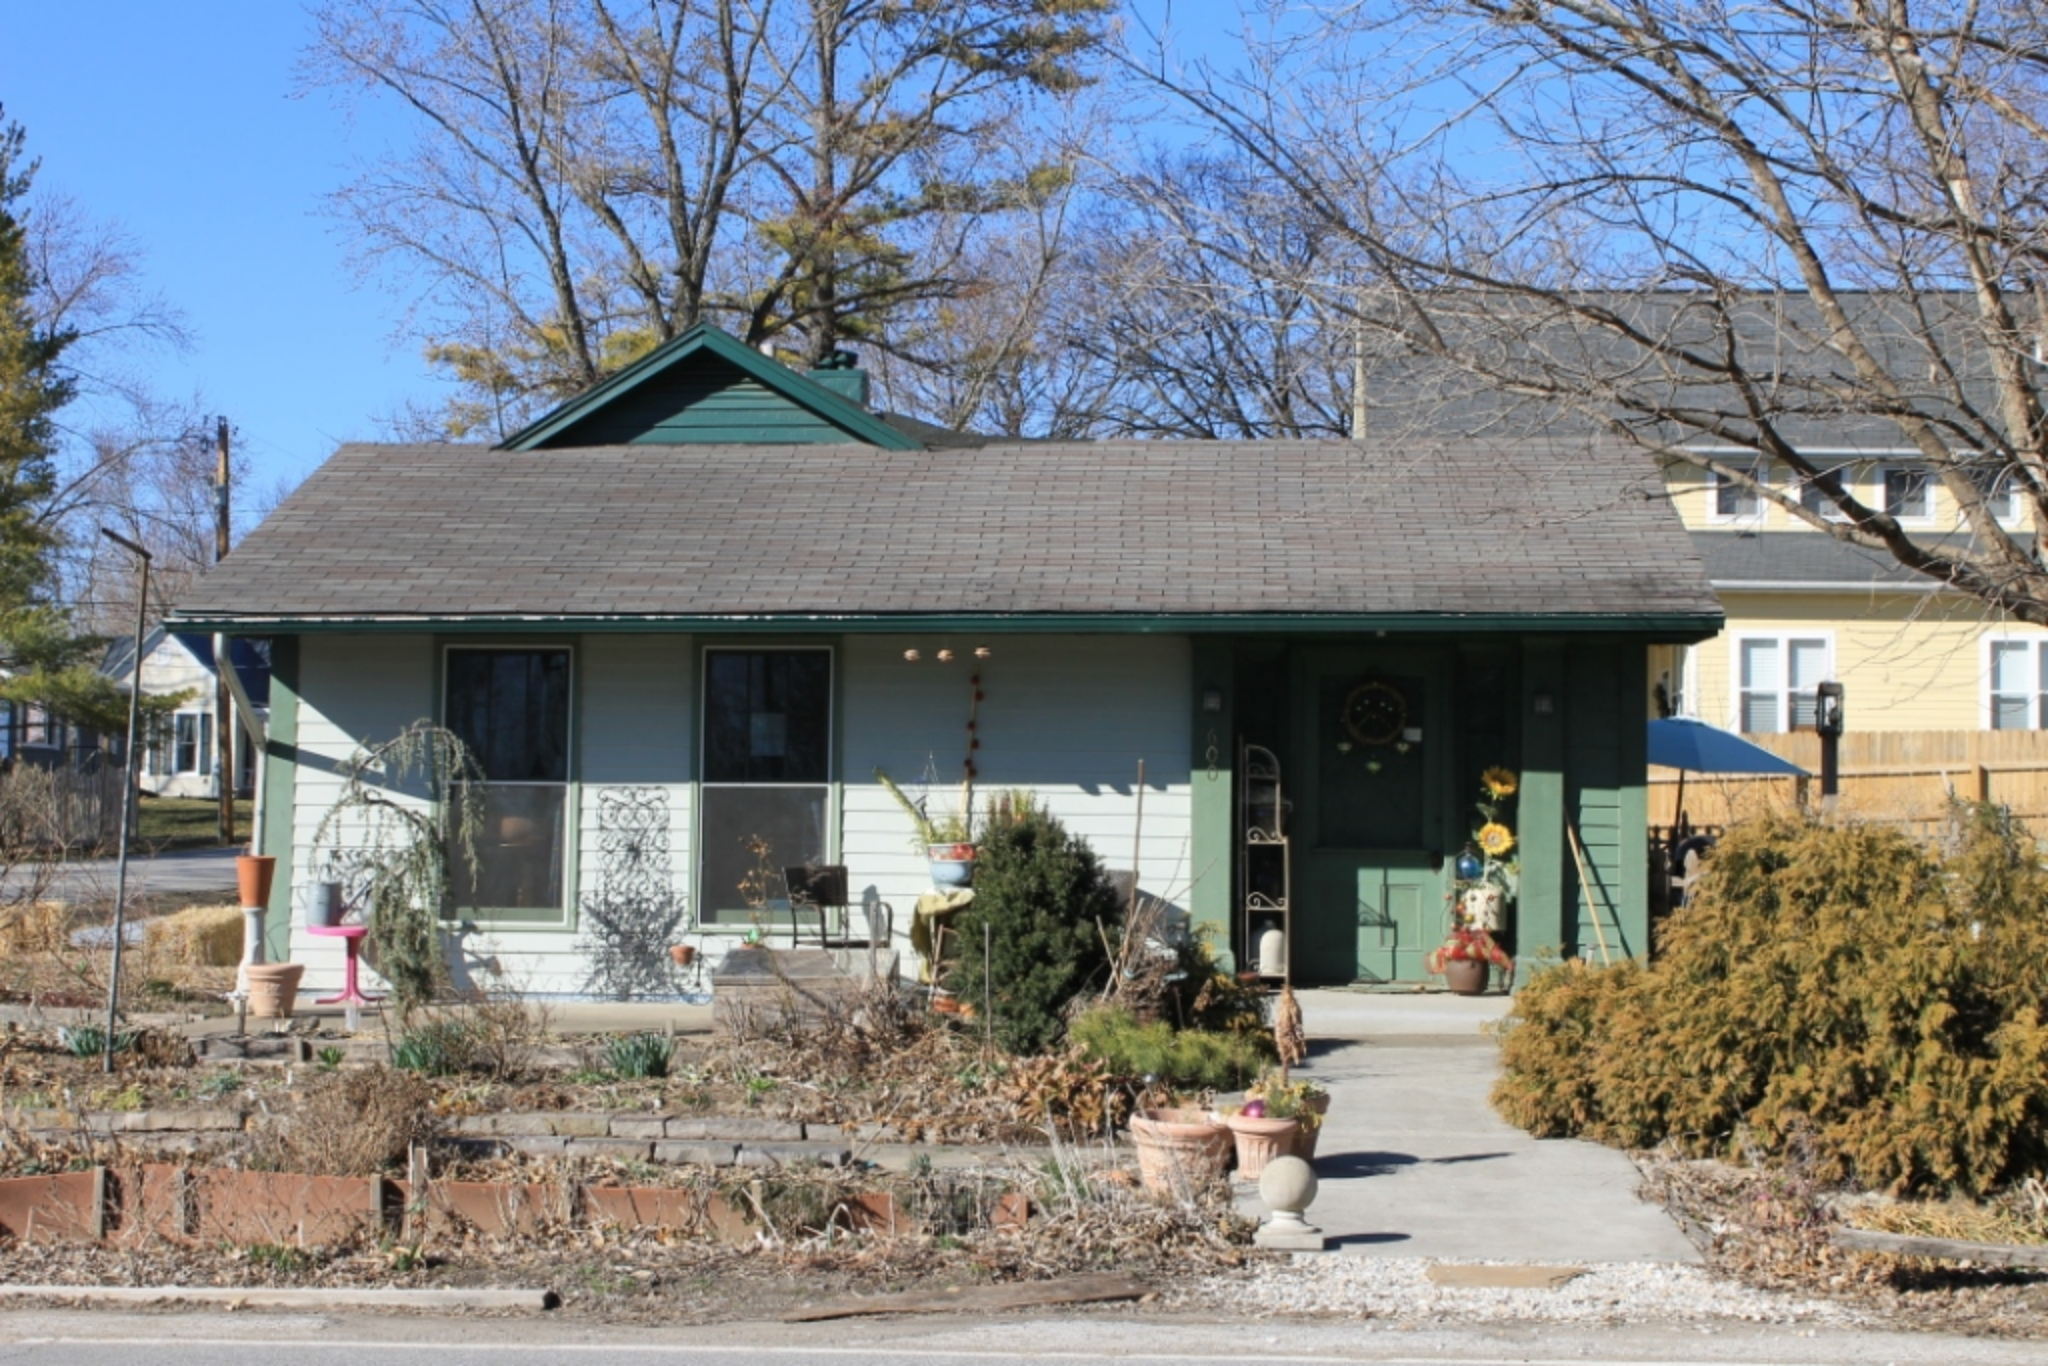
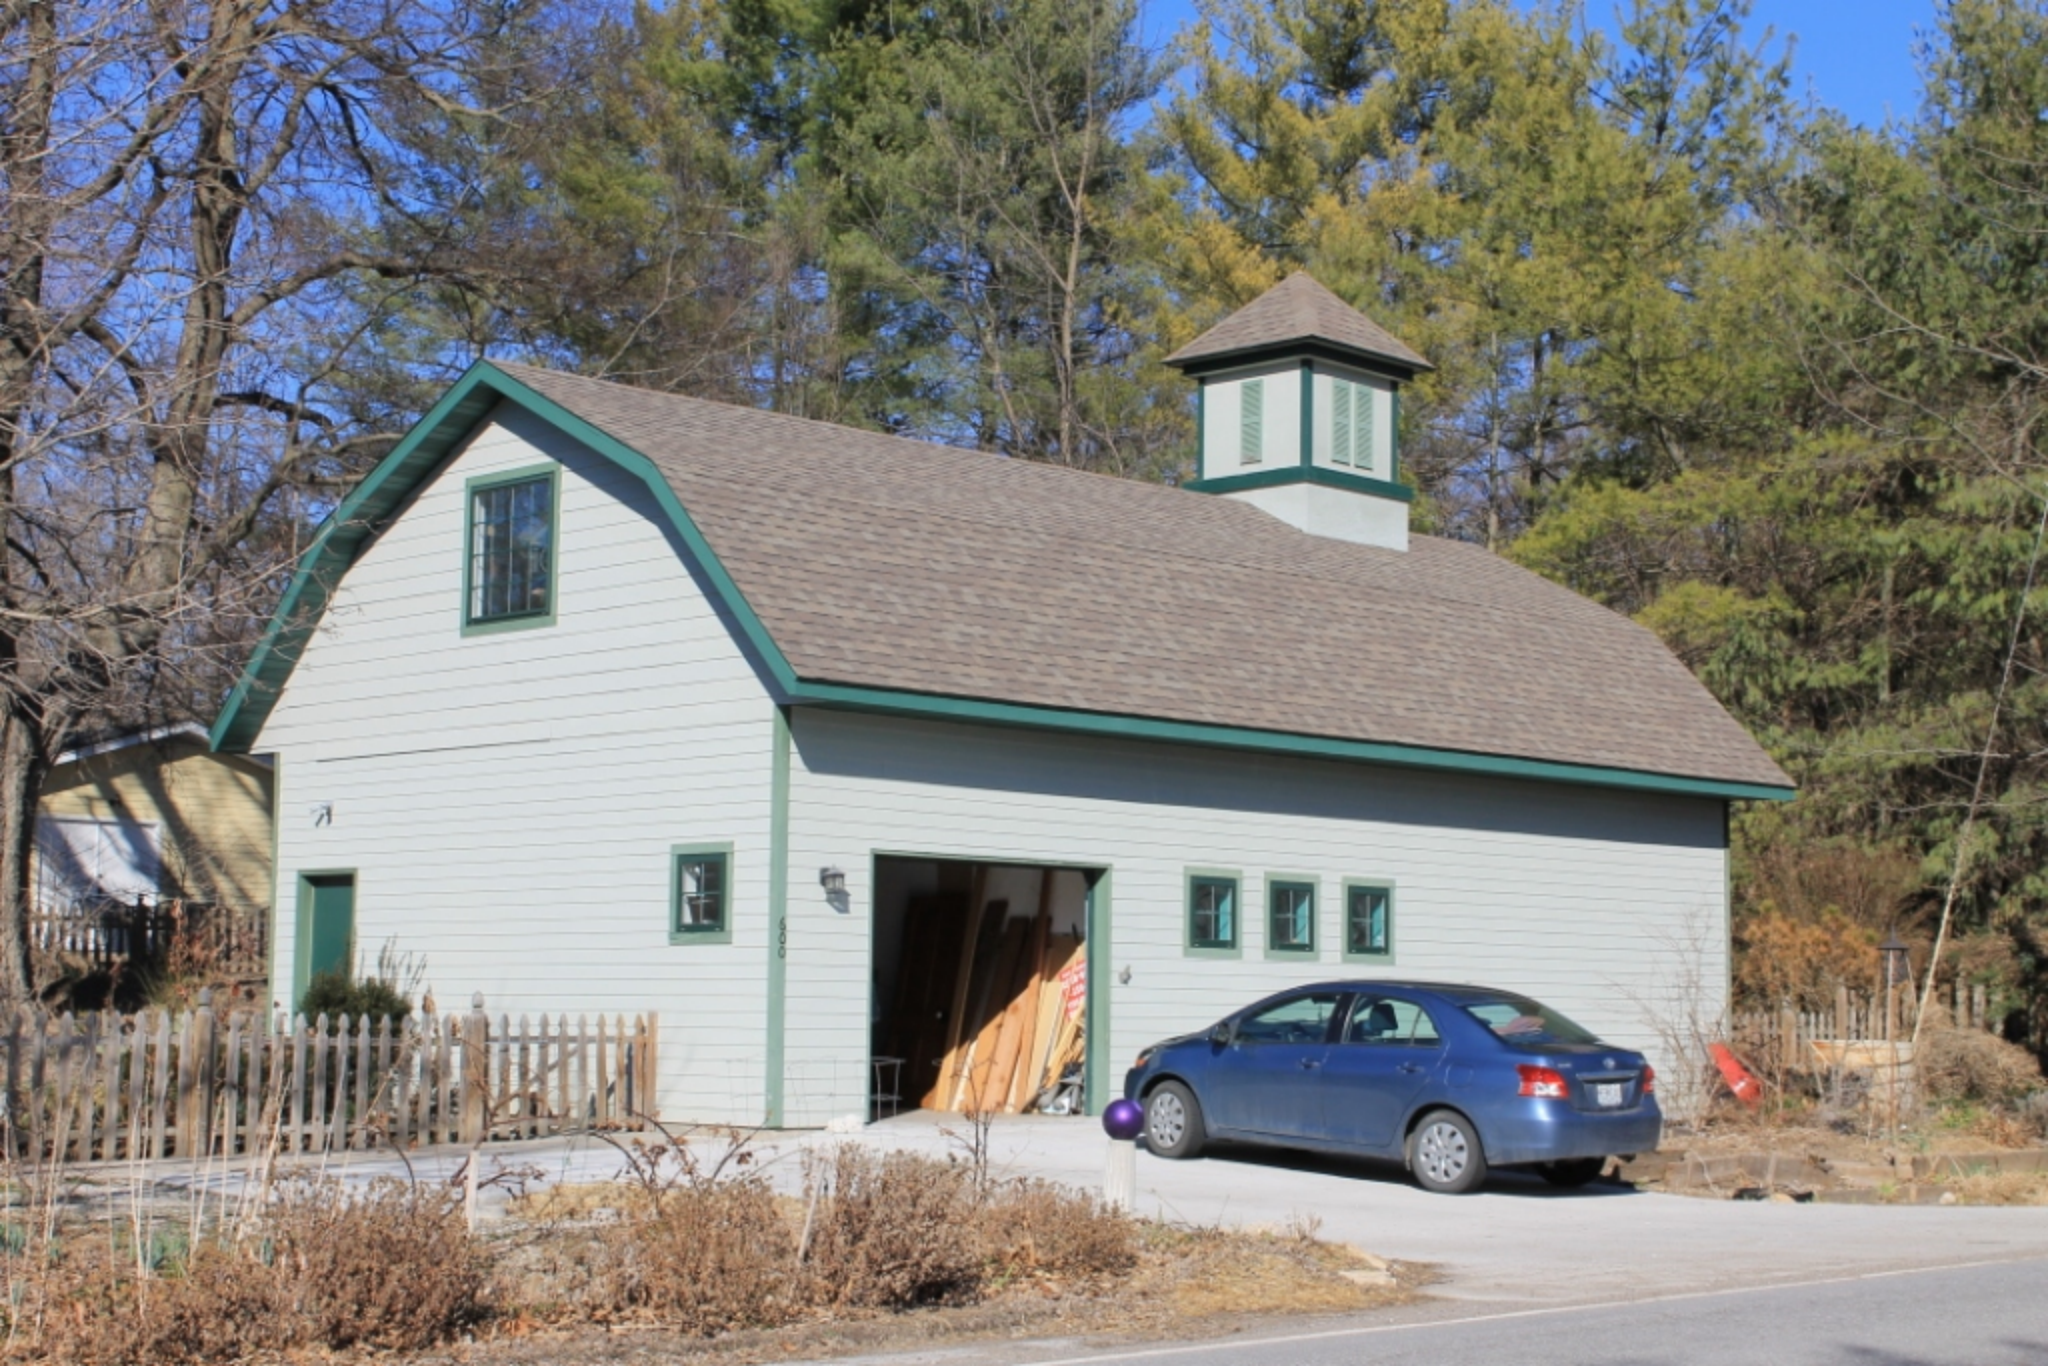
This main block of this one-story, frame building with a low gable roof has a front facing gable wing on the rear; the front facing gable extends above the roof line of the main block of the building. The front (south) facade of the main block of the building has three bays. The left bay contains a six-over-six wooden window. The center bay contains a six-over-six wooden window. The rightmost bay contains an inset porch opening onto a recessed doorway. The bay is accented by pilasters. The door has a diamond paned leaded glass window above two panels. Sidelights with three panes above wooden panels flank each side of the door.

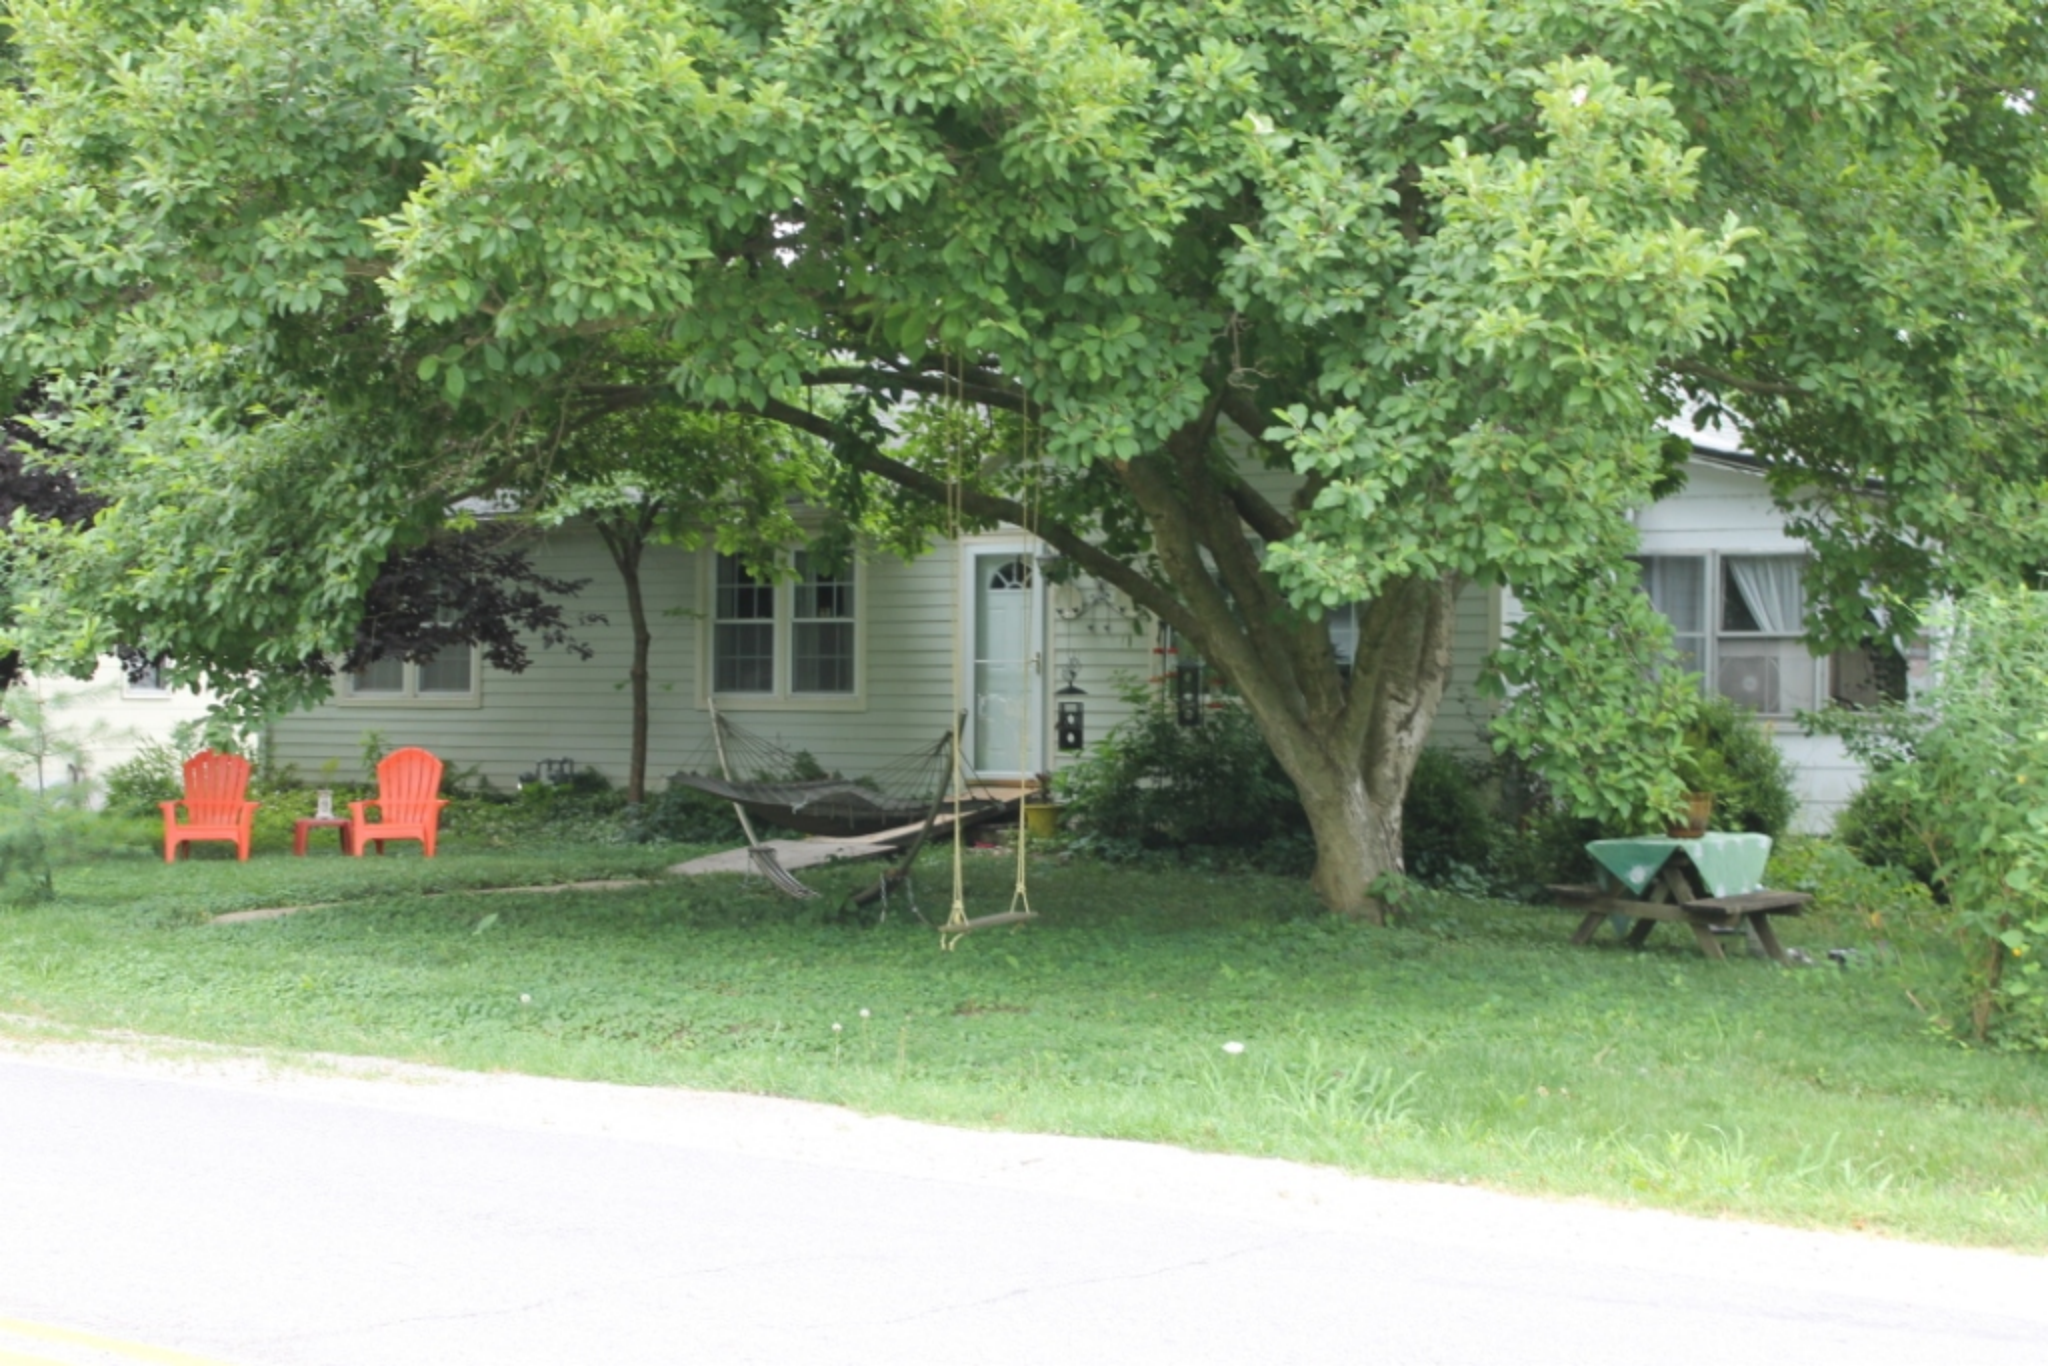
This one-story, massed plan, frame ranch house has a cross gable roof covered in asphalt shingles. A wing with a lower roofline extends to the west of the house. The building is clad in clapboards. The roof is covered in asphalt shingles. The front (north) facade has five bays. The left most bay contains a pair of six-over-six single hung windows. The next bay contains a pair of six-over-six single hung windows. The next bay contains a door that opens onto a stoop. The next bay contains a pair of six-over-six single hung windows. The rightmost bay, which is located in the wing to the west of the main block of the house, contains a pair of one-over-one windows.

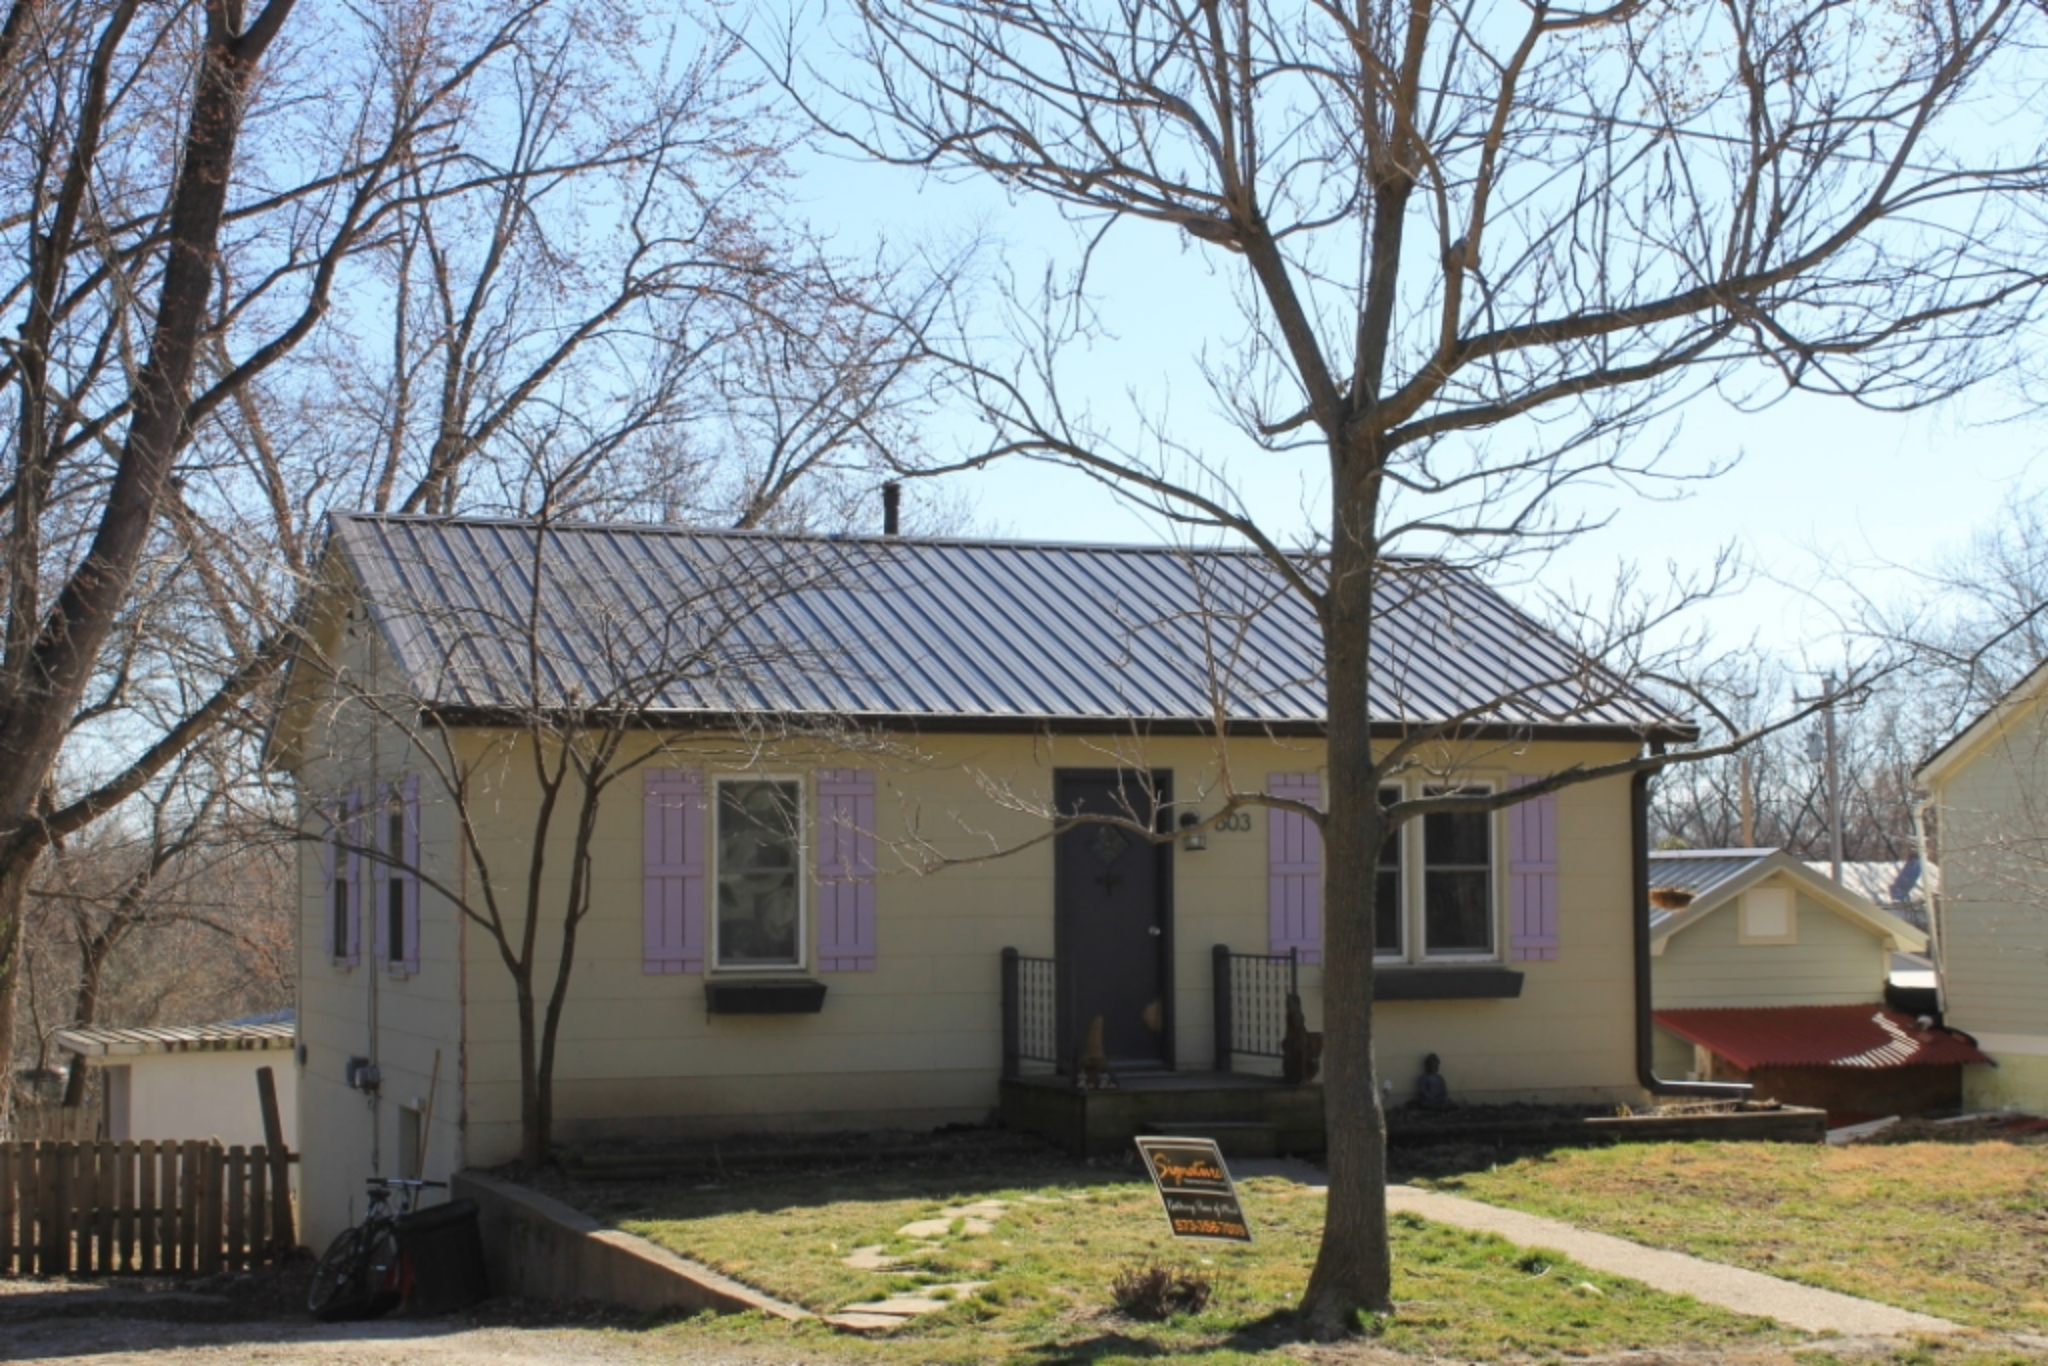
This one-story, frame, massed plan side gable, ranch house sits on a basement that is partially exposed on the east by the sloping terrain. The walls are clad in wide clapboards, and the medium gable roof is covered in asphalt shingles. The front (north) facade has three bays. The left bay contains a one-over-one single hung window. The center bay contains a door that opens onto a stoop with wrought iron railings on either side. The right bay contains a pair of one-over-one single hung windows. The windows are accented with shutters and window boxes.

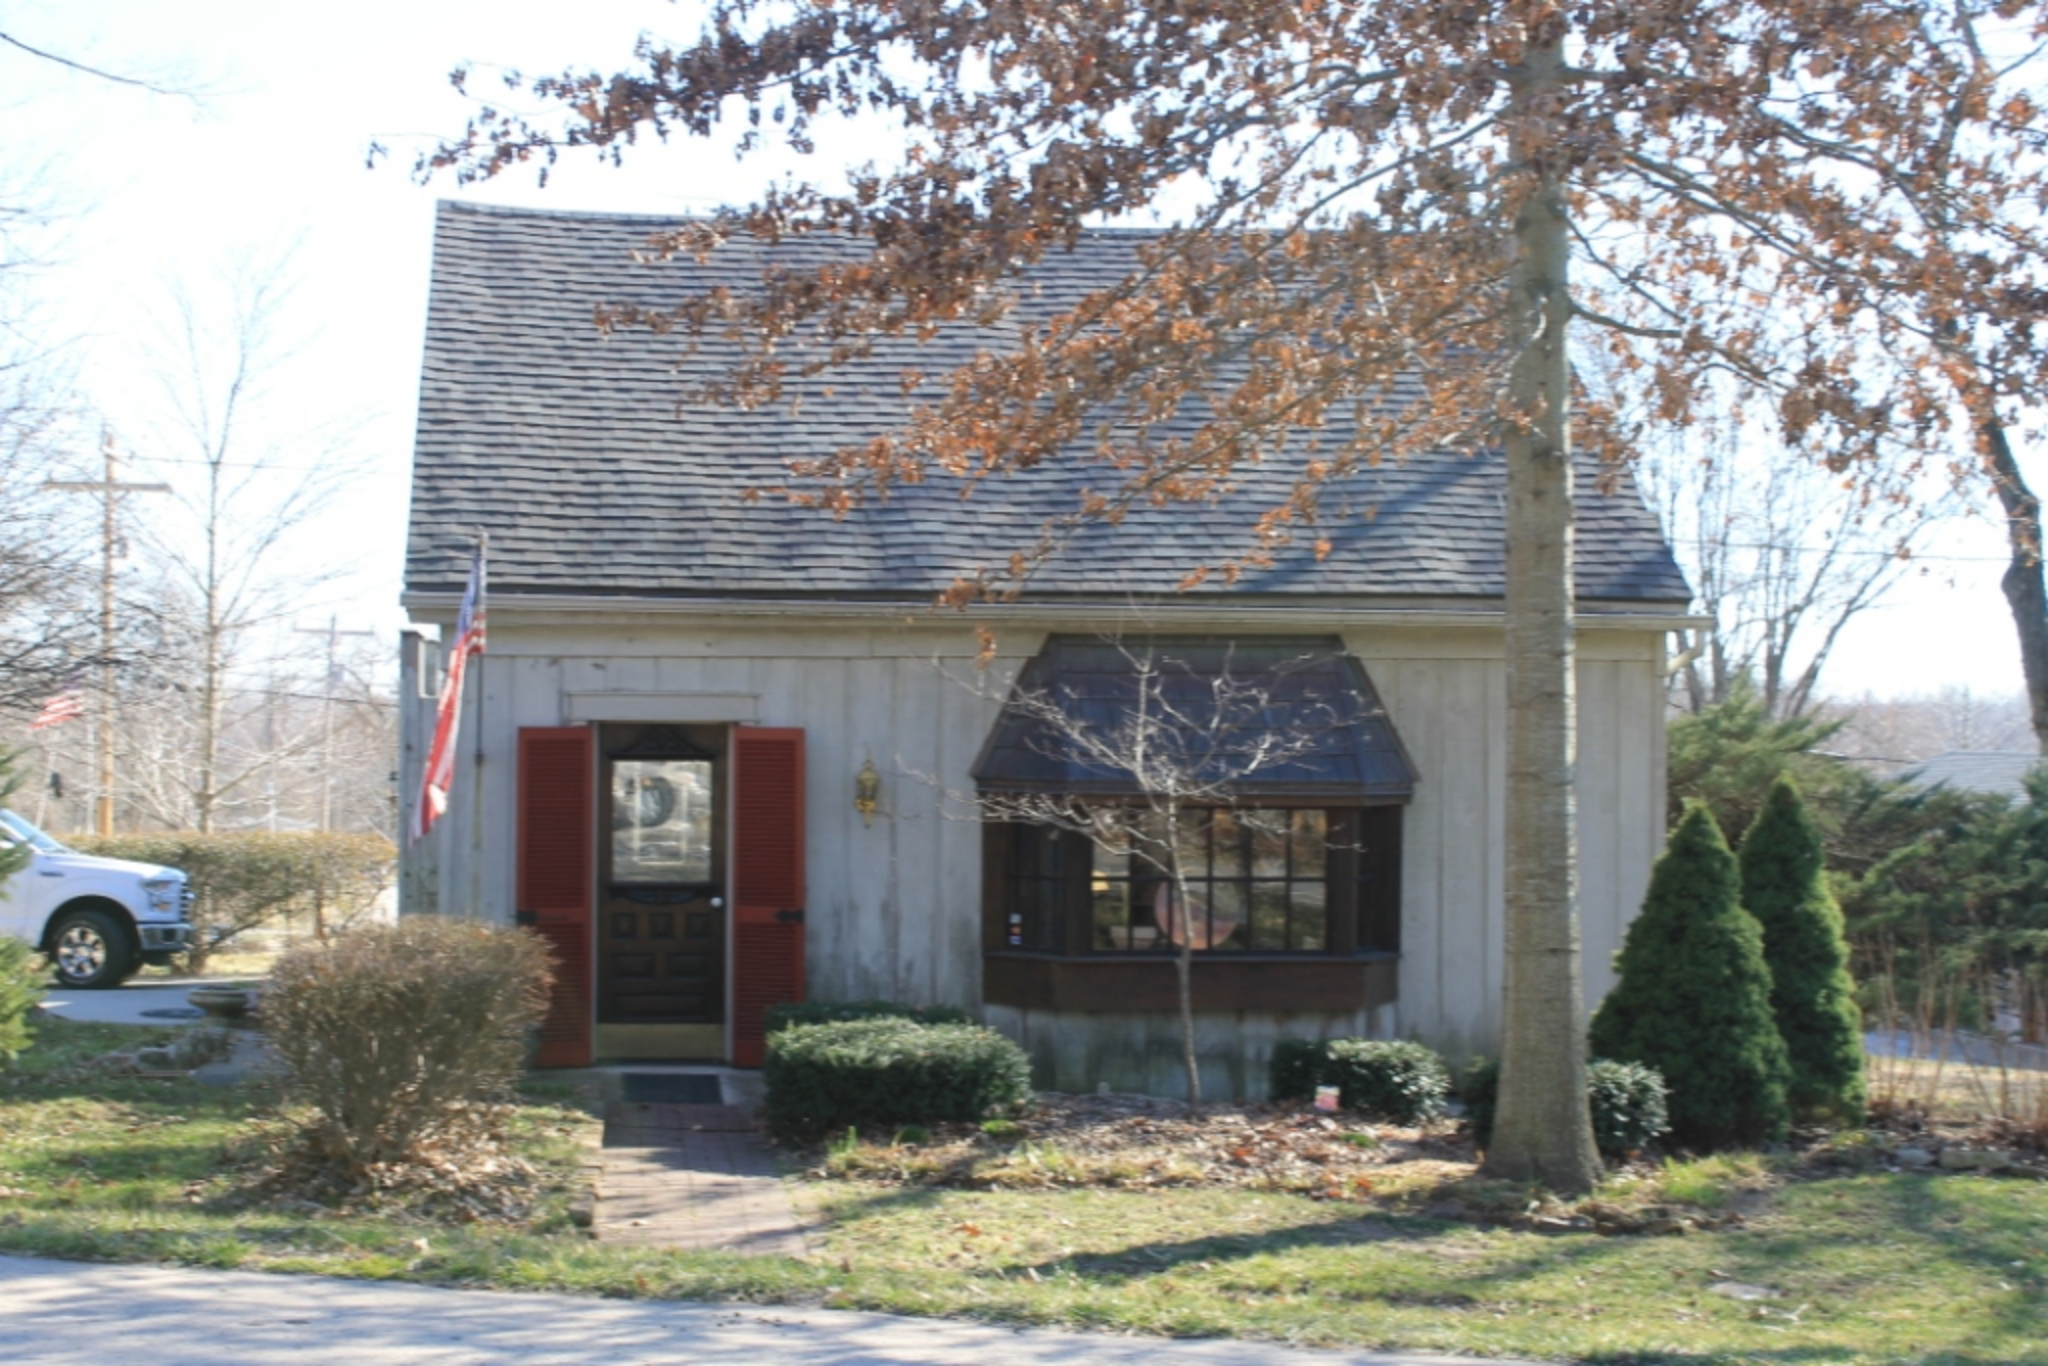
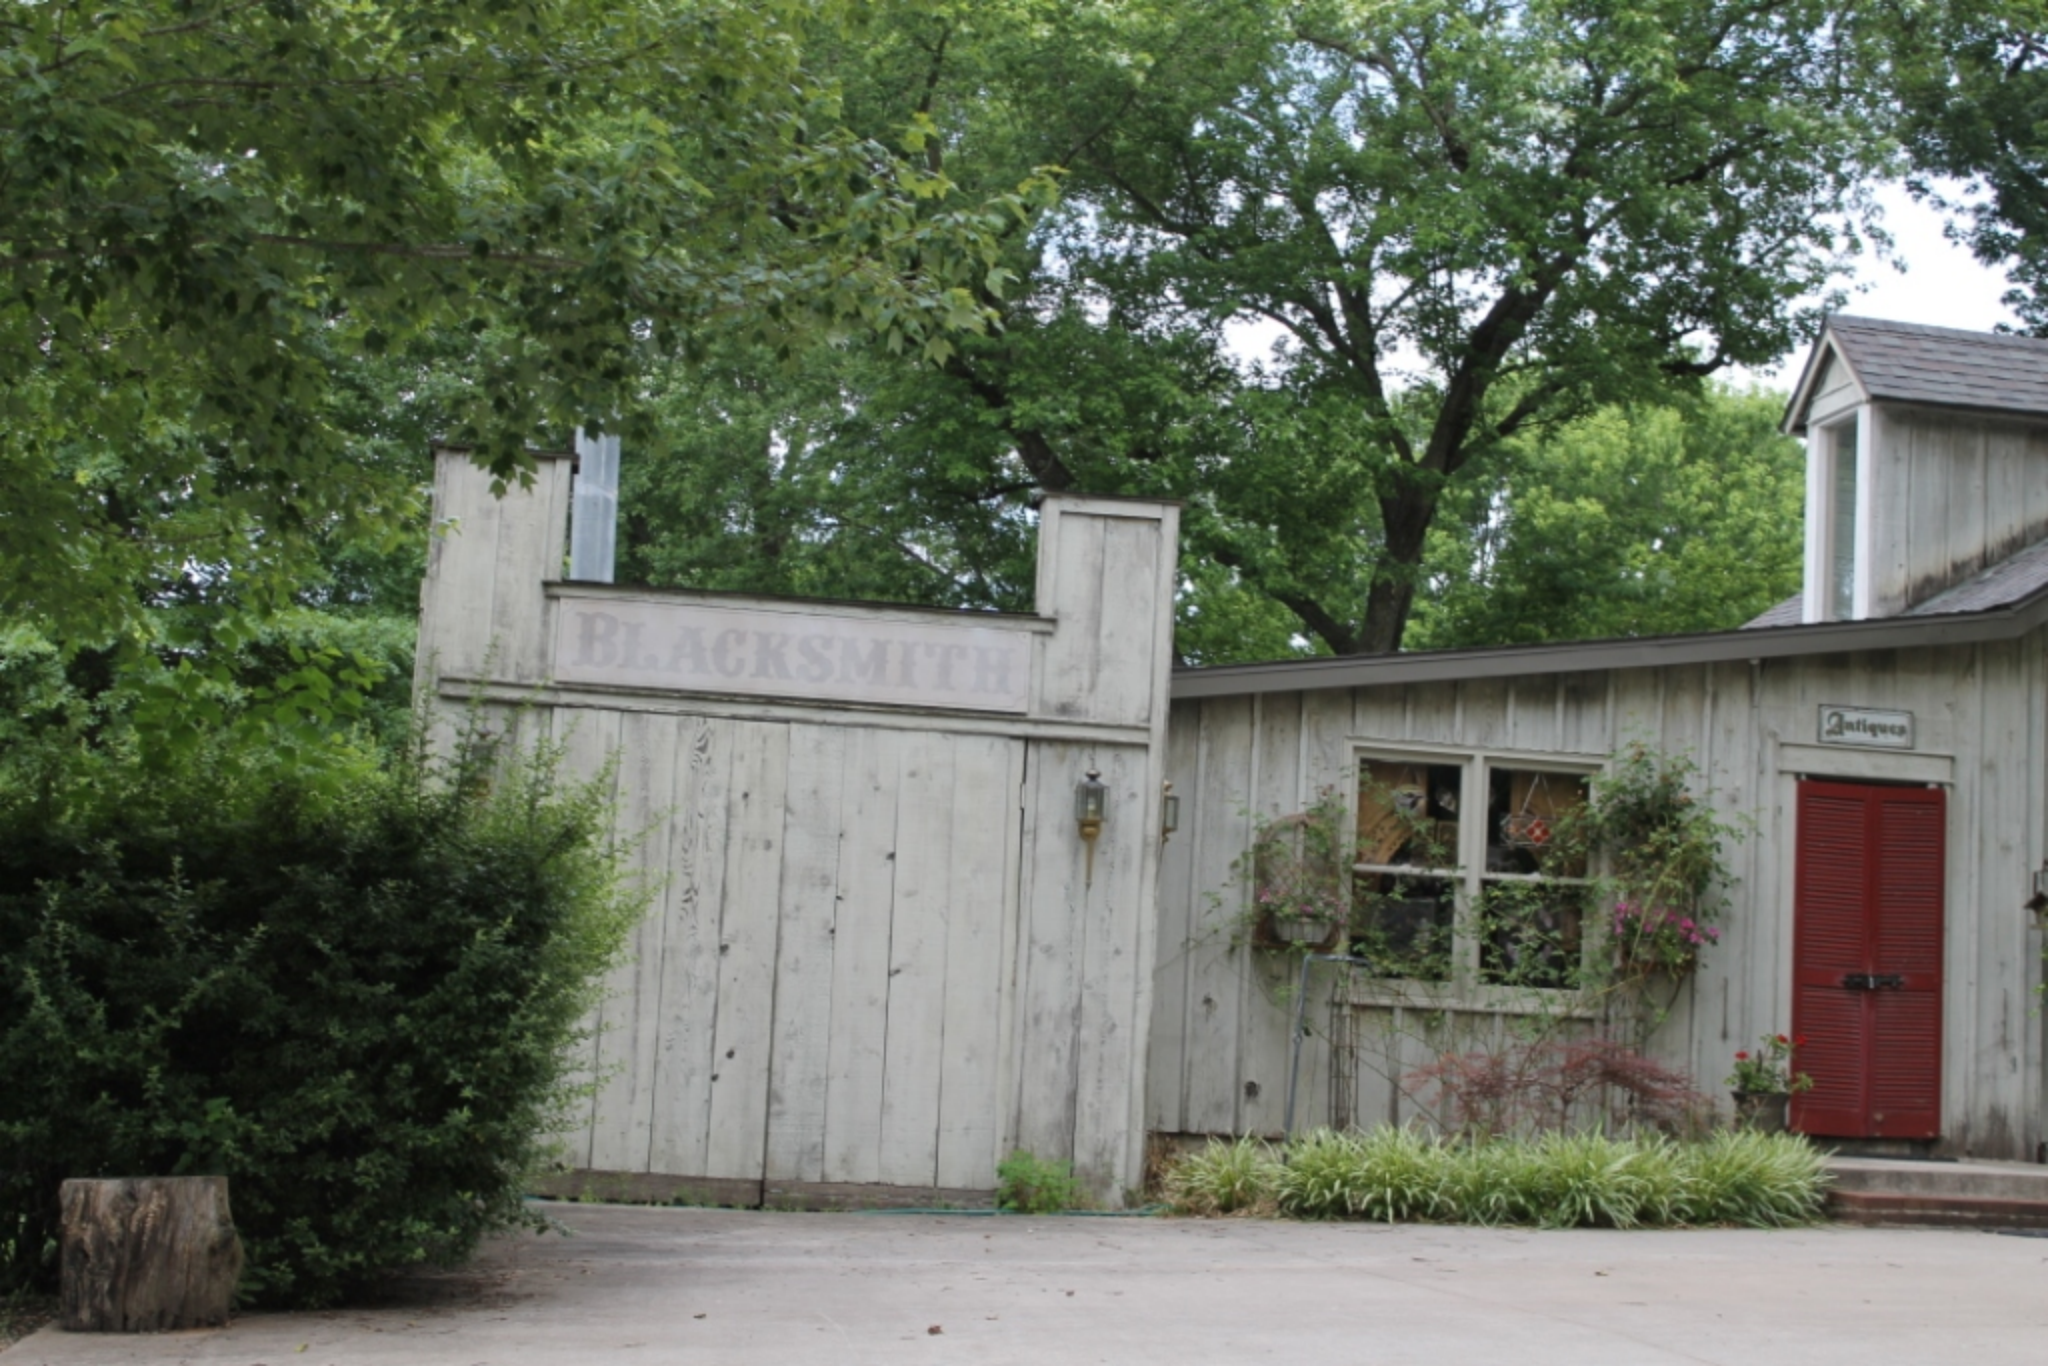
This building is a rectangular shaped, massed plan side gable 1 1/2 story building with a high pitched gable roof that extends to a low pitched shed roof to cover the rear portion of the building. The front facade has two bays. The left bay contains a doorway with a fixed pane window and decorative shutters on either side. The right bay contains a fixed glass bay window with twelve panes on the front and six panes on each side. The rear wing has blacksmith shop where decorative ironwork is produced. A metal flue rises from the rear wing of the building.

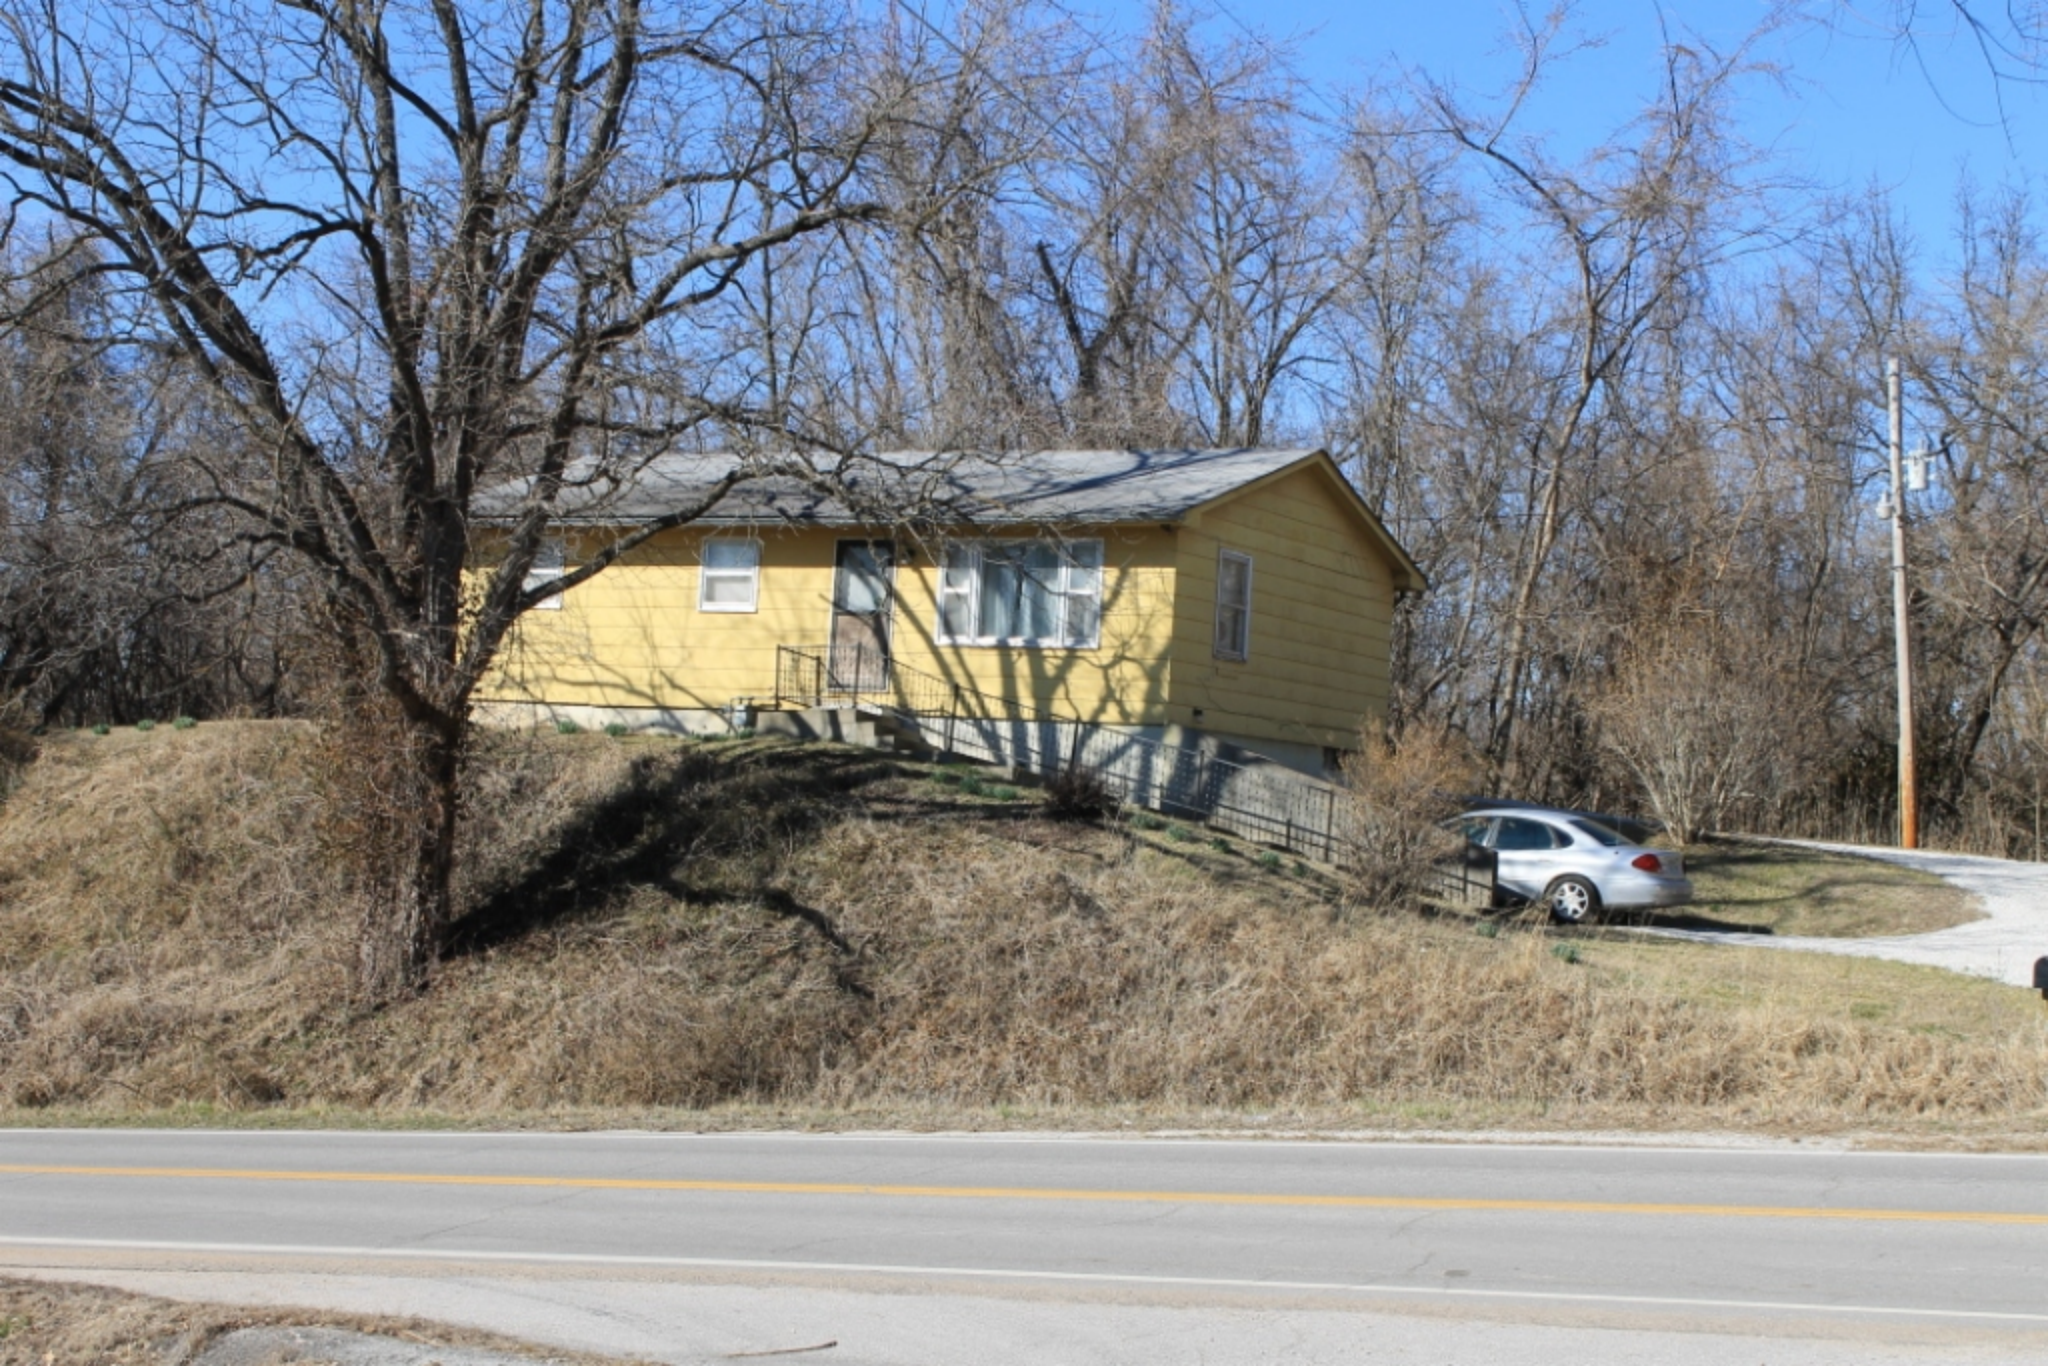
This one-story, massed plan side gable, frame ranch house with a low gable roof has a basement that houses a garage. The house is clad in clapboards and the roof is covered in asphalt shingles. The front (south) facade of the house has four bays. The leftmost bay contains a one-over-one single hung window. The next bay contains a one-over-one single hung window. The next bay contains a door with a window in the top. To the far right is a bay containing a large single paned picture window flanked on each side by a one-over-one single hung window. A metal railing surrounds a small stoop located slightly right of center on the front facade.
