MISSOURI DEPARTMENT OF NATURAL RESOURCES
STATE HISTORIC PRESERVATION OFFICE, P.O. Box 176, Jefferson City, MO 65102
ARCHITECTURAL/HISTORIC INVENTORY FORM

1. SURVEY NO. BO-AS-009-0001		2. SURVEY NAME: Rocheport Historic District	
3. COUNTY: Boone		4. ADDRESS (STREET NO.)	STREET (NAME) Katy Trail
5. CITY: Rocheport	VICINITY: <input checked="" type="checkbox"/>	6. UTM: / /	LAT: LONG: T: 48W R: 15W S: 1

8. HISTORIC NAME (IF KNOWN): M.K.&T. Railroad tunnel		9. PRESENT/OTHER NAME (IF KNOWN): Katy trail tunnel	
10. OWNERSHIP: <input type="checkbox"/> PRIVATE <input checked="" type="checkbox"/> PUBLIC		11A. HISTORIC USE (IF KNOWN): railroad tunnel	11B. CURRENT USE: Katy Trail tunnel
HISTORICAL INFORMATION

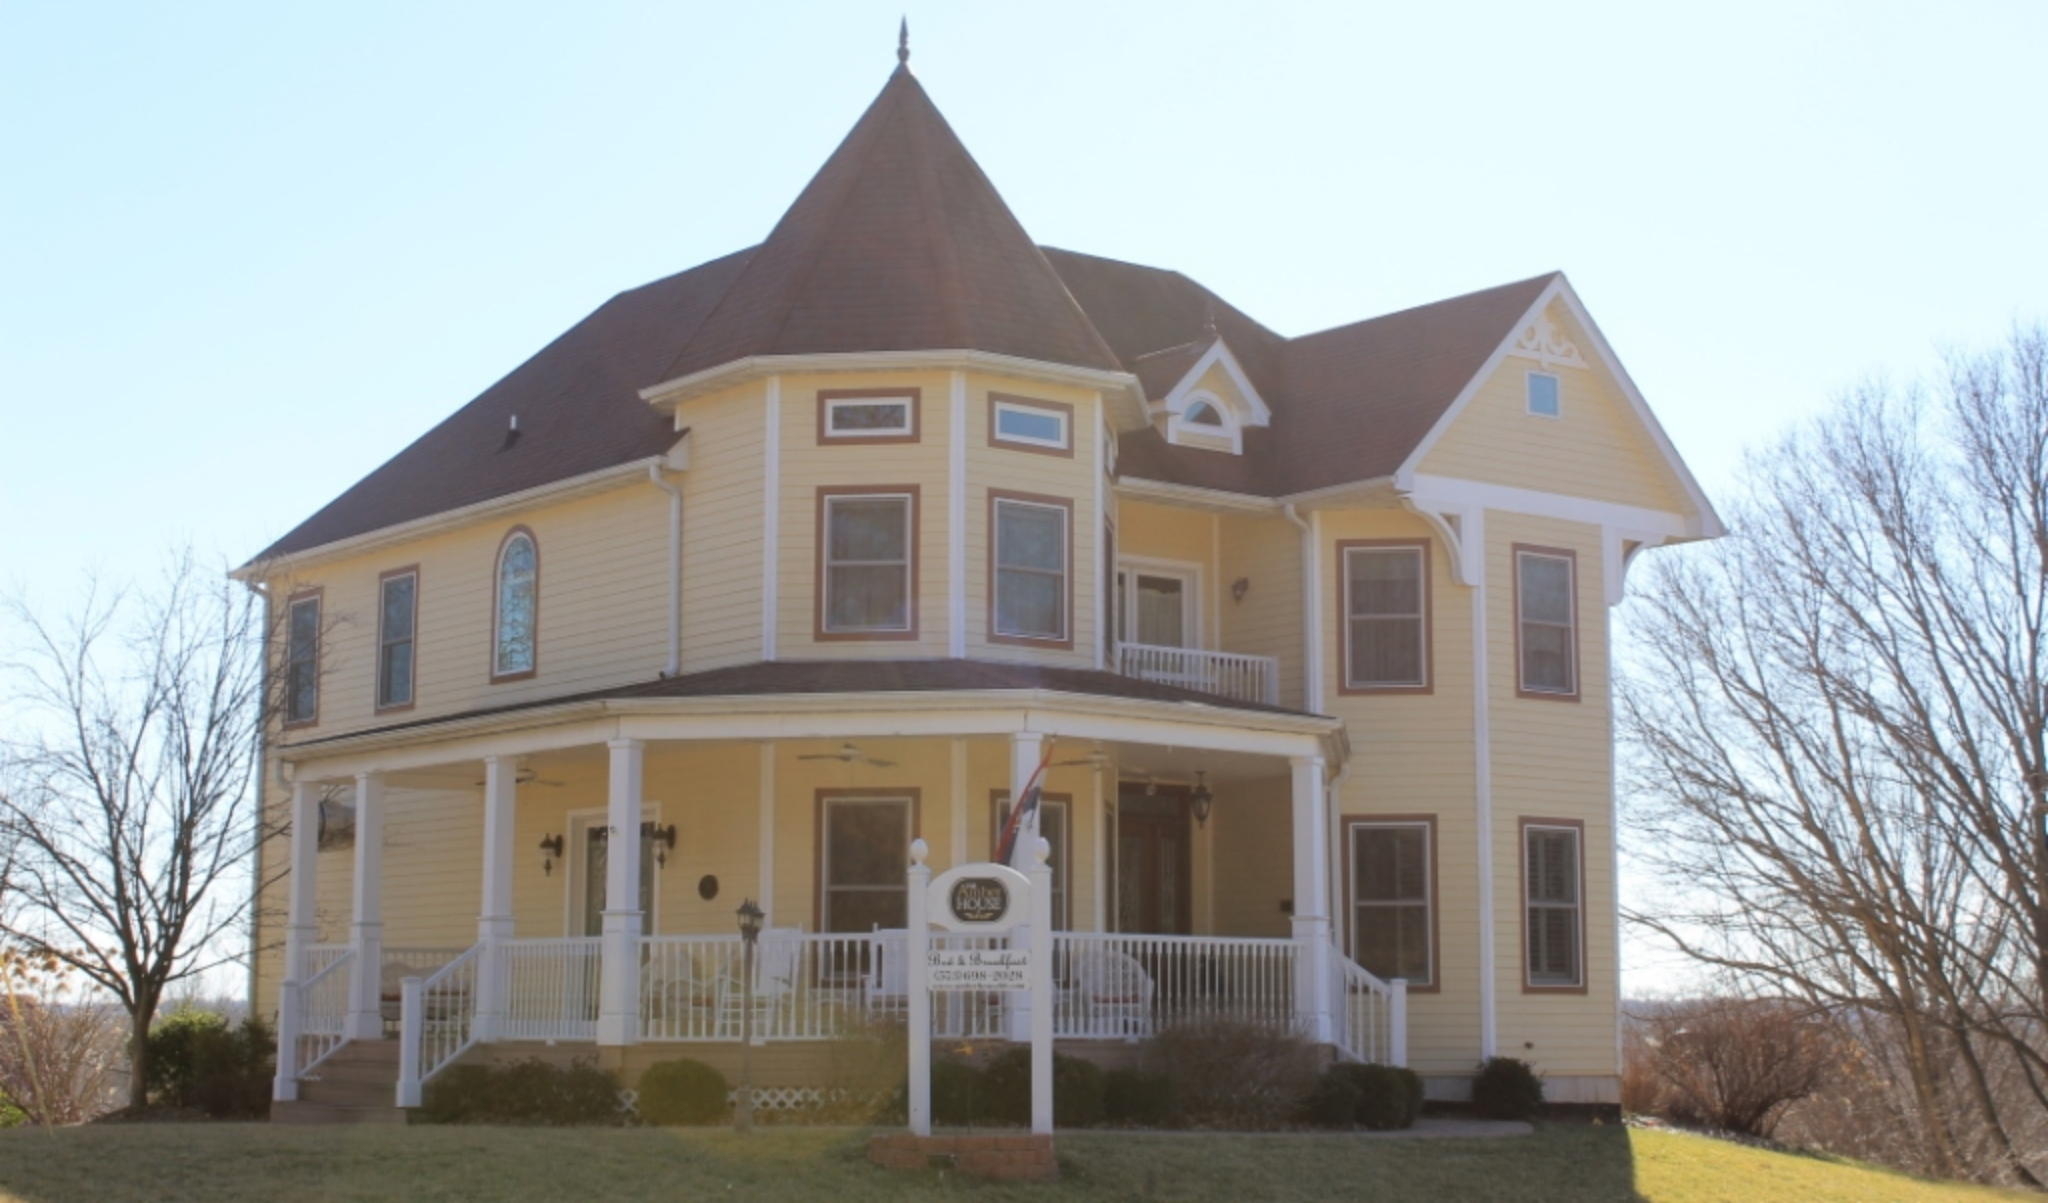
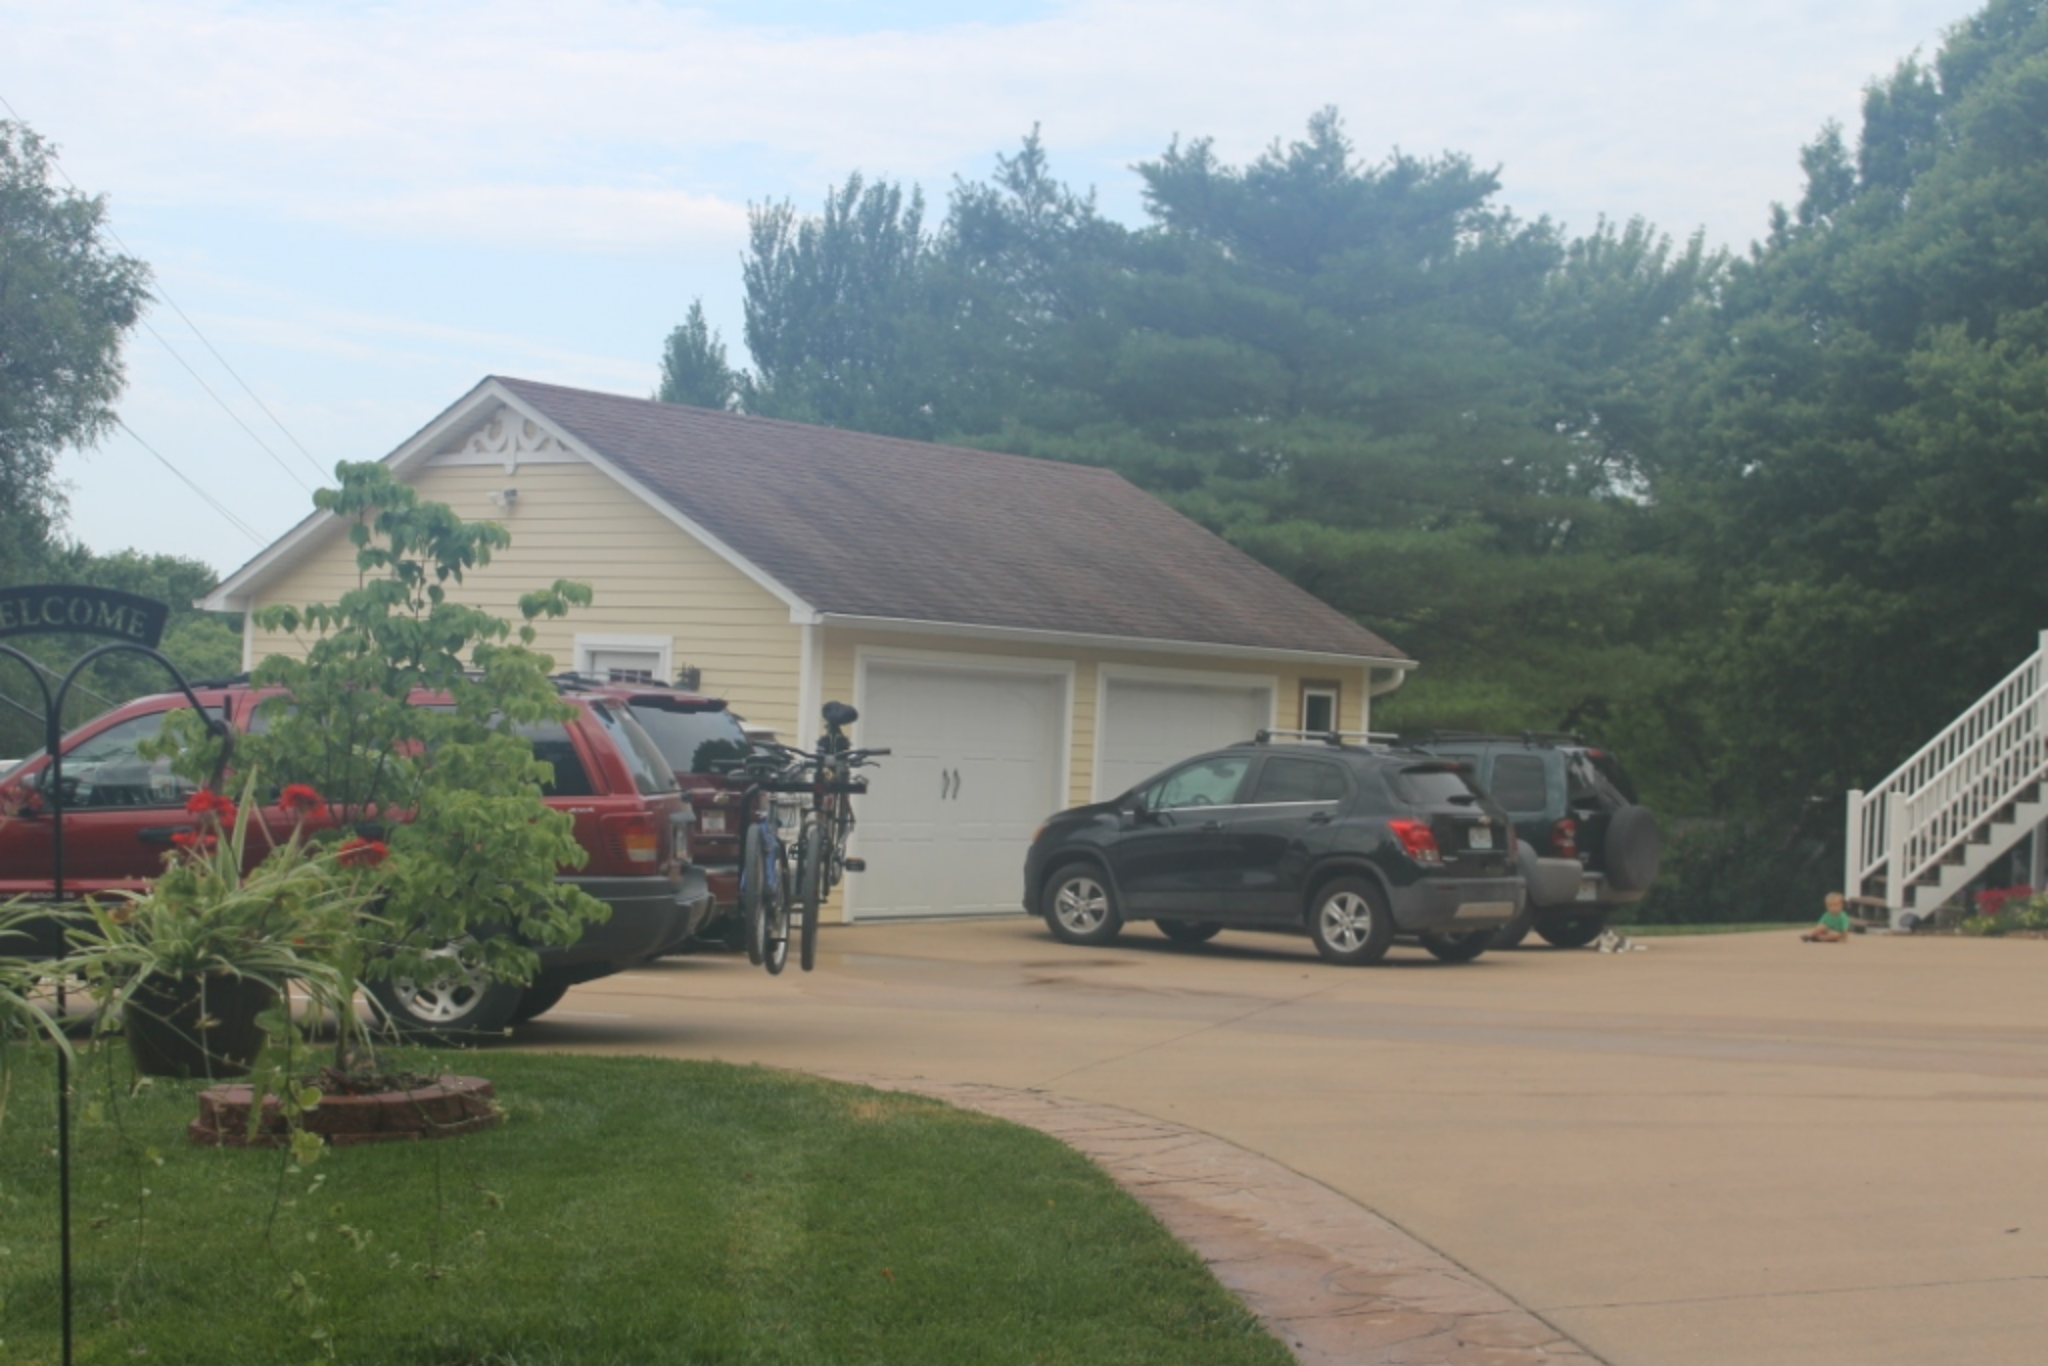
This two story, massed plan building is a New Traditional-Queen Anne style. On the north (front) facade, a five sided, two story tower is on the left end of the building and a three sided two-story bay window is on the other. Between the tower and the bay window is a recessed area covered with a slightly hipped roof porch that wraps around the east and north portions of the house. The porch posts are tapered; the balustrades are square. The porch has steps from the front and from the side. The front facade has seven bays. The three leftmost bays are in the tower; each contains a one-over-one single hung window. The center bay contains a door. The three right bays, each containing a one-over-one single hung window, are in the bay window. On the second story, the tower has three one-over-one windows, as well as fixed pane windows close to the top of the tower. On the second story of the bay window are three windows. Between the tower and the bay window on the attic level is a gable roofed dormer with a small half-round window. On the attic level of the bay window is a small louvered vent. A bargeboard accents the peak of the gable. On the first story of the side (east) facade is one bay containing a French door. On the second story of the facade are three bays, the left two containing rectangular one-over-one windows and the other bay containing a round arched stained glass window.

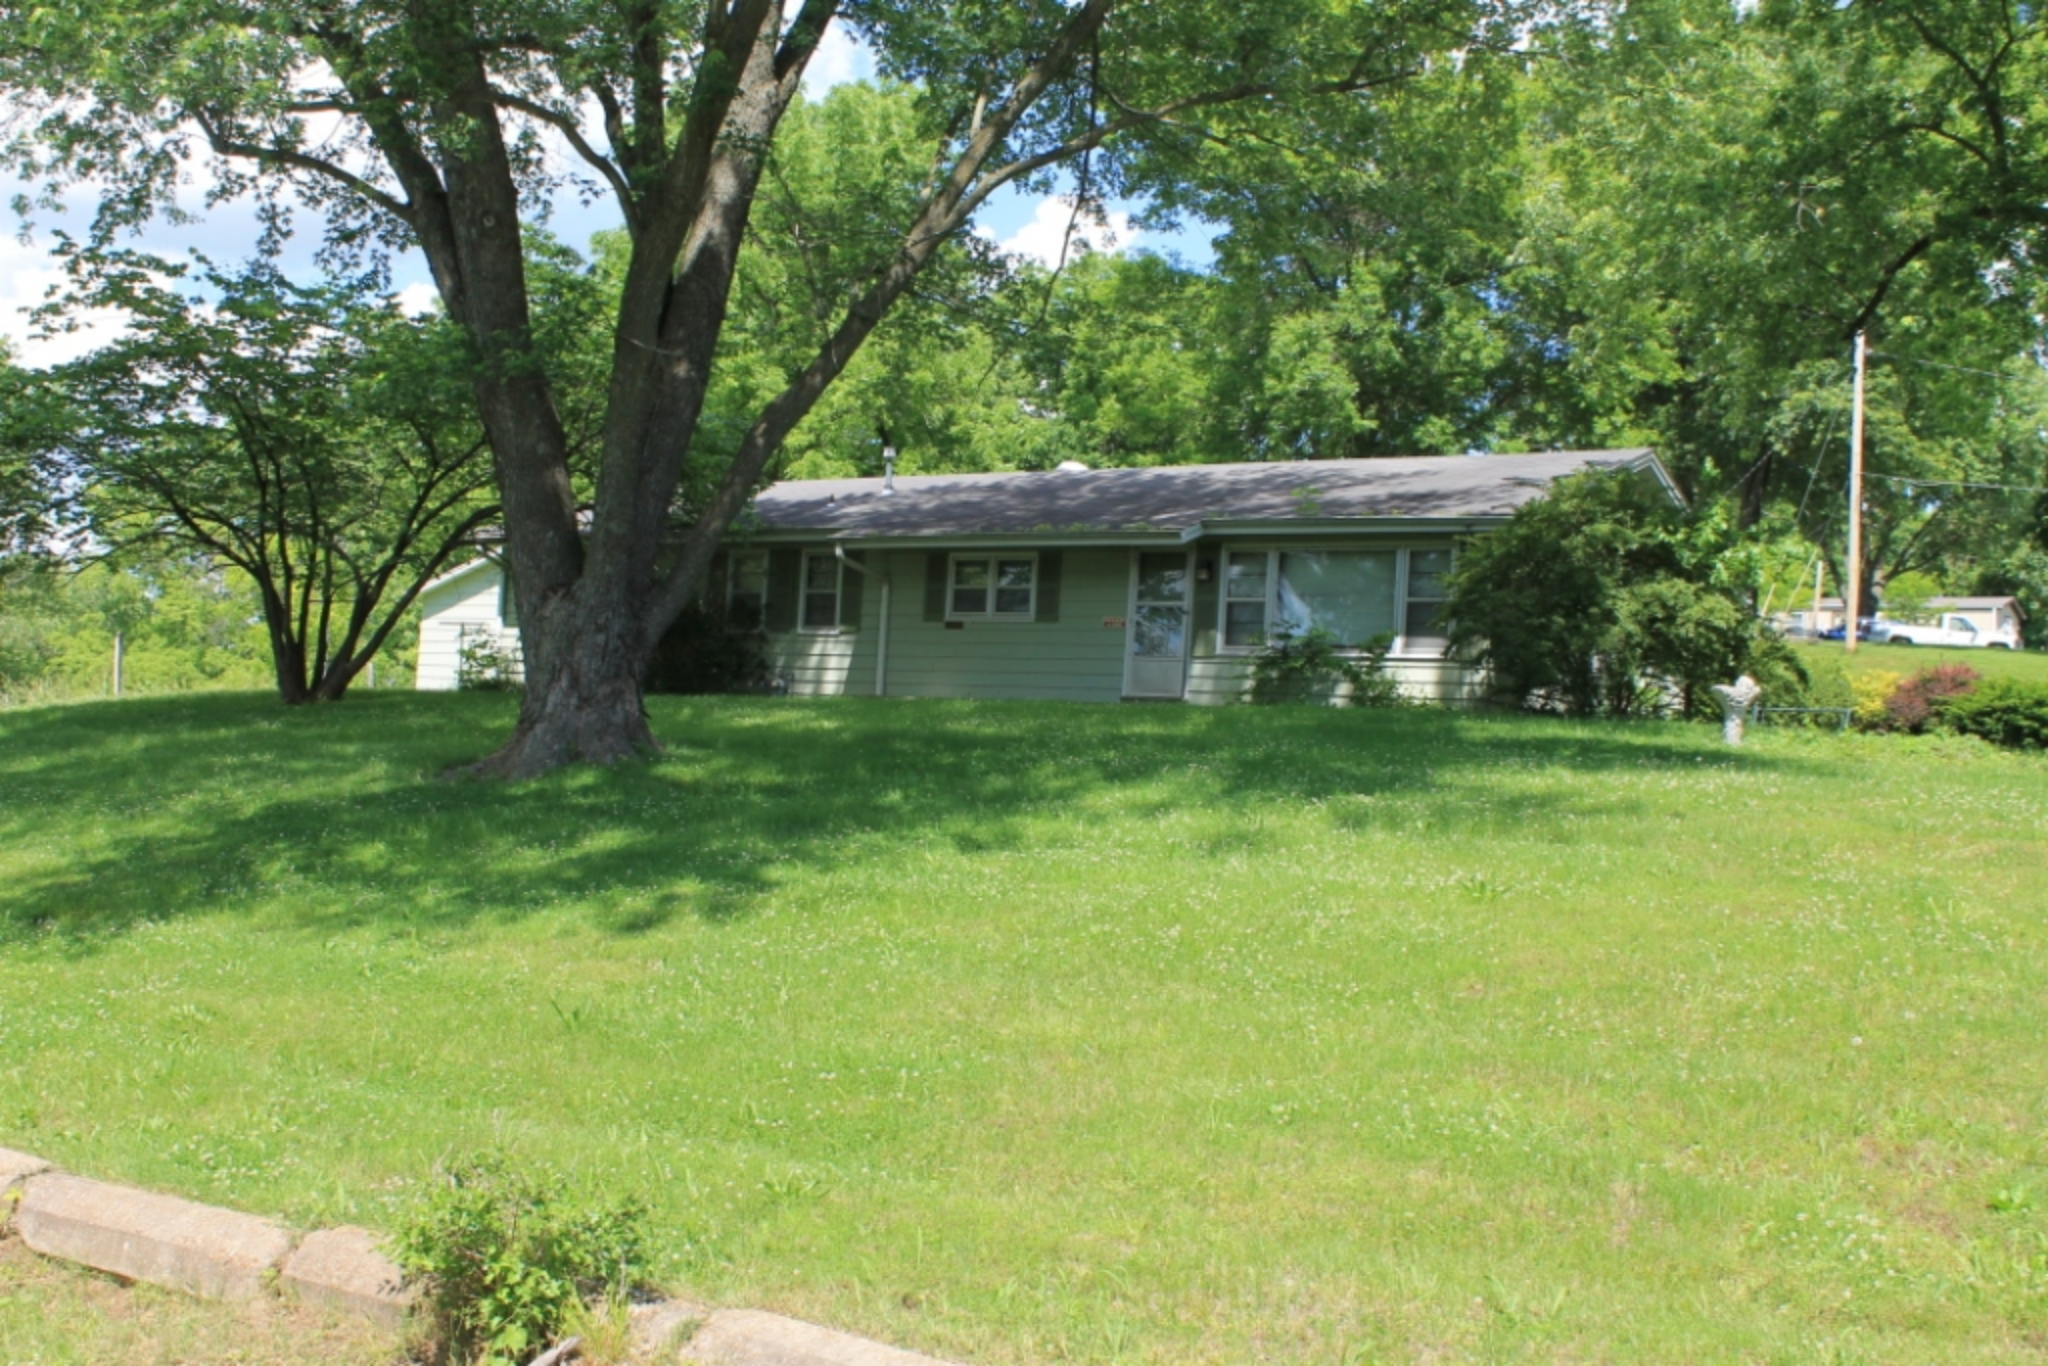
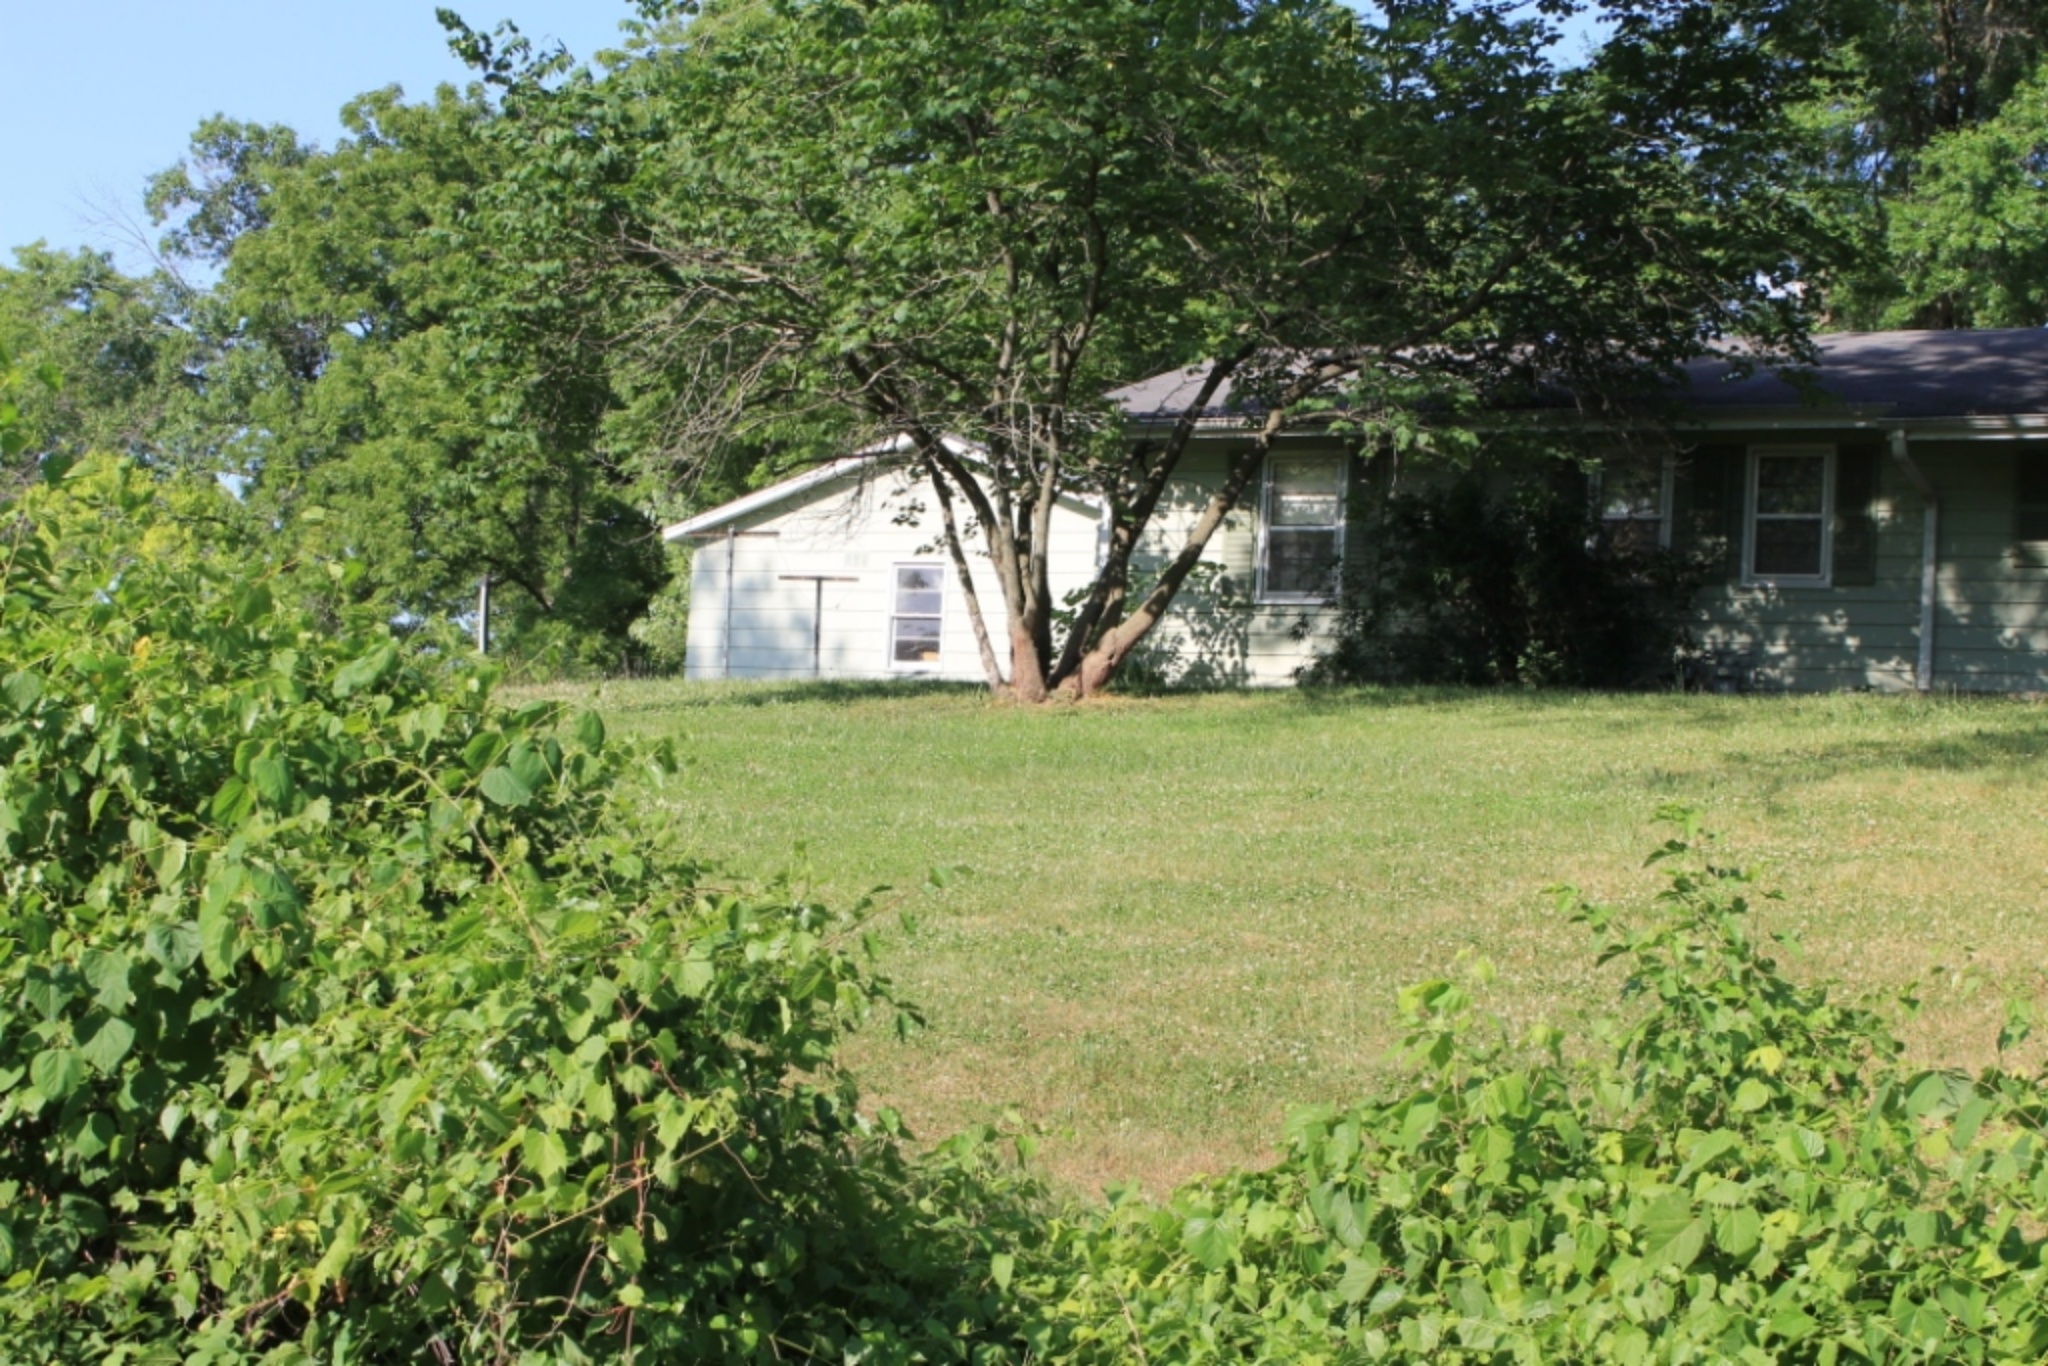
This one story, massed plan side gable, frame, ranch house has a low gable roof that extends over a porch in the center part of the front facade. The house is clad in clapboards and the roof is covered in asphalt shingles. The front facade of the house has six bays. The leftmost bay contains a one-over-one single hung window. The next bay contains a pair of one-over-one single hung windows. The next bay, which is under the porch roof, contains a pair of one-over-one single hung windows. The next bay, which is also under the porch roof, contains a door with a metal and glass storm door. The far right bay contains a large fixed pane picture window flanked on either side by a one-over-one single hung window.

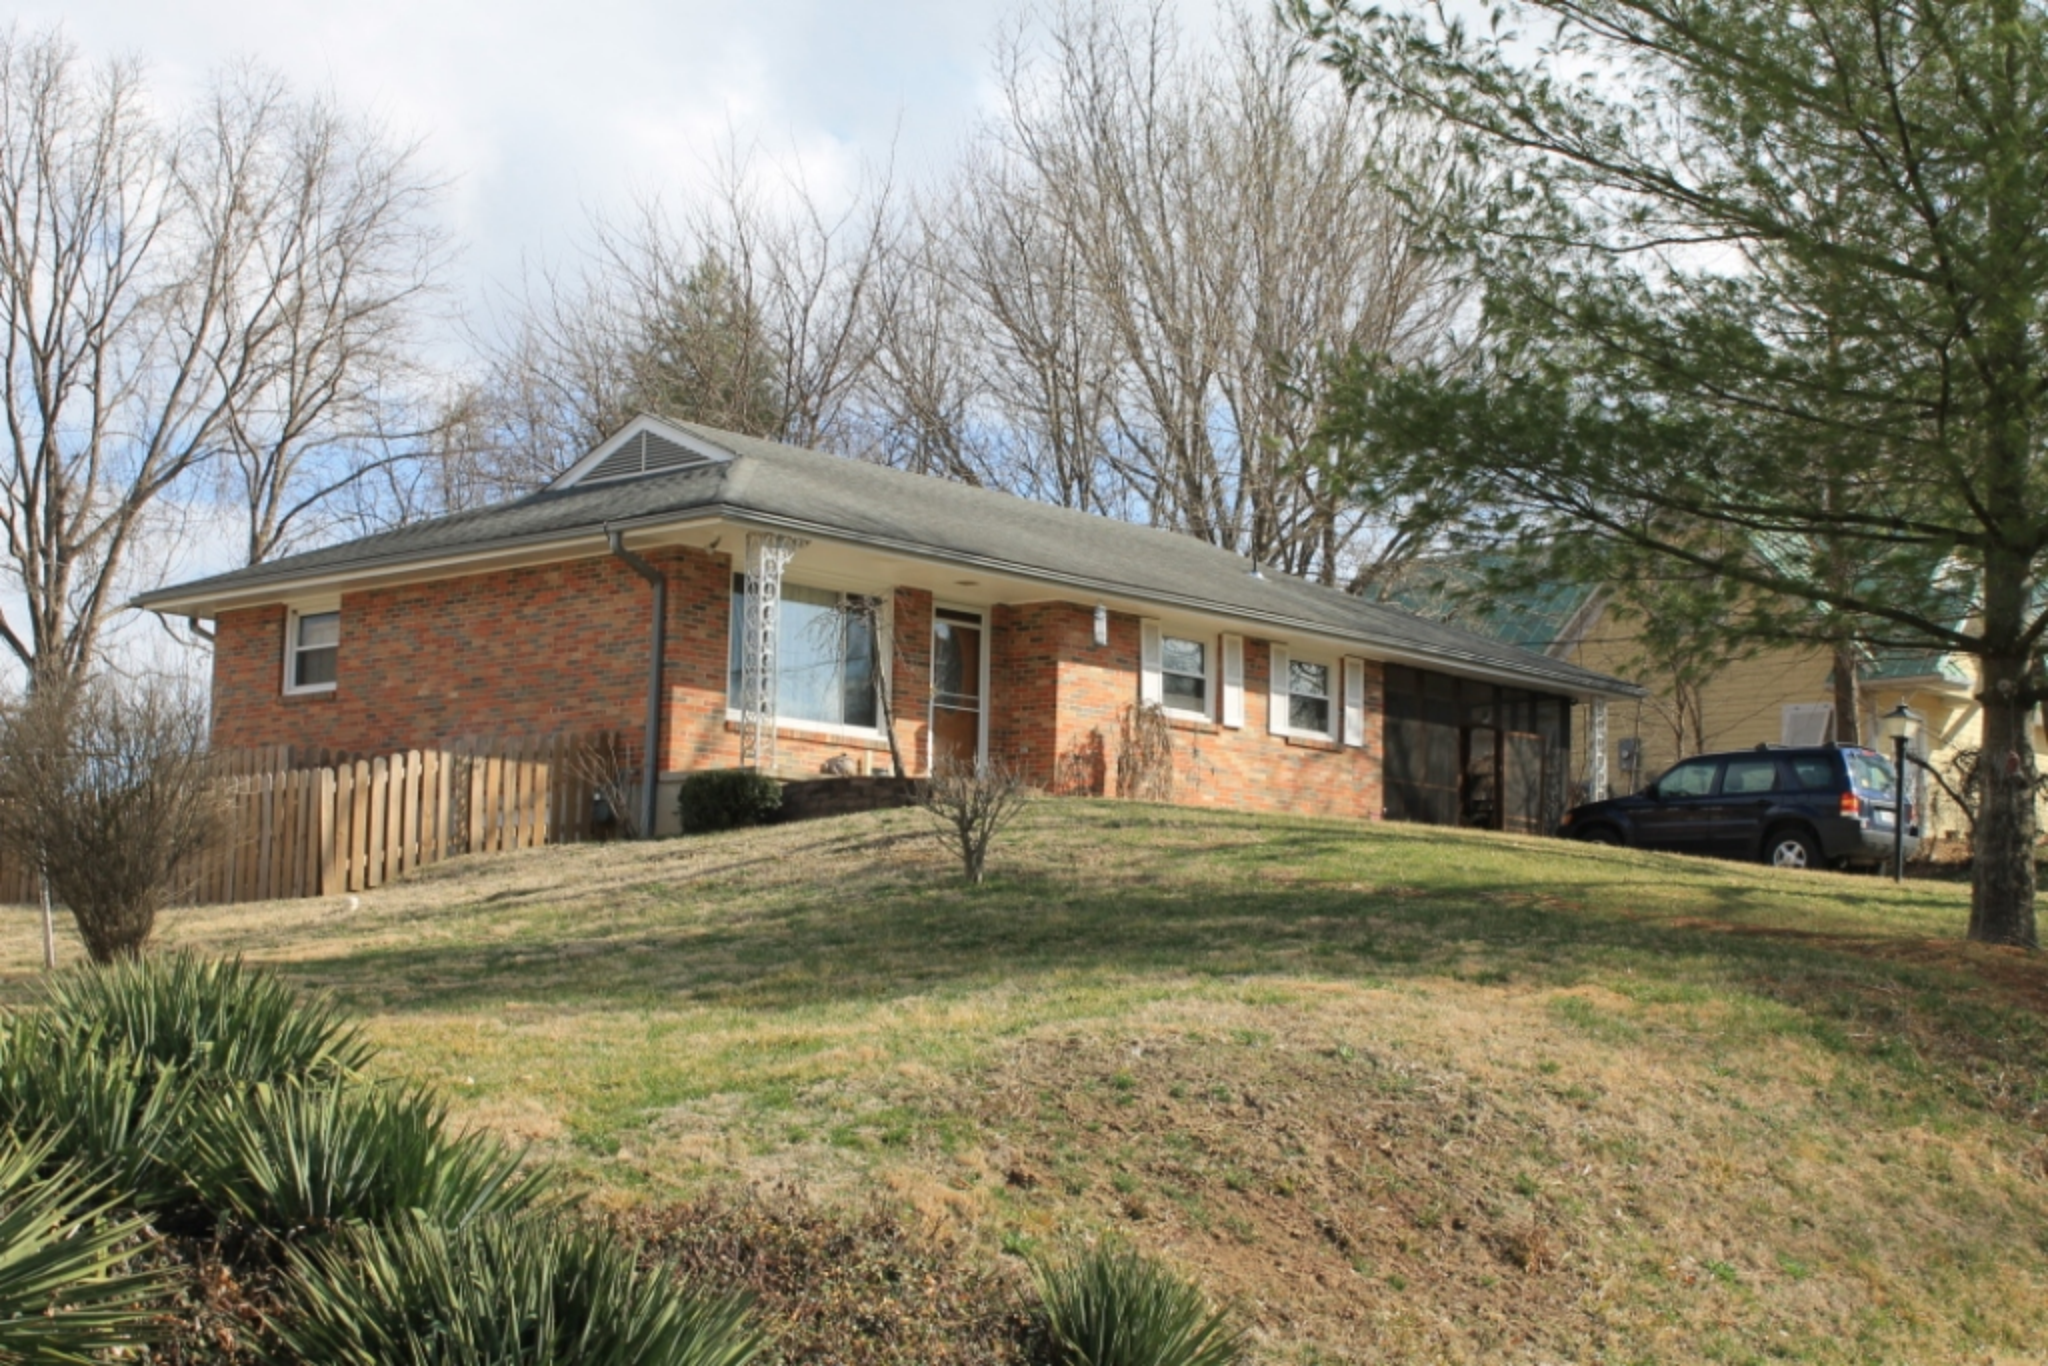
This one story, massed plan, brick ranch house has a gable hipped roof covered in asphalt shingles. An extension of the roof shades a concrete porch. A white wrought iron post supports the porch roof. To the right of the porch, the building wall projects to the south. The front (south) facade has five bays. The left bay, which is located under the porch roof, contains a fixed pane picture window. The next bay, which is also under the porch roof, contains a wooden door with a glass and metal storm door. The next two bays, which are in the protruding portion of the facade, each contain a one-over-one single hung window. The rightmost bay contains a carport that is screened in.

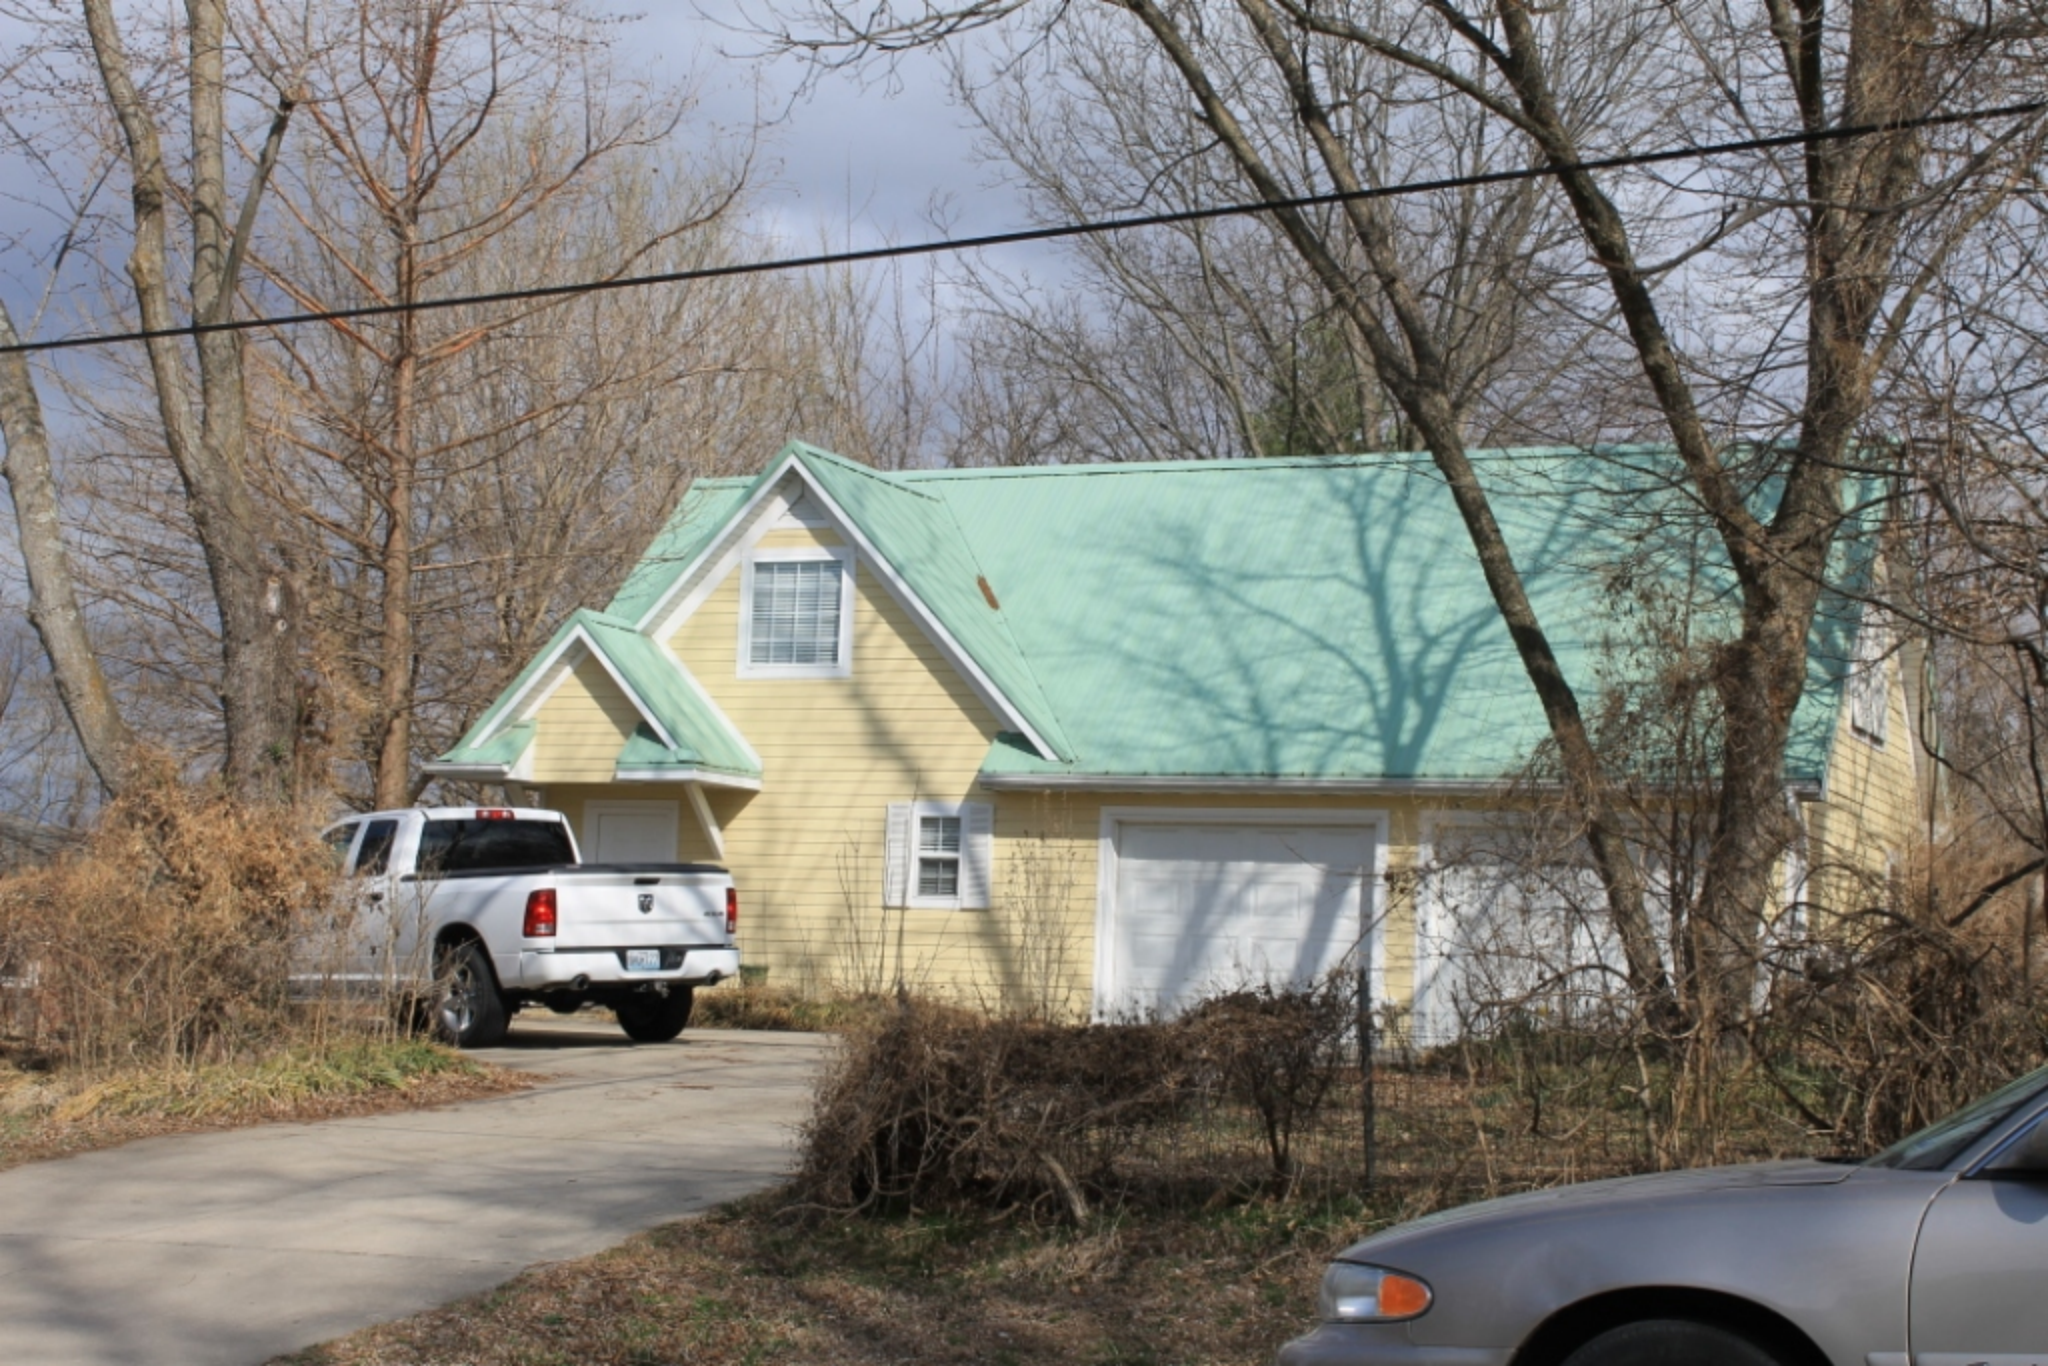
This 1 1/2 story, massed plan, frame house has a high cross gabled roof with prominent gable returns. The walls are clad in clapboards and the roof is metal. A front facing smaller gable with prominent gable returns forms a hood that covers the stoop. The hood is supported by angled wooden brackets. The first story of the front (south) facade of the building has four bays. The left bay, which is under the hood, contains a door. The next bay, which is located near the point where the large cross gable meets the rest of the roof, contains a small four-over-four single hung window with decorative shutters. The two right bays each contain an overhead garage door. On the upper story under the cross gable is a bay containing a sixteen fixed pane window.
