MISSOURI DEPARTMENT OF NATURAL RESOURCES
STATE HISTORIC PRESERVATION OFFICE, P.O. Box 176, Jefferson City, MO 65102
ARCHITECTURAL/HISTORIC INVENTORY FORM

1. SURVEY NO. BO-AS-009-0001		2. SURVEY NAME: Rocheport Historic District	
3. COUNTY: Boone		4. ADDRESS (STREET NO.)	STREET (NAME) Katy Trail
5. CITY: Rocheport	VICINITY: <input checked="" type="checkbox"/>	6. UTM: / /	LAT: LONG: T: 48W R: 15W S: 1

8. HISTORIC NAME (IF KNOWN): M.K.&T. Railroad tunnel		9. PRESENT/OTHER NAME (IF KNOWN): Katy trail tunnel	
10. OWNERSHIP: <input type="checkbox"/> PRIVATE <input checked="" type="checkbox"/> PUBLIC		11A. HISTORIC USE (IF KNOWN): railroad tunnel	11B. CURRENT USE: Katy Trail tunnel
HISTORICAL INFORMATION

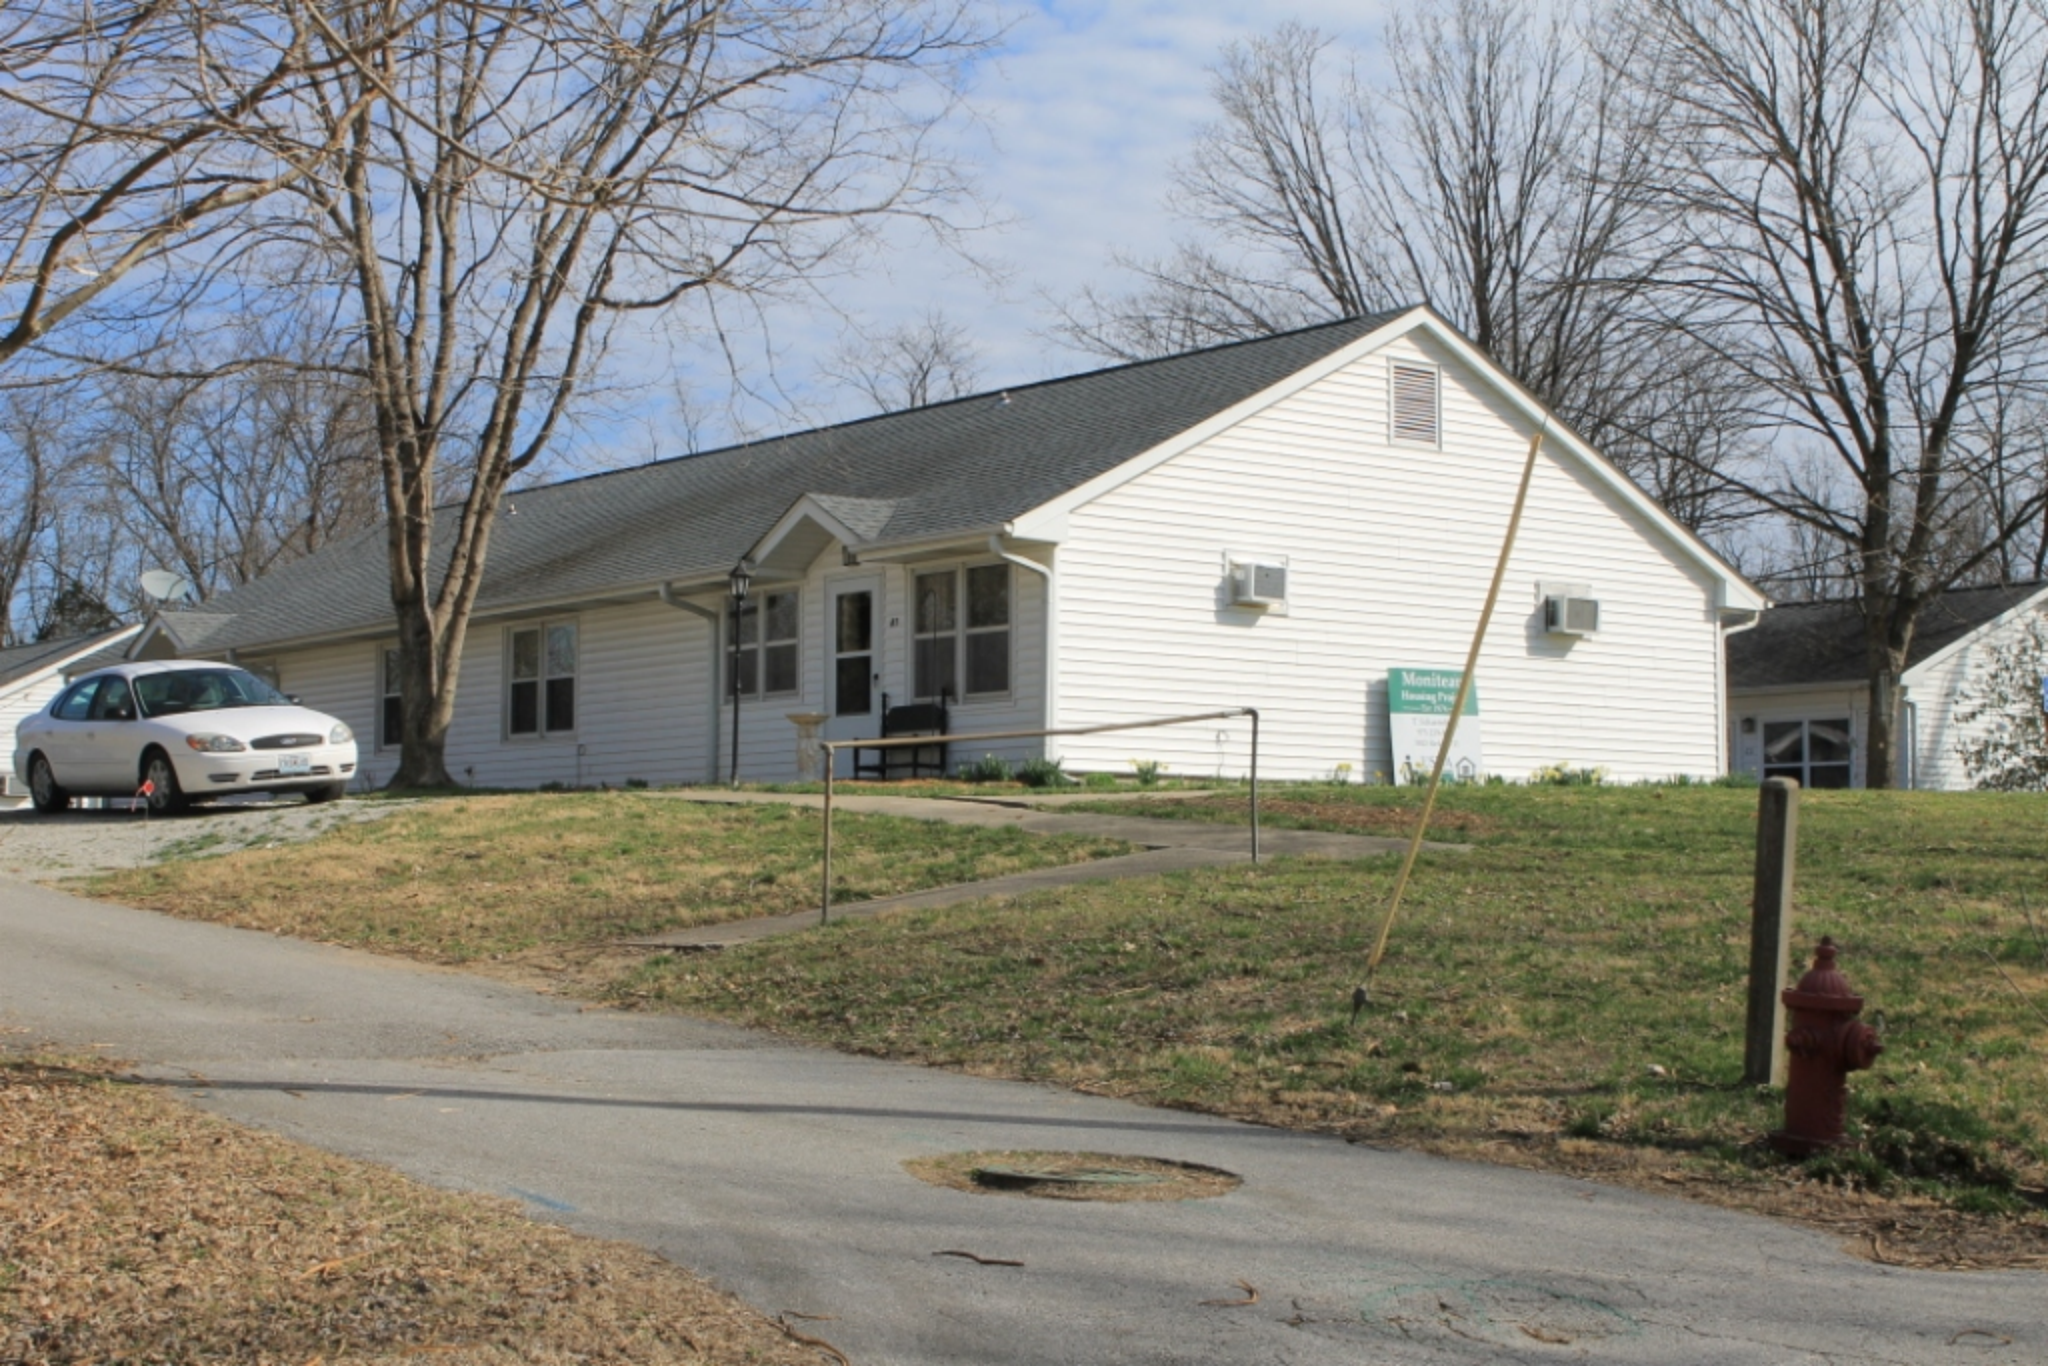
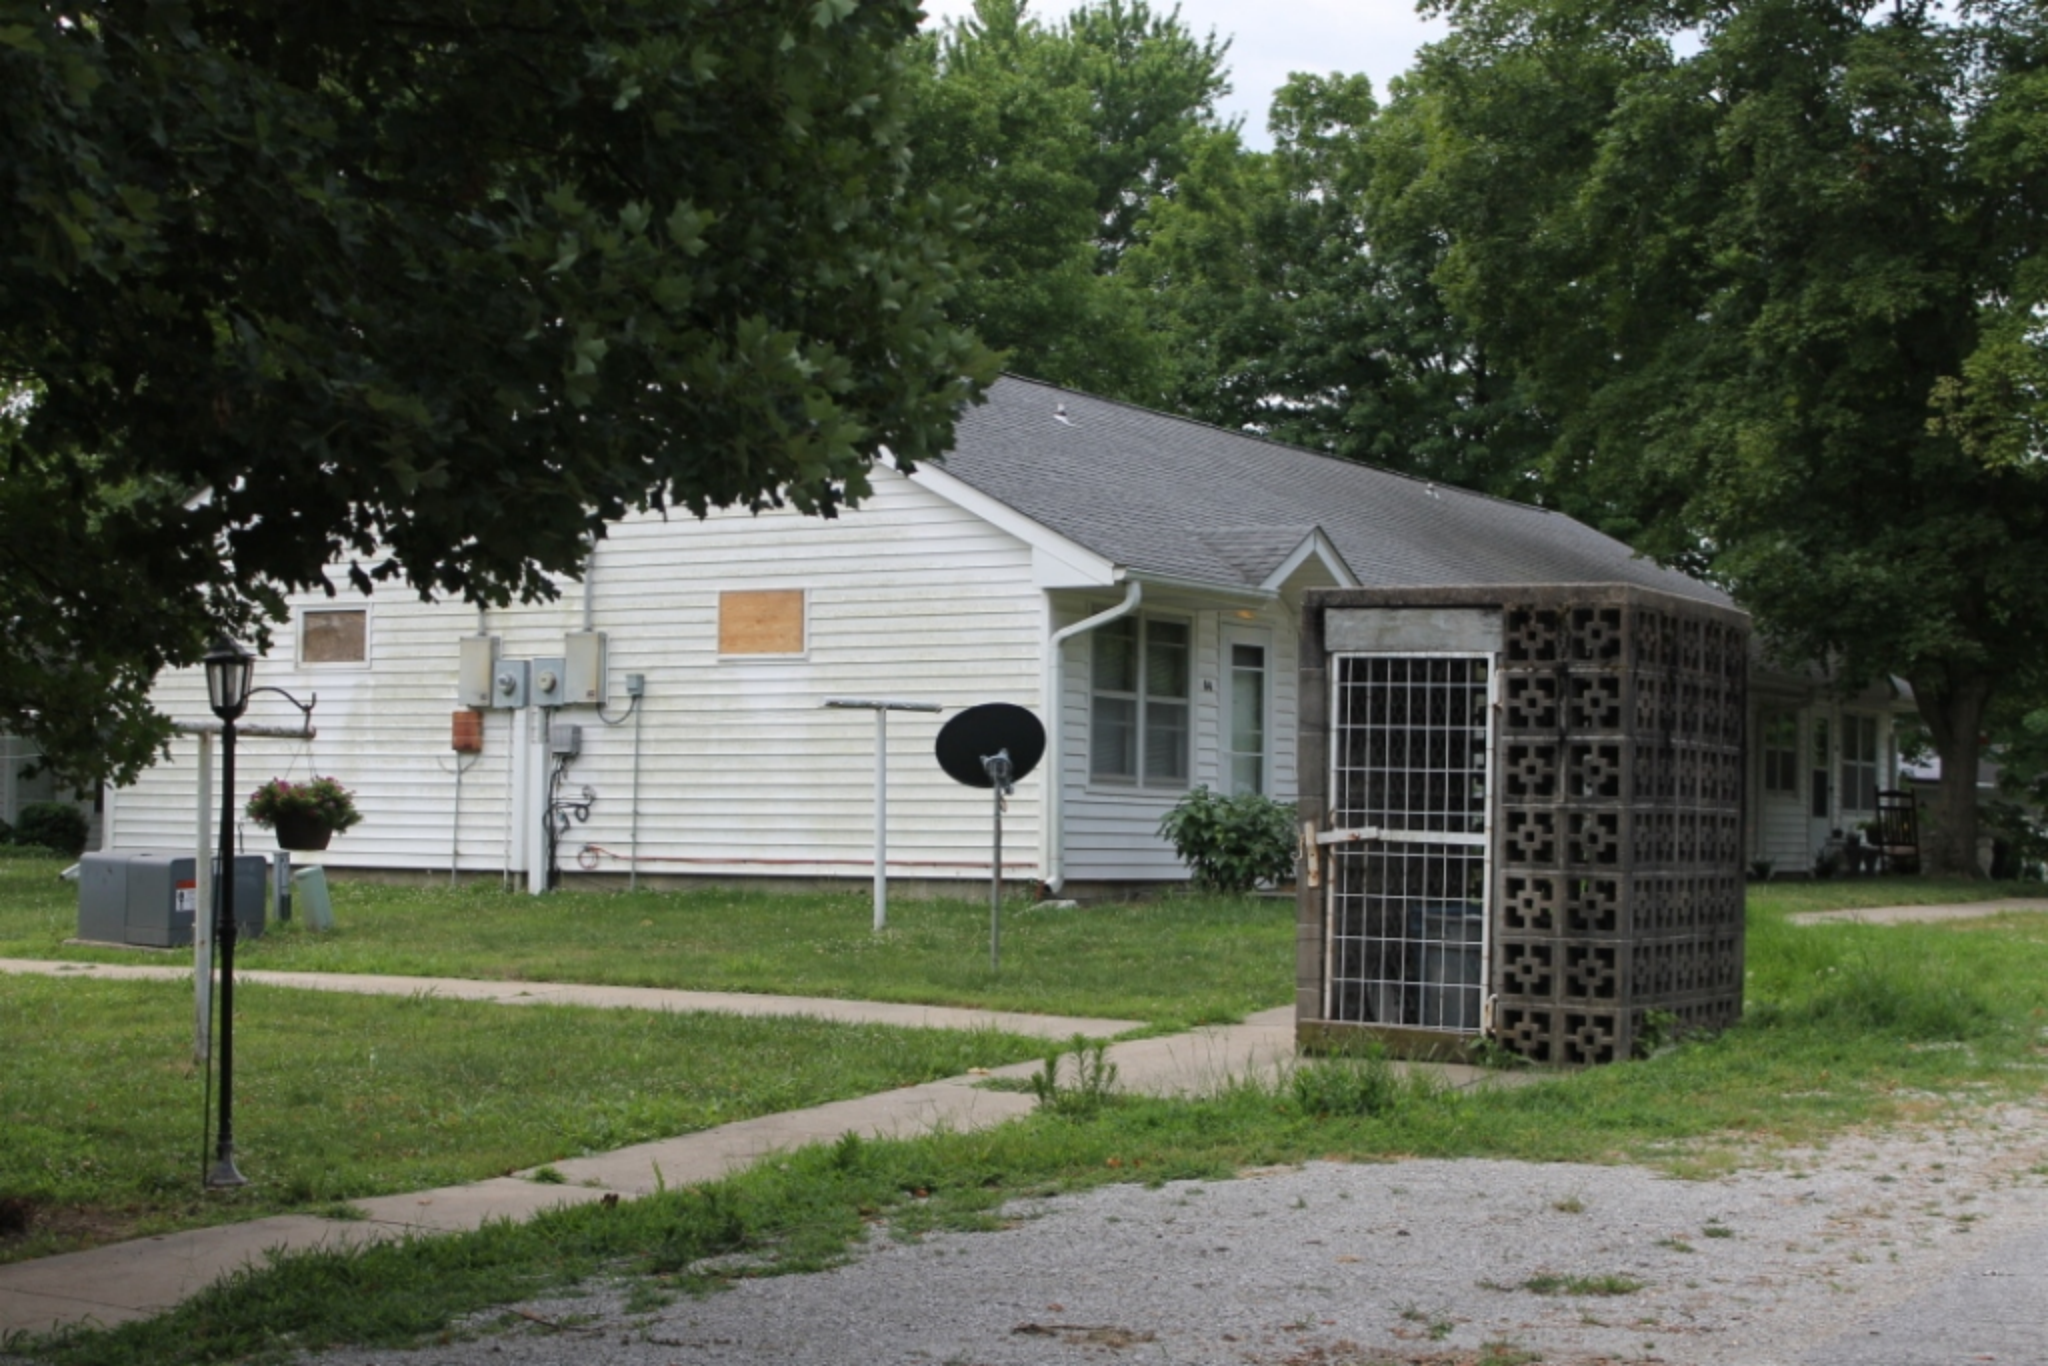
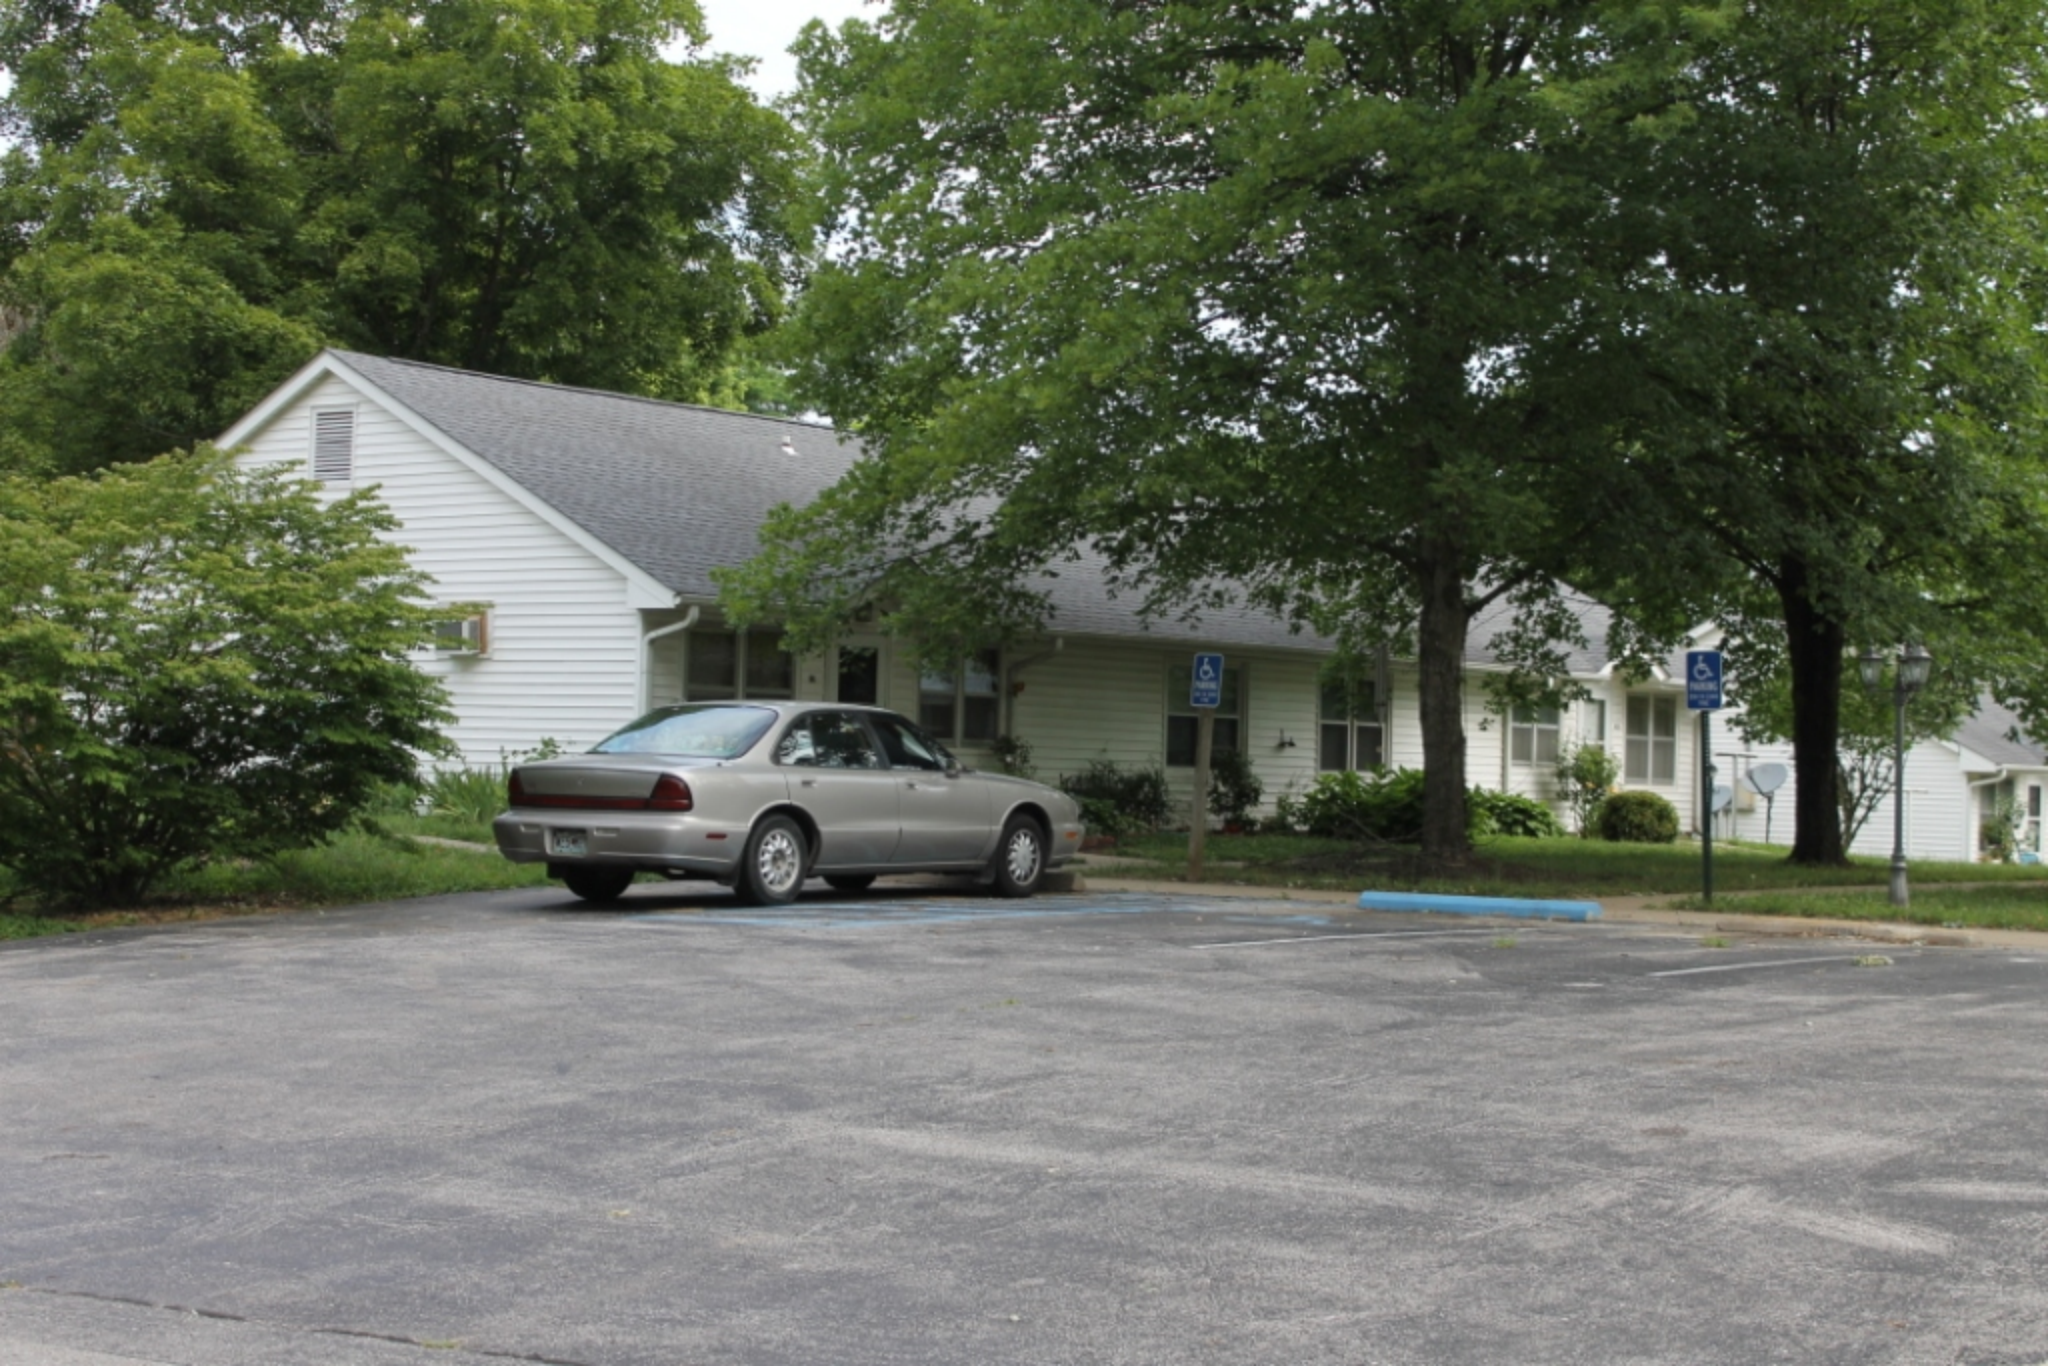
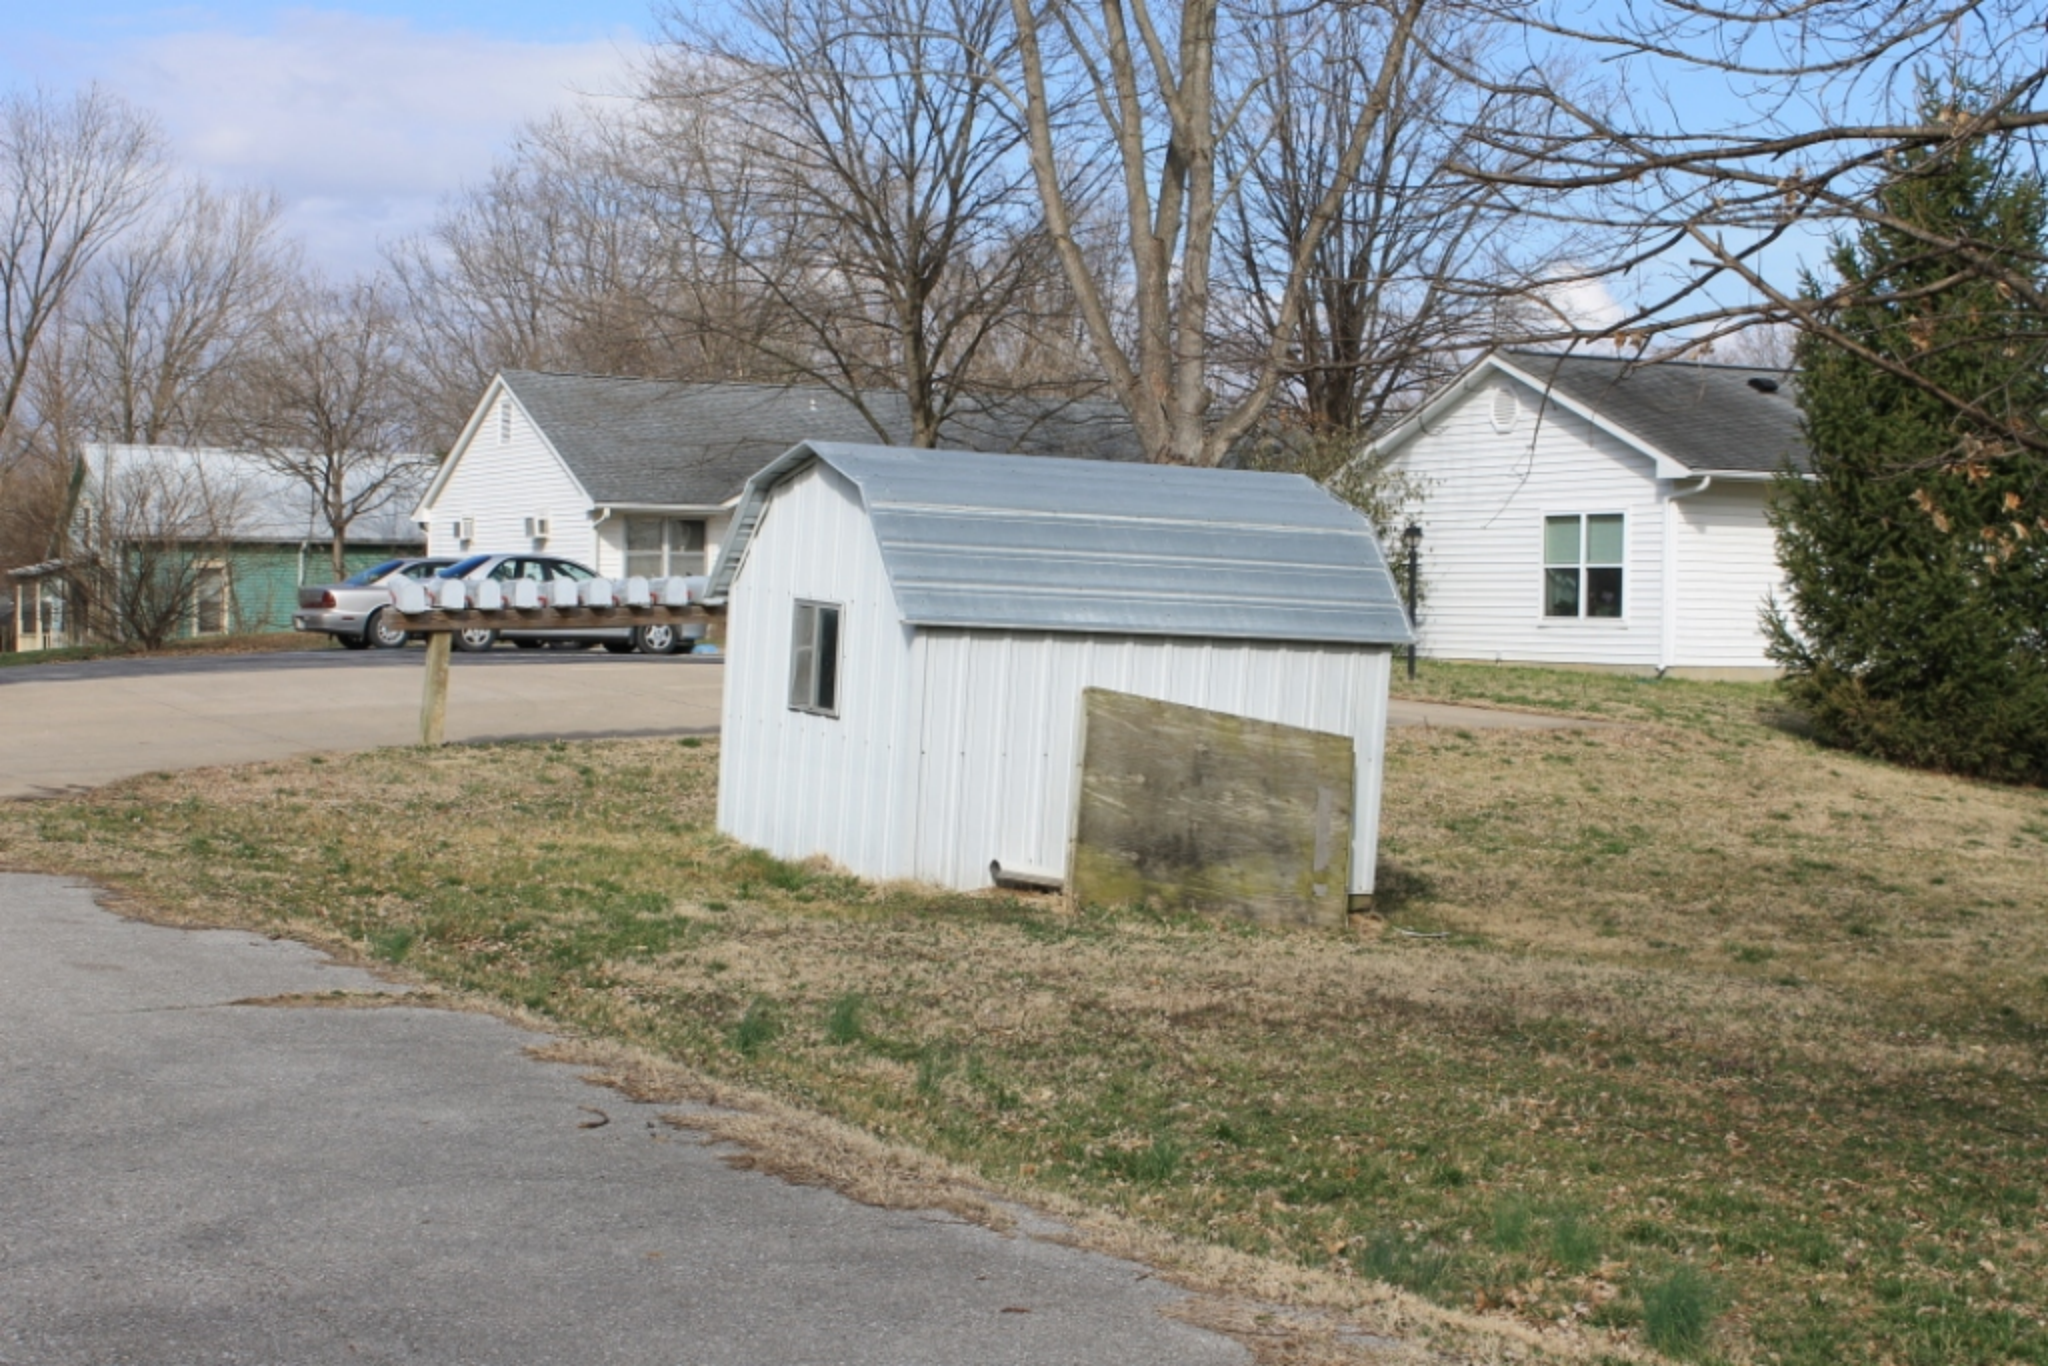
The Moniteau Senior Housing project consists of three massed plan side gable plan buildings built c. 1988. The entire complex contains ten one-bedroom units. On the east and west facade of each building are two gable roofed hoods over stoops; the hoods and stoops mark the entry to each unit. The east and west facades of each building have 8 bays. The leftmost bay contains a pair of one-over-one single hung windows. The next bay contains a door with a metal and glass storm door. The next four bays each contain a pair of one-over-one single hung windows. The seventh bay contains a door with a metal and glass storm door. The rightmost bay contains a pair of one-over-one single hung windows. The north and south facades each have two bays, each containing an air conditioner unit. Under the gable on the north and south facades is a large vent.

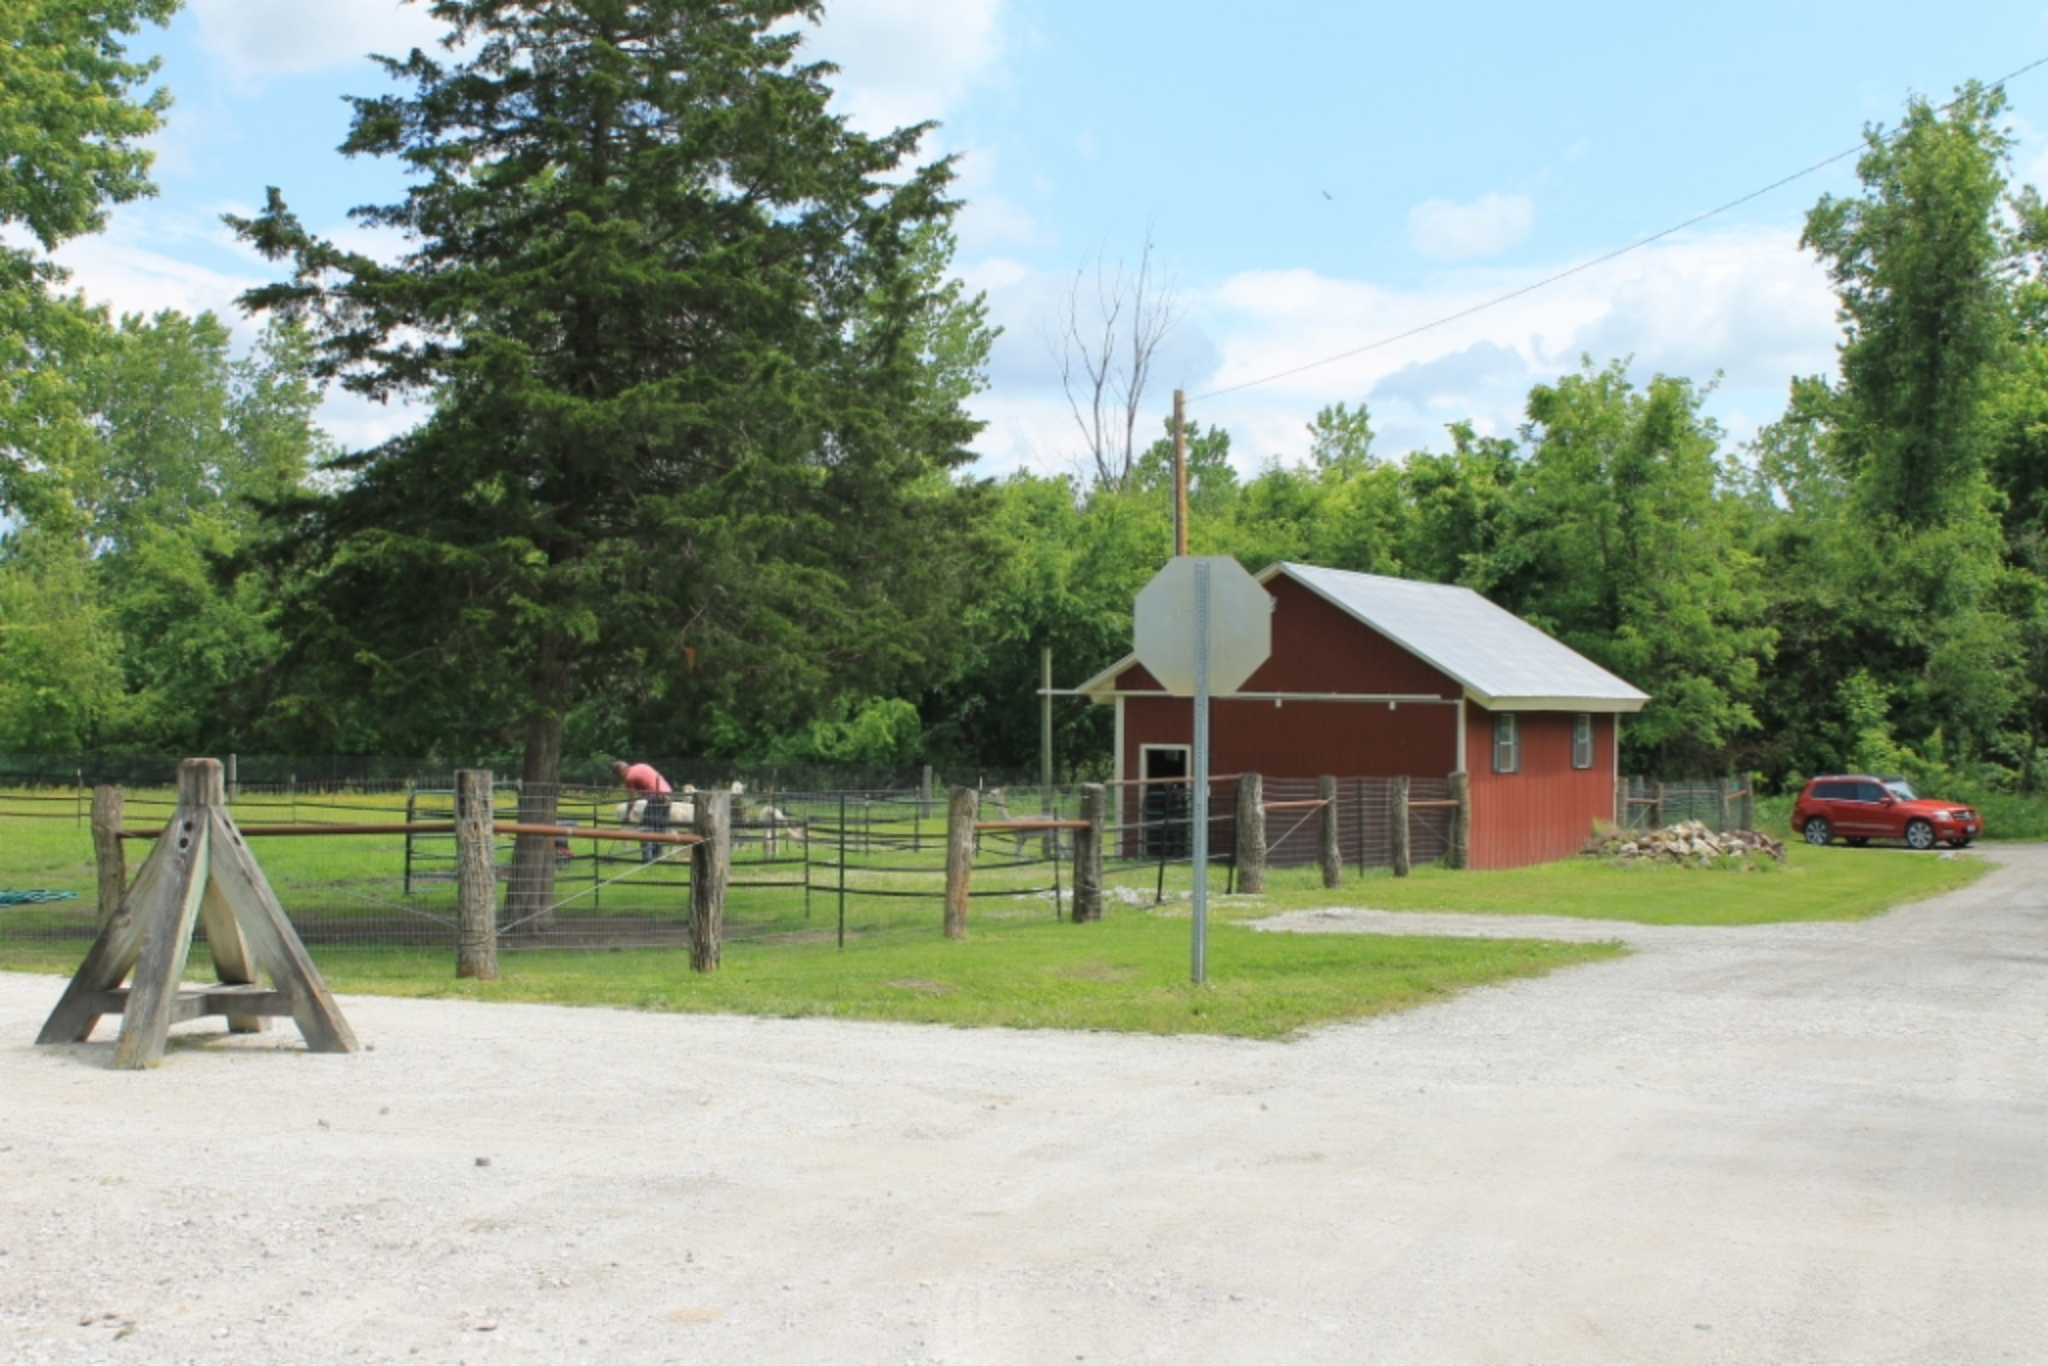
This one story, modern, metal barn building has a medium gabled metal roof. The front (north) facade has one bay containing a door. The side (west) facade has two bays, each containing a small one-over-one single hung window.

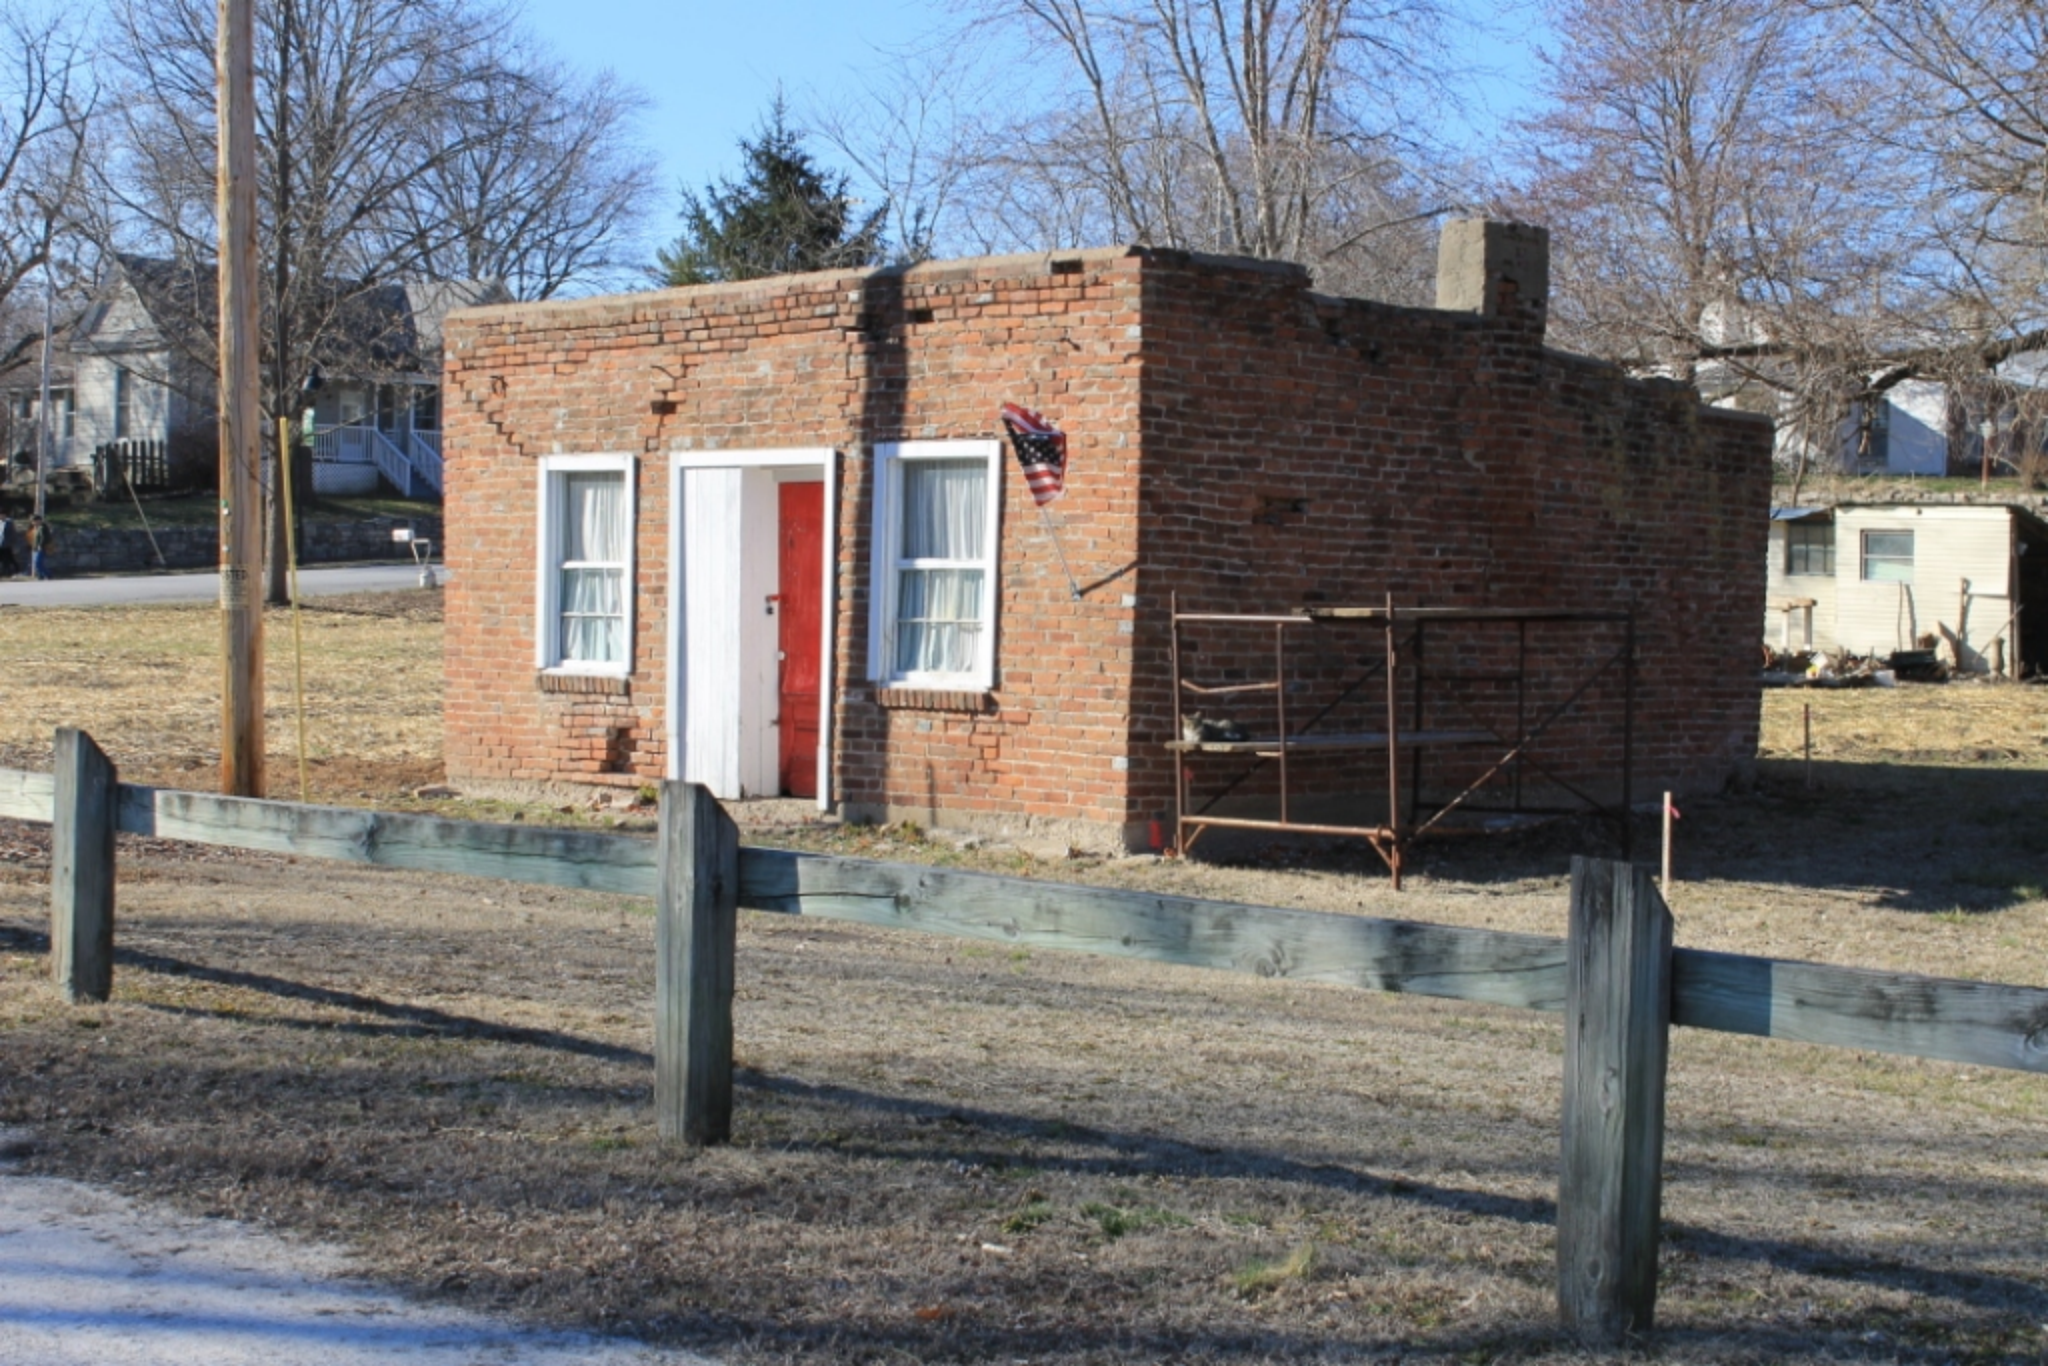
This one-story, brick building with a slightly sloping roof and stepped parapet side walls has a concrete foundation. The roof is covered in asphalt. The front (south) facade has three bays. The left bay contains a one-over-six wooden single hung window. The center bay contains a modern door set into a doorway wider than the door; a wooden panel fills in the larger door frame. The right bay contains a one-over-six wooden single hung window. The window sills are formed of a course of row lock bricks. The building is in poor condition. Some of the bricks have fallen from the walls, mortar is missing, and diagonal cracks run from the tops of the left windows and vertical cracks run from the top of the door to the roof line.

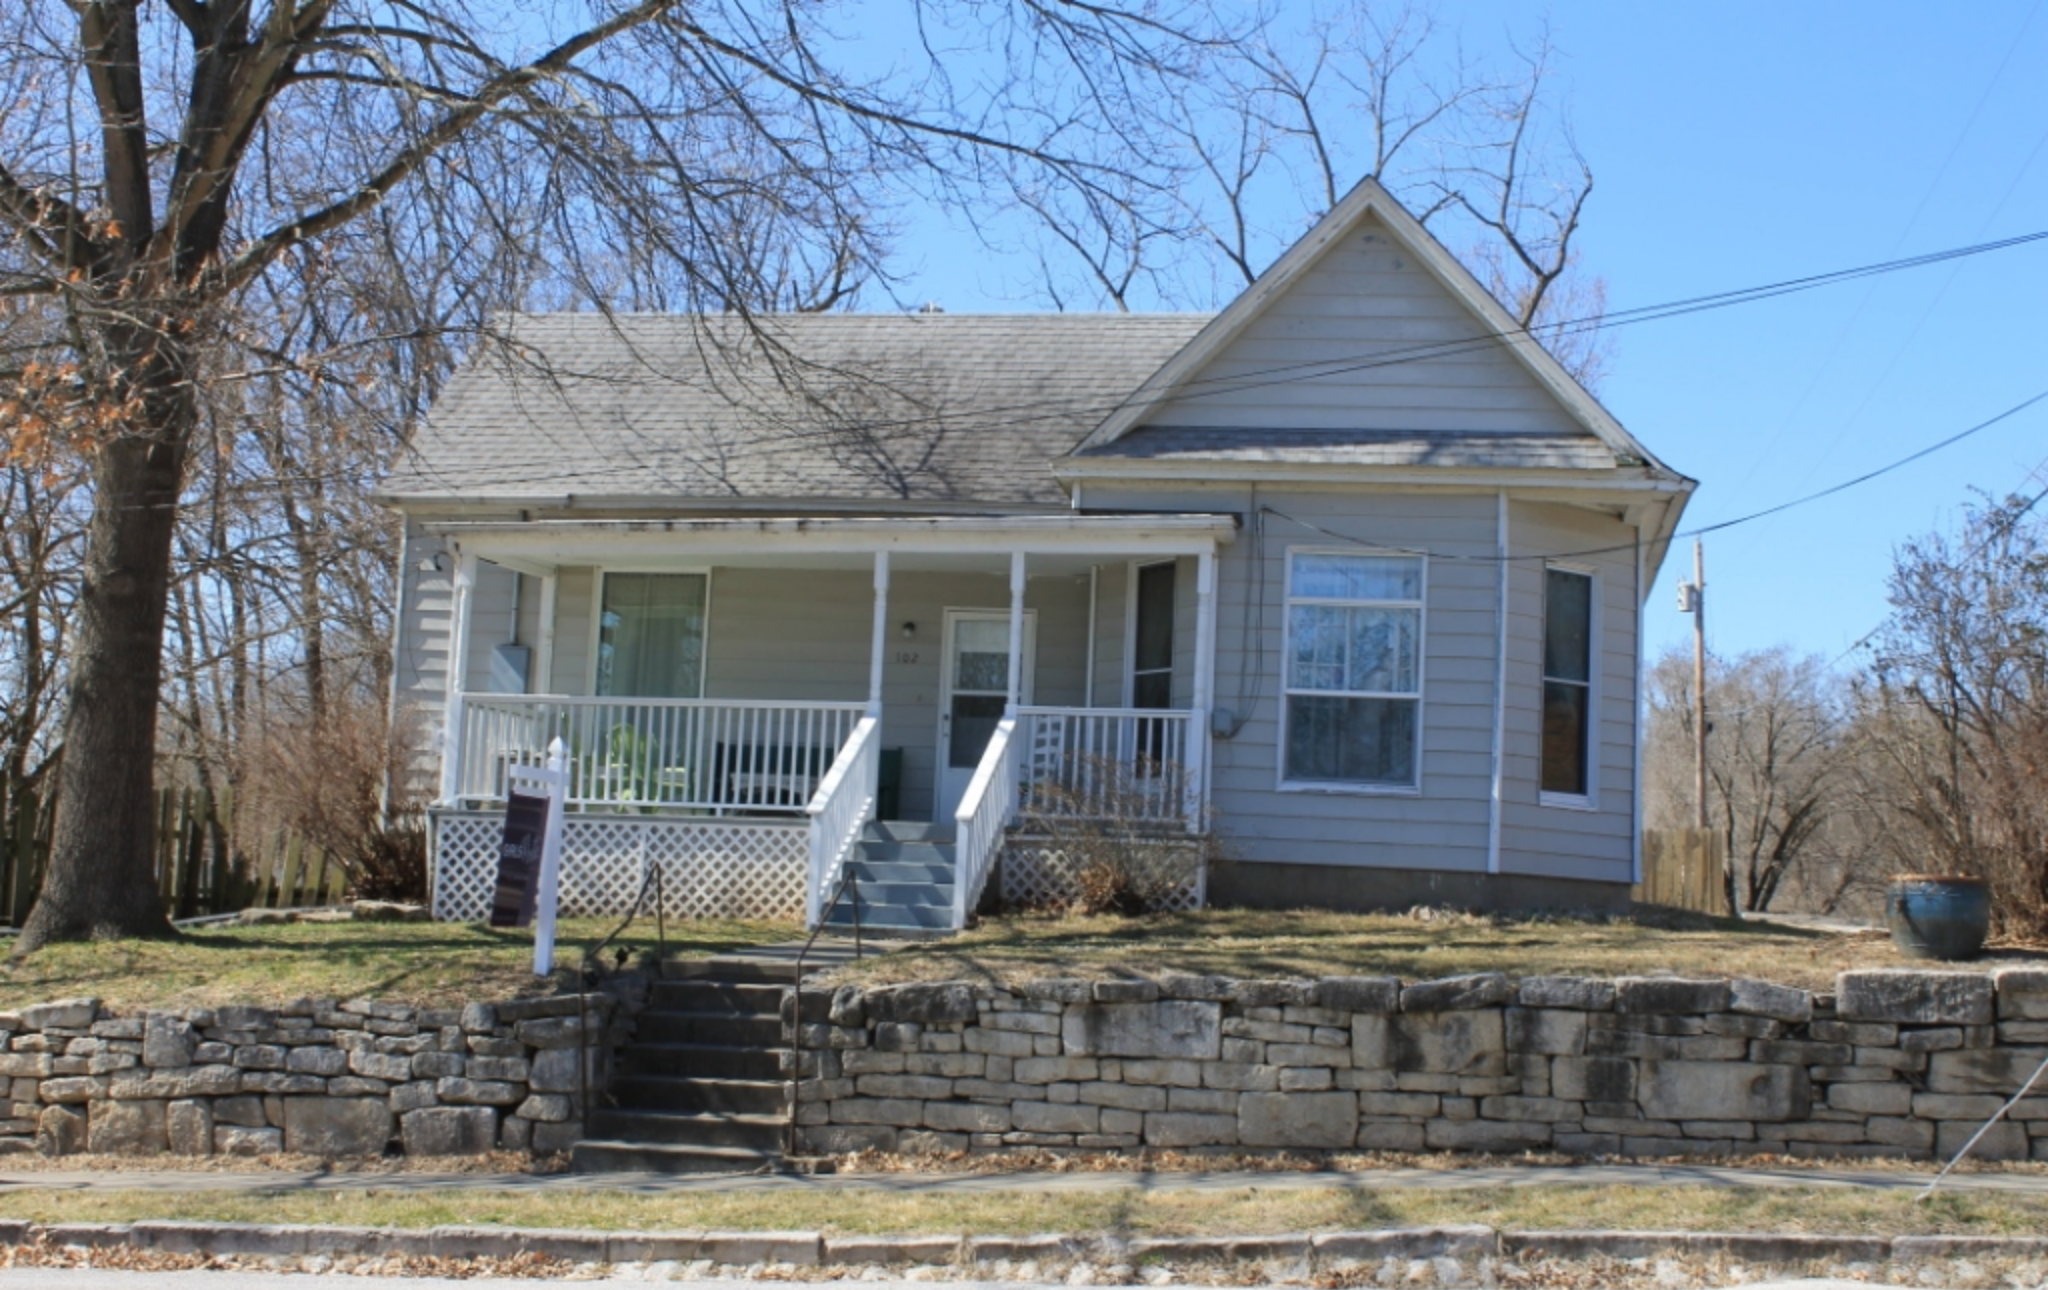
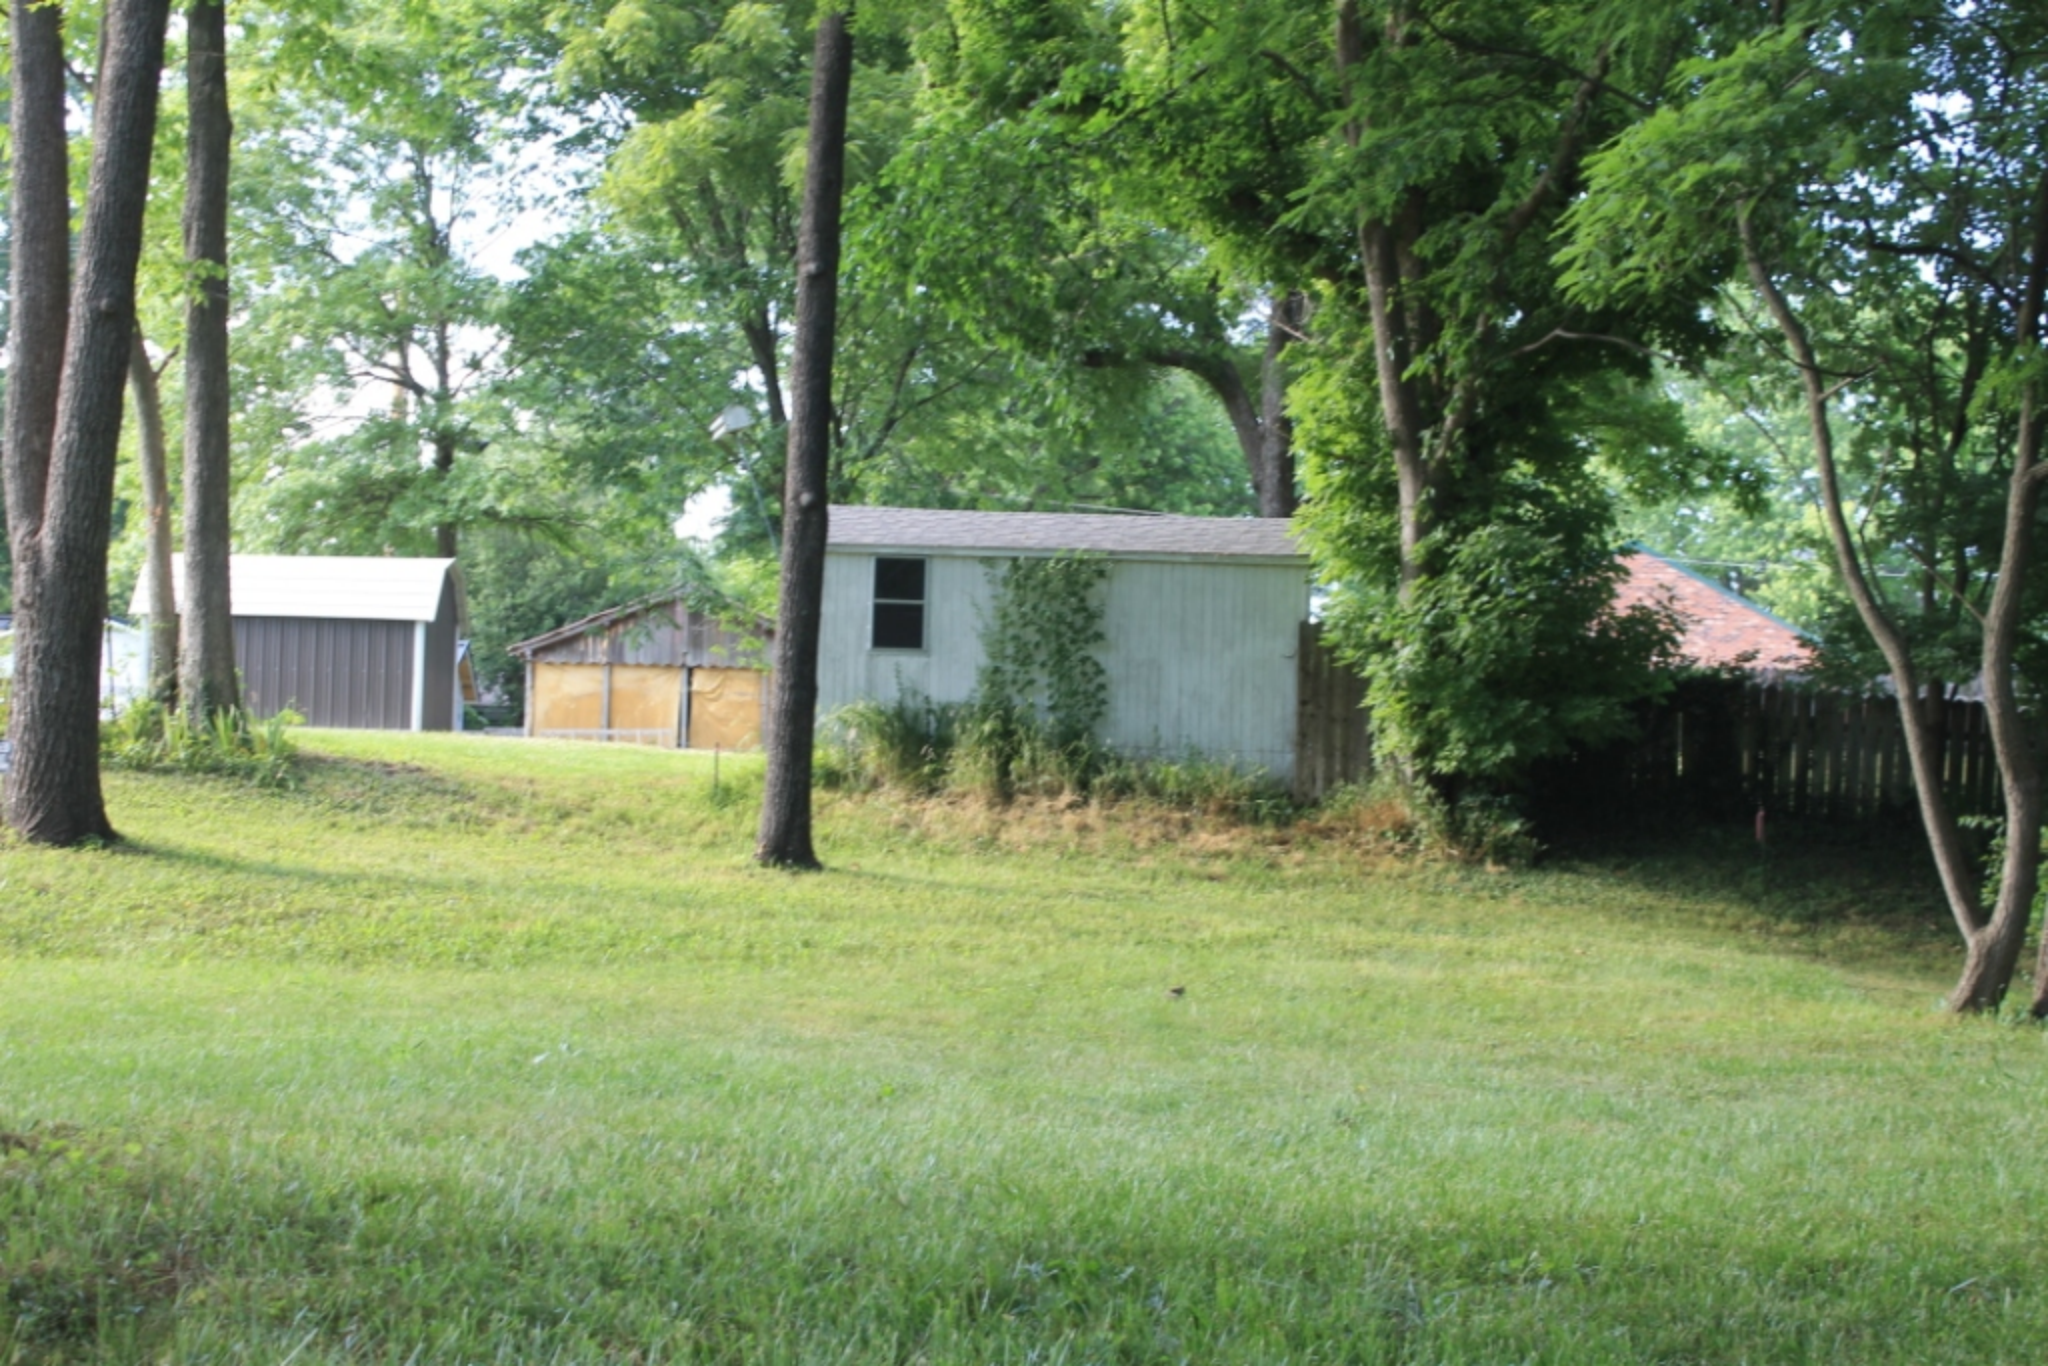
This one-story, massed plan gable and wing, frame house is clad in vinyl siding the same width as the original clapboards, and the roof is covered in asphalt shingles. The wing of the house under the cross gable roof has canted corners. At the point where the cross gabled wing meets the main block of the house is a flat roofed open porch with modern turned posts and railing and modern lattice under the porch. The house has 5 bays on the front (west) facade. The left bay, which is under the porch roof, contains a one-over-one vinyl single hung window. The next bay is also under the porch roof and contains a door covered non-with a modern storm door. The next three bays are in the bay window created by the canted corners of the gable roofed wing of the house. Each of these bays contains a one-over-one vinyl replacement window.
